MISCELLANEOUS PAPER GL-90-21

EFFECTS OF VARIABLE TIRE PRESSURE ON ROAD SURFACINGS

Robert W. Grau

September 1990

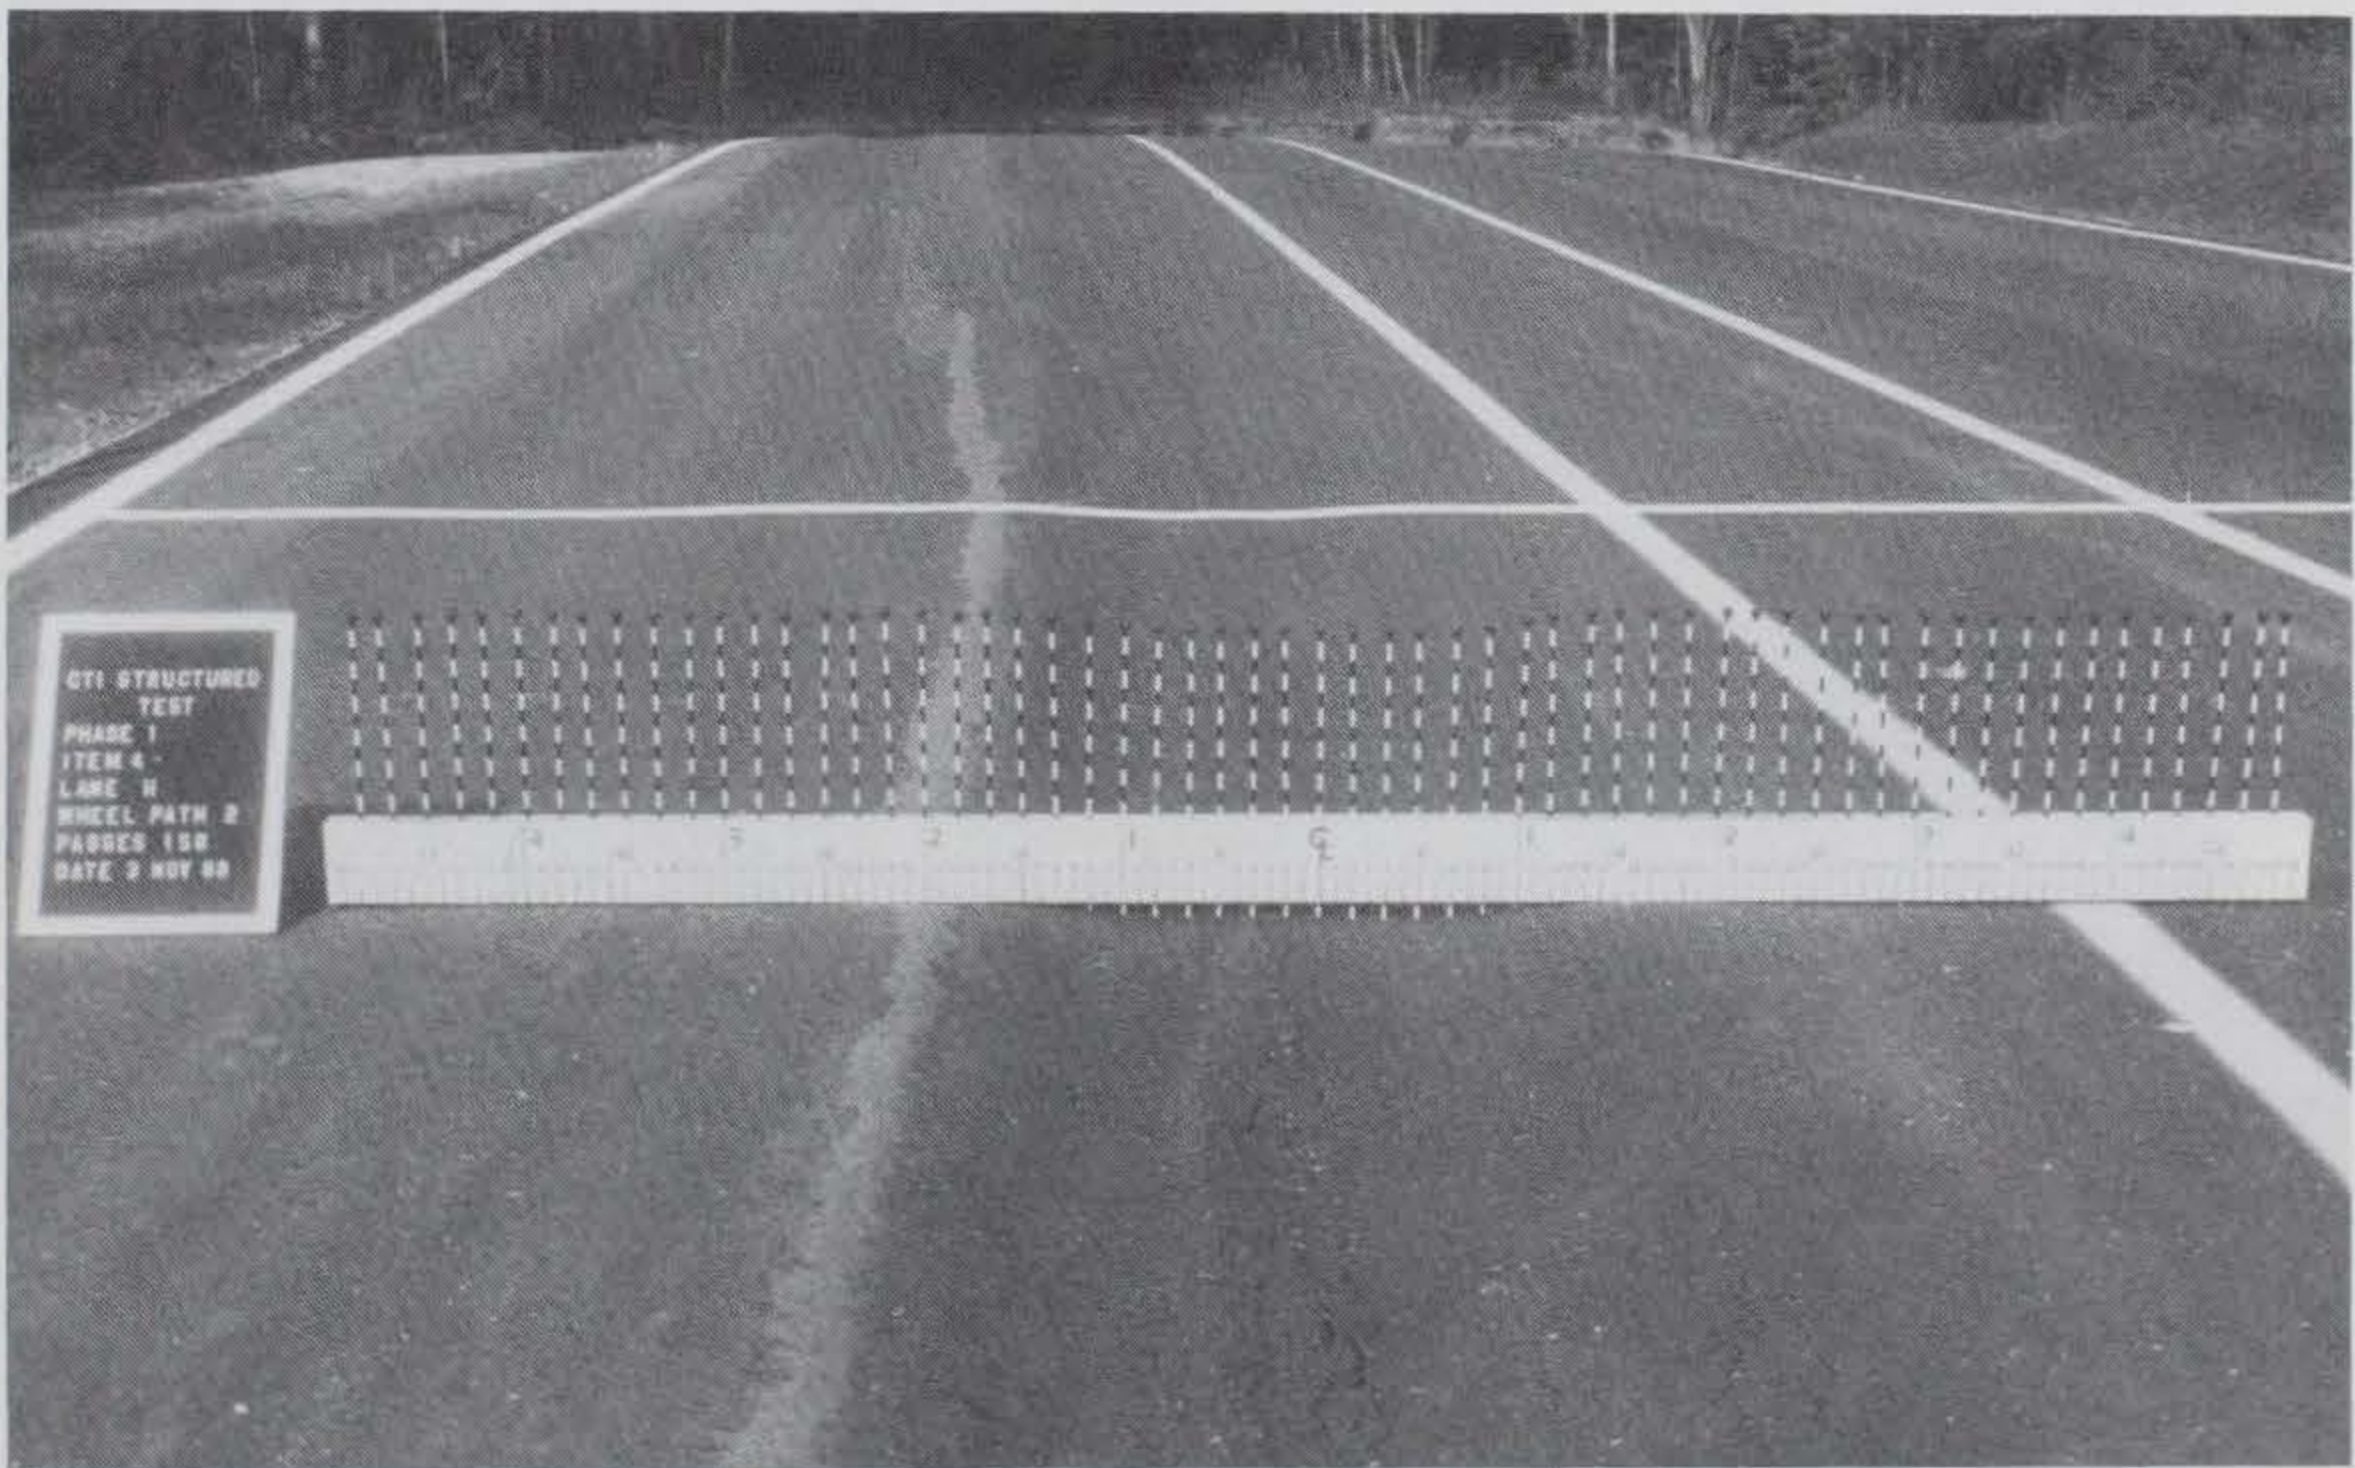
19. At the beginning of traffic, slight pumping of the surface was observed as the high-tire-pressure truck traversed the 2-in.-thick AC sections. Surface deformation and pumping was most evident in the outside wheelpaths of the horizontal curves. After about 71 passes, distinct rutting and hairline longitudinal cracking along the outside edges of wheelpath 2 were noticed in section 4. As traffic continued, the rutting and cracking in section 4 became more severe; one area was rated as failed after 158 passes. Figure 9 depicts a general view of this initial failure in the AC portion of the rest road. The maximum rutting in this area was 2.3 in. deep, and the cracking had progressed into alligator cracking. After an additional 165 passes, for a total of 323 passes, a second failure occurred in section 4, wheelpath 2. Figure 10 shows a general view of this second failure. It

Figure 9. High-tire-pressure lane, section 4, general view of initial failure, 158 passes

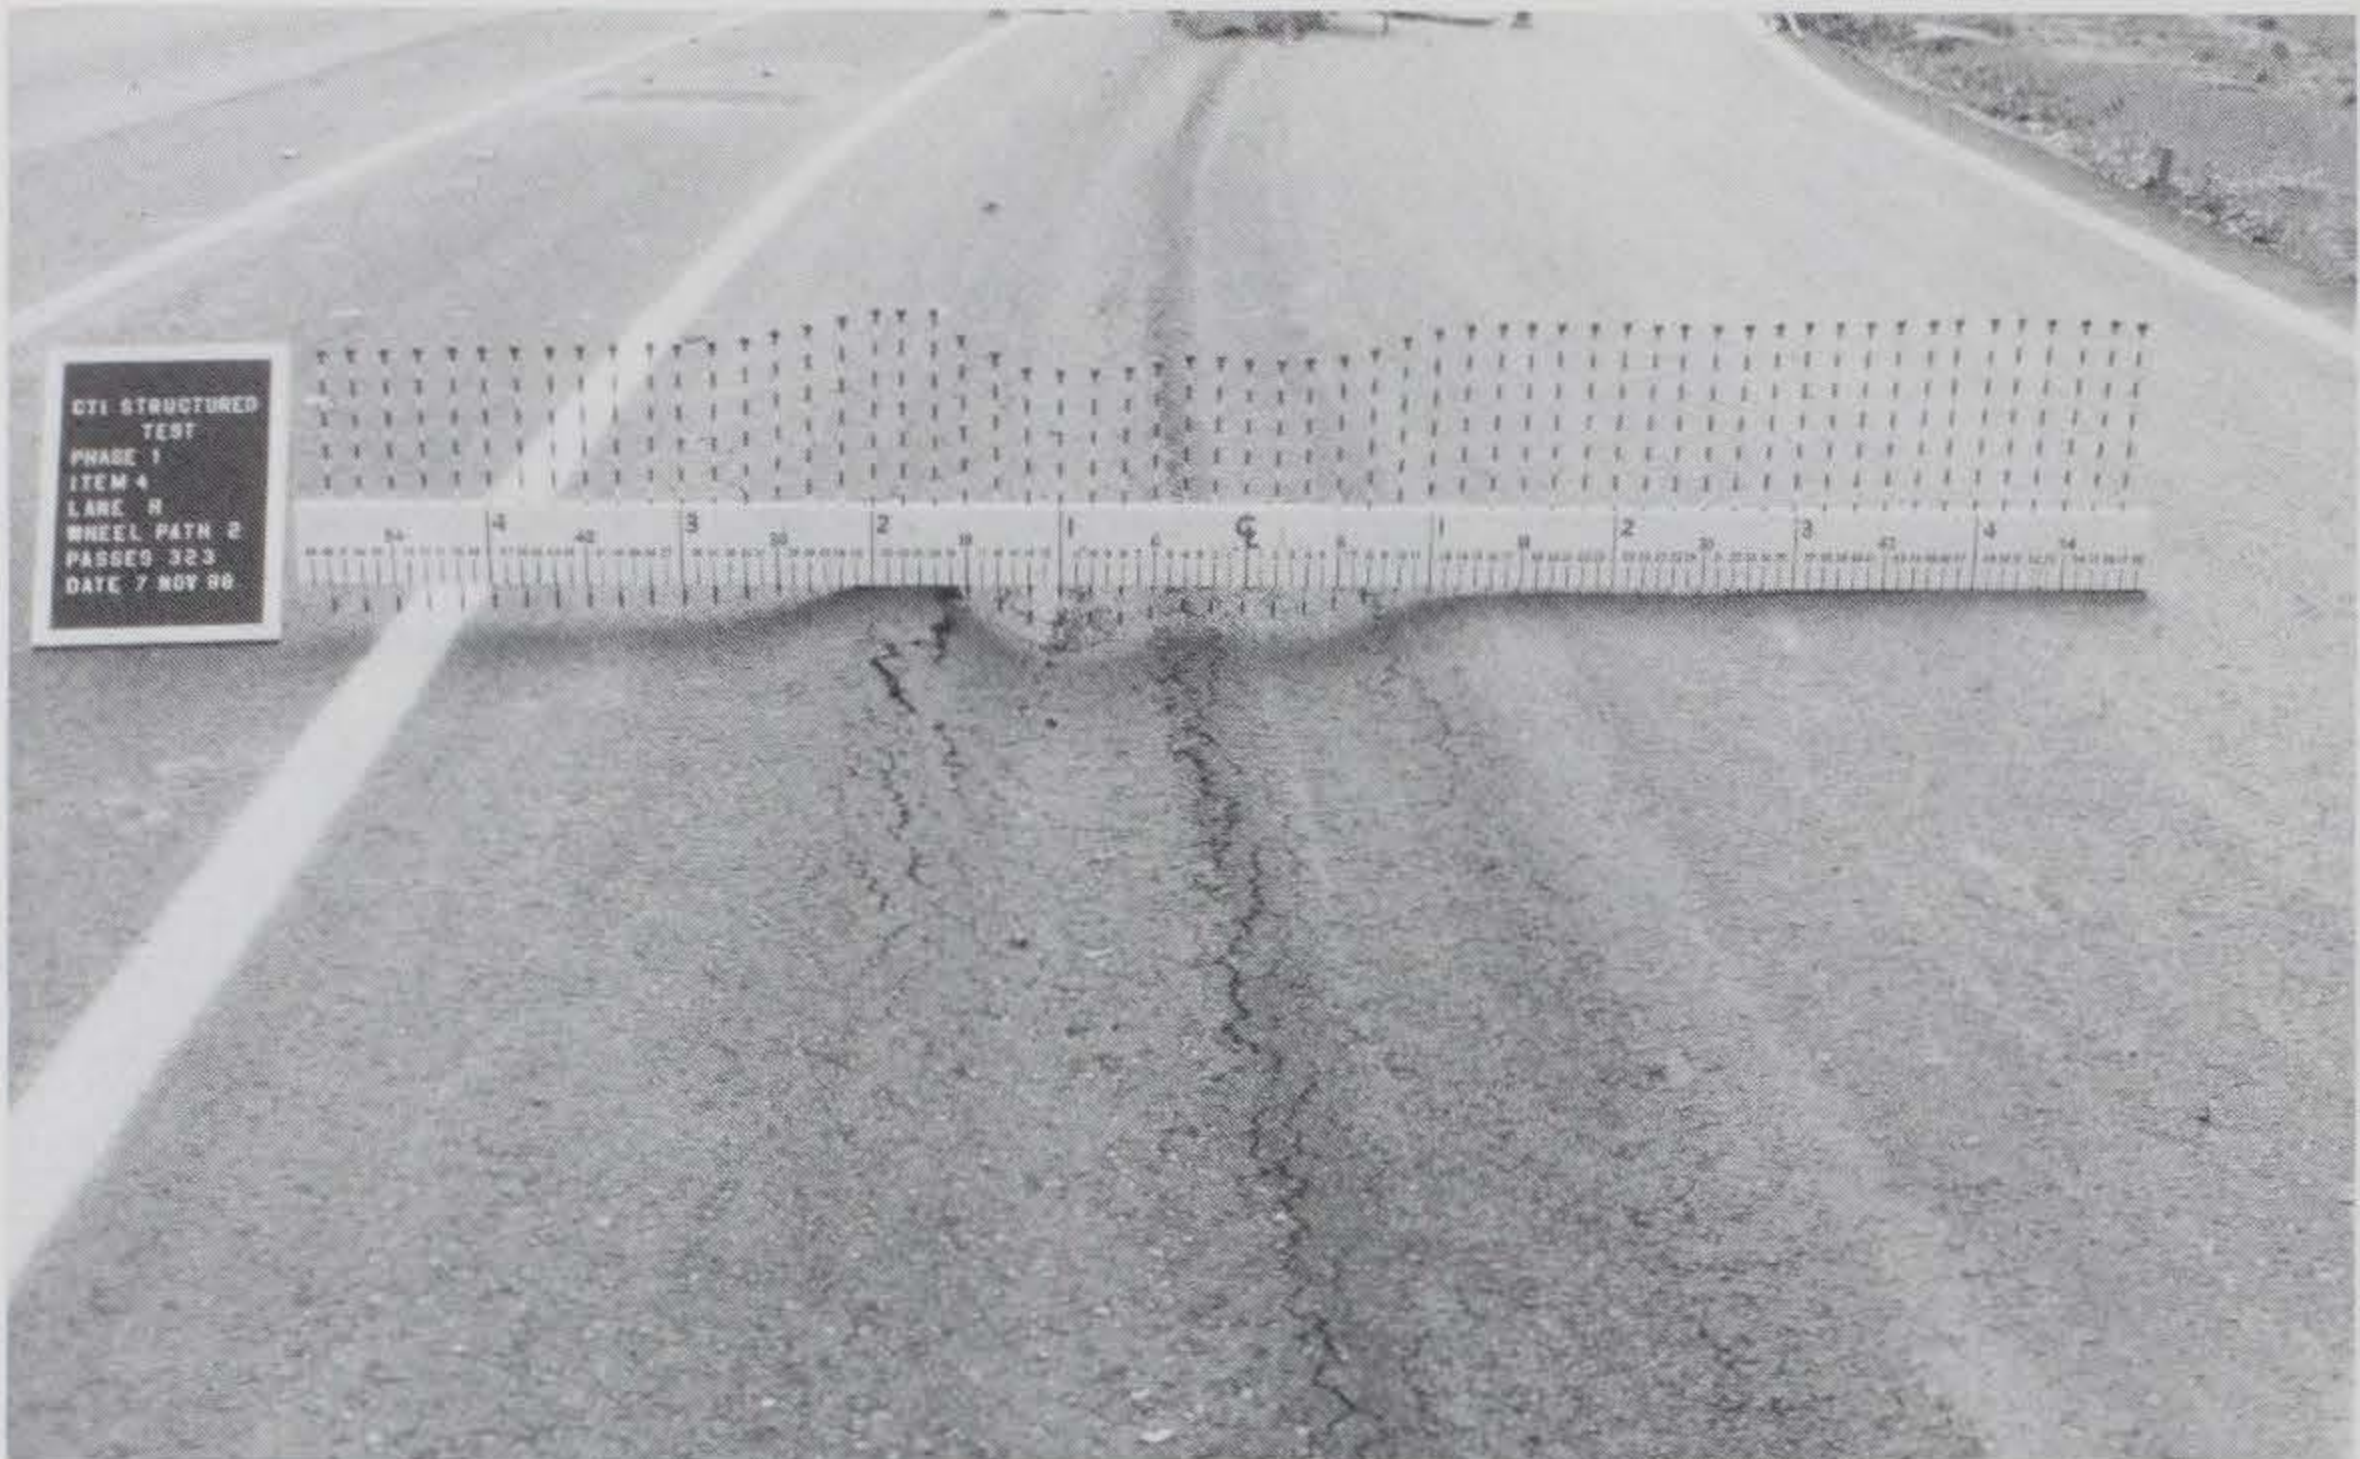
should be noted that again the majority of the rutting occurred in wheel-path 2, and very little distress had occurred in wheelpath 1. Wheelpath 1 in section 4 is located in the inside portion of the curve. This failure is attributed to overloading or failure of the subgrade. Figure 11, which is a view of a test pit excavated in the failed area, indicates severe rutting of the subgrade. At the time of this second failure in the high-tire-pressure lane (323 passes), very little distress was present in the low-tire-pressure lane. There was no cracking evident, and the maximum rut depth was only 0.5 in. The rate of pavement deterioration with traffic decreased after the second failure. The next failures occurred after 1,104 and 1,414 passes in wheelpath 1 of sections 6 and 5, respectively. When these sections were judged failed in the high-tire-pressure lane, only hairline cracking and minor rutting were detected in the low-tire-pressure lane. The average rut depth in the low-tire-pressure lane of section 6 after 1,104 passes was about 0.7 in. and in section 5 about 0.4 in. after 1,414 passes. Throughout the remainder of traffic in the high-tire-pressure lane (6,764 loaded passes), only two additional failures occurred, one in section 5, wheelpath 1 after 2,210 passes and another in section 10, wheelpath 1 at 2,210 passes also. The mode of failure in section 5 was the same as the previous failures, and the section 10 failure was attributed to severe shoving of the top lift of AC after 1,812 passes (see Figure 12) and then severe cracking and rutting of the surface as shown in Figure 13. The failure in section 10 occurred in an area where the traffic was entering a horizontal curve and at the beginning of warm weather traffic. Test traffic was applied to the AC section during two periods, from October 1988 to February 1989 and from June to November 1989. The shoving, shown in Figure 12, occurred after 245 passes had been applied in June 1989. Shoving (Figure 14) was detected in the low-tire-pressure lane of section 10 after 1,200 passes of warm weather traffic or a total of 4,200 passes.

Figure 10. High-tire-pressure lane, section 4, second failure, 323 passes

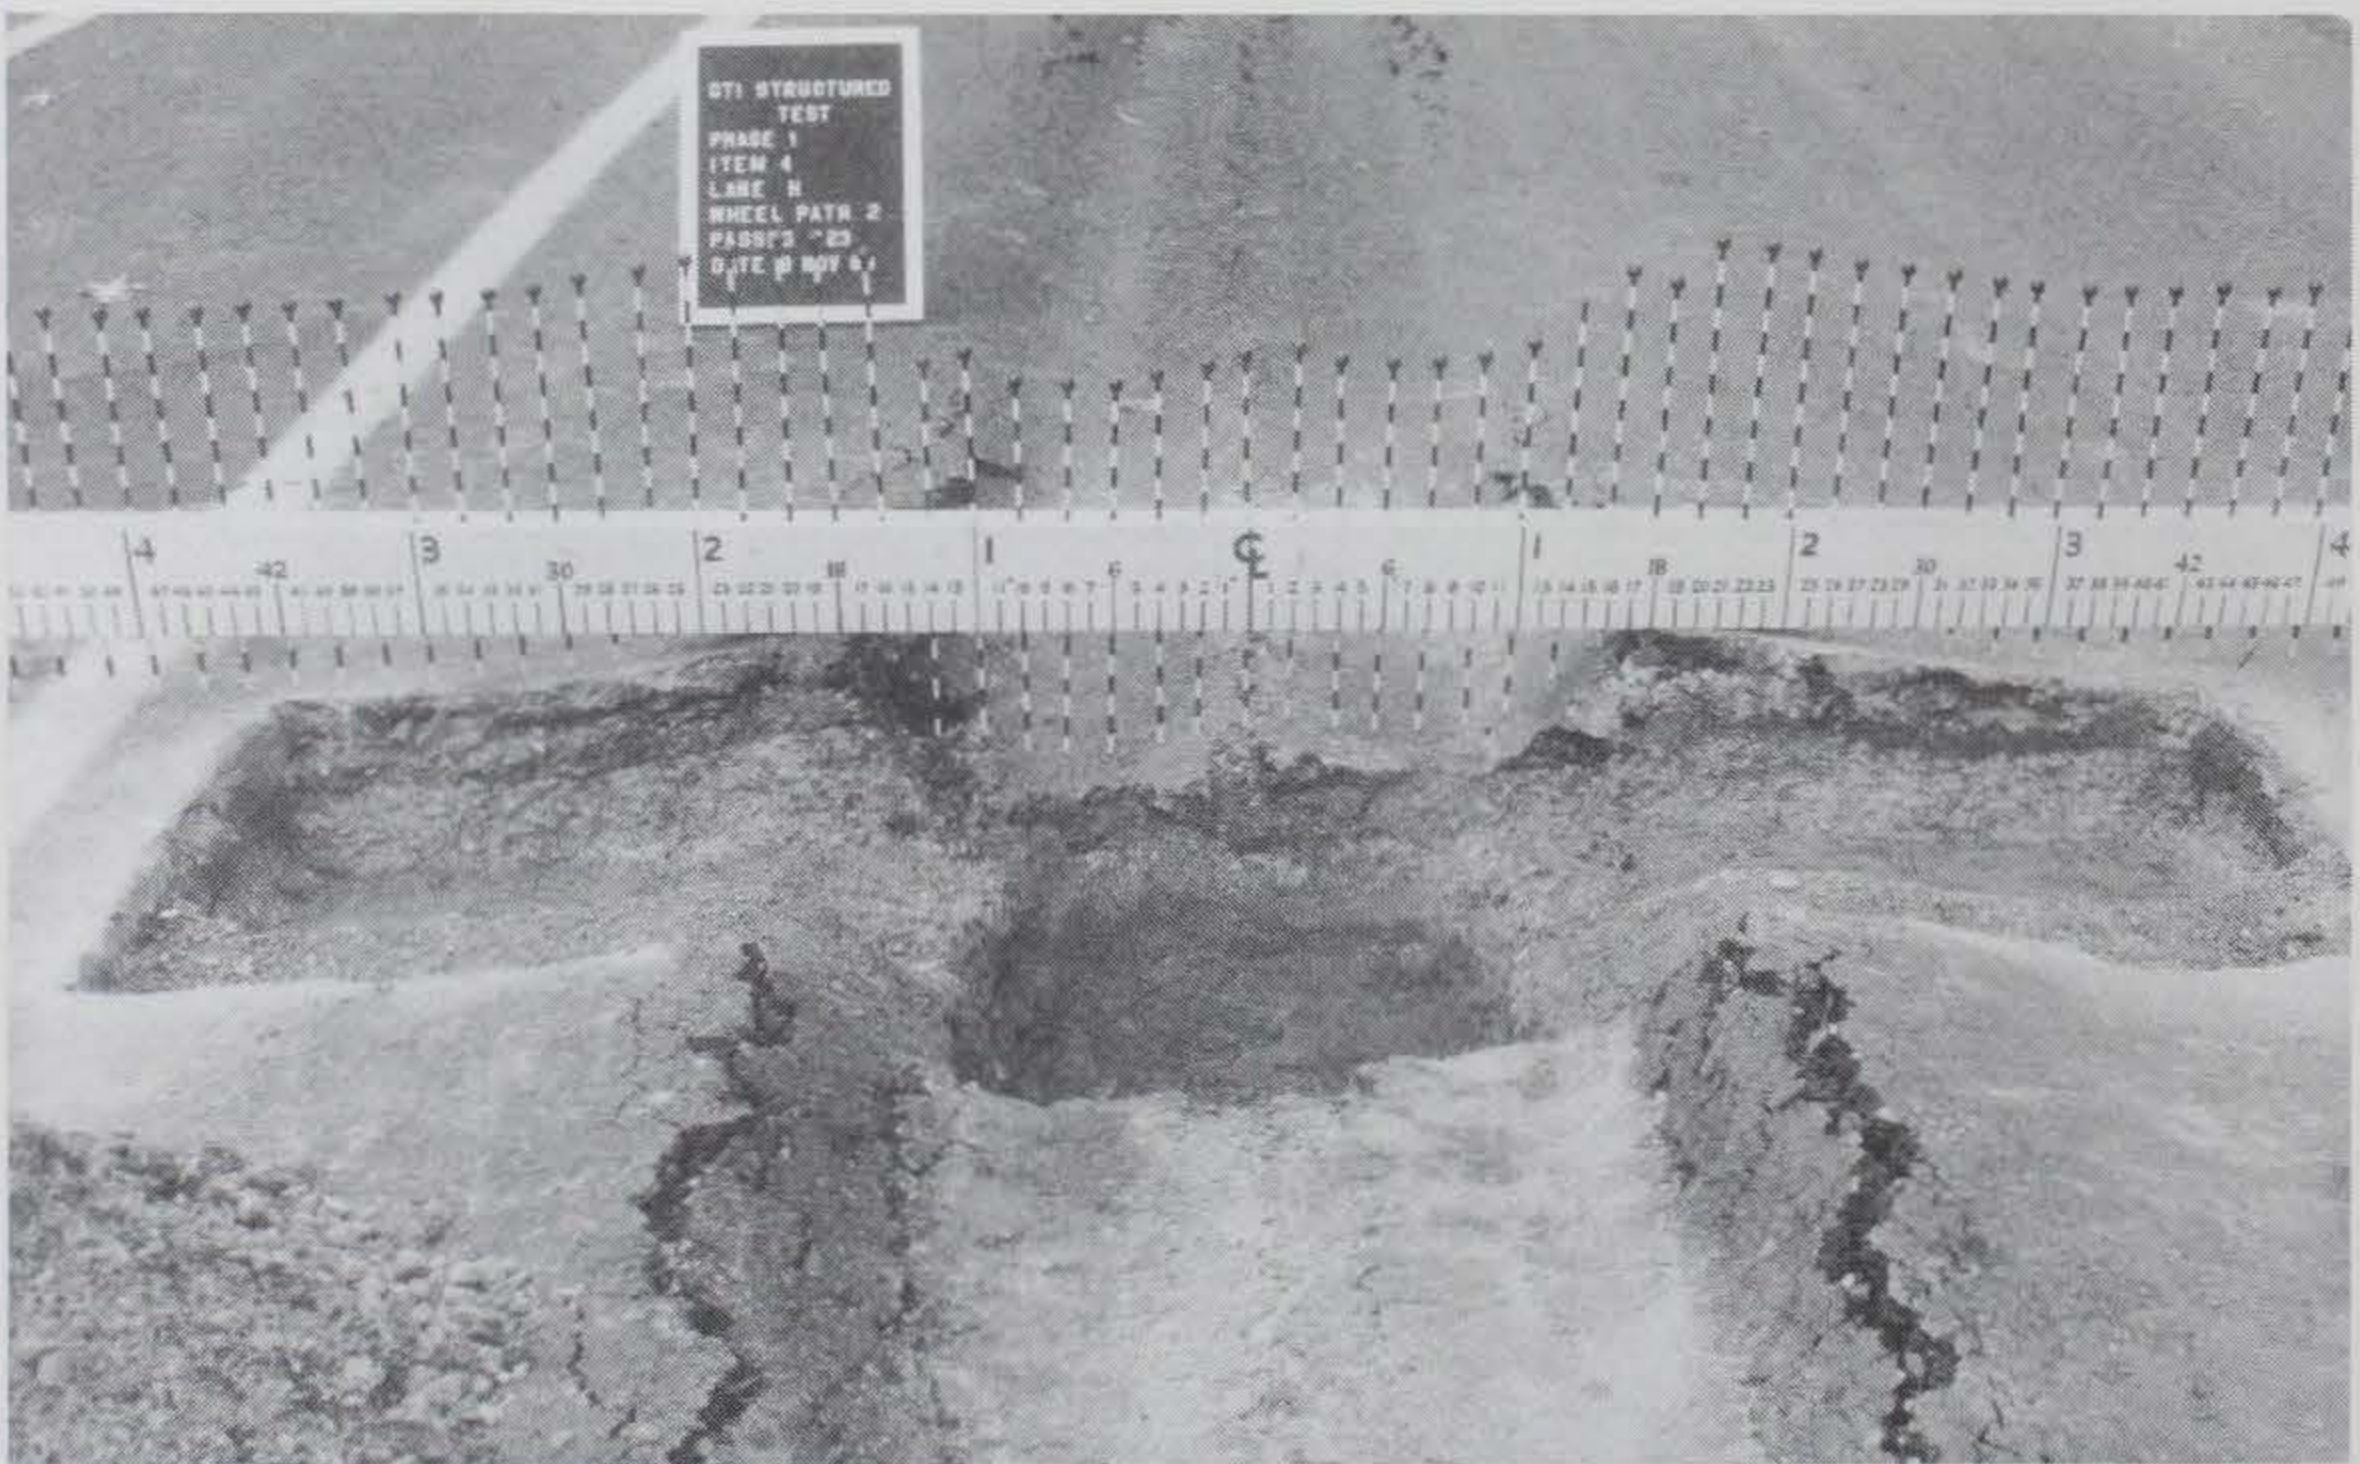
Figure 11. High-tire-pressure lane, section 4, test trench after 323 passes

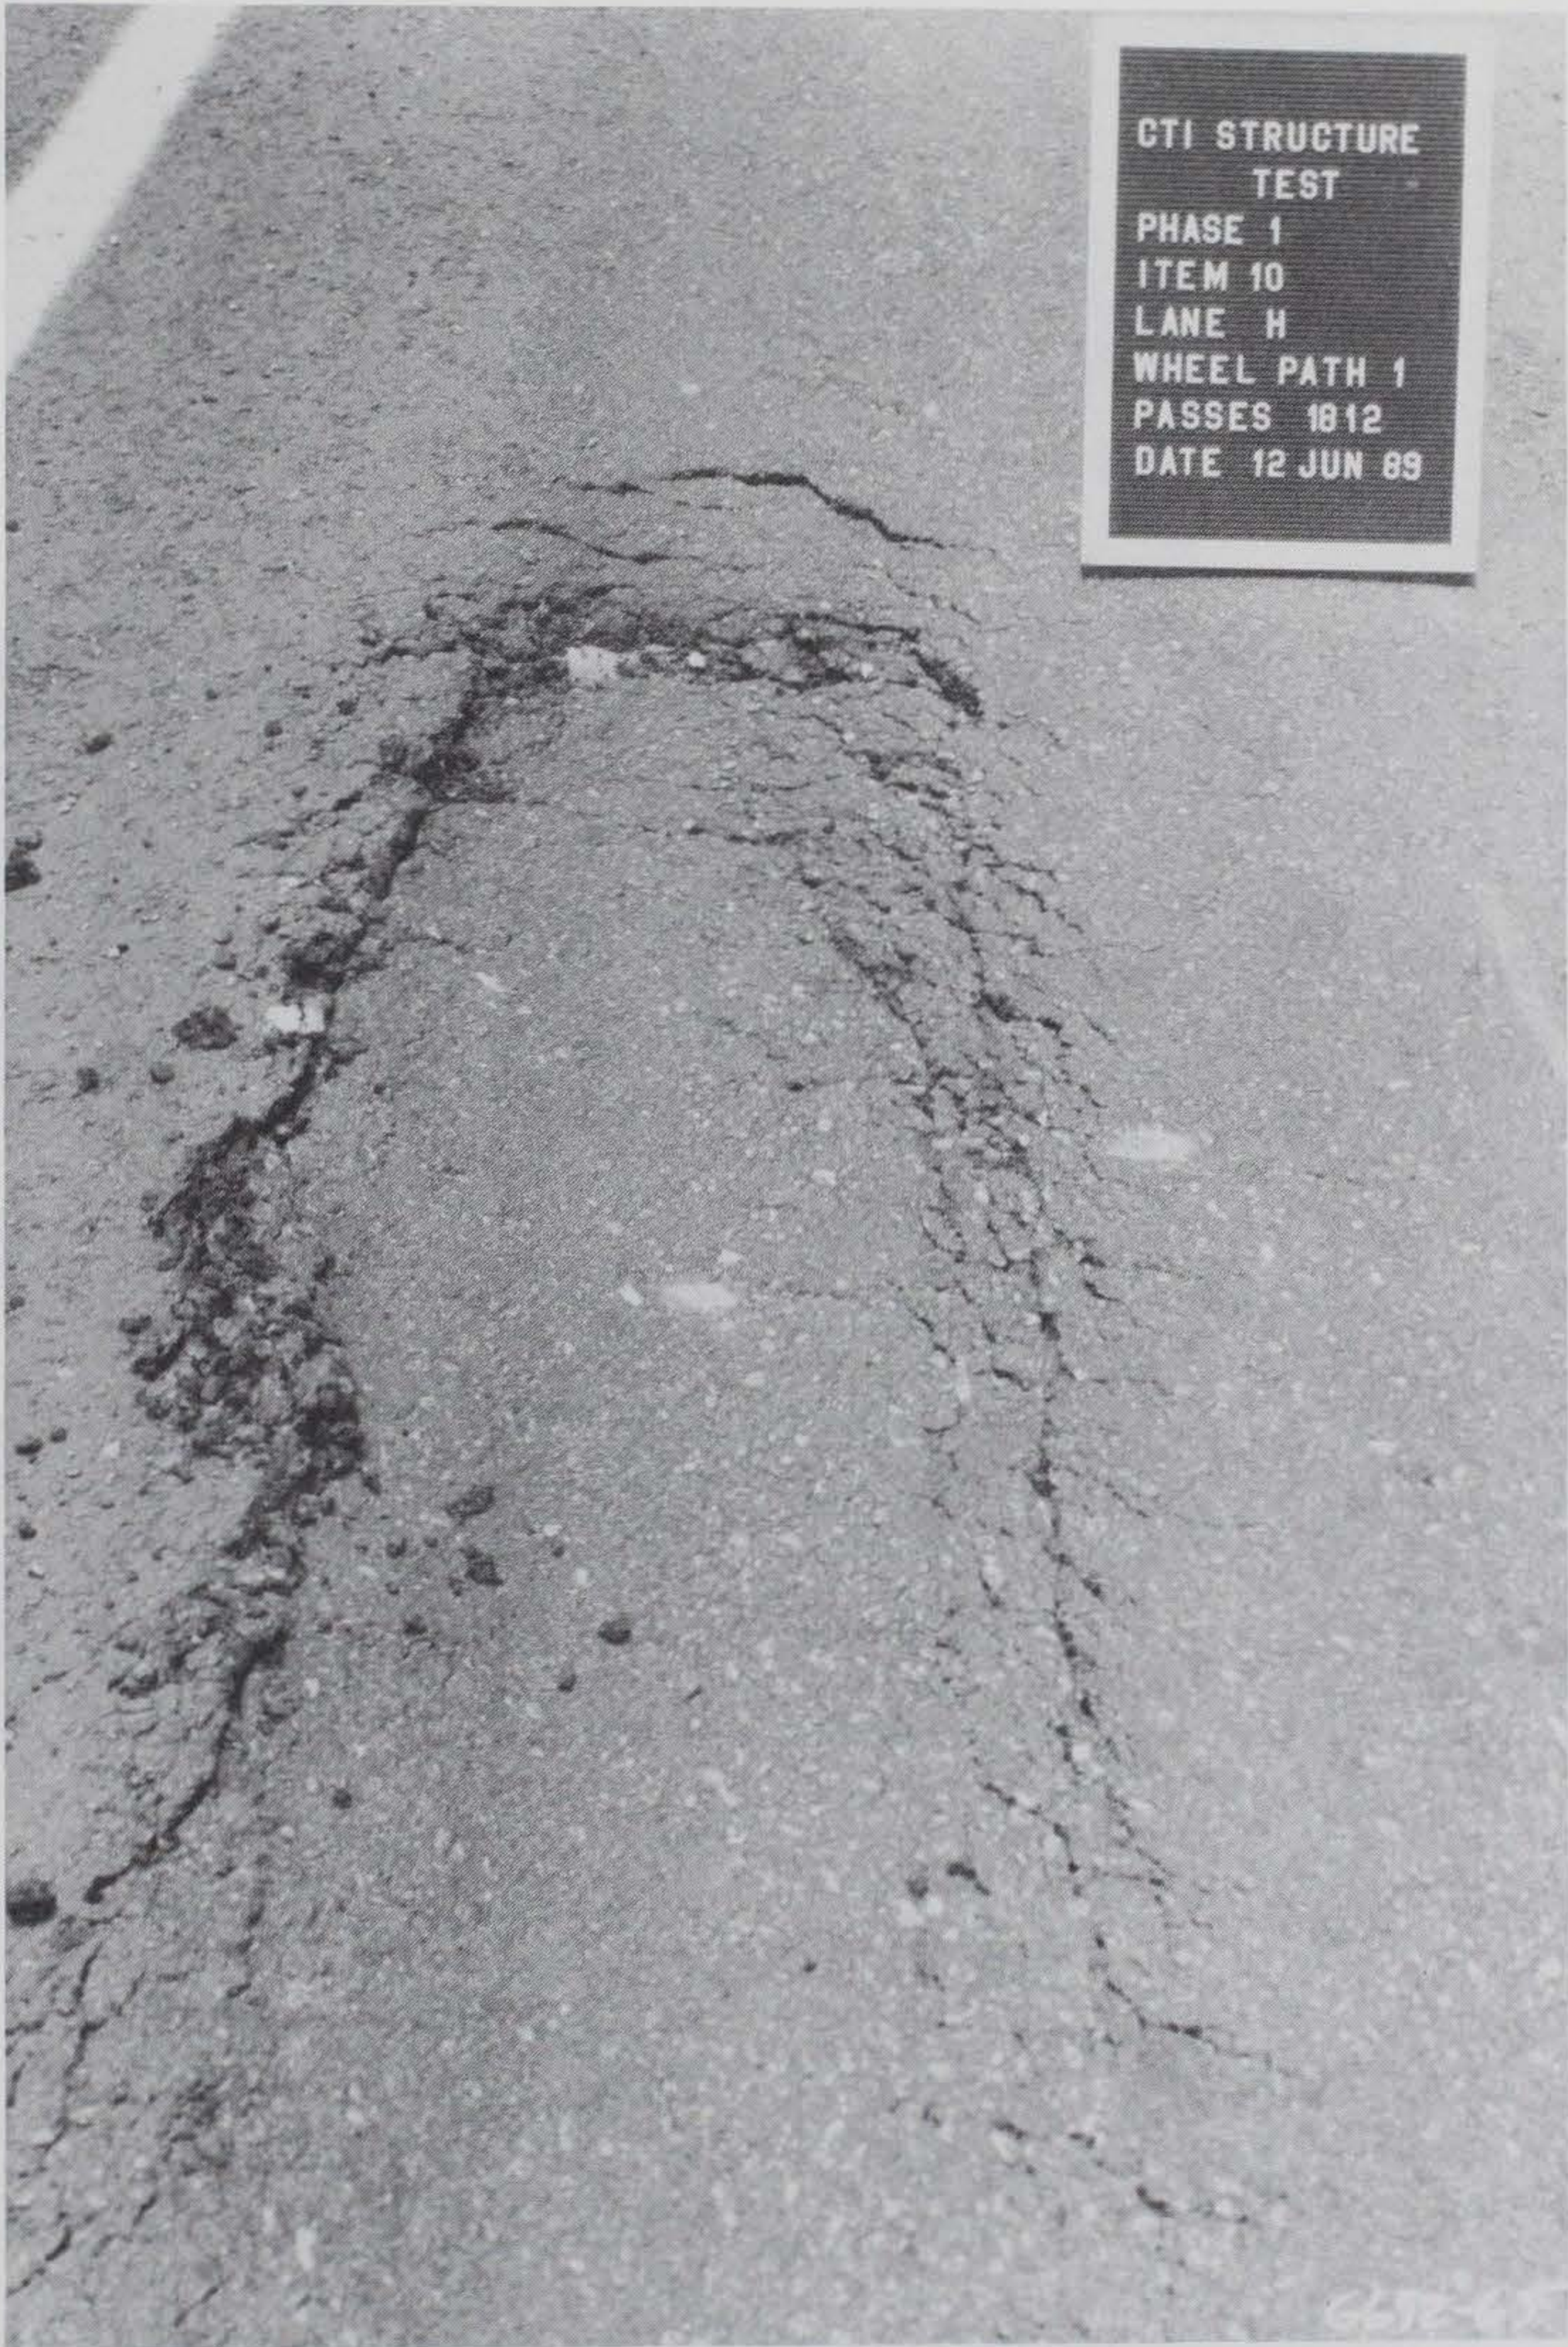
Figure 12. High-tire-pressure lane, section 10, shoving after 1,812 passes

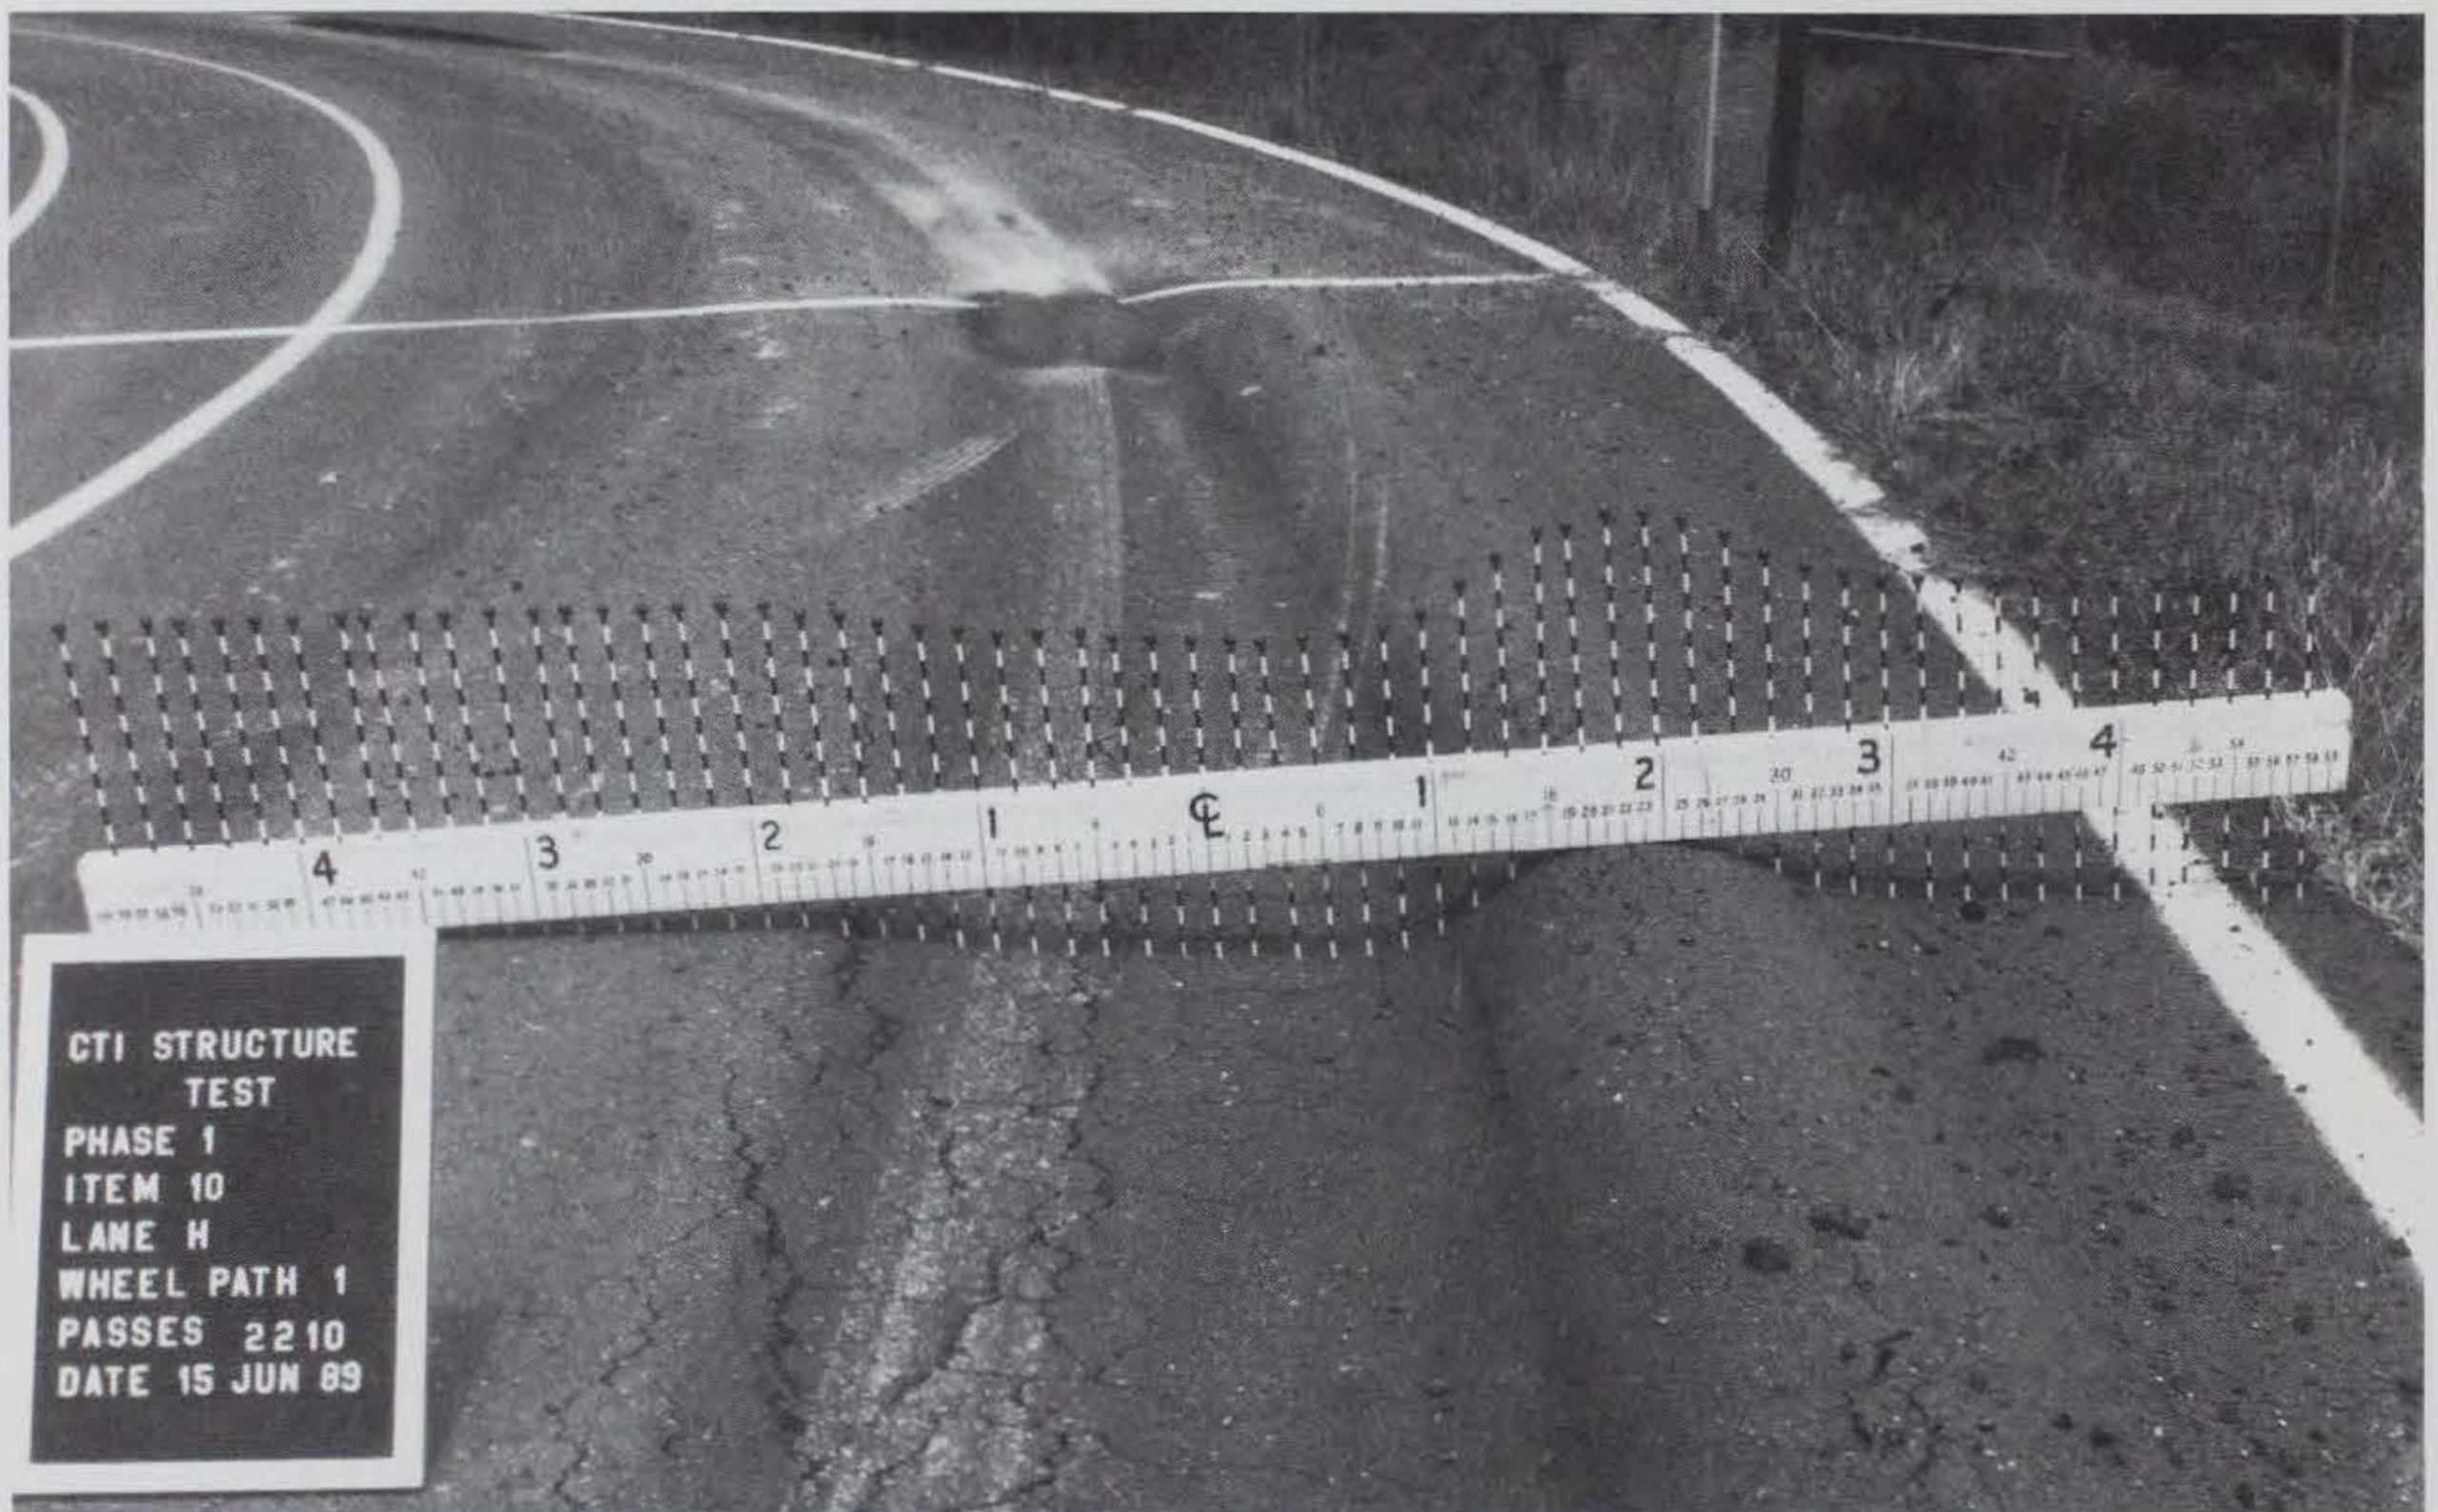
CTI STRUCTURE
TEST
PHASE 1
ITEM 10
LANE H
WHEEL PATH 1
PASSES 2210
DATE 15 JUN 89

Figure 13. High-tire-pressure lane, section 10,
failure after 2,210 passes

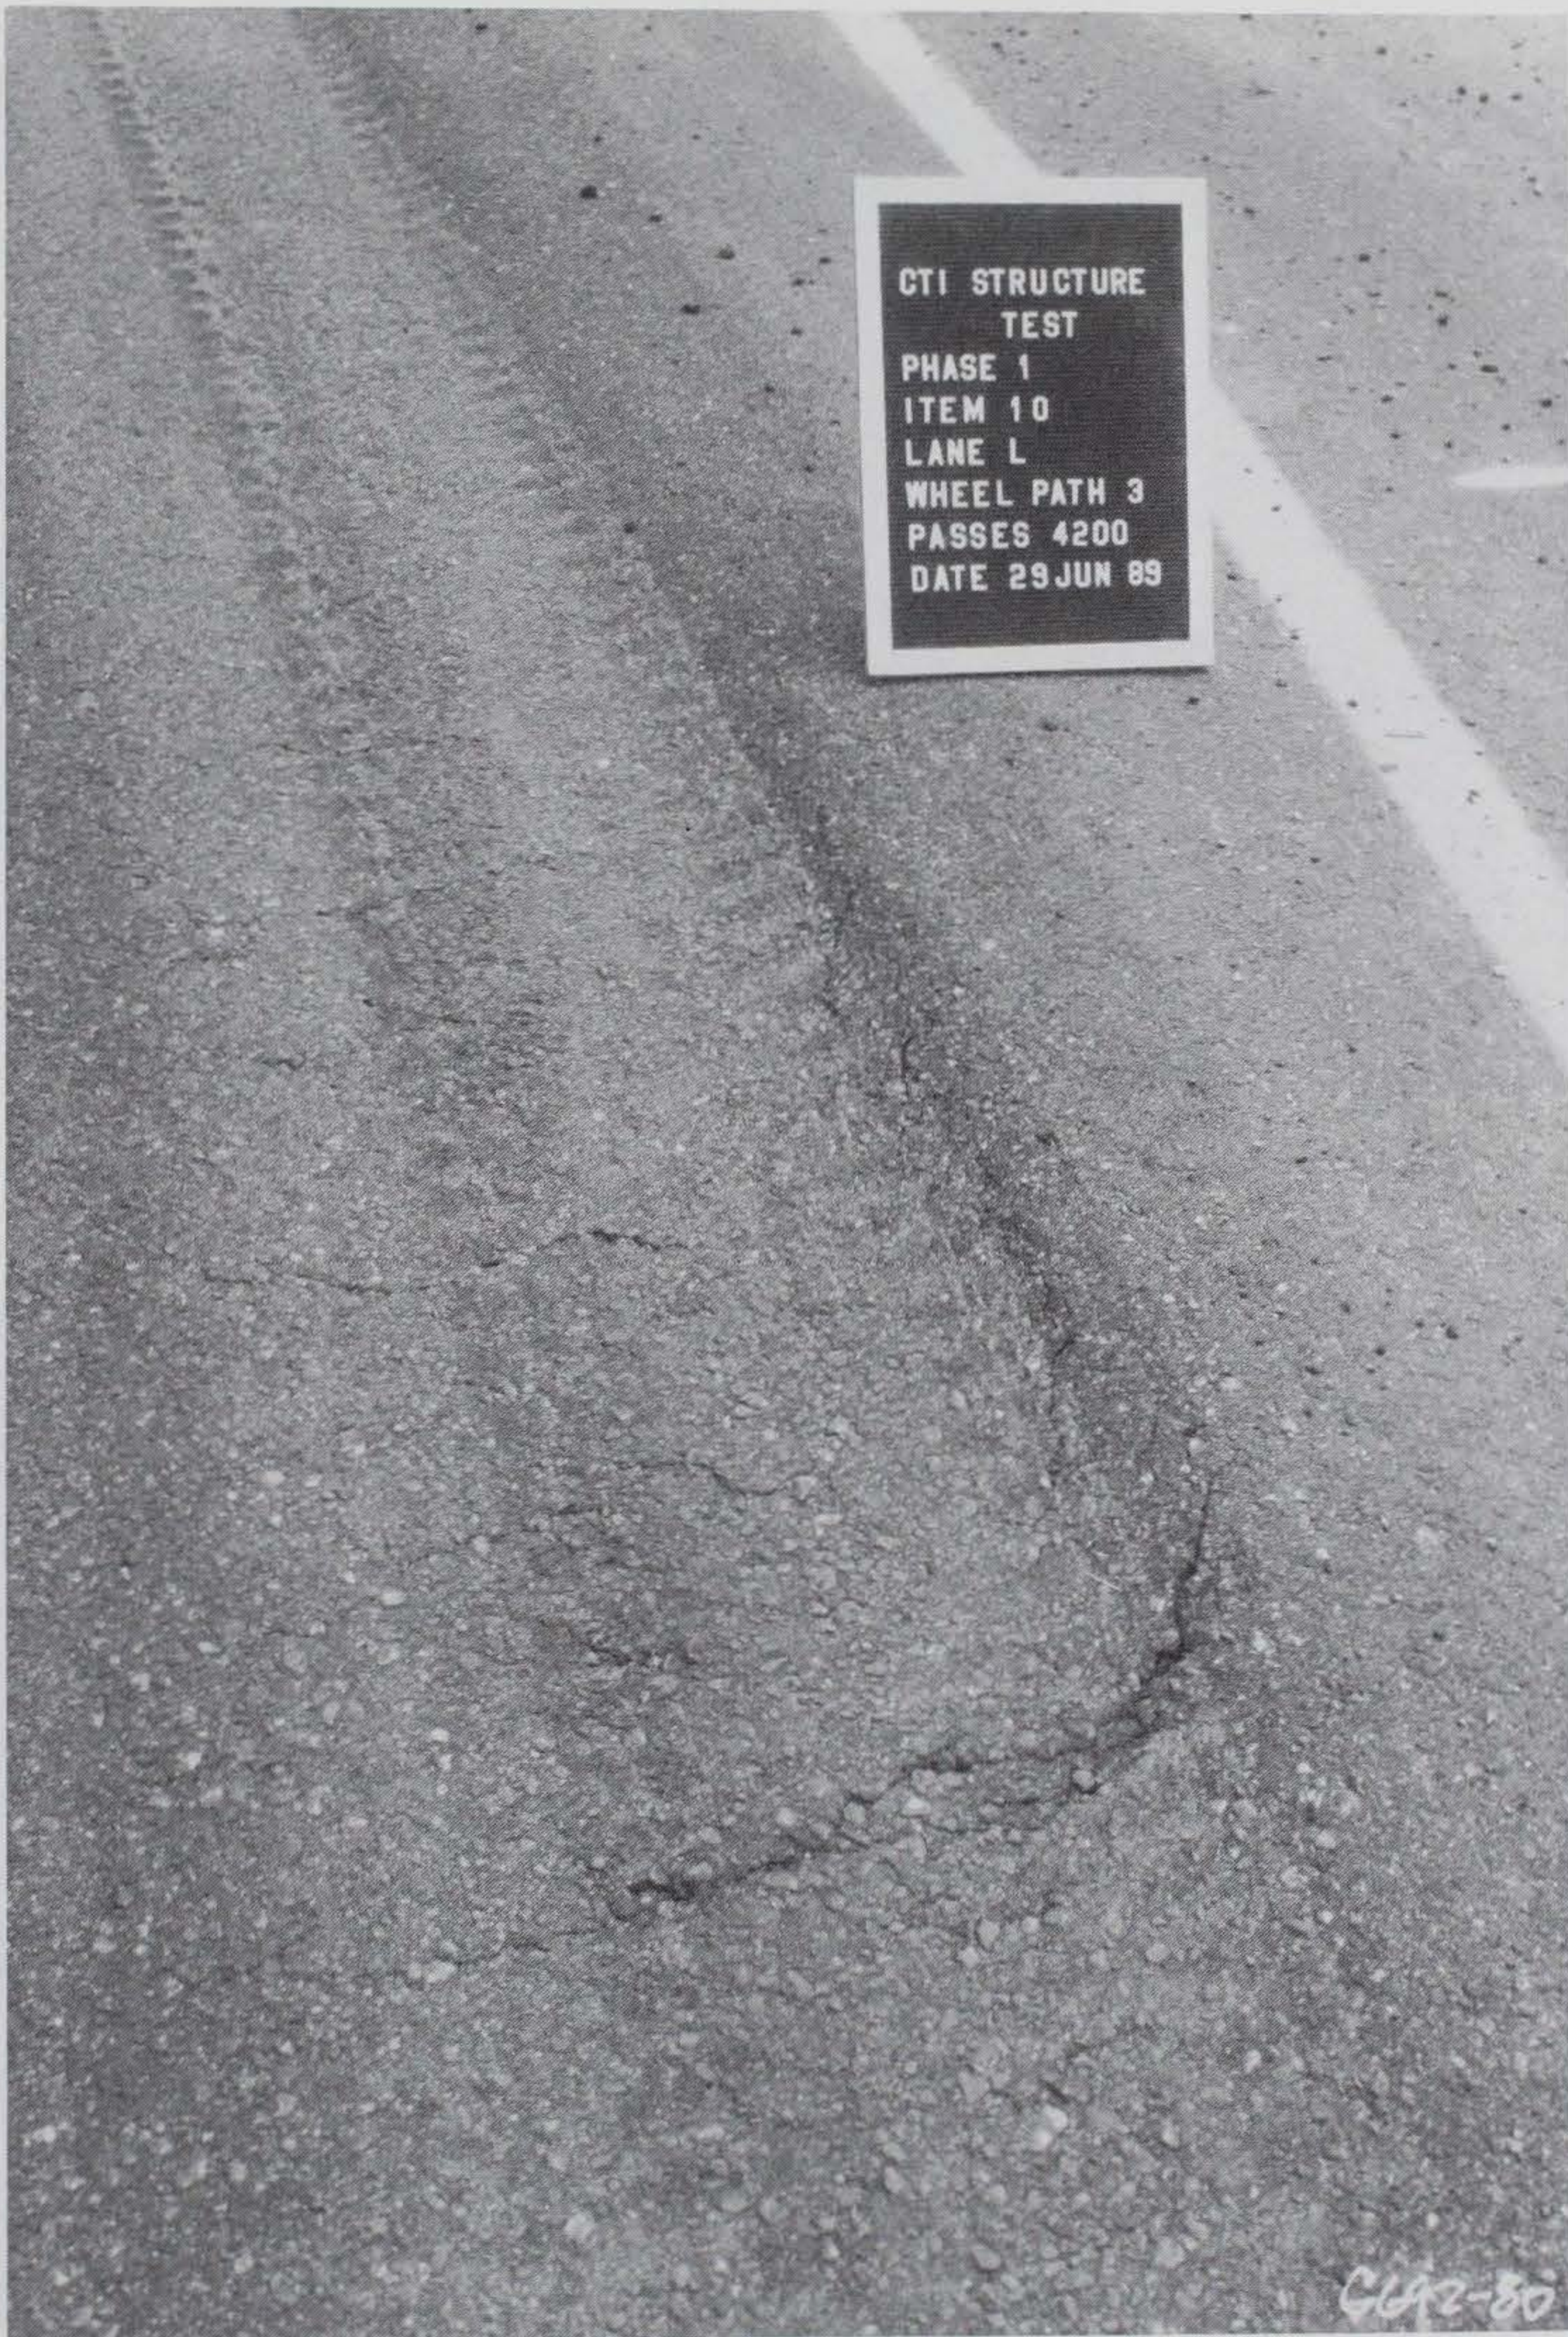
Figure 14. Low-tire-pressure lane, section 10, low severity shoving after 4,200 passes
