MISCELLANEOUS PAPER GL-90-21

EFFECTS OF VARIABLE TIRE PRESSURE ON ROAD SURFACINGS

Robert W. Grau

September 1990

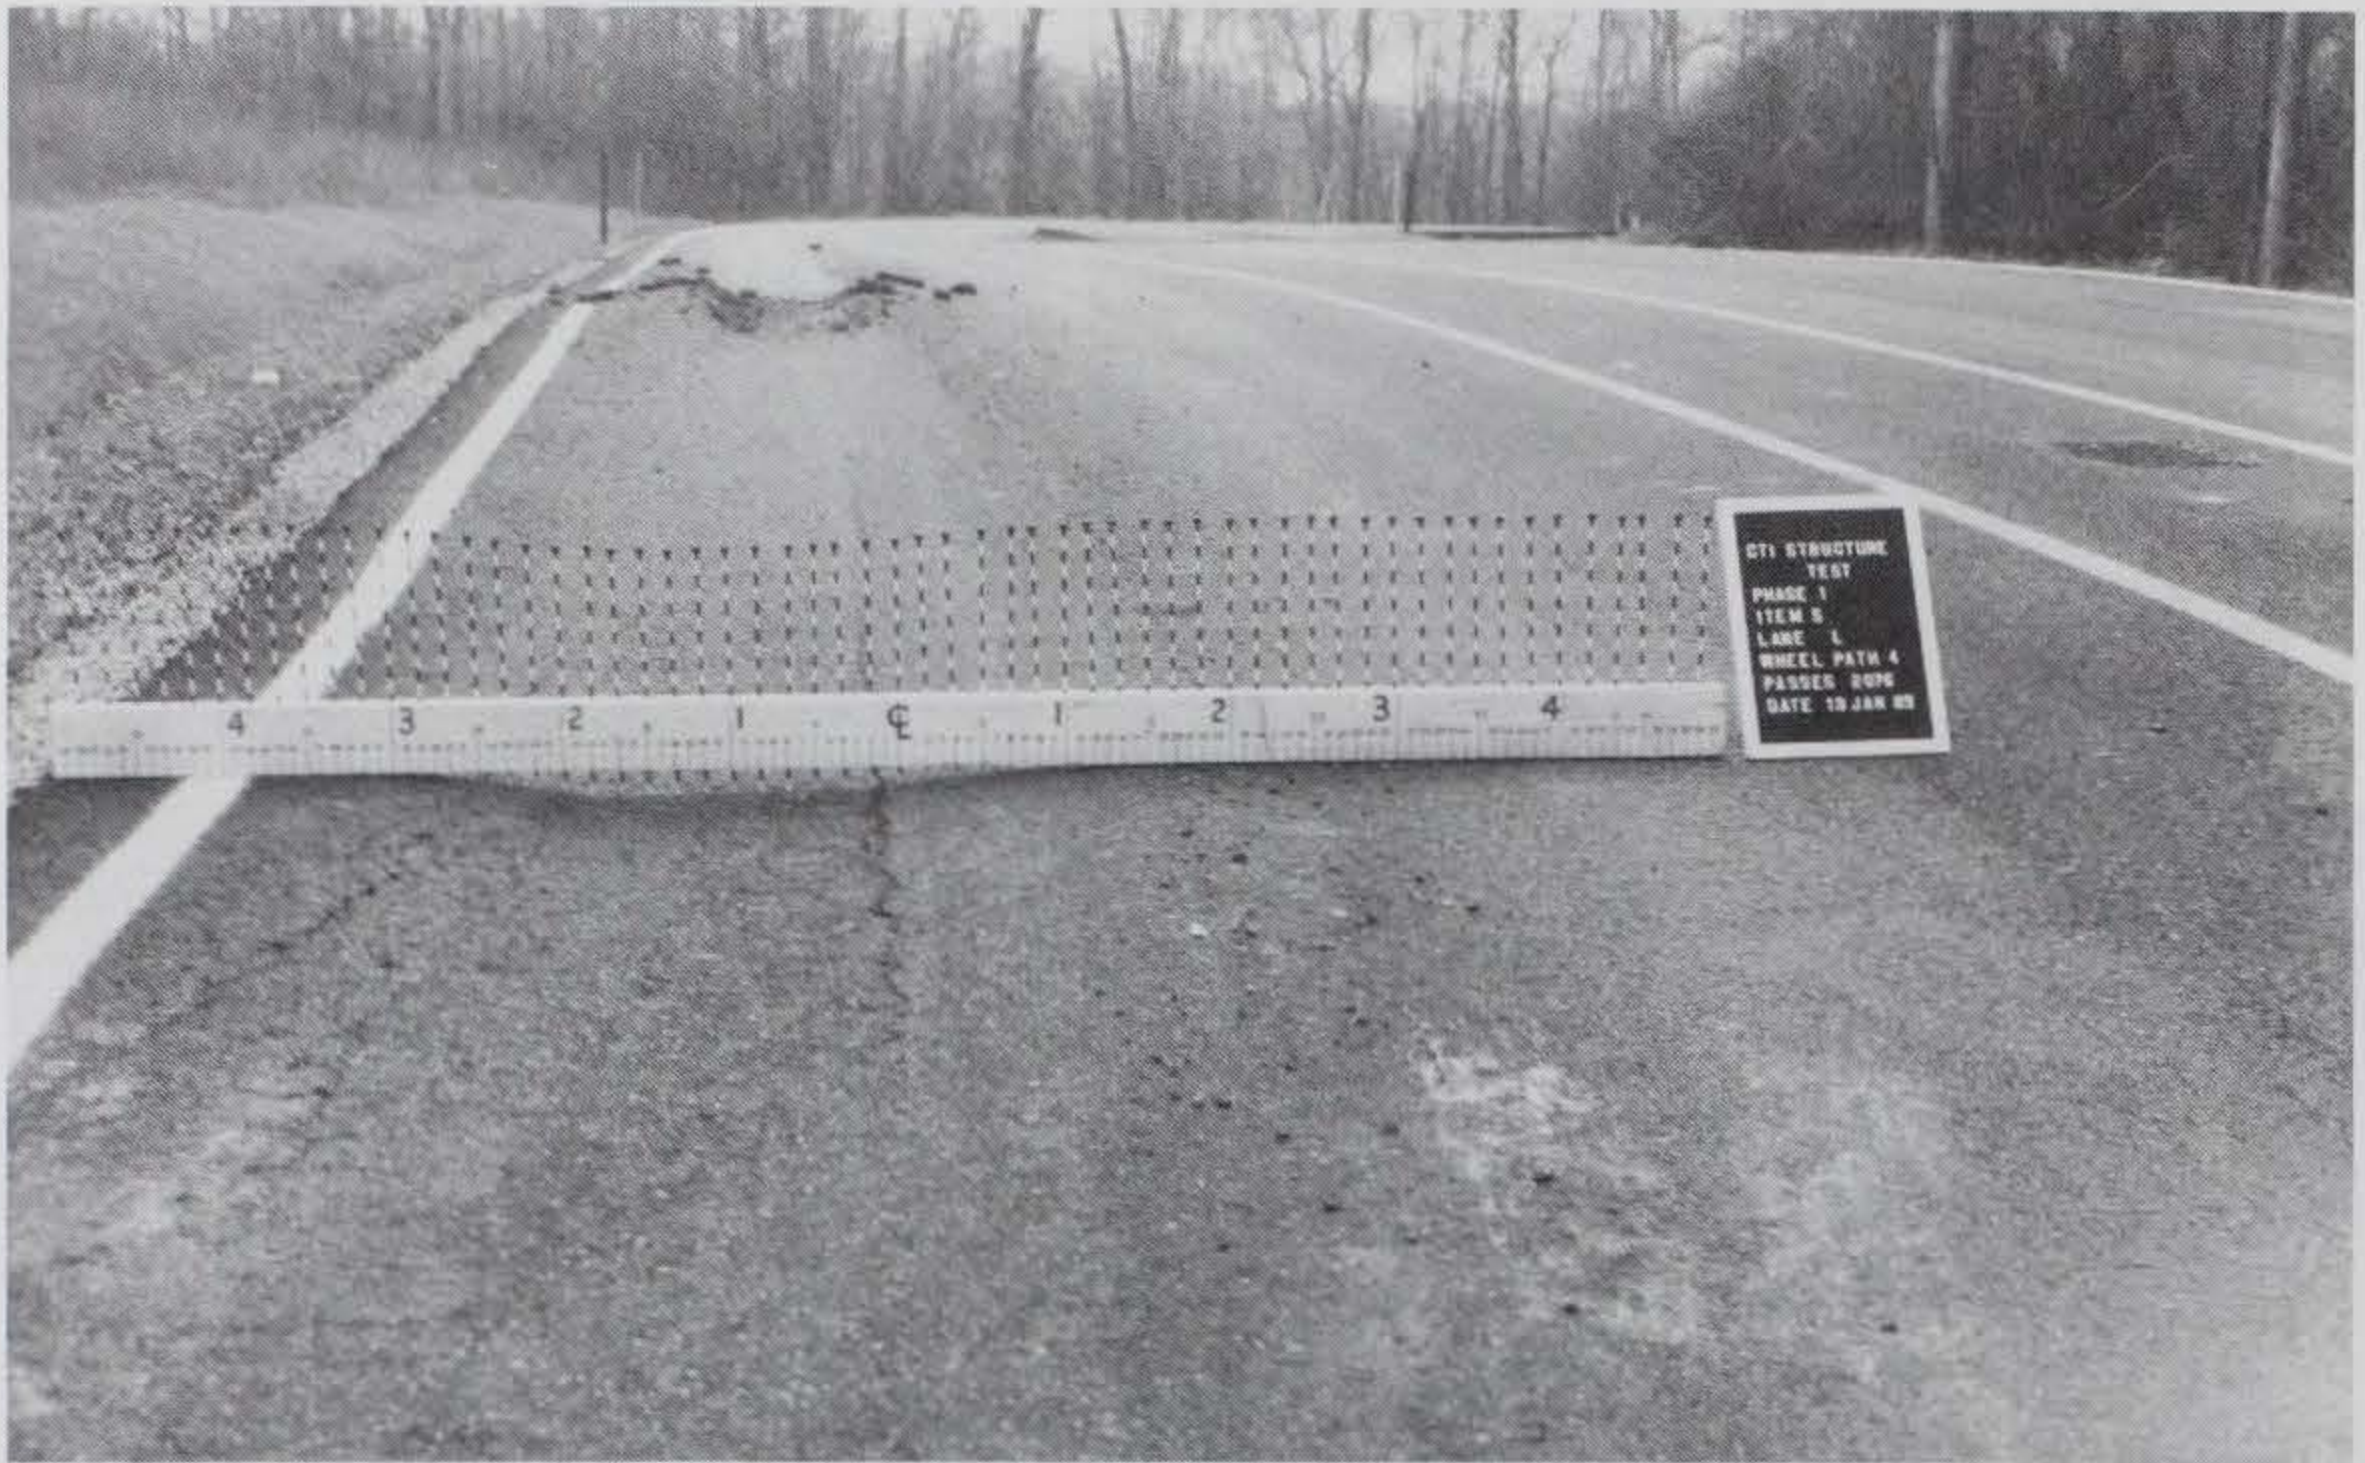
20. Four failures, two in section 4 and one each in sections 5 and 6, occurred in the low-tire pressure lane. The failures in sections 5 and 6 were judged as failed after 2,076 passes and those in section 4 after 3,324 and 3,845 passes. Severe cracking and rutting were the mode of each of these failures. A general view of the portion of section 5 was failed after 2,076 passes as shown in Figure 15.

Figure 15. Low-tire-pressure lane, section 5, failure after 2,076 passes

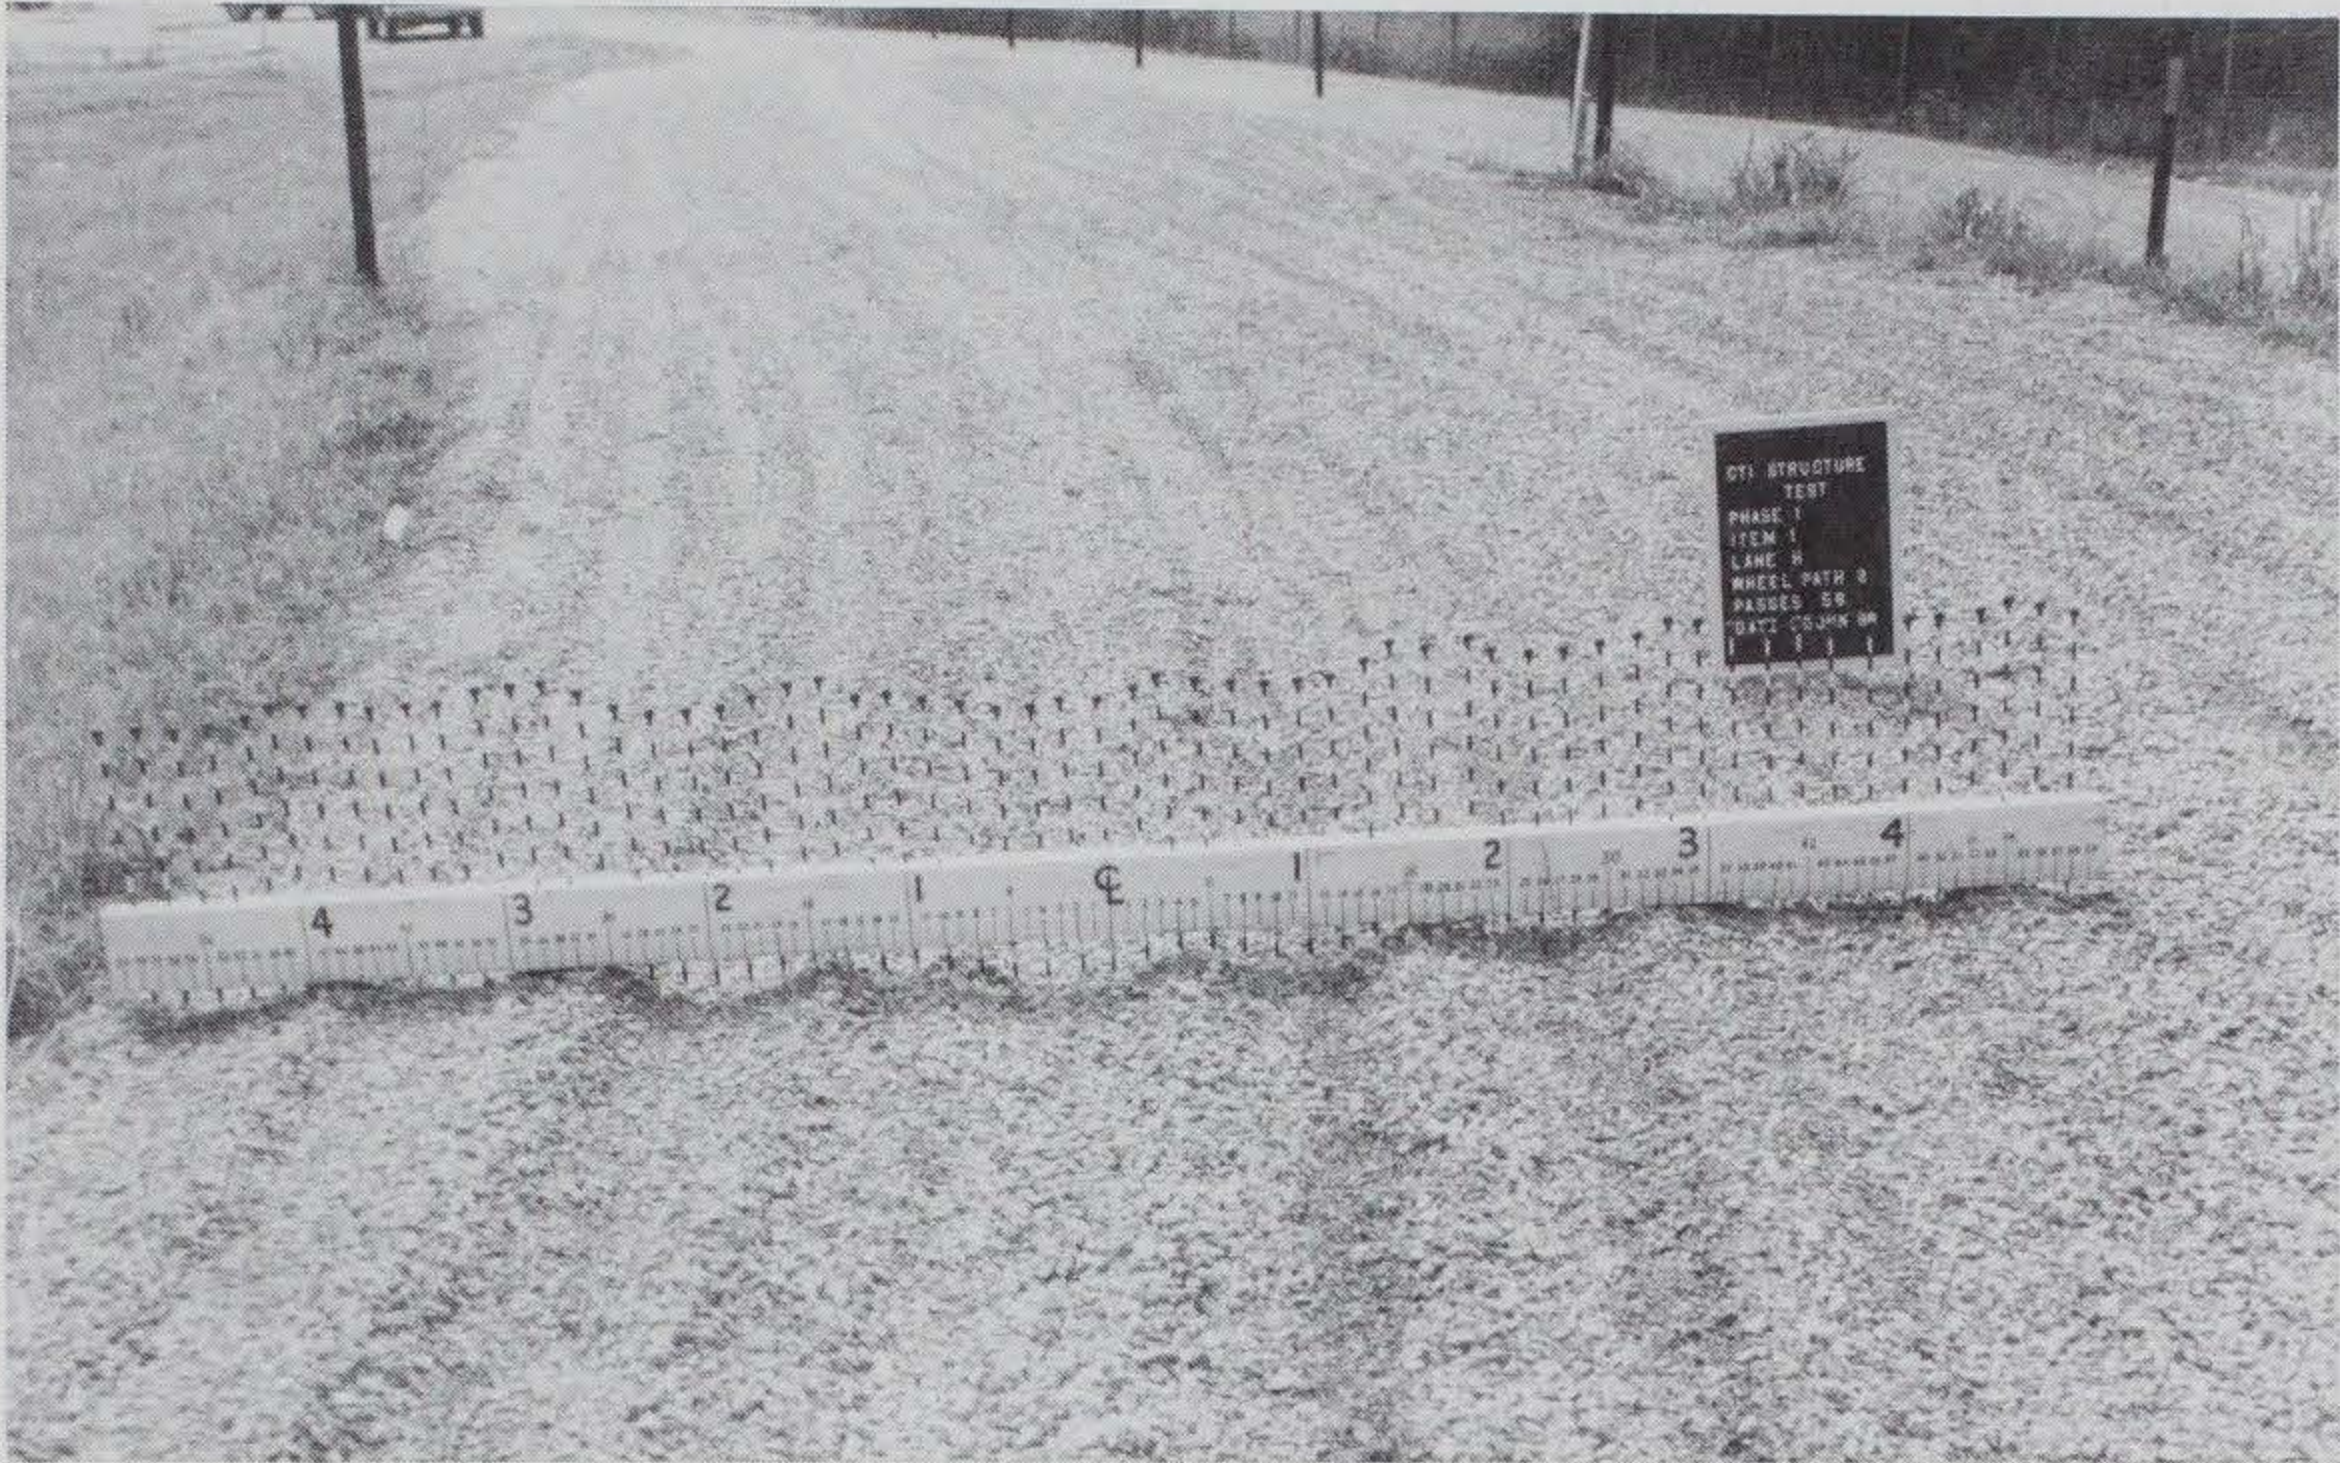
deep. When traffic was switched to loaded, the maximum depth of washboarding decreased about an inch. The high-tire-pressure unloaded traffic continued to cause severe distress in section 2, and after 584 loaded and 556 unloaded passes this section was graded for the fourth time. Performance at this section was then discontinued. Very little distress was observed in the low-tire-pressure lane of section 2, and grading was never required. The greatest distress occurred when a pothole occurred in the no-test-section area adjacent to this section which resulted in washboarding migrating into section 2. However, as shown in Figure 19, the low-pressure tires seemed to dampen out the bouncing of the truck which resulted in no corrugation 15 to 20 ft from the pothole. The horizontal curves in section 1 perform approximately the same under low- and high-tire-pressure traffic. Neither required grading after being overlaid. The high-pressure-tire lane received 2,586 and 1,172 passes of loaded and unloaded traffic, respectively, and the low-tire-pressure lane received a total of 3,023 loaded and 1,384 unloaded passes of the log truck. By the end of traffic, the only distress observed was minor rutting in both lanes and low-severity corrugation in the high-tire-pressure lane. Figures 20 and 21 show general views of the high- and low-tire-pressure lane, respectively, of section 1 depicting the above distresses.

Figure 17. High-tire-pressure lane, section 1, failure after 58 passes

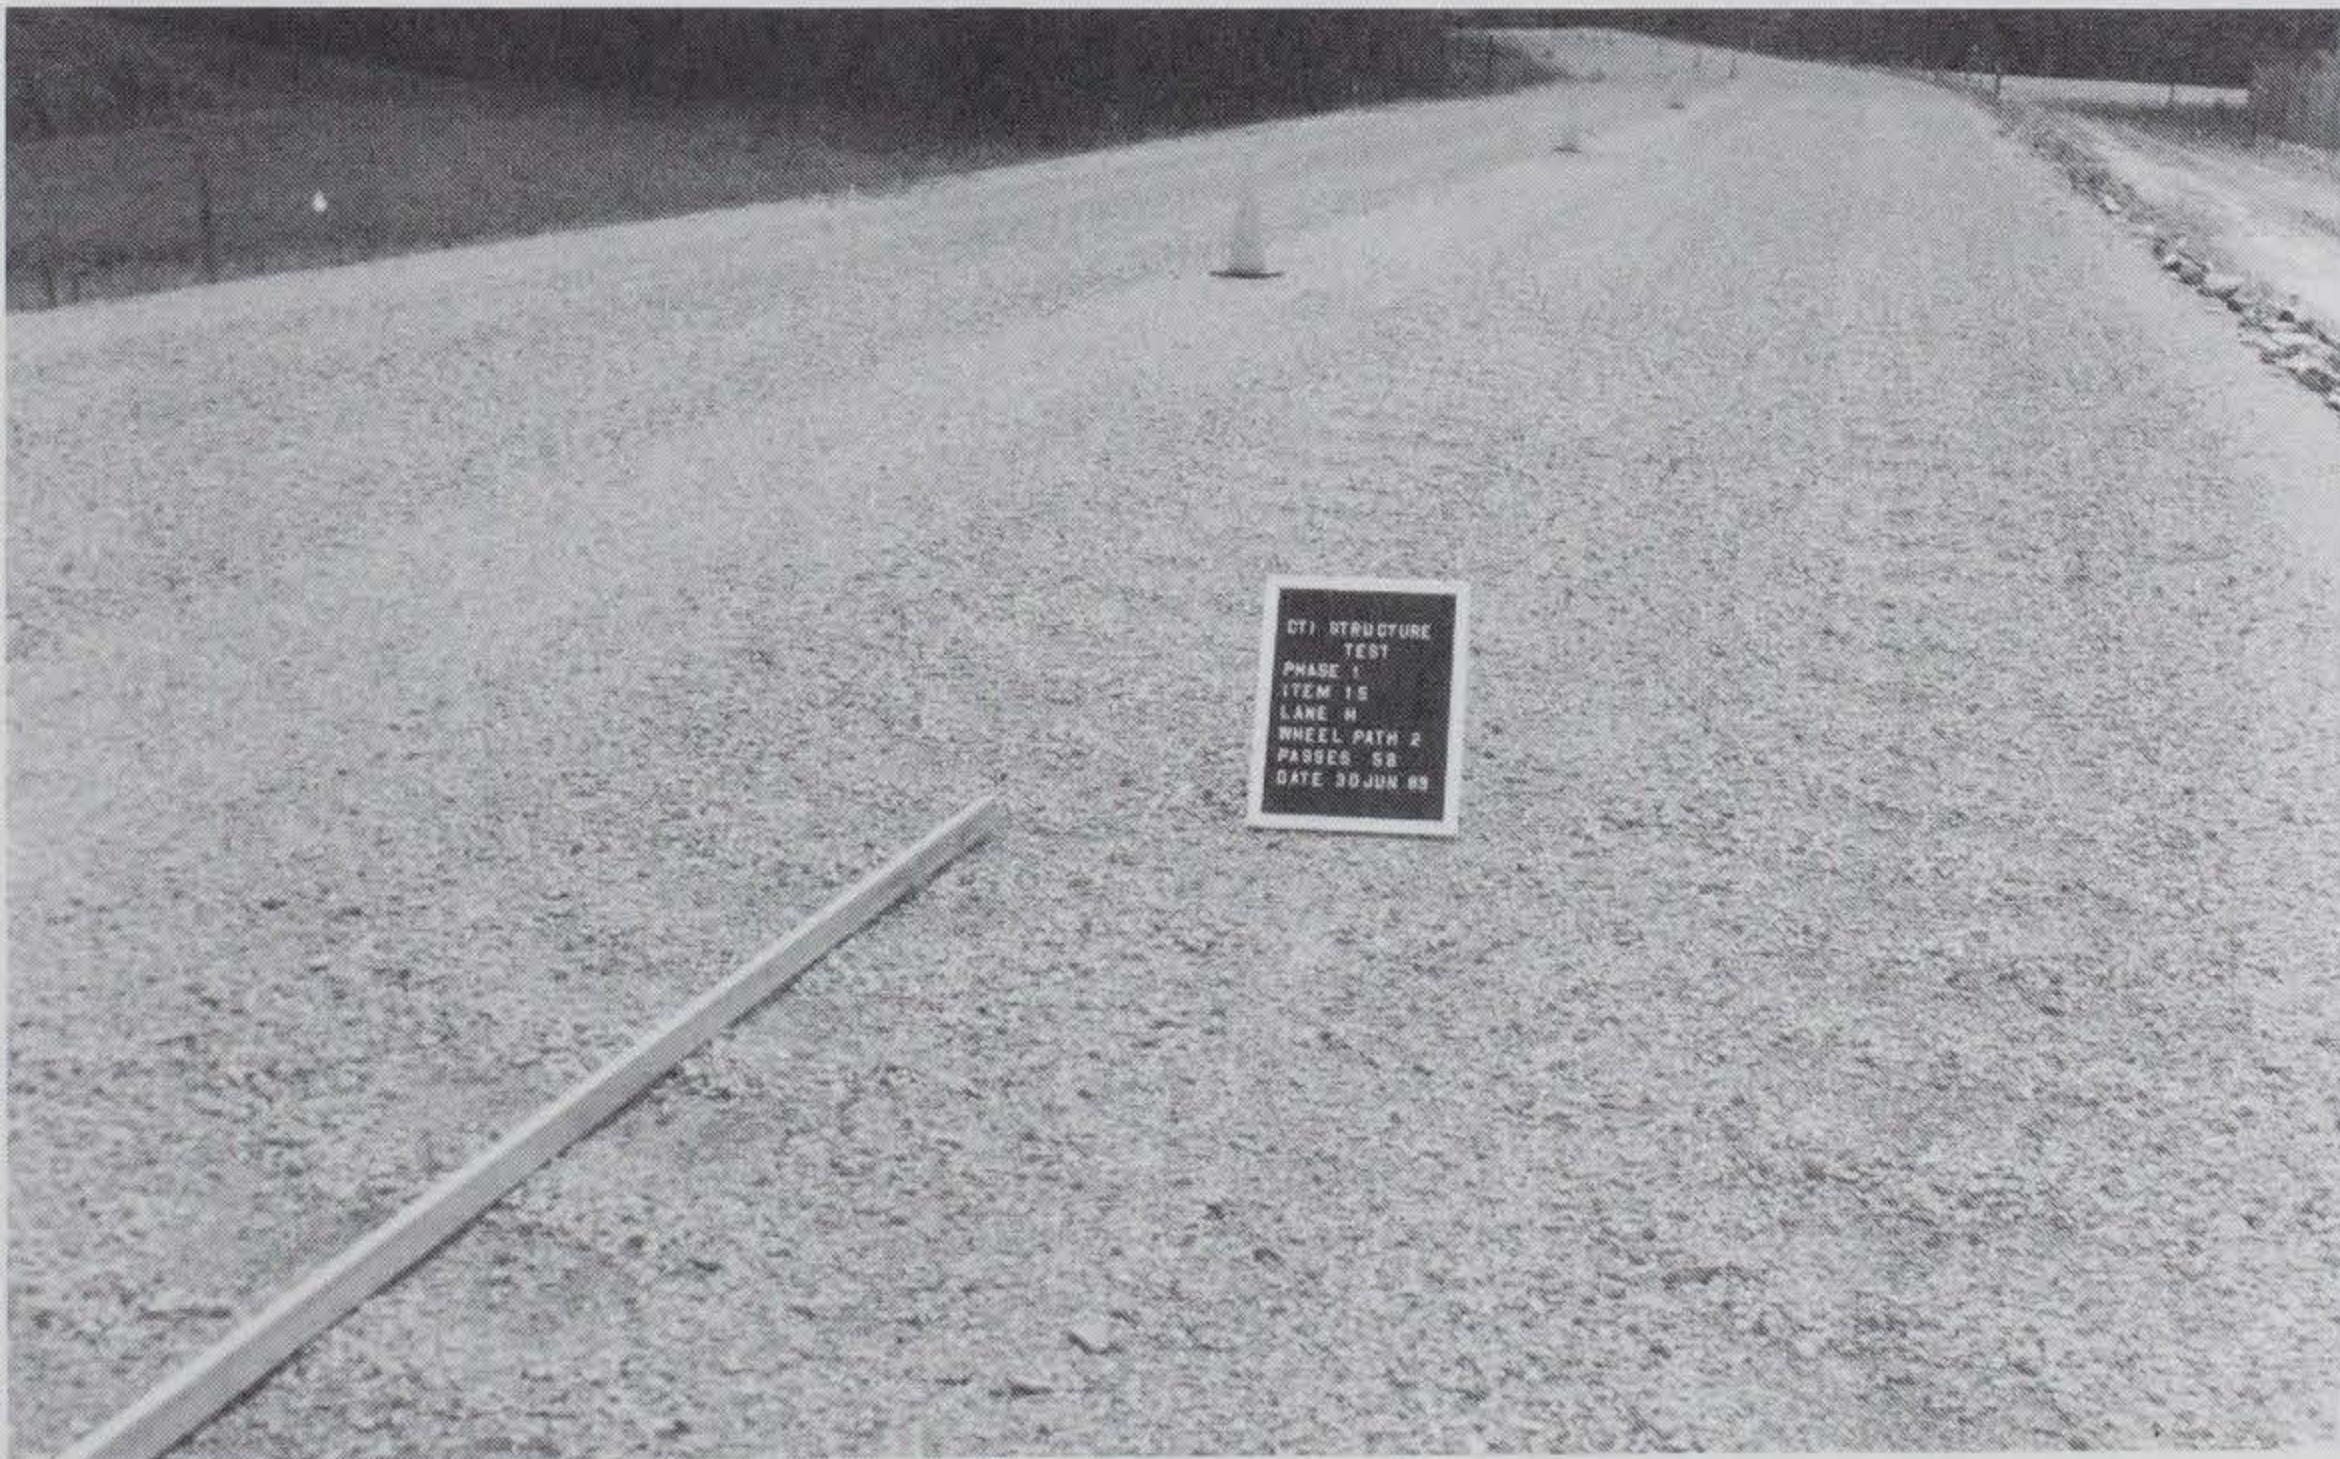
Figure 18. High-tire-pressure lane, section 15, low severity washboarding after 58 passes

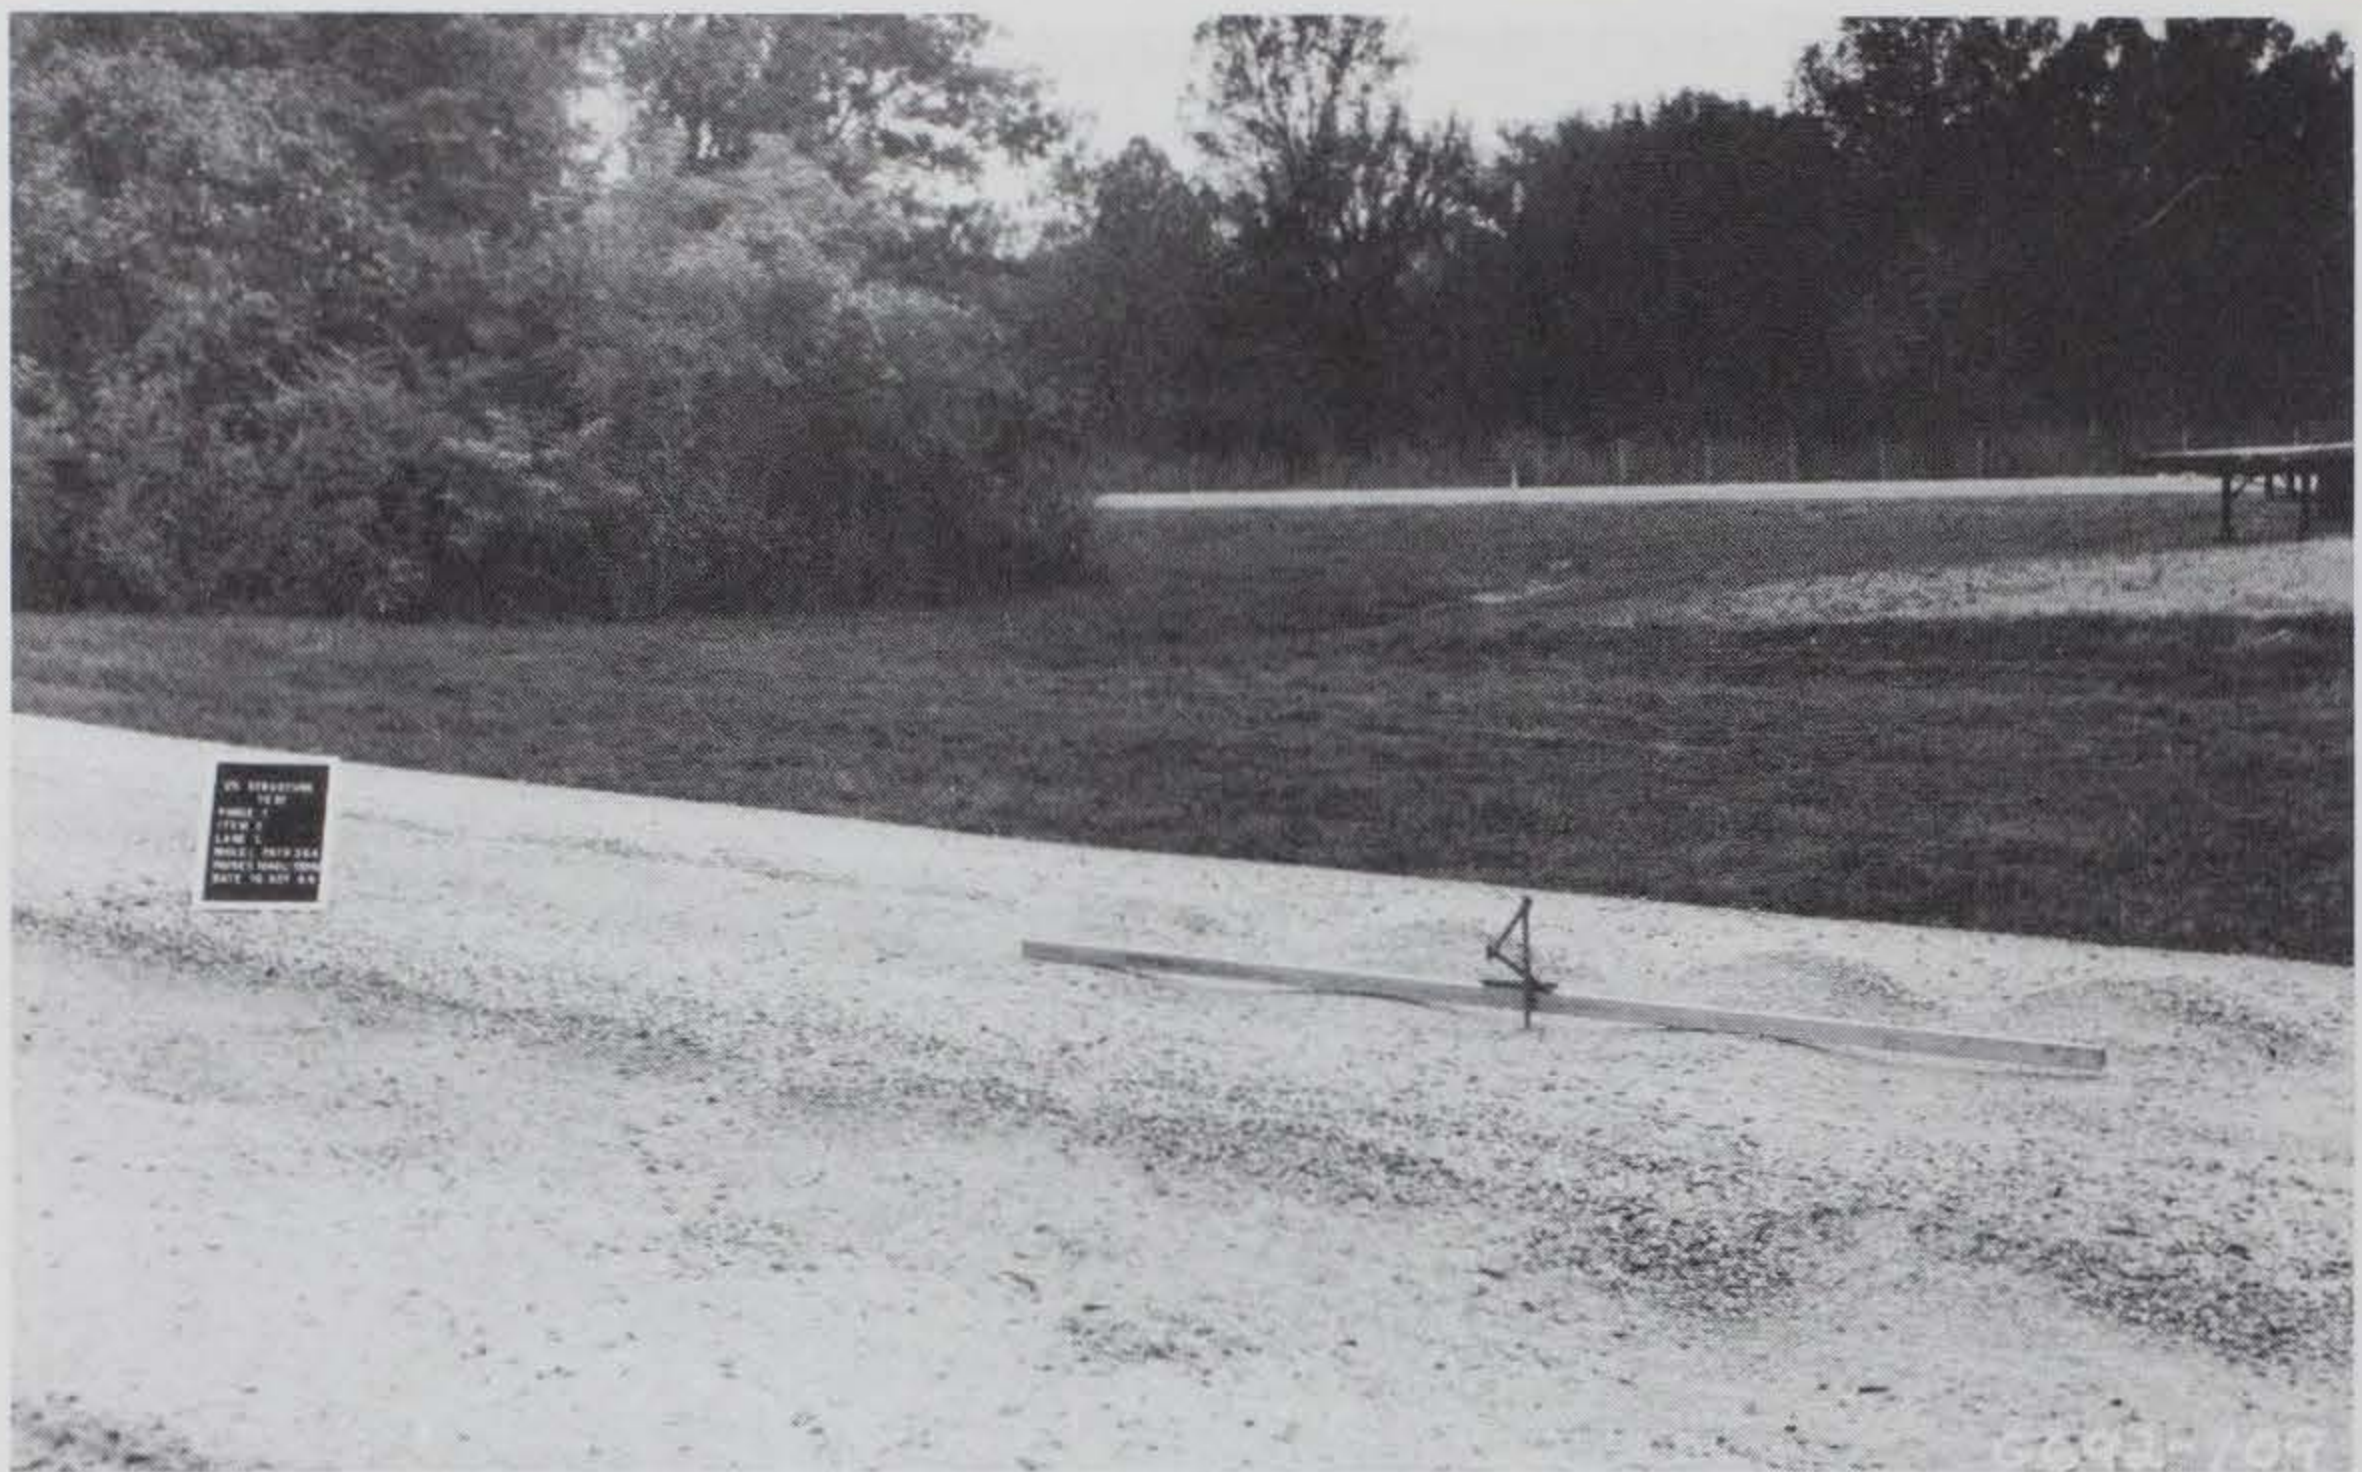
Figure 19. Low-tire-pressure lane, section 2, long intervals between corrugations

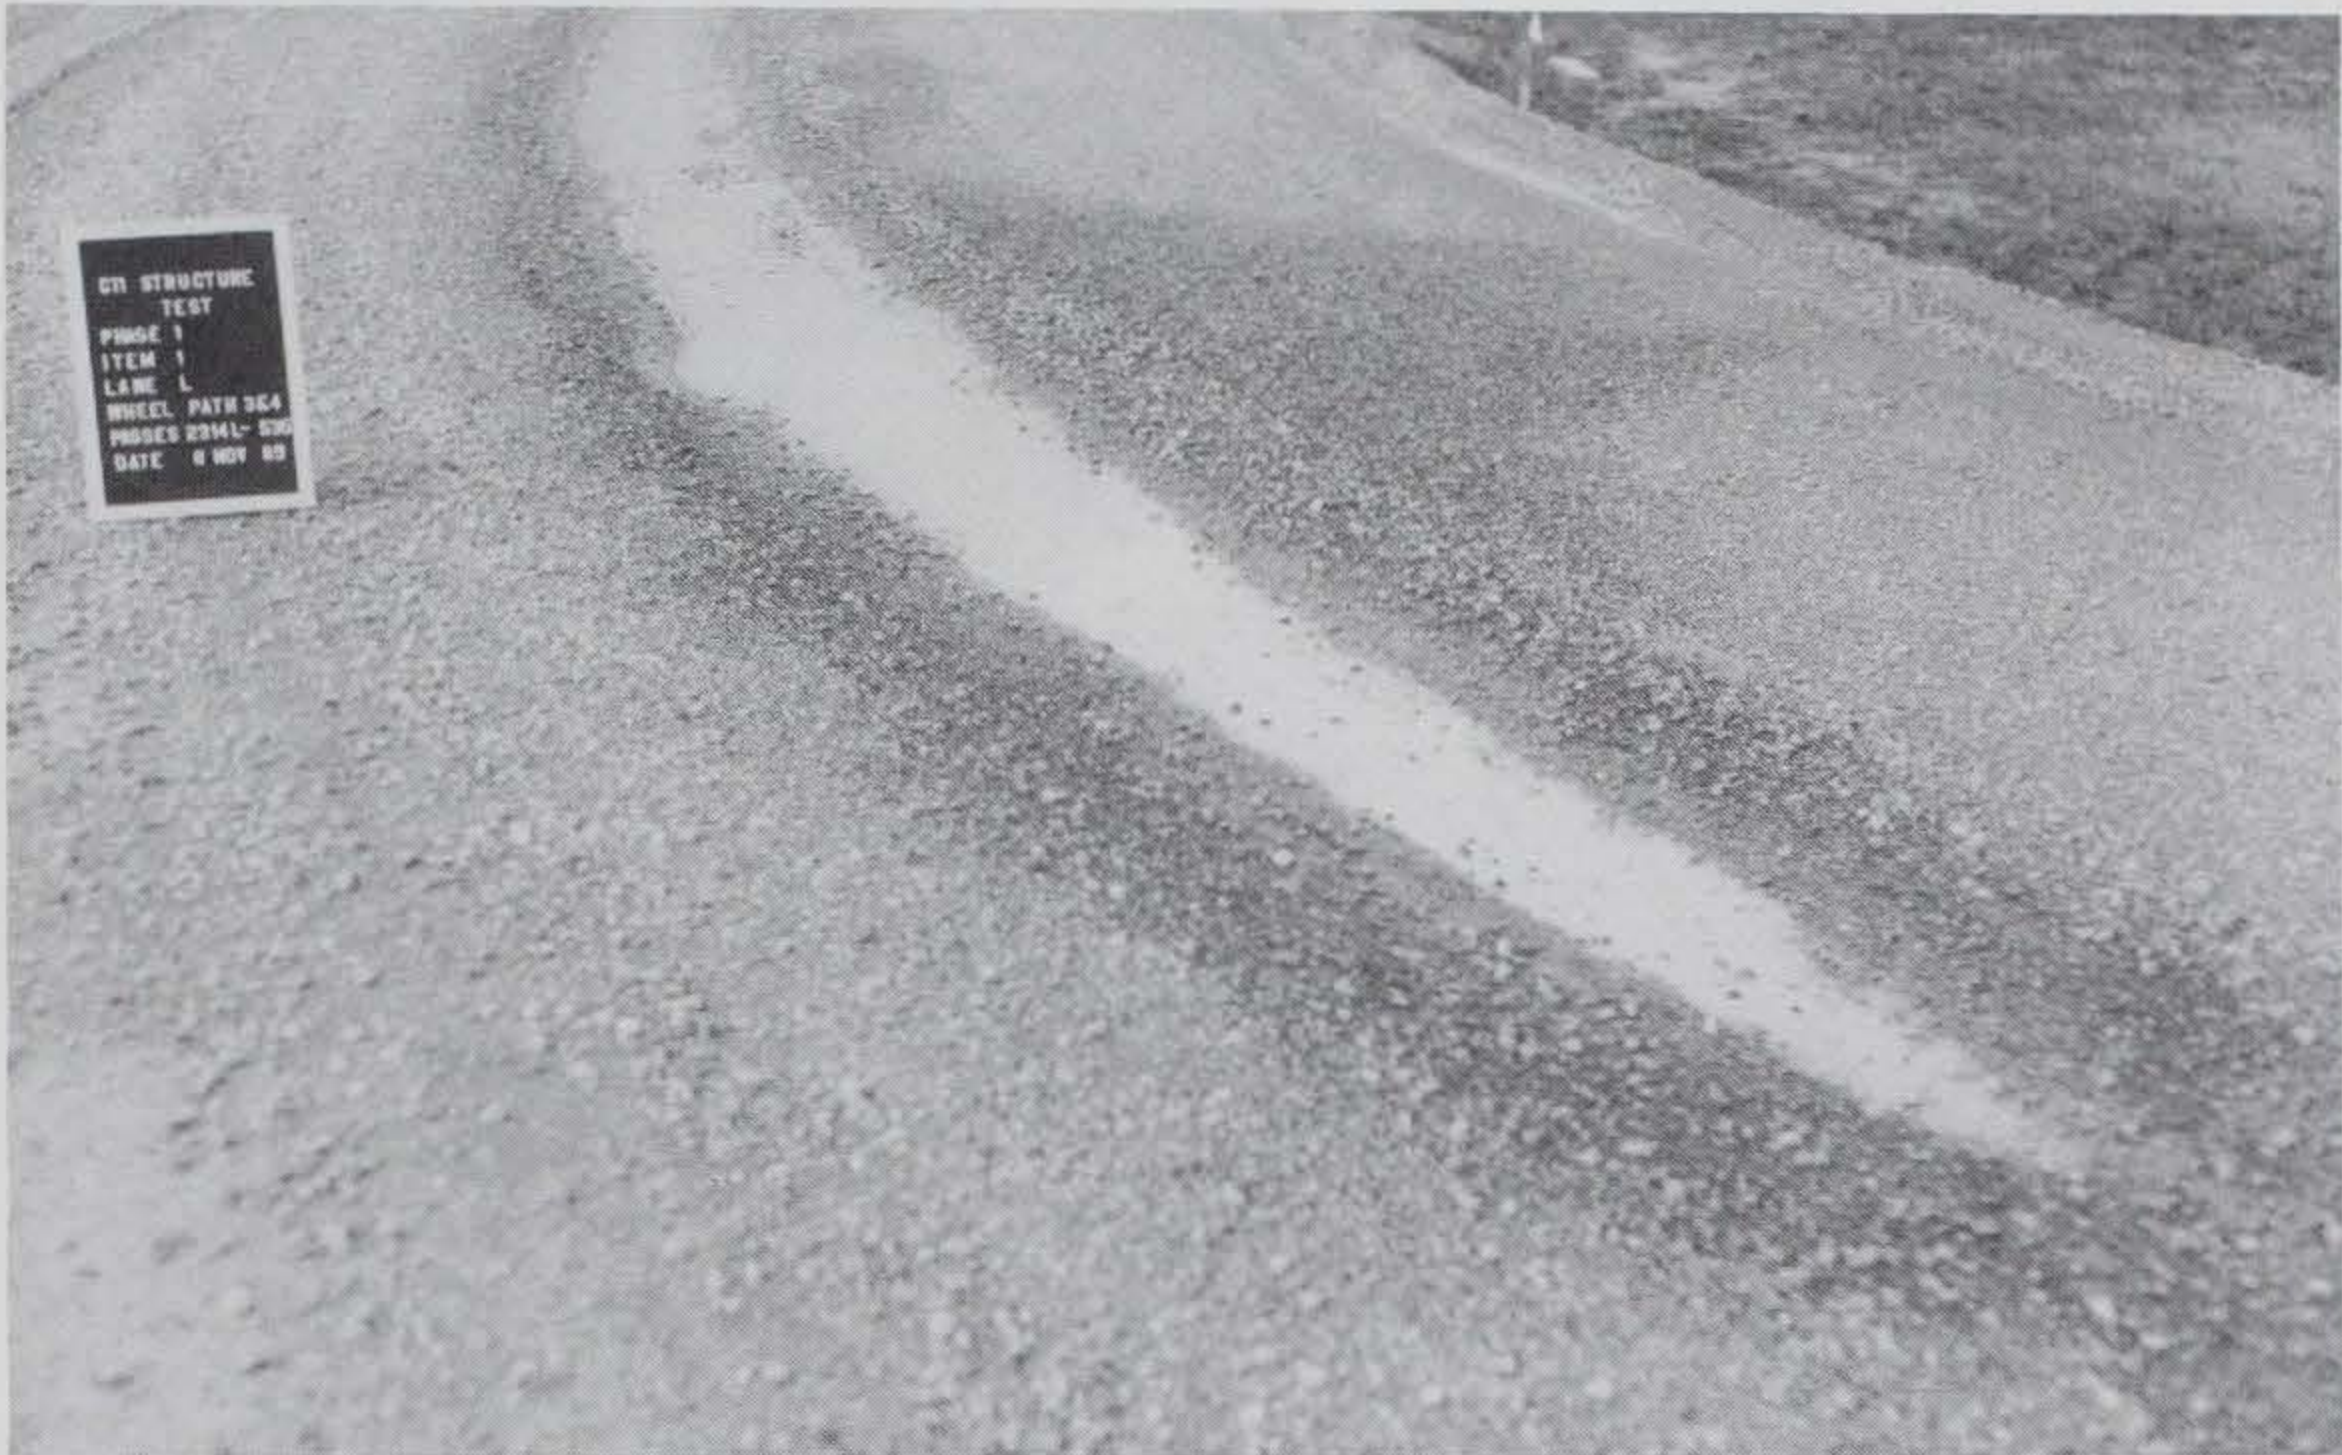
Figure 21. Low-tire-pressure lane, section 1, low-severity rutting

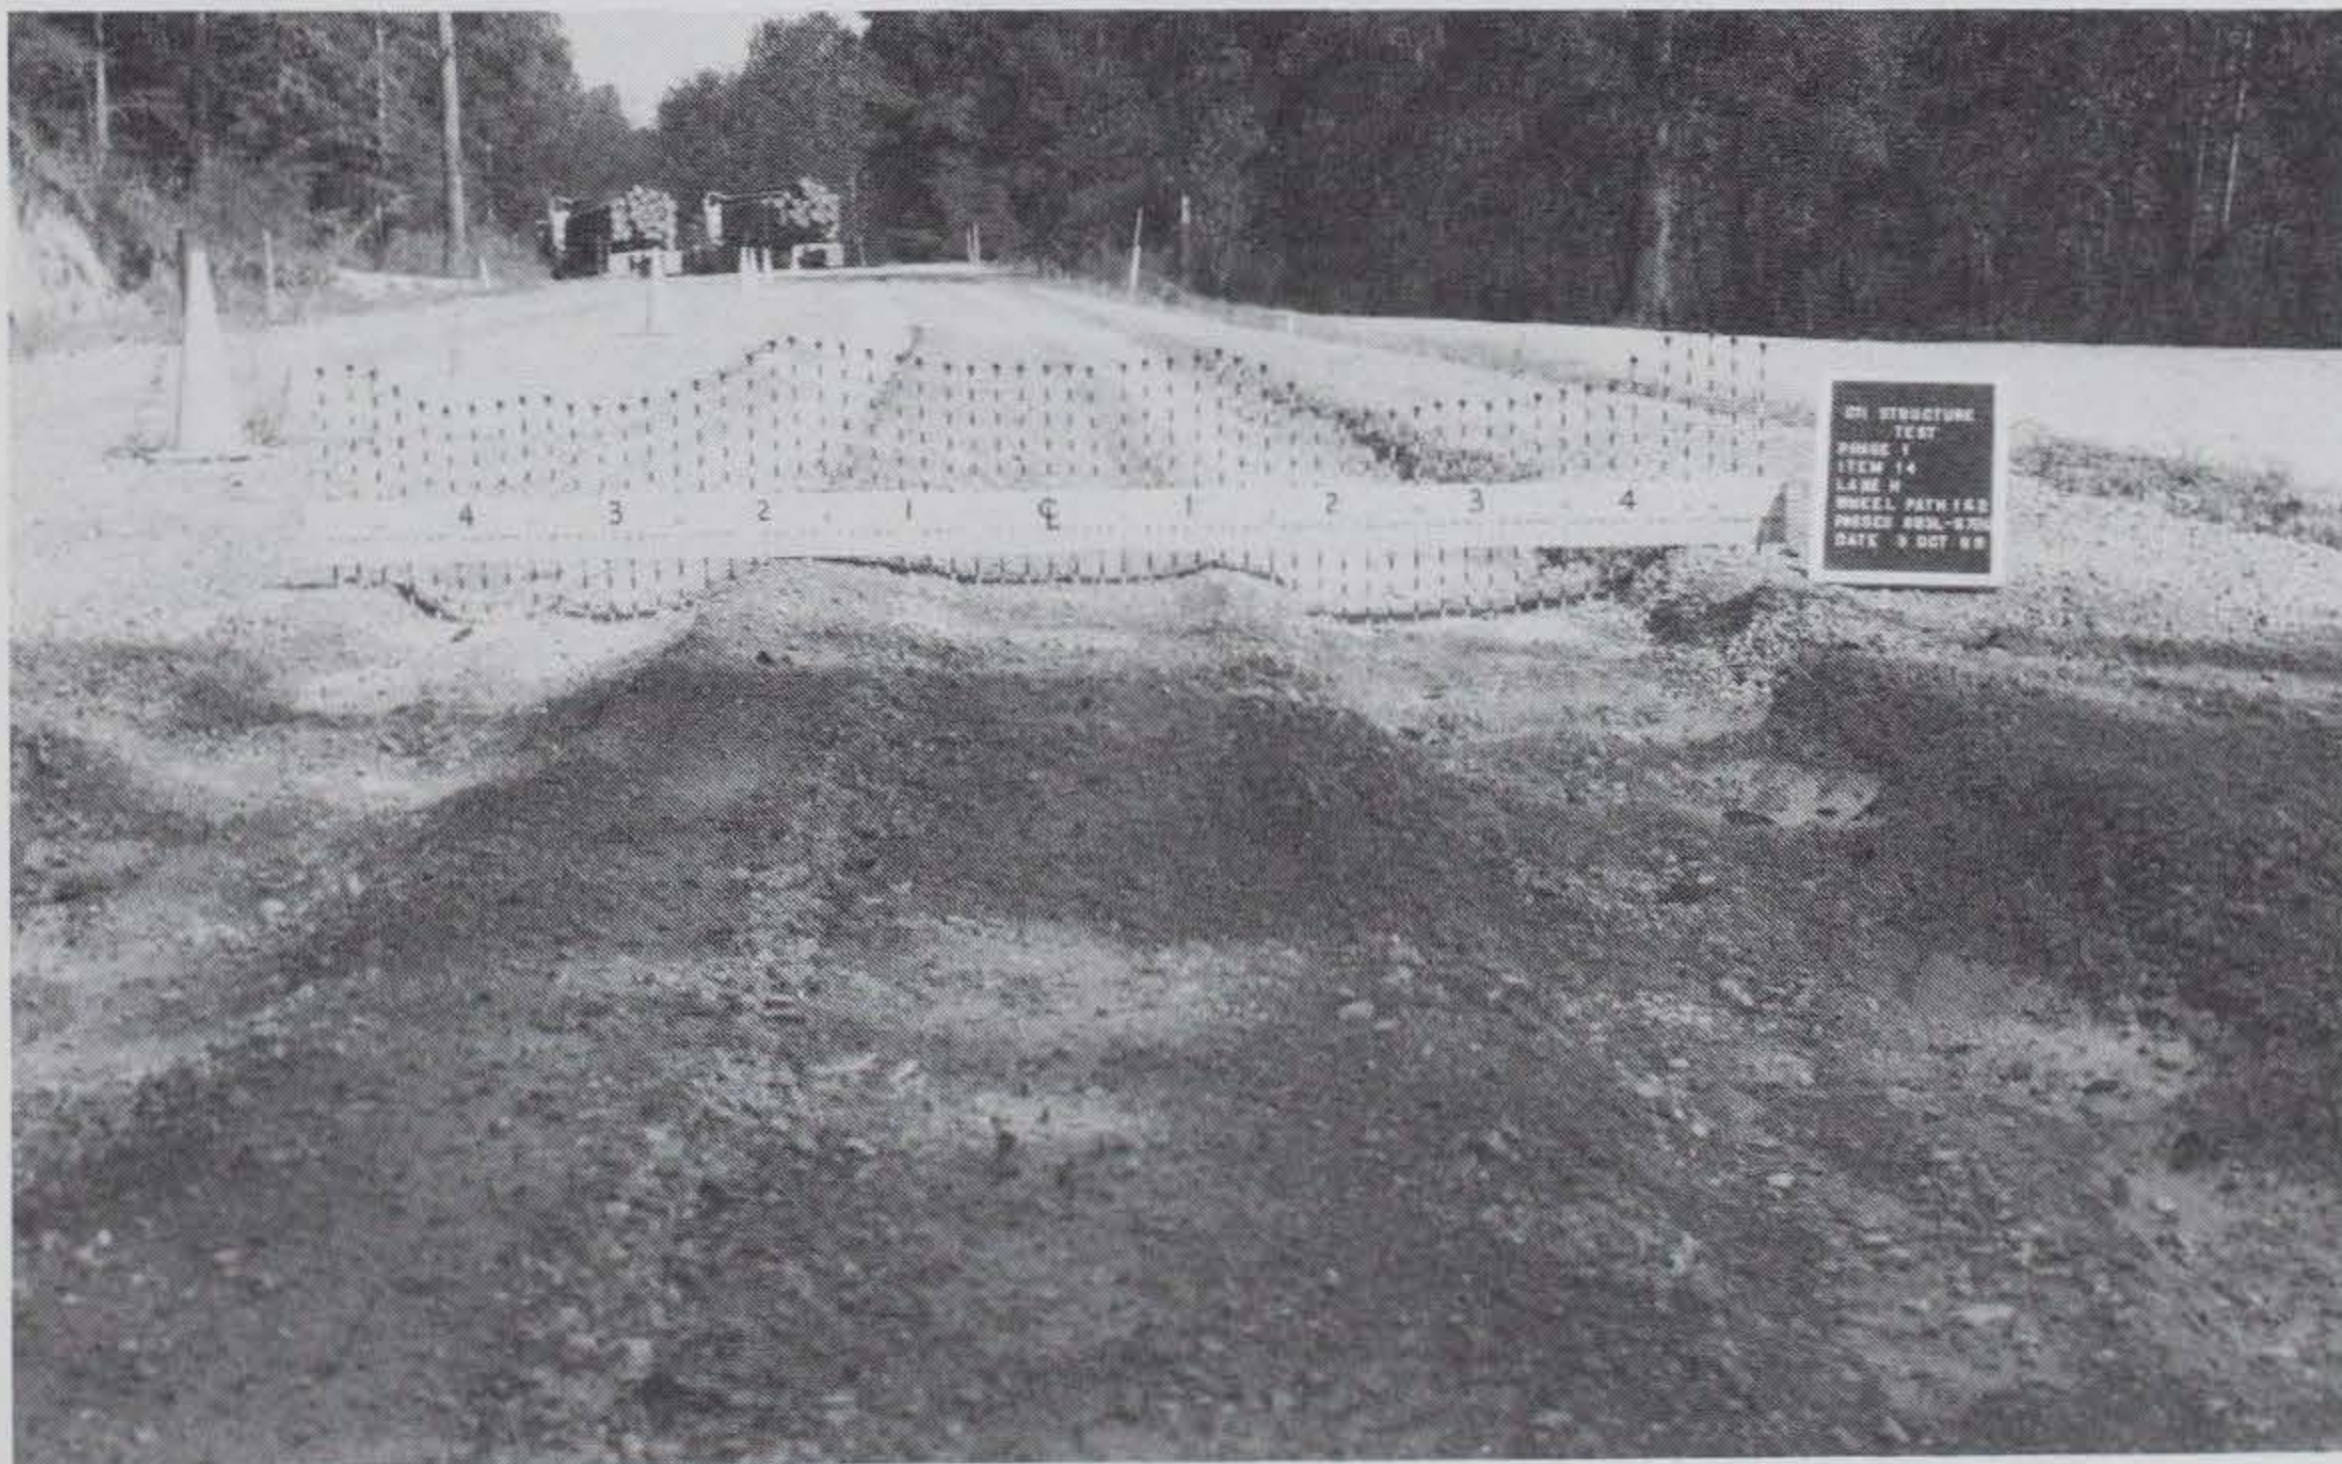
Figure 22. High-tire pressure lane, section 14, high-severity rutting after 90 passes in the rain
