MISCELLANEOUS PAPER GL-90-21

EFFECTS OF VARIABLE TIRE PRESSURE ON ROAD SURFACINGS

Robert W. Grau

September 1990

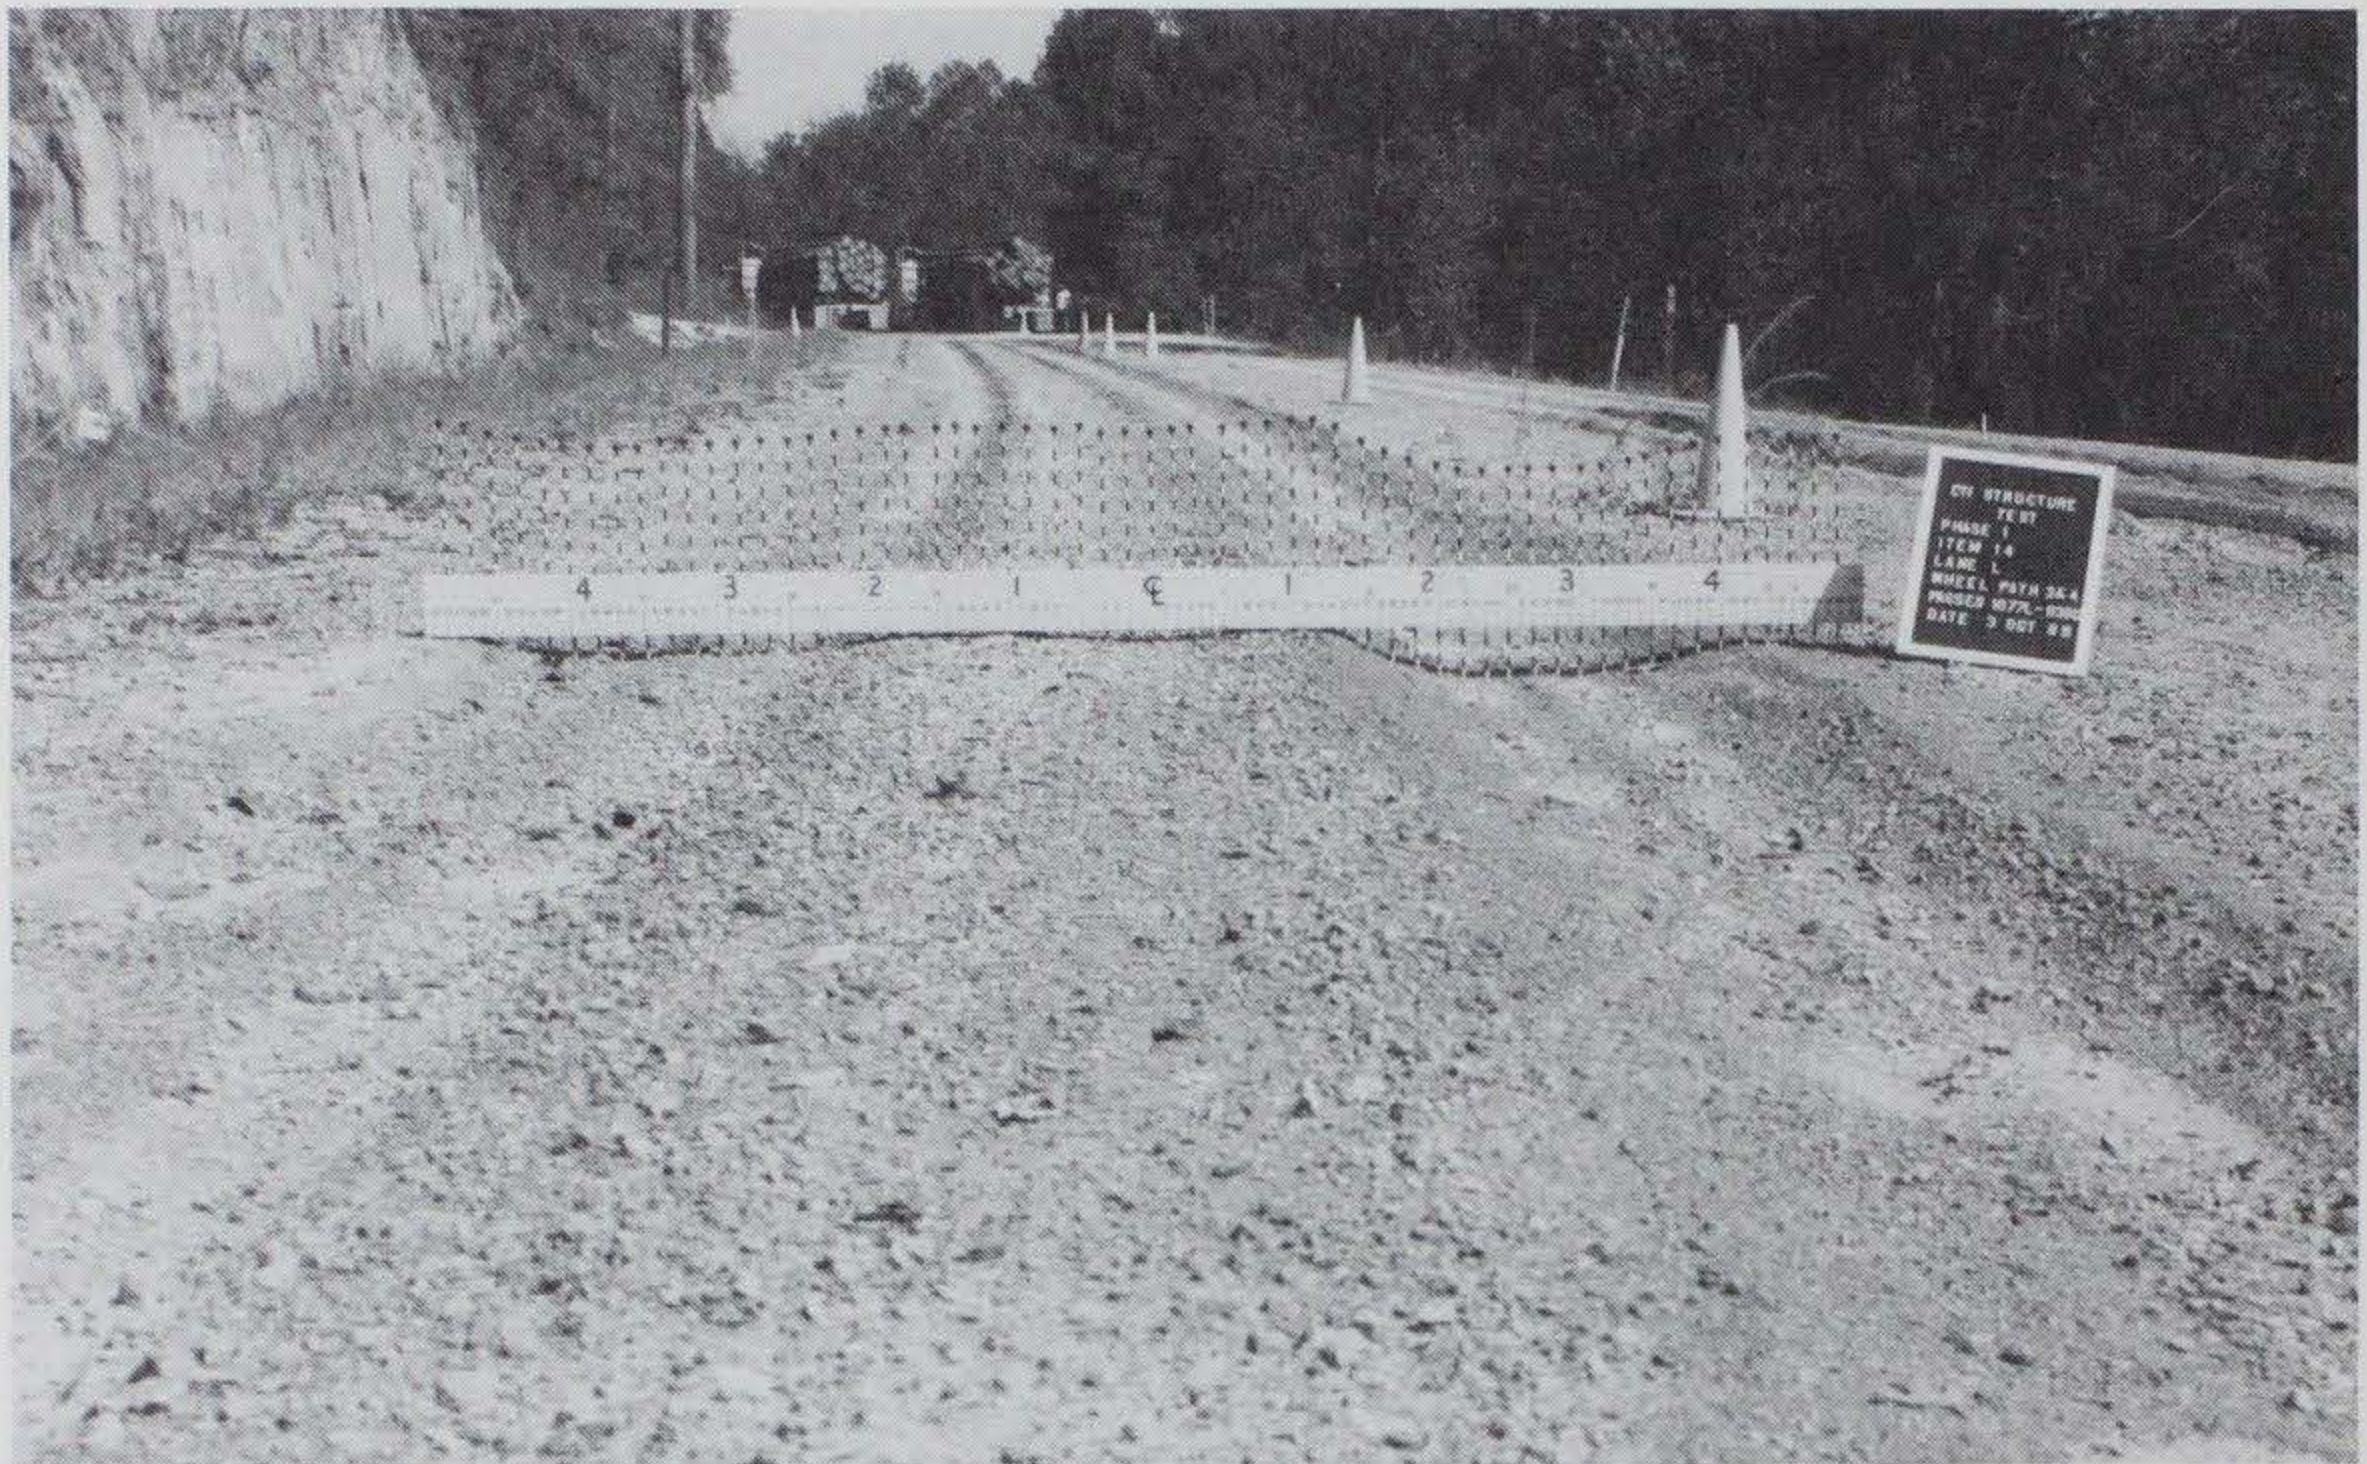
Figure 23. Low-tire-pressure lane, section 14, high-severity rutting after 90 passes in the rain

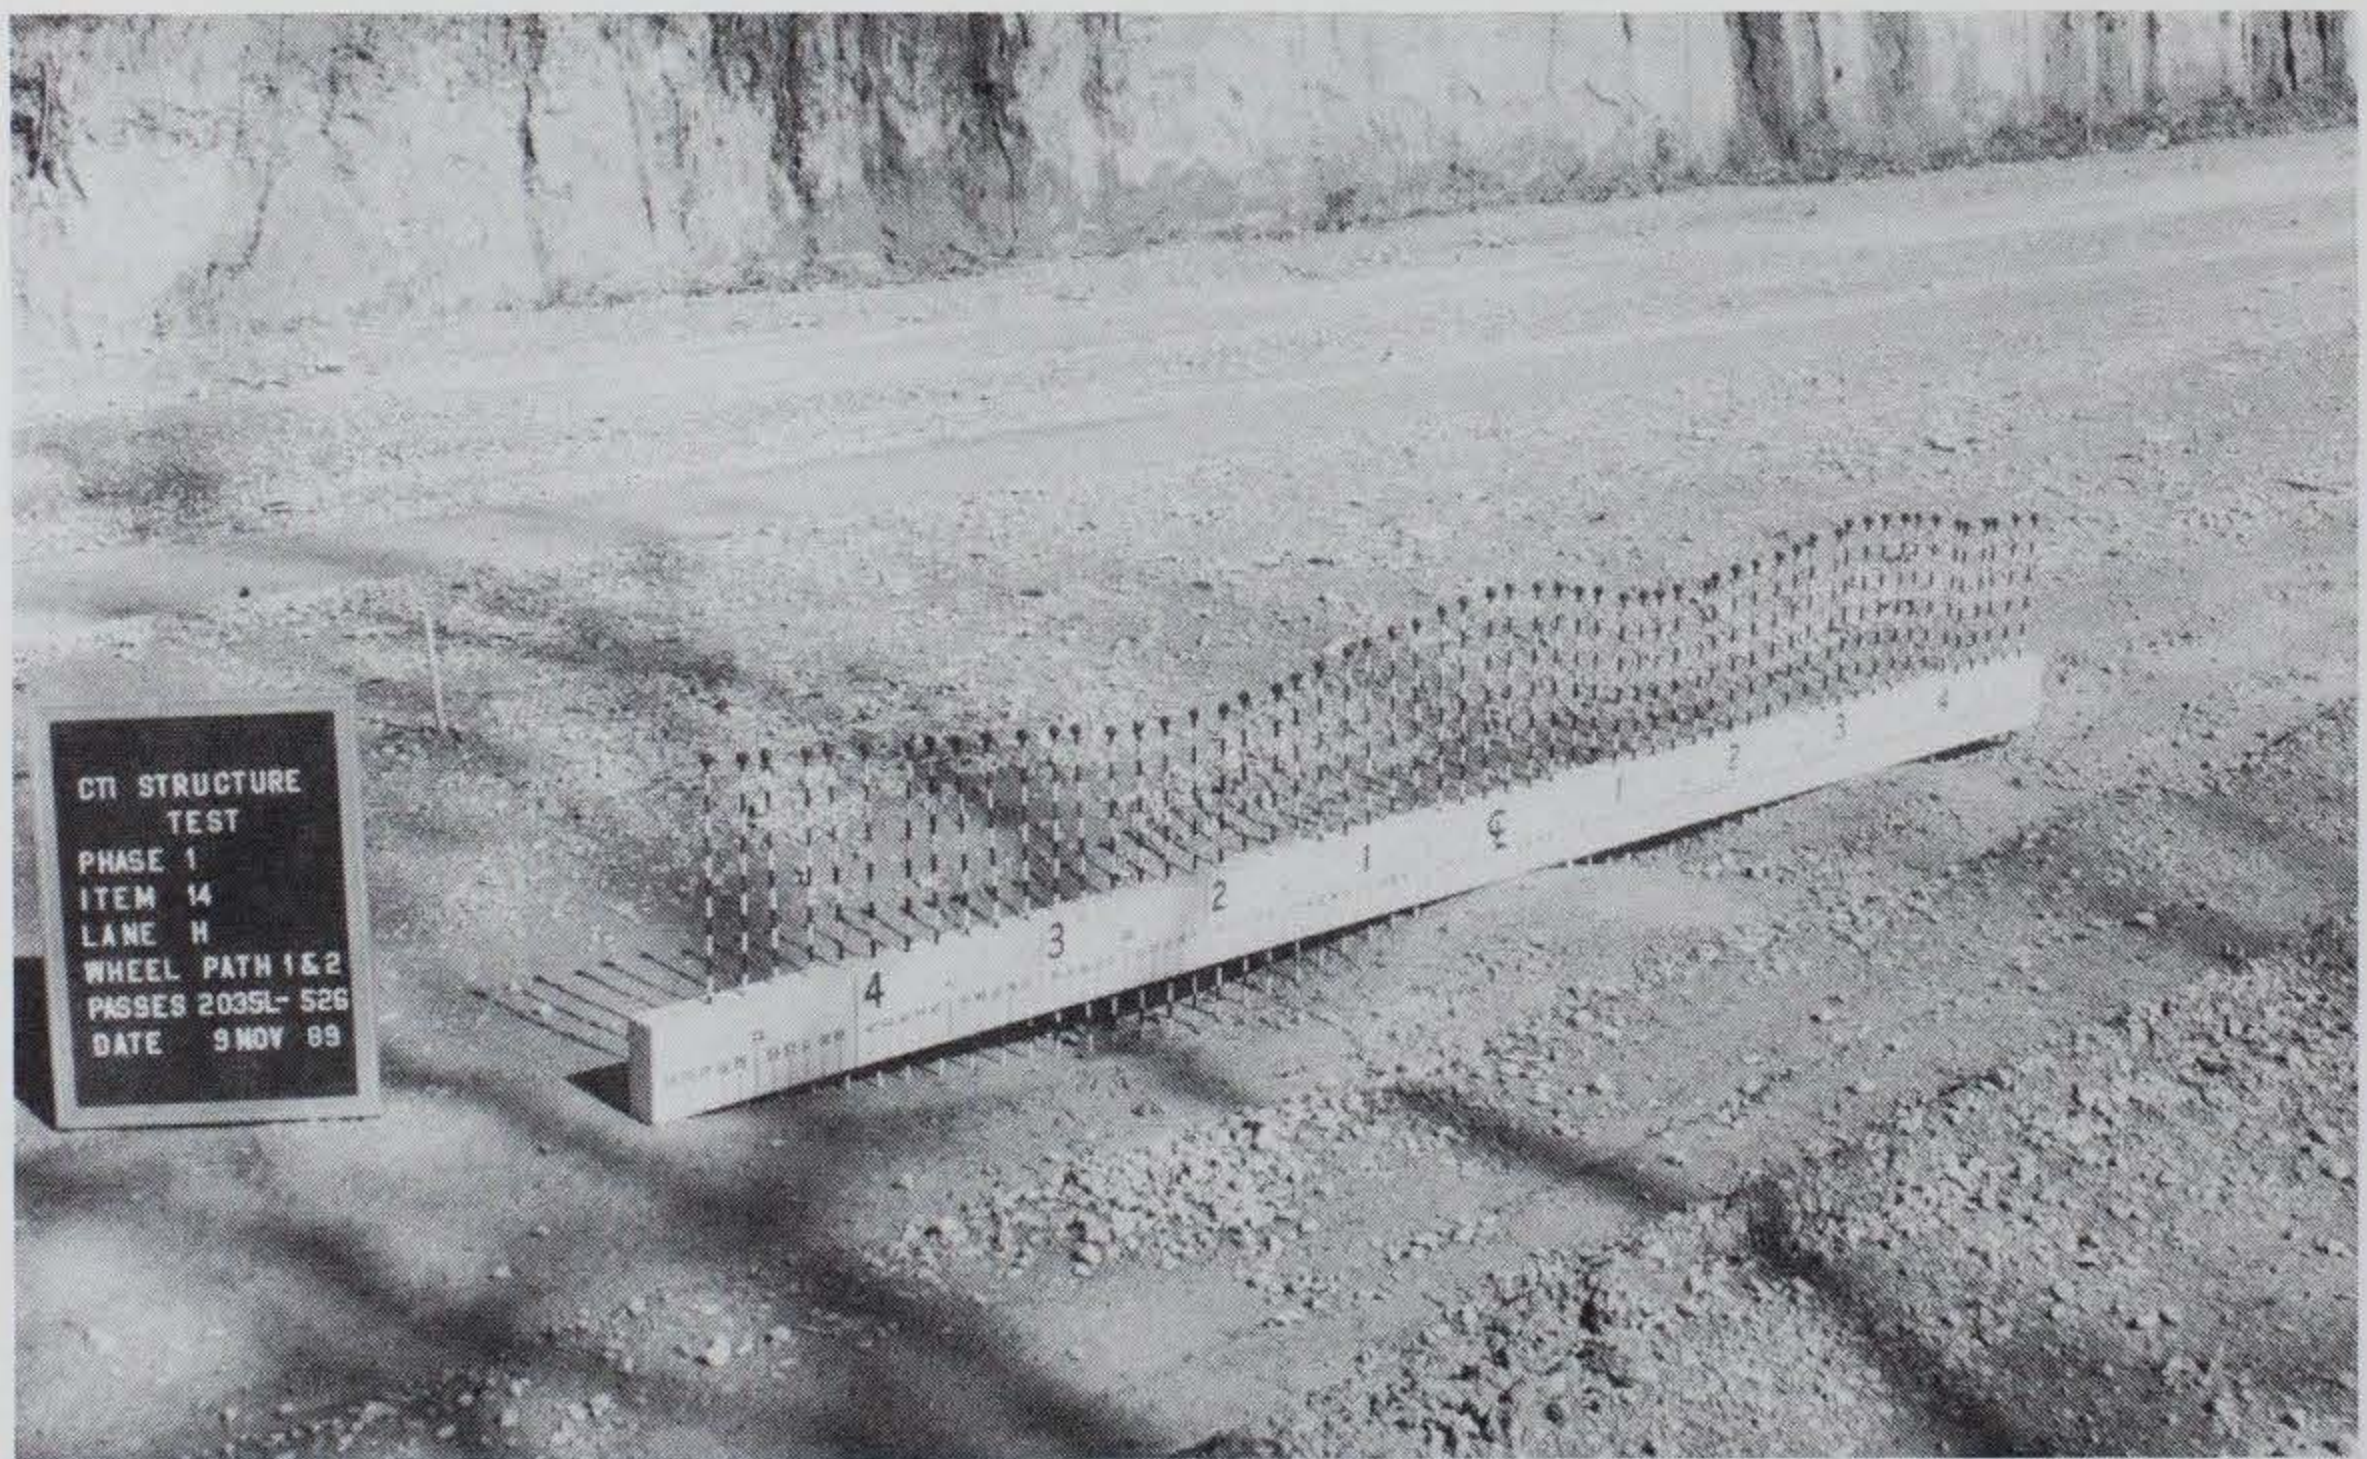
Figure 24. High-tire-pressure lane, section 14, high-severity washboarding

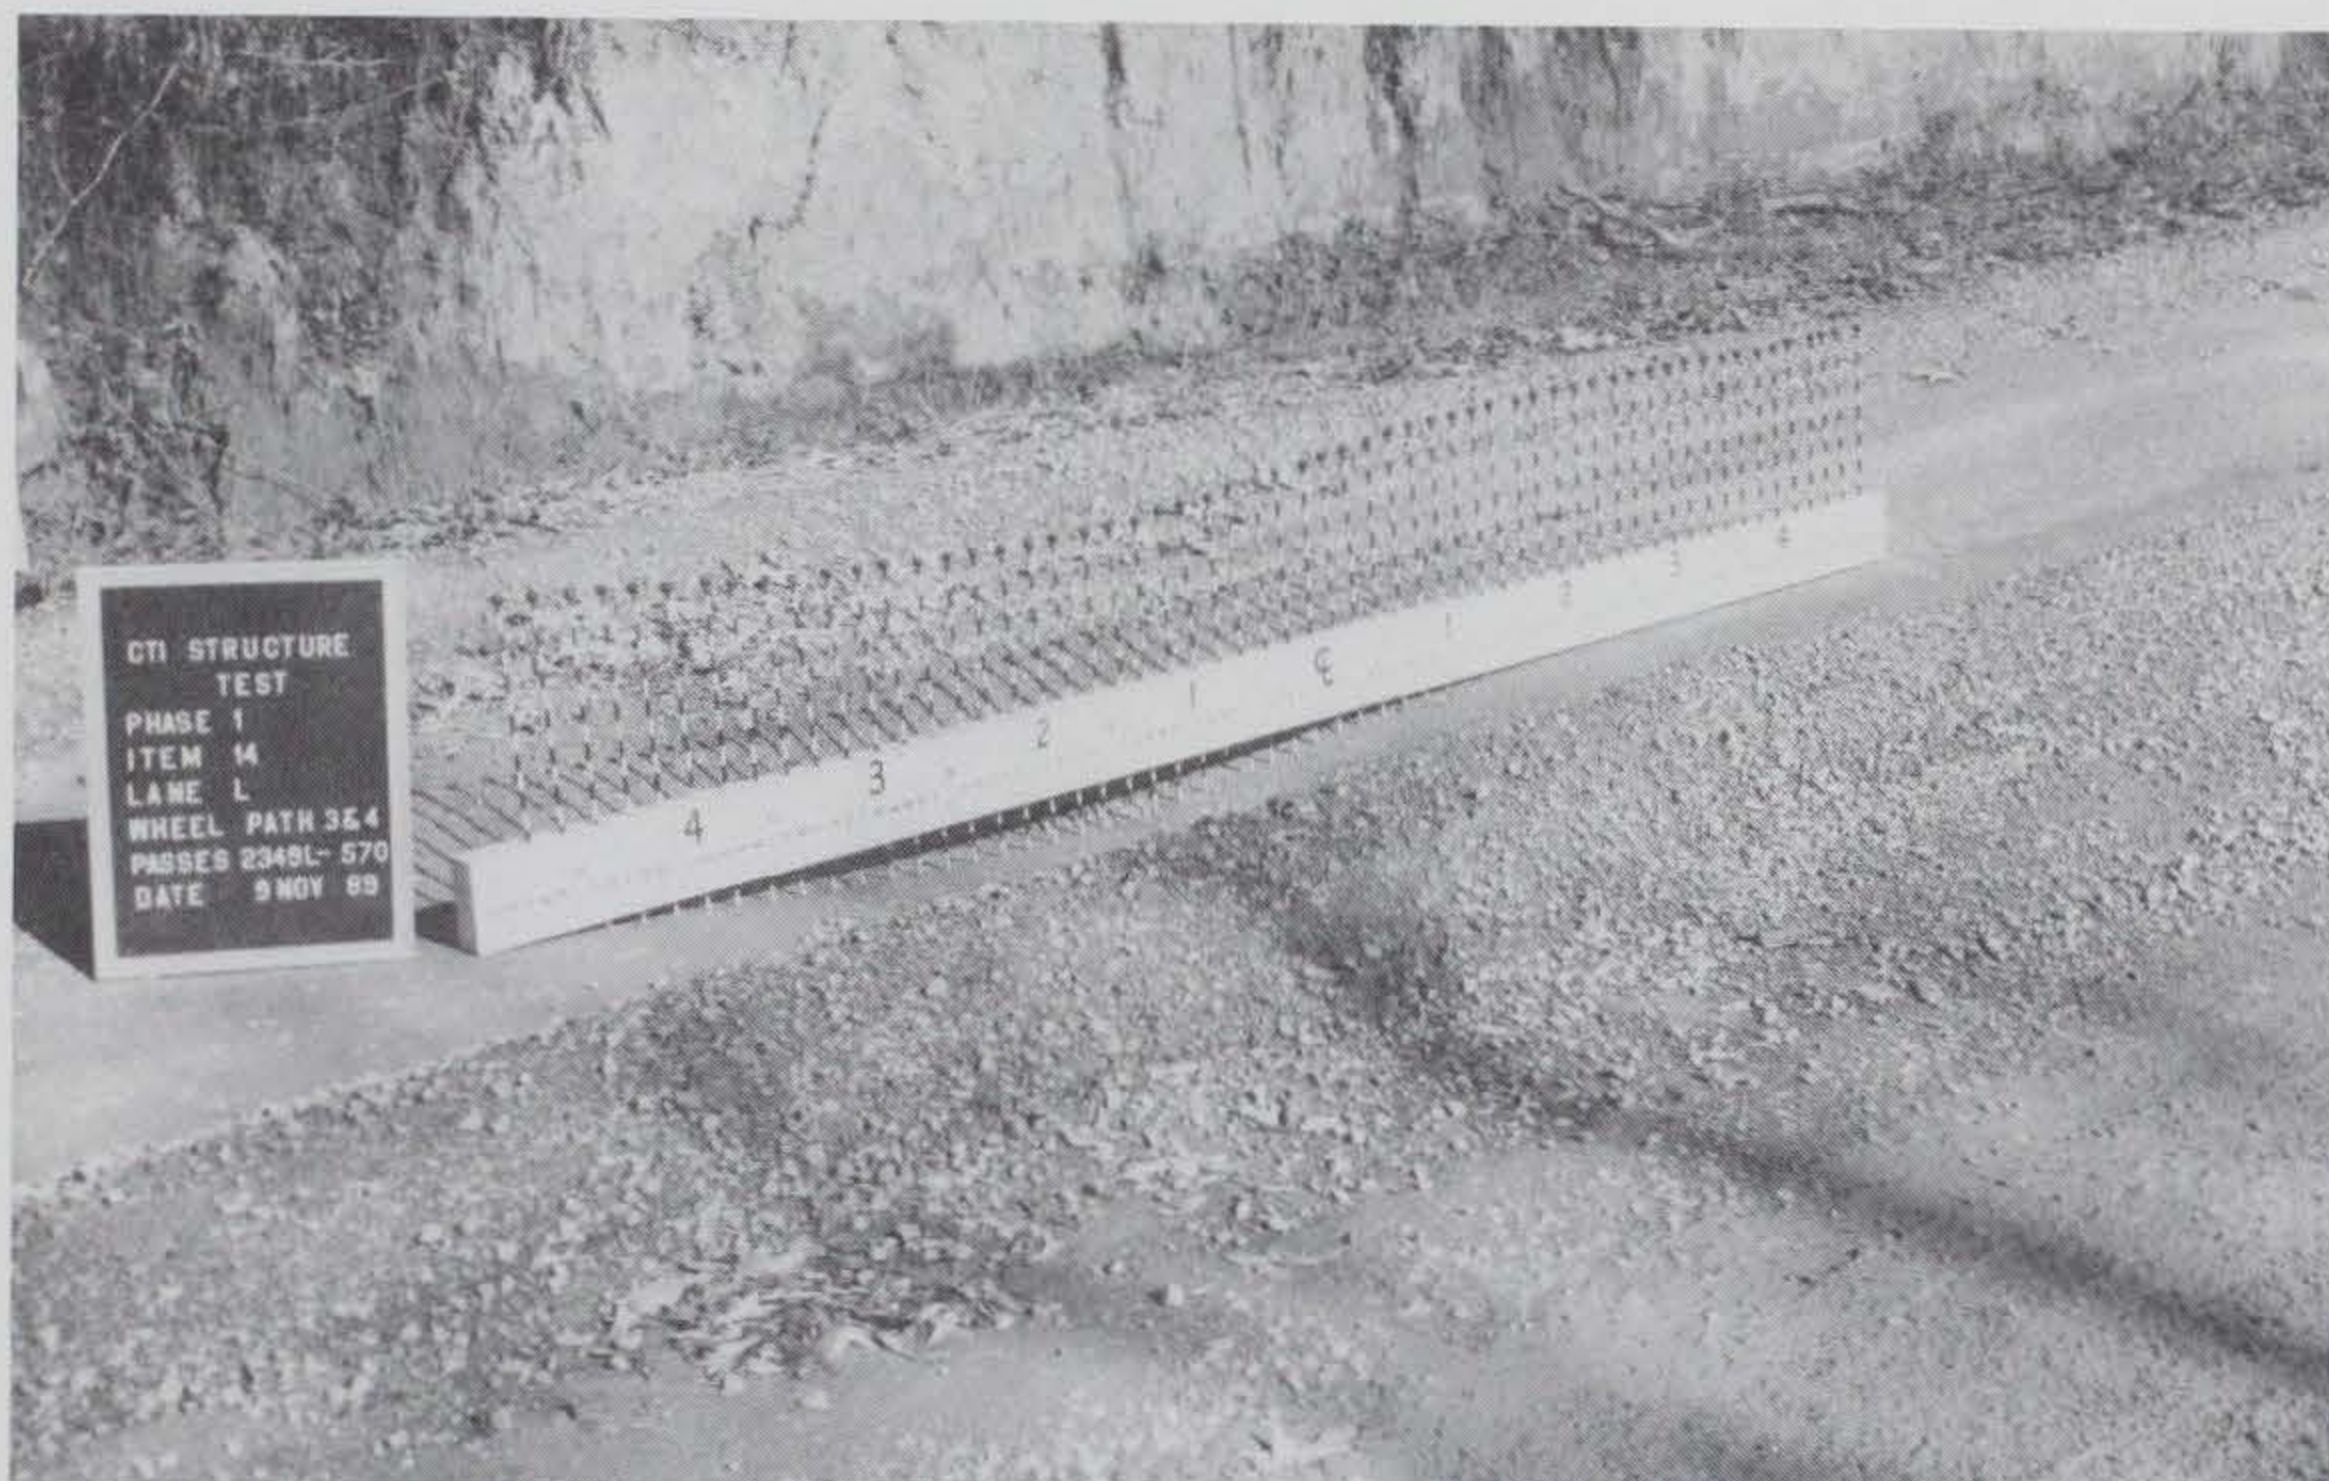
rainfall and weaken the pavement structure at a controlled rate. As water was applied, drop cone penetrometer measurements were taken in order to monitor the aggregate and subgrade strengths. As traffic was applied, failure was reached once it enter into the high-tire-pressure lane of section 14 and three times in section 15 due to rutting and severe washboarding. No failures were recorded in the low-tire-pressure lane. Figure 24 shows the high-severity washboarding in the high-tire-pressure lane of section 14 at failure. For comparison purposes, a view of the maximum distress in the low-tire-pressure lane of section 14 at the same time the high-tire-pressure lane was rated failed is shown in Figure 25.

Figure 25. Low-tire-pressure lane, section 14,
low-severity depression
