MISCELLANEOUS PAPER GL-86-5

# FIELD EVALUATION OF THE WATER WEDGE FOR CUTTING PORTLAND CEMENT CONCRETE PAVEMENTS FOR REPAIR AND RESTORATION OF PAVED SURFACES (REREPS)

January 1986

Final Report

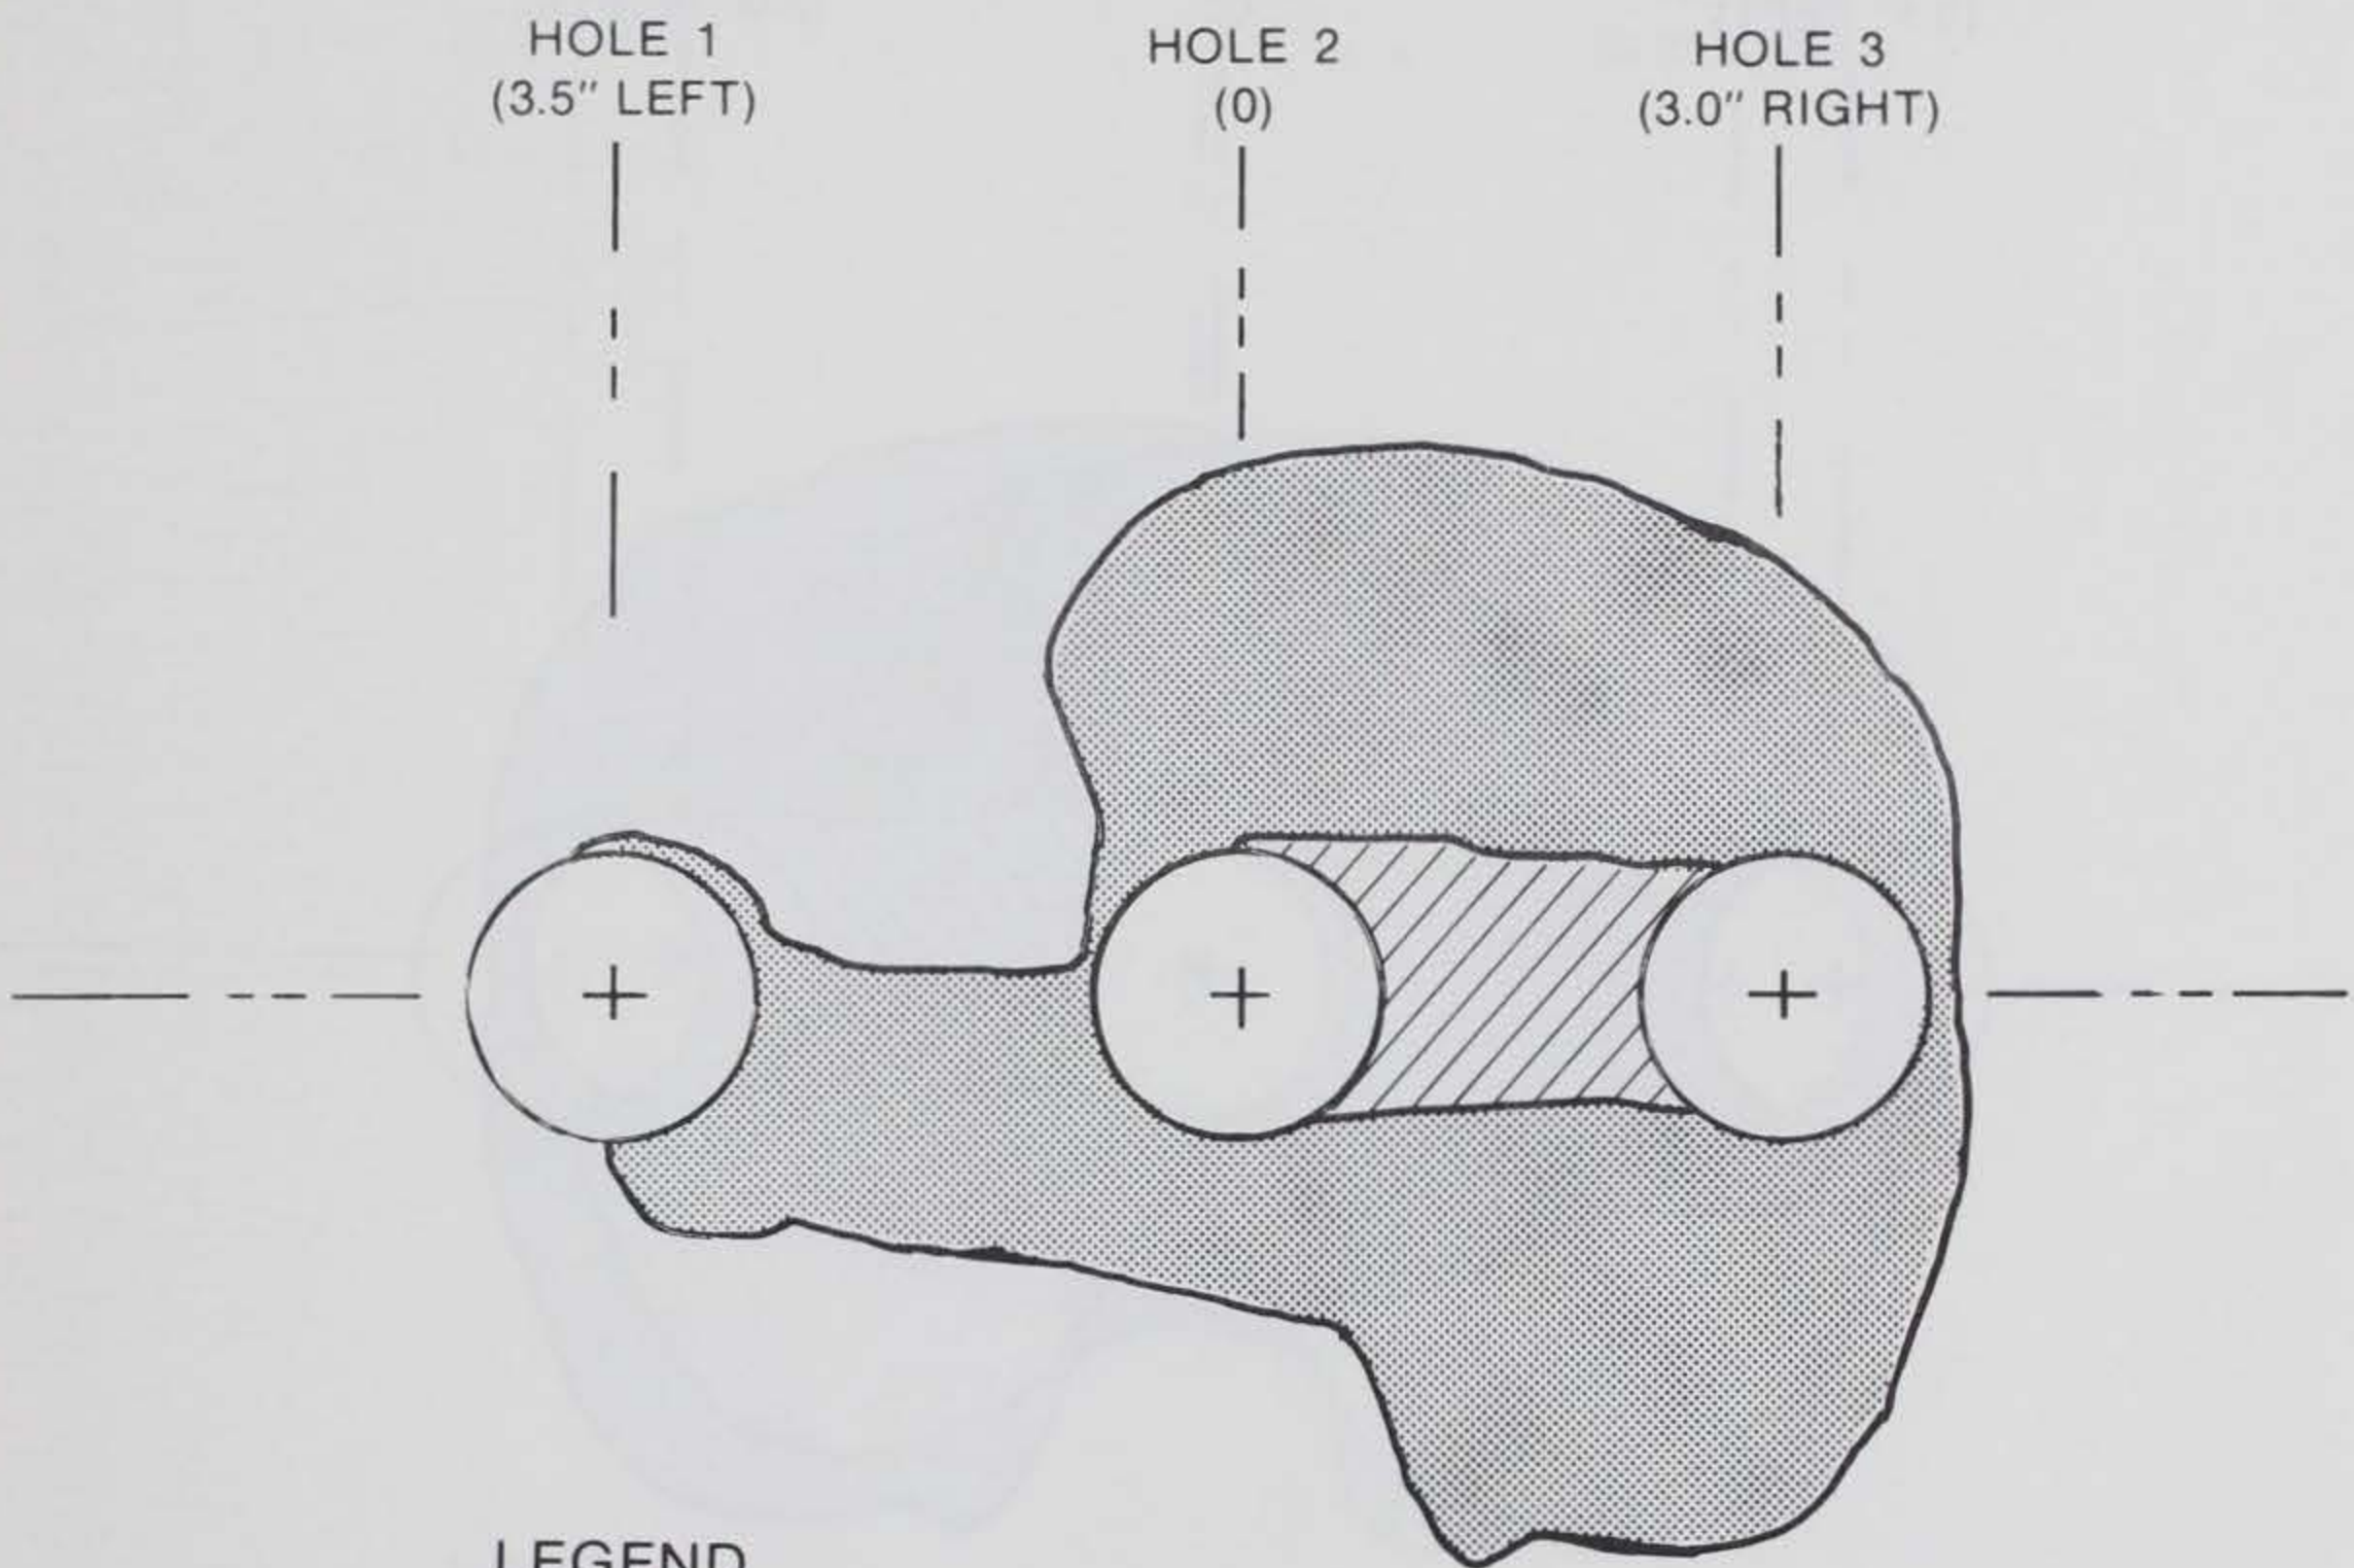
Figure 1. Spall depths after test 1A, shot 1

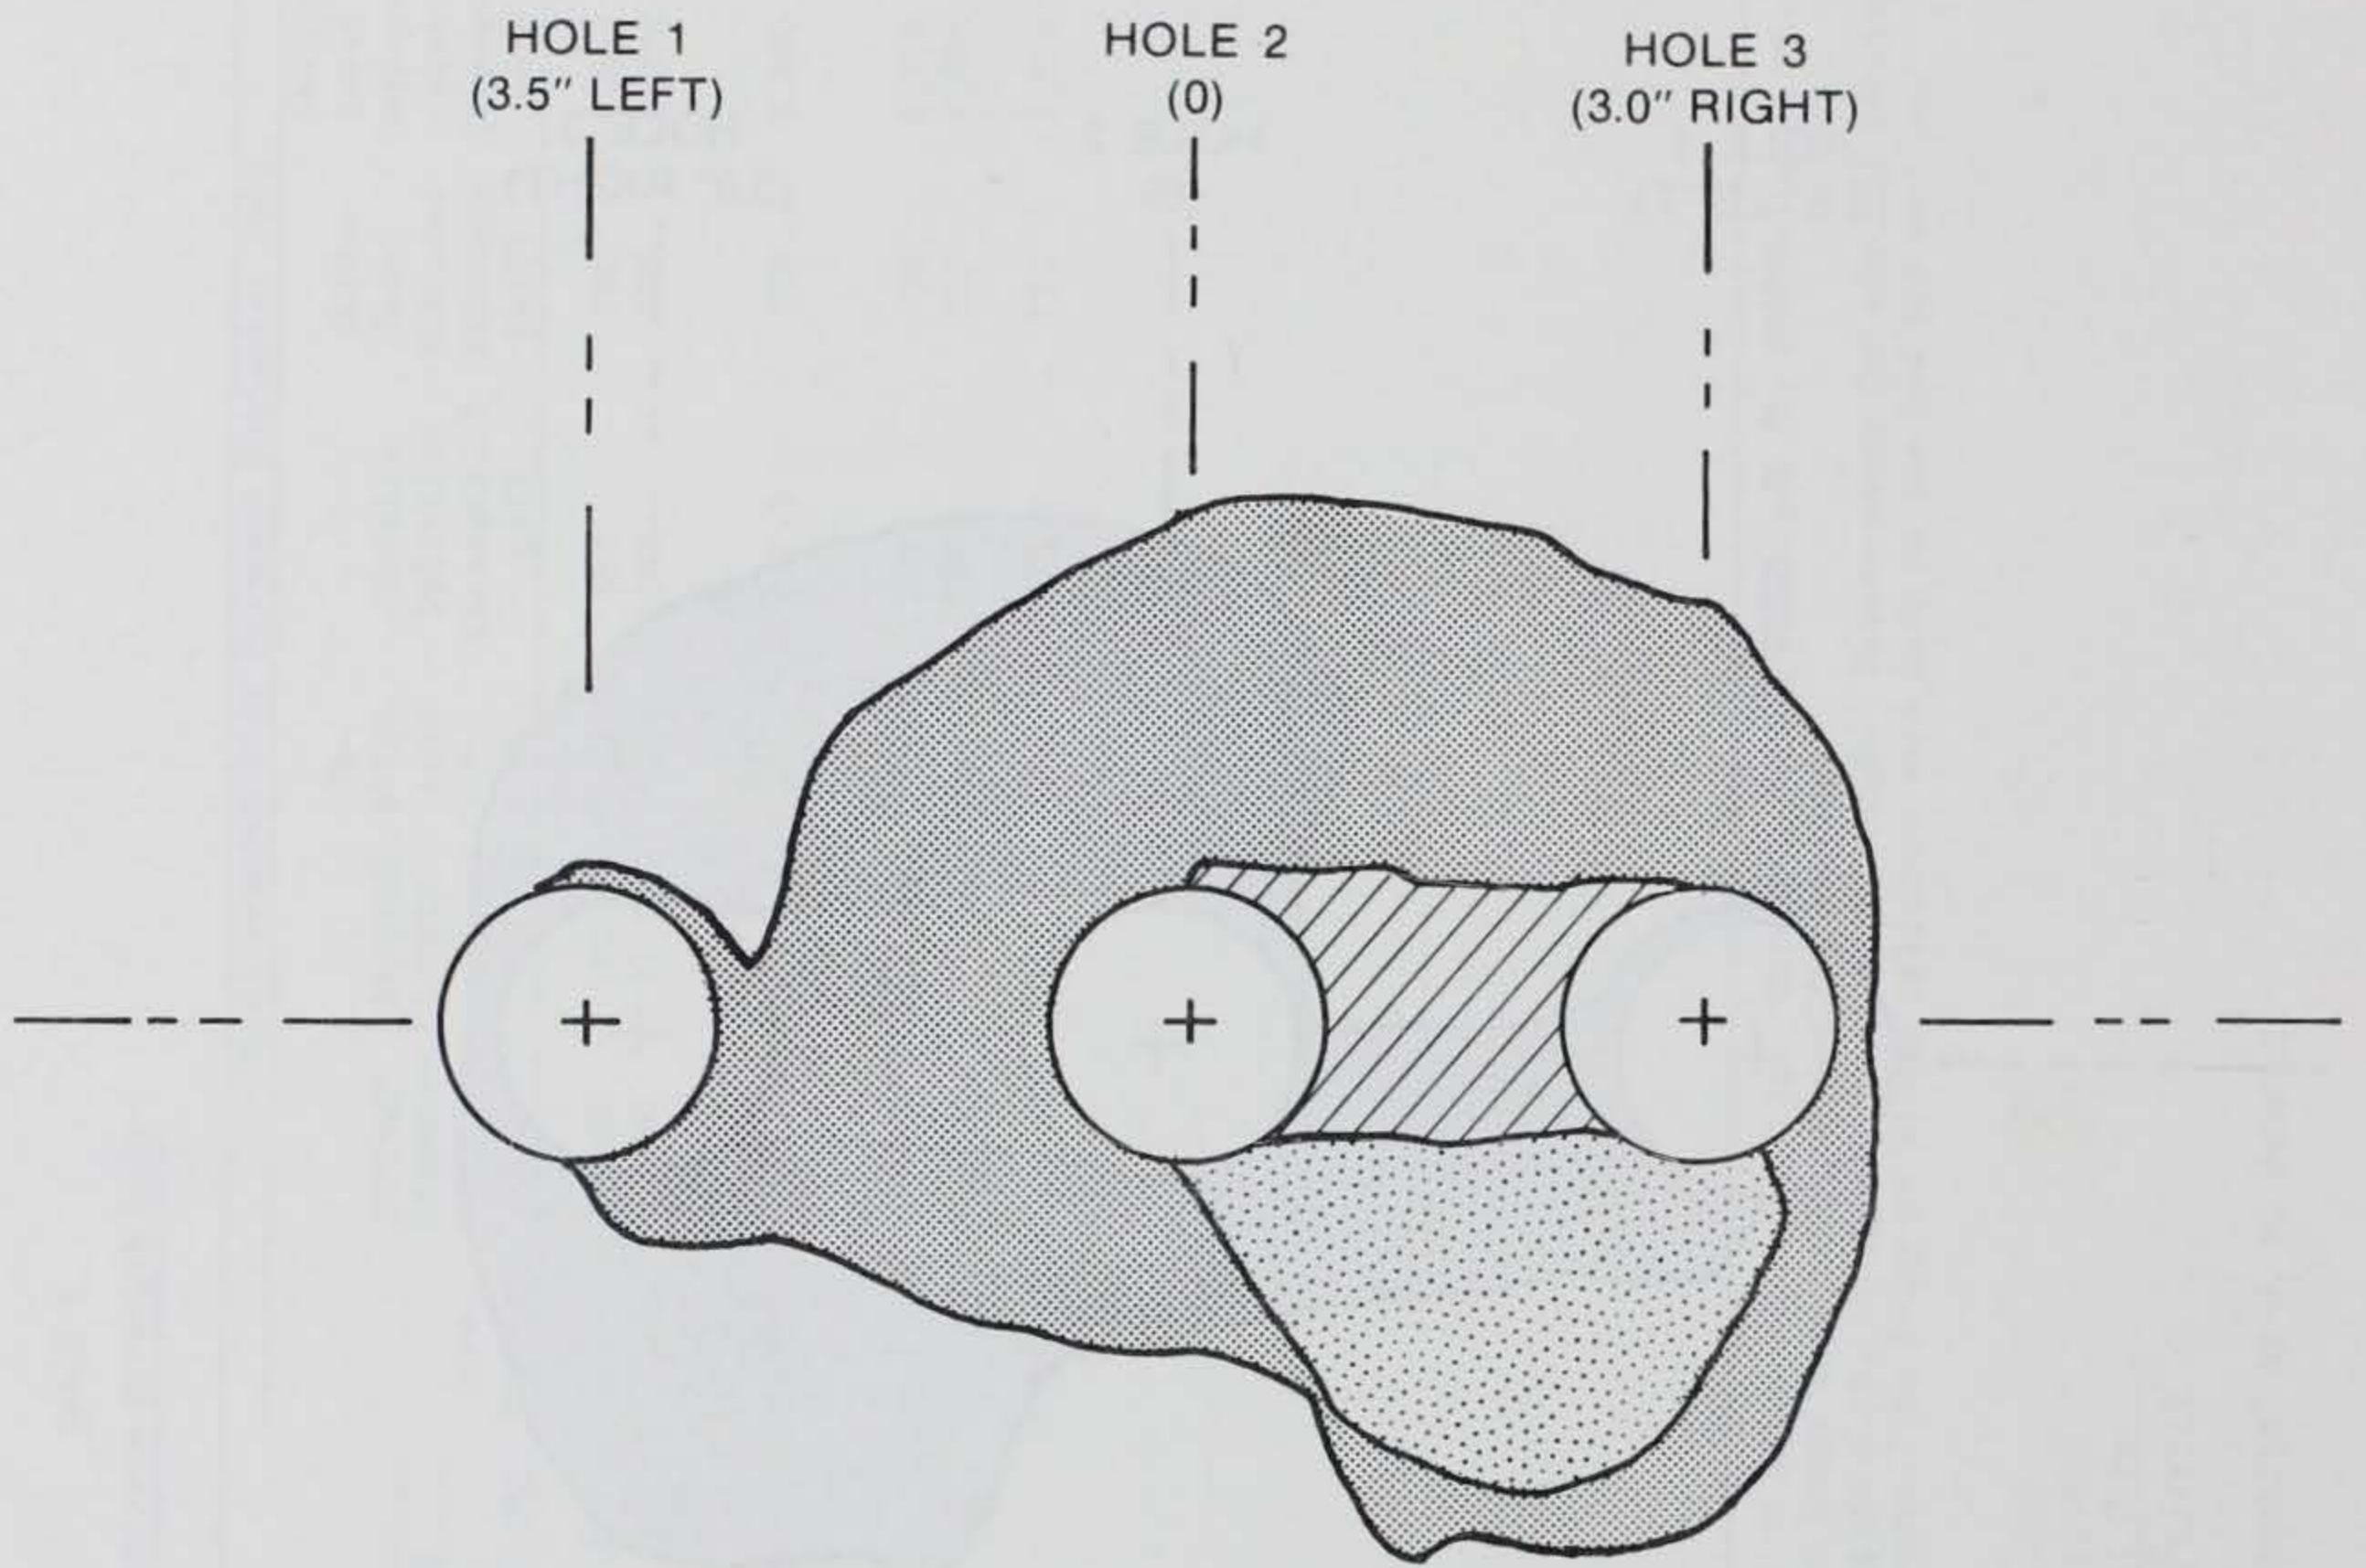
Figure 2. Spall depths after test 1A, shot 2

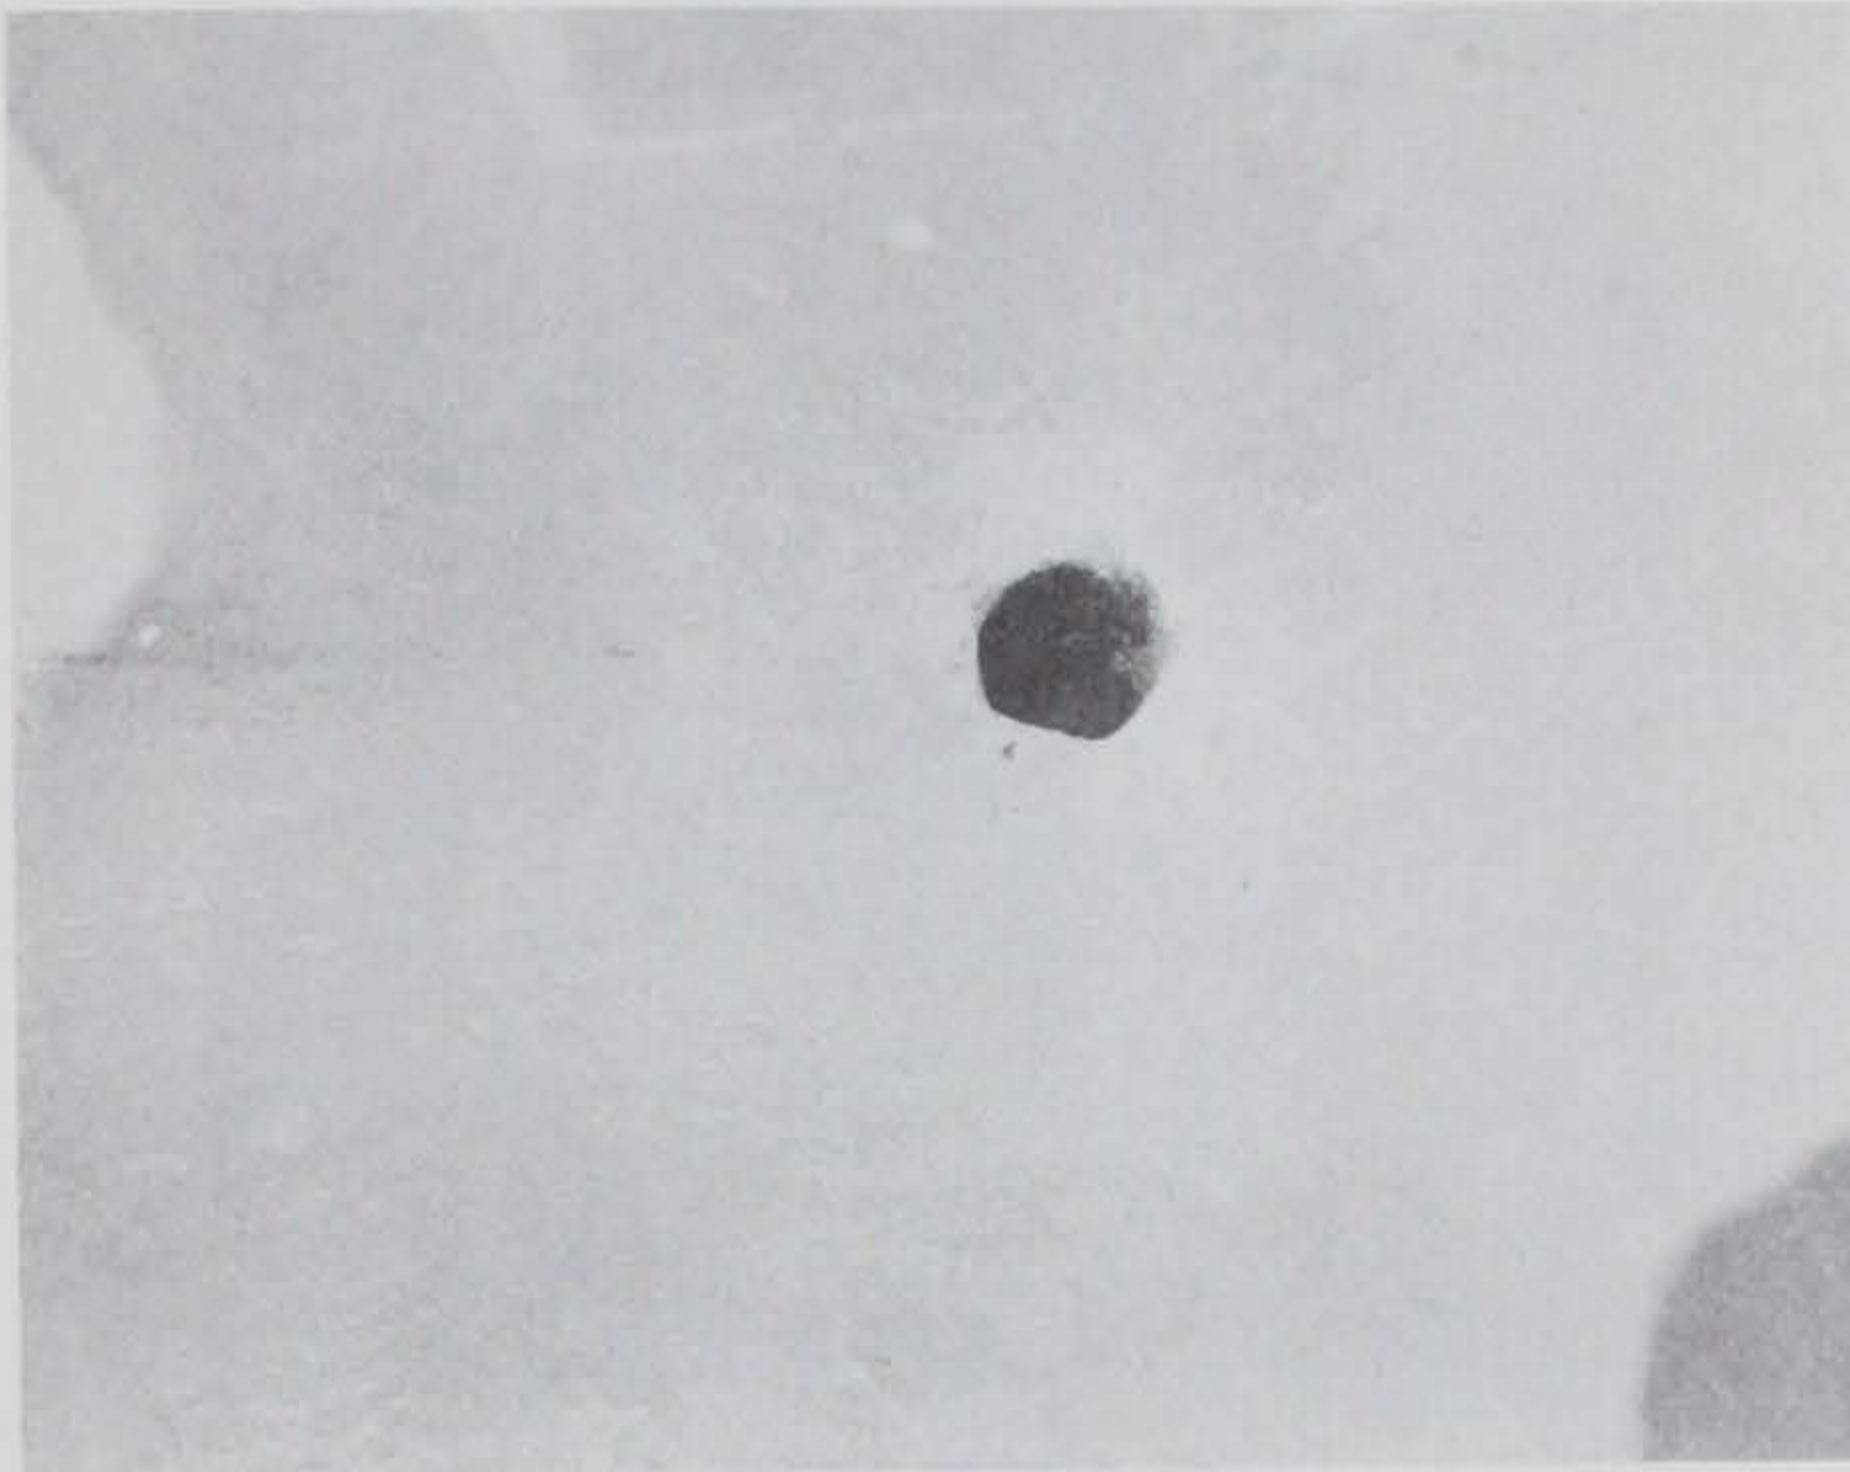
Photo 4. Spalling around hole after test 1, shot 1

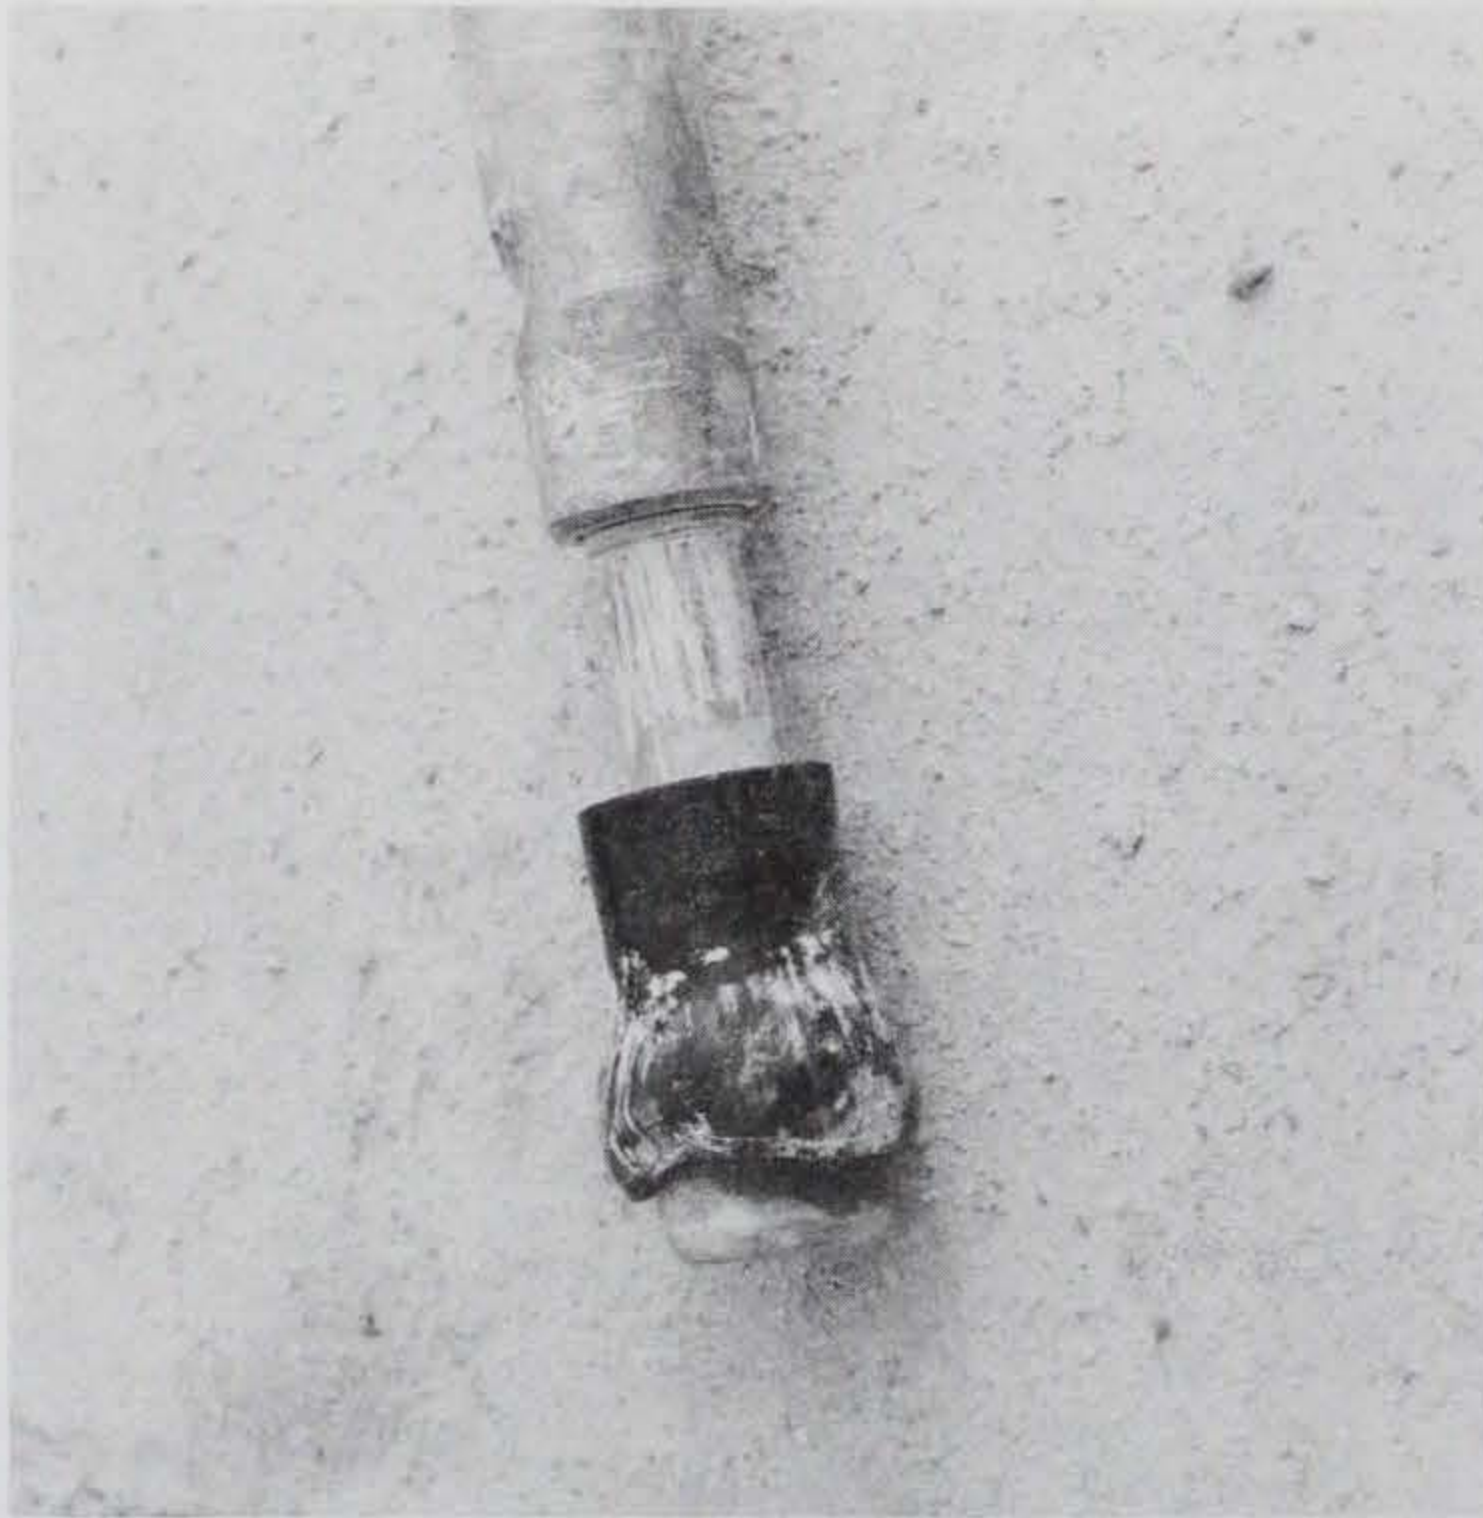
11. Test 2 was a repeat of Test 1 using the 100 percent charge power cartridges. The first shot resulted in a small amount of spalling around the top of the hole, and the device once again stuck. The spalling extended approximately 1/2 in. away from the hole. No cracking was observed in the pavement surrounding the hole. Once again the device had to be broken out with an air hammer. The rubber sleeve was once again found to be pushed down over the cap as shown in Photo 6. Conversations with the manufacturer indicated that the rubber sleeve should be pushed upward to the extreme top of the stem prior to insertion into the hole. This allows approximately 3/4 in. of travel for the sleeve to contract before it hits the cap.

Photo 6. Rubber sleeve forced down over cap,  
test 2

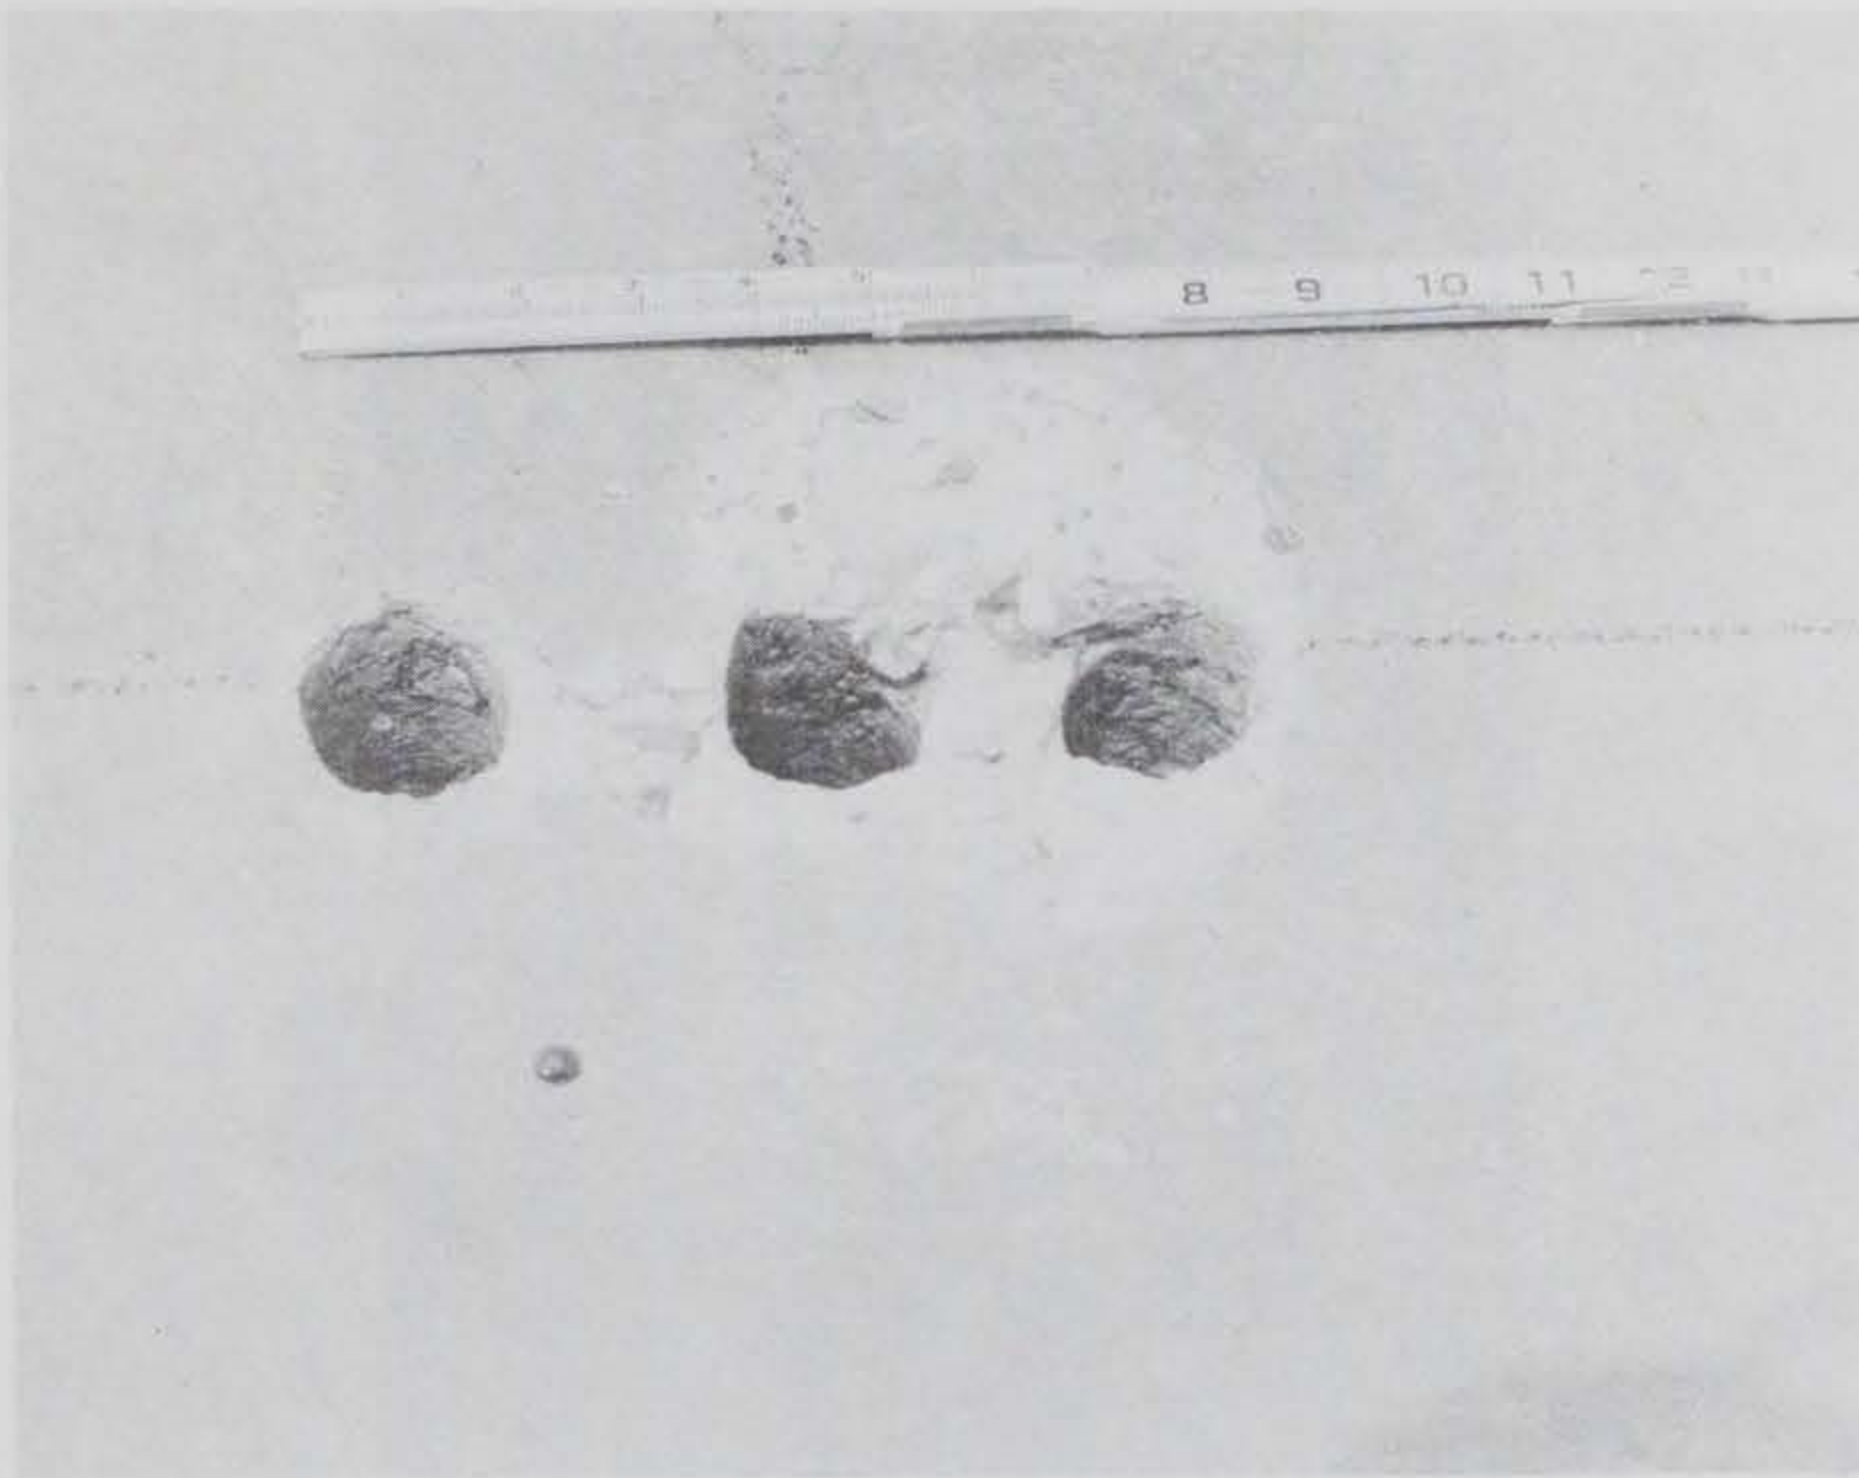
Photo 8. Spalling resulting from test 1A, shot 1

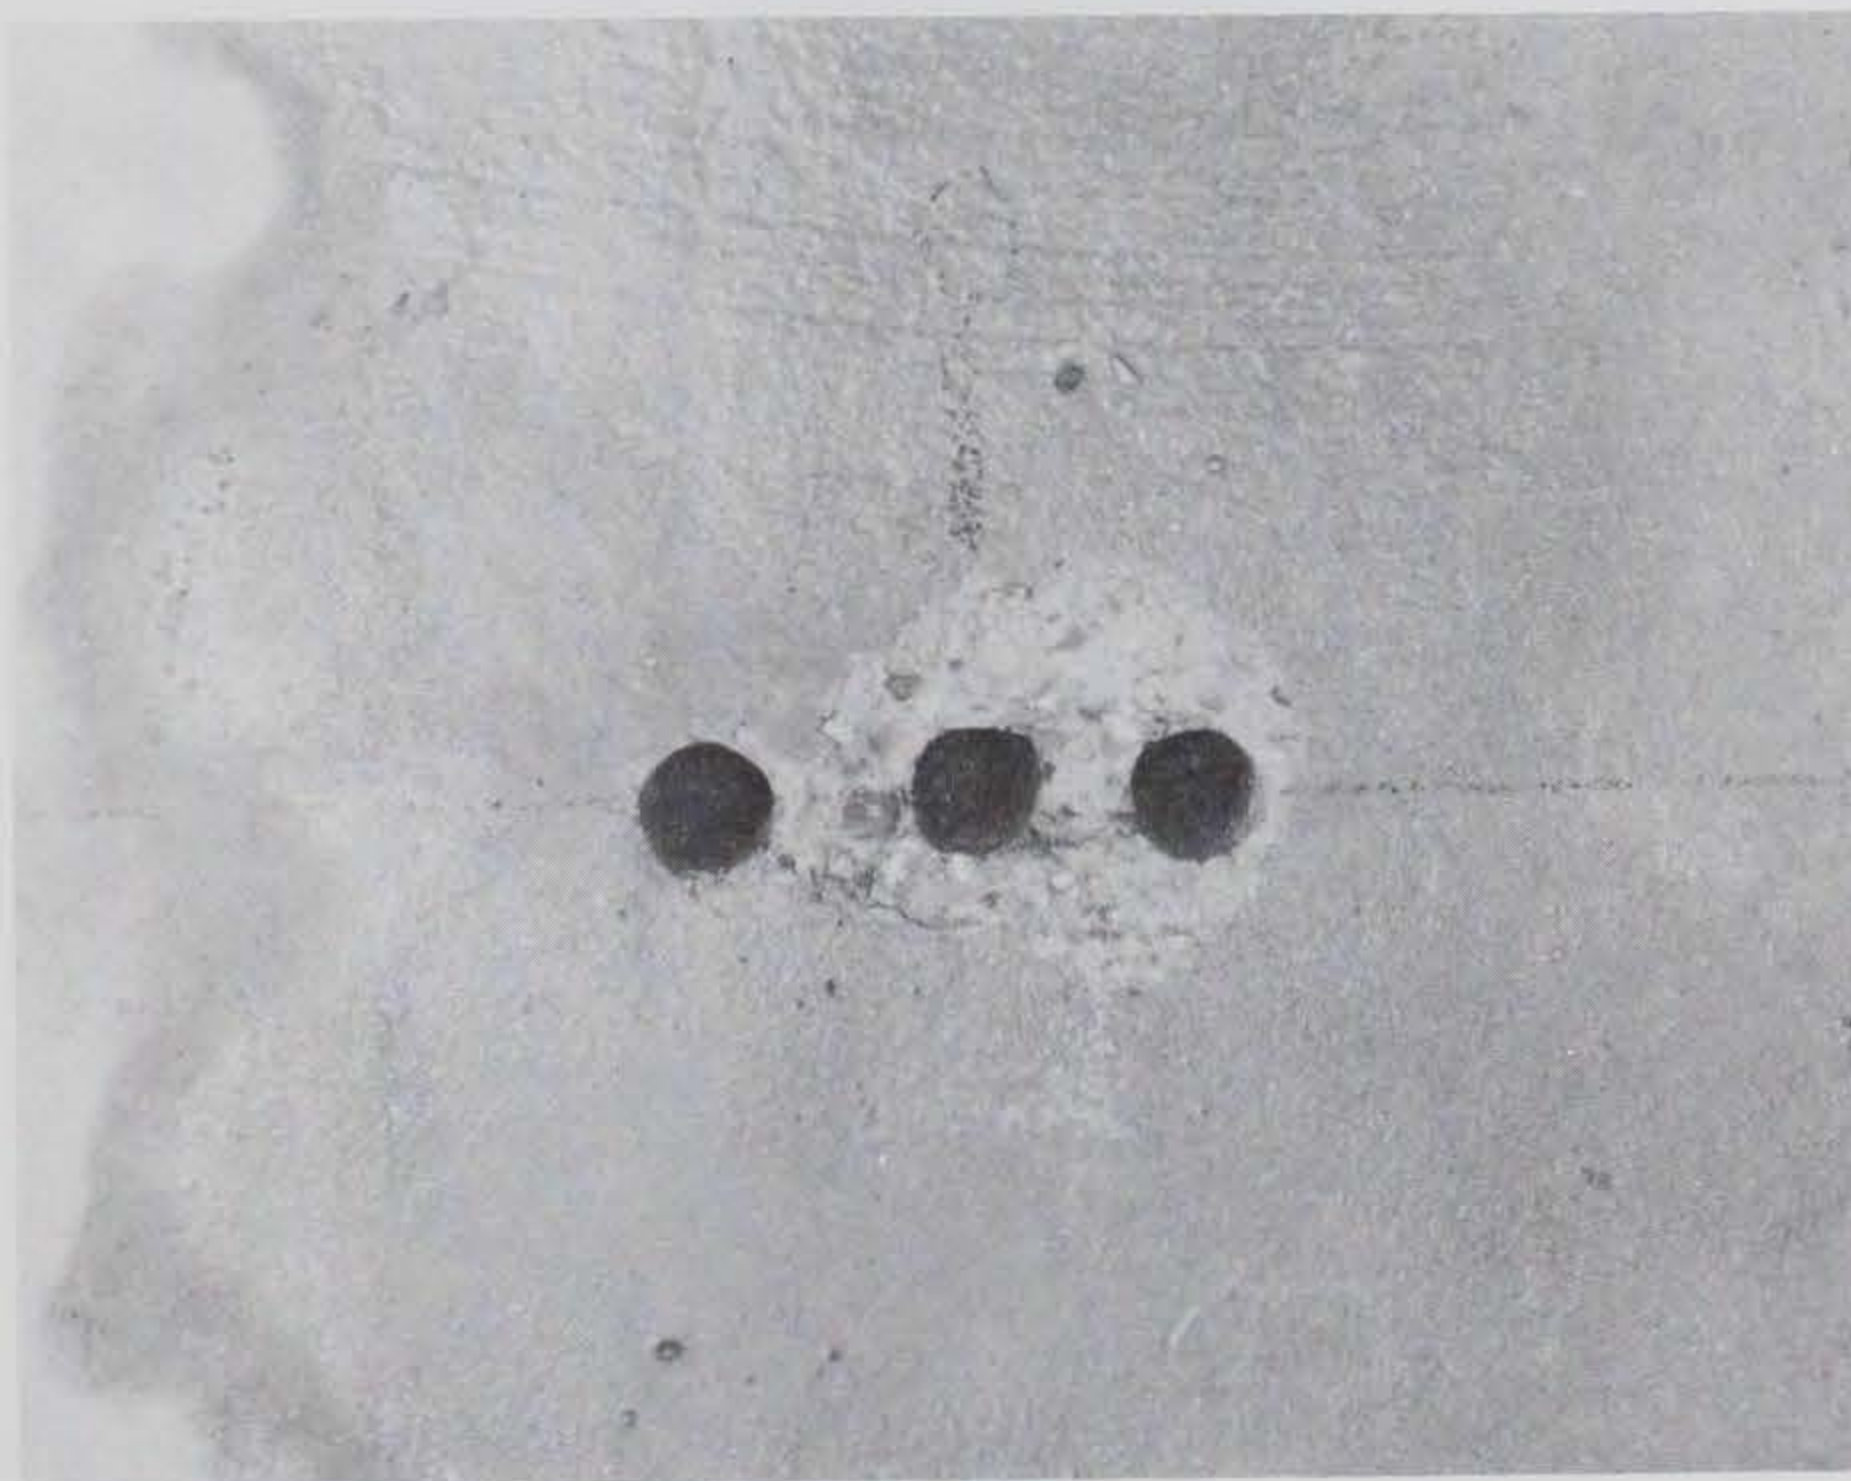
Photo 9. Spalling resulting from test 1A, shot 2

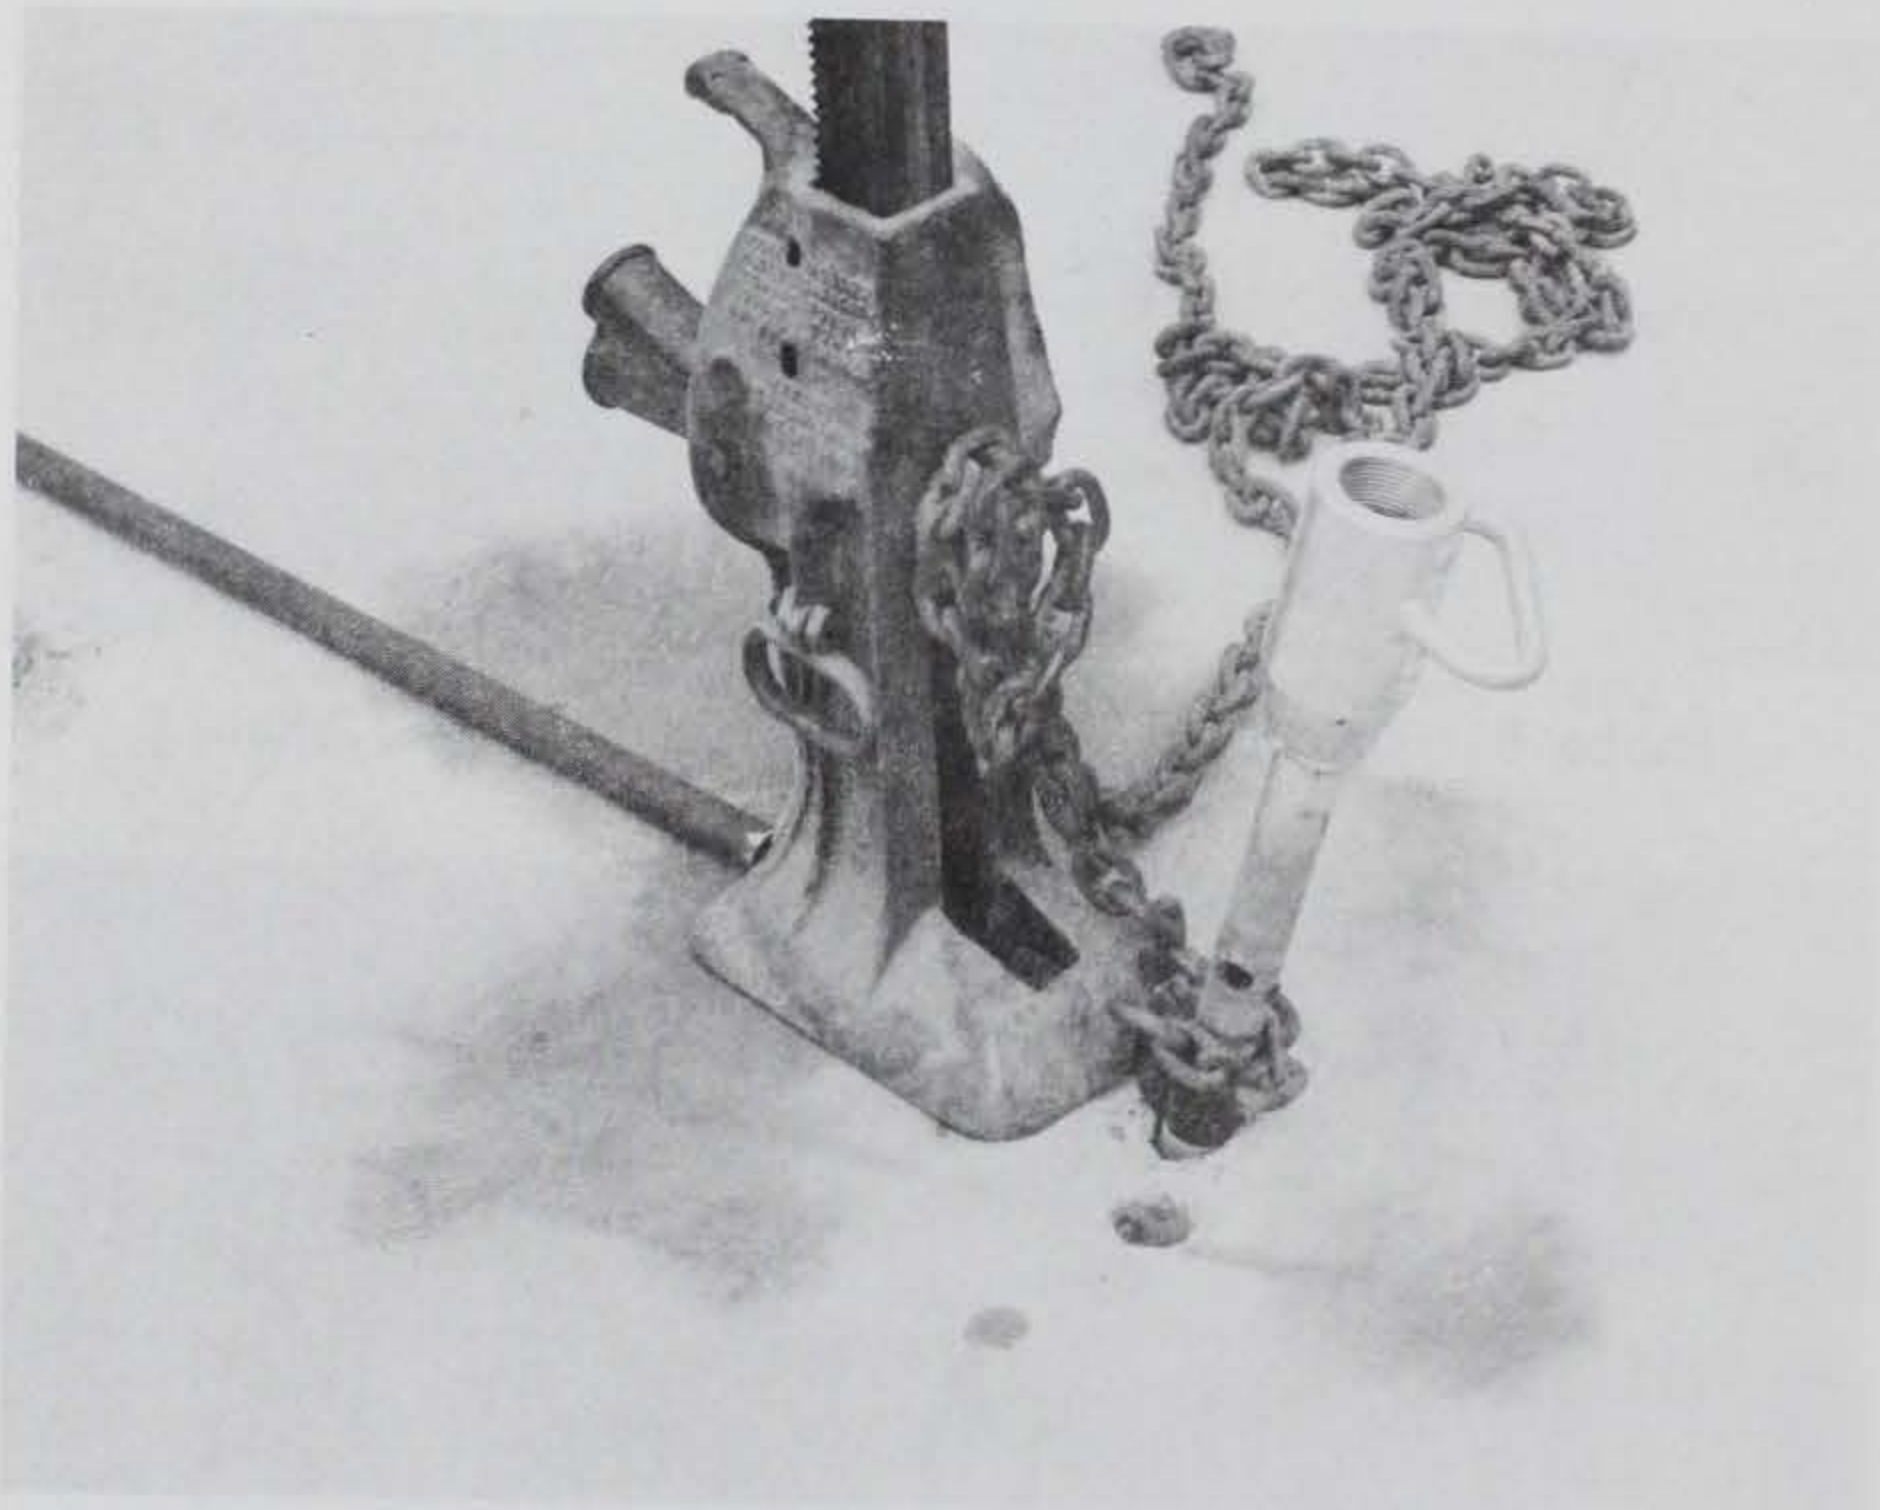
Photo 10. Removing stuck Water Wedge device with jack,  
test 1A, shot 3
