MISCELLANEOUS PAPER GL-86-5

# FIELD EVALUATION OF THE WATER WEDGE FOR CUTTING PORTLAND CEMENT CONCRETE PAVEMENTS FOR REPAIR AND RESTORATION OF PAVED SURFACES (REREPS)

January 1986

Final Report

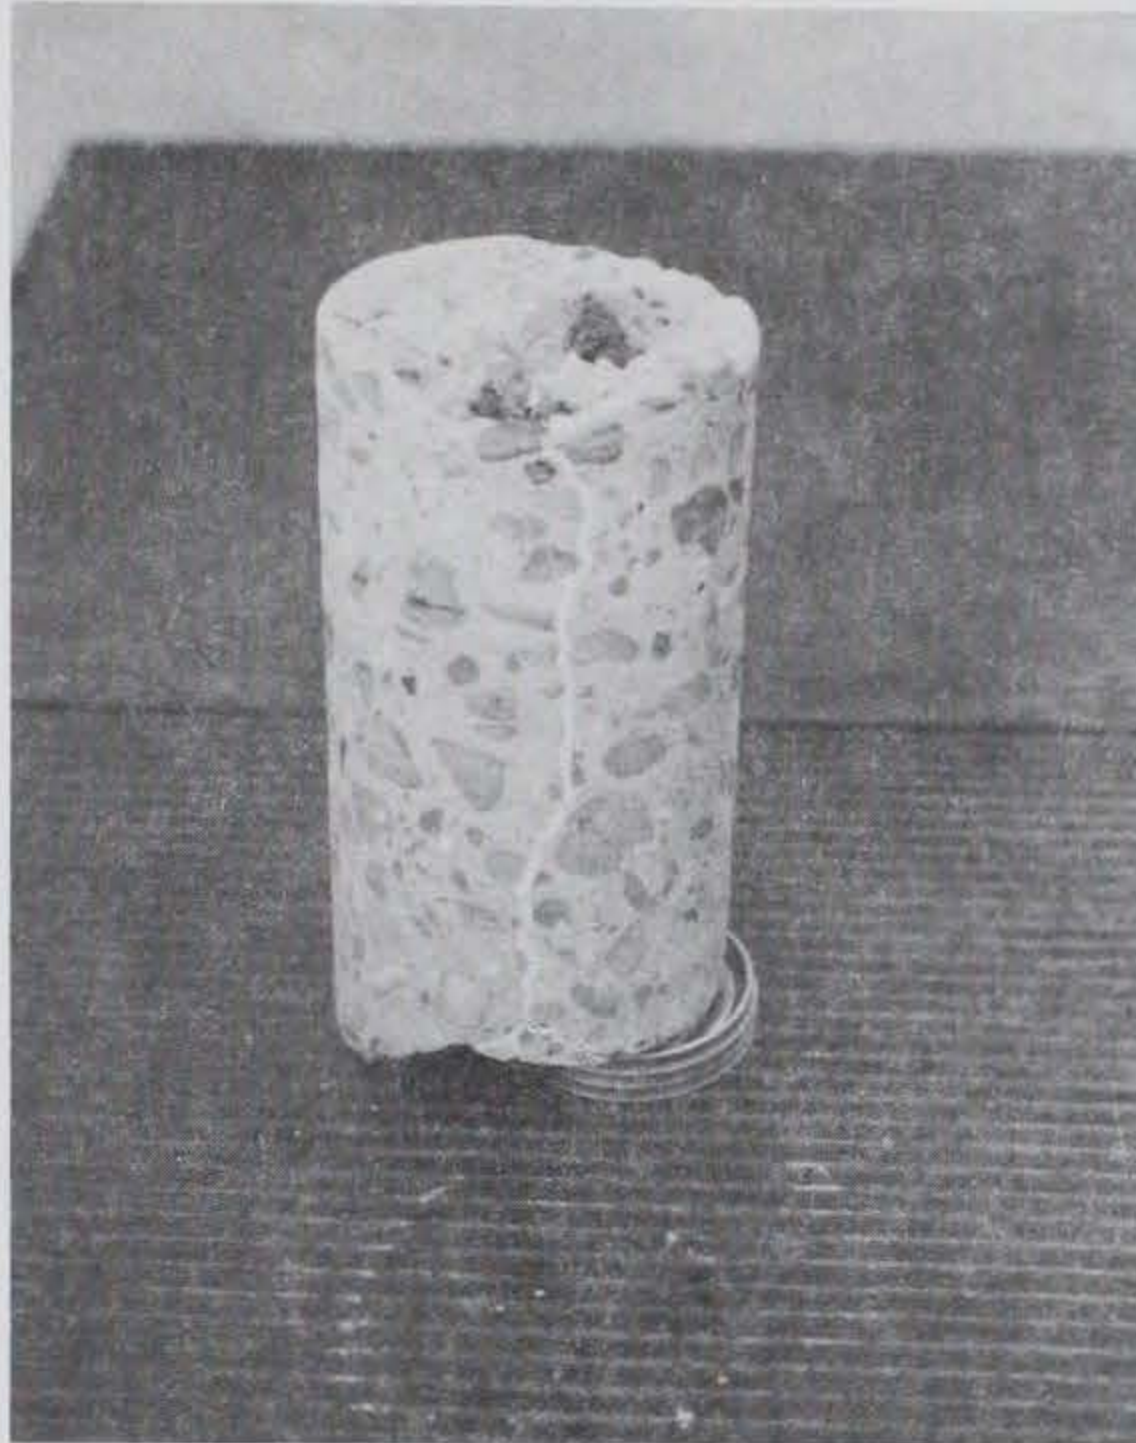
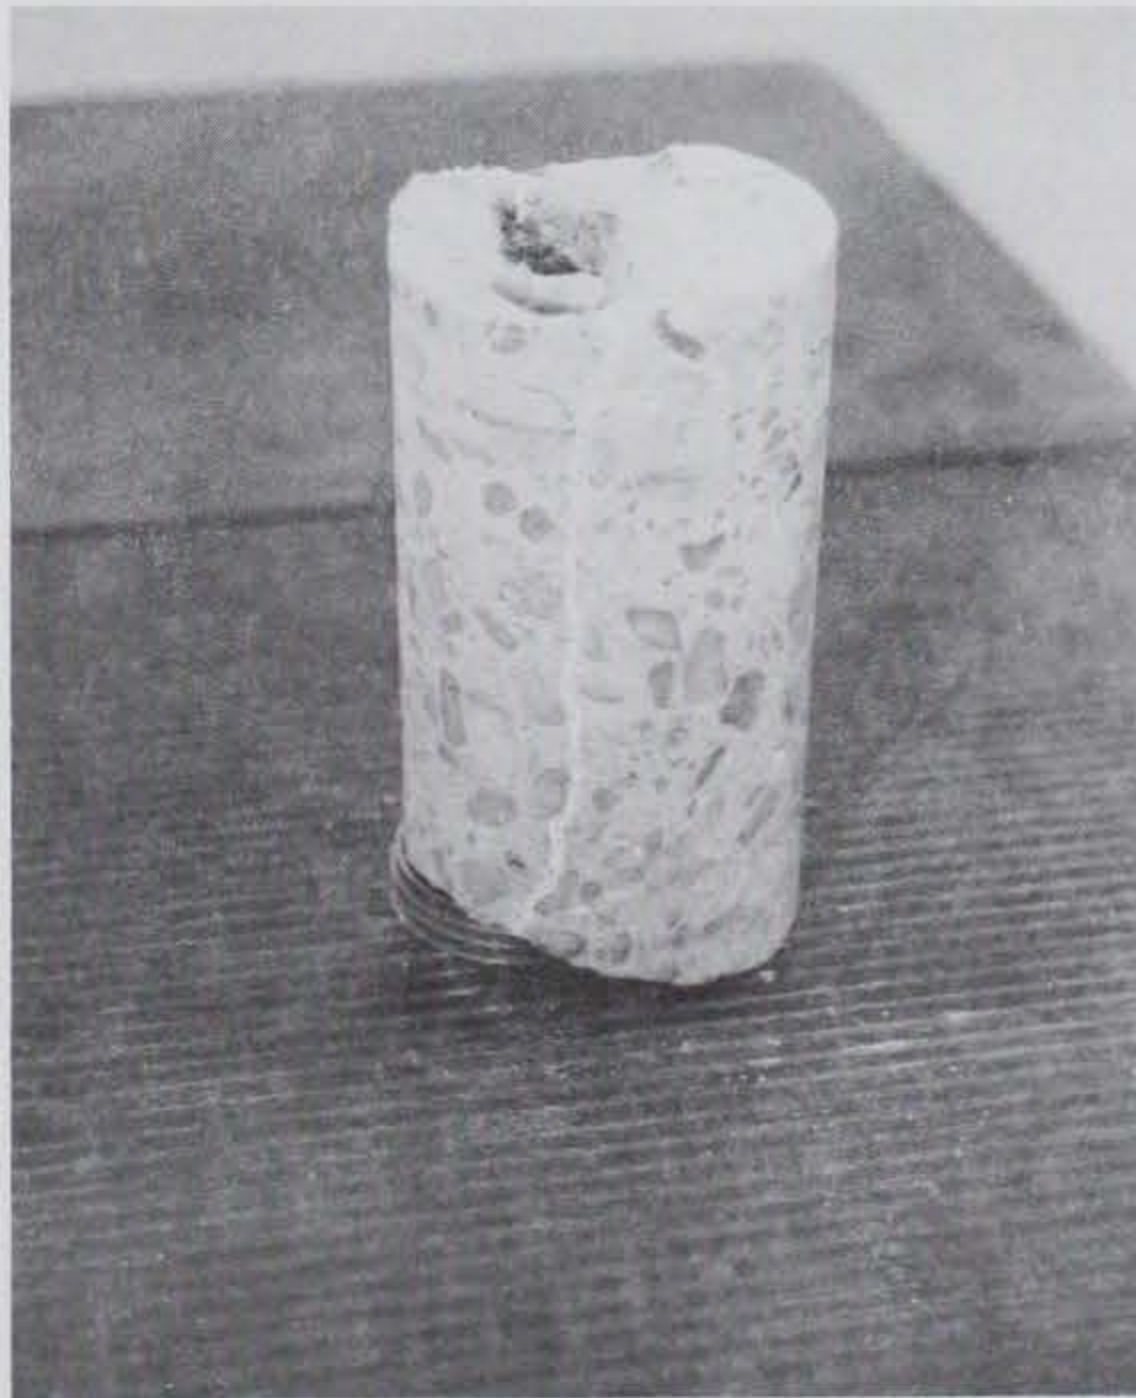
taken from Test Area 1A. This core included holes 2 and 3. The core was cracked completely through as seen in Photos 11 and 12; however, the crack was not large enough to break the core into two pieces when it was removed from the core barrel.

Photo 11. Core taken from test 1A  
(west side between holes 1 and 2)

Photo 12. Core taken from test 1A  
(east side between holes 2 and 3)

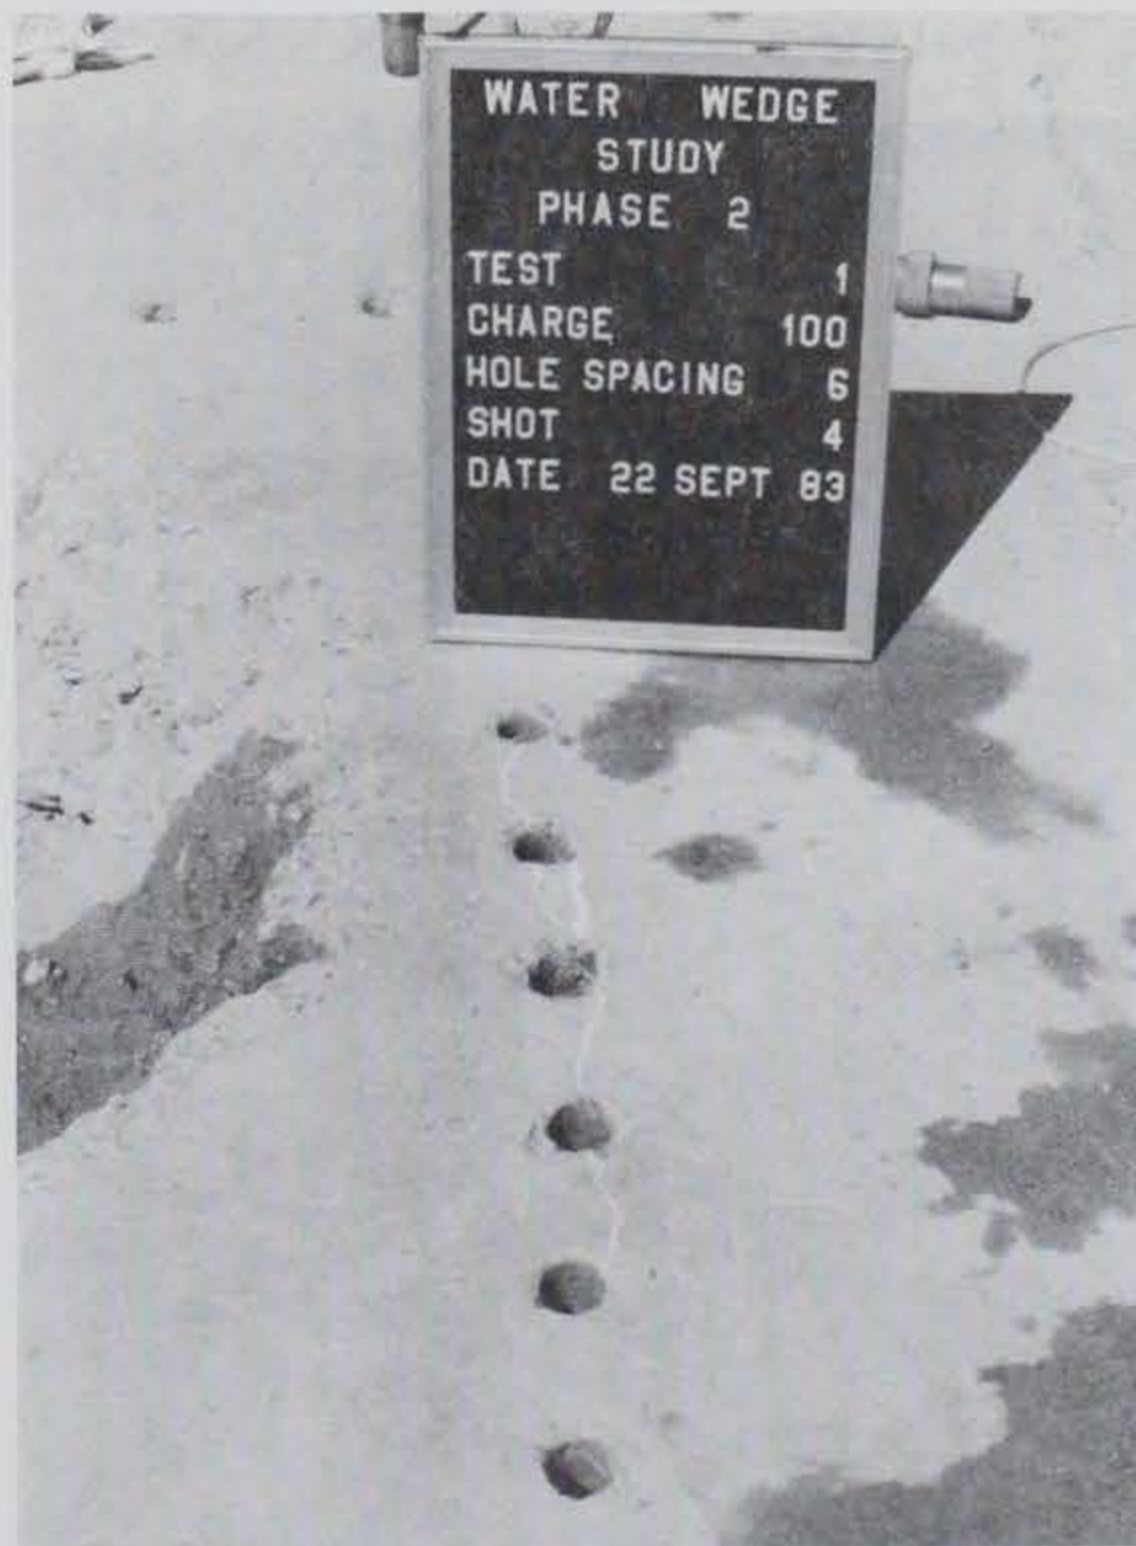
Photo 15. Extent of cracking after test 1, shot 4

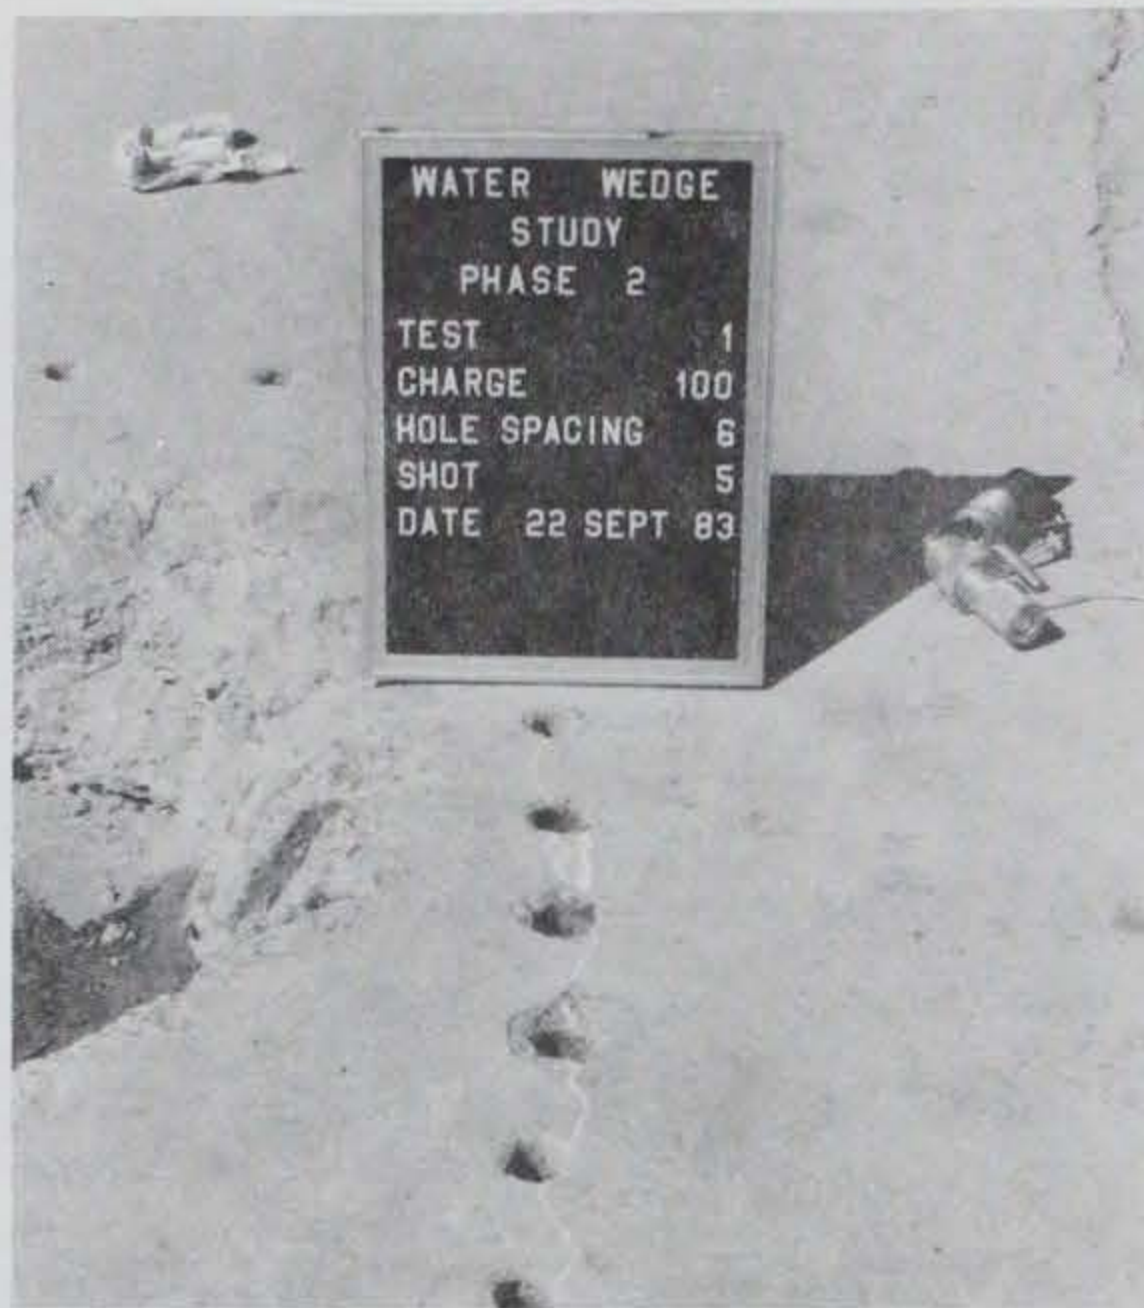
Photo 16. Extent of cracking and spalling after test 1, shot 5

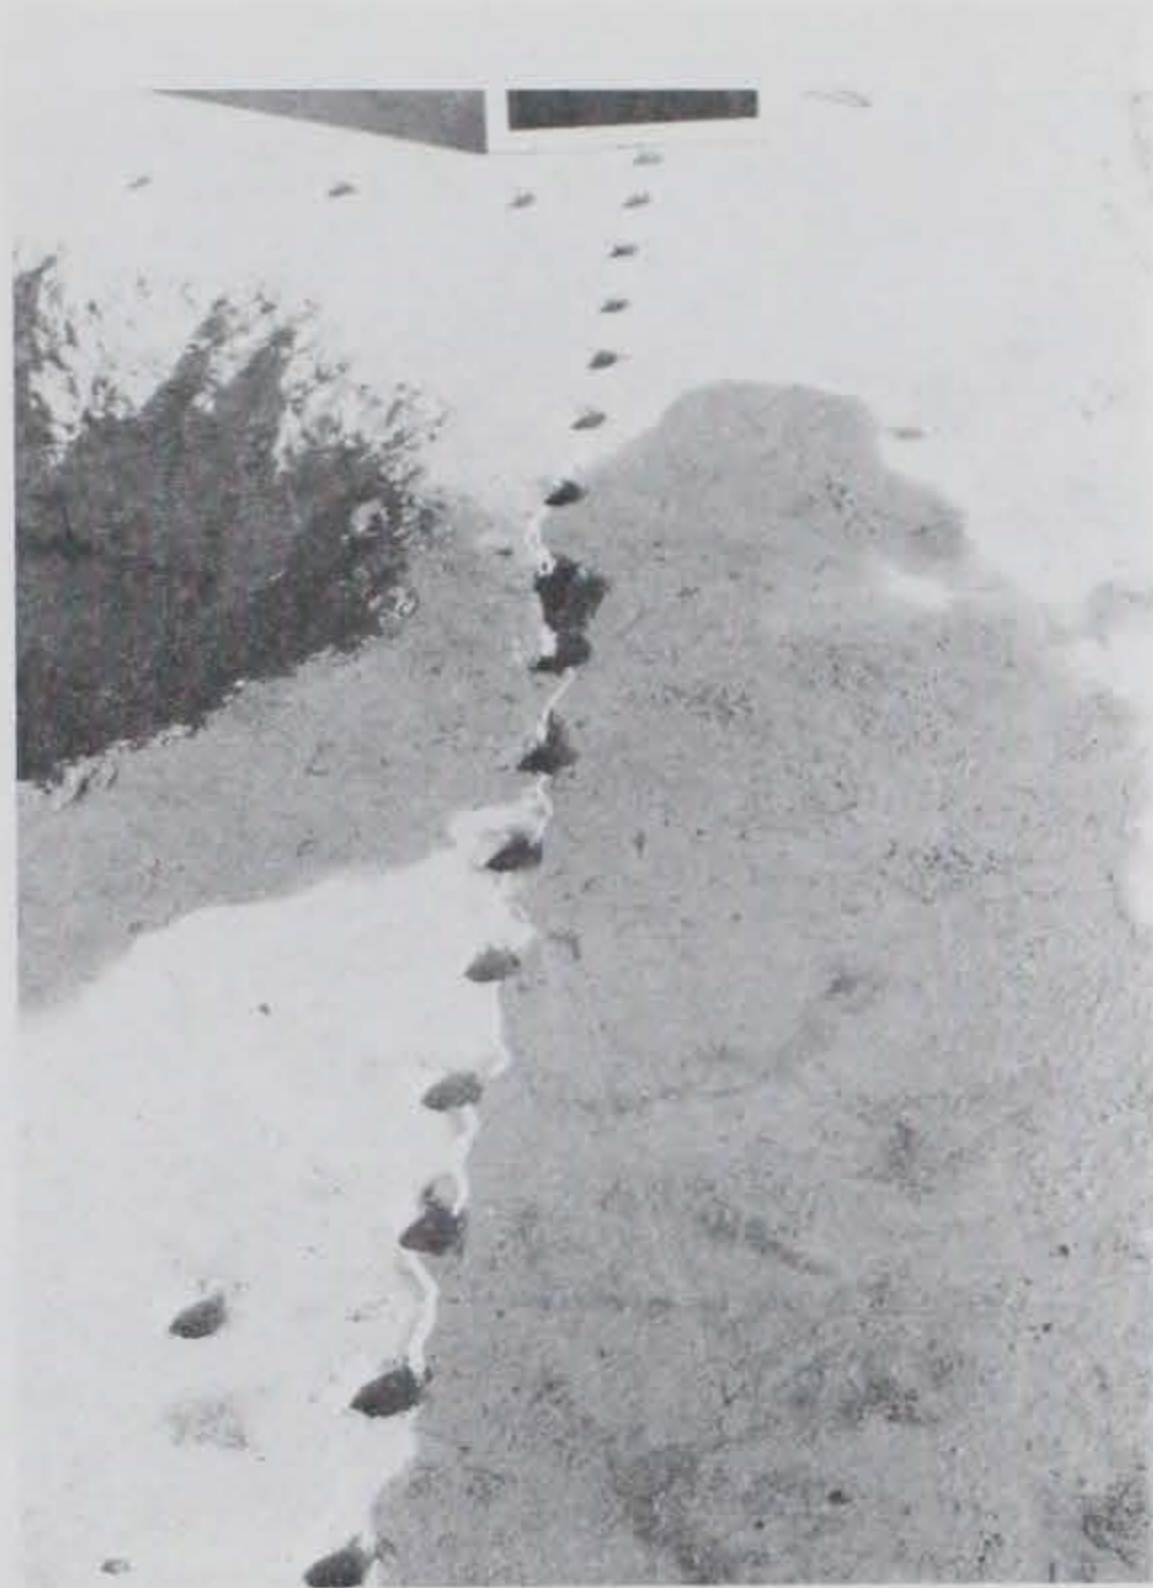
Photo 18. Extent of cracking after test 1, shot 7

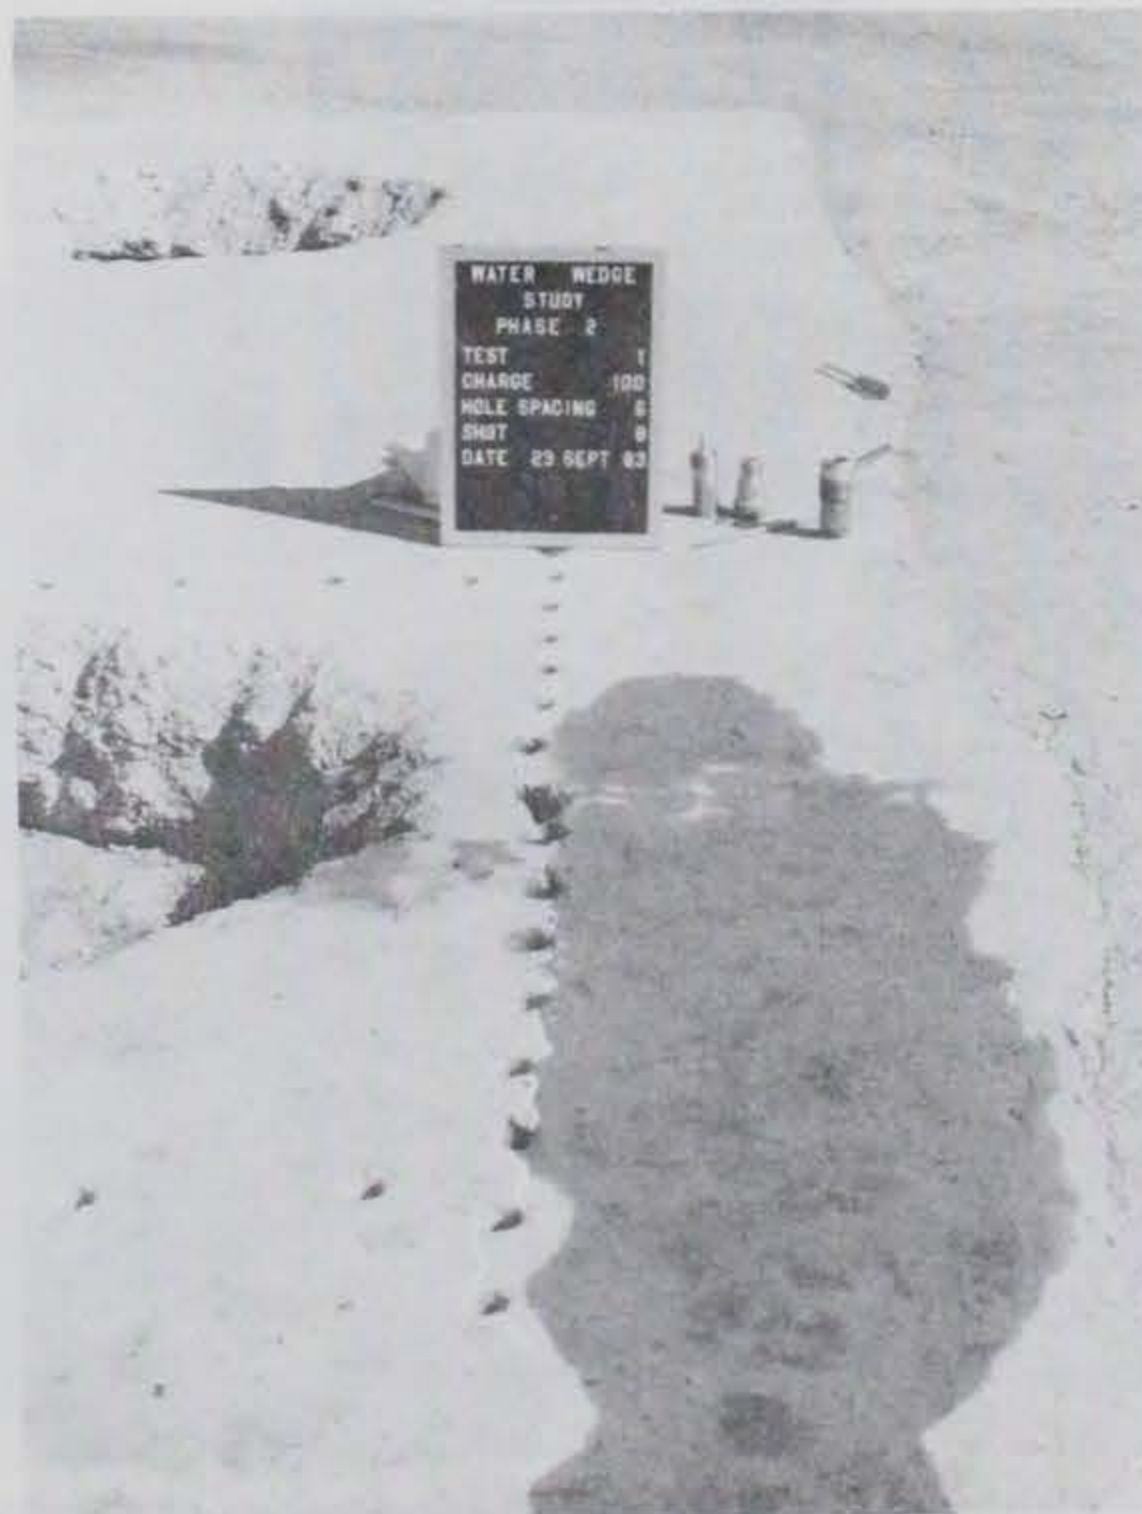
Photo 19. Cracking and spalling after test 1, shot 8

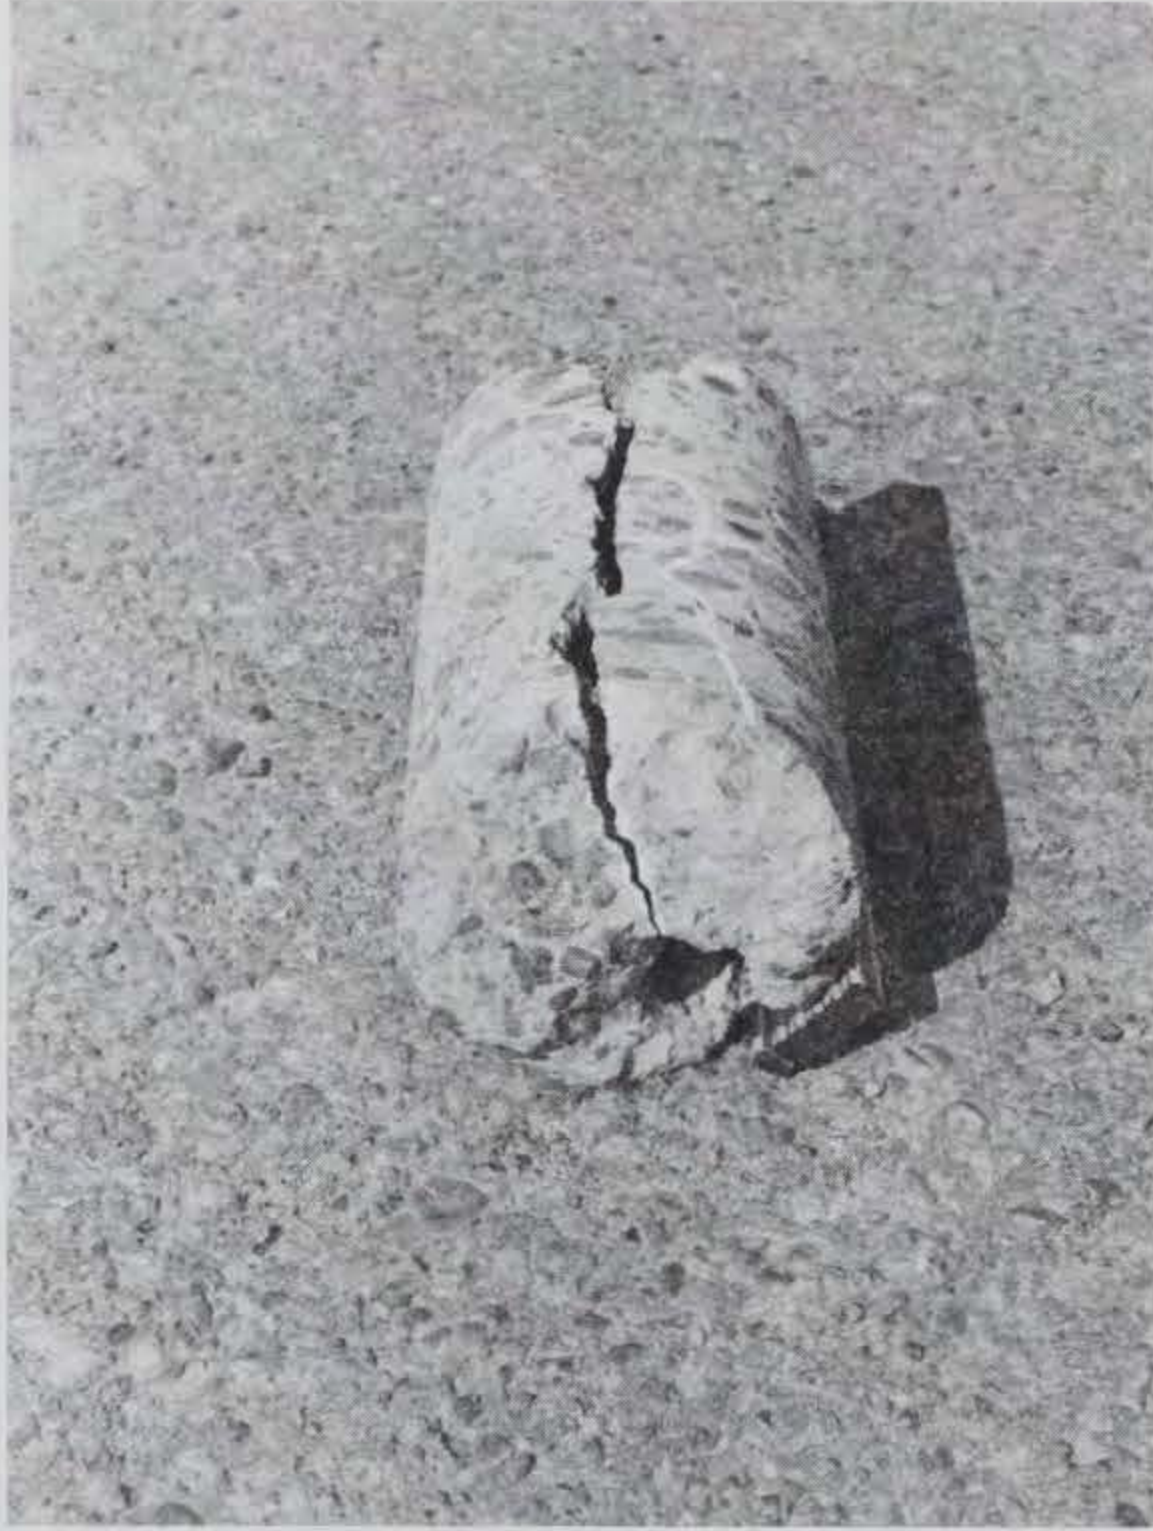
16. A core taken from the area between hole 0 and hole 1L was cracked vertically completely through (Photo 20), and the core broke apart when removed from the core barrel. The core was approximately 10 in. long indicating approximately 2 in. of the bottom had been blown loose. The side of the core adjacent to the crater has a horizontal crack about  $5-1/2$  in. down from the top. Examination of the core hole indicated a slab thickness of 10 in. at hole 0 and extending out about  $3-1/2$  in. from the center of hole 0. Seven inches from the center of hole 0, the slab was  $11-1/4$  in. thick. This material was found in the bottom of the core with the largest piece approximately 2 in. by 3 in. by 1 in. in size. A second core was removed from the area between 6L and 7L. This core had a vertical hairline crack extending 7 in. below the top of the core on the side adjacent to hole 6L. The side of the core adjacent to hole 7L had a vertical crack extending only 2 in. below the top of the core.

Photo 20. Core removed from area of hole 0, test 1

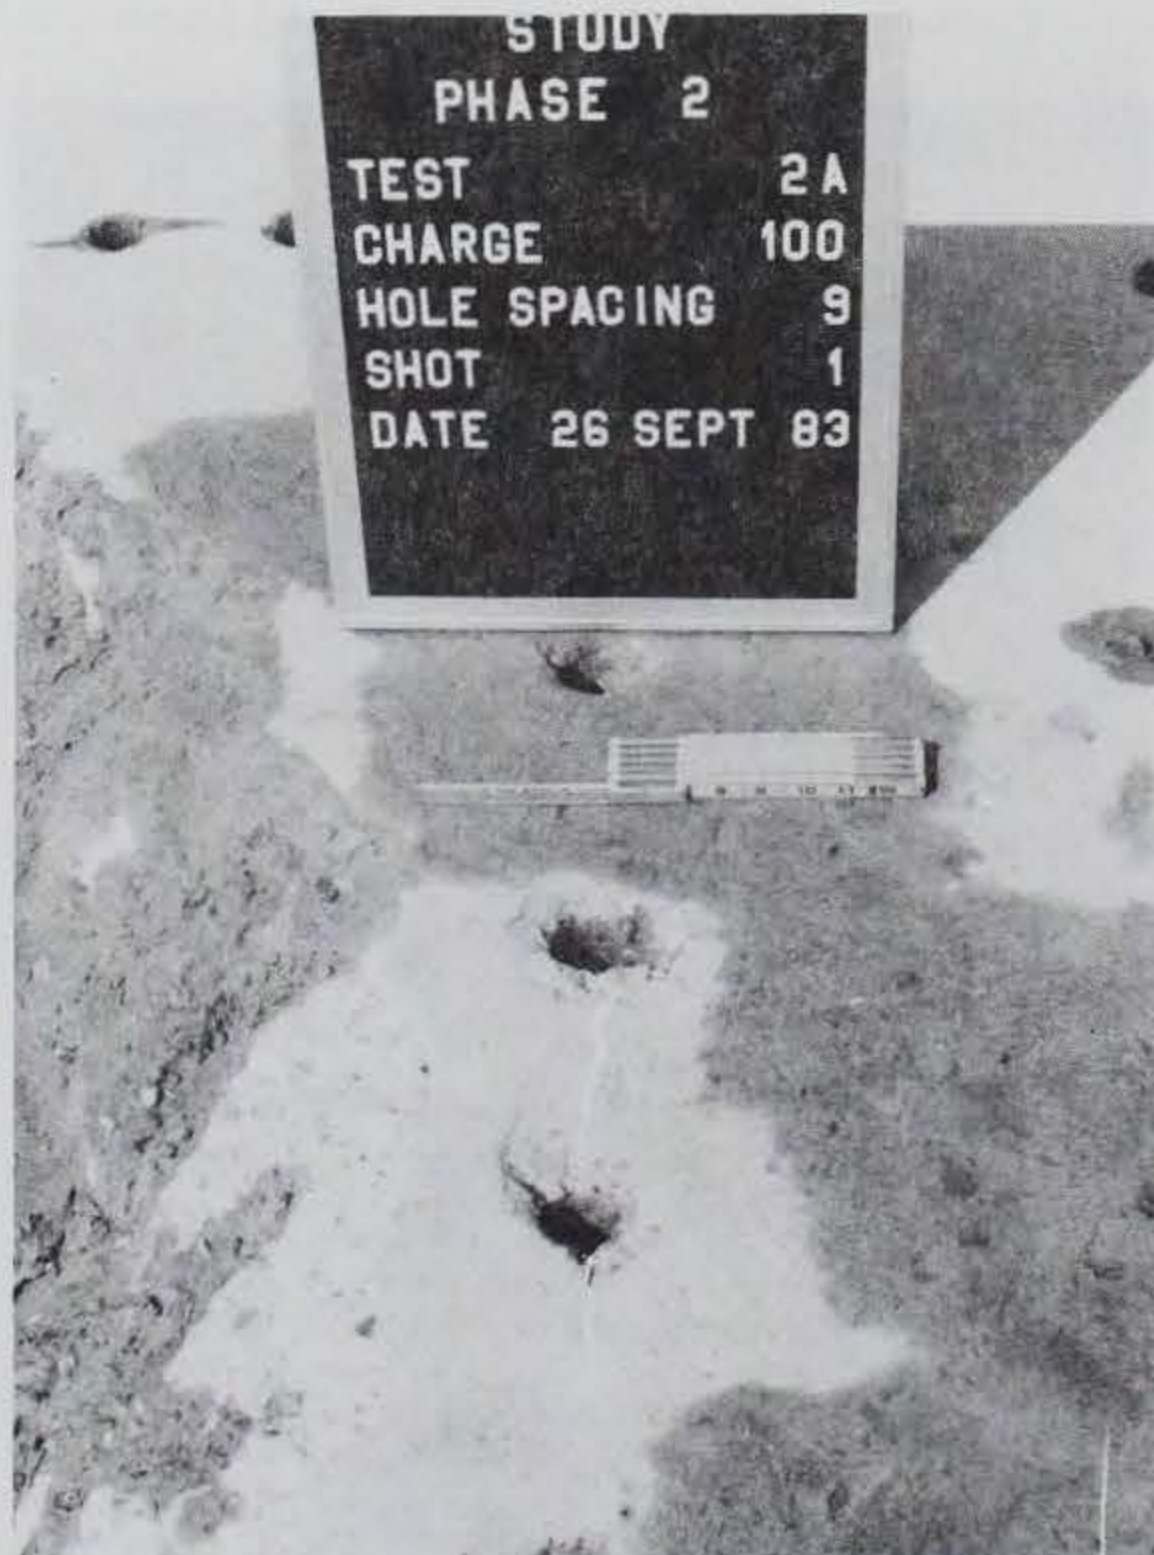
Photo 21. Cracking and spalling resulting from test 2A

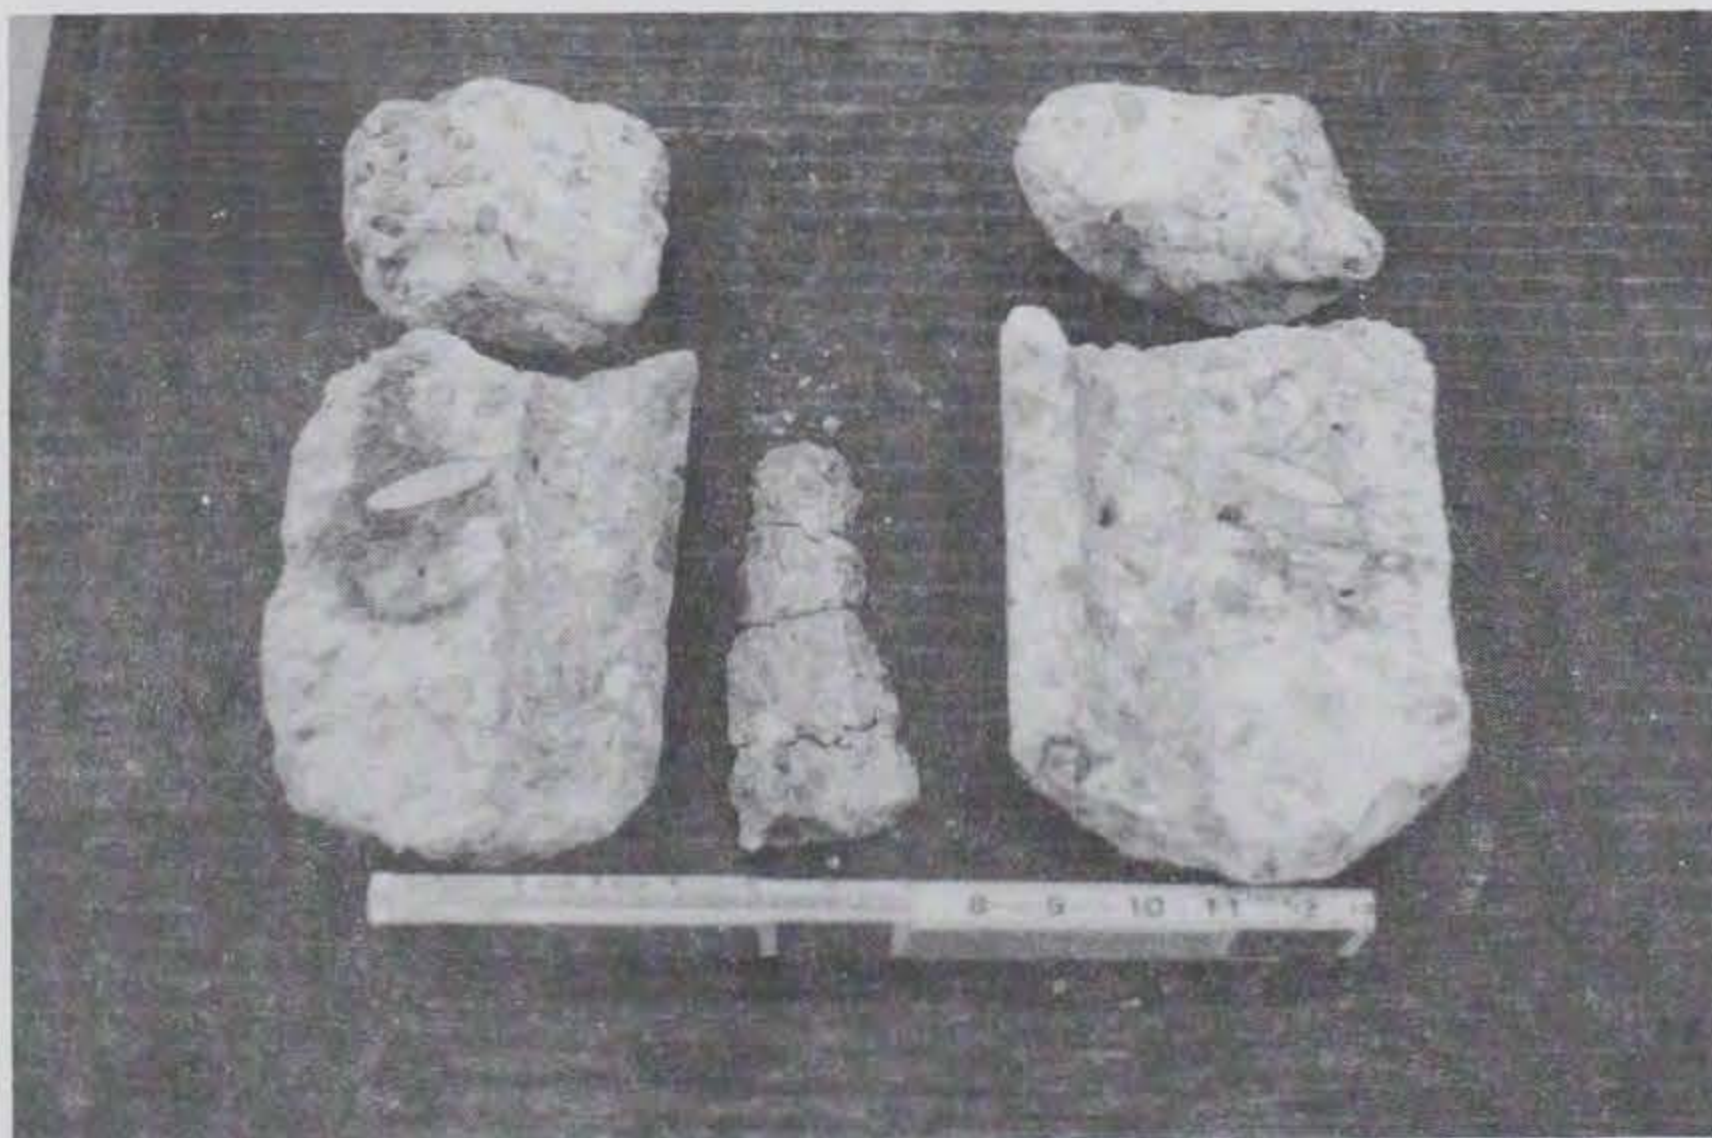
Photo 23. Core removed from test 3, hole 0

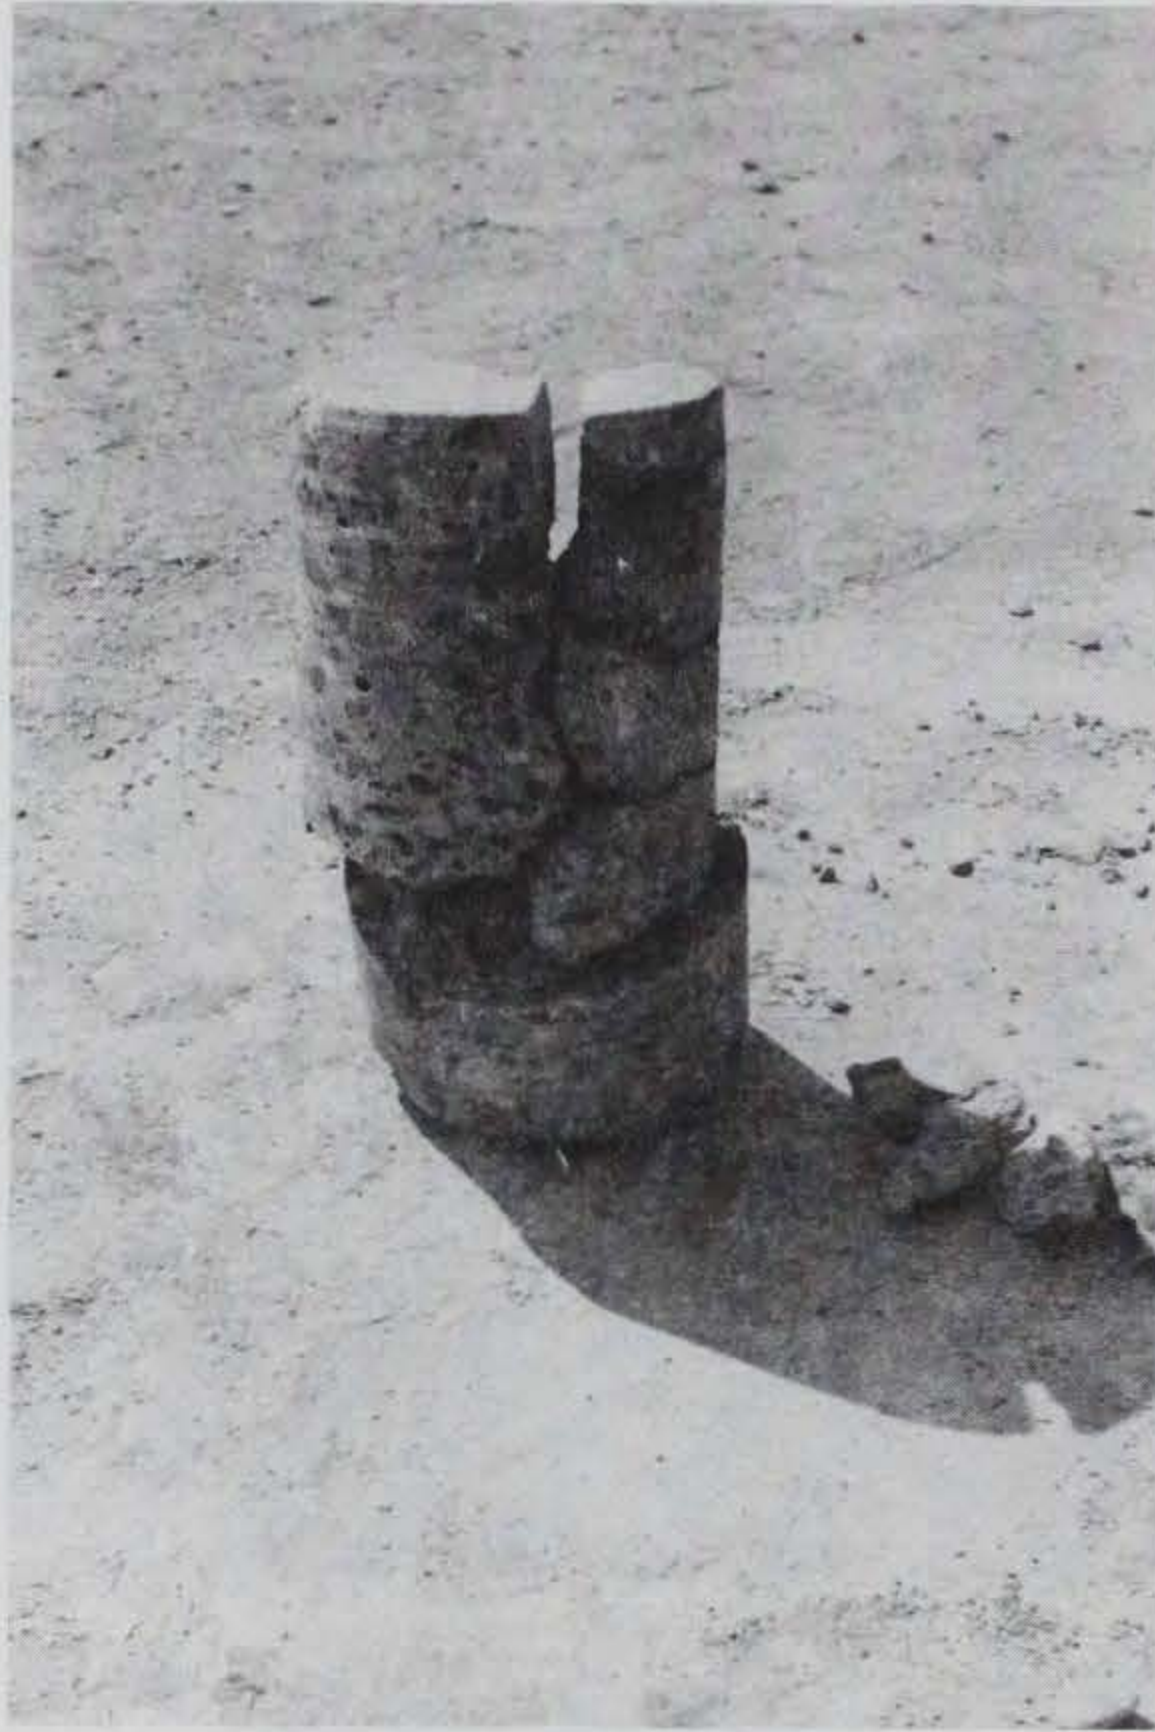
Photo 24. Core removed from test 3,  
hole 5R (6R side)

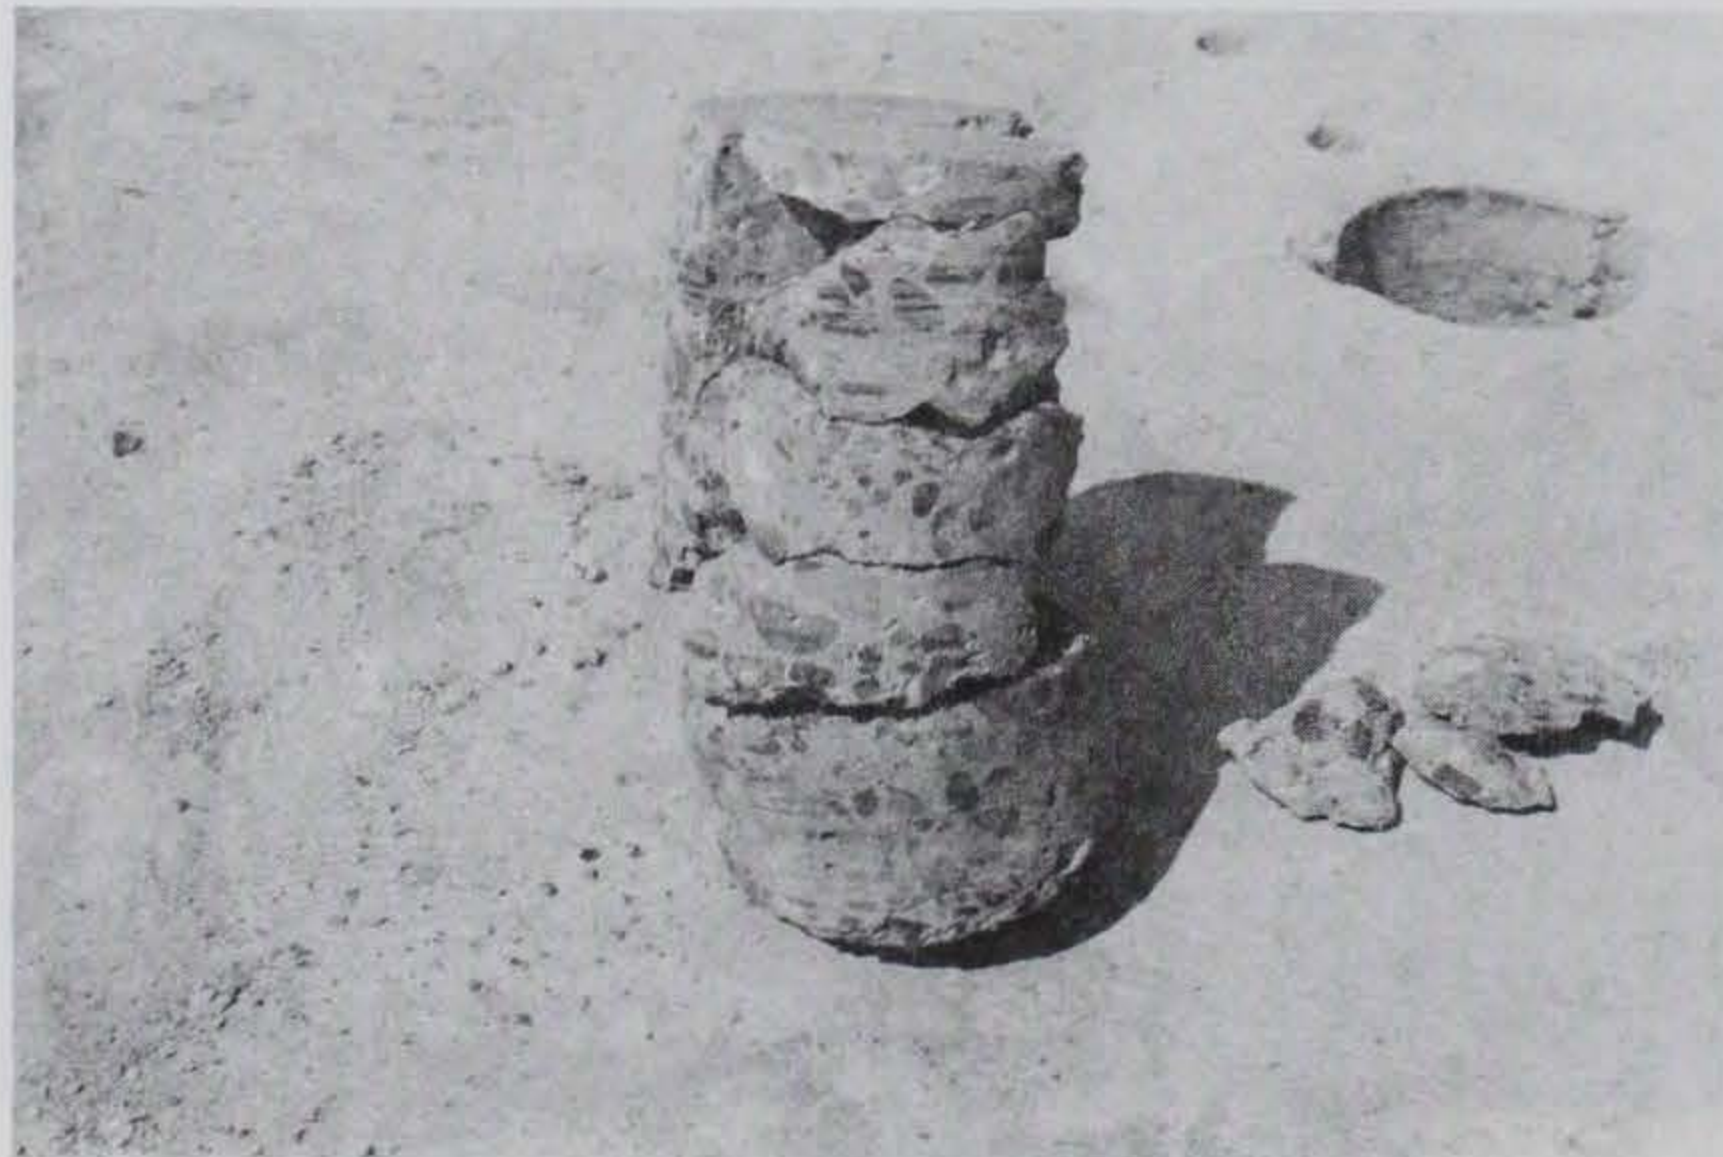
Photo 25. Core removed from test 3, hole 5R  
(4R side)

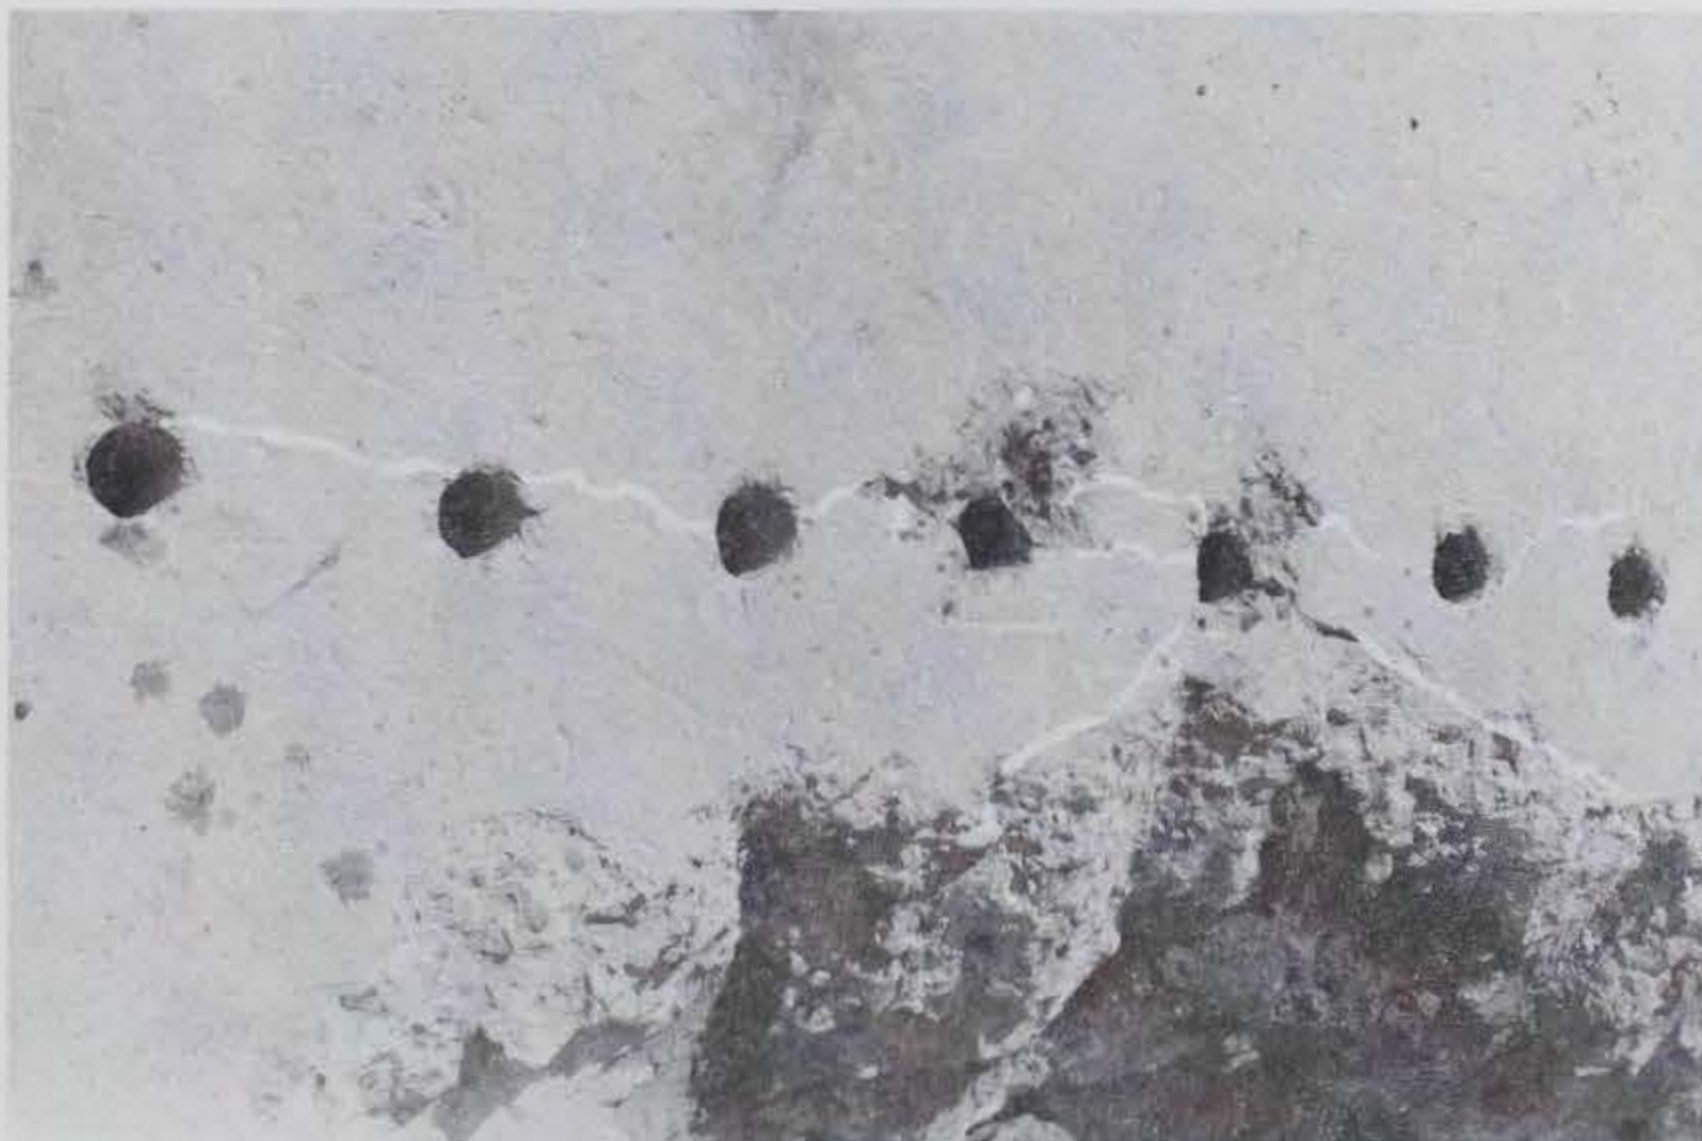
Photo 27. Extent of cracking after shot 2, test 4
