MISCELLANEOUS PAPER GL-86-5

# FIELD EVALUATION OF THE WATER WEDGE FOR CUTTING PORTLAND CEMENT CONCRETE PAVEMENTS FOR REPAIR AND RESTORATION OF PAVED SURFACES (REREPS)

January 1986

Final Report

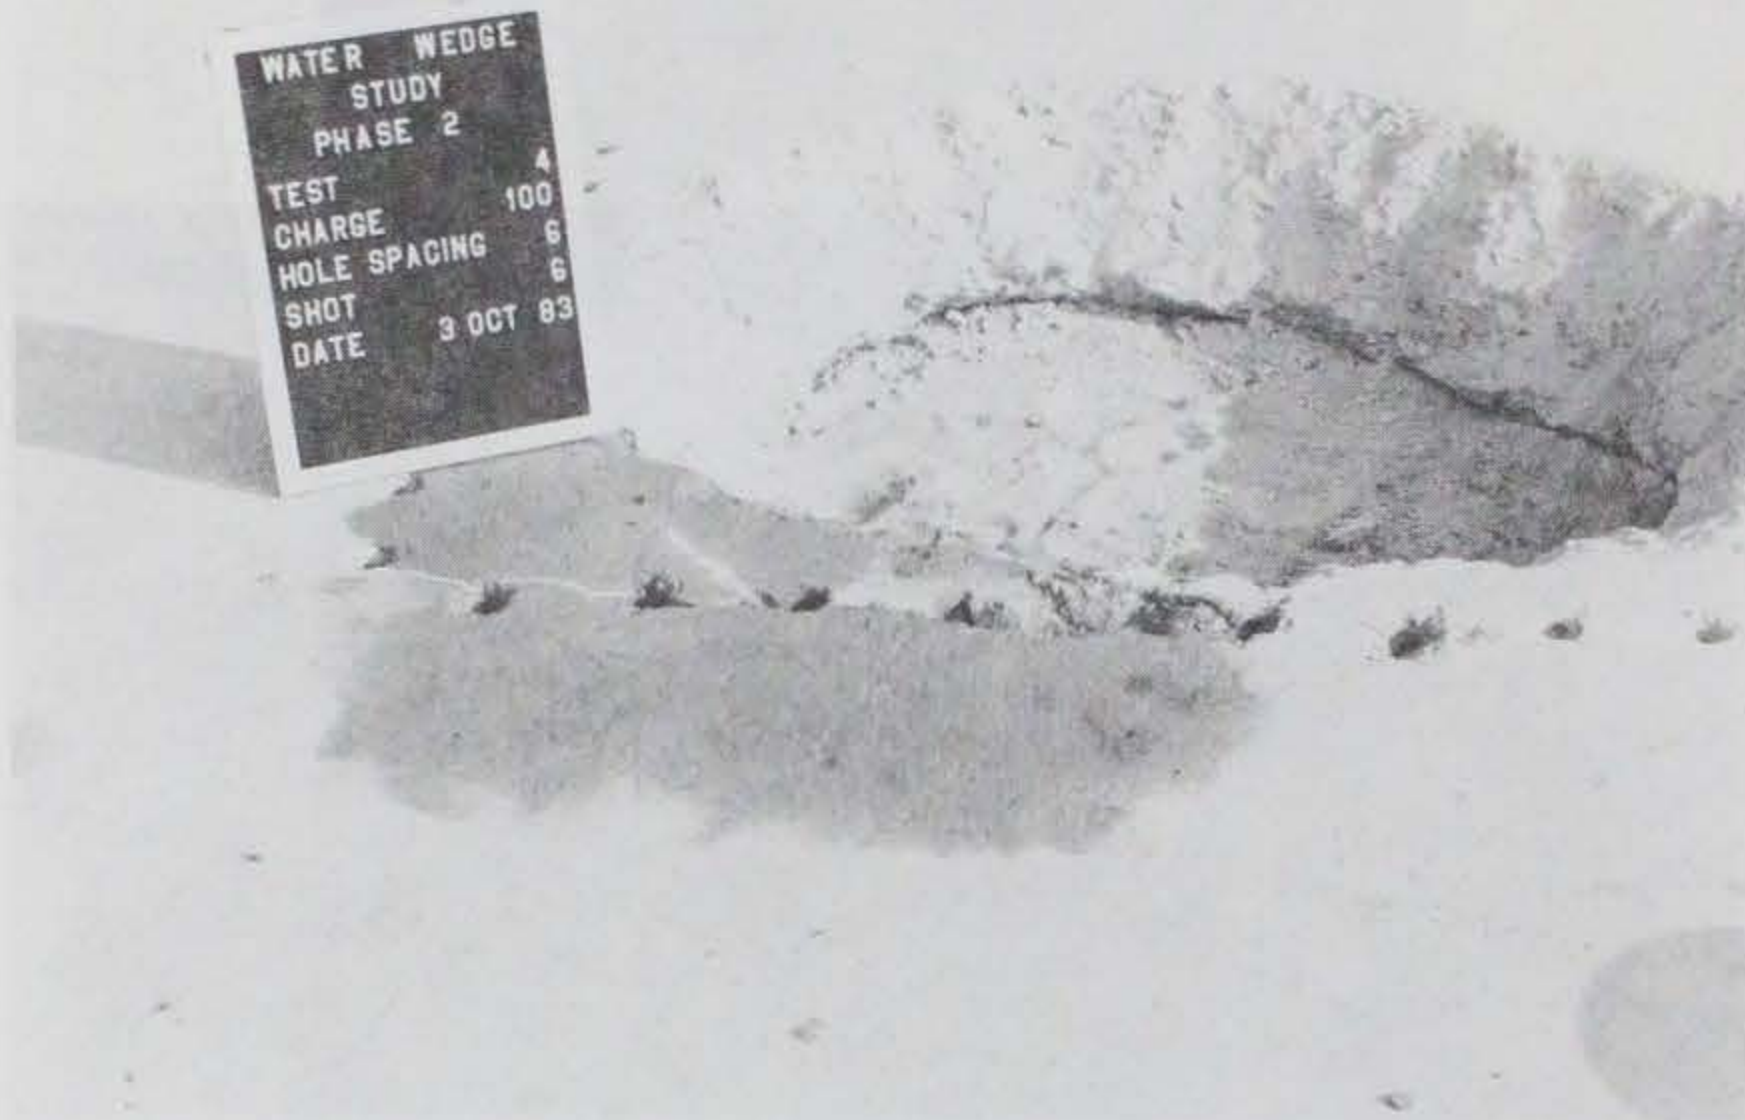
Photo 28. Extent of cracking and spalling after shot 6, test 4

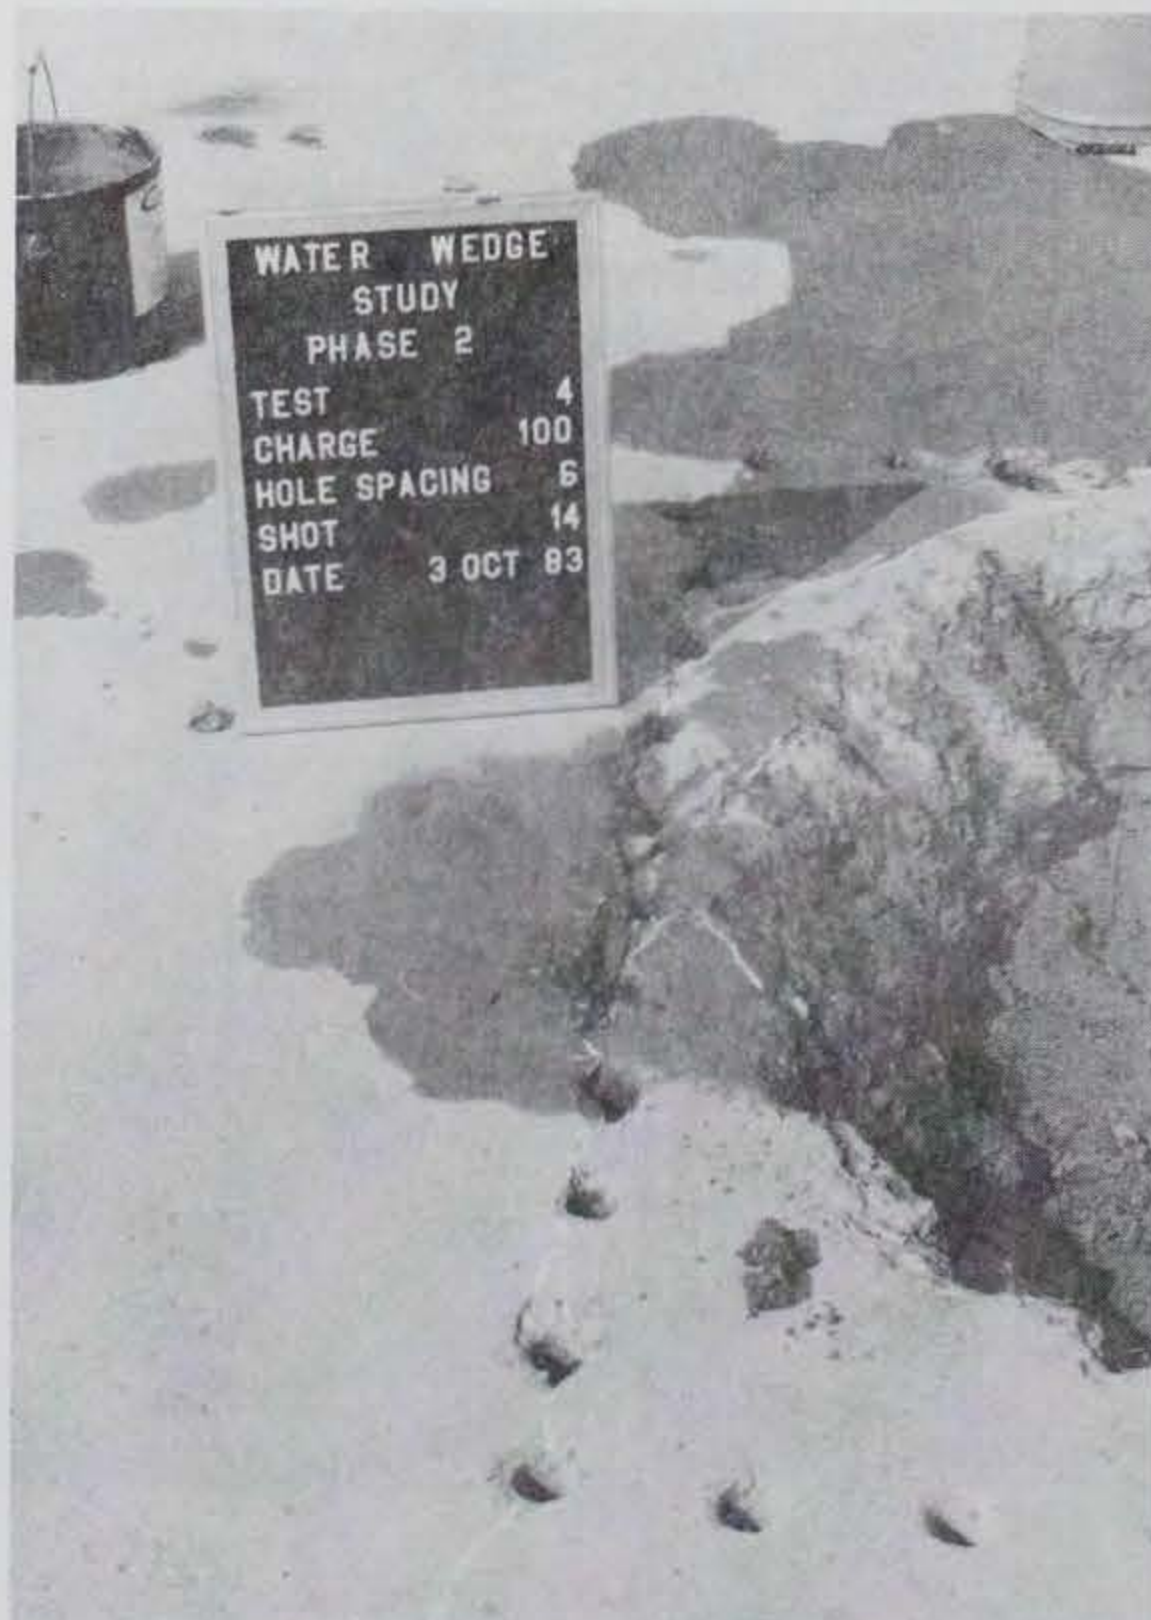
Photo 29. Extent of cracking and spalling after shot 15, test 4

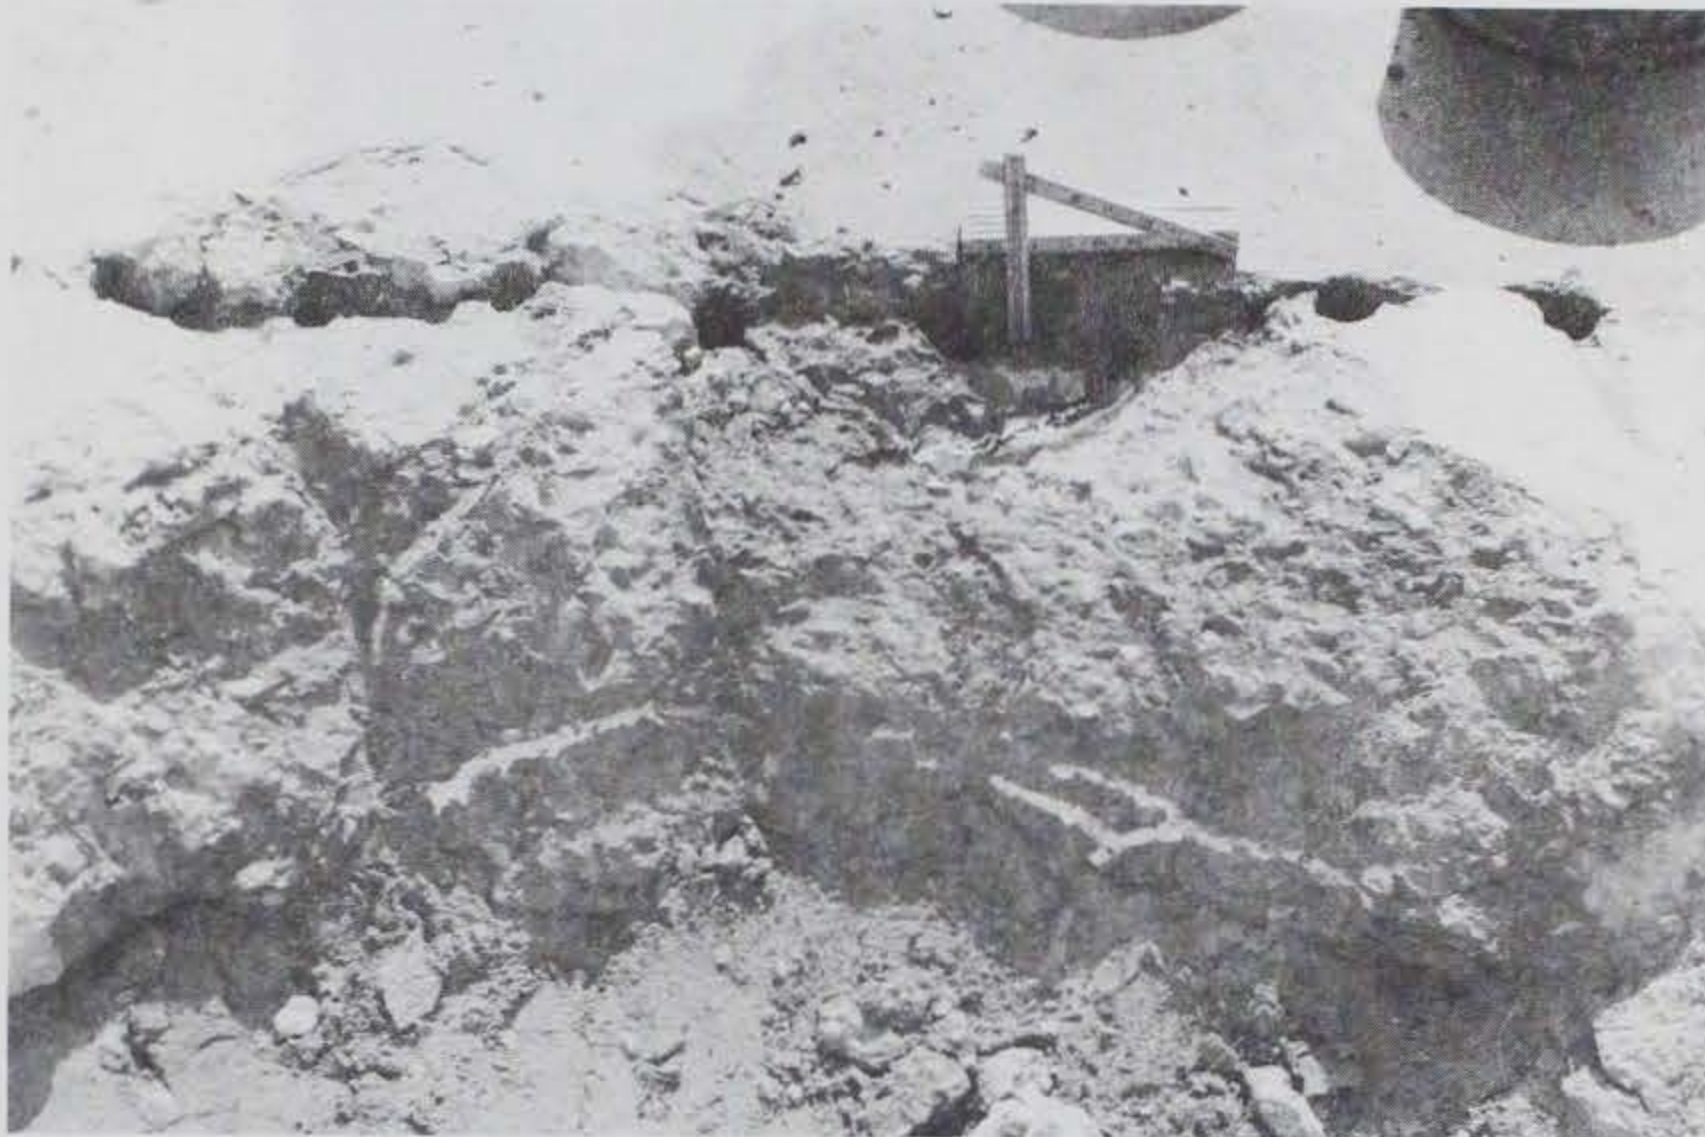
Photo 30. Cracks occurring in wall of crater after shot 23, test 4

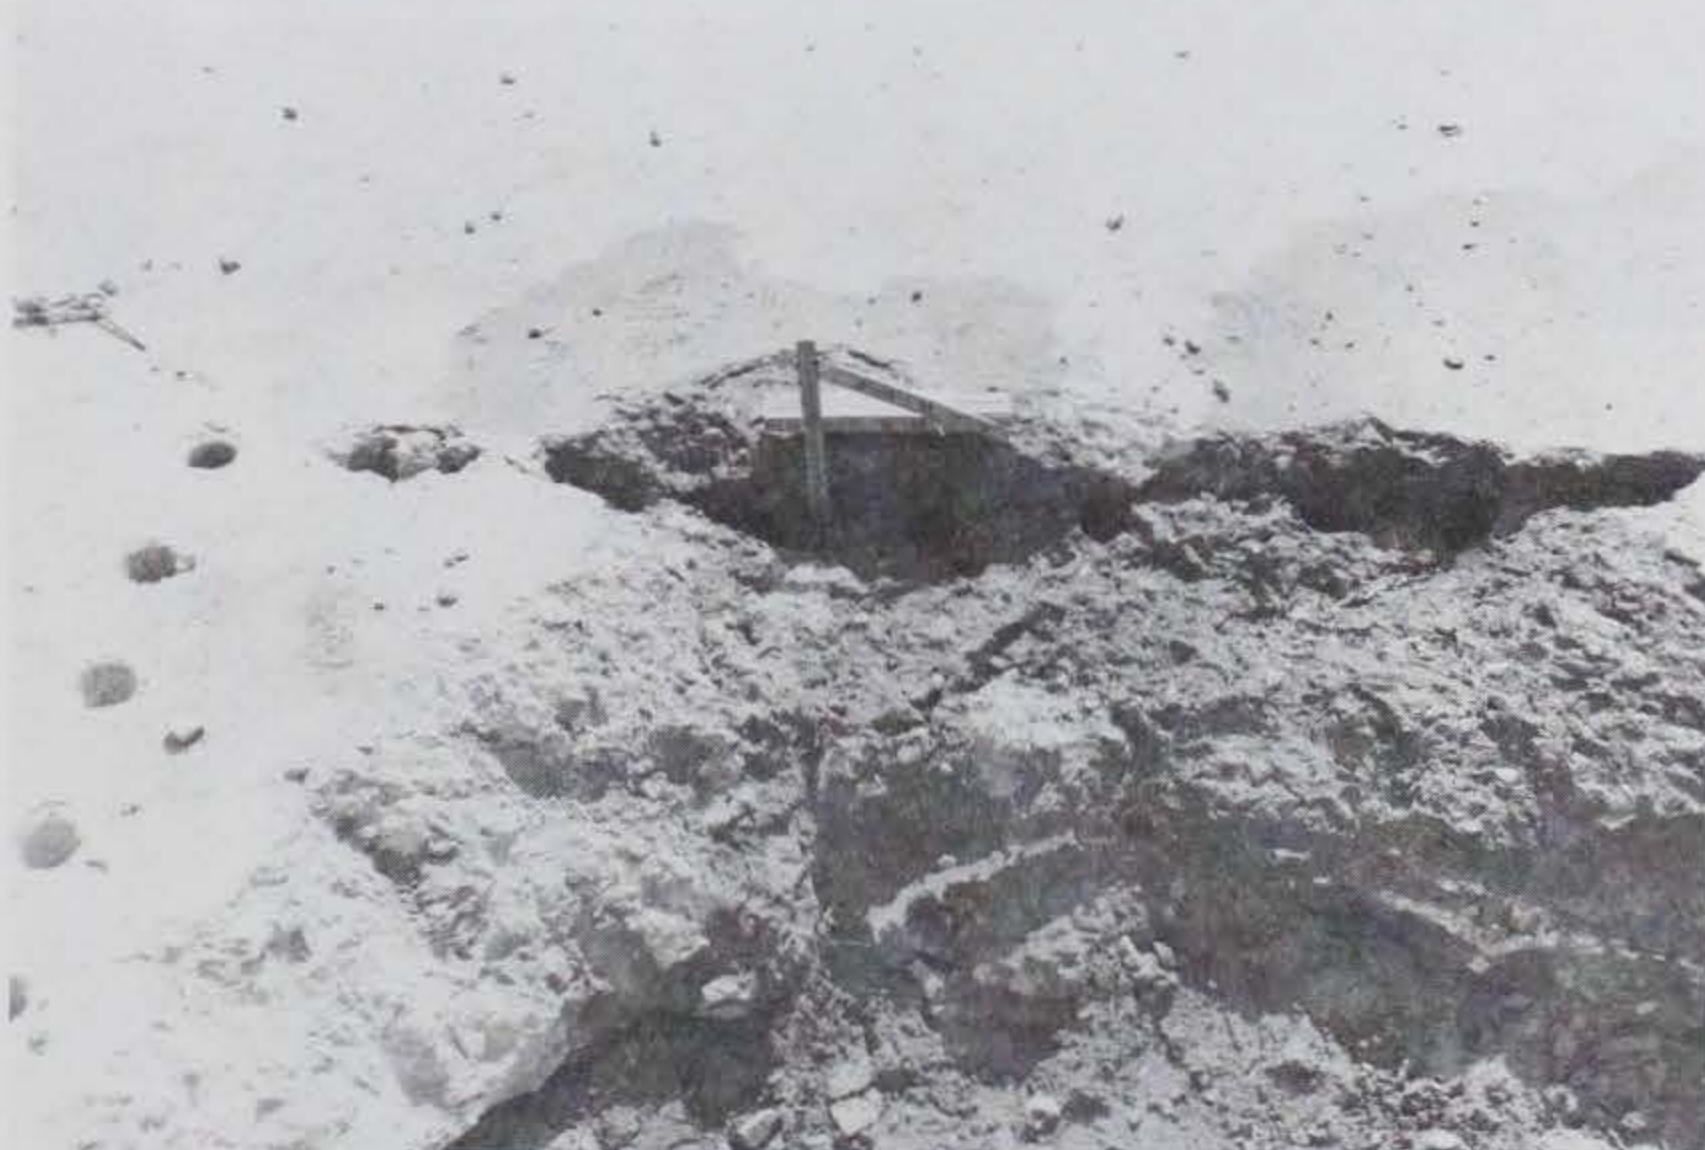
Photo 31. Extent of spalling after shot 29, test 4

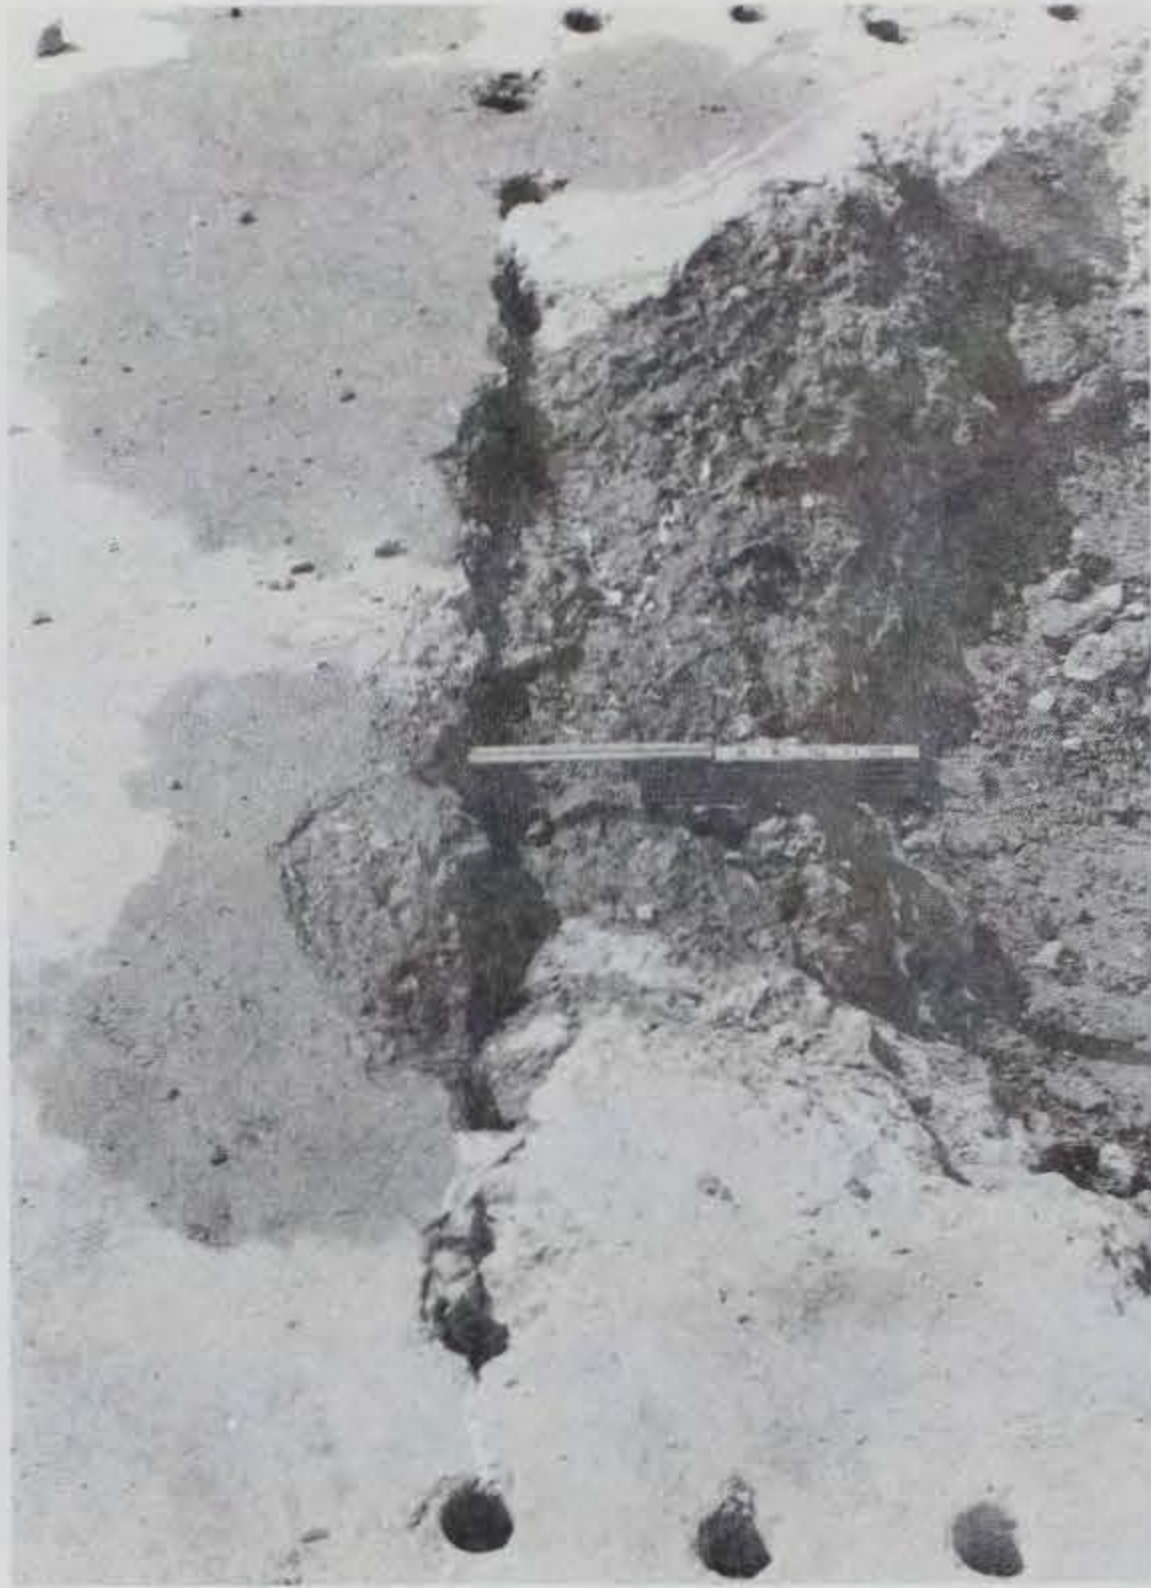
Photo 32. Extent of cracking and spalling after shot 29, test 4

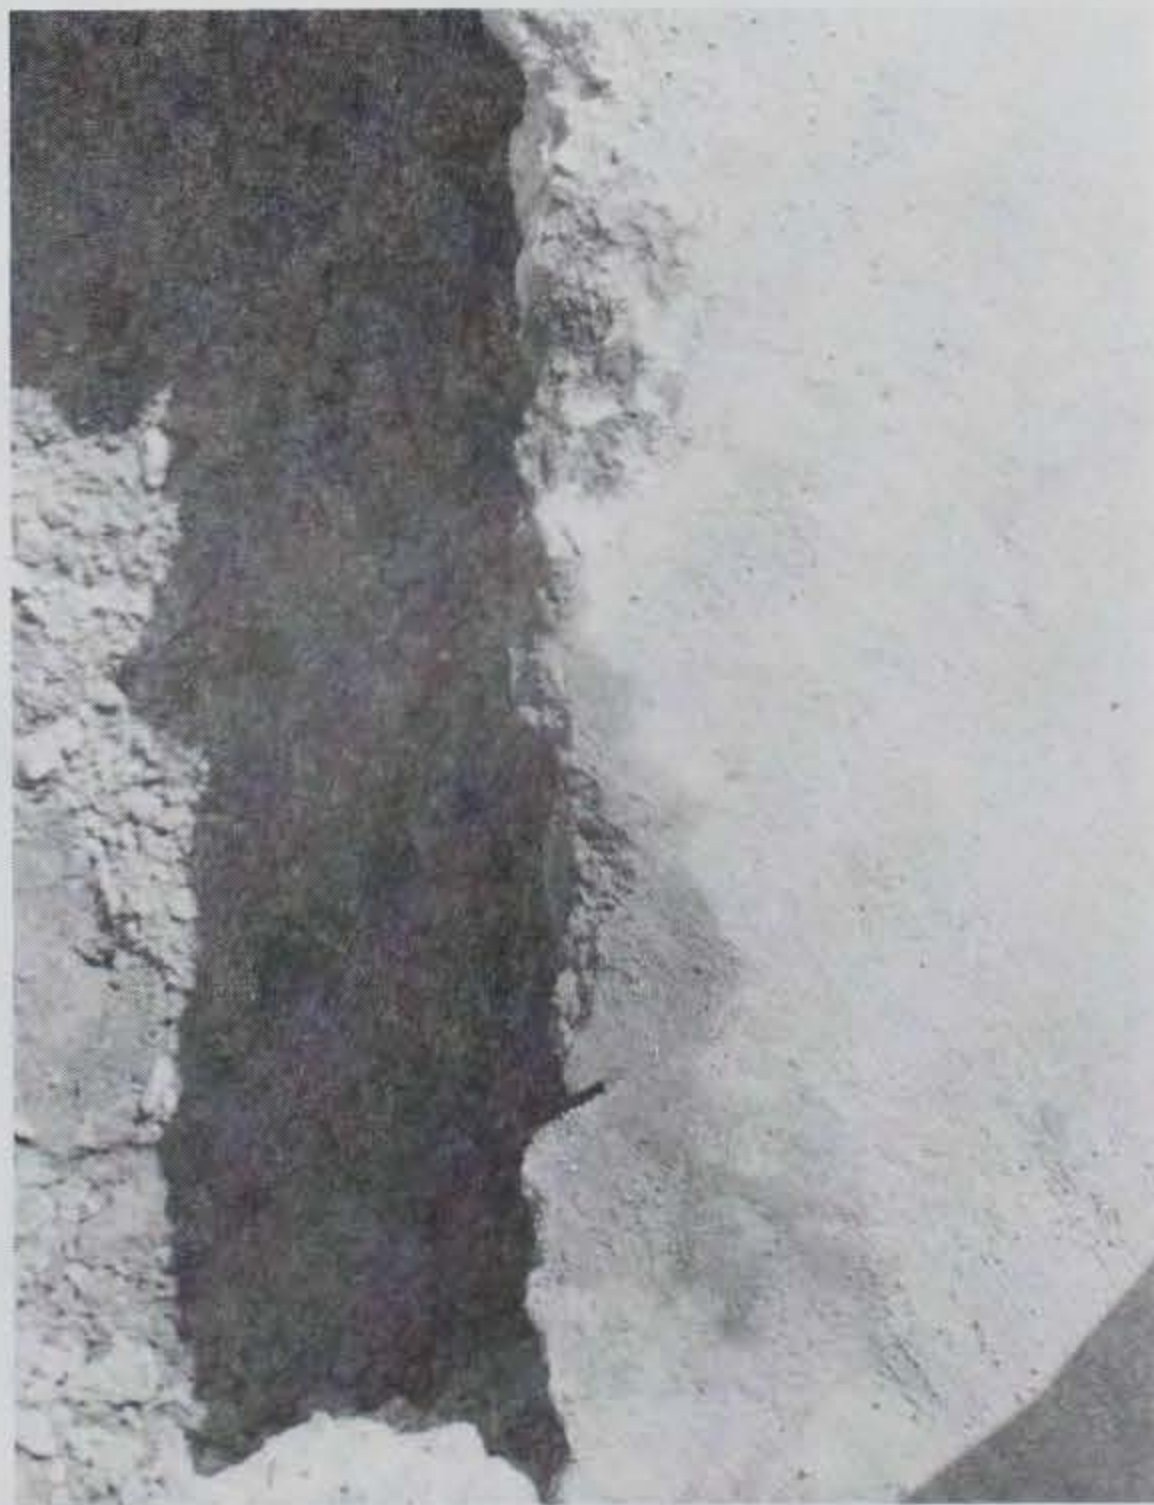
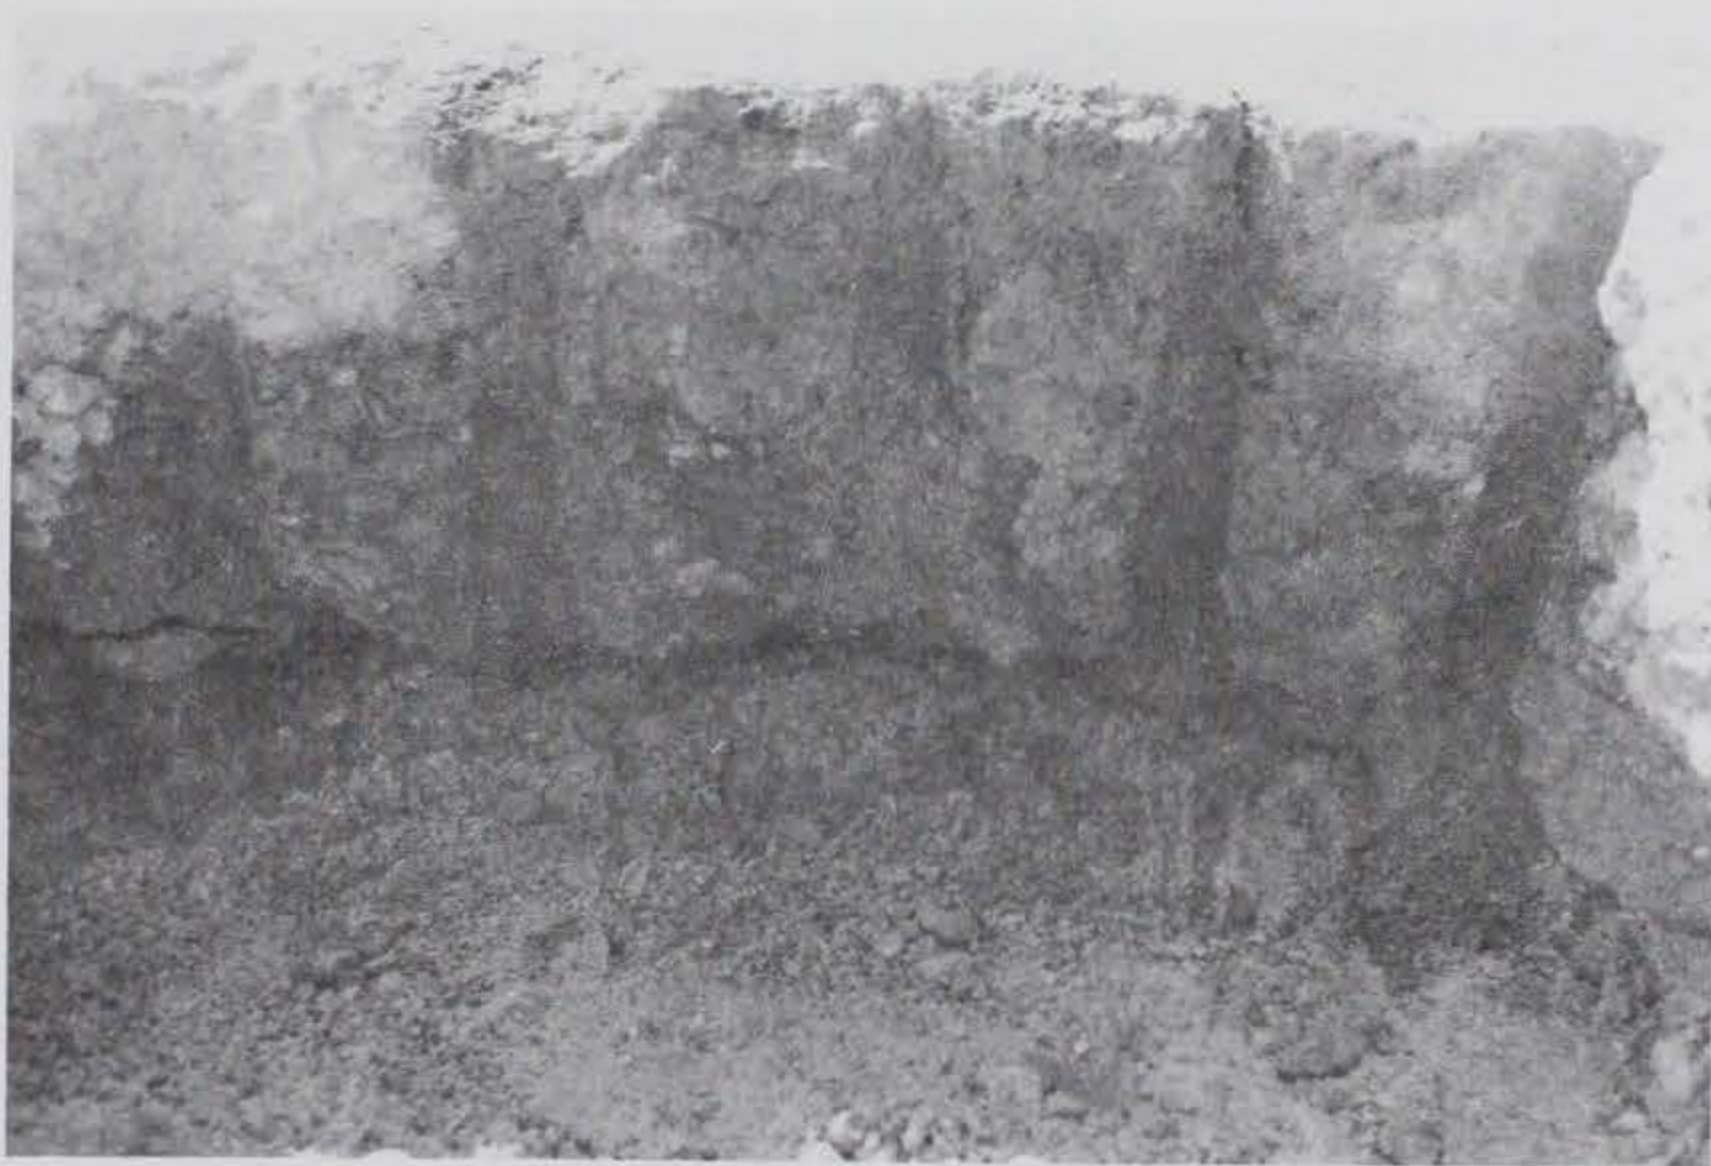
- f. The edge resulting from the cracking produced by the Water Wedge device is uneven, and some grinding or saw cutting will be required to produce a smooth edge.

Photo 33. Edge resulting from Water Wedge cutting

Photo 34. Edge resulting from Water  
Wedge cutting
