US Army Corps
of Engineers

MISCELLANEOUS PAPER GL-92-17

A CASE STUDY: DAMAGE TO THE METROPOLITAN OAKLAND INTERNATIONAL AIRPORT CAUSED BY THE LOMA PRIETA EARTHQUAKE

July 1992

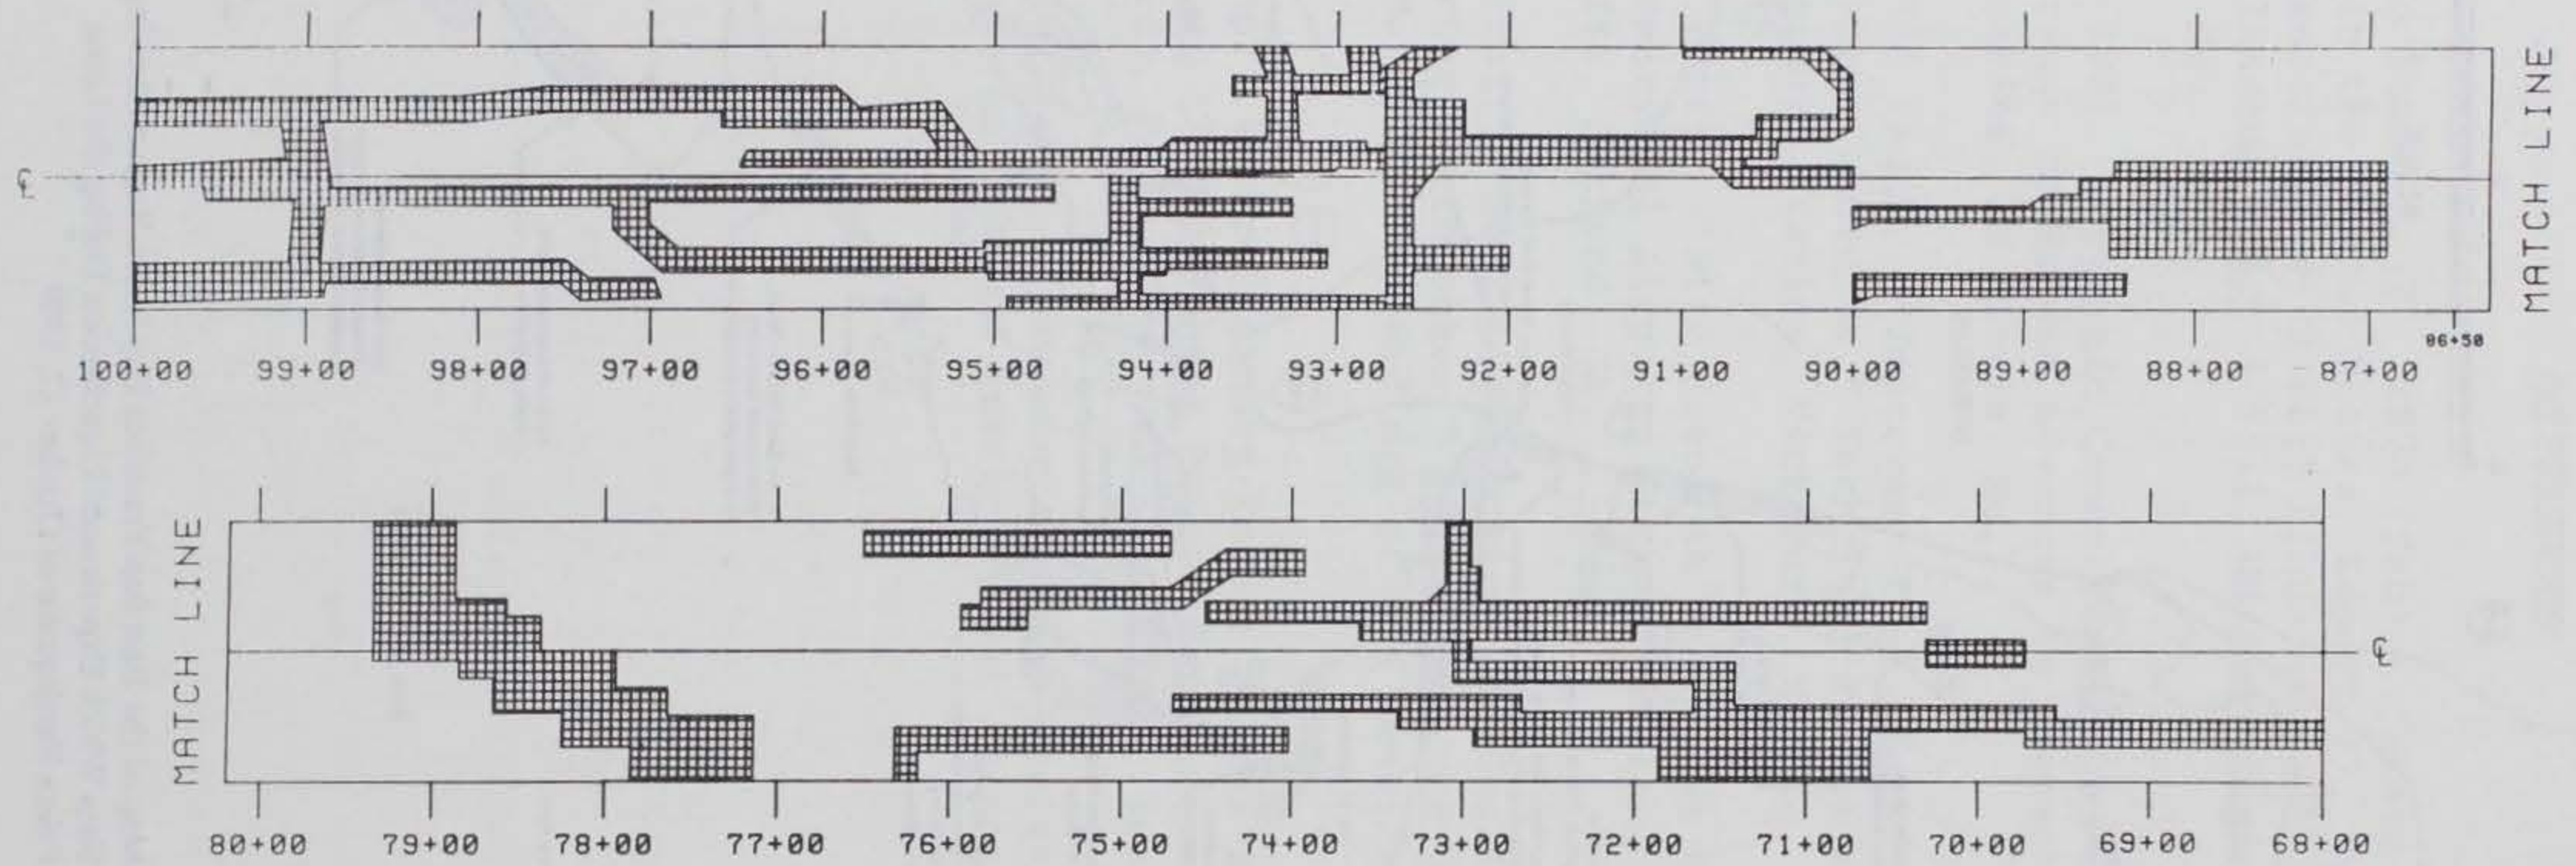
the MOIA airfield runway pavement that had to be repaired due to cracks as a result of the Loma Prieta Earthquake. This report presents and discusses the conditions that lead to the failure of the 3,000 ft of runway, describes the damage which occurred, recites what was done to repair the runway, and gives an overview of possible solutions to reduce the susceptibility of the airfield to damage in the event of a future earthquake.

Figure 2. Plan view of areas requiring repair after earthquake

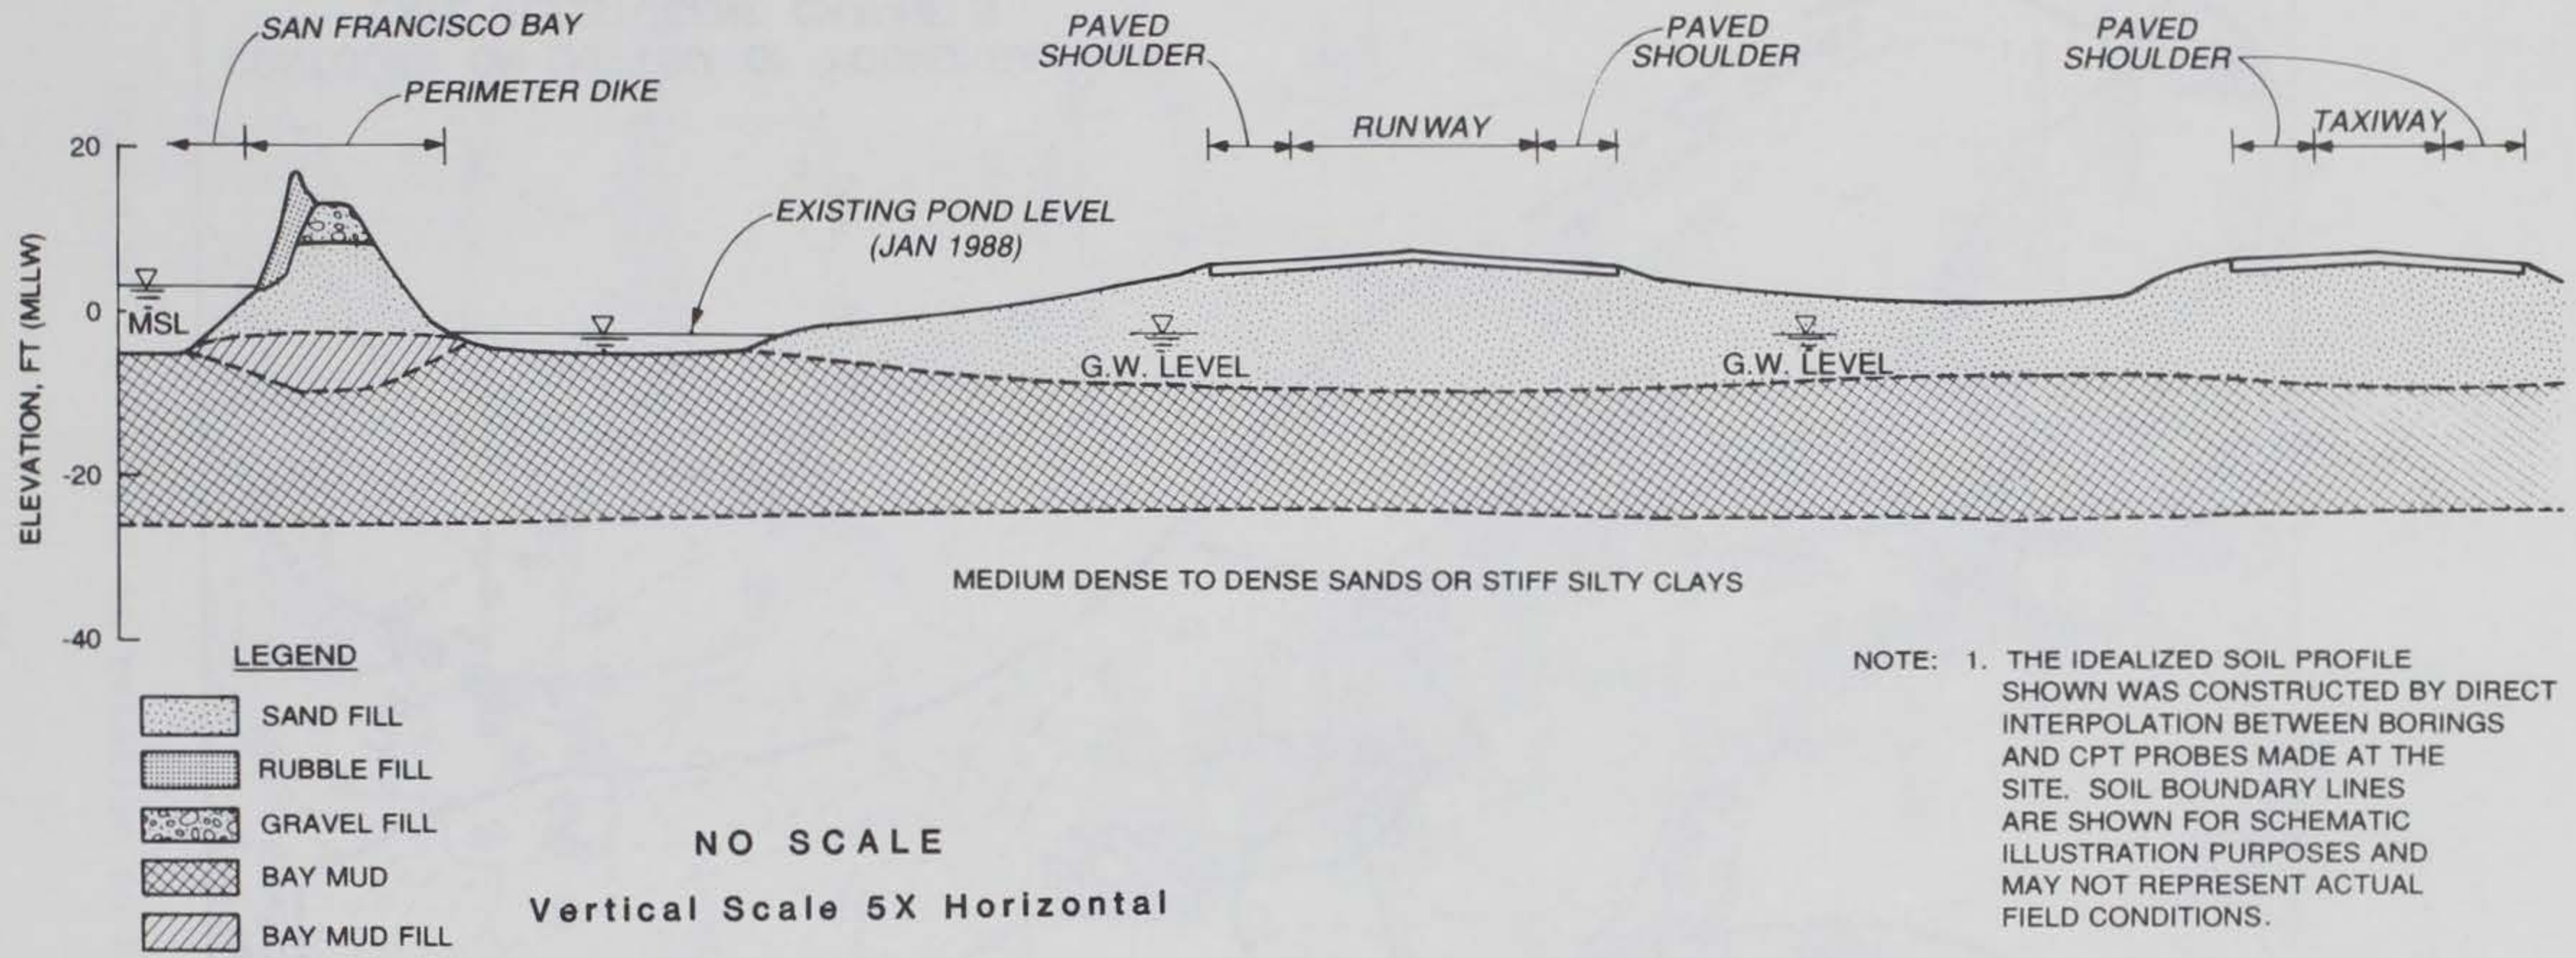
8. A cross section of the airfield through the dike, the runway, and the taxiway is shown in Figure 3. Figure 3 shows some critical items that make this site susceptible to liquefaction damage. The relatively loose hydraulic sandfill with a high water table over bay mud on medium to dense sands or stiff silty clay makes the MOIA site vulnerable to liquefaction. The layers underlying the fill intensified the ground shaking helping to cause the sandfill to liquefy. The mean high sea level at 5.8 ft maintains a high water table in the sandfill. Typically the water table is approximately 7 to 10 ft

32. A final contributing factor causing the last 3,000 ft of runway to sustain damage was the geology of the area. As shown in Figure 3, the last part of the runway was constructed over an area of mud deeper than that over which the rest of the airfield was constructed. This difference in geology led to a different response to the earthquake loading.

Figure 3. Cross section through dike and runway

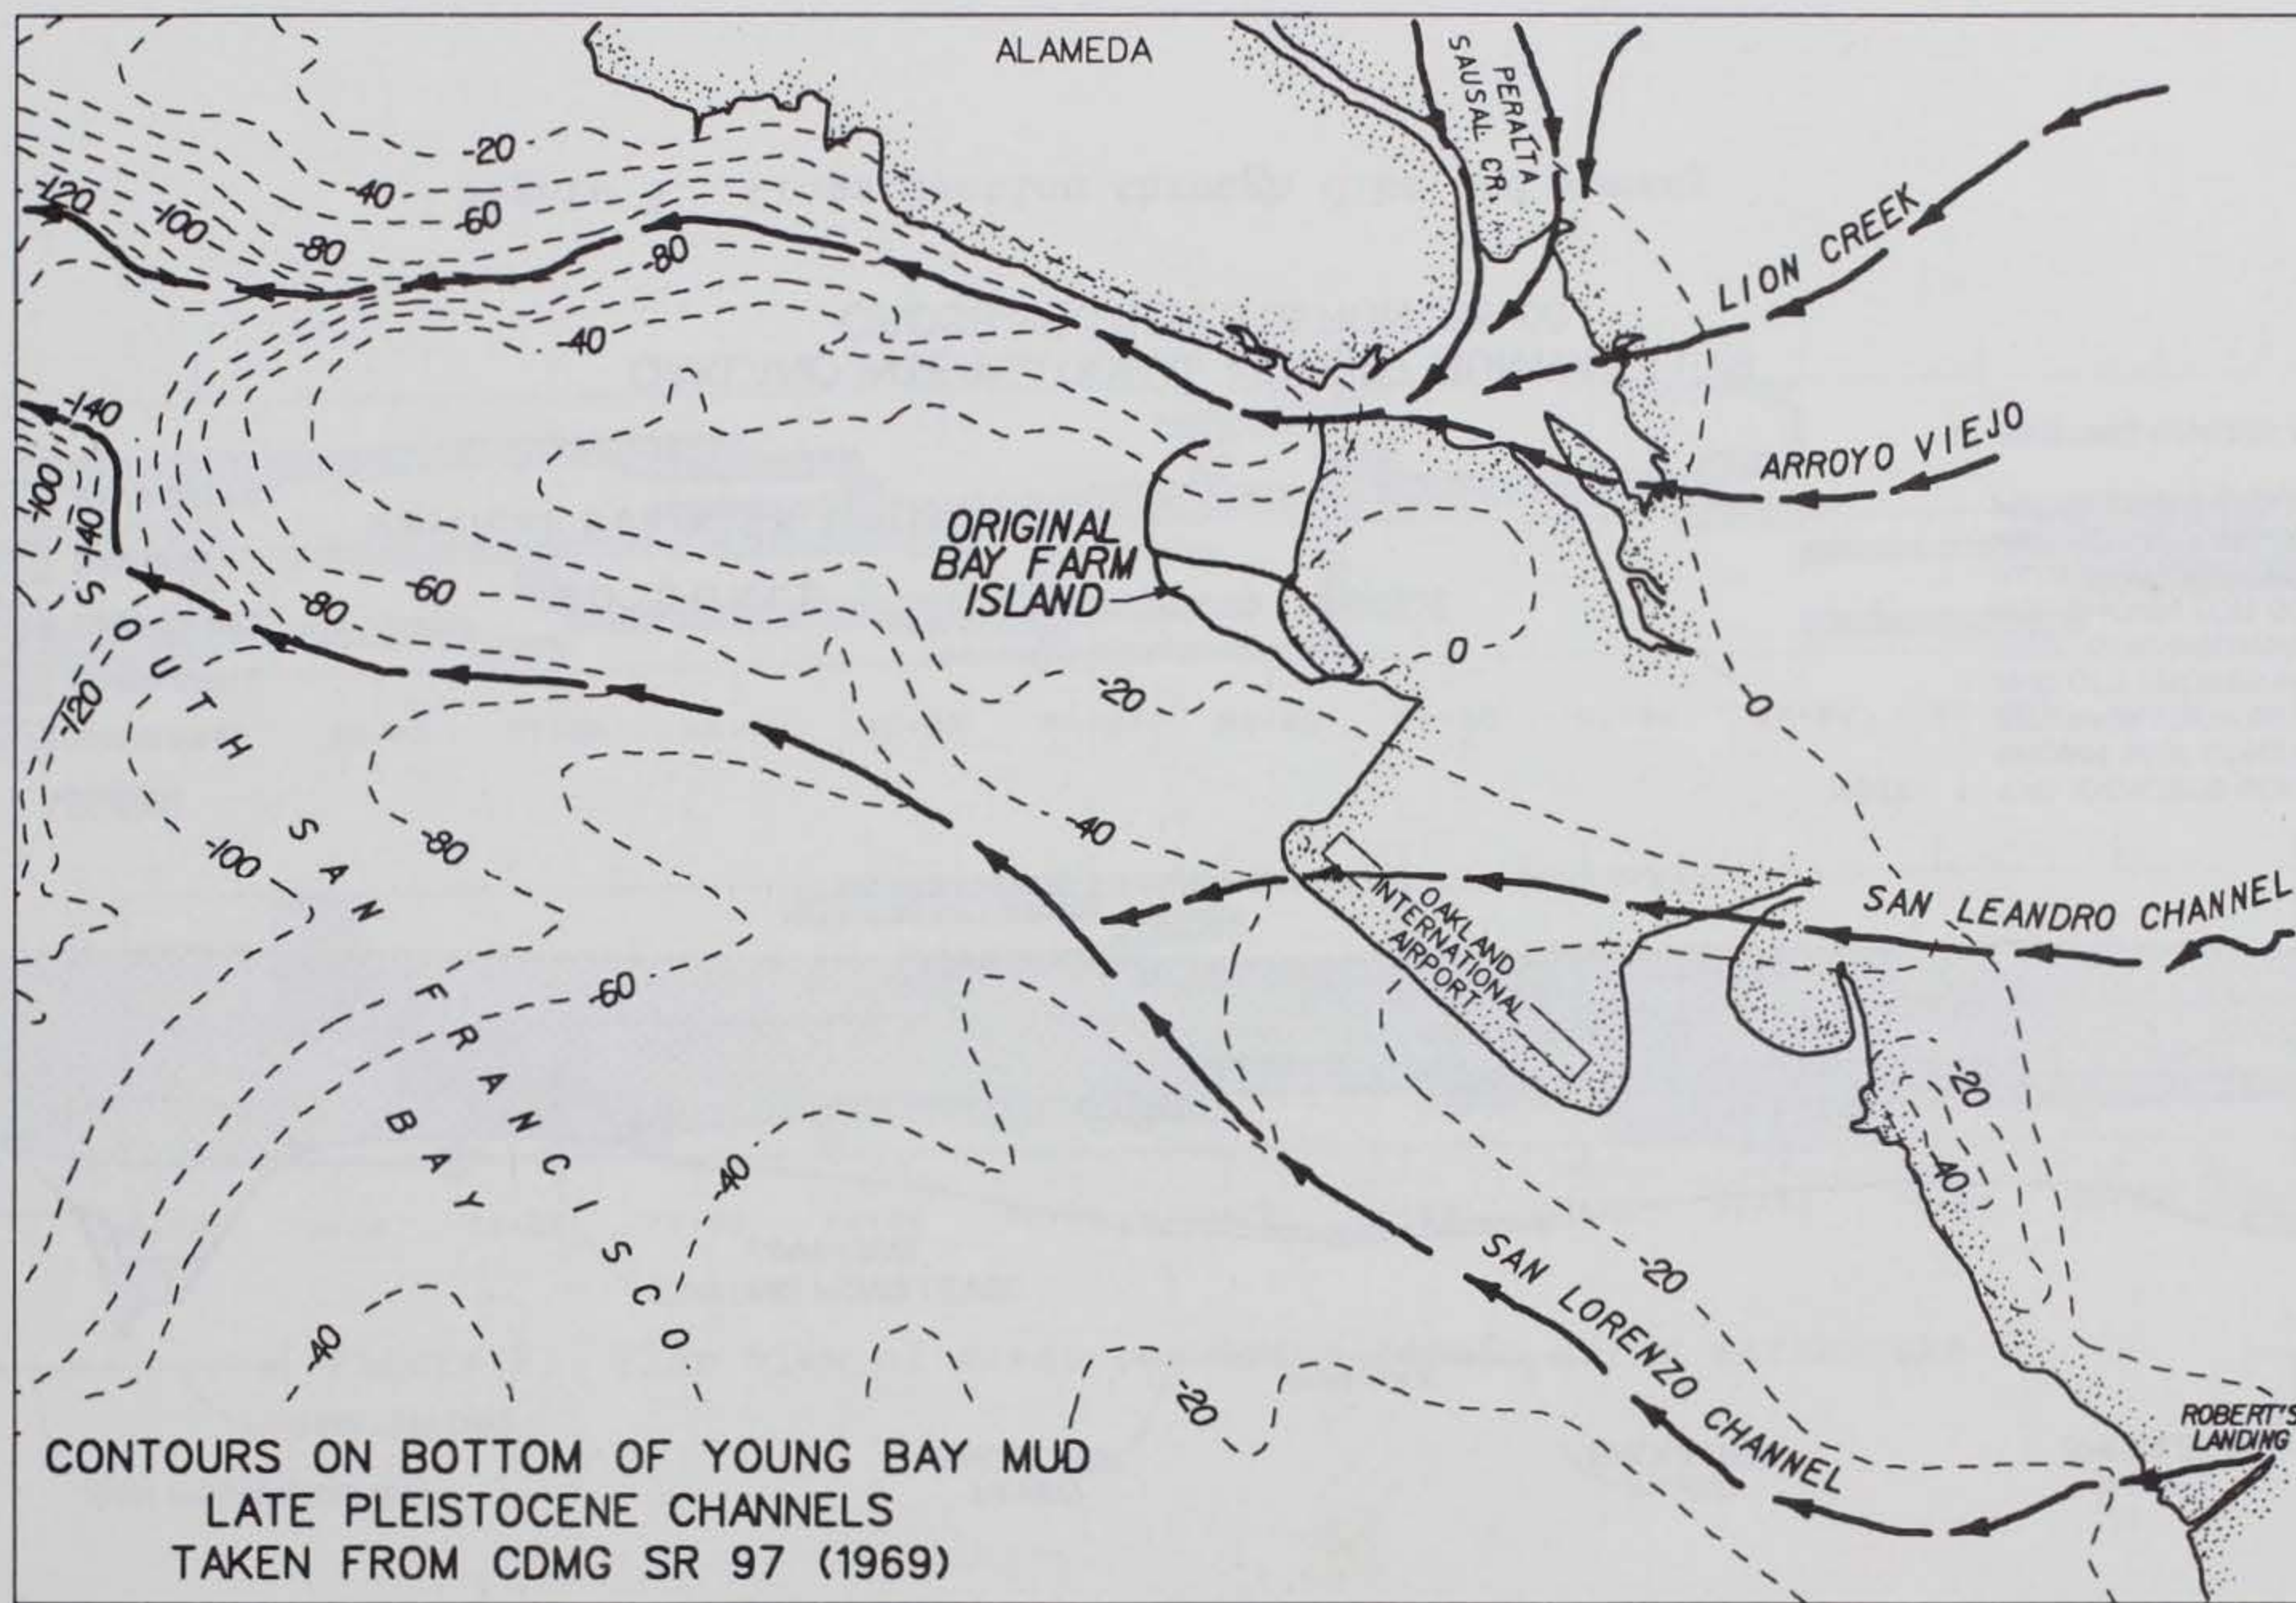
12. An interesting geologic feature may have added to the susceptibility of the west end of the runway to liquefaction. A map entitled "Contours on Bottom of Young Bay Mud", found in the California Division of Mines and Geology (CDMG) Special Report 97, shows the Late-Pleistocene topography before the rising sea levels and the deposition of the Young Bay Muds. Figure 4 shows the topography around the airport from CDMG Special Report 97 with some interpolations. The contours in Figure 4 show the San Leandro Creek channel crossing the western end of the MOIA Runway 11-29. The deeper Young Bay Muds (Rogers 1990) in this area would lead to lengthened site periods and amplified strong motion components. The strong motions resulting from this deeper mud would provide for more intense ground shaking in the liquefaction susceptible soils underlying the western part of the runway than under the eastern part. Liquefiable soils underlie the entire runway, but the increased ground motion in the area of the deeper muds may have made the west end of the runway more vulnerable to liquefaction damage than the rest of the runway.

Figure 4. Topography of Young Bay Muds

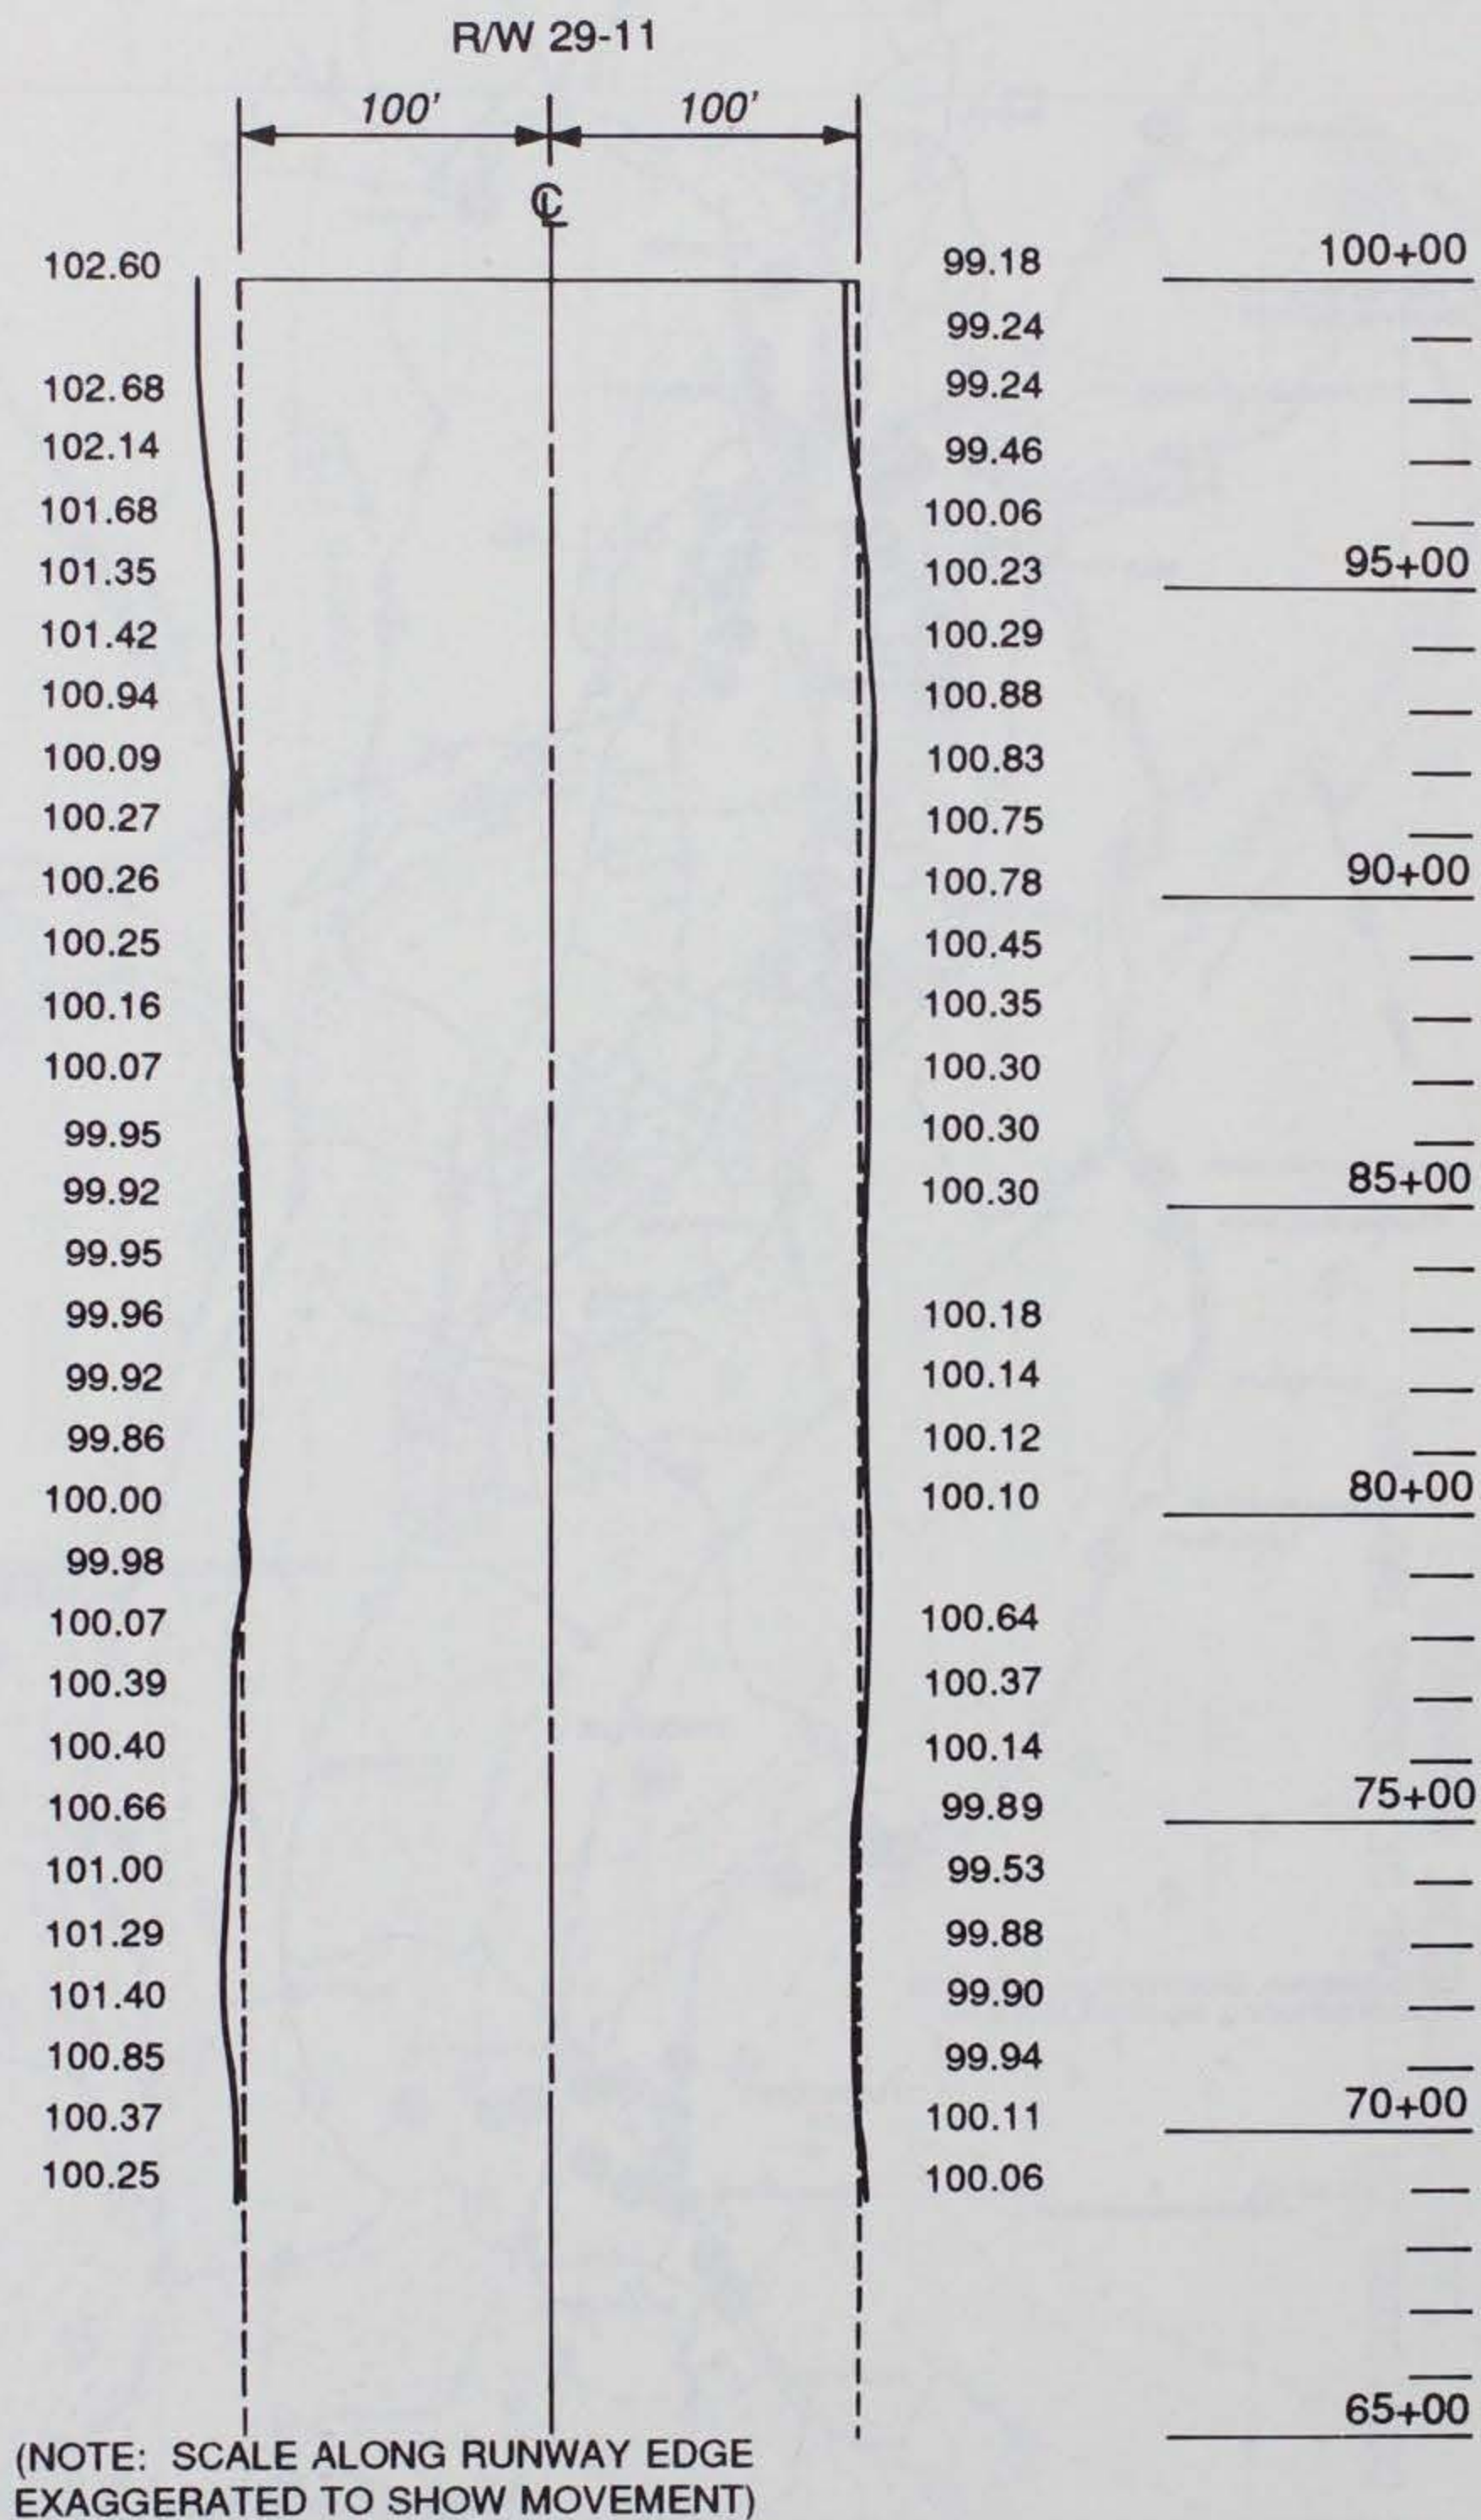
LATERAL SPREADING @ OAKLAND AIRPORT DUE TO LOMA PRIETA EARTHQUAKE

Figure 6. Lateral spreading of runway

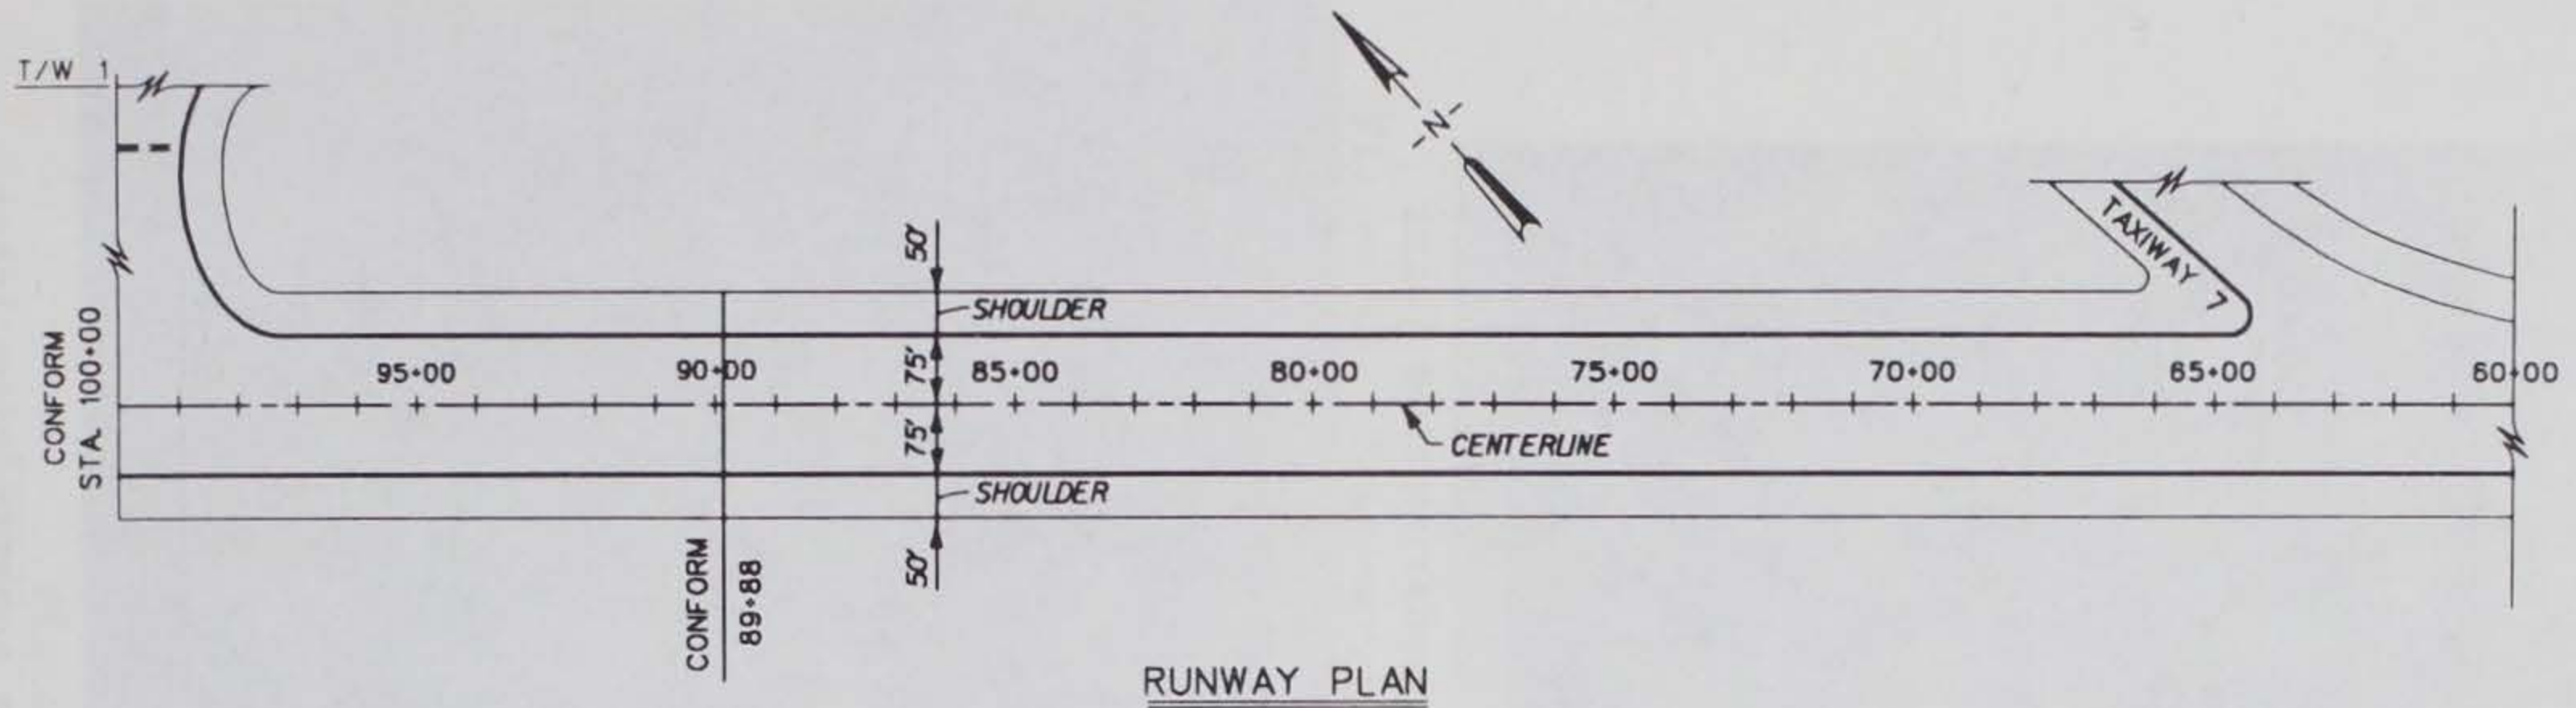
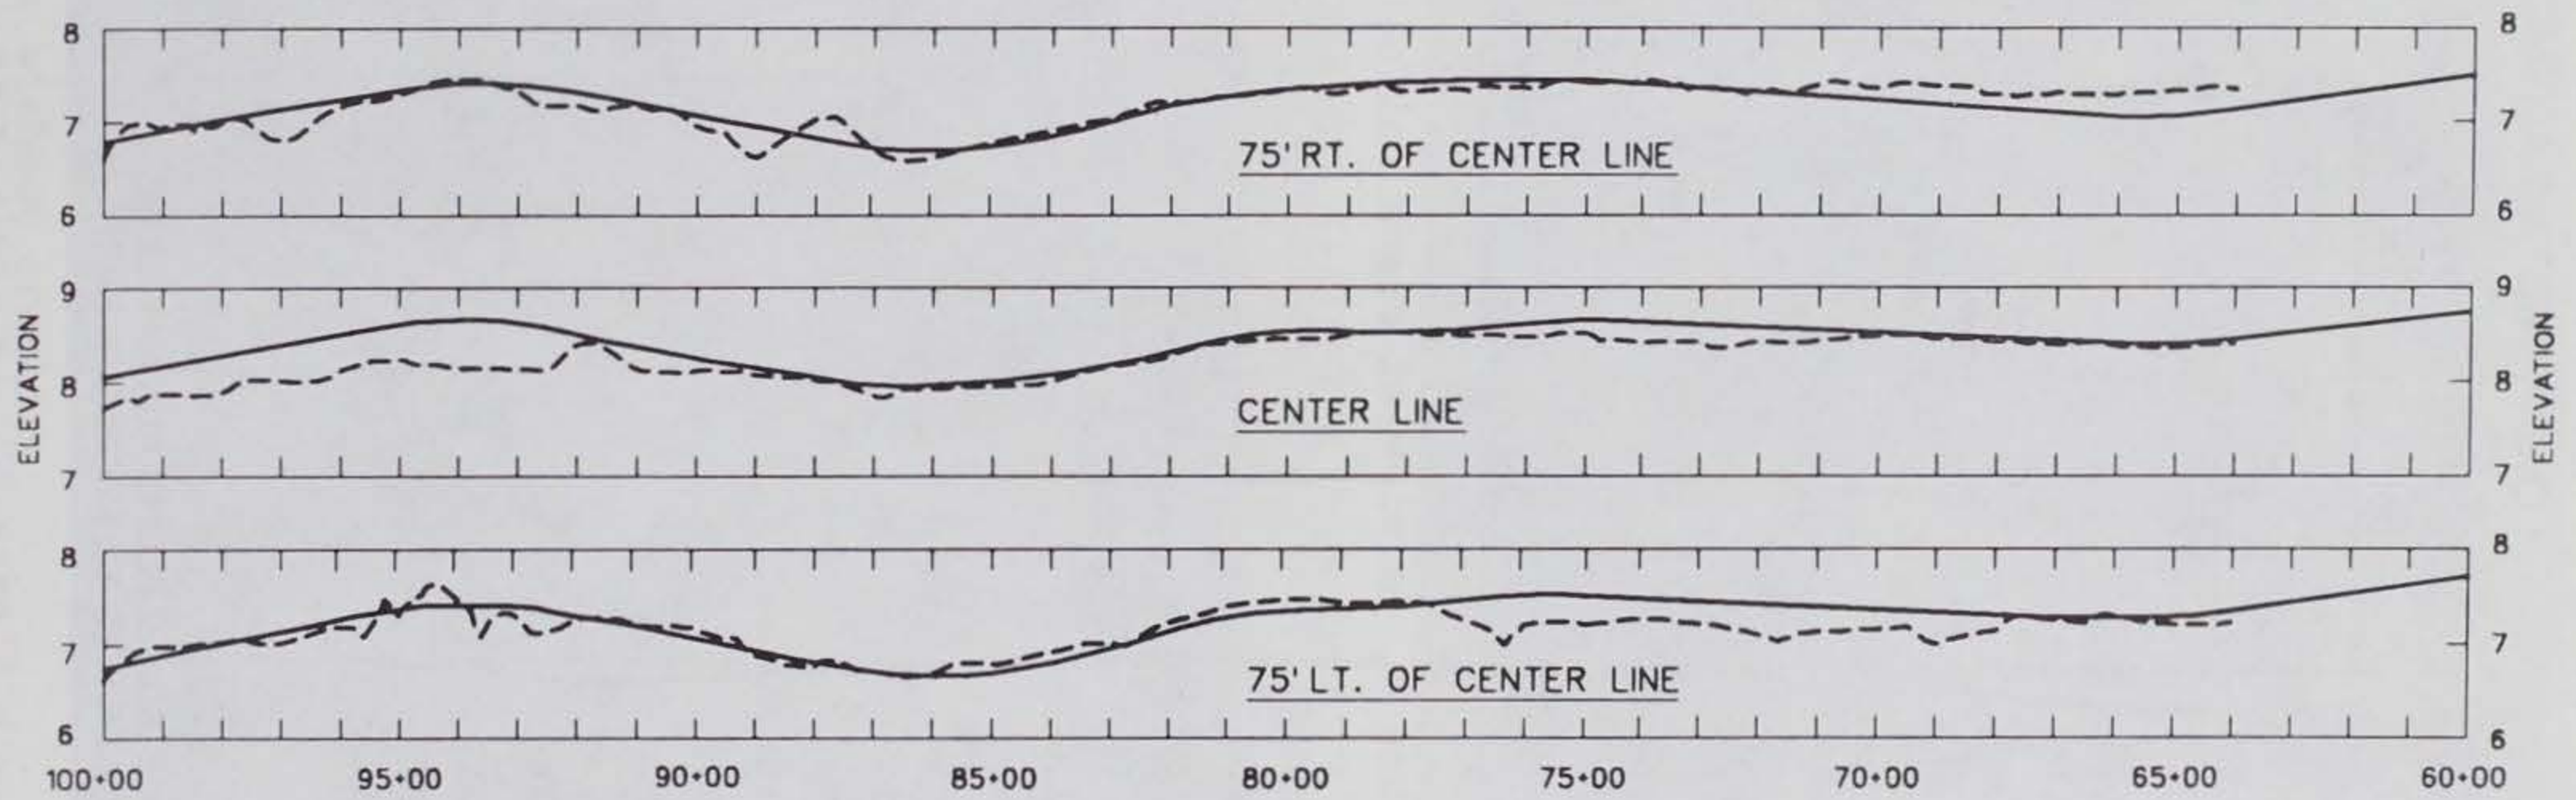
Figure 7. Runway profiles

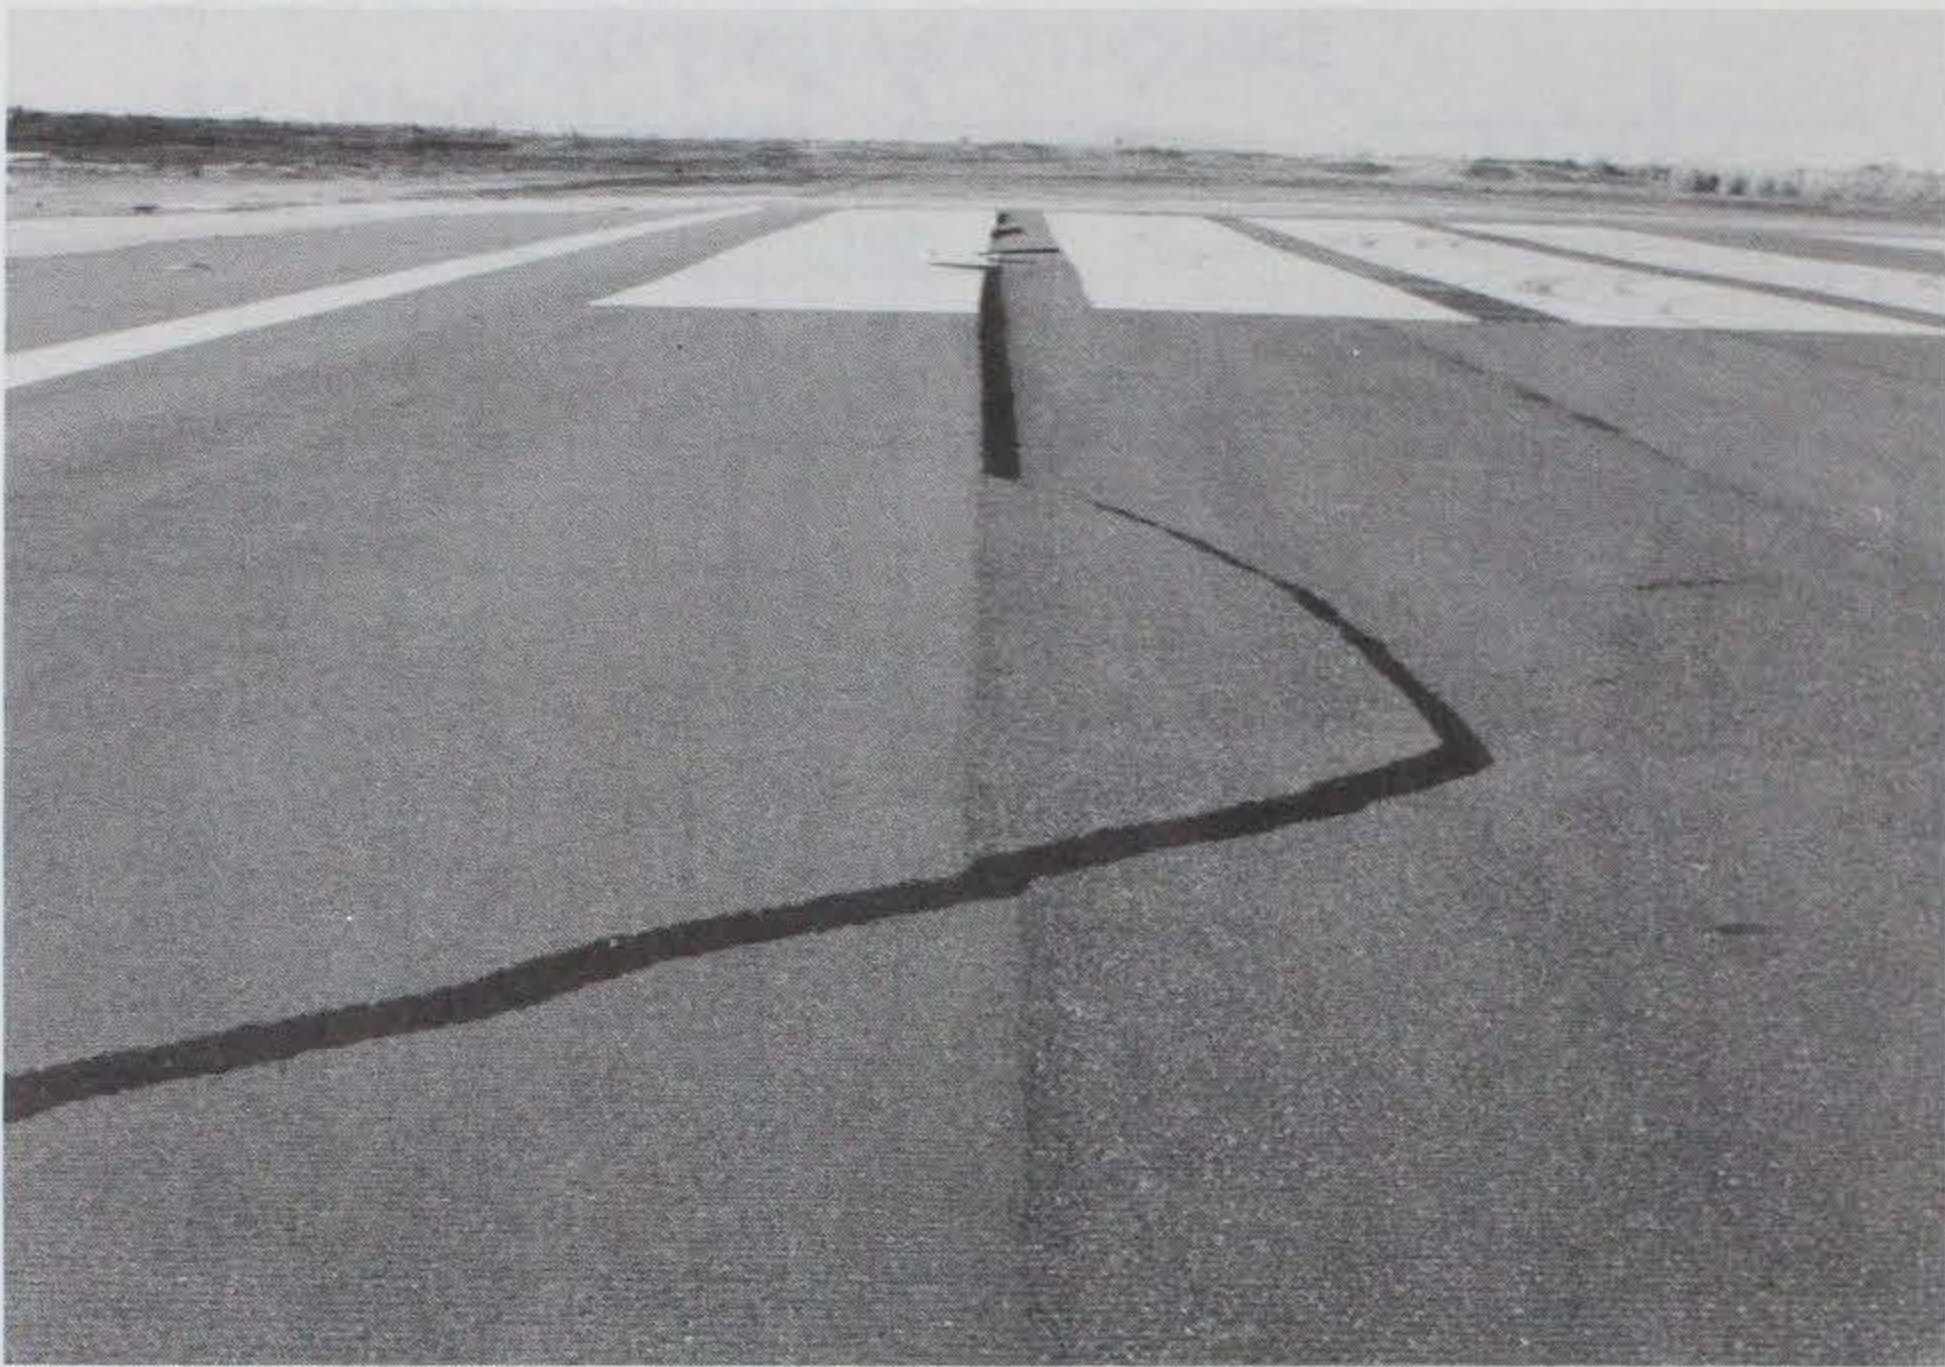
23. The majority of the cracks that formed in the pavement as a result of the earthquake followed joints in the pavement and then skewed off at various angles until they met another joint which they would then follow. Figures 8 and 9 show where the cracks followed construction joints in the AC pavement. Figure 10 shows a transverse crack, which did not follow a joint. Figure 11 shows a longitudinal crack; one side of the crack dropped in elevation significantly greater (8 in.) than the adjacent side of the crack. It should be noted that the 8-in.-thick, 15-year old AC pavement, showing signs of embrittlement, deformed 8 in. over a span of 11.2 ft without visible surface cracking at the location shown in Figure 11. Sand boils formed at many cracks. Figures 12 and 13 show sand boils that formed.

Figure 8. A view of crack following construction joint
