US Army Corps
of Engineers

MISCELLANEOUS PAPER GL-92-17

A CASE STUDY: DAMAGE TO THE METROPOLITAN OAKLAND INTERNATIONAL AIRPORT CAUSED BY THE LOMA PRIETA EARTHQUAKE

July 1992

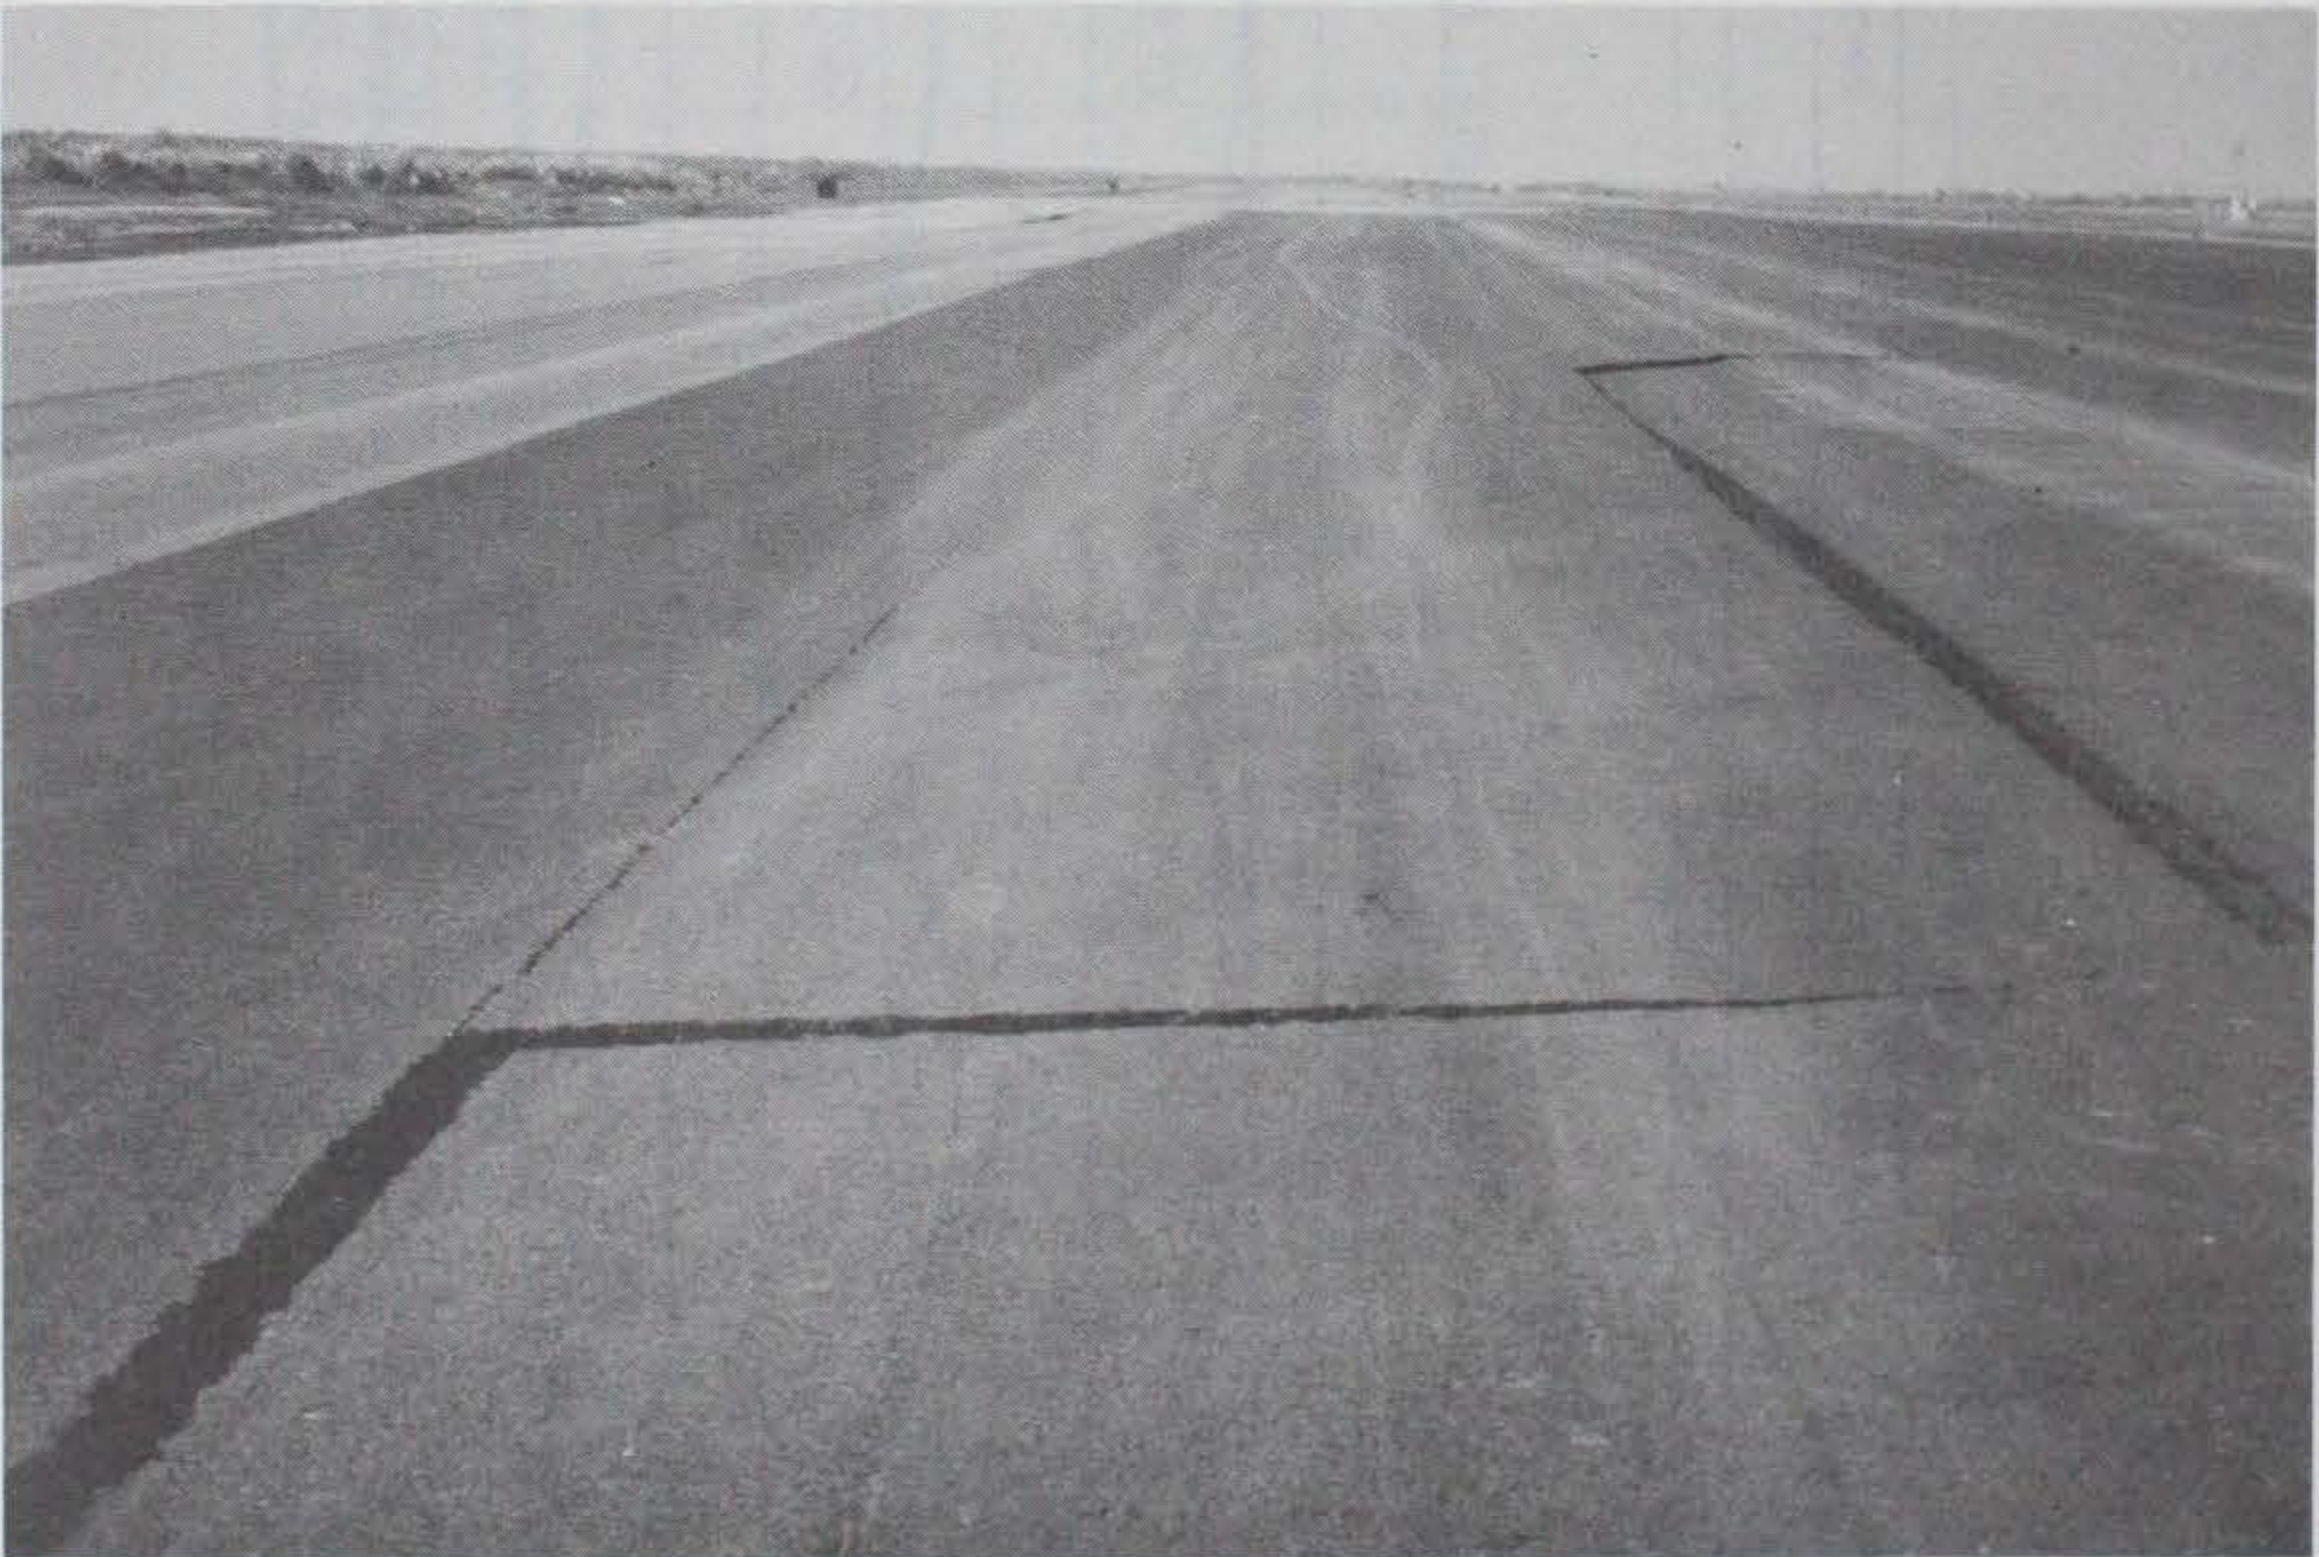
23. The majority of the cracks that formed in the pavement as a result of the earthquake followed joints in the pavement and then skewed off at various angles until they met another joint which they would then follow. Figures 8 and 9 show where the cracks followed construction joints in the AC pavement. Figure 10 shows a transverse crack, which did not follow a joint. Figure 11 shows a longitudinal crack; one side of the crack dropped in elevation significantly greater (8 in.) than the adjacent side of the crack. It should be noted that the 8-in.-thick, 15-year old AC pavement, showing signs of embrittlement, deformed 8 in. over a span of 11.2 ft without visible surface cracking at the location shown in Figure 11. Sand boils formed at many cracks. Figures 12 and 13 show sand boils that formed.

Figure 9. Close-up of crack following construction joint

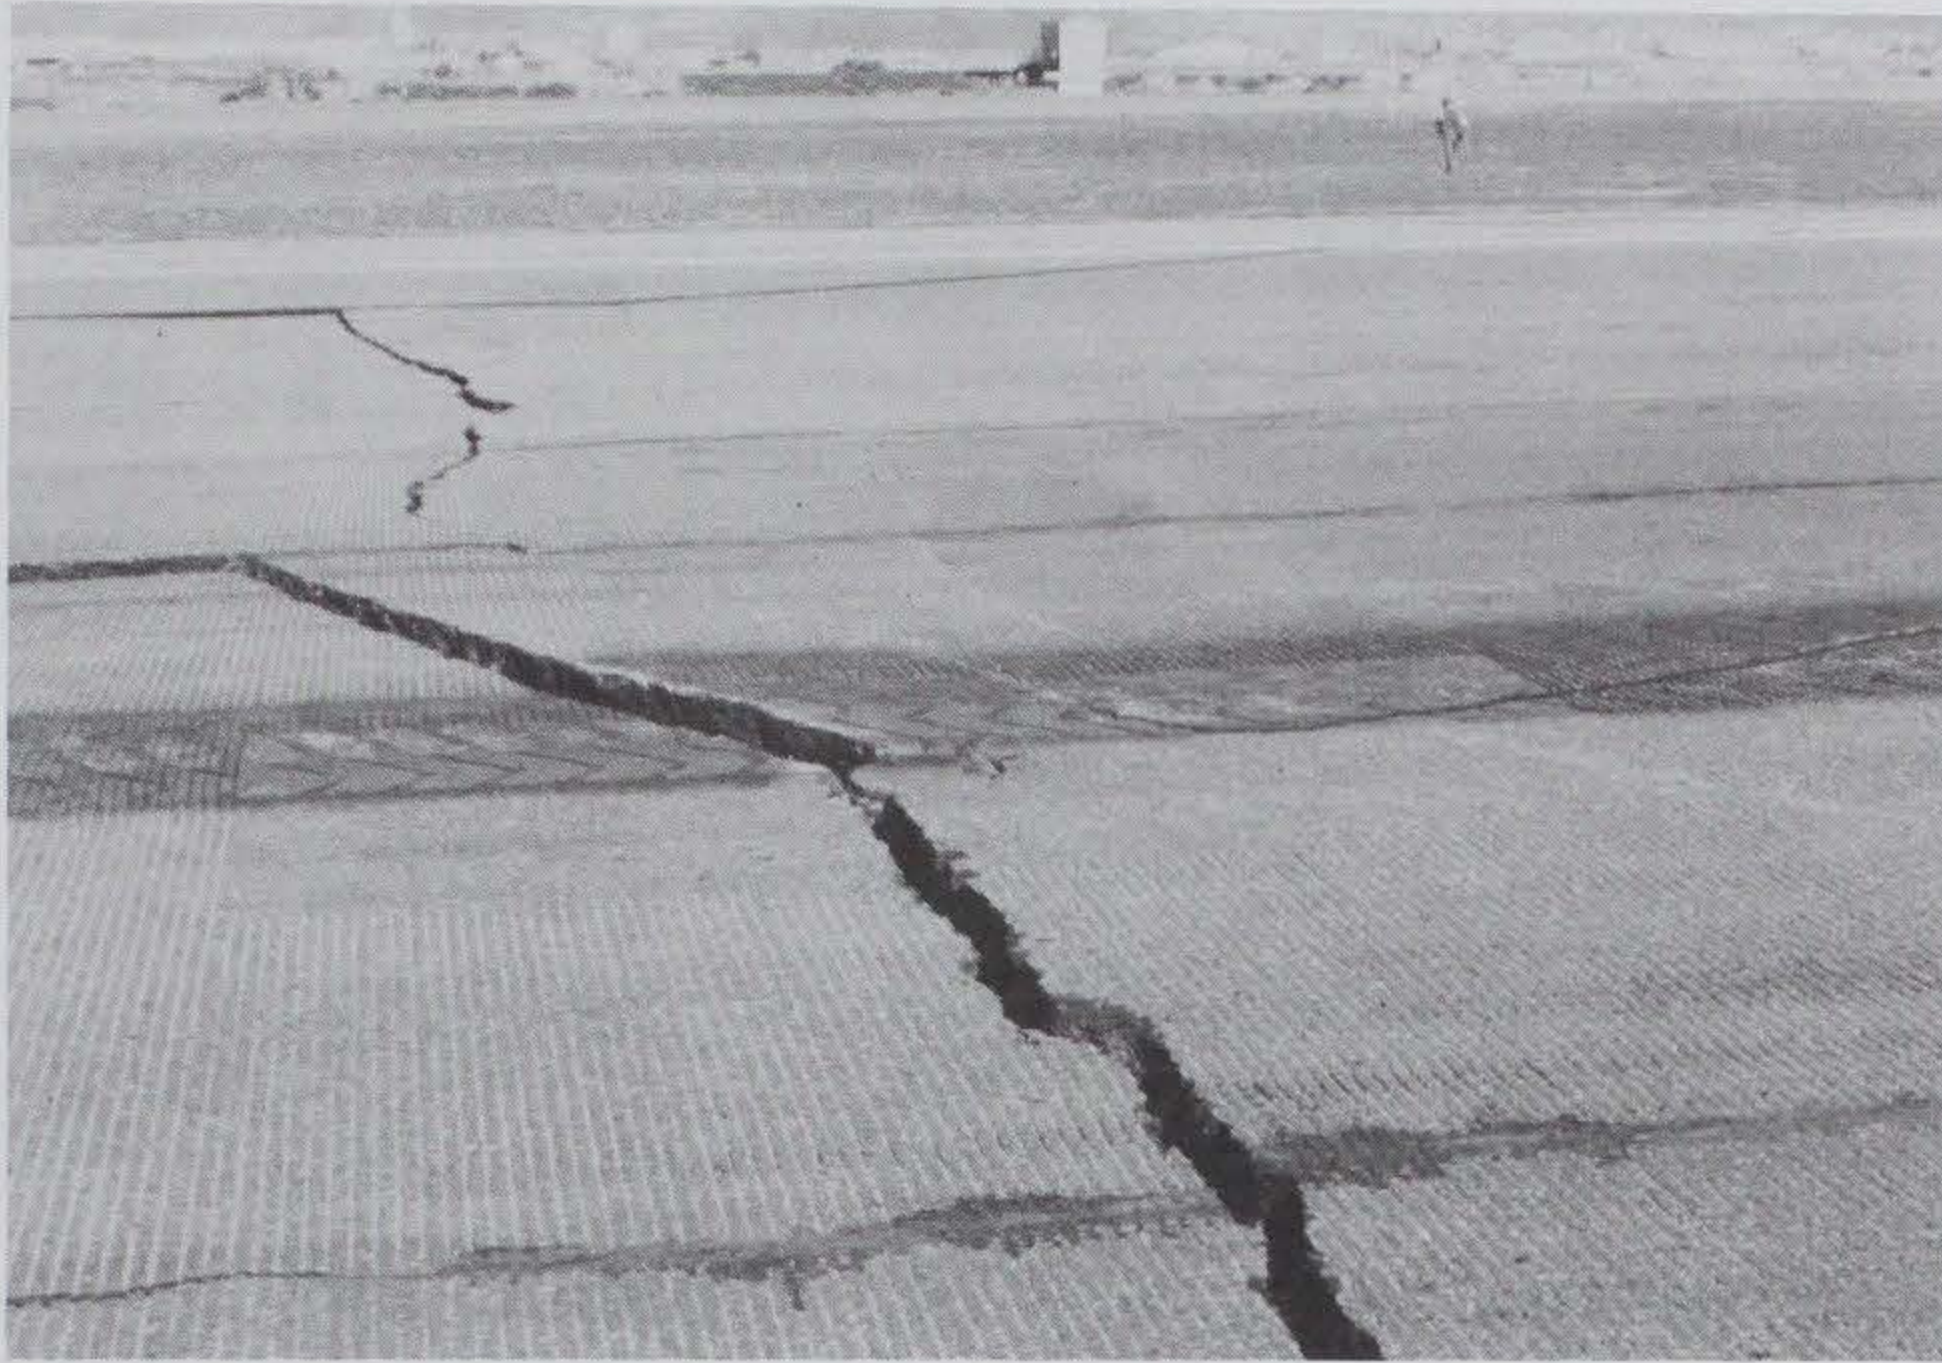
Figure 10. Transverse crack not following construction joint

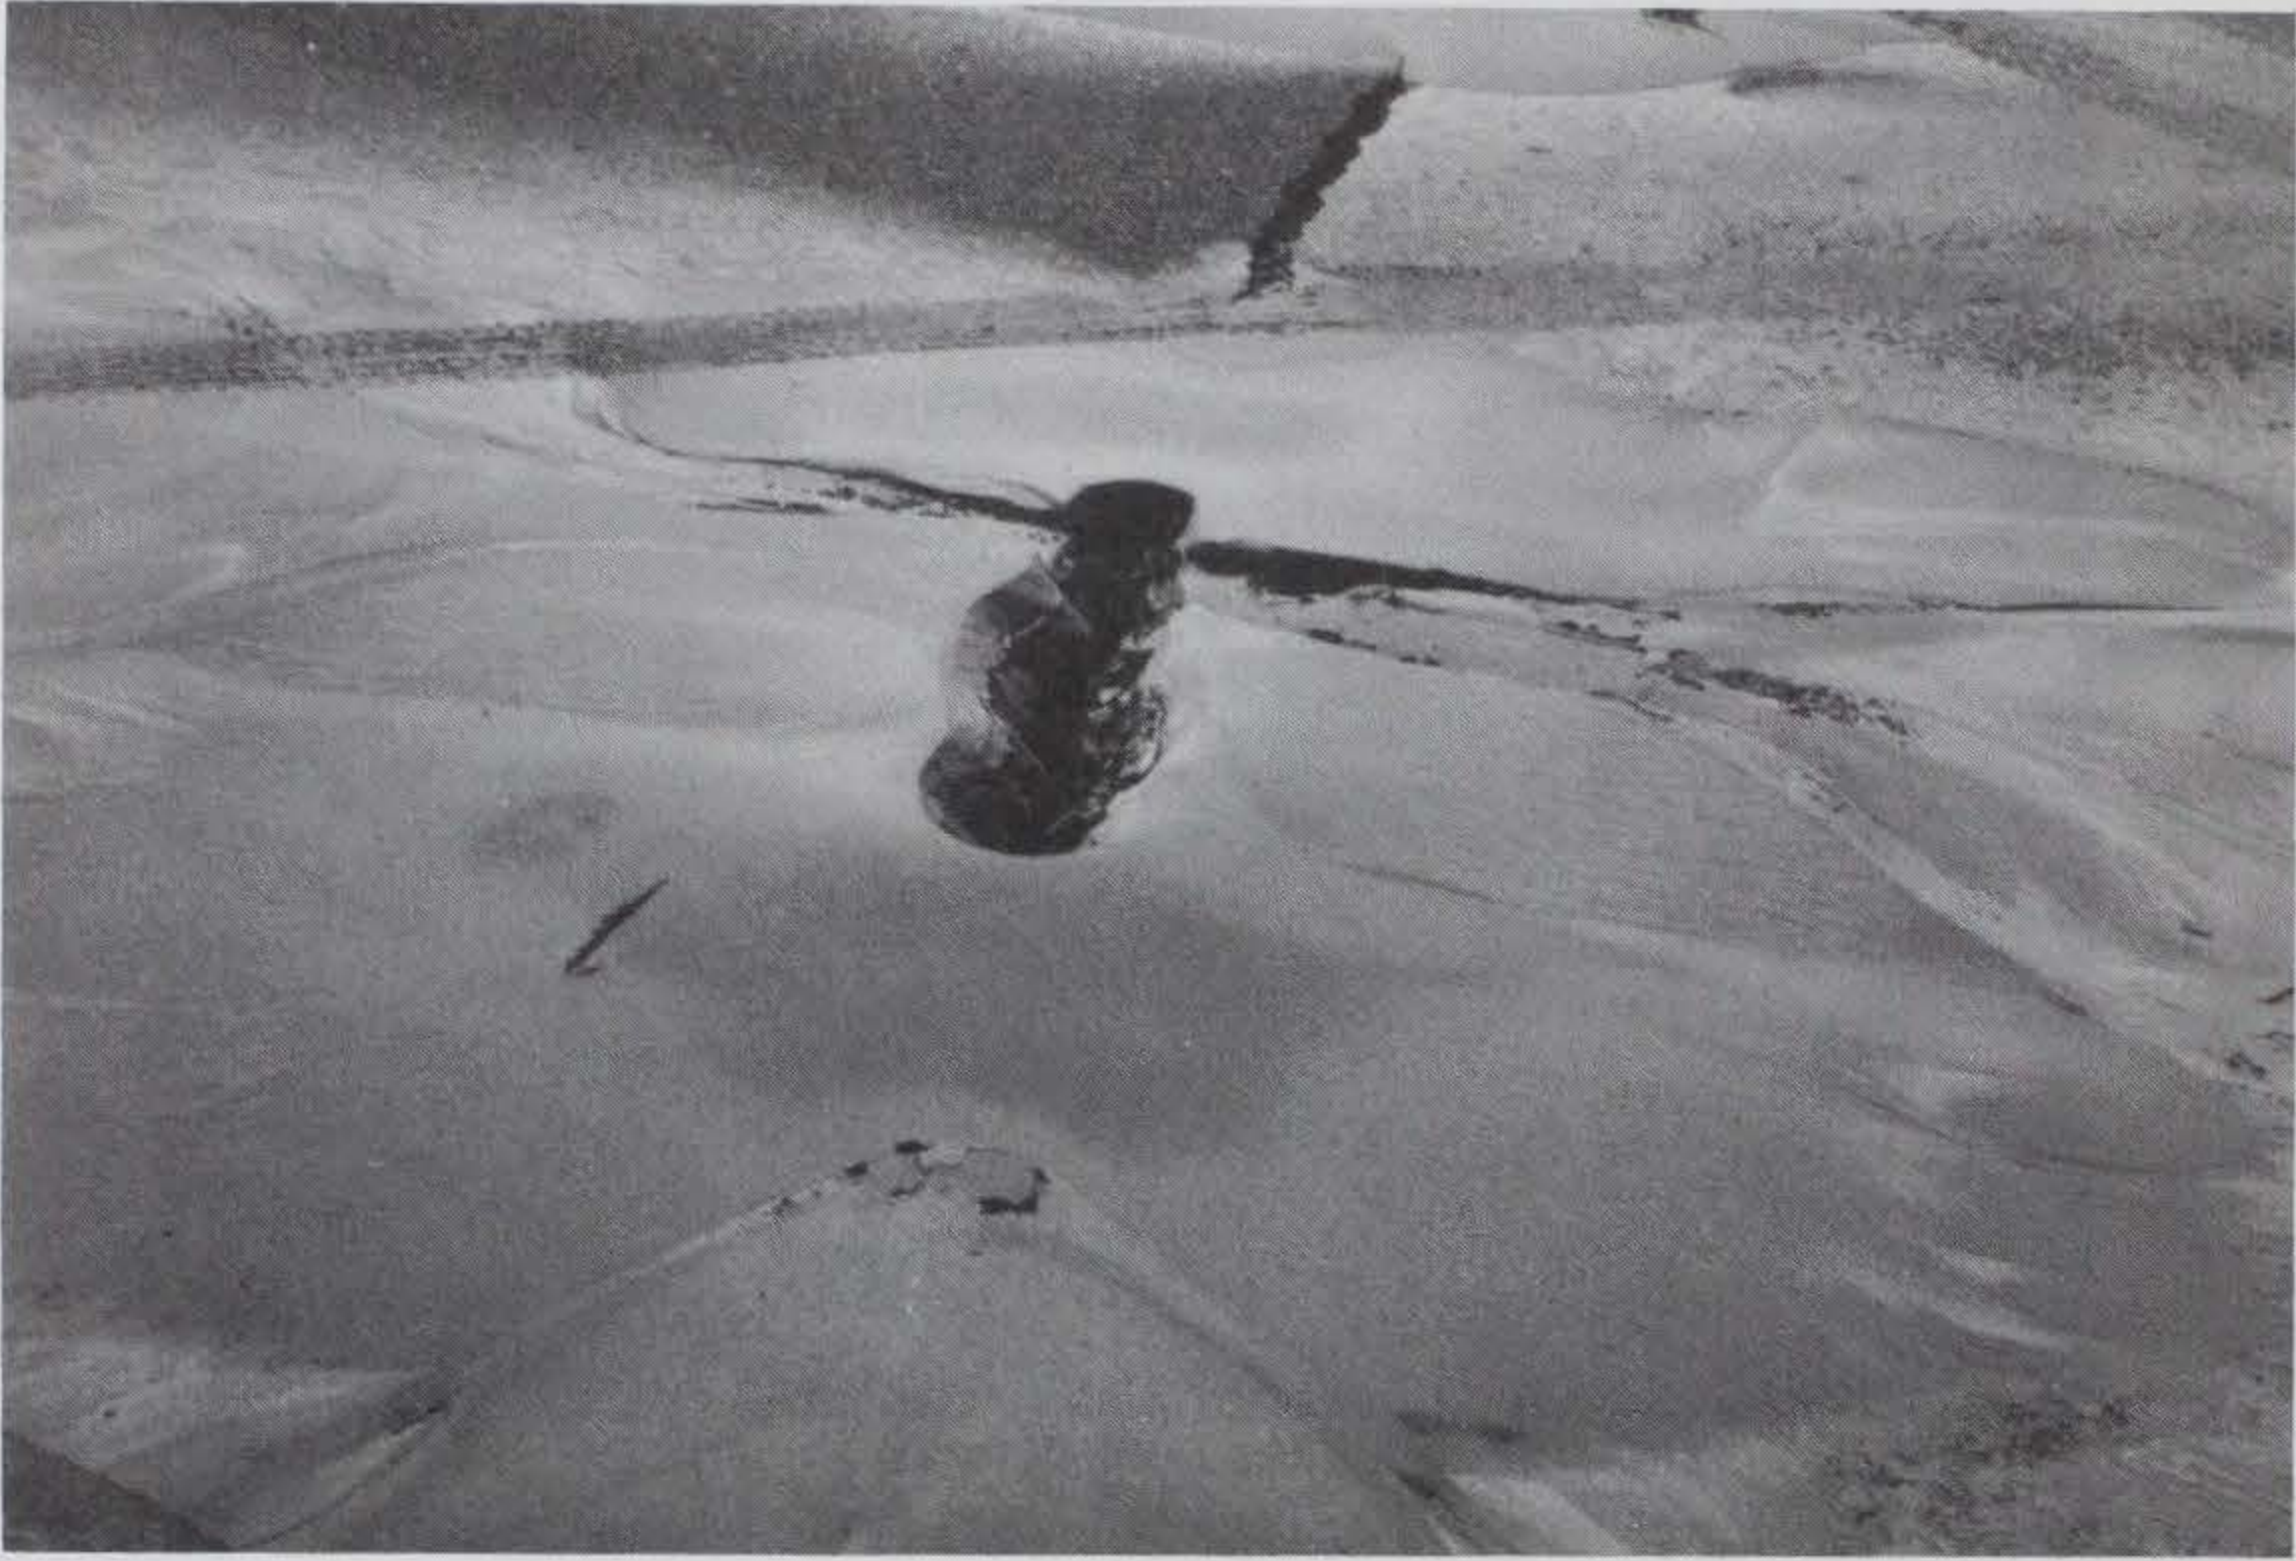
Figure 12. Close-up of sand boil on Runway 11-29

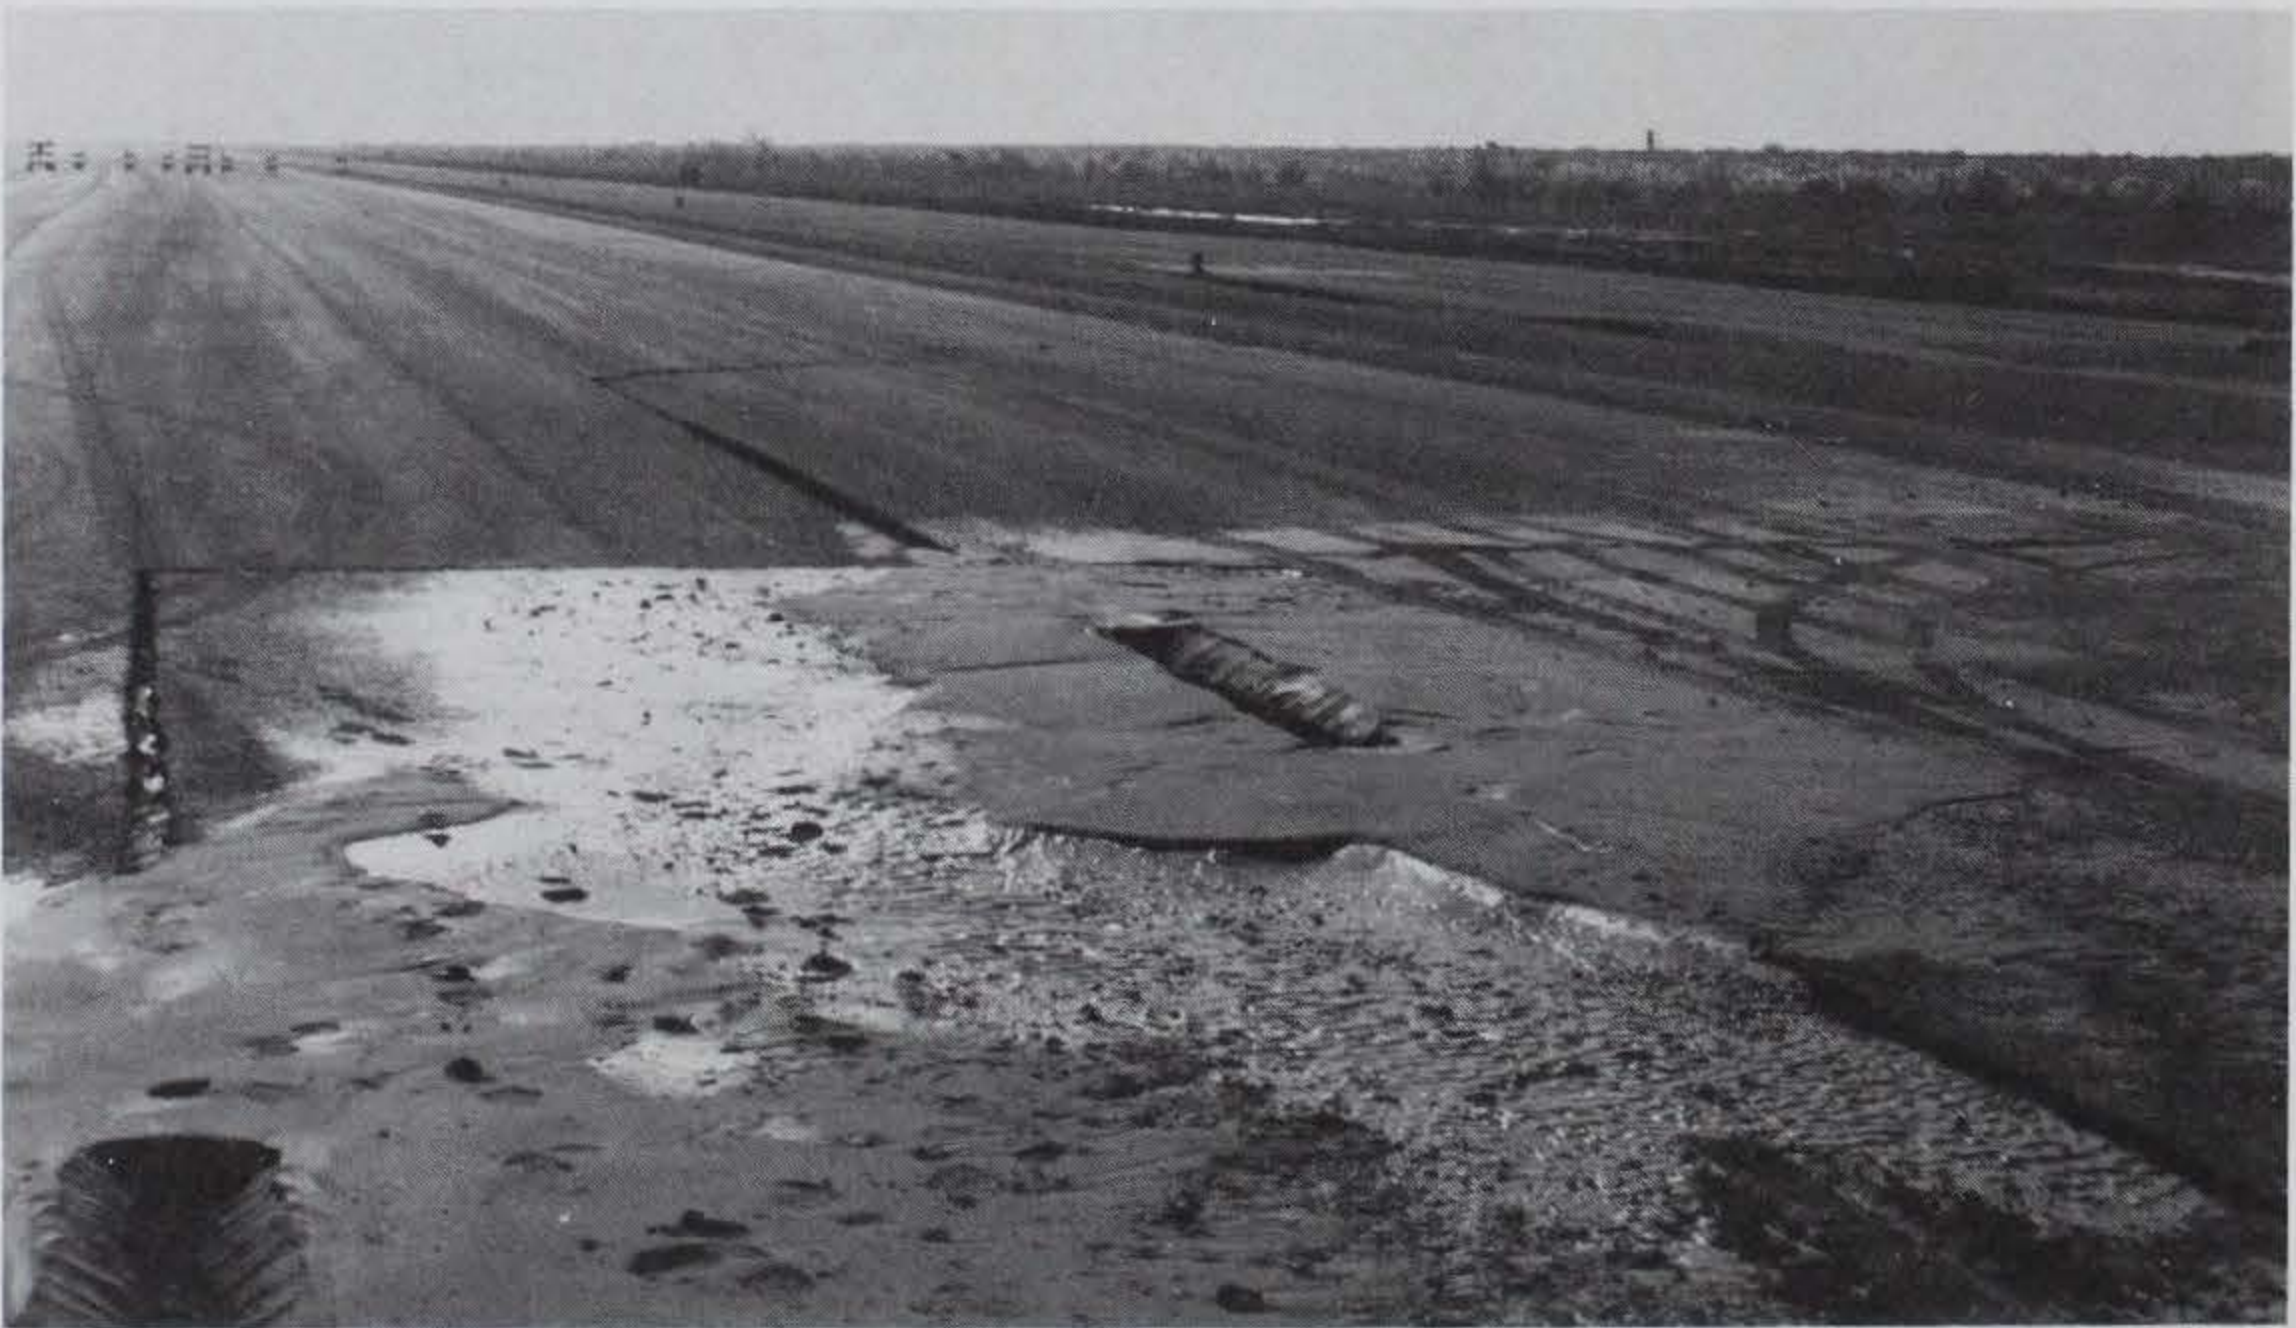
Figure 13. Overall view of sand boil on Runway 11-29

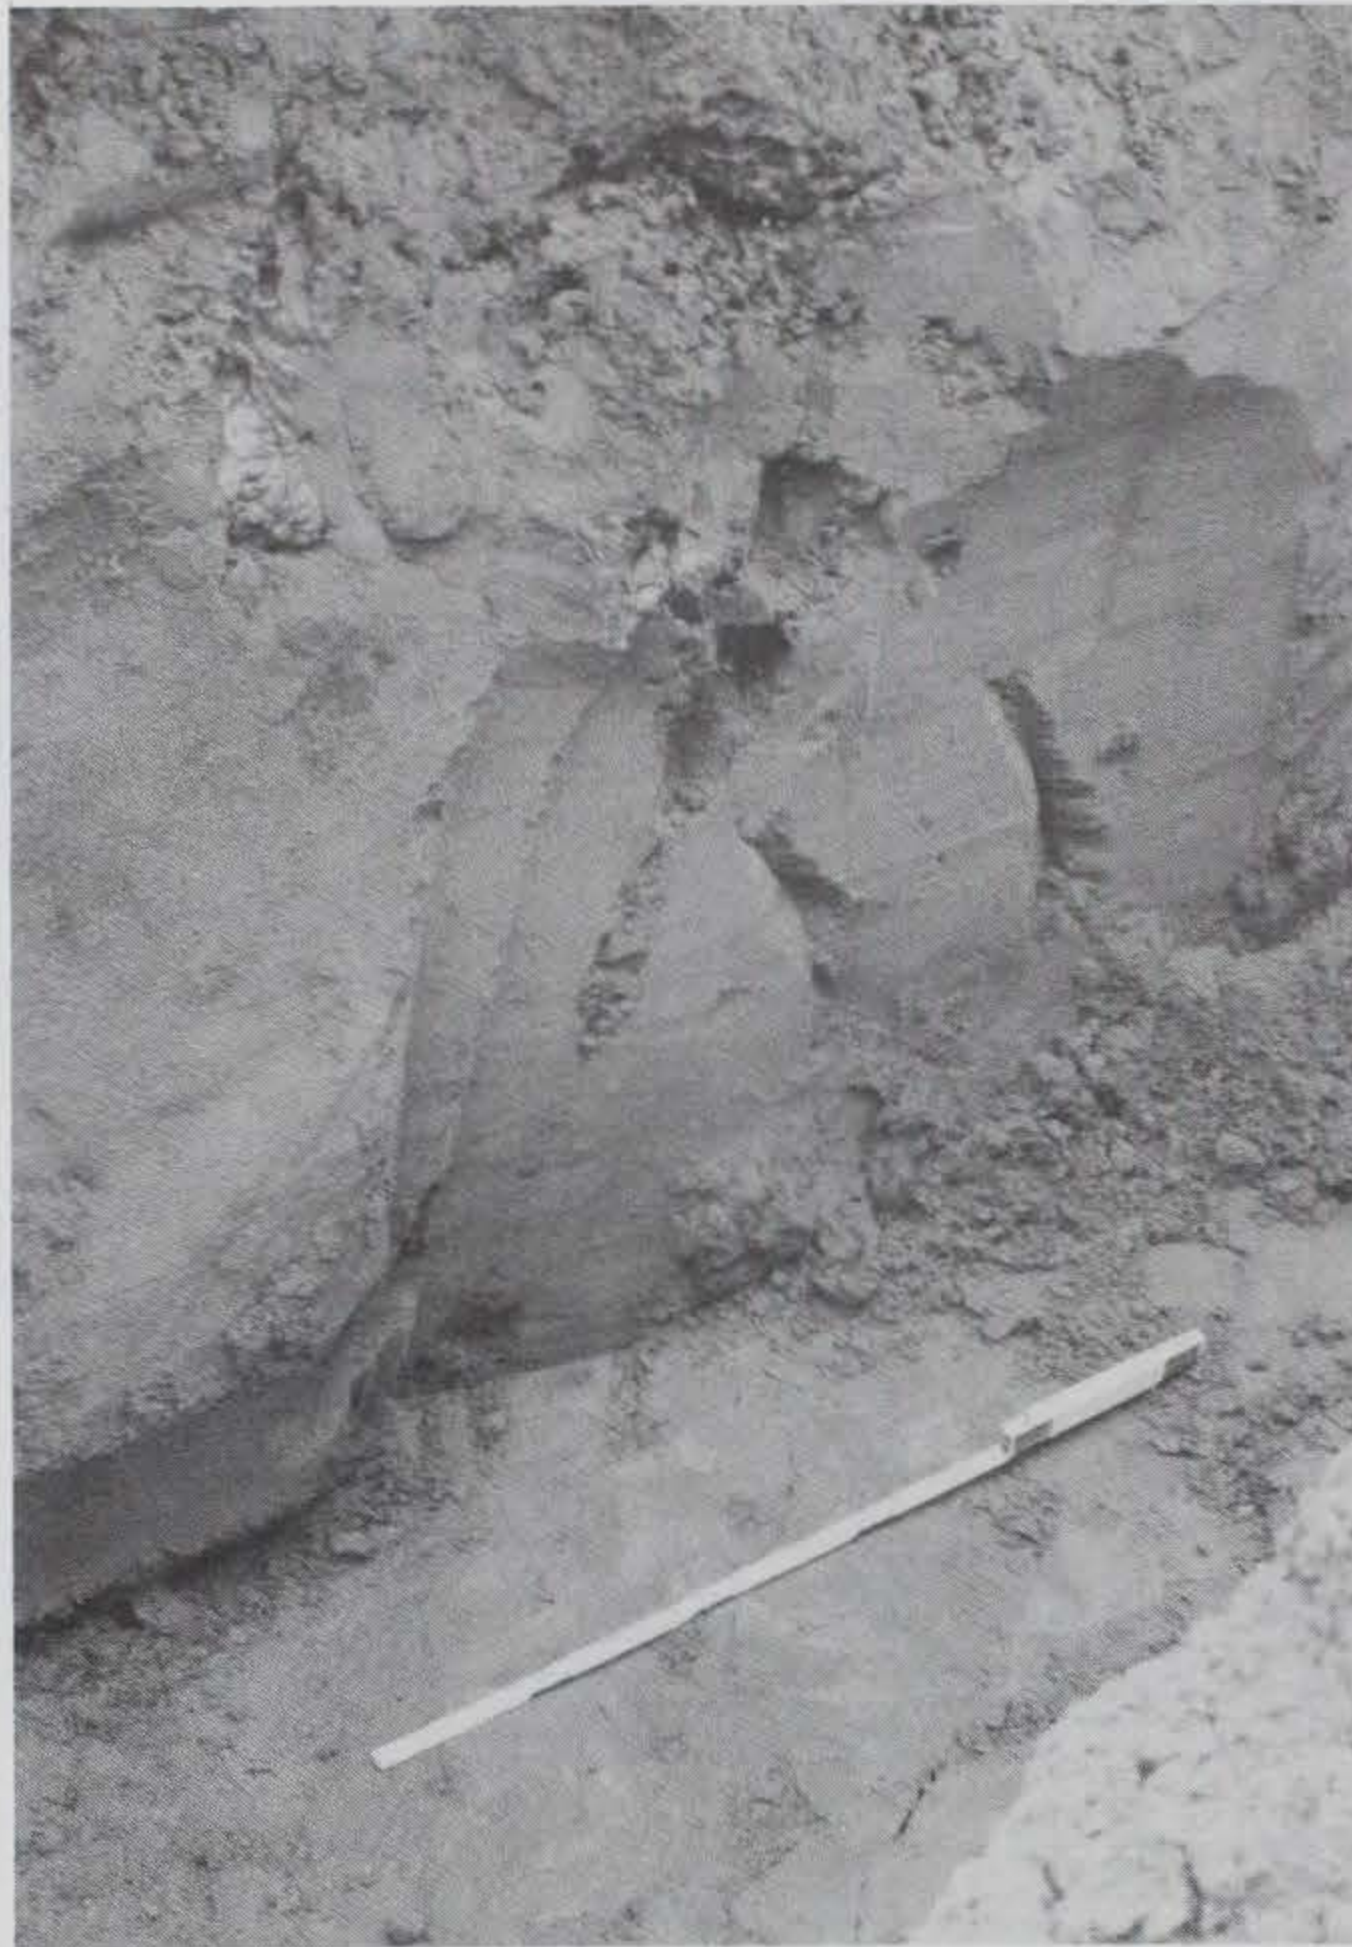
36. Following the Benkelman Beam tests, a crack was excavated to determine what might be expected under the pavement. Figure 17 shows the top of the excavation of a crack that was associated with a sand boil. A slight void is shown under the pavement AC surface at the edges of the crack in Figure 18 where the base material sloughed off into the crack. Figure 19 shows the crack further down. The crack can be followed down a distance of a couple feet, but then it becomes indistinguishable from the surrounding material. From this excavation and the Benkelman Beam deflections, it was concluded that there would probably not be any cavities found under the pavement except at both sides of the earthquake-induced cracks immediately below the asphalt concrete paving.

Figure 17. Top of excavated crack

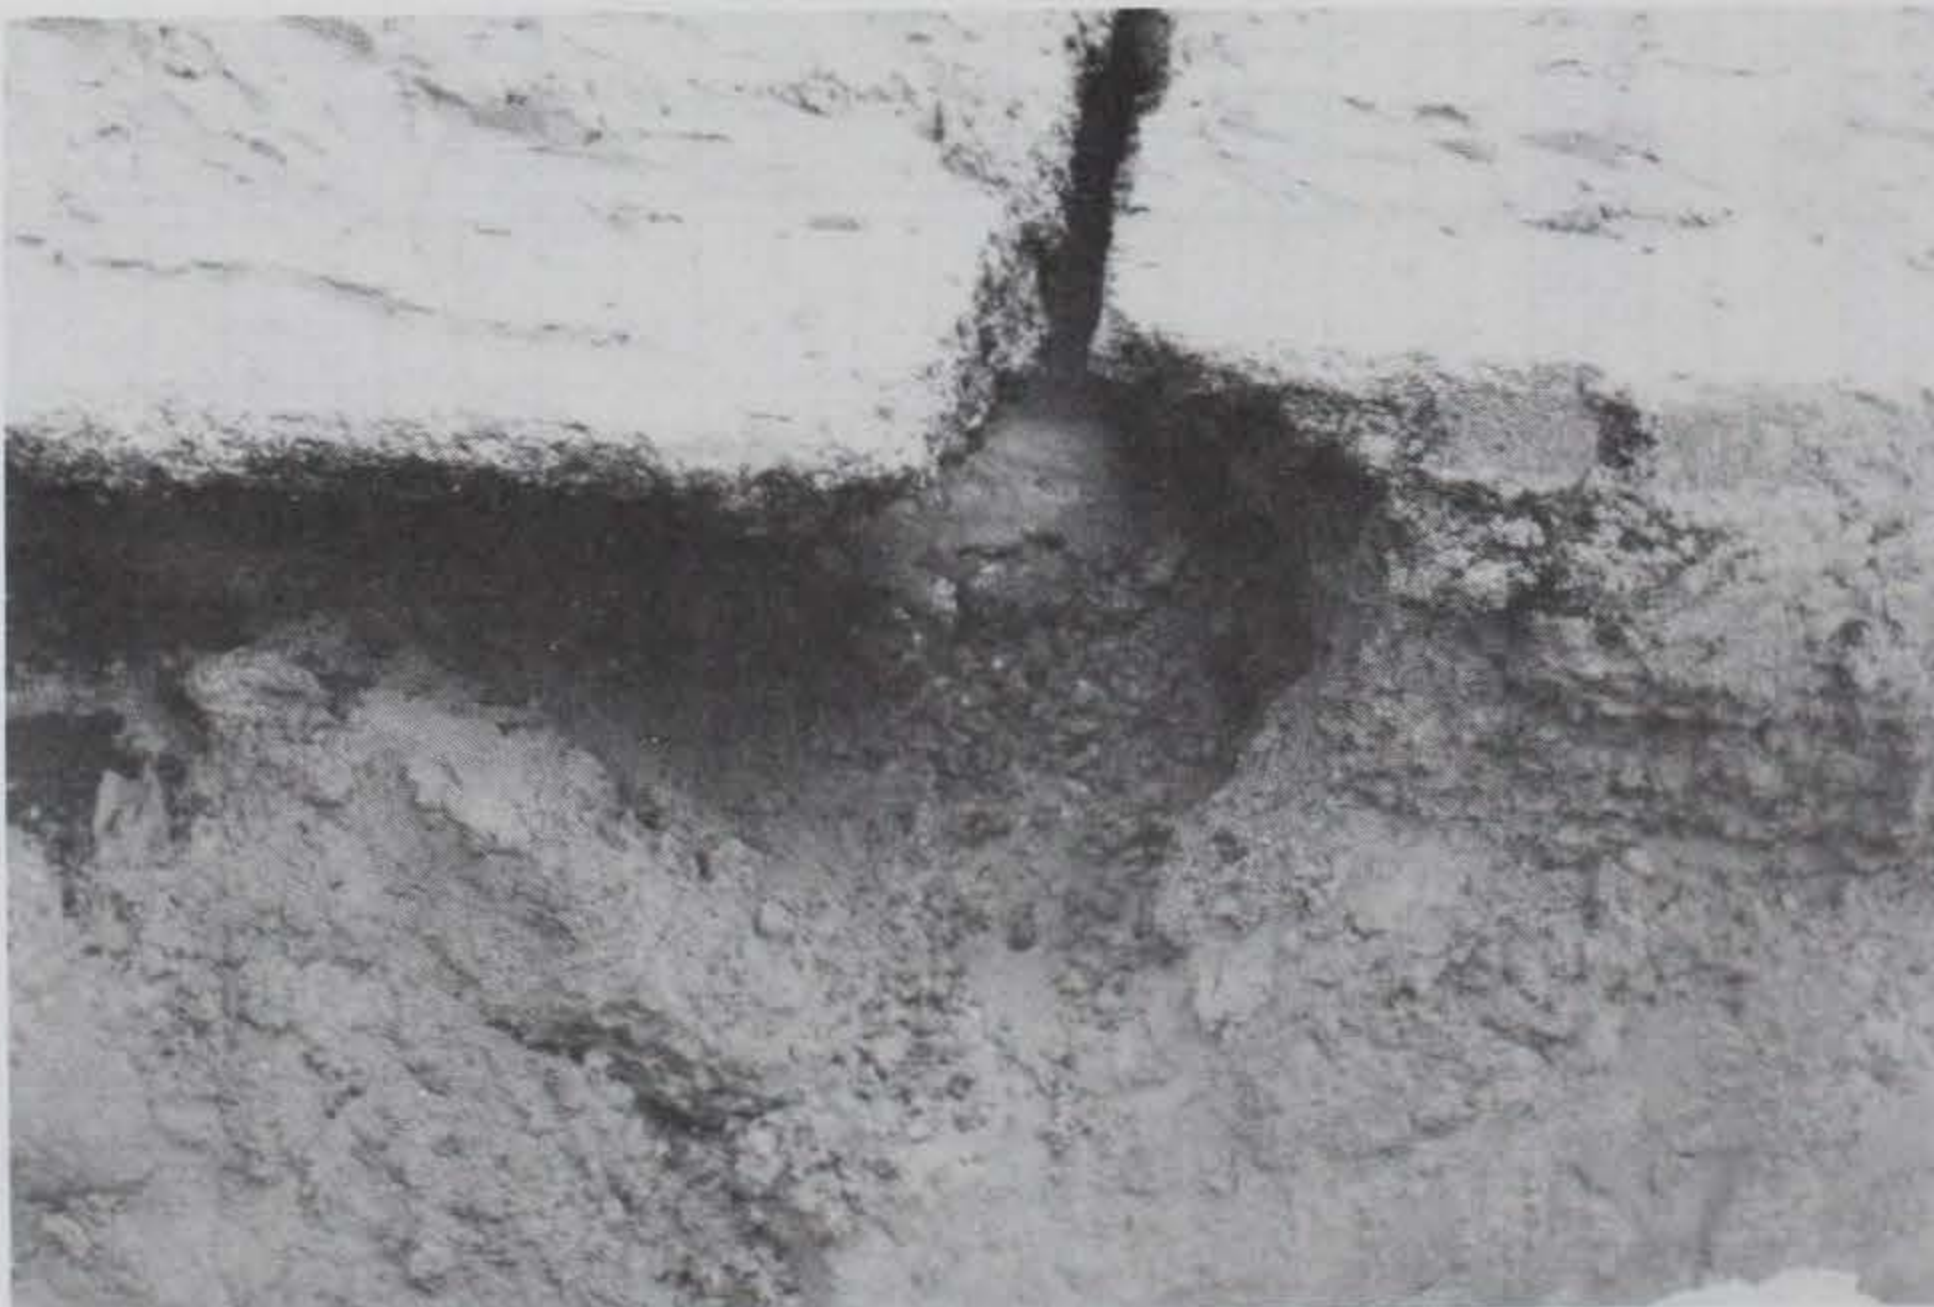
Figure 18. Void under AC pavement next to crack

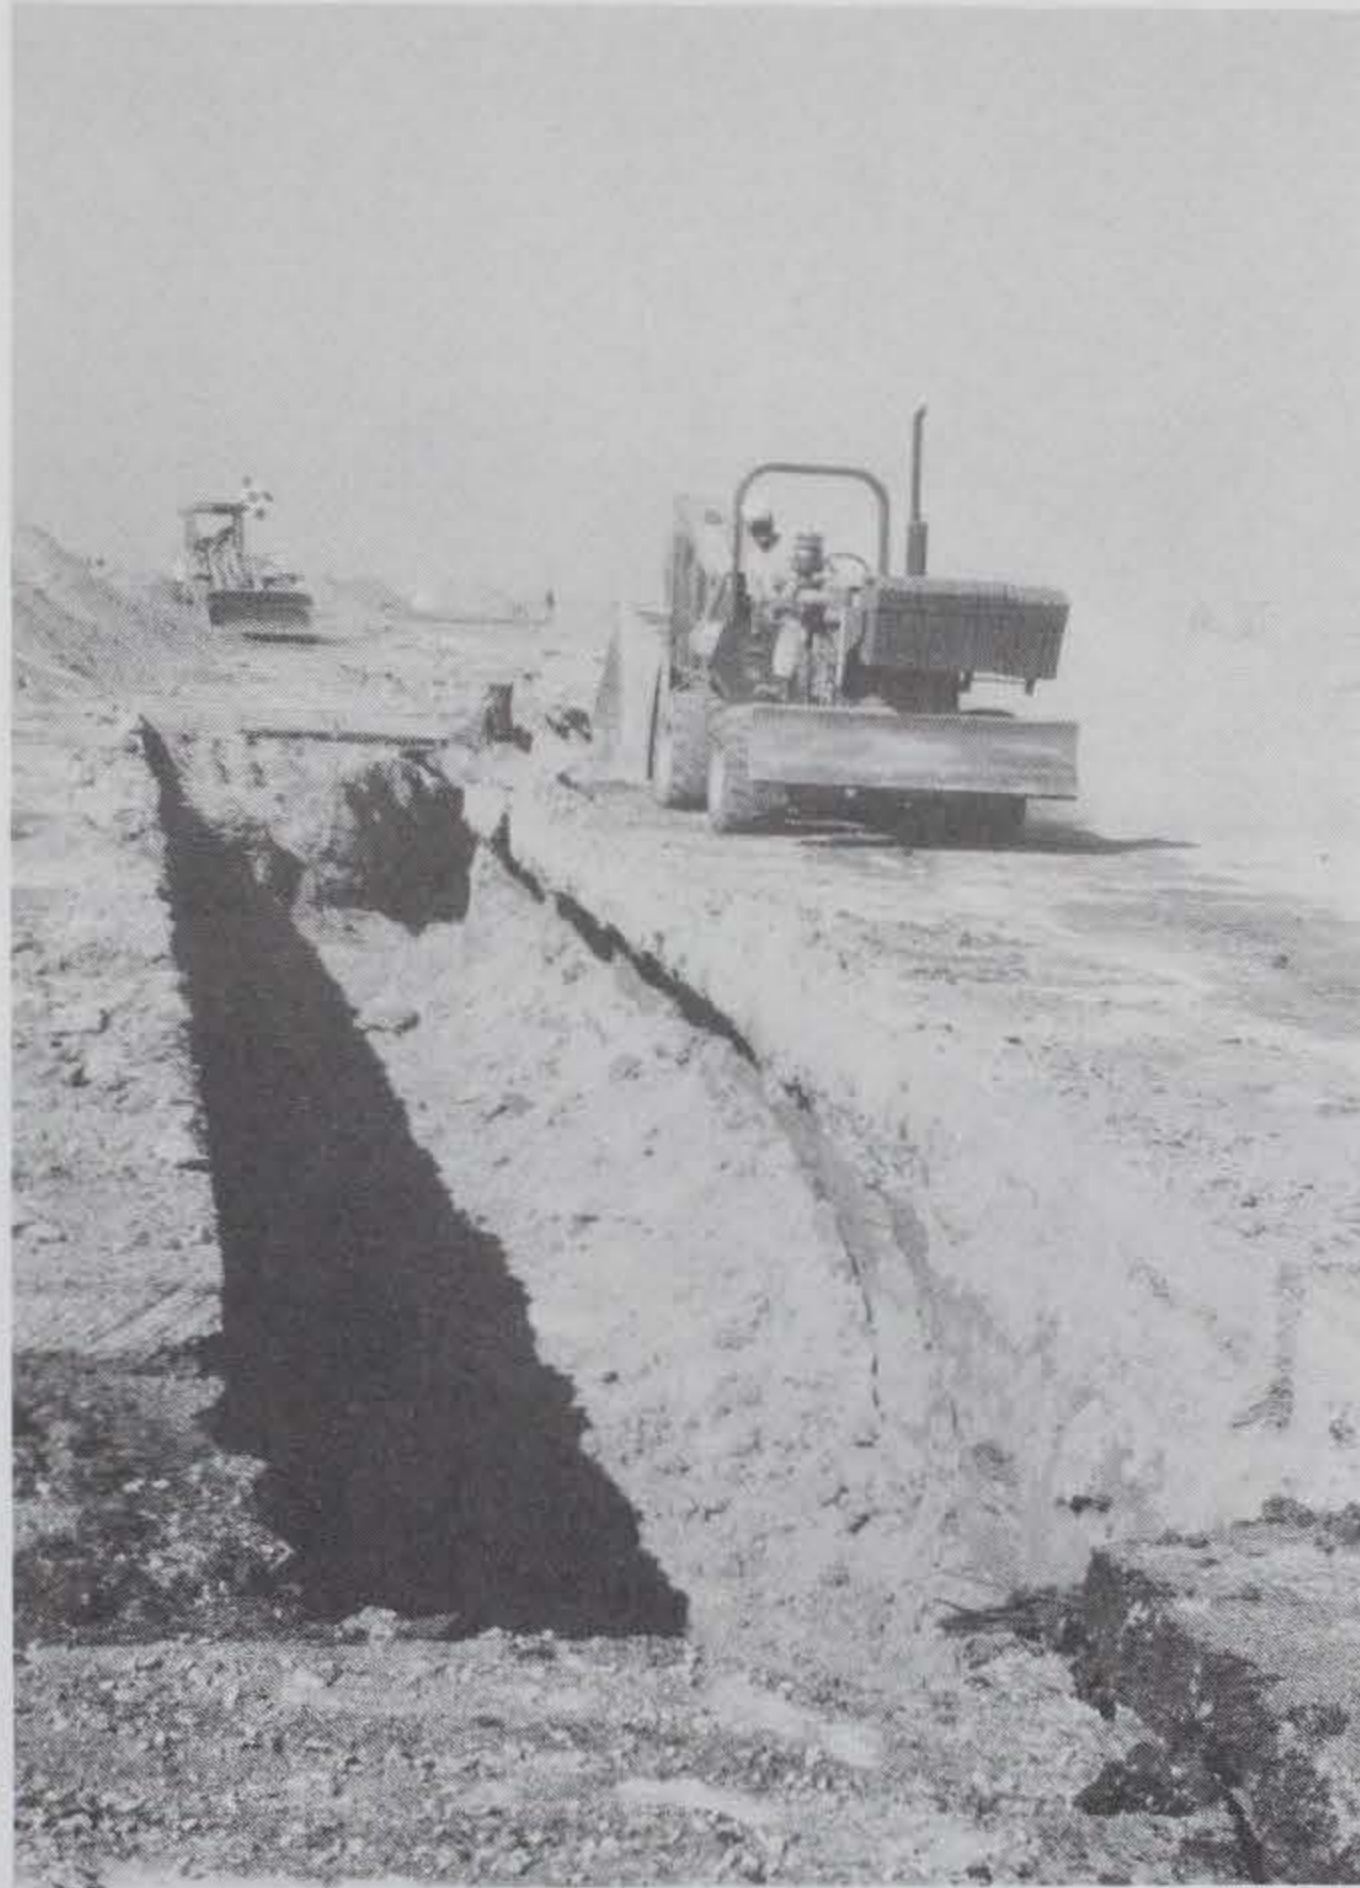
Figure 19. Excavated crack
