US Army Corps
of Engineers

MISCELLANEOUS PAPER GL-92-17

A CASE STUDY: DAMAGE TO THE METROPOLITAN OAKLAND INTERNATIONAL AIRPORT CAUSED BY THE LOMA PRIETA EARTHQUAKE

July 1992

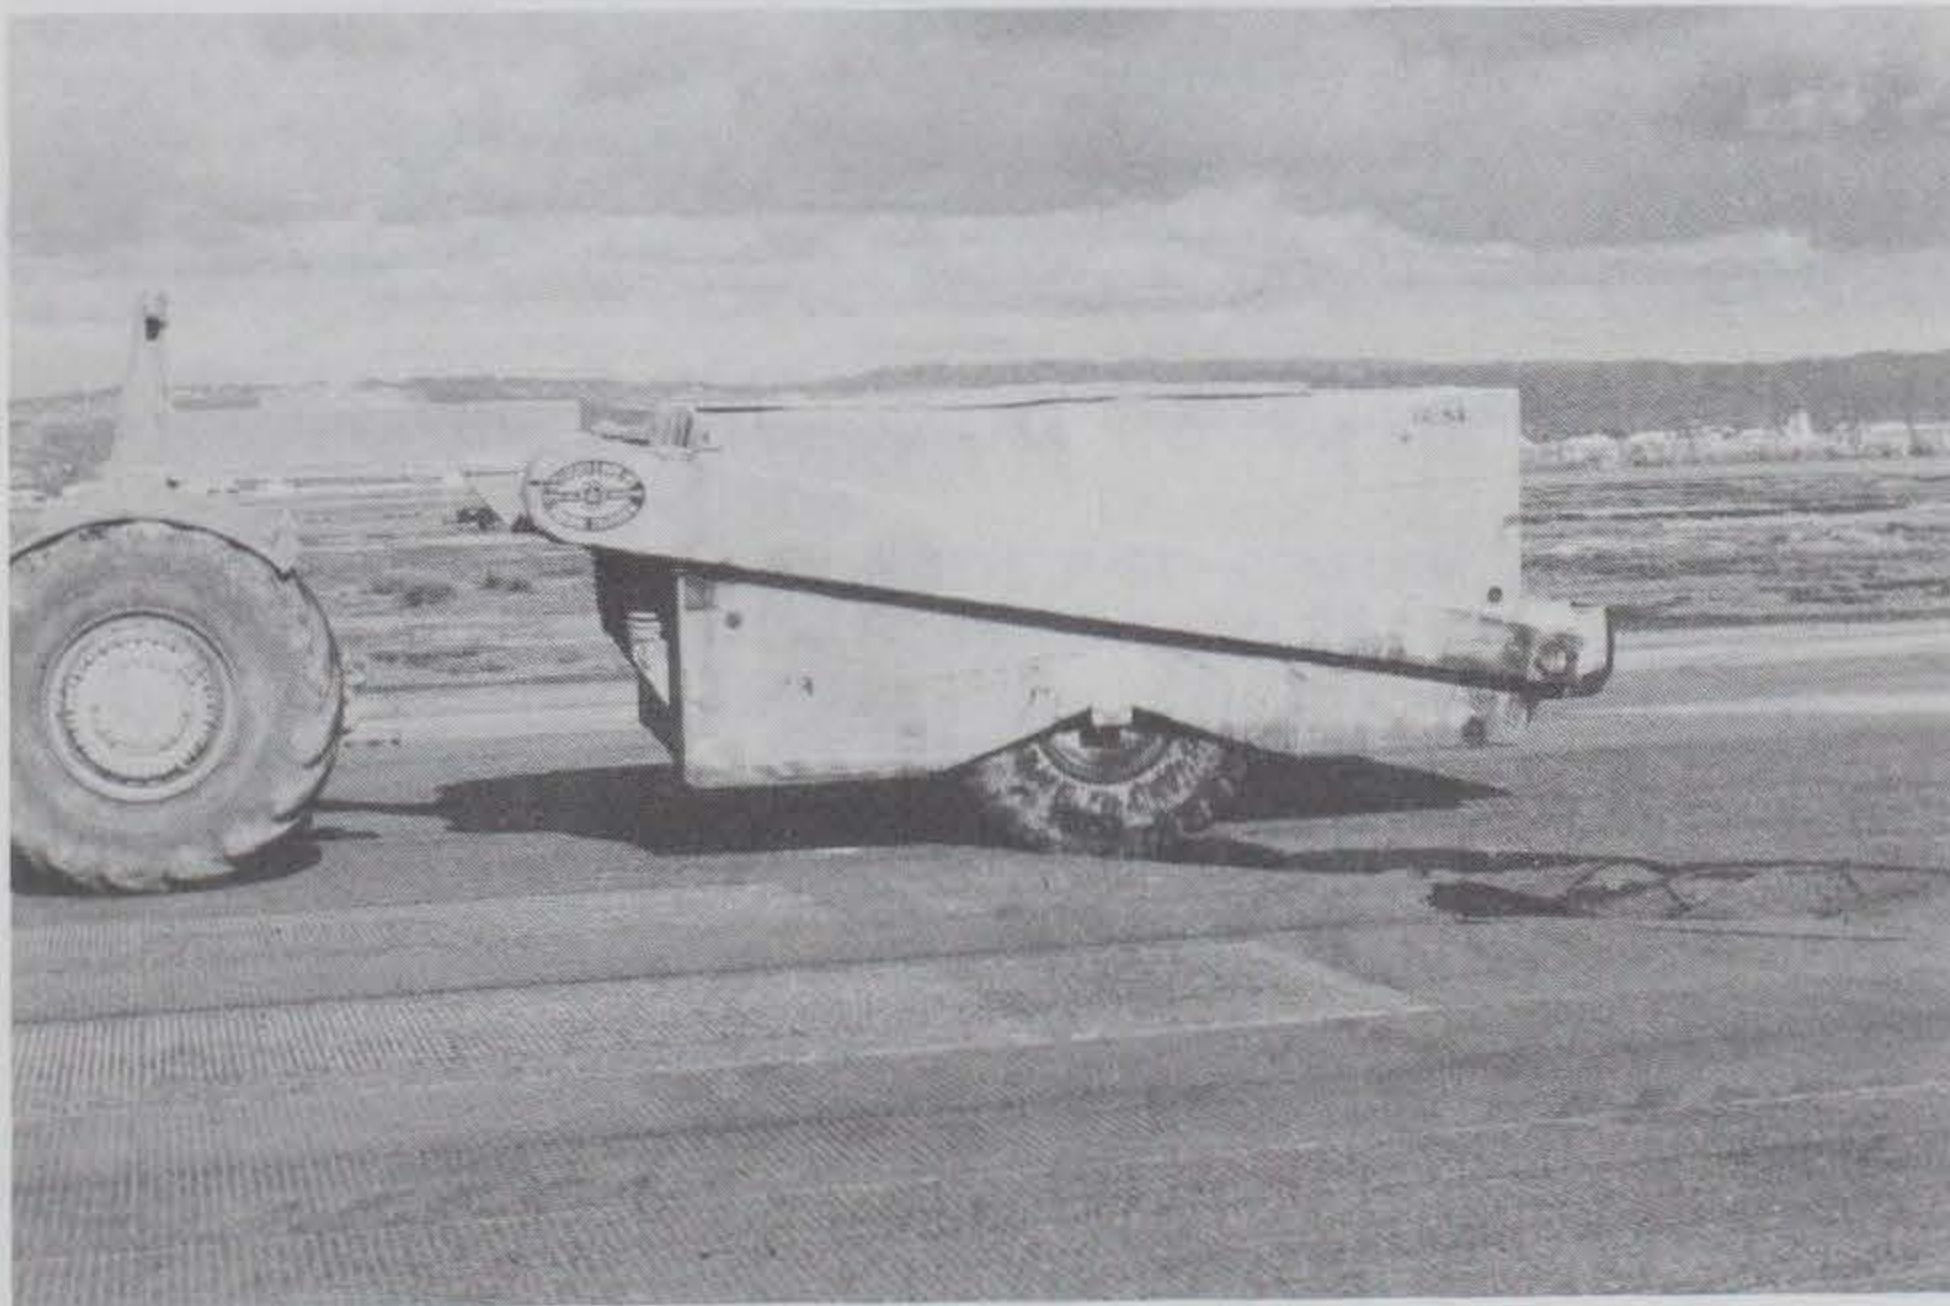
37. To ensure there were no cavities or weak spots, a 50-ton proof roller was used to proof roll the pavement as shown in Figure 20. Three coverages of the proof roller were made over the full 150-ft width over the 3,000-ft long earthquake damaged portion of the runway. There were no weak spots or cavities detected anywhere by the proof roller except directly adjacent to cracks where the base course had sloughed off into the cracks that had

Figure 20. A 50-ton proof roller

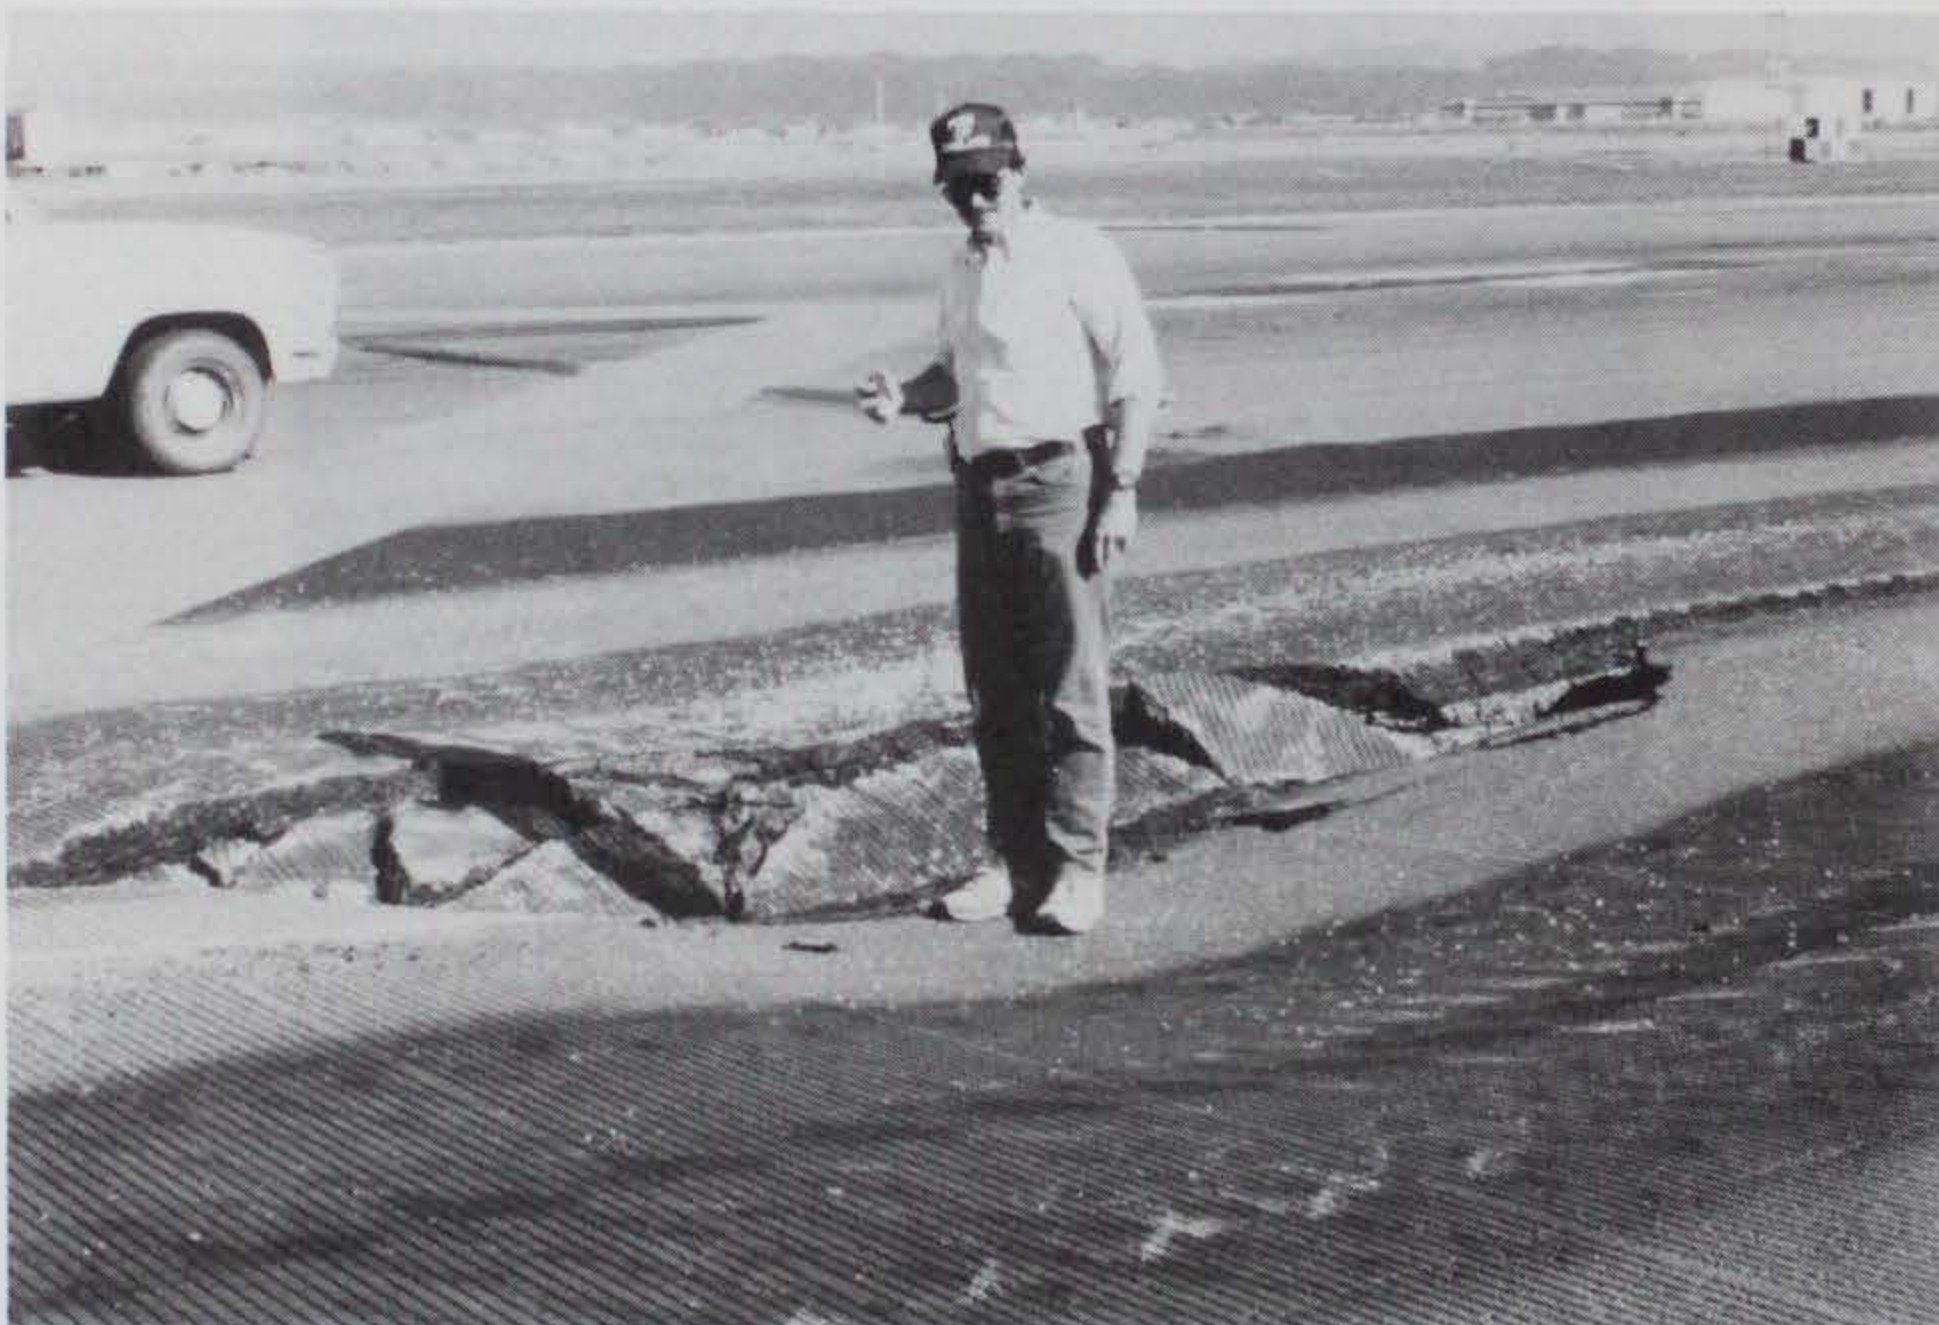
formed at the time of the earthquake. Figure 21 illustrates a typical area of broken pavement adjacent to an earthquake crack produced by proof rolling.

Figure 21. Pavement broken by proof roller adjacent to crack
