Evaluation of Supa-Trac Matting for Expeditionary Roads

Timothy W. Rushing, Jeb S. Tingle, Timothy J. McCaffrey,
and Todd S. Rushing

August 2009

Final report

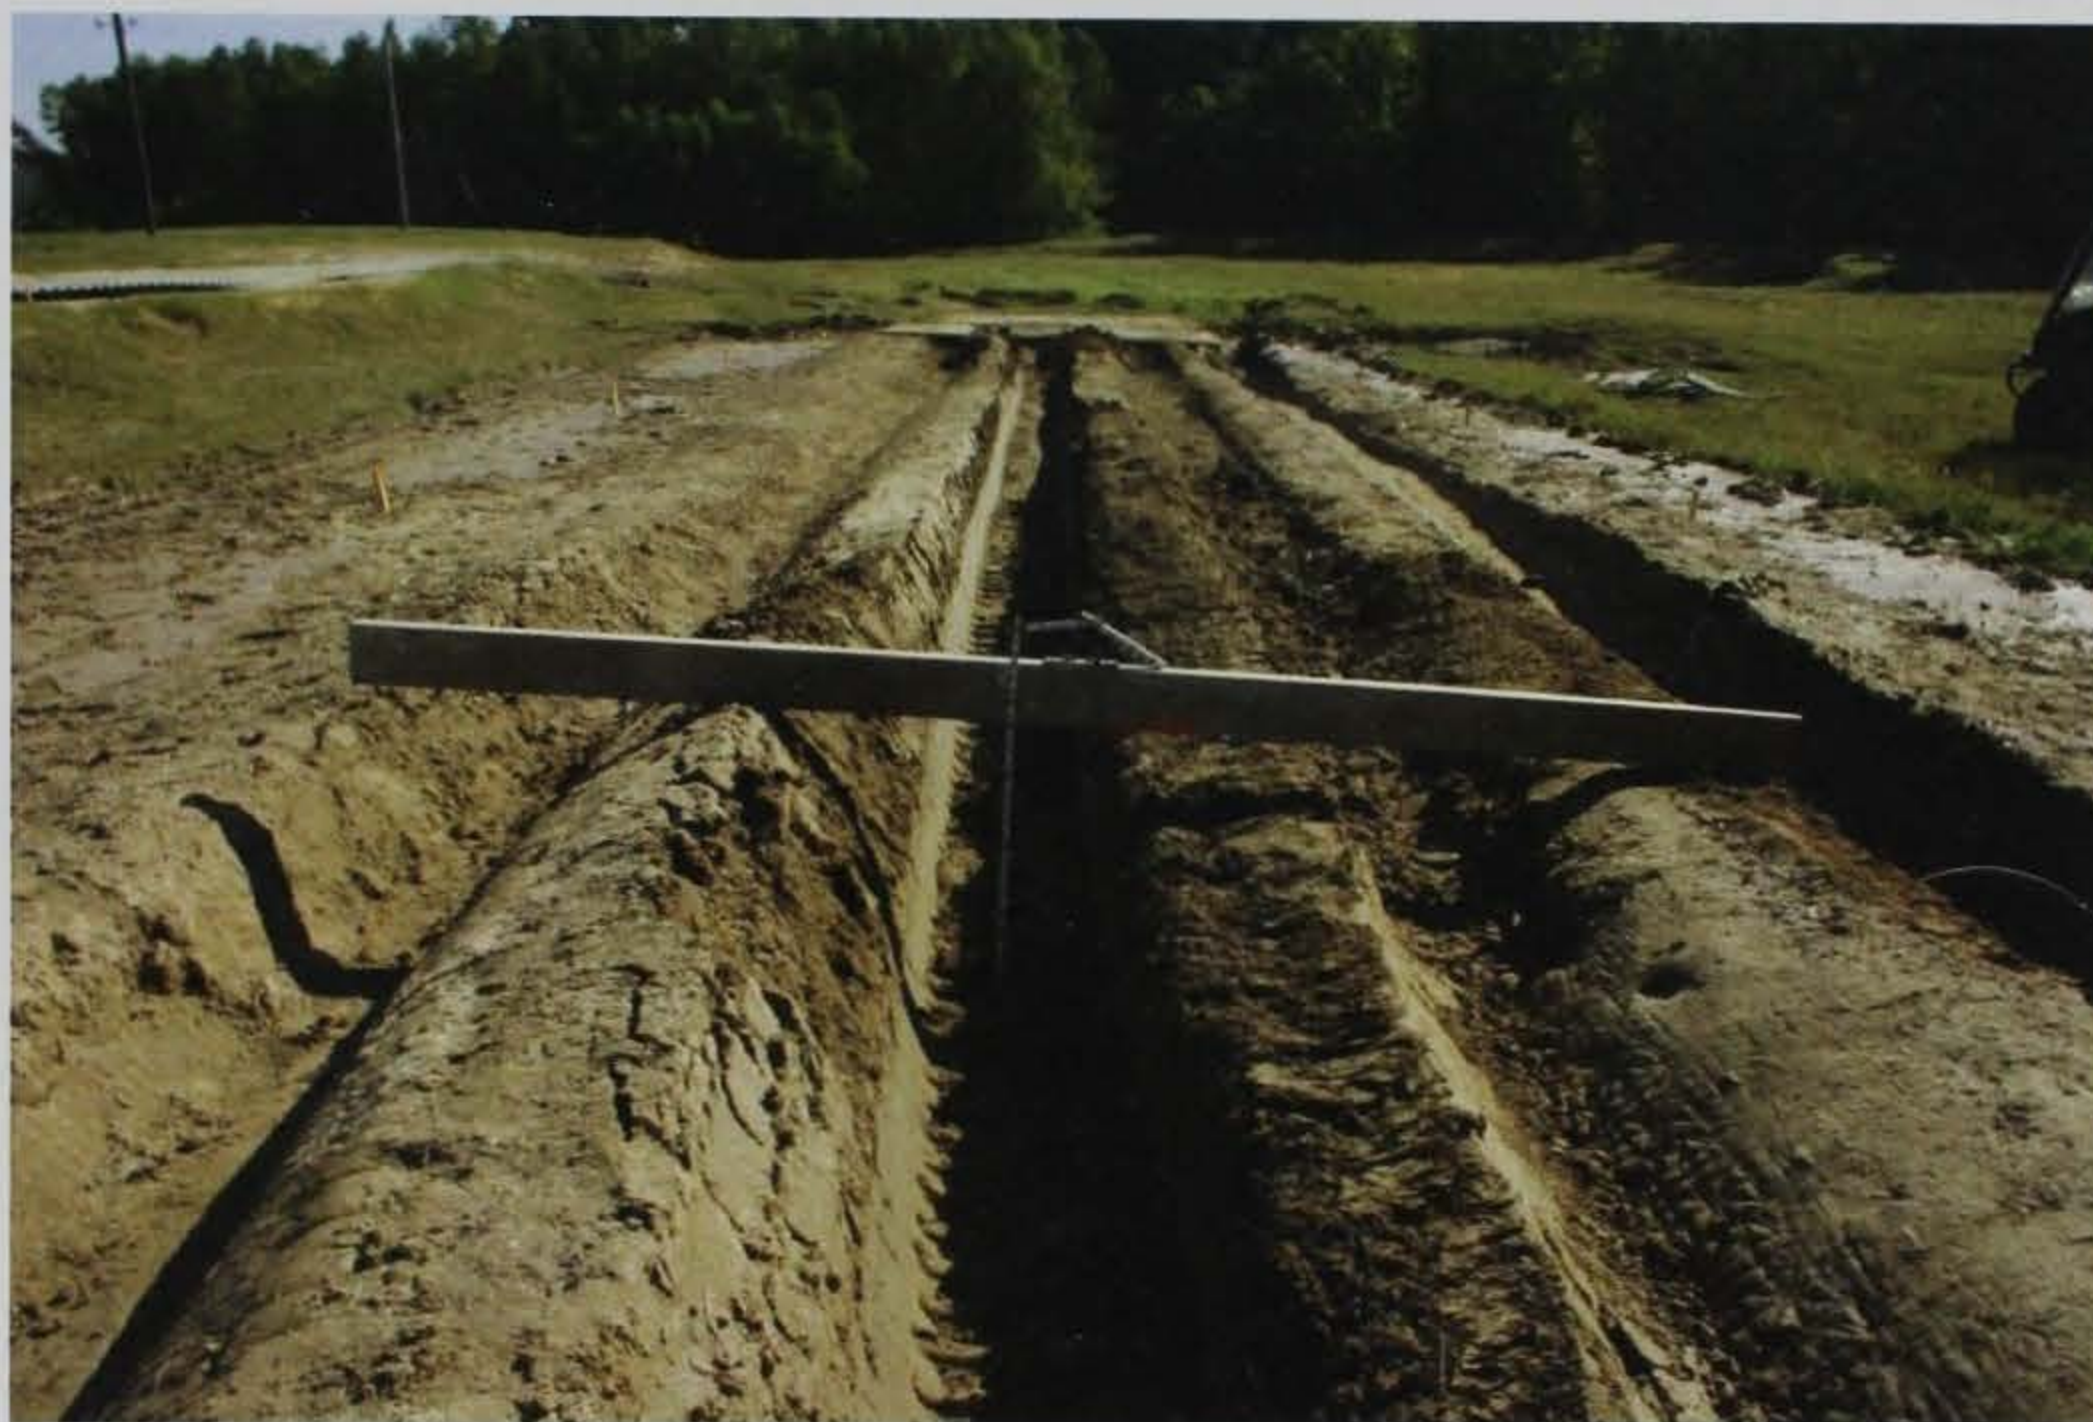
Figure 53. SM-1 control rut depth after 4 passes.

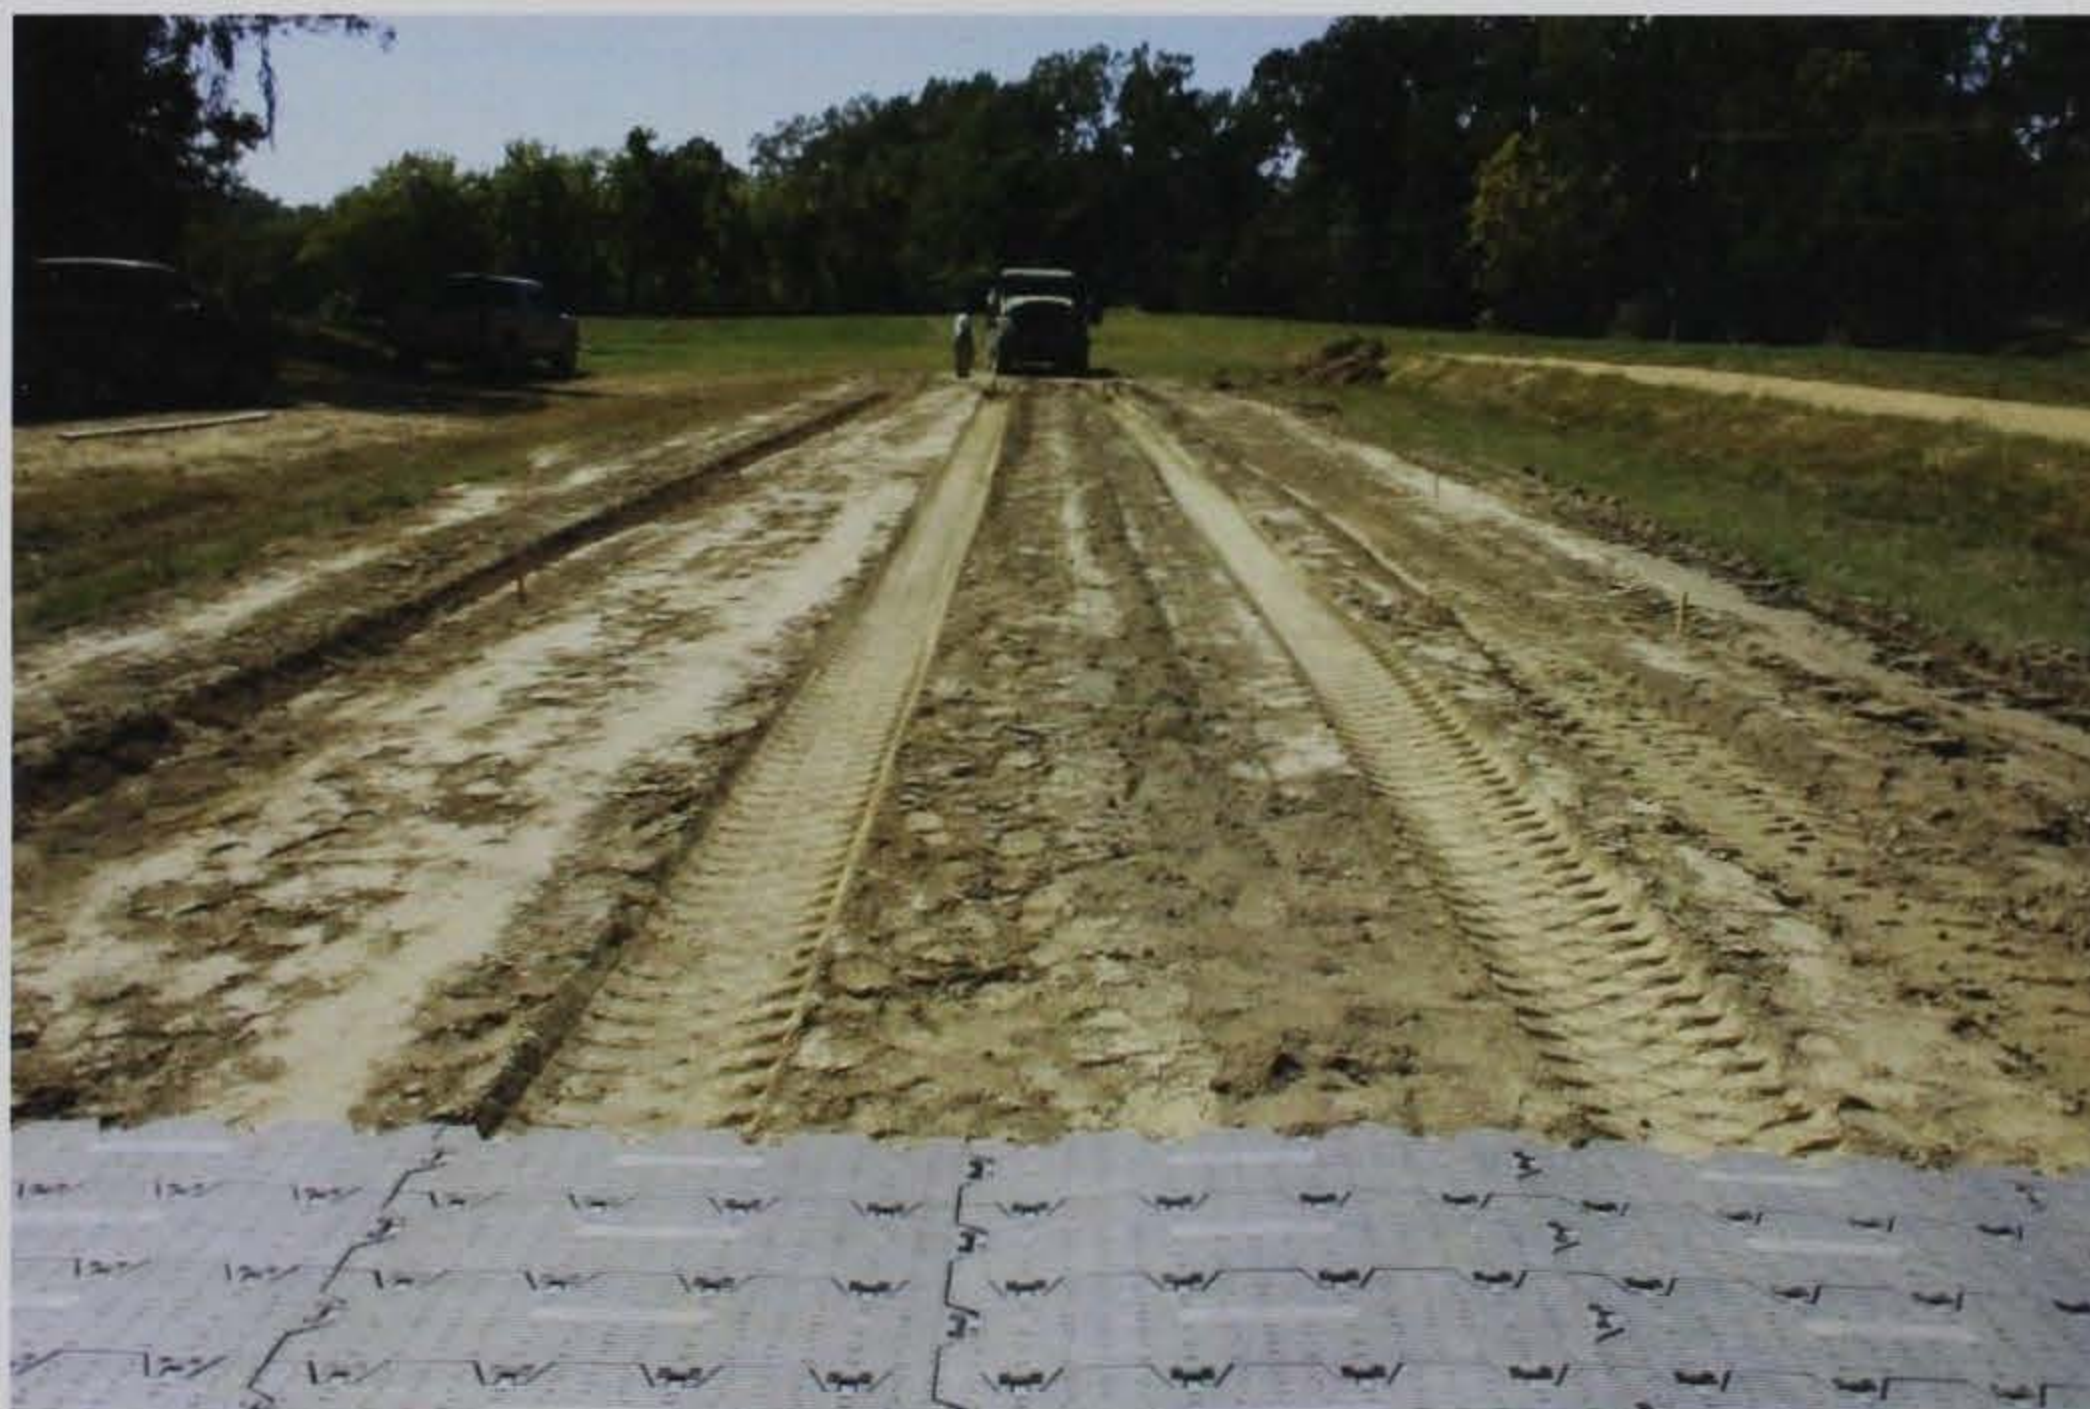
Figure 54. SM-2 control after 6 passes.

Data from the SM-2 control experiment are reported in Figures 26 and 41. After four passes, the rut depth on the control section averaged 3.4 in. This average rut depth increased to 3.9 in. after 10 passes. The rate of rut formation on the SM-2 test section (approximately 5 CBR) was much lower than that of the SM-1 test section, as was expected. The subgrade did not inhibit vehicle movements after 10 passes, but the test was concluded due to failure of the matted section. The Supa-Trac matting reduced the rate of rut formation, with an average of 2.5 in. after 10 passes. Therefore, the mat system offered some improvement over the control section, although the control was capable of sustaining several passes without the inclusion of the mat system.

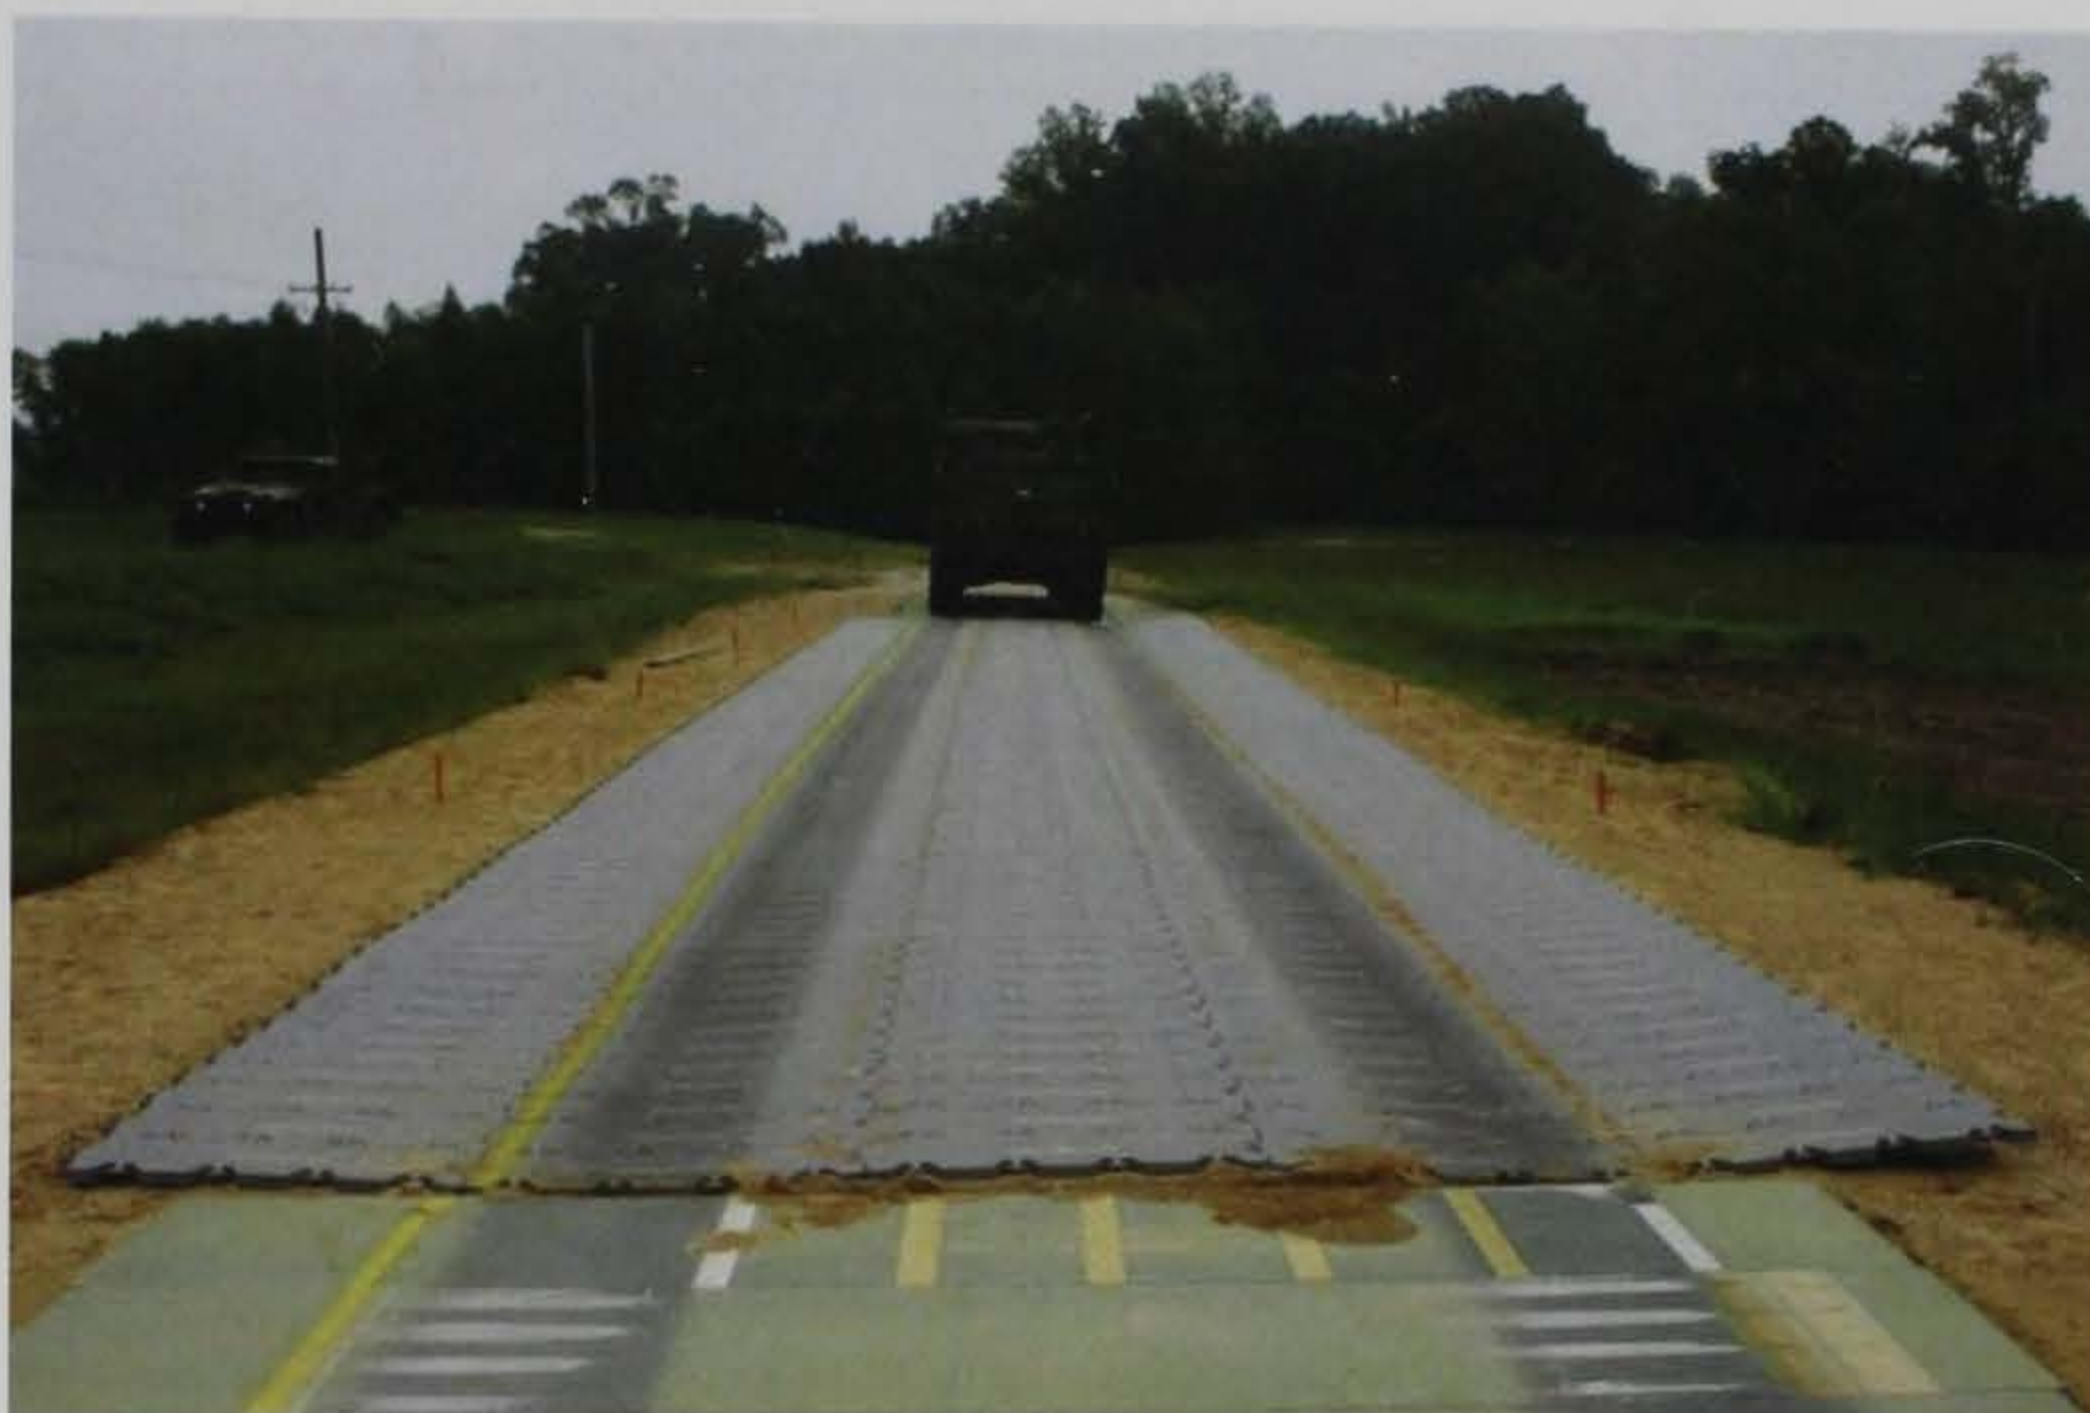
After 3,500 passes, almost no mat damage was noted to the Supa-Trac mat system. Only five plastic retainer clips were broken, and all remained in place. Therefore, no functionality of the mat system was lost. Additional replacement clips were included in the mat installation kit, although none were required to be replaced (Figure 4). A photo of the Supa-Trac system after 3,500 passes is shown in Figure 57. The Supa-Trac system performed adequately to prevent rut formation and to sustain 3,500 truck passes with only minor damage.

Figure 57. SS-1 after 3,500 passes.

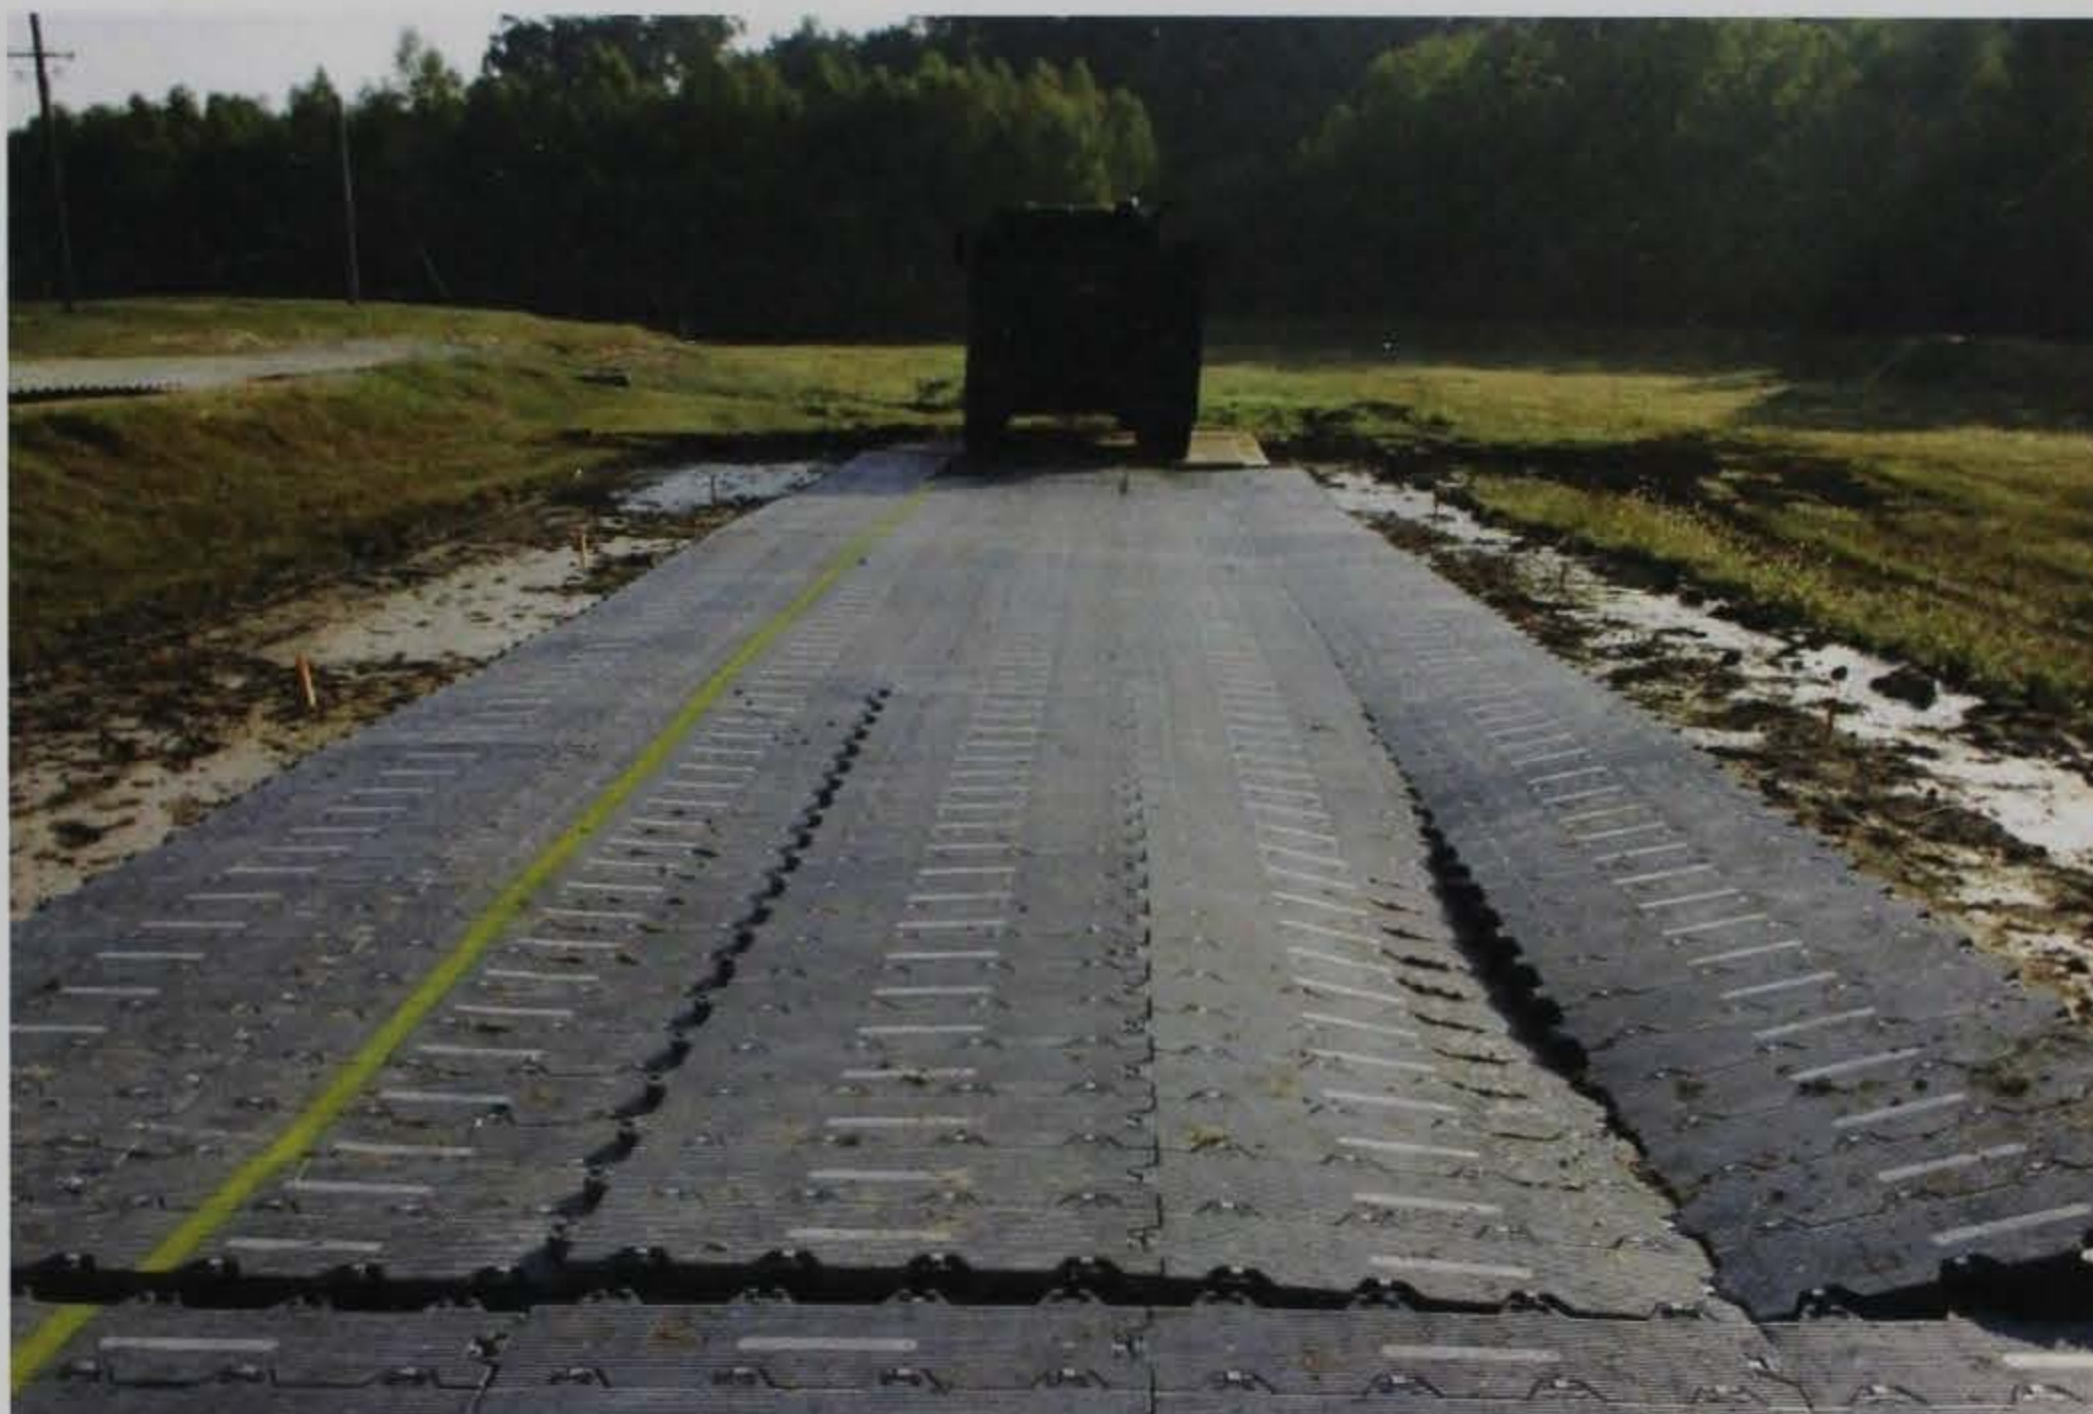
After 4 passes, 19 panel connections broke completely from the Supa-Trac system in the center along the wheel path of the truck. After 6 passes, 55 panel connections were broken. The number of connections continued to increase until over 200 connections, or greater than 50% of the mat section, were destroyed after 10 passes. The T-shaped connectors tore from the receptor pieces, leaving small pieces of plastic littered over the surface of the mats. This was the same failure mechanism seen in the SM-1 test section. At this point, the test section was considered failed due to mat

Figure 58. SM-1 after 1 pass.

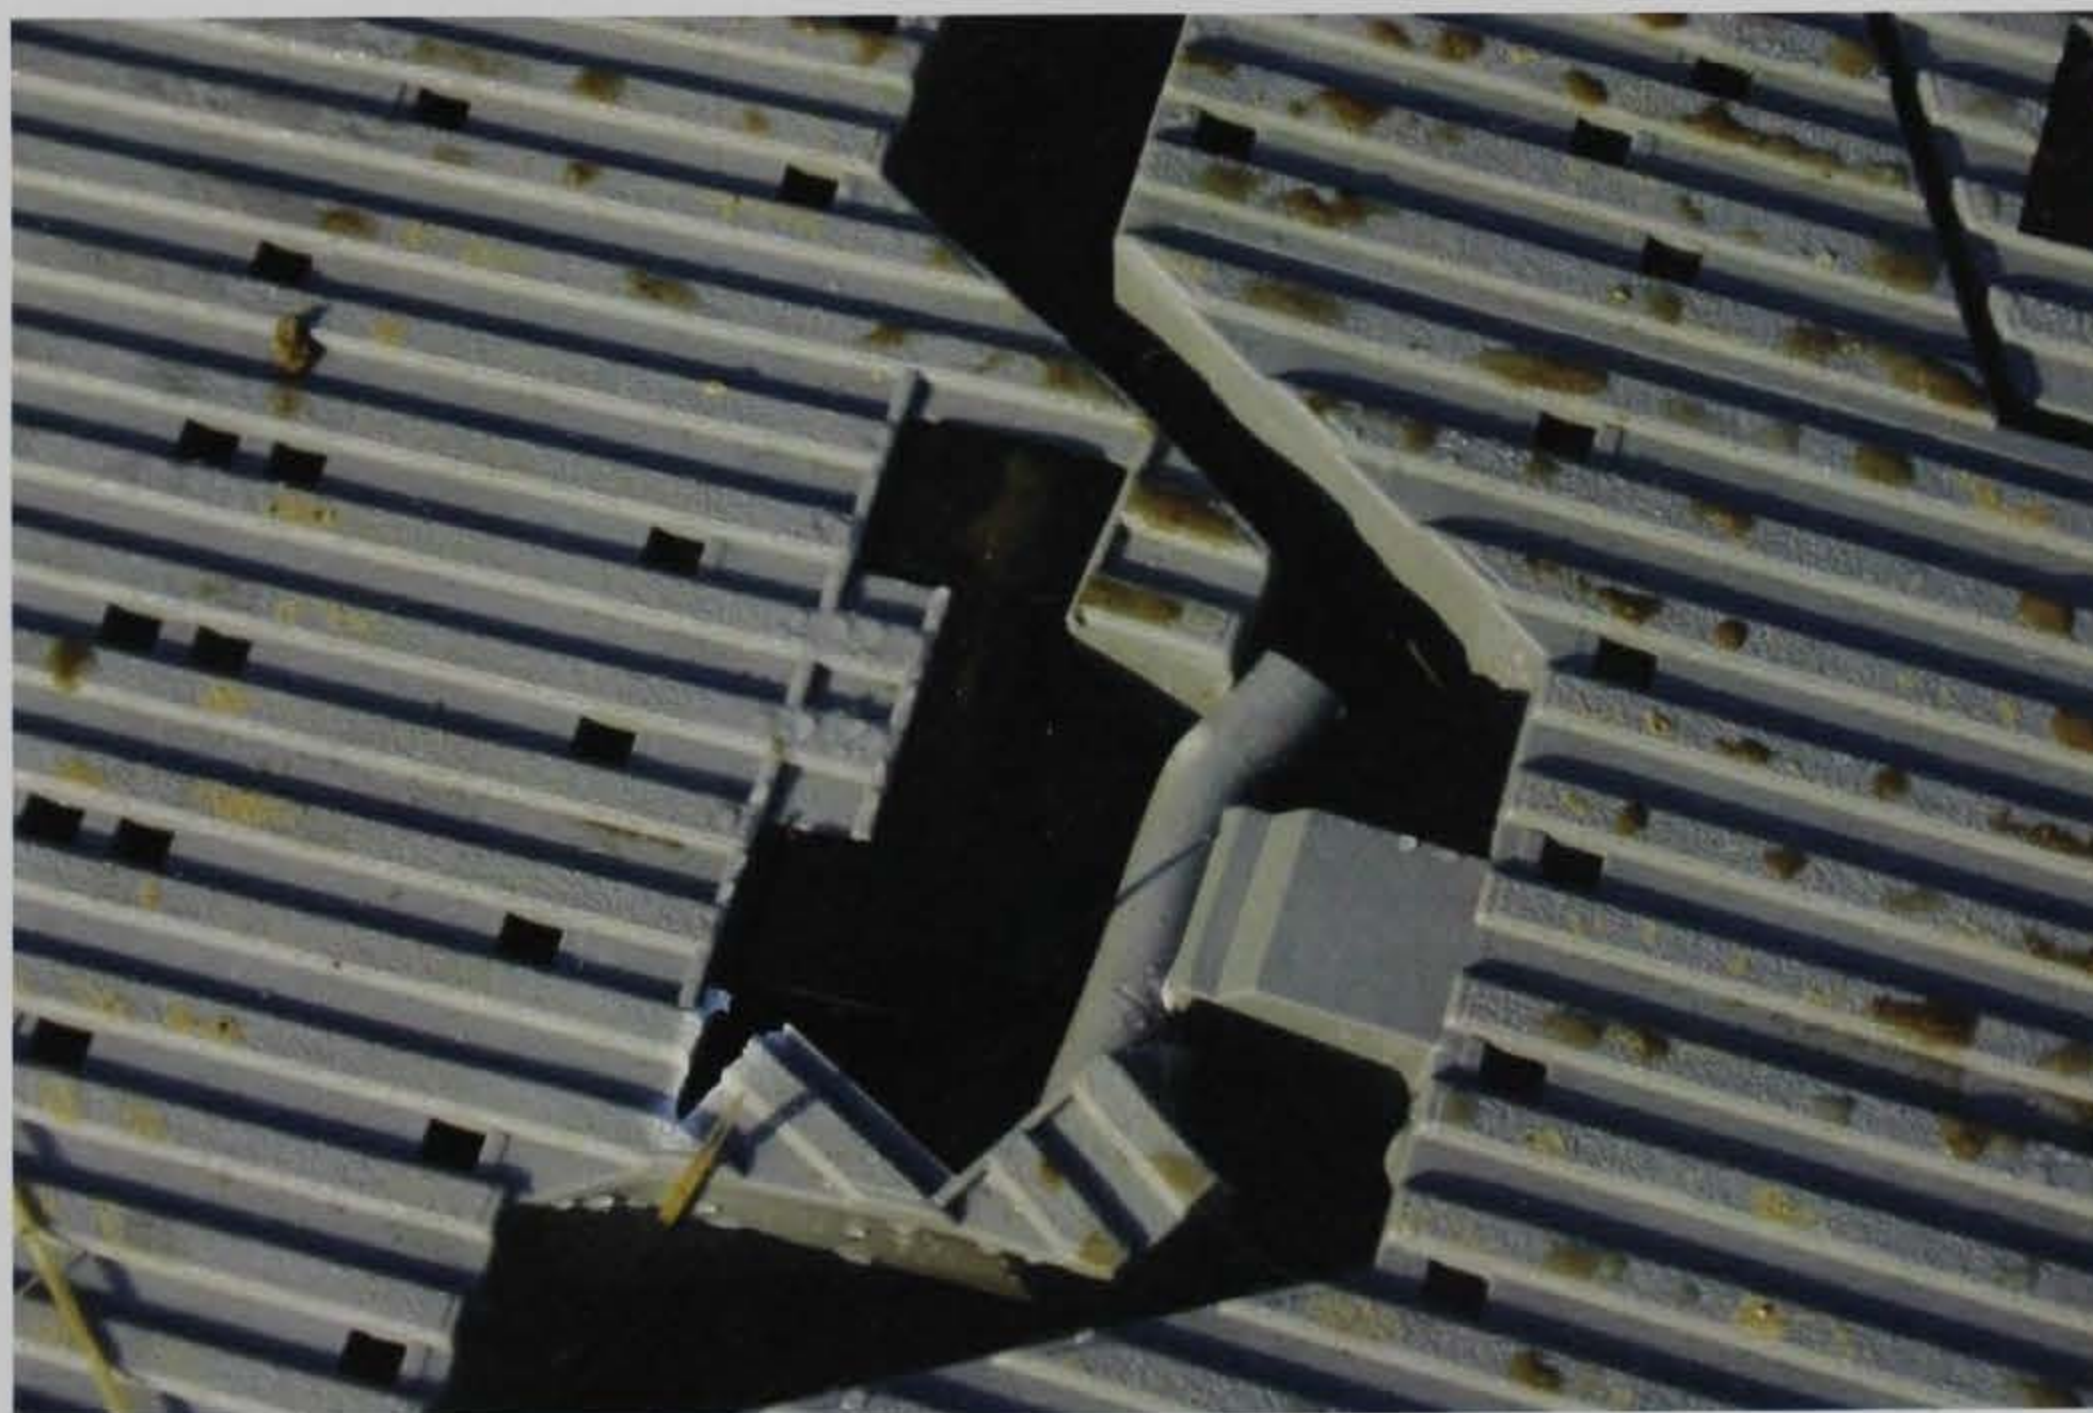
Figure 59. Typical broken connection on Supa-Trac matting.

breakage greater than 20%. The connections were unable to withstand the applied stresses when the subgrade rutted from underneath the mat system. The subgrade rut depth after the mat was removed revealed an average rut depth of approximately 3 in. Since only a minimal rut was discovered under the mat, and the control system was capable of sustaining several additional passes, it was concluded that that any deformable nongranular subgrade would yield similar results. A photograph of the trafficked Supa-Trac section is shown in Figure 61.

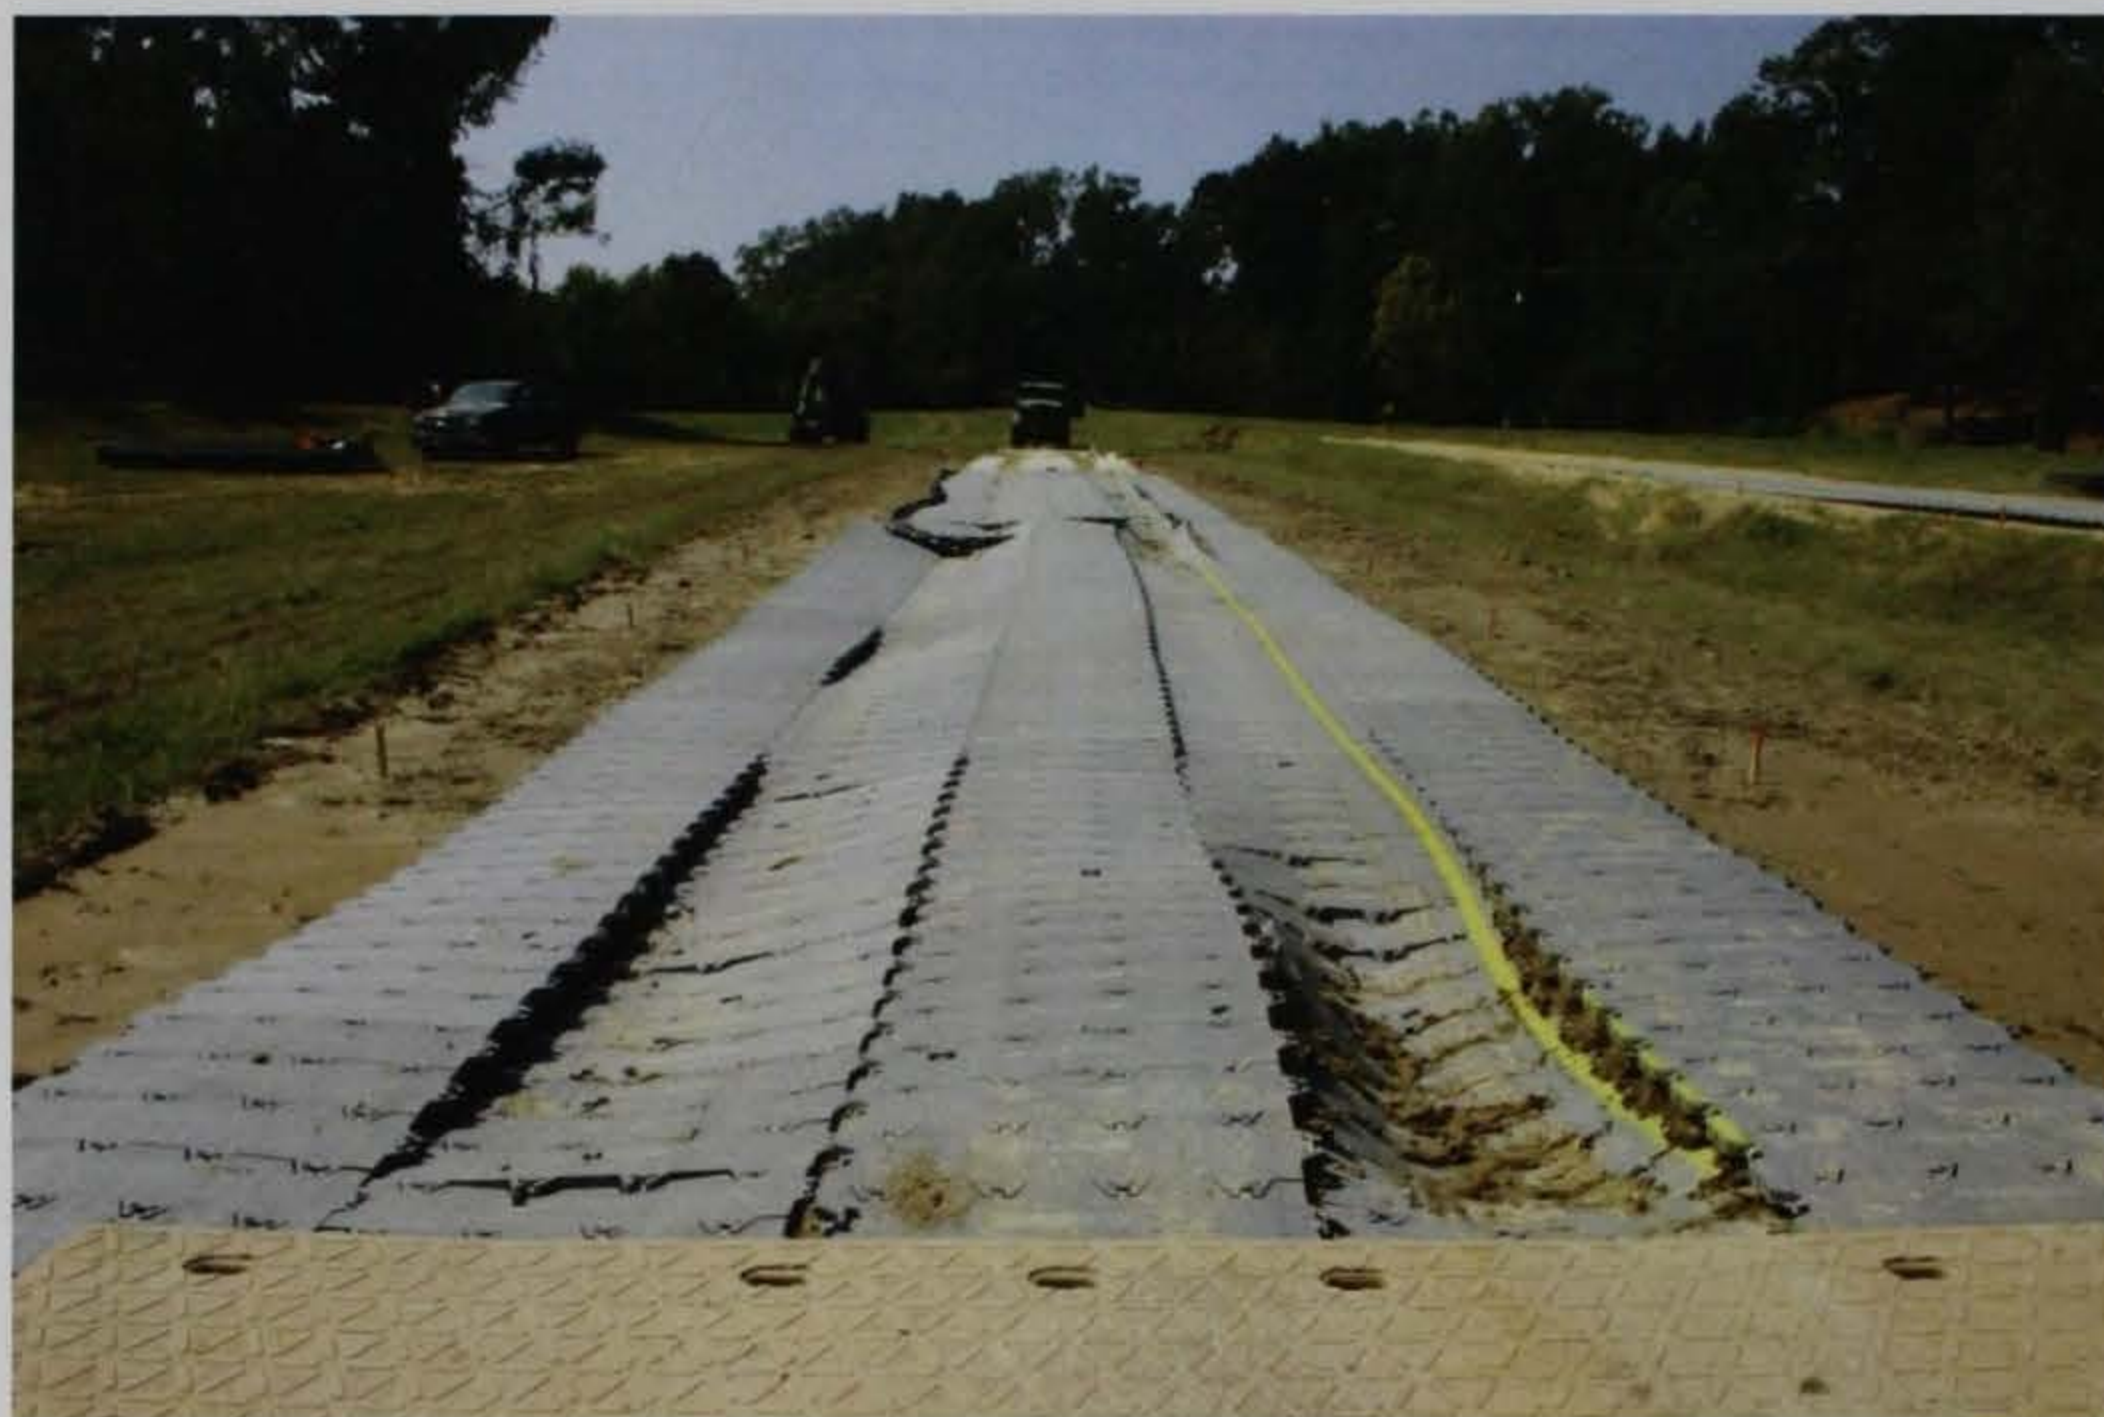
Figure 60. SM-1 after 5 passes.

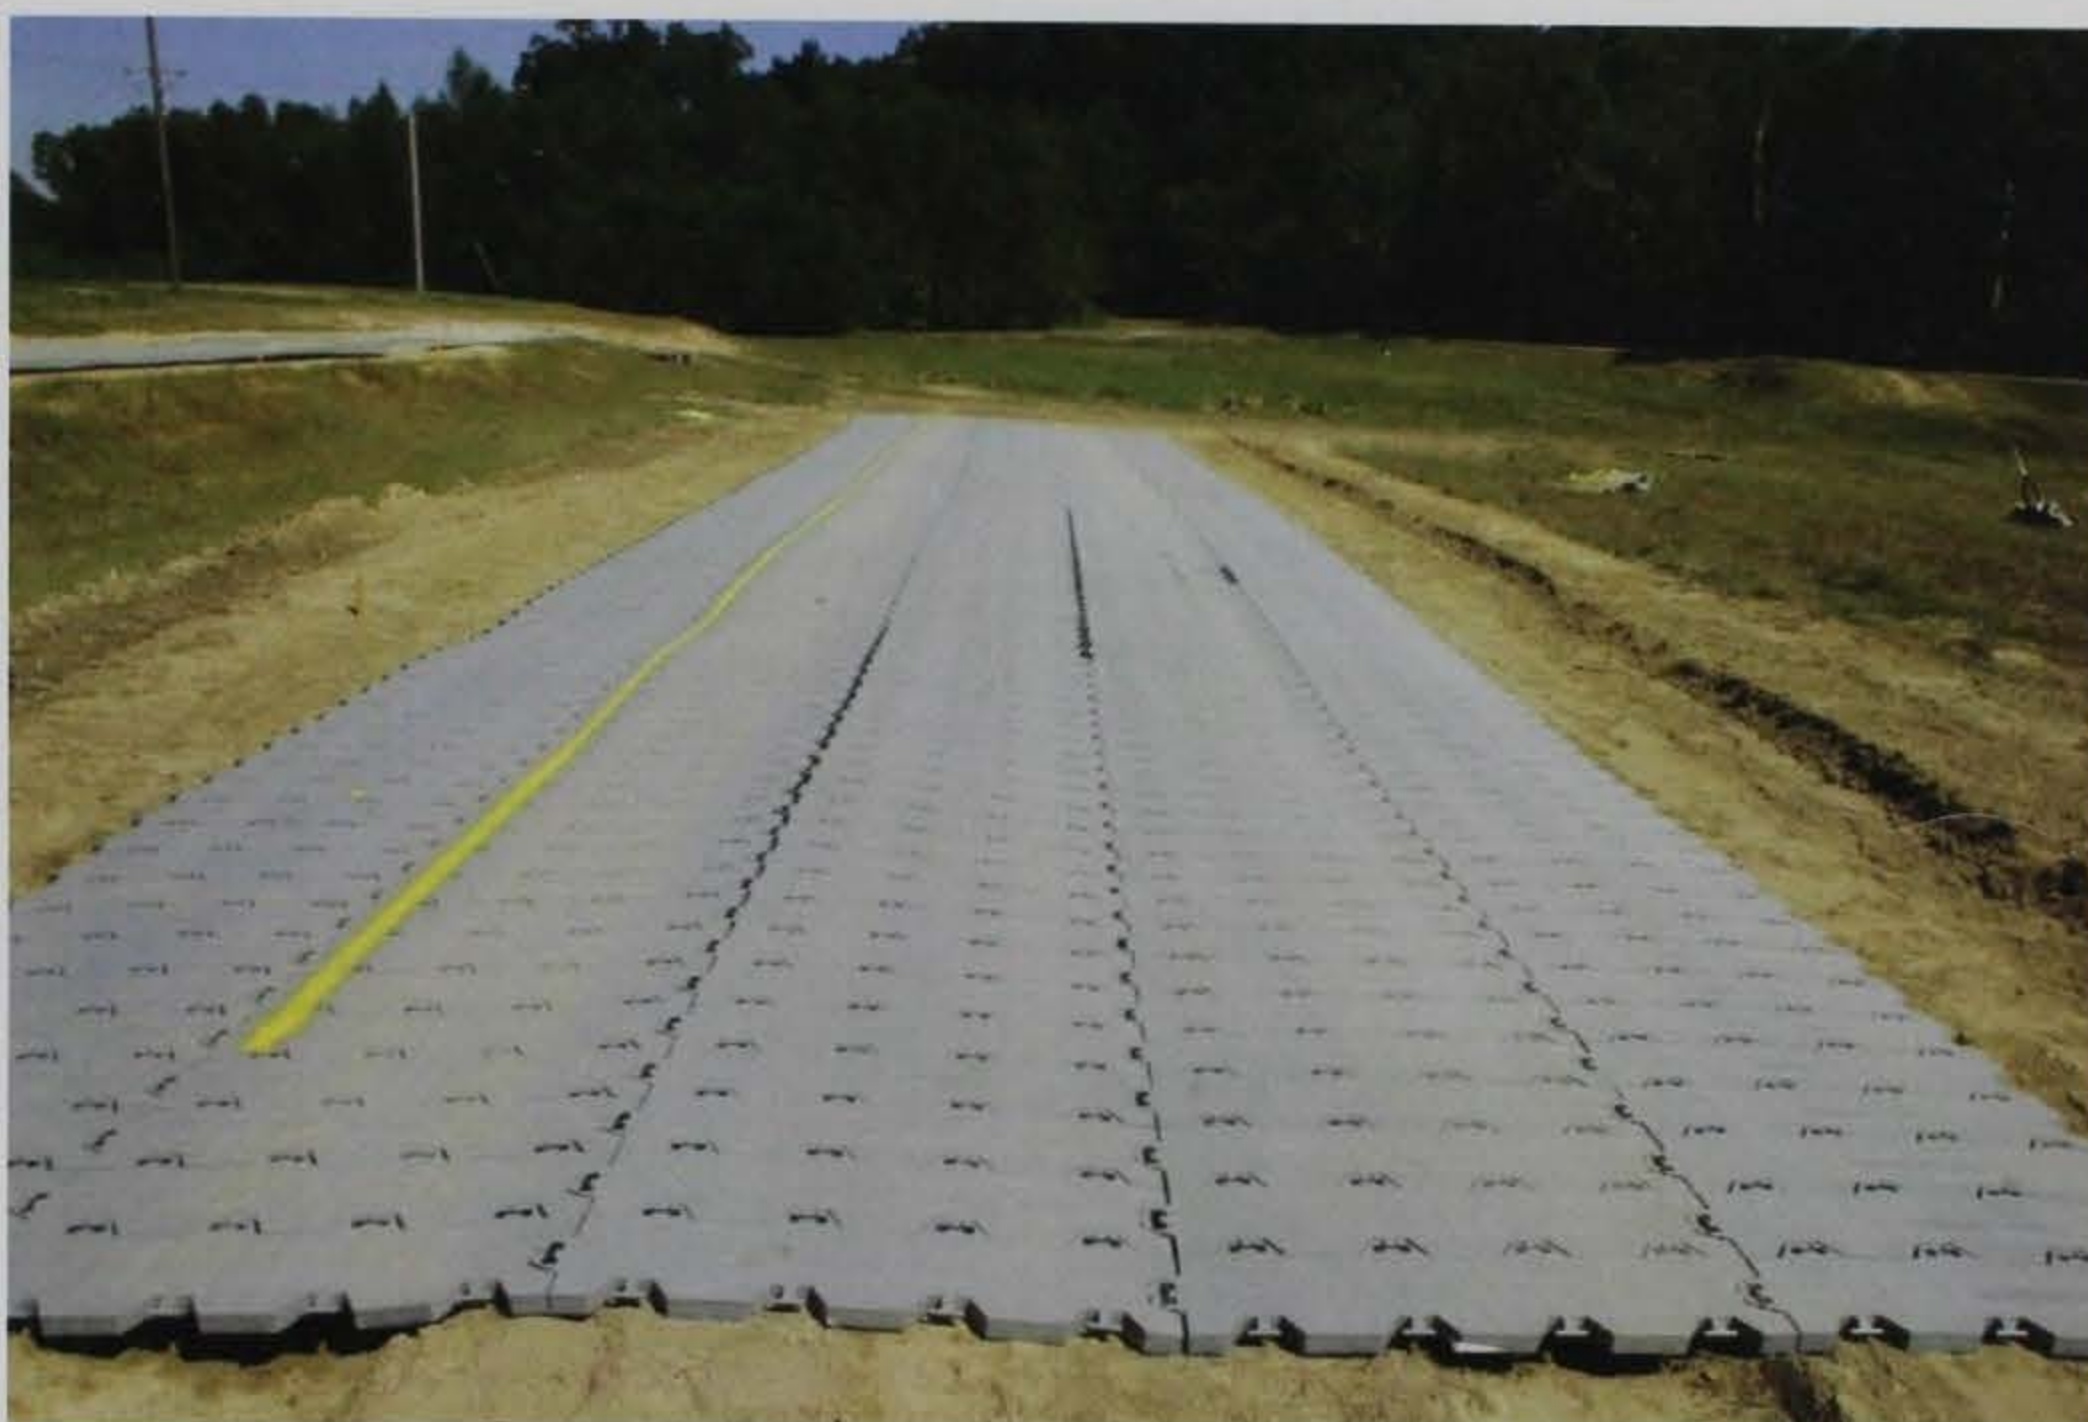
Figure 61. SM-2 after 6 passes.

traffic was concluded due to total failure of the Supa-Trac system. Once the matting system was removed, the final average rut depth on the subgrade measured nearly 7.0 in. Since the ML-CL subgrade strength was similar to that of the SM-2 test section, it can be concluded that the brickwork panel configuration of the matting system better distributes the applied load, slows the rut formation, and therefore extends the number of passes the mat can sustain before failure. The brickwork configuration prevented the “unzipping” effect seen along the panel joints of sections SM-1 and SM-2.
