Evaluation of Supa-Trac Matting for Expeditionary Roads

Timothy W. Rushing, Jeb S. Tingle, Timothy J. McCaffrey,
and Todd S. Rushing

August 2009

Final report

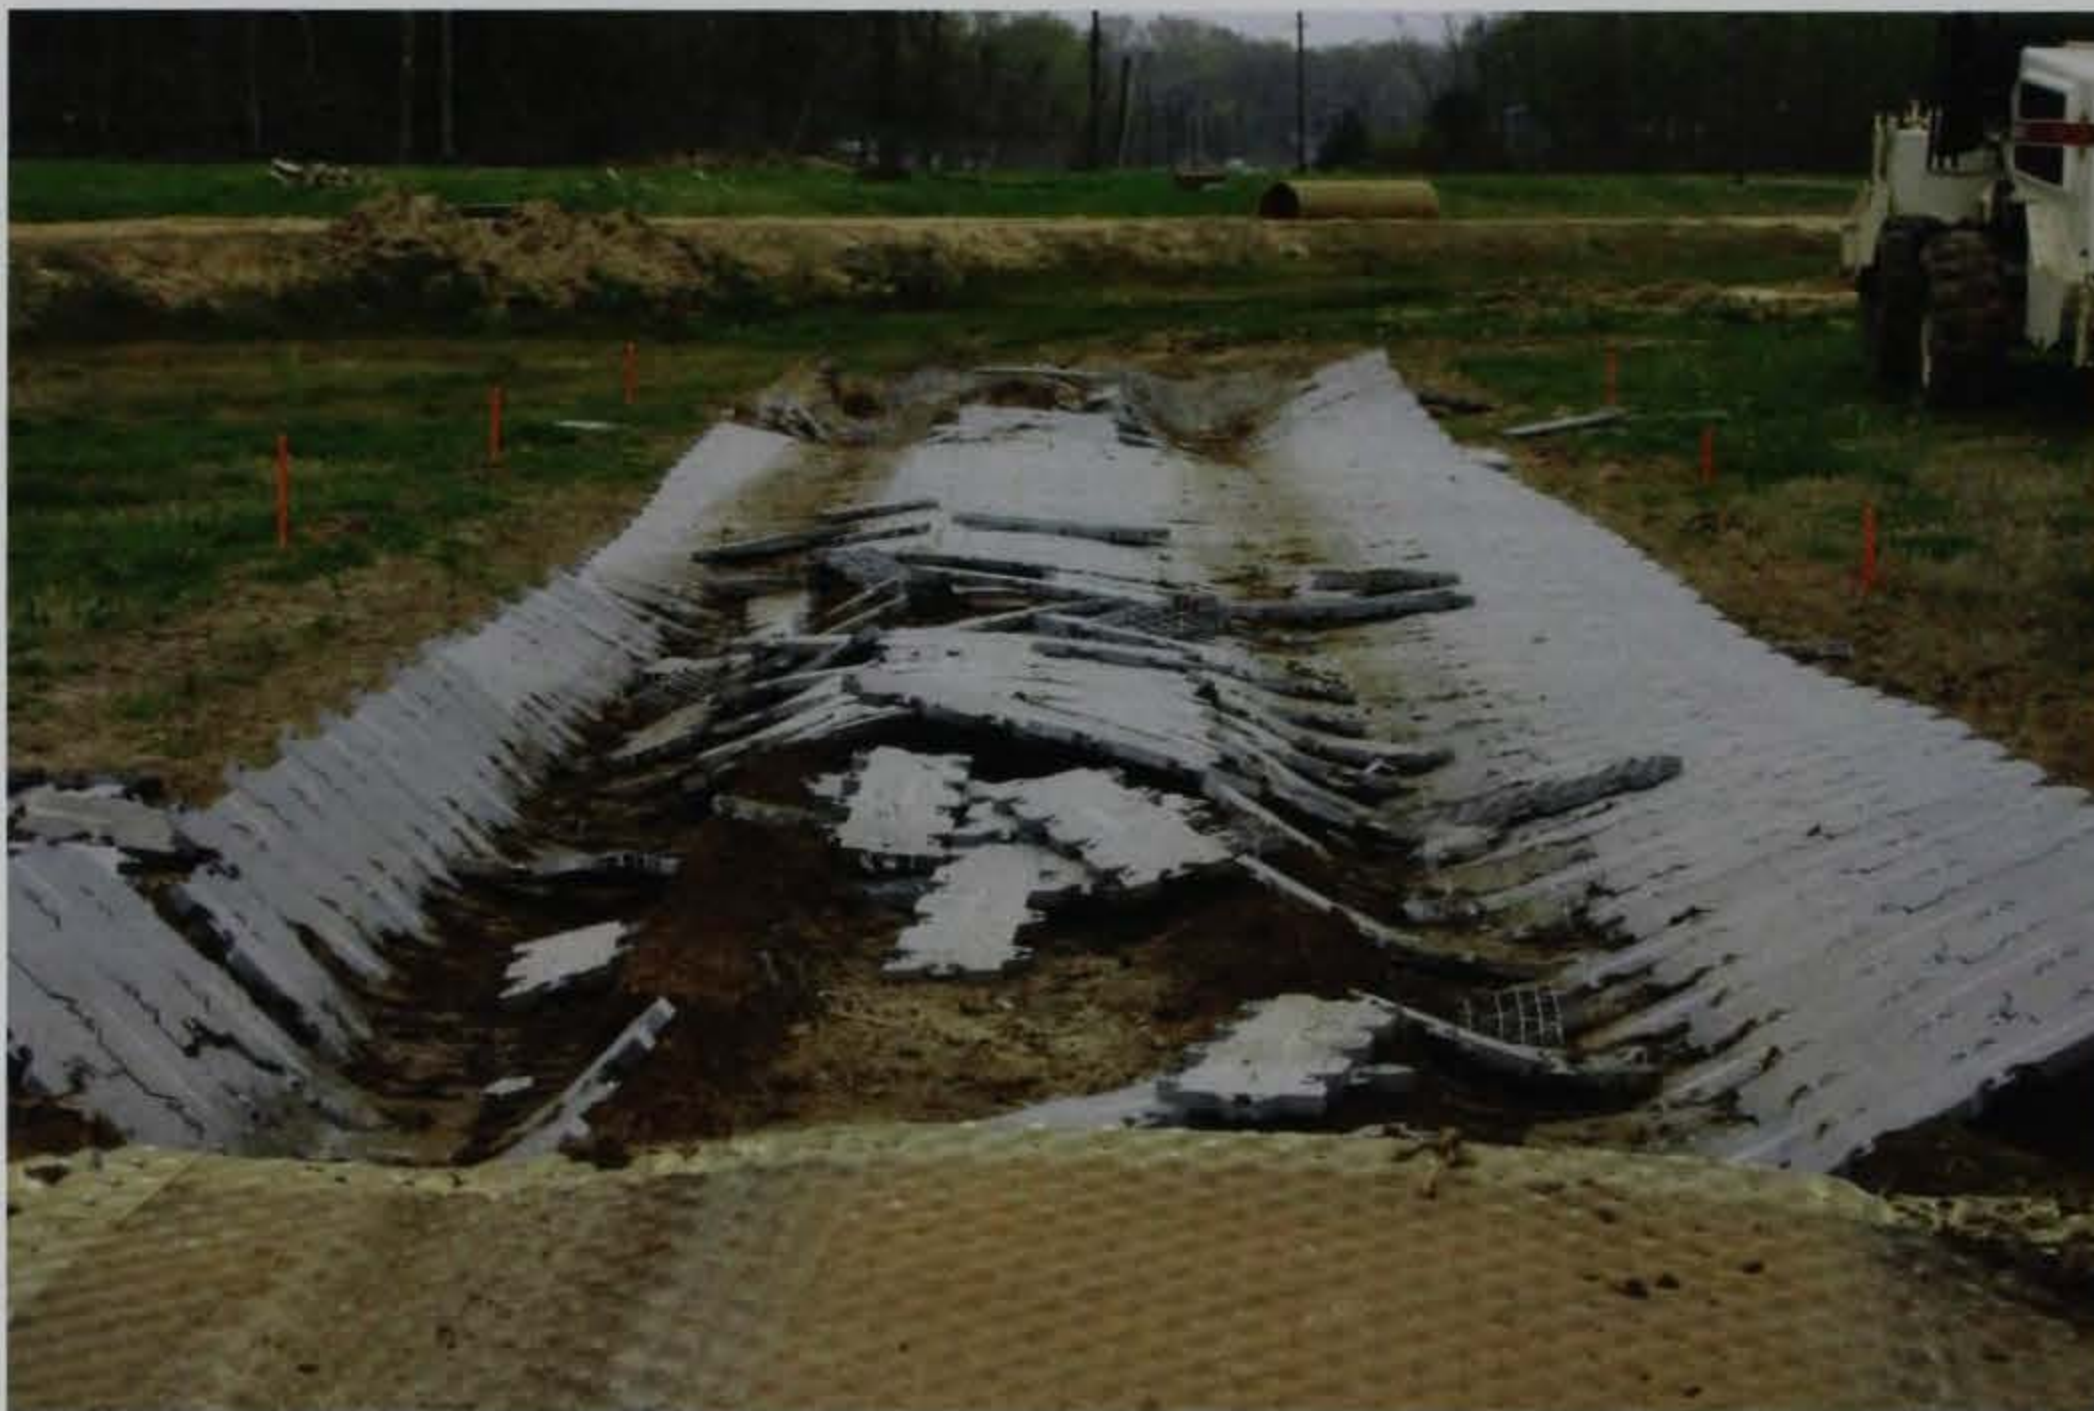
to withstand the applied stresses when the subgrade rutted from underneath the mat system. Trafficking was continued until the mat was completely destroyed after 140 passes. Nearly every connection in the wheel path of the test vehicle was cracked or broken. A photograph of the SM-3 Supa-Trac section after 140 passes is shown in Figure 62.

Figure 62. SM-3 test section after 140 passes.

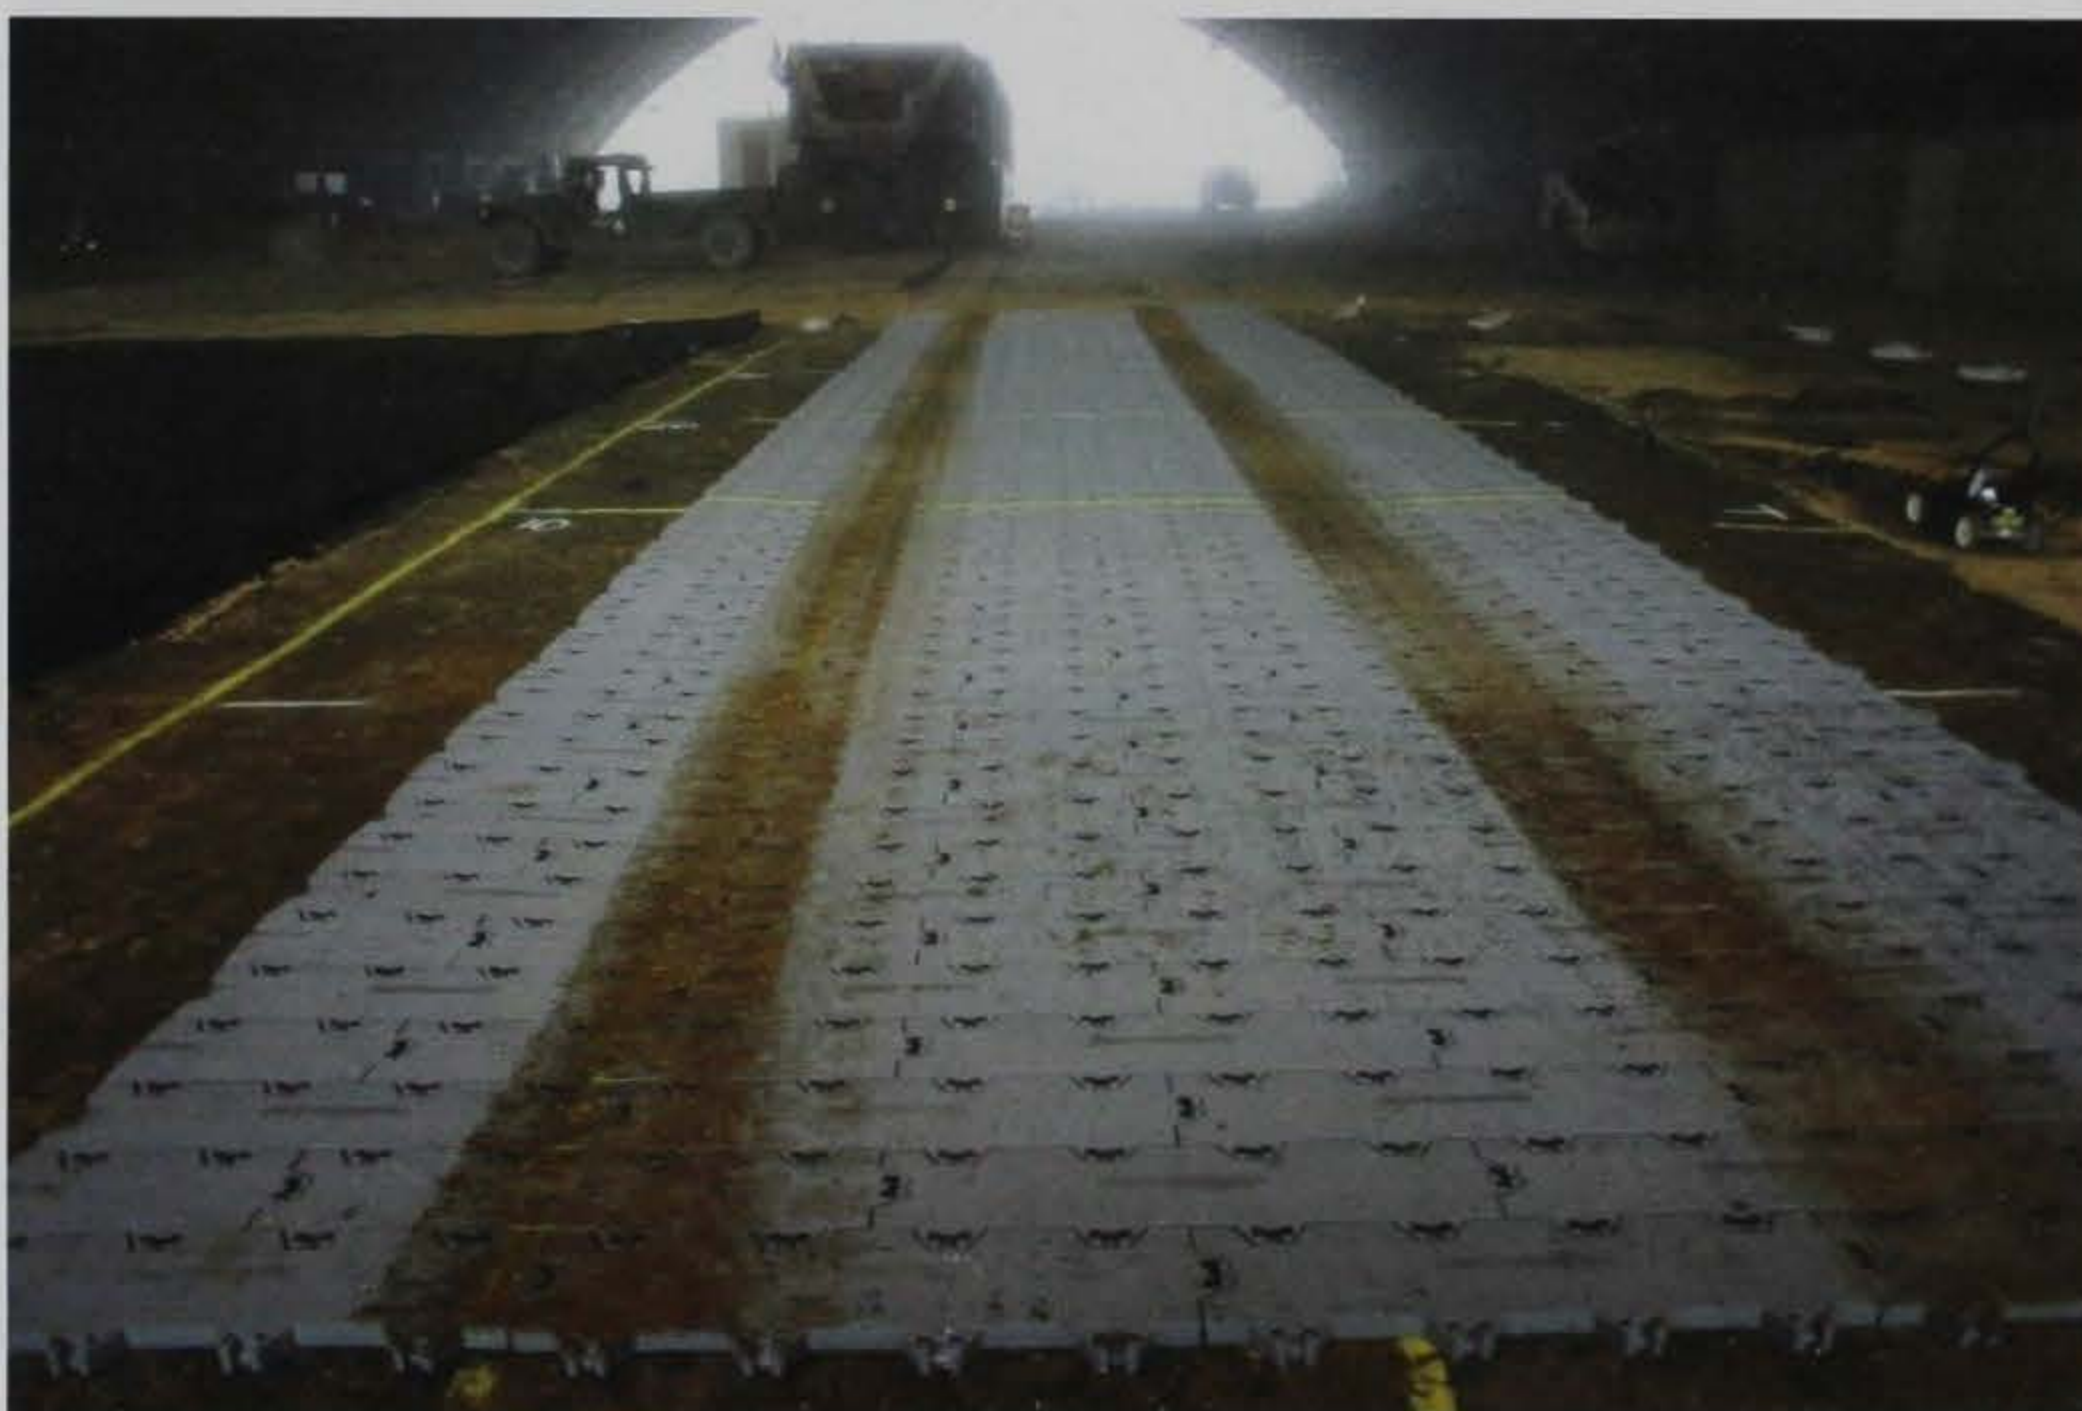
After 2,000 passes, no mat damage was noted to the Supa-Trac mat system. A photo of the Supa-Trac system after 2,000 passes is shown in Figure 63. The Supa-Trac system performed adequately to prevent rut formation and to sustain 2,000 truck passes with no damage.

Figure 63. SM-4 test section after 2,000 passes.

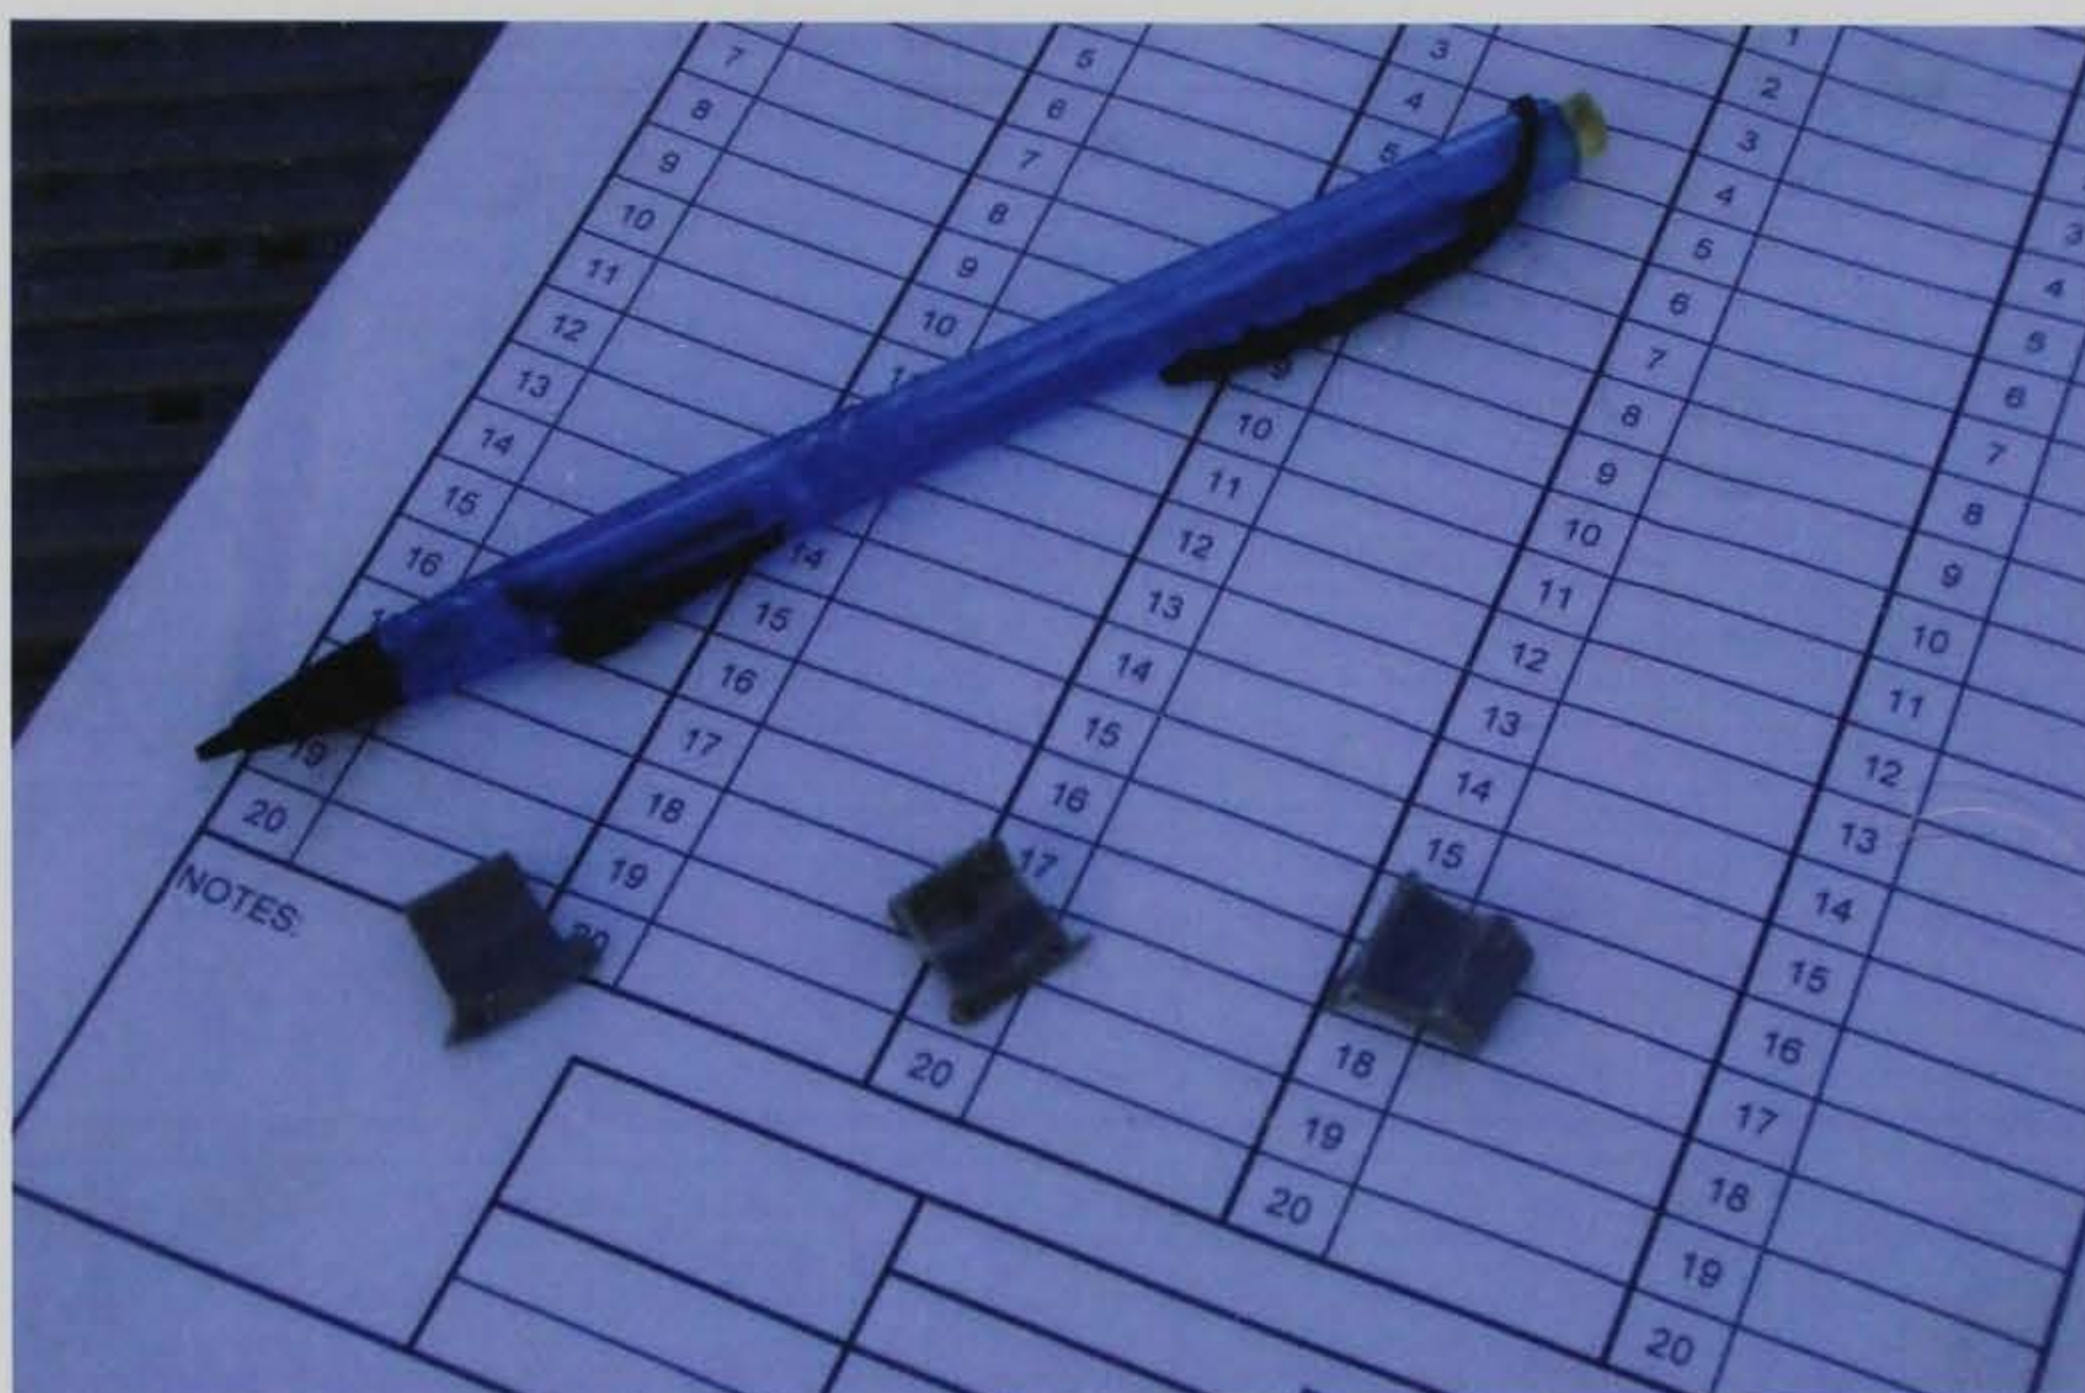
Figure 64. Small pieces of matting broken free after 10 passes of SC-1.

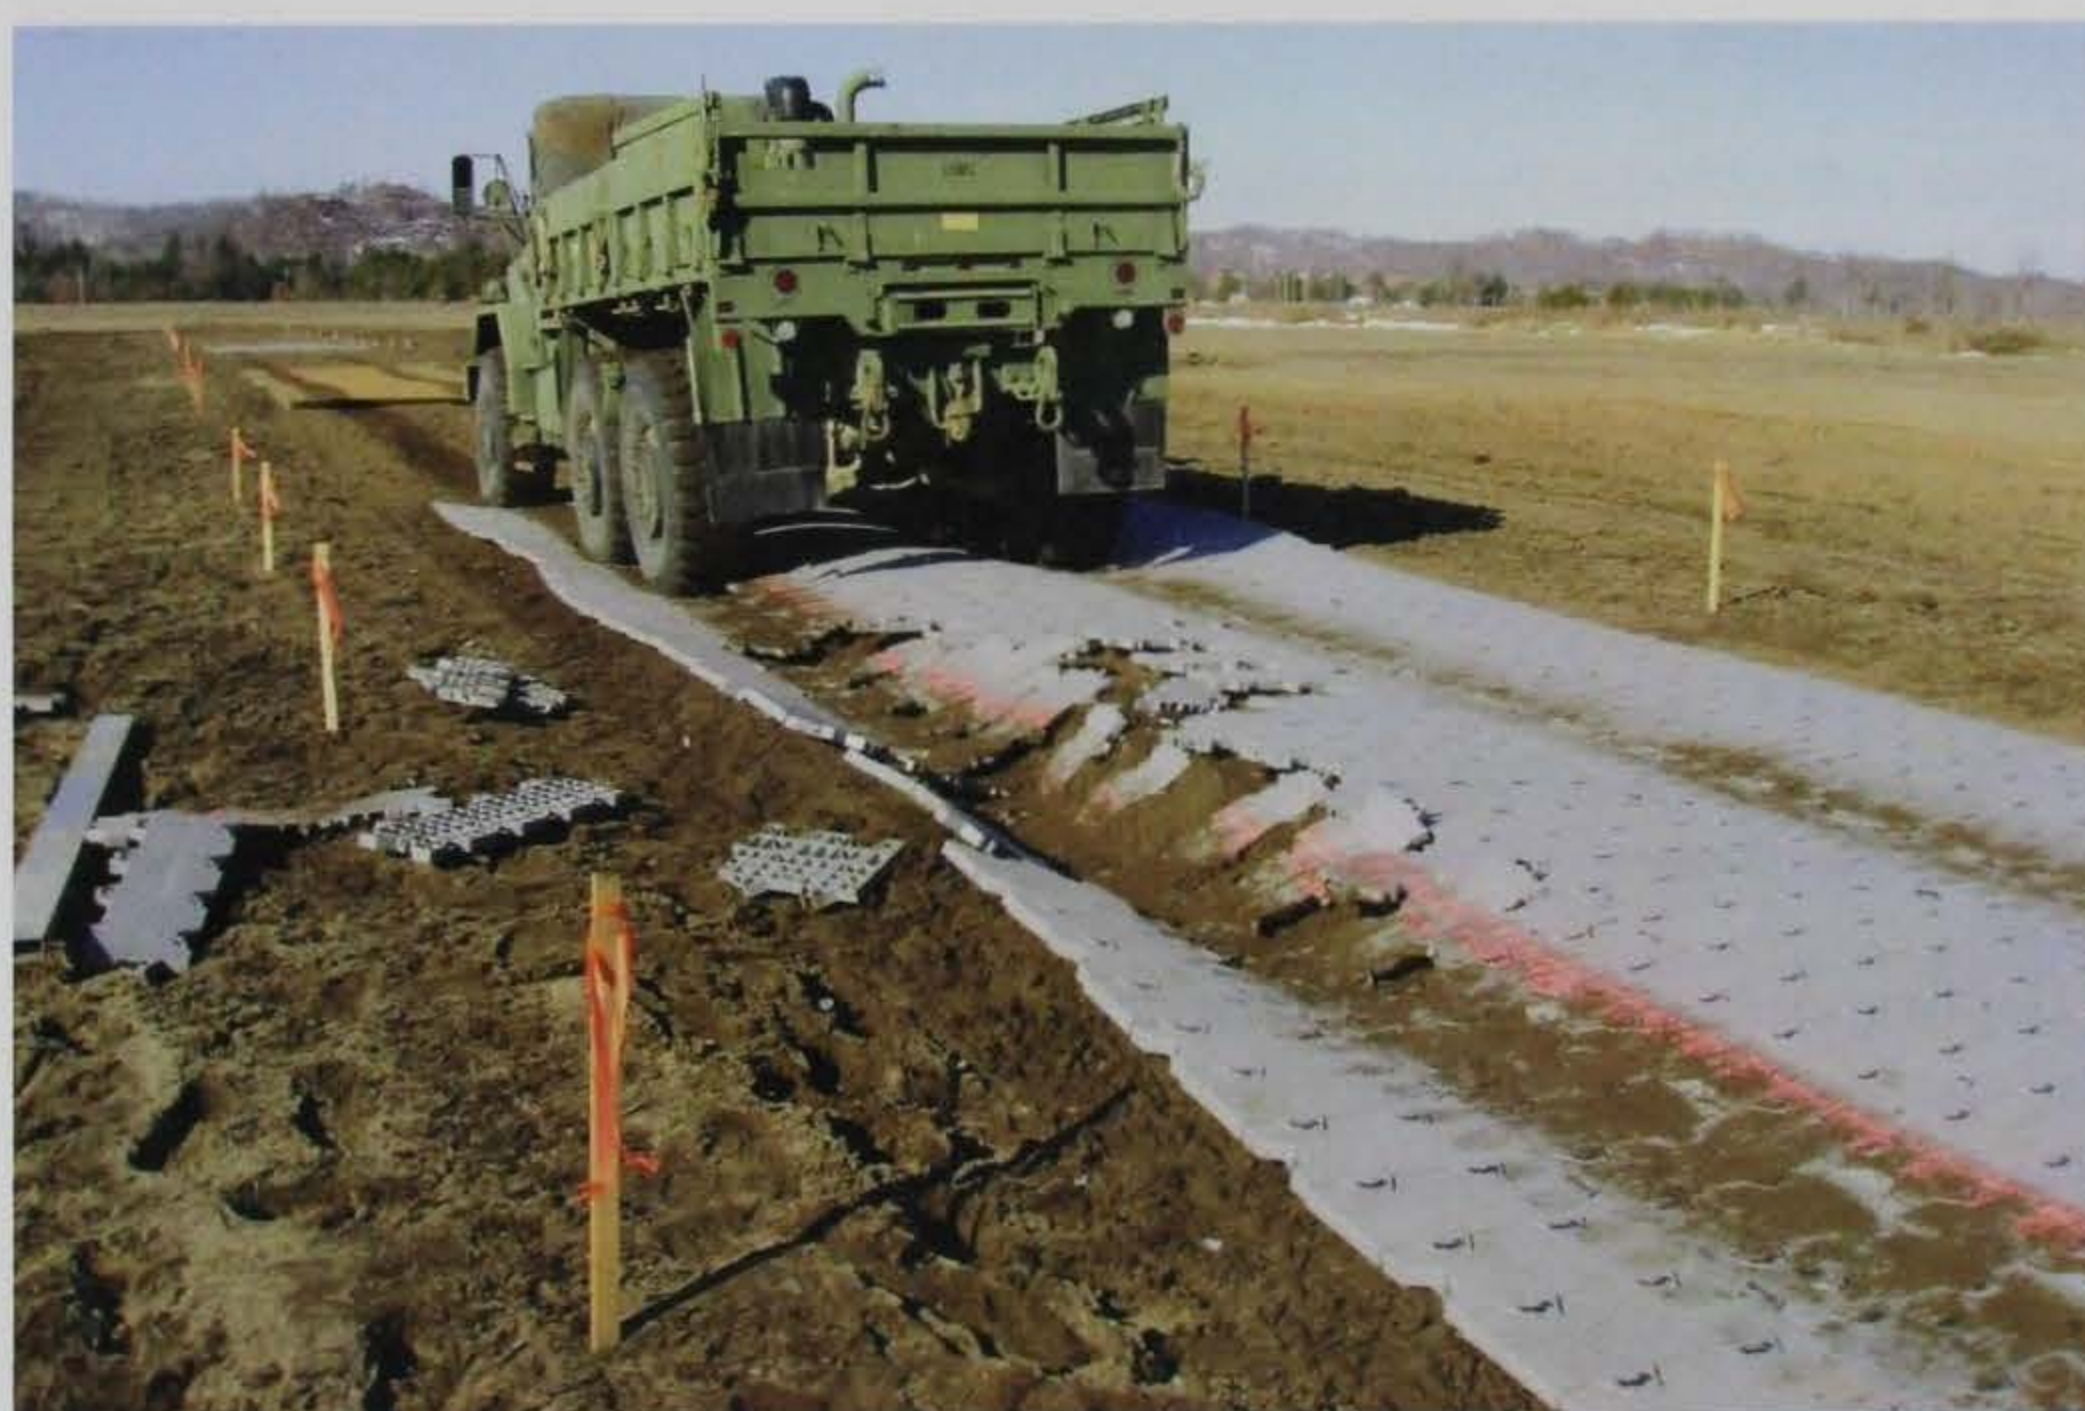
After 100 passes, approximately 40% of the panels were broken. Most of the damage was located on the east side of the test section where the rut depth was deeper, but panels were also beginning to break on the west side as well. After 120 passes, the amount of damage had increased to approximately 60% (Figure 65). Major damage had occurred on the west side of the section. Pieces of panels were breaking off with each pass, and entire panel sections were unattached. The connections were unable to withstand the stress when the subgrade rutted from underneath the mat system. Trafficking was continued until the mat was completely destroyed after 146 passes. Nearly every connection in the wheel path of the test vehicle was cracked or broken. A photograph of the SC-1 Supa-Trac section after 146 passes is shown in Figure 66.

Figure 65. SC-1 test section after 120 passes.

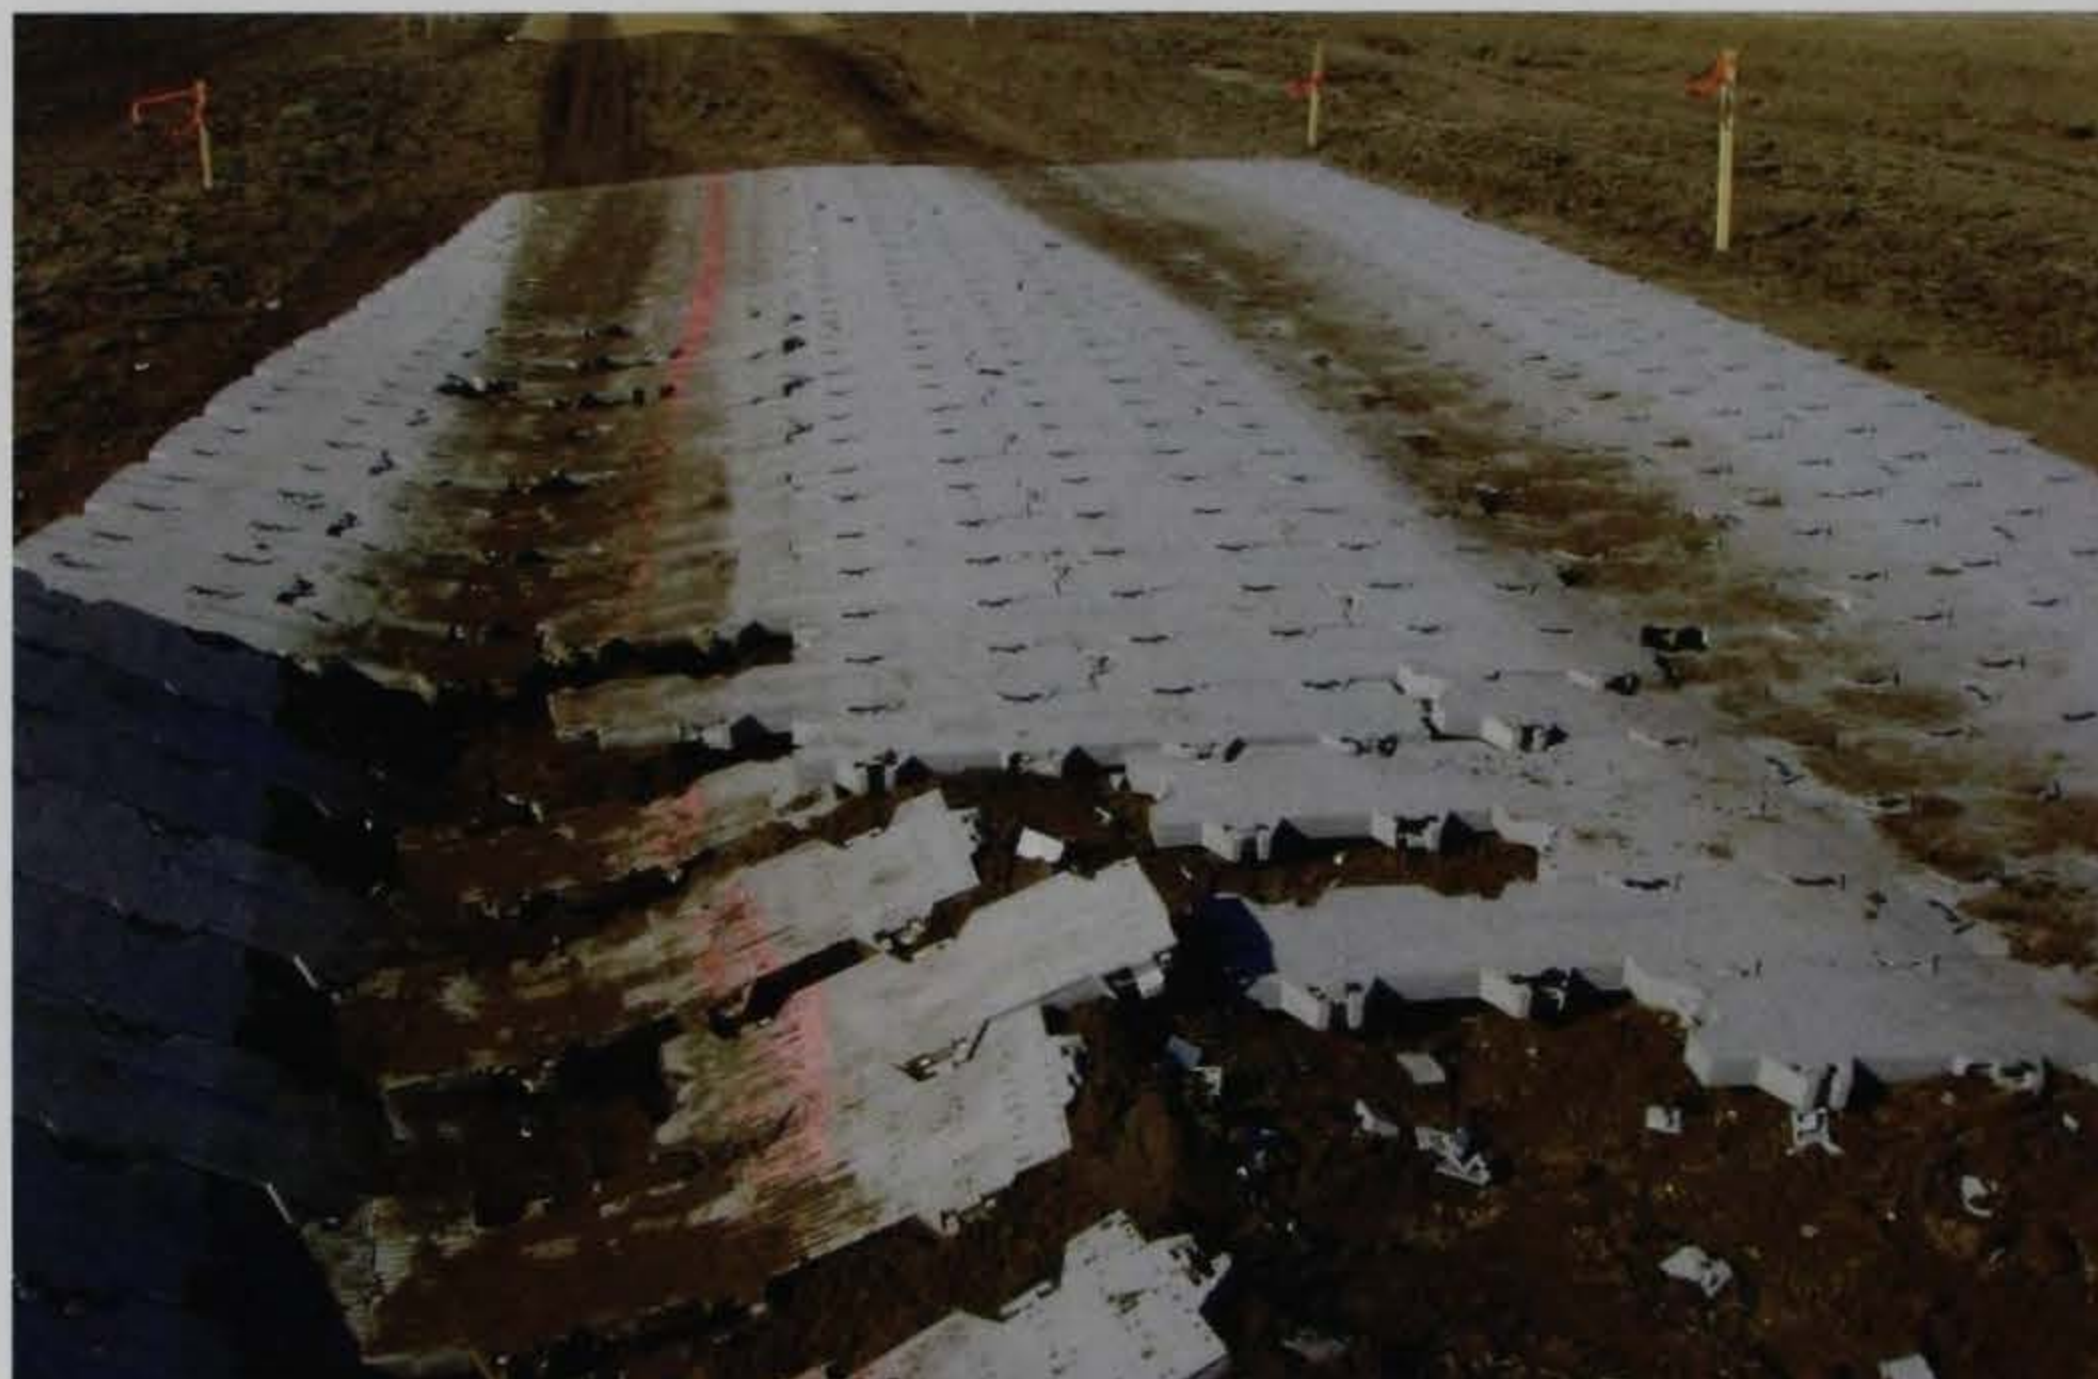
Figure 66. SC-1 test section after 146 passes

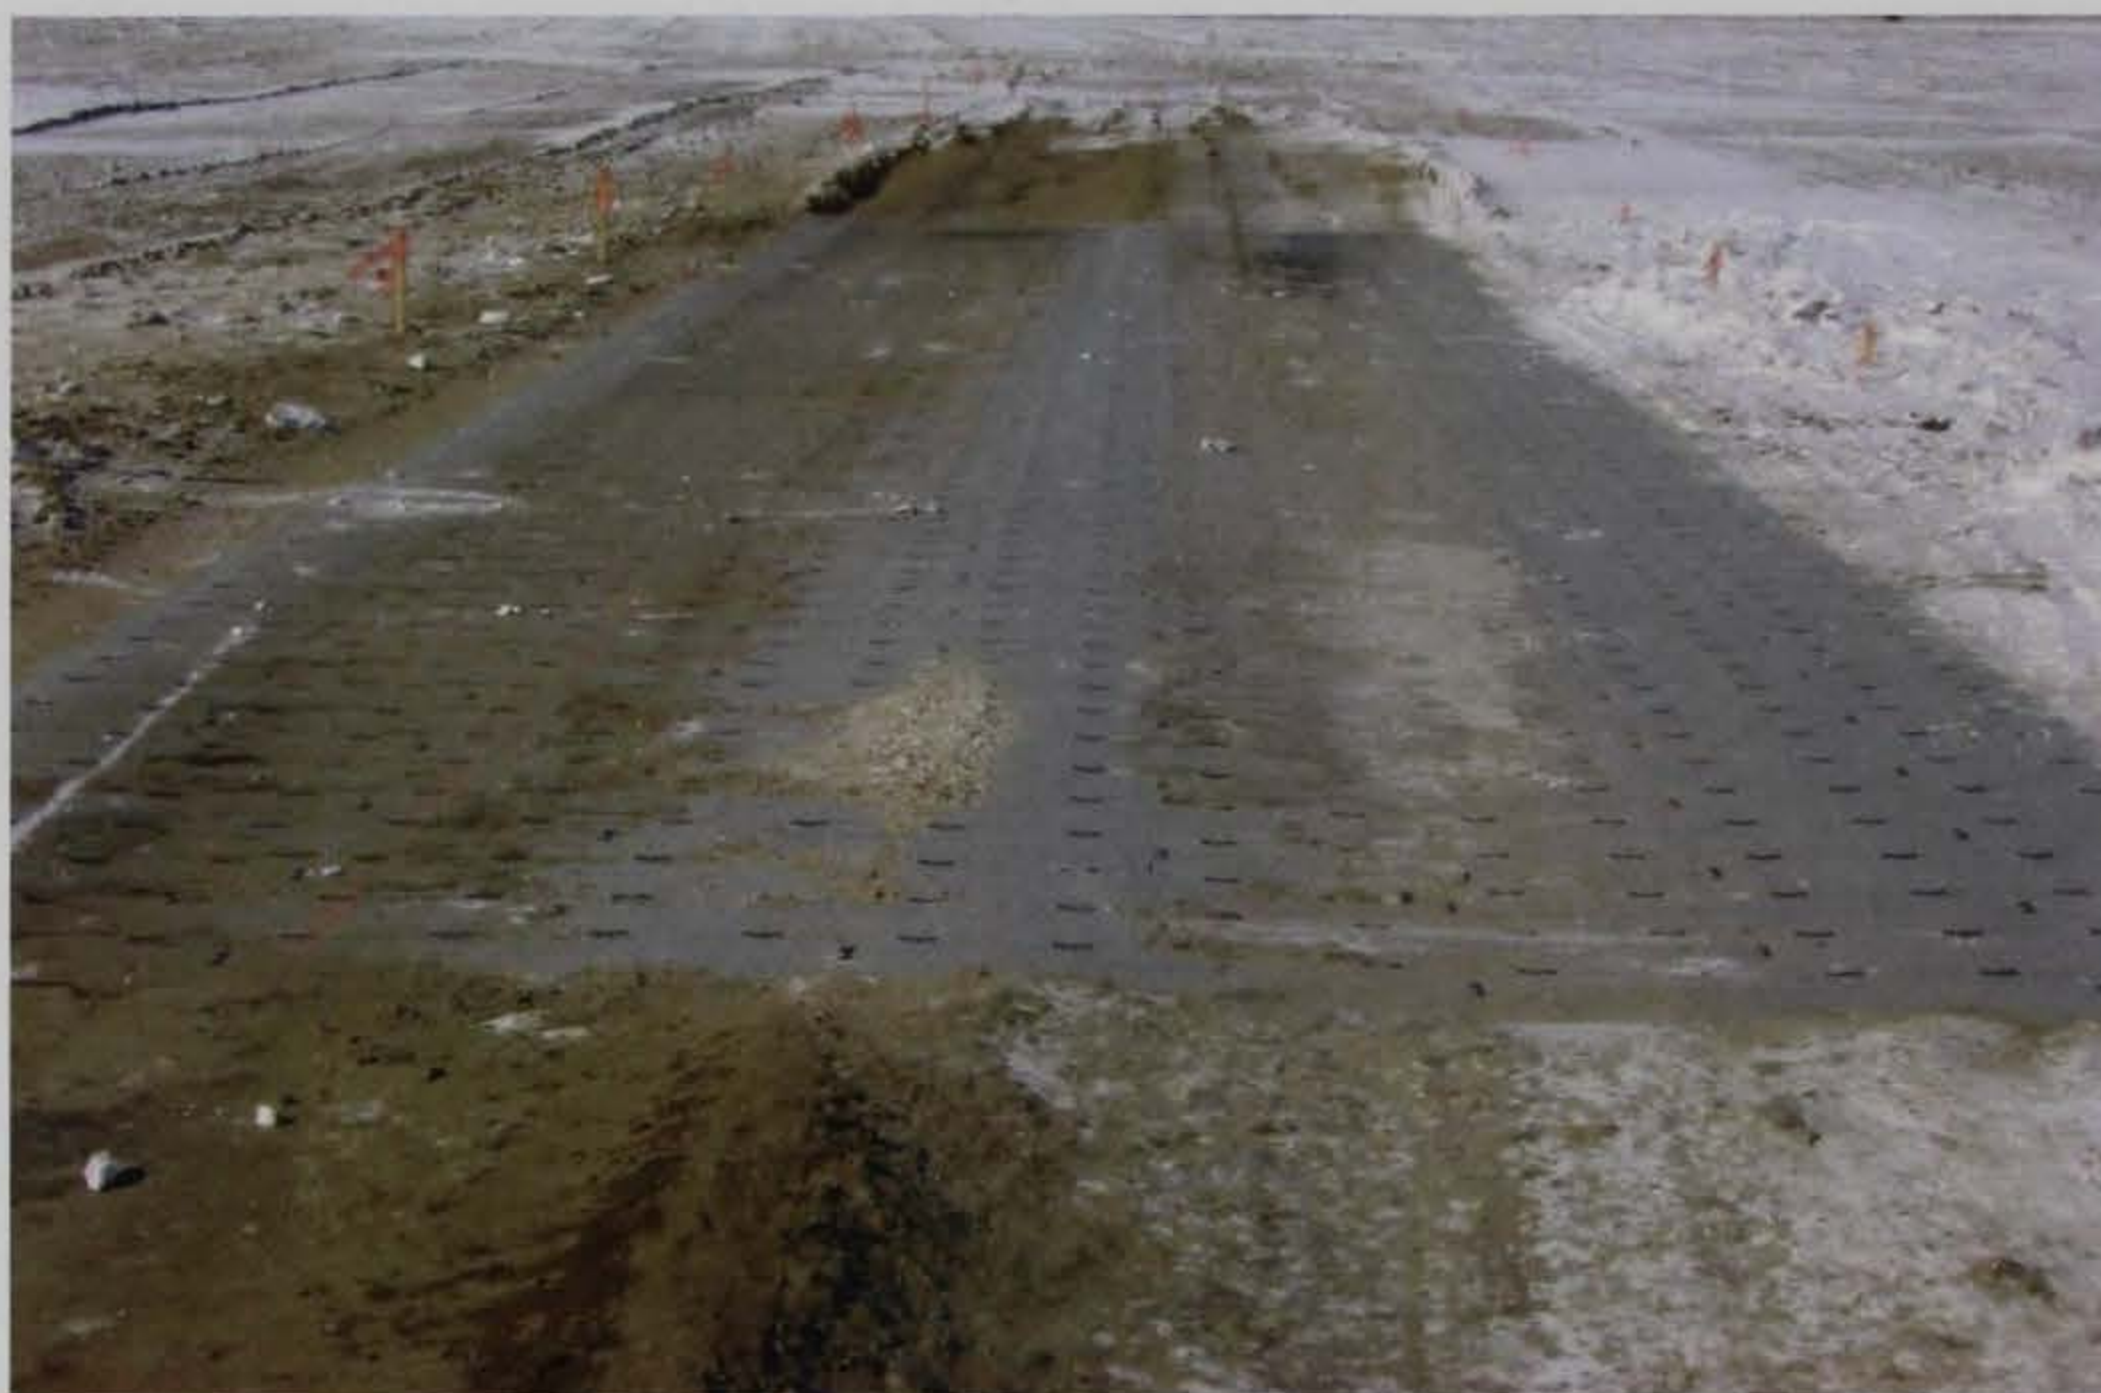
Figure 67. SC-2 test section after 2,000 passes.

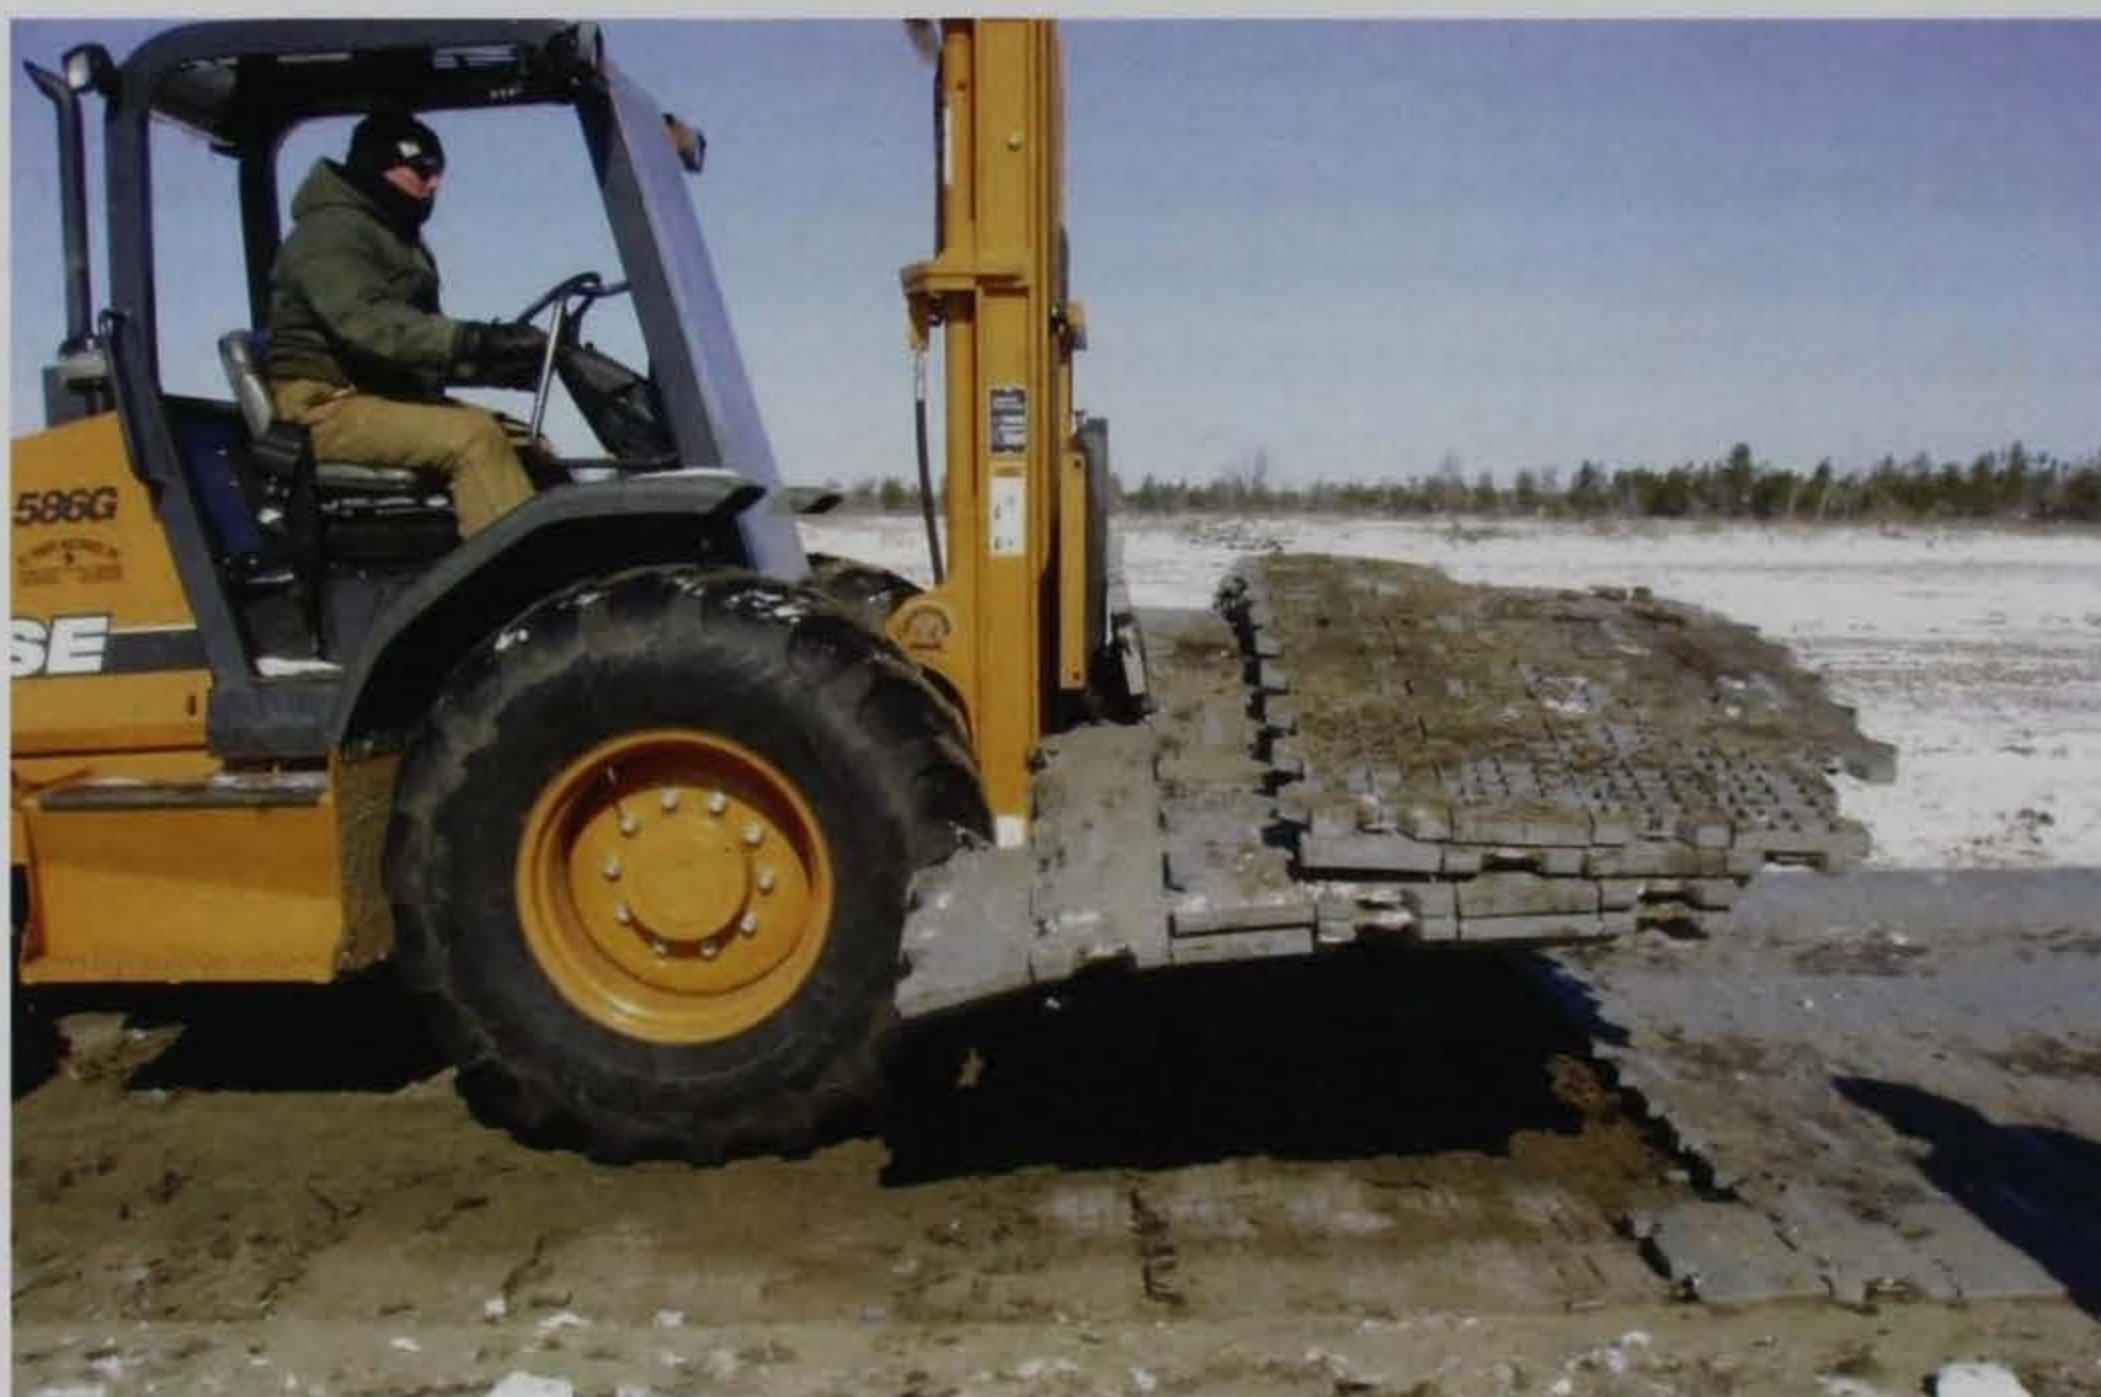
Although there was almost no damage to the system, it was impossible for three personnel to roll the mat for recovery. A forklift was used to free one end of the mat. When the personnel attempted to roll the mat, it shattered at the connections and fell apart. A forklift was used to loosen additional panel rows. When the mat was lifted from the subgrade, it again shattered and fell apart. Removal could only be achieved by removing small sections with the forklift while destroying the mat (Figure 68). The connections had become very brittle and could not handle even small amounts of stress. After removal, small pieces of broken matting had to be picked up by hand as seen in Figure 69. Figure 70 shows the completely frozen subgrade after removal of the Supa-Trac matting.

Figure 68. Removal of matting with a forklift on SC-2 test section.
