Evaluation of Supa-Trac Matting for Expeditionary Roads

Timothy W. Rushing, Jeb S. Tingle, Timothy J. McCaffrey,
and Todd S. Rushing

August 2009

Final report

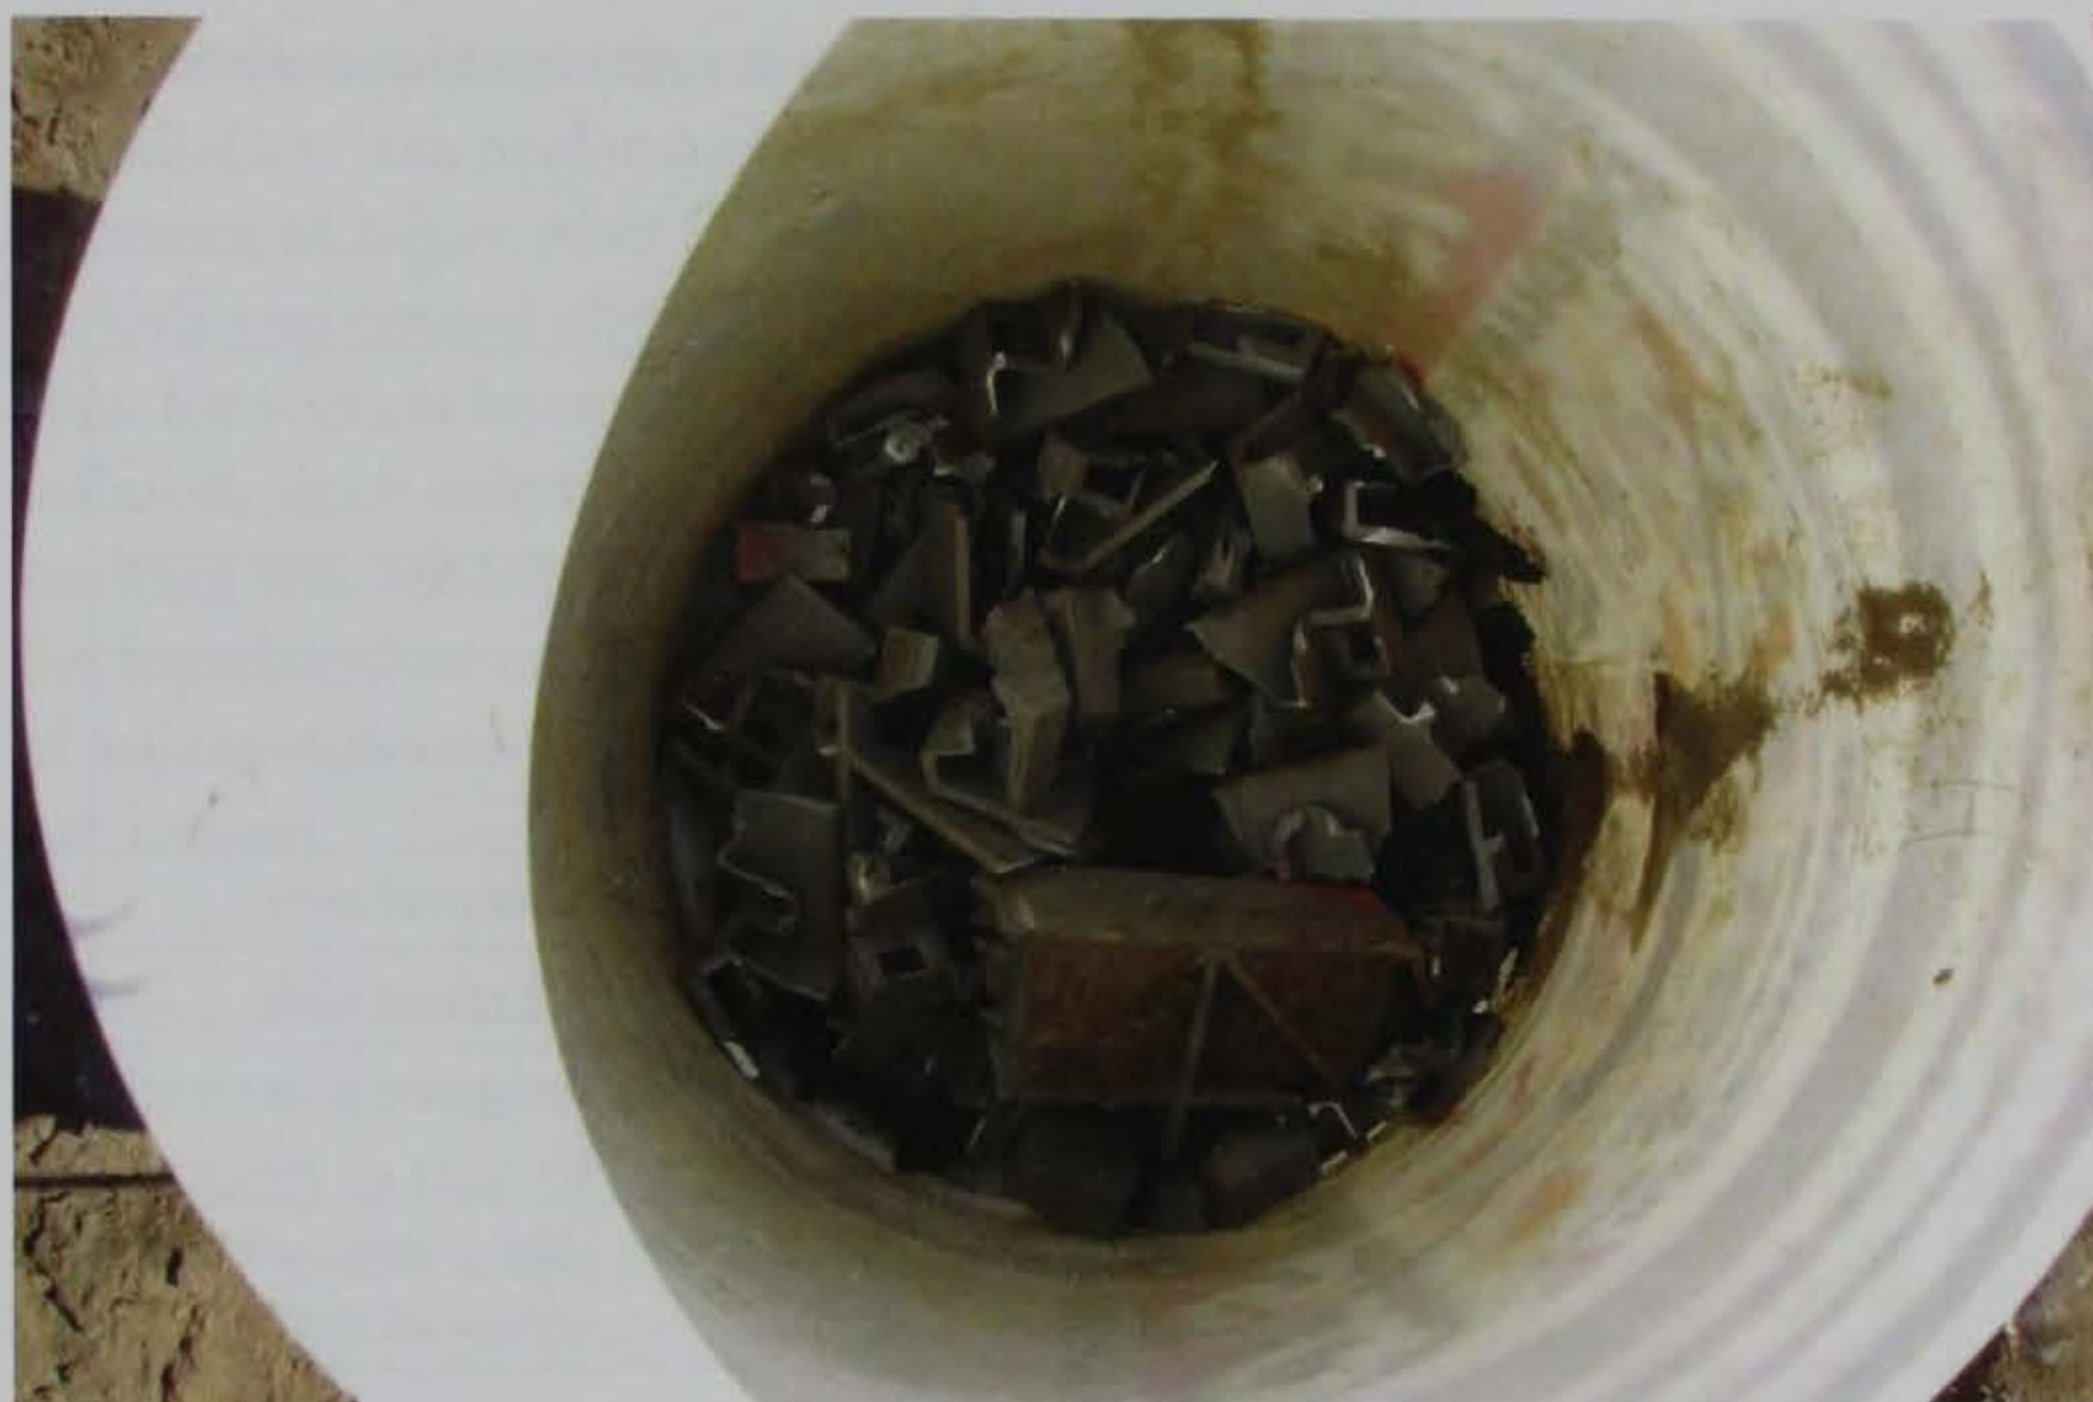
Figure 69. Bucket full of broken pieces of Supa-Trac collected after removal.

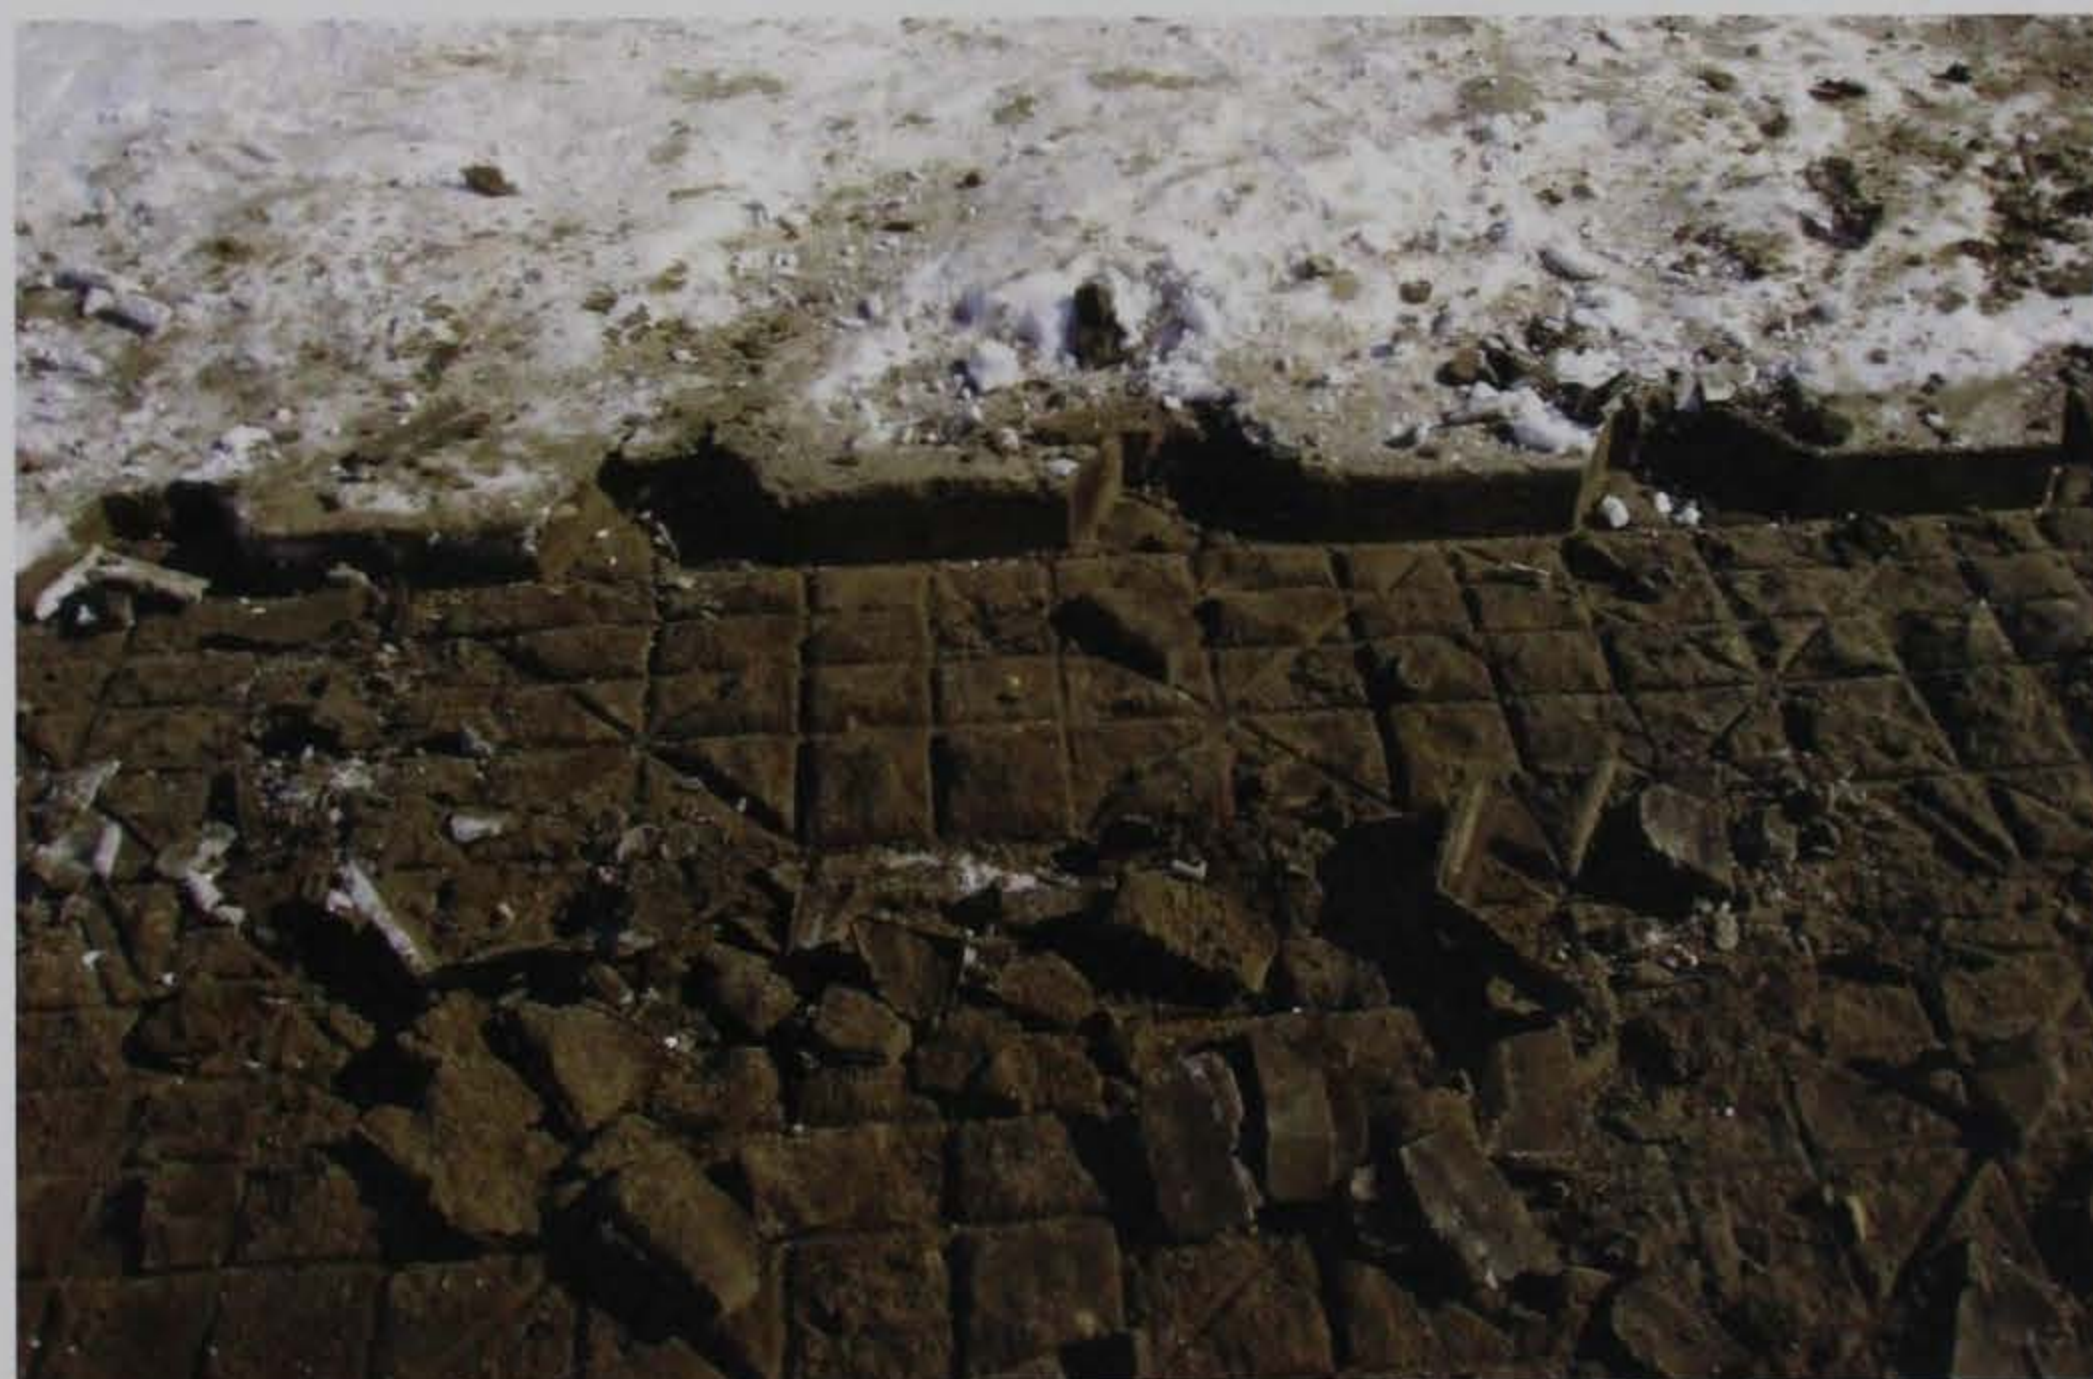
Figure 70. Frozen subgrade after removal of matting from SC-2.
