E-Krete™ Polymer Composite Micro-Overlay for Airfields: Laboratory Results and Field Demonstrations

J. Kent Newman and James E. Shoenberger

November 2003

Final report

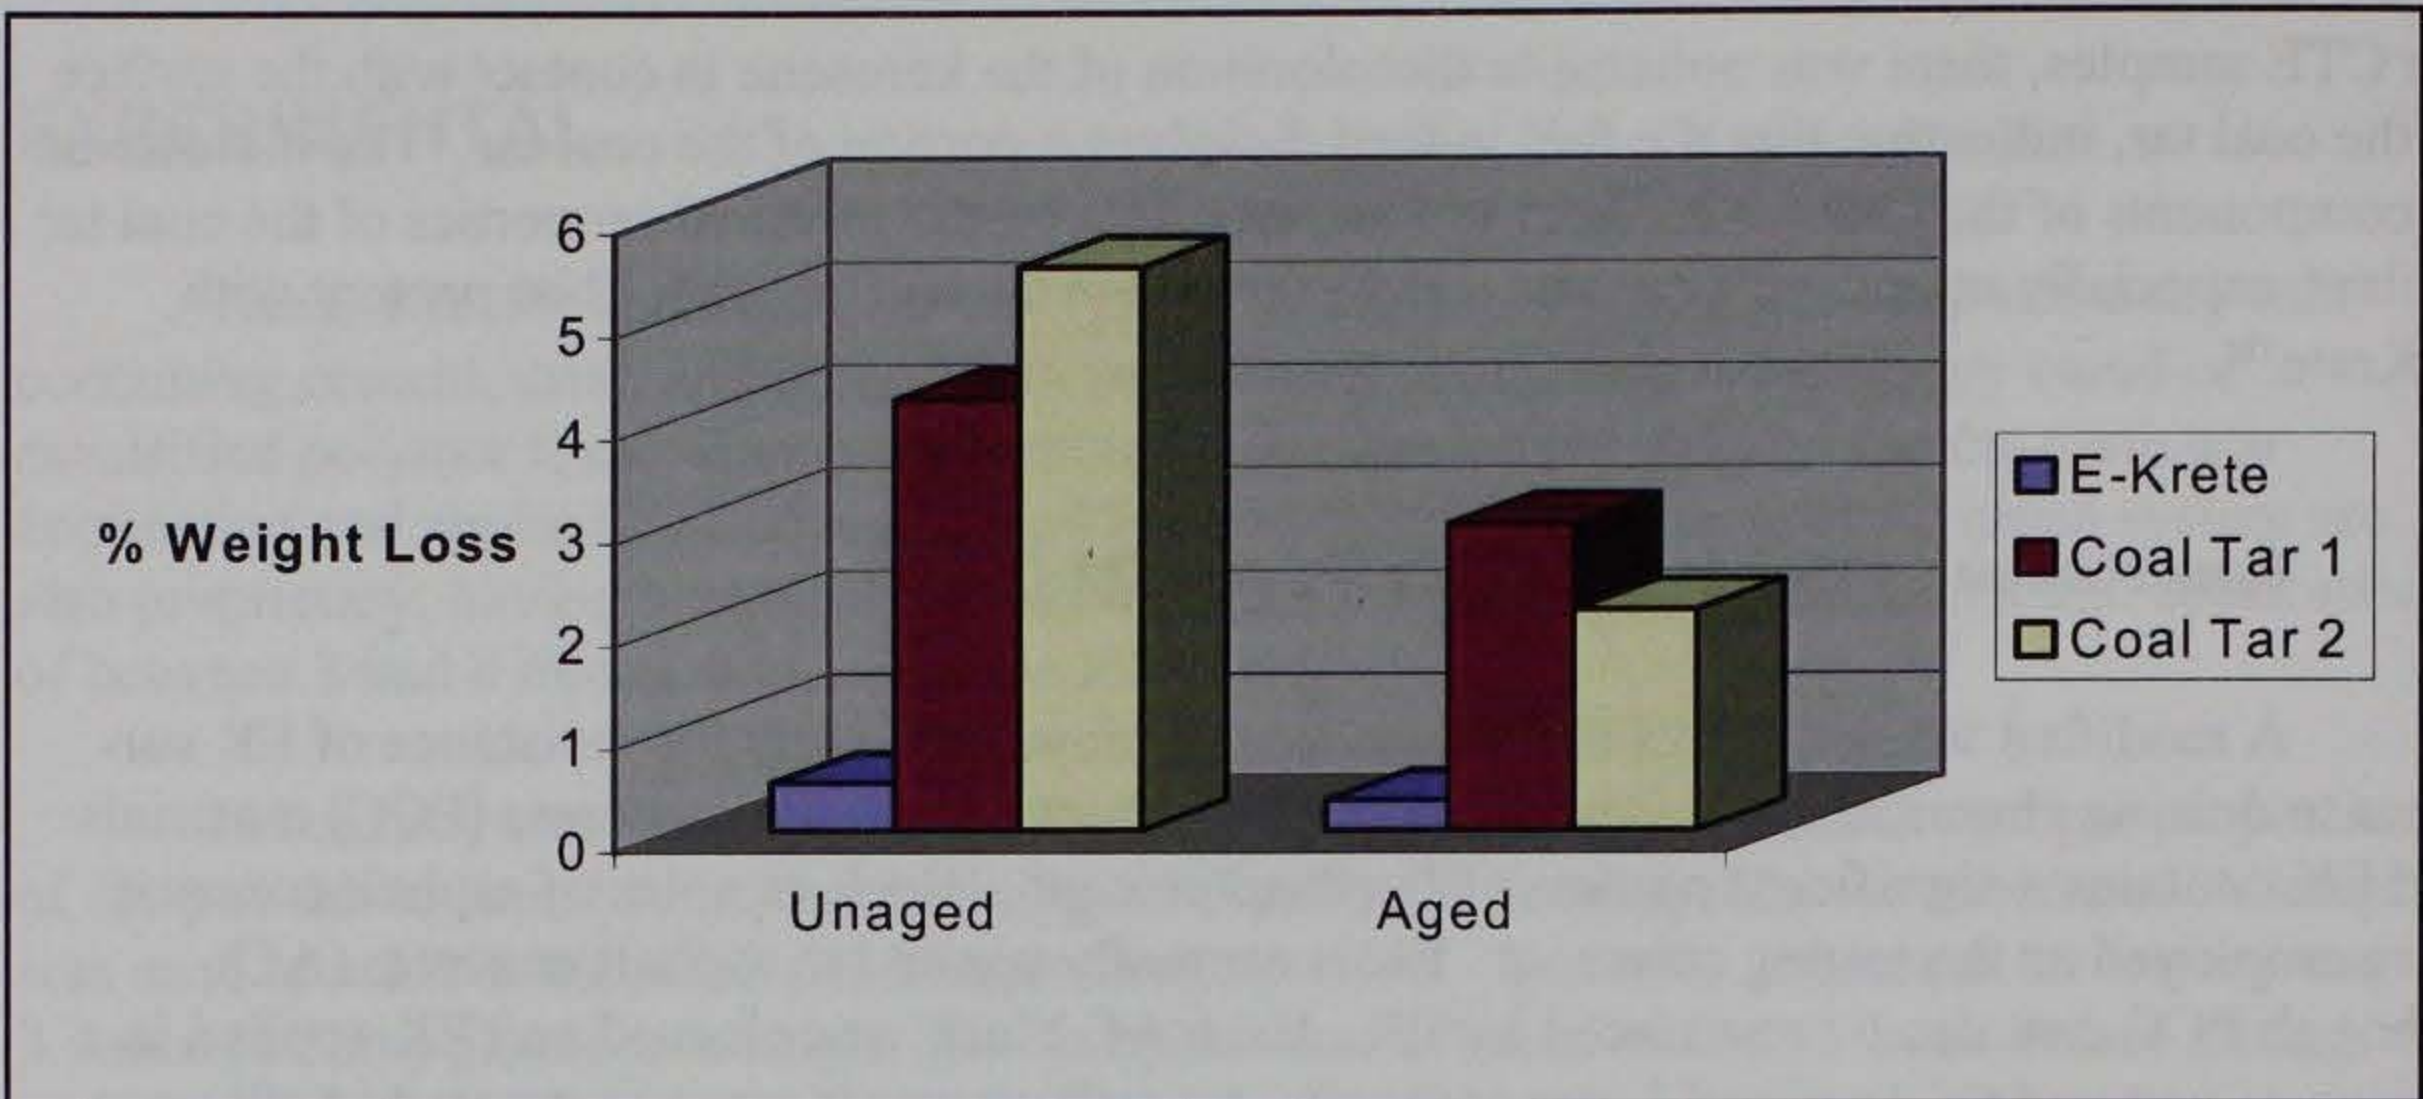
The results of the abrasion testing indicate that the unsealed E-Krete™ material is approximately 8 to 10 times more abrasion resistant than a standard coal tar emulsion. The sealed E-Krete™ is approximately two times more abrasion resistant than the CTE. The difference between the sealed and unsealed E-Krete™ indicates that the surface sealer is abraded more rapidly than the E-Krete™ base. Although the abrasion resistance of the CTE's is higher after aging because of the embrittlement, it is well documented that these materials exhibit severe "chicken-wire" or "map" cracking with age and must be resealed every 3 to 6 years (Shoenberger 1993 and Saraf, Majidzadeh, and Kumar 1992). There is no statistical loss in abrasion resistance after aging of the E-Krete™ material. The reduced variation in the test results for E-Krete™ indicates the consistency of the product.

Figure 1. Abrasion resistance of E-Krete™ compared to coal tar emulsion using a modified form of the wet track abrasion test

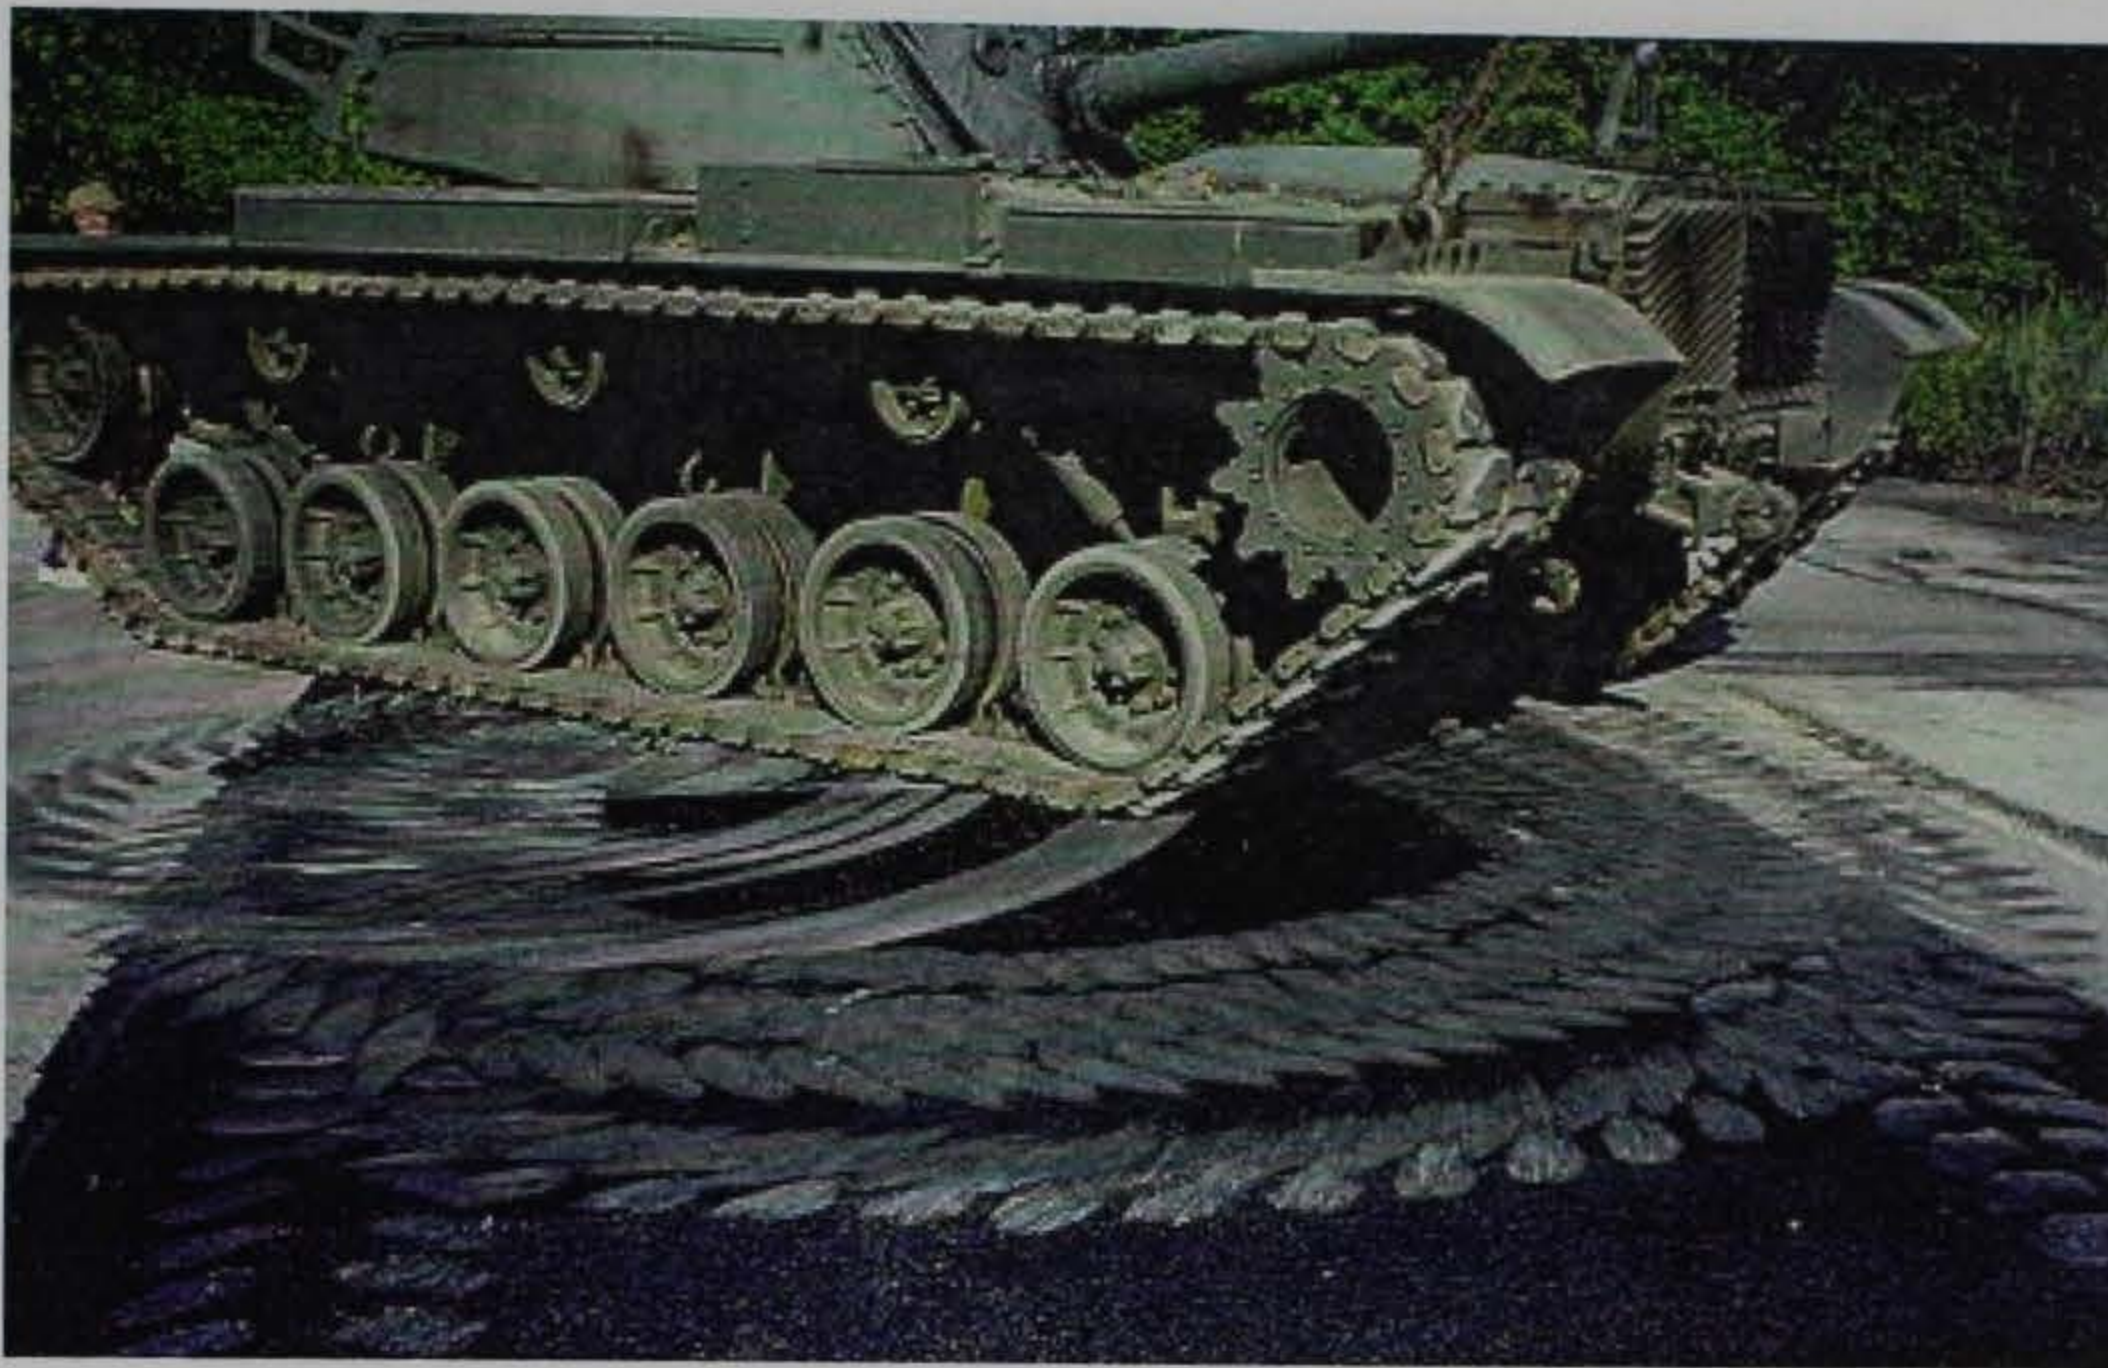
On Friday, August 28, 1998, an M-60 tank (approximately 106,000 lb gross weight or approximately 53 tons) was employed as a test vehicle (Figure 3). This vehicle was chosen for several reasons. It was readily available and tracked vehicles (with rubber pads) have a history of causing significant raveling of aggregate particles from the surface of asphalt pavements. In particular, conducting “pivot steers” in which the vehicle spins while remaining in one location, placing substantial shear forces on the pavement surface. This would certainly be a “worst case scenario” for virtually any type of normal road or airfield traffic.

Approximately 10 total pivot steers were conducted on the E-Krete™ surfaces with no delamination from the underlying asphalt. The damage to the E-Krete™ surface was some slight scuffing of the surface in areas with a surface layer of broadcast sand. The sand had sheared loose from the surface and caused scuffing under the tank treads. The areas that had no surface

Figure 3. 106,000-lb M-60 tank conducting pivot steers on E-Krete surface at ERDC

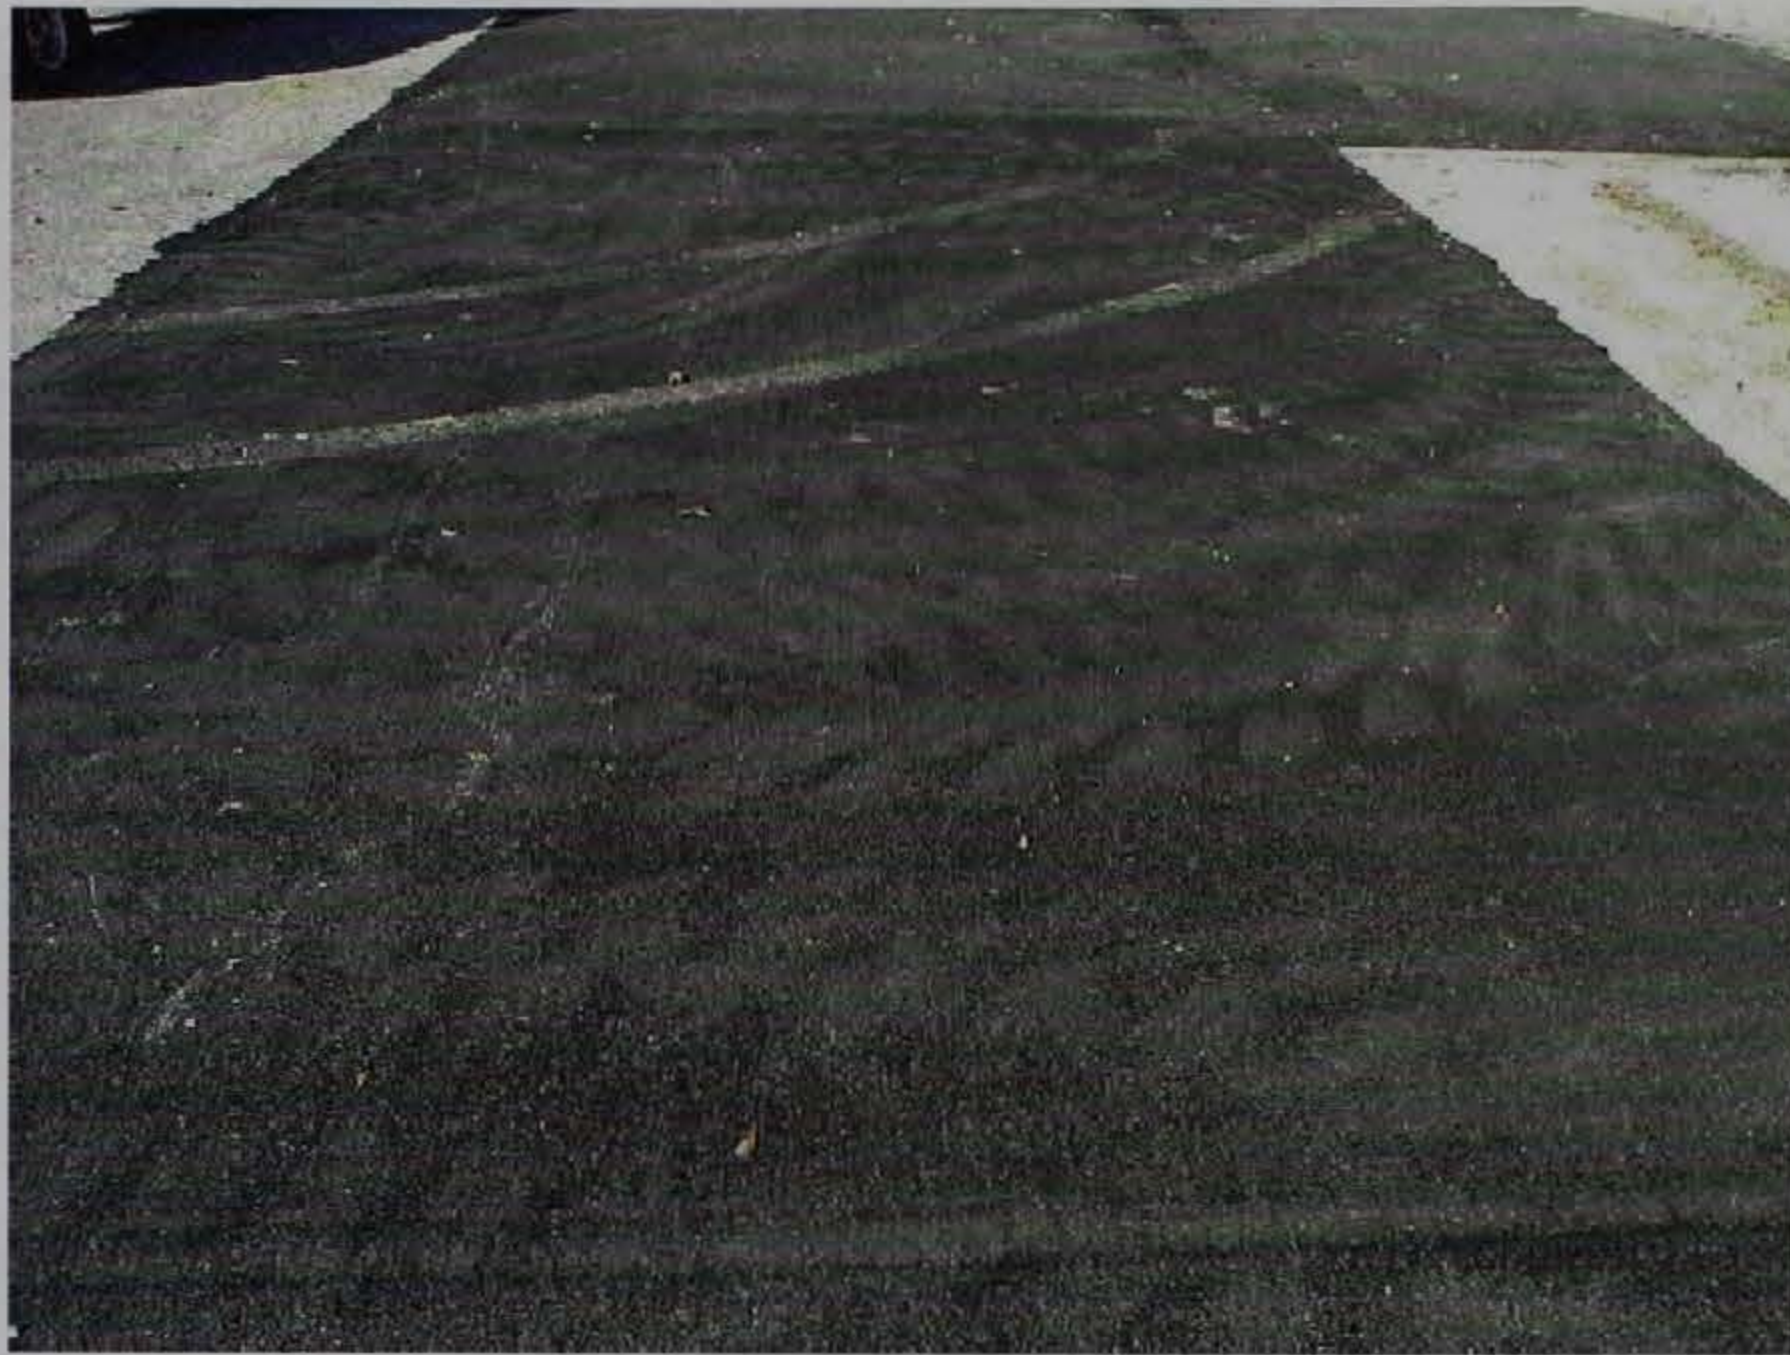
In October 2000, the E-Krete™ section at Vicksburg displayed two cracks, both reflecting from cracks in the underlying asphalt. Both of the cracks were smaller in width than the underlying cracks in the asphalt. Scuff marks from the tank testing were still visible although not distinctive (Figure 4). Some staining was apparent from water pooling in one area. BPNs were on the order of those from typical asphalt. The adhesion tests showed excellent adhesion to the asphalt. The asphalt pulled apart (cohesive asphalt failure) rather than the E-Krete™ pulling away from the asphalt surface (adhesive failure). This indicates strong adhesion to the asphalt.

Figure 4. E-Krete surface in October 2000. Some scuffing of the surface from the tank testing in August 1998 is apparent

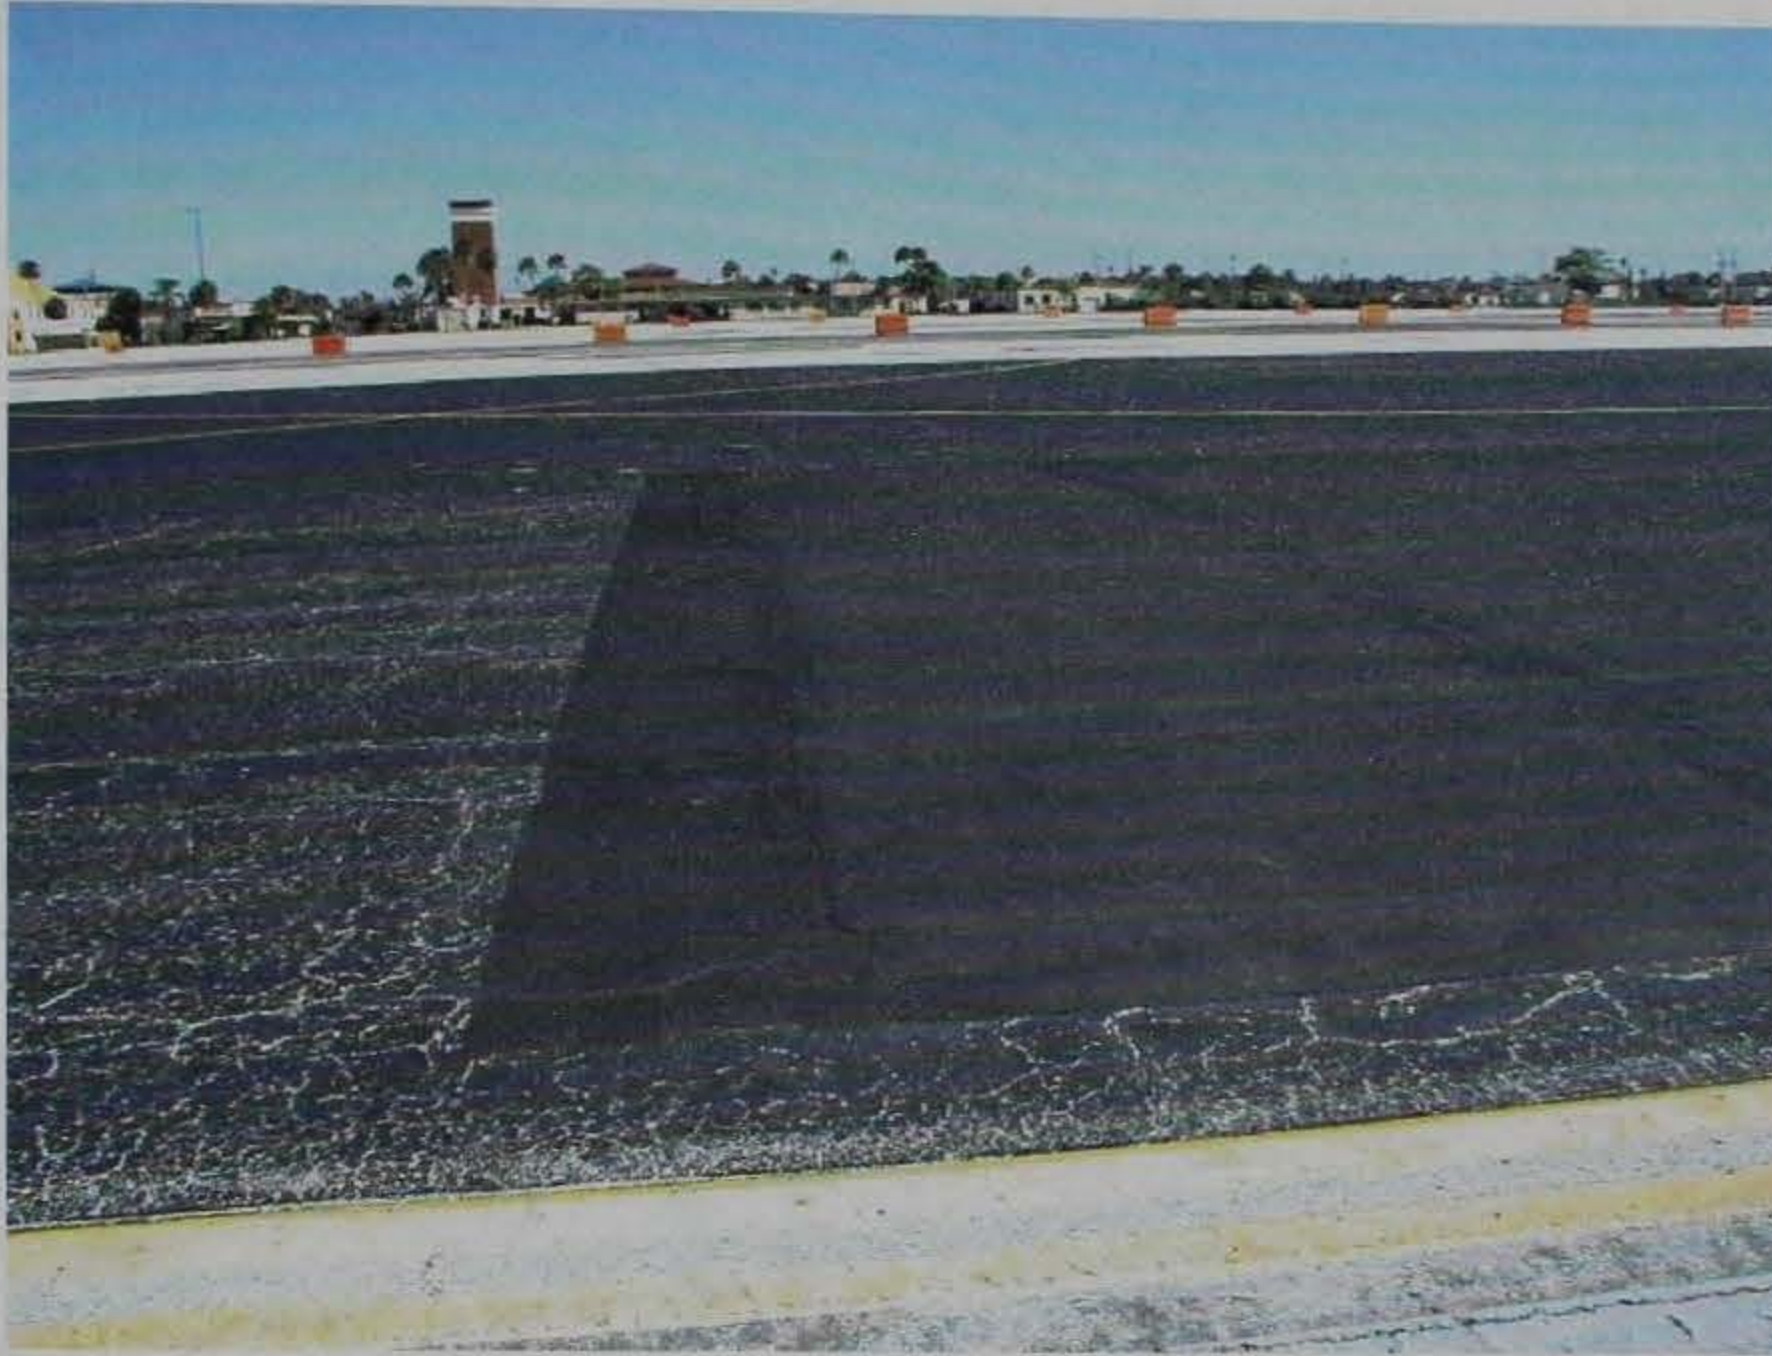
Figure 5. E-Krete surface in October 2000 at MacDill AFB. The adjacent pavement is coal tar that is approximately 14 years old and is severely deteriorated

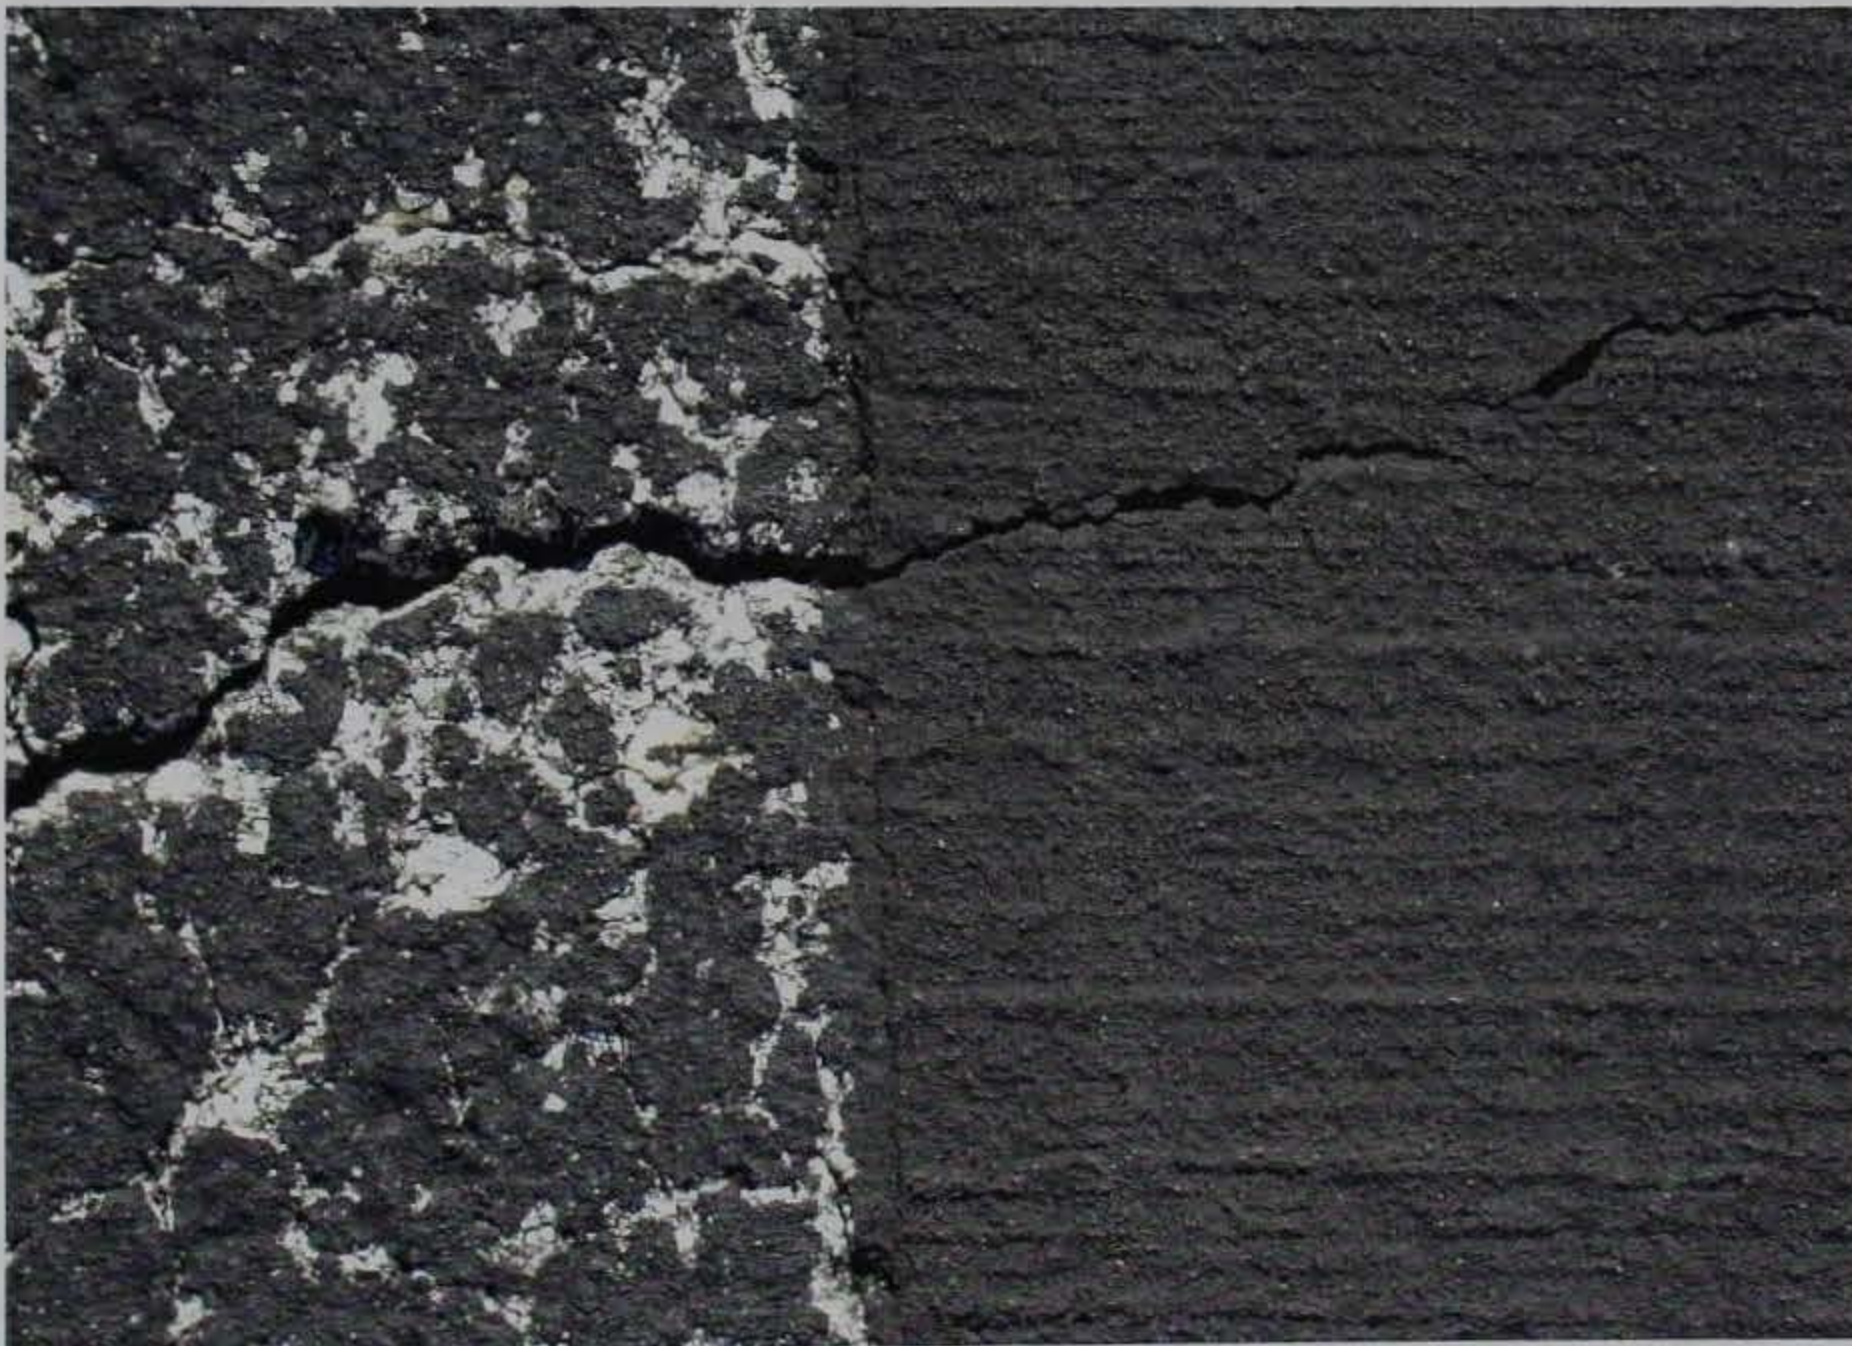
Figure 6. E-Krete section at MacDill AFB showing reflective cracking. Note that the crack has not widened or displayed any raveling from the crack face

In October 2000, the E-Krete™ and PermaStripe™ sections were in excellent condition. In the E-Krete™ area, reflective cracks had propagated up from a severely map-cracked underlying coal tar surface (Figures 5 and 6) and a small area (approximately 2 sq m or 3 sq yd) was stained with some type of aircraft fluid (Figure 7). The fluid had caused a noticeable softening of the E-Krete™ and is most likely a synthetic jet turbine lubricant. Recent laboratory studies have noted that certain types of synthetic jet turbine fluids may cause softening of the E-Krete™. This softening could be prevented by a topcoat sealer in areas where aircraft park. It was noted that many of the reflective cracks in the coal tar layer did not propagate up through the E-Krete™ layer. In several locations along the edge of the E-Krete™ sections, cracks in the coal tar were visible running up to the edge but did not proceed into the overlying E-Krete™ layer. Adhesion tests pulled up the underlying coal-tar and the frictional resistance was similar to asphalt. The PermaStripe™ line was in excellent condition when compared to the distressed conventional paint striping (Figure 8).

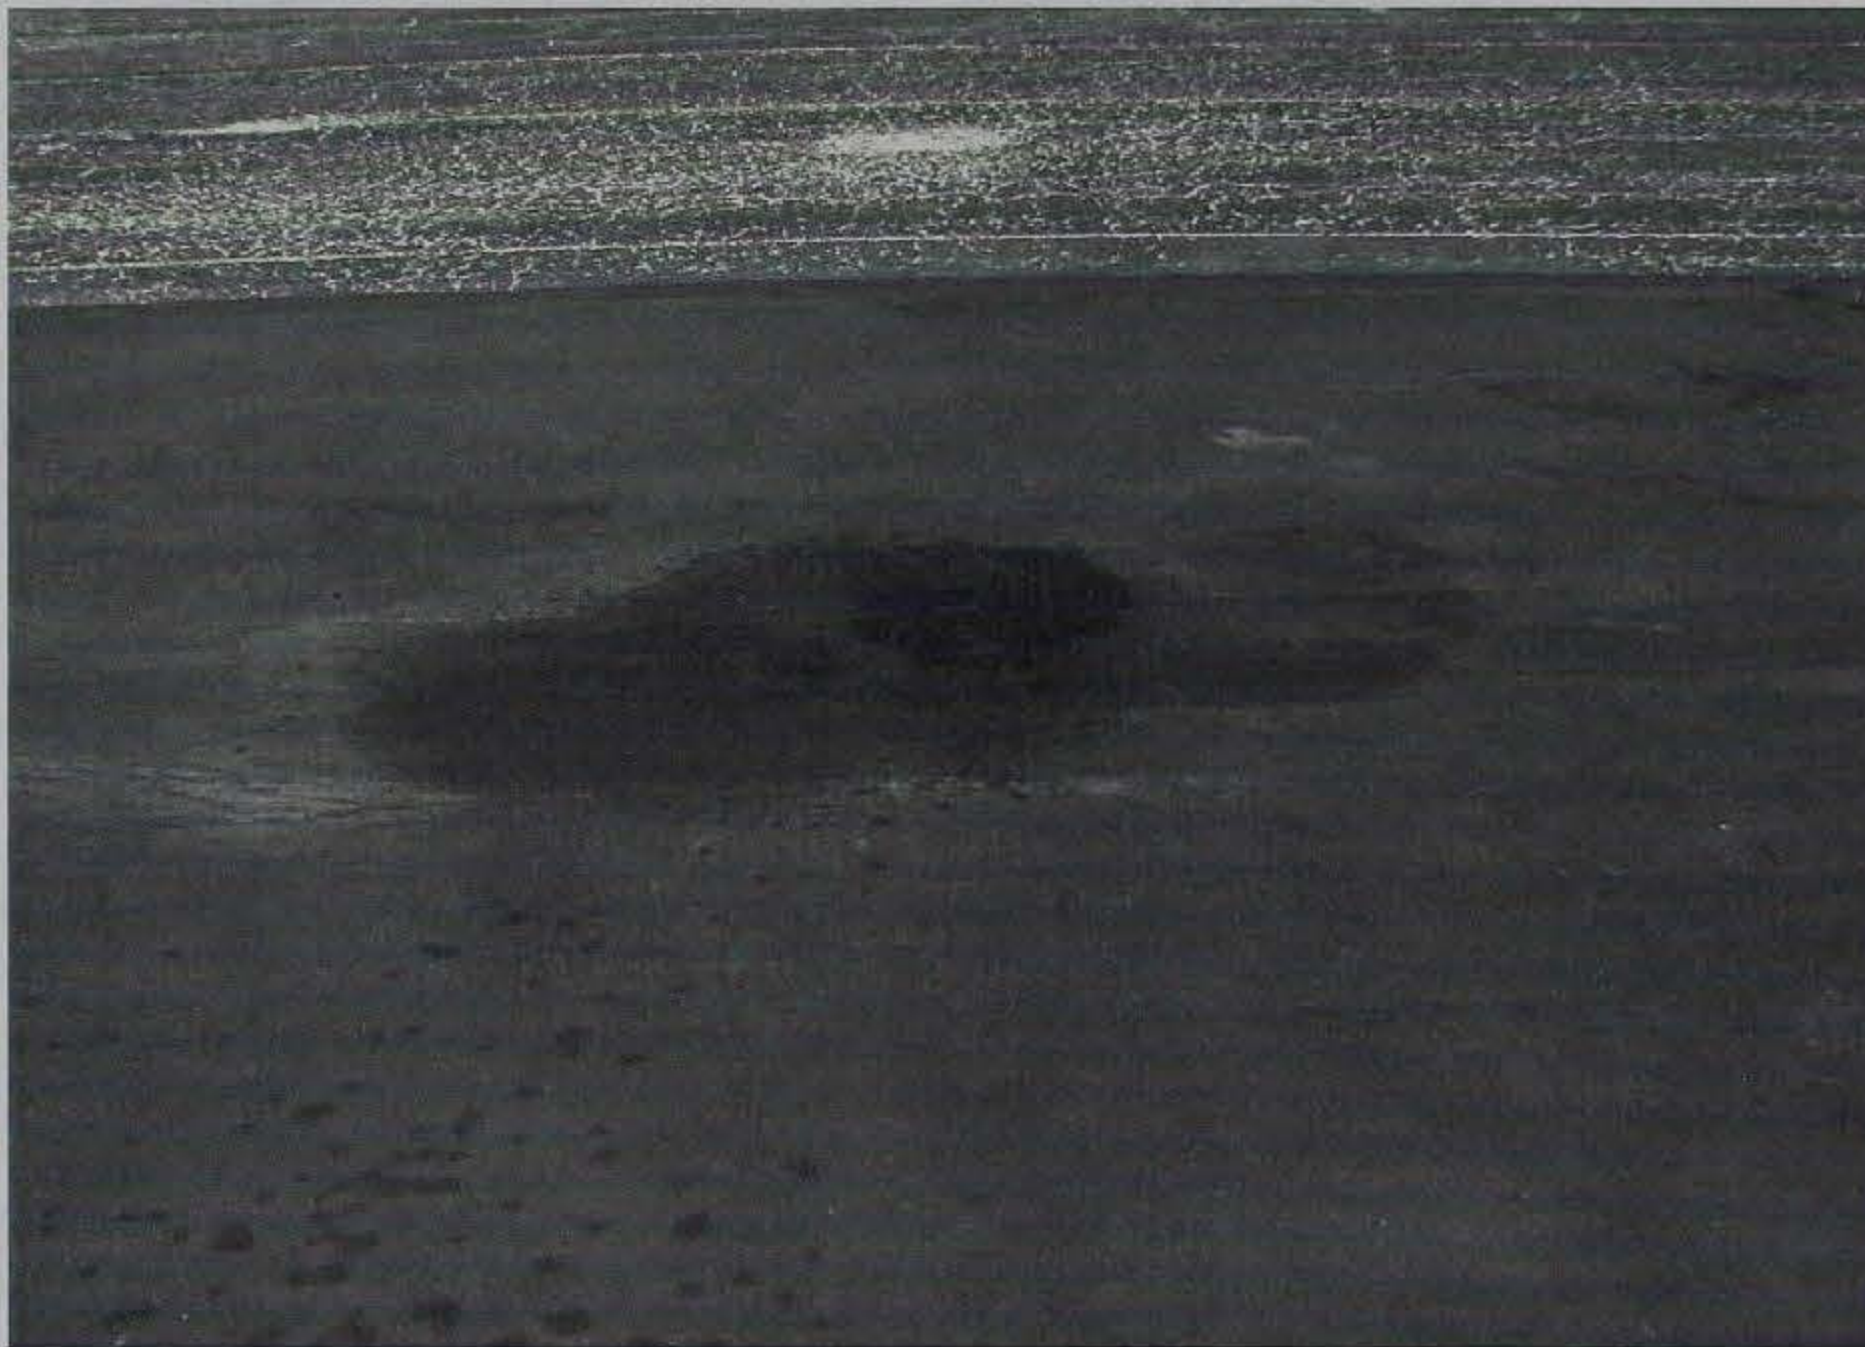
Figure 7. E-Krete section at MacDill AFB exhibiting staining from synthetic jet turbine lubricant

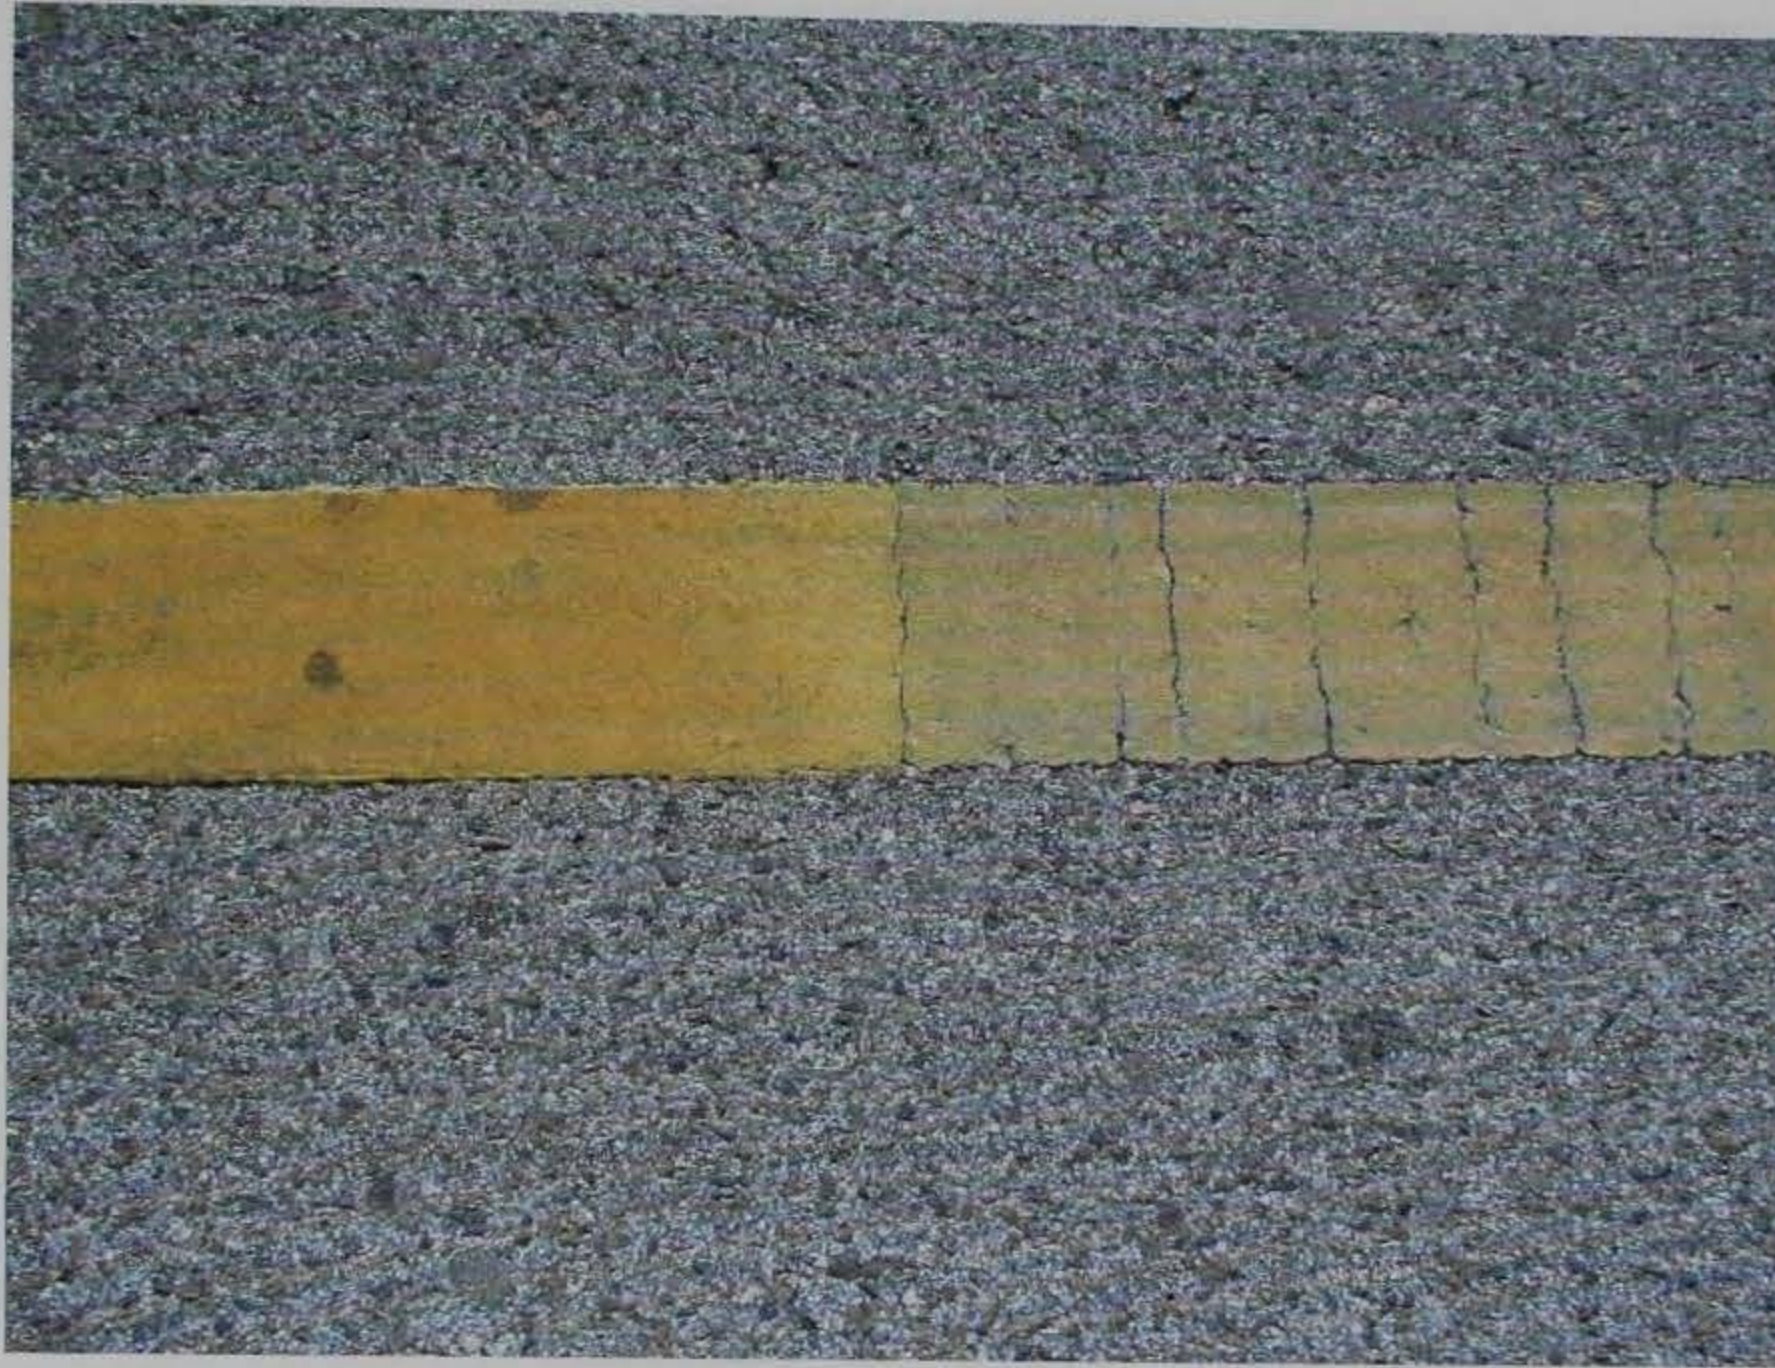
Figure 8. PermaStripe line at MacDill AFB in October 2000 after a full 2 years in service. Note the transverse cracking in the conventional airfield pavement marking paint. The marking paint is approximately 3 years old in this picture

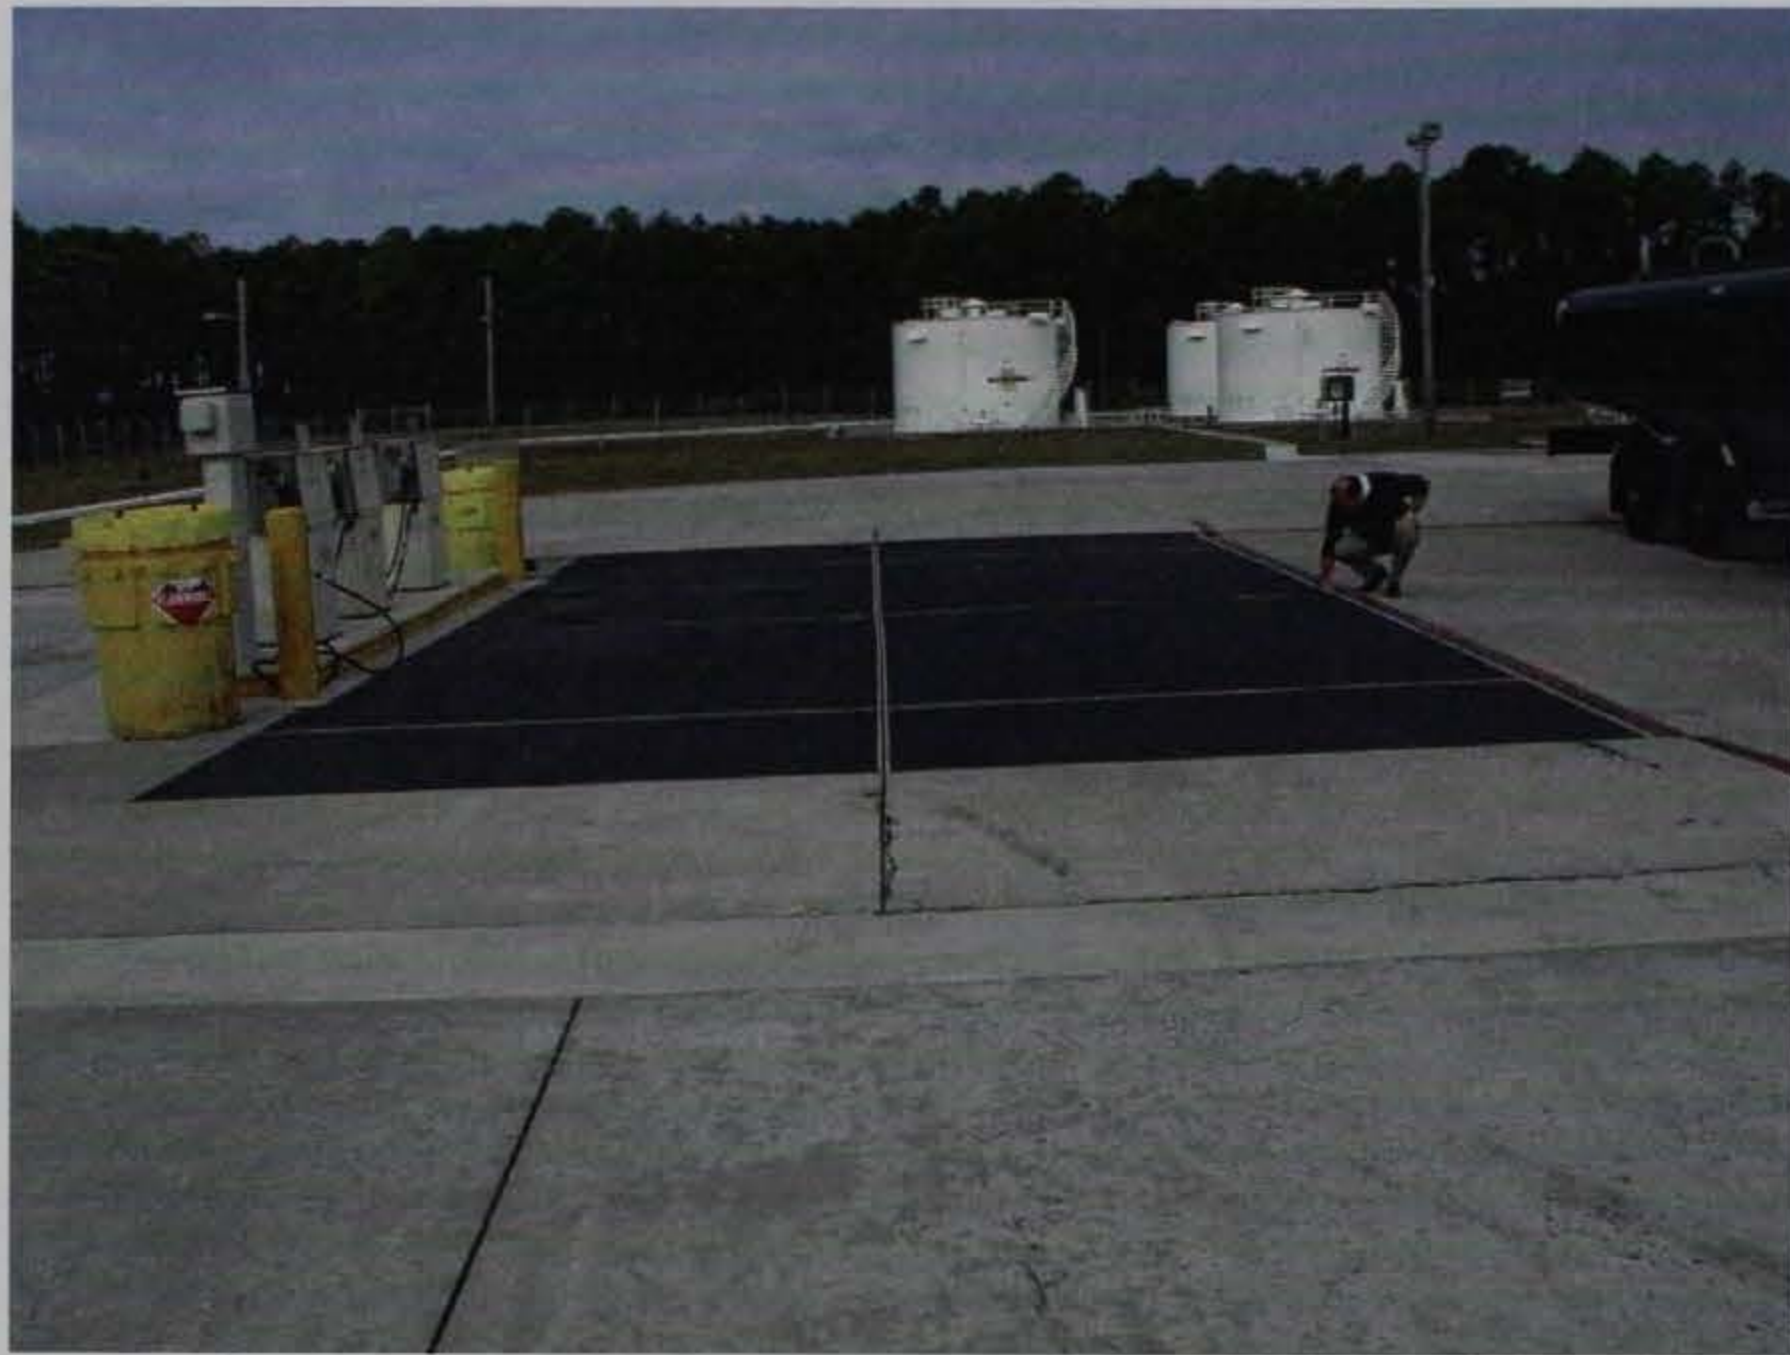
The condition of the E-Krete™ test site in October 2000 was excellent (Figures 9 through 11) with some oil-stains and scuffing from recent construction activity. However, a marking crew placed standard road marking paint over the top of the PermaStripe™ in September 2000 so no assessment of that feature is given. Base personnel commented on the ease of cleaning the E-Krete™ surface with simple detergent, water, and a broom. Stains from fuel and oil spills were easily removed in this manner. Testing with the elcometer demonstrated that adhesion was good, with the E-Krete™ exhibiting a cohesive failure (the E-Krete™ pulled apart rather than losing adhesion and pulling off the concrete surface). Frictional resistance was similar to asphalt.

Figure 9. E-Krete section in fuel depot at Tyndall AFB, October 2000
