E-Krete™ Polymer Composite Micro-Overlay for Airfields: Laboratory Results and Field Demonstrations

J. Kent Newman and James E. Shoenberger

November 2003

Final report

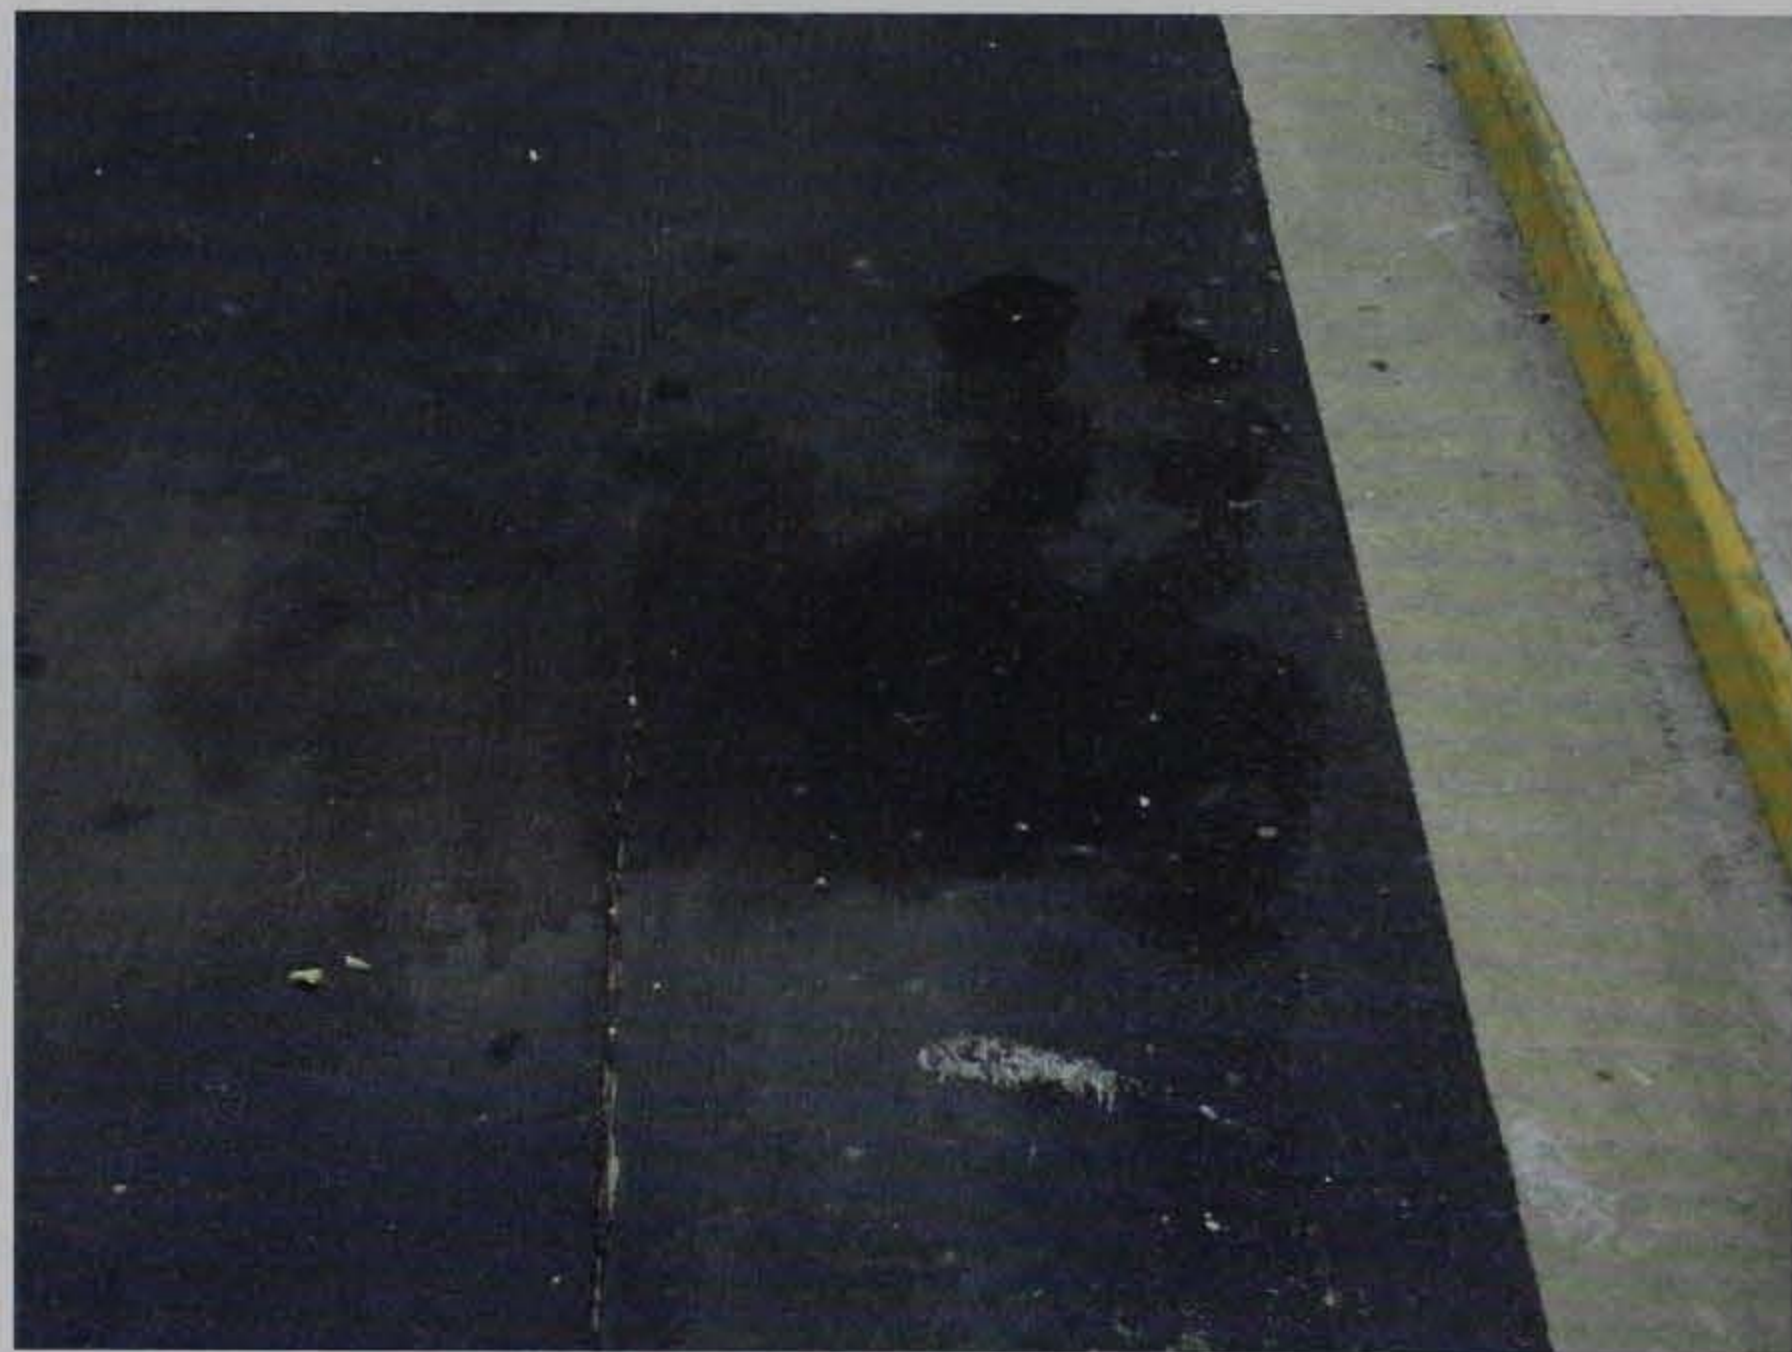
Figure 10. Oil staining of the E-Krete section at Tyndall AFB, October 2000

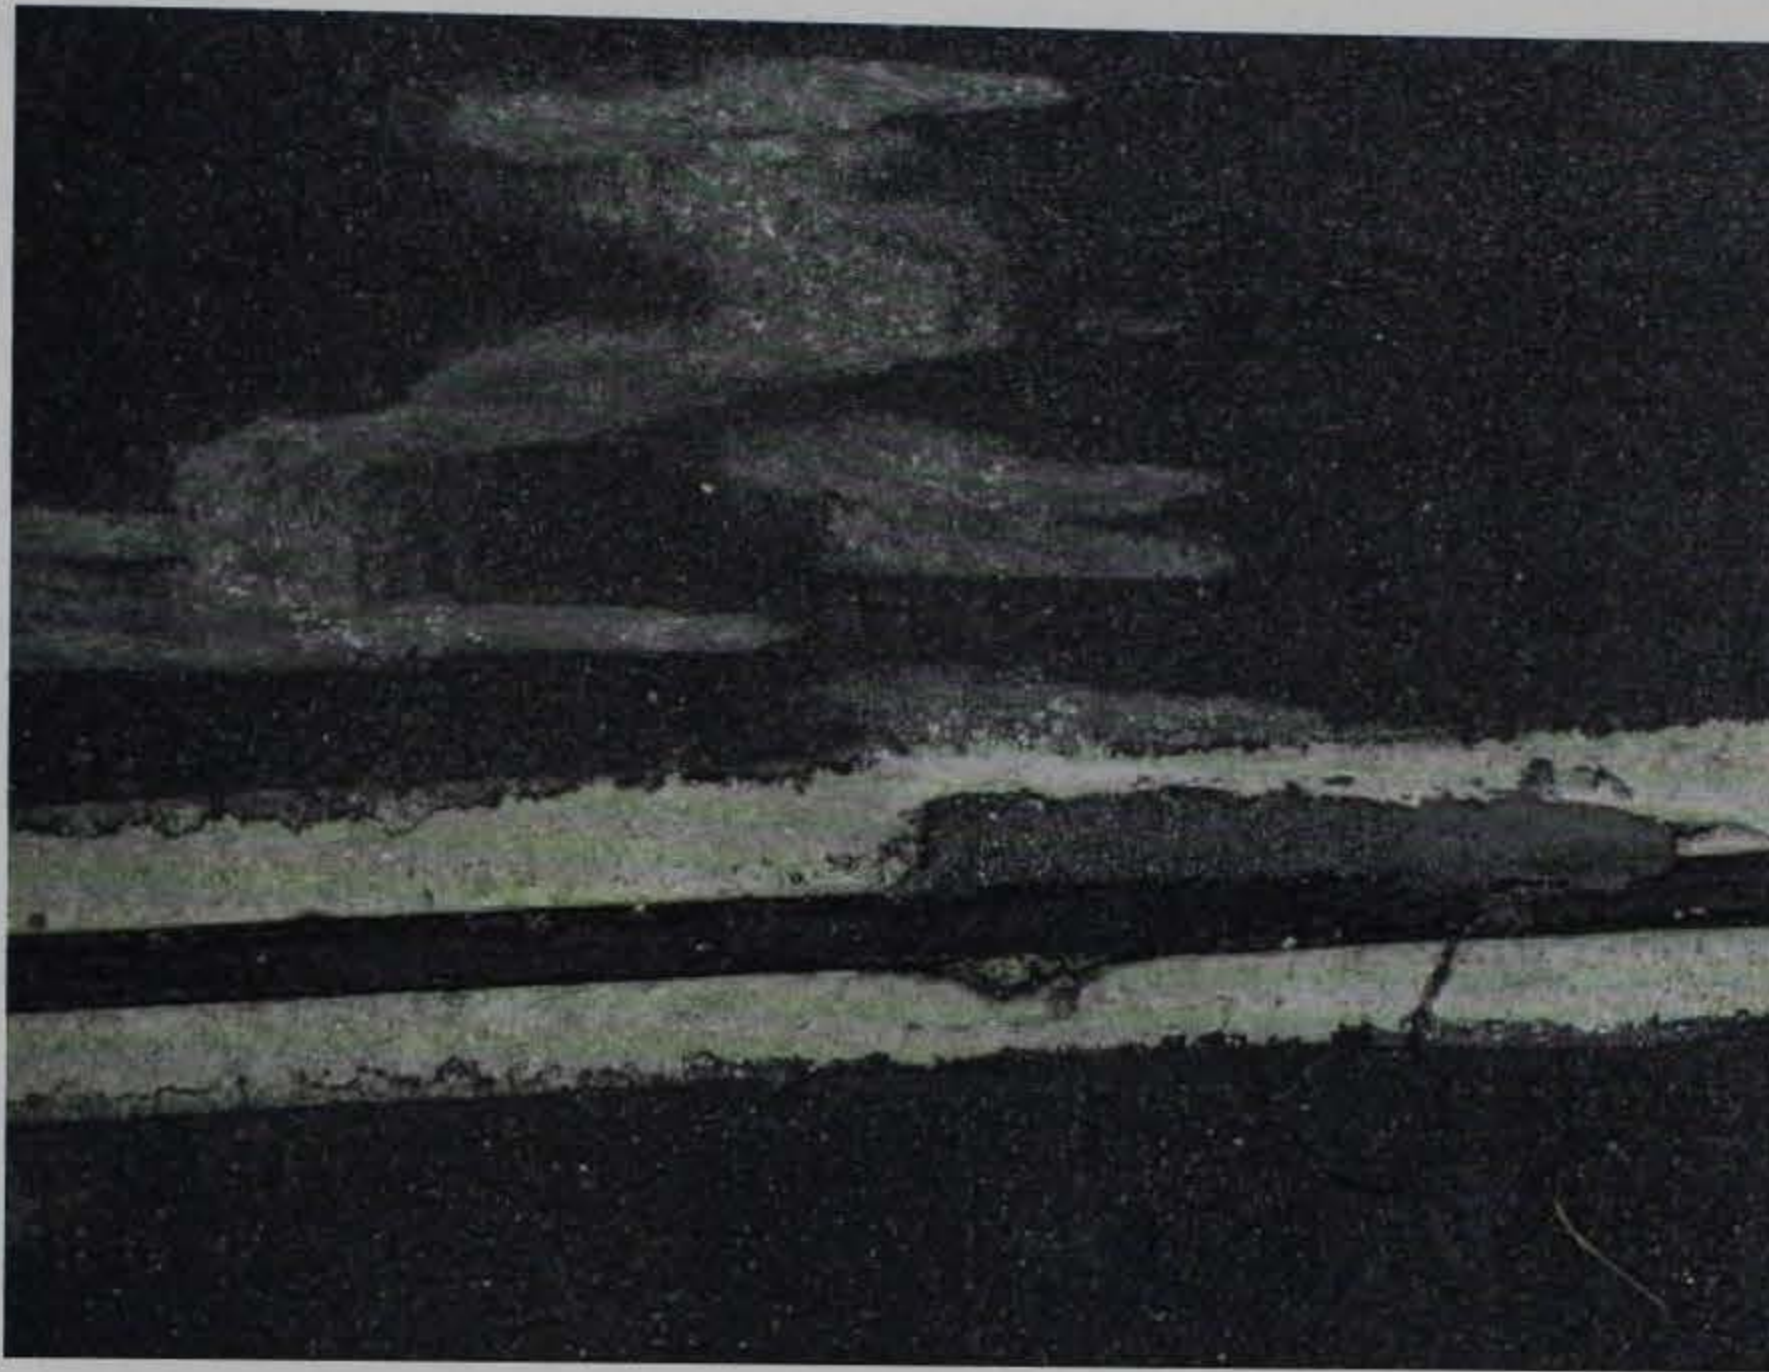
Figure 11. Scuff marks from backhoe stabilizers on the E-Krete section at Tyndall AFB, October 2000. The marks do not penetrate to the underlying cement

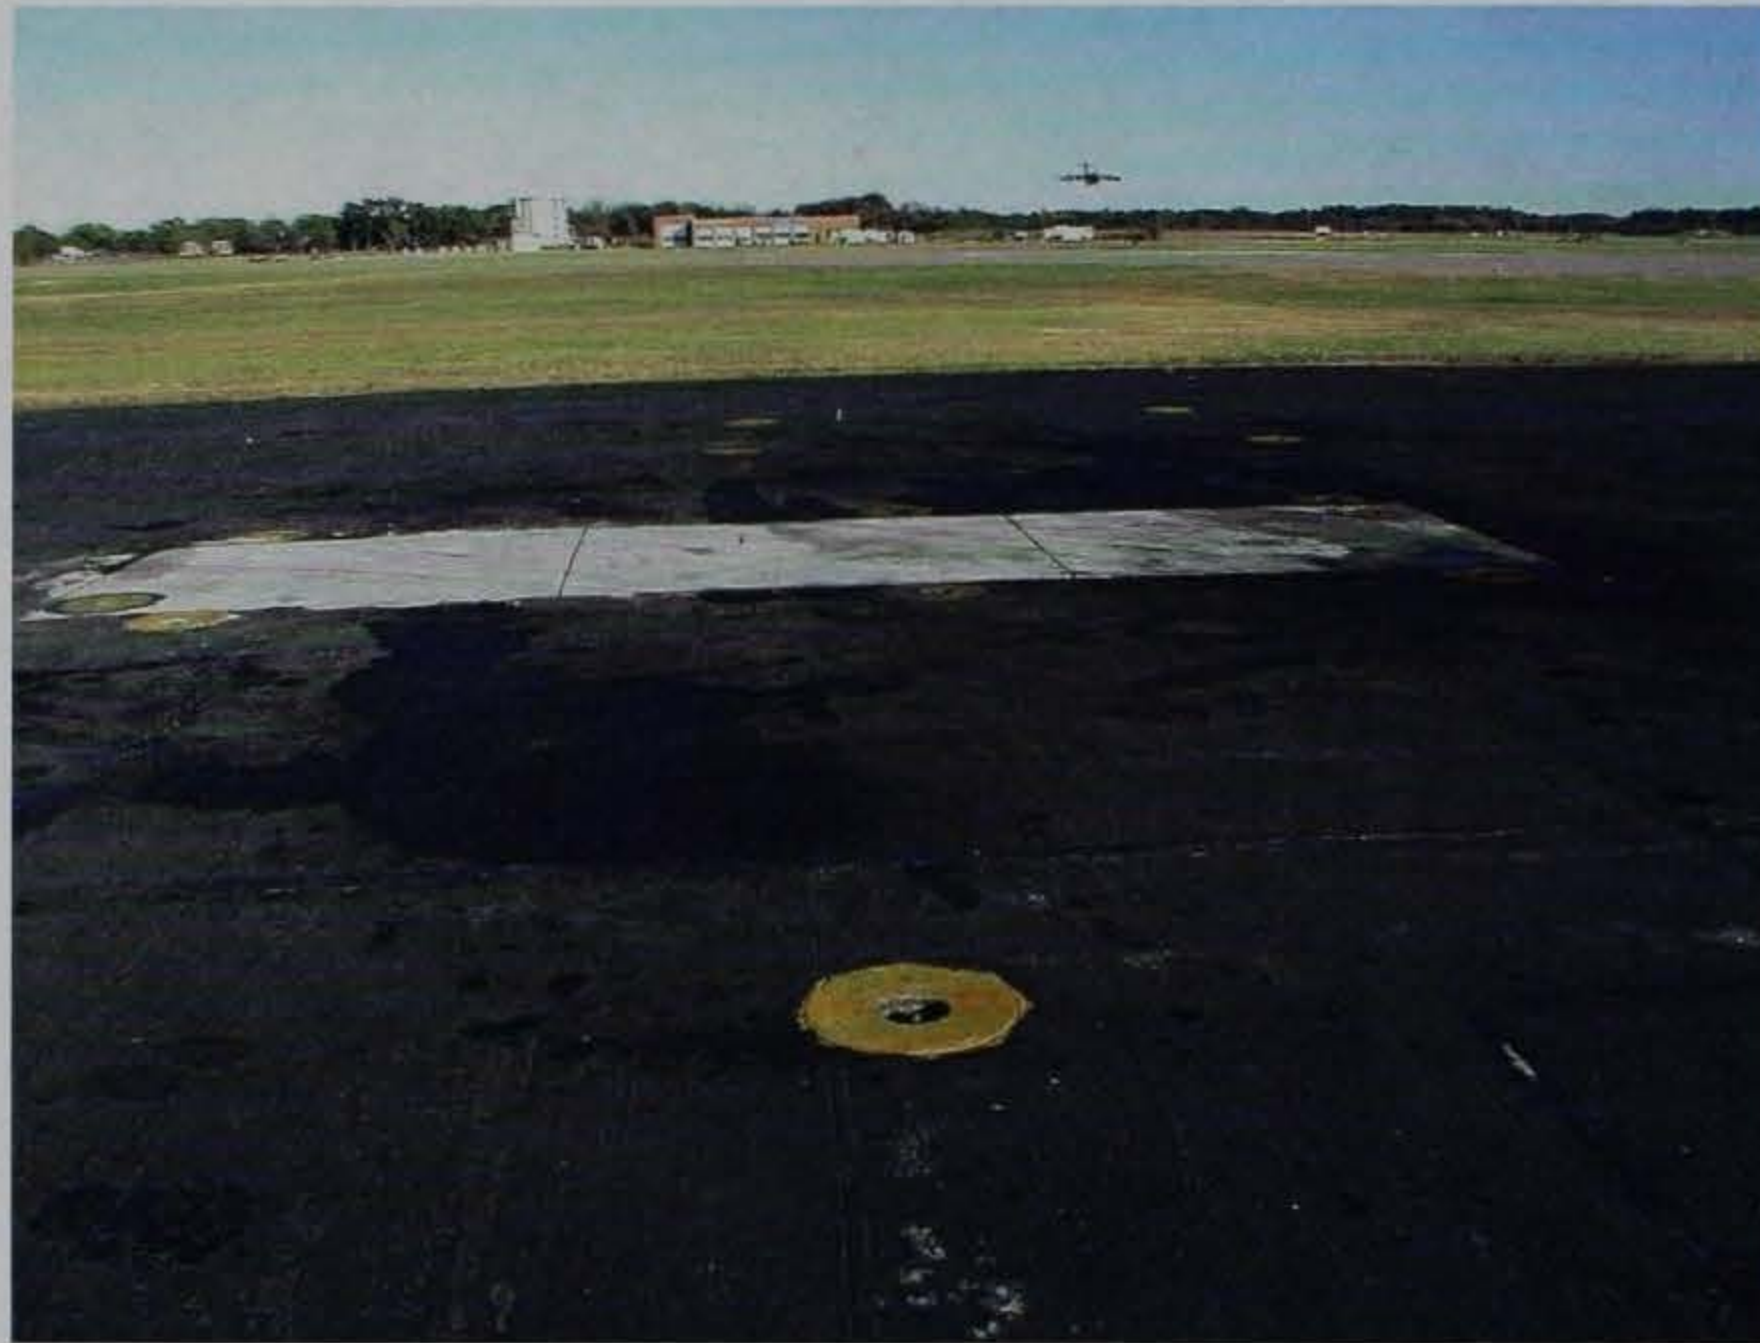
Figure 12. E-Krete and PermaStripe at Norfolk Naval Station. Note the severe hydraulic fluid staining around the concrete island. This area has been used repeatedly for servicing aircraft

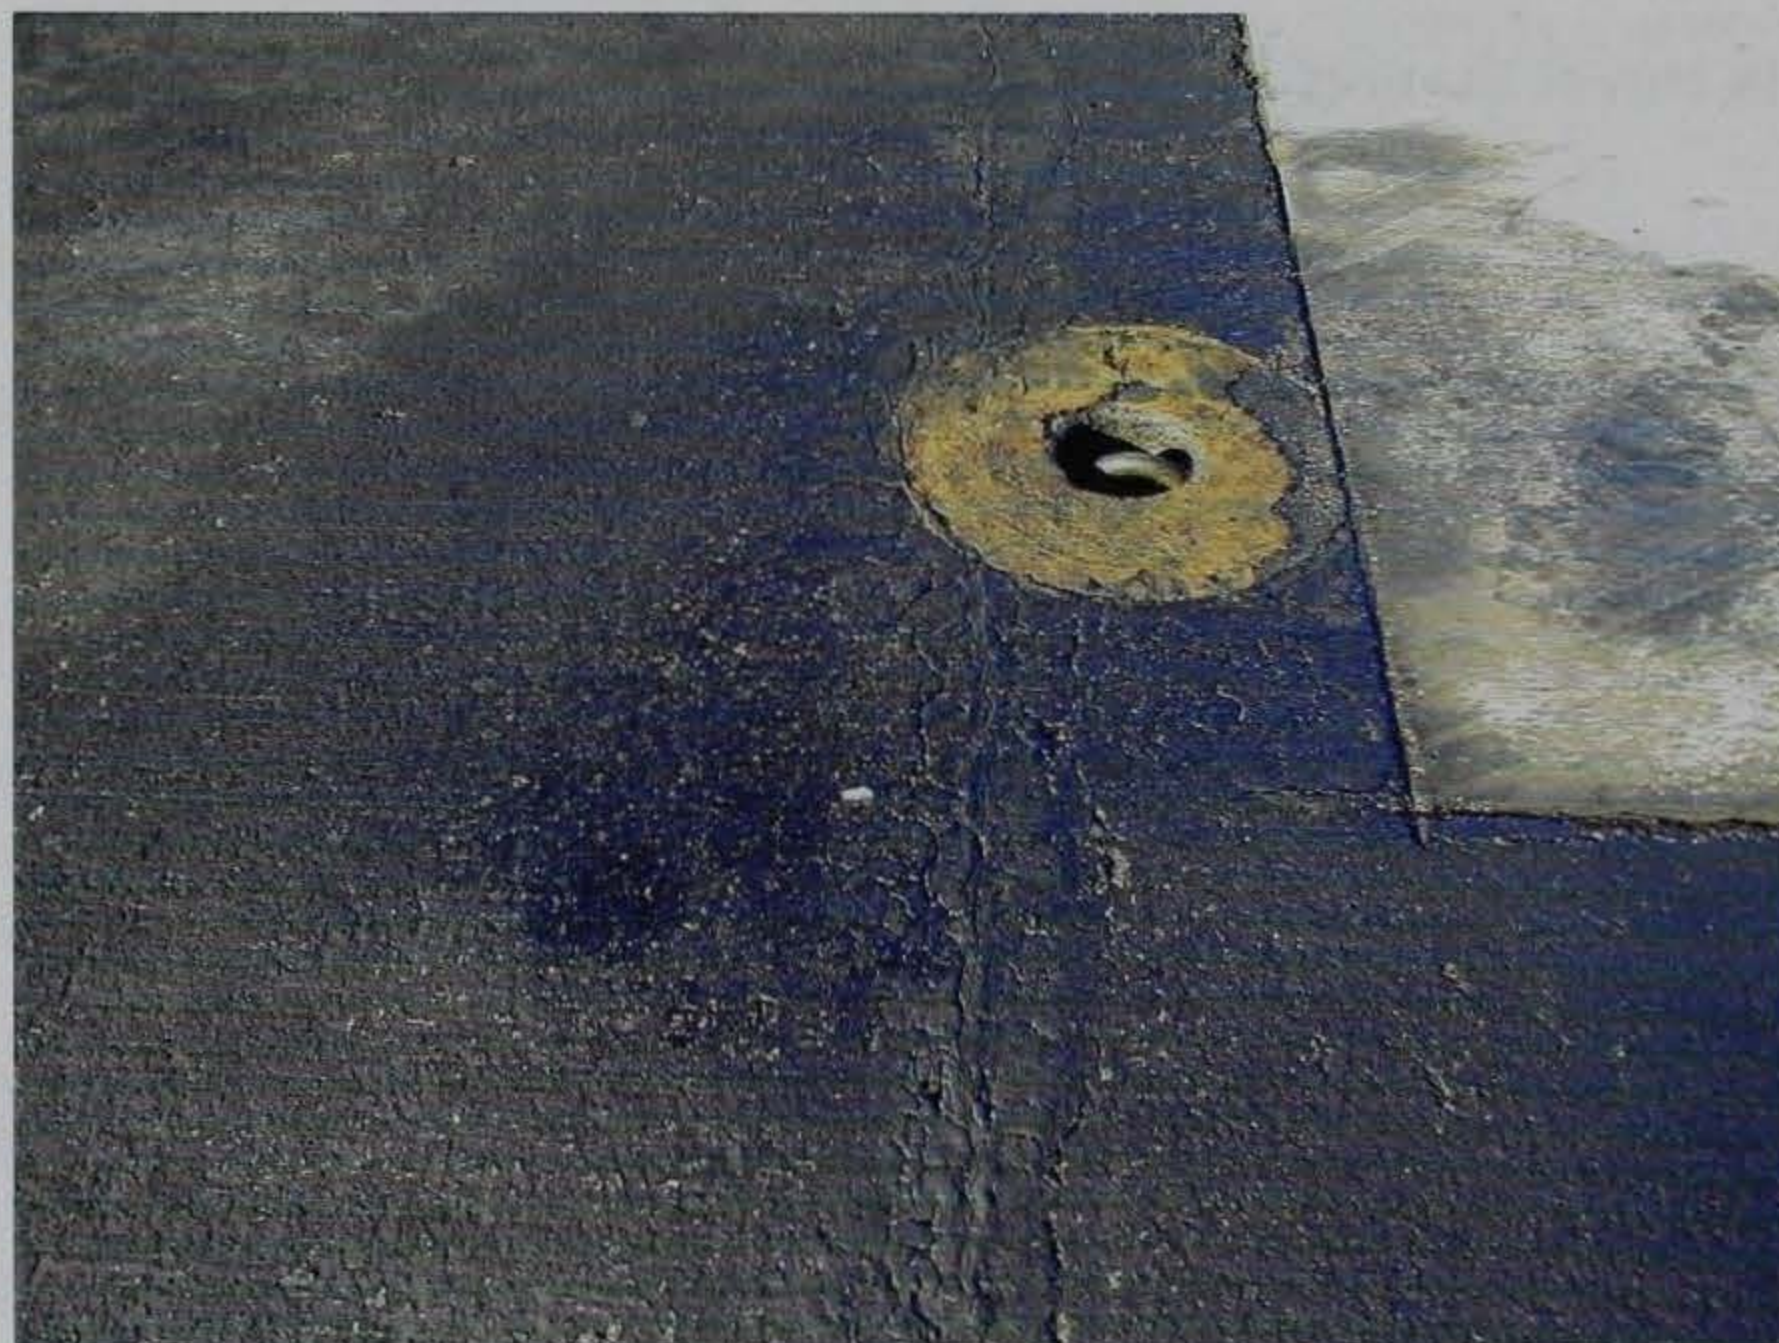
Figure 13. Closeup view of the E-Krete and PermaStripe at Norfolk Naval Station. The hydraulic fluid is literally pooled around the PermaStripe tie-down. Some delamination of the PermaStripe has occurred because of the ingress of hydraulic fluid under the surface of the PermaStripe where the asphalt and concrete meet

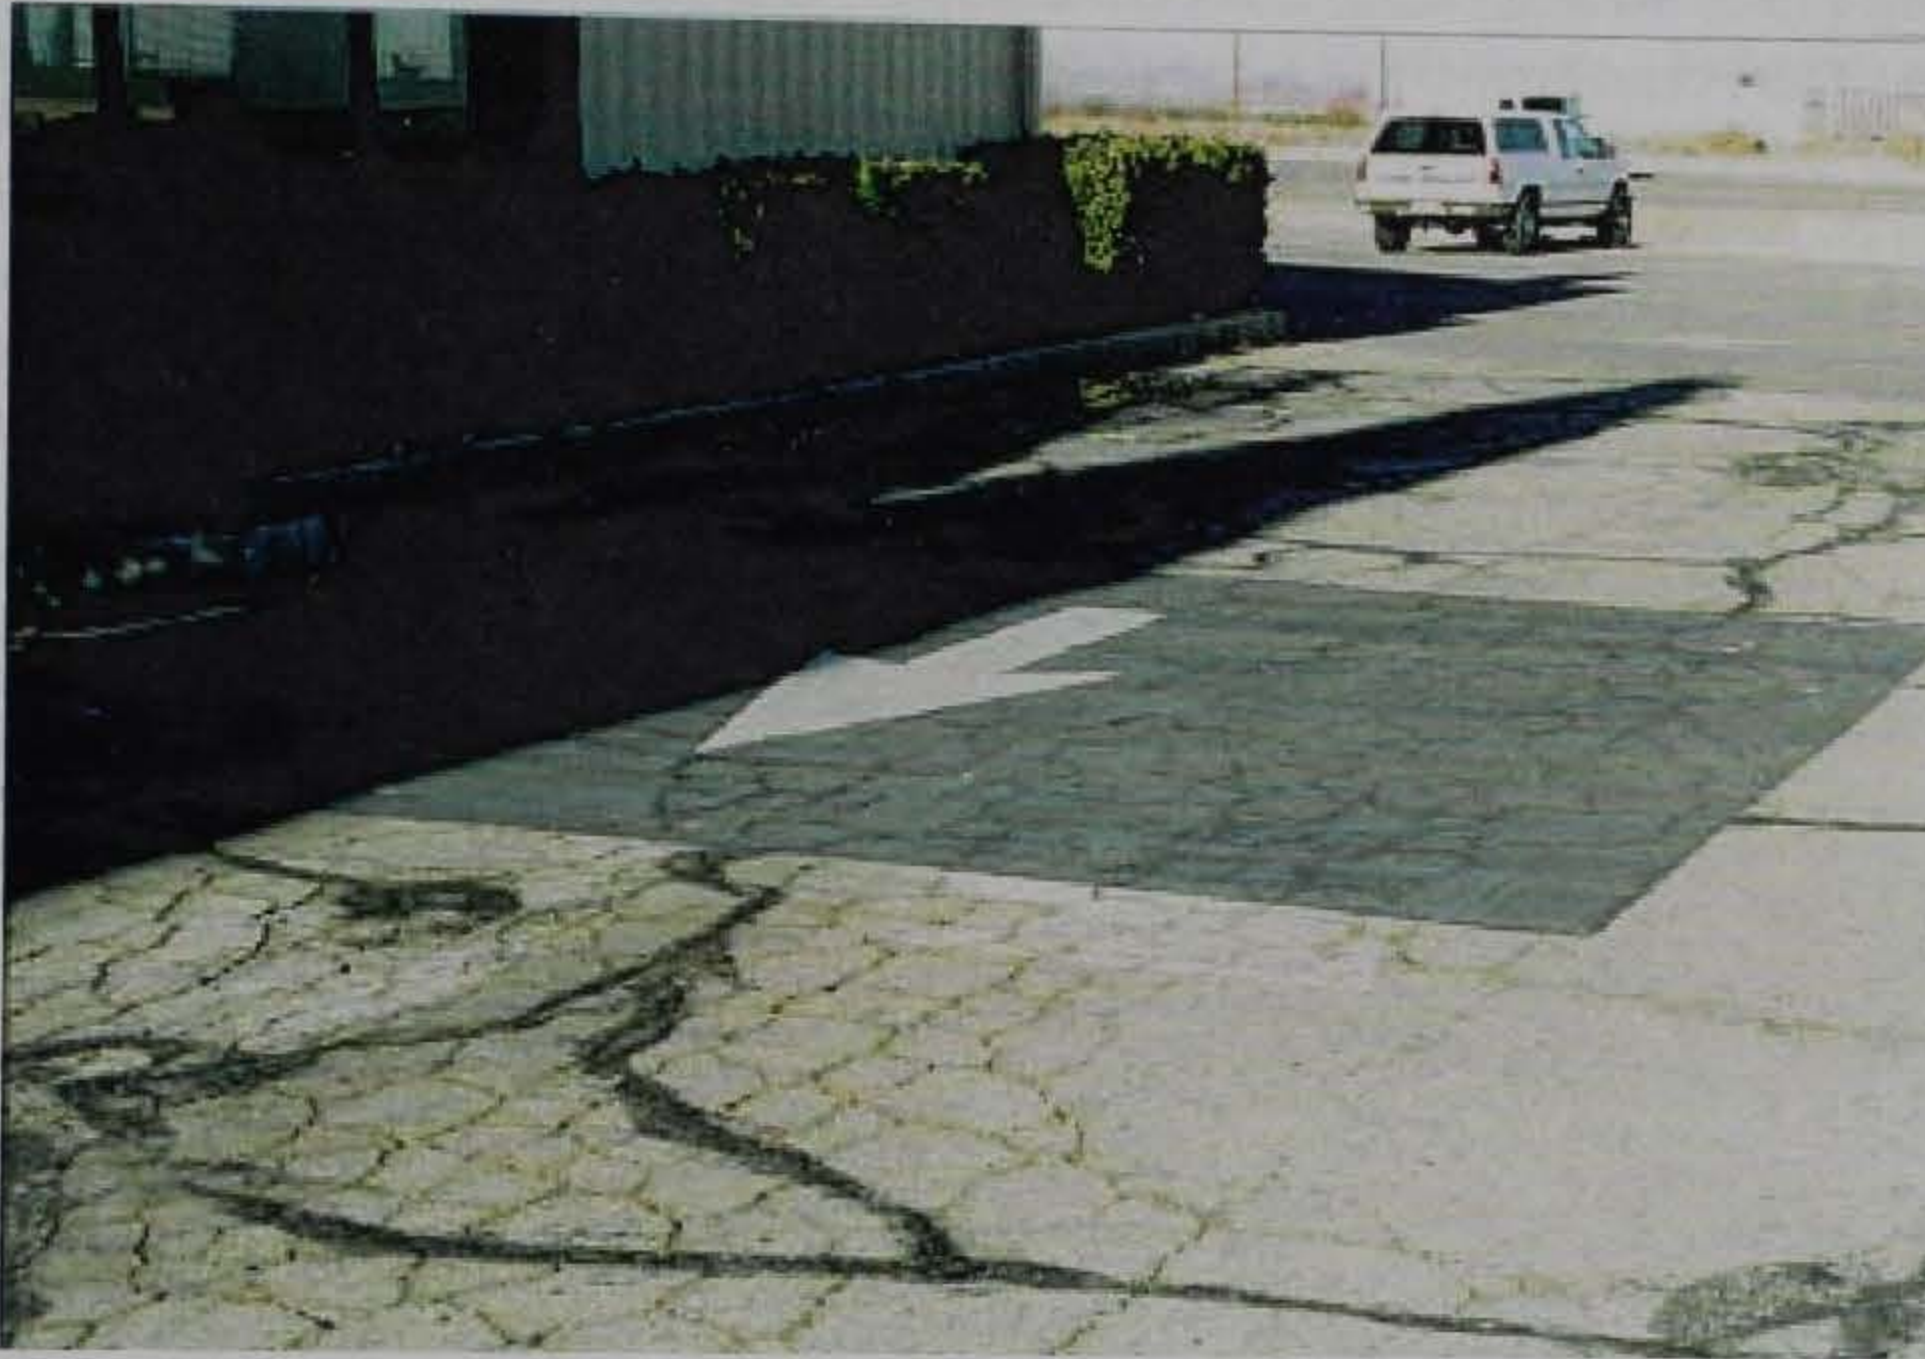
Figure 14. E-Krete and PermaStripe at Edwards AFB. Note the severely cracked asphalt surface upon which the E-Krete was placed. Although many of the cracks have reflected back up through the E-Krete, it is in much better condition than the asphalt with virtually no raveling, unlike the surrounding pavement

The condition of the E-Krete™ was excellent aside from the reflective cracks from the underlying asphalt. The reflective cracking is excessive but no distresses related to the E-Krete™ were noted. Some minor raveling from the crack faces had occurred where there is noticeable unevenness in the substrate and in areas where the underlying asphalt cracks were about ½ in. wide. Some cracks have also reflected through the white arrow. The color of the E-Krete™ is darker than the surrounding pavement and is holding the color well. There is a white arrow of PermaStripe™ in the middle of this section that was placed directly on top of the E-Krete™. This section receives car and light truck traffic only. Frictional resistance was not measured since traffic was present during the inspection. Adhesion tests conducted on the E-Krete™ section pulled up the underlying asphalt.

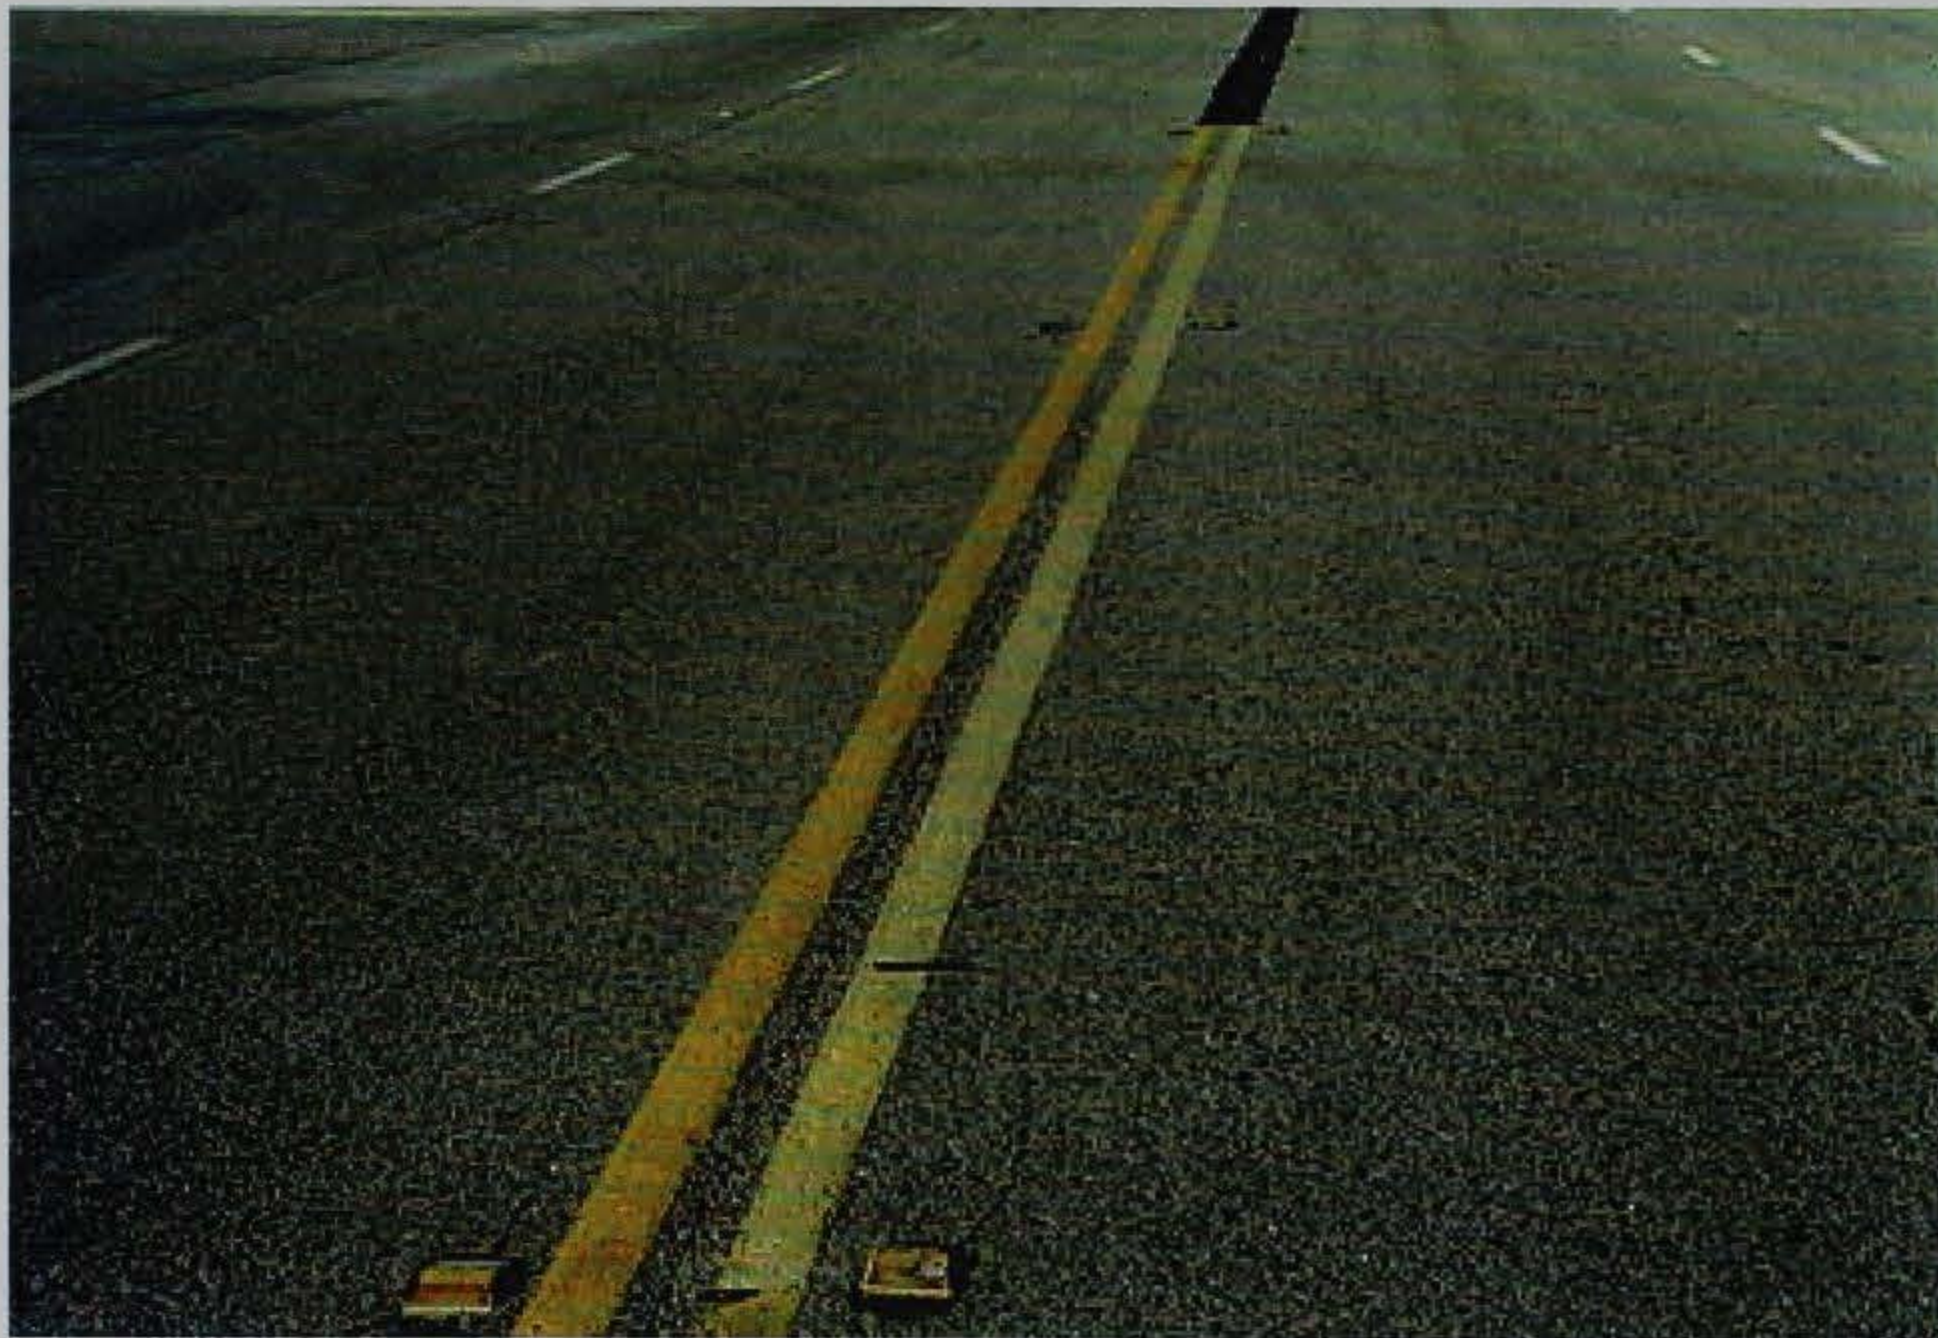
A yellow center-line PermaStripe™ stripe was placed on Rosemond Avenue (a four-lane highway), across from the northern CE exit. It is a double yellow line with one side being their conventional yellow paint (Figure 15). The section is about 200 ft long and at two locations the lines are covered with black paint, where traffic crosses. Both the PermaStripe™ and the paint appear to be in good condition. The paint is approximately 1 year old. PermaStripe™ was placed on one side of a pedestrian walkway across Rosemond Ave. at the CE building. The paint is beginning to fade somewhat from wear; and of course it is thinner. Generally, a paint stripe is 38 to 76 microns (15 to 30 mils) thick and PermaStripe™ is from 76 to 152 microns (30 to 60 mils) in thickness. The PermaStripe™ is somewhat darker in the wheel paths from dirt or grime from traffic. "Stop" and "Stop Ahead" pavement markings had been placed on Rosemond Ave. approaching N. Muroc Street. They alternated the markings made of Polycon and those painted between each lane; doing one of each type at every location. The markings of both types are still in relatively good condition. The only distress noted was in areas where the underlying pavement had cracked, the pavement markings had also cracked. The only cracks observed were reflective.

Figure 15. PermaStripe (on the left) roadway lines at Edwards AFB. The PermaStripe has not faded but is close to the original color as placed

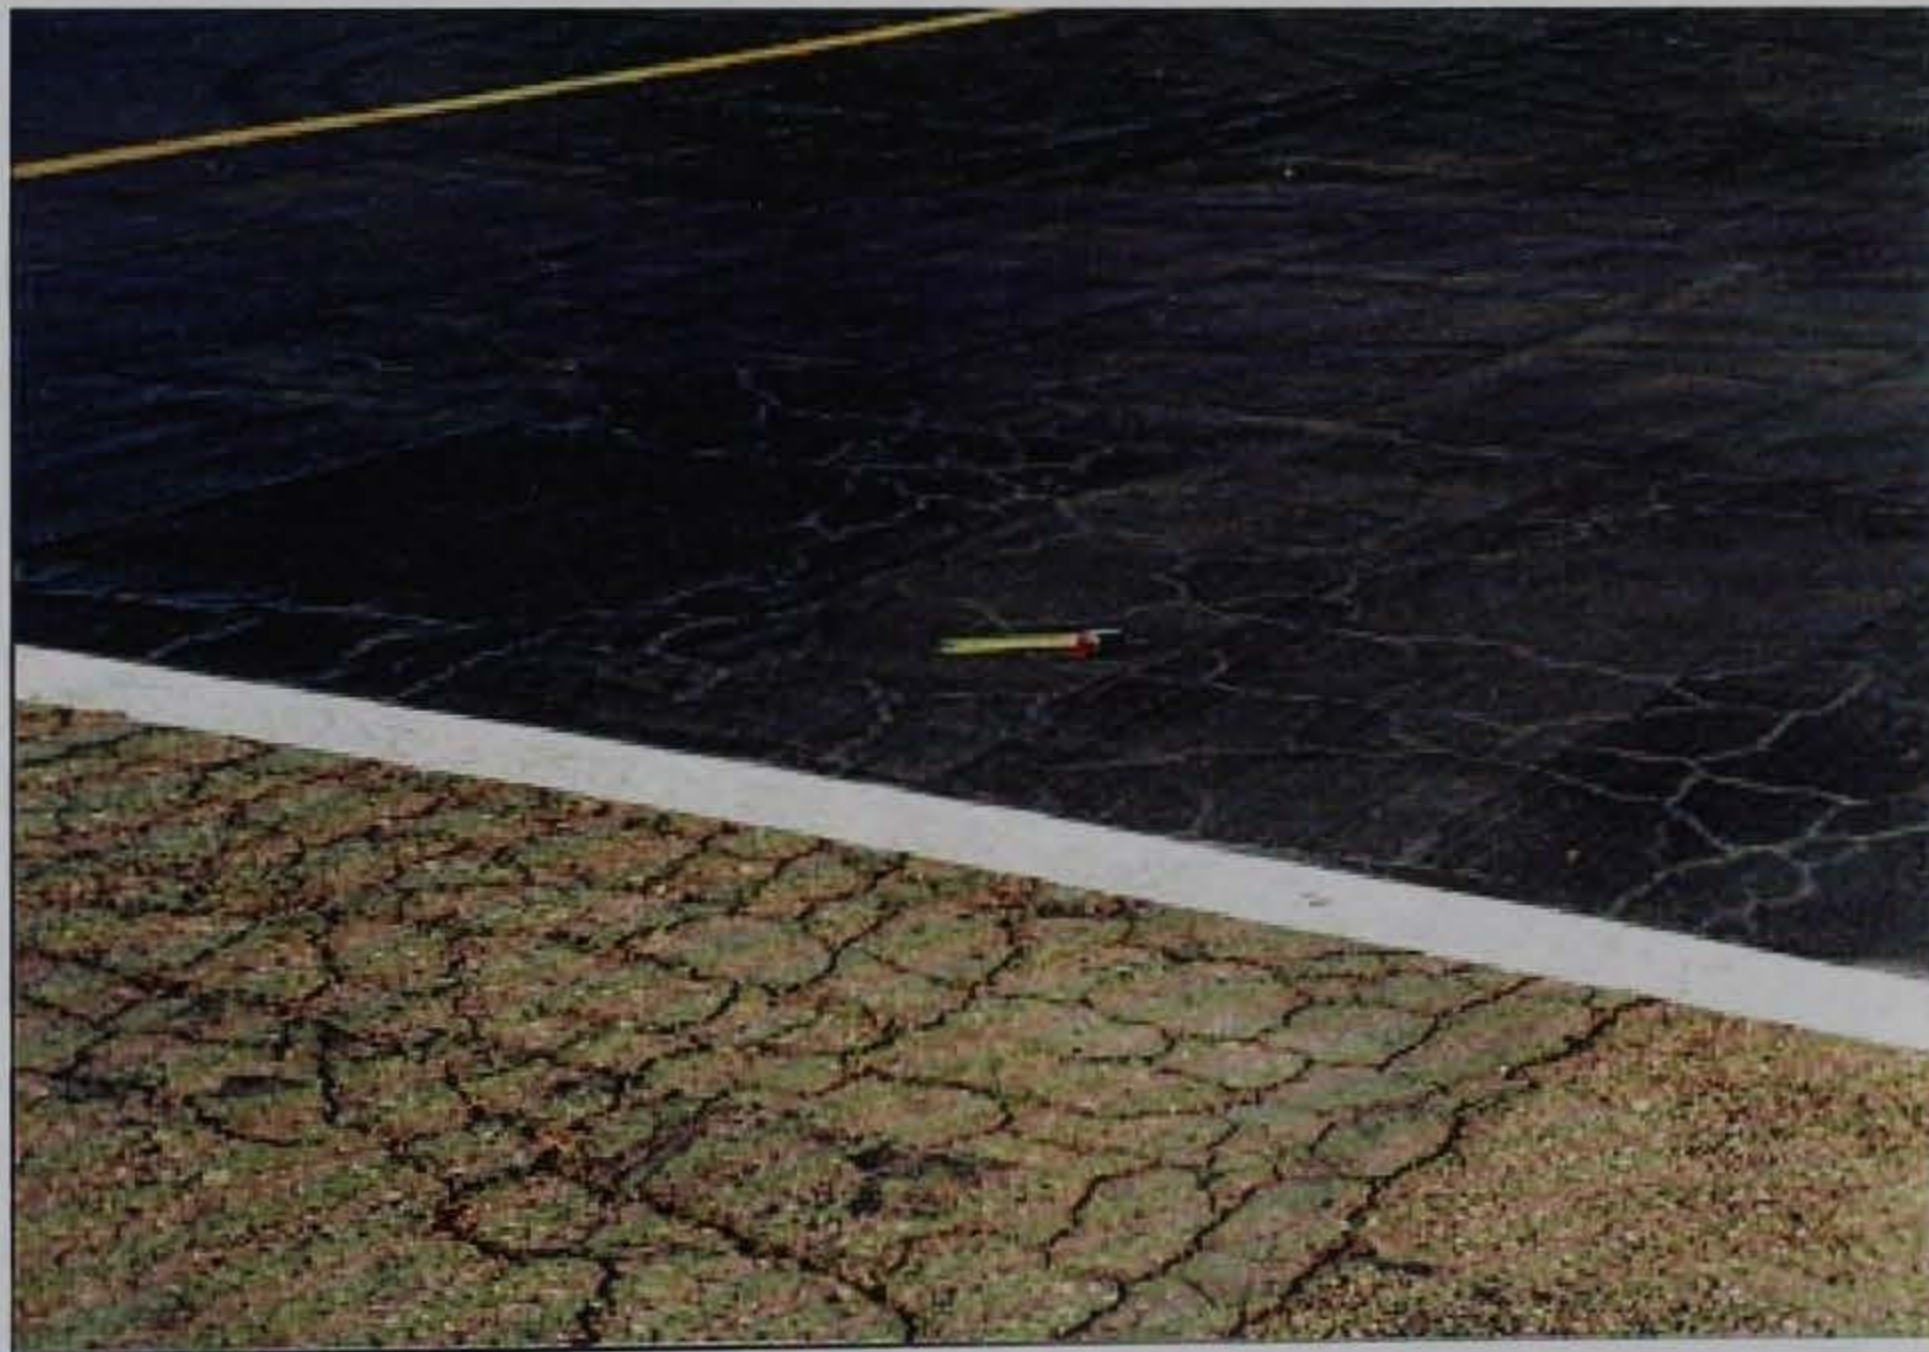
The overall condition of the pad is better than the surrounding pavement. A white discoloration is noticeable on the E-Krete™, in areas adjacent to hairline cracking. A similar condition was noted on one of the E-Krete™ sections at Forbes Field. There were only a few areas where raveling had occurred from the crack faces and these were in areas with large underlying cracks. Generally, most of the cracks vary from hairline up to 3 mm (1/8 in.). The largest cracks are up to 6 mm (1/4 in.) wide. These types of cracks, while widespread, did not cover the entire pad. The yellow center strip did not appear to have cracks and is holding color well with little apparent fading. All of the cracks were reflecting up from the underlying asphalt.

Figure 16. E-Krete and PermaStripe at North Island NAS. Note the severely cracked asphalt surface upon which the E-Krete was placed. Although many of the cracks have reflected back up through the E-Krete, it is in much better condition than the asphalt with virtually no raveling, unlike the surrounding pavement

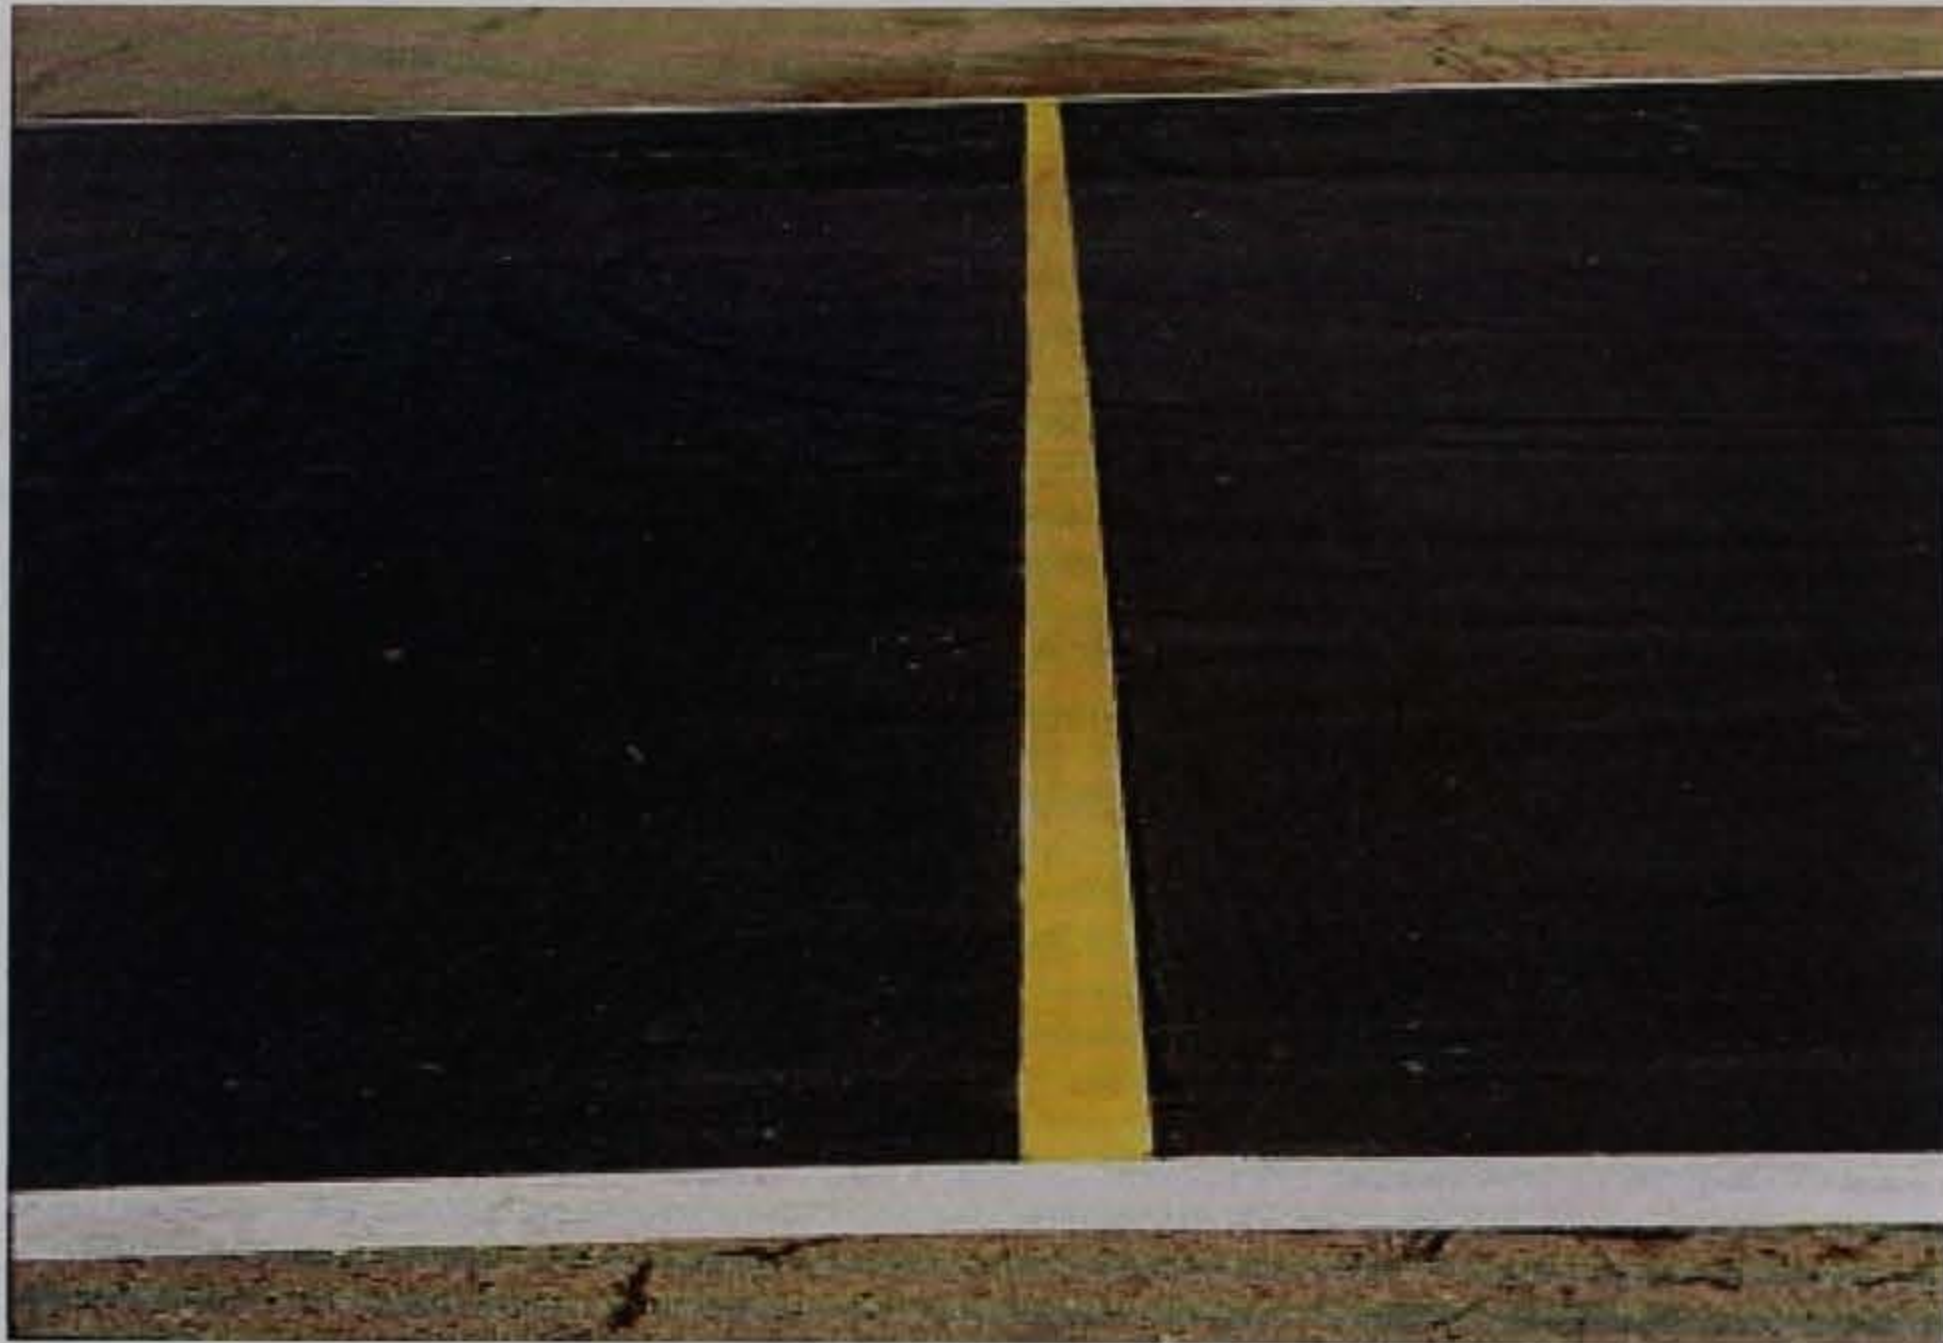
Figure 17. E-Krete and PermaStripe at North Island NAS. The PermaStripe has not faded and is holding its color well
