E-Krete™ Polymer Composite Micro-Overlay for Airfields: Laboratory Results and Field Demonstrations

J. Kent Newman and James E. Shoenberger

November 2003

Final report

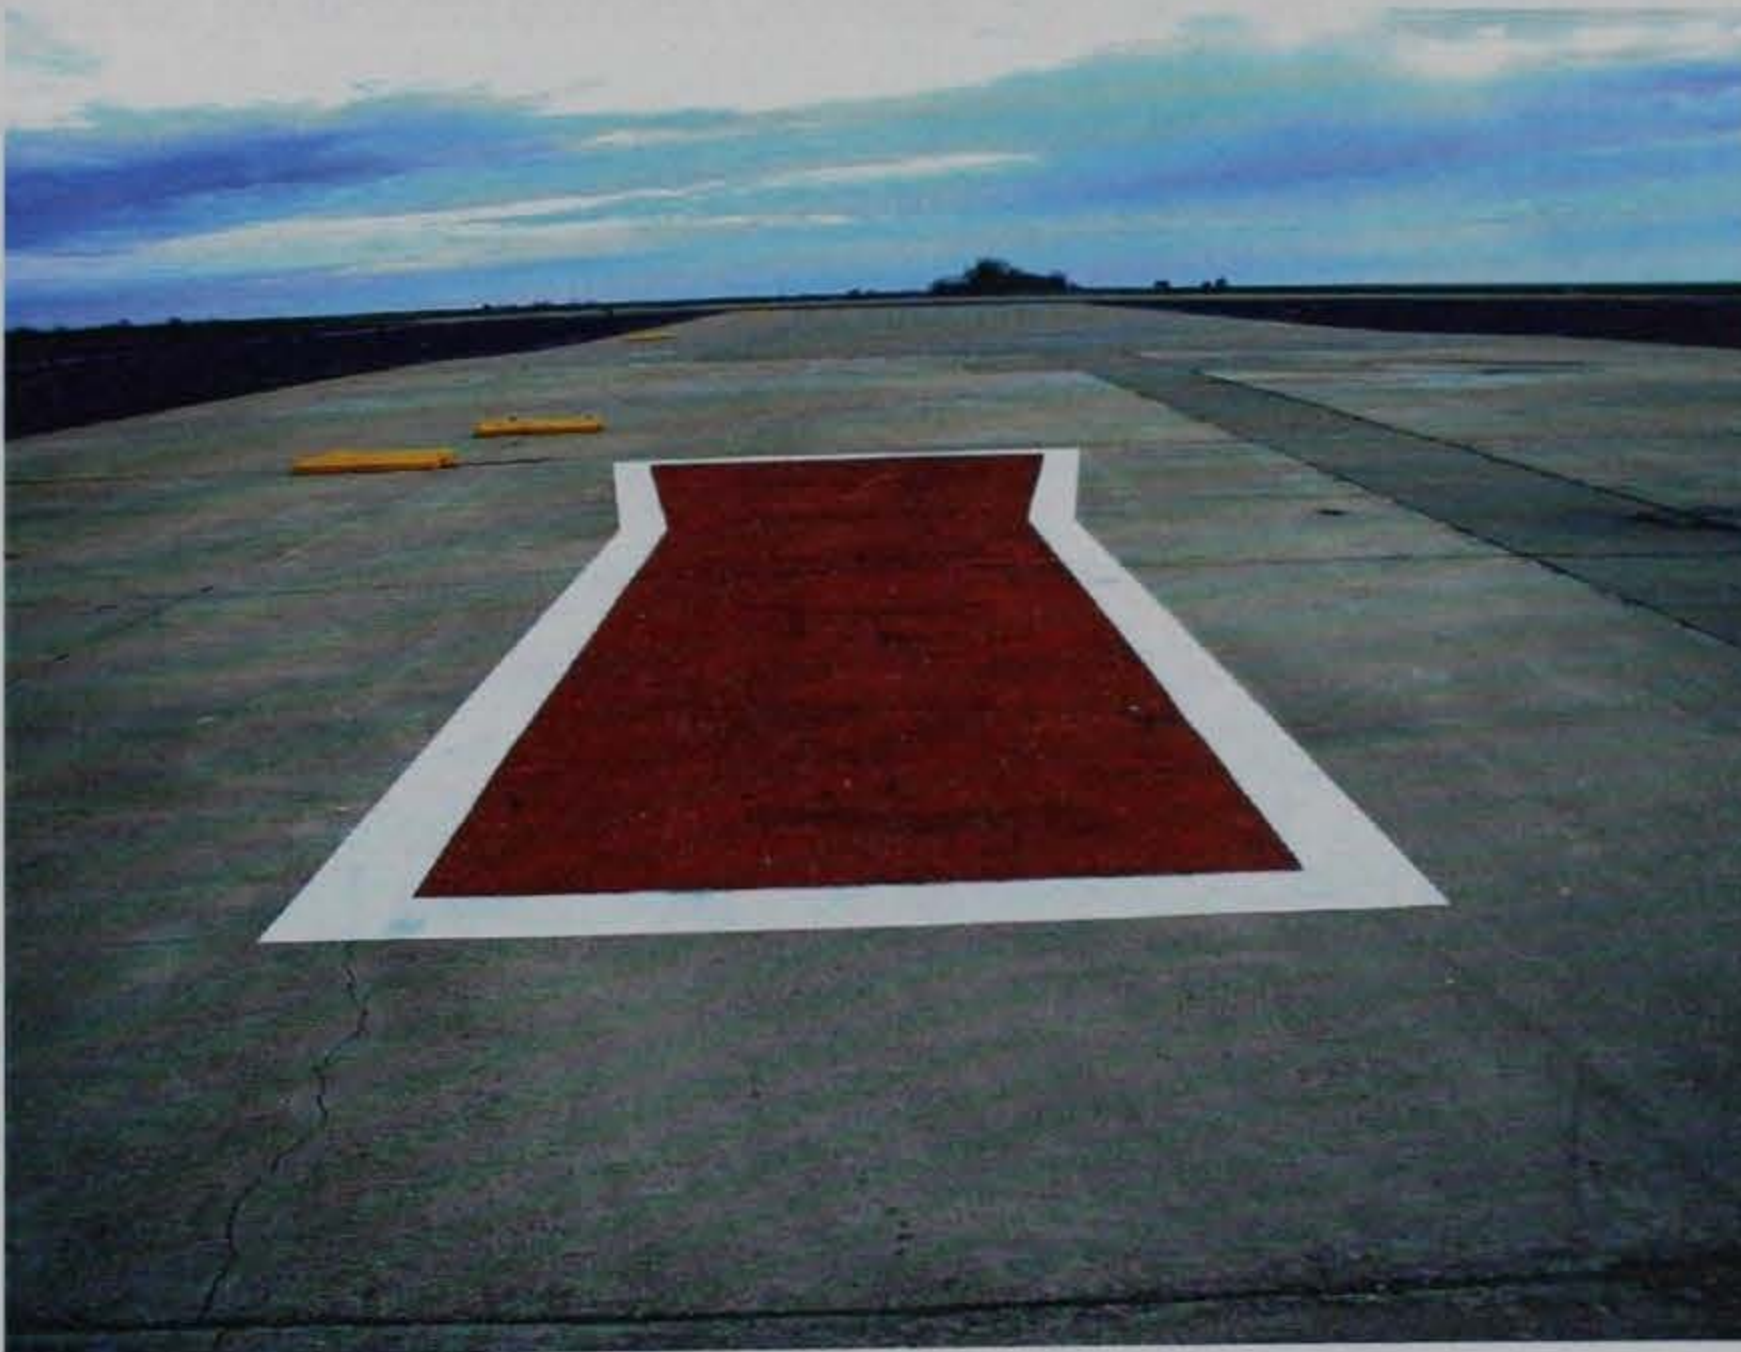
Figure 19. "Red Carpet" area in November 2000. Some fading of the red has occurred and reflective cracks are present, but overall, this section is in excellent condition

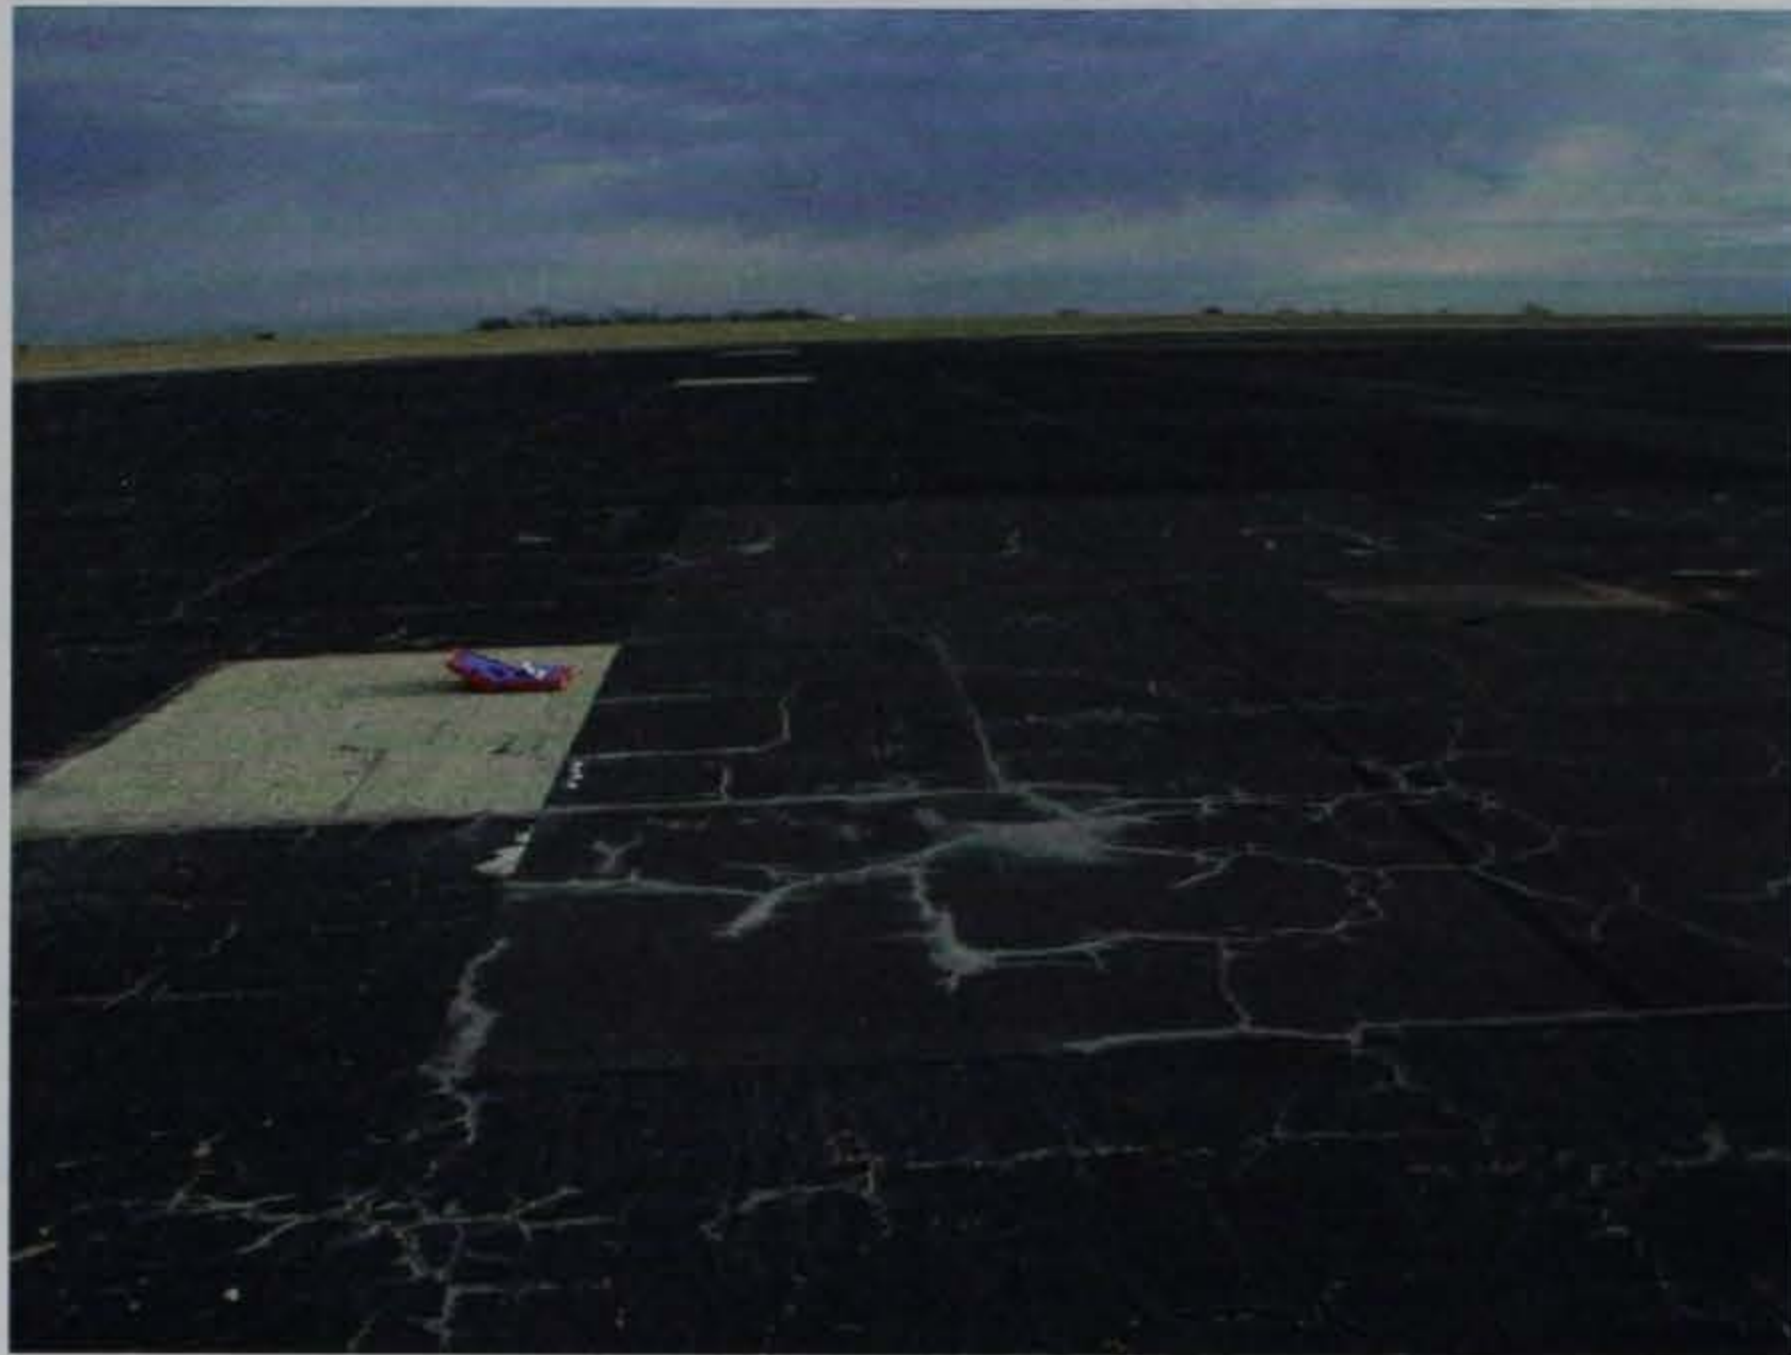
Whitening of the E-Krete™ surface adjacent to the cracks has occurred in Section 1 (Figure 20). This may be related to unreacted Portland cement in the E-Krete™ that slowly leached out over time as water seeped from the cracks after precipitation. This does not seem to have affected the performance. Many of the cracks from the coal tar substrate have reflected up

Figure 20. Large E-Krete section at Forbes Field. This section was placed on severely cracked coal tar and a portion of a small concrete island. The white staining about the reflective cracks is most likely effervescence from the cement powder within the E-Krete resulting from poor application conditions (see text for more detail).

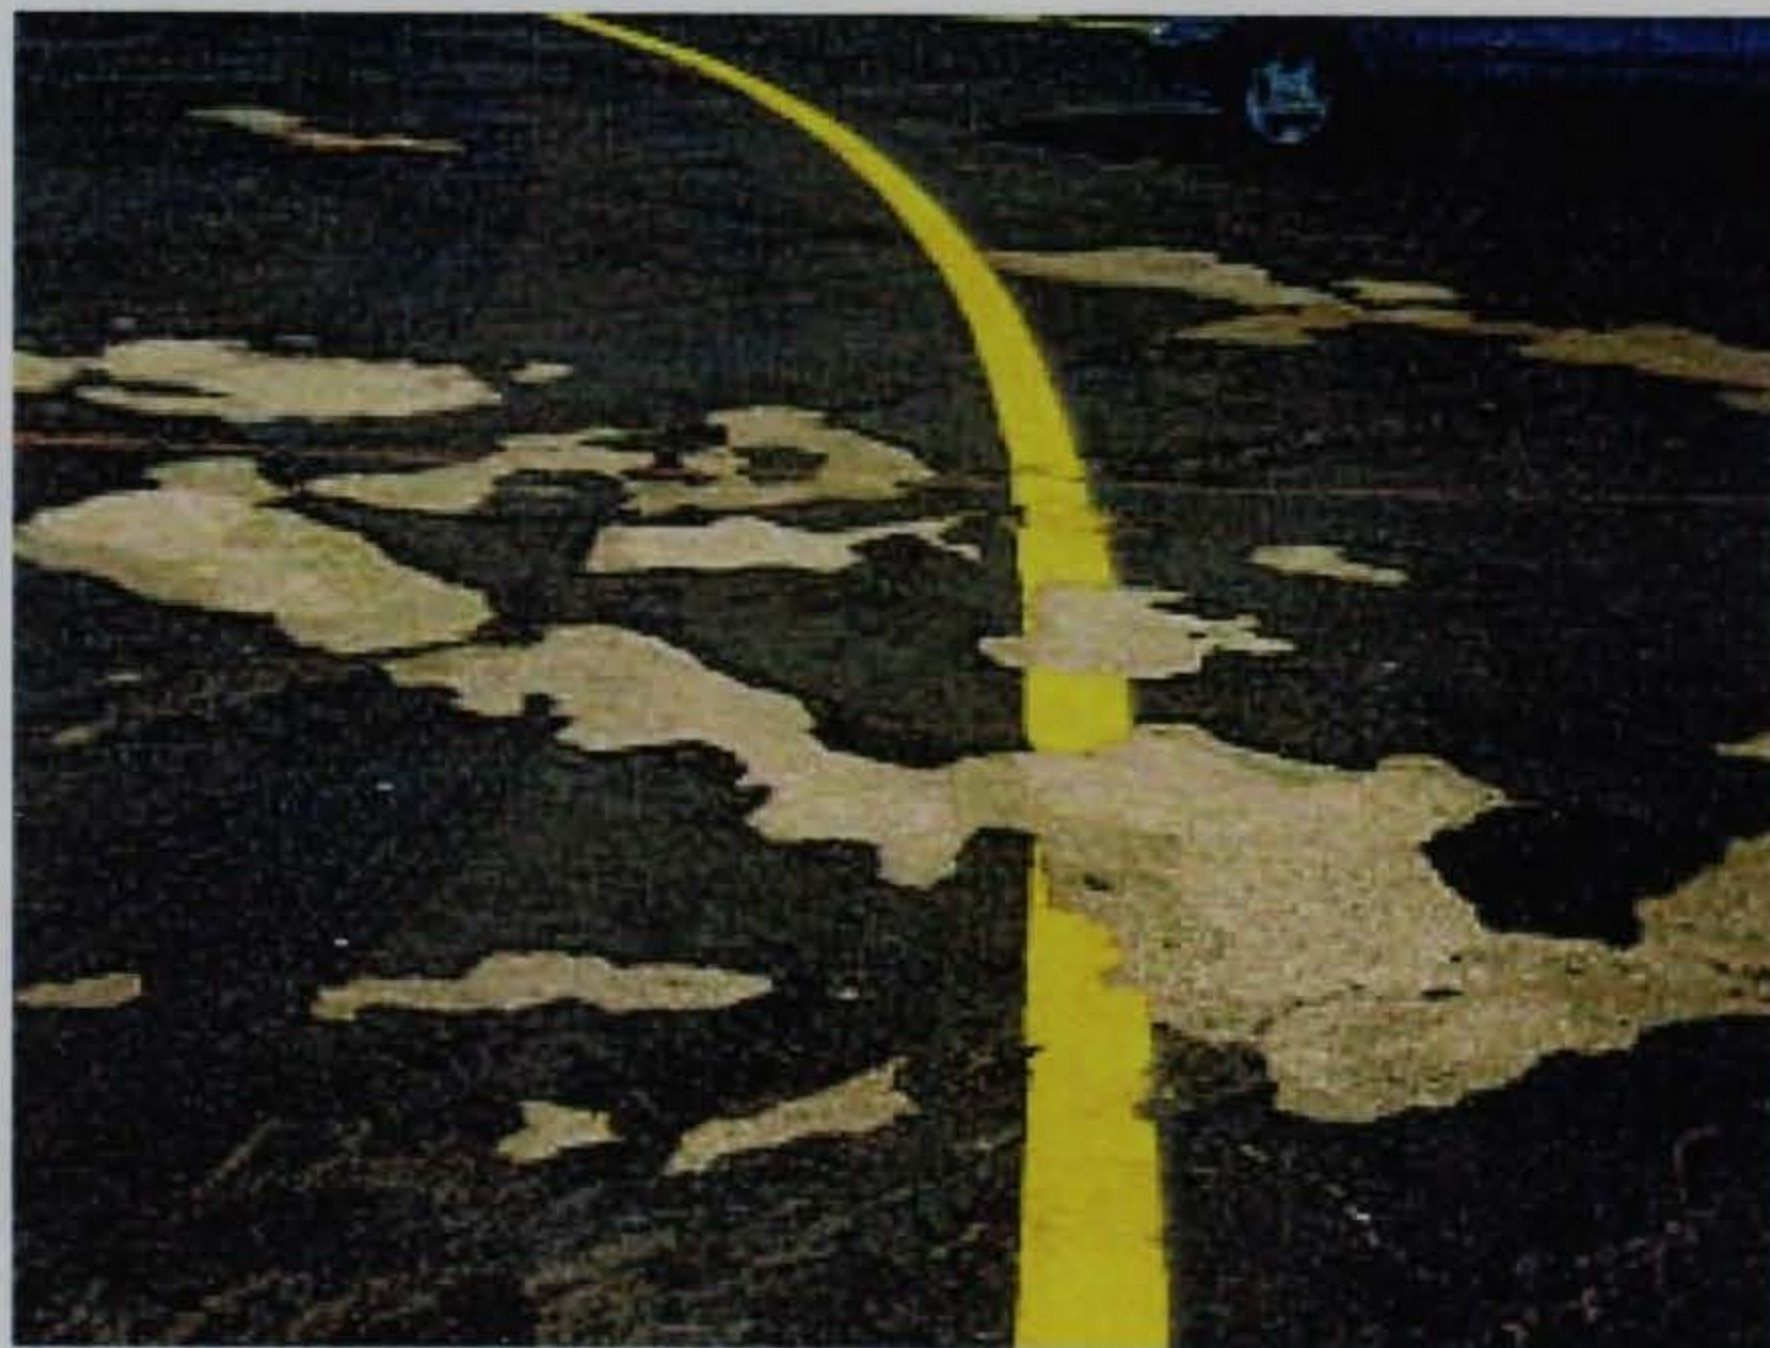
Figure 21. Severe delamination of existing coal tar surface (prior to E-Krete application)

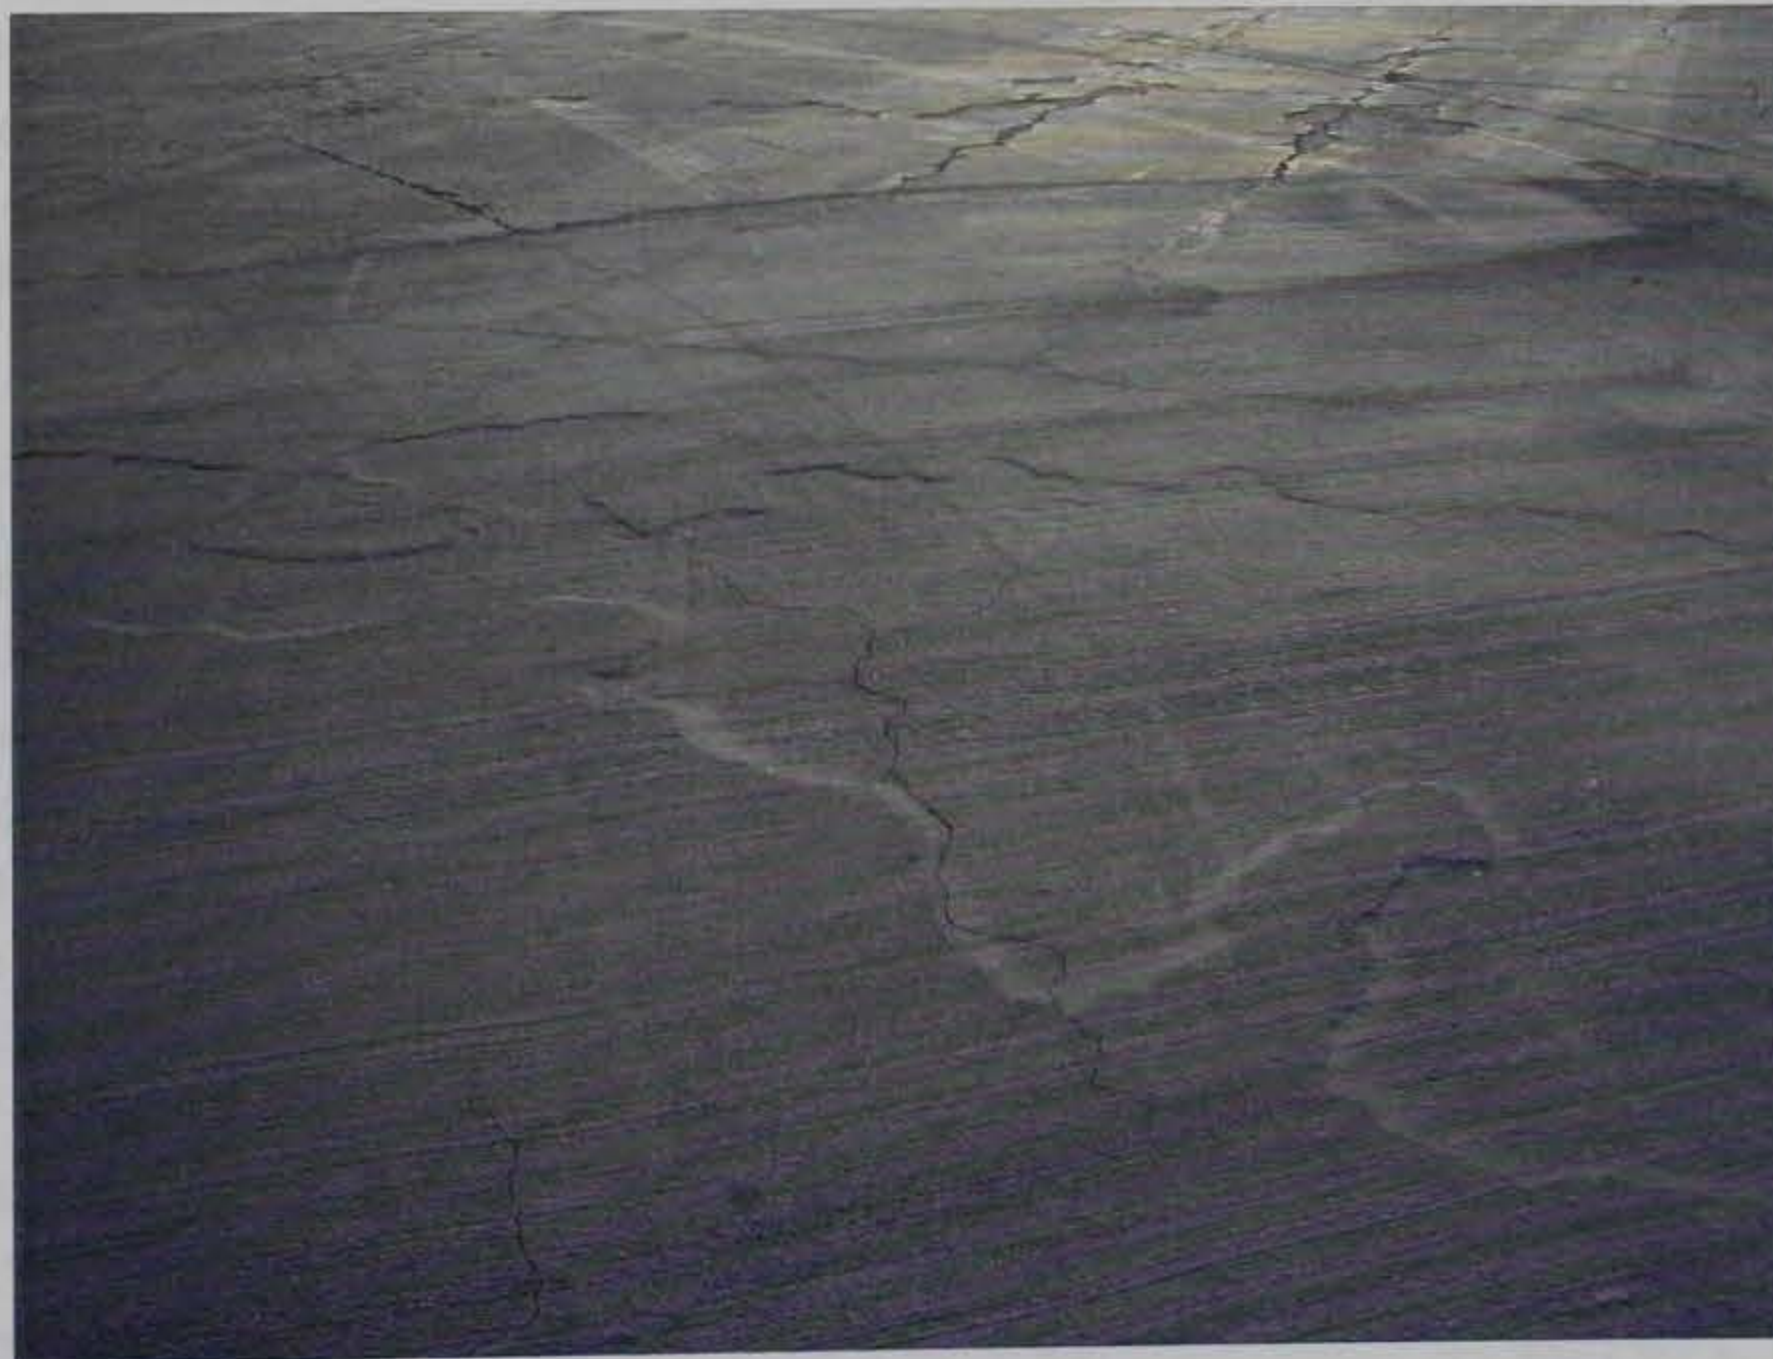
Figure 22. Area from Figure 20, about 2 years after E-Krete application. The large areas of missing coal tar have been completely encapsulated with no further delamination

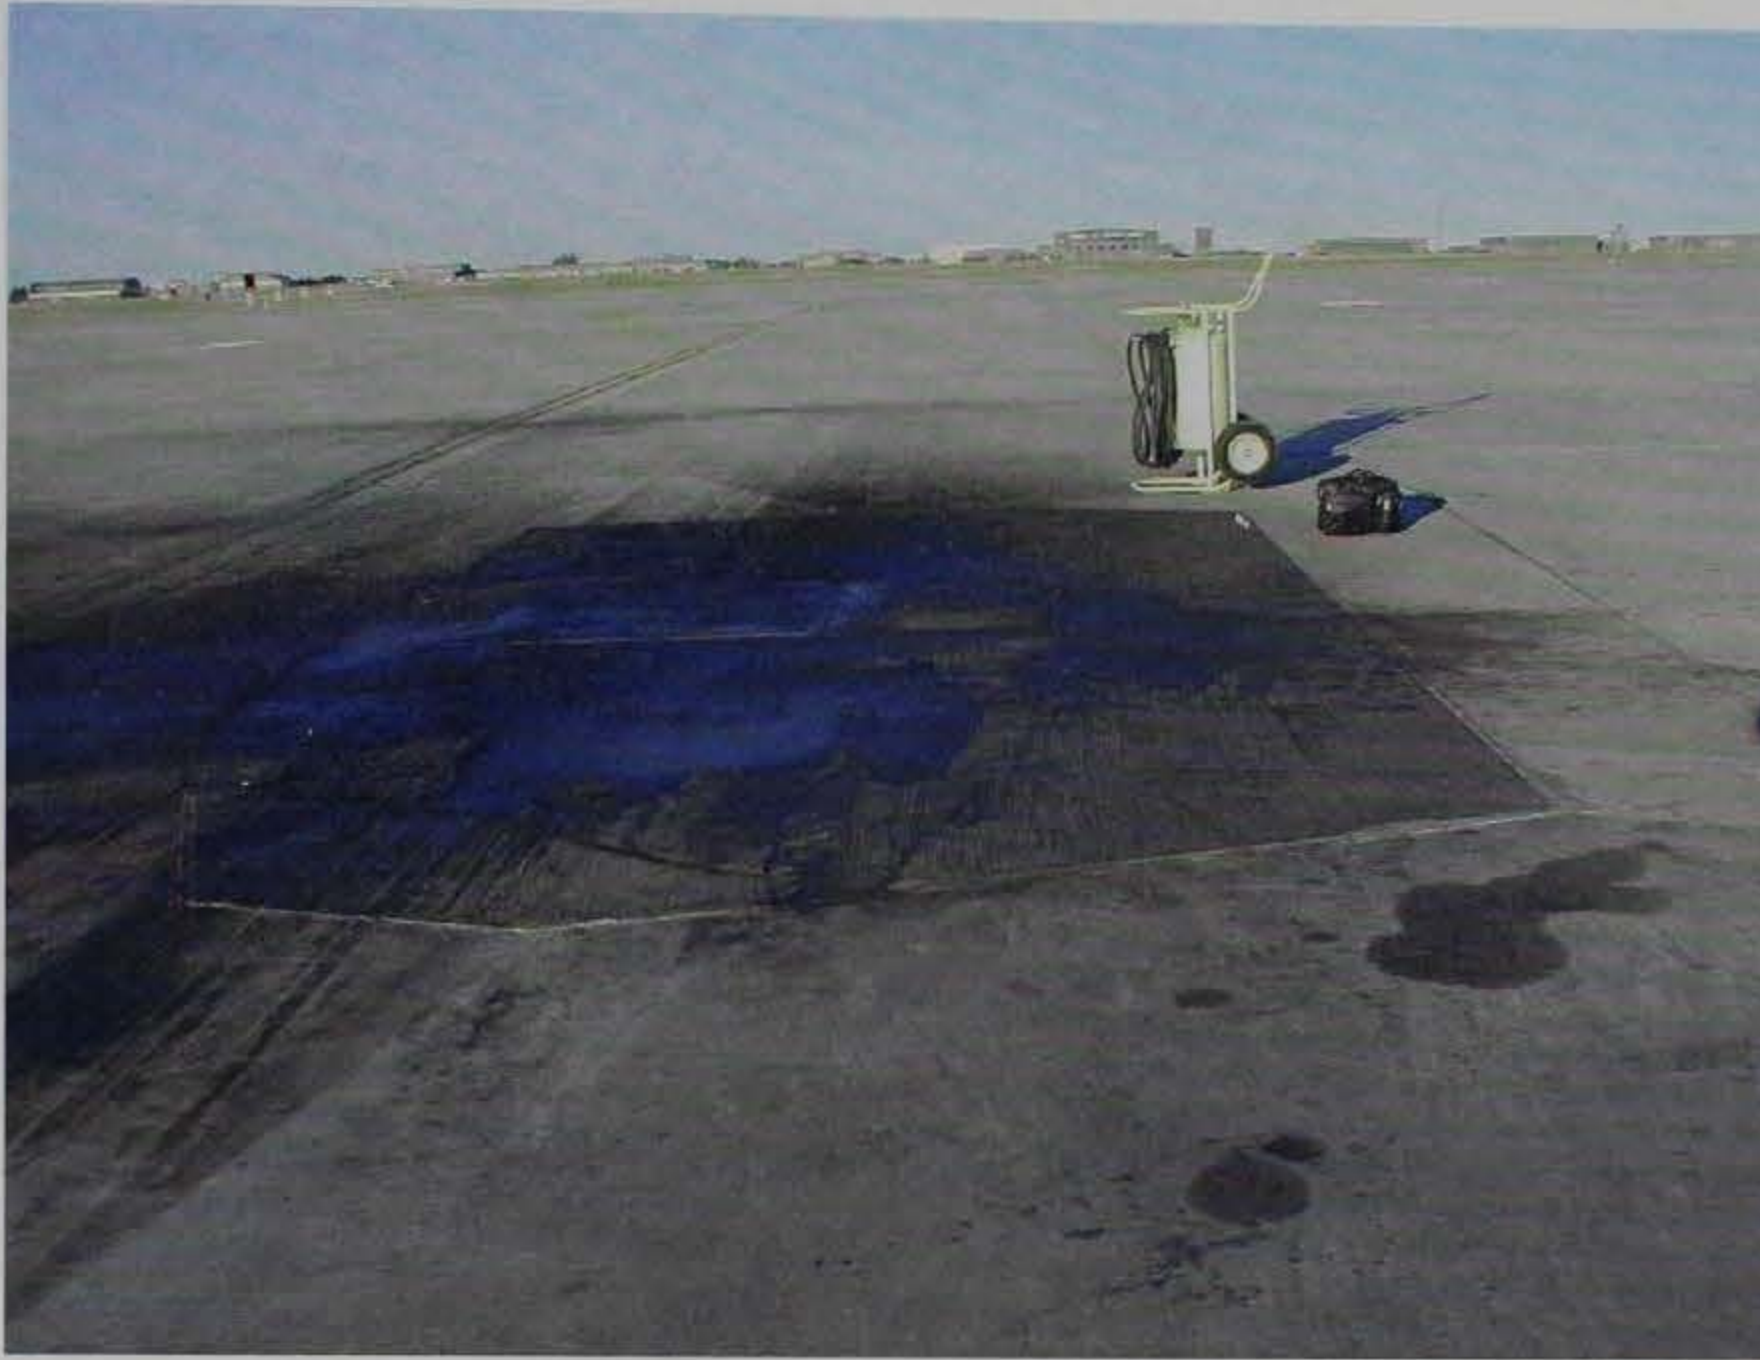
In November 2000, a detailed inspection of the B-1B pads was conducted. The overall condition of the E-Krete™ was described as good. Approximately 10 percent of the E-Krete™ surface has delaminated, with severe staining from hydraulic fluid. In pads B10 and B12 the E-Krete™ had turned rubbery. This rubbery condition is resulting from swelling of the polymer within E-Krete™ by synthetic jet turbine fluid. The condition of the E-Krete™ on pad B11 (Figure 23) was better than B10 (Figure 24) and B12, but some rubbery areas were noted. Despite this condition, the E-Krete™ has prevented the aircraft fluids from causing serious damage to the underlying concrete substrate. Given that concrete replacement under the B1B aircraft generally occurred every 2 years, the performance of the E-Krete™ coating was considered highly successful. Delamination of the E-Krete™ occurred from poor adhesion resulting from existing aircraft fluids already present on the concrete and proceeded from the joints towards the center of the concrete slab (Figure 25). It is apparent that using E-Krete™ with a fuel-resistant top coating to prevent aircraft fluid ingress into the concrete is a viable and economical solution to prevent concrete damage under B-1B aircraft. Further use of the E-Krete™ product is planned at McConnell AFB in the fall of 2001.

Figure 23. Overall view of B1B aircraft pad B11 in November 2000. The E-Krete is completely soaked with hydraulic and turbine fluid and is in good condition

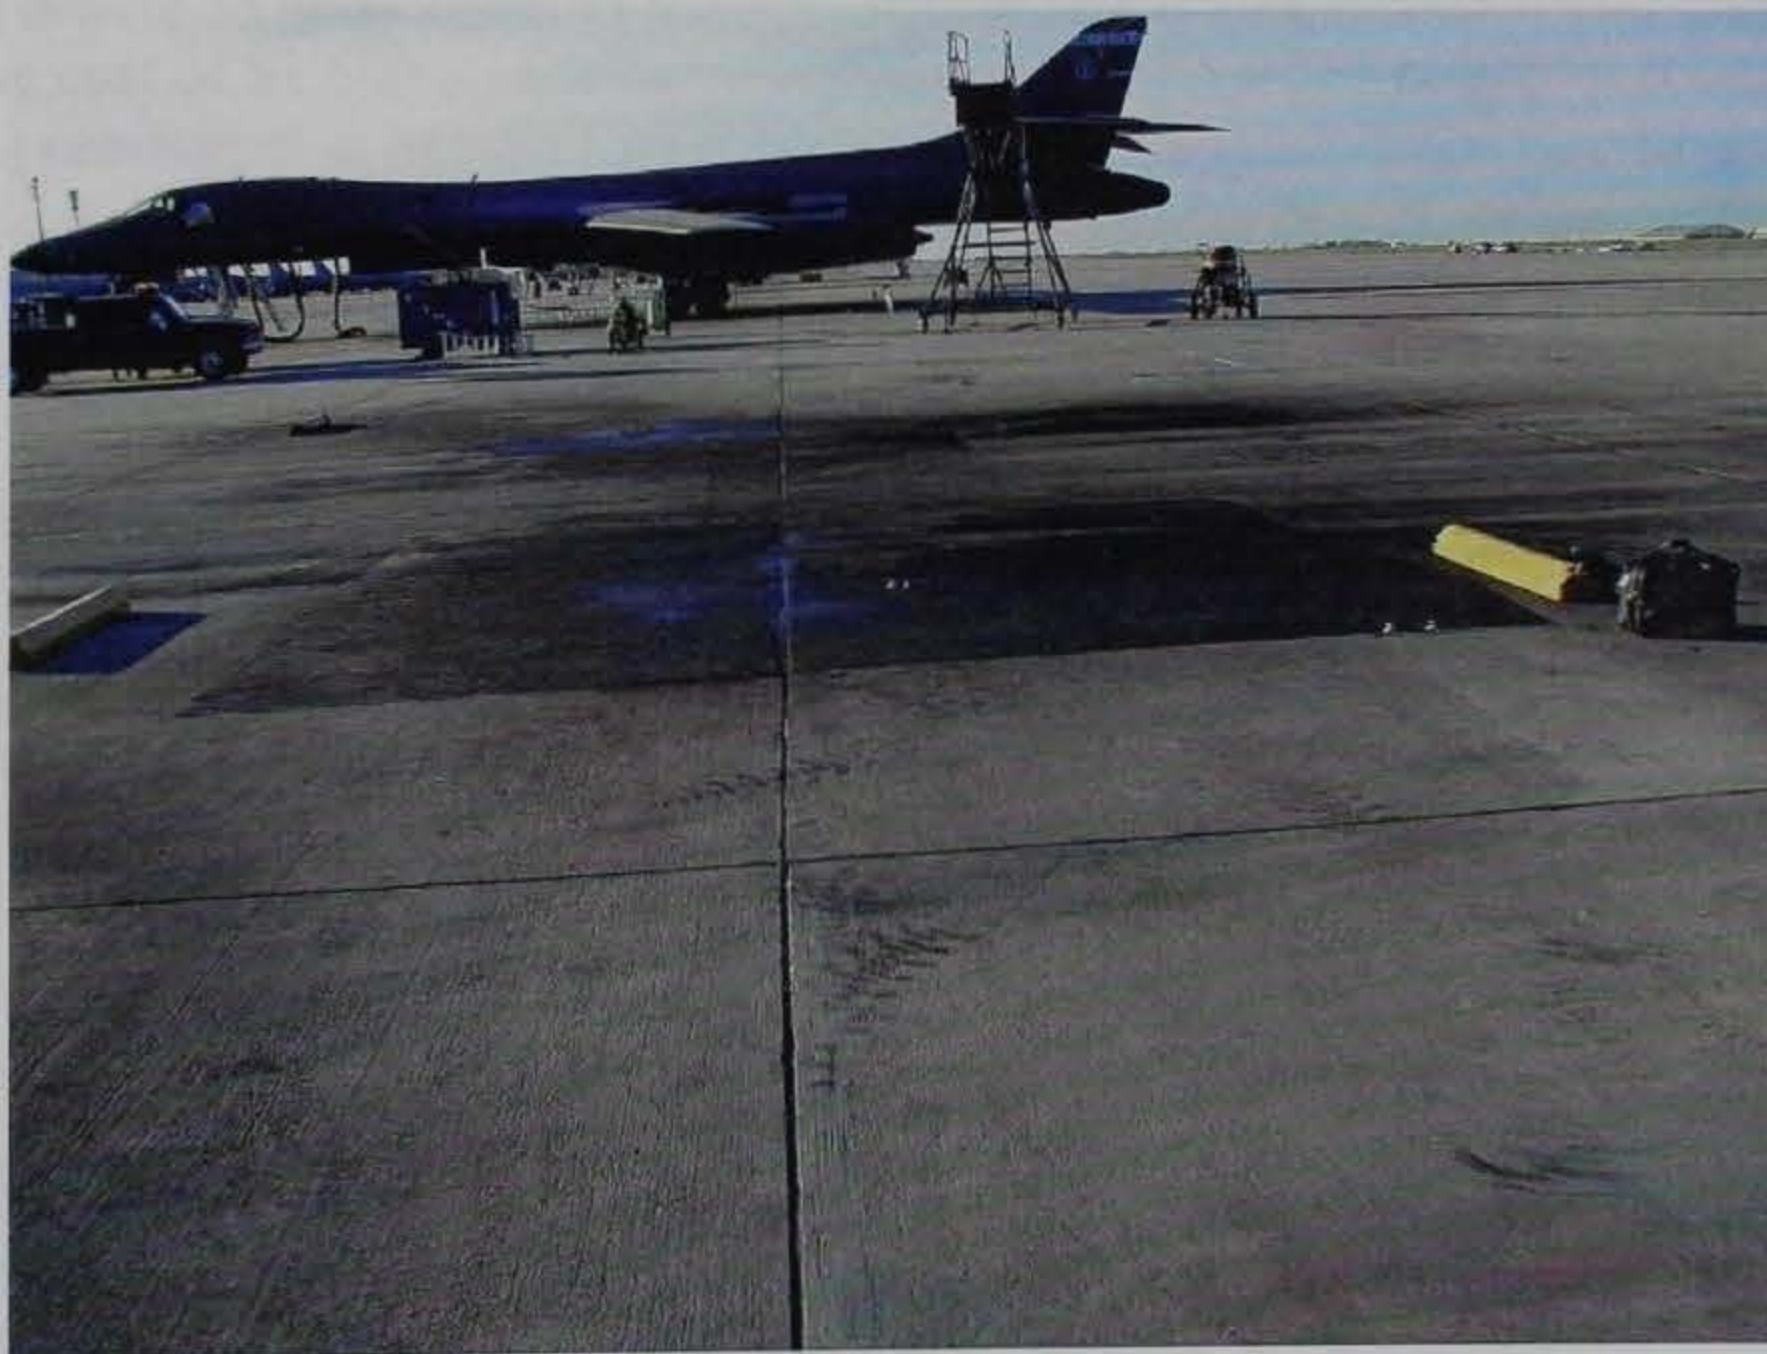
Figure 24. Overall view of B1B aircraft pad B10 in November 2000. As with B11, the E-Krete is completely soaked with aircraft hydraulic and turbine fluid and is in good condition.

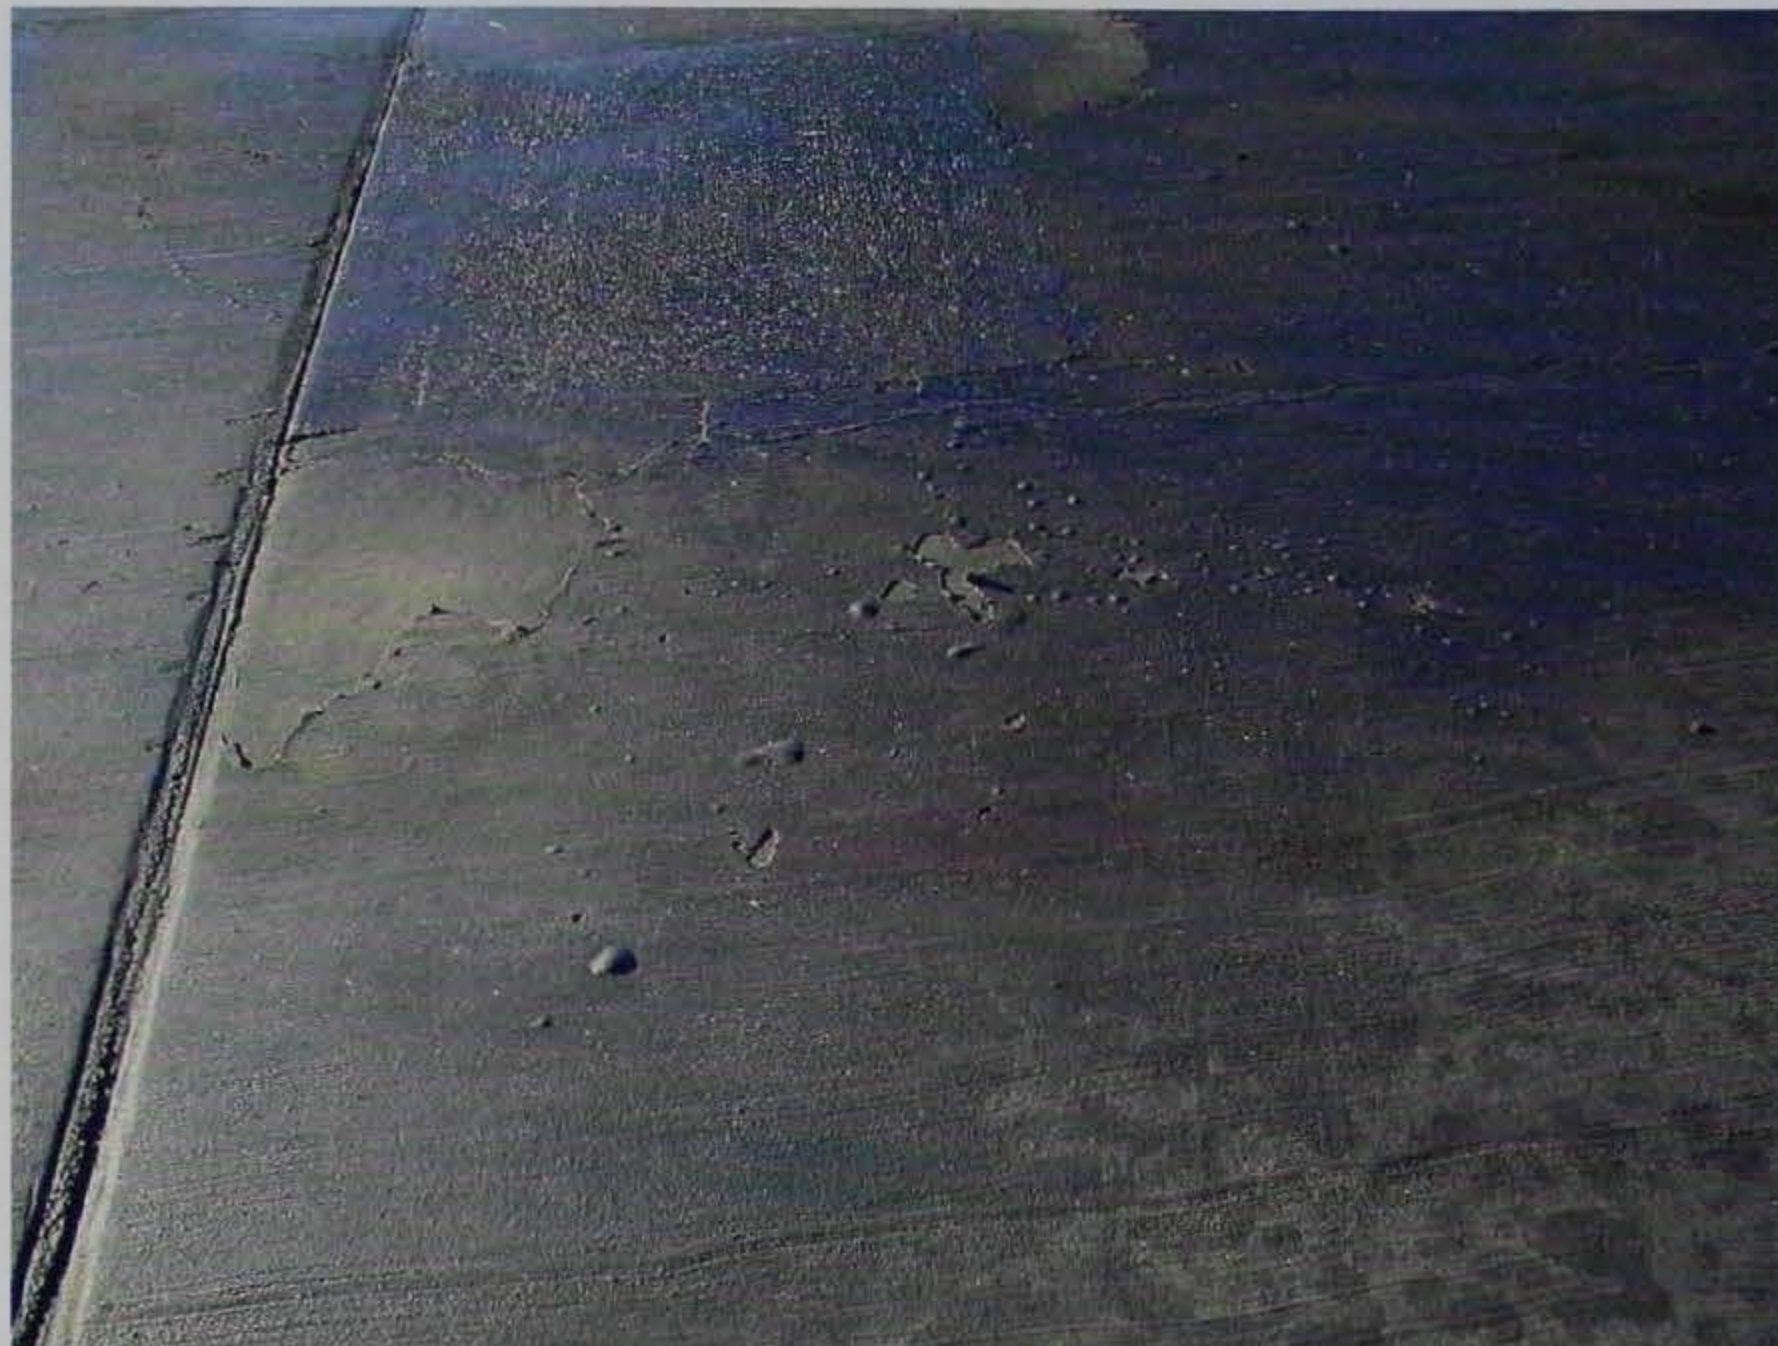
Approximately 2 months after placement of the E-Krete™, it was noted that delamination was occurring in some areas. A visit to the site and inspection of the areas revealed that the delamination was progressing from the concrete joints towards the center of the slabs. After discussions with Polycon representatives and the E-Krete™ placement crew, it was discovered that the masking tape covering the joints was not removed until well after the E-Krete™ had begun to harden. During removal of the tape, some of the coating stuck to the tape and pulled away from the slab. It was in these areas that delamination was occurring. Additionally, it was also in these areas where the hydraulic fluid had stained the concrete before application of the E-Krete™. Thus, it was surmised that the hydraulic fluid on the concrete had prevented a proper bond of the E-Krete™ to the concrete substrate. Removal of the masking tape from the joints pulled up some of the coating because it was prevented from bonding to the concrete by the hydraulic fluid.

Figure 25. Closeup view of B-1B pad B11. On the left side of the joint, the E-Krete is intact but rubbery and has prevented ingress of aircraft fluid into the underlying concrete. On the right side of the joint, some delamination and blistering is evident. The delamination and blistering was likely the result of preexisting oil on the surface before application of the E-Krete
