## **Fluvial Instability and Channel Degradation of Amite River and its Tributaries, Southwest Mississippi and Southeast Louisiana**

D. Ryan Hood, David M. Patrick, and Maureen K. Corcoran

September 2007

Final report

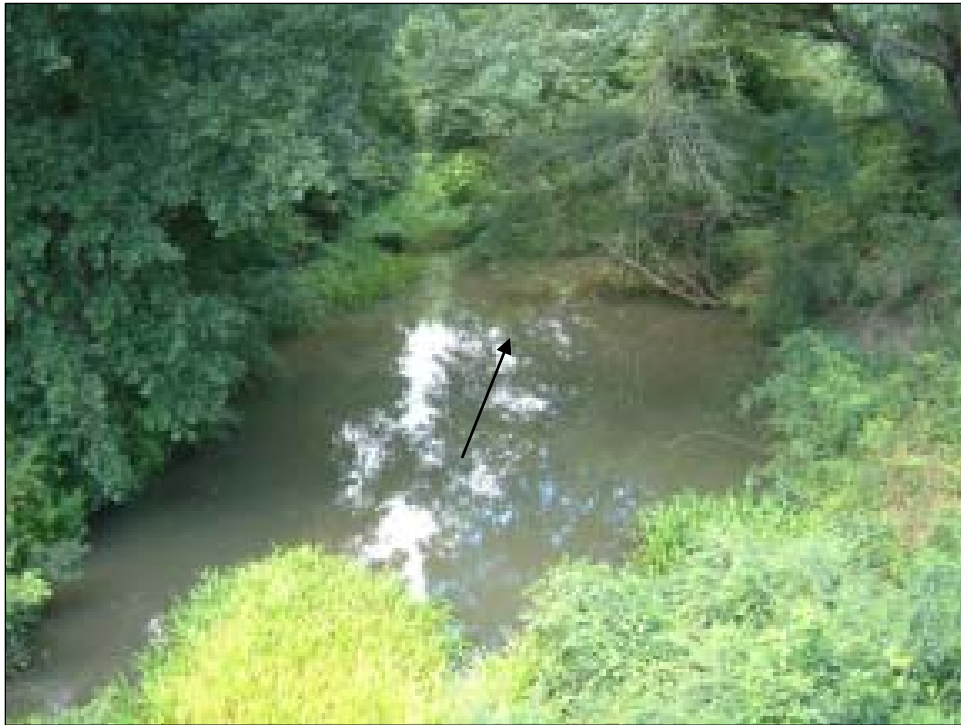
Figure 5. Downstream view of the East Fork Amite River at the Hwy 98 crossing near Smithdale, MS (July 2003) (arrow notes flow direction).

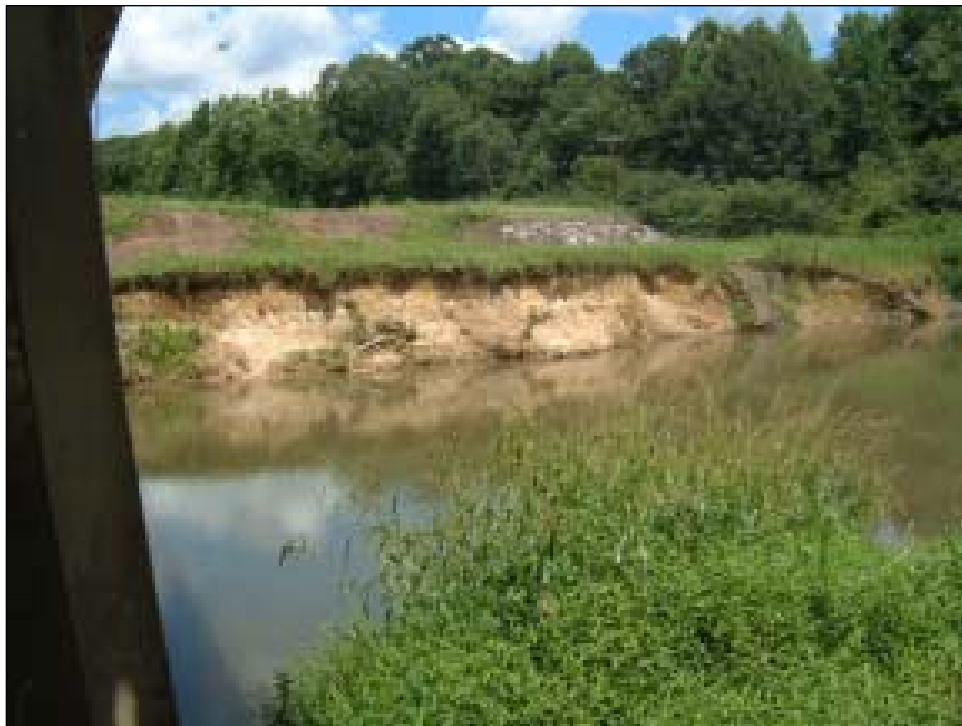
Figure 11. Steep, eroded right bank of the East Fork at the Hwy 570 crossing near Mars Hill, MS (July 2003).

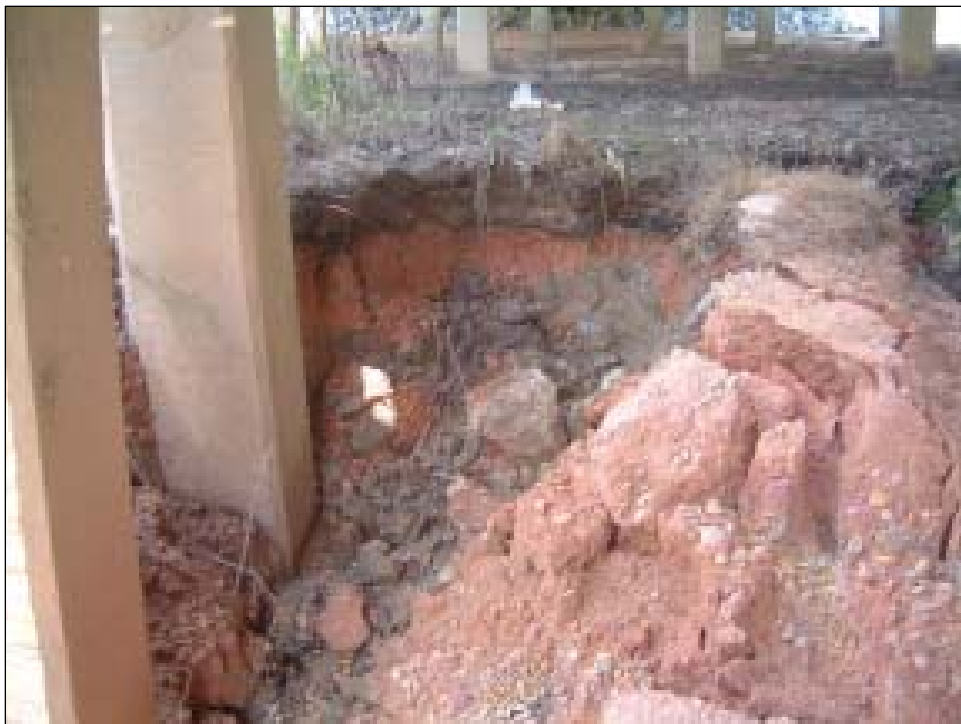
Figure 15. Scour of bridge piers at the Hwy 24 crossing of the East Fork near Peoria, MS (July 2003).

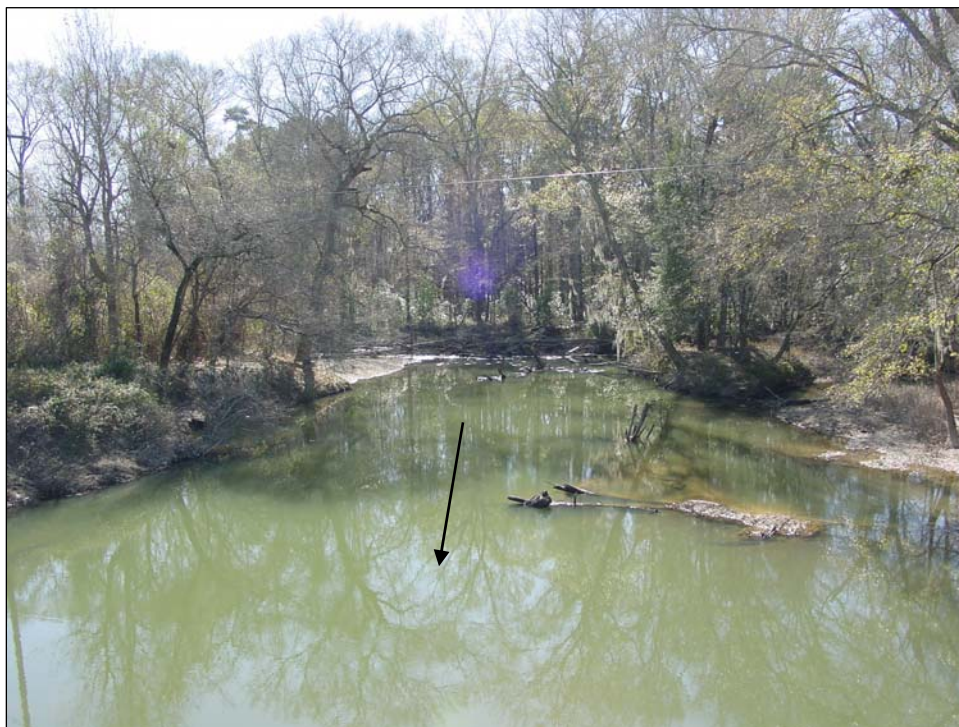
instability by leaning dead and living vegetation (Figure 16). The overall condition of the channel and banks of the East Fork Amite River appeared to reflect a state of semi-stability although some localized areas of channel bed incision and bank erosion were observed.

Figure 16. Upstream view of the East Fork Amite River at the MS Hwy 584 crossing near Liberty, MS (October 2003) (arrow notes flow direction).

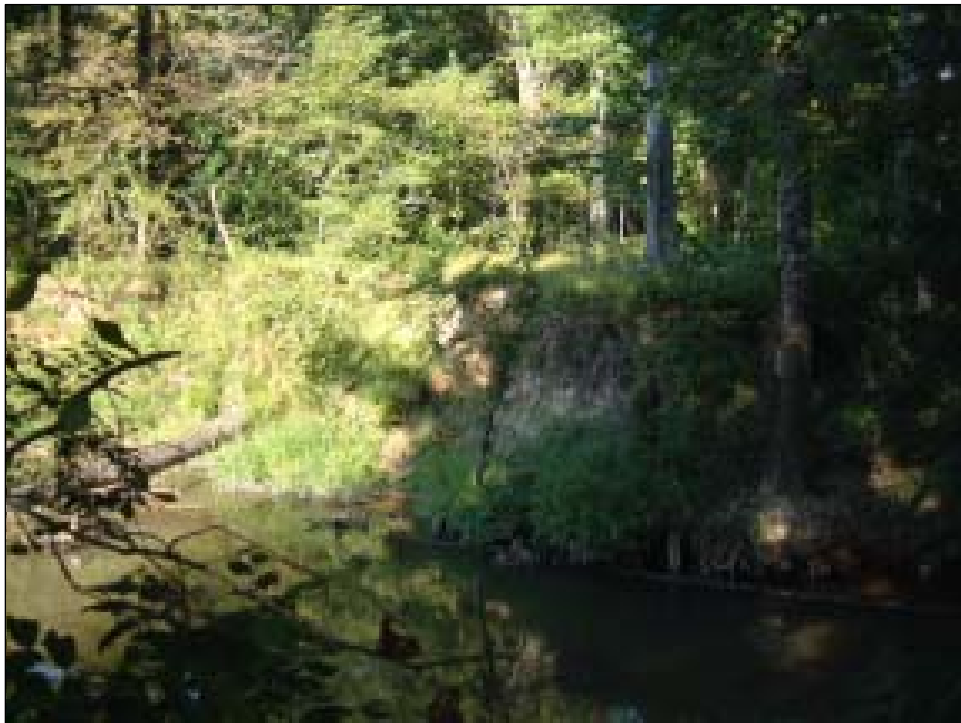
Figure 24. Steep, eroded left bank of the West Fork at the Hwy 48 crossing near Liberty, MS (July 2003).

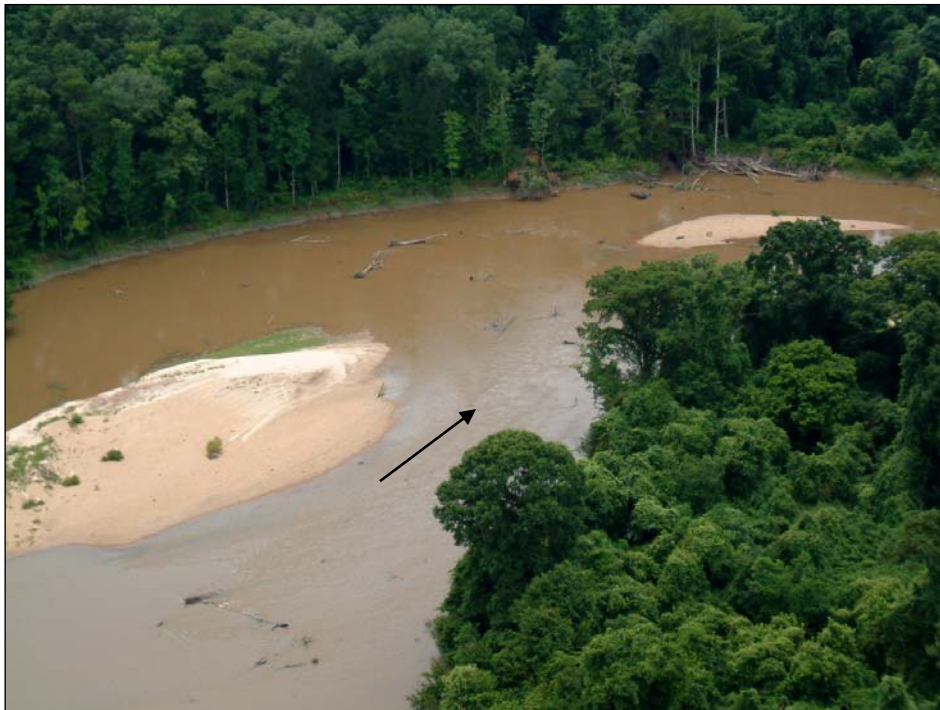
Figure 28. Divided flow conditions of the Amite River in southeast Louisiana just north of the Louisiana Hwy 432 crossing near Felixville, LA (arrow notes flow direction—July 2004).

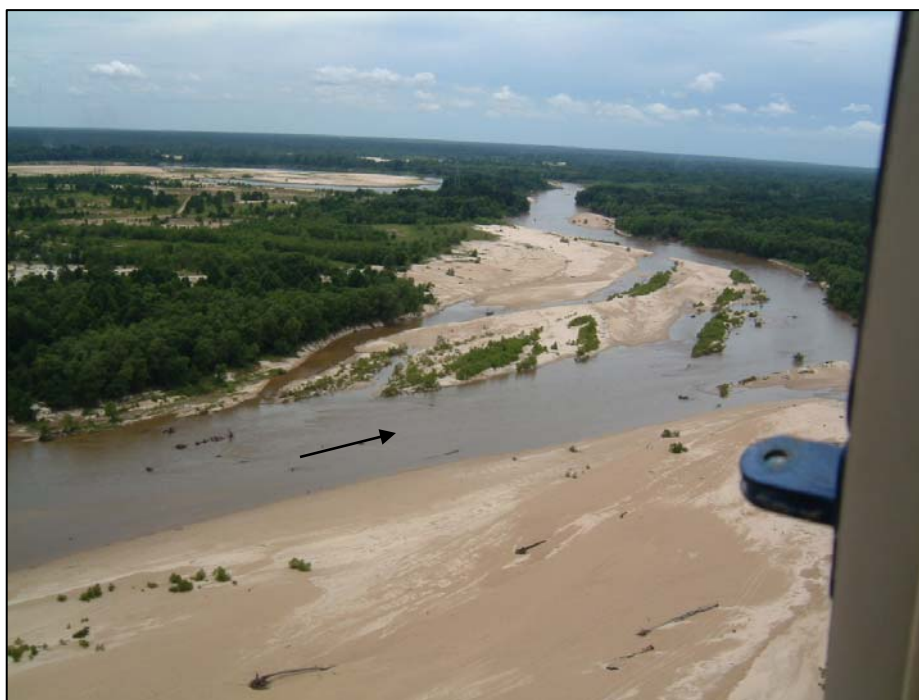
Figure 37. Divided flow conditions of the Amite River just upstream of the Louisiana Hwy 37 crossing near Grangeville, LA (view is downstream—July 2004) (arrow notes flow direction).

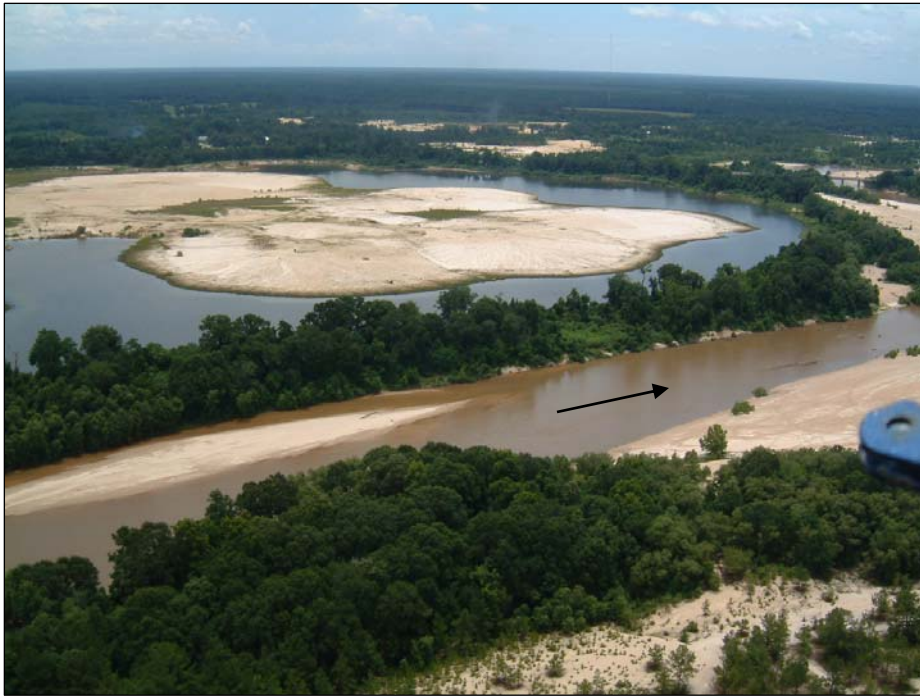
Figure 38. Large abandoned gravel mine on the left bank of the Amite River just upstream of the Louisiana Hwy 37 crossing near Grangeville, LA (arrow notes flow direction—July 2004)

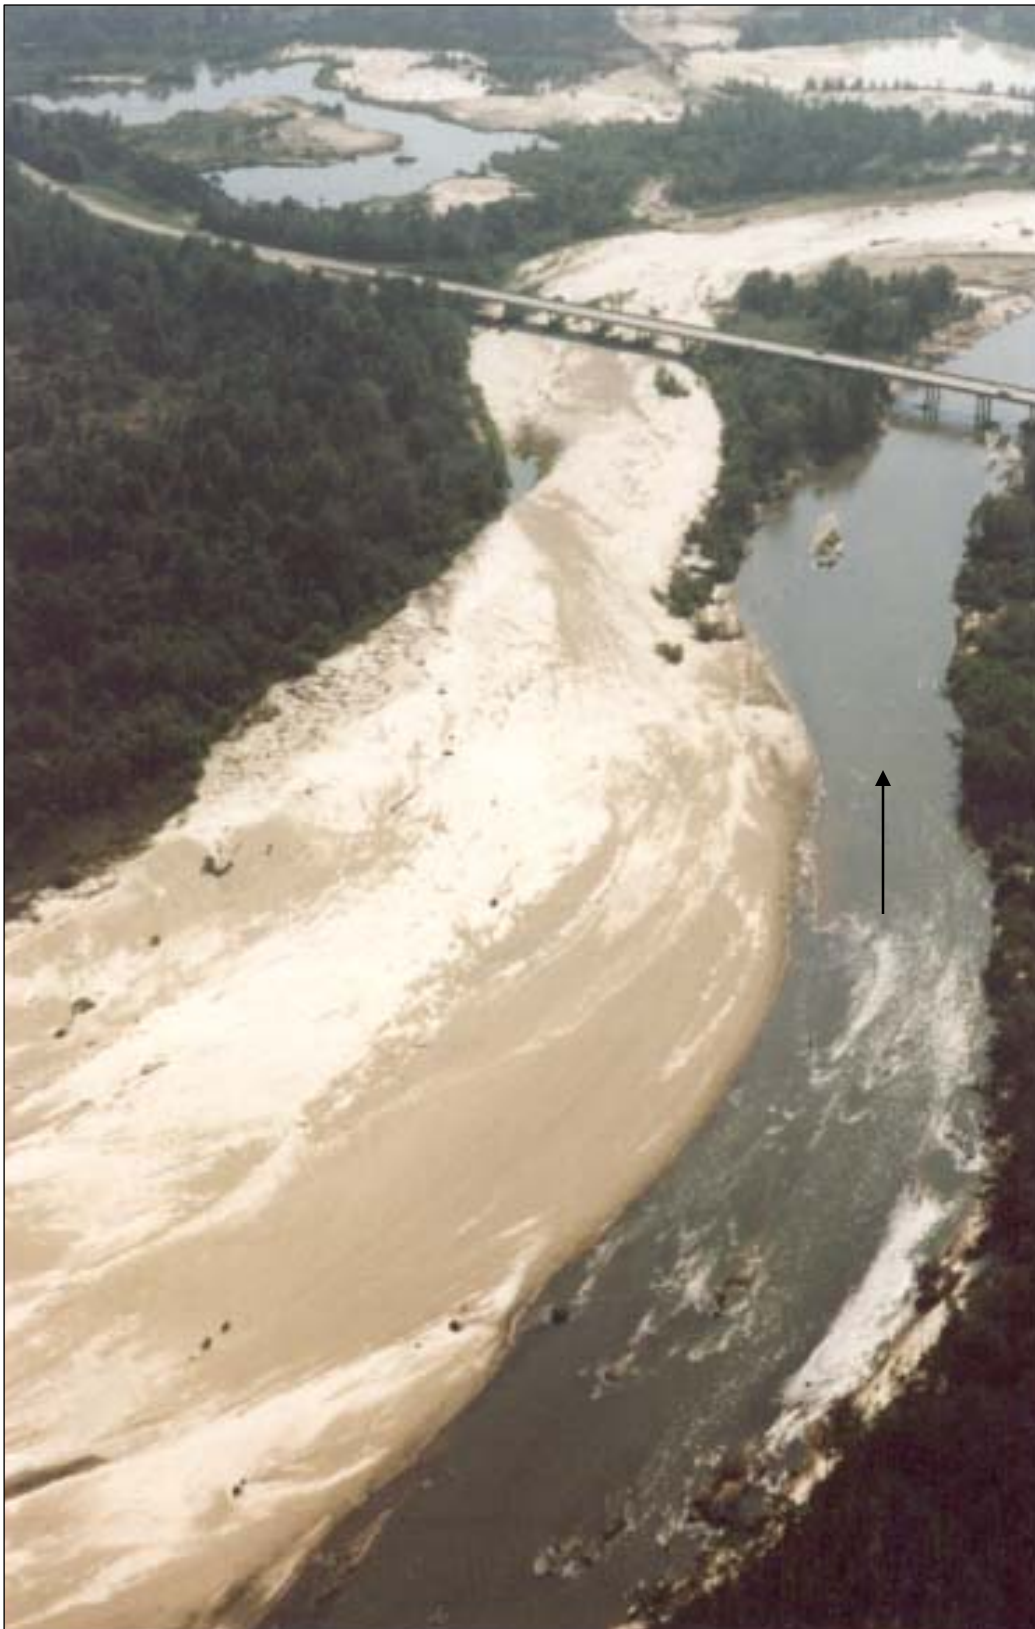
Figure 40. 1995 downstream view of the Amite River at the Louisiana Hwy 37 crossing near Grangeville, LA, showing abandoned riverbed (Meadows and Patrick 1999) (arrow notes flow direction).

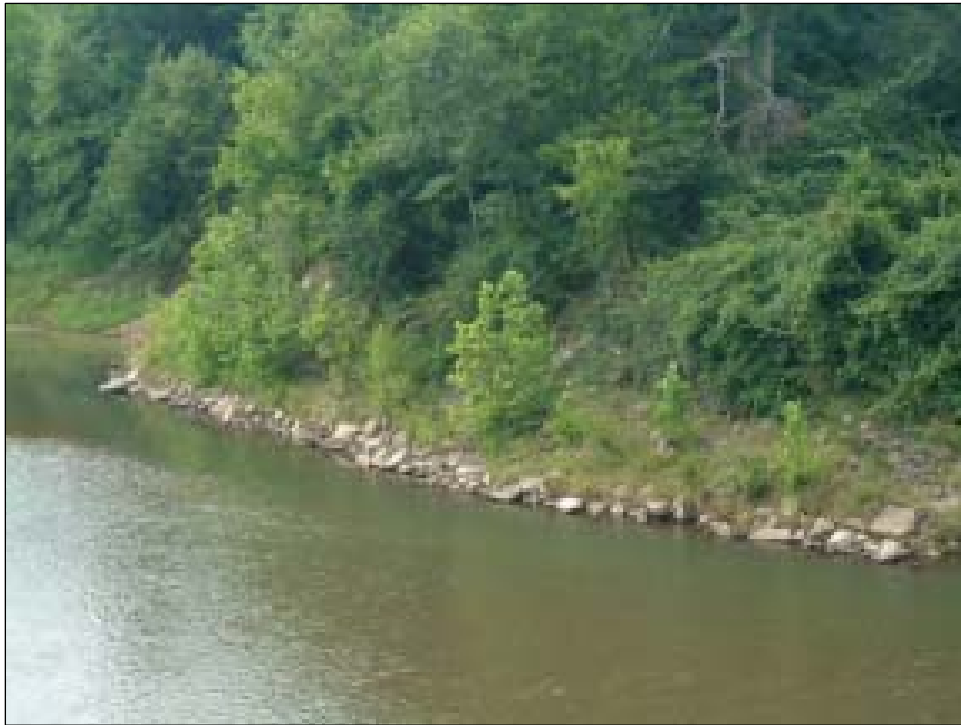
Figure 43. Riprap on the left bank of the Amite River at the Louisiana Hwy 37 crossing near Grangeville, LA (September 2003).

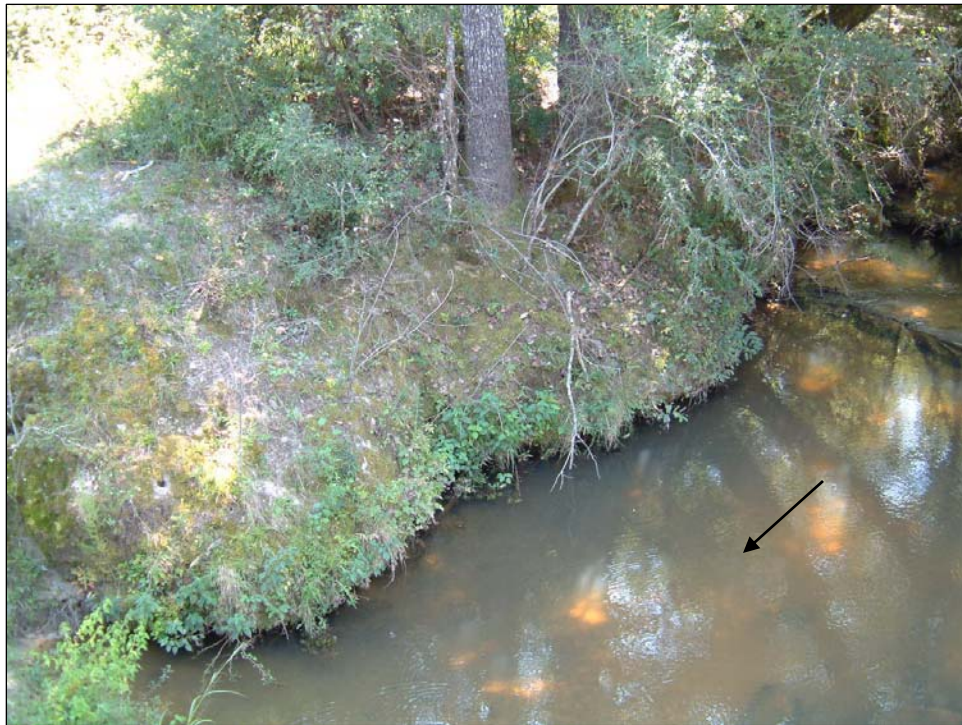
Figure 54. Undercutting of the right bank of Darling Creek at the Louisiana Hwy 38 crossing near Darlington, LA (view is upstream—September 2003) (arrow notes flow direction).

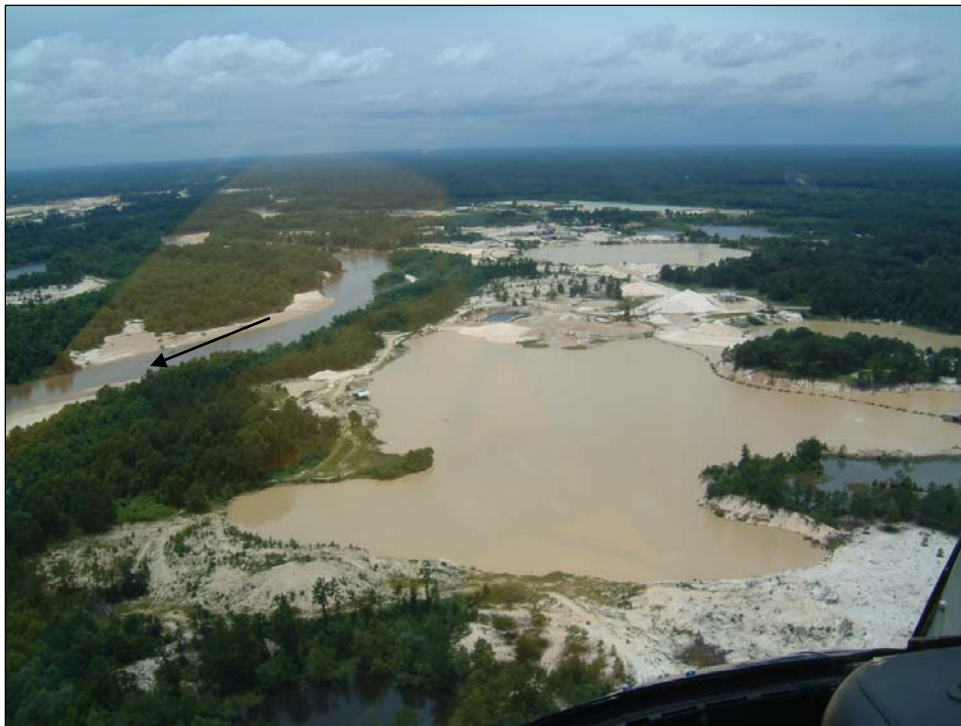
Figure 58. Large gravel mine on right bank of the Amite River near Magnolia, LA (arrow notes flow direction—July 2004).

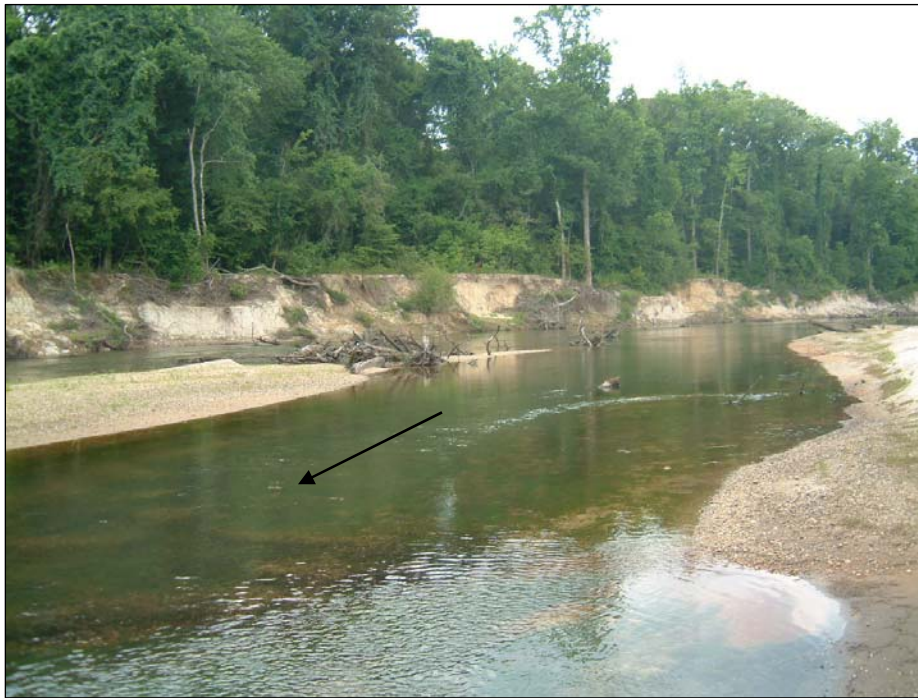
Figure 67. Upstream view of the Amite River adjacent to active gravel mine near Magnolia, LA (note steep, eroding banks and divided flow conditions—June 2003) (arrow notes flow direction).

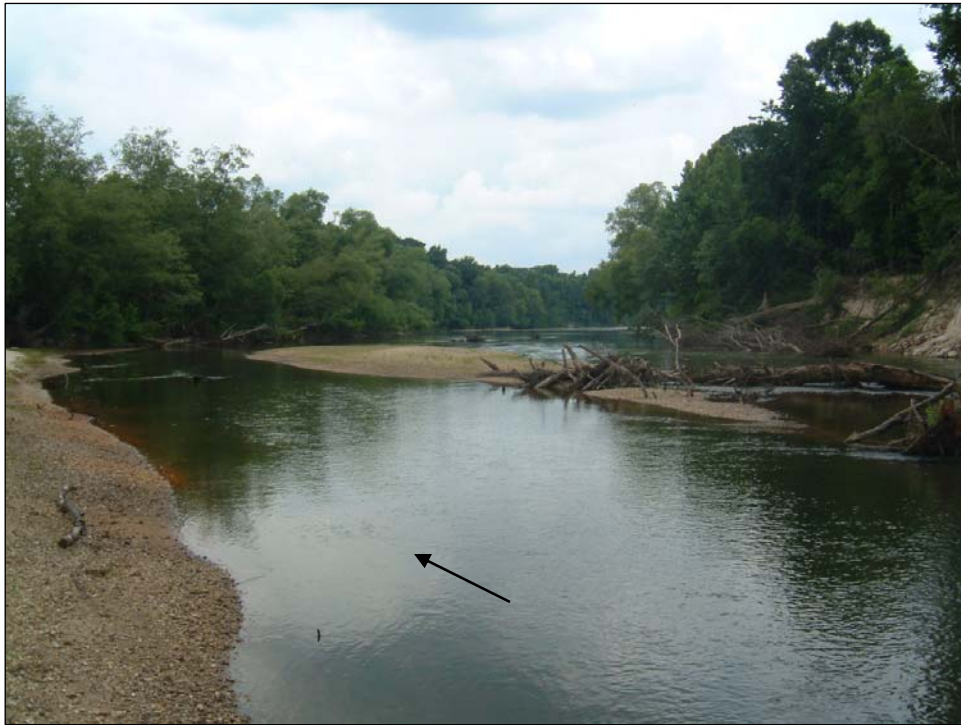
Figure 68. Downstream view of the Amite River adjacent to active gravel mine near Magnolia, LA (note divided flow conditions and debris in the channel—June 2003) (arrow notes flow direction).

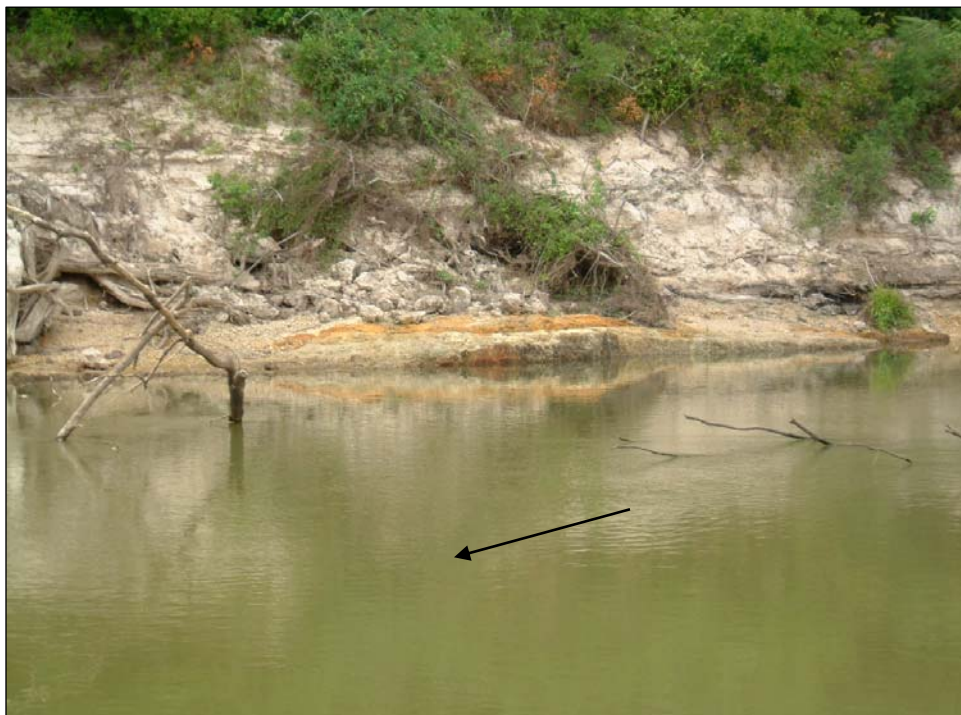
Figure 69. Steep, eroding right bank exhibiting a reddish-brown lens or zone near the waterline adjacent to active gravel mine near Magnolia, LA (arrow notes flow direction—June 2003).

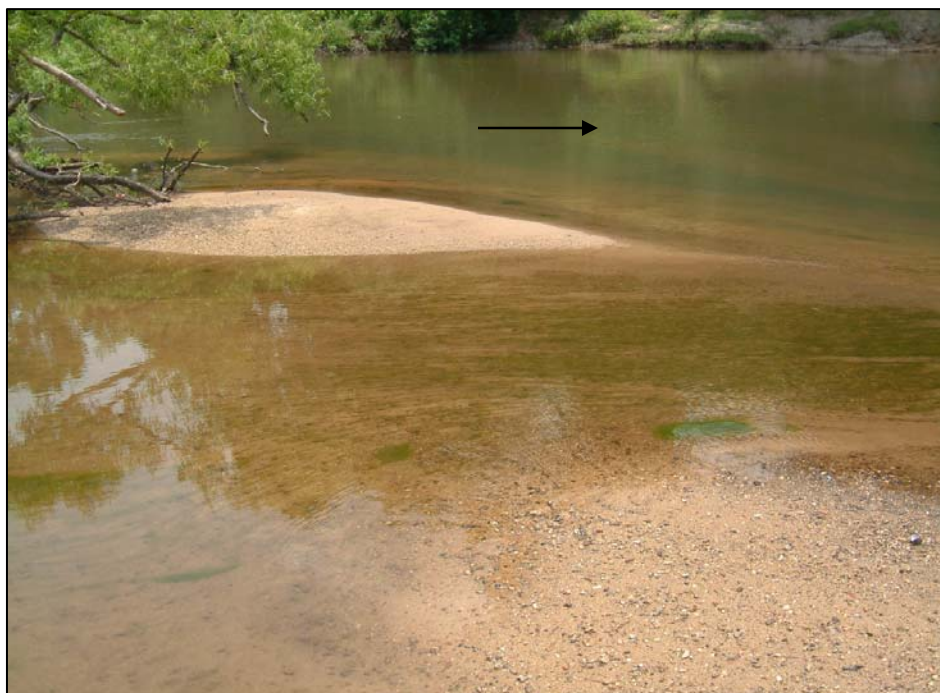
Figure 78. Sand and gravel bar in the Amite River channel at the Louisiana Hwy 64 crossing near Magnolia, LA (arrow notes flow direction—June 2003).

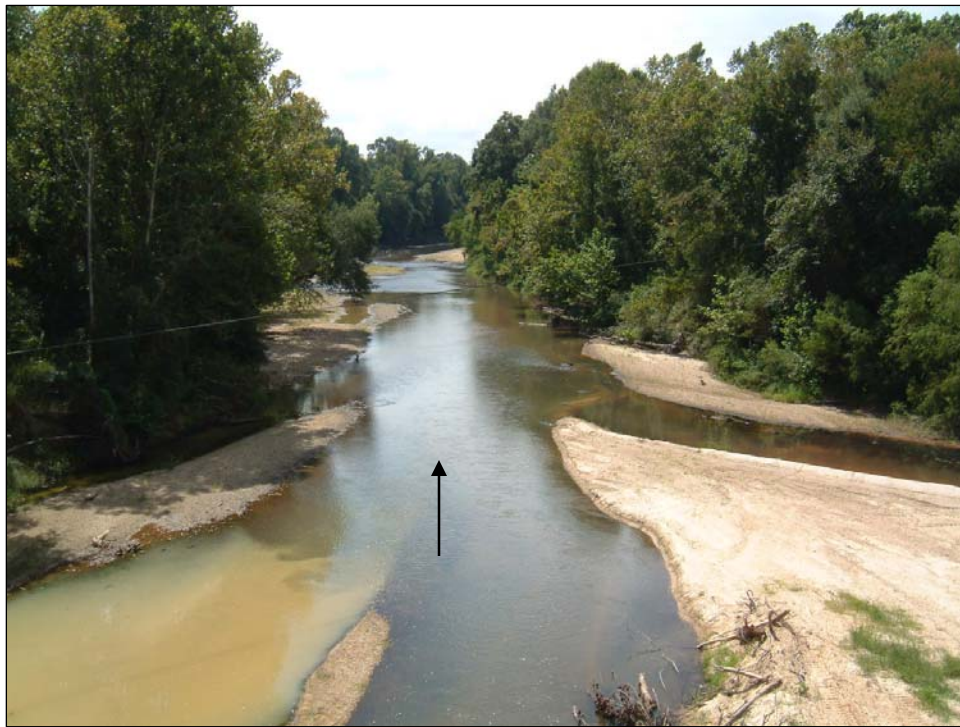
Figure 92. Downstream view of the Comite River at the Louisiana Hwy 67 crossing near Olive Branch, LA (note divided flow conditions—July 2004) (arrow notes flow direction).

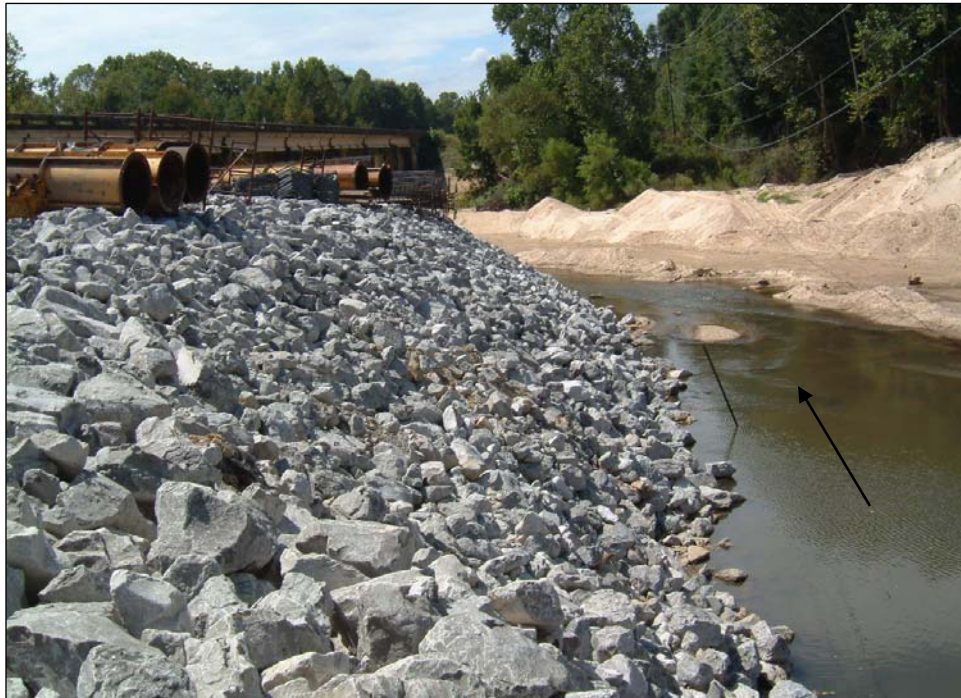
Figure 93. Newly installed riprap on the left bank of the Comite River at the Louisiana Hwy 67 crossing near Olive Branch, LA (downstream view—July 2004) (arrow notes flow direction).

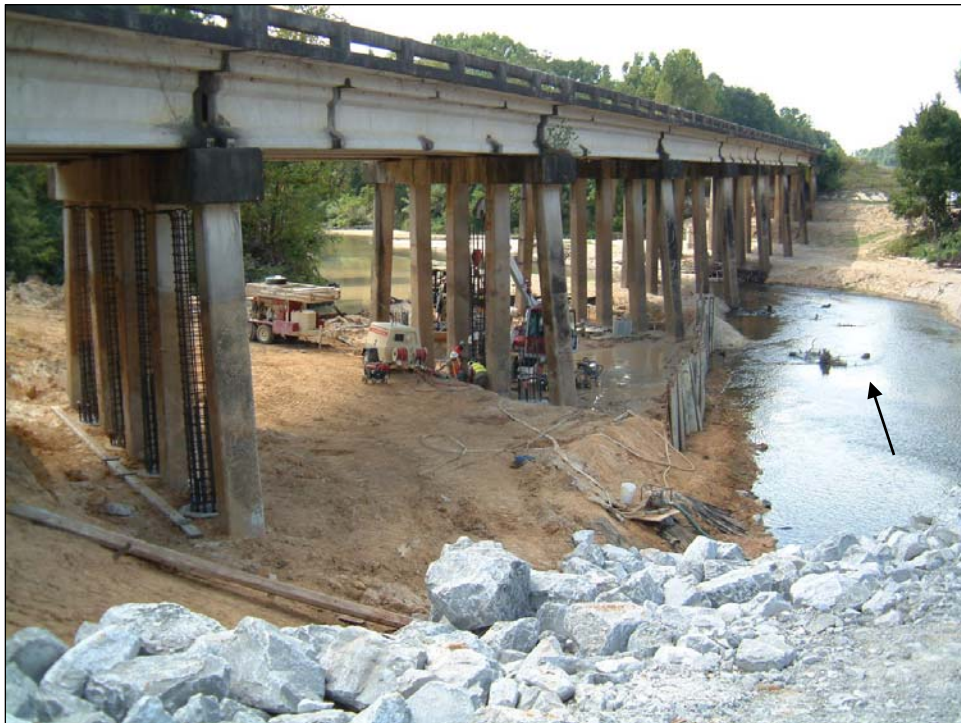
Figure 94. Bridge pier repair at the Louisiana Hwy 67 crossing of the Comite River near Olive Branch, LA (downstream view—July 2004) (arrow notes flow direction).
