MISCELLANEOUS PAPER SL-82-2

DURABILITY OF POST-TENSIONED CONCRETE BEAMS EXPOSED TO SEVERE NATURAL WEATHERING

Edward F. O'Neil

Final Report

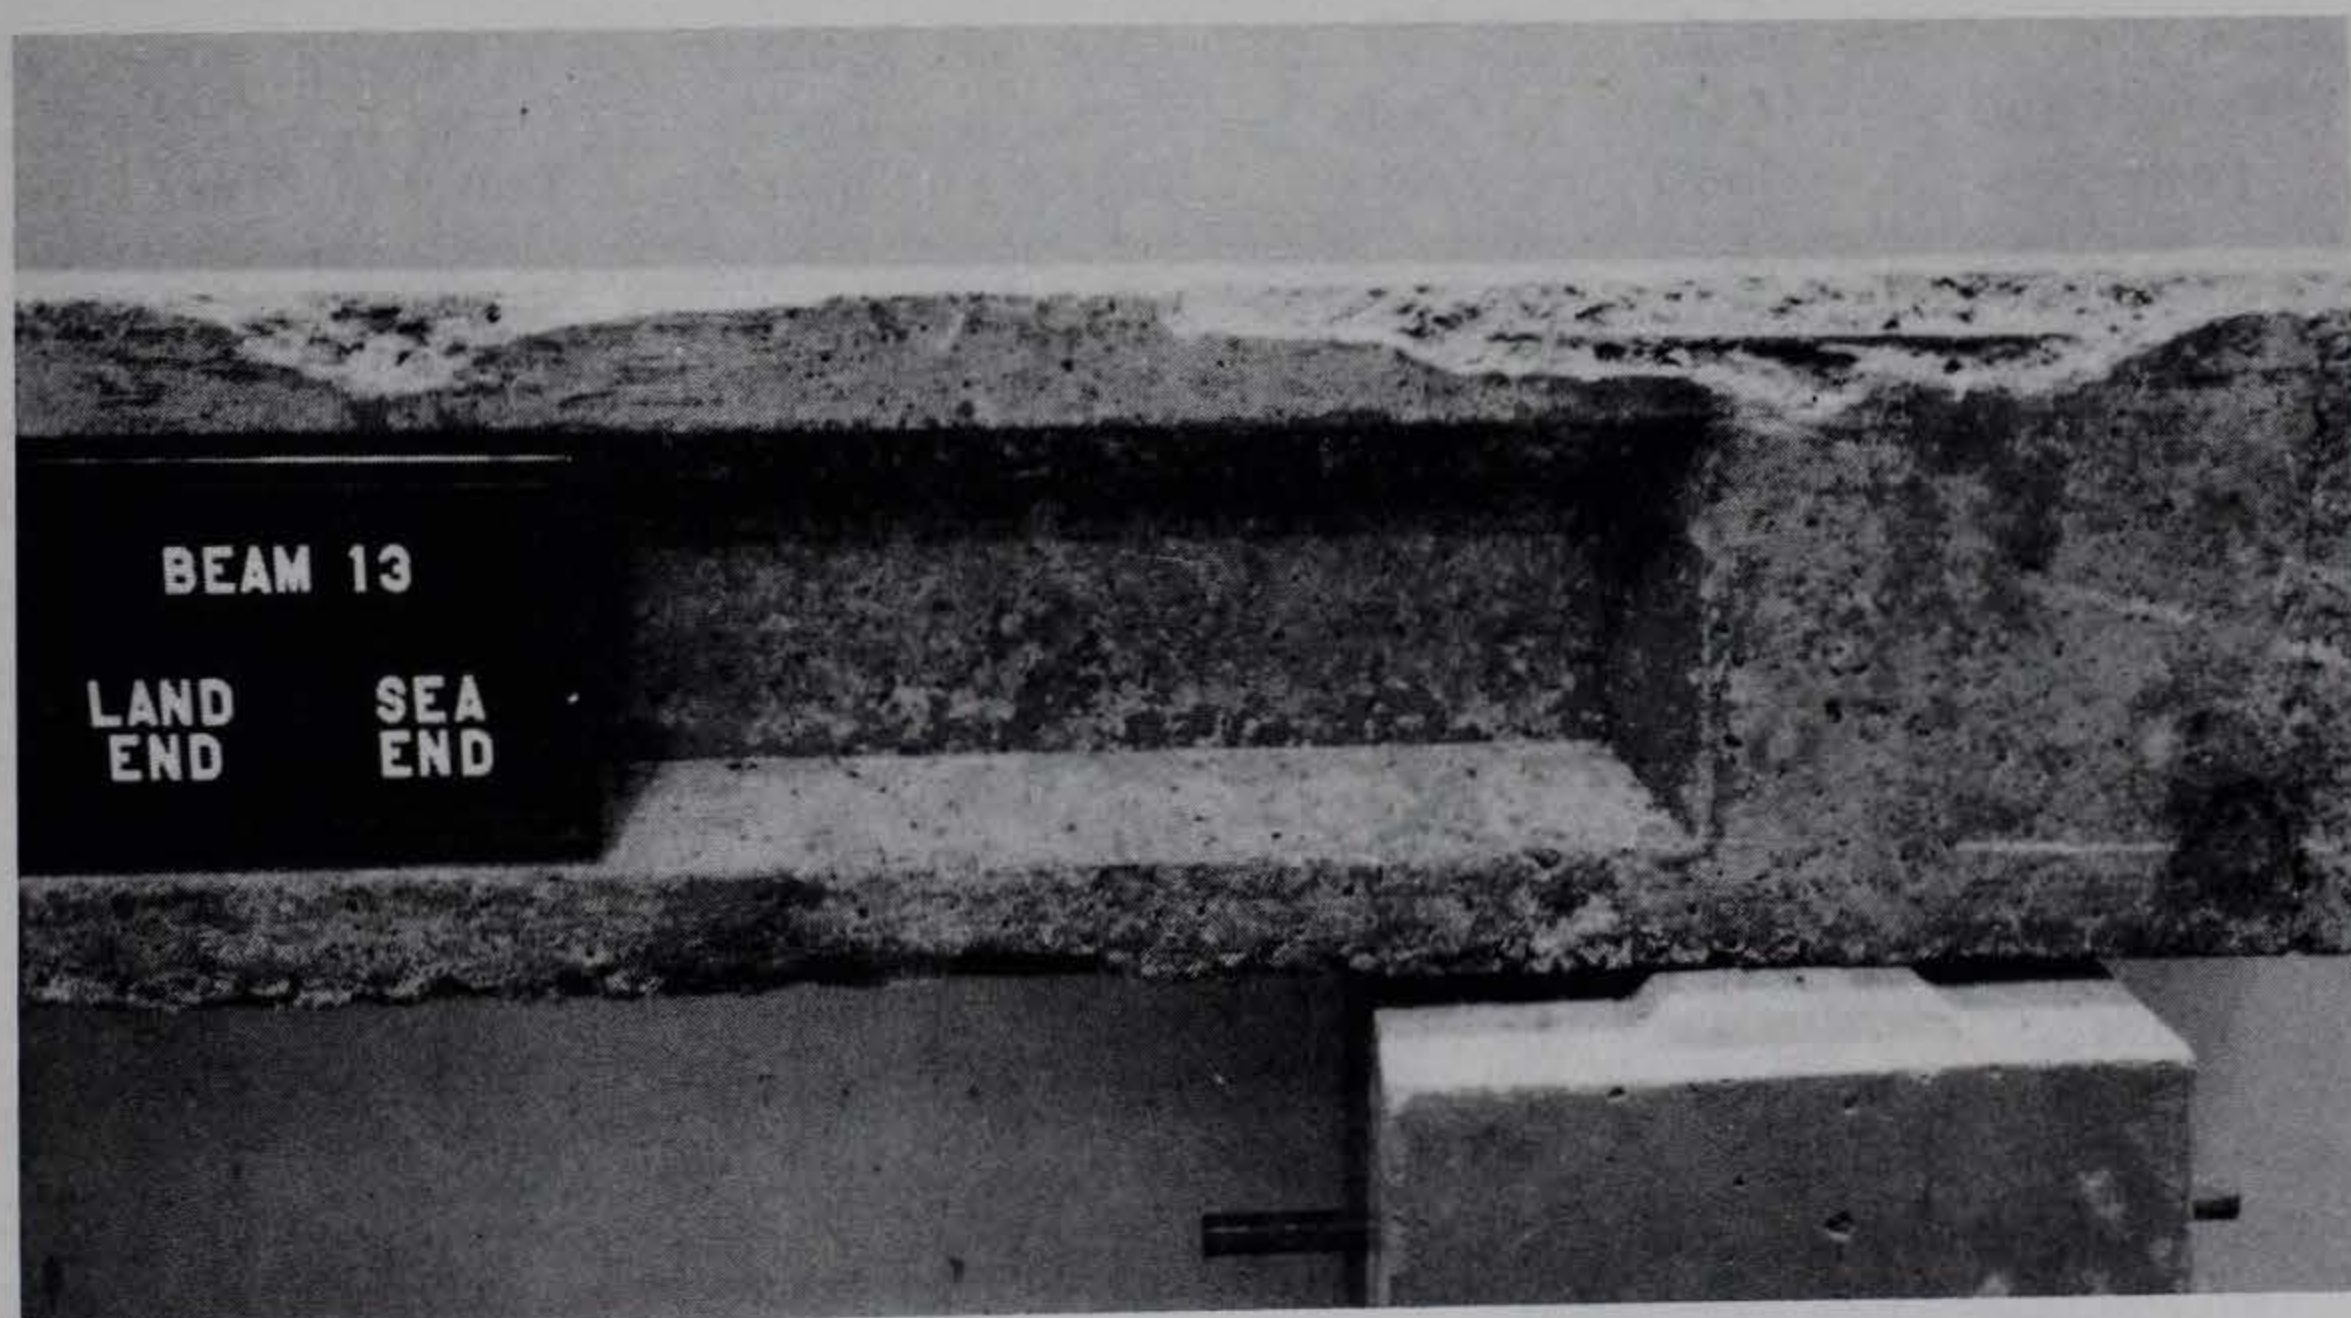
Condition of the Beams and Conventional Reinforcement—From the results of the annual visual inspection of the beams it was found that spalling and corrosion to the conventional reinforcement had begun after only 2 years. Observation of the beams when returned to the laboratory showed large areas of concrete spalled from the longitudinal reinforcement and the reinforcement that was exposed had corroded heavily. Figure 1 shows a typical beam with the heavy spalling adjacent to the longitudinal reinforcement. This photograph also shows the beam relatively unspalled in the area where the stirrups are located. When the beams were broken open and the reinforcement cage removed it was found that the stirrups were relatively uncorroded.

The heavy spalling to the concrete surrounding the conventional, longitudinal reinforcement was caused by penetration of oxygen and salt water to the level of the steel and a chloride concentration at that level sufficient to destroy the passivating oxide coating on the steel. This condition caused rusting of the steel and tensile stresses in the concrete from the buildup of rust products sufficient to spall the concrete from the beam. This condition confirms the fact that a 19-mm cover of concrete over conventional reinforcement is insufficient to protect the steel in a severe weathering

FIG. 1—Condition of spalling and corrosion to the reinforcement of Beam 13.

atmosphere. It is believed that the stirrups remained relatively free from corrosion due to their becoming cathodic in relation to the corroding longitudinal steel. This, coupled with the fact that the longitudinal steel was located in the corners of the beam and susceptible to penetration of oxygen and moisture from two surfaces rather than just one in the case of the stirrups, caused the stirrups to receive smaller amounts of corrosion.

The heavy spalling to the concrete and corrosion to the conventional reinforcement confirms the fact that 19 mm of cover is not sufficient to protect steel reinforcement from corrosion in a severe weathering environment.

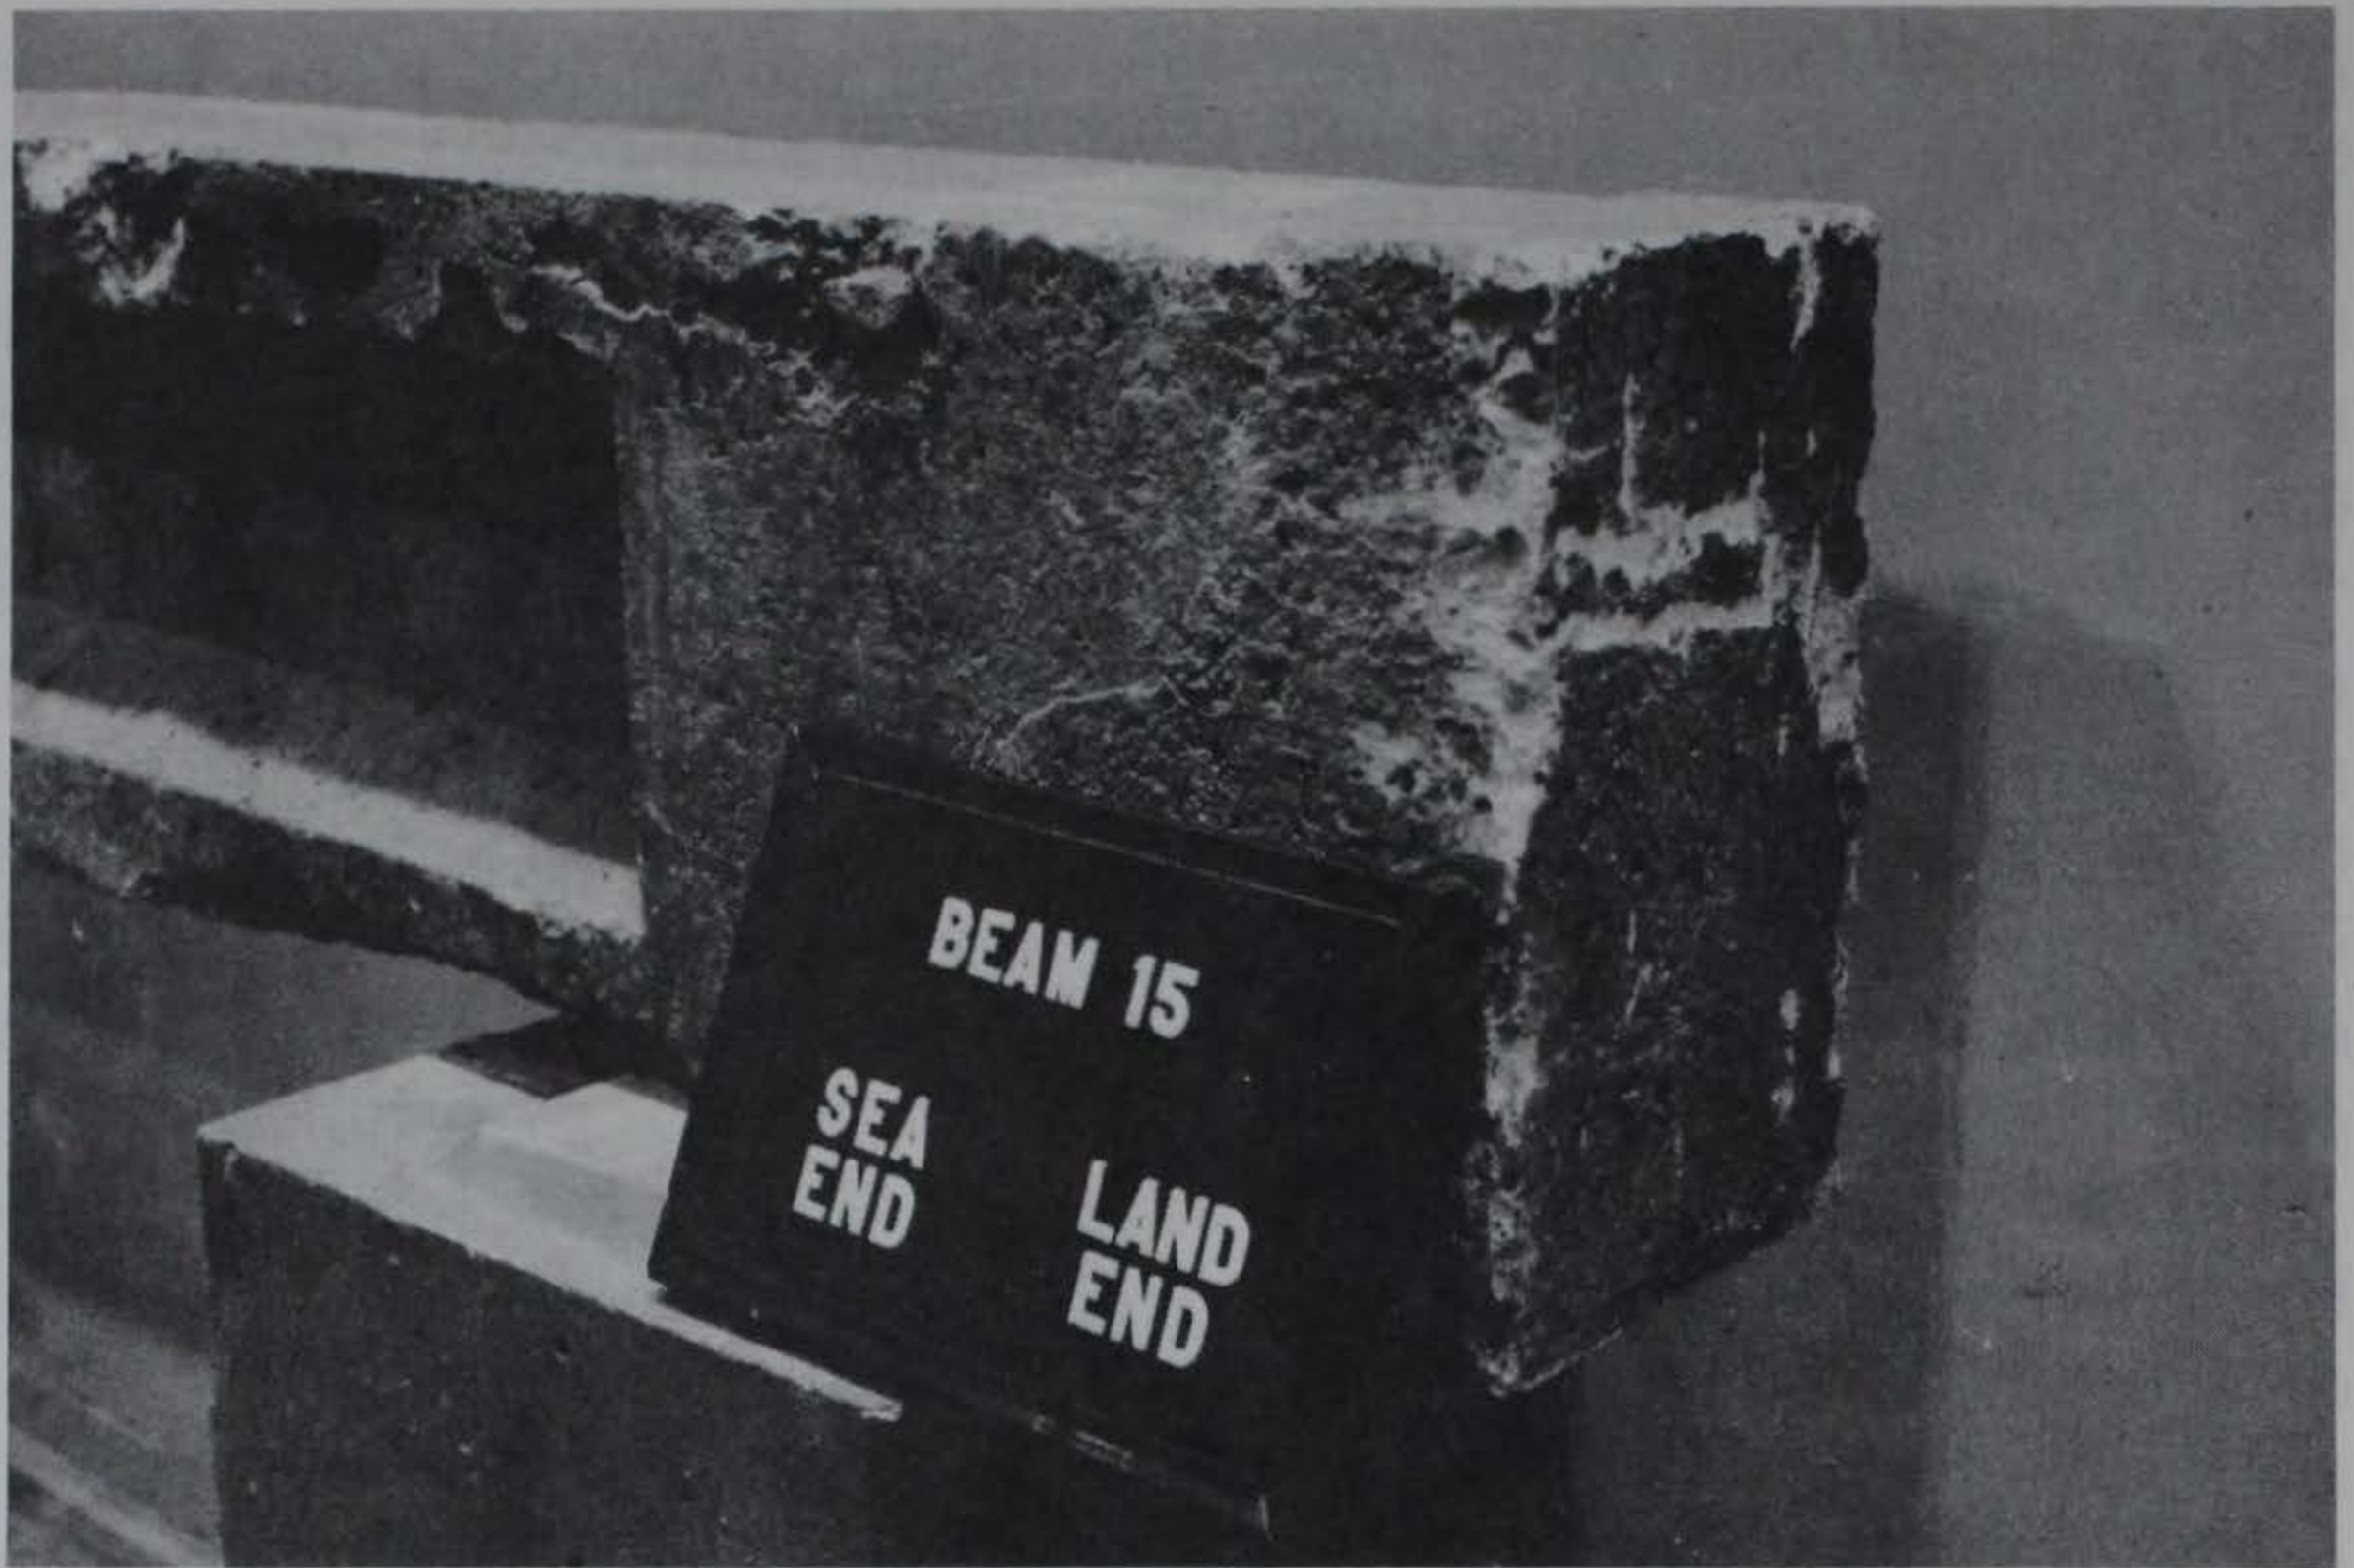
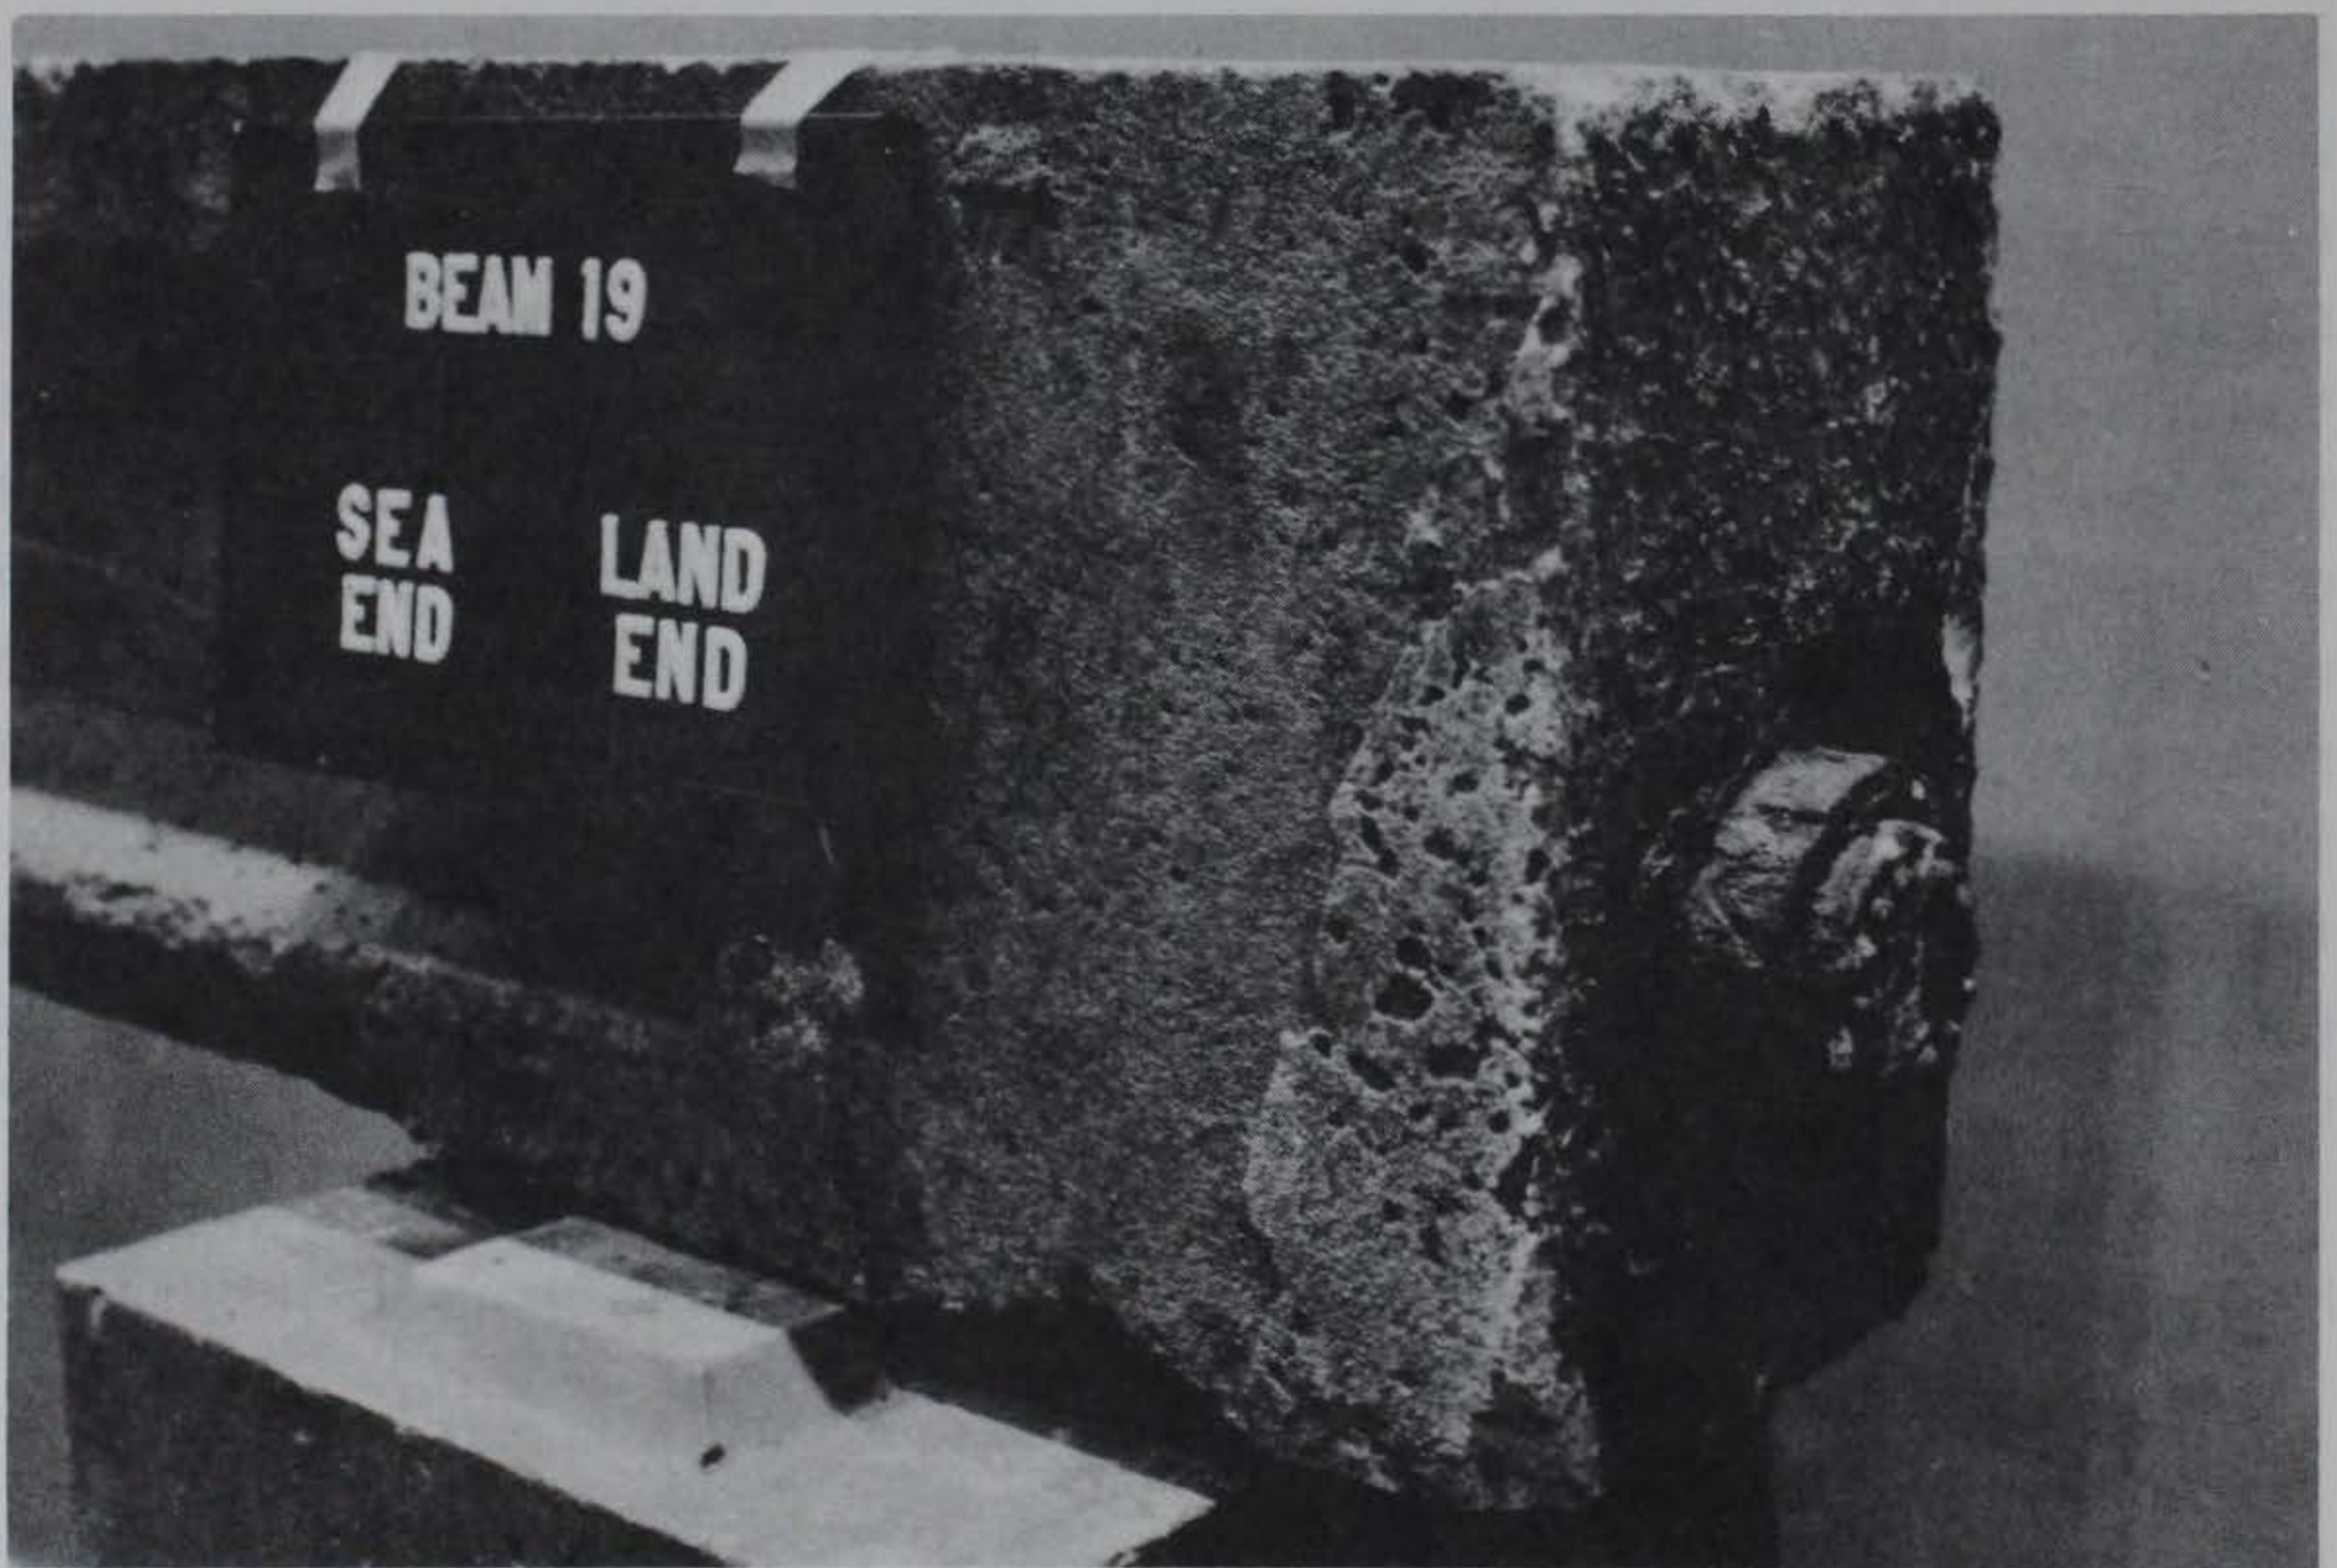
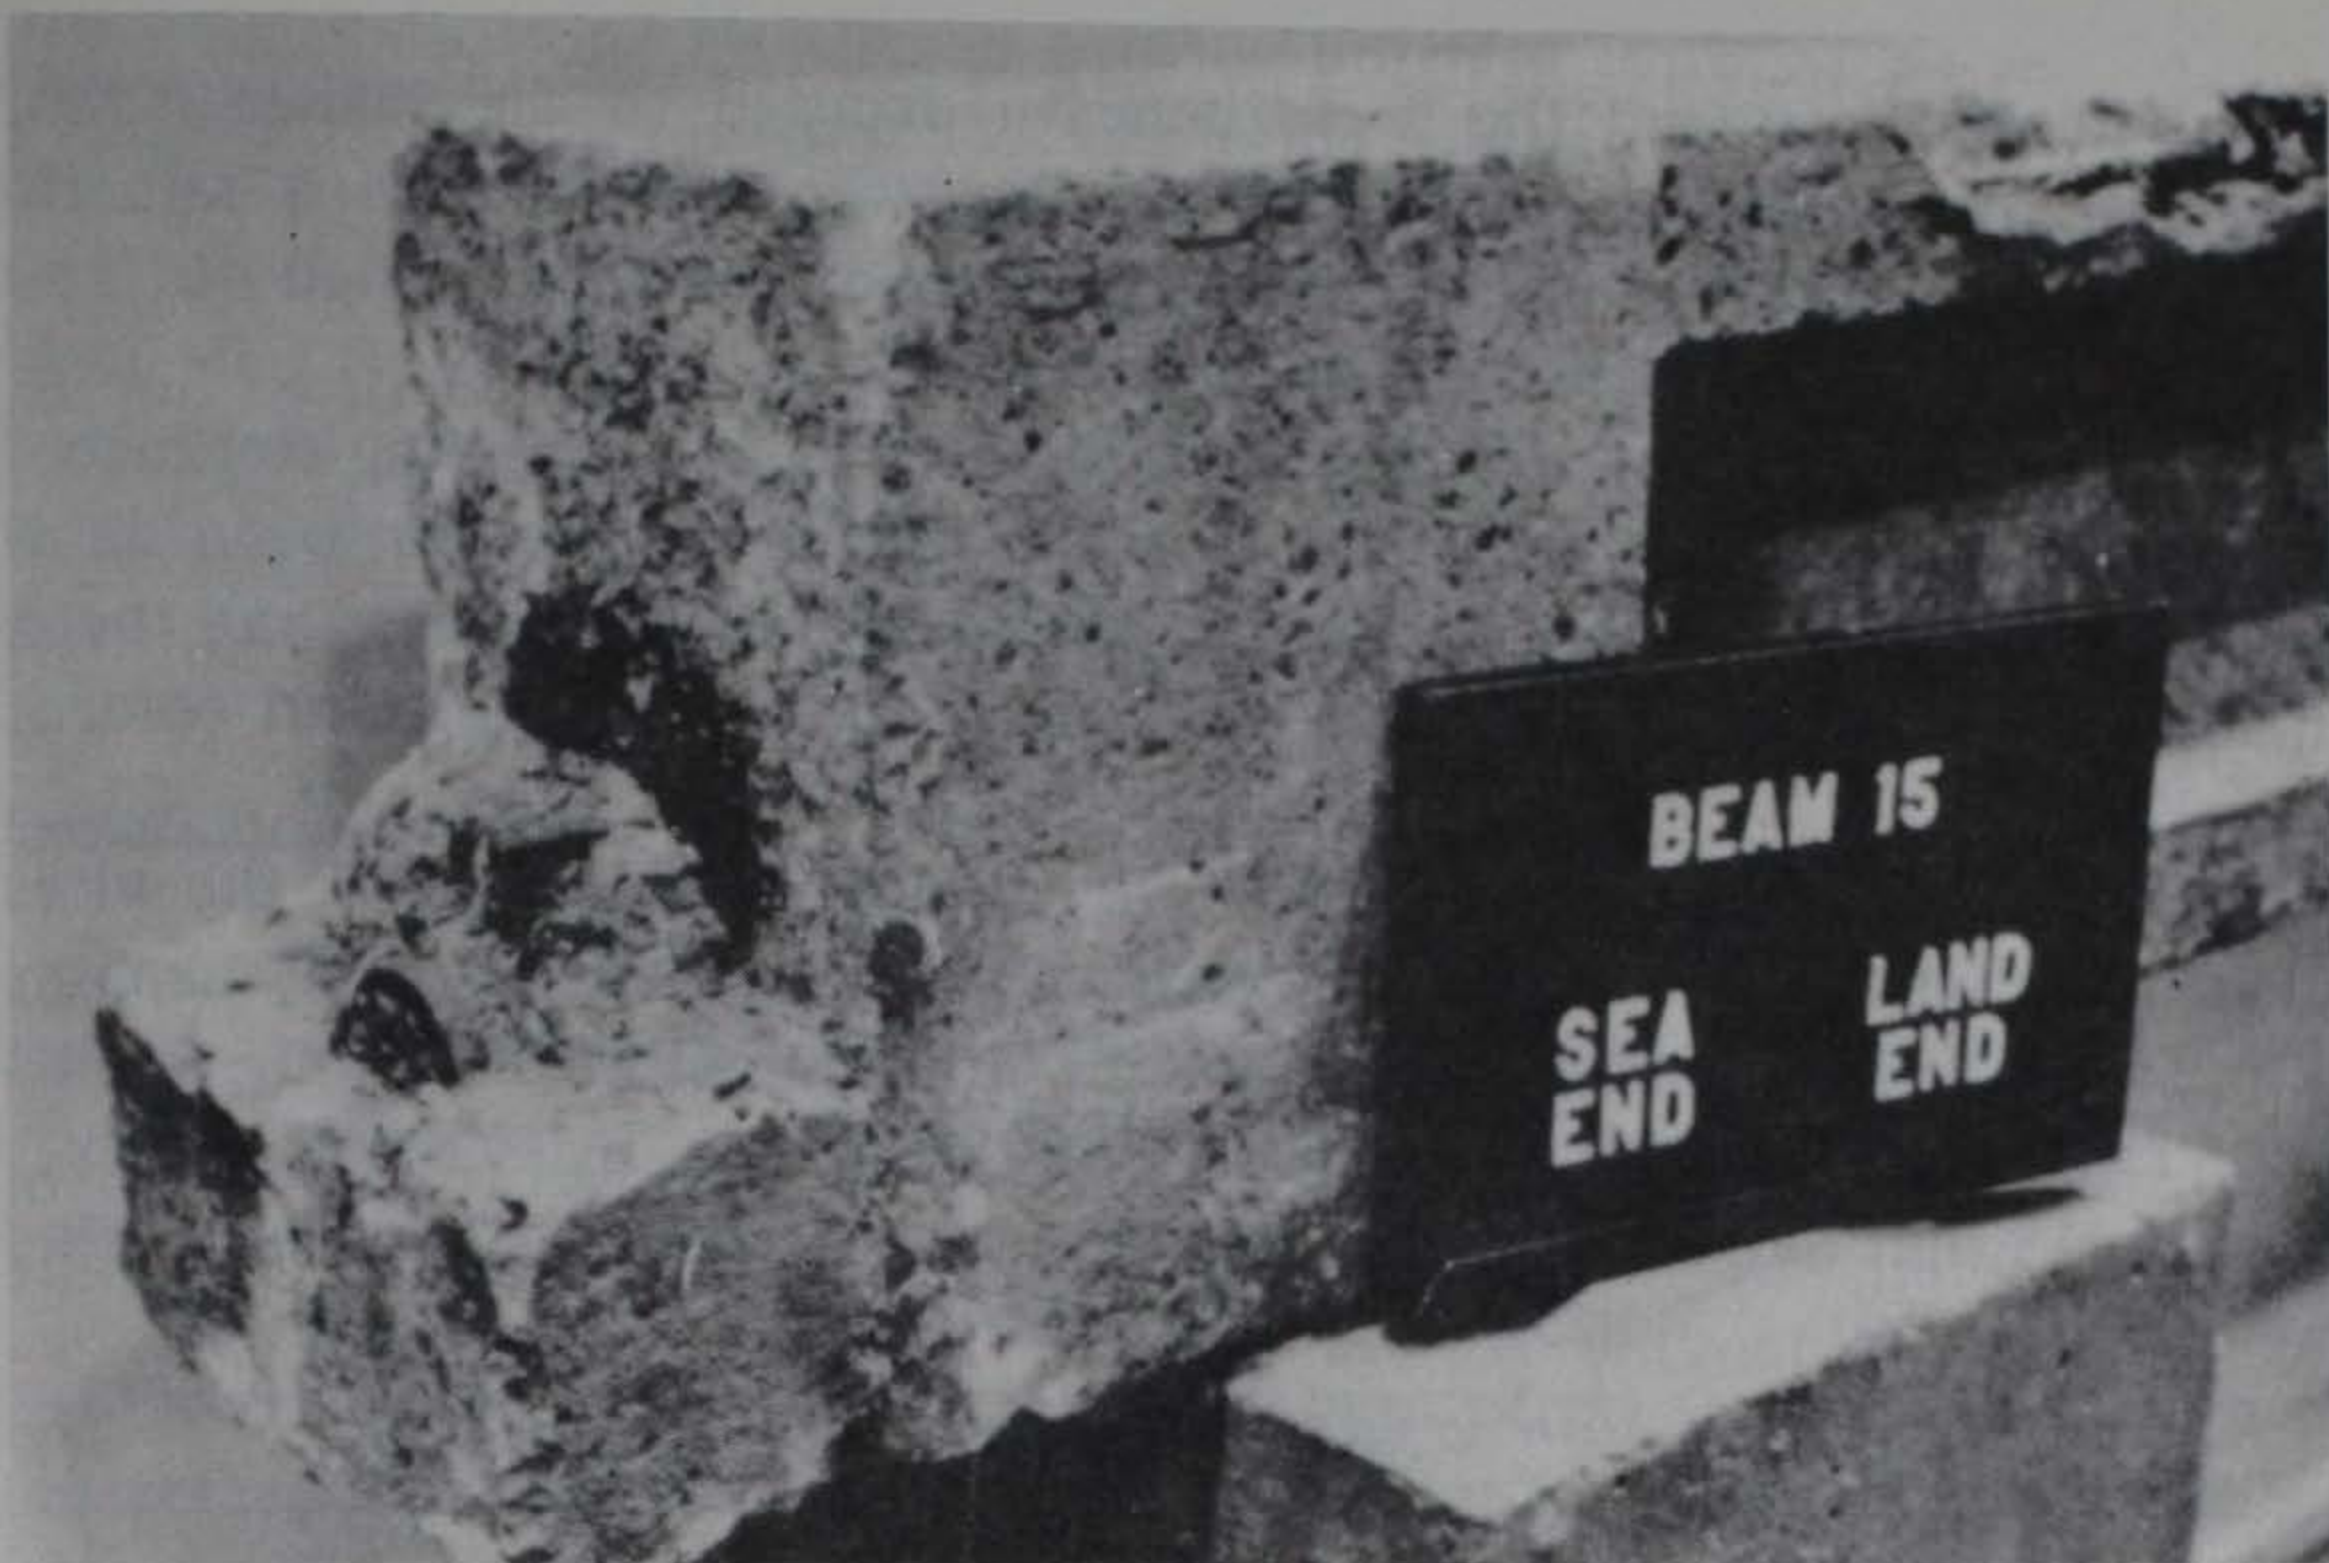
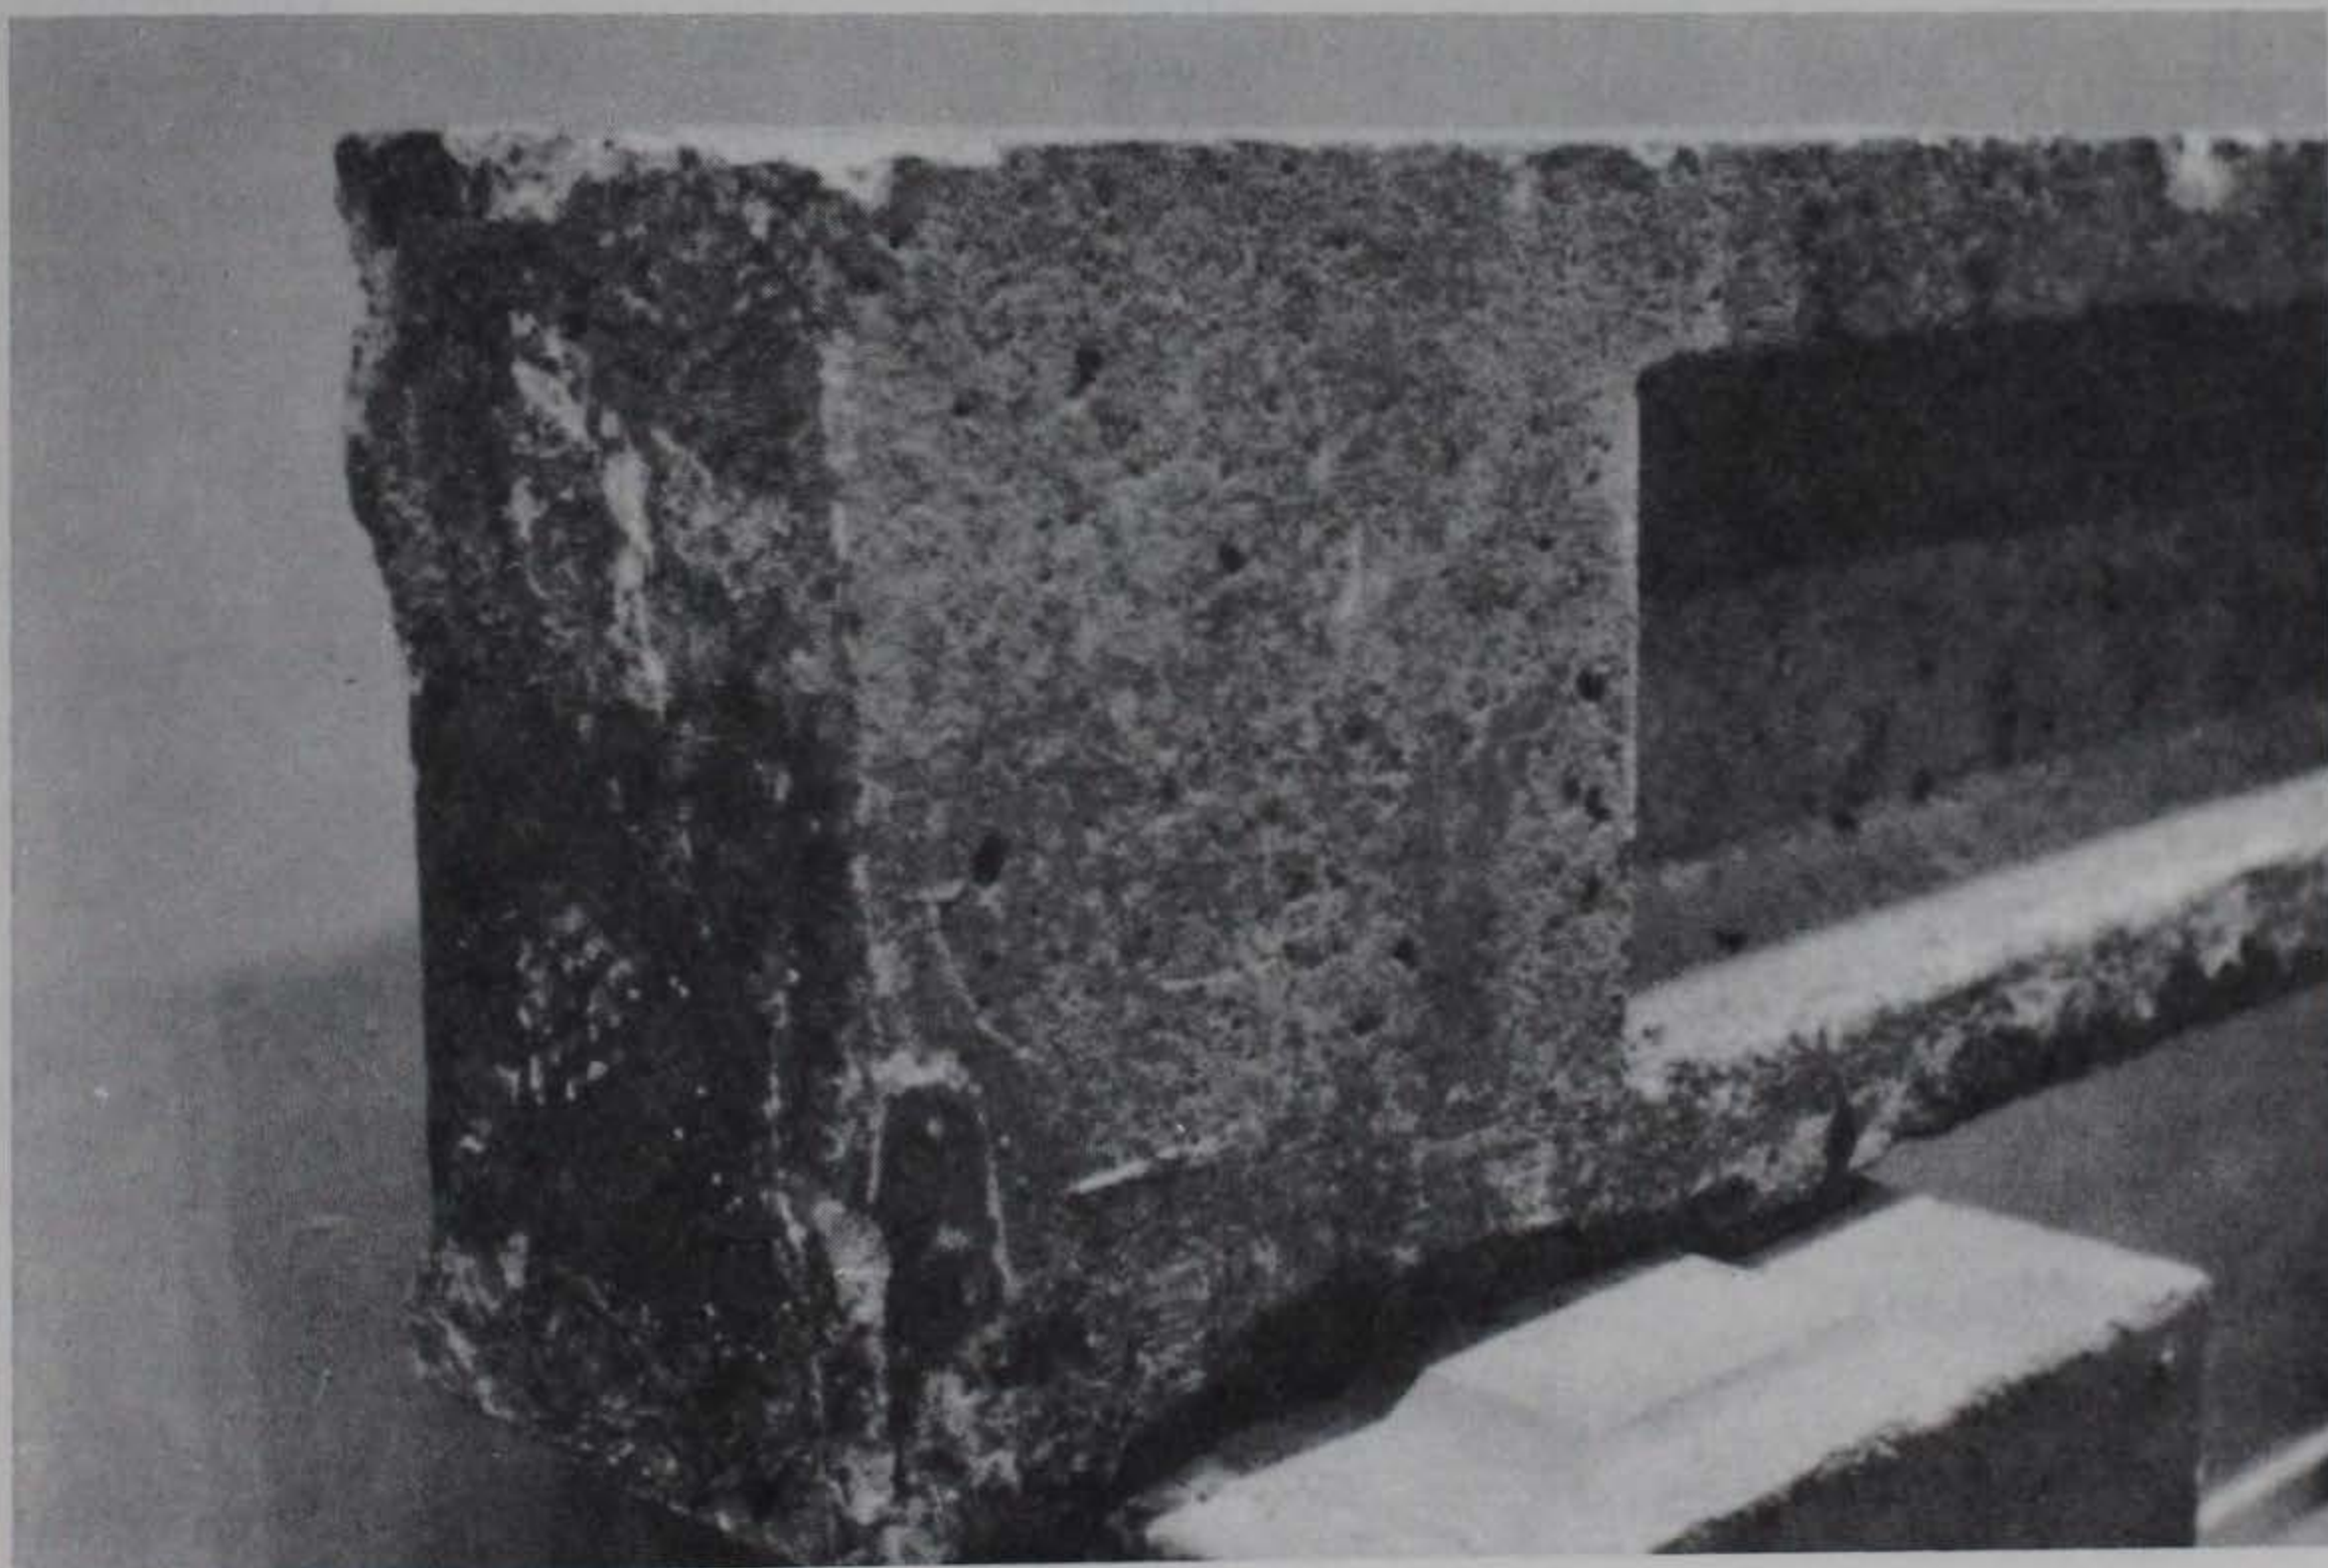
There did seem to be a correlation between the ability of an end cap to resist the forces of freezing and thawing and the sizes of the end anchor. Figure 2 shows the as-received condition of four of the end caps on Beams 15 and 19. The anchorages of Beam 19 were flat compared to those of Beam 15 and both the caps of Beam 19 were missing when returned to the laboratory. All the anchorages that had lost their end caps in this investigation were shallow in depth. In other words, the deeper an end anchorage is, the better its end cap will remain attached throughout any exposure period. This does not mean that the end anchorage will be well protected; however, if the end cap does pry loose, it has been determined that greater corrosion will occur on the steel. In this respect the depth of the end anchorages acted as reinforcement similar to the beams that had reinforcing bars running between the beam itself and the cap over the anchorage. Of the 40 joints on the 20 beams of the study, twelve had reinforcement between the beam and cap and none of these caps pried loose or cracked during the 12 to 13 years of exposure.

FIG. 2—Typical conditions of the end anchorage protection as returned from the exposure site.

FIG. 2—Continued.

There is no correlation between method of beam end preparation and condition of the anchorage of the beam, however, as concerns the use of end caps, end anchorages that had substantial depth acted as reinforcement to hold the end cap in place.
