TECHNICAL REPORT SL-83-6

AN EVALUATION OF THE SEPARATED BAY CONCEPT FOR A MUNITION ASSEMBLY COMPLEX; AN EXPERIMENTAL INVESTIGATION OF THE DEPARTMENT OF ENERGY BUILDING 12-64 COMPLEX

Robert D. Volz, Sam A. Kiger

September 1983

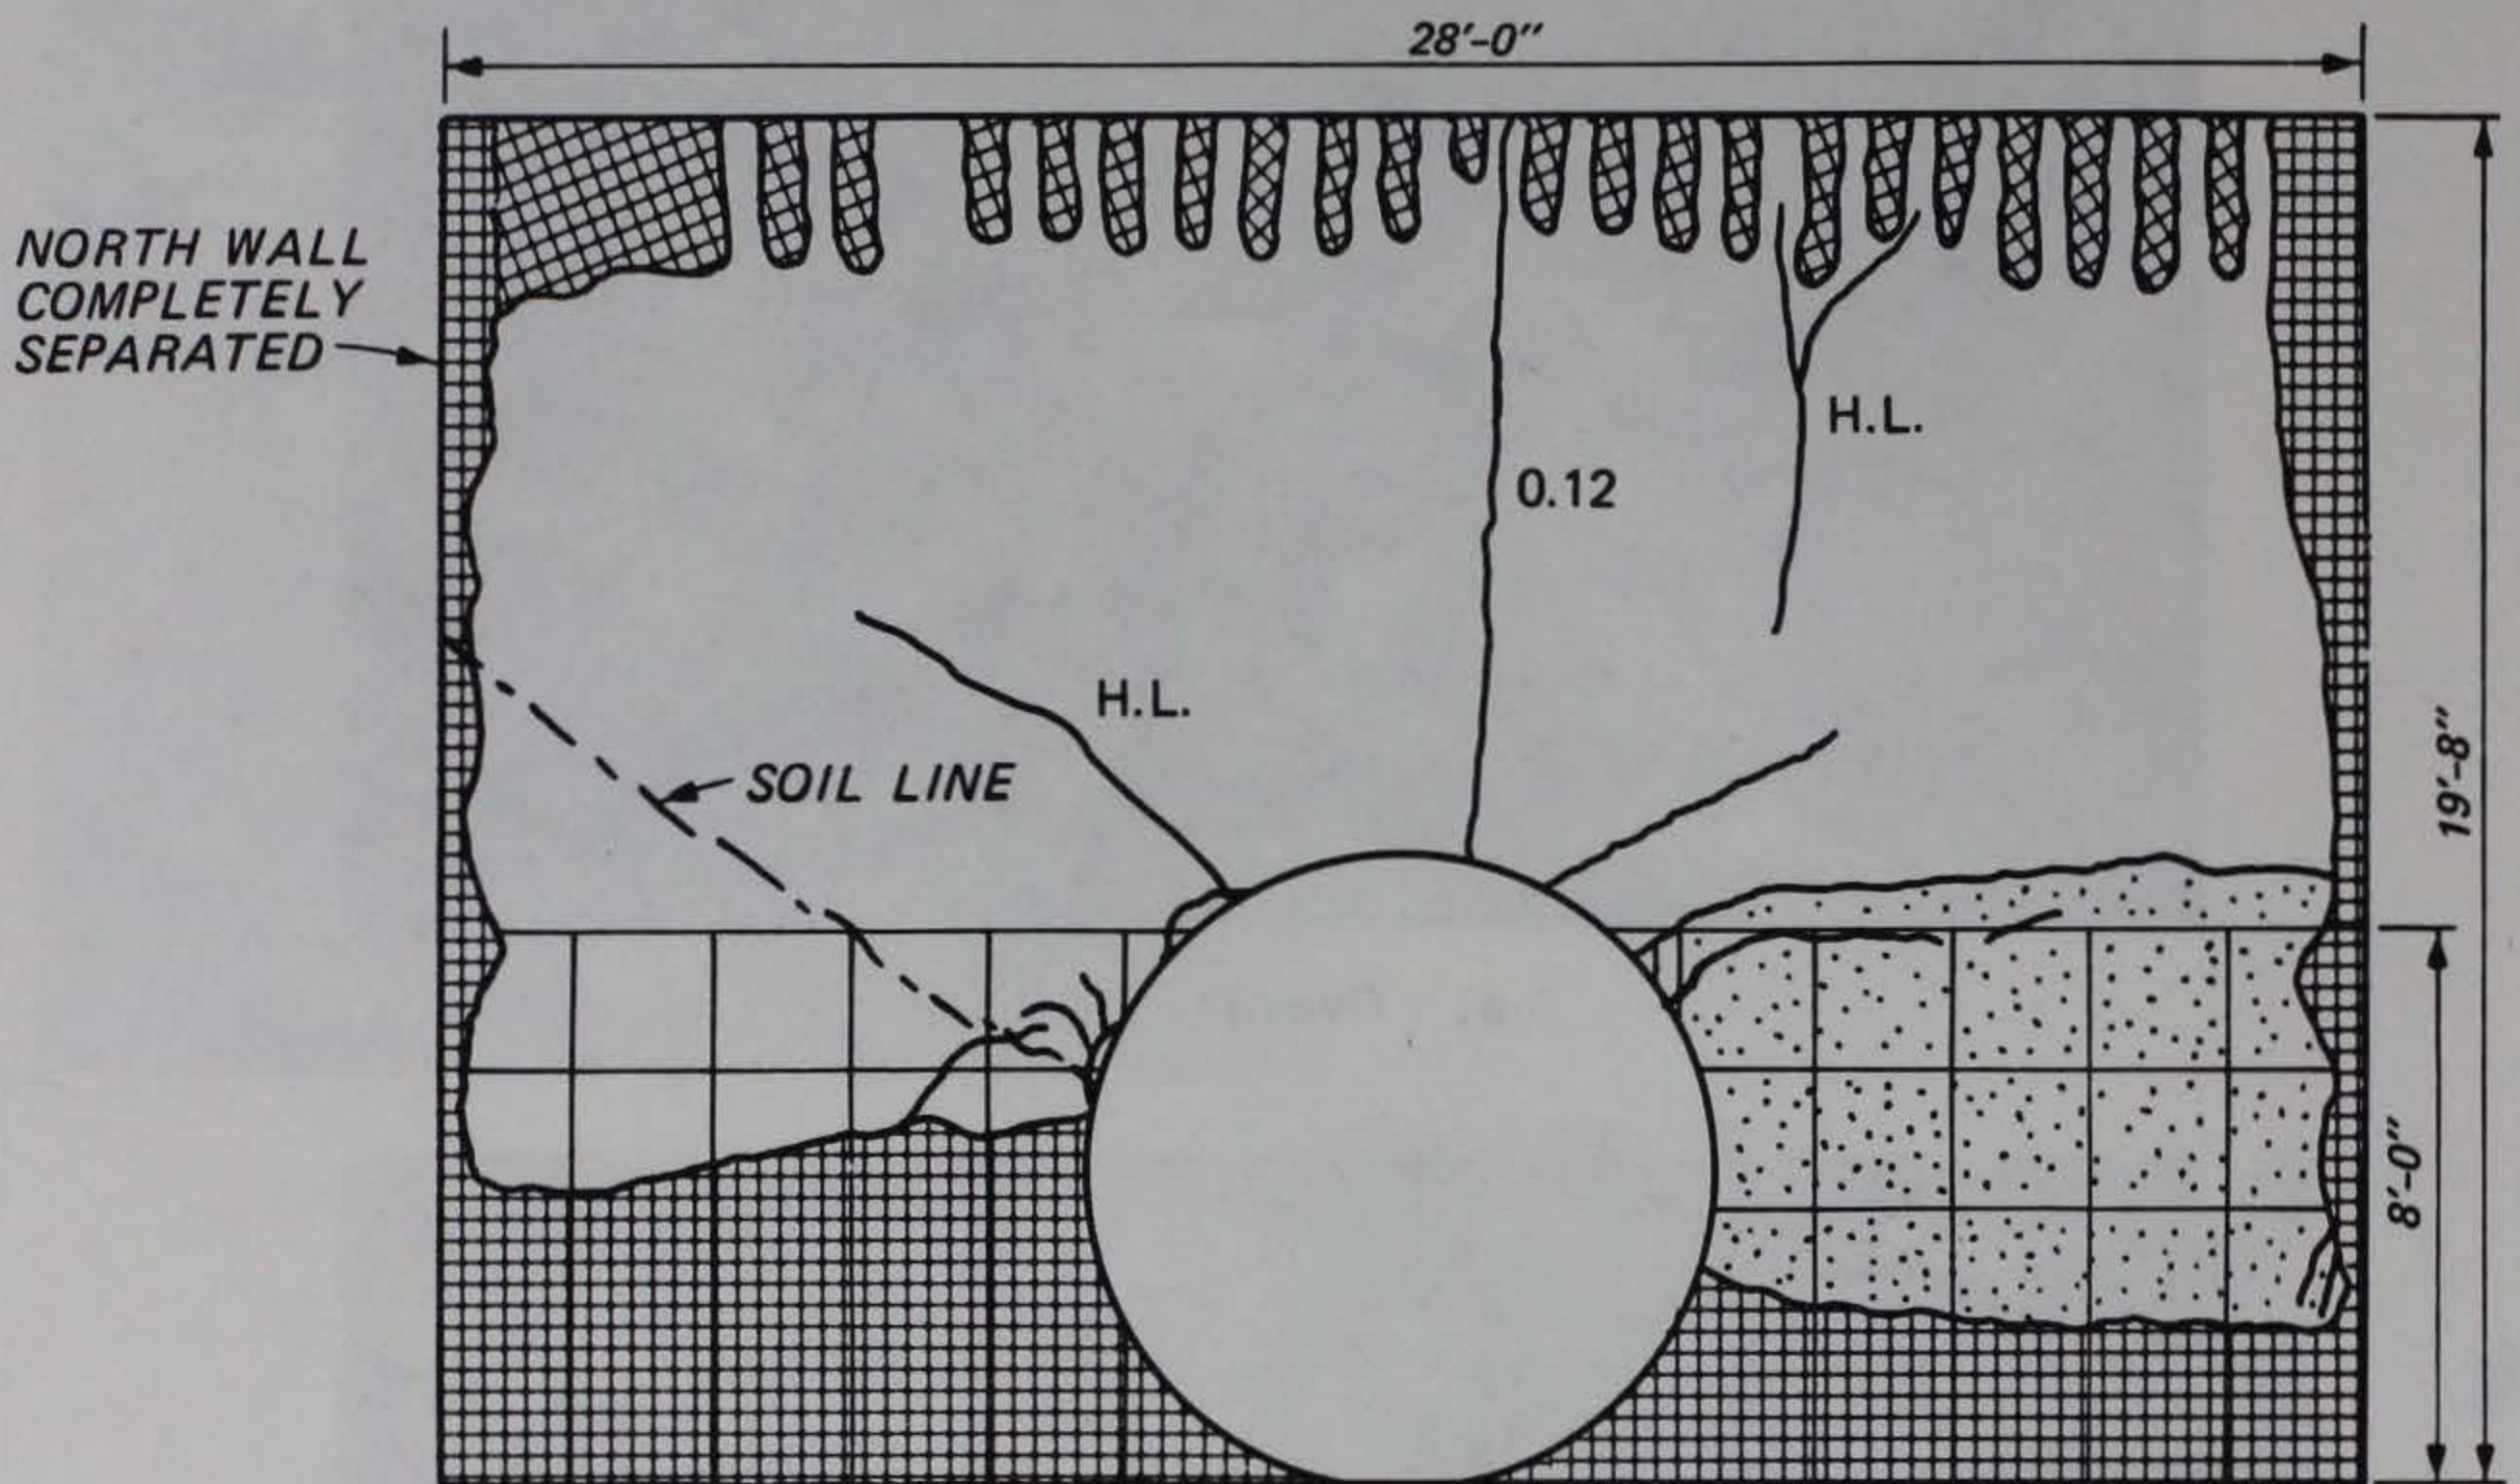
Figure 4.13. Posttest damage to east donor bay wall.

A pictorial view of the east wall is shown in Figure 4.12. Damage to the wall is identified in Figure 4.13. The top of the wall was rotated away from the center of the bay producing posttest angular displacements ranging from 5.4 deg at the north side to 11.1 deg at the base of the south side. This rotation is evident in Figure 4.12a and caused the inner face reinforcing steel mat to separate from the floor dowels as shown in Figure 4.12b. The inward displacement of the No. 9 vertical rebar was 8.75 in. where the photograph in the figure was taken. The concrete covering these bars was separated from the wall to an elevation of approximately 8.5 ft from the floor. One major vertical crack ran from near the crest of the entrance pipe to the top of the wall.

SIX #5 DOWELS REMAINED IN TOP OF WALL

REBAR PULLED OUT OF CONCRETE
- H.L. HAIRLINE CRACKS

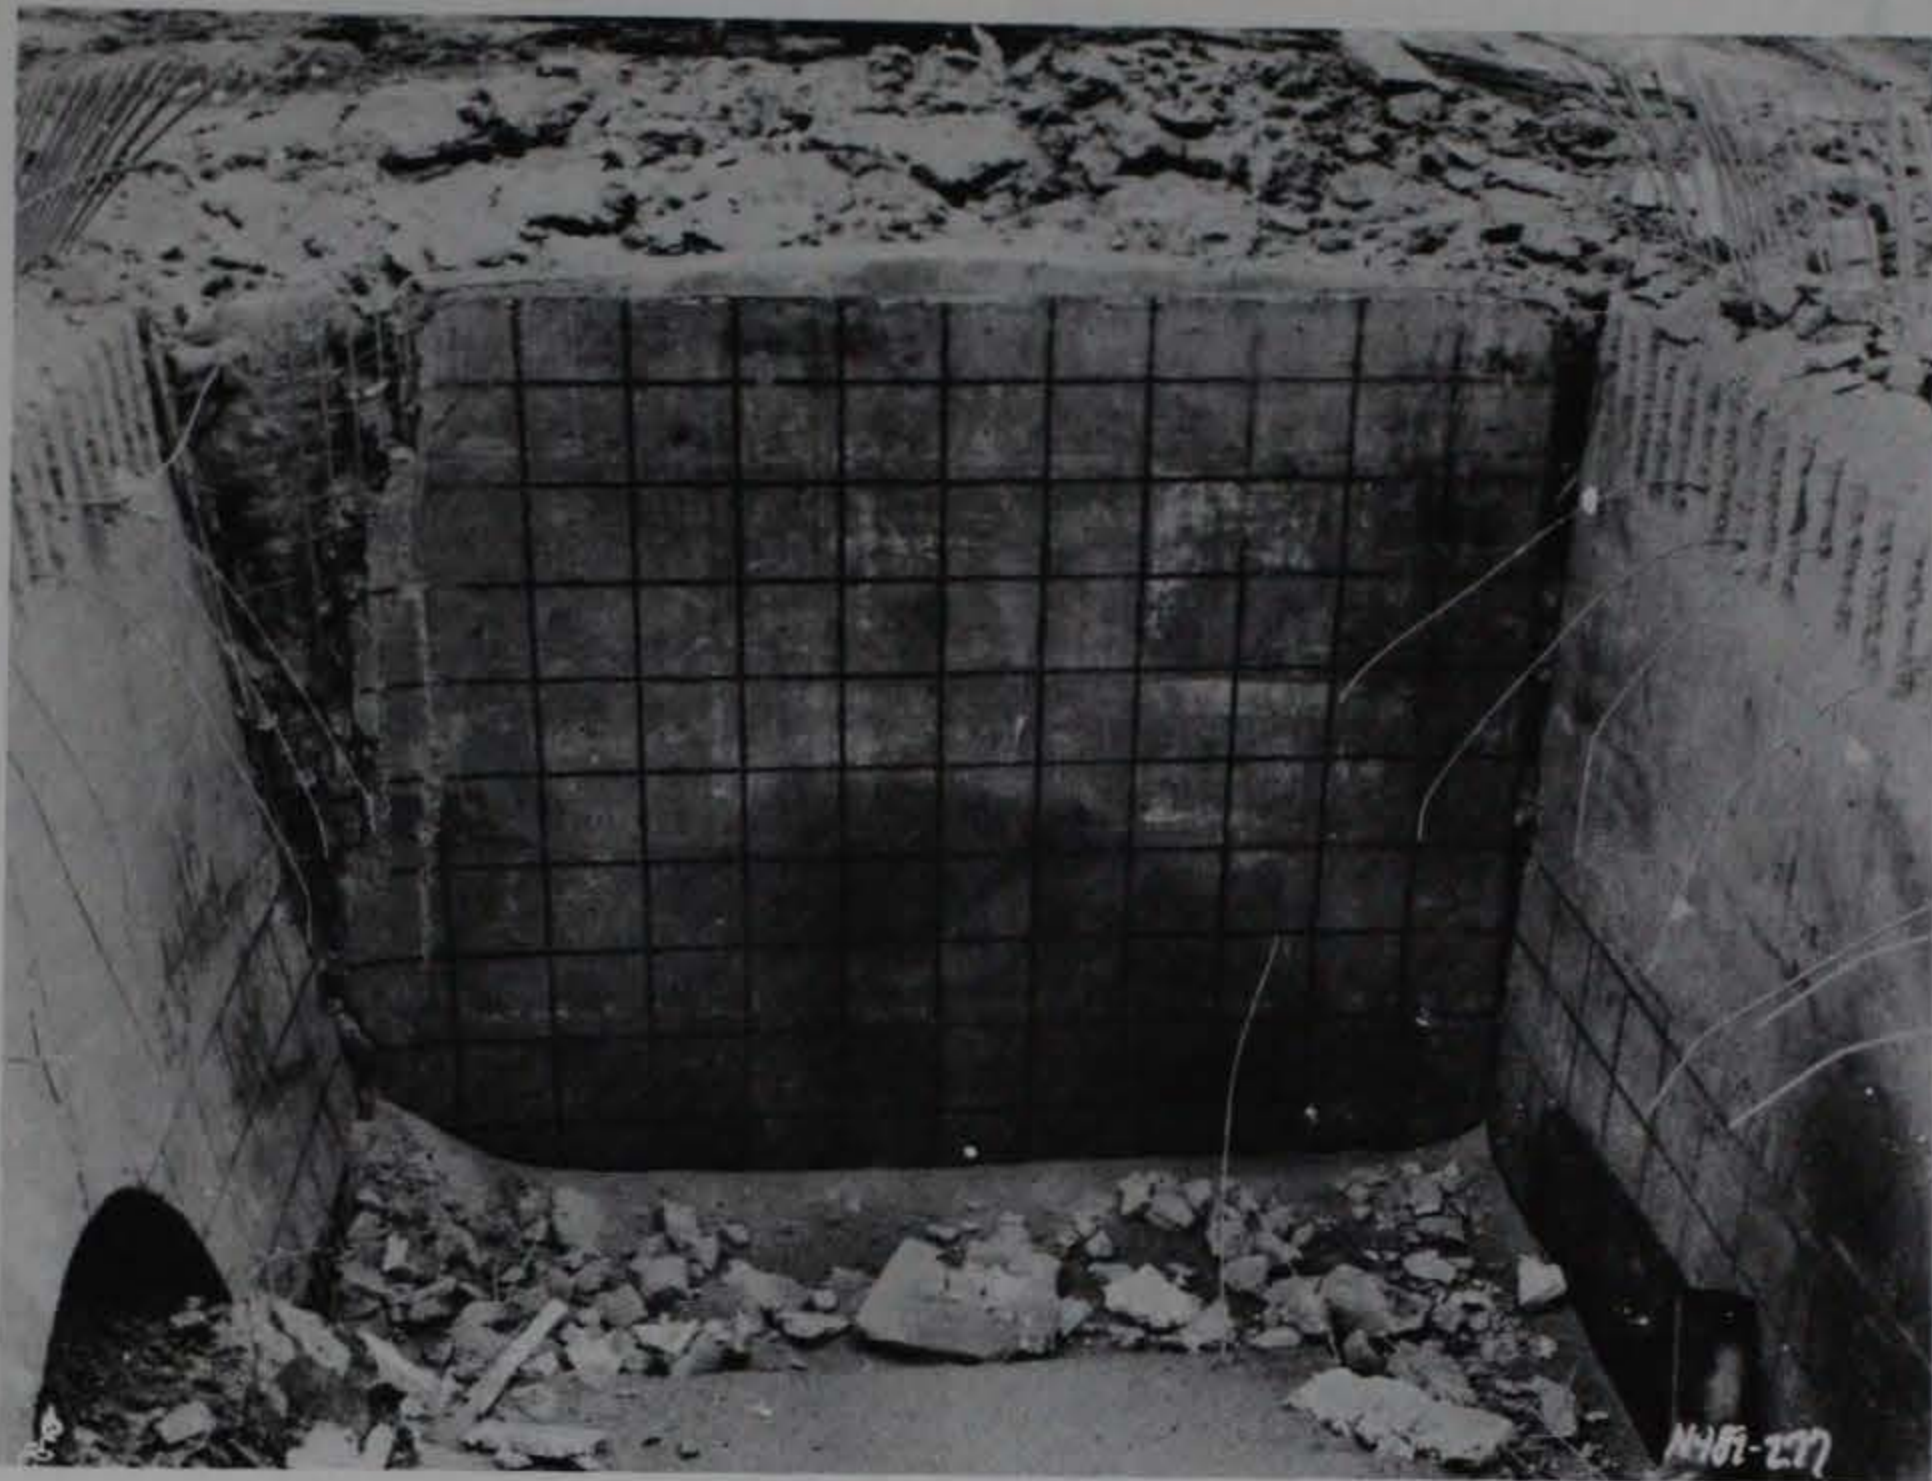
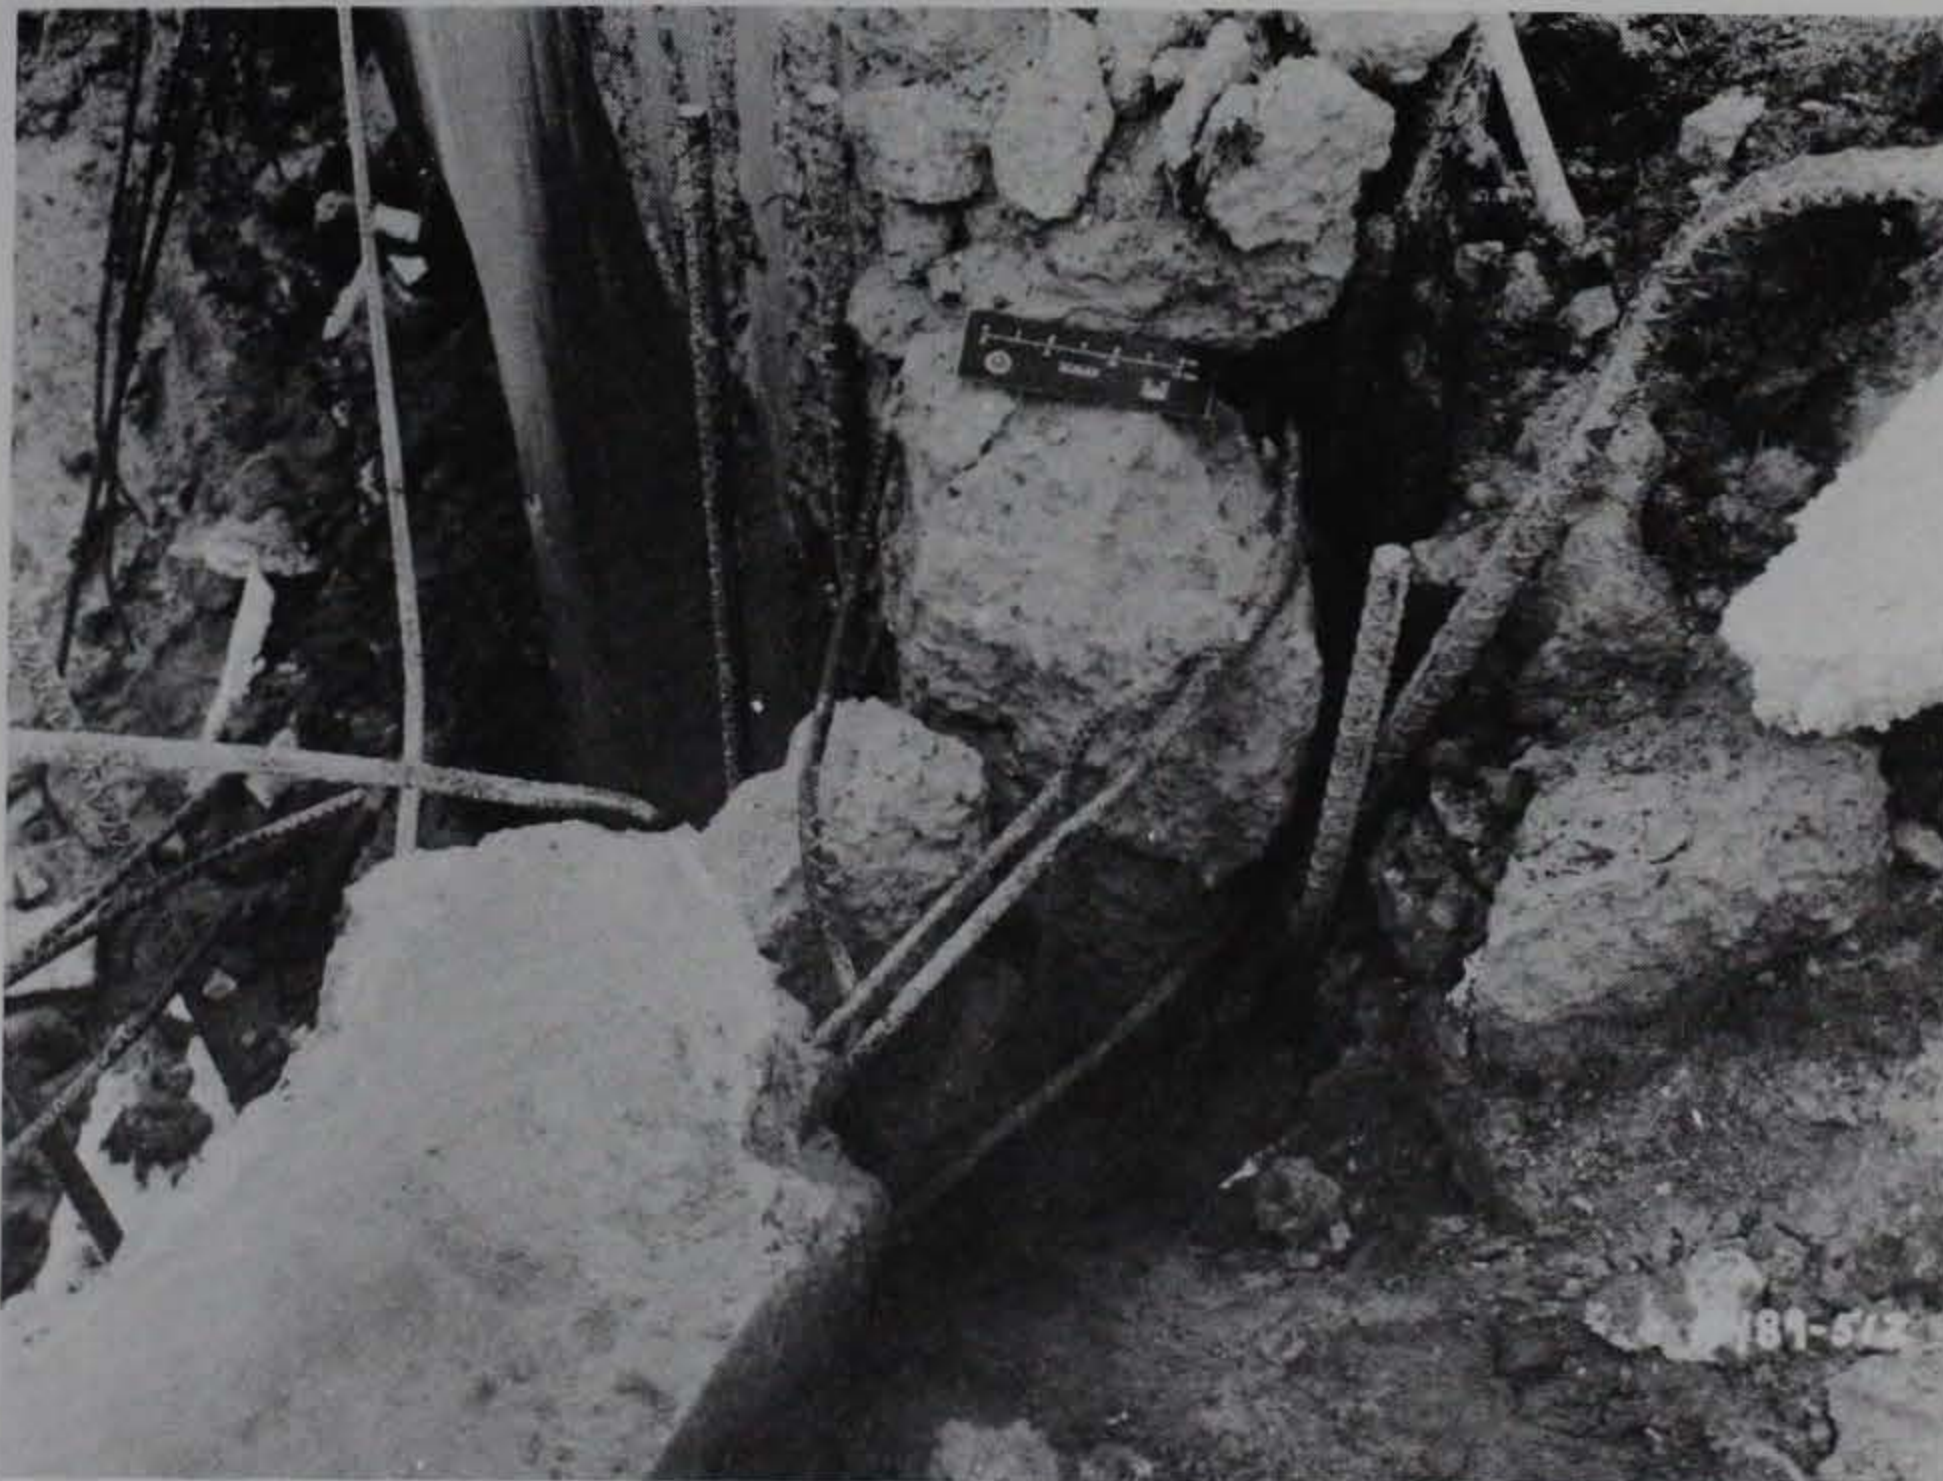
Figure 4.14. Posttest damage to donor bay south wall (Sheet 1 of 3).

a. Overall view.

b. Exterior of southeast corner.

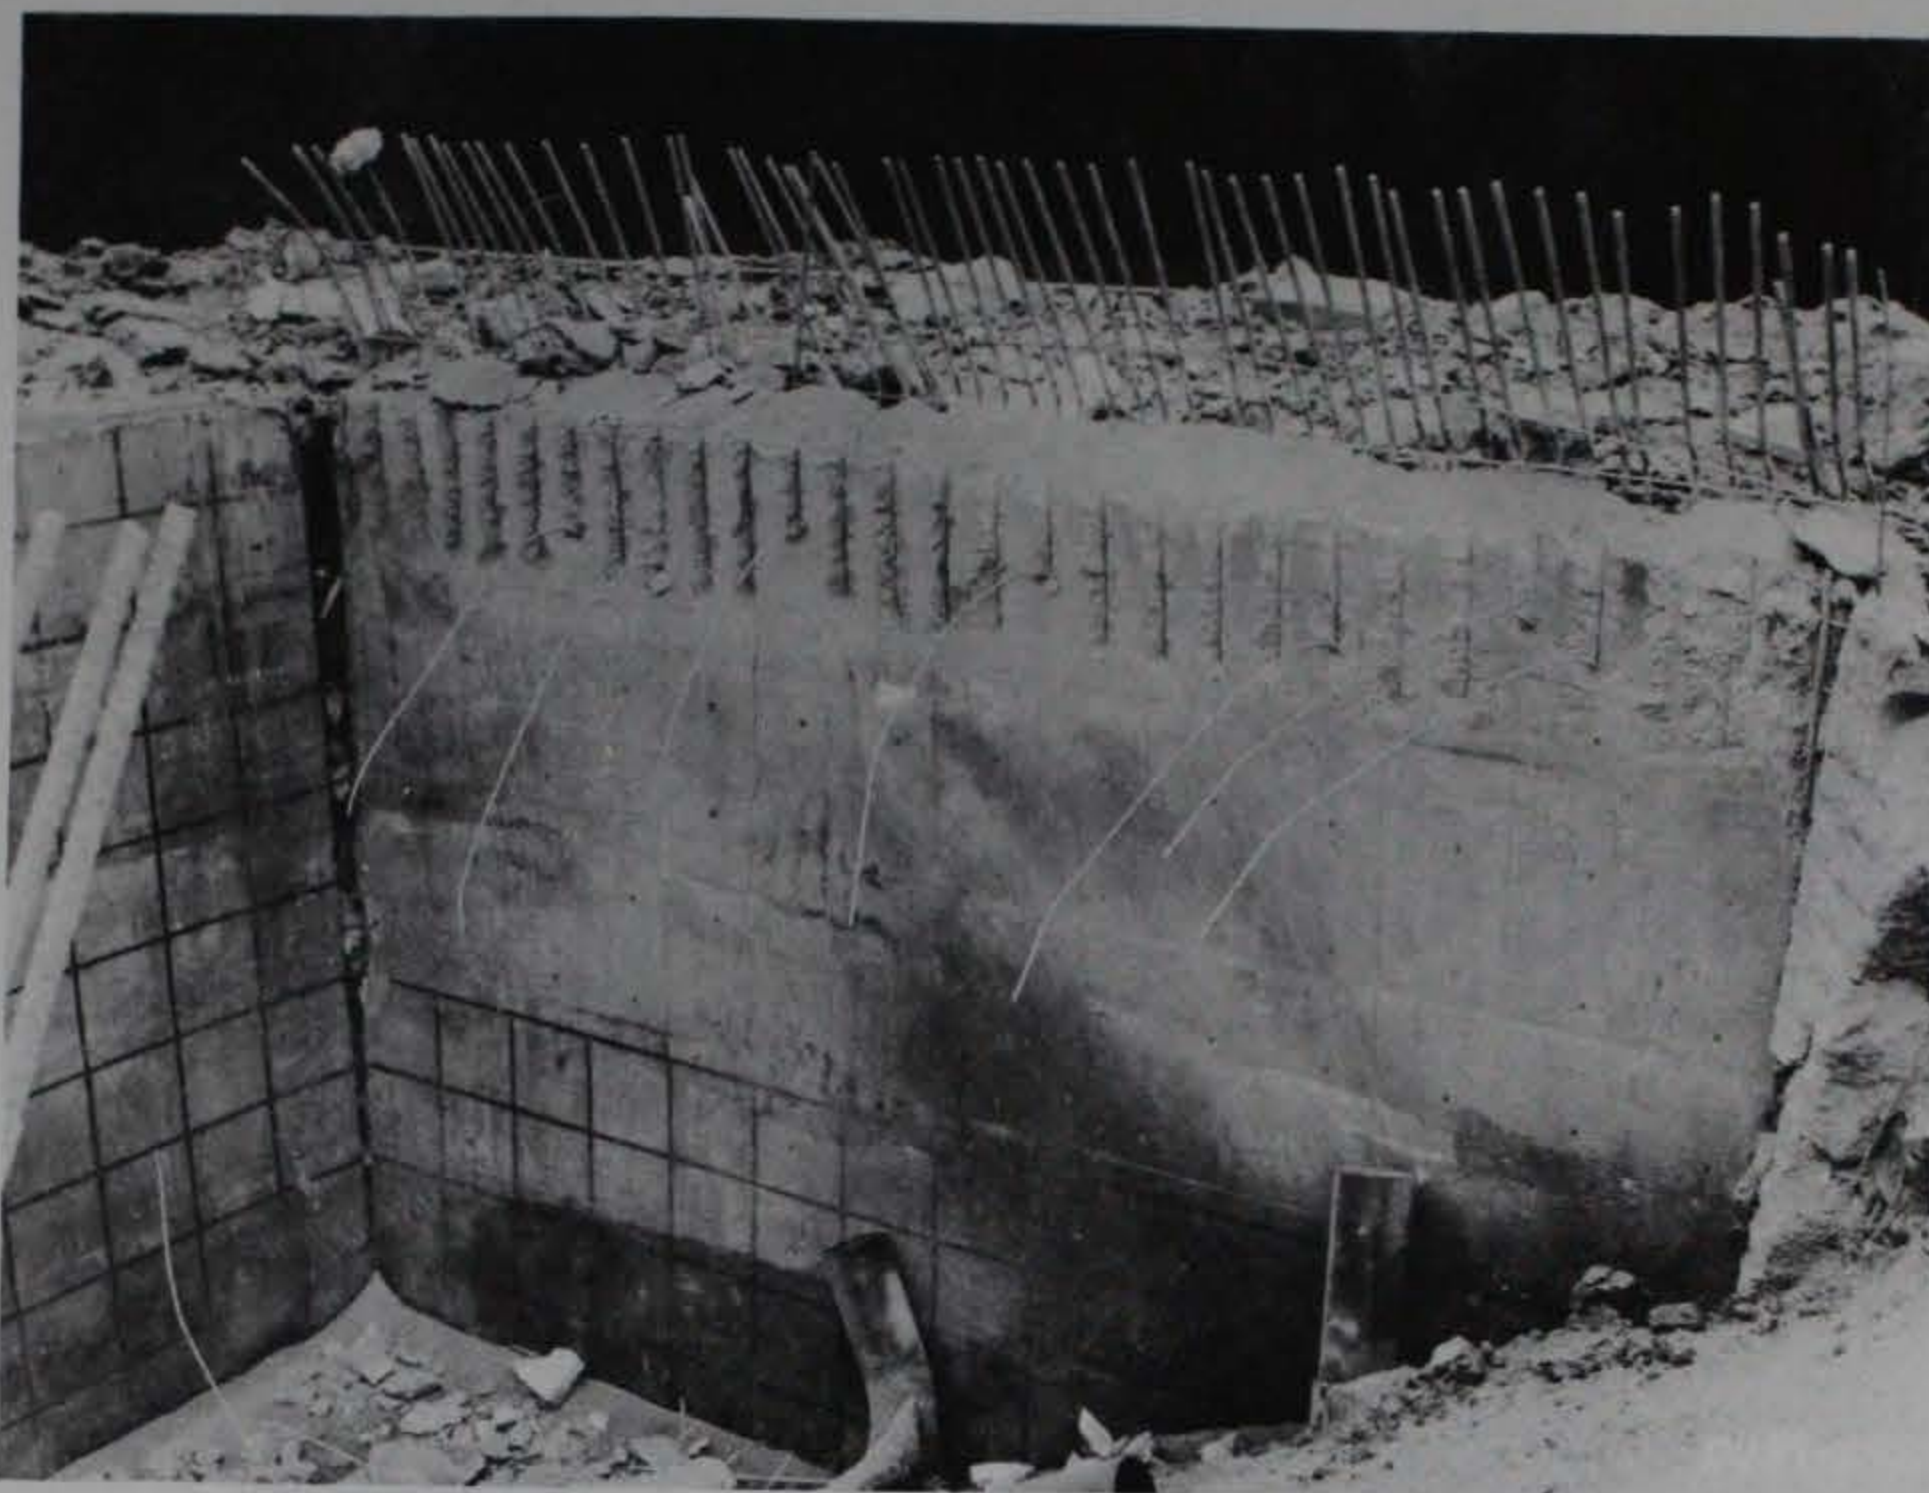
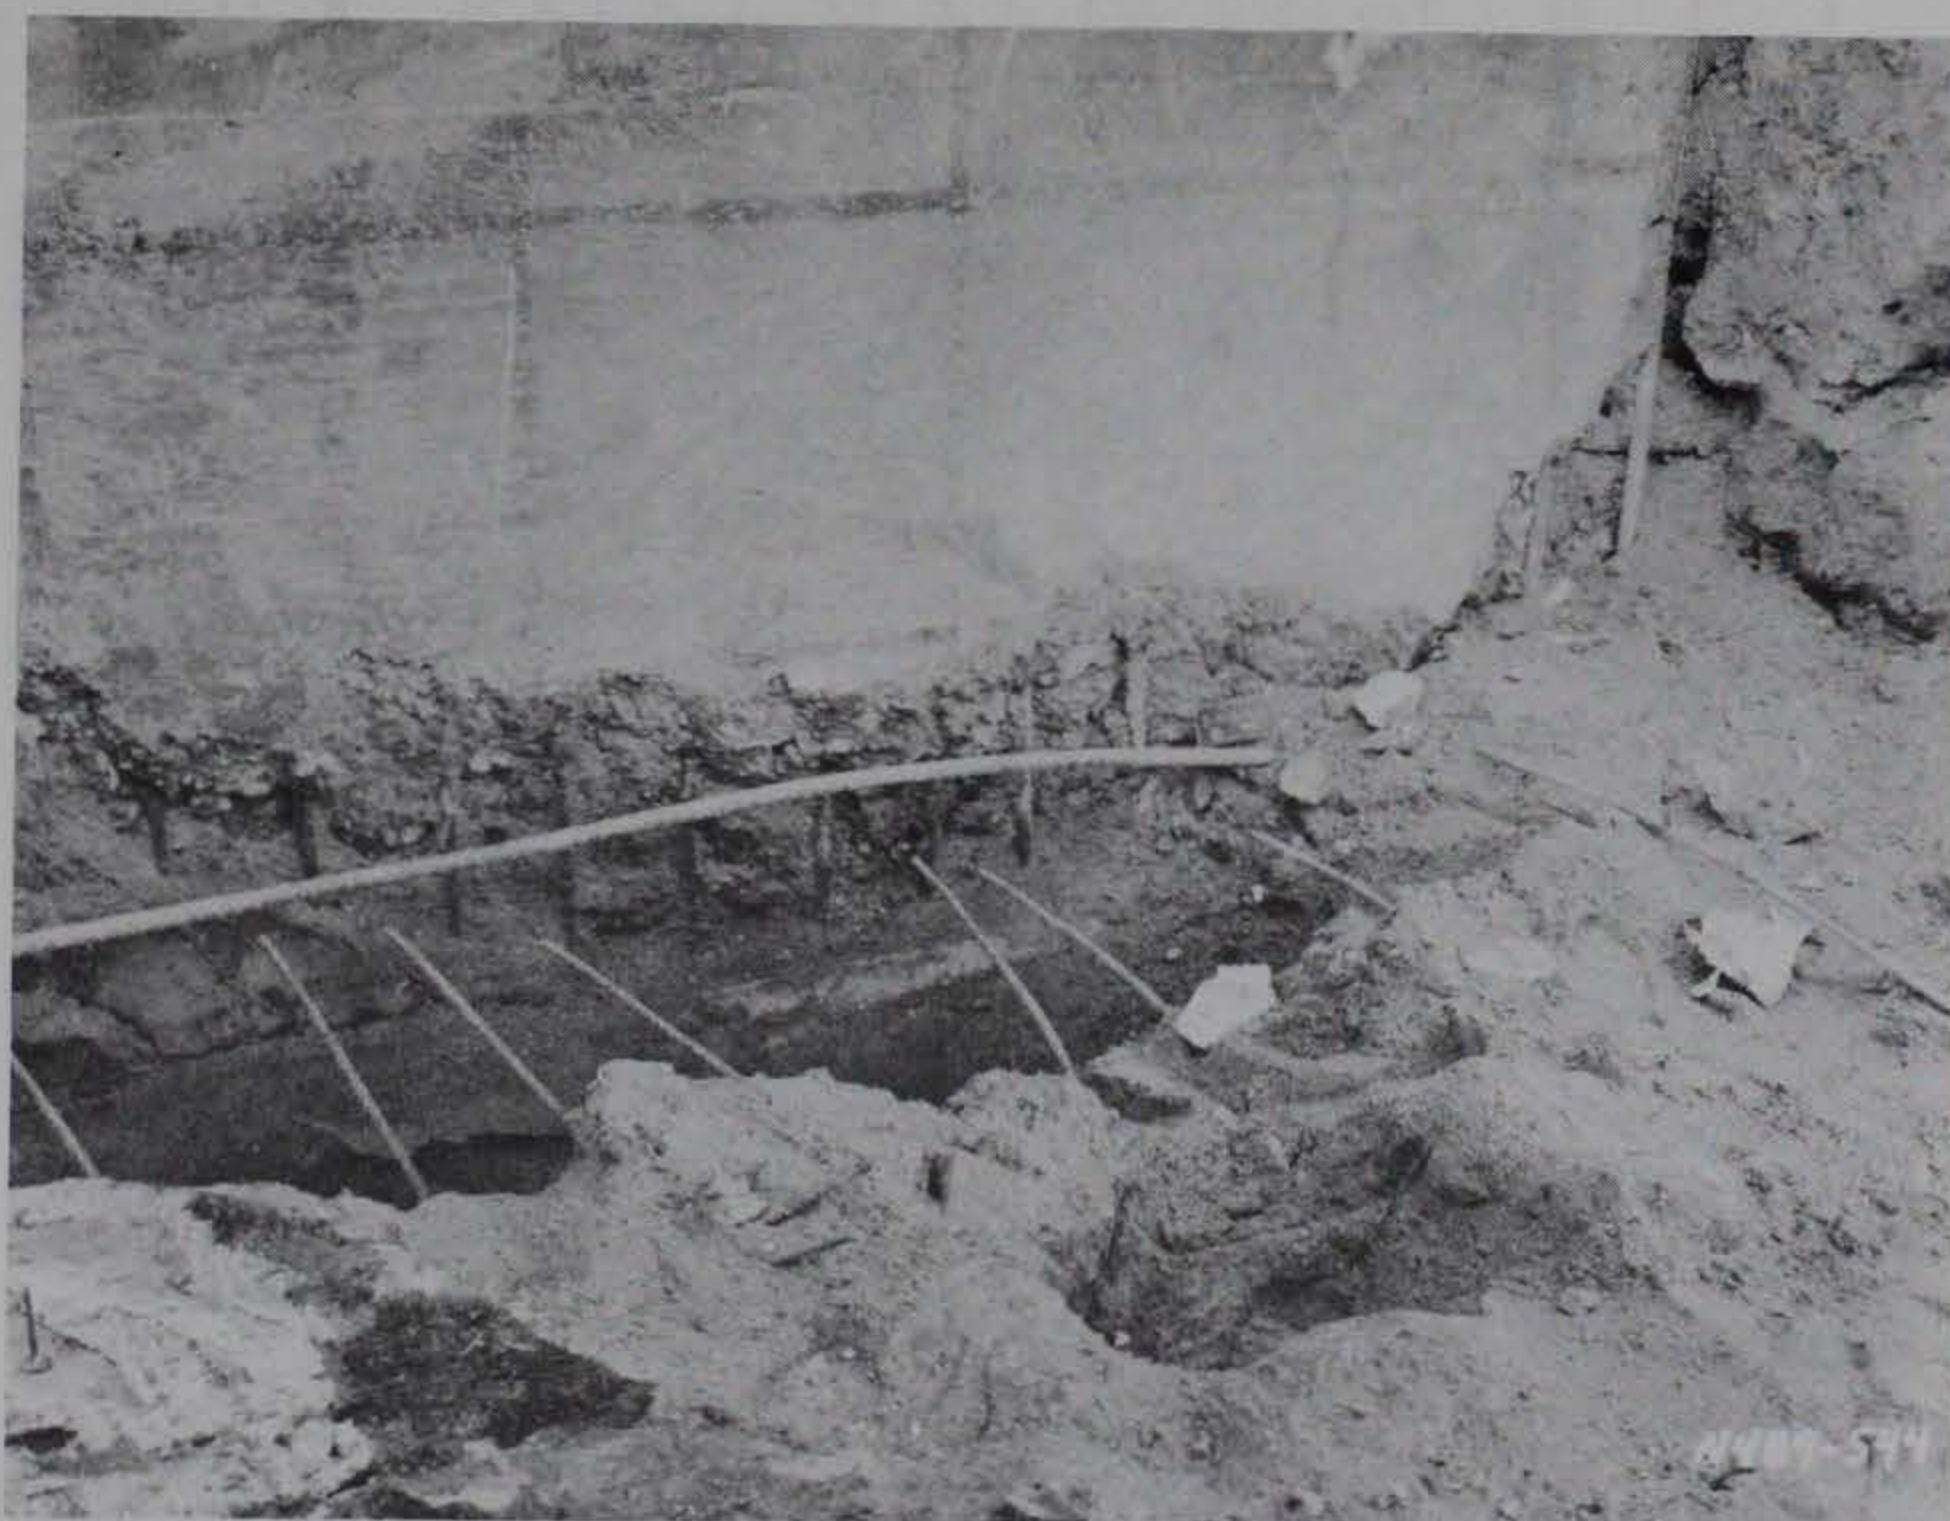
Figure 4.16. Posttest damage to west donor bay wall.

a. Overall view.

b. Base of wall at the north end.

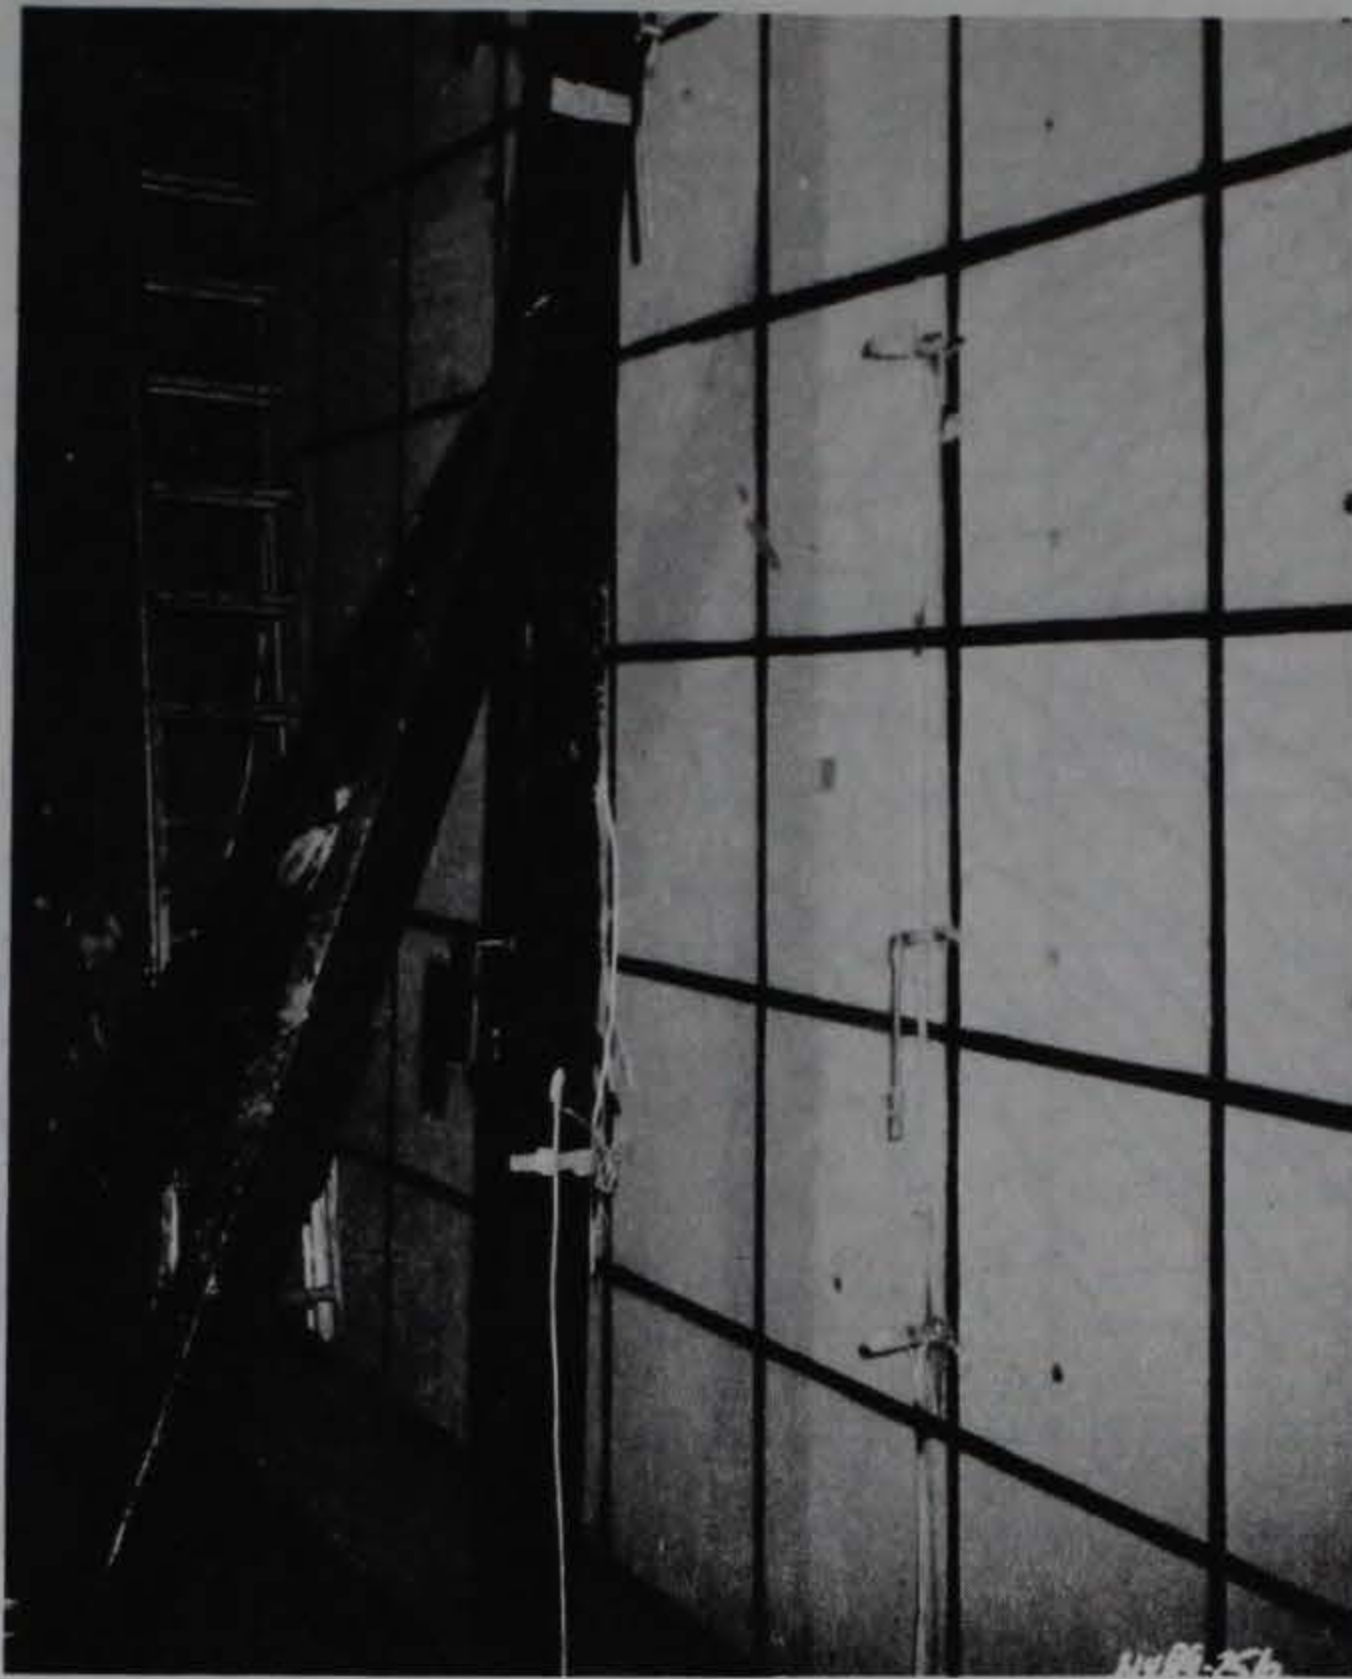
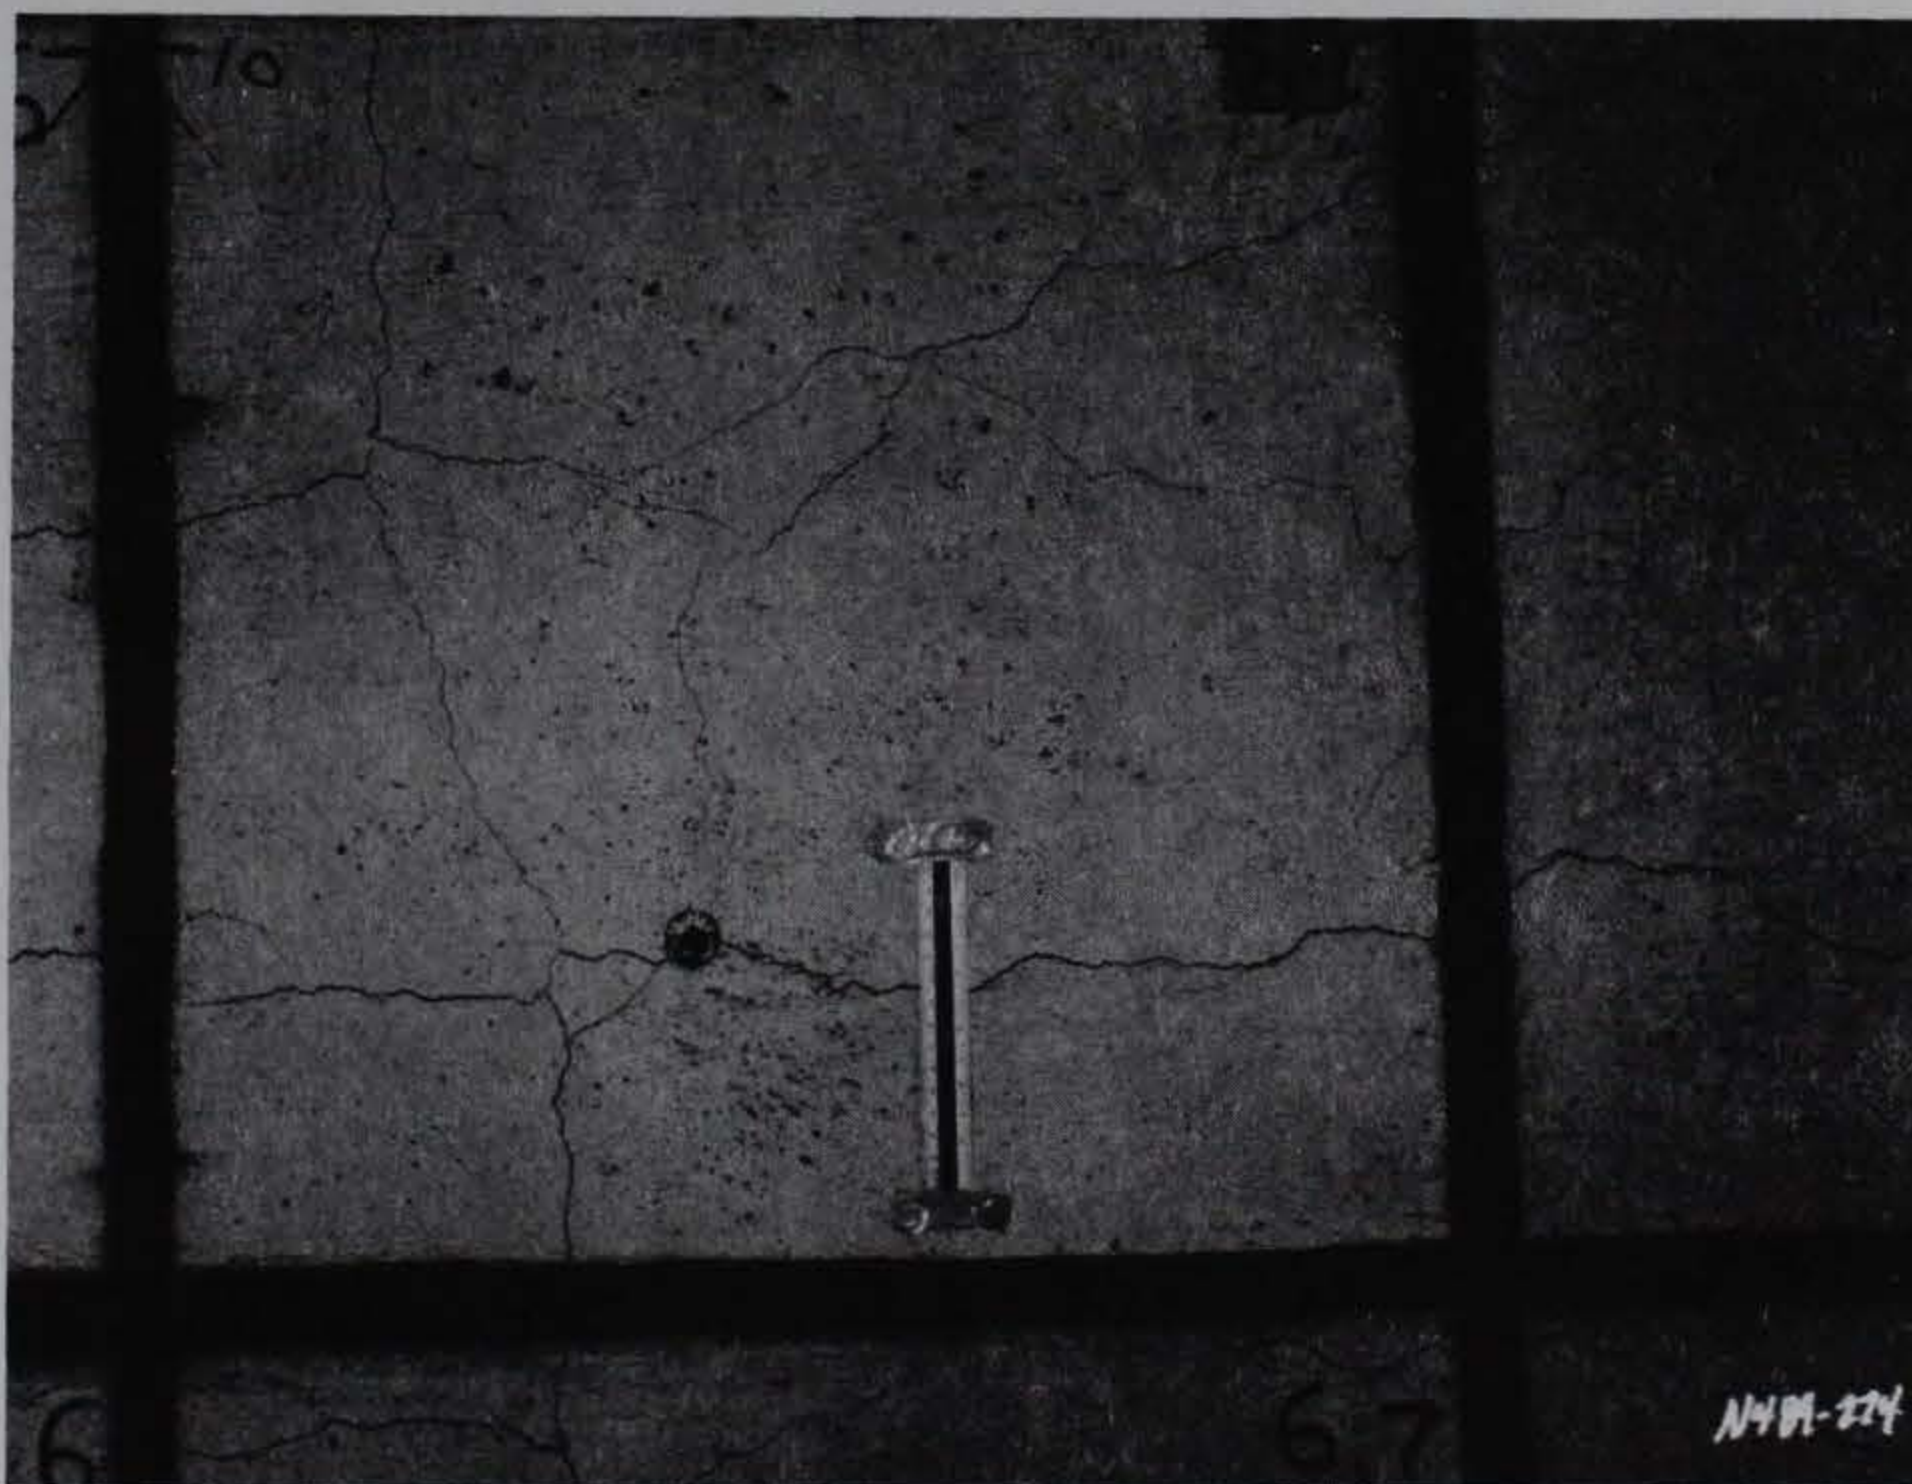
Figure 4.18. Posttest view of acceptor bay south wall.

a. Central portion of wall.

b. Detail of widest cracks.
