TECHNICAL REPORT SL-83-6

AN EVALUATION OF THE SEPARATED BAY CONCEPT FOR A MUNITION ASSEMBLY COMPLEX; AN EXPERIMENTAL INVESTIGATION OF THE DEPARTMENT OF ENERGY BUILDING 12-64 COMPLEX

Robert D. Volz, Sam A. Kiger

September 1983

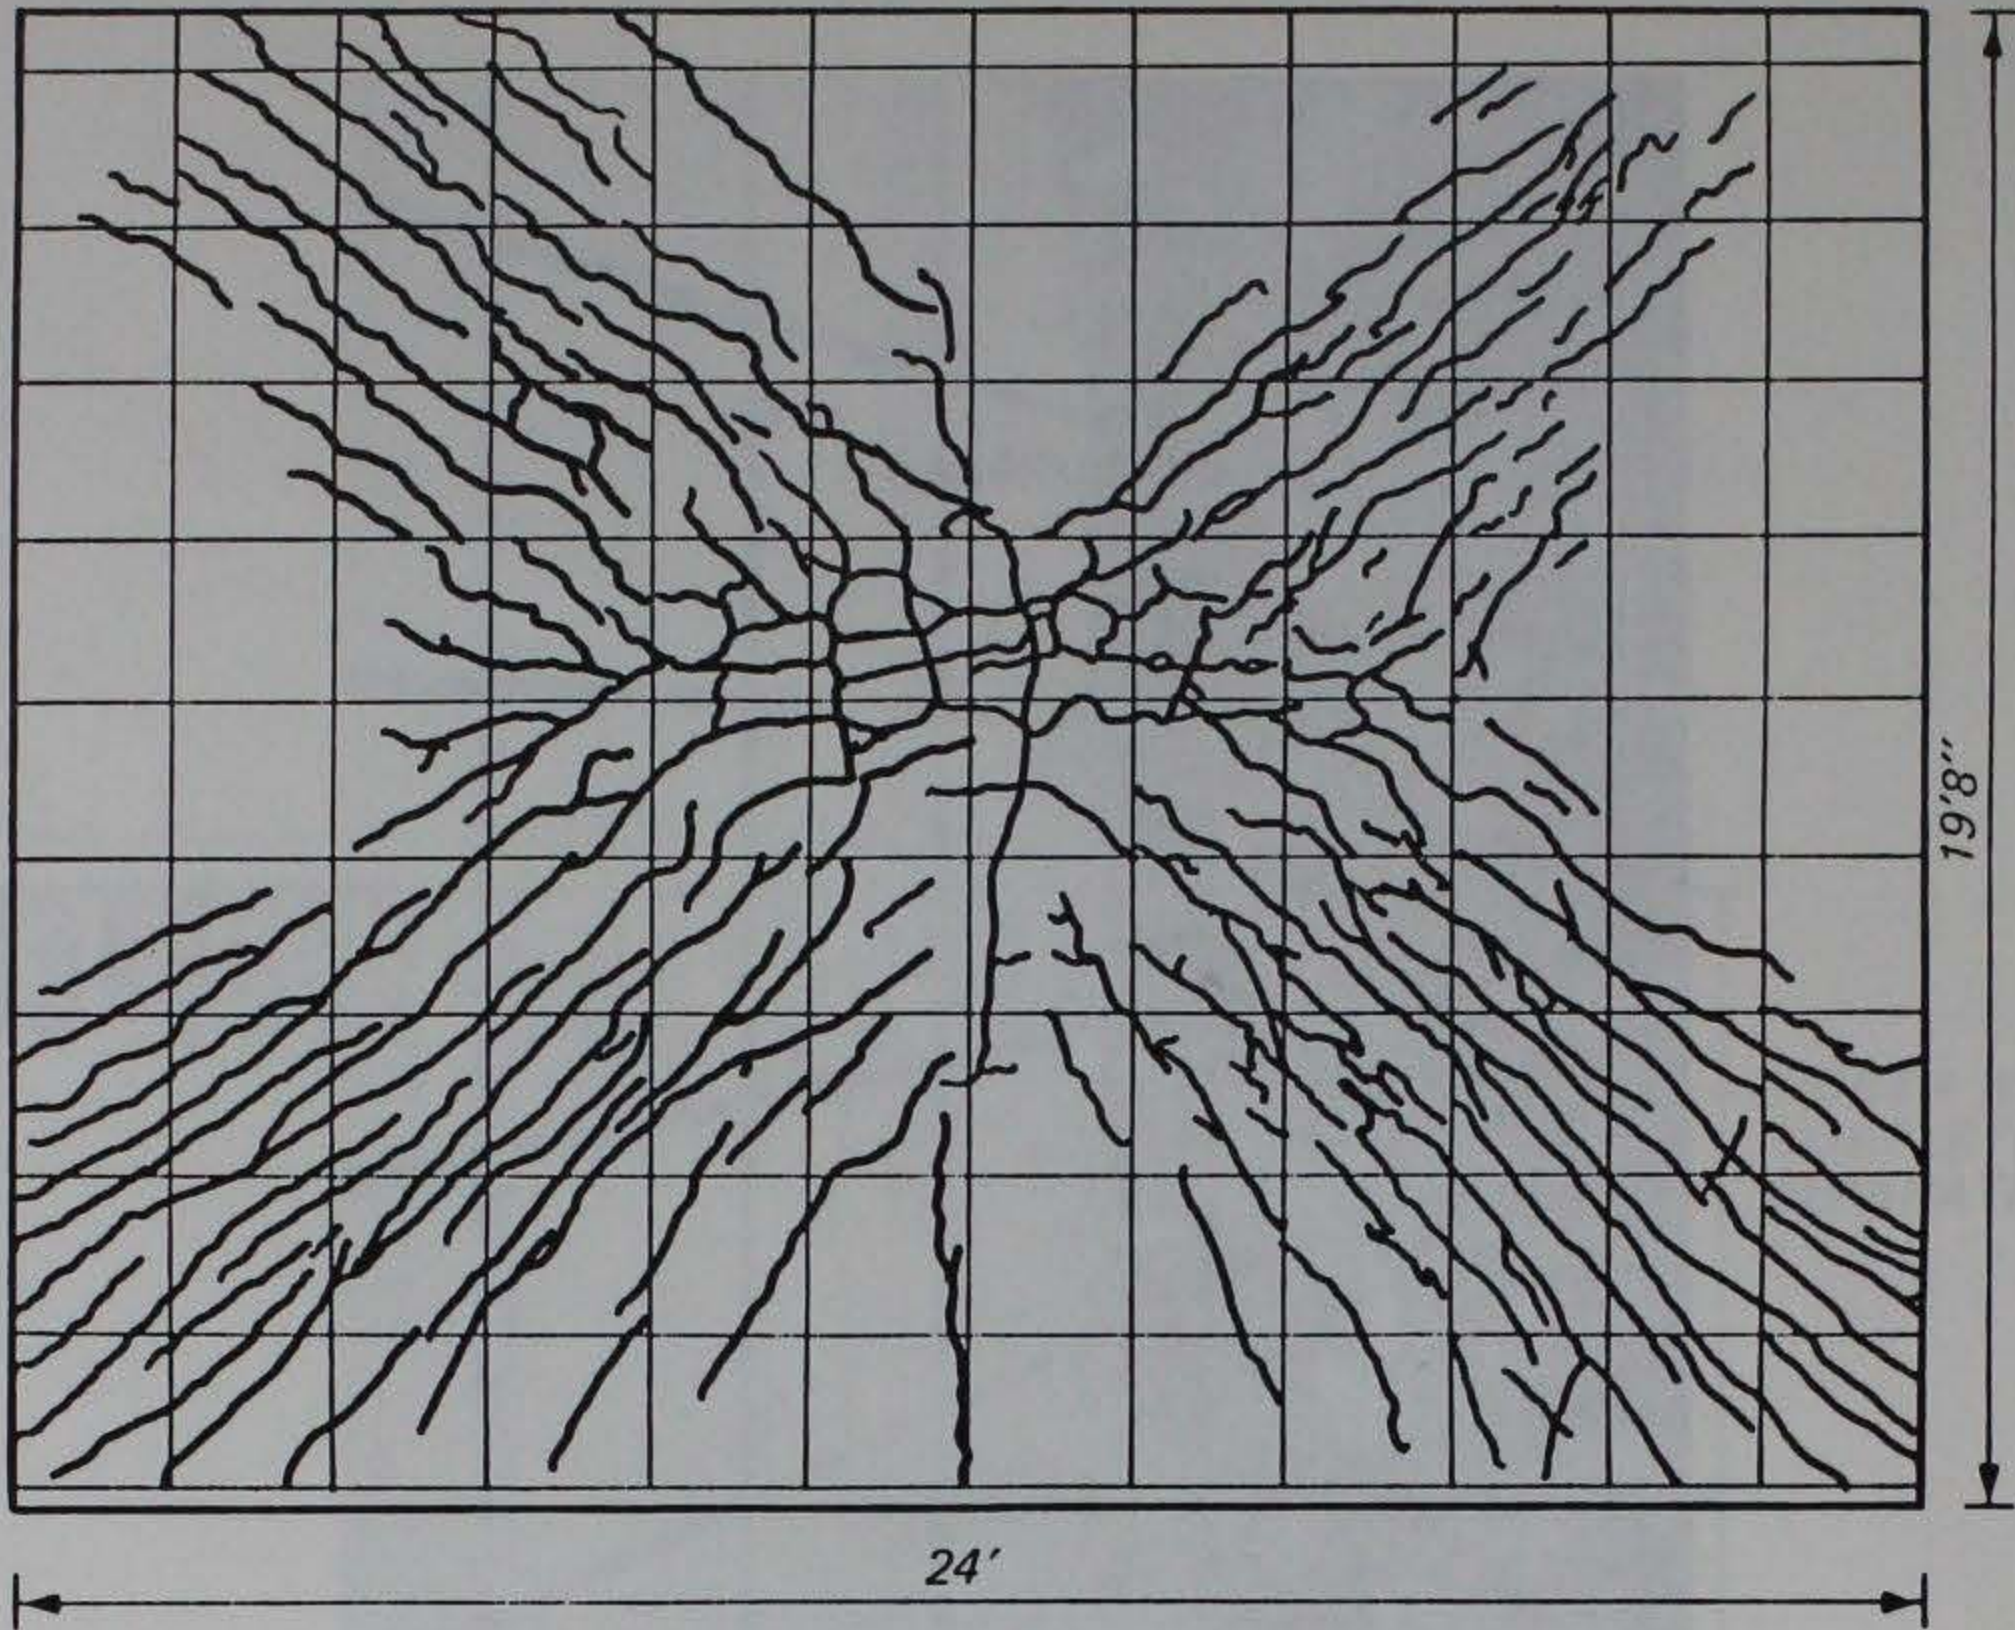
Figure 4.19. Posttest crack pattern on acceptor bay wall.

ALL CRACKS LESS THAN 1 mm WIDE
 GRID IS 2 FEET ON CENTERS

The crack pattern and posttest deflections show that the acceptor bay wall responded in a flexural mode. This is consistent with the load distribution measured on the face of the wall. There was no indication of a punching shear failure.

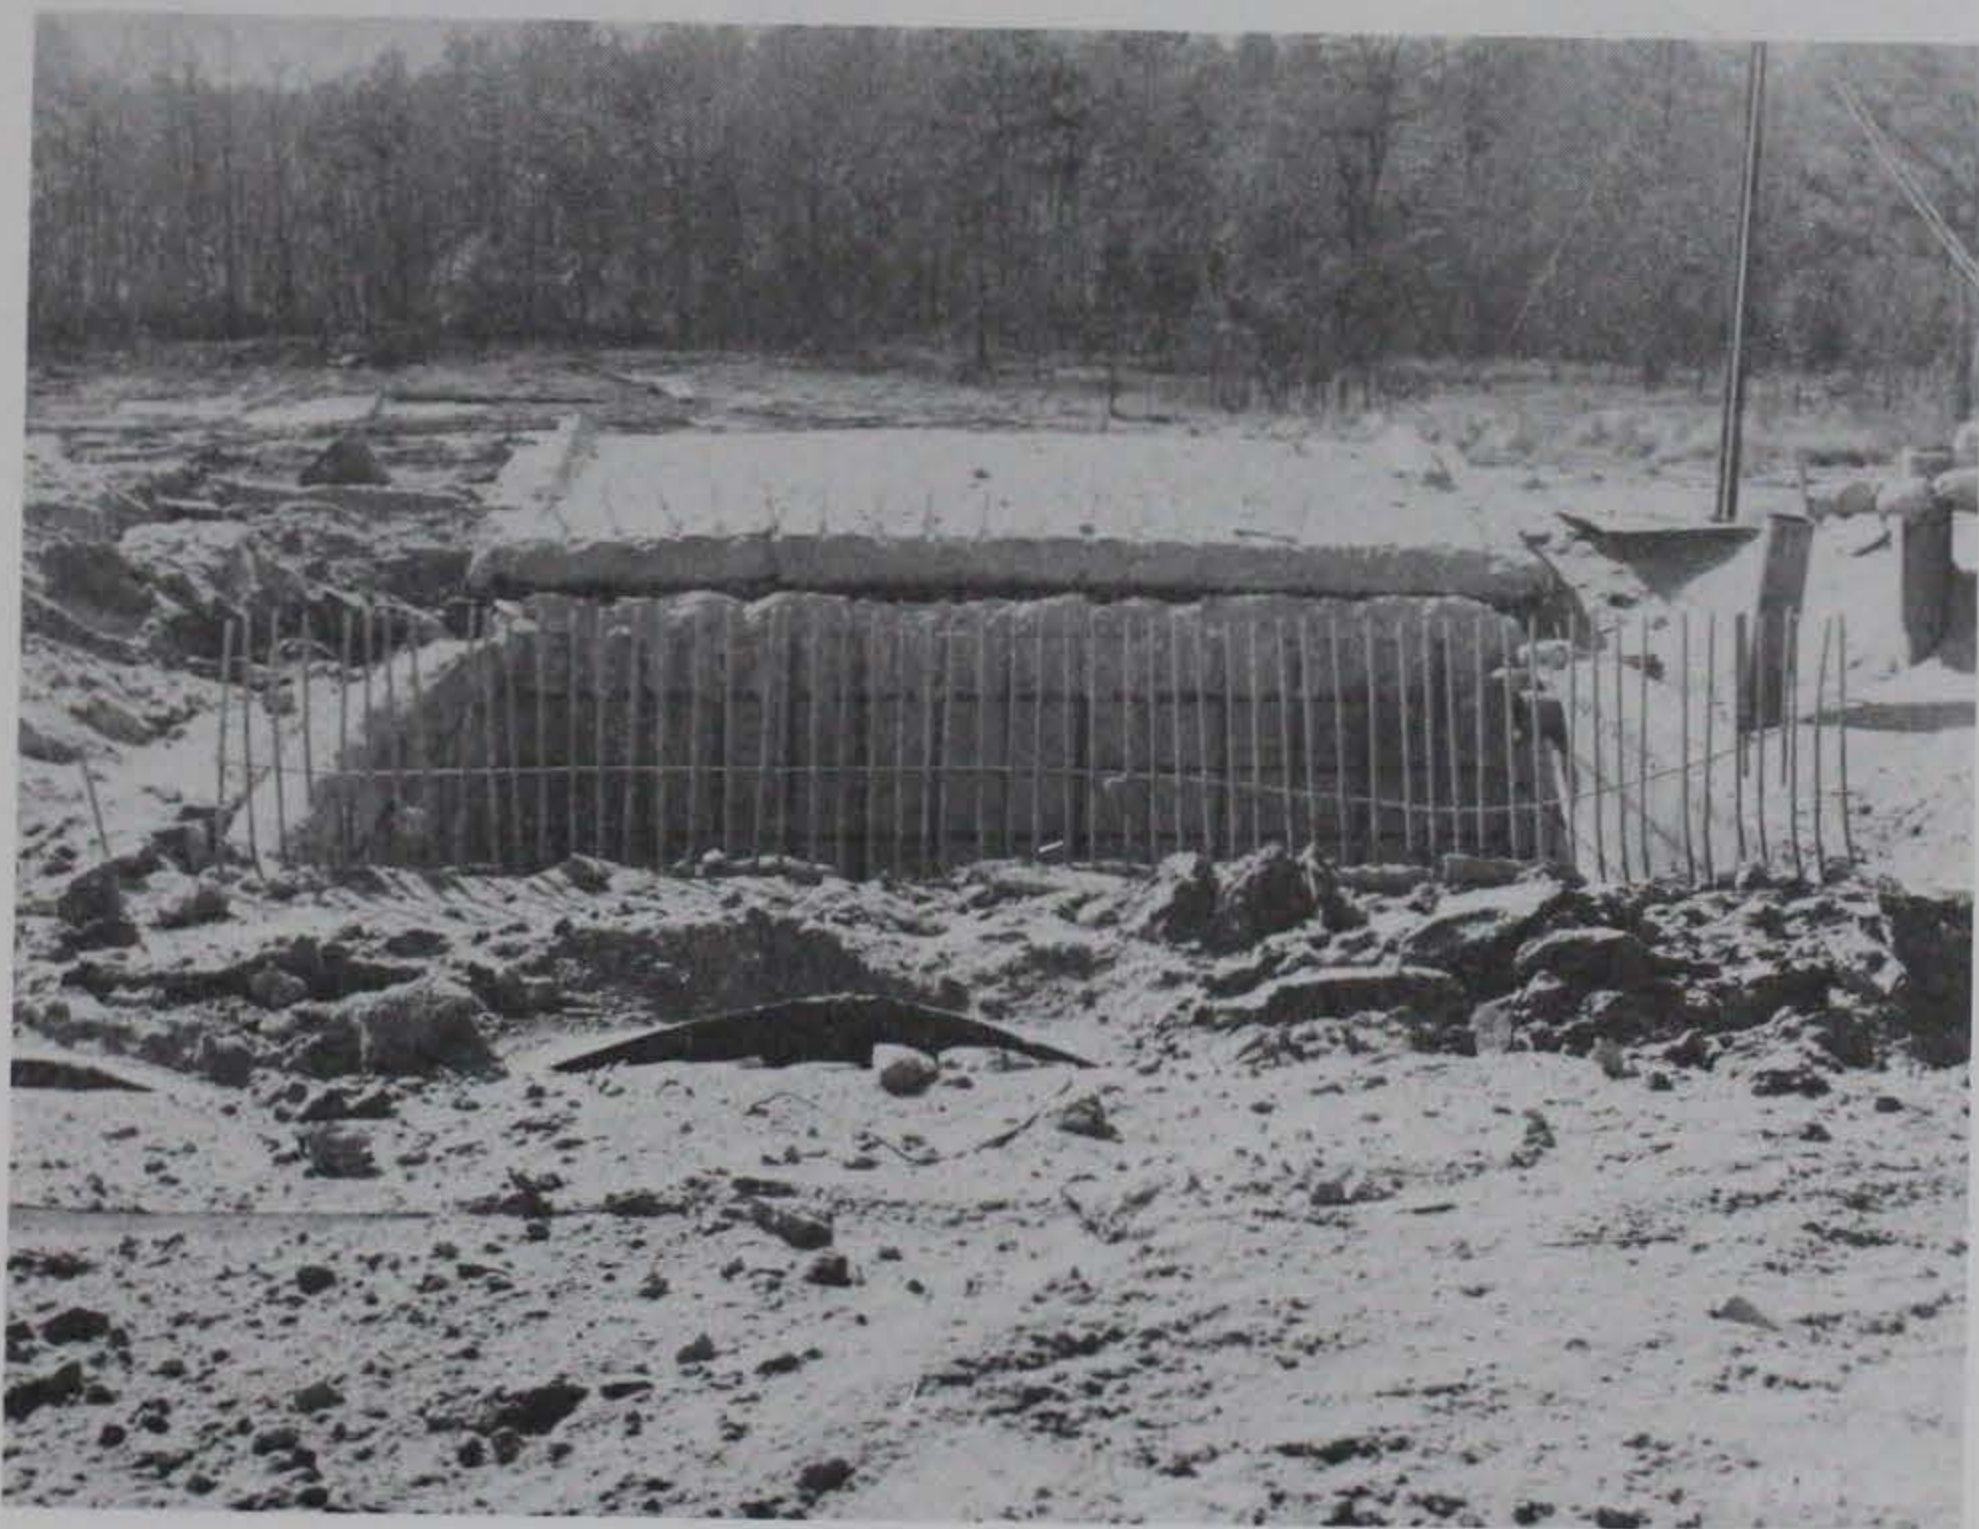
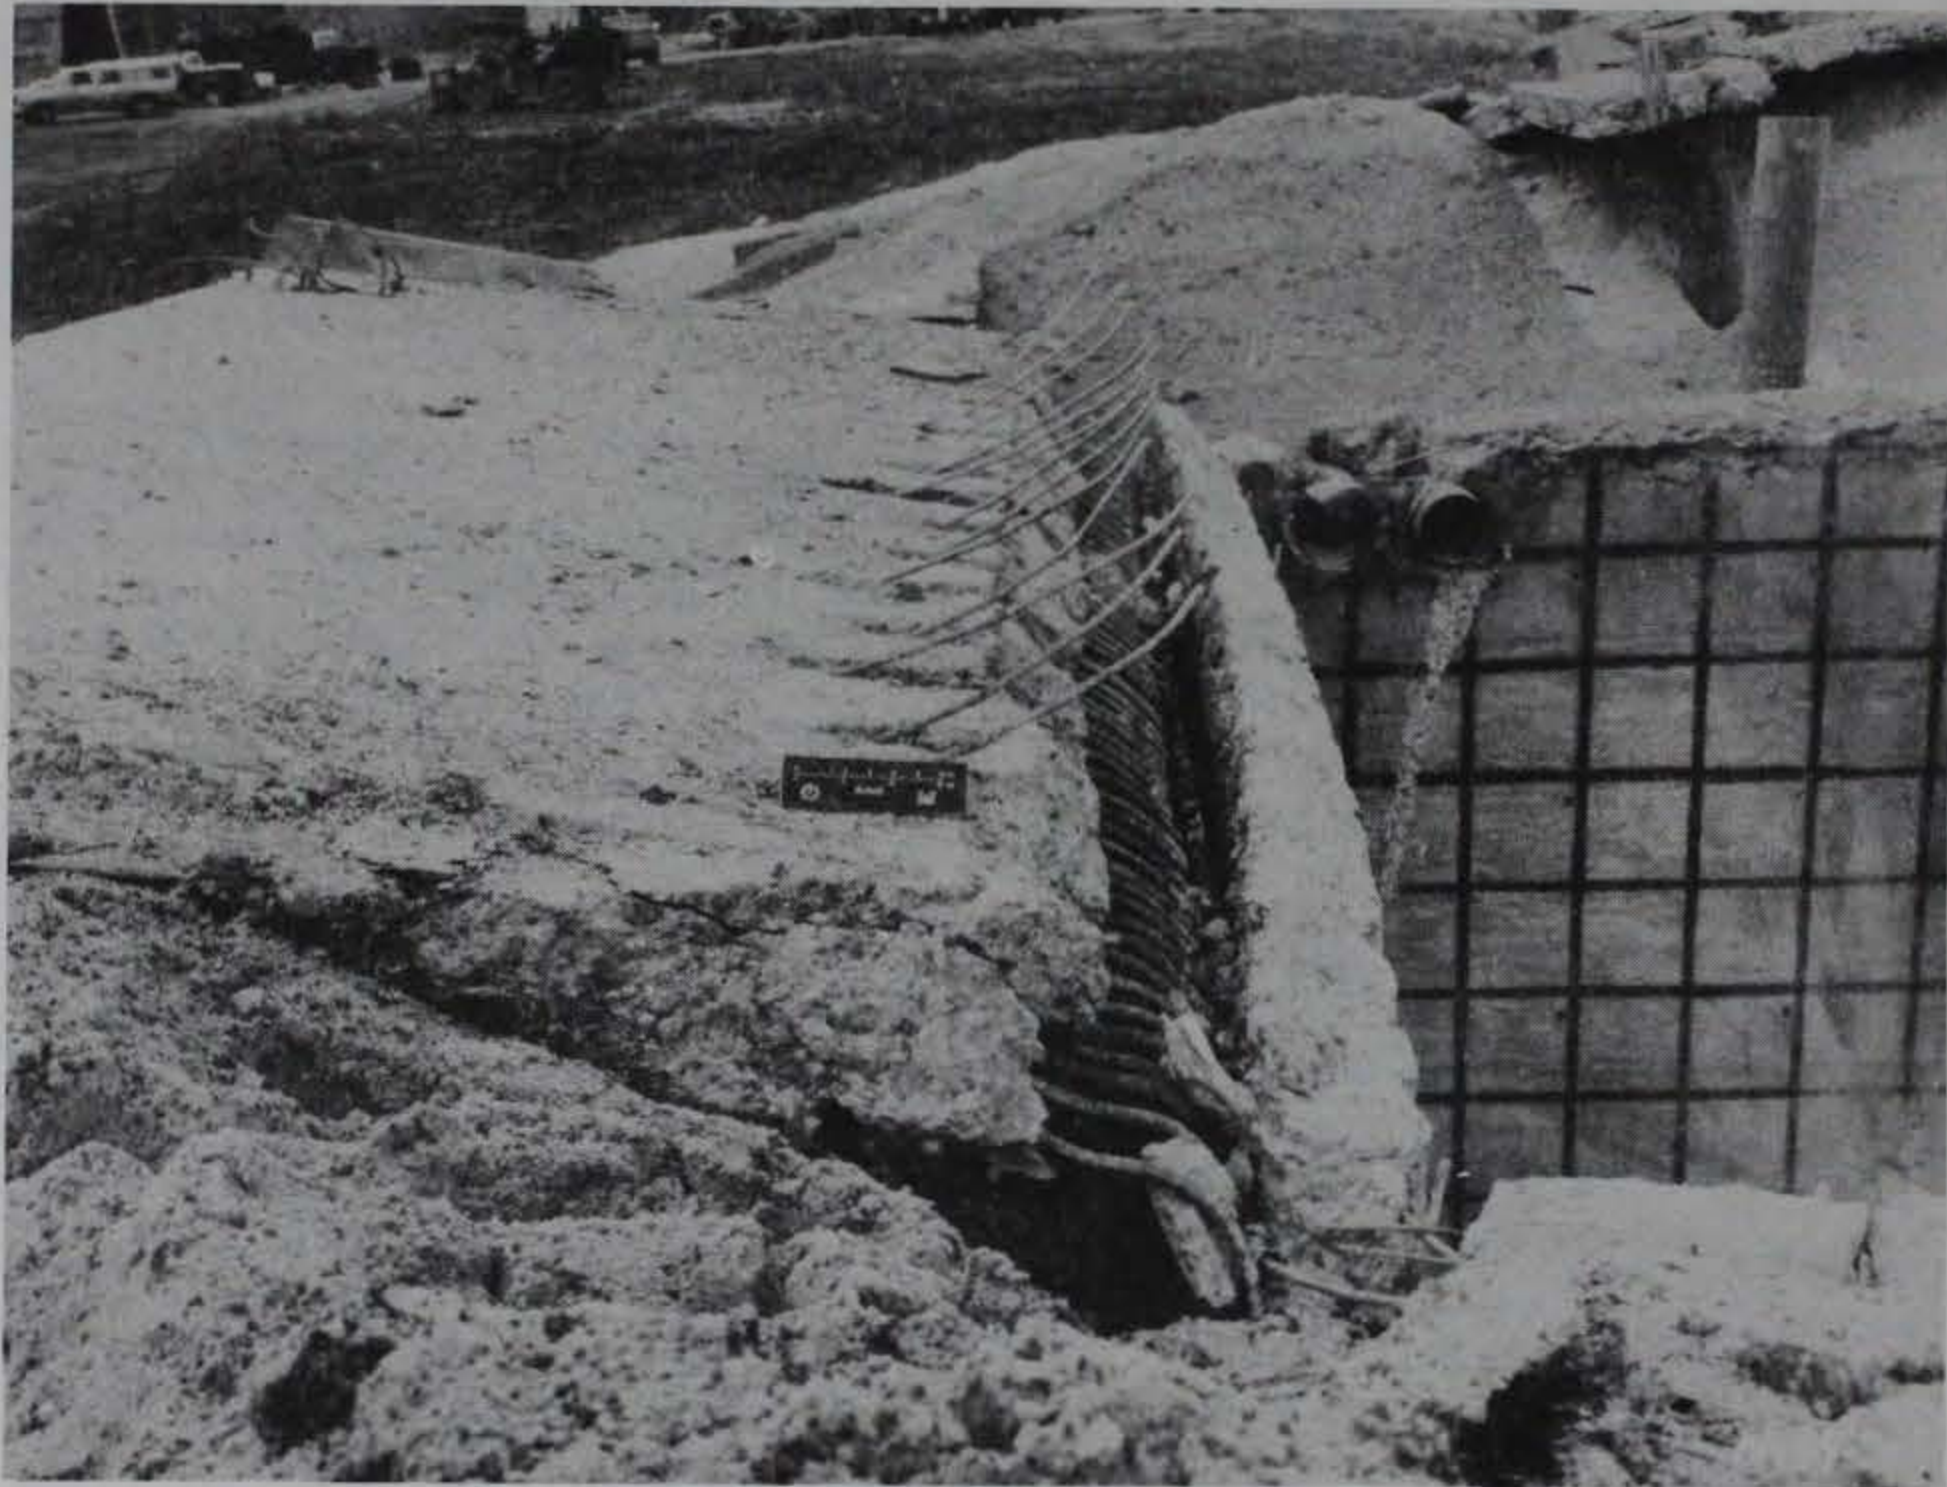
Figure 5.2. Damage to donor bay roof (Sheet 1 of 2).

b. View facing west.

c. Detail of west half of roof slab.

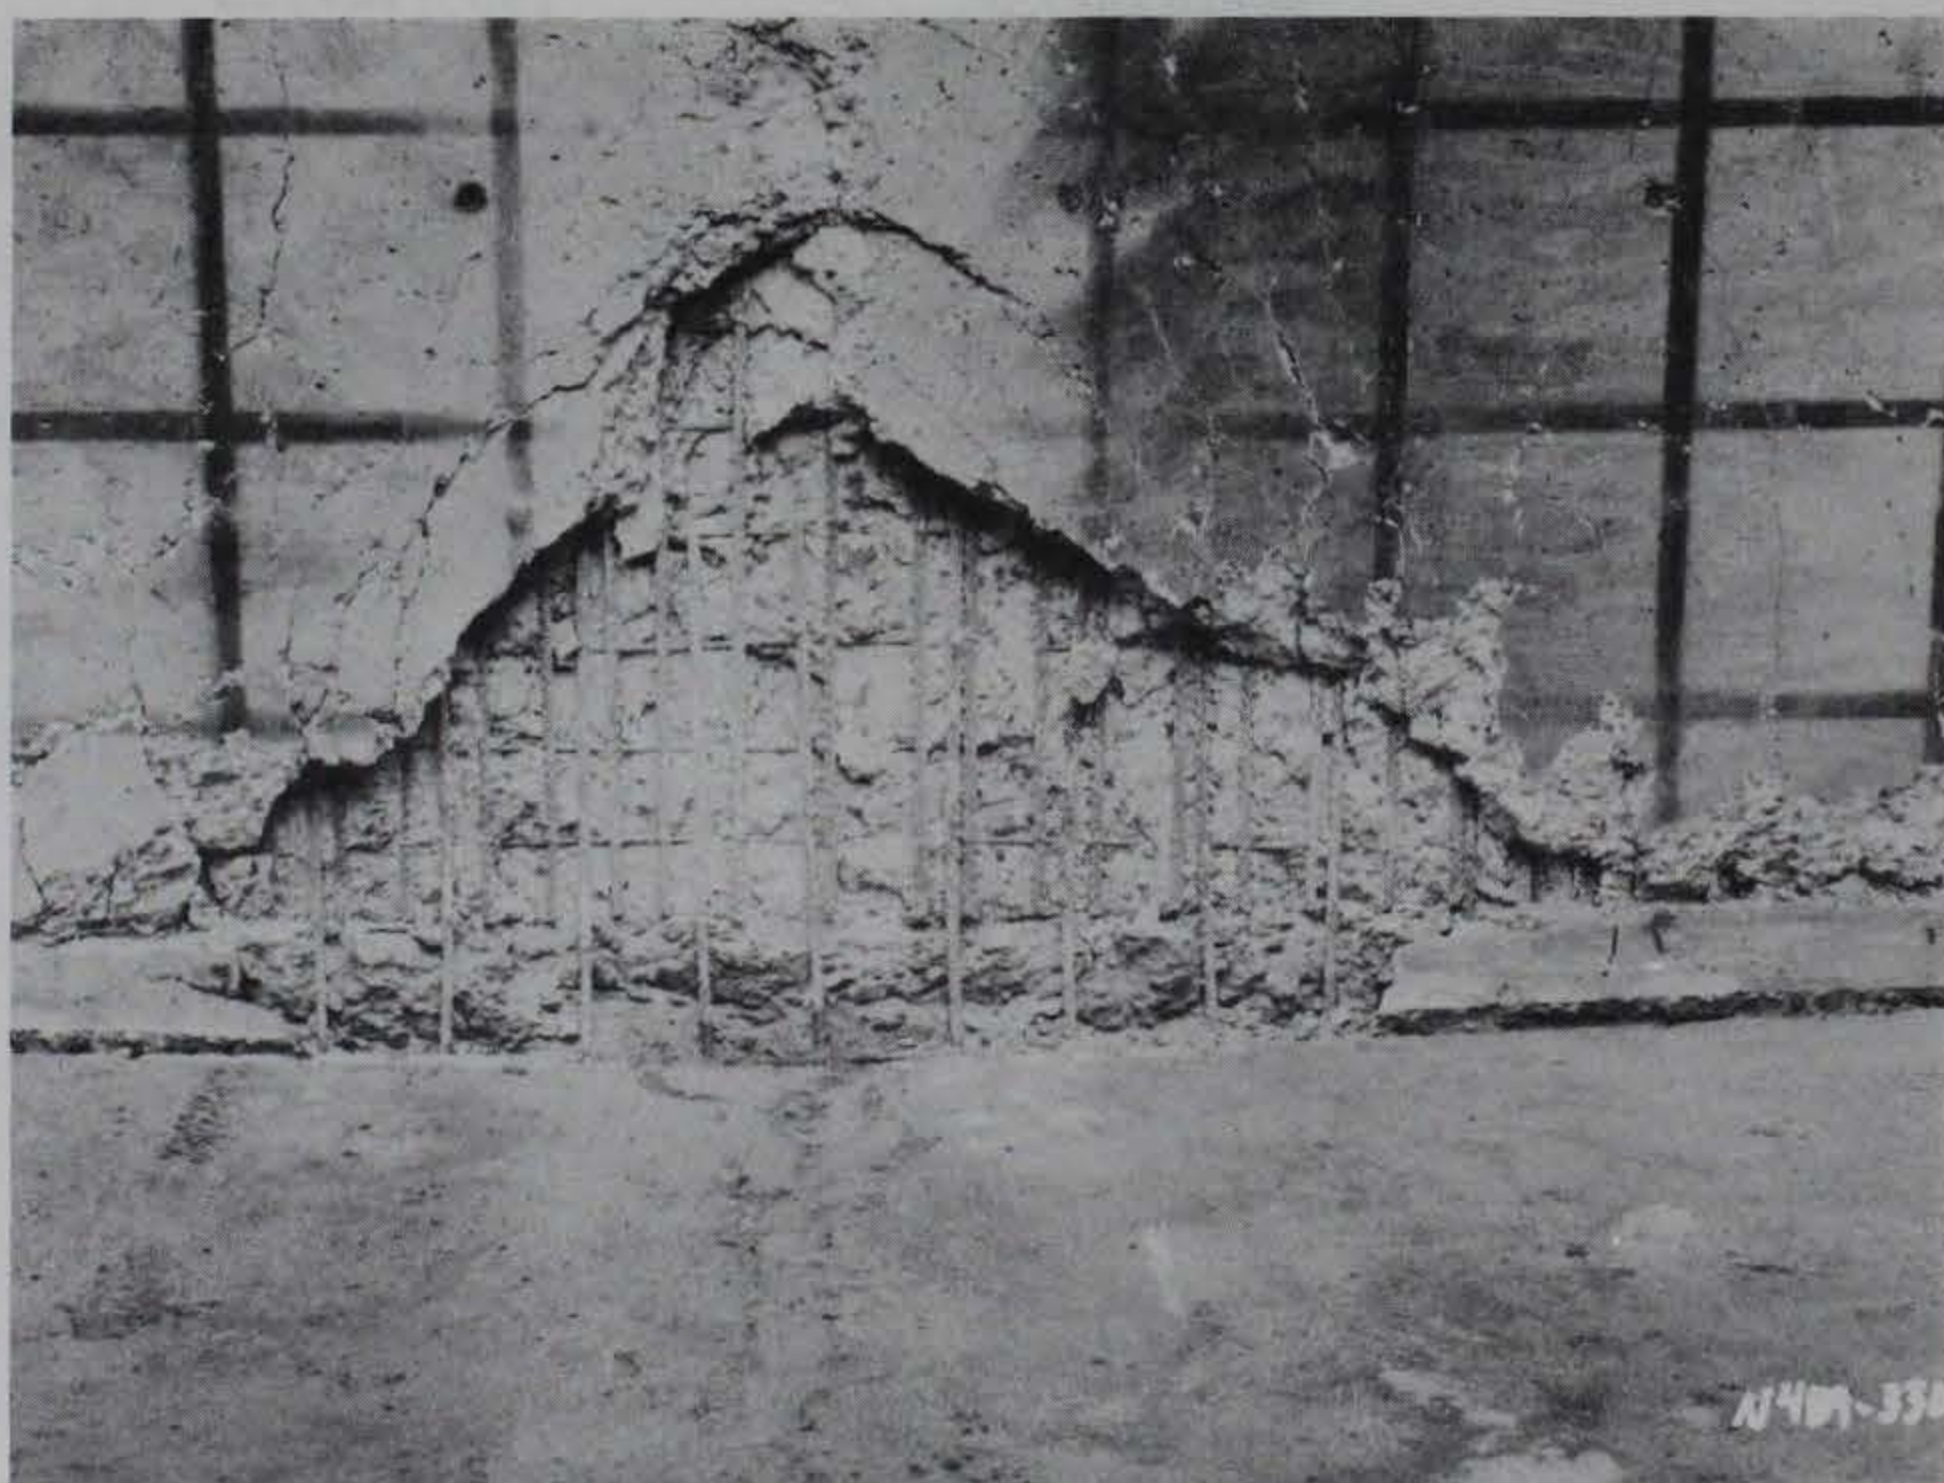
Figure 5.6. Posttest view of north donor bay wall
(Sheet 1 of 2).

b. Damage adjacent to explosive charge.

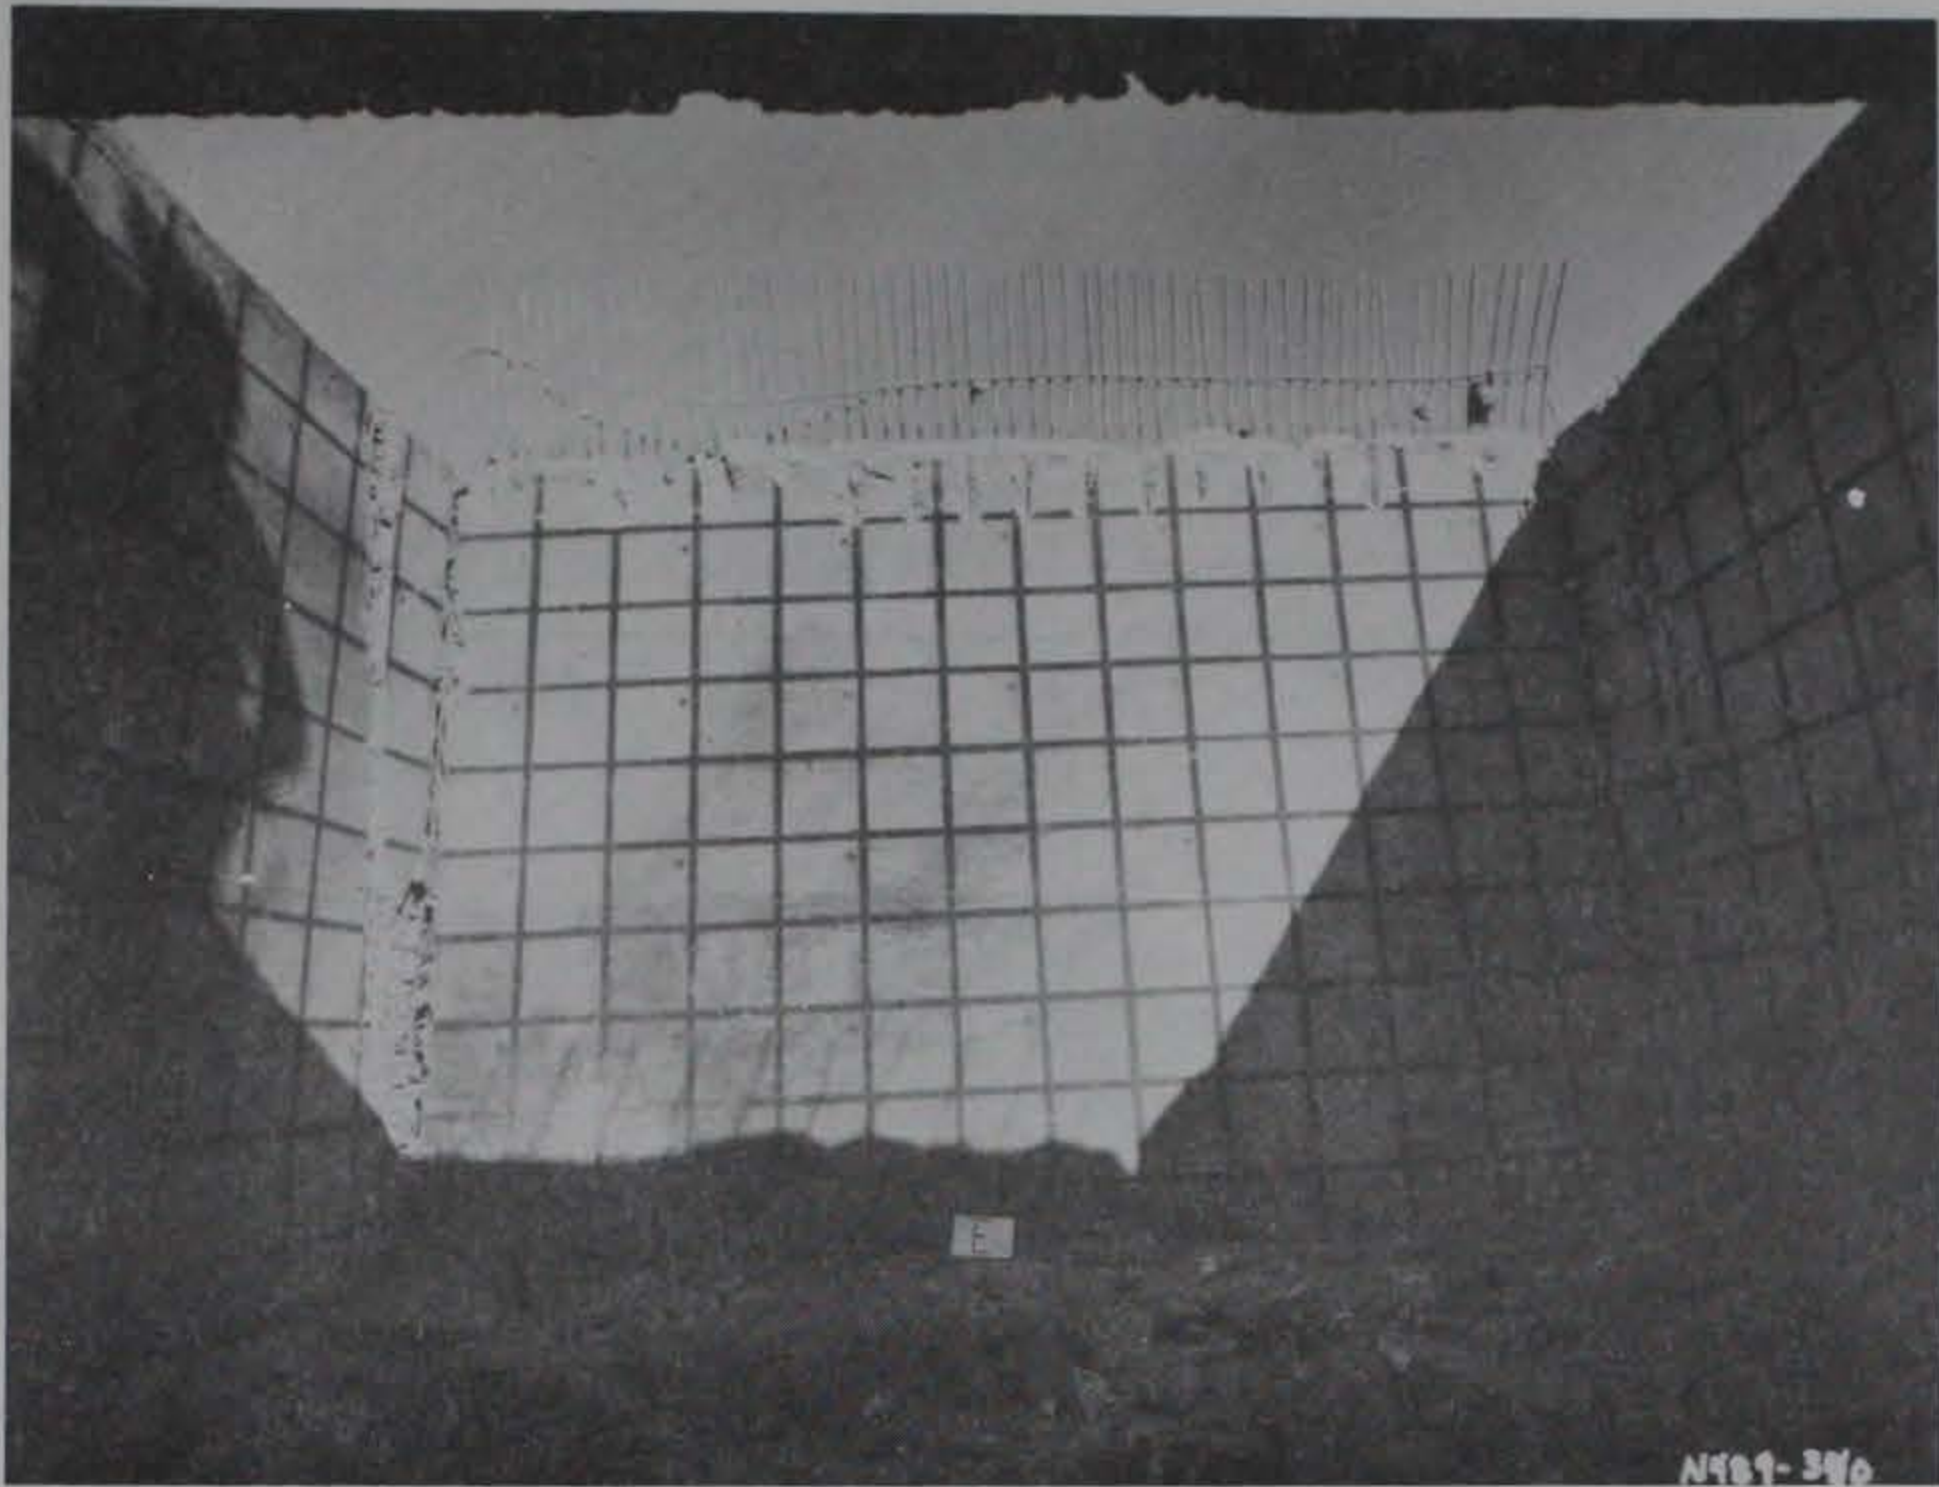
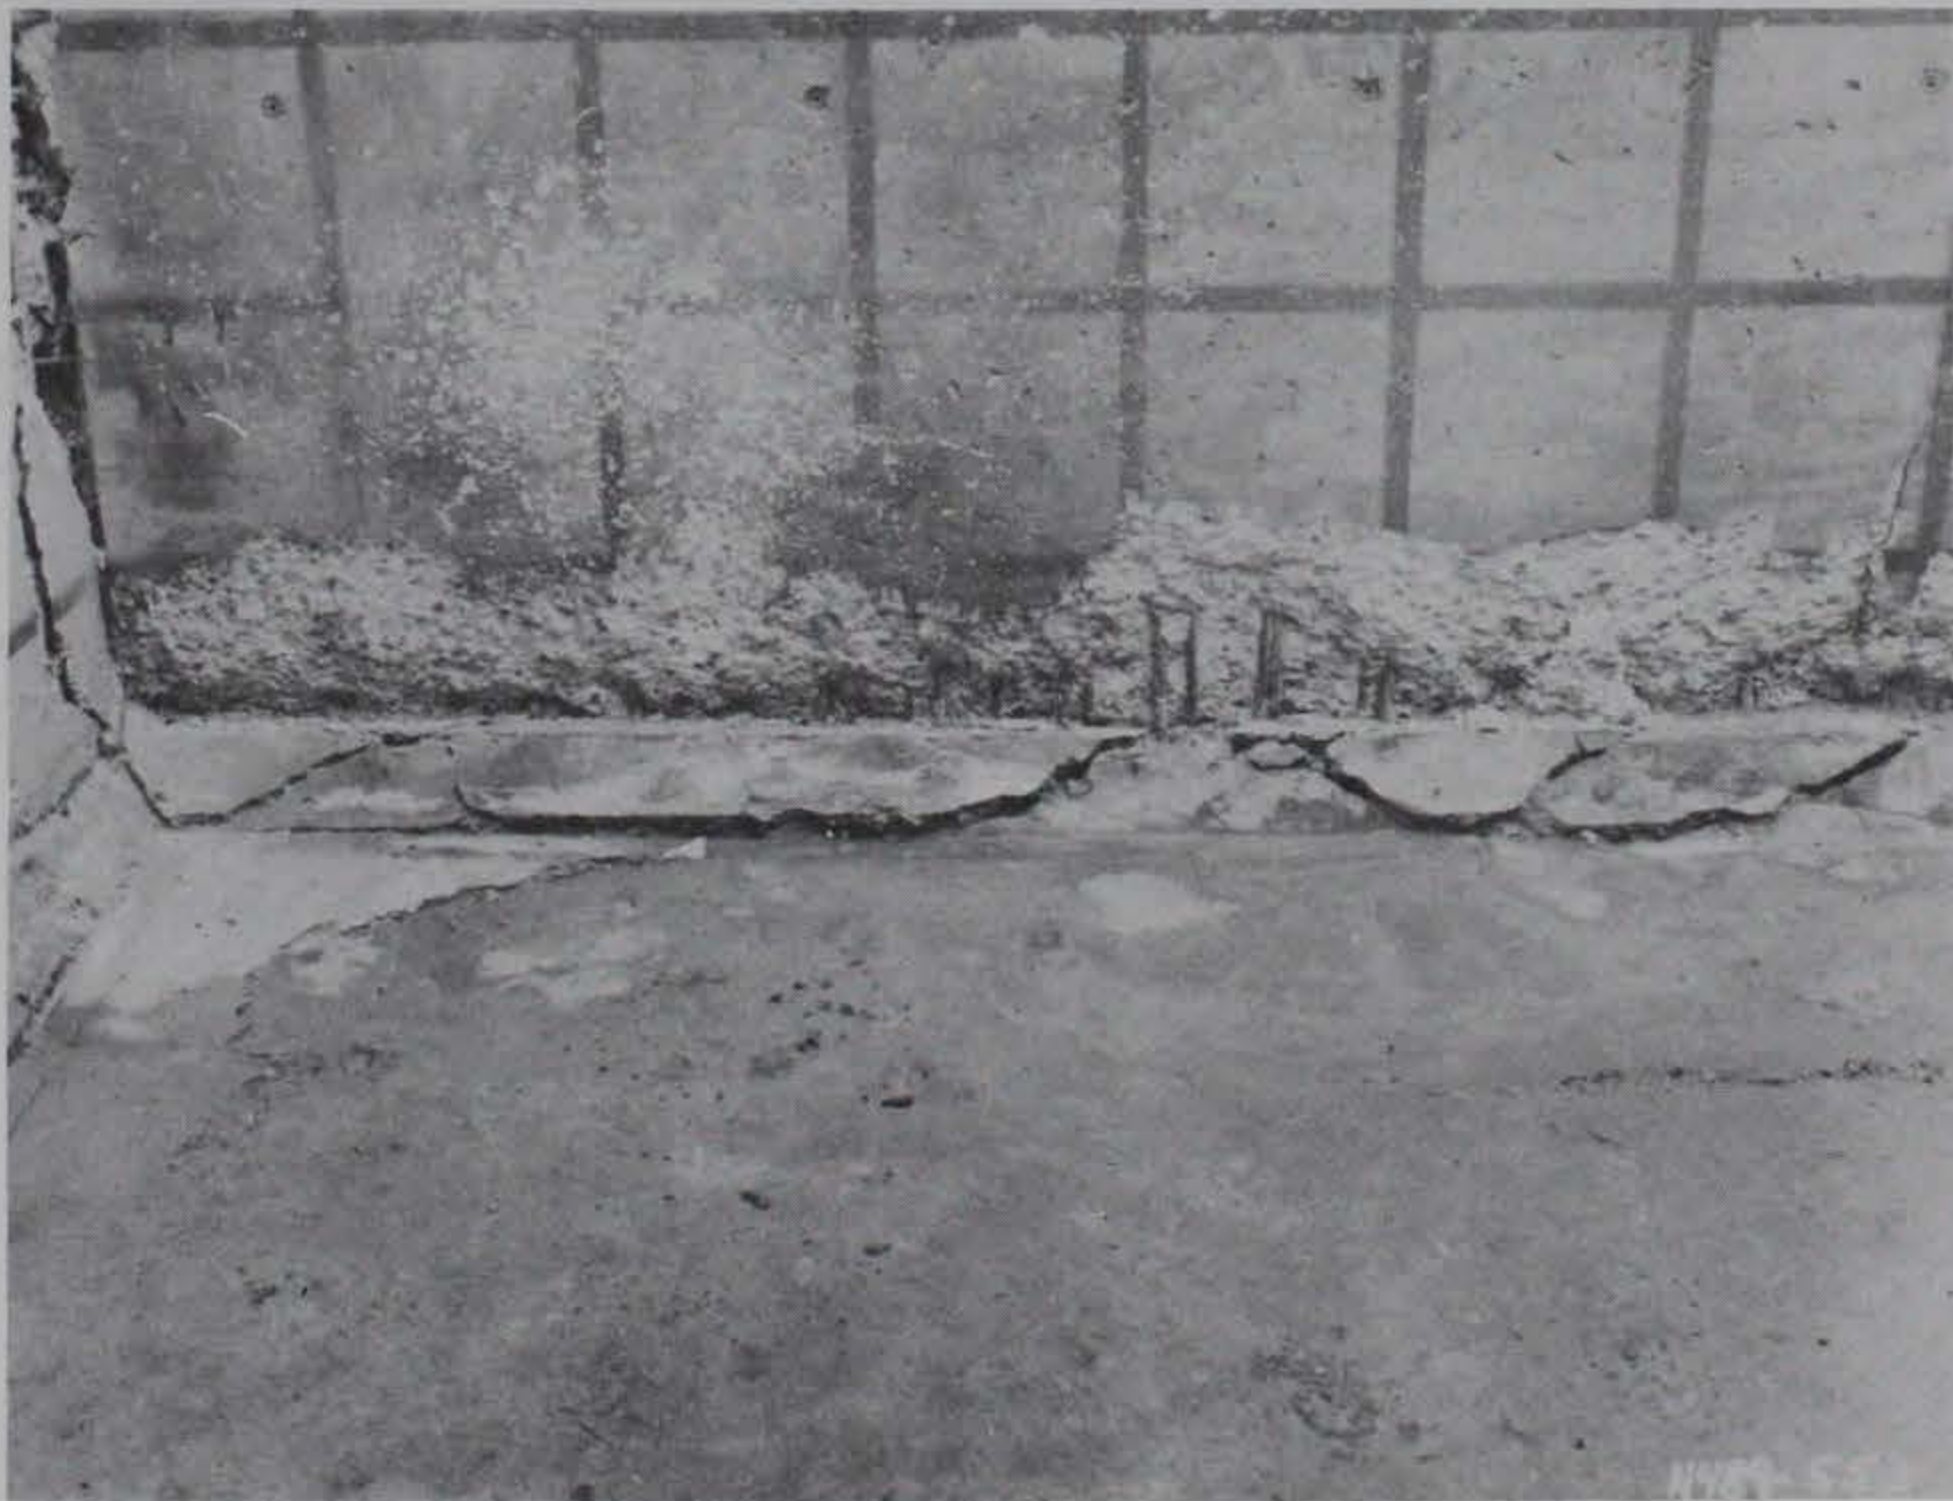
Figure 5.8. Posttest view of donor bay east wall.

b. Damage to lower north corner.

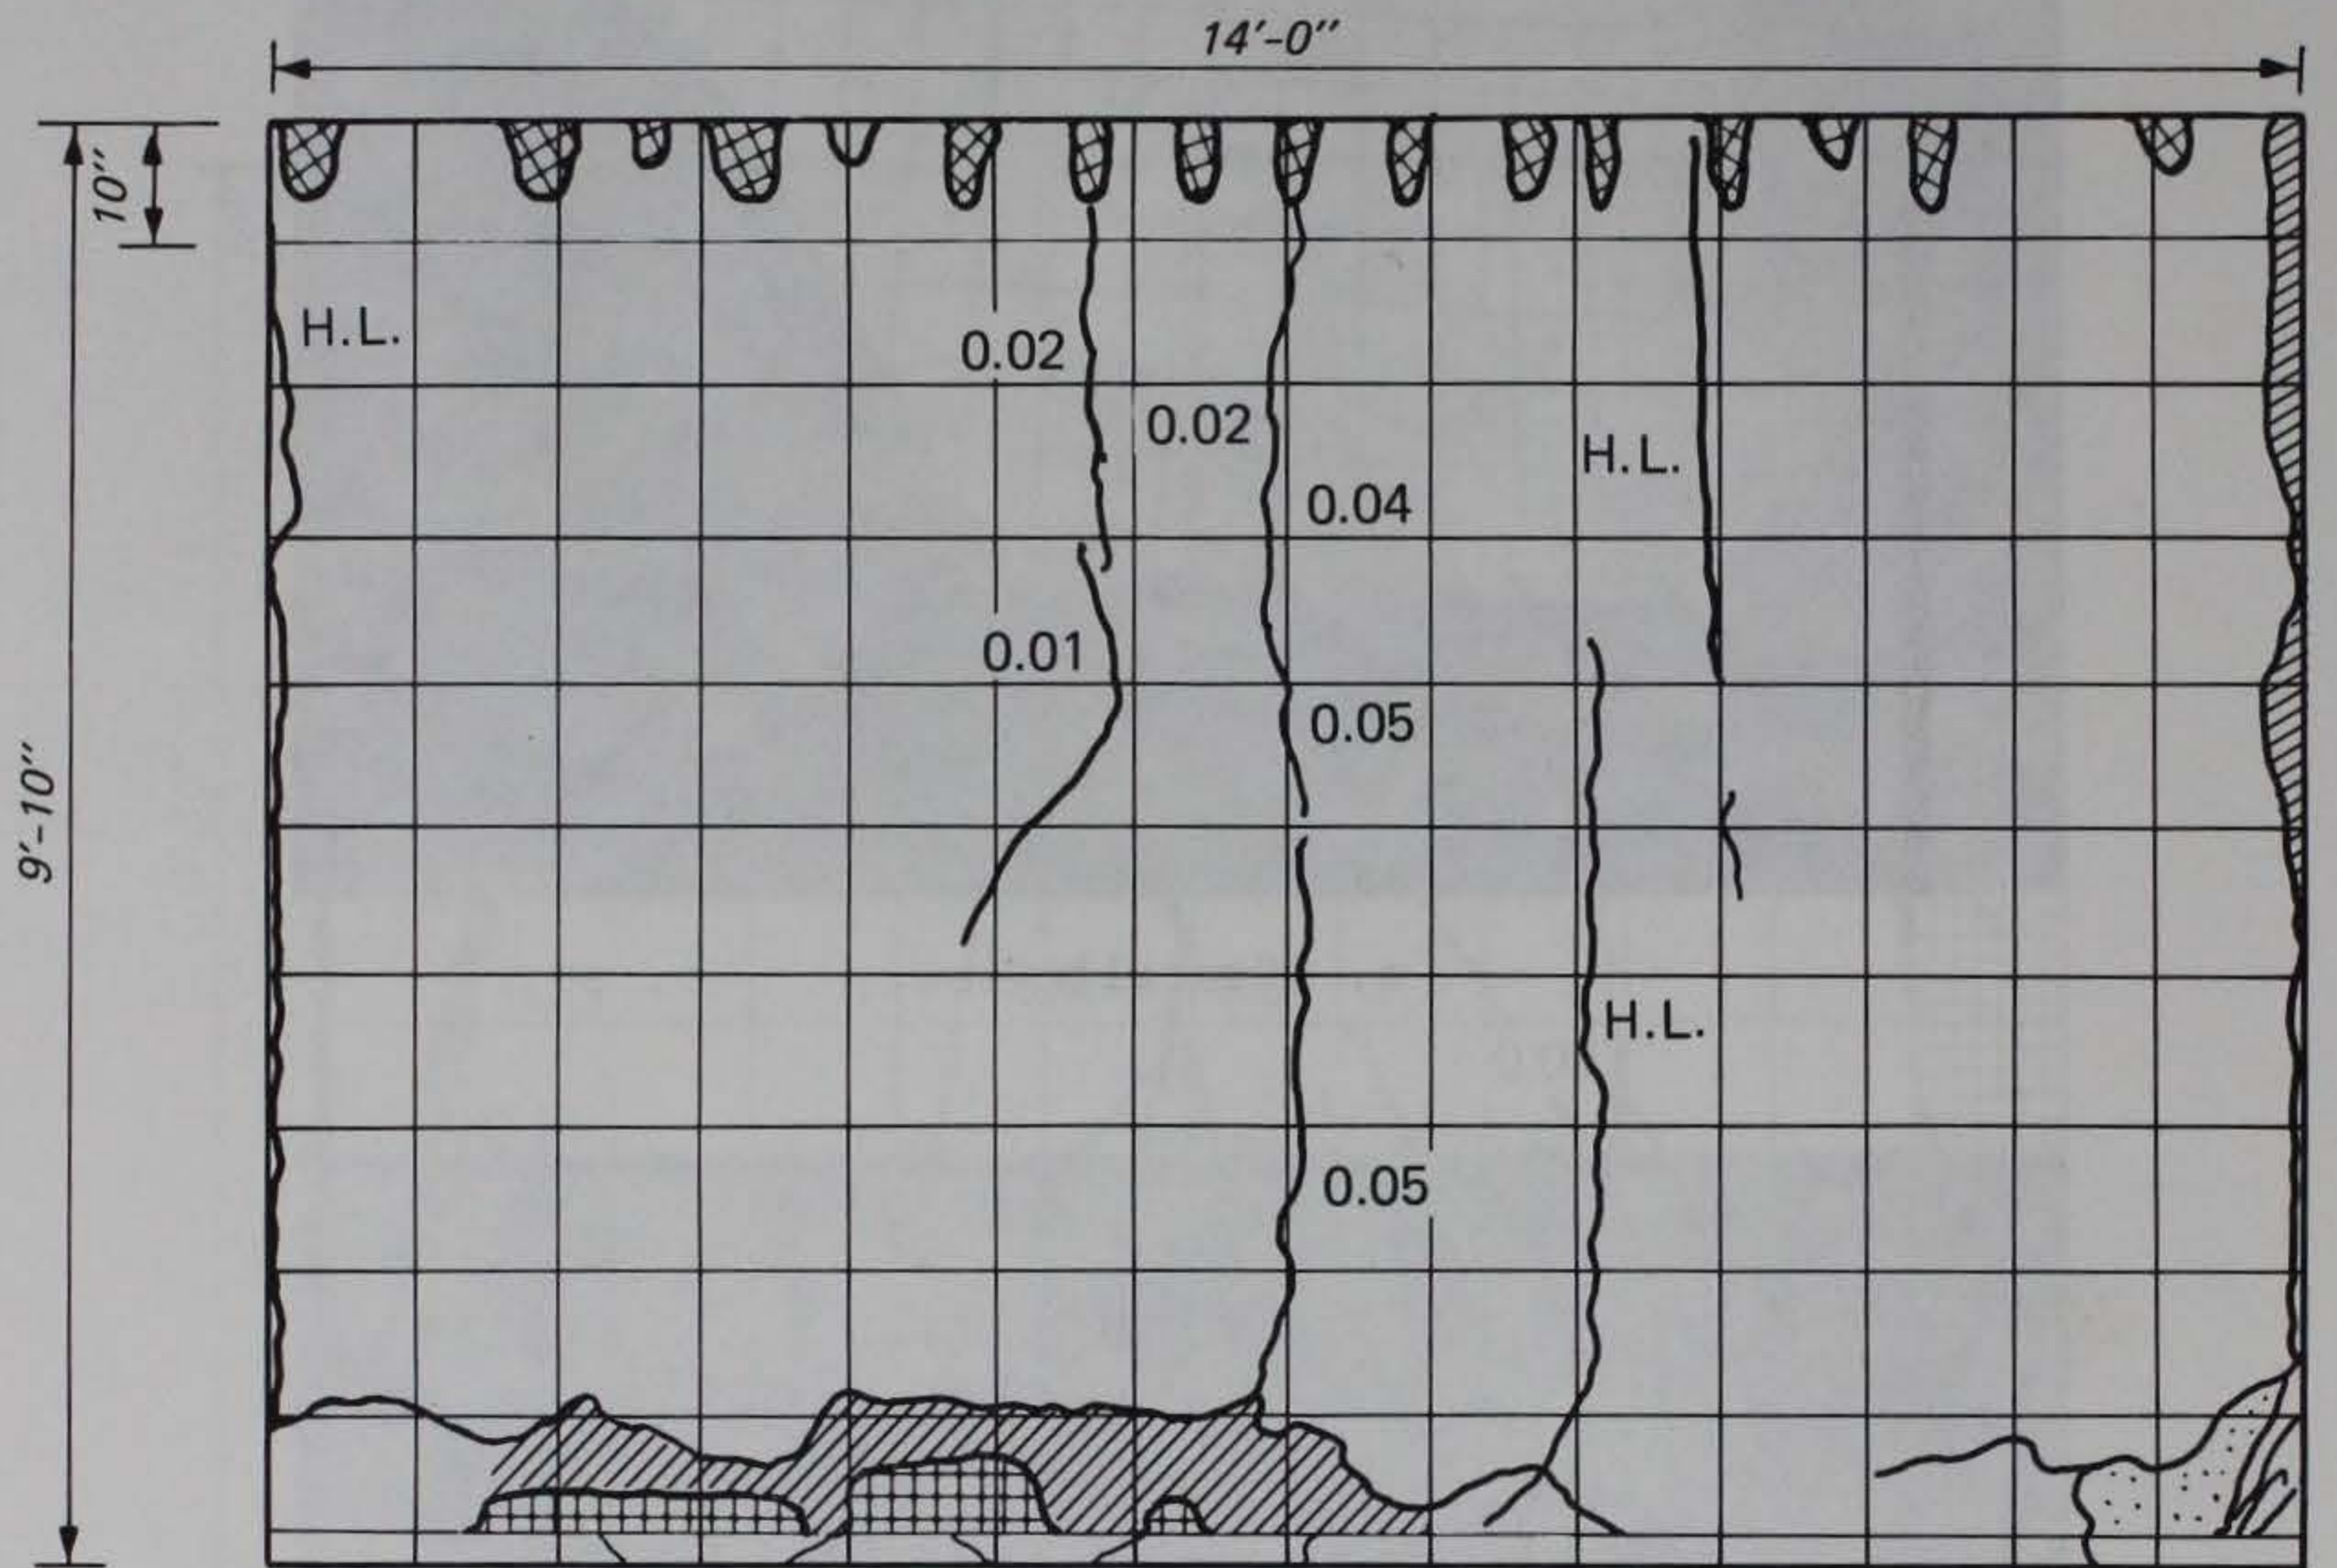
Figure 5.9. Posttest damage to east donor bay wall.

REBAR PULLED OUT OF CONCRETE
- H.L. HAIRLINE CRACKS
