TECHNICAL REPORT SL-83-6

AN EVALUATION OF THE SEPARATED BAY CONCEPT FOR A MUNITION ASSEMBLY COMPLEX; AN EXPERIMENTAL INVESTIGATION OF THE DEPARTMENT OF ENERGY BUILDING 12-64 COMPLEX

Robert D. Volz, Sam A. Kiger

September 1983

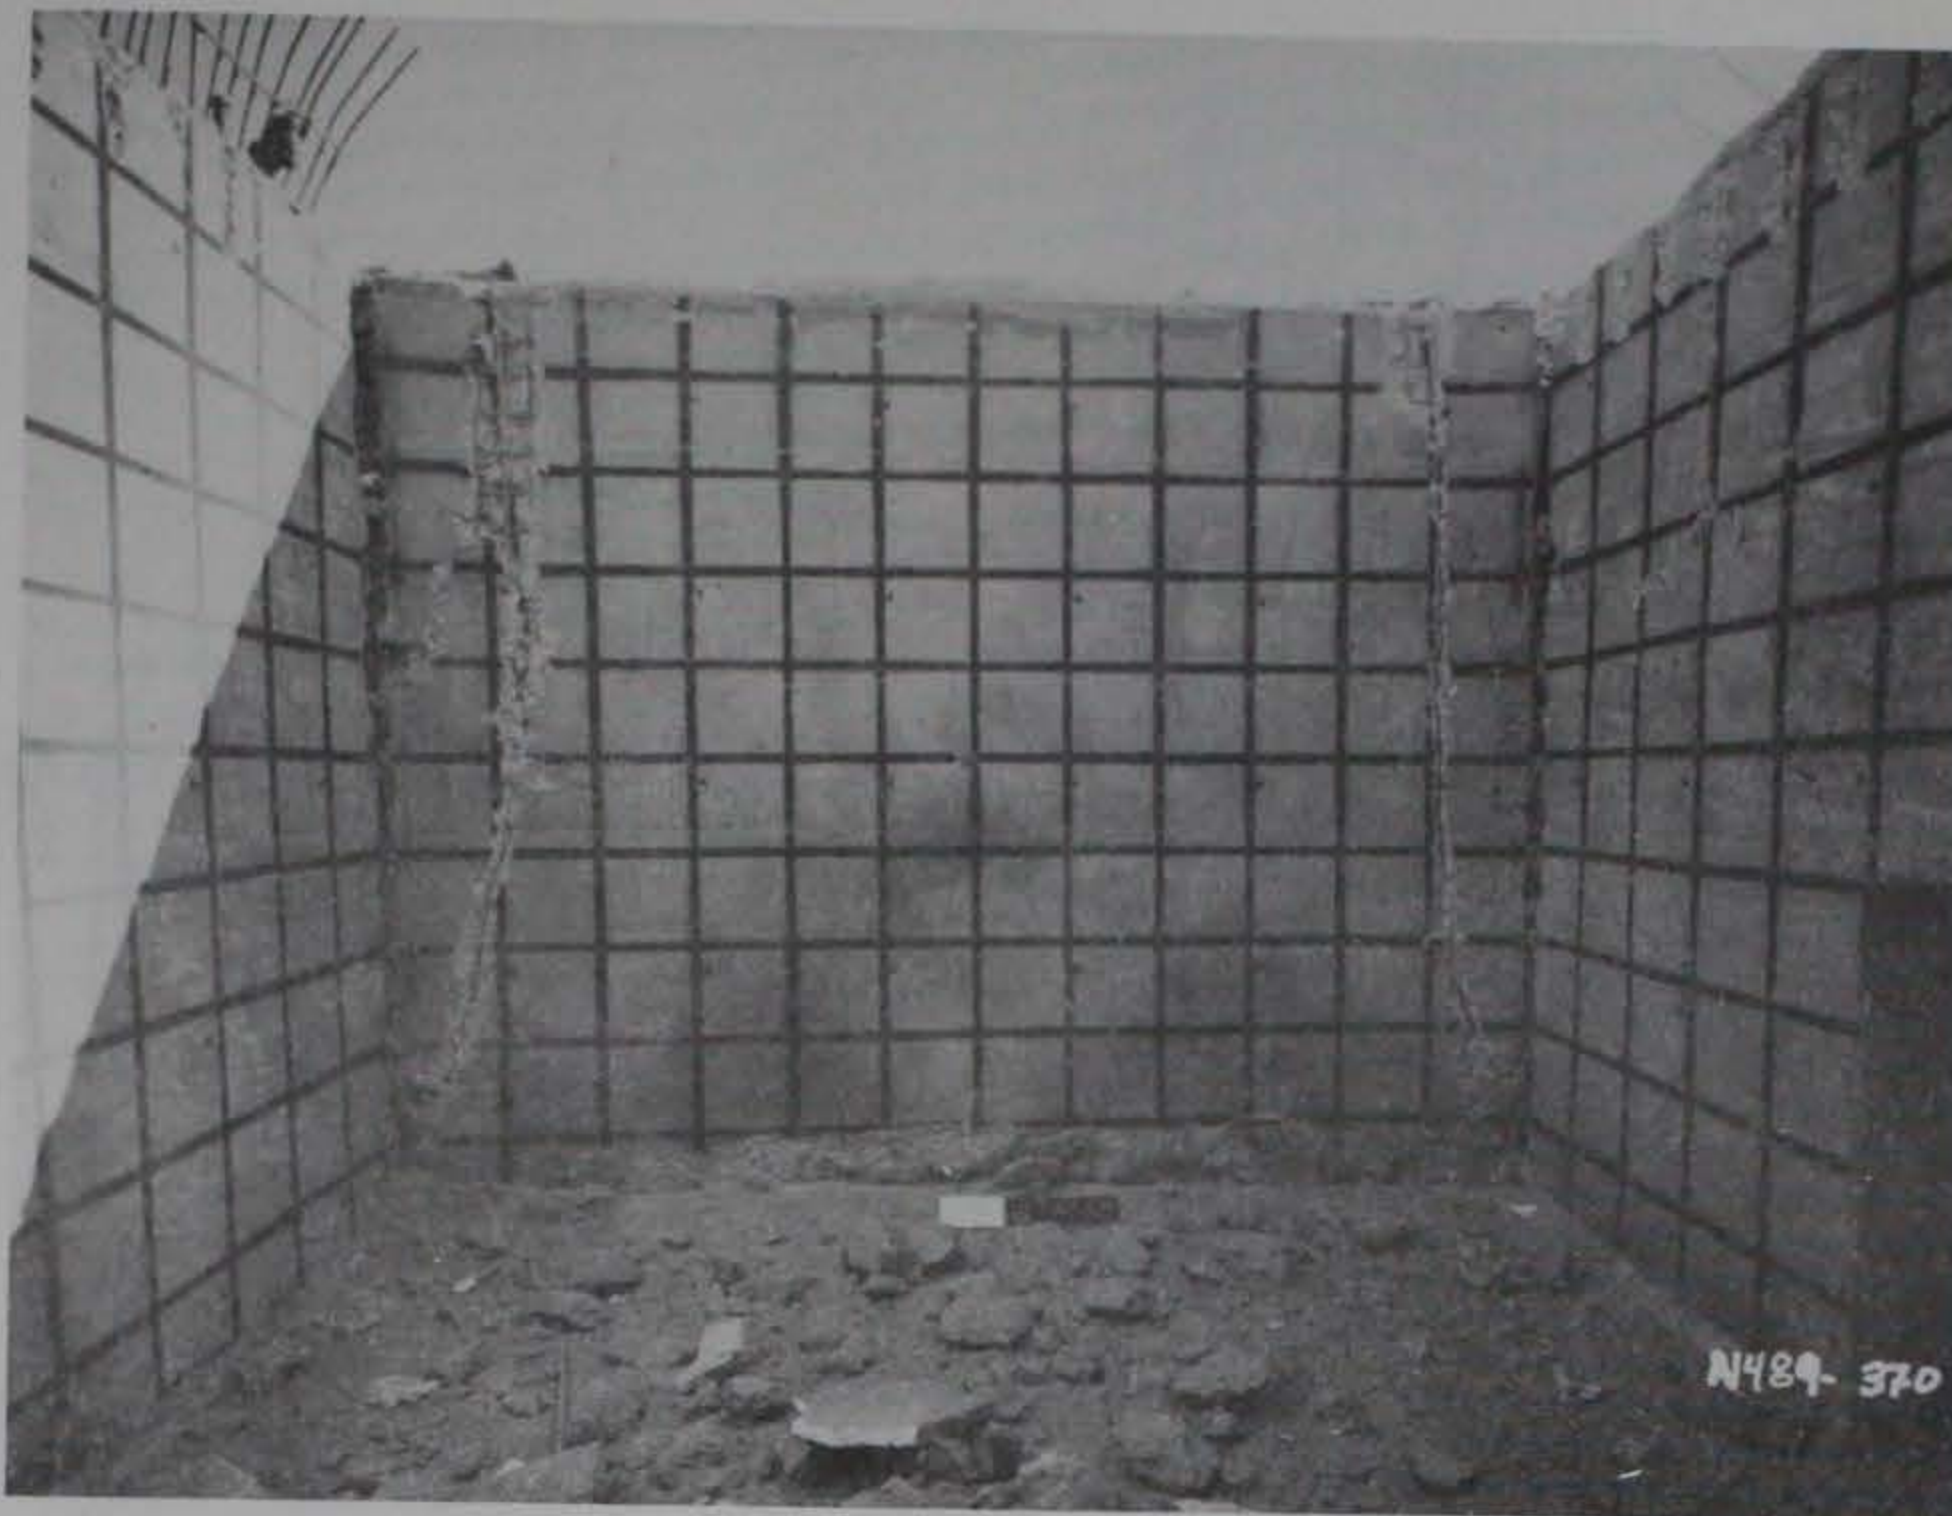
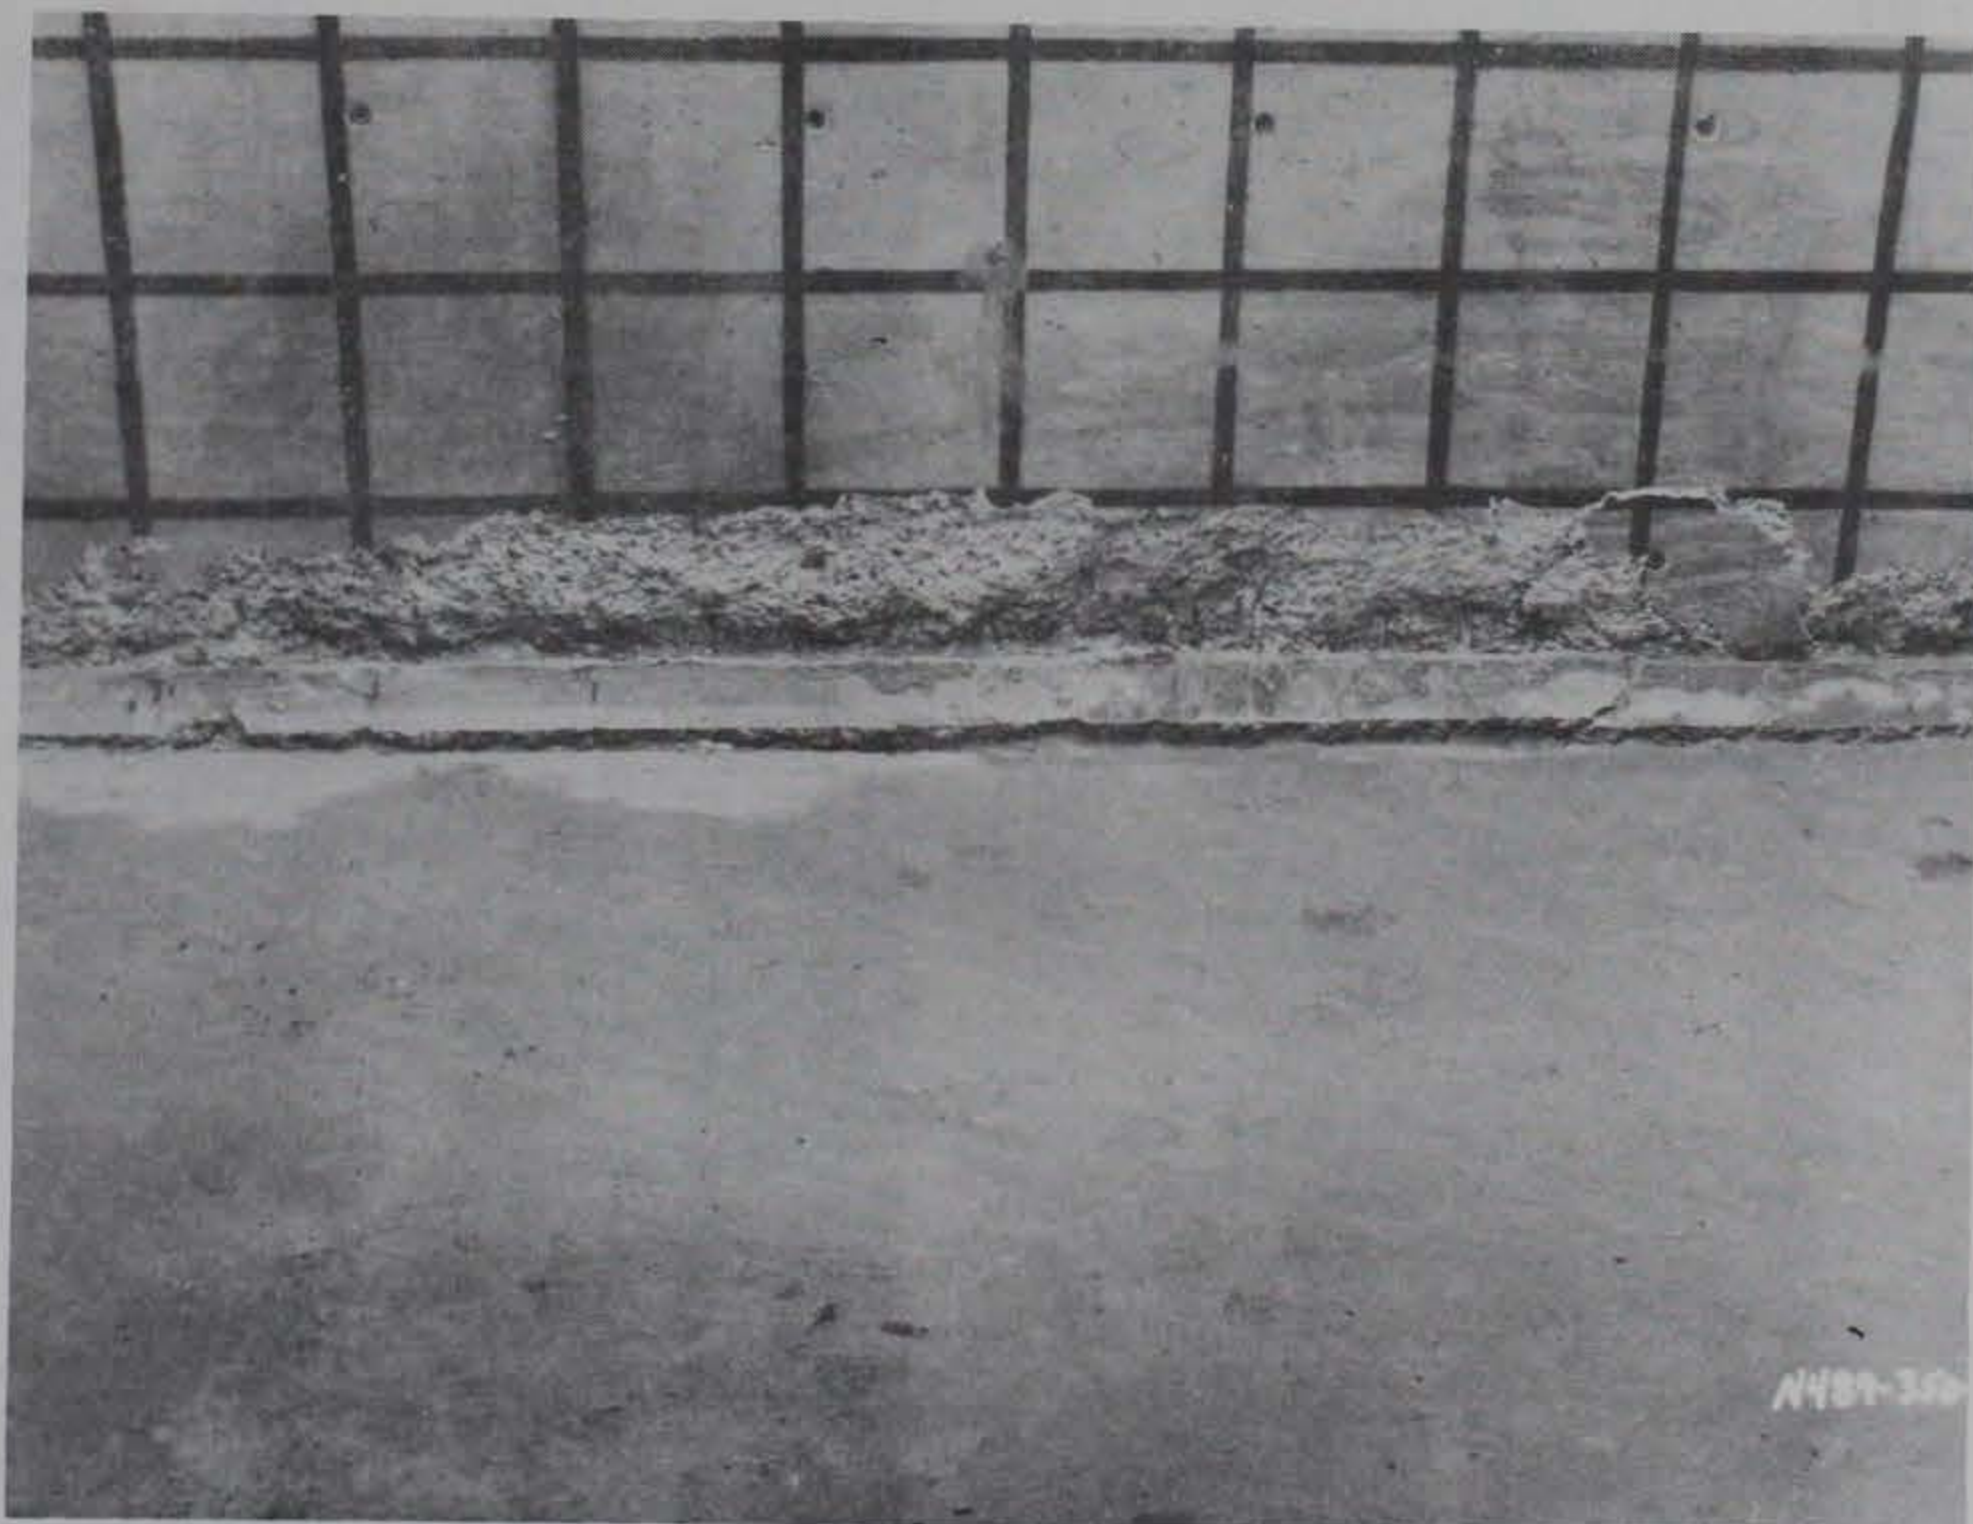
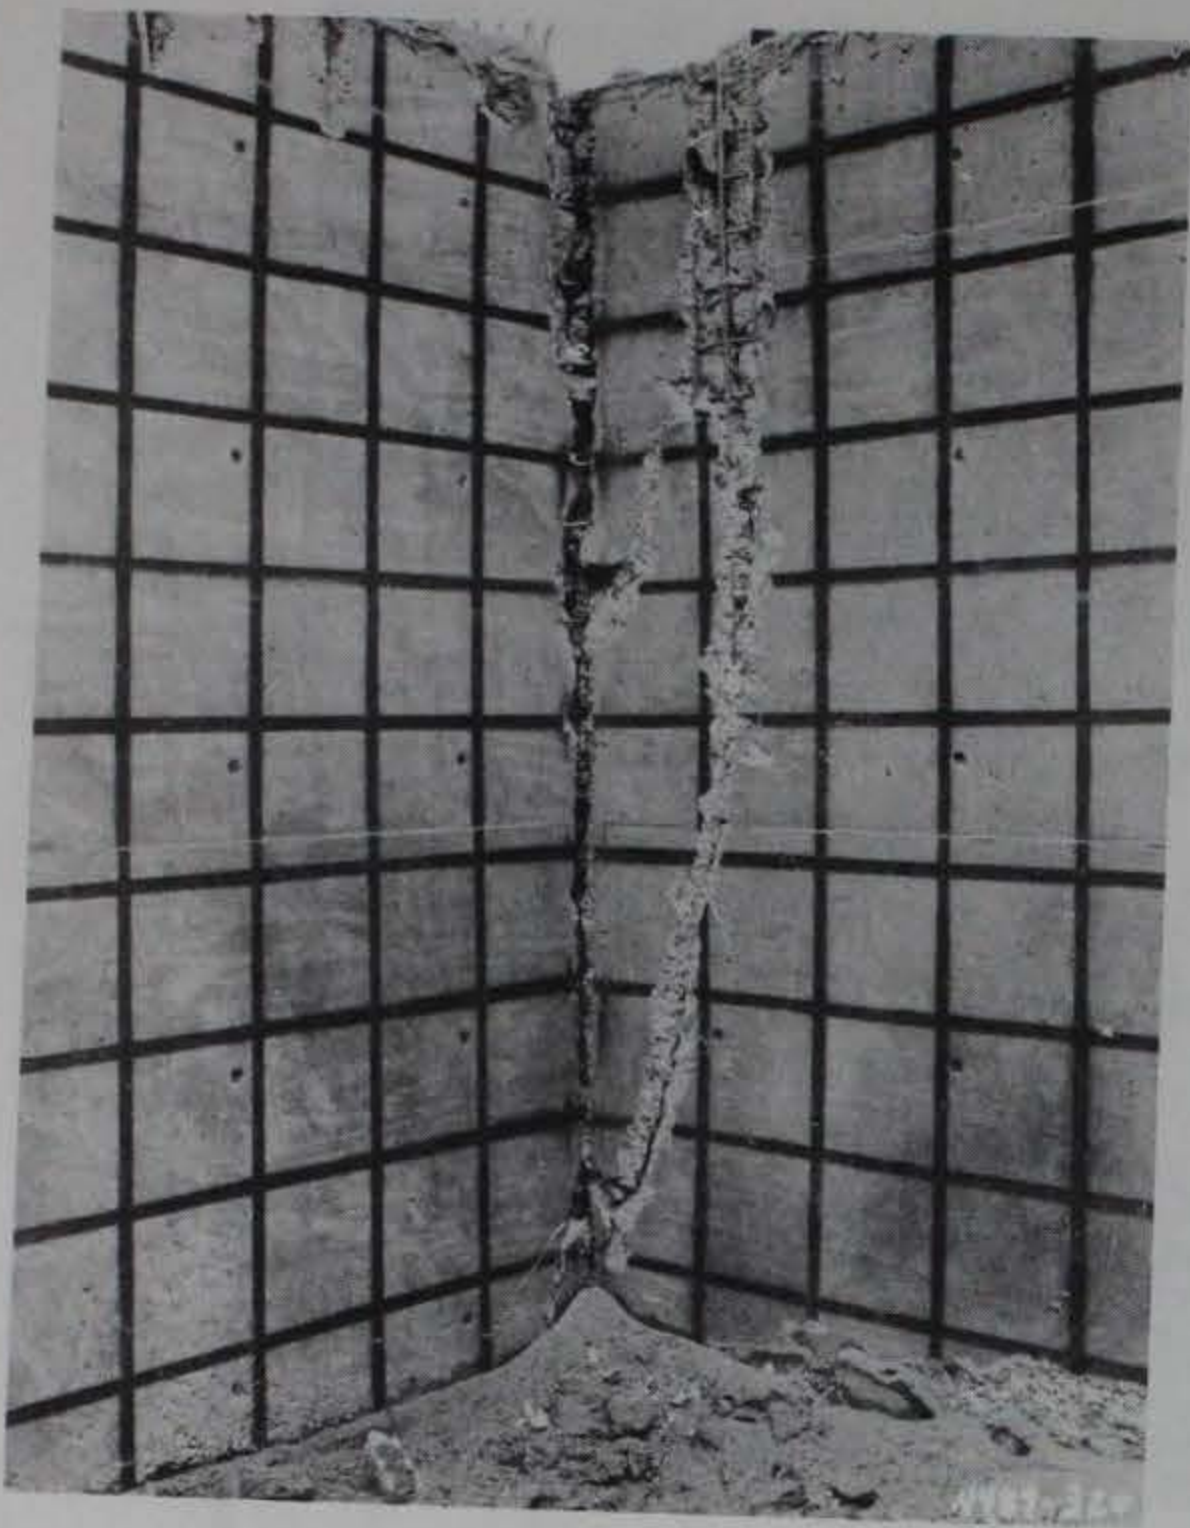
Figure 5.10. Posttest view of south donor bay wall (Sheet 1 of 2).

b. Damage to lower edge.

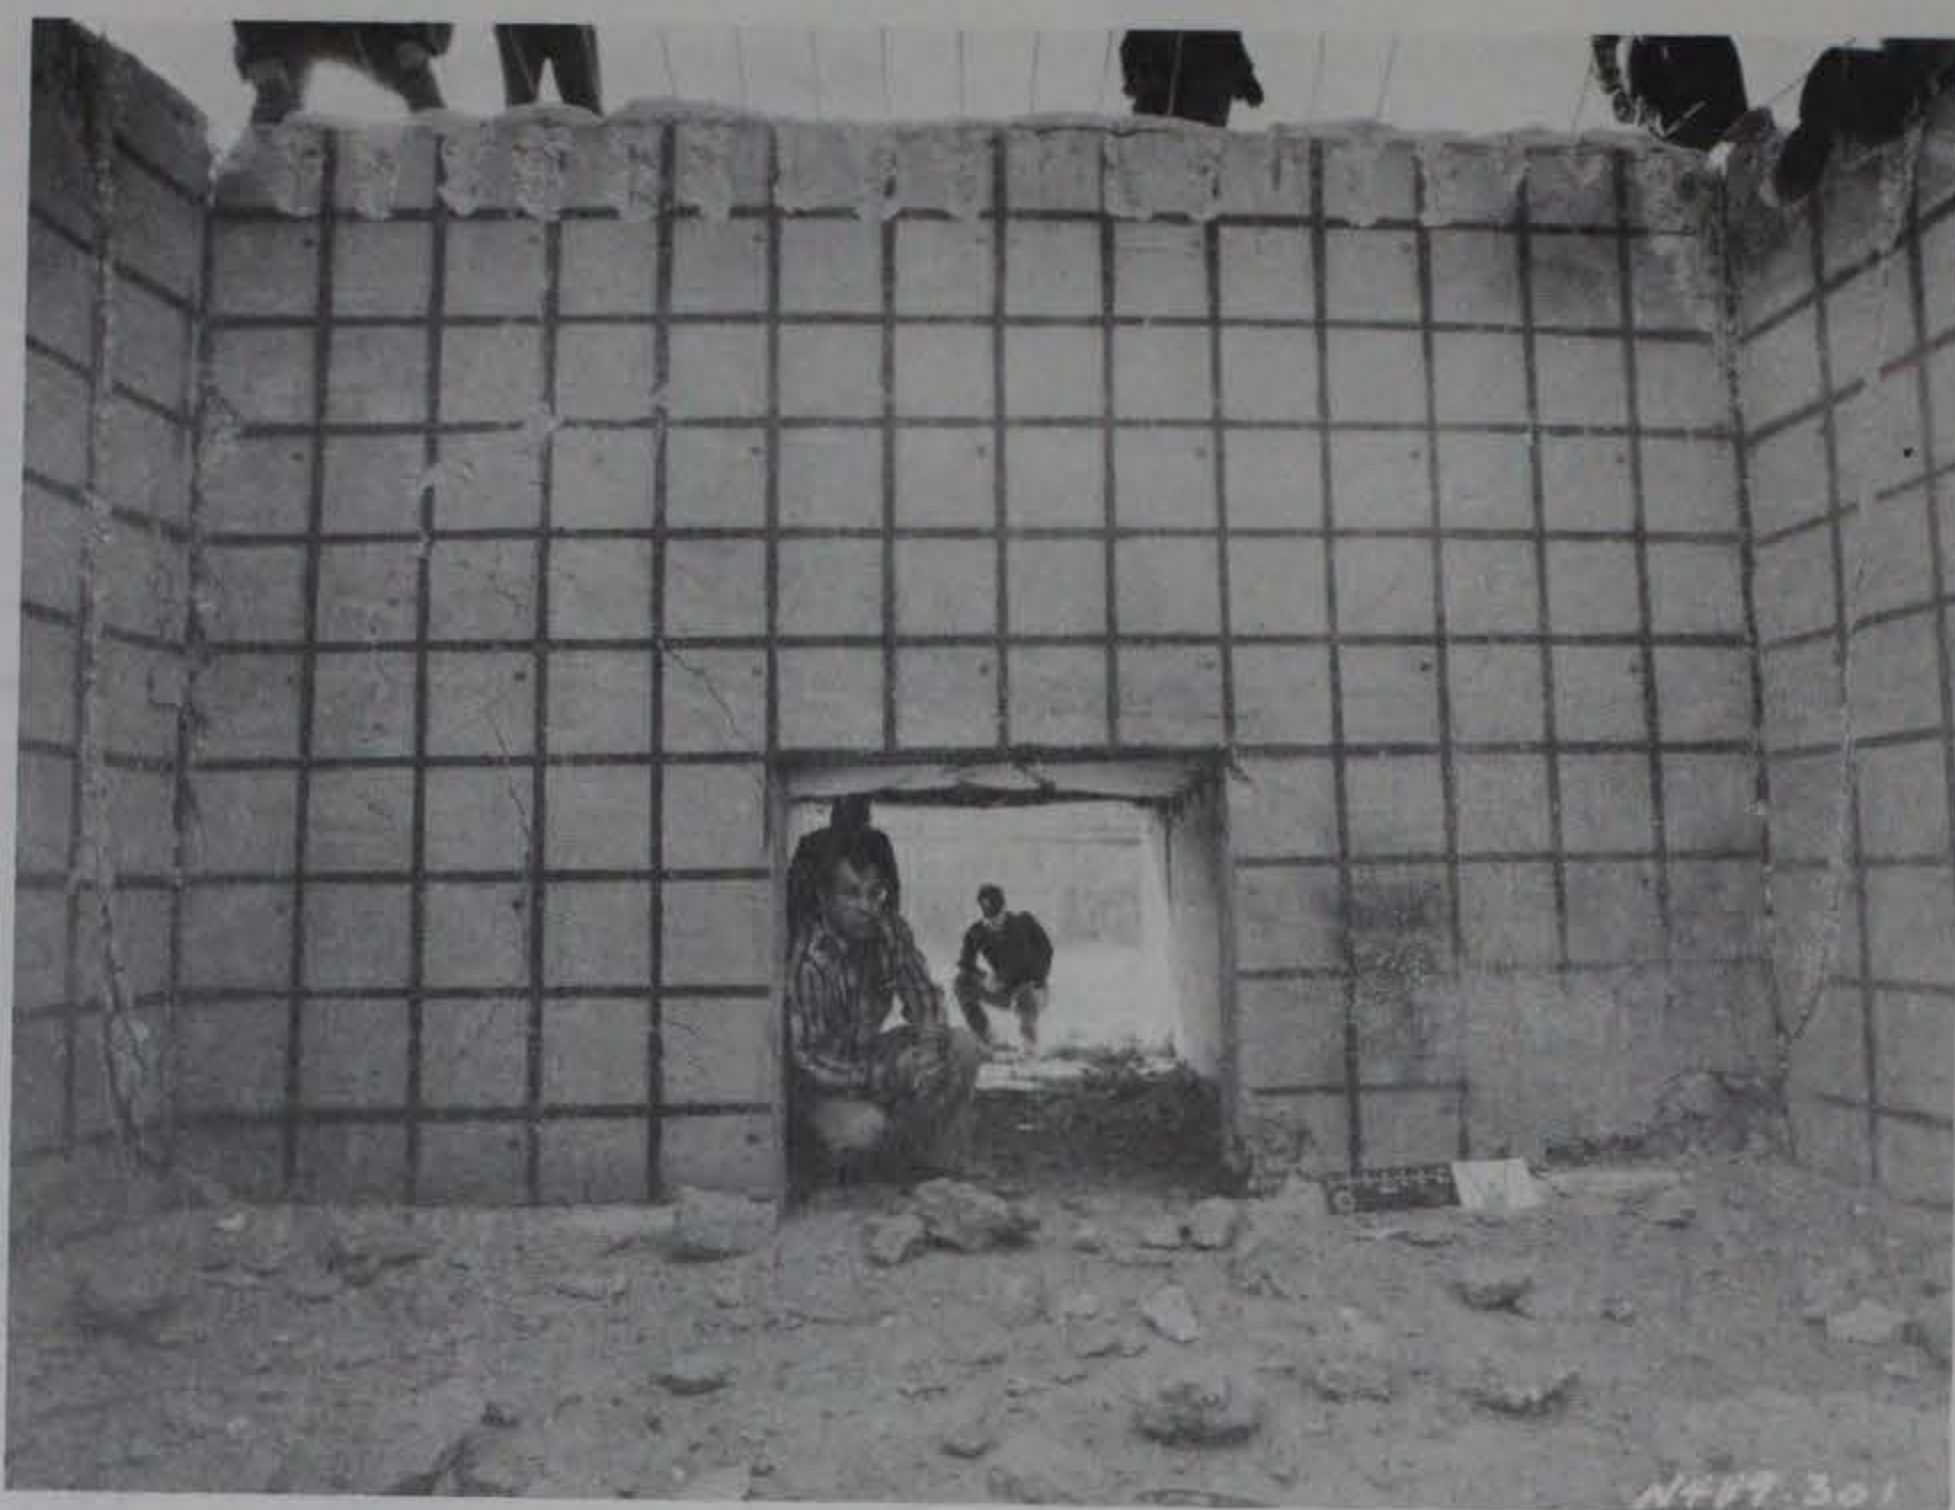
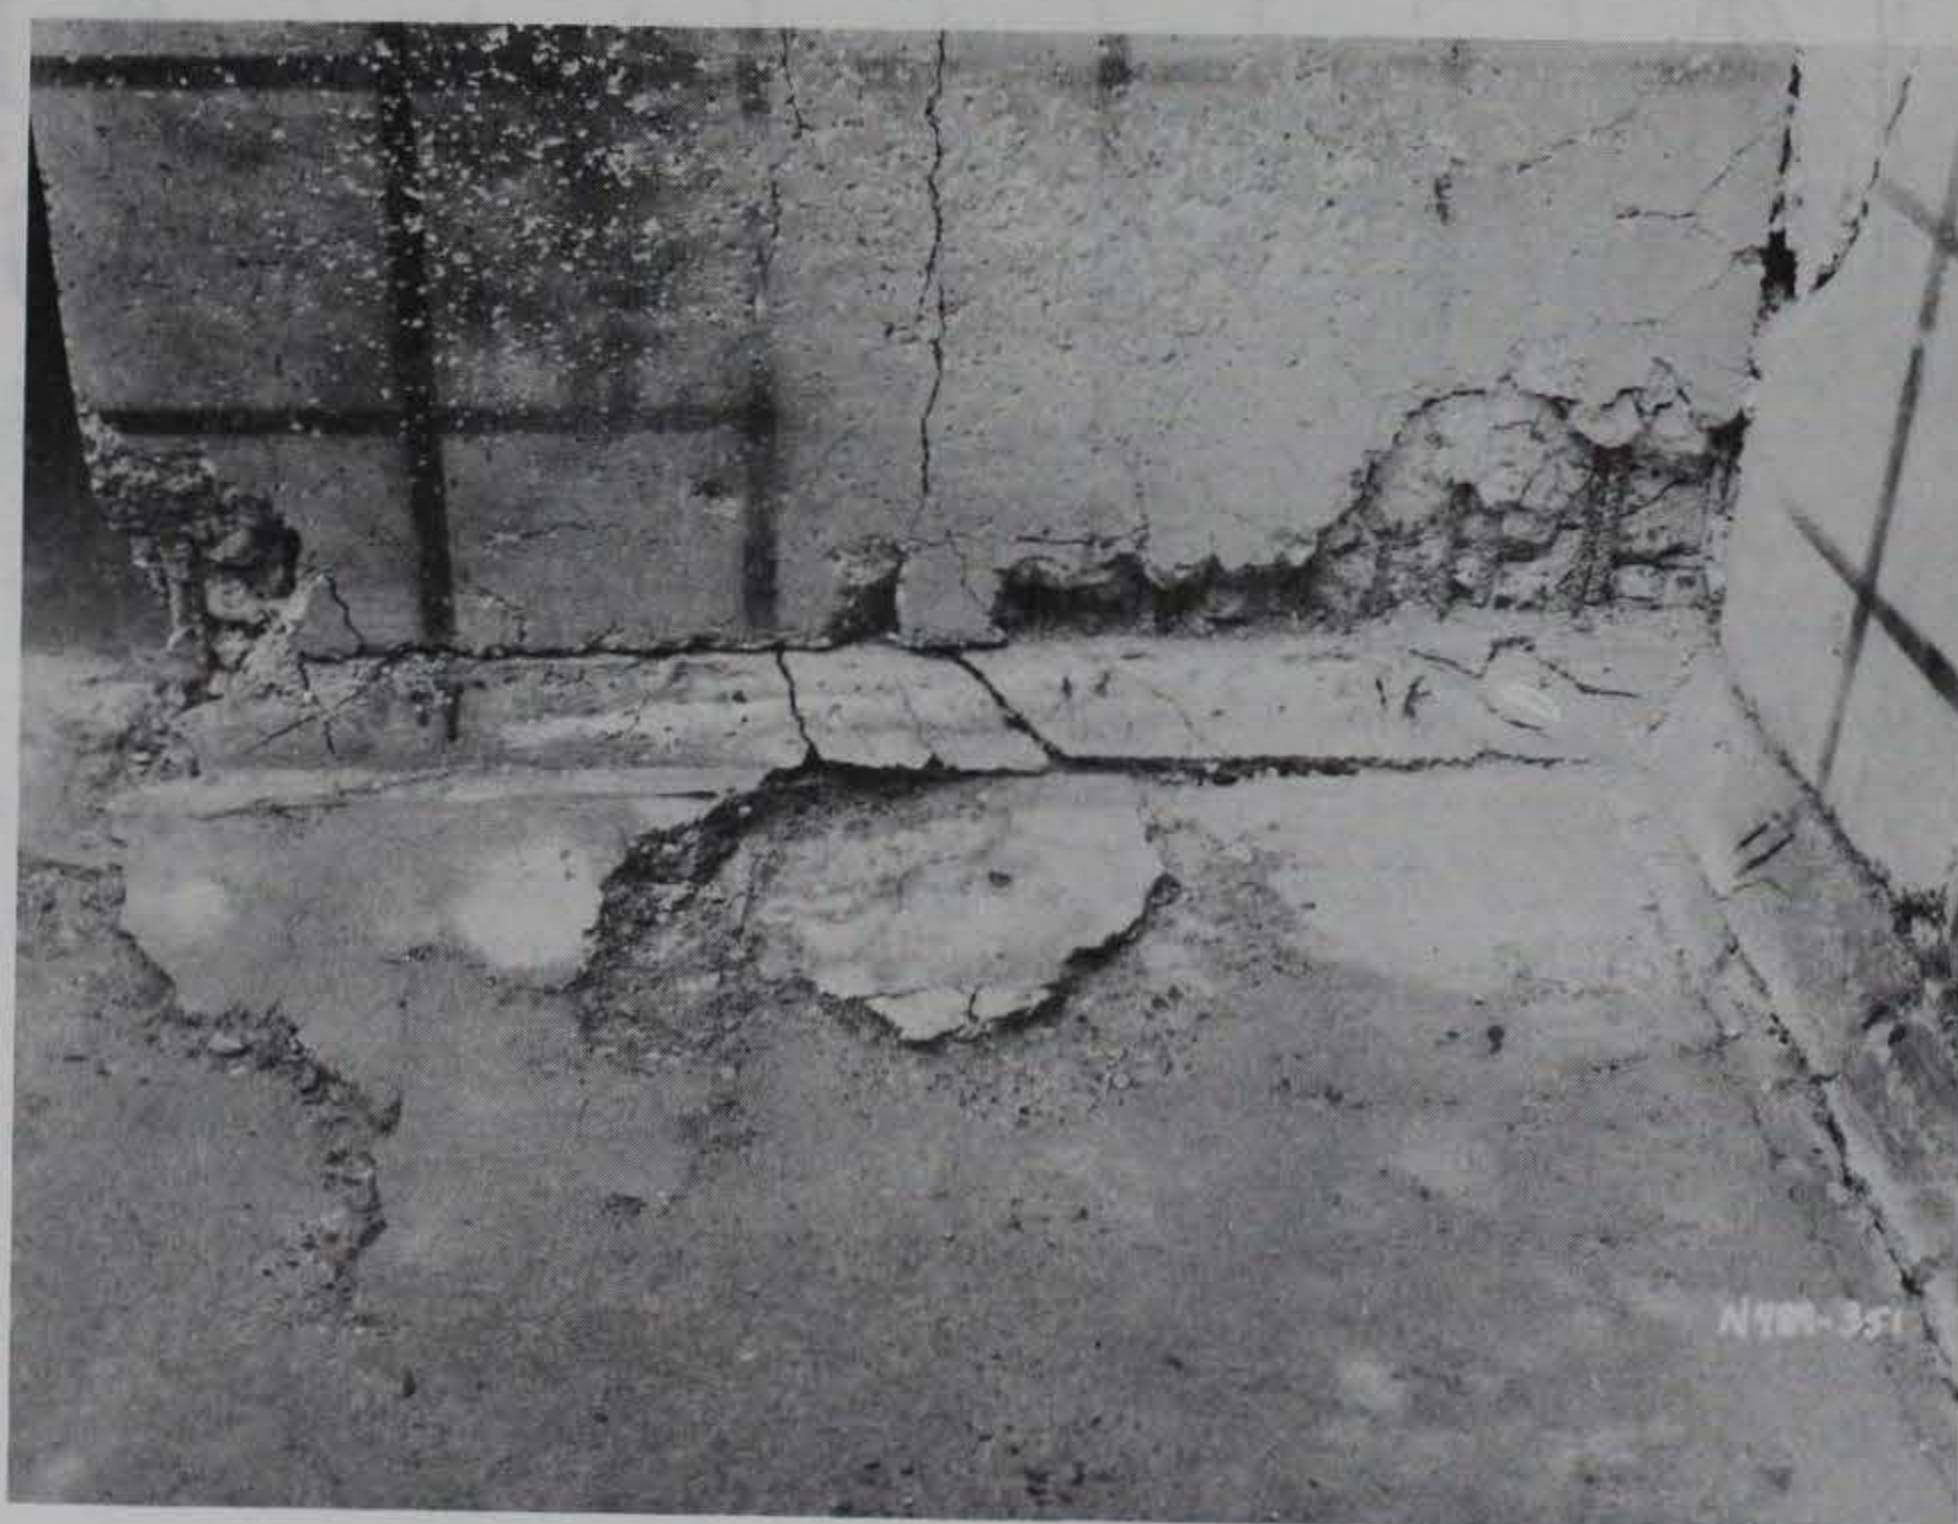
Figure 5.12. Posttest view of west donor bay wall.

b. Damage to lower north corner.

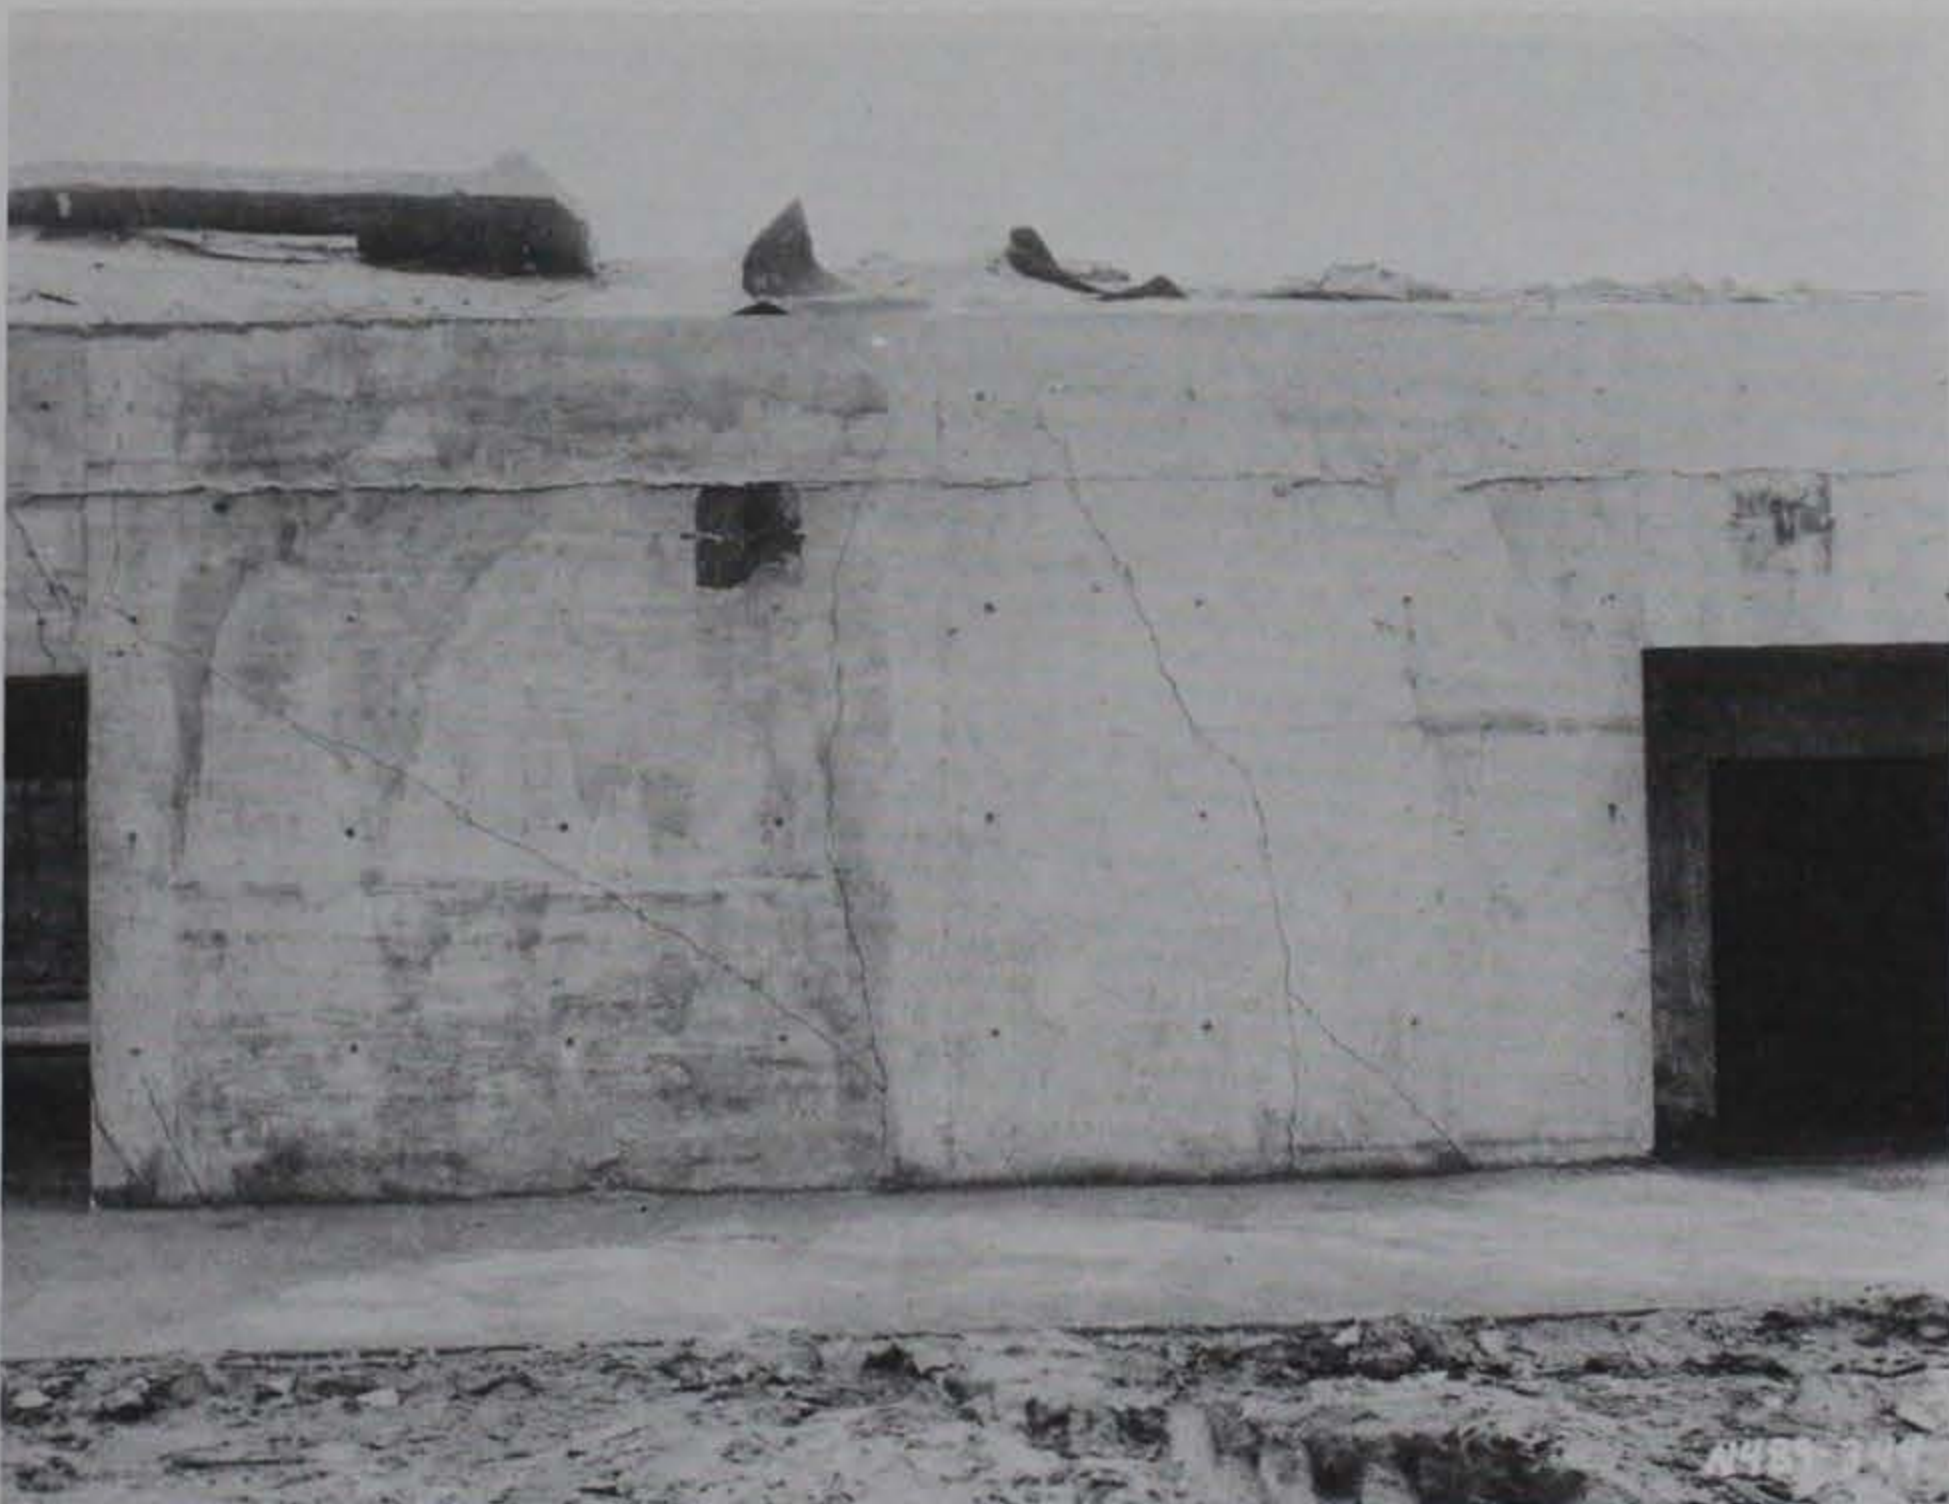
Figure 5.23. Posttest cracking in retaining wall.

b. South of donor air lock.

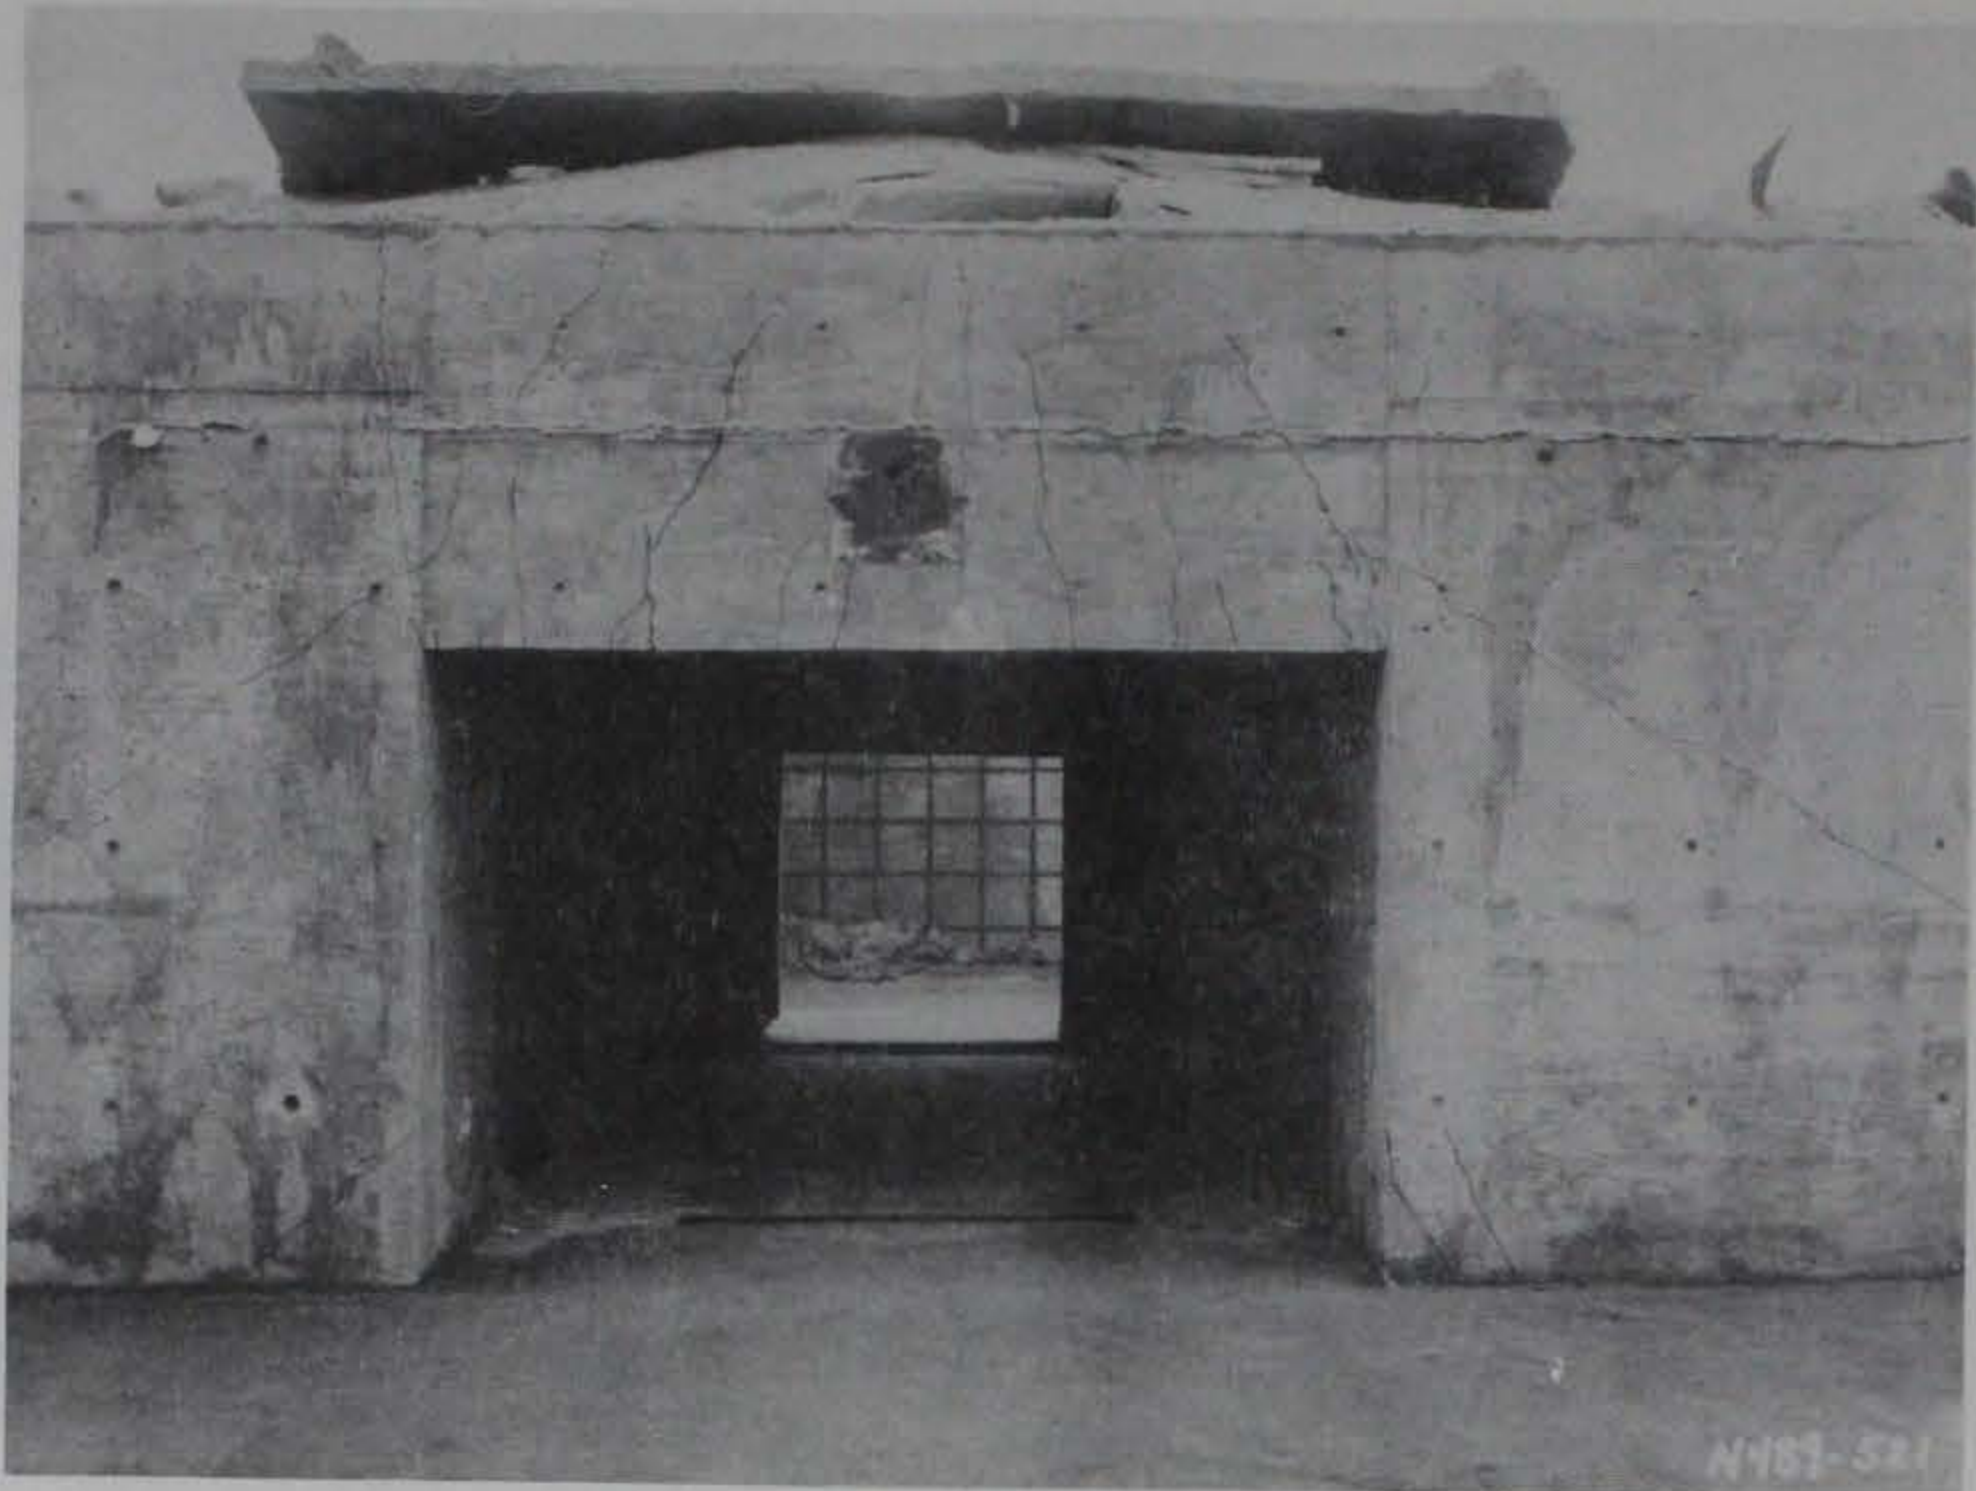
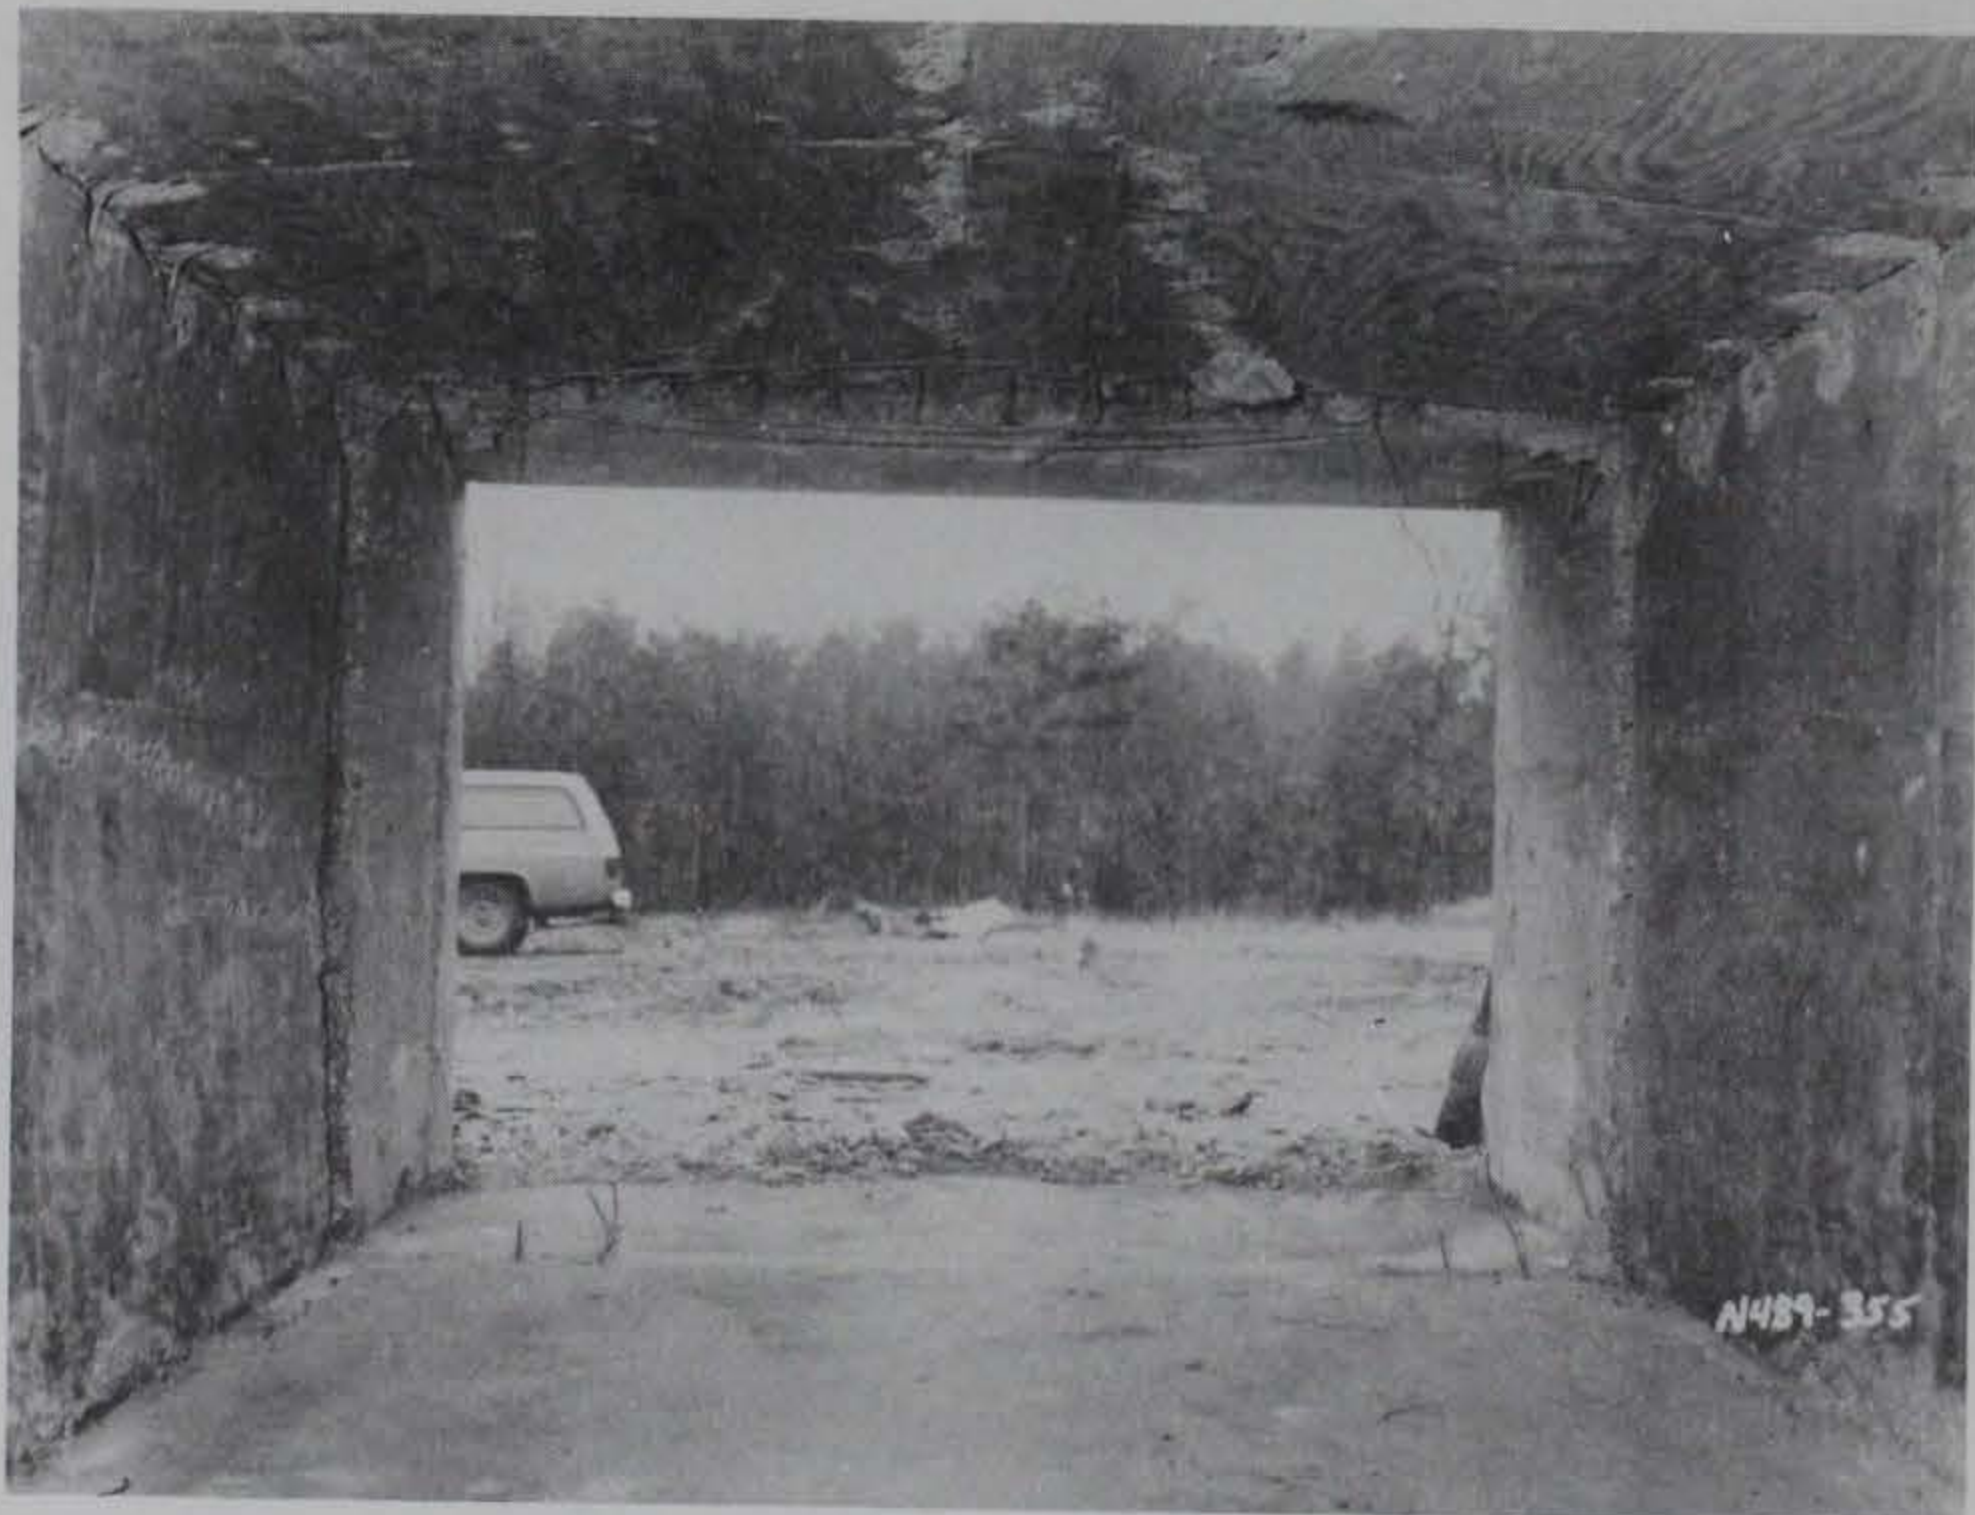
Figure 5.24. Damage to donor bay air lock.

a. Exterior view.

b. Internal view at door bulkhead.
