TECHNICAL REPORT SL-83-6

AN EVALUATION OF THE SEPARATED BAY CONCEPT FOR A MUNITION ASSEMBLY COMPLEX; AN EXPERIMENTAL INVESTIGATION OF THE DEPARTMENT OF ENERGY BUILDING 12-64 COMPLEX

Robert D. Volz, Sam A. Kiger

September 1983

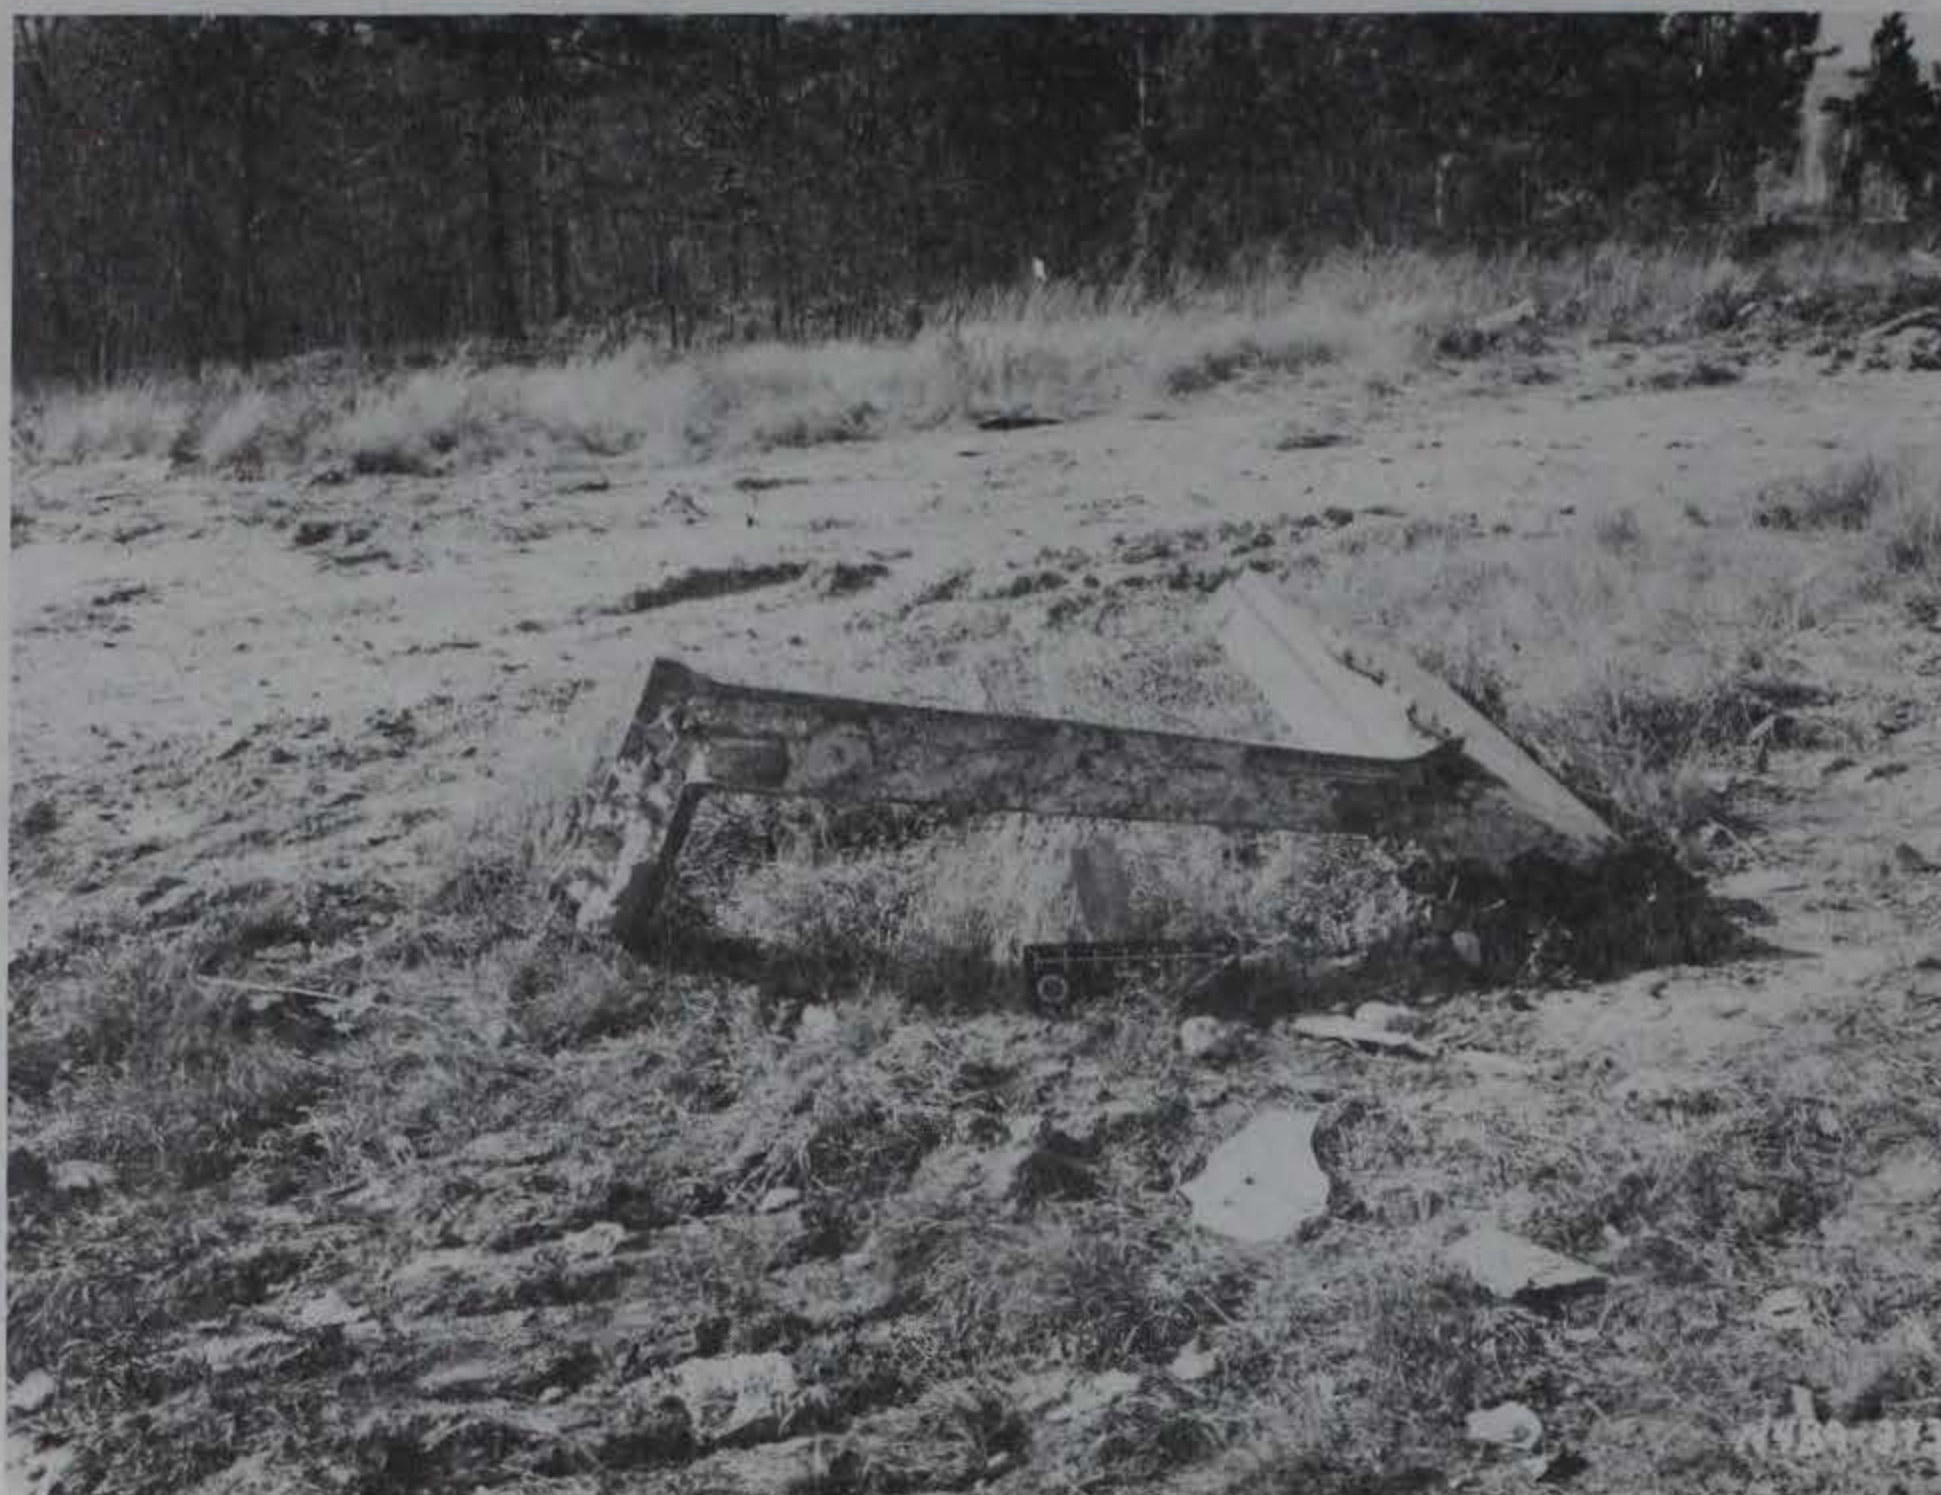
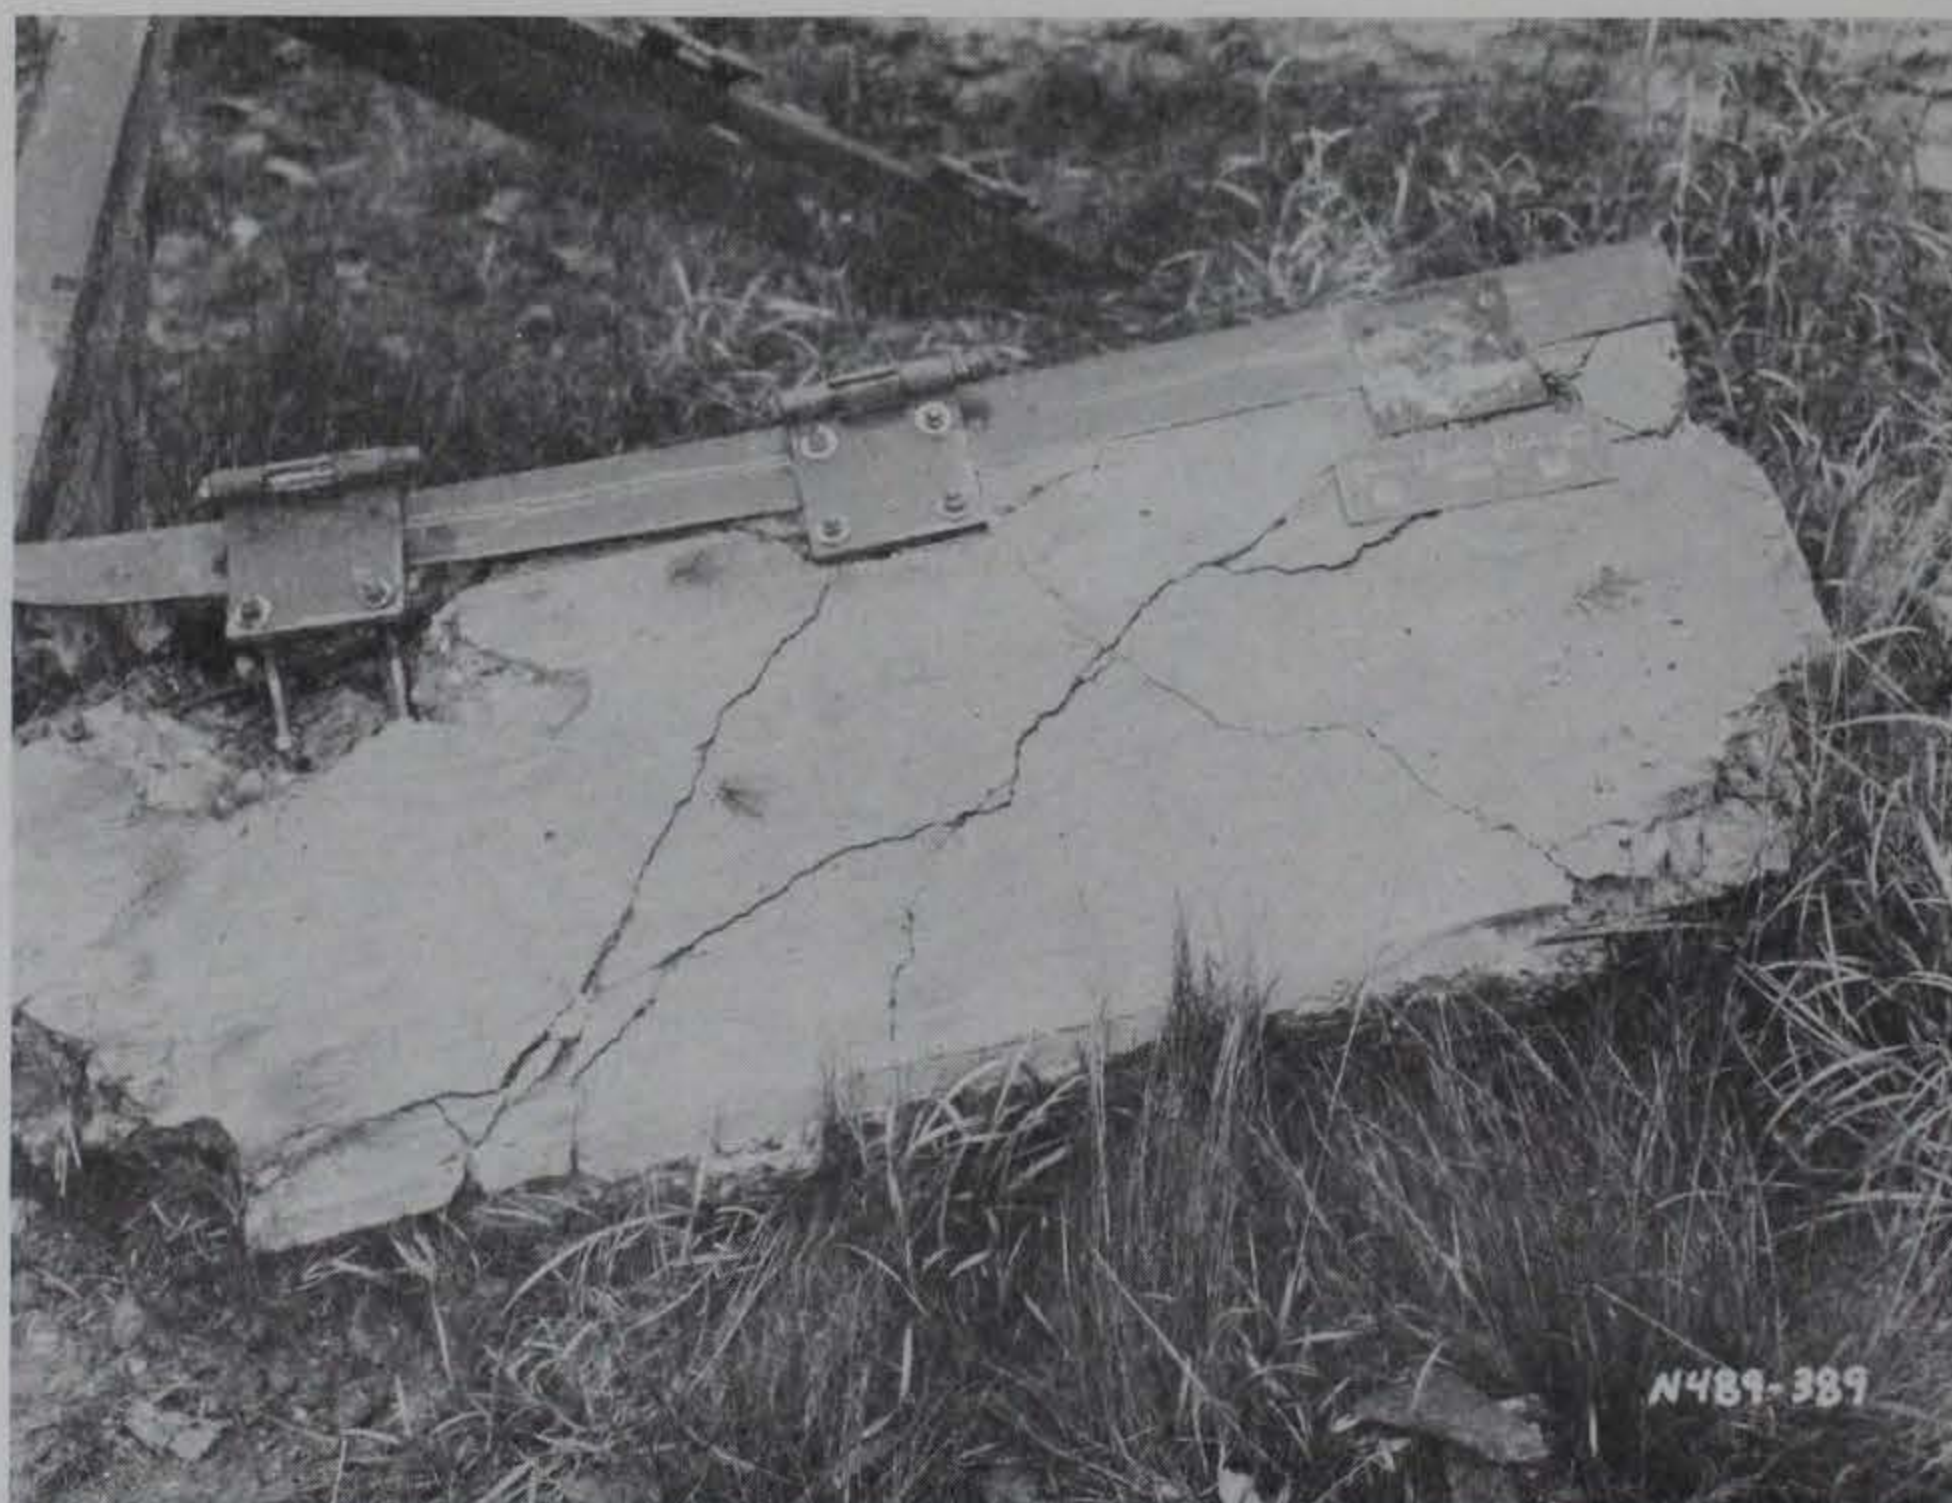
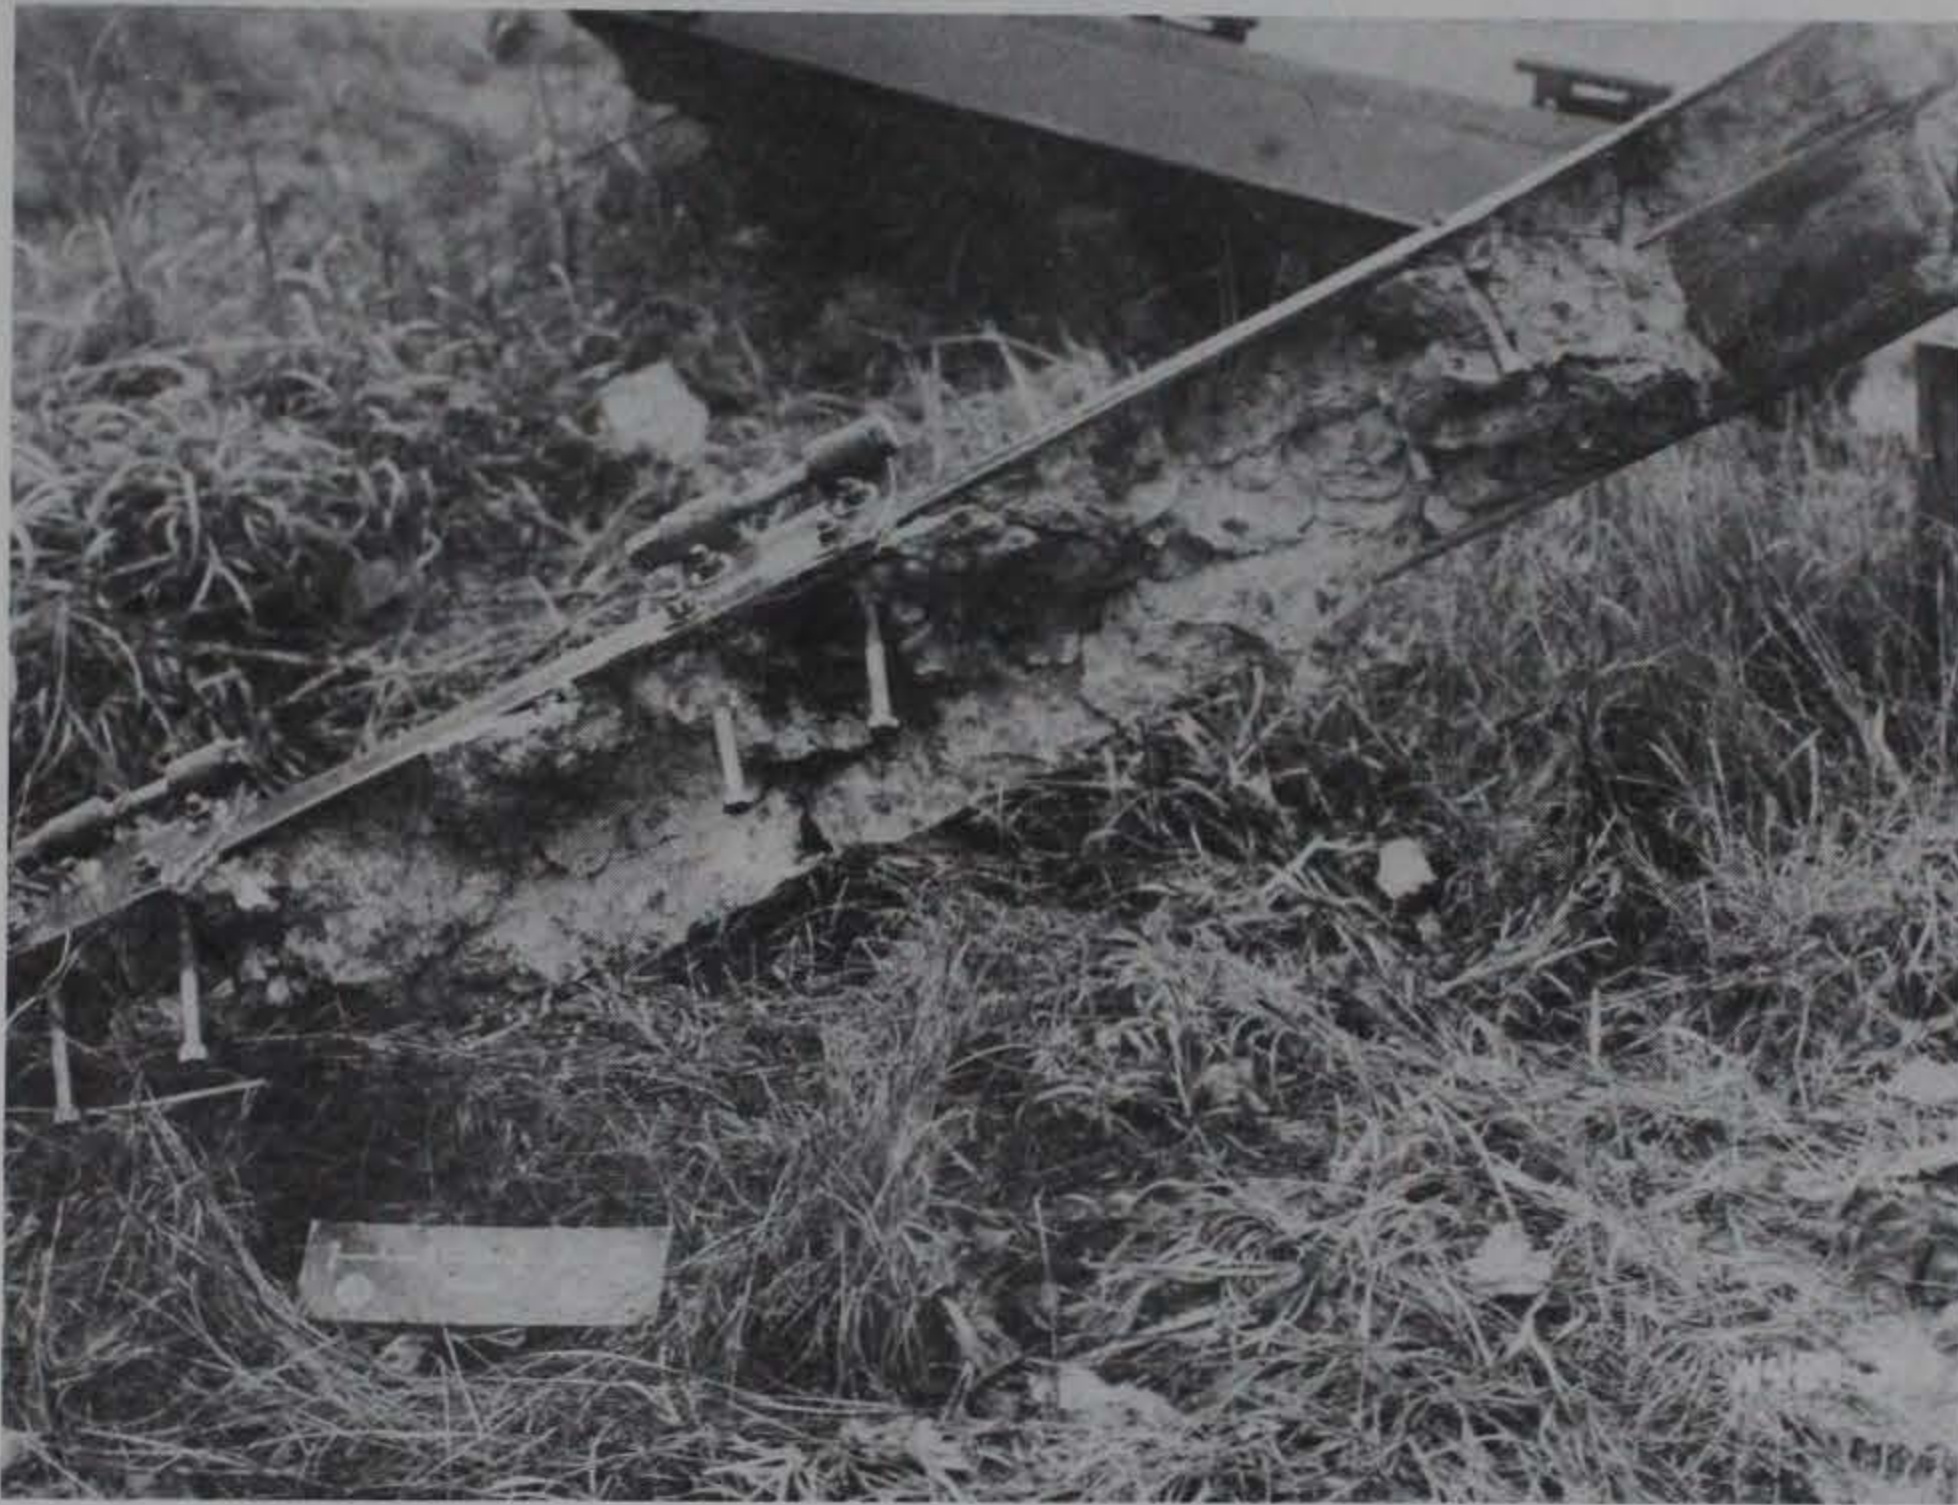
Figure 5.27. Damage to donor bay blast door frame and north part of bulkhead (Sheet 1 of 2).

b. Detail of north side.

c. Detail of south side.
