Technical Report SL-93-5
April 1993

Investigation of Probable Causes of Cracking, Aircraft Weather Shelters, Kadena Air Base, Okinawa

Prepared for U.S. Army Engineer District, Japan
Camp Zama, Japan

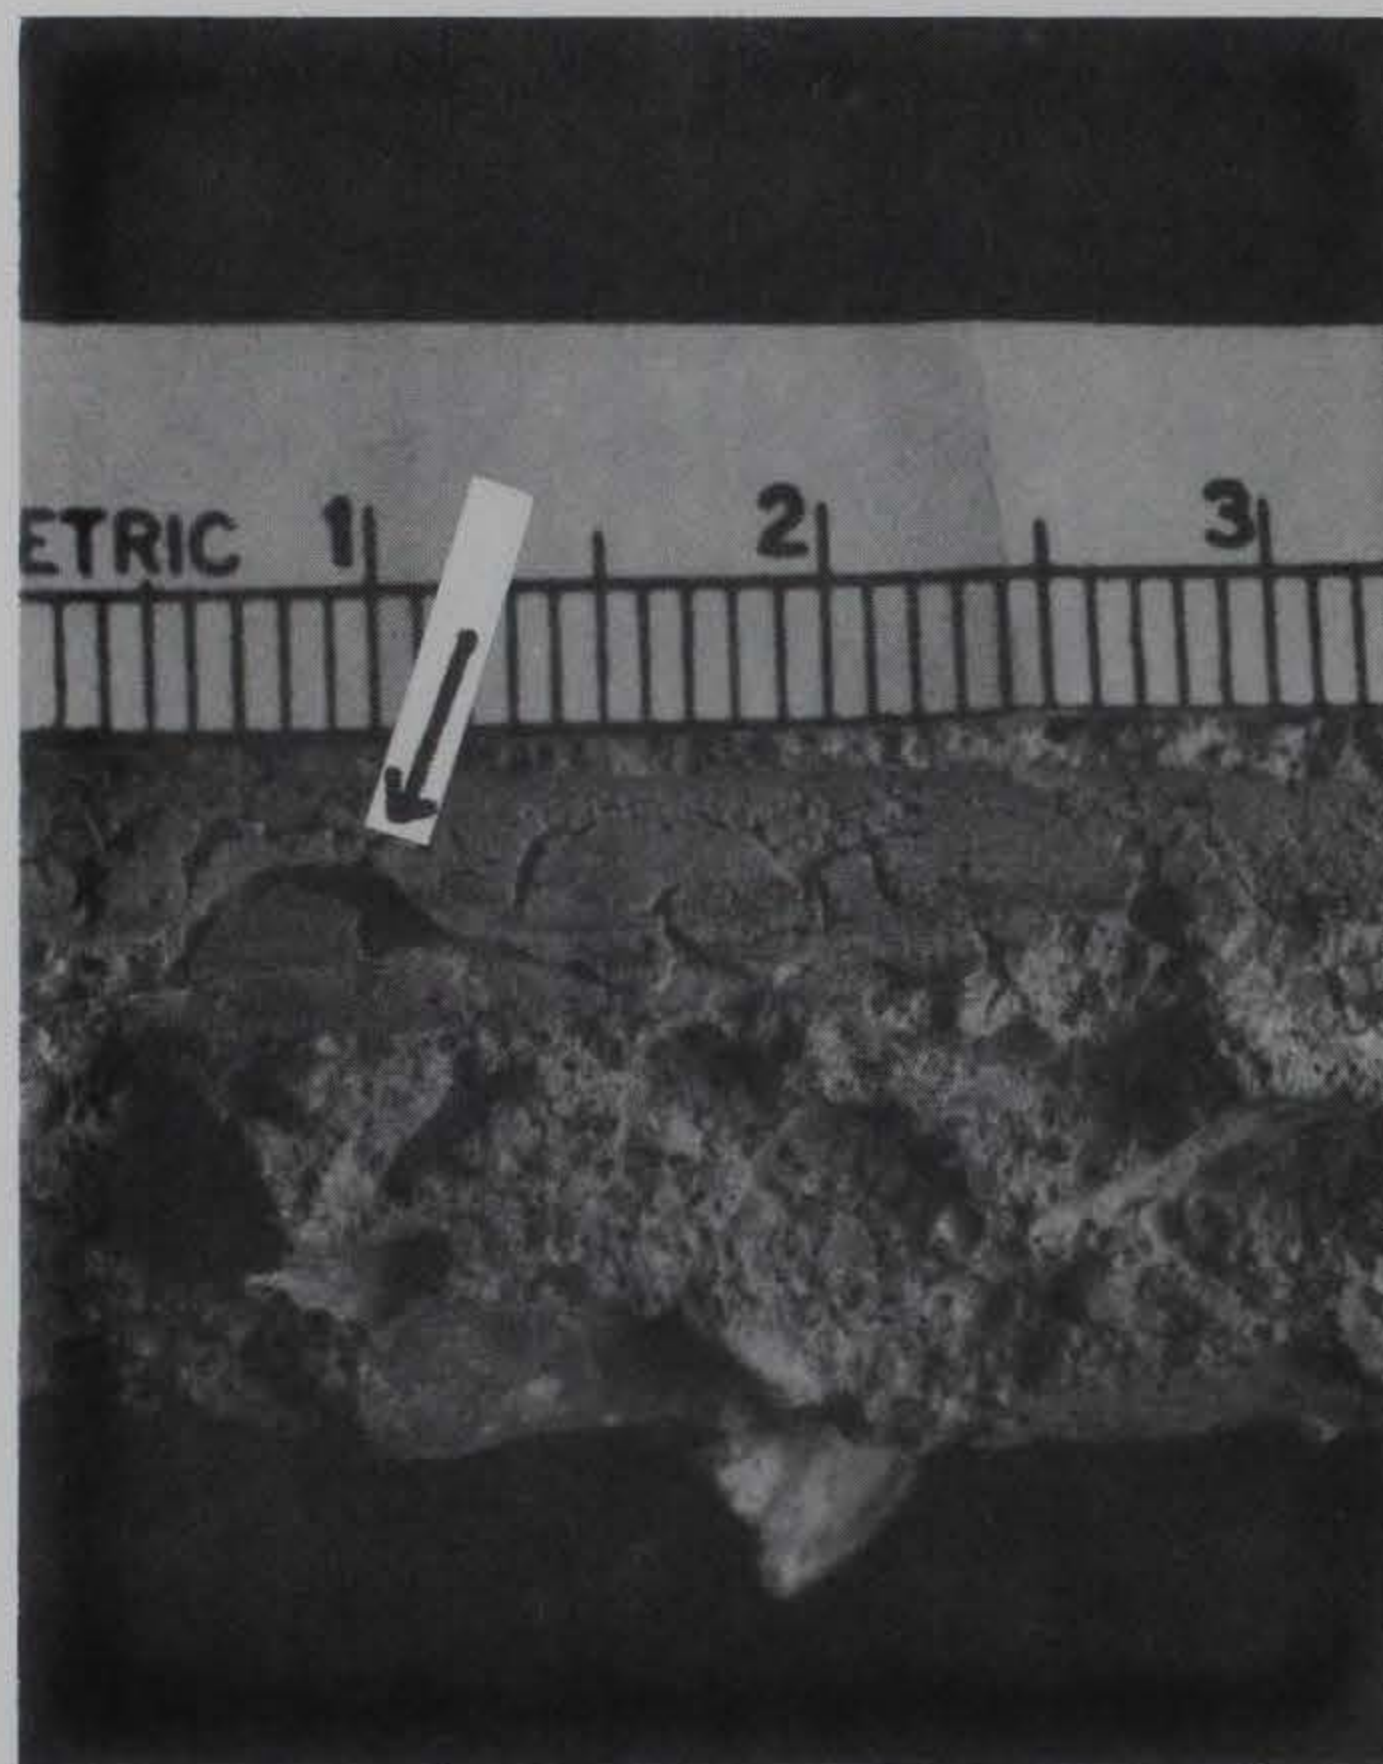
Figure 2. Broken surface of concrete core after rebar removed showing water channel, core 920109 (Bay 42, upper portion)

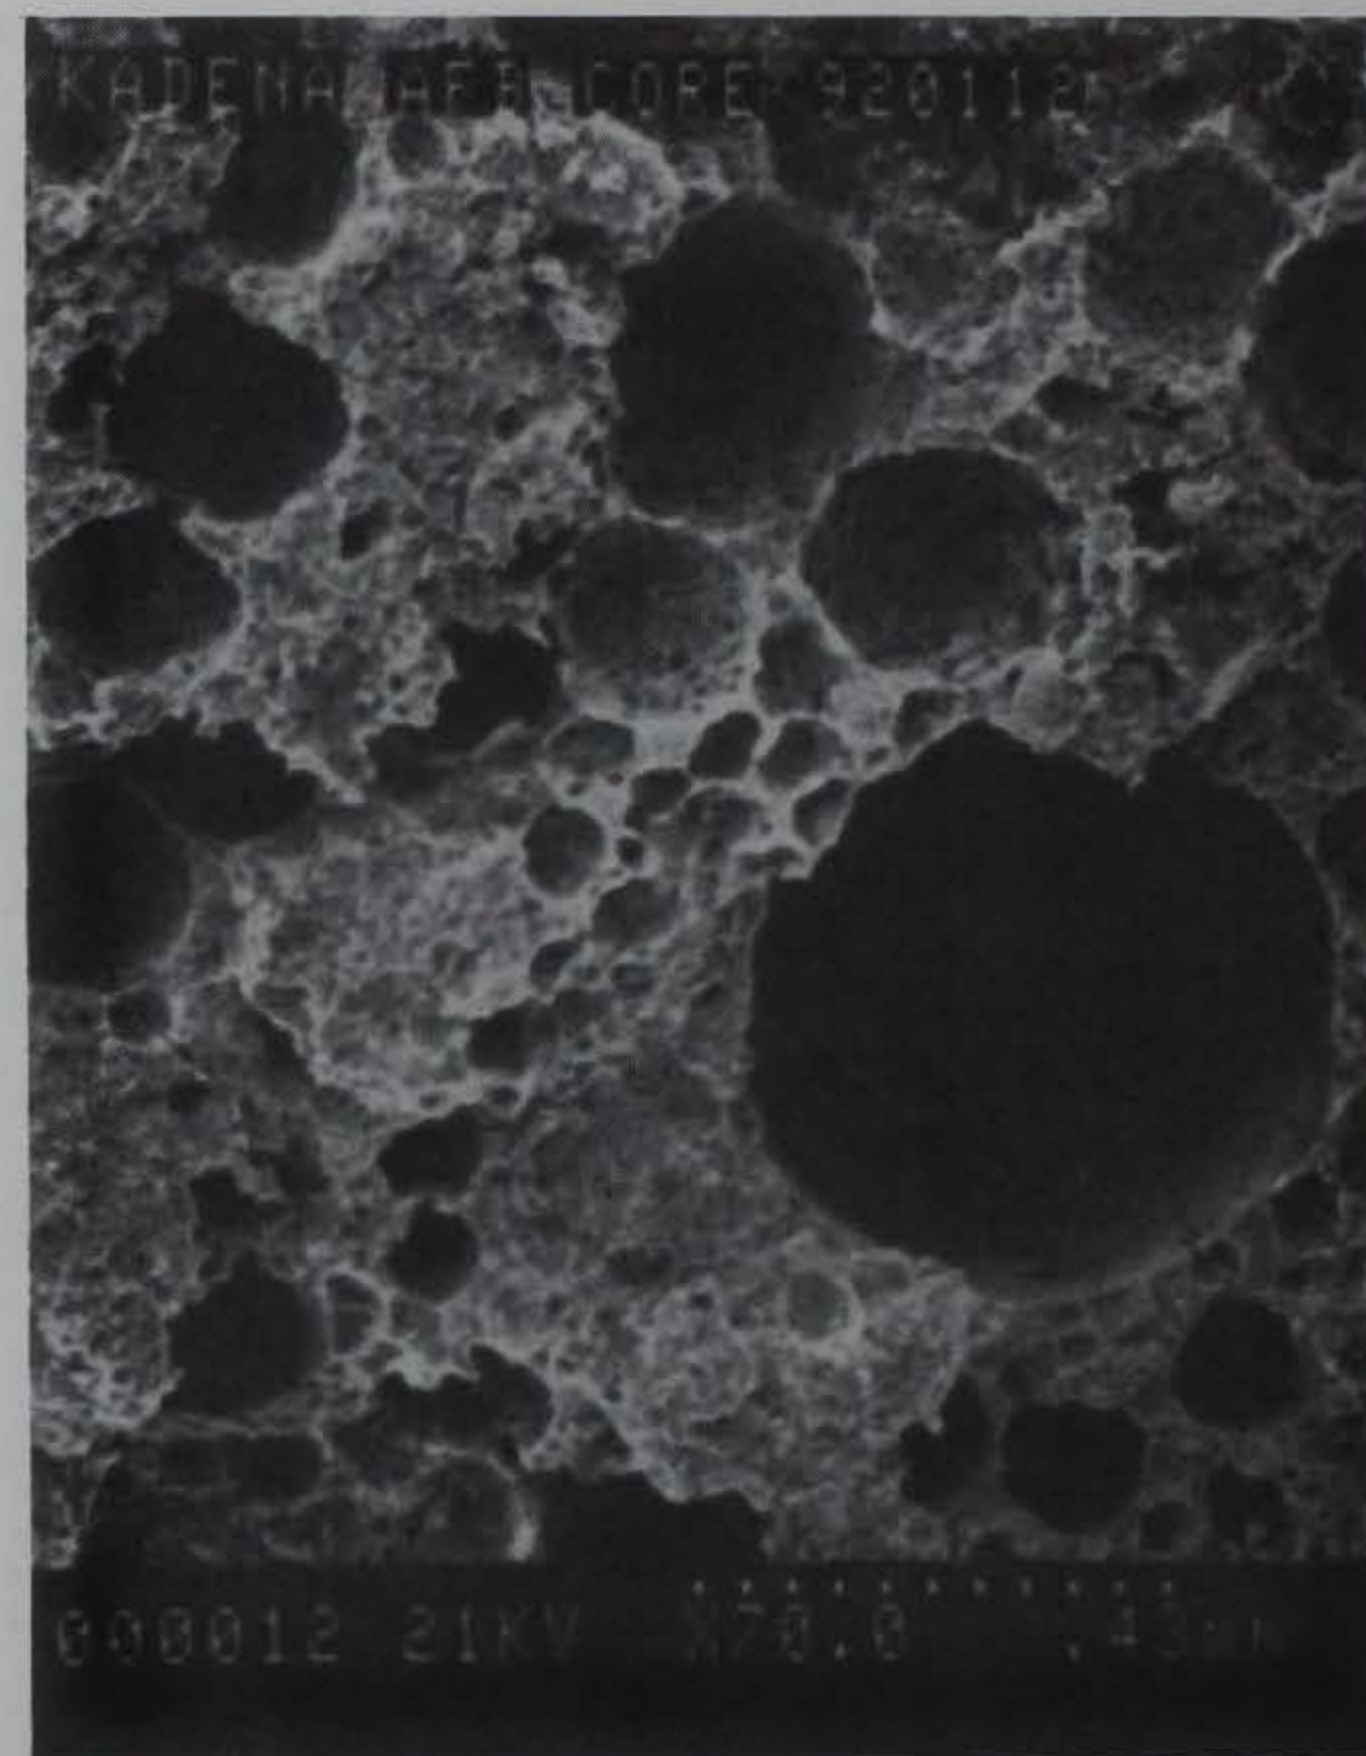
Aggregate surfaces were unreacted. We found only the expected background level of chlorides in paste, at aggregate surfaces, and along cracks. Ettringite, a phase that can cause cracking if it forms in a restrained condition, was minimally present on free crack surfaces (except where cracks were carbonated, as explained below); however, it was not in an amount or configuration to indicate it had caused the cracks to form. Ettringite appeared to have crystallized on free surfaces of preexisting cracks (Figure 5) and was not present in open pores in the paste (Figure 3).

Figure 3. Electron micrograph of cement paste at aggregate interface showing open, porous microstructure; dotted line at bottom is 0.43 mm long

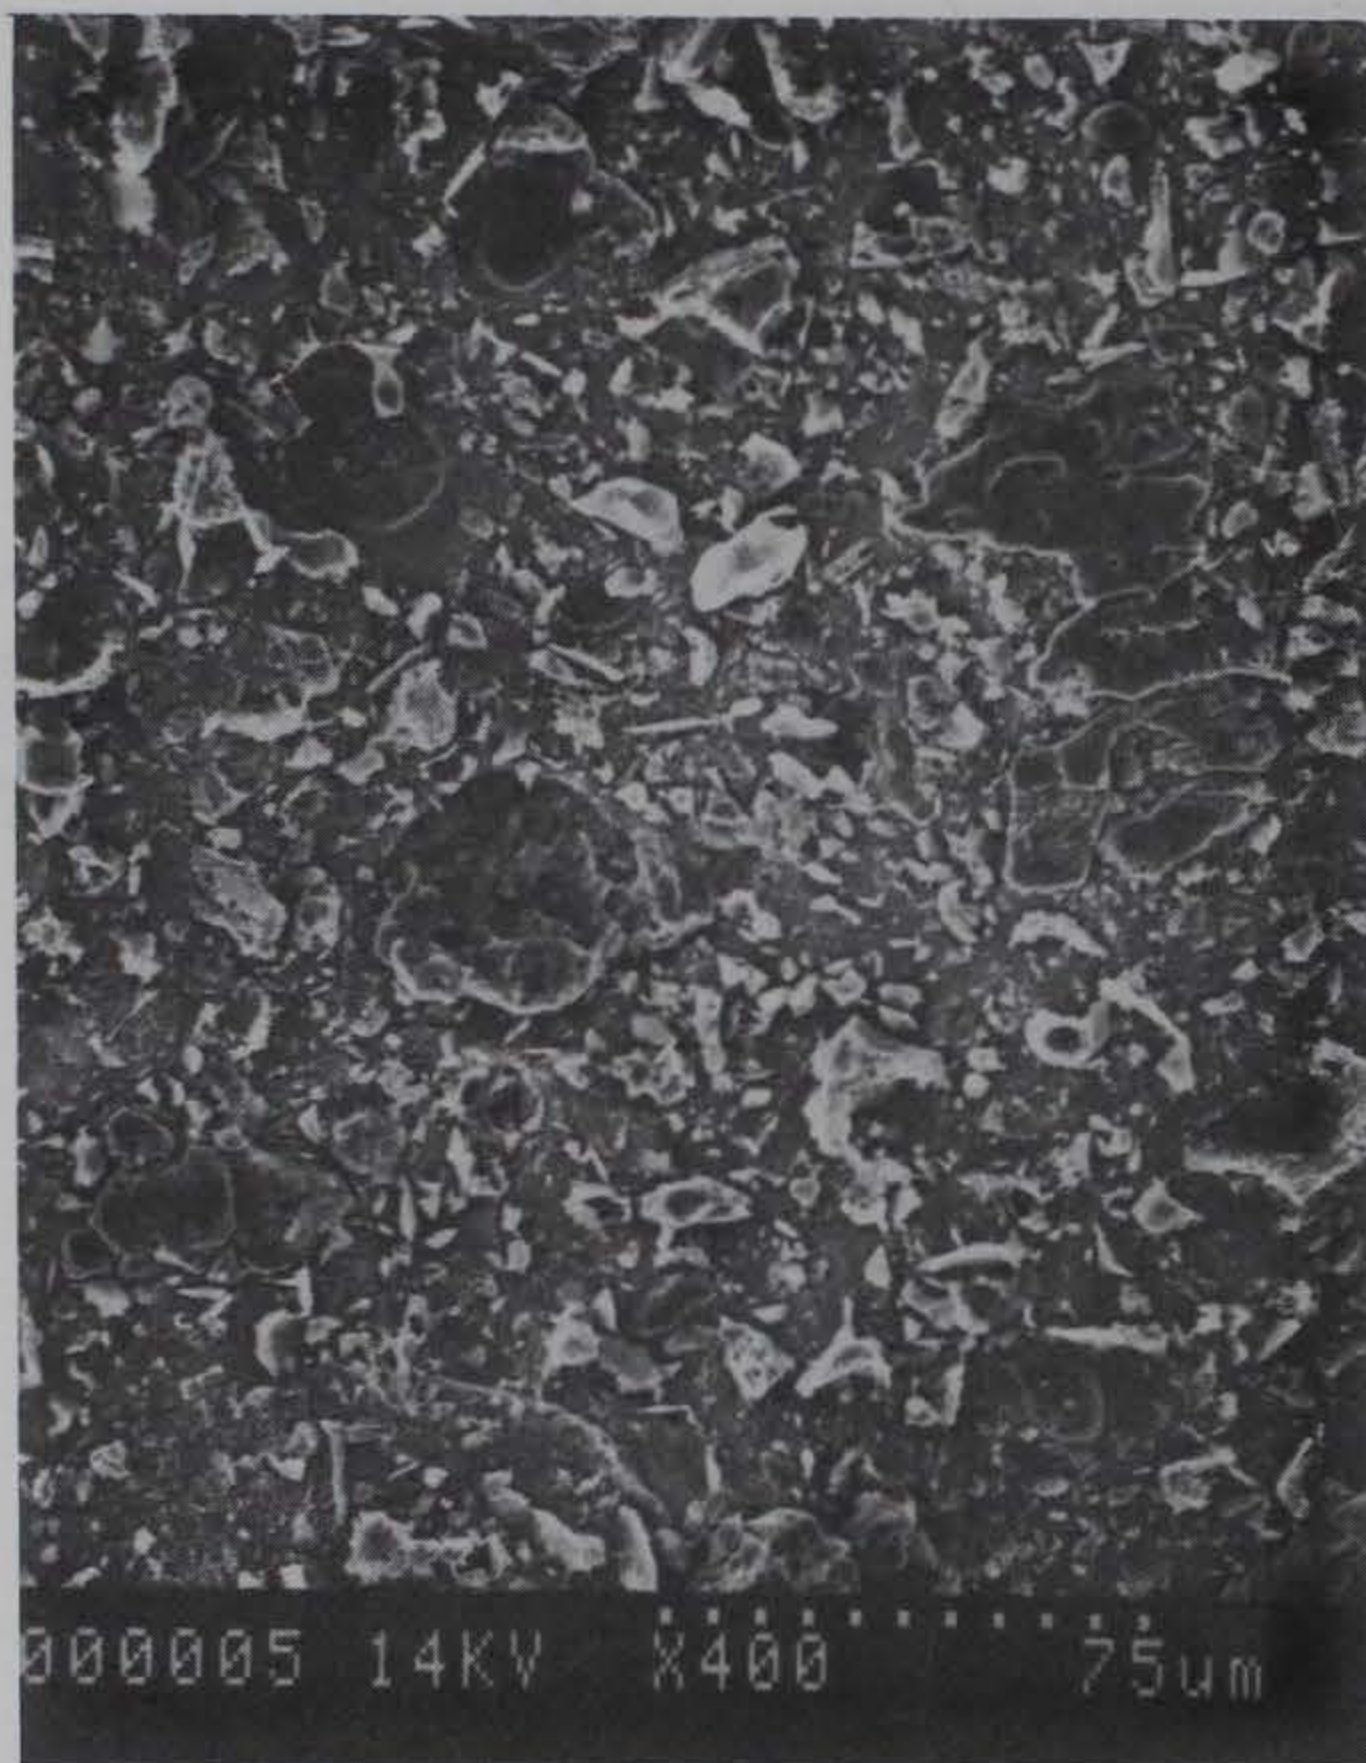
Our study revealed no evidence that deleterious chemical reactions had caused or contributed to cracking. The crystalline phases present were those expected from normal cement hydration. The only unusual feature of the cement-paste portion of the concrete, studied in thin sections and by SEM, was the presence of a large amount of finely divided mineral matter ("fines"), as shown in Figure 4.

Figure 4. Electron micrograph showing finely divided mineral matter in cement paste; dotted line is 75 μm

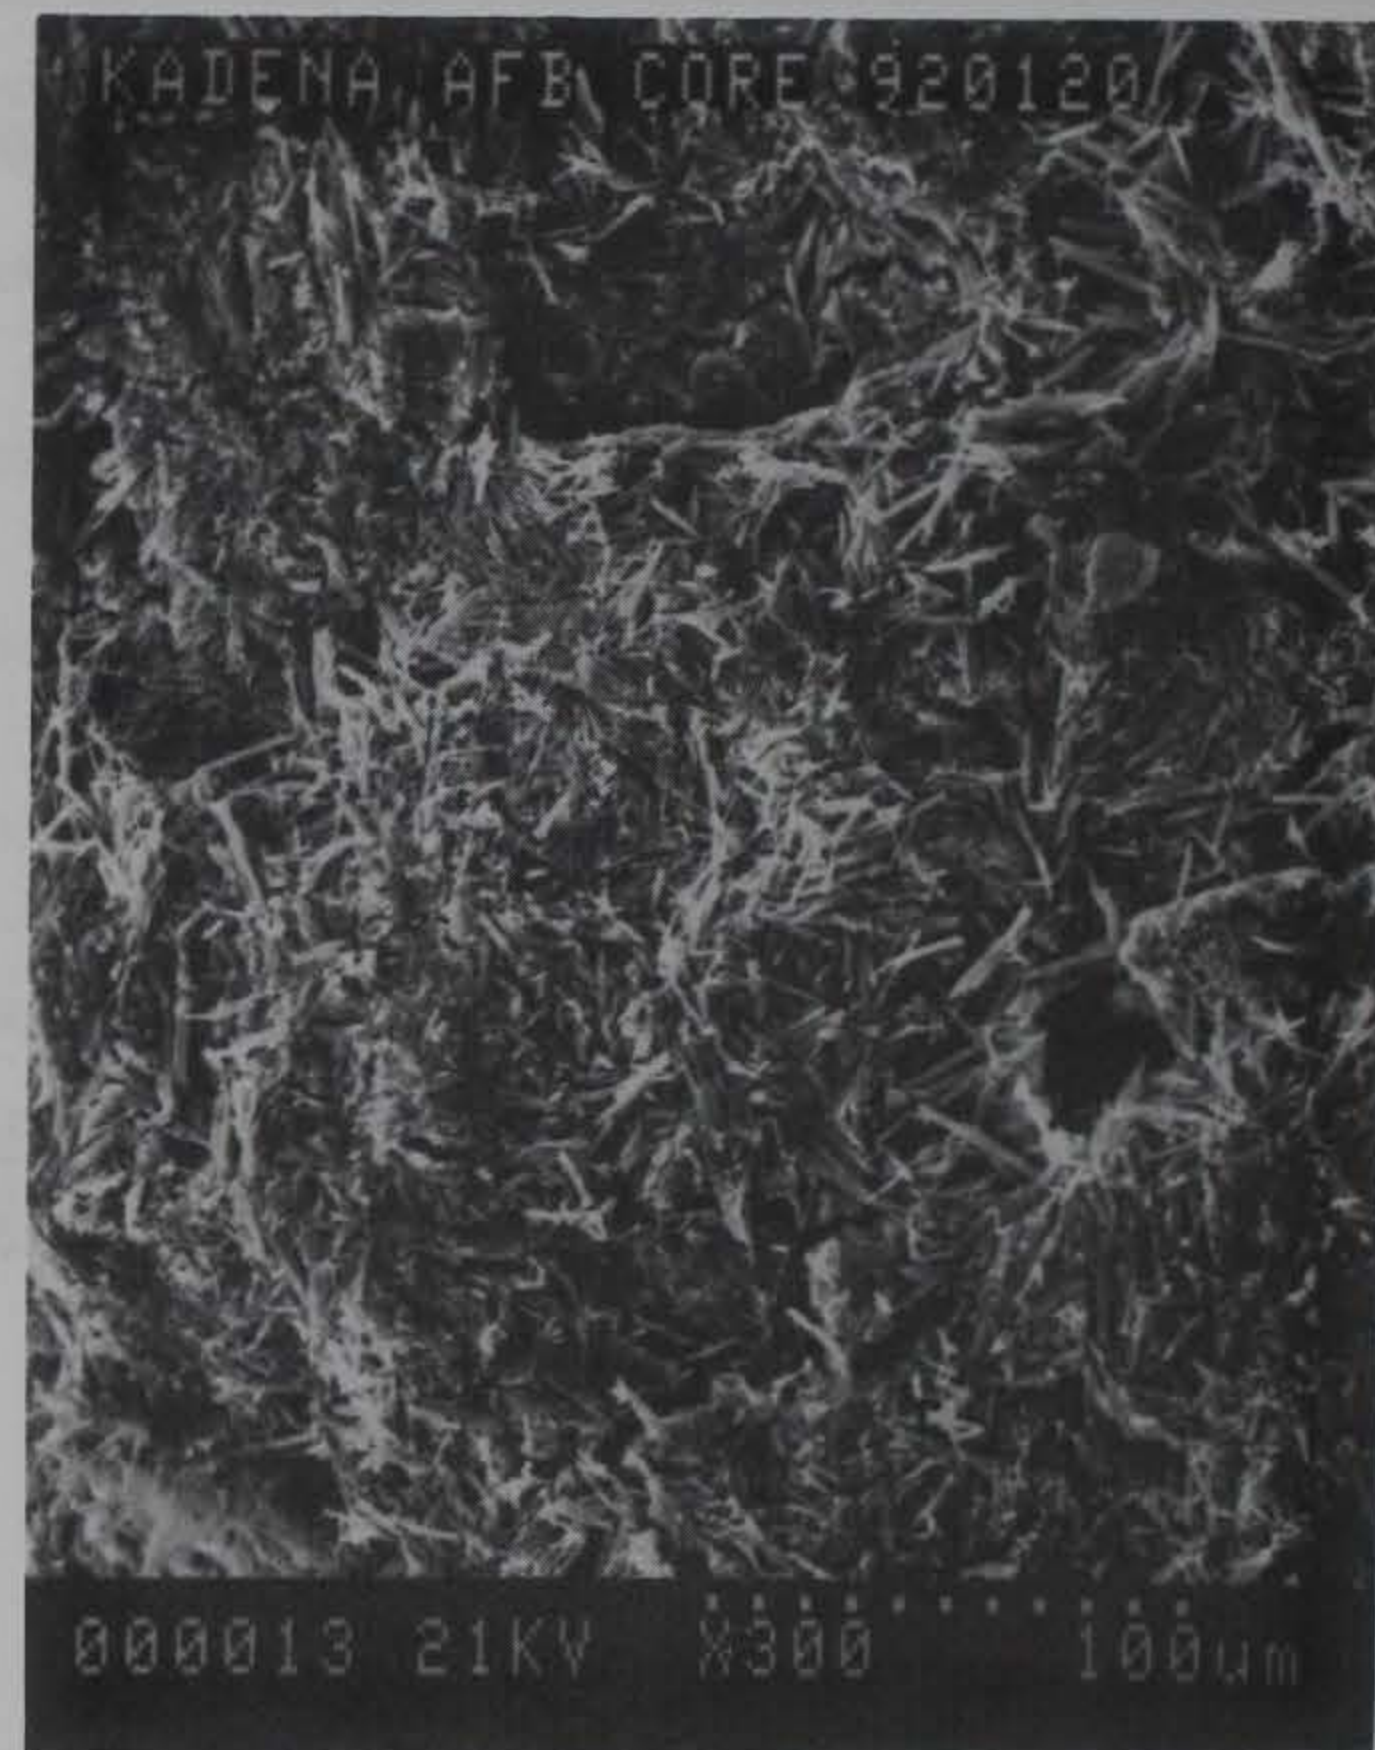
Figure 5. Electron micrograph of ettringite on crack surface below depth of carbonation; dotted line is 100 μm

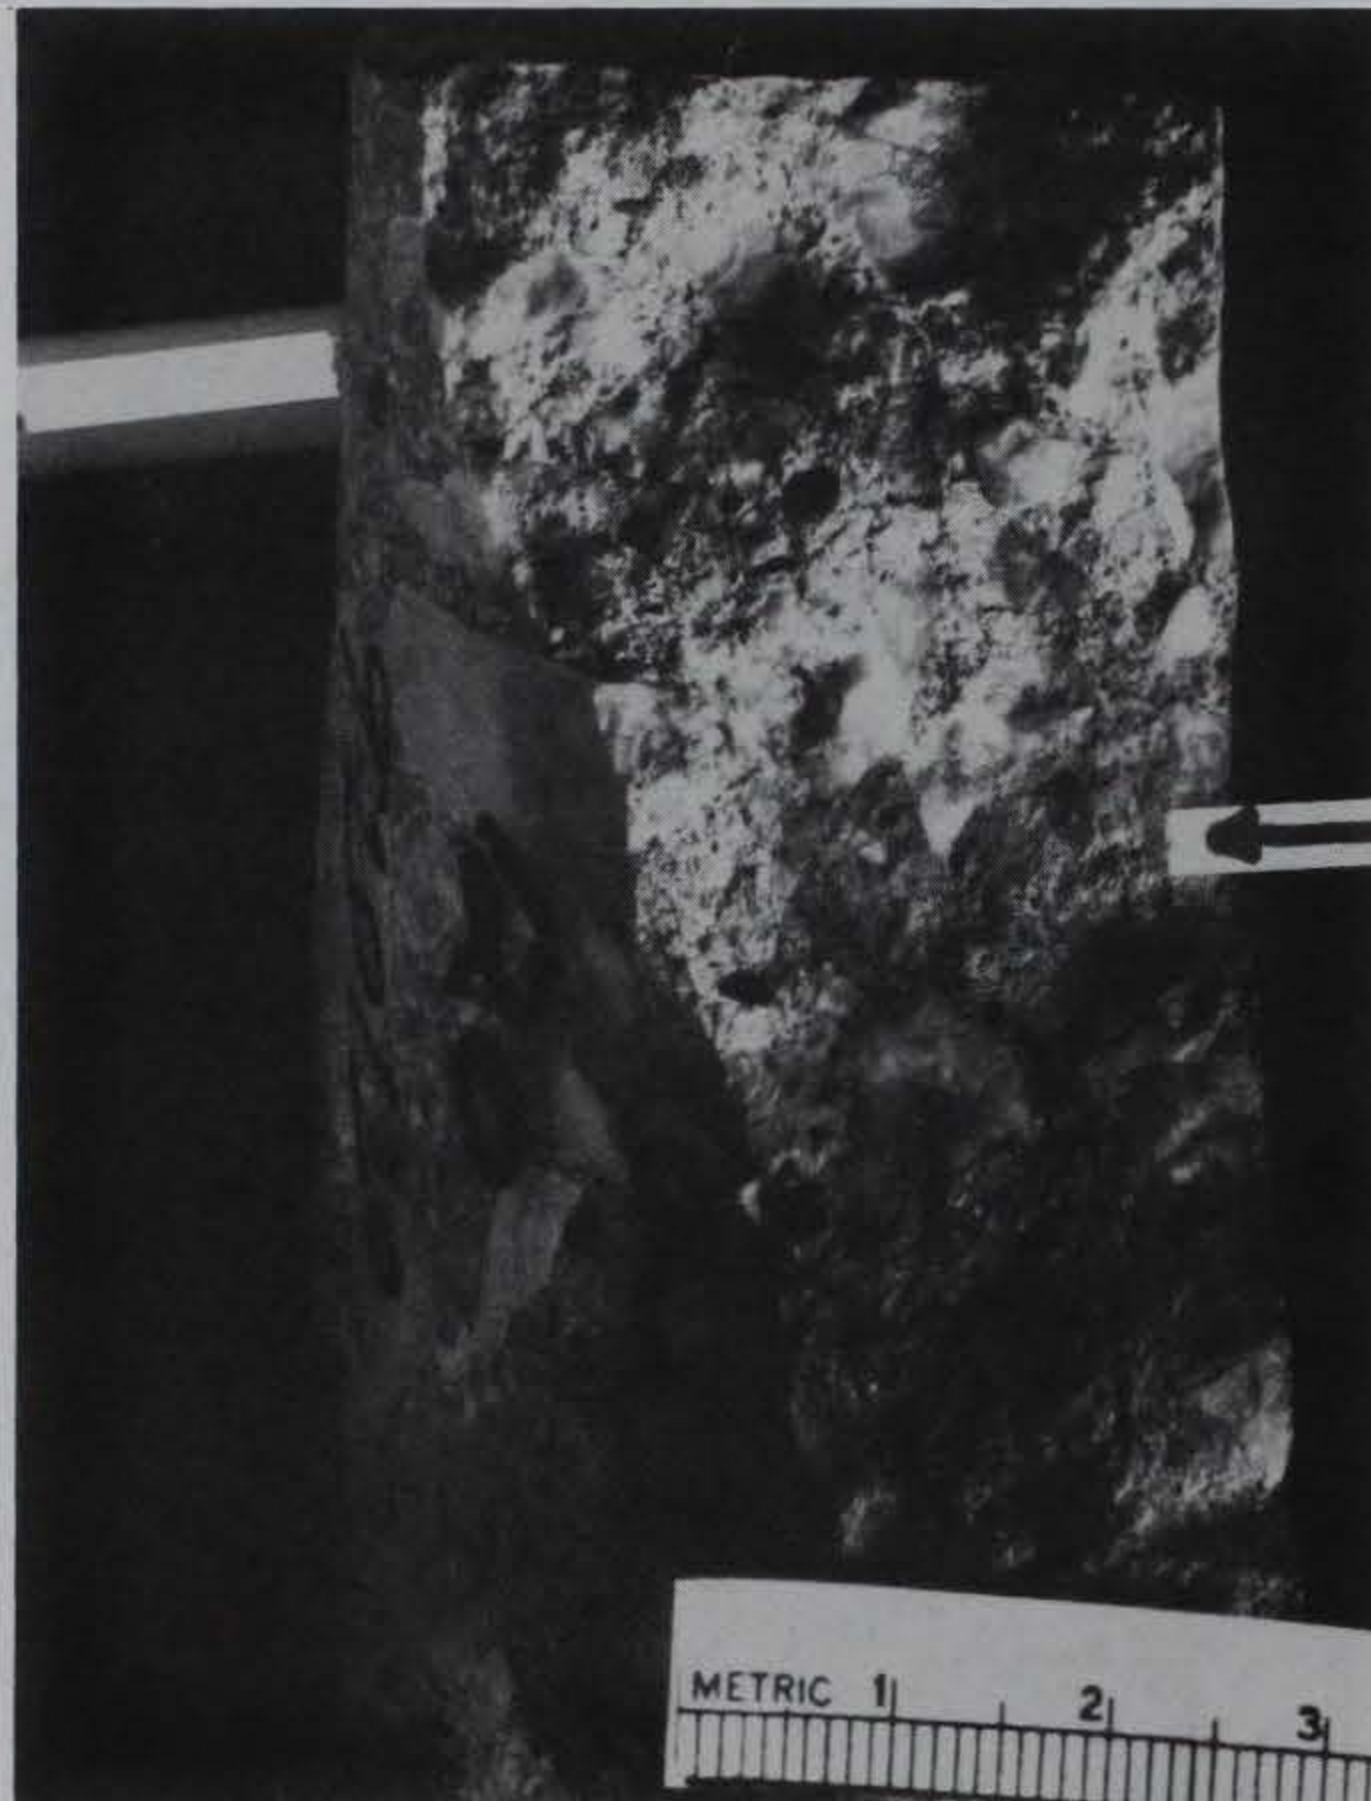
The pattern of carbonation revealed more about the cracking than did any of the other techniques. Open crack surfaces were carbonated from the upper surface of the slab down to a depth of about 30 mm (1.3 in.) (Figure 6). From the surface to this depth, cracks had stepped carefully around coarse aggregate particles. Below 30 mm (1.3 in.), crack surfaces were not carbonated, and the cracks wandered both around and through coarse aggregate particles (Figure 7). Relative to the rate of crack propagation, carbonation was a slow process. Thus, the cracks have been open longer at the top of the slabs where the surface is carbonated and are younger downward.

Figure 6. Photograph of crack surface showing depth of carbonation along crack (light-colored upper part); lower noncarbonated surfaced reacted with phenolphthalein indicator (darker)

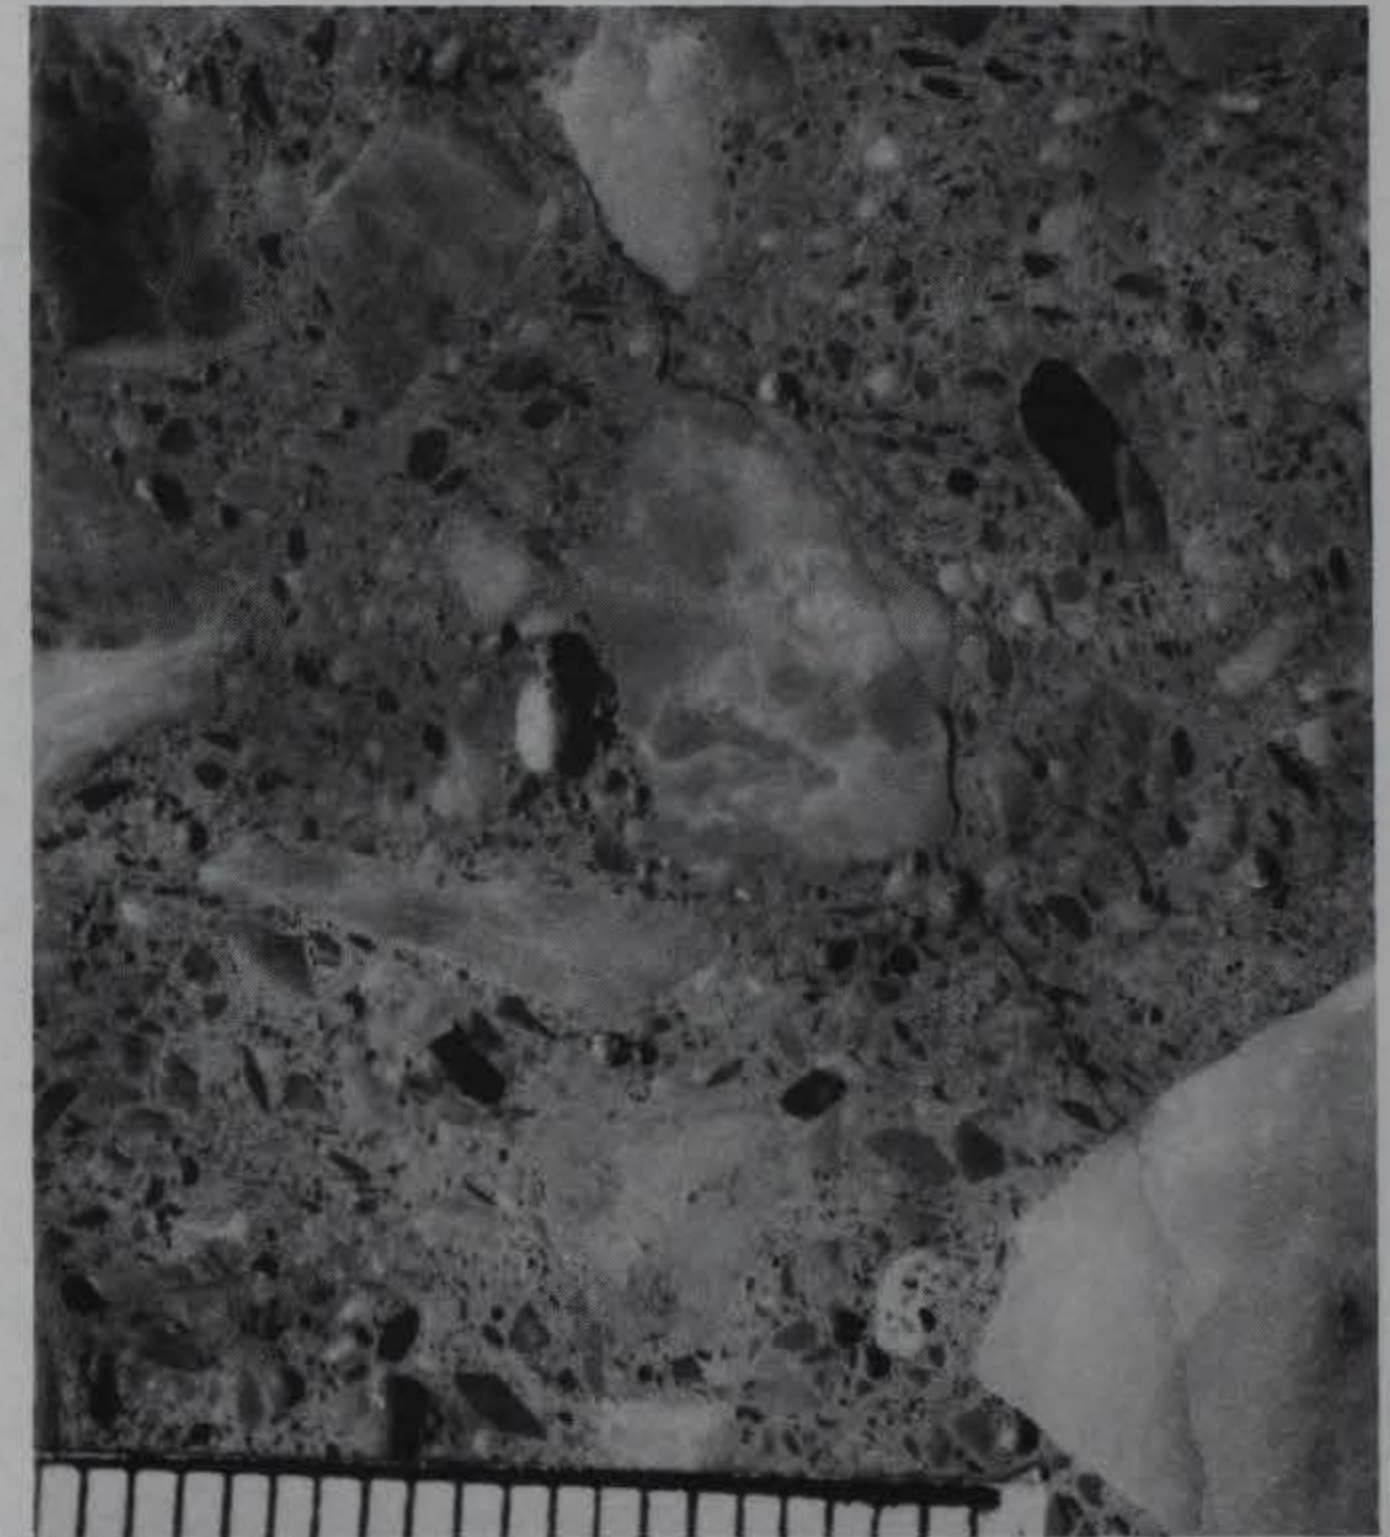
The relationship between cracks and aggregates indicates the same trend. If the upper part of the slab cracked soon after placement, the paste would have been weaker than the aggregates; therefore, only the paste cracked.

Later, the concrete had gained strength, so that the strengths of the paste and aggregates were similar. Cracks then propagated without differentiating between them, leading to the lower zone of cracking through both paste and aggregates.

Figure 7. Photograph of concrete slab in reflected light showing crack going through aggregate particles (scale in millimetres)

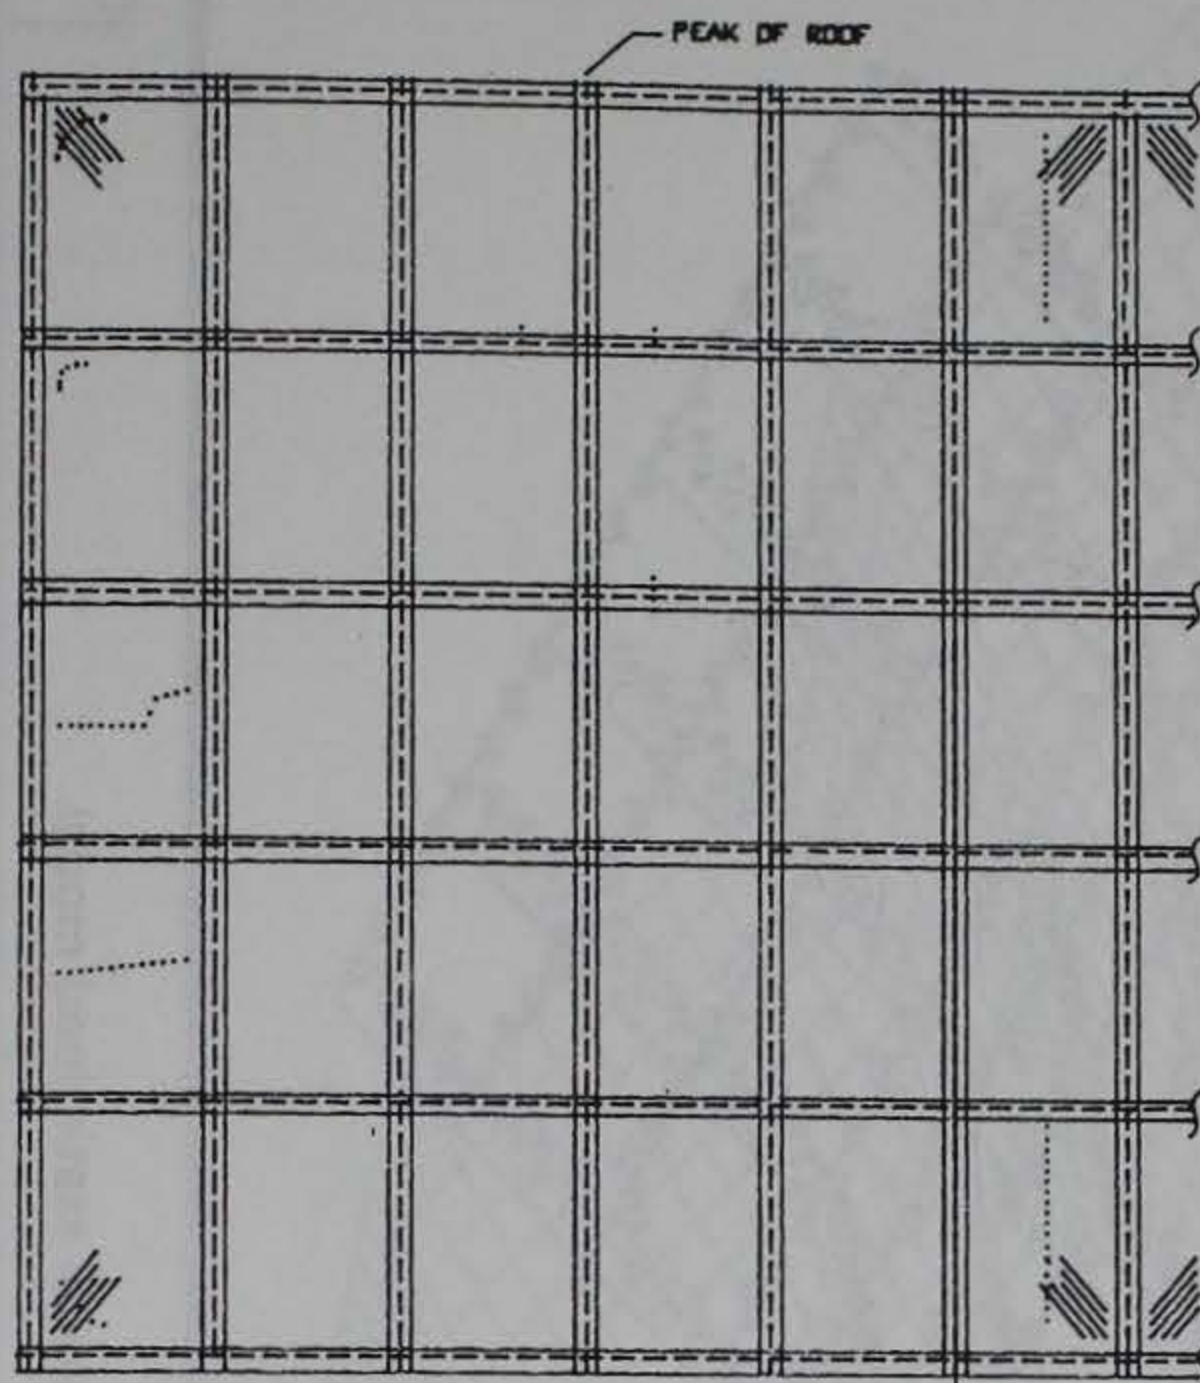
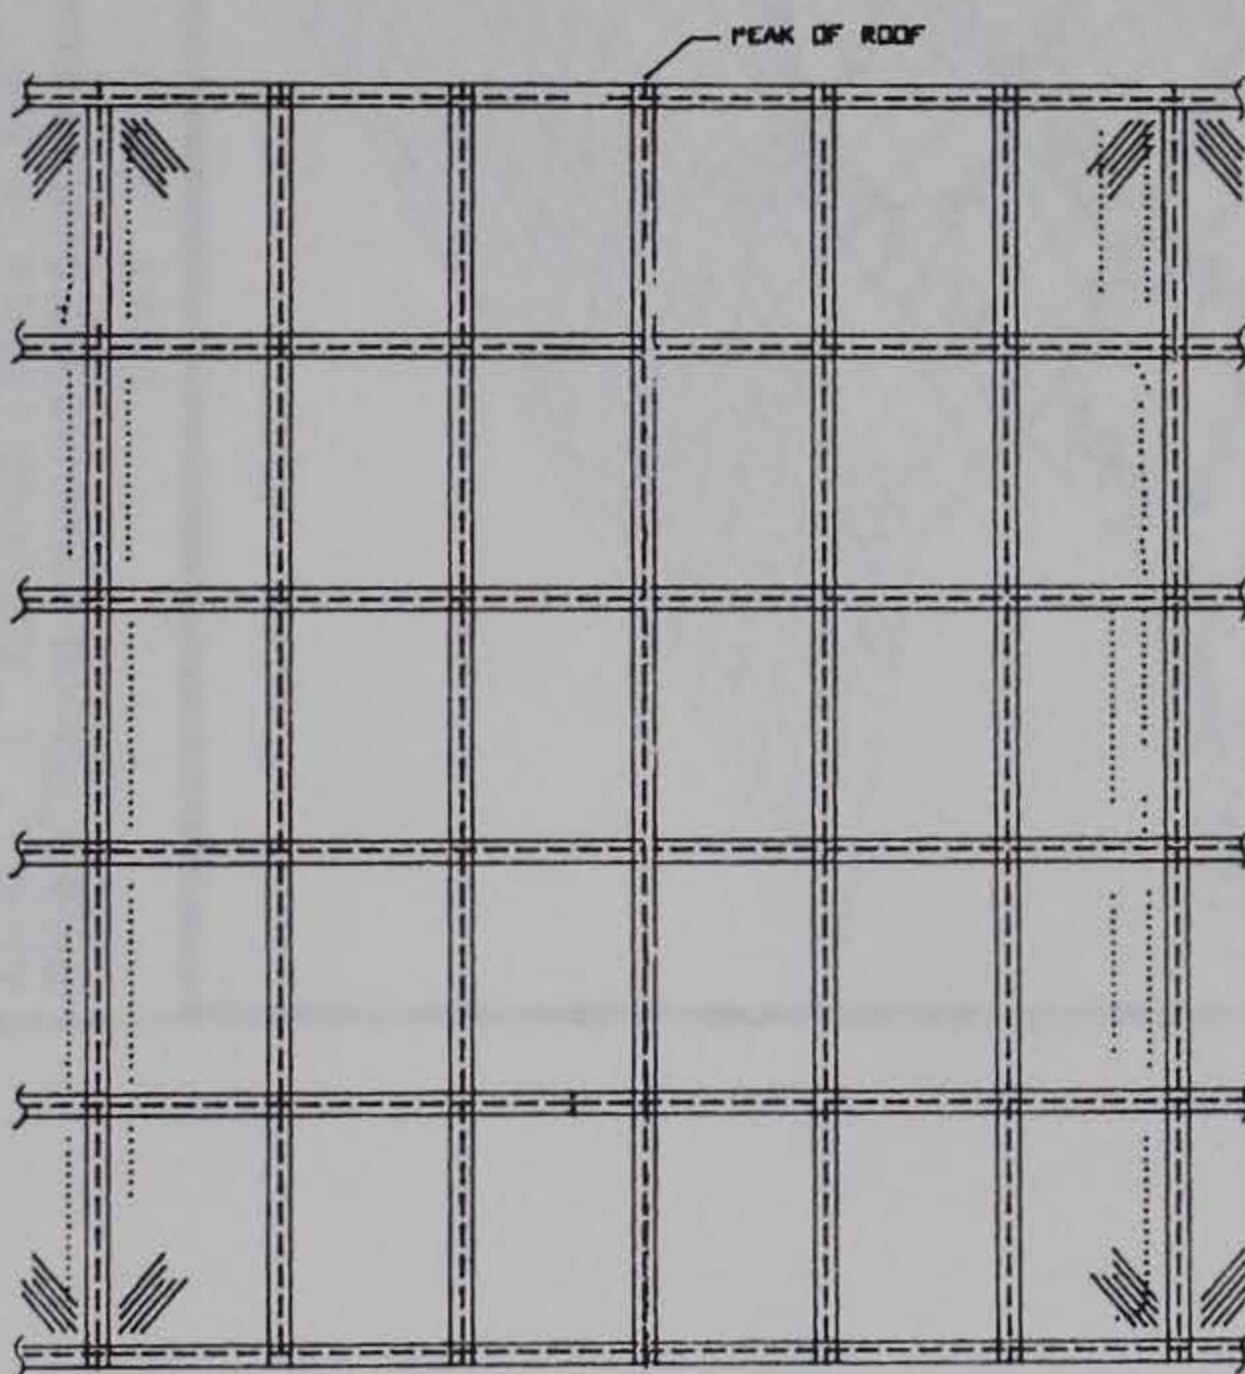
After elimination of the bend and the increase in total reinforcing in the slabs, cracking still occurred. In general, the cracking became less severe and the cracking pattern changed somewhat after the modification. Figure 8 gives a comparison of cracking geometry for two bays of the structure as supplied to WES by USAED, Japan, personnel. It shows a distinct difference in

cracking geometry following placement of additional steel and elimination of the bend just described. Although this is a limited comparison, it appears that in the newer structures (with additional steel) the cracks have been forced farther up the slope. In some cases, the direction of the cracks has changed from parallel to the valleys to perpendicular to the valleys. This points to the flexibility of individual slab "panels" in the structure, but for the comparison given in Figure 8, this could also be the result of boundary conditions. Bay 35 has one "free" edge and one continuous edge while both edges of Bay 43 are continuous. Individual panel flexibility is brought about by the large width-to-thickness ratio of the panels (minimum of approximately 22:1) and the placement of steel with respect to the panel depth.

Further evidence for the above argument is found in the changes in crack orientation following addition of steel at the column heads. In the original nine structures, almost all cracking is parallel to the valleys of the structure and is located near the valleys. Further, the cracks do not appear to extend across the girder areas. This points to excessive stresses in the individual slab panels brought about by negative moment loads at the column heads. The girders are sufficiently reinforced to resist cracking; however, the slab panels appear to crack due to direct tension over the column heads resulting from negative moment at these points (and possibly exacerbated by reversing loads). In the newer structures, it appears that many of the cracks have changed orientation, which indicates that the additional steel may have been adequate to handle the direct tension over the columns but not adequate to handle individual panel loads (probably dominated by wind). No additional steel was added in the orthogonal direction, thus cracking occurred in the weaker direction. For Bay 35, the change in crack orientation at the free edge could also be partially attributable to boundary conditions (Figure 8).

Figure 8. Plan view of Bays 35 and 43, showing locations of beams and cracks; peak of each folded plate is in the center of the bay

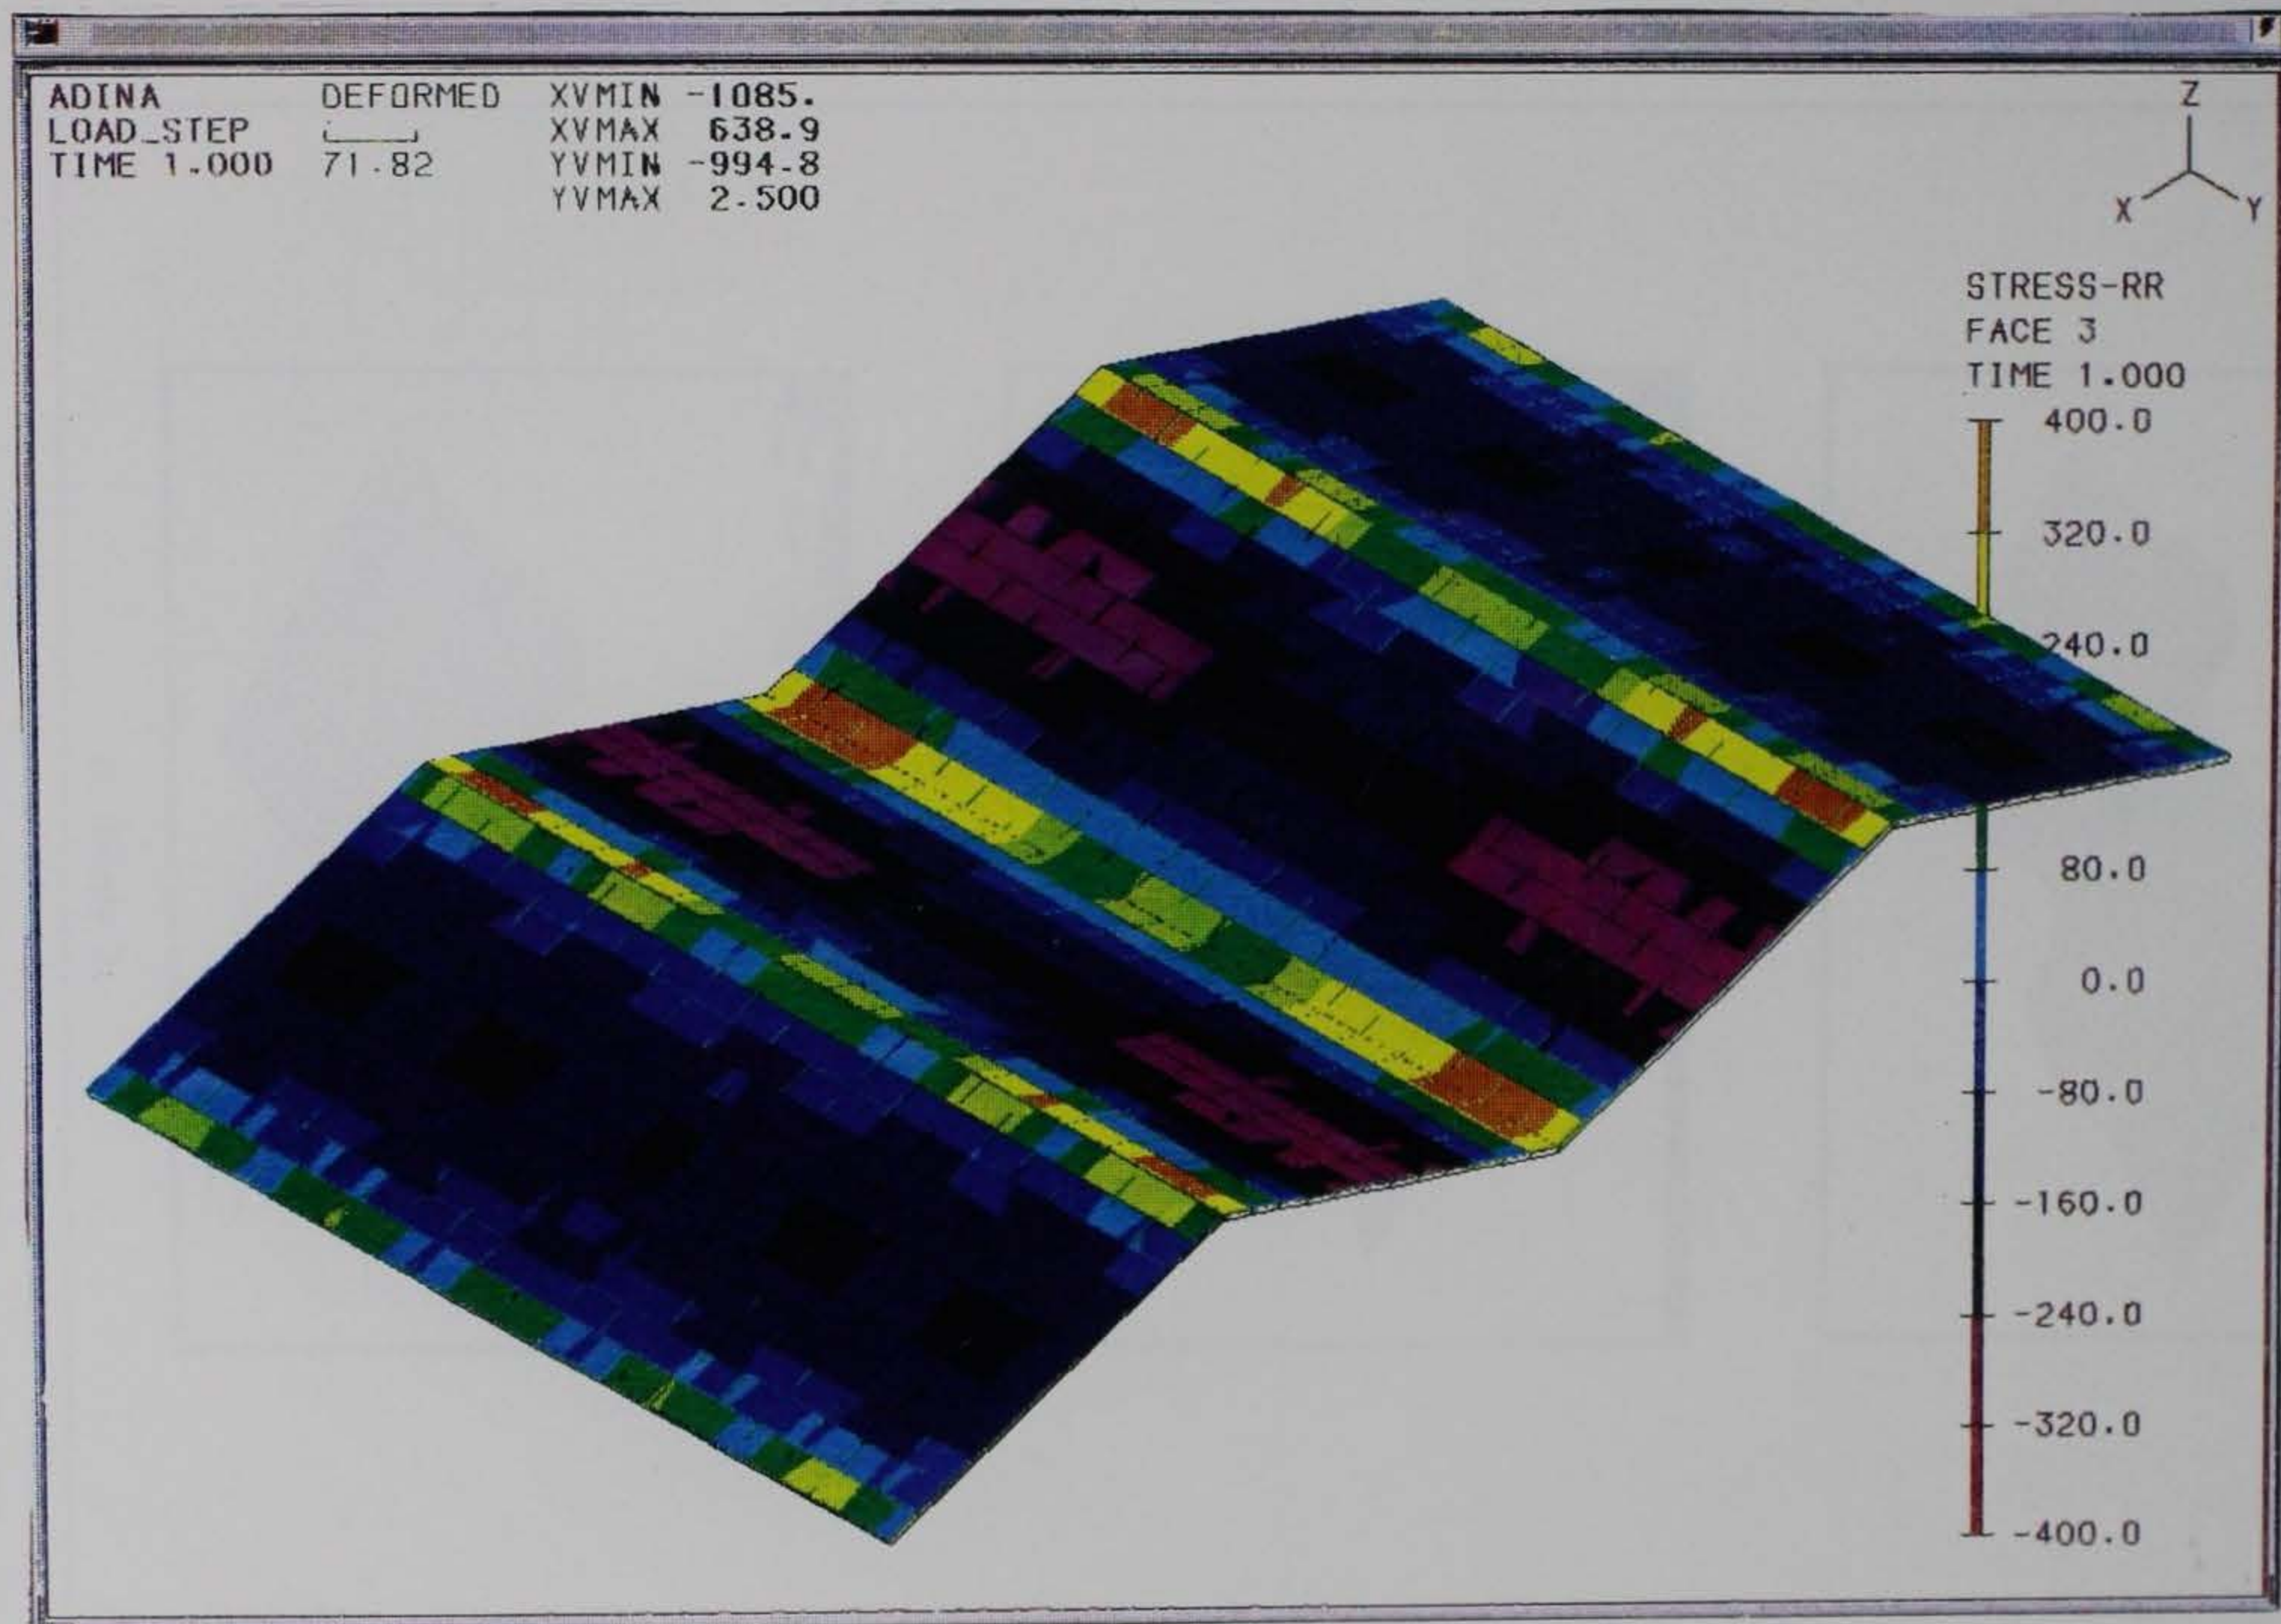
Case 1 is the simple static condition. It revealed larger stresses perpendicular to the valley on the top face of the shell elements and also near the peaks (Figure 11). The crack map of the Kadena shelters (as shown in Figure 8) indicates a stress distribution similar to that predicted by this case, which gave the best fit of those we considered. Stresses along the valleys of the real shelters probably are even greater than those indicated by this case, due to the presence of the flat segment joining the two slopes of adjacent bays (the model has a v-shaped valley).

Figure 11. Stress distribution of two-bay model in simple static condition (Case 1)
