Technical Report SL-93-5
April 1993

Investigation of Probable Causes of Cracking, Aircraft Weather Shelters, Kadena Air Base, Okinawa

Prepared for U.S. Army Engineer District, Japan
Camp Zama, Japan

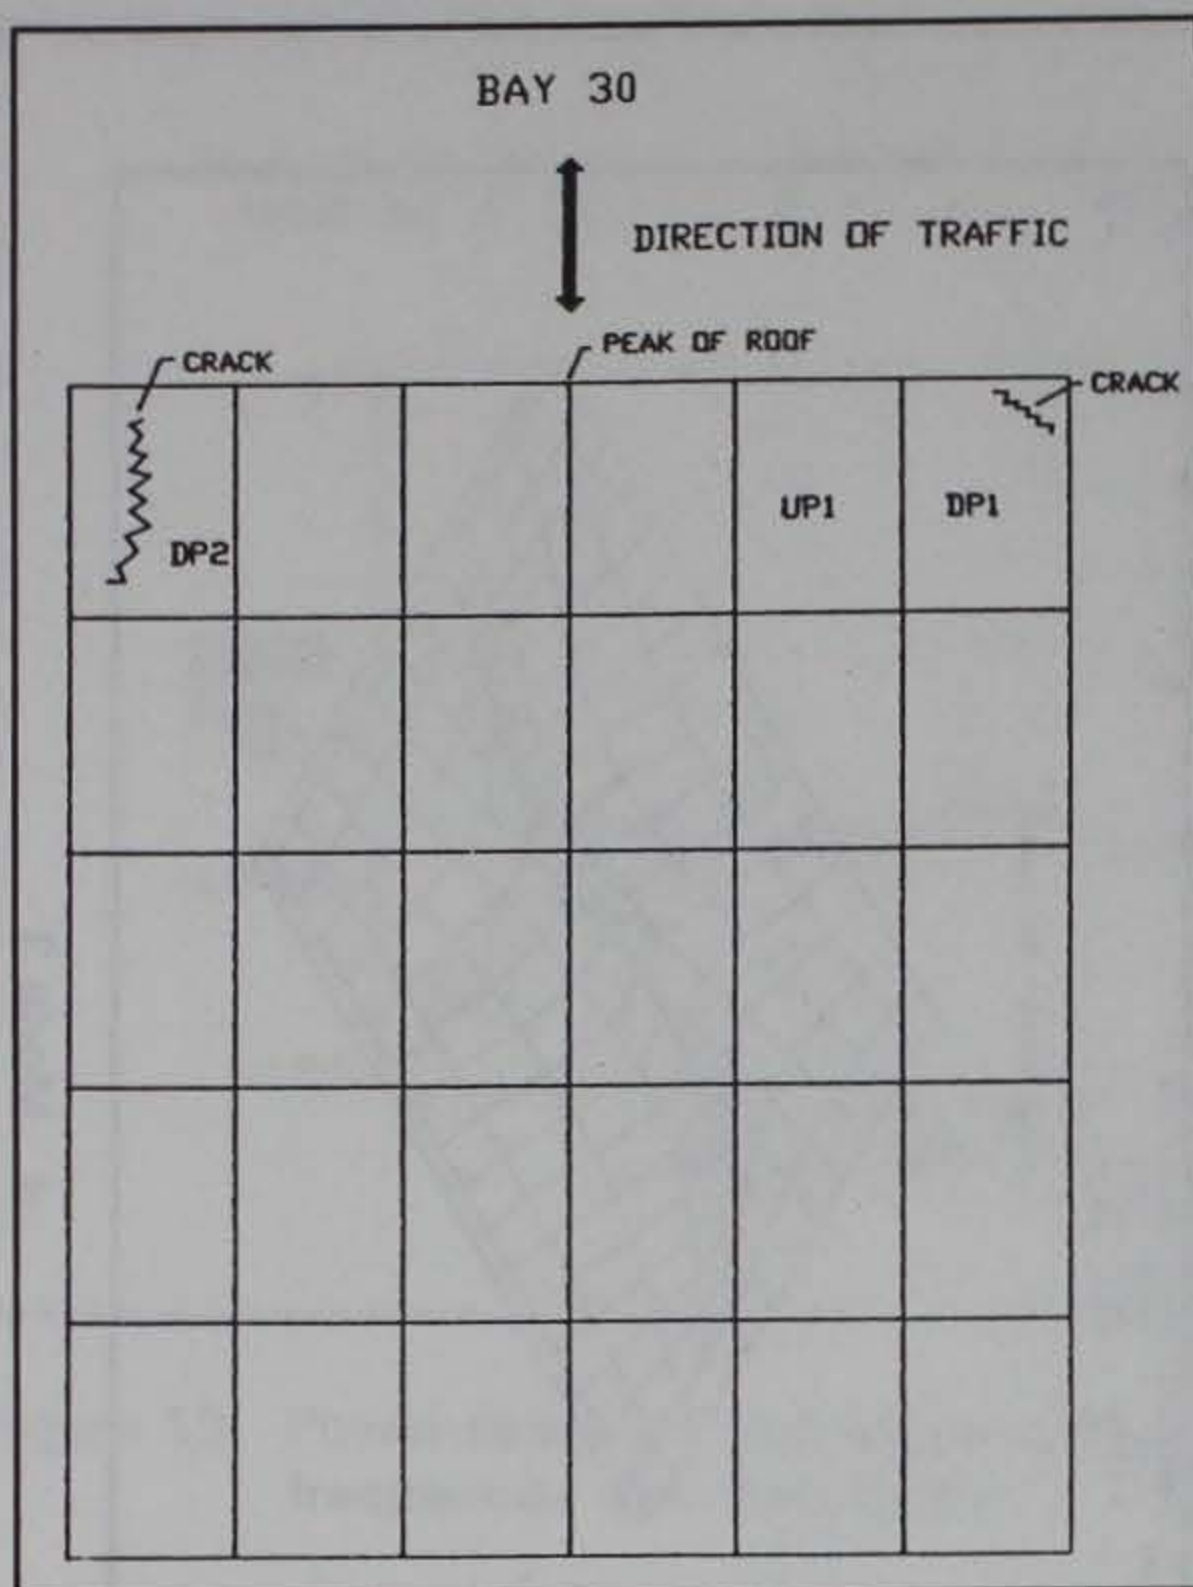
The damaged panels (DP1 and DP2) chosen for impact tests represented two of the more common crack configurations. One panel (DP1 in Figure 15) had a diagonal crack across one corner and penetrating the full depth of the slab. The same procedures were used for this panel as were used for the undamaged panel to define the mode shape. Figure 18 shows the first three experimentally derived modes for DP1. The results for this mode of DP1 appear to be identical to those of the undamaged panel. A minimal effect of the crack on structural behavior is indicated. The second and third modes for this panel compare very well visually with experimental results for UP1 and with calculated results.

DP2 is located as indicated in Figure 15. Damage to this panel consisted of a longitudinal crack running parallel to the long dimension of the slab and approximately 1.5 m from the valley edge of the panel. The experimental fundamental frequency for the first mode was 46.25 Hz, the same as it was for the other two panels. The first three mode shapes are presented in Figure 19. Table 5 gives a comparison of the first three frequencies for the calculations and test results.

Figure 15. Plan view of roof of Bay 30, showing locations of UP1, DP1, DP2, and cracks; arrow marks roof peak and shows direction of aircraft traffic

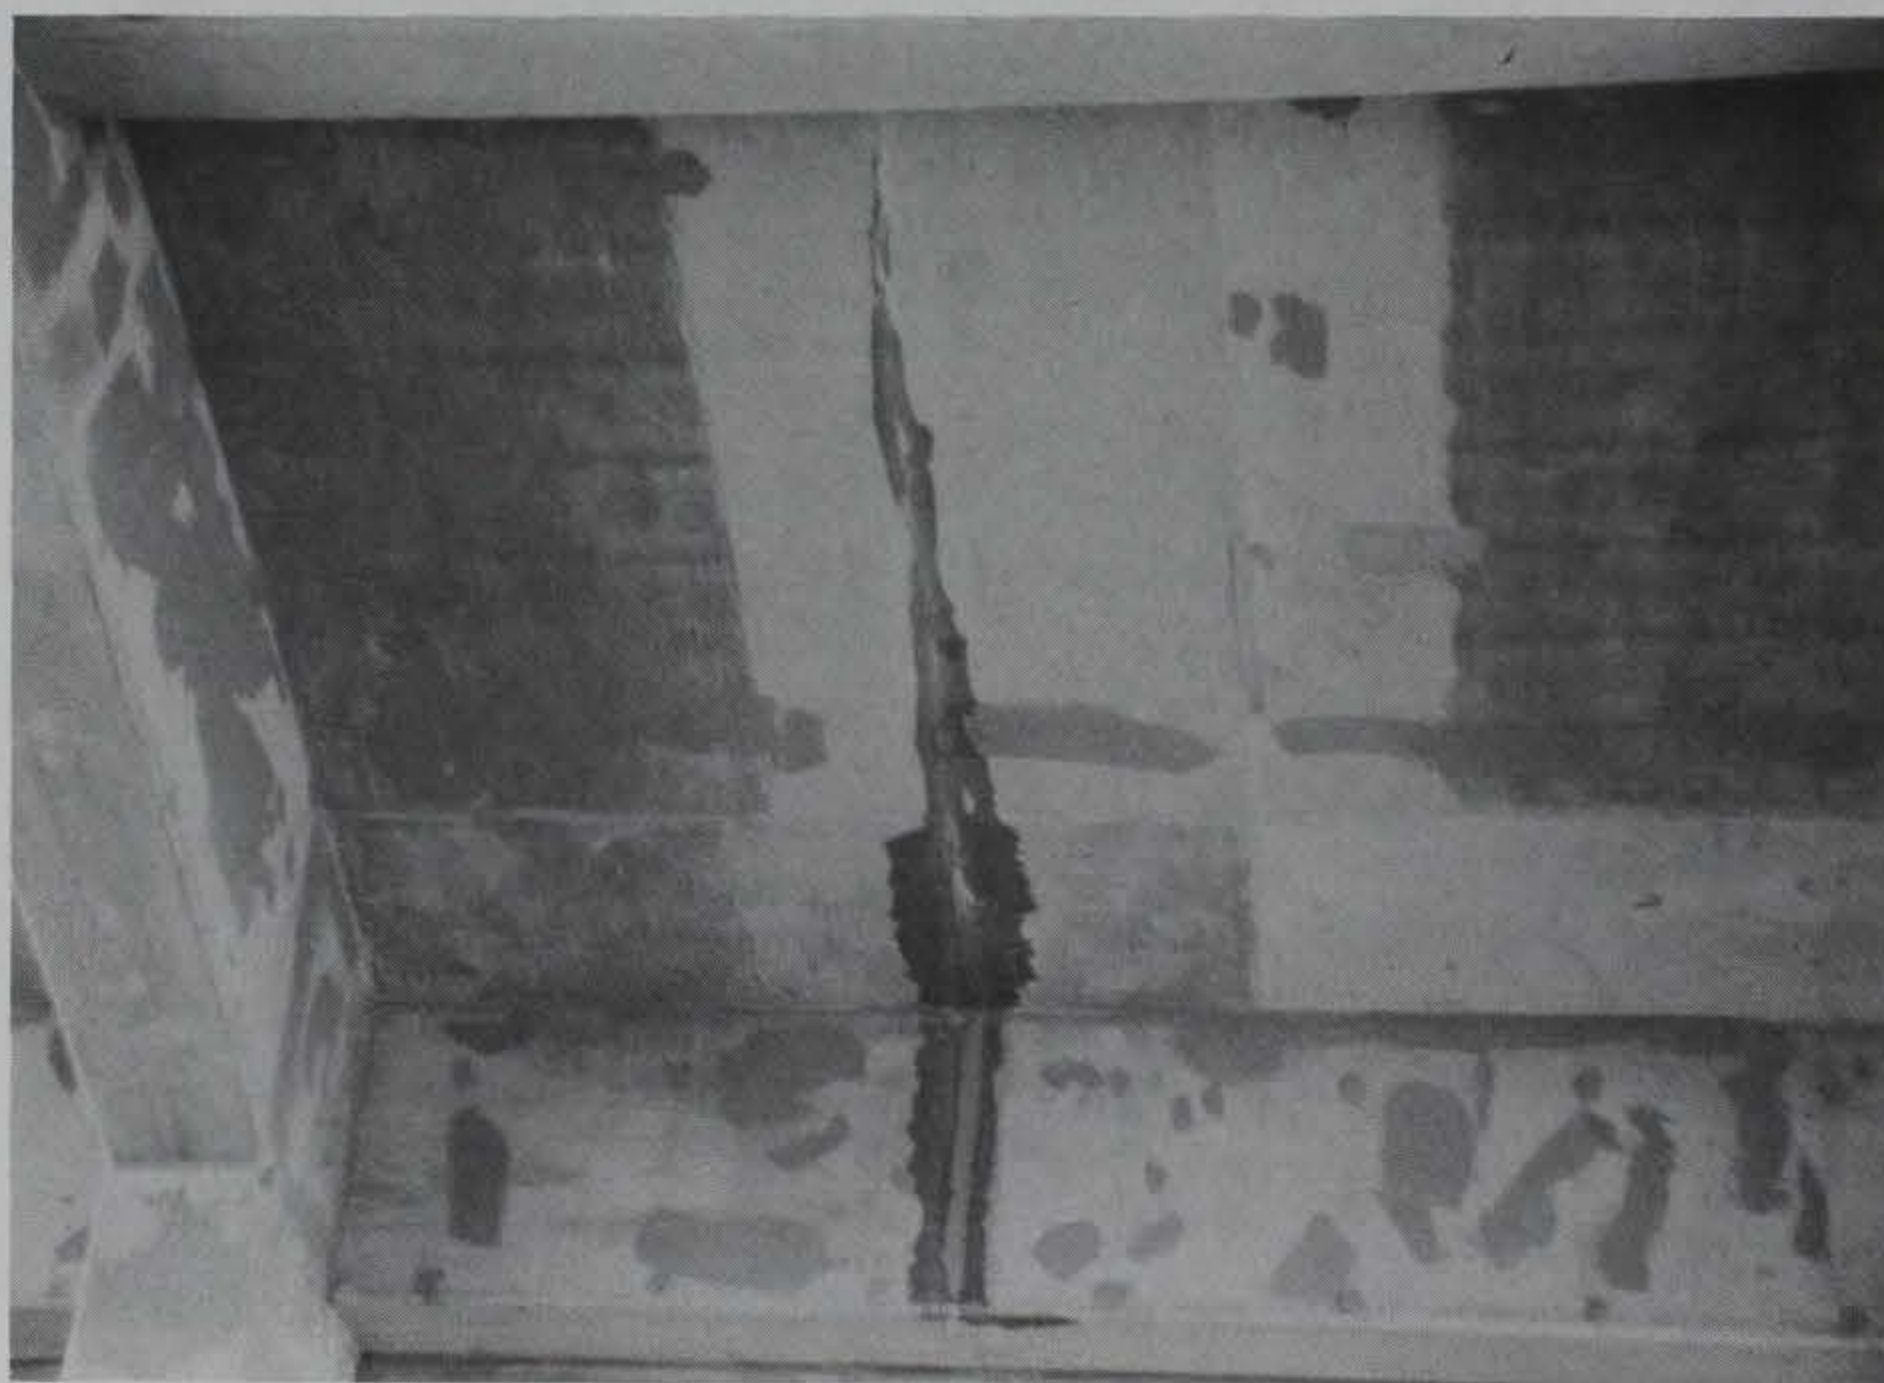
b. We observed that an apparently bituminous material had been applied to the top surface of the shelters' roofs. The purpose of the material was to prevent water from penetrating through cracks in roof slab sections and, thus, potentially causing corrosion of steel reinforcement. However, during rain storms on 28 and 29 Jul, water was observed seeping through one crack in shelter 30, apparently penetrating both the bituminous material and portland-cement concrete roof slab. Figure A13 shows water seepage through a crack located in shelter 30.

Figure A13. Water seepage, roof slab panel, shelter 30
