MISCELLANEOUS PAPER C-78-4

# CONCRETE AND ROCK TESTS REHABILITATION WORK, BRANDON ROAD DAM, ILLINOIS WATERWAY CHICAGO DISTRICT

Richard L. Stowe

> May 1978 Final Report

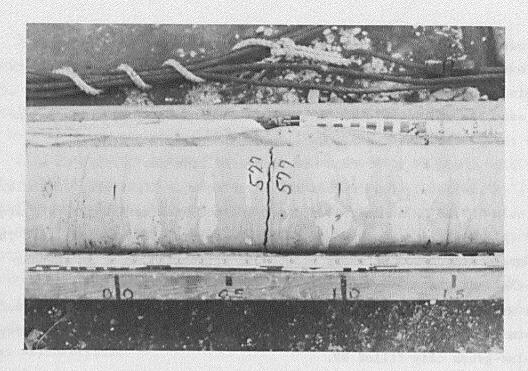
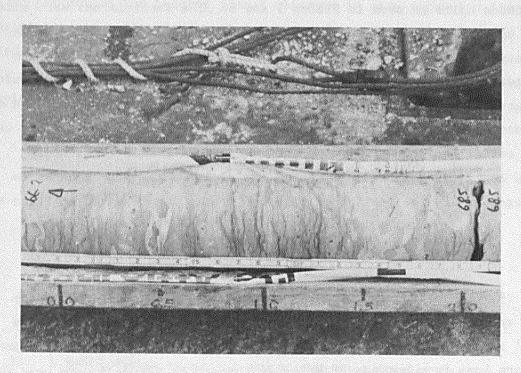
a. Sample of upper rock

h. Sample of lower rock showing numerous bedding plains Figure 5. Typical bedrock samples

- 30. The bedrock is considered competent and massive. No appreciable dip could be measured on the bedding surfaces, therefore bedding is assumed to be horizontal over the foundation. The bedding surfaces are irregular with a nominal 1-in. differential between the peaks and valleys both of which are generally rounded (Figure 5).

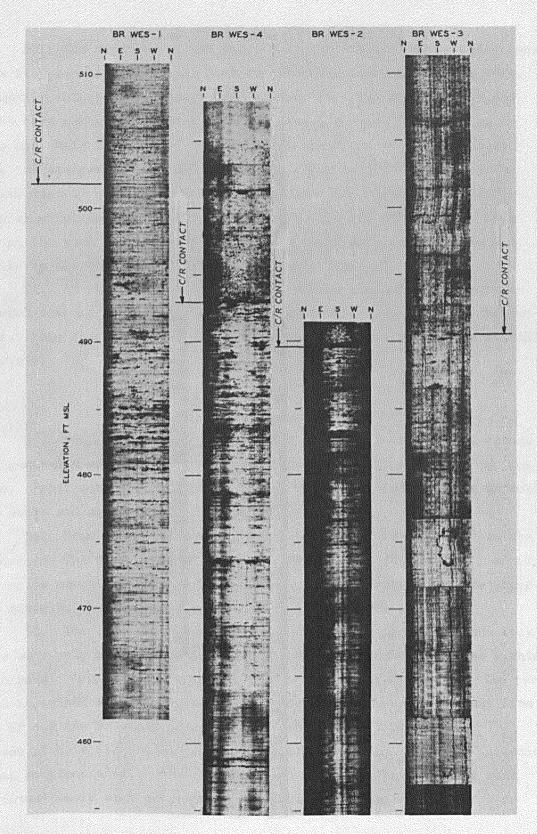
Figure 6. Televiewer logs, section A'-A'

Drill Hole No.	E1, ft	Strike and Dip
BR WES-1-76	491.0 to 488.8	N 50° E, 75° NW
BR WES-3-76	476.1 to 473.3	N 45° W, Vert.
BR WES-3-76	458.9 to 457.4	N 45° W, Vert.
BR WES-6-76	489.6 to 486.6	n 90° E, 78° S

- 53. The majority of the other features visible on the televiewer logs are probably horizontal bedding-related structures such as vugs, primarily solution cavities, zones of soft material such as clay and shale that washed out during drilling, and light and dark banding by clay and shale interbeds. The fractures occurring in the boreholes were too scattered to establish the existence of joint sets or set orientations. Deere's rock quality designation (RQD) classifies rock as excellent if the RQD is between 90 and 100 percent. On this basis, the rock at Brandon Road would be rated excellent because all breaks in the core were classified as mechanical.
- 54. In three of the four borings across the dam, the concrete-bedrock contact was loose. The headgate boring shows a very tight contact. This fact should be seriously considered when making the stability analysis.
