MISCELLANEOUS PAPER C-78-12

CONCRETE AND ROCK CORE TESTS MAJOR REHABILITATION OF STARVED ROCK LOCK AND DAM, ILLINOIS WATERWAY CHICAGO DISTRICT, PHASE I, REHABILITATION

Richard L. Stowe, Barbara A. Pavlov, Ging S. Wong

September 1978

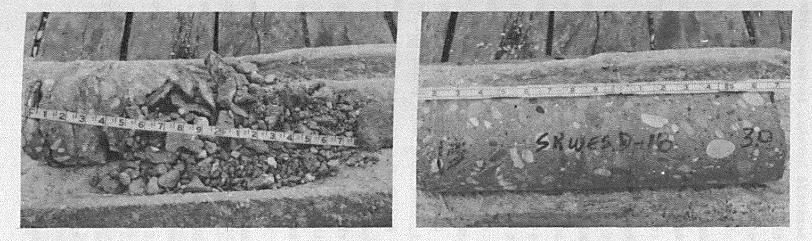
The concrete core varied greatly in its physical condition over 36. the project (see Figures 3 and 4). Some core was so badly deteriorated (broken to gravel-size pieces) that intact samples could not be obtained for testing. Therefore concrete test specimens were selected from the intact near surface portion and the bottom portion of the core. The near surface core sometimes contained cracks but remained intact. This procedure was used for the short core and for core with lengths up to 5.1 ft. For the deeper borings, GW-1 and GW-2 test specimens were selected from the near surface, middle, and bottom portions of the core. Characterization properties, effective (wet) unit weight (m), compressional wave velocity (Vp), and compressive strength (UC), and engineering design properties Young's Modulus (E), and Poisson's ratio $(v)^{*}$ were determined or calculated. Test assignment locations can be gotten from appropriate tables of test results.

Figure 3. Concrete core from ice chute pier (horizontoal boring SR WES D-18-77) showing broken condition of core

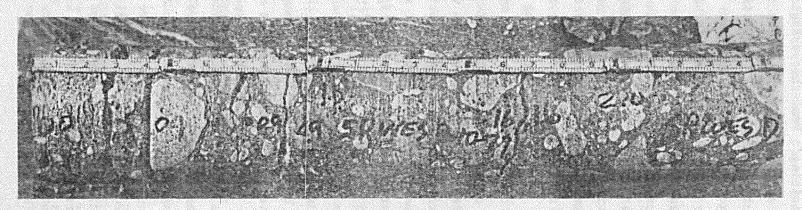
Figure 4. Concrete core from tainter gate pier No. 2 (horizontal boring SR WES D-10-77) showing subparallel cracking due to frost action

67. Examination of the core shows that while some of the concrete is in good condition from the old finished surface to the greatest depth drilled, many of the cores show cracks subparallel to the face surface of the concrete and to depths ranging from 2 in. to 3 ft. These subparalle

cracks are the results of freezing and thawing. All structures at the lock and dam contain frost-damaged concrete. Within some of the frostdamaged zones cracks at right angles to the free surface (formed surfaces) of the core were observed. Similar cracking occurred outside frost-damaged zones. Longitudinal cracks normal to the free surface are associated with alkali-silica reaction in hydraulic structures and some bridges. Core SR WES D-22 is a good example of both types of cracking; see photograph B2 in Appendix B. The photograph shows a particle of white chert next to the large longitudinal crack that goes to a depth of 3.0 ft; the chert is apparently the most reactive aggregate in the structure. Similar cracks were found in about one-fourth of cores examined.

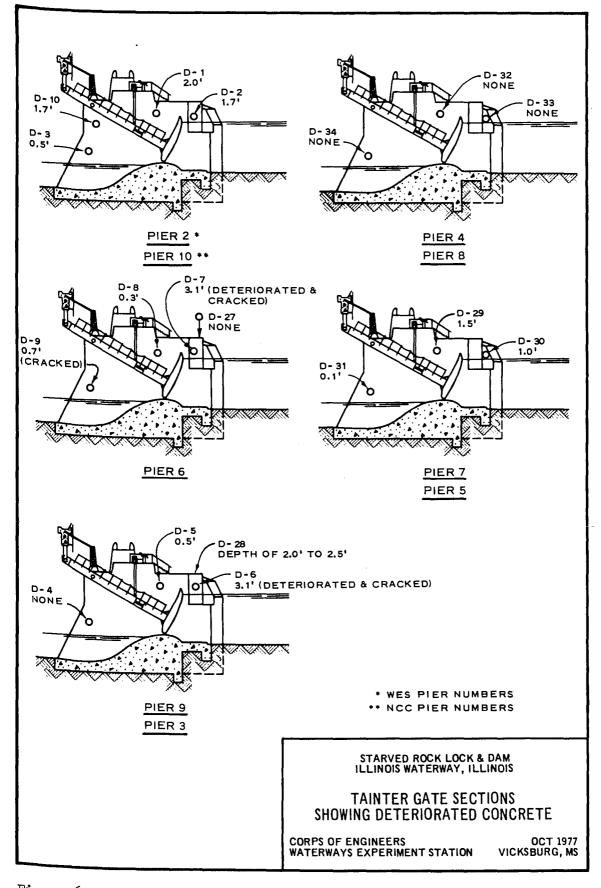
Figure 6. Location of deteriorated concrete, tainter gate sections

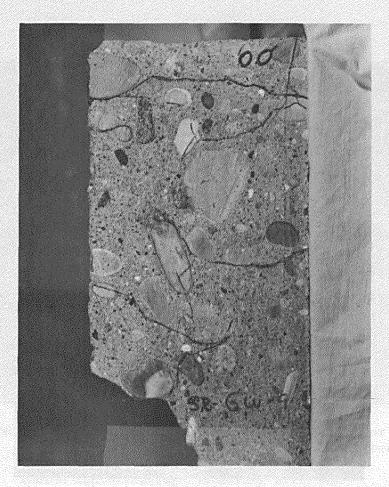
Photograph B1

Core SR WES GW-9-77 contained traverse cracks near the top of the core and incipient cracks deeper in the core.

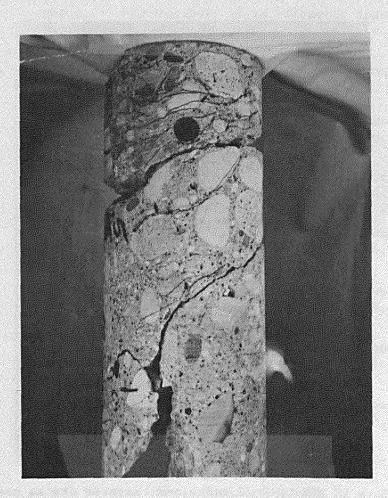
Photograph B2

Core SR WES D-22-77 is typical of several cores showing subparallel to parallel fractures going through both aggregate and paste indicating frost damage near the surface and a transition to horizontal cracking related to alkali-silica reaction deeper in the hole.

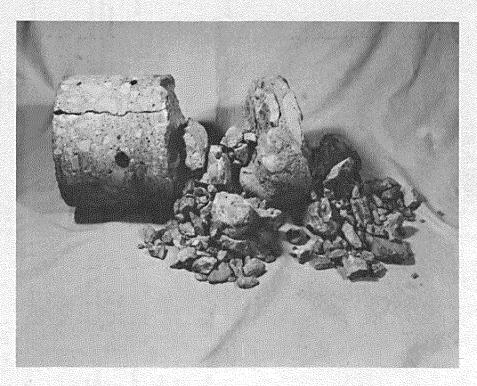
Photograph B3

Core SR WES D-1-77 has been resurfaced with a layer of new air-entrained concrete. The zone directly beneath the resurfacing was damaged by frost action and disaggregated during drilling.
