MISCELLANEOUS PAPER C-76-9

ENGINEERING CONDITION SURVEY AND STRUCTURAL INVESTIGATION OF LOCKS AND DAM 3, MONONGAHELA RIVER

August 1976

Prepared for U. S. Army Engineer District, Pittsburgh
Pittsburgh, Pennsylvania 15222

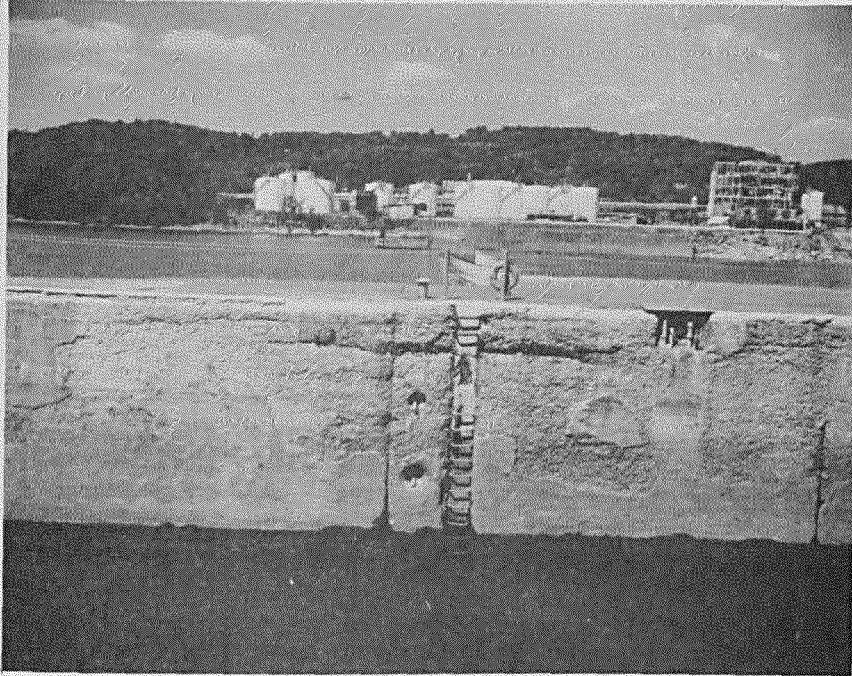
Figure 2.1 shows the downstream areas of the chamber face of the river wall. They illustrate the appearance of the gunite, the areas of old concrete where the gunite cover has come off, and some opening between the gunite and the underlying concrete in the gate recess. Figure 2.2 shows an area on the top of the river wall near the chamber face where the overlying concrete repair has spalled off exposing the old concrete beneath it. The aggregate particles in the old concrete are loose in their sockets and pieces of mortar can be removed by hand; this area of loose aggregate and fragmented mortar looks like and probably represents damage due to long-time frost action. Figure 2.3 illustrates the damaged surface of the guard wall just above the upper gate of the large chamber. This type of damage is common in the guard wall surfaces, and is caused by continued impact and scraping by boats and barges upon

a. Chamber Wall of River Wall at about Sta. 2+50B
Showing Loss of Gunite Cover

b. Downstream Gate Recess of River Wall
Showing Loss of Gunite Cover

Figure 2.1. River Wall Showing Loss of Gunite Cover.

frost-weakened concrete. The amount of deteriorated concrete in the lock wall is not surprising in view of the length of time the nonair-entrained concrete has been exposed to the severe climate where freezing and thawing are common occurrences. Continued maintenance and repair of the exterior concrete will be required at Lock and Dam 3.

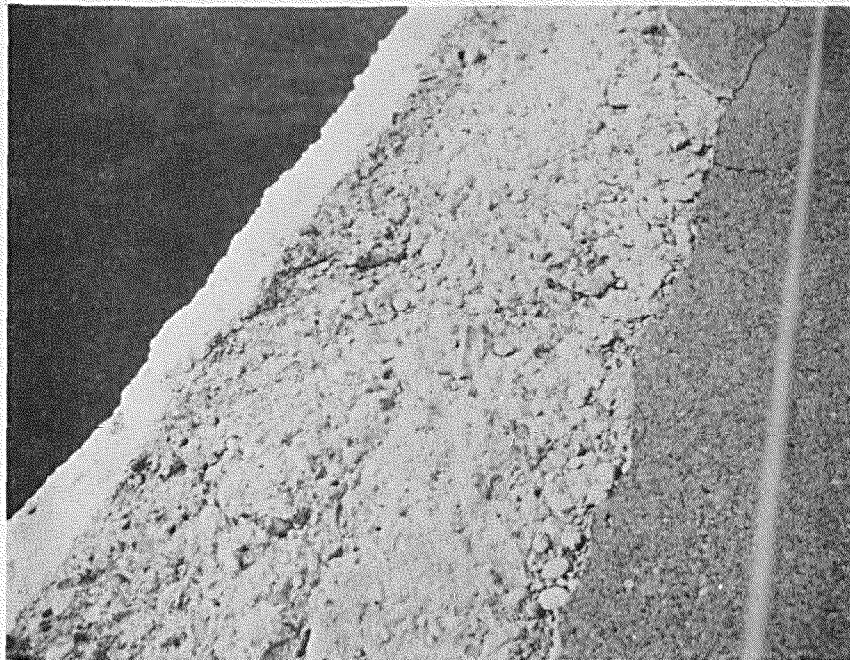
Figure 2.2. Top Surface of River Wall on Chamber Side Showing Spalling.

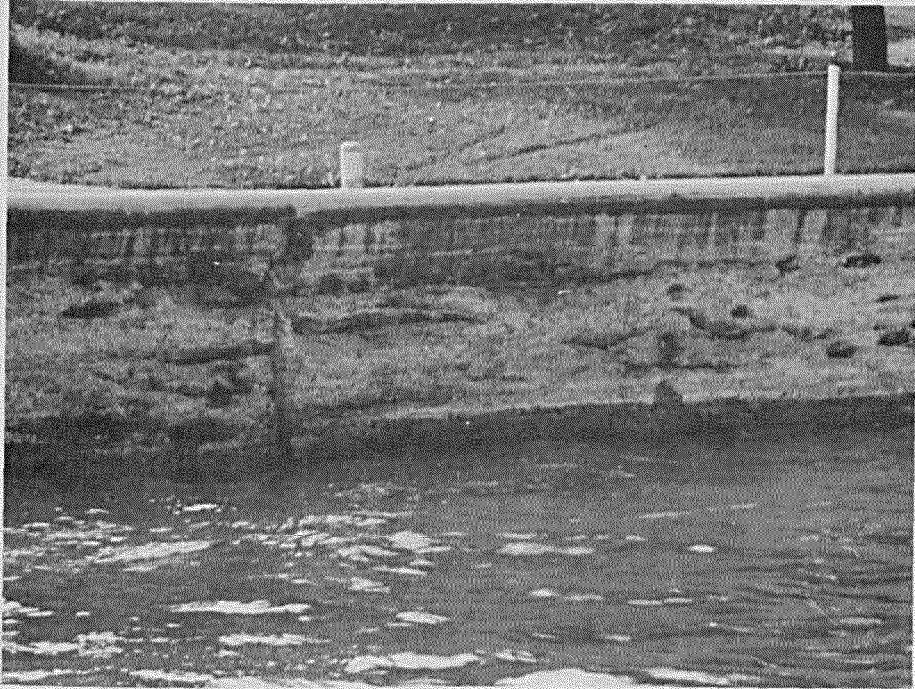
Figure 2.3. Upstream Guard Wall Near Upper Gate
at about Sta. 0+00.

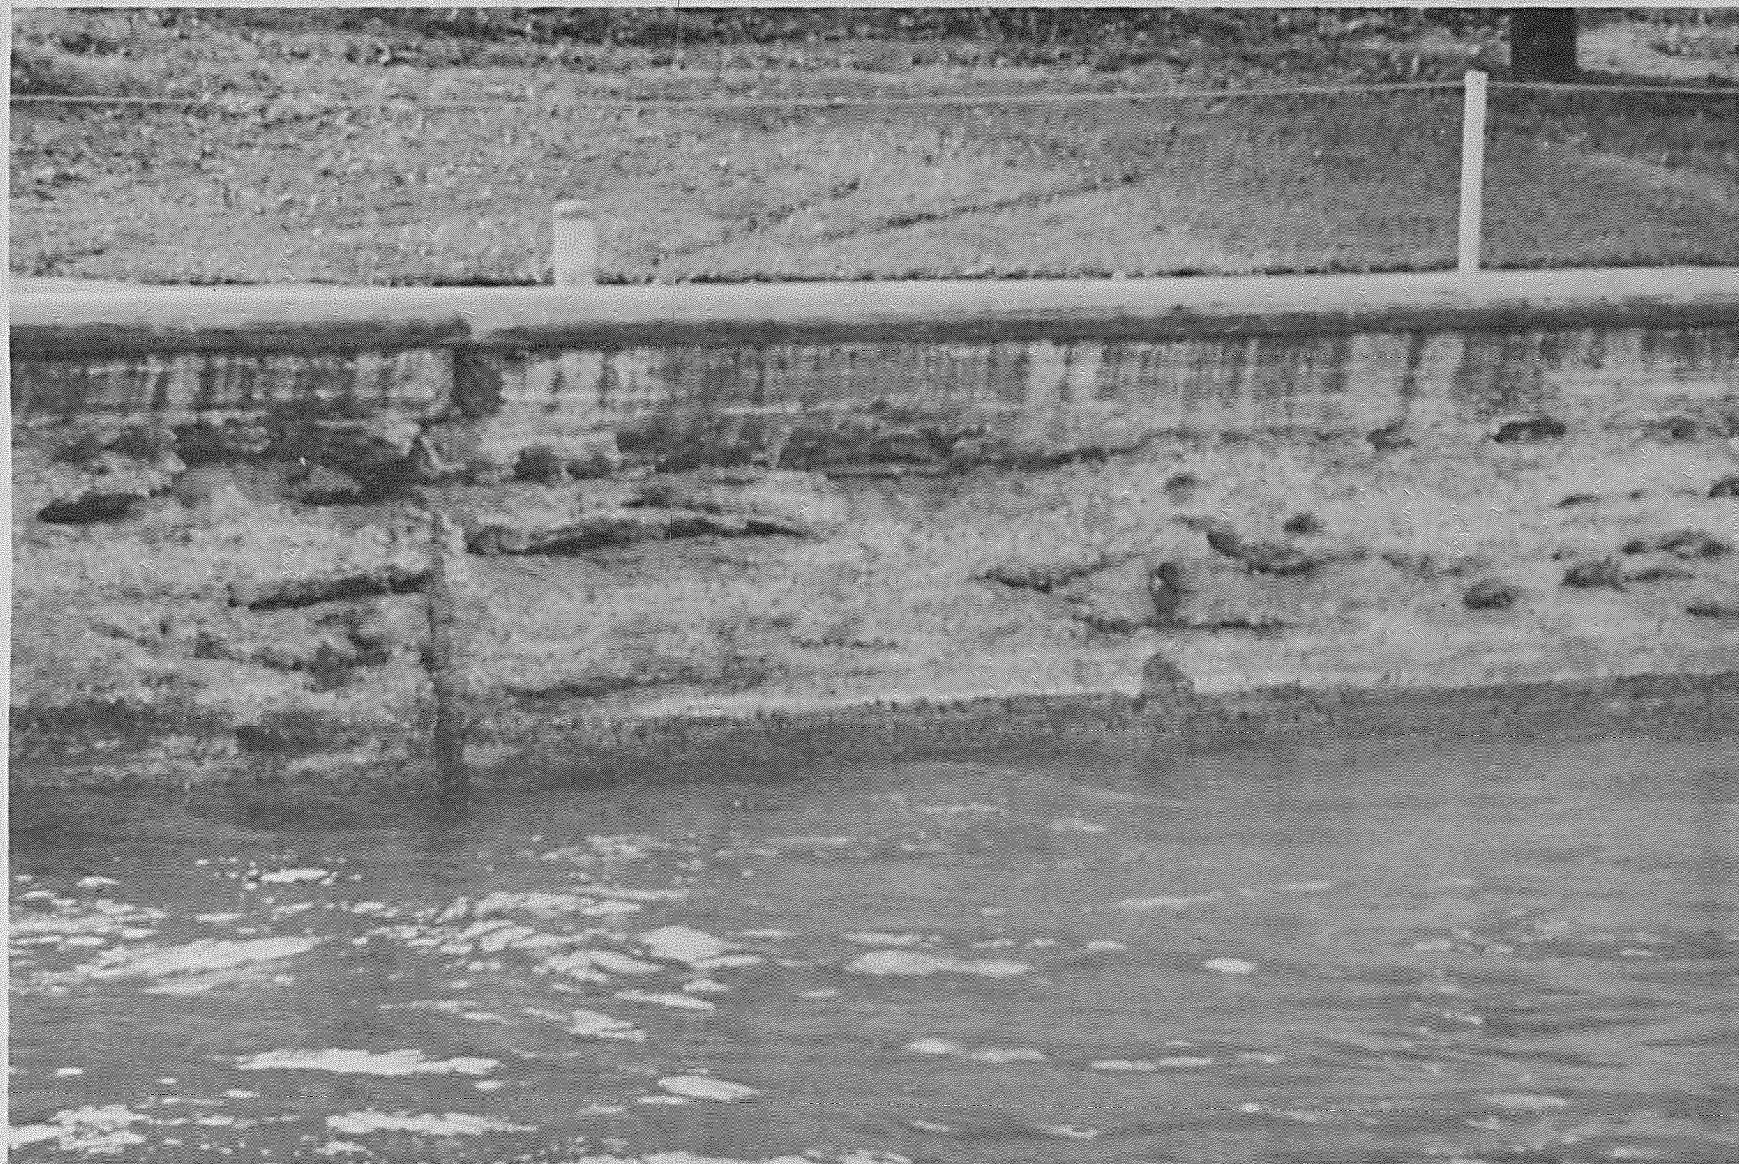
The upstream guide wall has never had wall armor; therefore, it has been badly gouged. The addition of a filling and emptying flume covered by a structural slab and supporting beams was added in the land wall monoliths. This addition resulted in construction joints at the interface of the original and newer additions which could cause the structures to act as separate units and not as monoliths. The units can be overturned much easier than the total monolithic structure because the effective base area is reduced and loads can be applied at the top of a unit by strut action (for example, through the structural slab) making them deficient in resistance to overturning. In certain case loadings these additions can also result in overstressing.

Figure 6.1. Gouged Upper Guide Wall

The gouges in the upper guide wall are as much as 3 ft deep and under certain loading conditions can cause overstressing in tension and possibly failure. If the consideration of stress in the upper guide wall is made by formulating and solving the depth of slit or gouge required to produce excessive tensile stress in good quality concrete, some idea of gouge effect can be determined. The gouges are considered at elevations of either the first three steps at the back and from the top of the guide wall. The calculations are given for maximum gouge depth at the first step and results from similar calculations tabulated for the next two lower steps.

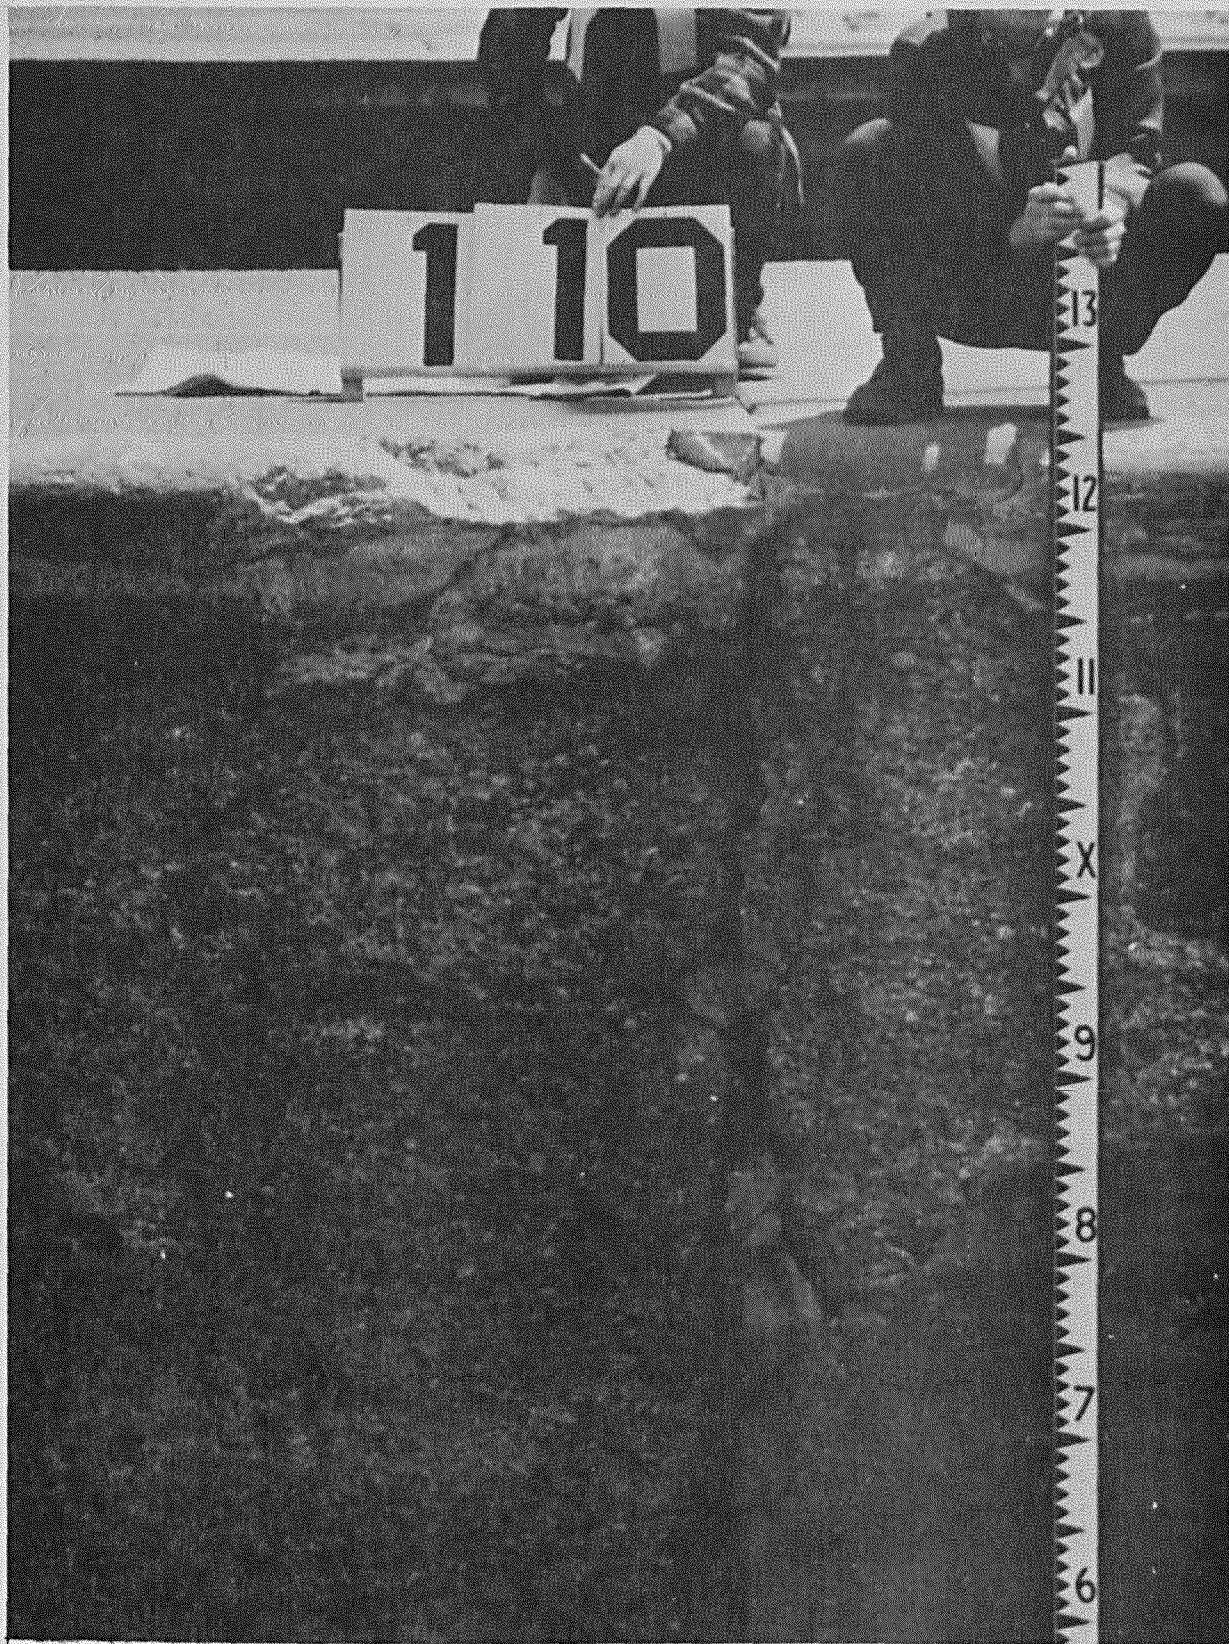
Figure 6.2. Deteriorated Construction Joint

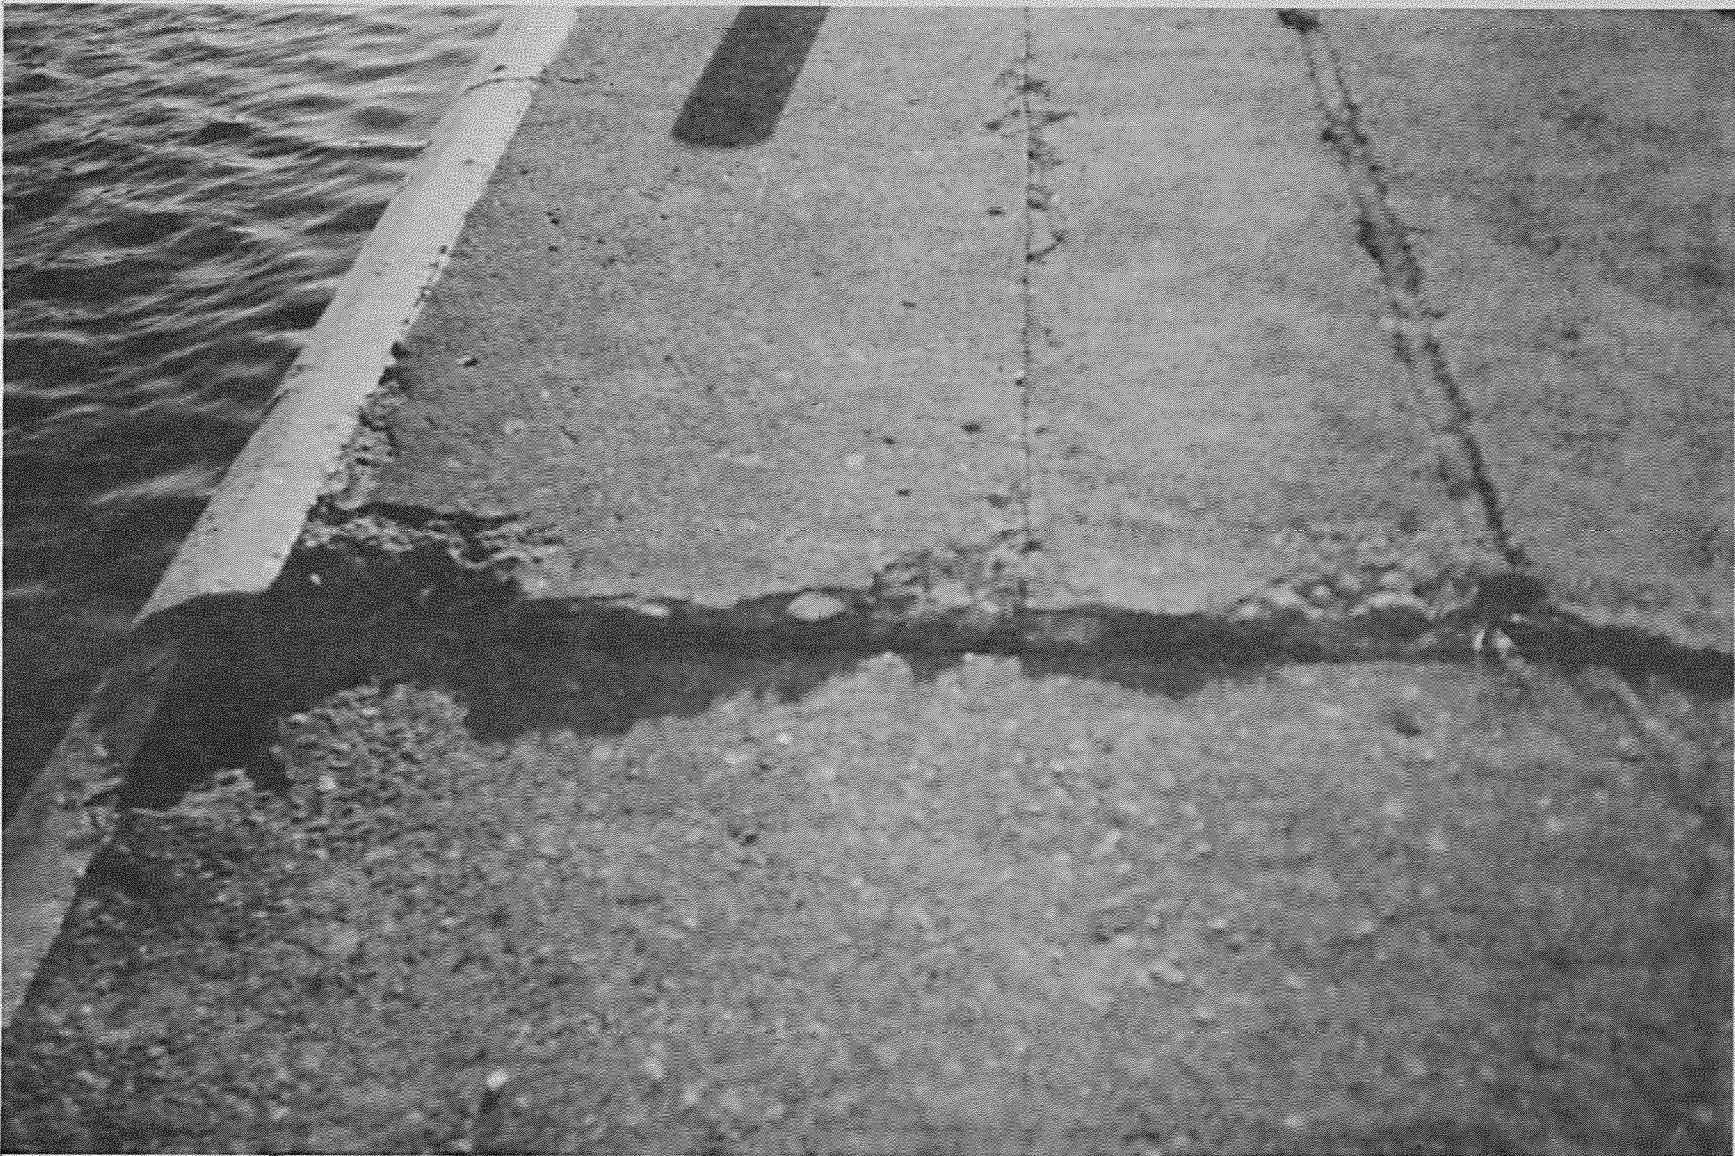
The upper guard wall has excessive bearing pressures between the upper and lower timber cribbing sections and has tilted riverward. There are probably some rocks between the cribbing members which result in more bearing area and, therefore, reduce the calculated stresses considerably. However, the tilting of the guard wall shows that the bearing pressures are still excessive. Tow impact can cause this guard wall to fail.

Figure 6.3. Tilted Upper Guard Wall

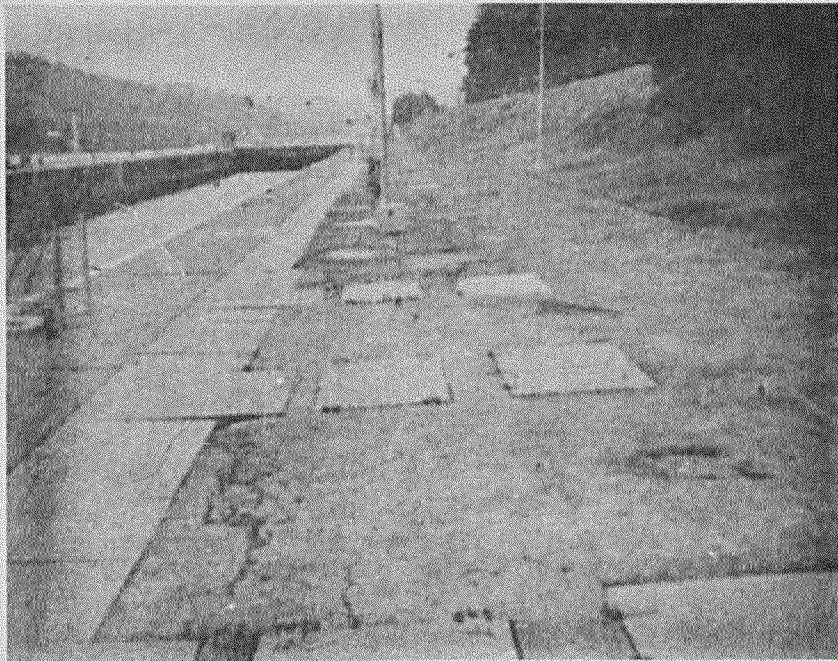
Structural cracking has occurred in the roof structure over the landward flume. The roof forms the open deck of the work area and is of a concrete beam and slab construction. Observed cracking in beams renders the area unsafe for other than very light loaded vehicles or equipment.

Figure 7.1. Cracking and Deterioration in Structural Slab Over Filling and Emptying Flume

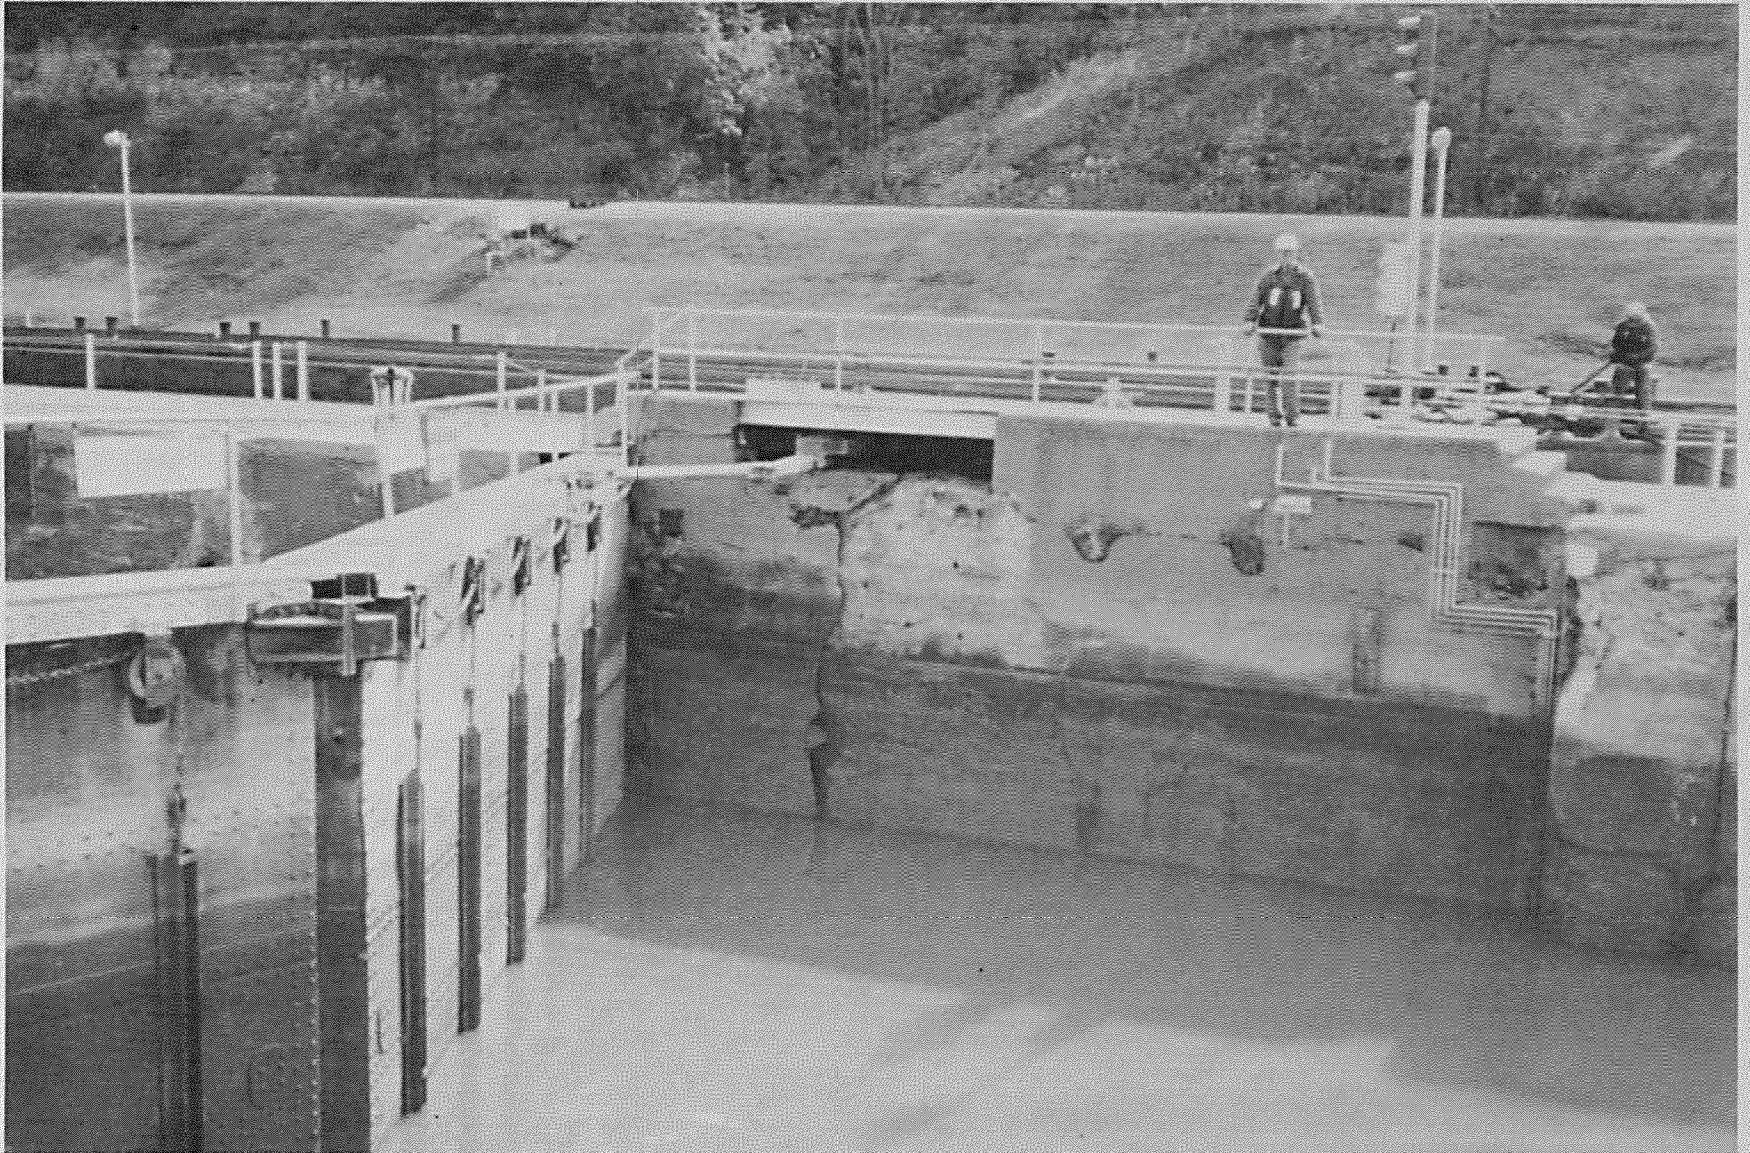
Figure 7.2. Deteriorated Locations at Gate Anchorages
