Special Report 80-14

CRREL ROOF MOISTURE SURVEY, PEASE AFB BUILDINGS 35, 63, 93, 112, 113, 120 and 220

Charles Korhonen and Wayne Tobiasson

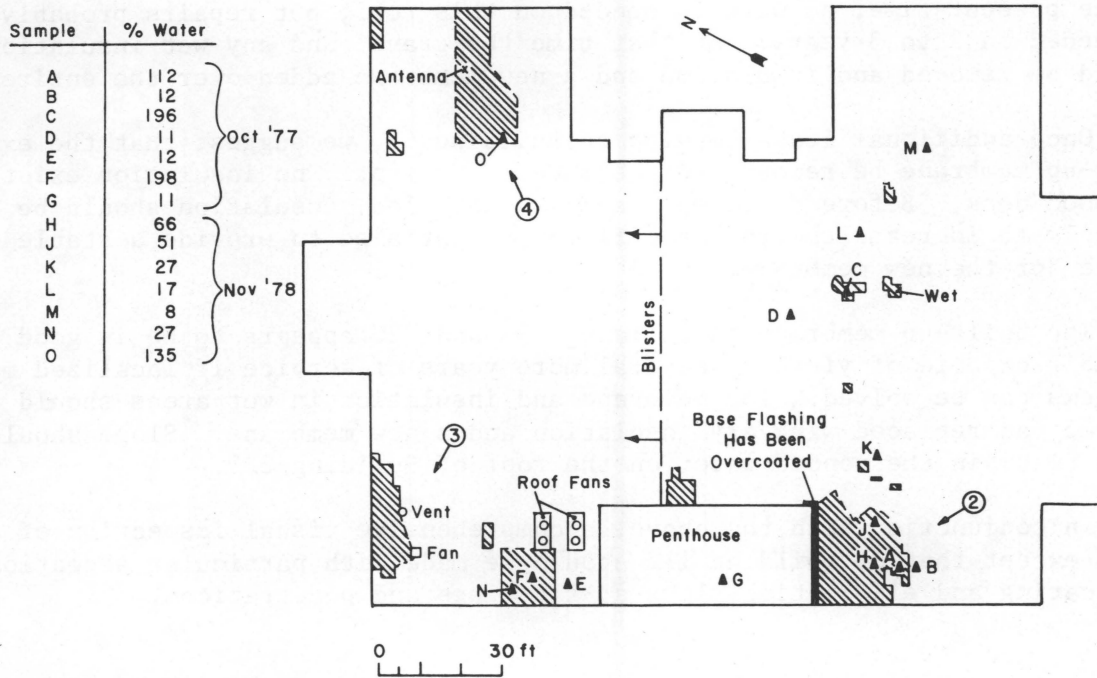
The roof on this building comprises a gravel-covered, built-up membrane underlain by 2 1/4 in. (5.7 cm) of wood fiber insulation. We identified several areas suspected of containing wet insulation (shown by the hatched areas in Fig. 1).

Several small blisters were noted in the northern portion of this roof (left of the dashed line in Fig. 1). Brief visual examinations of this roof were made in September and November 1978. At those times blisters were present over the entire roof, suggesting progressive membrane deterioration.

Figure 1. Plan view of Building 113. On all roof plans, circled numbers indicate the location and viewing direction of thermograms or photographs, dotted lines are general boundaries, and solid lines are exact boundaries of wet areas, which are depicted by hatching.

Since only a small percentage of this roof contains wet insulation but the entire membrane appears to be rapidly deteriorating, we suggest that all the gravel be removed and the tops of all blisters cut away. All wet insulation should then be cut out and replaced with dry insulation. Additional insulation should be added over the entire roof to improve its thermal resistance. It may be possible to affix the new insulation to the existing membrane with hot bitumen, but it may be necessary to use mechanical fasteners.

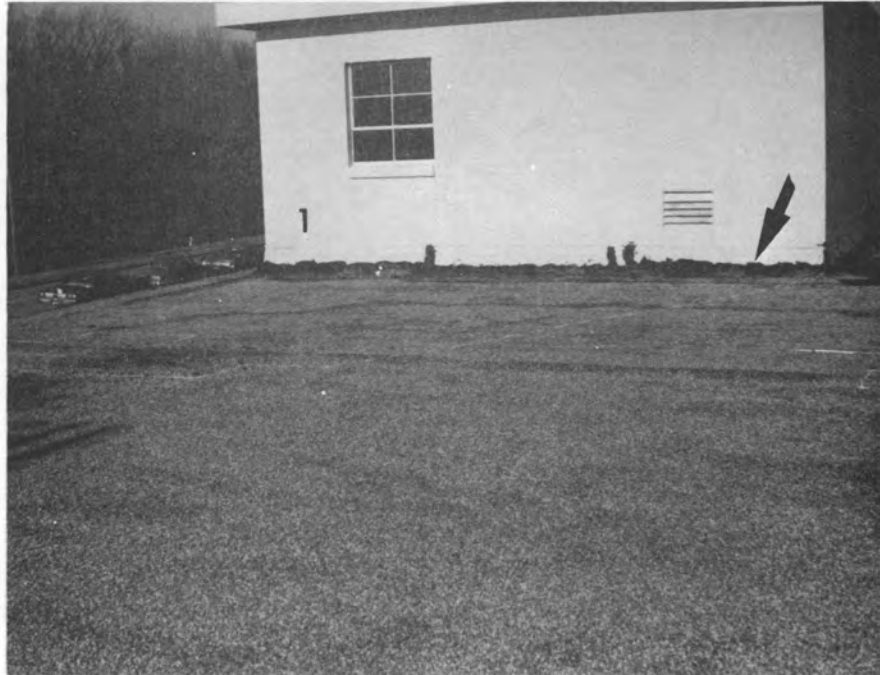
Thermograms and photographs of three large wet areas are shown in Figures 2 - 4. We suspect that flashing defects and punctures in the built-up membrane are the cause of these wet areas even though we did not observe any during this survey.

Figure 2. Thermogram and photograph of wet area abutting the penthouse on Building 113 (arrow points to patched flashing).

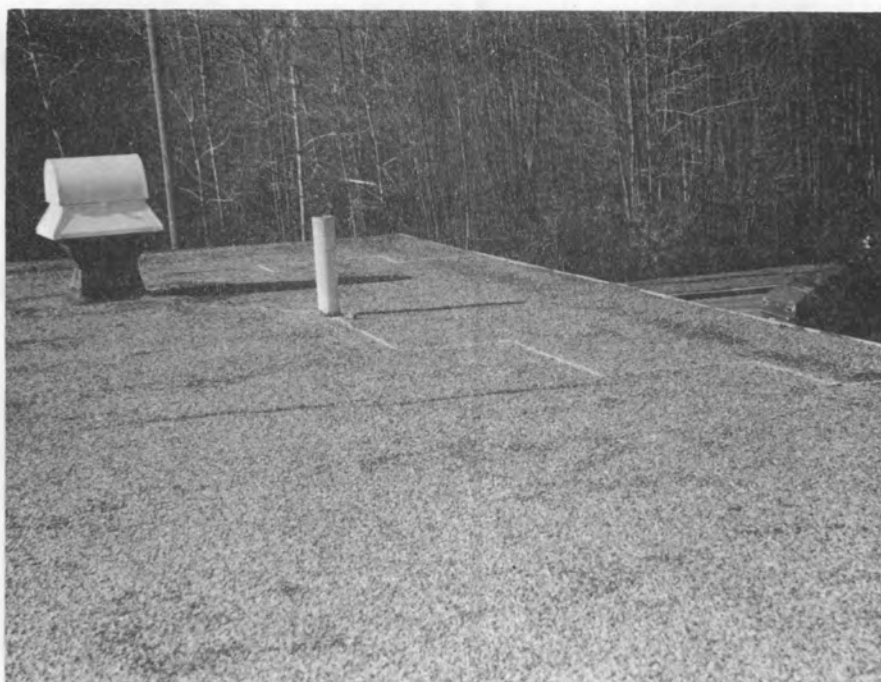
Figure 3. Thermogram and photograph of wet area that appears to be emanating from the base of a roof fan, Building 113.

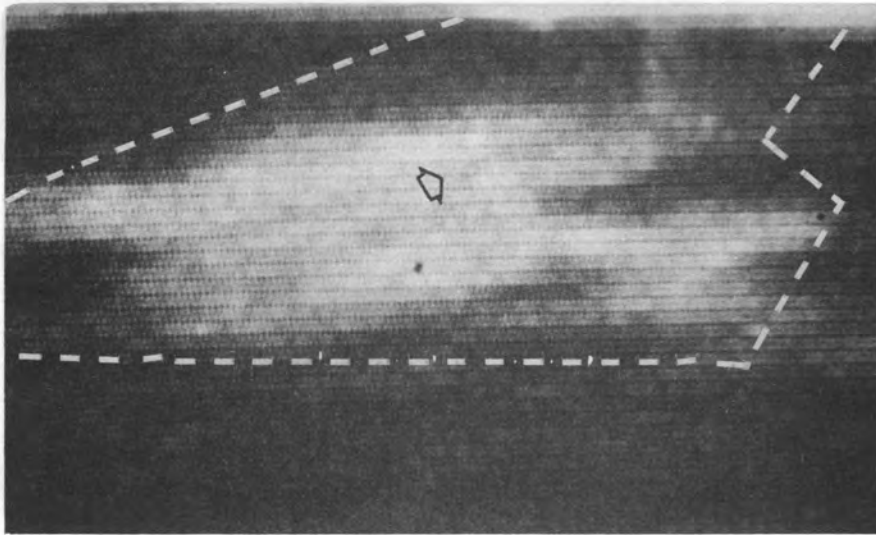
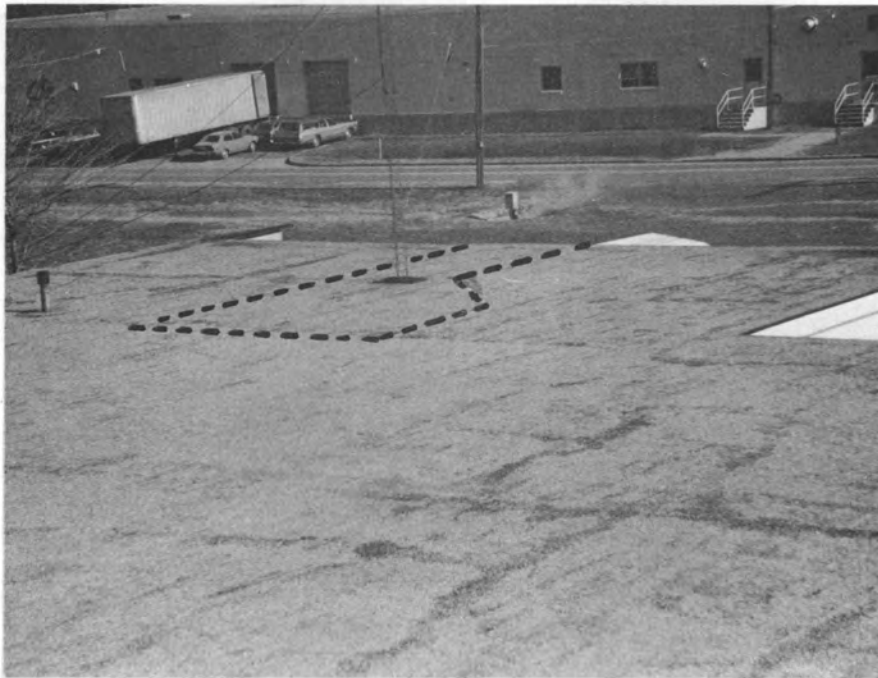
Figure 4. Thermogram and photograph of wet area surrounding antenna, Building 113 (arrow points to antenna).

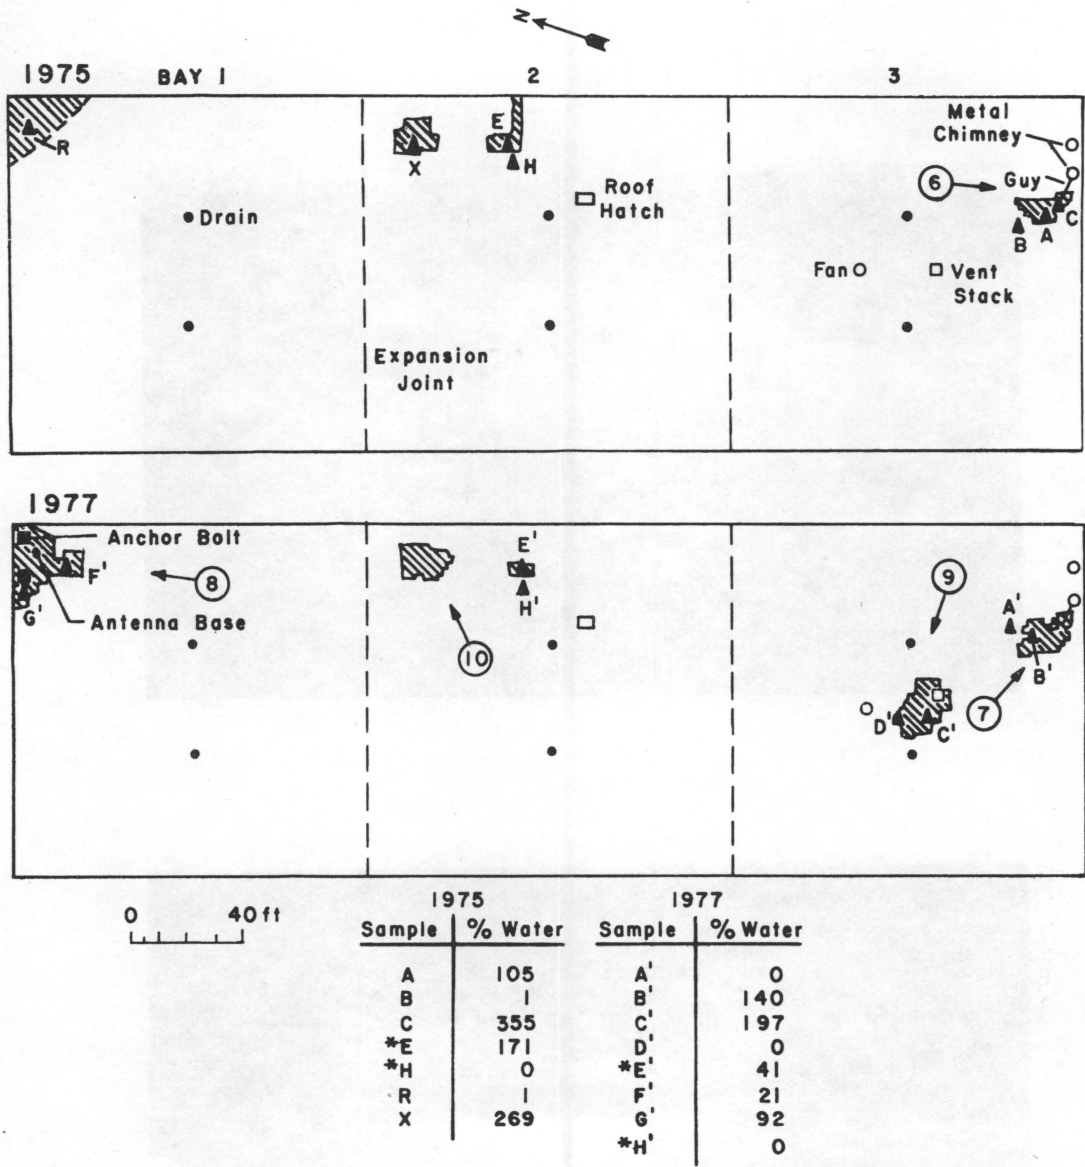
Figure 5 presents the results of the 1975 and 1977 surveys. The number and size of wet areas have greatly increased, indicating that moisture is entering the roof. One contradiction exists: the wet area surrounding sample E (Fig. 5) decreased in size and water content. This area may have lost moisture through the edge of the roof.

Figure 5. Plan views of the 1975 and 1977 survey results for Building 120.

Low blisters were noted over much of this roof and the membrane from each sample was brittle. We expect that a new built-up roof will be required shortly. Rather than wait until severe leaks occur, we suggest that the gravel be removed from this membrane and all areas of wet insulation be cut out and replaced with dry insulation. A new layer of insulation, perhaps mechanically fastened to the deck, should be added over the entire roof and a new gravel-covered built-up roof installed.

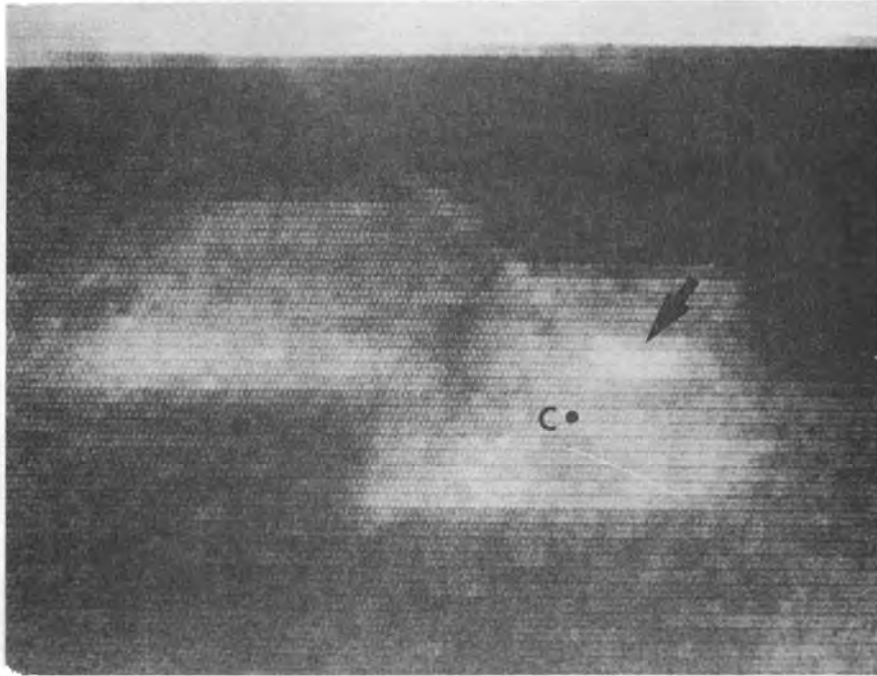
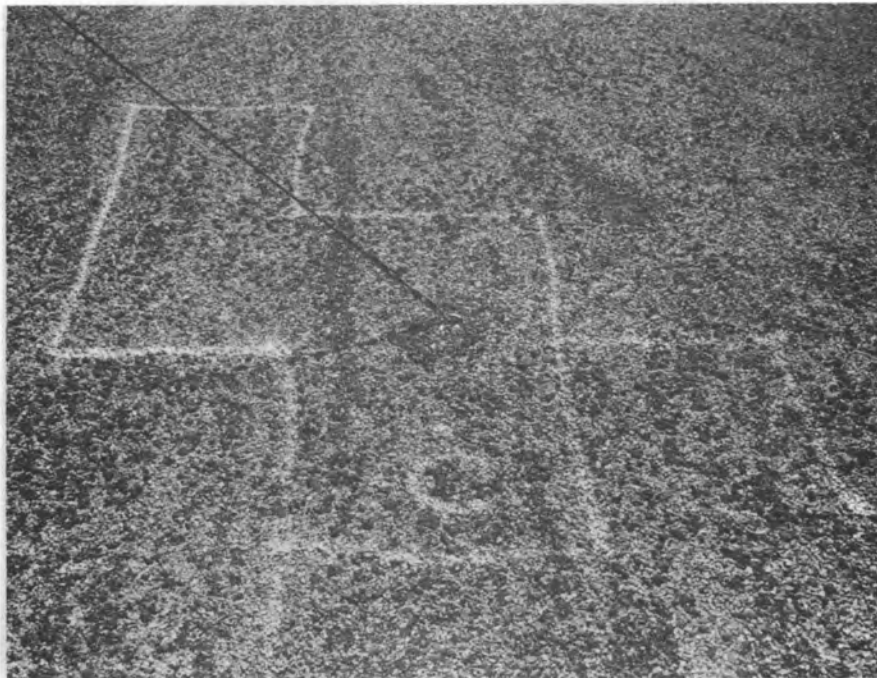
We consider membrane punctures created by guy wire anchor bolts responsible for the wet insulation found at each end of this roof. Figure 6 is a 1975 thermogram of a bright area surrounding the anchor bolt in the southeast corner and a photograph of the same area. From a comparison of the water content of the 1975 Samples C and A (C = 355% and A = 105%) it is evident that the insulation was much wetter near the bolt than at a distance from it, strongly suggesting that moisture enters the roof near the anchor bolt. The thermogram in Figure 7 shows the extent of wetting in 1975; the photograph shows the boundaries painted in 1977.

Figure 6. 1975 thermogram and 1975 photograph of wet area surrounding bolt, Building 120 (arrow points to bolt).

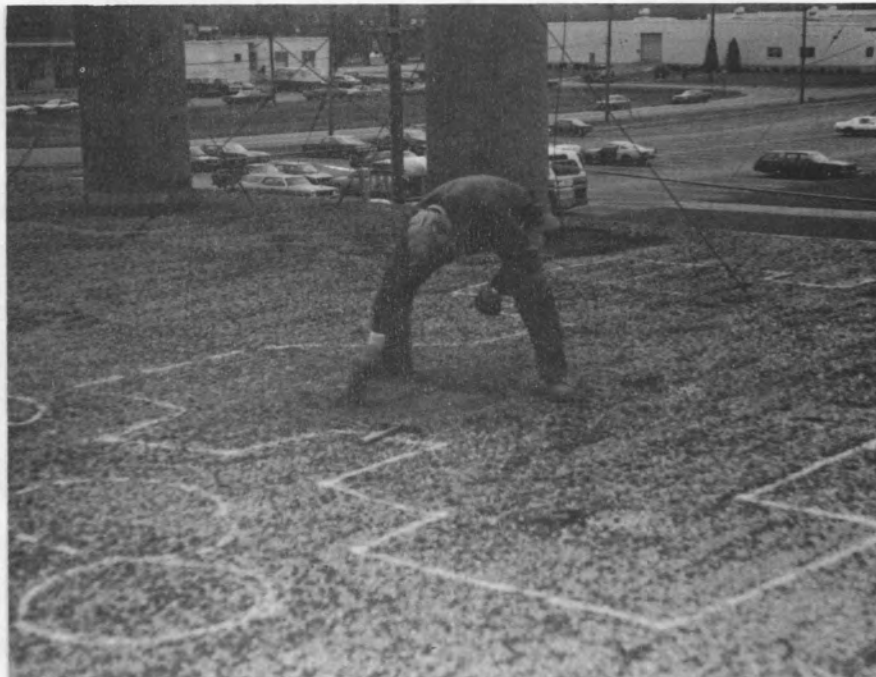
Figure 7. 1975 thermogram and 1977 photograph showing extent of wet area surrounding bolt, Building 120.

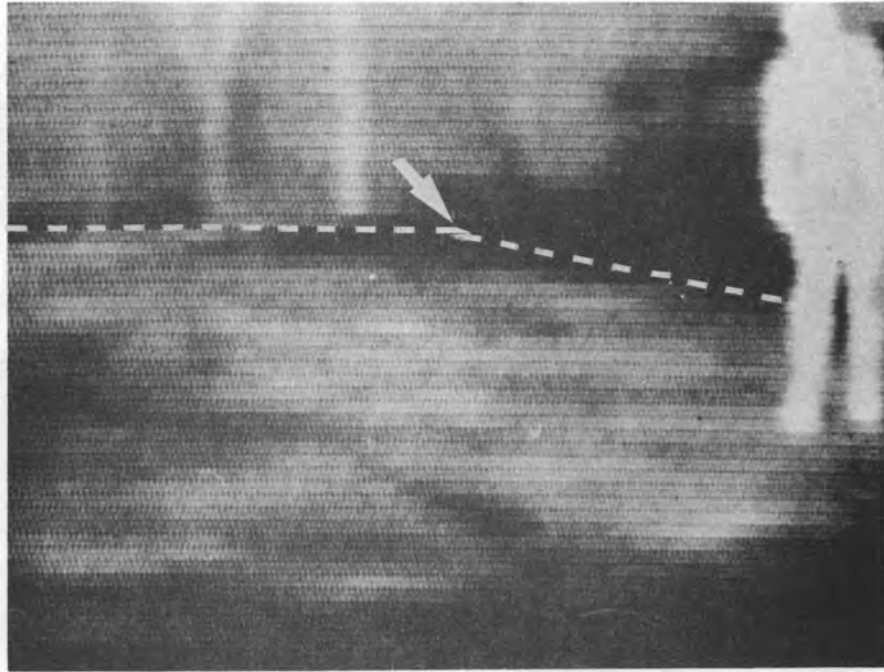
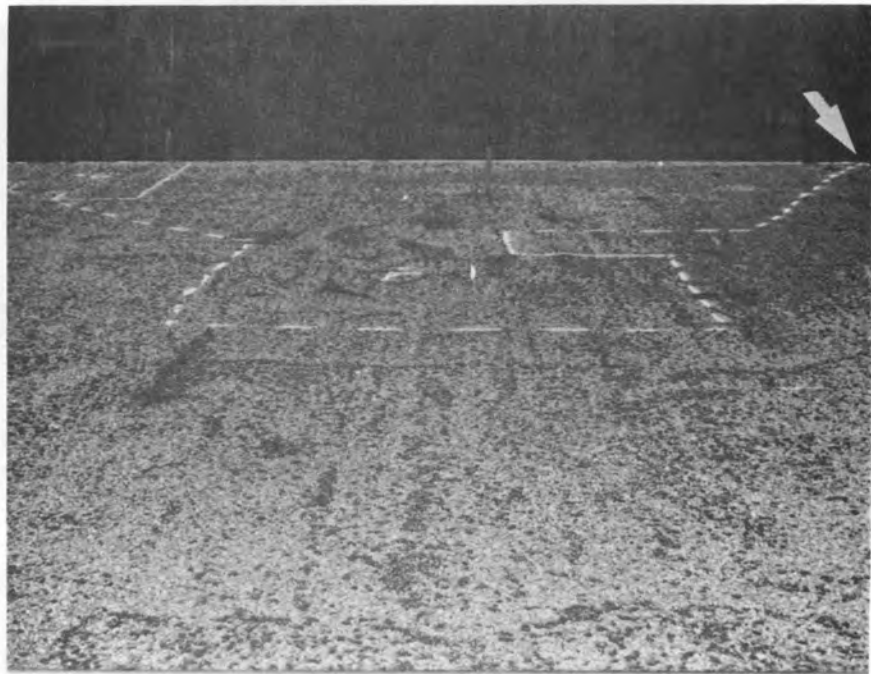
A 1975 thermogram (Fig. 8) shows that the thermal anomaly in the northeast corner is somewhat mottled, suggesting that this area of the roof was not uniformly wet. Since the infrared camera was not used to select a sample location from this mottled area, we believe that sample R was inadvertently selected from a dry (dark) portion of the mottled area. This explains its low water content even though it is located within a "wet" area. In 1977 this area was again mottled. However this time the infrared camera was used to select two sample sites. Samples F' and G' were both wet as expected. The photograph in Figure 8 shows the boundaries of this wet area.

Figure 8. 1975 thermogram and 1977 photograph of wet area in northeast corner of roof, Building 120 (arrow points to the corner of roof).

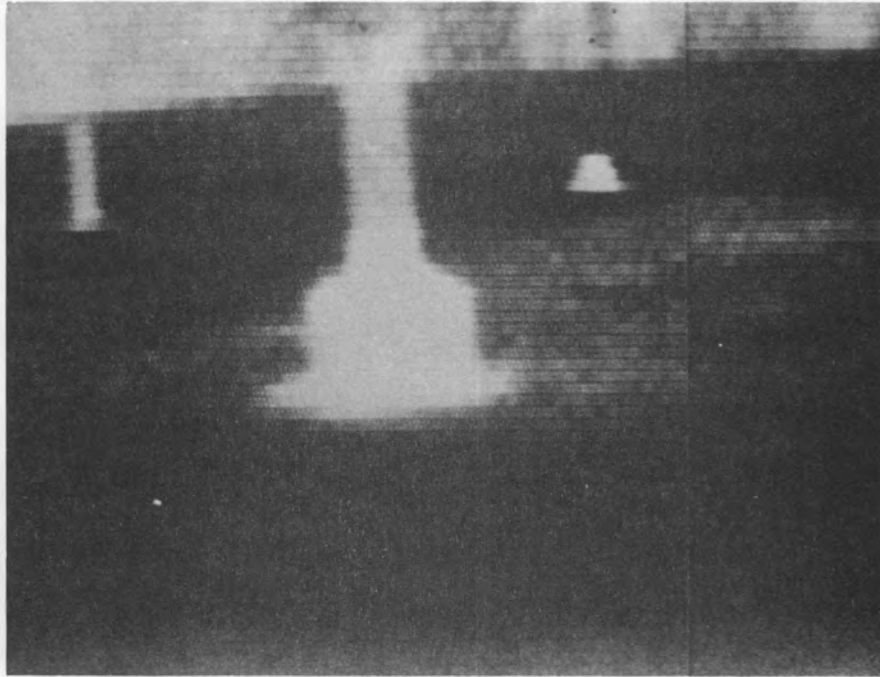
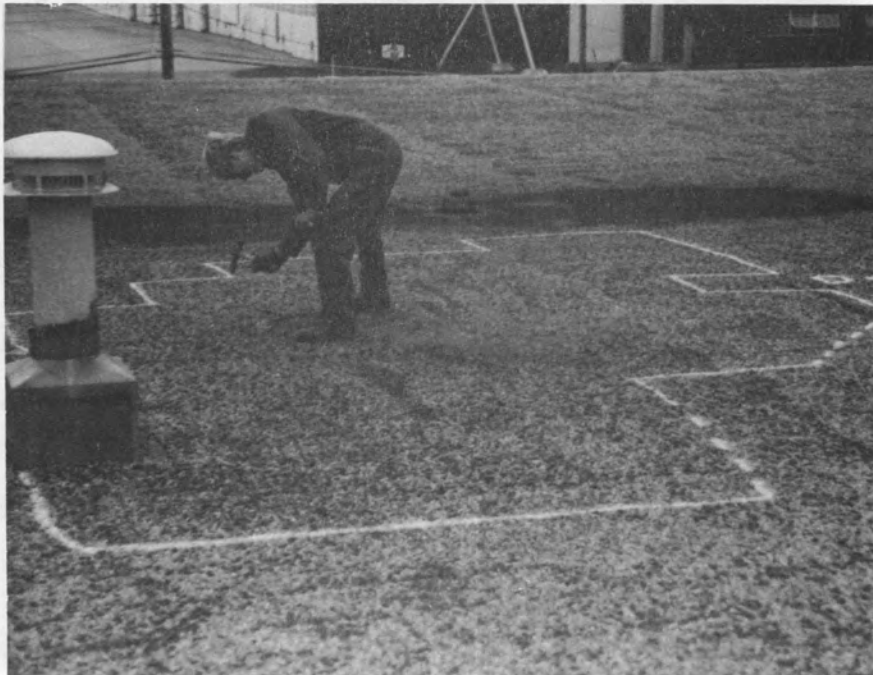
The area of wet insulation shown in Figure 9 was first detected during the 1977 survey. Although no membrane defects were noted, the shape and location of the anomaly seem to indicate that moisture enters this area from the base of the vent stack.

Figure 9. 1977 thermogram and 1977 photograph of wet area, Building 120.

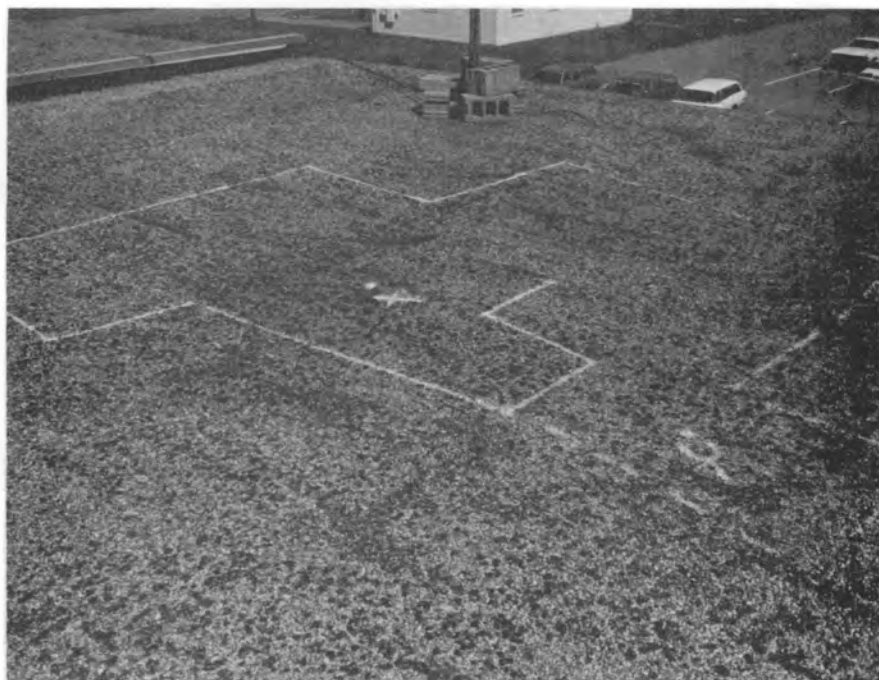
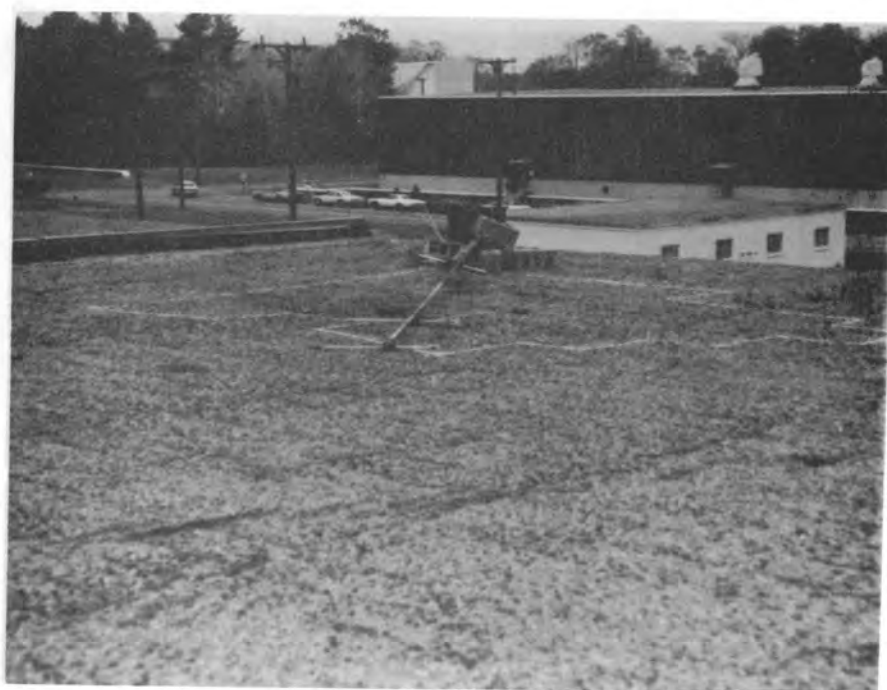
The top photograph in Figure 10, taken in 1975, shows an antenna mounted on the surface of the roof. In the foreground, a wet area is outlined with spray paint. In 1977 this same antenna was tipped over and the wet area had increased in size. This sequence strongly suggests that water enters this area of the roof through membrane defects associated with the antenna.

Figure 10. 1975 (top) and 1977 photographs of wet area in bay 2, Building 120. Notice increase in extent of outlined area.

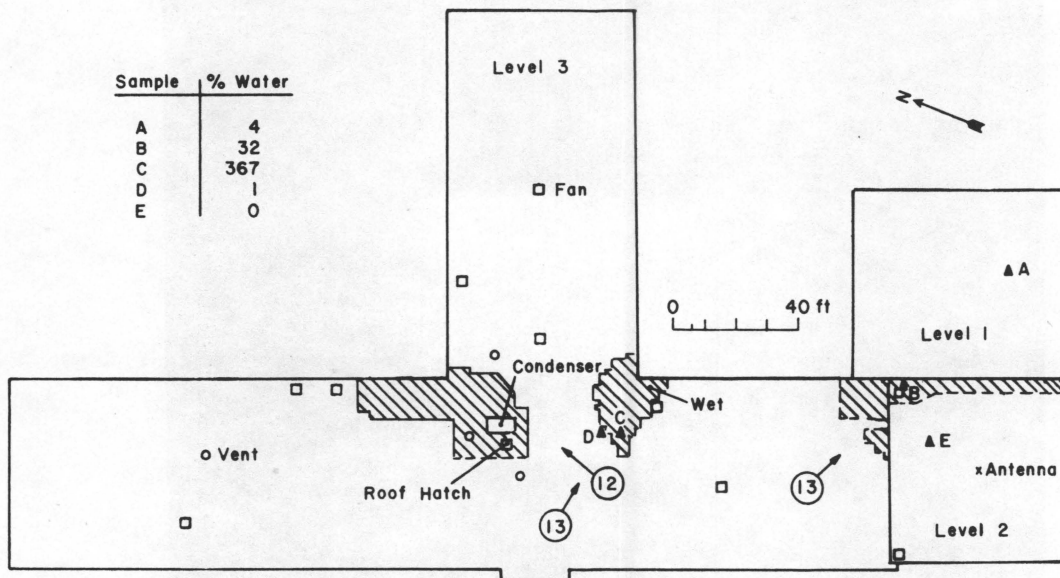
Figure 11. Plan view of Building 35.

This roof is composed of three levels (see Fig. 11). Approximately 2 ft (0.6 m) separates each level, with Level 1 the highest and Level 3 the lowest. Level 1 is gravel-covered while Levels 2 and 3 have a gravel surface that is over-coated with a bituminous seal coat. Overall, Level 1 appeared much brighter than the other two levels when viewed with the infrared camera. Core samples revealed that Level 1 had wood fiber insulation which is only 1/2 in. (1.3 cm) thick, while Levels 2 and 3 had glass fiber insulation 1 1/2 in. (3.8 cm) thick. Thus the thermal image was brighter on Level 1 because that section had less insulation than the other two levels. Because the Level 1 roof was uniformly bright we expected it to be free of wet insulation. Sample A, taken on Level 1 (see Fig. 11), was dry, which verified this expectation. Visually, the built-up membrane on Level 1 appeared to be in excellent condition. No remedial work is necessary there.

Five thermal anomalies were detected with the infrared camera on the Level 2 and 3 roofs. They are shown as hatched areas in Figure 11. Core samples subsequently verified that the insulation in these areas was wet. Figures 12 and 13 show a thermogram and three daytime photographs of these wet areas.

Unlike sample A, the membrane of samples B through E was brittle. It delaminated during the sampling process. This lack of interply bonding indicates that the membrane is very aged and probably will not last much longer. Due to the heavy over-coating on levels 2 and 3, we do not feel that the gravel can be removed without damaging the glass fiber insulation. We expect that simply cutting out and patching the wet areas is not an economical repair alternative because the entire membrane is so old and brittle. We recommend that all the membrane and insulation on Levels 2 and 3 be removed and replaced with new, insulated, built-up roofing.

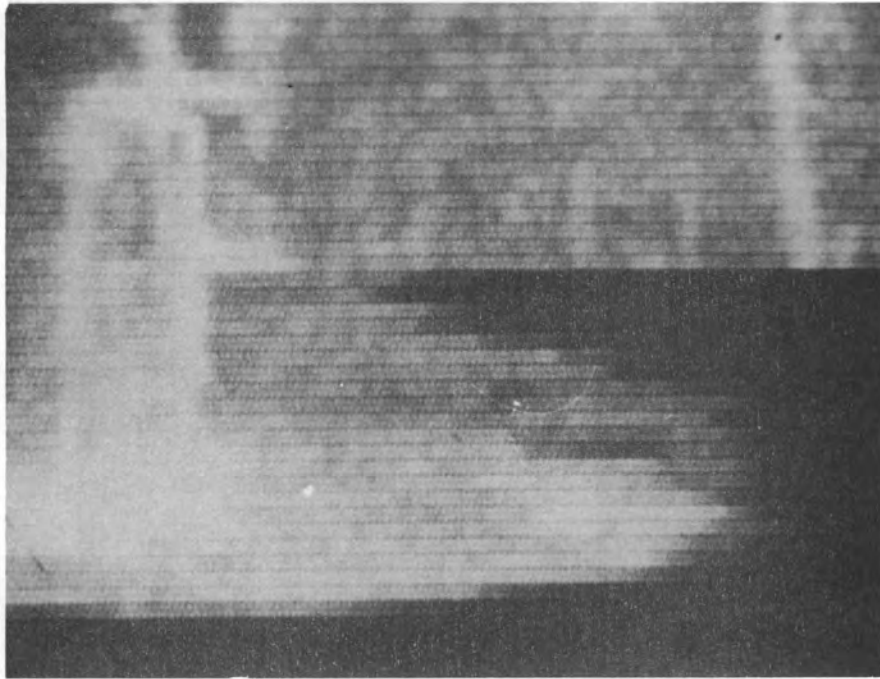
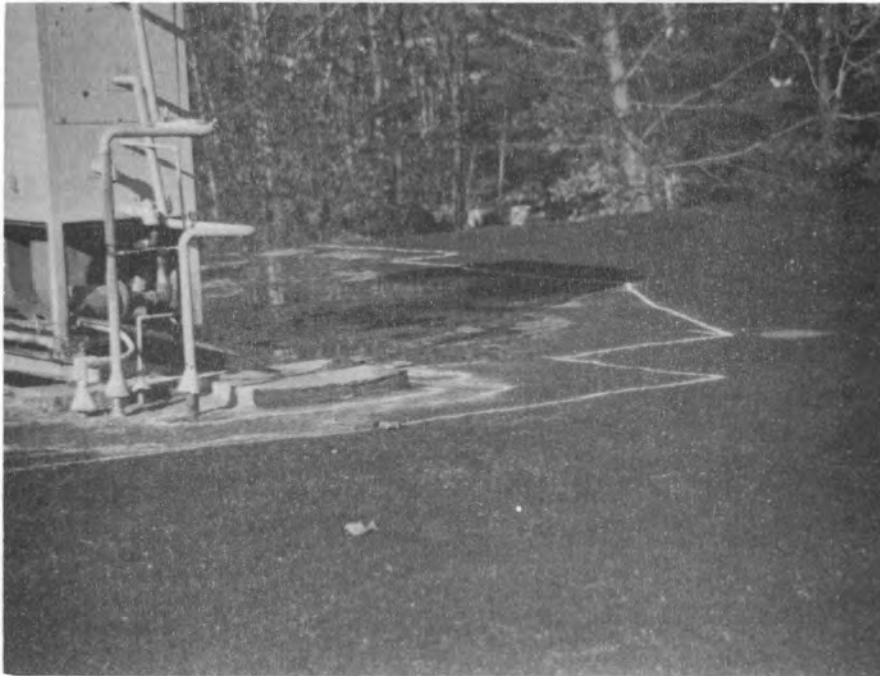
Visually, only one obvious moisture entry point was uncovered. The arrow in Figure 13 points to a deep split in the over-coating. It is likely that moisture entered the roof at this location. Building occupants pointed out two sections of ceiling stained by leaks which occur each winter. One leak is under the split shown in Figure 13; the other leak coincides with the area shown in Figure 12.

Figure 12. Thermogram and photograph of a wet area on Building 35.

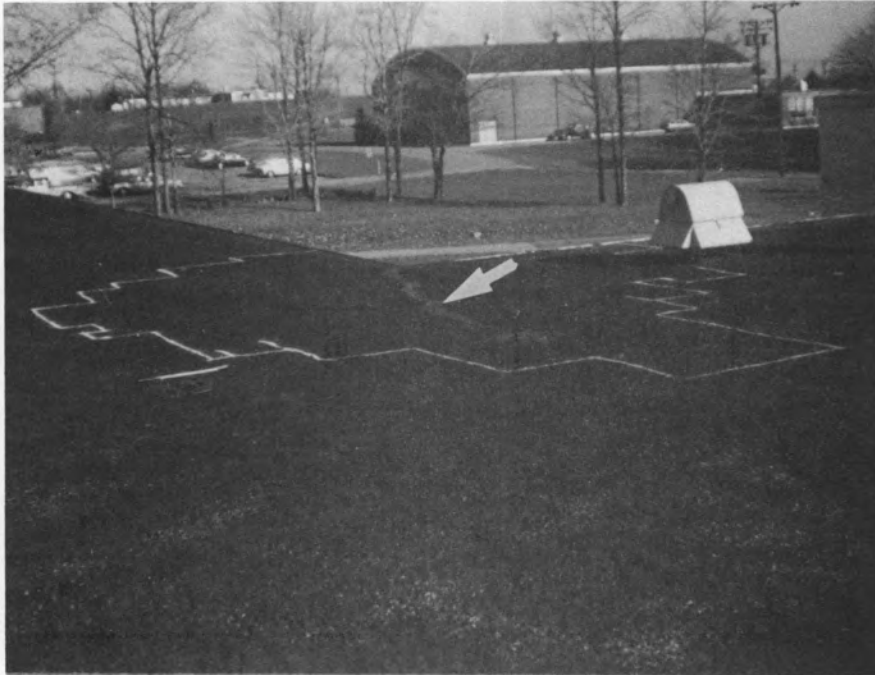
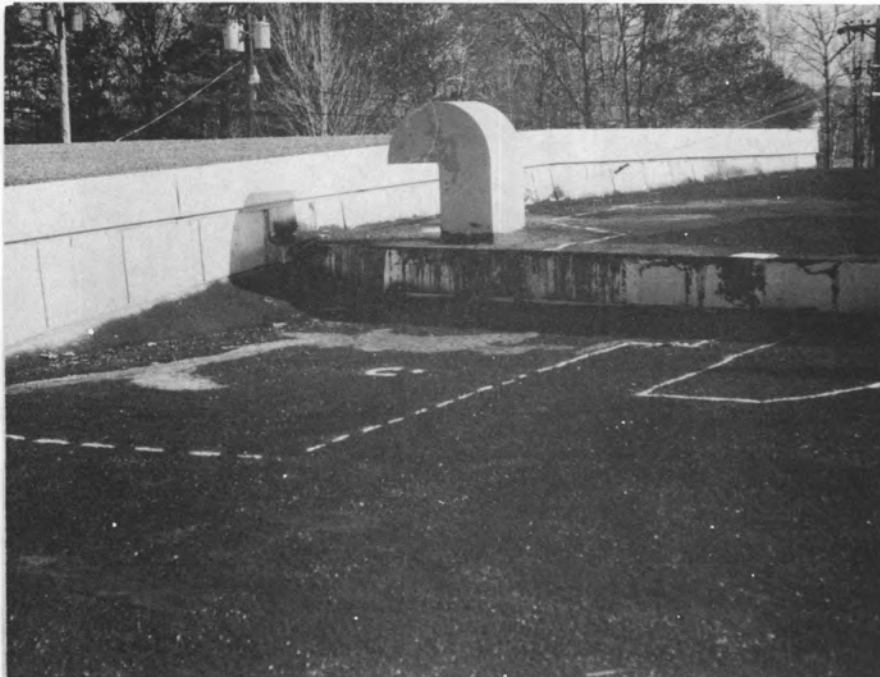
Figure 13. Wet areas on roof of Building 35 (arrow points to a split in the roof membrane).

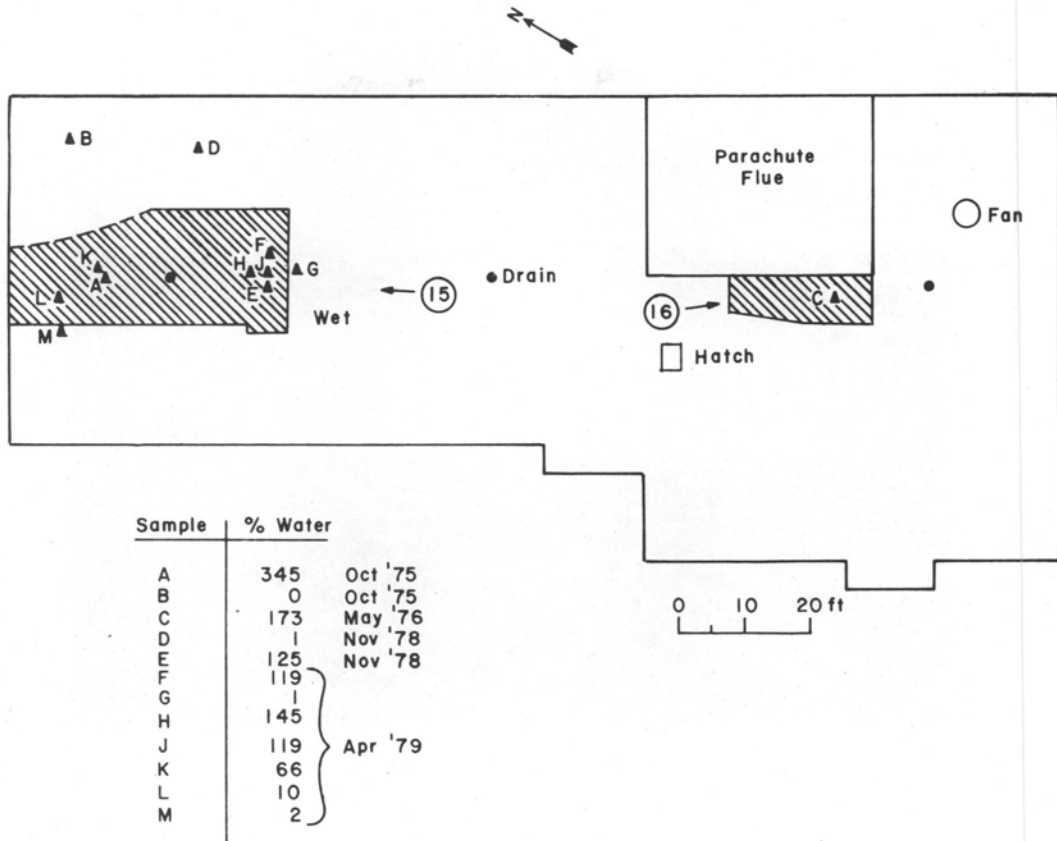
Figure 14. Plan view of Building 112.

Infrared surveys were conducted on the main roof of this building in October 1975 and in May 1976 in addition to this survey (October 1977). Brief follow-up surveys were also conducted in November 1978 and April 1979. Essentially the wet areas shown in Figure 14 have been detected each time. The main roof consists

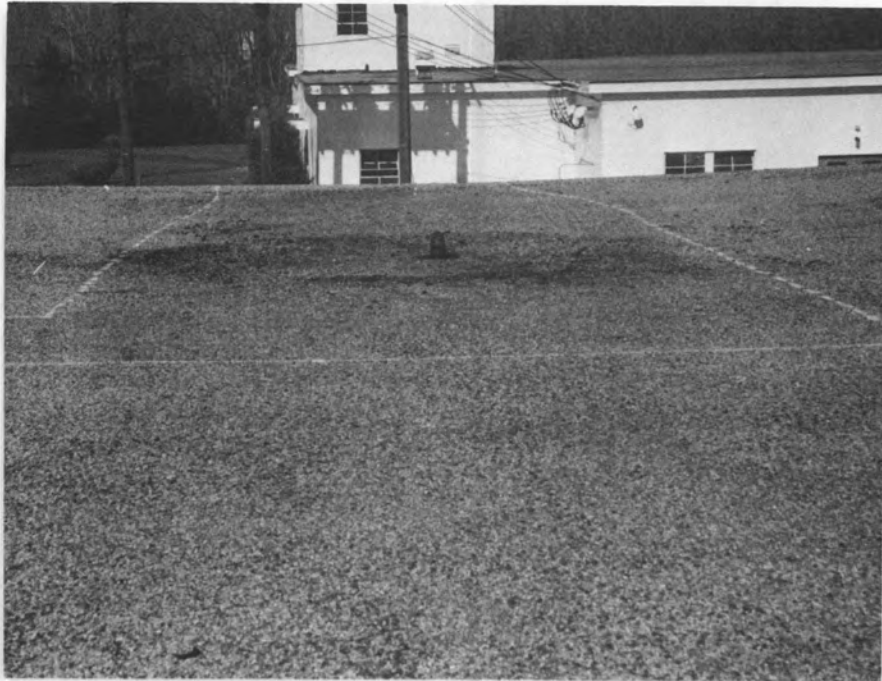
Severe roof leaks plagued the northern end of this building in 1975. An infrared survey at that time revealed that a rectangular area surrounding a drain contained wet insulation. A pond of bitumen poured around that drain stopped those leaks. However, a 1977 thermogram (Fig. 15) indicates that moisture is still entrapped there.

Figure 15. 1977 thermogram and photograph of wet area, Building 112.

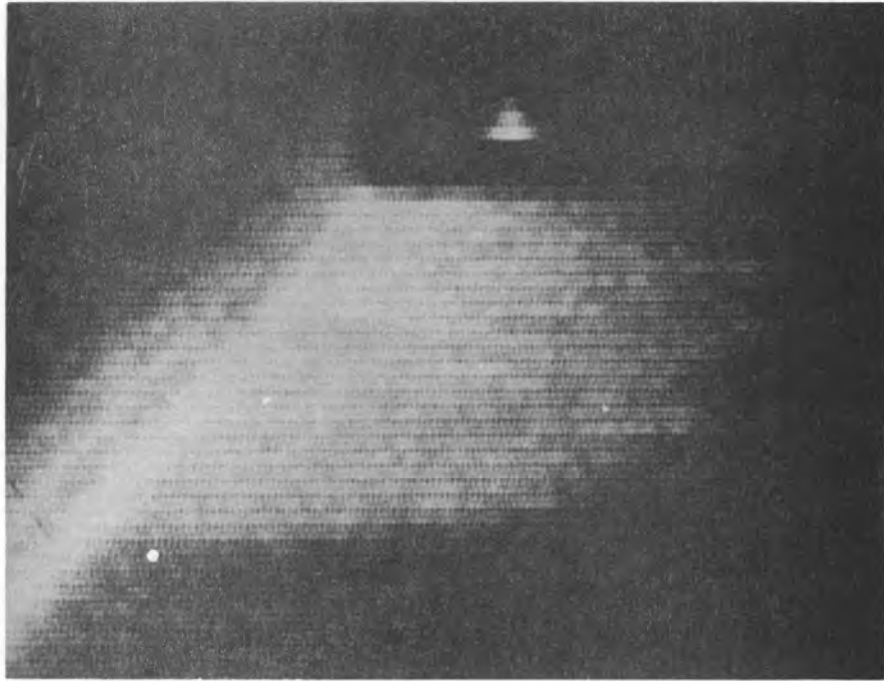
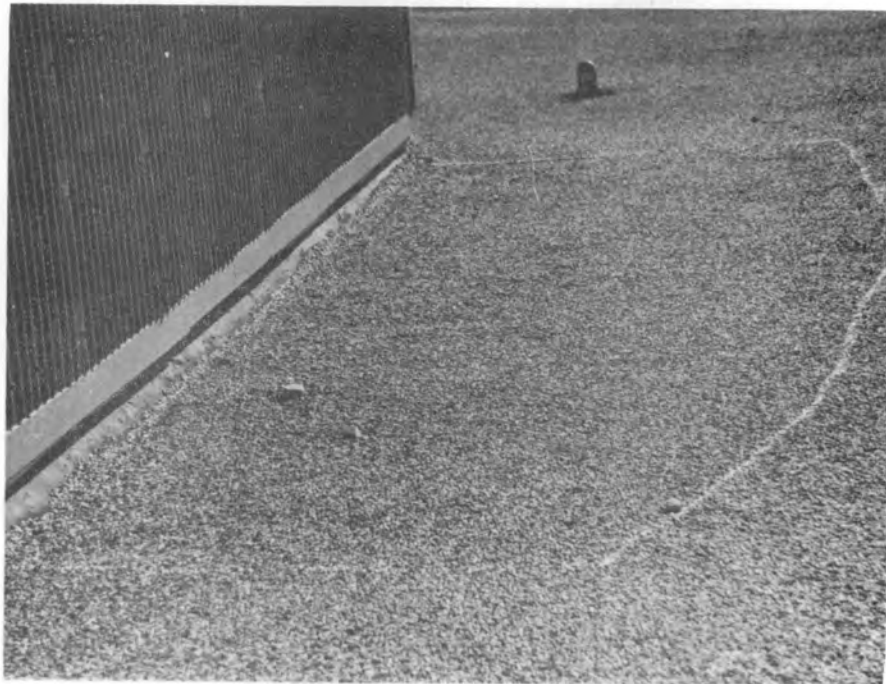
The other wet area detected on this roof is shown in Figure 16. Visually, that area appeared to be in good condition. We suspect that moisture entered through the wall flashing adjacent to this area.

Figure 16. 1977 thermogram and photograph of wet area abutting parachute flue, Building 112.

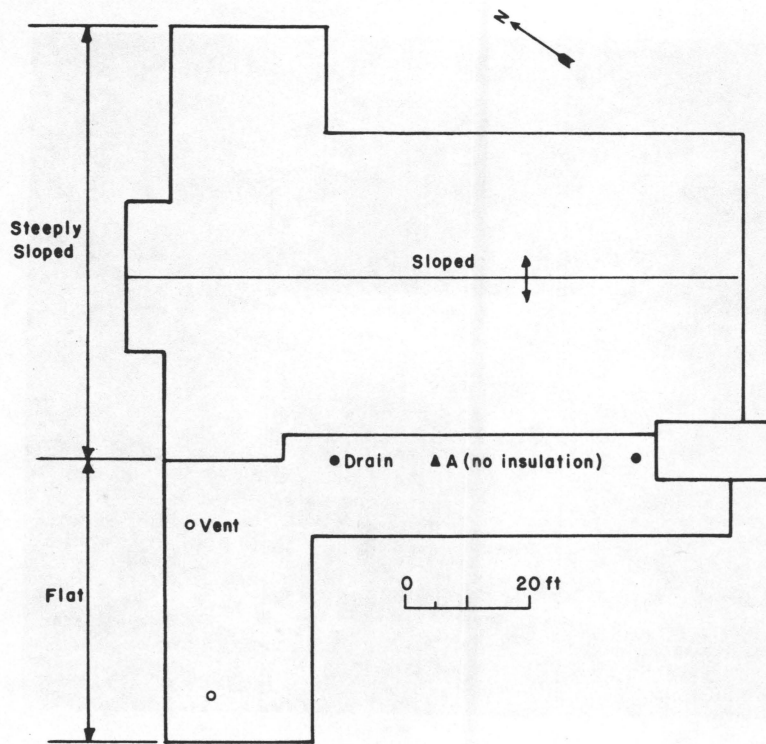
We detected subtle thermal anomalies unrelated to entrapped moisture on the flat portion of this roof (Fig. 17). The main roof is steeply sloped and was not surveyed. The anomalies were attributed to variations in surface color caused by differences in the extremely heavy bituminous overlays previously applied to this roof. Sample A showed that there is no insulation above the wood deck so we cannot make recommendations based on entrapped moisture.

Figure 17. Plan view of Building 63. The sloped portion was not surveyed. The flat area contained subtle thermal anomalies when viewed with the infrared camera.

Visually, the base flashings appear to be in good condition. Although the overlay is dry and cracked, the membrane of sample A exhibited good interply bonding. Barring any leaks, we feel that a few more years of serviceable life can be expected from this roof. The heavy overlay will hinder any patching attempts. For this reason and because this roof is rather small, we suggest that the existing membrane be replaced by a new built-up membrane and insulation if leaks develop.

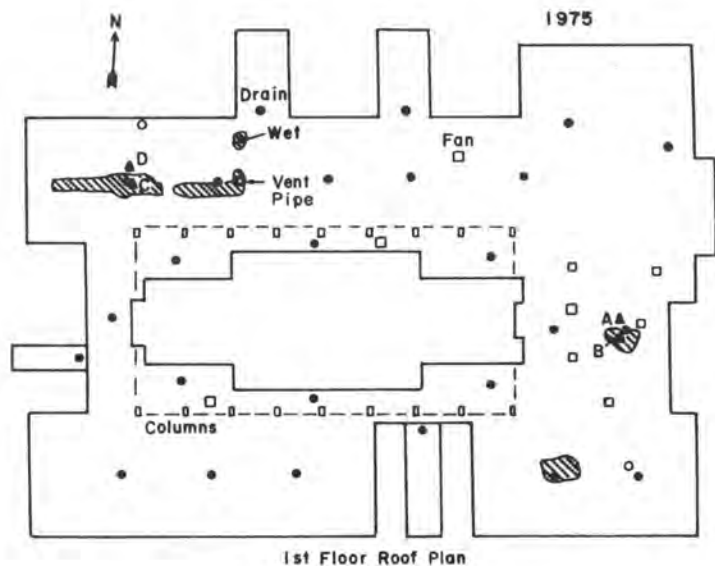
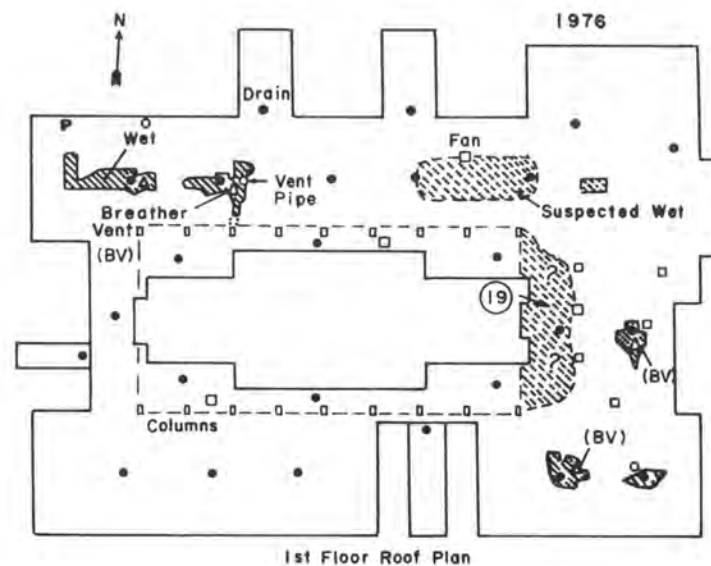
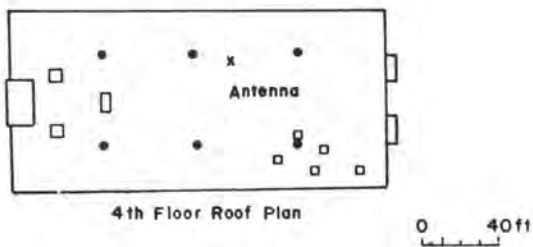
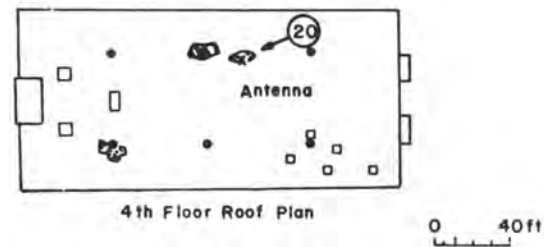
roof generally show that most areas of wet insulation are associated with membrane penetrations, especially roof drains (Fig. 18).

Five areas of wet insulation were uncovered during the 1975 infrared survey (Fig. 18a). Since the roof was still under warranty, the contractor decided to patch all visual defects in flashings and install insulation breather vents in an attempt to dry these areas.

In 1976 seven new "suspected wet" areas were also detected. They are shown by dashed hatching in Figure 18b. They are termed "suspected wet" since no samples were taken in 1976. These "suspected wet" areas strongly suggest that in 1976, moisture was entering the roof at several membrane penetrations. Three of these areas were located on the fourth floor roof which had not contained any problem areas in 1975. Two are shown in Figure 20. We examined the drains in this area and in one case found that the lead flashing was not well bonded to the membrane. We also noted numerous flashing flaws (Fig. 21).

Figure 18. Plan view of Building 93. Because no samples were taken in 1976, dashed hatching is used to indicate suspected wet areas which were not wet in 1975.

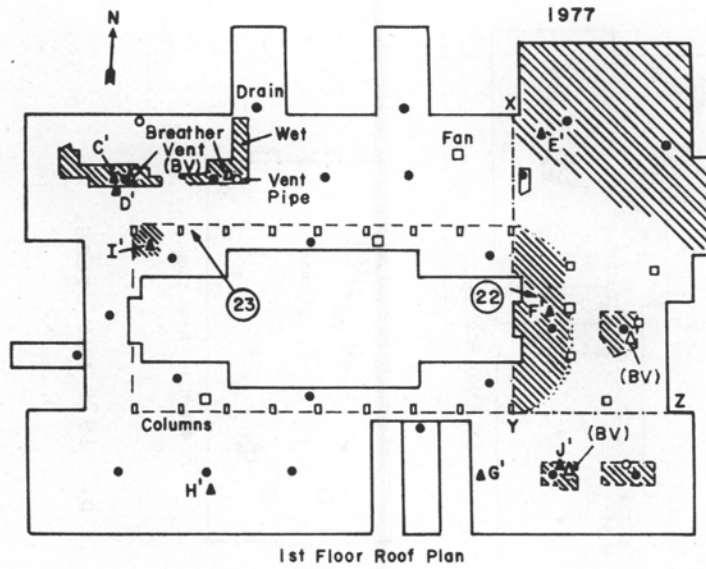
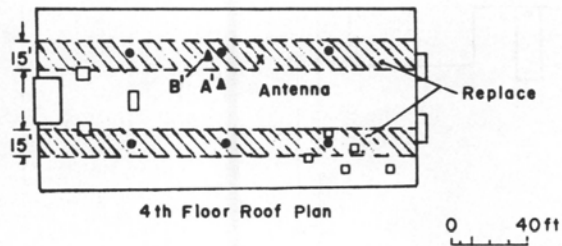
The 1977 survey (Fig. 18c) revealed even greater wetting of the insulation. Figure 22 shows a larger wet area than that in Figure 19.

The wet area in the northwest corner of the lower roof is shown in Figure 23. Breather vents installed within this wet area have not been able to dry it out. Sample C' (Fig. 18c), which was taken in 1977 close to 1975 sample C (Fig. 18a), showed the moisture content increasing from 132% in 1975 to 190% in 1977. Although this roof is continuing to collect moisture, core samples indicate that the membrane is in fairly good condition. If the leaks can be eliminated, several years of serviceable life can be expected from this membrane. Therefore, we suggest that only the membrane and insulation in wet areas be cut out and replaced with new dry materials. Extra attention should be directed toward effective sealing of flashing and roof penetrations to avoid a repetition of the current problem.

The wet area where sample E' was obtained (Fig. 18c) was not well defined. It is possible that internal moisture from the kitchen caused insulation in this area to accumulate moisture. The same argument can be advanced for the area surrounding sample F'. Wetting of that area might also be explained by entry of driving rain along the east wall of the high portion of the building. If these areas are cut out and replaced, attention should be given to achieving a continuous vapor barrier along this wall and providing effective cap flashing where the wall and roof abut. Because the root cause of moisture for this area is not well defined, it may be wise to replace all roofing and insulation to the north-east of dashed line XYZ in Figure 18c. A tight vapor barrier should be installed and the insulation should be edge-vented to prevent creation of a vapor trap.

The northern valley of the high roof accumulated considerable moisture from 1976 to 1977. Some early signs of moisture entry were also detected in the

Figure 18. (cont'd) Plan view of Building 93.

southern valley of that roof. We recommend that a 15-ft (4.6-m) wide strip of membrane and insulation down both valleys be removed and replaced with dry insulation and a new built-up membrane. The four parallel dashed lines in Figure 18c delineate the two areas requiring replacement.

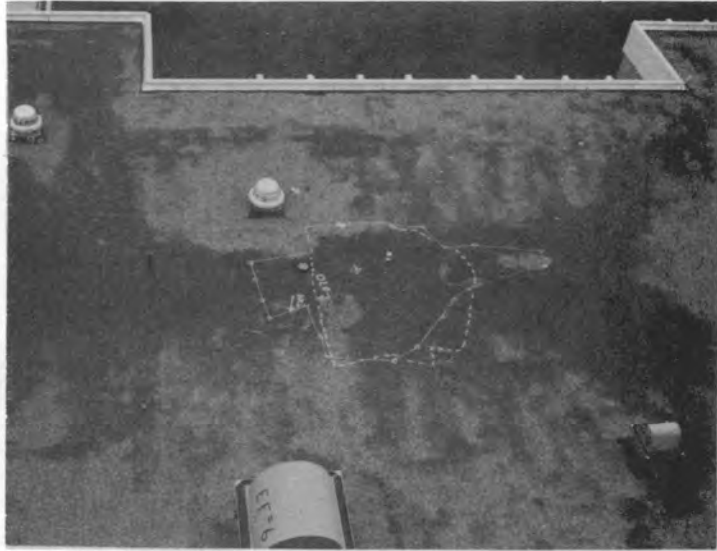
A second infrared survey was conducted in 1976. Comparison with the 1975 survey showed that the five wet areas detected in 1975 were about the same size in 1976. The 1975 and 1976 boundaries of one wet area are shown in Figure 19. Either the vents were ineffective at drying insulation or additional moisture entered the insulation at about the same rate it escaped. We believe the former is the correct explanation.

Figure 19. 1976 view from upper roof showing 1975 boundary (dashed) and 1976 boundary (solid) of the thermal anomaly on the eastern end of the lower roof.

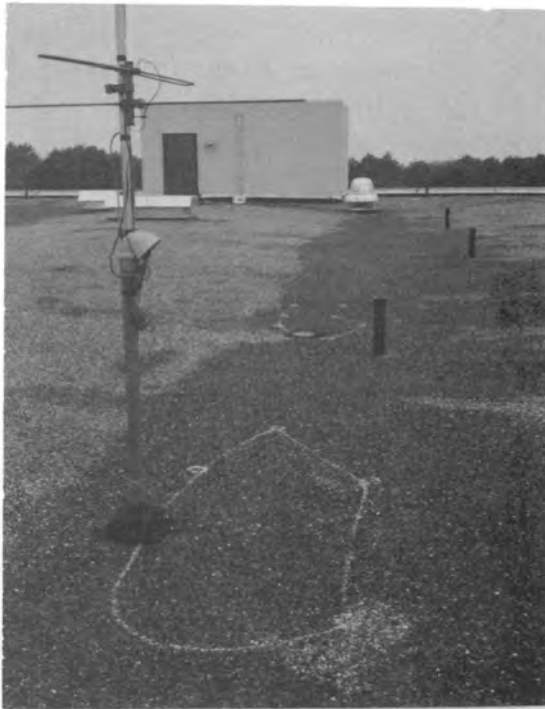
Figure 20. Painted boundaries of two 1976 thermal anomalies on the upper roof. Both anomalies are associated with roof penetrations (i.e., an antenna and a drain).

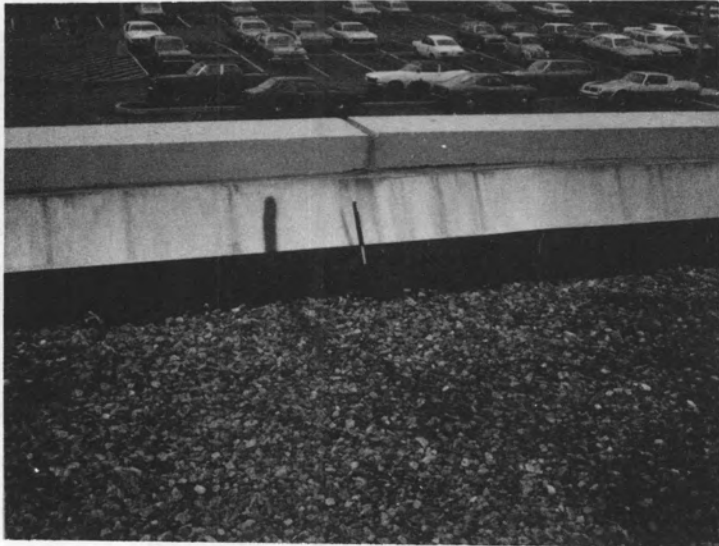
Figure 21. A typical flashing defect. Over 30 defects were noted in 1976. Note that a pen has been inserted into the split.
