Special Report 80-14

CRREL ROOF MOISTURE SURVEY, PEASE AFB BUILDINGS 35, 63, 93, 112, 113, 120 and 220

Charles Korhonen and Wayne Tobiasson

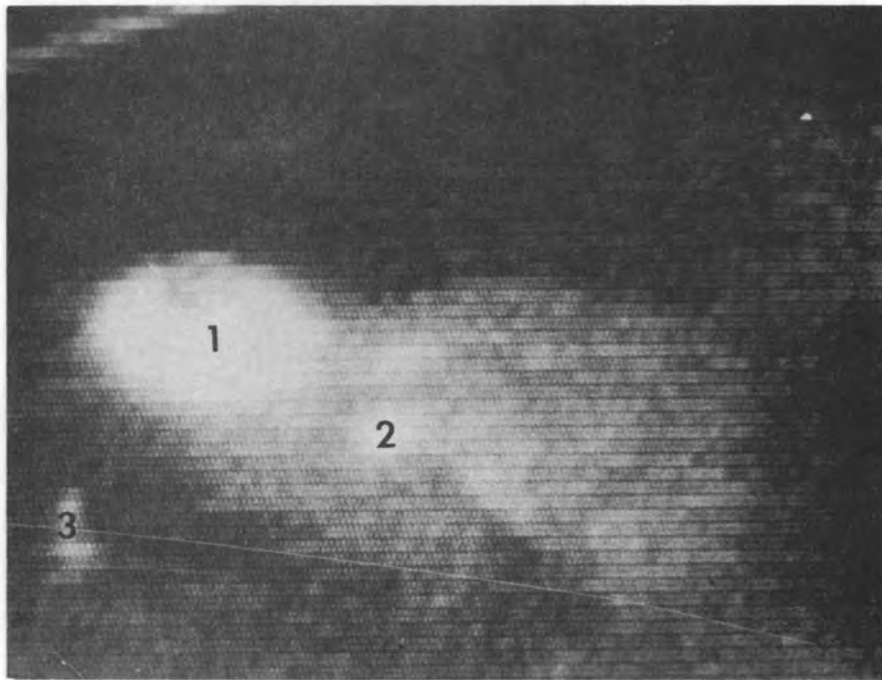
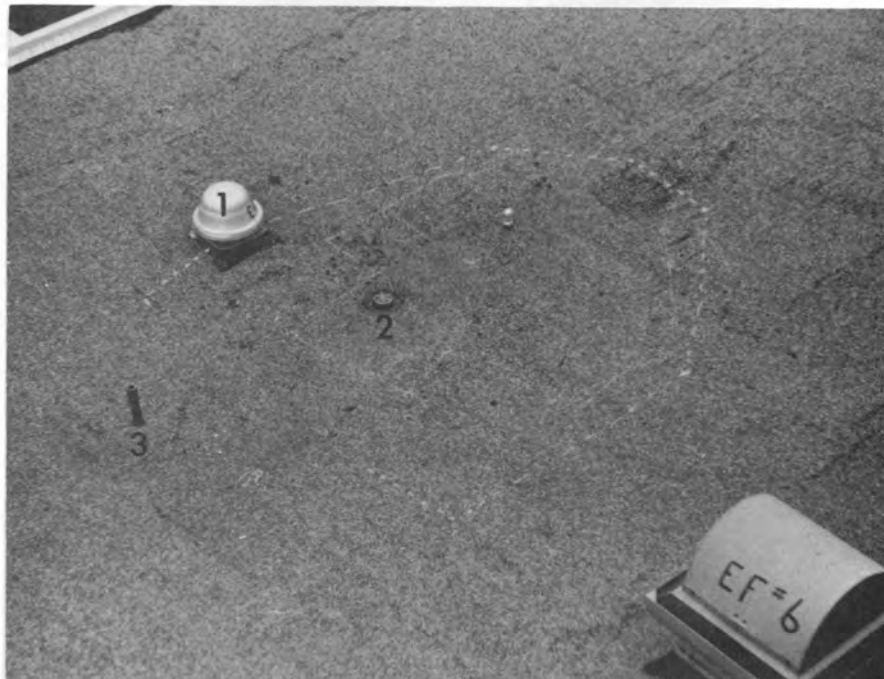
The 1977 survey (Fig. 18c) revealed even greater wetting of the insulation. Figure 22 shows a larger wet area than that in Figure 19.

Figure 22. 1977 thermogram and photograph of wet area in Figure 19.

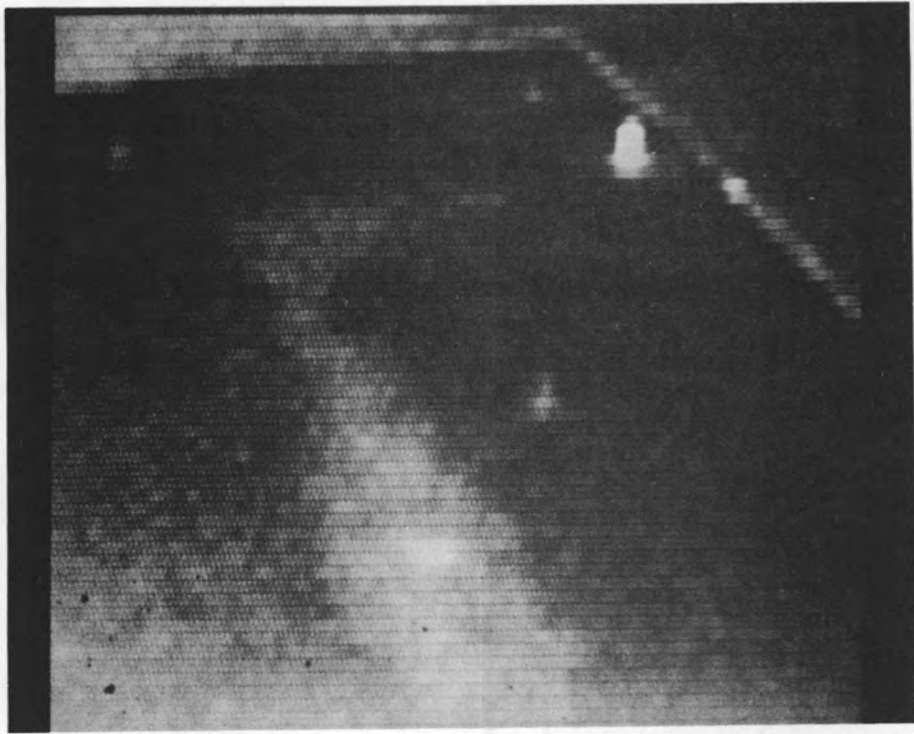
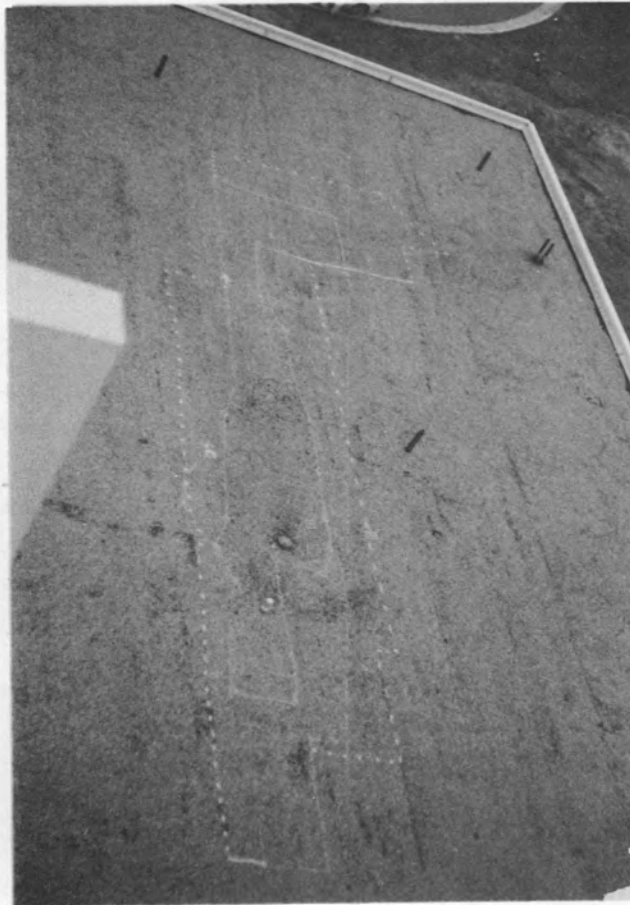
The wet area in the northwest corner of the lower roof is shown in Figure 23. Breather vents installed within this wet area have not been able to dry it out. Sample C' (Fig. 18c), which was taken in 1977 close to 1975 sample C (Fig. 18a), showed the moisture content increasing from 132% in 1975 to 190% in 1977. Although this roof is continuing to collect moisture, core samples indicate that the membrane is in fairly good condition. If the leaks can be eliminated, several years of serviceable life can be expected from this membrane. Therefore, we suggest that only the membrane and insulation in wet areas be cut out and replaced with new dry materials. Extra attention should be directed toward effective sealing of flashing and roof penetrations to avoid a repetition of the current problem.

Figure 23. Thermogram and photograph of wet area on Building 93 (solid line shows extent of wet area in 1976, dotted line shows extent of wet area in 1977).

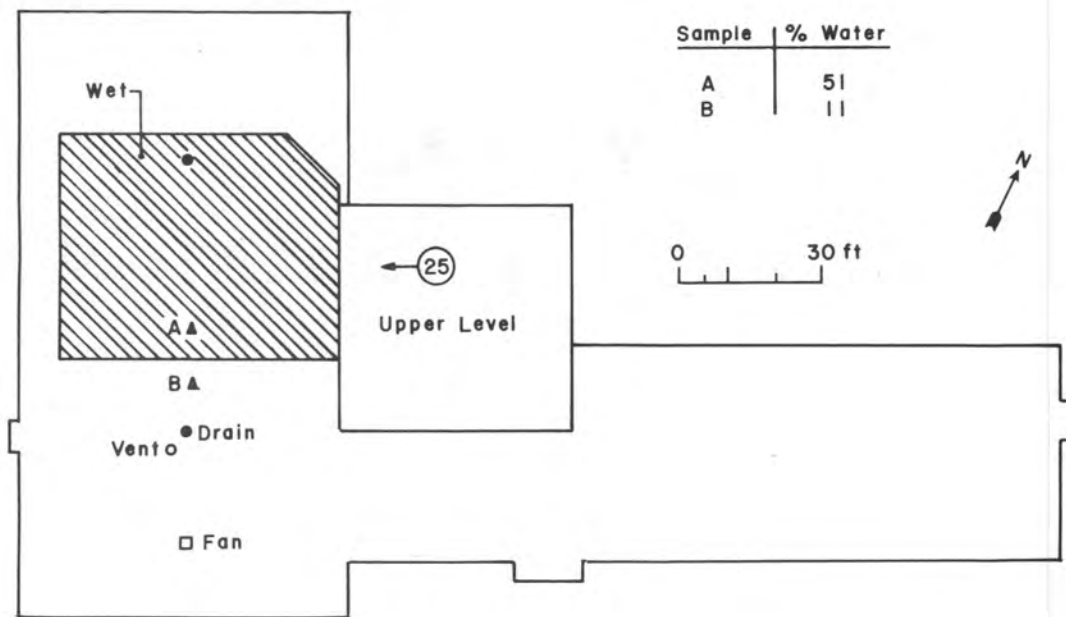
Figure 24. Plan view of Building 220.

This two-level roof consists of a wood deck, 2 1/4 in. (5.7 cm) of wood fiber insulation, and a gravel-covered built-up membrane. One large area of wet insulation was uncovered on this roof (see Fig. 24). The remainder of the roof is considered dry since no other thermal anomalies were detected and since sample B had a water content of only 11%. Building occupants indicated that leaks occurred below the wet area following a heavy rain or snowfall.

Samples A and B show this membrane to be in good condition. The useful life of this roof can be extended by cutting out the portion containing wet insulation and replacing it with dry insulation and a new membrane. By replacing the wood fiber insulation with a similar thickness of more efficient urethane-perlite composite insulation, the insulating value of the roof can be significantly improved.

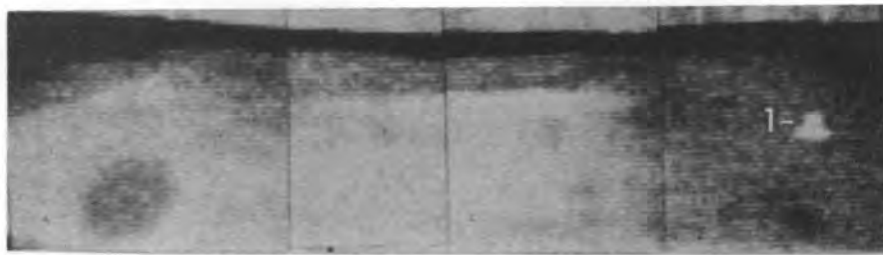
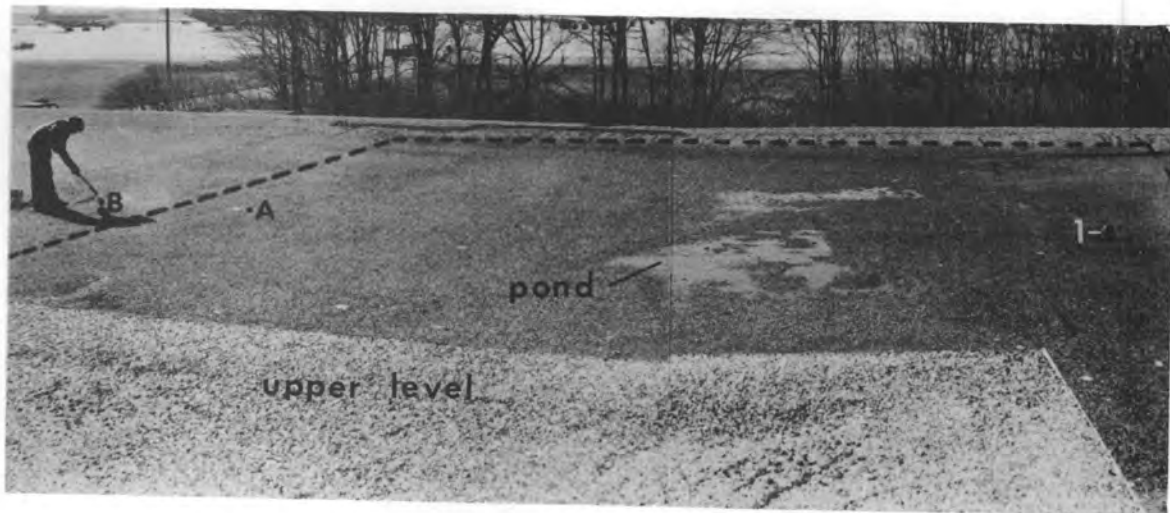
Patches applied in the spring of 1977 appear to have stopped the leaks. Although the immediate problem may be corrected, the problem of entrapped moisture remains (see Fig. 25).

Ponded water was noted between the two drains (Fig. 25). When the wet insulation is being replaced, slope should be added to eliminate ponding.

Figure 25. Thermogram mosaic and photograph of wet area on Building 220 (1 - drain).
