4. TITLE (and Subtitle) INUNDATION DAMAGE TO VEGETATION AT SELECTED NEW ENGLAND FLOOD CONTROL RESERVOIRS	5. TYPE OF REPORT & PERIOD COVERED	
	6. PERFORMING ORG. REPORT NUMBER

7. AUTHOR(s) Harlan L. McKim, Lawrence W. Gatto and Carolyn J. Merry	8. CONTRACT OR GRANT NUMBER(s) USA ED 74-C-7	
9. PERFORMING ORGANIZATION NAME AND ADDRESS U.S. Army Cold Regions Research and Engineering Laboratory Hanover, New Hampshire 03755	10. PROGRAM ELEMENT, PROJECT, TASK AREA & WORK UNIT NUMBERS

11. CONTROLLING OFFICE NAME AND ADDRESS Water Control Branch, Environmental Resources Branch and Recreation - Resources Management Section, U.S. Army Engineer Division, New England, Waltham, Massachusetts	12. REPORT DATE March 1975

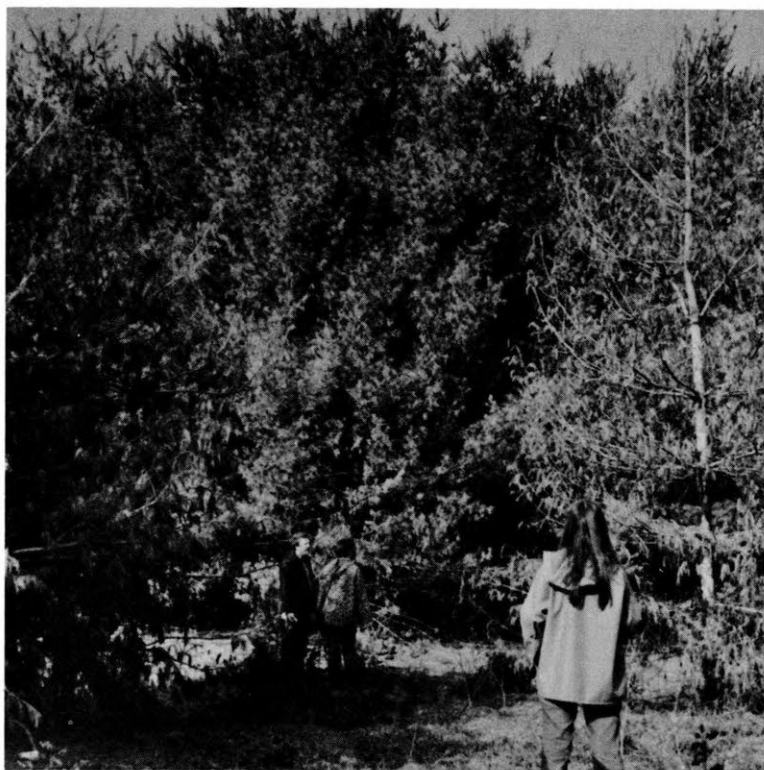
The dominant tree species identified along five transects at Franklin Falls were oak, pine, birch, hornbeam, aspen and maple (Table V). Generally, maple and oak trees were least affected by inundation and silt damage regardless of their geomorphic setting. Silver maples located on the floodplain and on islands in the upstream portions of the reservoir were least affected by inundation and appeared to have minimal silt damage as the tree canopy remained above the floodwaters. Revegetation of the lower branches on the maples and oaks occurred during the following spring. Field observations indicated that coniferous trees, especially the white pine, seemed to be more affected by silting than deciduous trees (Fig. 5).

Figure 5. Damaged white pines along transect 3A, Franklin Falls reservoir.

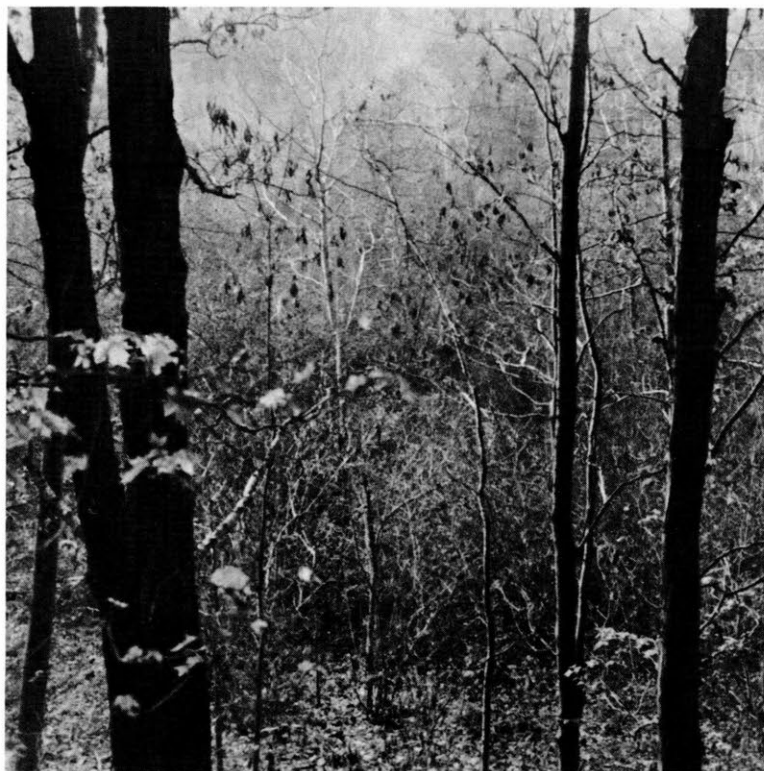
The inundated understory vegetation, such as hornbeams less than 30 ft in height, was defoliated; however, new growth was observed on many of the lower branches in October (Fig. 6). The understory on the lower floodplain was extensively damaged by ice during the December 1973 flood. The tops of many trees less than 5 in. in diameter were cracked or completely broken in transects 1A, 1B and 1C (Fig. 7).

Figure 6. New growth on lower branches along transect 1B, Franklin Falls reservoir.

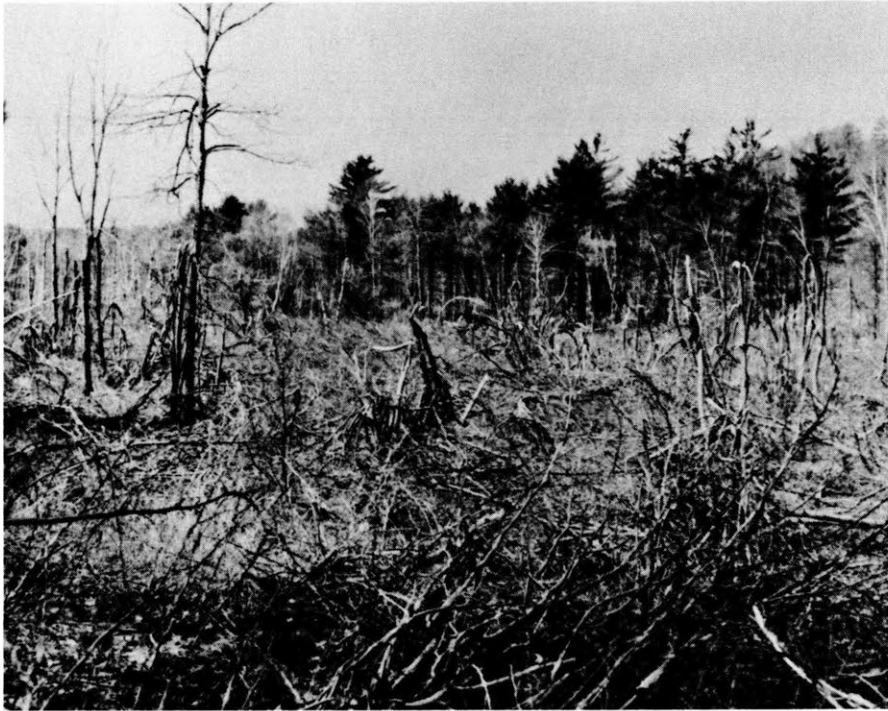
Alders and willows grow in wet, low-lying locations. The alders were more severely damaged by inundation than the willows, but both were extensively damaged by the ice conditions present during the December 1973 floods. Elm trees observed primarily in the abandoned portion of the town of Hill had previously been killed by Dutch elm disease or floods.

Figure 7. Ice-damaged alders and willows on floodplain near transect 1B, Franklin Falls reservoir.

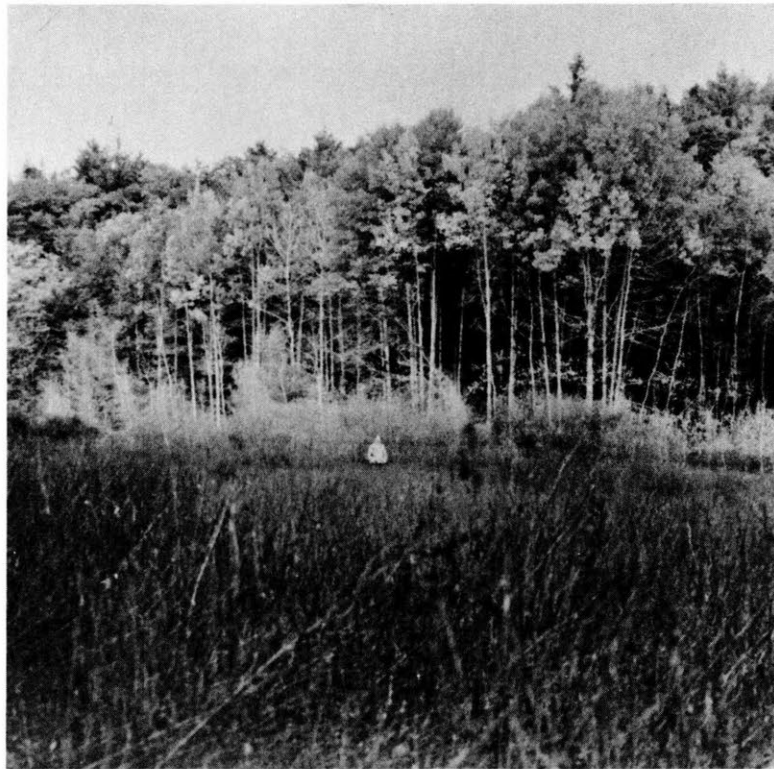
Shrub vegetation in the meander scar located approximately four miles upstream from the dam appeared dead in fall 1973 (Fig. 8). However, revegetation had occurred by the summer of 1974 (Fig. 9). Slumping along stream banks occurred in the steep side slopes composed of unconsolidated loamy sands deposited

Figure 8. Meander scar at end of transect 3A, Franklin Falls reservoir.

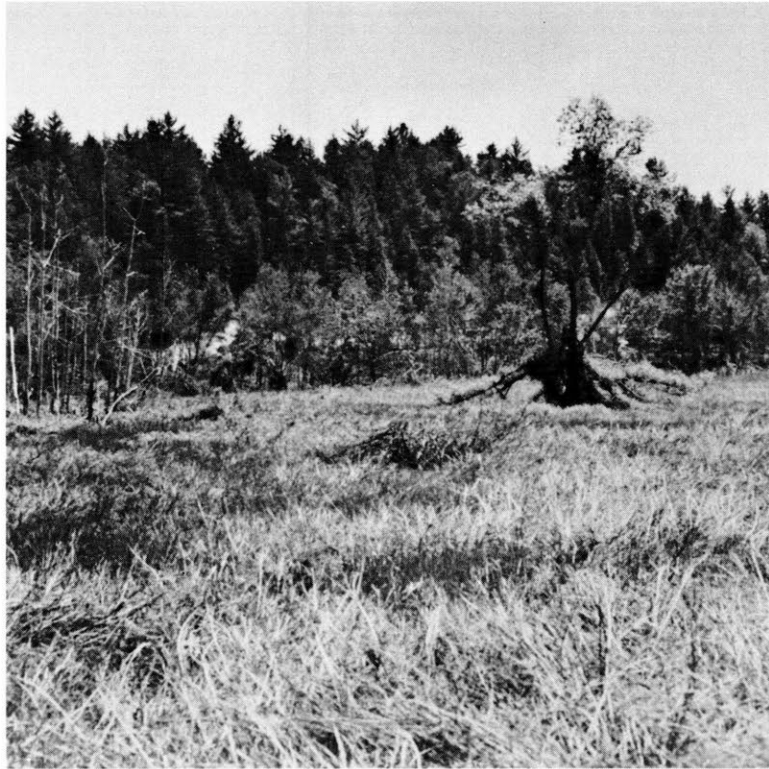
Figure 9. View across meander scar (see Fig. 8).

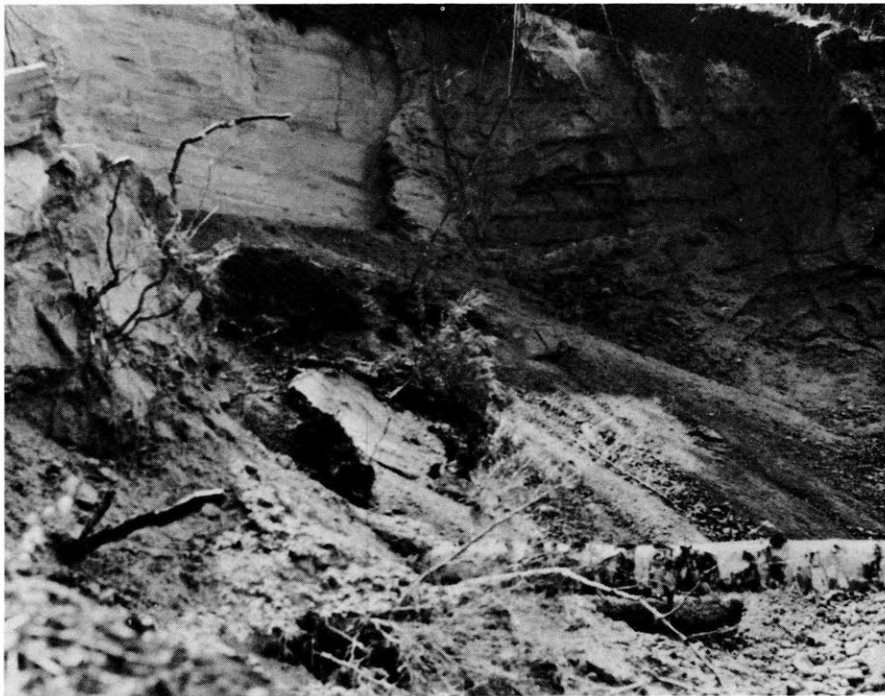
Figure 10. Slumping in the loamy sand deposits along the east bank of the Pemigewasset River near transect 1A, Franklin Falls reservoir.

The most extensive vegetative damage occurred in the Franklin Falls reservoir as a result of inundation, siltation and slumping. Slumping occurred primarily in a highly erodable glaciofluvial terrace at five sites on the northeast side of the Pemigewasset River. While damage was confined to narrow bands on either side of the river, it extended nearly the entire length of the reservoir. In the Ball Mountain area the steep-sided, V-shaped valley confined the vegetation damage to the very narrow floodplain and lower slopes adjacent to the West River. At Franklin Falls, the ice conditions associated with the December 1973 flood, added to the effects of the summer inundation, caused extensive damage to trees on the floodplain. Tree damage was less at the remaining reservoirs with the least damage occurring at North Springfield and Townshend reservoirs.

1. Methods should be considered to stabilize the slopes within the Franklin Falls reservoir. Floods have increased bank slumping at this project, resulting in accelerated vegetative damage. Research during the next two years should be directed toward the development of revegetation and landscape technique to maintain or improve slope stability.

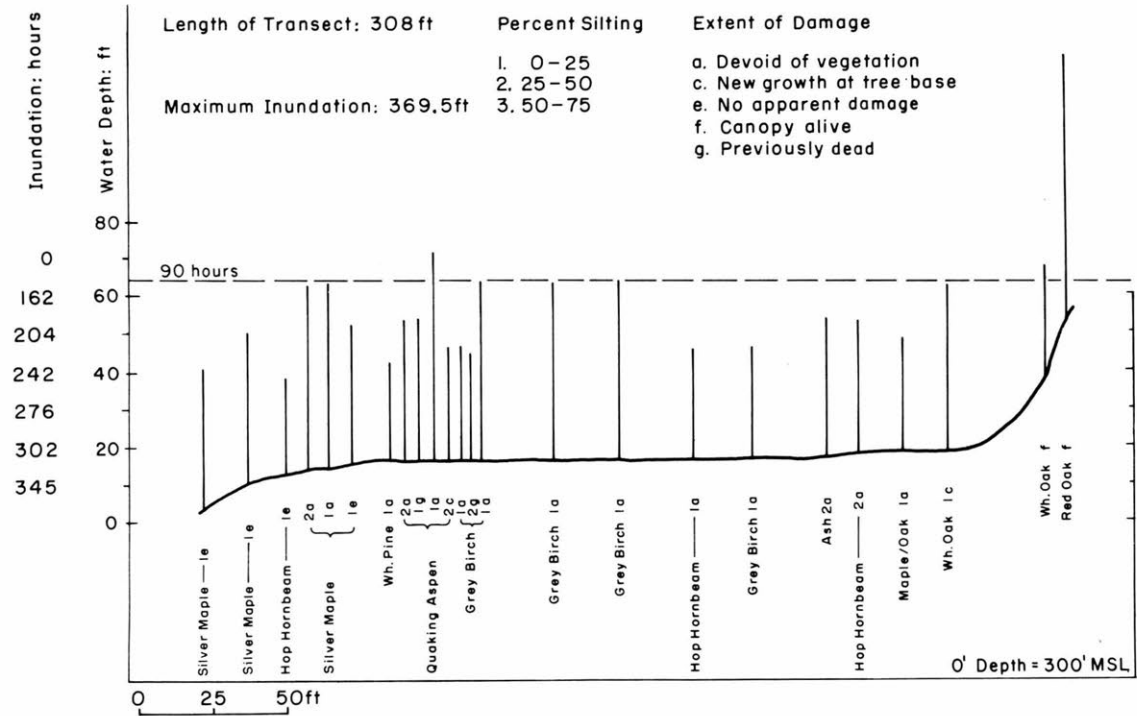
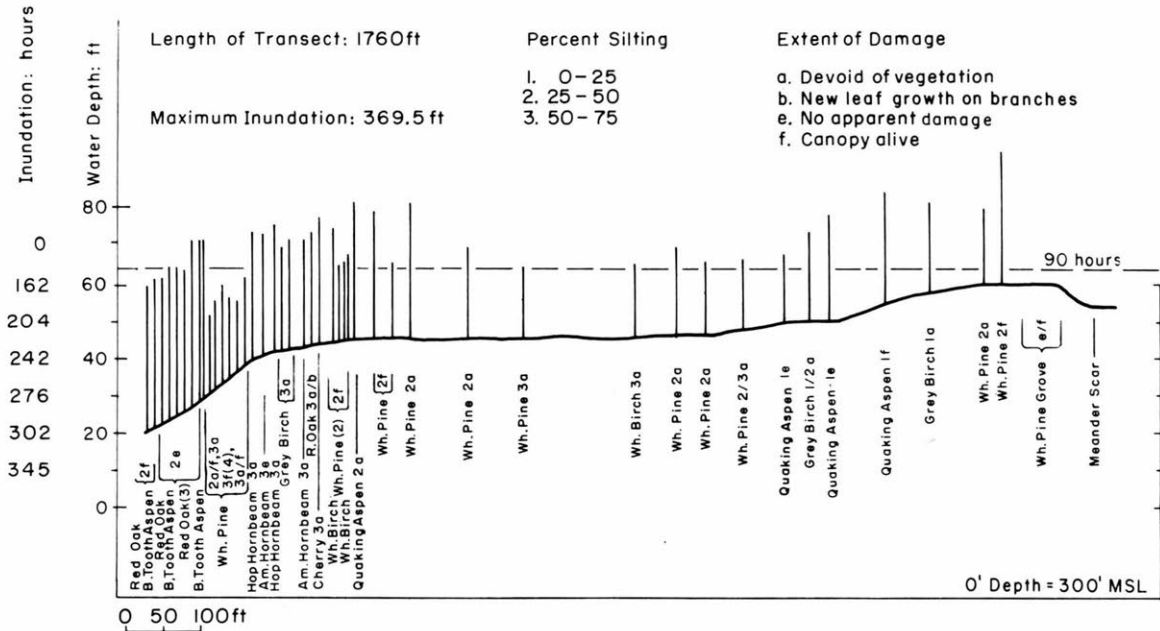
Figure 11. Relationship of duration and depth of inundation, topographic position, tree height, vegetative damage and siltation at Franklin Falls reservoir.

Figure 11 shows profiles of two transects, 1A and 3A, representative of the damage at Franklin Falls reservoir. Illustrated are tree heights and species, water depth in feet, inundation time in hours, topographic setting, percent silting and extent of damage. Percent silting is a visual estimate of the degree to which the tree was silt-covered and was recorded as follows: 1) 0-25%, 2) 25-50%, 3) 50-75%, and 4) > 75%. The extent of tree damage was categorized according to the following criteria: a: completely devoid of leaves, b: new leaf growth on branches, c: new growth at base, d: ice damage, e: no damage, f: canopy alive, and g: previously dead. On the diagram a number and letter following the tree species name indicate the percent of silting and the extent of damage. For example, the first tree on transect 3A (Fig. 11b) is designated red oak 2f. The percent of silting, 2, was 25-50% and the designation f indicates that the damage was restricted to the lower branches while the canopy remained alive.

A critical relationship was determined from these transect profiles between species susceptibility and inundation time: trees completely covered by water for more than 90 hours during the flood showed the most apparent damage. This damage is attributed to the duration of inundation and the degree of silting.

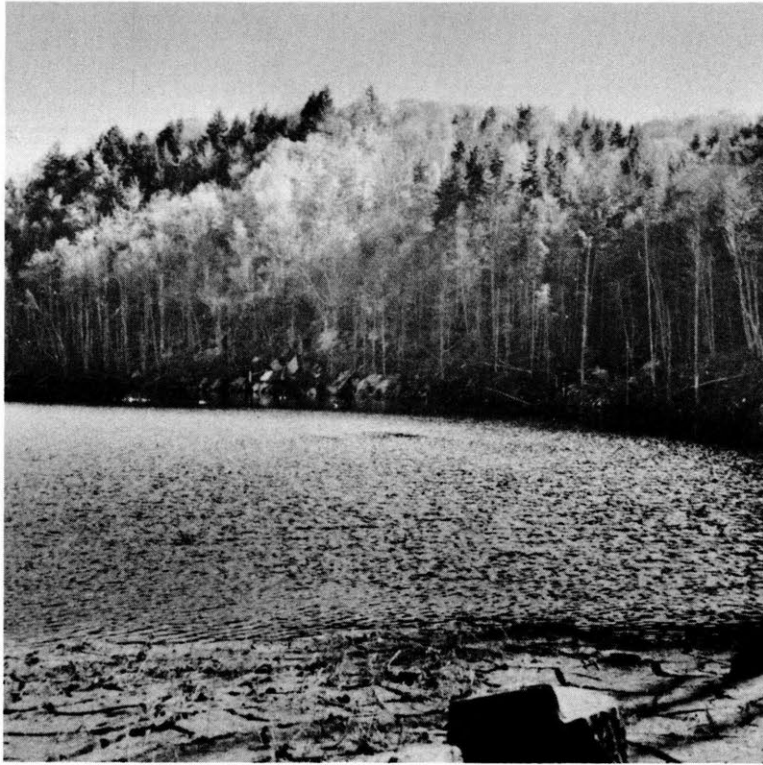
Figure 12. Silt deposition (5-7 in.) on bank of West River at beginning of transect 3A, Ball Mountain reservoir.

The coniferous trees, especially the red spruce, appeared to be most affected by siltation. Also, the red spruce did not appear as tolerant of high moisture conditions as the white pine and hemlock. Greater siltation occurred at Ball Mountain than at Franklin Falls. Many of the yellow birch at Ball Mountain were coated with large amounts of silt as compared to the birch trees in Franklin Falls. Many low-lying areas were covered with 5 to 7 in. of silt which by September has partially dried to form a mud-cracked surface (Fig. 12). This extensive siltation may have been the primary cause of vegetative damage.

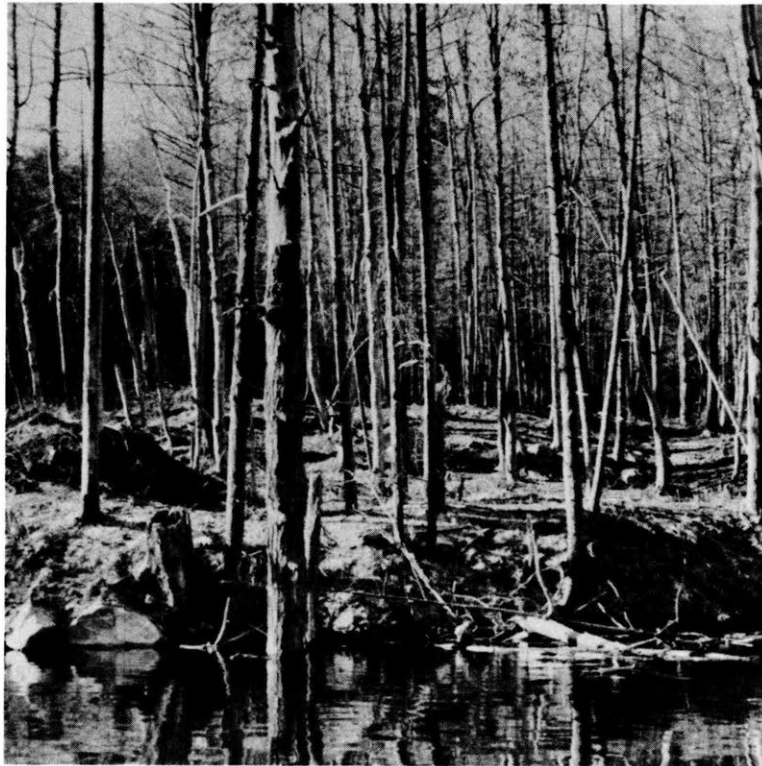
Figure 13. Trees killed by previous floods at beginning of transect 3A, Ball Mountain reservoir.

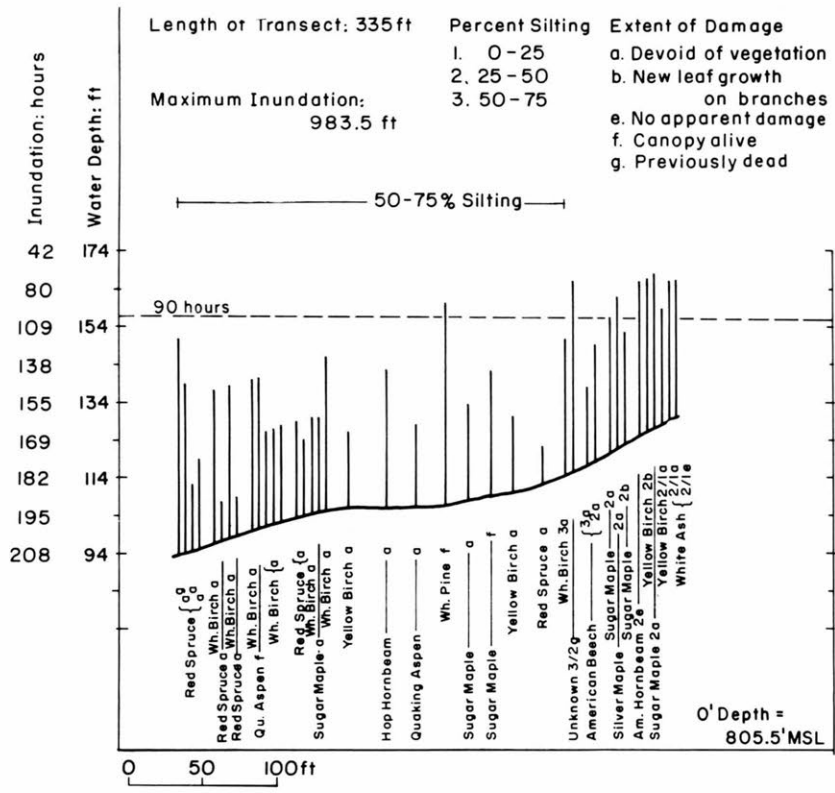
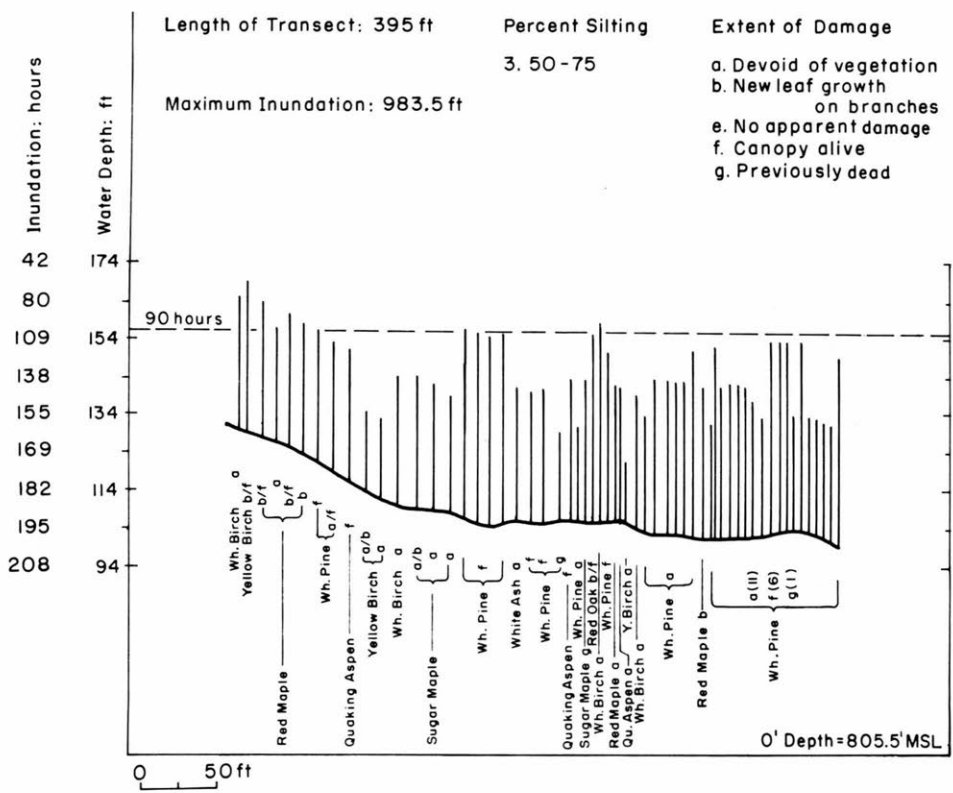
Figure 14. Relationship of duration and depth of inundation, topographic position, tree height, vegetative damage and siltation at Ball Mountain reservoir.

Figure 14 shows profiles of two representative transects, 4A and 4B, at Ball Mountain. As at Franklin Falls, trees completely covered by water for more than 90 hours during the June-July flood showed the most apparent damage.

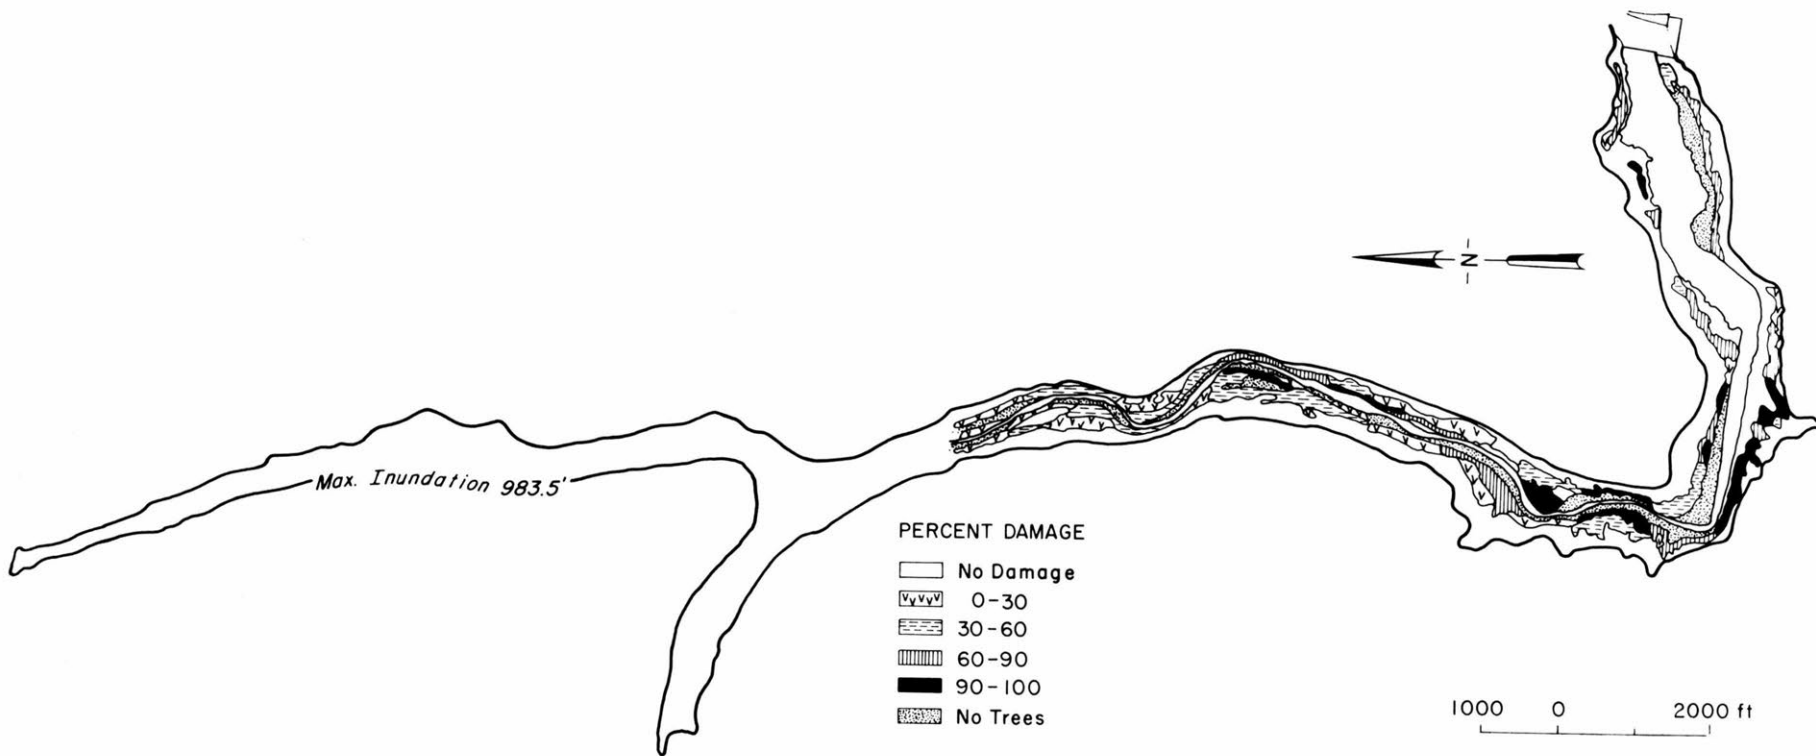
Ball Mountain was second to Franklin Falls in degree of affected vegetation (Fig. E1). Of a total inundated area of 550 acres, 154 acres contained some degree of damage (Table IV). The remaining reservoirs, North Hartland, North Springfield, Townshend and Union Village (Fig. E3-E6), did not contain as much vegetative damage as Franklin Falls and Ball Mountain.

Figure E1. Percentage of trees damaged at Ball Mountain reservoir, Jamaica, Vt.
