A SURVEY OF ROAD CONSTRUCTION AND MAINTENANCE PROBLEMS IN CENTRAL ALASKA

E.F. Clark and O.W. Simoni

October 1976

CORPS OF ENGINEERS, U.S. ARMY
COLD REGIONS RESEARCH AND ENGINEERING LABORATORY
HANOVER, NEW HAMPSHIRE

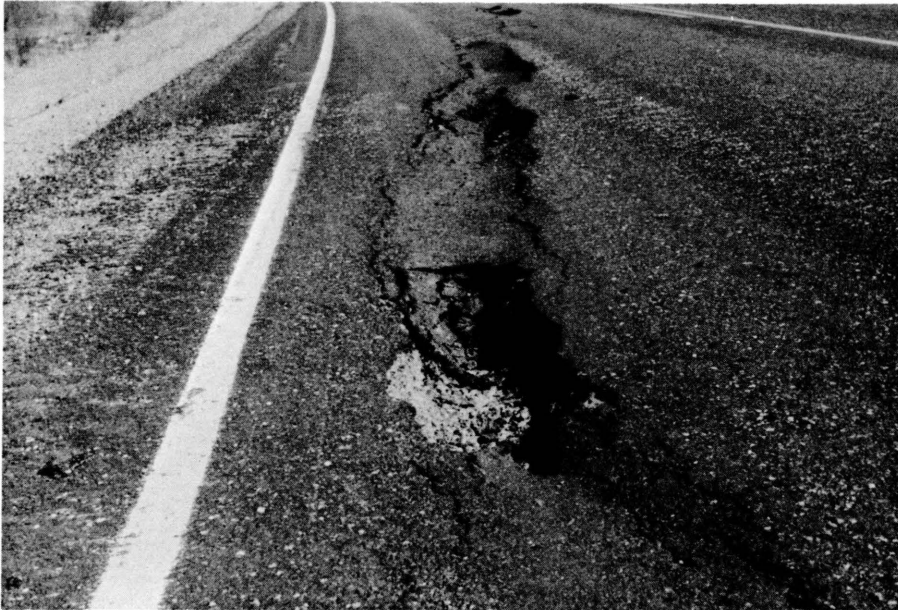
Figure 15 shows pavement failure on the Chena Hot Springs Road which was probably caused by degradation of underlying permafrost. This is one of many such failures noted along a five-mile section of this road. Figure 16 shows a section of the Richardson Highway where substantial subsidence of the pavement has occurred. Both the problems on the Chena

Figure 15. Pavement failure on Chena Hot Springs Road.

Hot Springs Road and the Richardson Highway may have been caused by disturbing the thermal regime in the subgrade. Staged construction would have allowed the degradation of the subgrade to stabilize before paving.

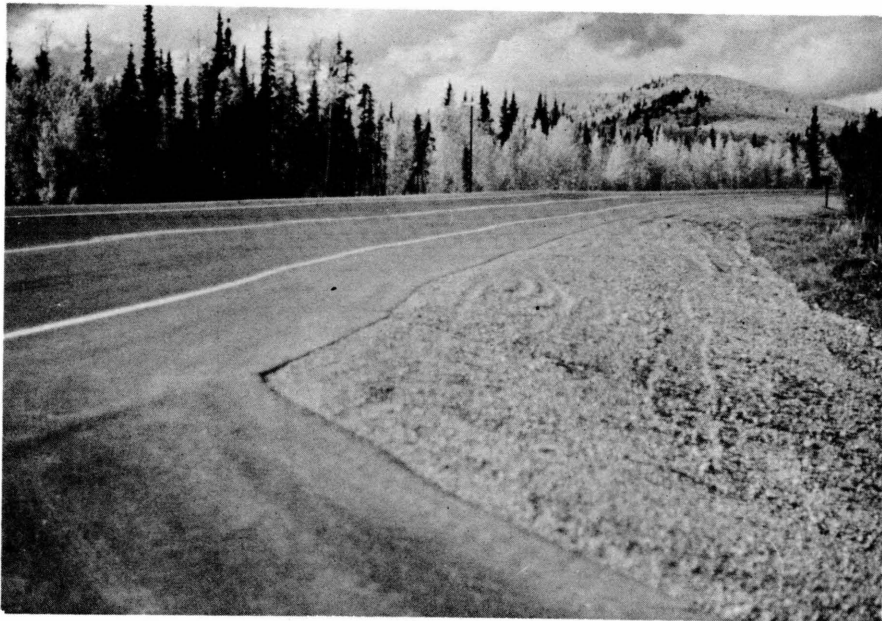
Figure 16. Undulation of pavement on Richardson Highway.

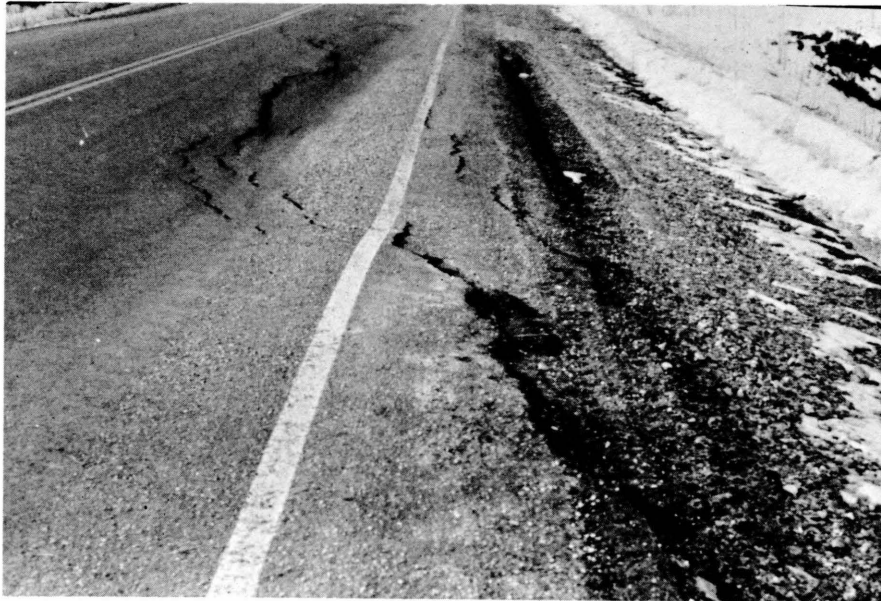
Figure 17, taken on the Elliott Highway, shows an embankment failure of a deep fill (approximately 15 ft) over a saddle. Severe road shoulder settlements and pavement cracking occurred on both sides of the road. Figure 18 shows a section of the Elliott Highway with a longitudinal crack that follows the center line. Tension cracks of this nature are

Figure 17. Embankment failure at road shoulder.

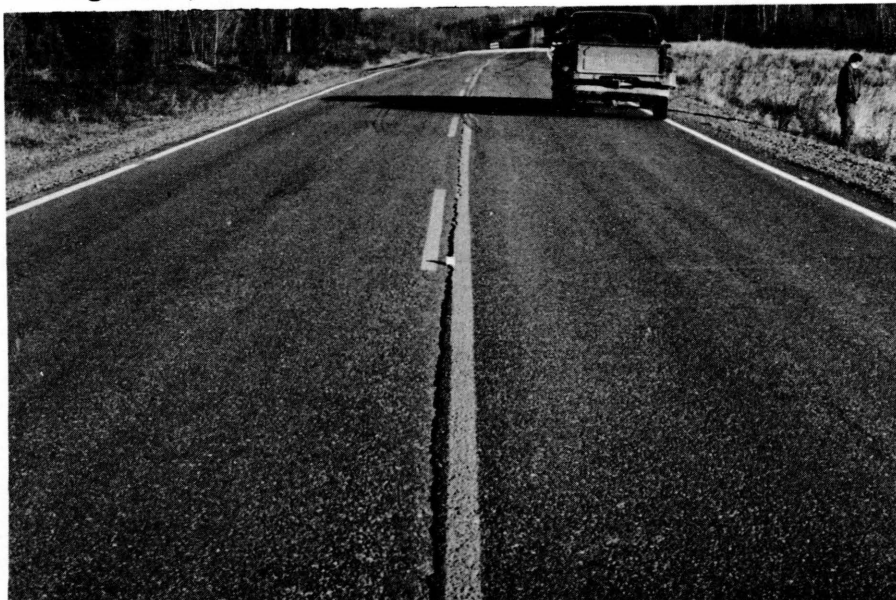
Figure 18. Longitudinal crack along center line.

prevalent in many places along Alaskan highways (as well as in more temperate regions). They permit intrusion of surface water into the embankment and result in subsequent failure. Some highway engineers have attributed these cracks to planes of weakness, resulting from paving one lane at a time with poor bonding between the two lanes.

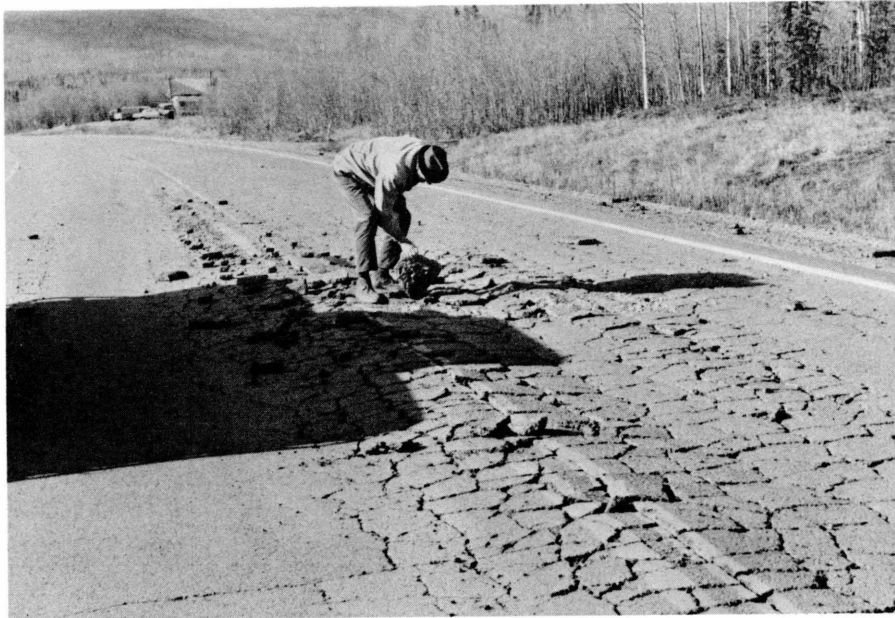
Figure 19 shows pavement failure along the Elliott Highway. This embankment is apparently weak, as evidenced by the rutting. A high water table may be a contributing factor, as there is a stream nearby.

Figure 19. Pavement failure on the Elliott Highway.

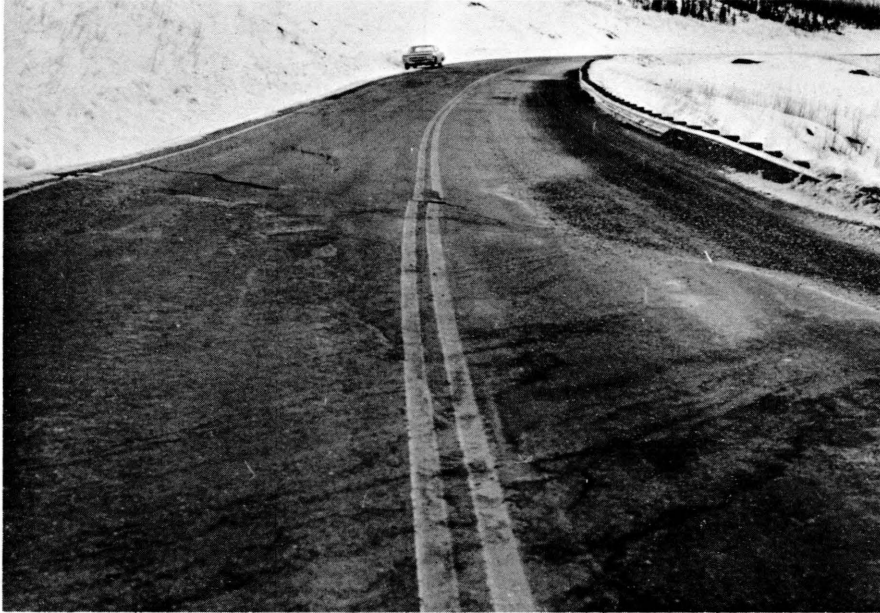
Figure 20. Creep on side hill on Steese Highway, mile 21.

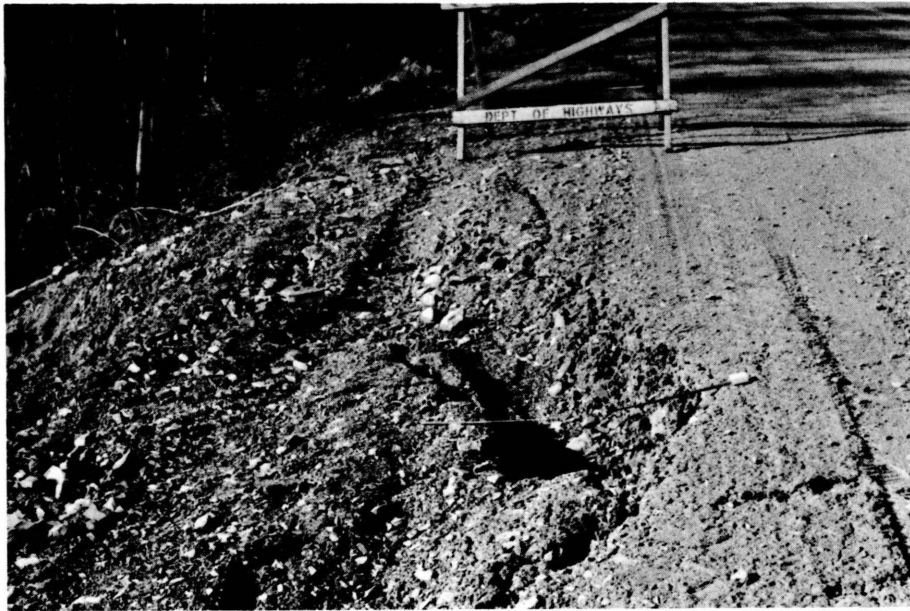
Many instances of shoulder failure were observed during April and May of 1973. Figure 21 shows a typical slope failure along the Elliott Highway. In this case, high water and washout of the toe of the embankment caused cracking and subsequent sliding of the shoulder. Figures 22 and 23 show shoulder failure along the Trans-Alaska Pipeline Service (TAPS) road, and Figure 24 shows a similar failure on the Chena Hot Springs Road.

Figure 21. Slope failure along the Elliott Highway

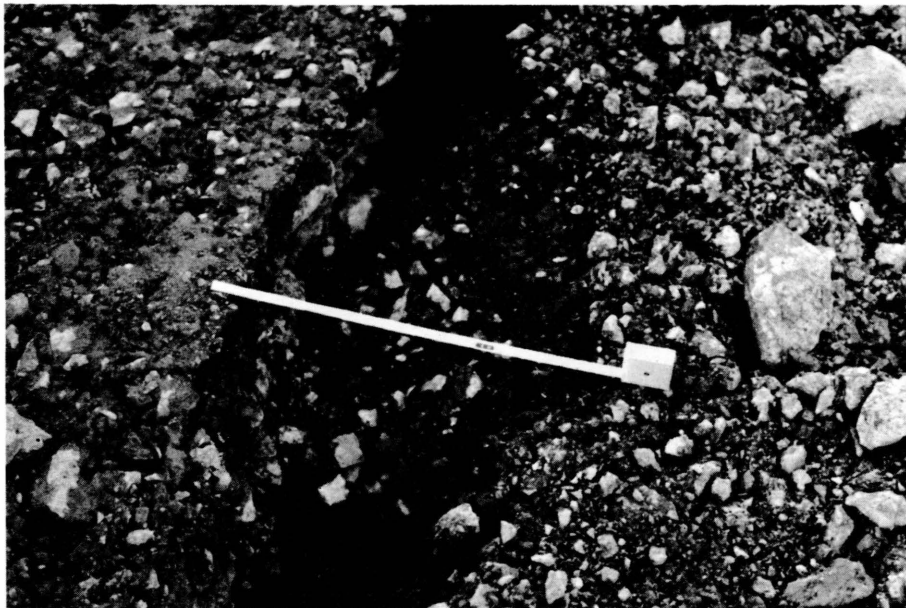
Figure 22. Shoulder failure along TAPS road

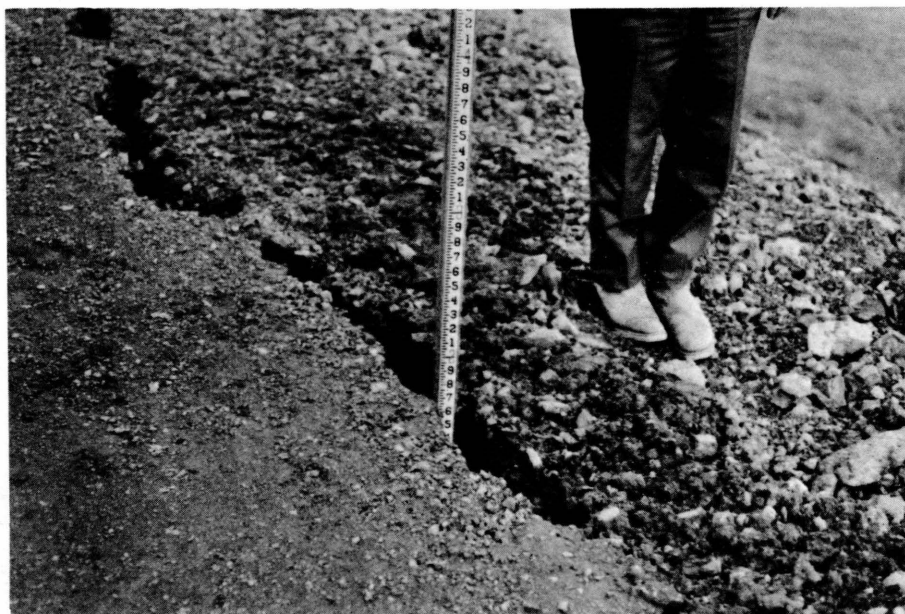
Figure 23. Longitudinal crack caused by settlement of embankment toe (TAPS road, mile 54.9).

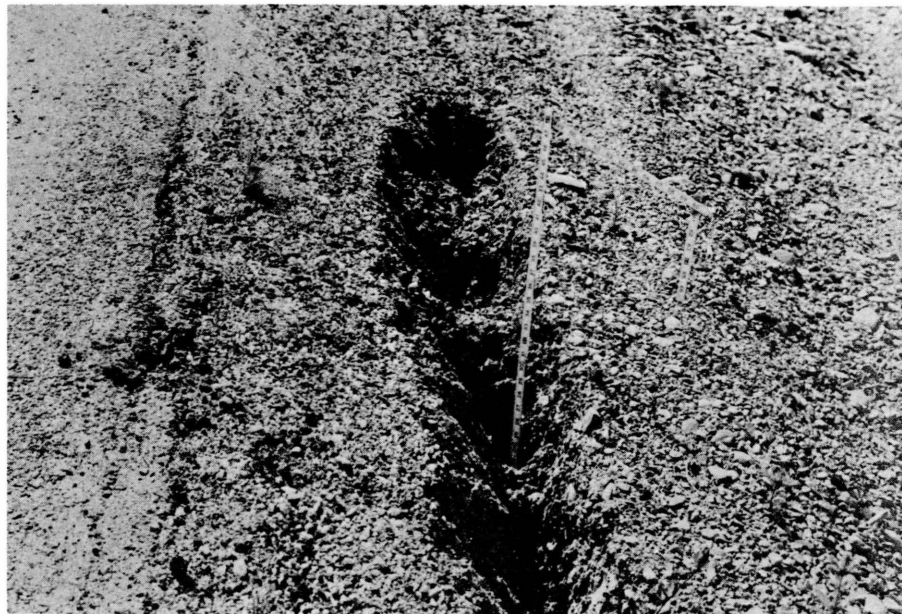
Figure 24. Shoulder failure caused by permafrost degradation under embankment toe (Chena Hot Springs Road, mile 12).

The above photographs illustrate but a few of many such failures observed. In cases in which failures are caused by permafrost degradation at or under the toe of the embankment, use of insulation such as polyurethane or polystyrene in and extending out from the shoulder might provide a solution (Fig. 25). Earth berms extending several yards from the embankment might also serve a useful purpose in preventing this type of failure.

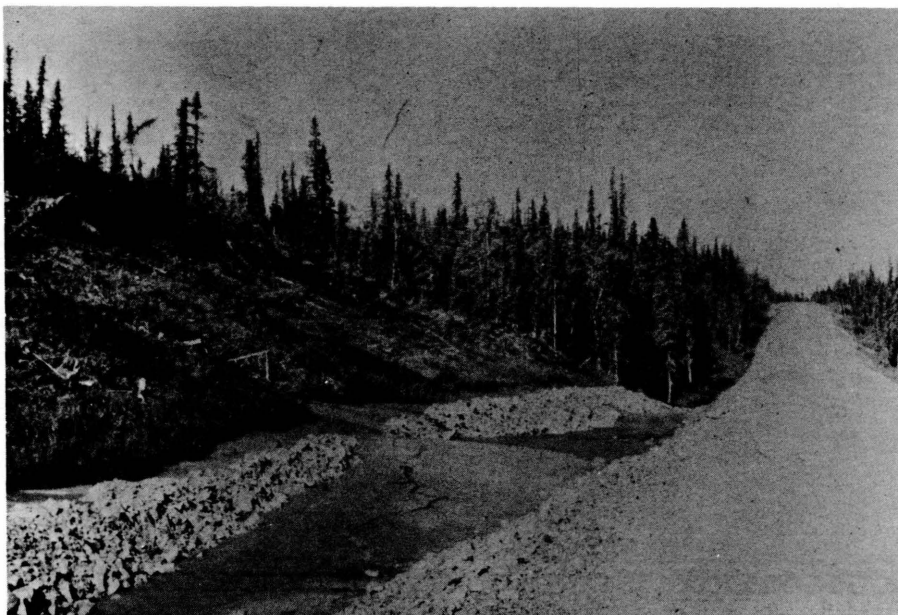
Another problem of great concern to Alaska highway engineers is that of slope stability where sidehill cuts have been made, particularly through ice-rich permafrost. Under these conditions, the uphill slope degrades with an ensuing flow of water and mud, which if not corrected may continue for years. Figure 26 shows such a condition along the TAPS road. In this case it is interesting to note that, three years after initial construction, water and mud are still filling the uphill ditch with silt. The rock berm at the toe of the slope, placed there for the retention of the mud and for assistance in stabilizing the toe of the slope, is only partially successful. The mud is continuing to flow over or through the rock berm.

Figure 26. Slope instability on TAPS road (from Smith and Berg 1973).

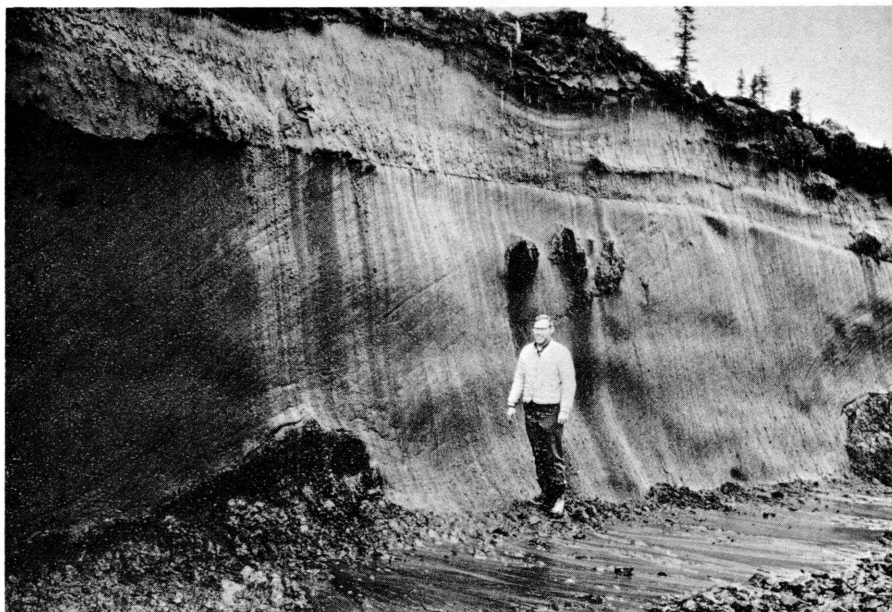
In a few instances sidehill cuts must be made through virtually pure ice, such as shown in Figure 27, which was taken along the TAPS road shortly after construction. In this case a vertical cut was made. Figure 28 shows another sidehill cut on the TAPS roads. Subsequent observations revealed that in less than two years the ice had receded about 4 ft, the grasses and other vegetation had sloughed down over the ice, and the cut had stabilized, as shown in Figure 29 which was taken in the same general location approximately two years after construction.

Figure 27. Vertical sidehill cut through ice at milepost 23.9 on TAPS road (from Smith and Berg 1973).

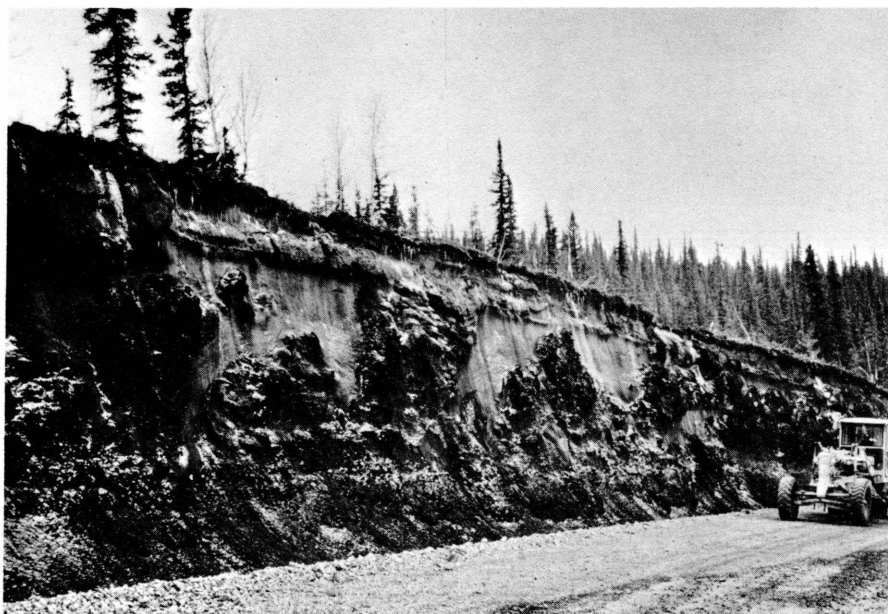
Figure 28. Vertical sidehill cut on TAPS road, 23 April 1970 (Smith and Berg 1973).

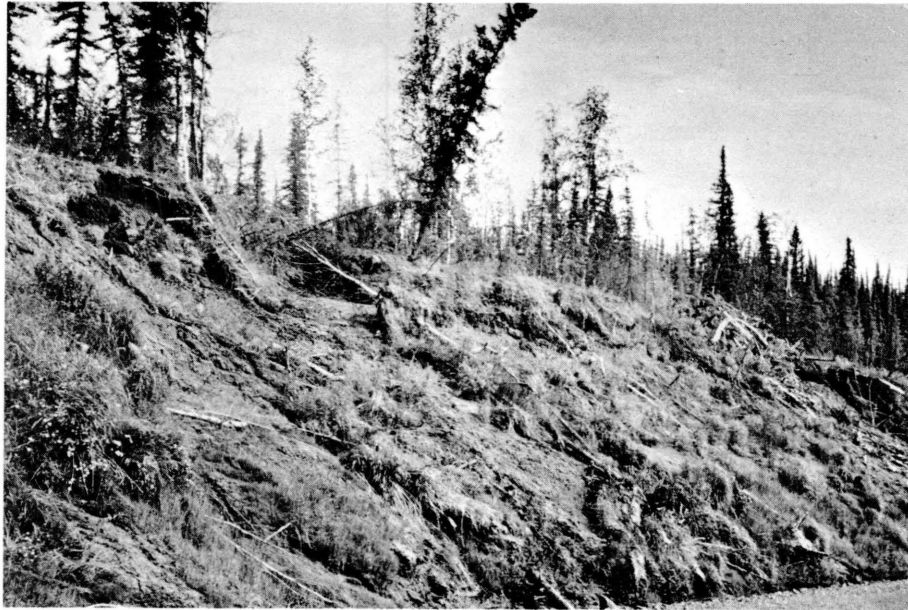
Figure 29. Same general location as shown in Figure 28 after approximately two years (photo. by N. Smith).

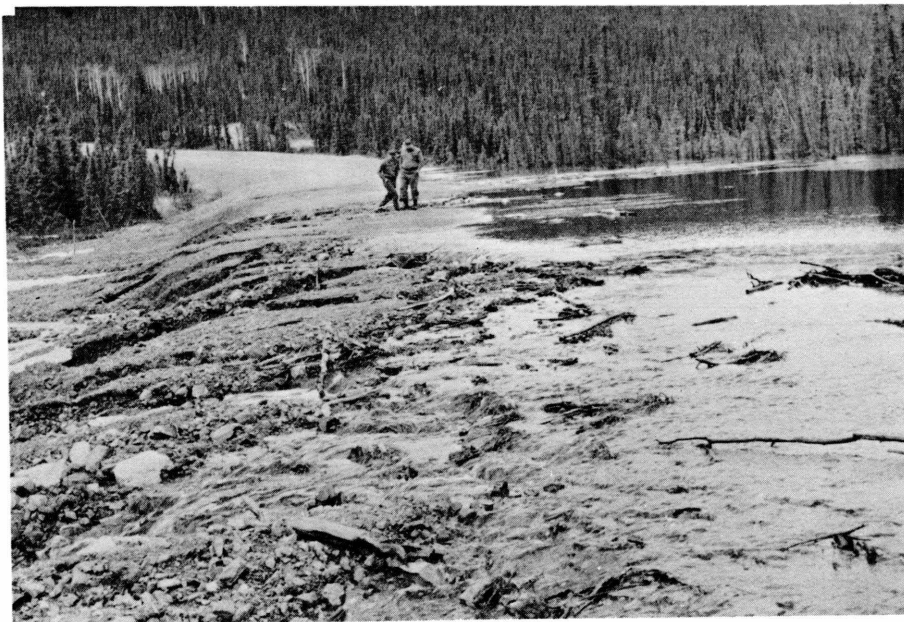
Figure 33. Washout along TAPS road (mile 5.6).

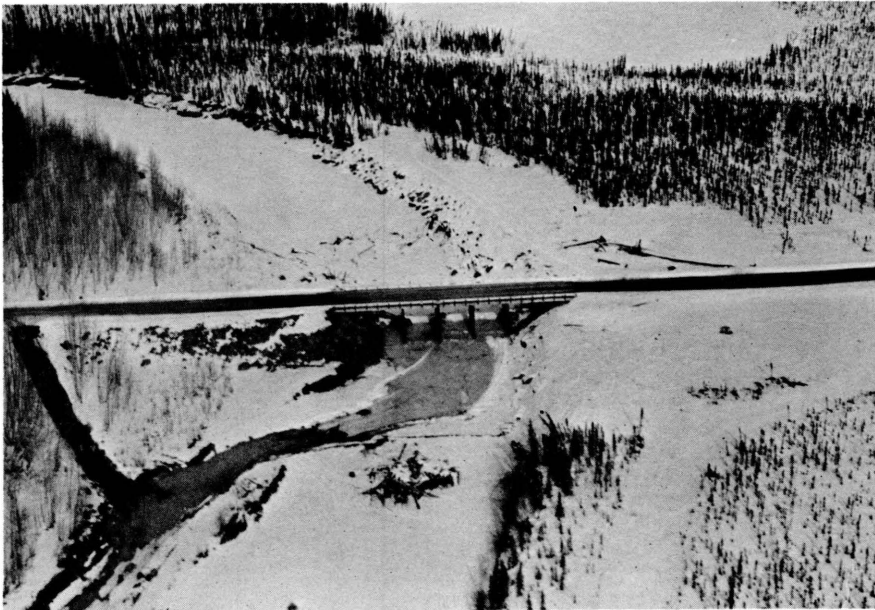
Figure 35 shows the Hess Creek bridge on the TAPS road. This is a pile bent bridge, constructed with "H" piles. The bents are probably

Figure 35. Hess Creek Bridge on TAPS road.

too close together, thus causing debris and ice buildup. Figures 36 and 37 show serious damage that this bridge sustained from log jams and repeated impacts from ice floes. Although unsuccessful at this location,

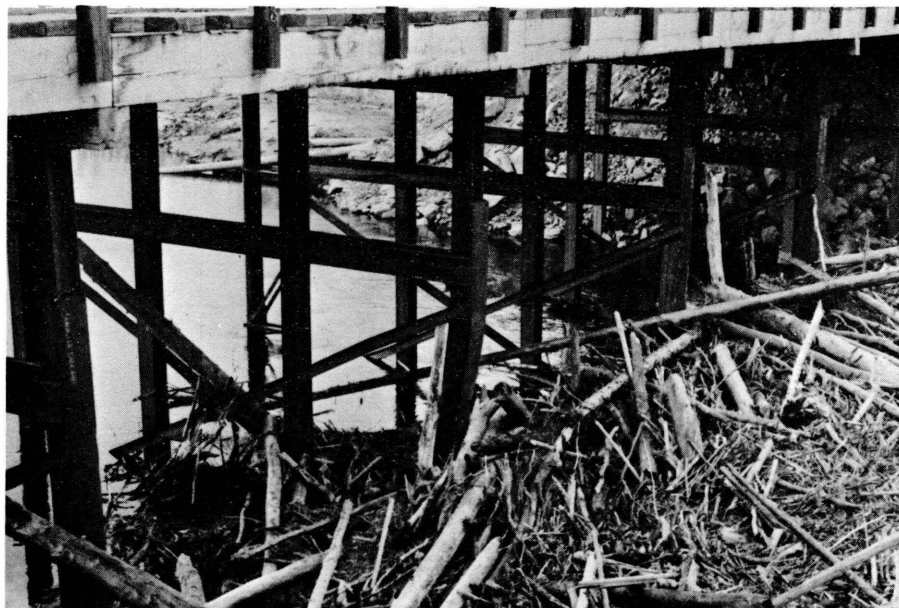
Figure 36. Damage to Hess Creek bridge from ice and debris during high water and ice breakup.

deflection devices such as those used for a pile bent bridge across the Chena River on Fort Wainwright (Fig. 38) have been found useful for some bridges. These deflectors are constructed of "H" beams and placed approximately 15 ft upstream from the bents. A crane is used to clear debris from the deflectors.

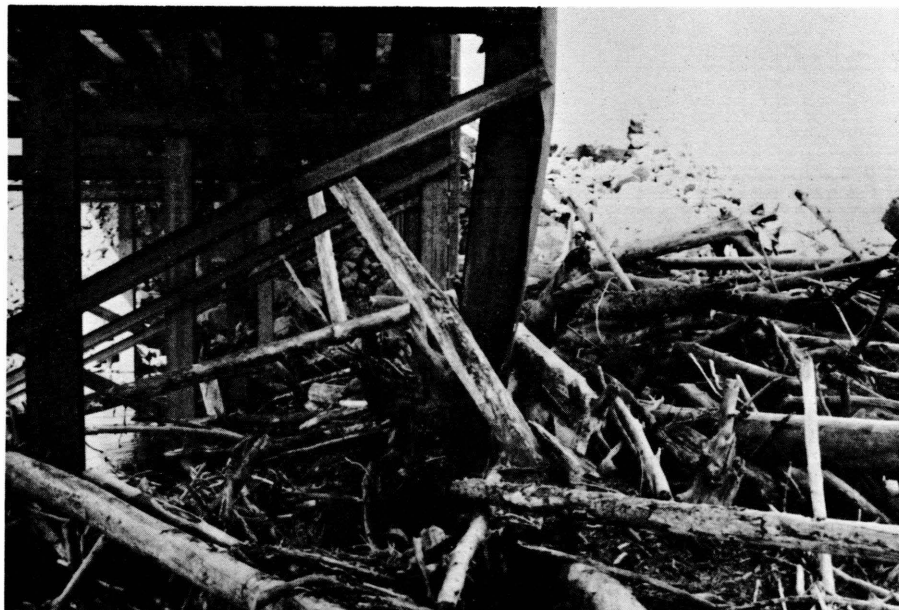
Figure 37. Closeup of damage to Hess Creek bridge.
