Special Report 77-8

REVEGETATION AND
EROSION CONTROL OBSERVATIONS
ALONG THE TRANS-ALASKA PIPELINE

1975 Summer Construction Season

March 1977

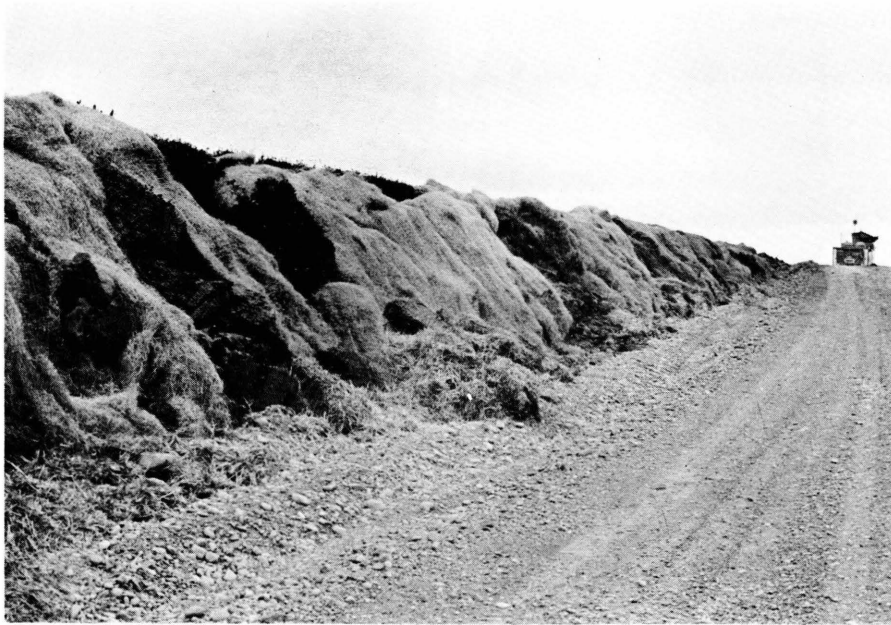
1. A.S. 131.3: Road cut near Franklin Bluffs airport slumping despite excelsior netting. (Plate 1)
- *2. Material sites 127-2.1A and 2.1B: Gravels were hydroseeded but erosion, slumping, development of large cracks, and minimal plant cover persist. (Plate 2)
3. A.S. 122: Happy Valley road cut with ice wedge meltout and slumping. (Plate 3)
4. A.S. 119.1: Slope Mountain material site, hydroseeded and mulched with little growth. (Plate 4)

Plate 1. A.S. 131.3: Road cut near Franklin Bluffs airport slumping despite excelsior netting.

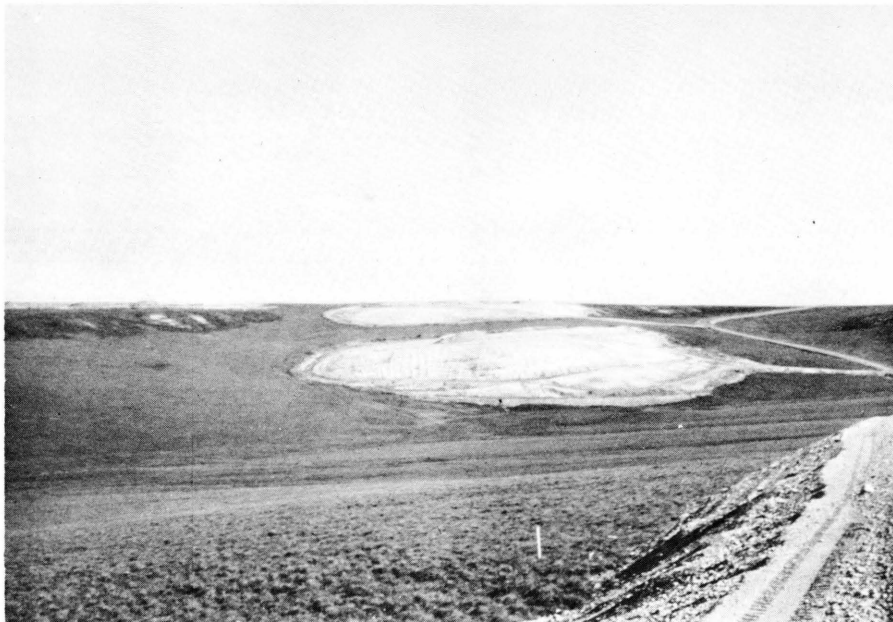
Plate 2. Material sites 127-2.1A and 2.1B: Gravels were hydroseeded but erosion, slumping, development of large cracks, and minimal plant cover persist.

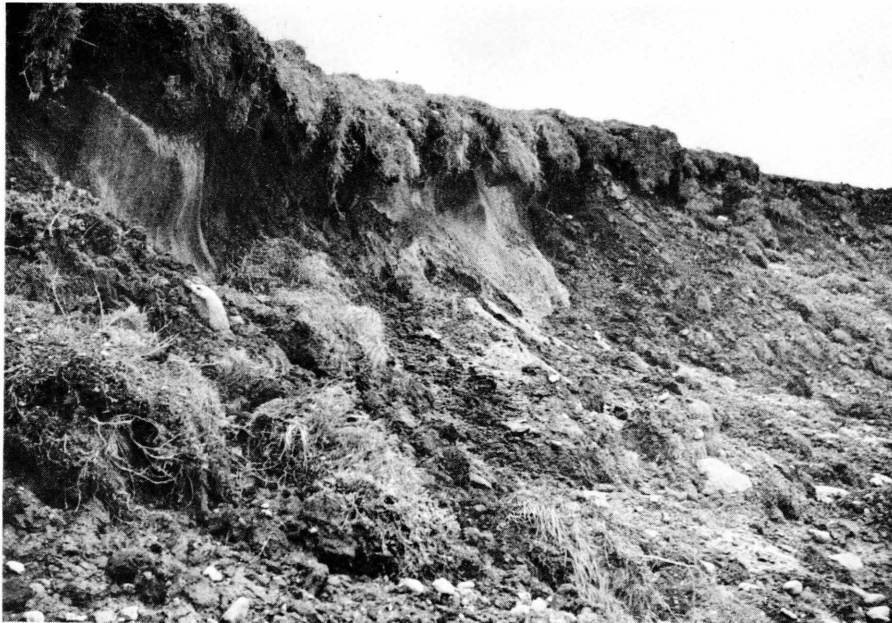
Plate 3. A.S. 122: Happy Valley road cut with ice wedge meltout and slumping.

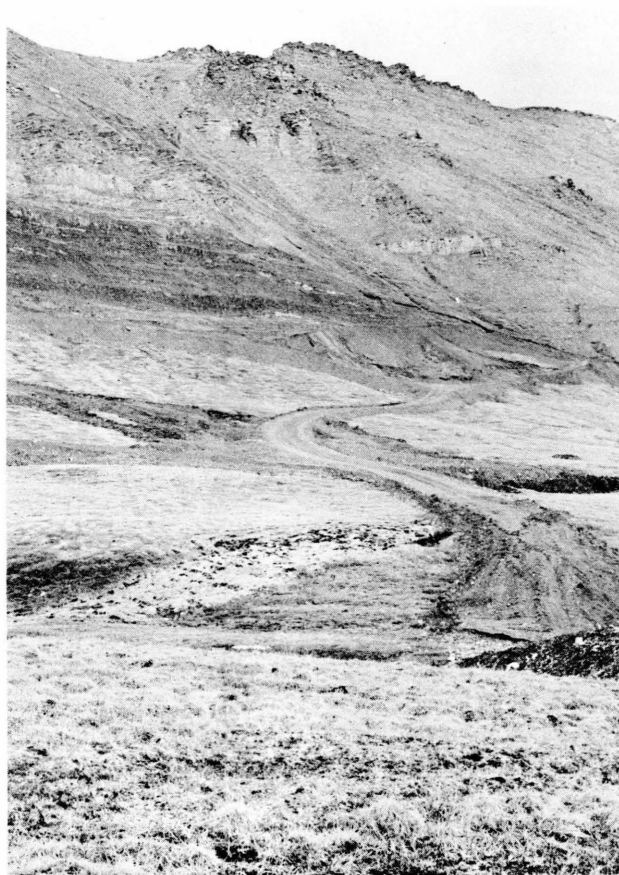
Plate 4. A.S. 119.1: Trail near Slope Mountain material site, hydroseeded and mulched with little growth.

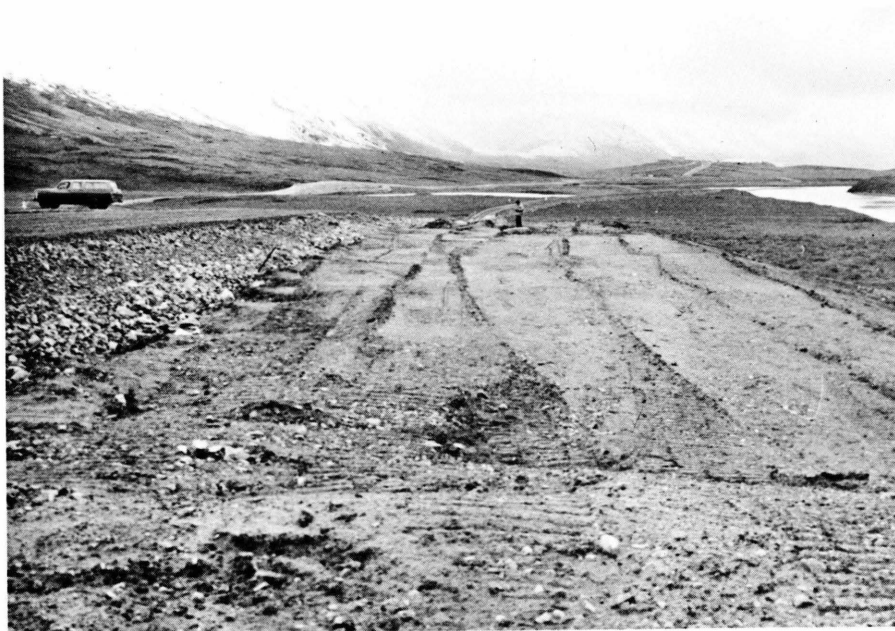
- *5. A.S. 114: Seeded disposal blankets along shoulder of road between Galbraith Lake access road and Atigun River cut. (Plate 5)

Plate 5. A.S. 114: Seeded disposal blankets along shoulder of road between Galbraith Lake access road and Atigun River cut.

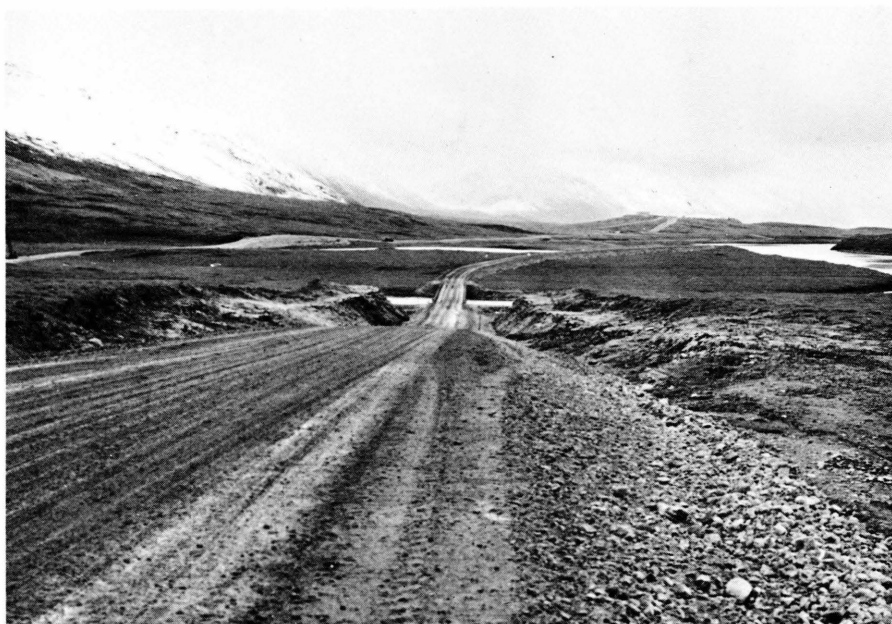
Plate 6. A.S. 114: Near vertical road cut hydroseeded and mulched on north side of Atigun River.

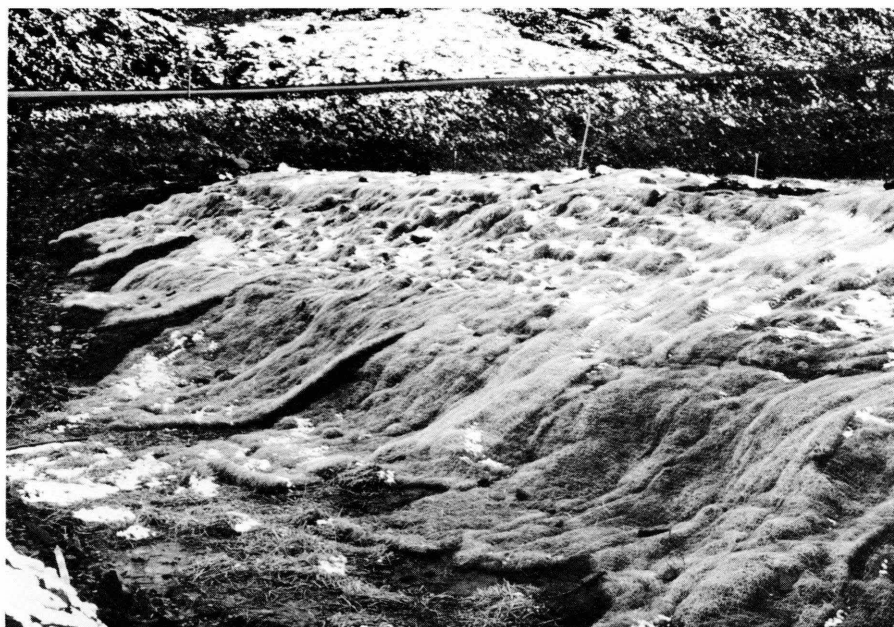
Plate 7. A.S. 110: A number of seeded and mulched slopes along the northern road approach to Atigun Pass.

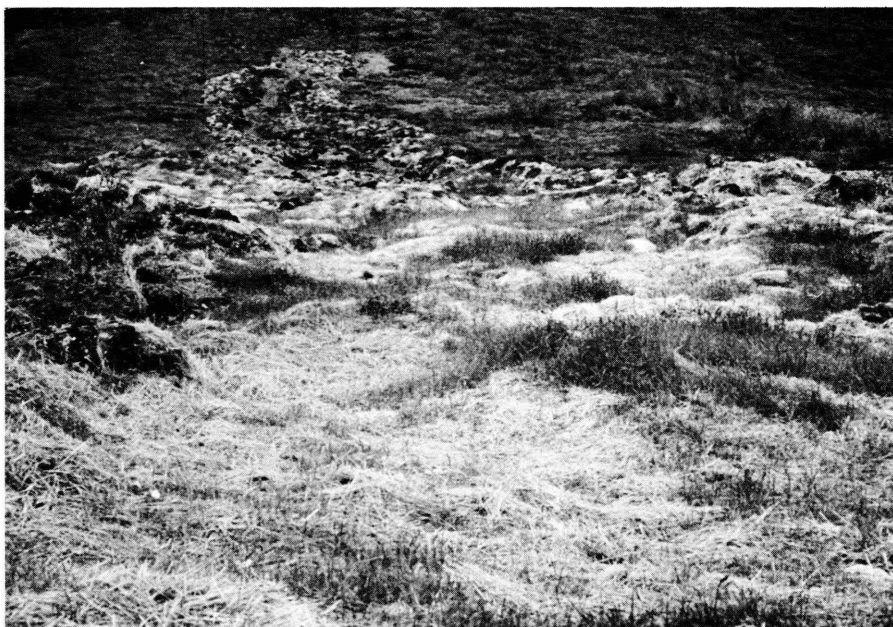
Plate 8. A.S. 108: View looking down slump. Stabilized with hay and excelsior matting.

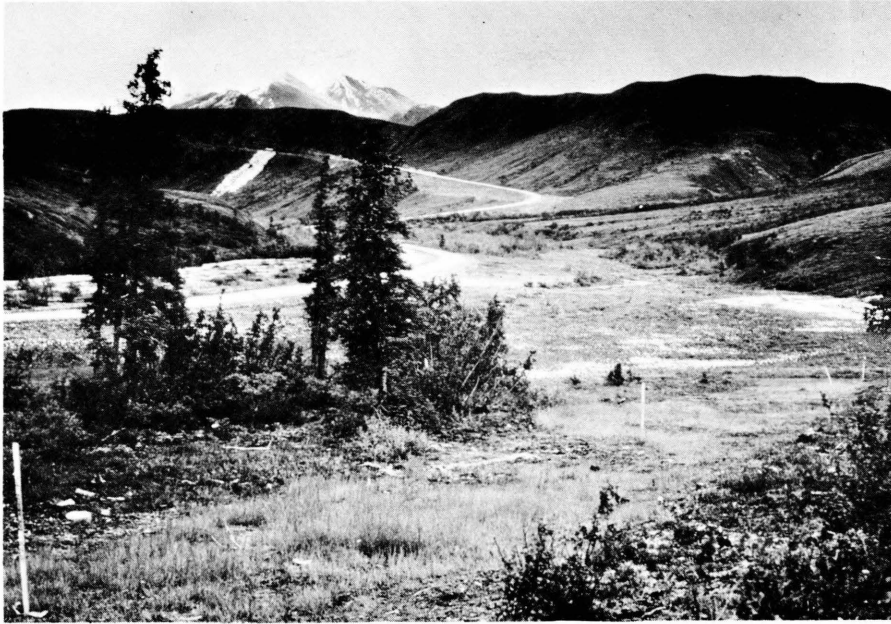
Plate 9. A.S. 108-109. Revegetated winter trail to east of road.

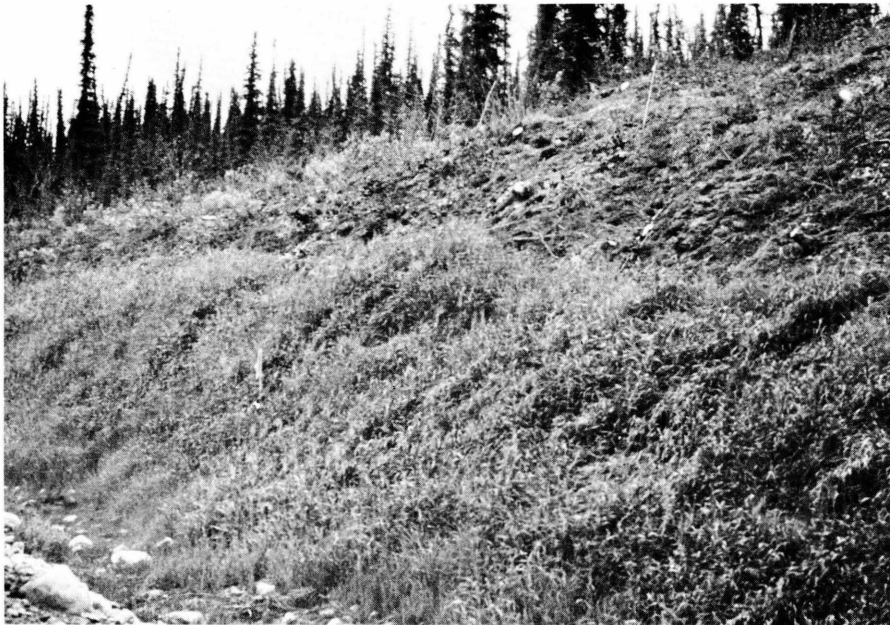
Plate 10. A.S. 107 (Station 35732): Organic mat folding over road cut. Trees were cut above the road cut to avoid shearing of the slumping organic mat.

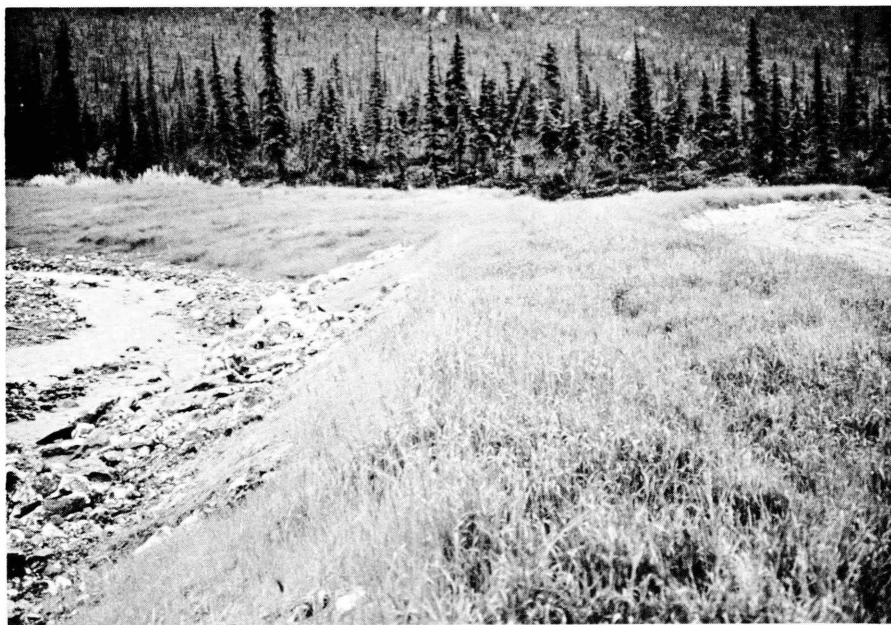
Plate 11. A.S. 104 (Station 2809+09): Lush stand of annual rye, along Unnamed Creek bank. Heavily grazed by moose in September.

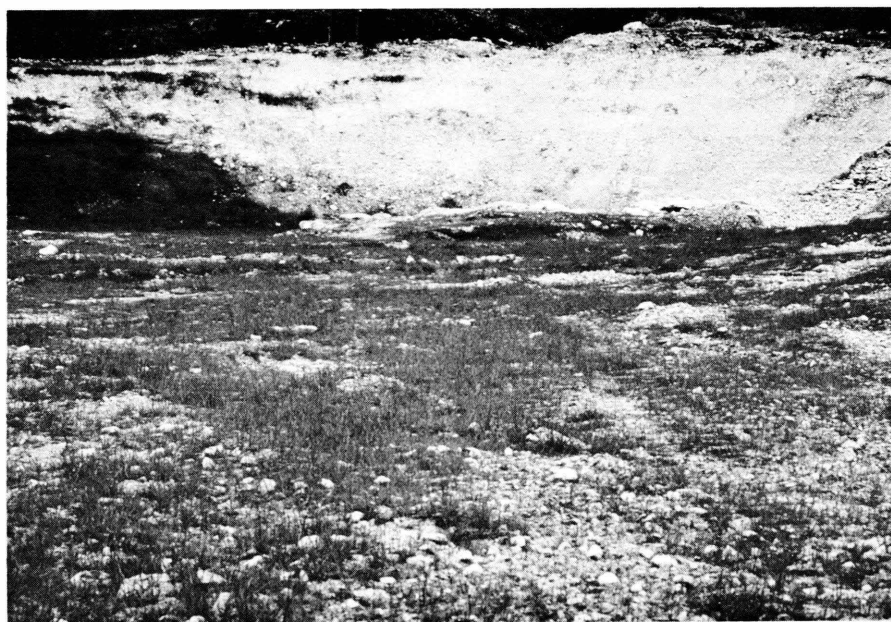
Plate 12. Material site 103-0.1: The area at base of Suk-akpak Mountain was revegetated but aesthetics may dictate natural vegetation be used instead. Cover 30-80% rye over gravelly substrate.

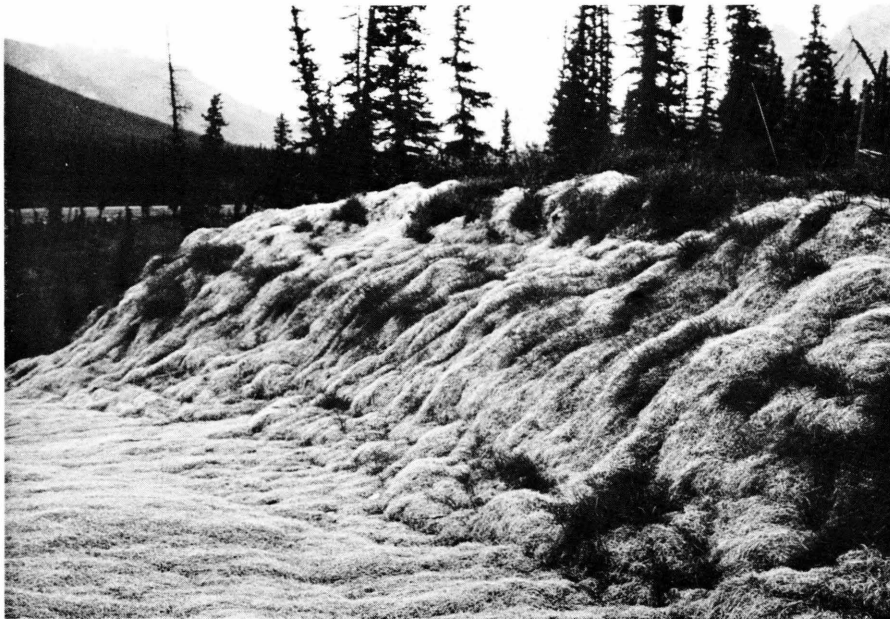
Plate 13. A.S. 102: Excelsior mats used to stabilize hand seeded cut on east side of work pad; growth mostly annuals.

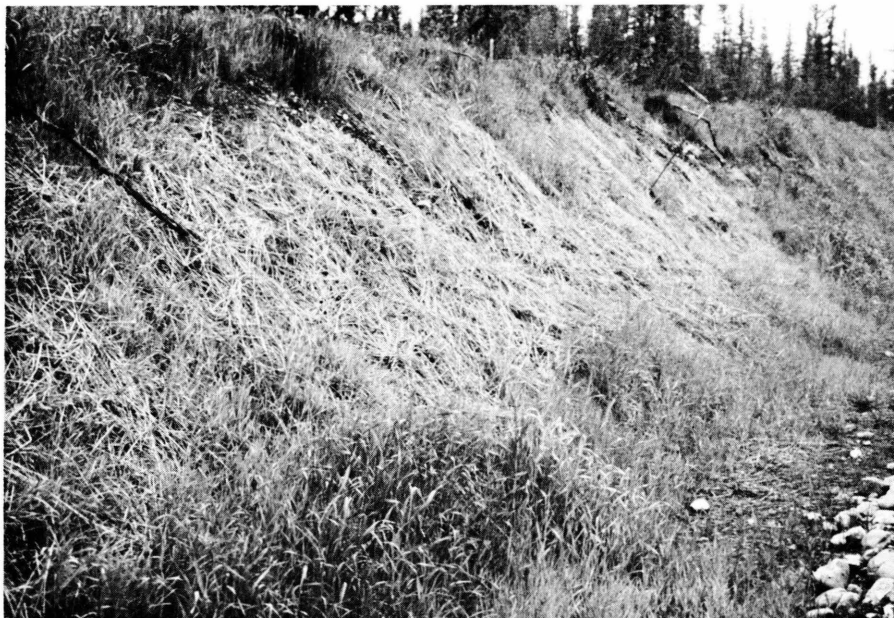
Plate 14. A.S. 101: Straw mulch and hydroseeded Haul road cut.

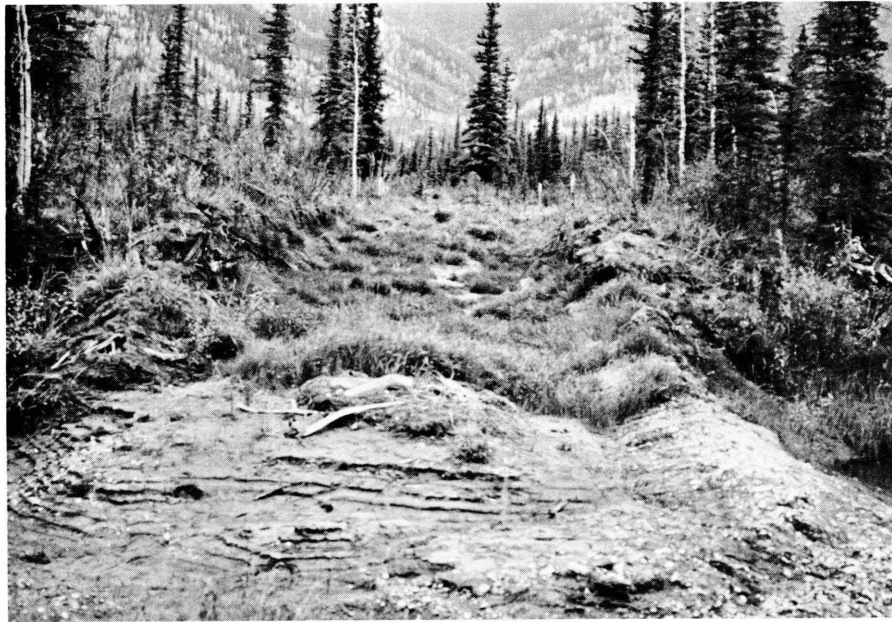
Plate 15. A.S. 100: Abandoned and bladed trail was seeded and mulched with hay just north of Middle Fork Koyukuk.

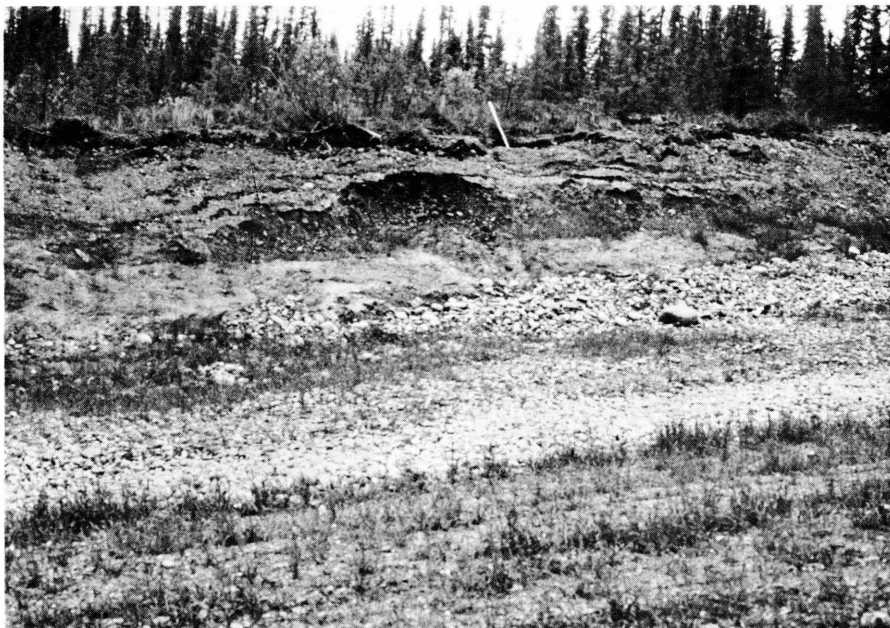
Plate 16. A.S. 97: Ice cut exposed by road cut and unseeded as of September 1975.

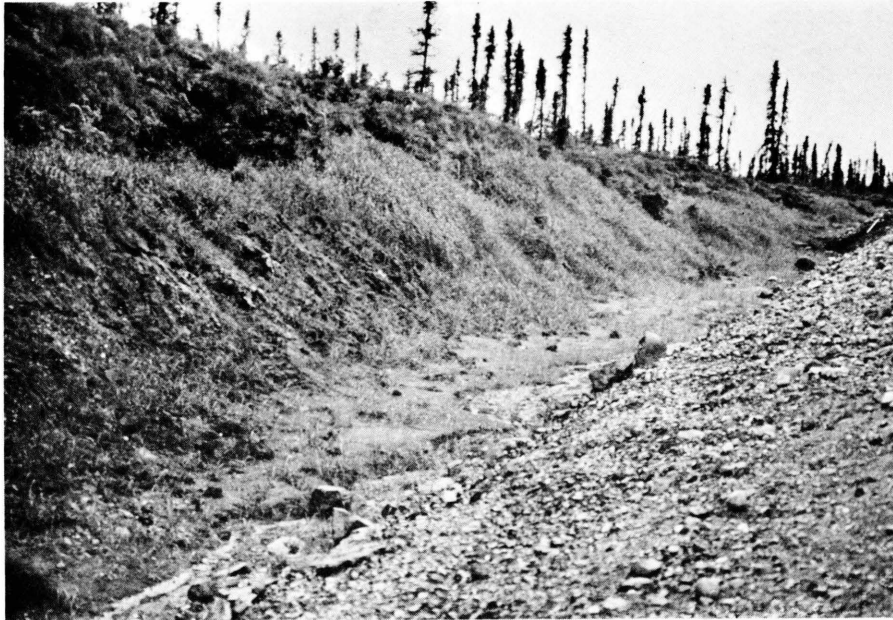
Plate 17: A.S. 91: Hydroseeded road cut with overhanging mat and some tussocks and black spruce.

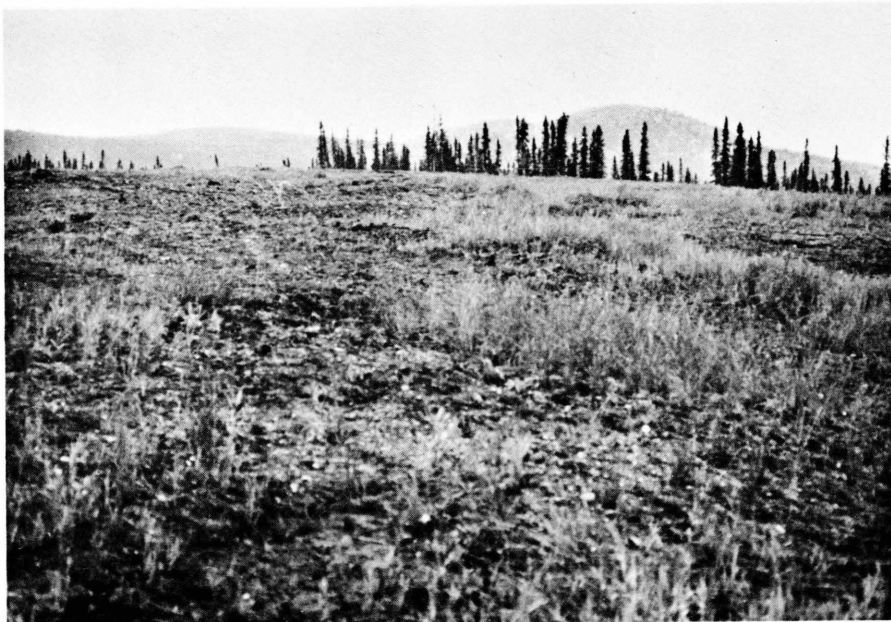
Plate 18. M.S. 91-3: Material site probably reseeded in 1974 and having 10-20% cover of annual rye, meadow foxtail, fescue, and fireweed.

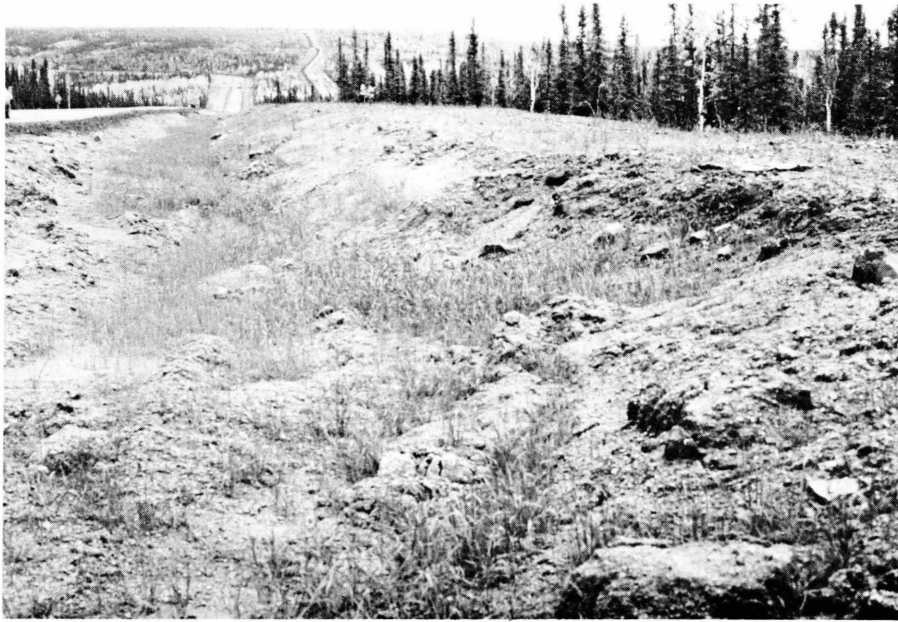
Plate 19. A.S. 90: Hydroseeding over weathered granite substrate.

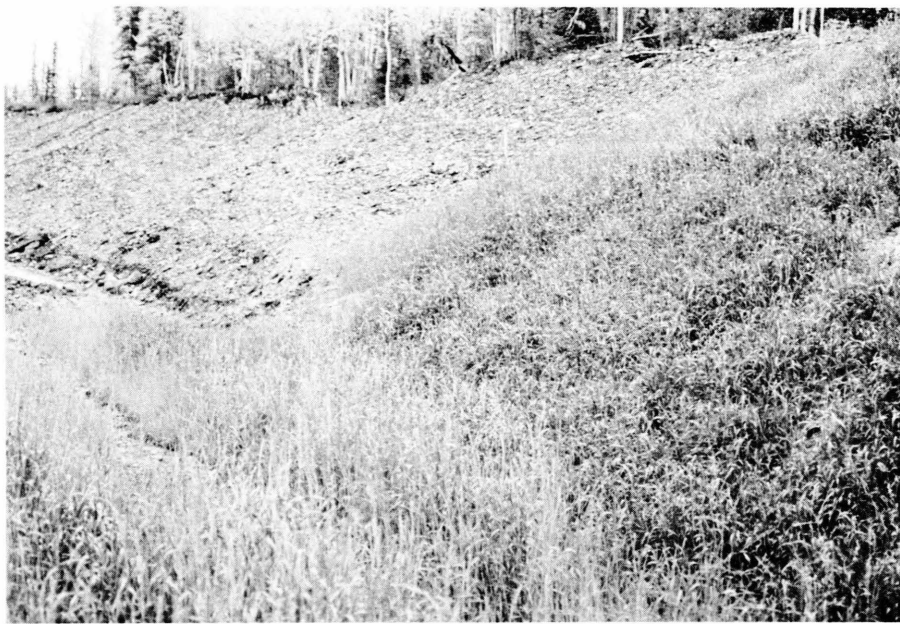
Plate 20. A.S. 88: East side of road cut, one-third of it seeded with good cover in 1975.

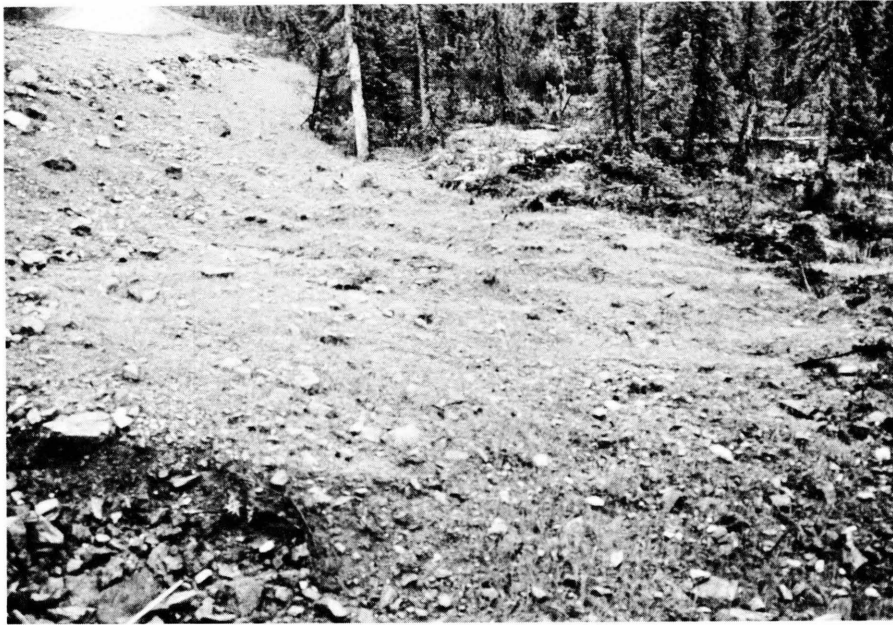
Plate 21. A.S. 84: West side of road hydroseeded with wood fiber mulch (beside a stream). Some barley and chenopods germinating from hay.

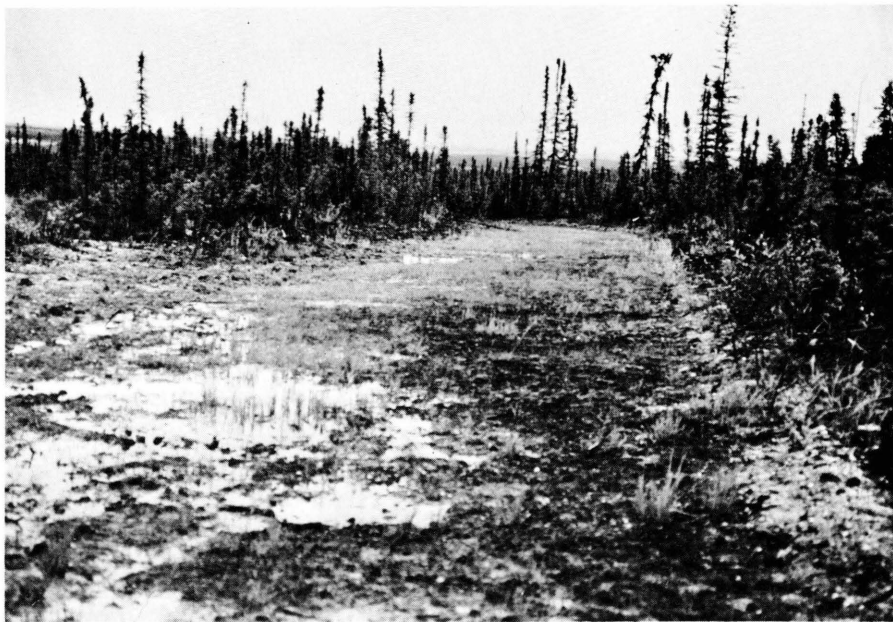
Plate 22. A.S. 81-82: Winter haul road on east side seeded, just south of No-Name Creek. Cover 10% on organic substrate and 20% on more sandy substrate.

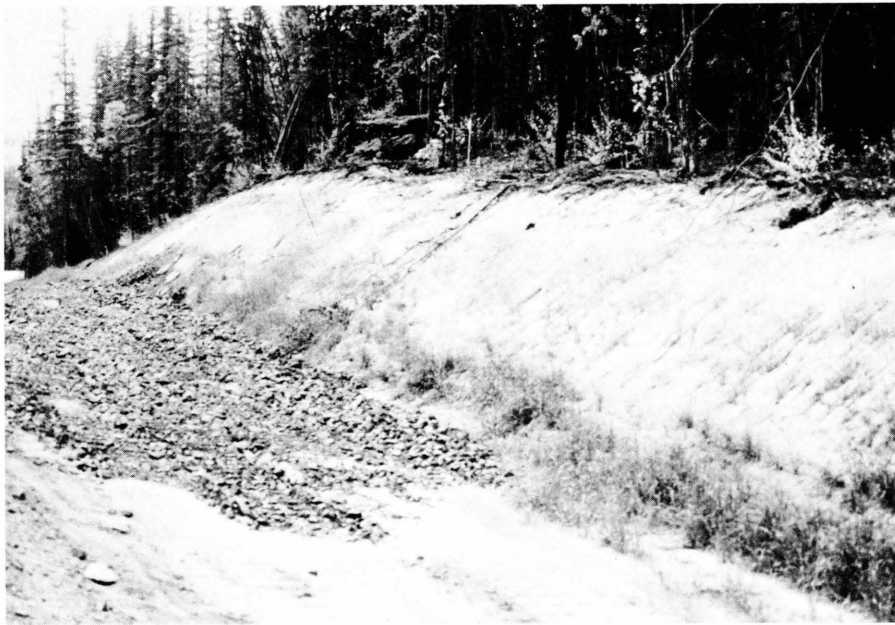
Plate 23. A.S. 80: Roadcut seeded on east side of Haul road north of 80-3.1. Germination very low on upper slope.

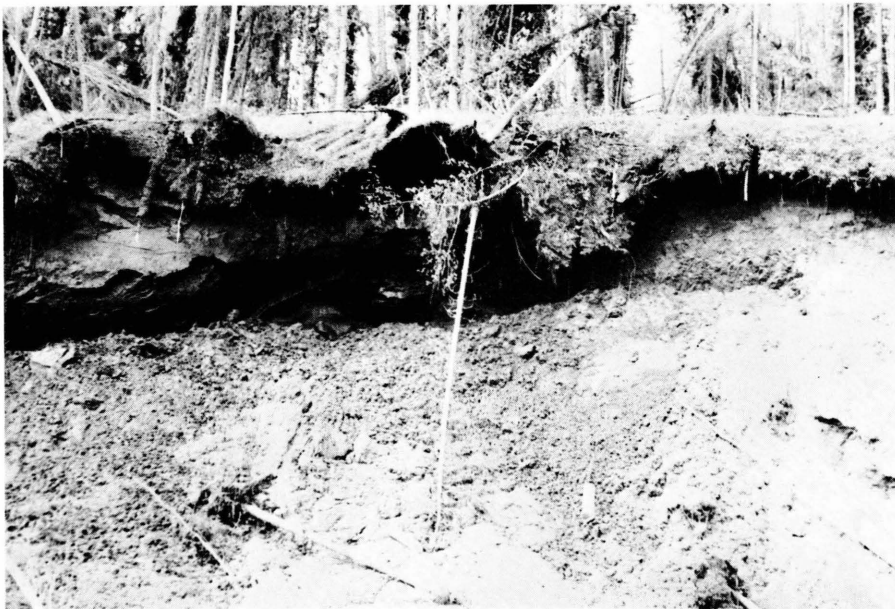
Plate 24. Ice cut at south abutment of Yukon Bridge. Large ice lenses in silt exposed by road cut. Trees left in place on vegetative mat are tearing the mat as they are undercut by thaw.

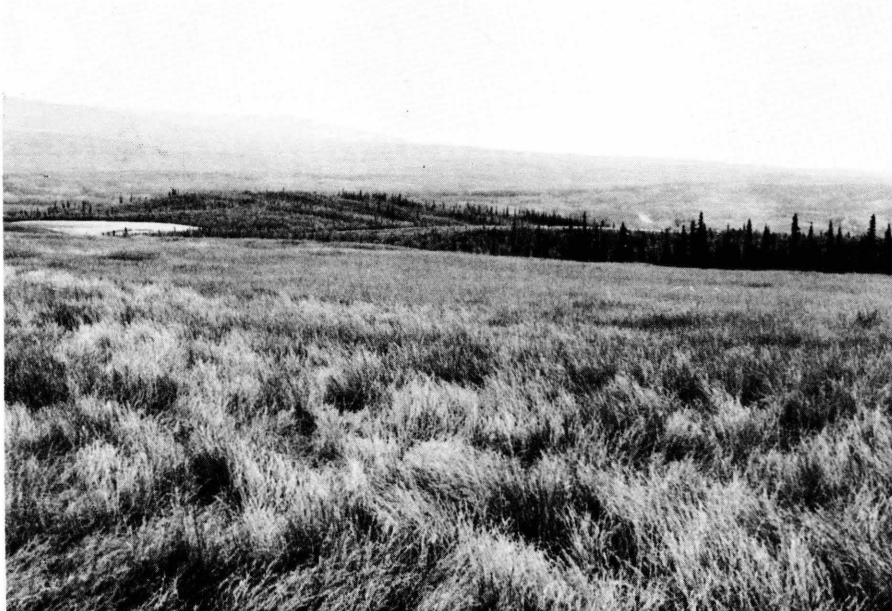
Plate 25. Pump Station 6: Large disposal area of wet silt north of station was aerielly seeded in May, producing a lush growth of annual ryegrass. Some areas of coarse gravel shoulder were sparsely seeded using wood fiber mulch. (Disposal site 77-48.)

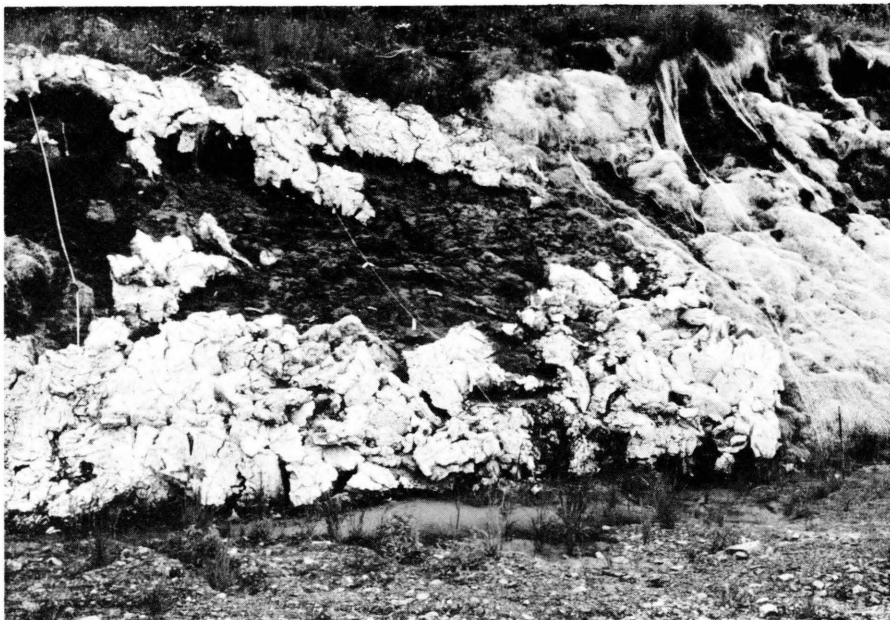
Plate 26. Mile 20.2 on Haul Road: Experimental plots on road cut treated with urethane foam and plastic nets.

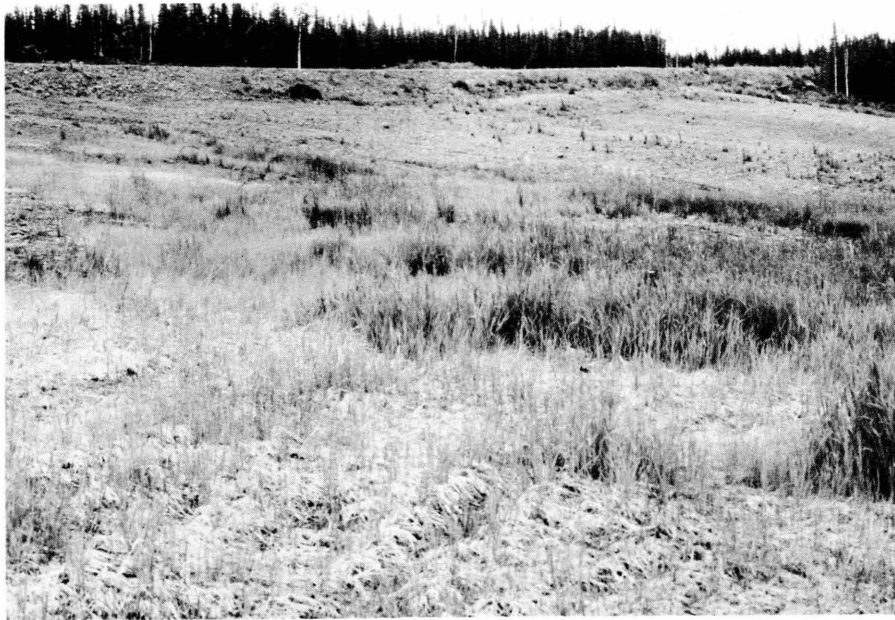
Plate 27. Mile 19.3 on Haul Road: Lower portion hydroseeded.

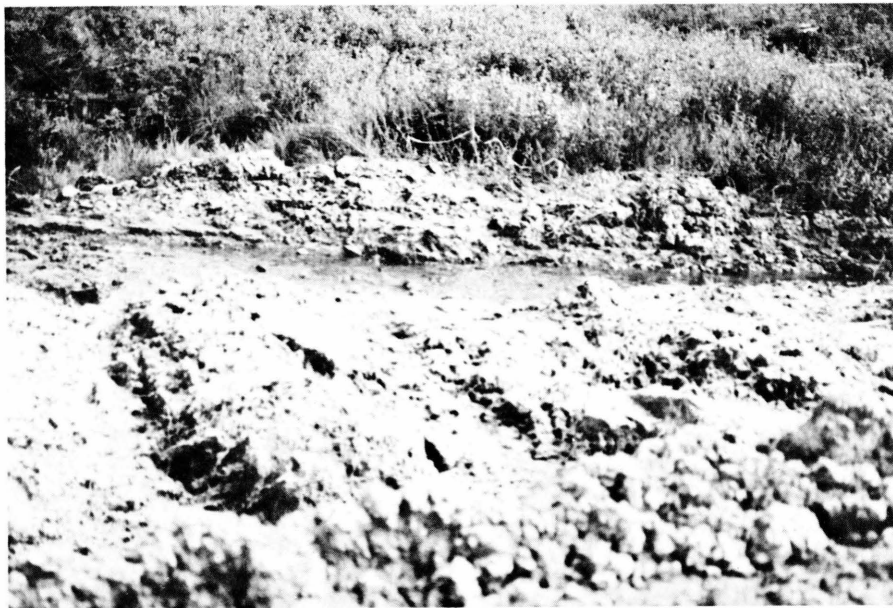
Plate 28. A.S. 66: MP 418 hydroseeded cut. Workpad was soft; several seeps appeared on work pad surface. Potential problems with icings and groundwater flow down trench.

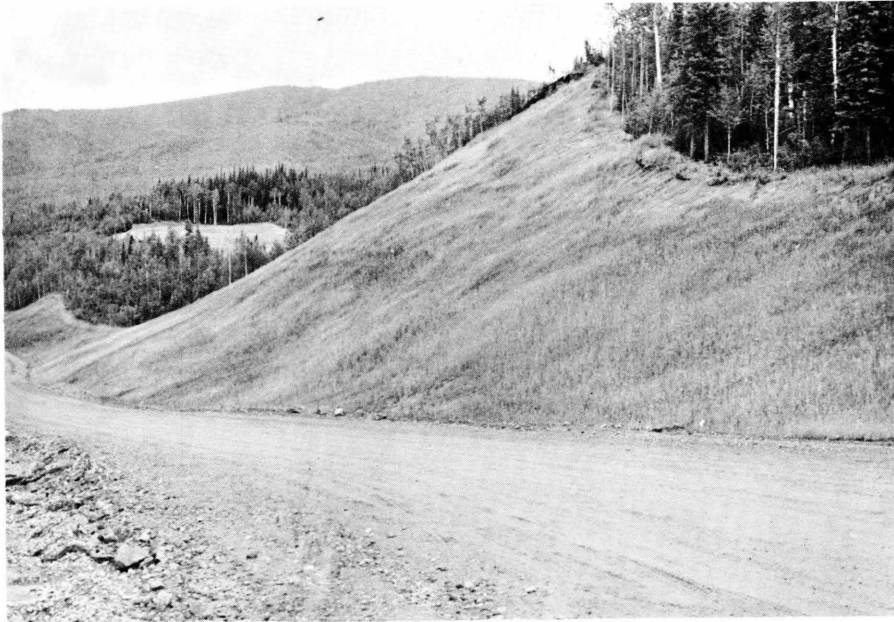
Plate 29. A.S. 51: Massive sandy slopes in vicinity of Rosa Creek. Hay and netting used to stabilize slopes as well as hydroseeded slopes in pipe storage yard and along access road.

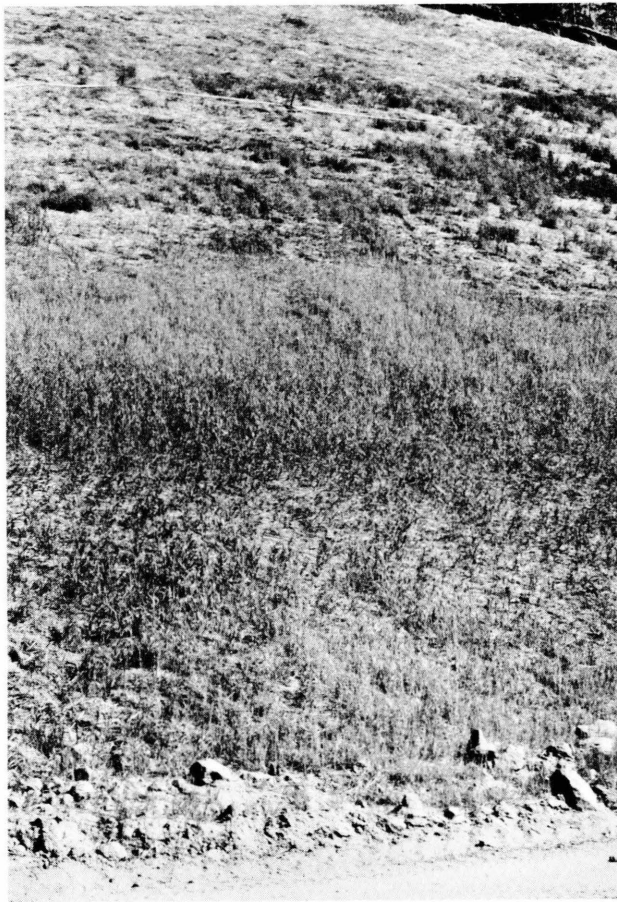
Plate 30. A.S. 48: About 1 mile north of Tanana River, road cuts in ice-rich silt, hydroseeded and hay mulched. Tractor had been run up and down the side slope to produce depressions for holding seed and moisture.

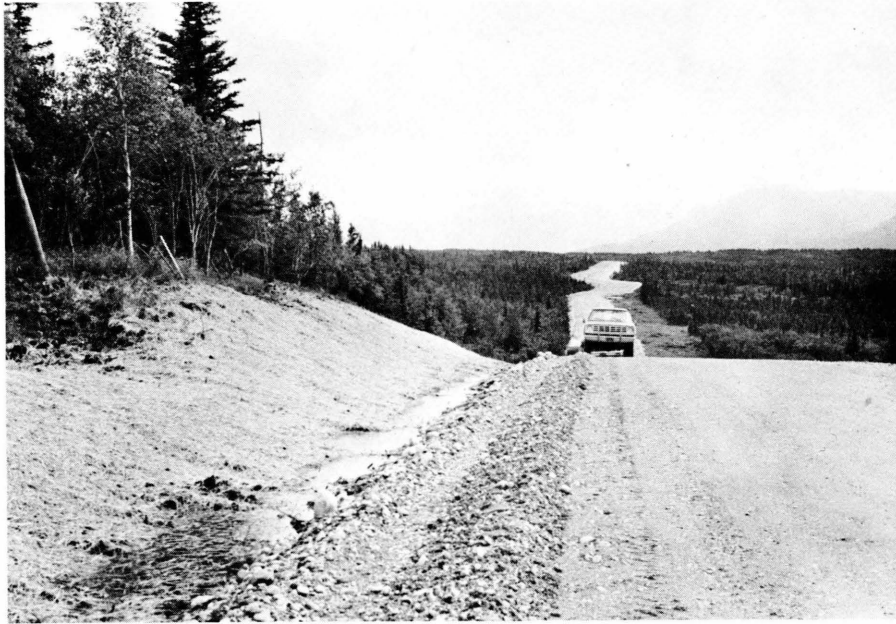
Plate 31. A.S. 42 and 41: Numerous cuts on sides of workpad hydroseeded in alpine area near Donnelly Dome.

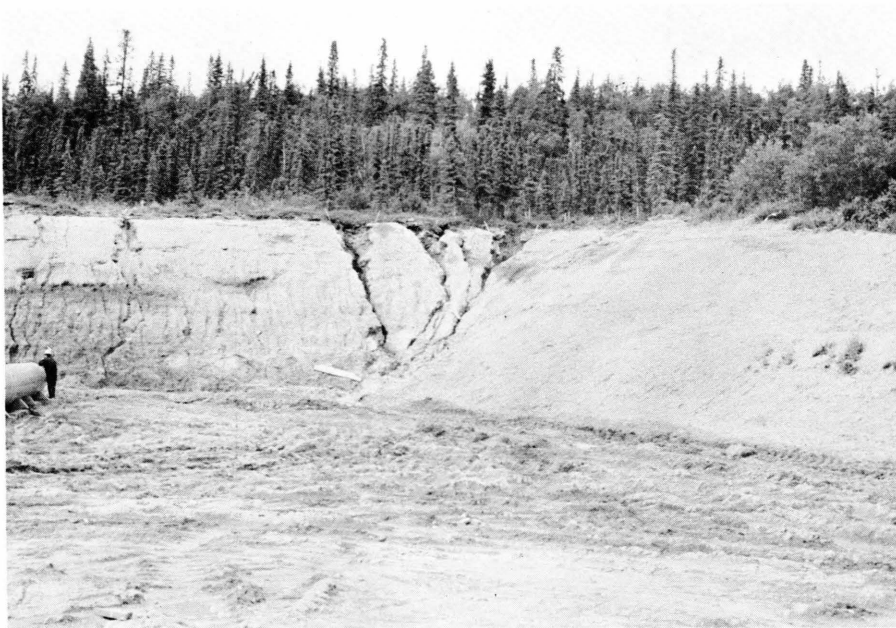
Plate 32. A.S. 28: Large pipe storage yard 2-1R north of Hogan Hill. Some erosion gullies despite hydroseeded slopes. Considerable amount of waste silt had flowed toward Haggard Creek in spring. Dikes used to contain waste silt.

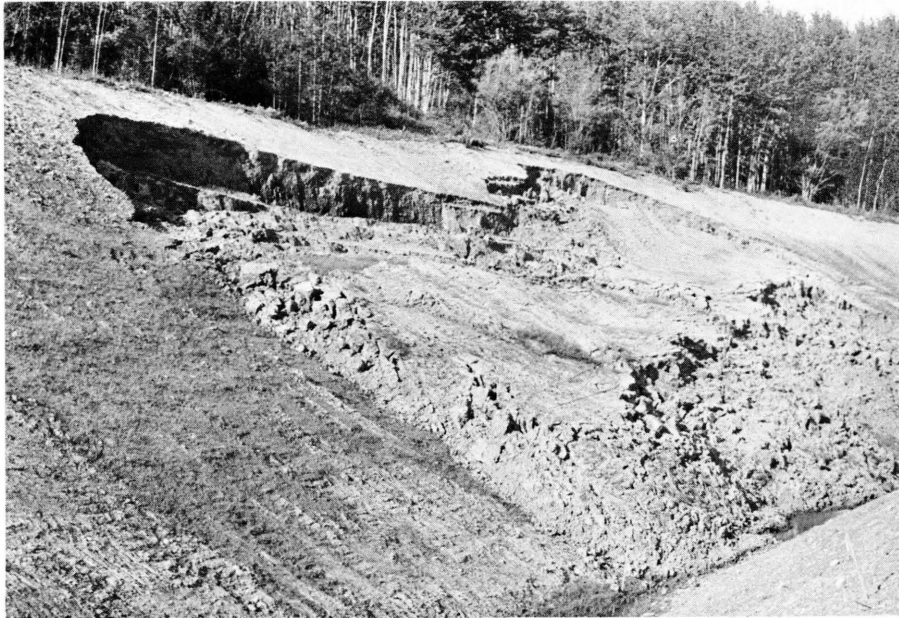
- *34. Pump Station 11: Massive deep seated slope failure. Failure began about mid June after a period of heavy rainfall. Some additional sliding occurred about mid-July. Seeded latter part of June. (Plate 33)

Plate 33. Pump Station 11: Massive deep seated slope failure. Failure began about mid-June after a period of heavy rainfall. Some additional sliding occurred about mid-July. Seeded latter part of June.

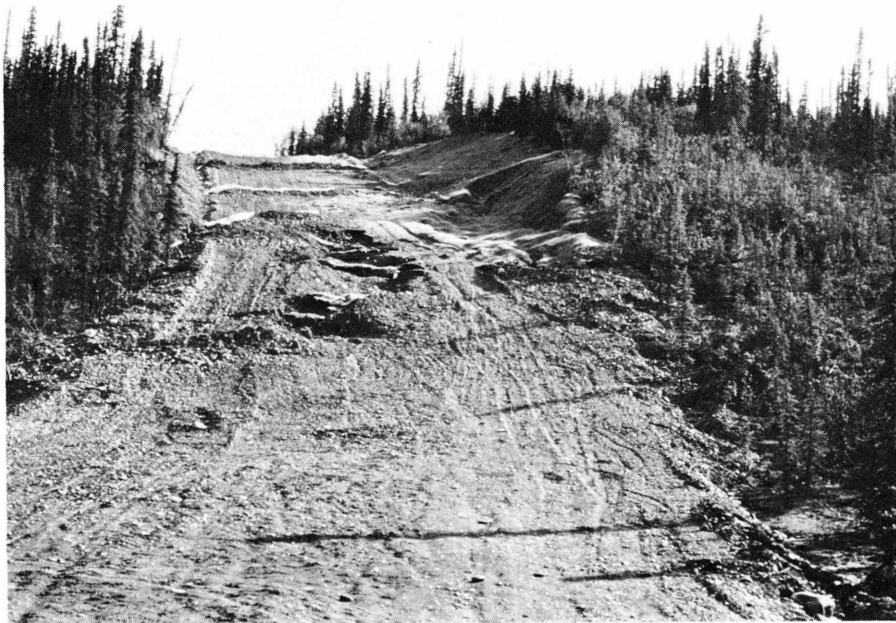
Plate 34. A.S. 18.1: Ice-rich soils exposed and eroding despite gravel overburden and thick hay mulch.

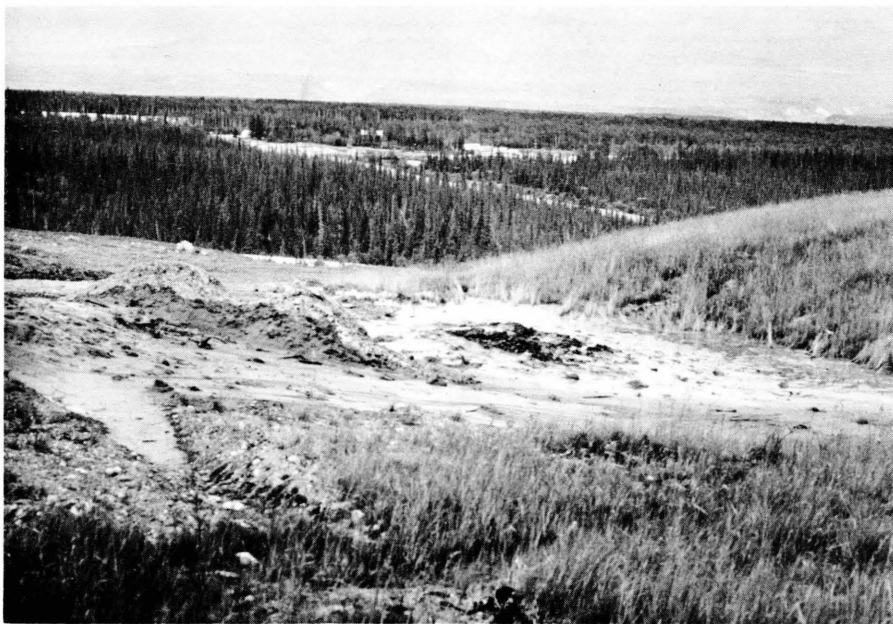
Plate 35. Material Site 17-5: Disposal materials used to cover gravel and then reseeded. Upper area had almost 100% plant cover.

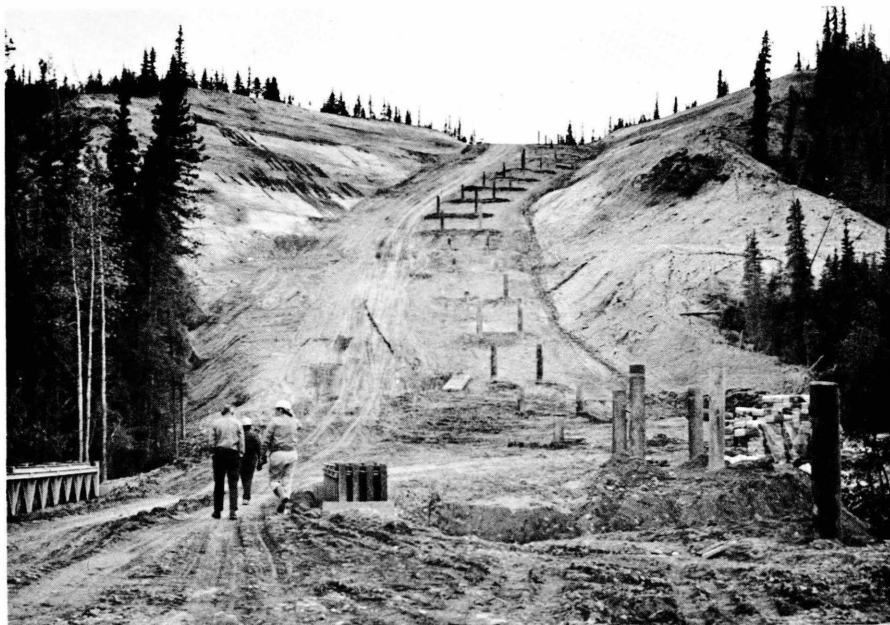
Plate 36. A.S. 16: Steep slope on south side of Squirrel Creek. Some erosion still evident. Wood fiber mulched at 2000 to 2500 lbs/acre. Additional erosion control efforts were planned in 1975.

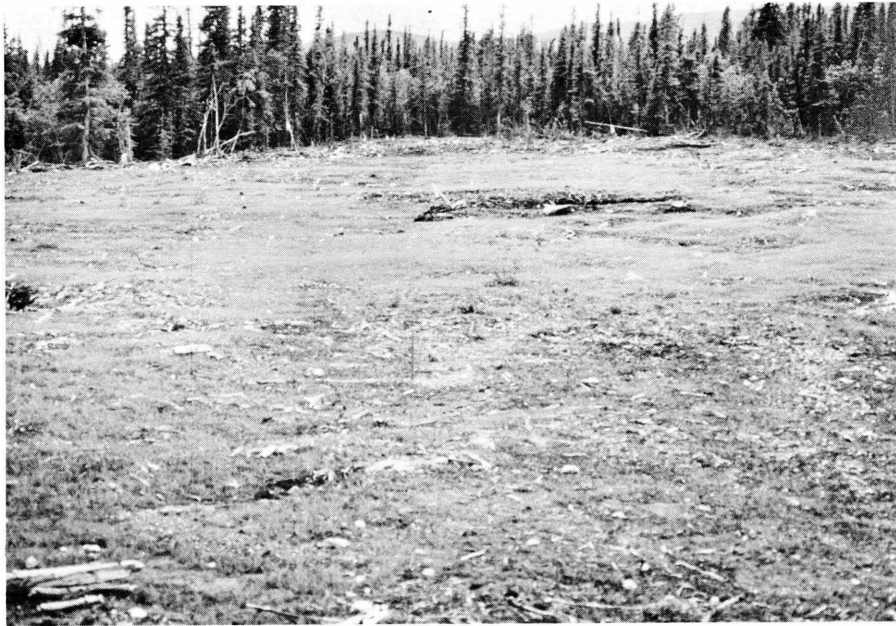
Plate 37. Disposal site 16-1: Brush covered with soil, wood fiber mulched and reseeded. Reasonable growth by mid-summer with willow and fireweed recolonizing.

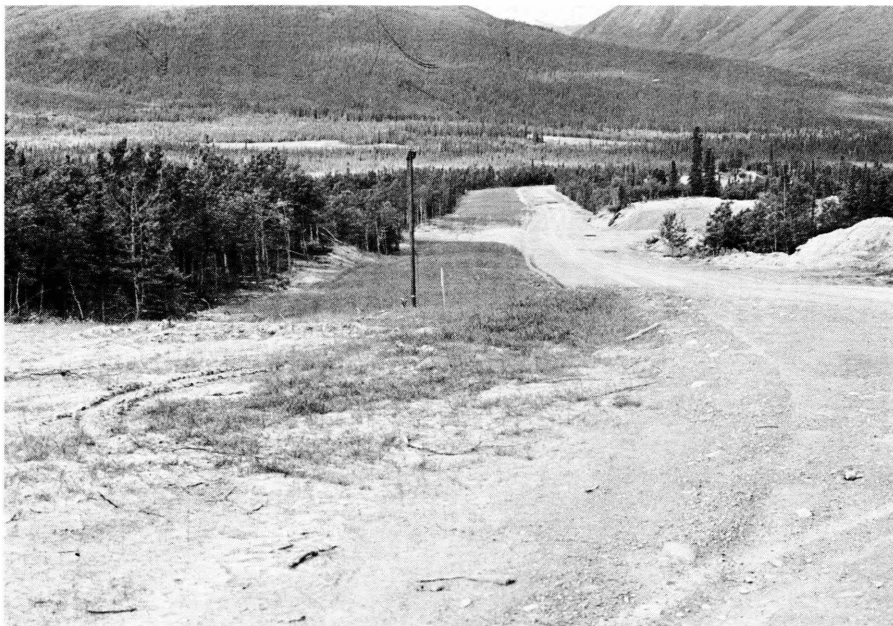
Plate 38. North of Pump Station 12: Intersection of workpad with Richardson highway. Entire width of workpad seeded over buried pipe.
