Special Report 77-8

REVEGETATION AND
EROSION CONTROL OBSERVATIONS
ALONG THE TRANS-ALASKA PIPELINE

1975 Summer Construction Season

March 1977

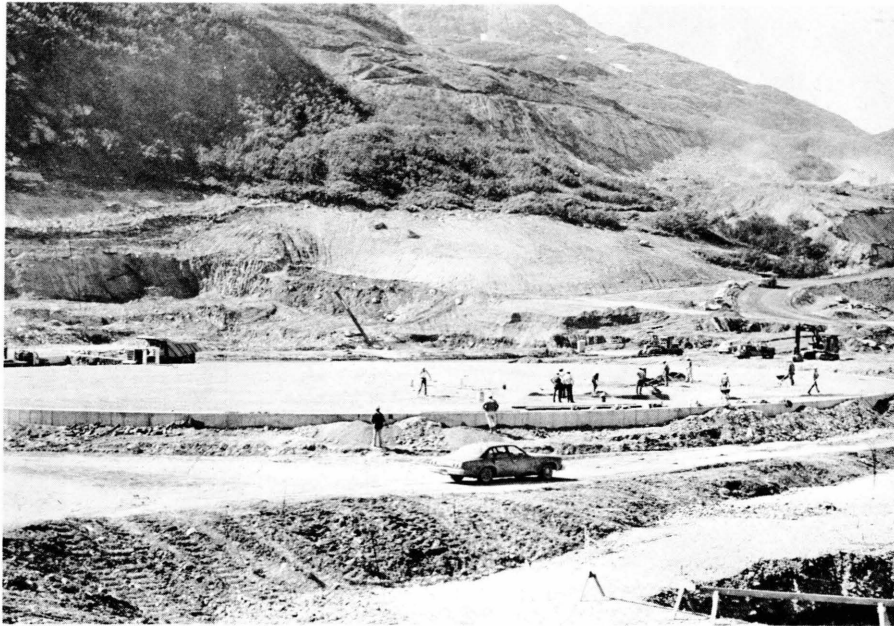
Plate 39. Valdez Terminal: Areas hydroseeded.
