Special Report 82-7

May 1982

Moisture detection in roofs with cellular plastic insulation — West Point, New York, and Manchester, New Hampshire

Charles J. Korhonen and Barry A. Coutermarsh

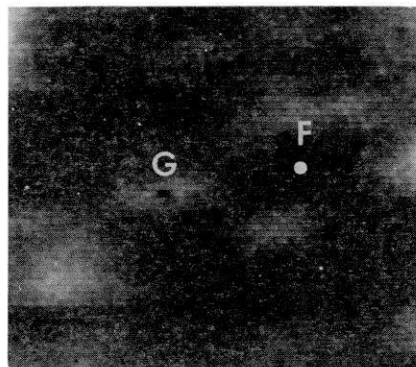
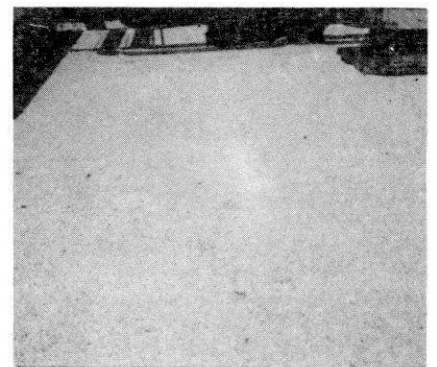
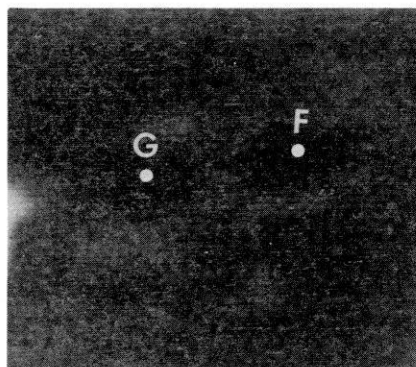
During the May and October surveys the thermal image of each level of the roof of Building 753 (Fig. 1) was mottled (i.e. with thermally light and dark areas blending into one another). By scraping the gravel cover and taking samples F and G (Fig. 2) in May we determined that the mottling was caused by varying gravel thicknesses and not wet insulation. Thick layers of gravel store more solar heat and remain warmer longer than thin gravel layers. Figure 2c, although mottled, does not have as pronounced mottling as Figure 2a, indicating less solar effect in October. The two black areas in Figure 2c were caused by patches at F and G.

Figure 2. Building 753, first level. The entire roof had a mottled appearance as shown in these two thermograms.

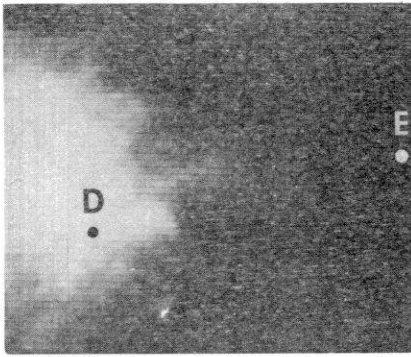
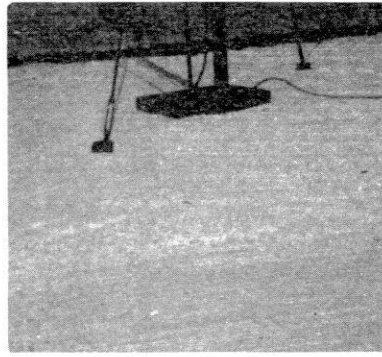
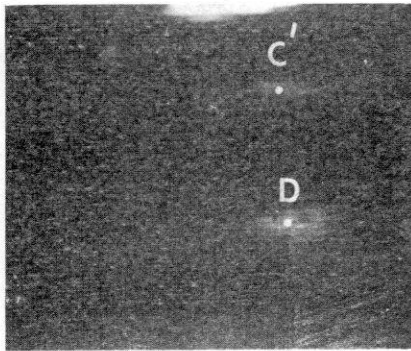
Figure 3. Building 753, second level. One bright thermal anomaly was detected.

On the second level of this three-level roof, one relatively bright area was detected (Fig. 3) that did not contain thick gravel. Core samples D and E taken in May showed that the insulation contained only 9 and 4% water, respectively, and that the built-up membrane at D was thicker than at E (1/2 vs 3/8 in.).

In October this thick area, although readily detectable, was not as bright (Fig. 3c) and sample C', taken from the area of the bright spot, contained only 3% moisture. The increased membrane thickness is considered to be the major cause of the bright area in Figure 3 because a thicker membrane can store more of the day's heat than can a thinner membrane. Since no other indications of moisture were detected, we feel that the second roof level contains no moisture entry points.

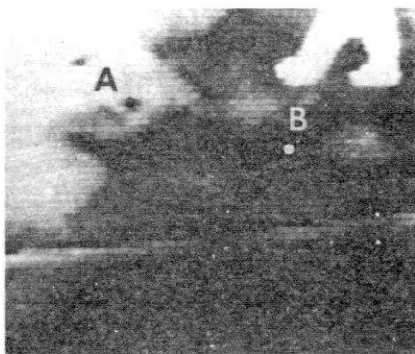
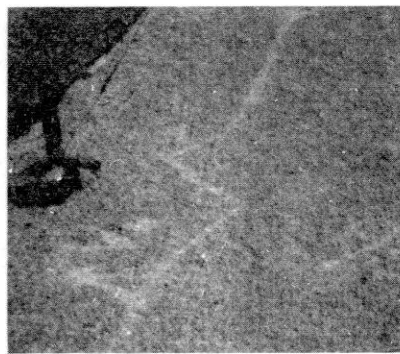
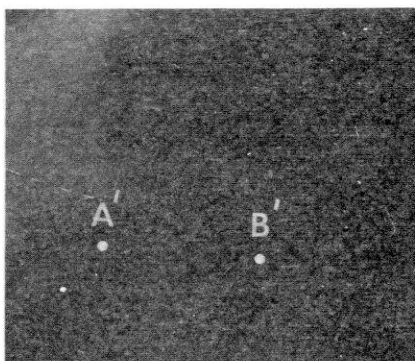
A bright area was present along the western edge (Fig. 4a) of the third roof level. If the anomaly had been only heat radiating onto the roof from the parapet wall it would have blended into the roof a short distance (2 to 3 ft) from the wall. Figure 4 shows the edge of this

Figure 4. Wet area around vent pipe on western edge of third roof level, Building 753.

anomaly to be well-defined and stepped, which is a strong indication of wet insulation. Sample A contained 94% water. Figure 5 shows that a guy wire installed in December 1978 from a nearby antenna had pulled the vent pipe flashing from the roof, thereby creating the moisture entry point for this area. The wire was removed and the flashing repaired sometime after May 1979.

In comparison to Figure 4a, Figure 4c (taken in October) shows that the thermal anomaly near the vent pipe is no longer as well-defined. It blends gradually into the roof. Sample A' shows a loss in water content from May near the vent pipe, but sample B' shows that moisture has increased during this time period just a short distance away. Based on this pattern it appears that the entrapped moisture has spread out into the insulation.

In May Building 753 contained wet insulation around a dislodged vent pipe flashing. Since the flashing was repaired and the wet area is relatively small, the overall thermal efficiency of the roof is still high. Therefore, no further action is recommended on this roof, other than normal maintenance.

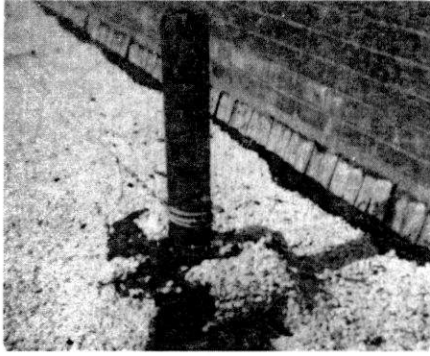
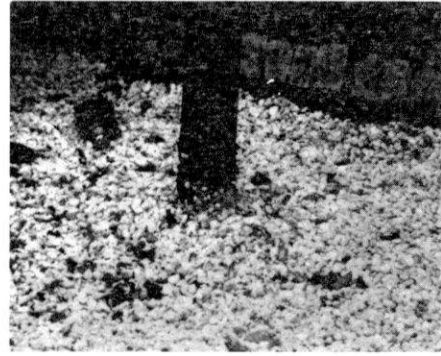
Figure 5. Area where tension from a guy wire pulled vent pipe flashing from the roof. It was patched shortly after our May survey.

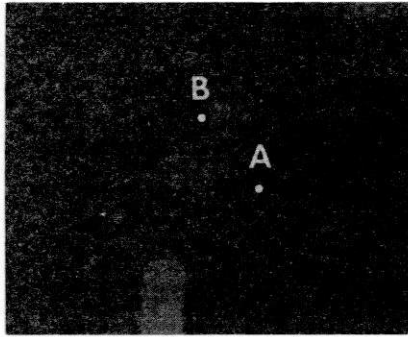
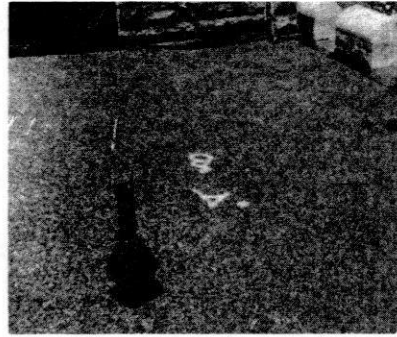
Figure 7. Sample areas A and B, Building 751.

thermal mottling on most of this roof was related to varying gravel thickness, but mottling was also observed in a few areas where the gravel thickness was uniform. Representative samples A and B (Fig. 7) contained only 2 and 3% water, respectively; therefore the thermal mottling was not considered moisture-related. Since both A and B had identical membrane thicknesses (3/8 in.), we expect that slight differences in the bitumen flood coat thickness caused the slight thermal mottling. Since the gravel and a portion of the flood coat are normally spudded off before coring, no measurements were obtained to verify this contention.

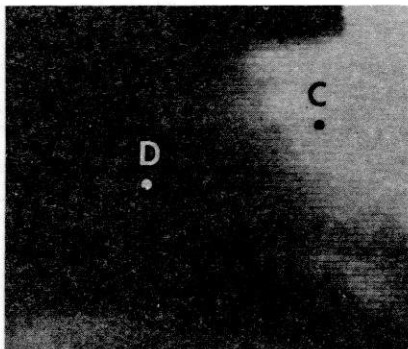
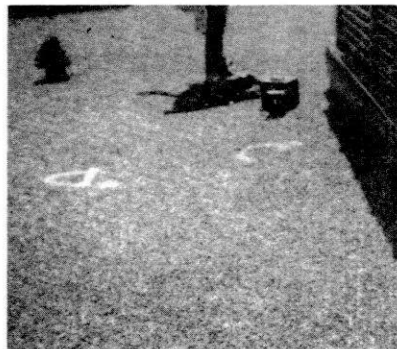
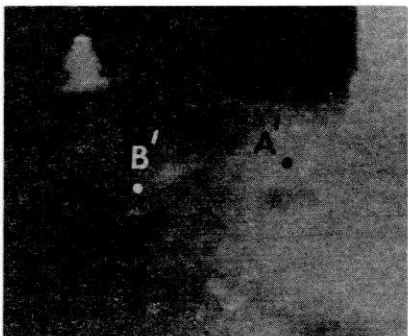
Figure 8. Sample areas C
and D, Building 751.

Figure 8 shows a bright thermal anomaly that appeared to be caused by

c. October 1979 thermogram.
Thermal anomaly seems to
have grown since May.

hot air blown onto the roof from the neighboring ventilator. But since we could not feel any movement of air from the ventilator, core samples C and D were taken; they contained only 2 and 3% water, respectively. A similar situation occurred in October except that the hot spot seemed to be somewhat larger and samples A' and B' again proved the hot spot to be dry.

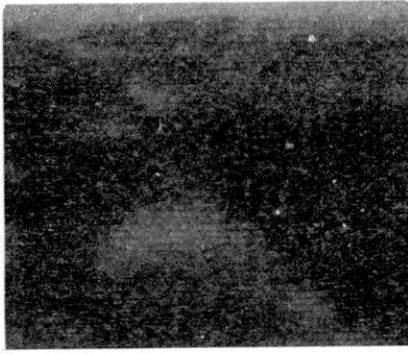
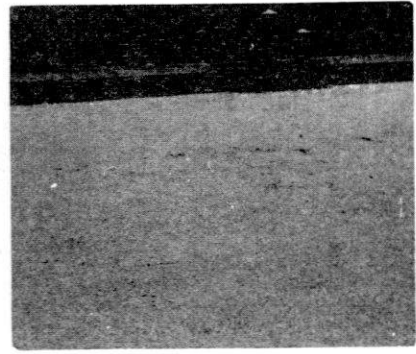
A plan view of the roof of Building 745A is shown in Figure 9. The thermal mottling, to which we had by now become accustomed, was present on this roof and could be attributed to varying gravel (or bitumen) thicknesses and not moisture. We did note that the mottling was somewhat fainter by the time we surveyed this roof. Figure 10 shows that the northern half of this roof was thermally brighter than the southern half, but that samples A and B taken from the southern and northern half, respectively, were dry. We were unable to gain access to the space below the roof but speculate that this thermal pattern was caused by room to room temperature differences.

a. May 1979 thermogram. We saw the same thermal image in October 1979.

Figure 10. Roof of Building 745A, showing thermal division, perhaps caused by rooms of different temperature below the roof.

Buildings 745A and 751 appear to have good roofs with no wet insulation present. No further action other than normal maintenance is recommended for these roofs.

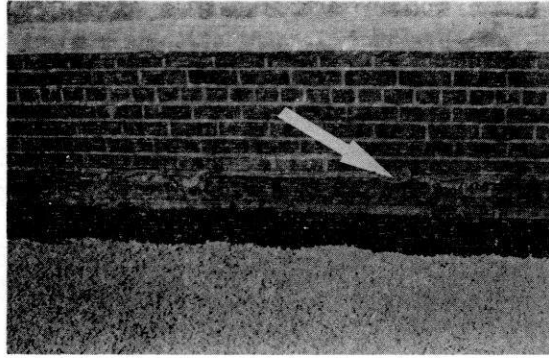
Several thermally bright areas were found on each wing. Core samples showed that they were areas of wet insulation. Most of this moisture can probably be traced to flashing problems. The counter-flashing shown in Figure 12 was not installed until six months after the roof membrane was finished. When the flashing was finally installed, the sealant and bond-breaker rod between the flashing and the wall began to fall out and had to

Figure 12. Parapet flashing that was not installed immediately after the roof was laid. Arrow shows the bond-breaker rod falling out of joint (May 1979 photograph).

be reinstalled in August 1979. This sequence of events and the infrared results suggest that water entered this roof there. Details are presented below.

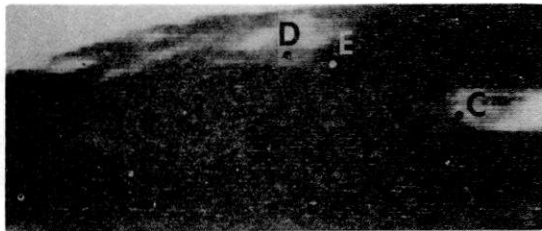
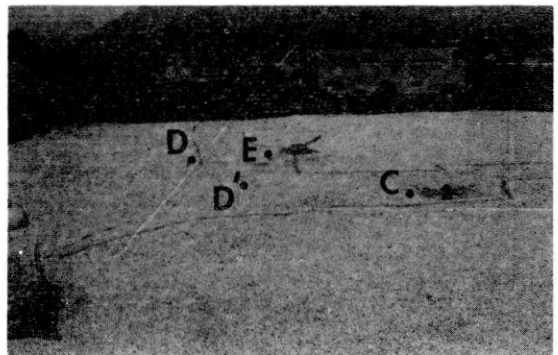
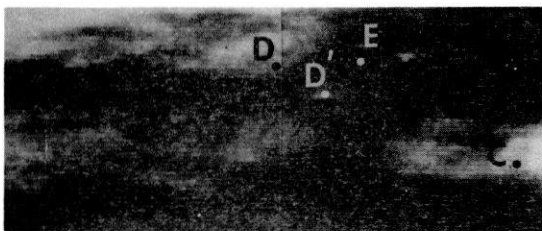
Figure 14. View of sample areas C, D, D' and E, Building 667A-west.

Figure 13 shows the boundaries of several well-defined bright areas detected in May. Samples A, C and D taken from those areas were quite wet. However, samples B and E, located outside the bright areas and assumed to be dry, also contained moisture (61 and 37%, respectively). Thus it became clear that a larger area was "wet." Tobiasson and Ricard (1979) show that these moisture contents mean approximate losses in insulating value of 25% and 10%, respectively. Normally we would have had to return to this roof and resurvey it, but since a second survey was planned for October we waited until then.

By October the bright areas had grown to include points B and E. However, Figures 14 and 15 show that they were not of uniform brightness, which indicates varying water contents. Confirmation of this came from sample A', taken from a dark area near point A, and sample D', taken from a bright area near point E. Sample A' contained 8% water and D' contained 118% water.

b. October 1979 photograph. Dashed paint line is extent of wet area found in May. Solid line is October.

Building 667A-west had areas of wet insulation around the penthouse and the northwest corner. The thermal efficiency of the insulation in these areas ranged from 65% of its dry R-value to less than 30% of its dry R-value. We recommended that the insulation and membrane in these areas be removed and replaced under the terms of the warranty. A third area on 667A-west, although not as thermally poor as the above, also contained moisture. The insulation should also be replaced in that area.

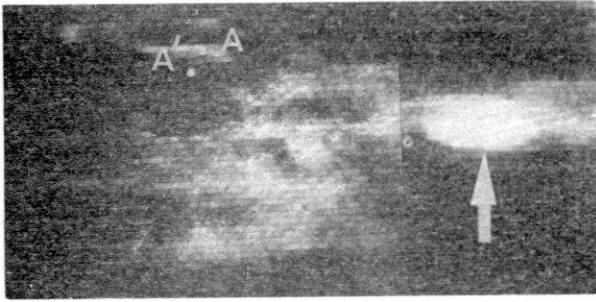
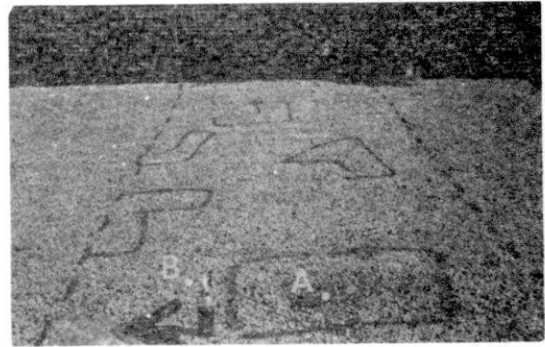
Figure 15. View of sample areas A, A' and B', Building 667A-west.

a. October 1979 thermogram. Arrow points to drain.

b. October 1979 photograph. The solid lines depict wet areas found in May and dashed lines are October boundaries.

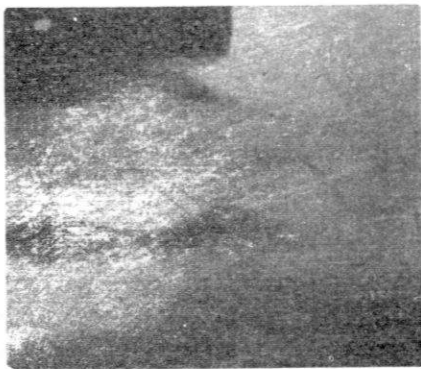
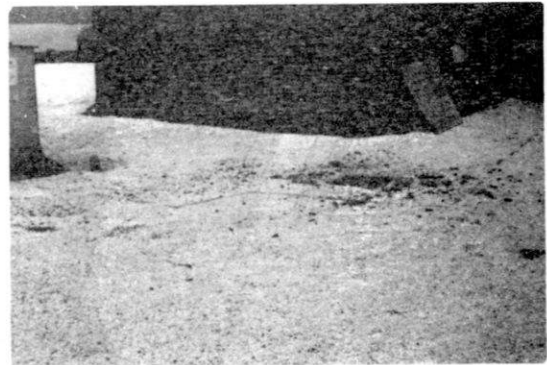
Figure 16. Wet areas surrounding penthouse on Building 667A-west.

Figure 16 shows a very bright thermal anomaly surrounding the penthouse in October. Within this area sample C' contained 285% water. We did not detect a thermal anomaly there in May.

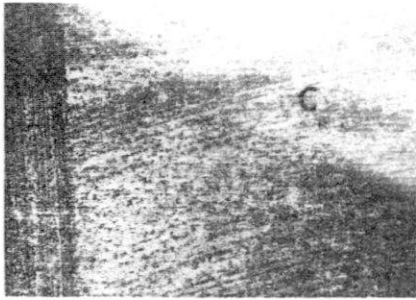
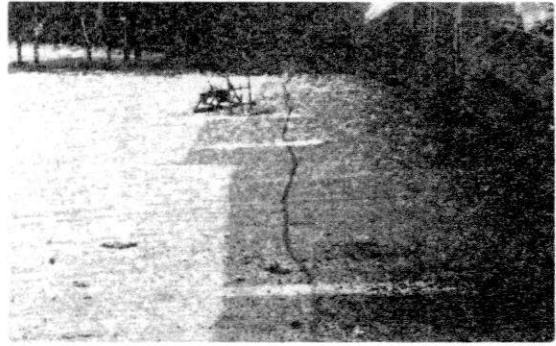
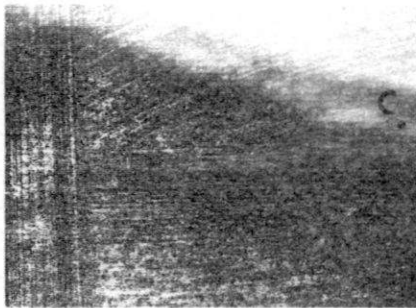
A plan view of this area (Fig. 17) shows two wet areas. Two thermograms and one photograph are shown in Figure 18 of the wet area bordering the southeast parapet. No appreciable change was detected in the shape or size of either wet area between the May and October surveys, suggesting that repairs to the counterflashings have been successful in preventing further wetting of this roof. Core samples indicate that little or no drying has taken place.

Figure 18. View of wet area along southeast parapet wall, Building 667A-east.

The roof on Building 667A-east had two areas of wet insulation. These areas along the southeast parapet wall and around the penthouse should be replaced under terms of the warranty.

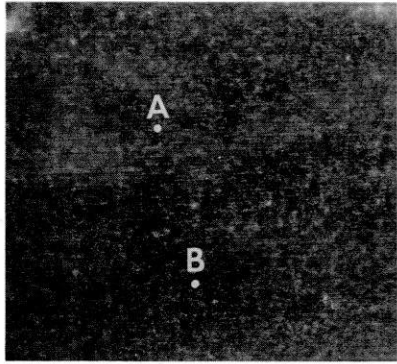
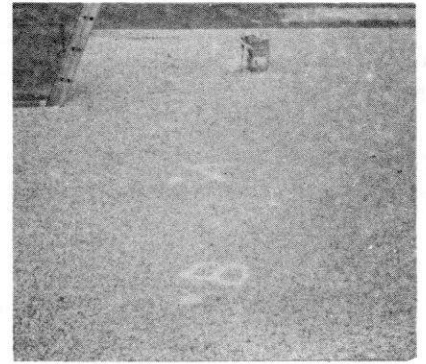
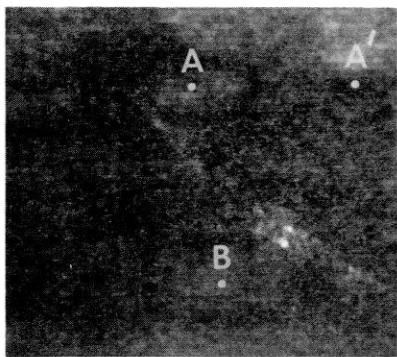
Figure 20. View of sample areas A, A', B and B', Motor Pool Garage.

A plan view of the roof of the Motor Pool Garage is shown in Figure 19. Thermally this roof was mottled during both the May and November surveys (Fig. 20). Samples A and B taken in May and samples A' and B' taken in November were dry, which convinced us that this mottling was not moisture-related. The bright areas in the Figure 20 thermograms correspond to areas of thicker gravel. Since all core samples were dry and no other thermal anomalies were detected, we feel that this roof contains no wet insulation.

The two roofs we were able to survey at Grenier Field appeared to be in good condition; no wet insulation was found. No further action other than normal maintenance is recommended there.

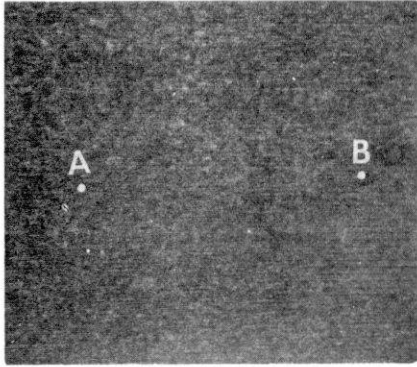
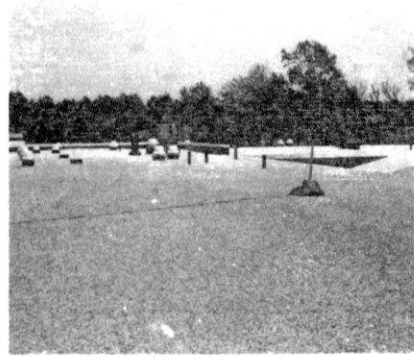
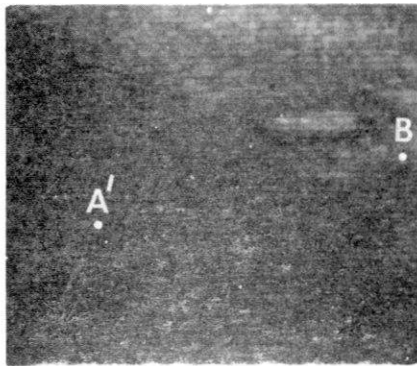
Figure 22. View of sample areas A, and B, Main Building. (The dark lines and circles in a and c are spray-painted markings for identifying the boundaries.)

Figure 22 shows a portion of a bright strip that ran down the center of this roof. The gravel, membrane and insulation thicknesses were the same for samples A and B taken in May 1979 and A' and B' taken on November 1979. Visually, the roof surface appeared to be uniform in this area. It is likely that the bitumen flood coat was heavier on this strip, thereby causing it to appear brighter, but no measurements were obtained to verify this explanation.

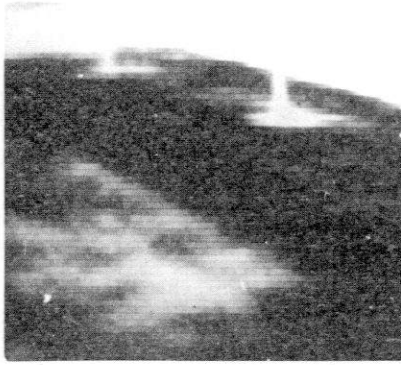
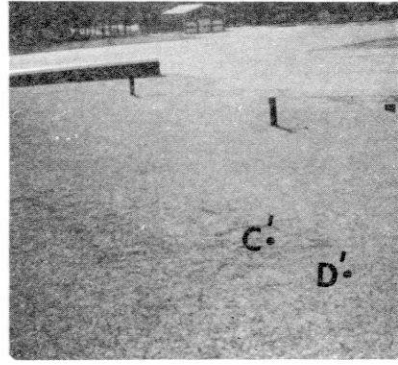
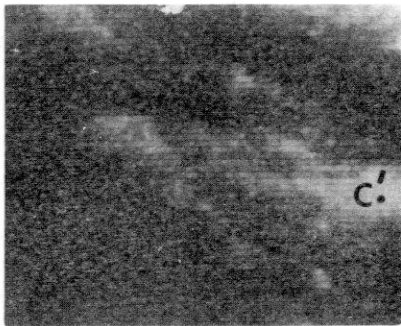
Figure 23. View of sample areas C' and D', Main Building.

The Figure 23 thermograms show an area of roof that was thermally brighter in May than in November. Such a thermal change could indicate a change in moisture content in the insulation. However, core samples C' and D' showed the insulation to be dry and the built-up membrane to be of uniform thickness. By scraping the gravel, we determined that the bright area had a thicker gravel cover. Thus the extra solar heat stored in this thicker gravel caused it to appear brighter to the infrared camera.

Since all samples on this roof were dry and no other indications of moisture were detected, we feel that the Main Building contains no wet roof insulation.
