Special Report 86-35

Roof blisters

Physical Fitness Building, Fort Lee, Virginia

Charles Korhonen and John Bayer

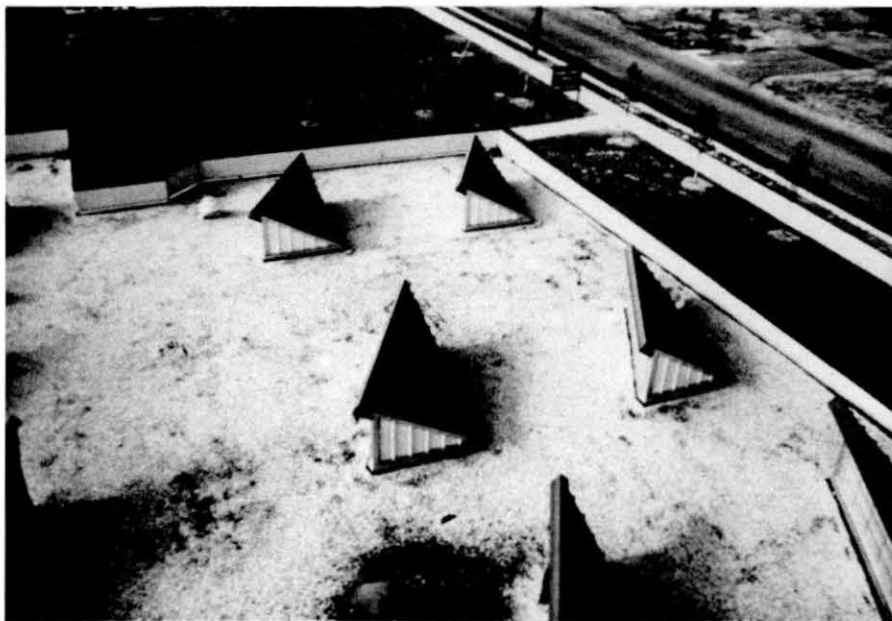
The manager of the warehouse section indicated that roof Level C leaked after every rain. Water stains on the concrete floor were shown as evidence of these leaks. The stains, of which we saw three, coincided quite well with roof skylights (Fig. 2), indicating that either the skylights were improperly flashed to the roof or that some of the many joints on the skylights were faulty. No roof leaks were reported for the other three roof levels.

After interviewing the building occupants and examining the interior of the building, we examined all four roof levels in detail. On Level C, no obvious joint defects were noted on the three "leaky" skylights, which left flashing flaws as a probable cause of the reported leaks.

Figure 2. Skylights on roof level C.

Particular attention was directed toward the roof areas near the "leaky" skylights on Level C. Comparing thermal images of areas near skylights that did not leak with those of the suspect skylights failed to reveal any signs of wet insulation. Therefore, it does not appear that the flashings are faulty. But if leaks persist, water testing of each skylight

is recommended, as joint defects too small to see could still be the cause of the problems.

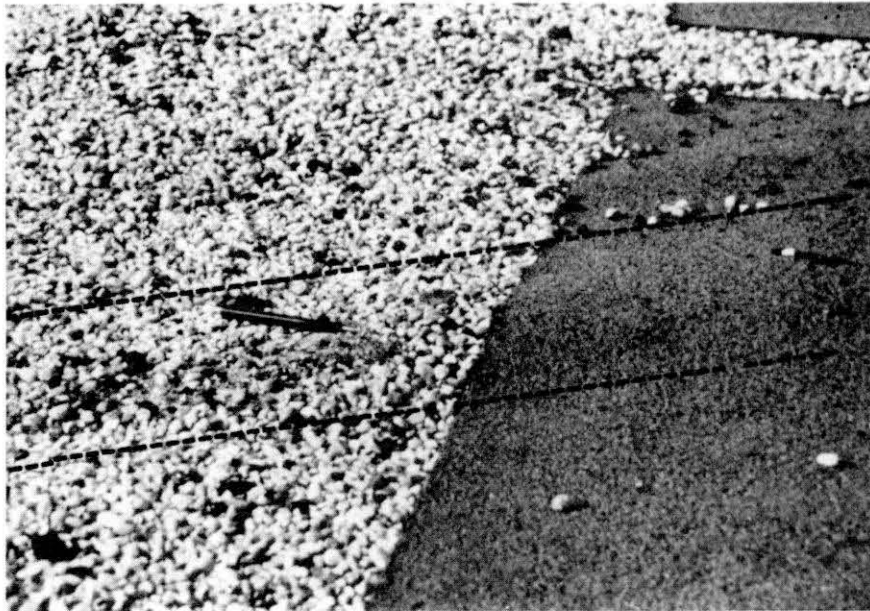
Figure 3. This blister (dotted line) extends past the edge of the walkway tread, indicating that it is a membrane blister.

Levels A and D contain the most blisters, while the largest blisters are on Level B under the walkway treads between the rows of solar collectors. In these situations, blistering often occurs between the built-up membrane and the tread, which presents no problem to the roof other than in appearance. However, several blisters extended past the edge of the tread (Fig. 3), indicating blistering of a more serious nature. The difference in size between these "walkway blisters" and the other blisters on the roof illustrates the value of a reflective roof surface in slowing down blister growth. The relatively dark walkway surface absorbs more solar heat and becomes hotter, causing blisters to grow faster than those covered by the lighter-colored gravel. These large blisters, in a foot traffic area, are quite vulnerable to damage.

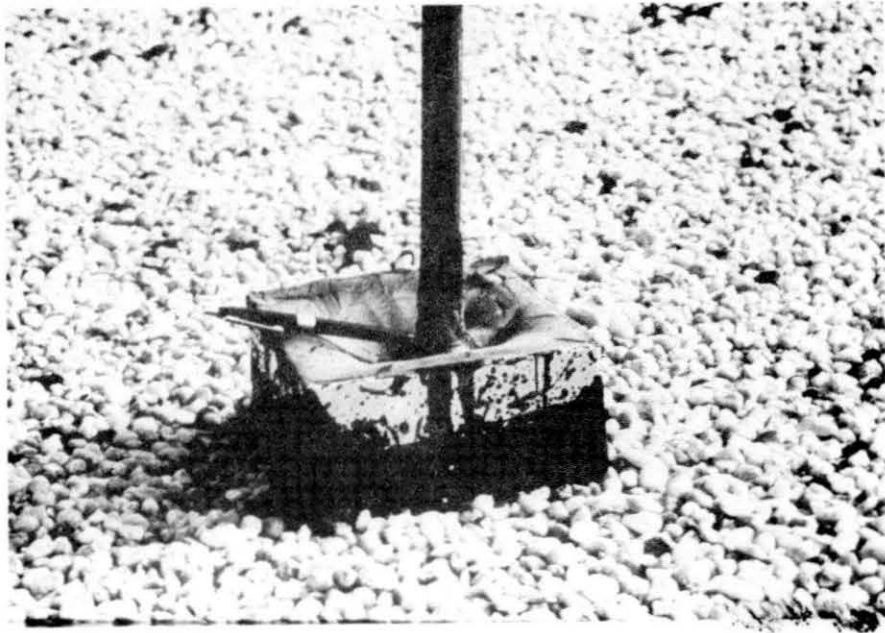
Figure 4. Pitch pocket in need of filling.

A few other roof items in need of immediate attention were also noticed during our examination. Nearly all the pitch pockets are in need of filling (Fig. 4). In their present condition water can be funnelled into the roof should cracks develop in the bitumen. On several of the roof drains the baskets were clogged with leaves (Fig. 5). These should be cleaned to prevent ponding of water. None of the access doors onto the

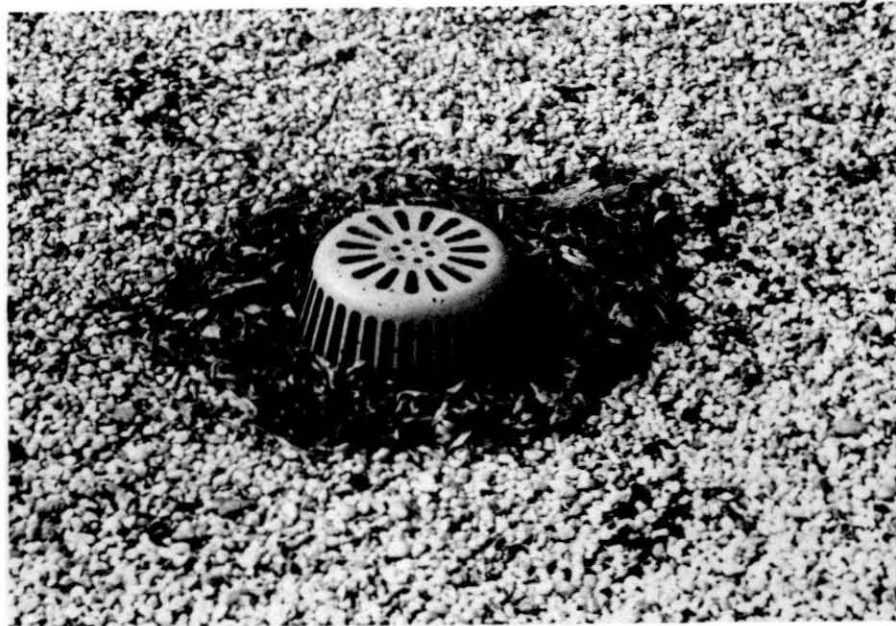
Figure 5. Debris-clogged drain.

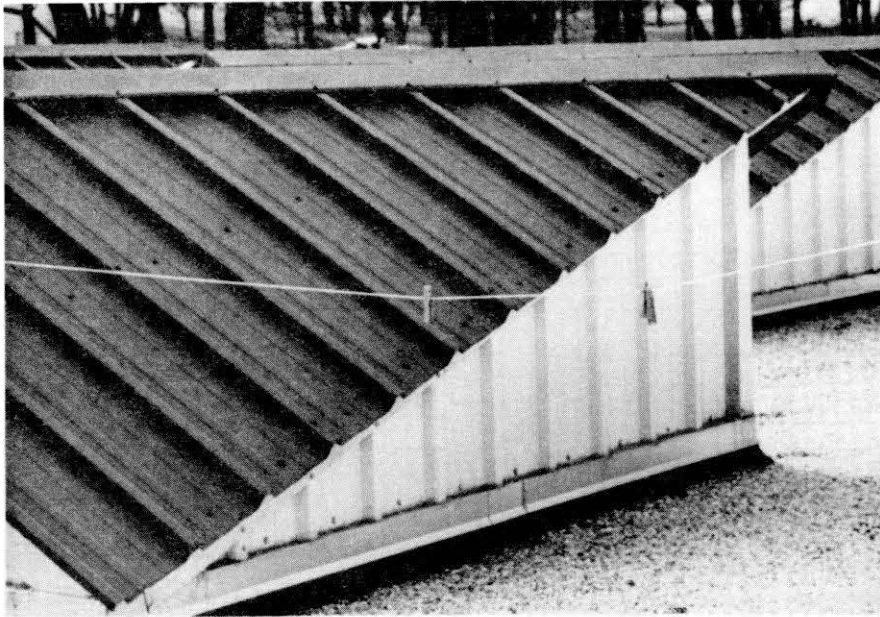
Figure 6. Clothesline strung between two skylights.

roof levels was locked. This invites unauthorized foot traffic, as evidenced by a clothesline (Fig. 6) on Level A, and increases the likelihood of damaged blisters and roof leaks. We had to patch one blister that had been previously broken near the clothesline. The doors should be locked to prevent further damage.

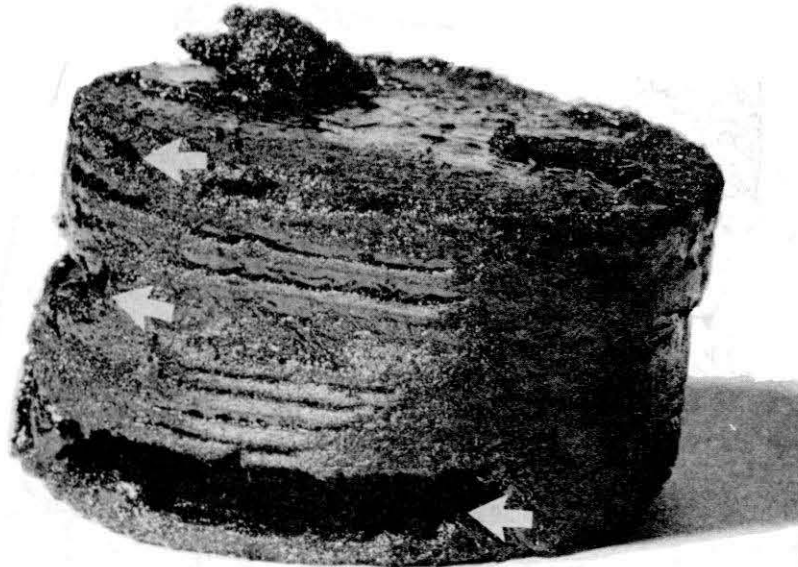
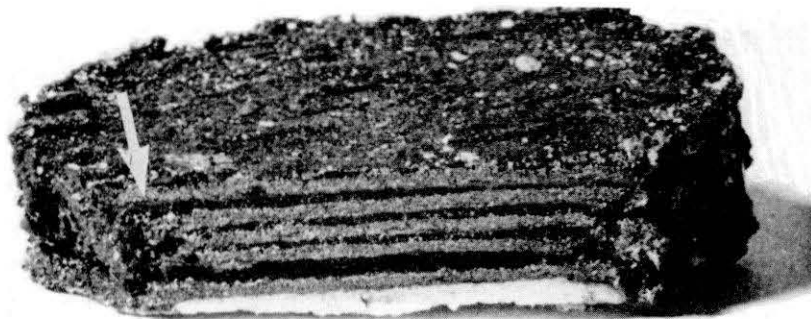
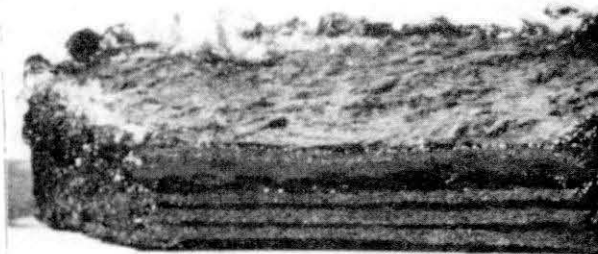
We are convinced that the many voids within the membrane samples were built in during construction. A close examination of each membrane sample cross-section in Figures 7 through 10 reveals not only the thinness of the interply moppings but also numerous voids within the moppings. Some of these voids were caused by entrapped particles (Fig. 11), but the majority were caused by a lack of interply adhesion. Breaking the samples apart revealed that the felt on either side of each of these voids contained some bitumen but not enough to bond one felt to another. Obviously, in these cases, the bitumen had been mopped on too thinly.* It is voids such as these that are the seeds of blisters.

Figure 7. Closeup of Level A membrane samples.
(Arrows show voids.)

sample A and likewise required extra protection. The extra felts in themselves are no problem but Figures 7a and 9a show voids within their interply moppings that most likely will lead to future blisters. If other such voids exist within this roof they will also lead to a future crop of blisters.

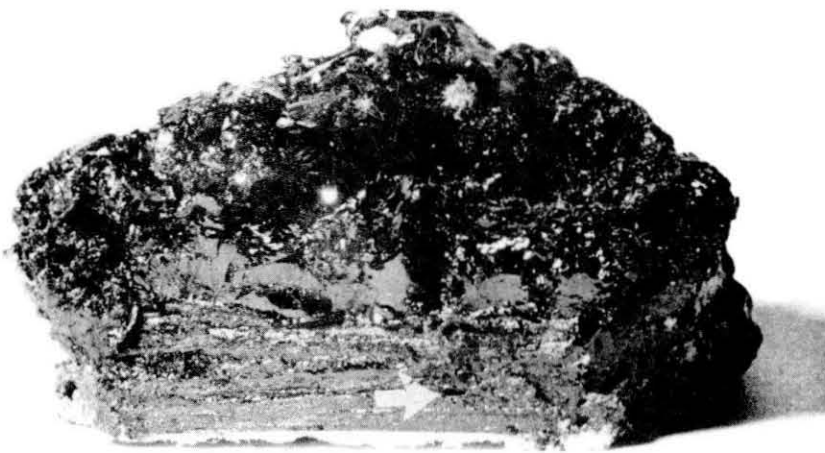
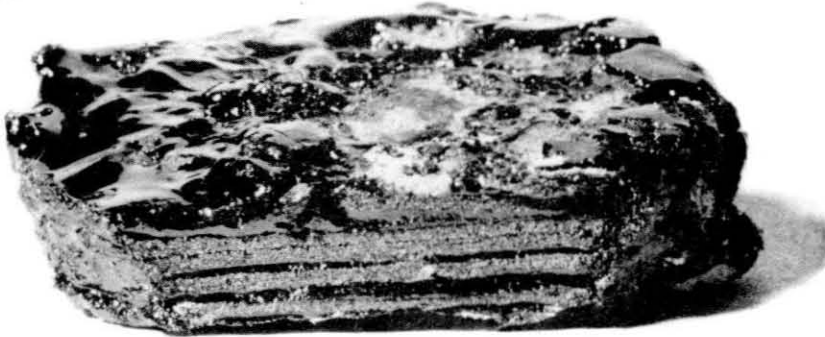
Figure 8. Closeup of Level B membrane samples. (Arrow shows void.)

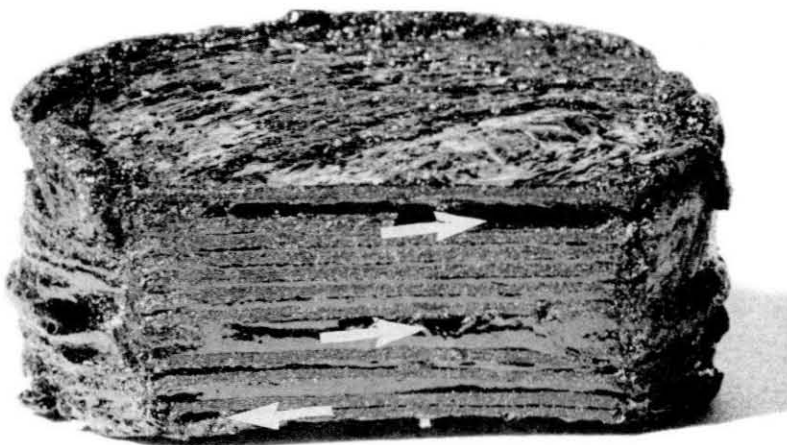
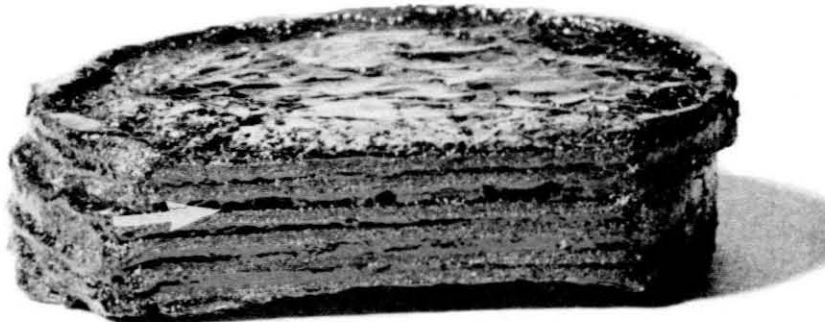
Figure 9. Closeup of Level C membrane samples. (Arrows show voids.)

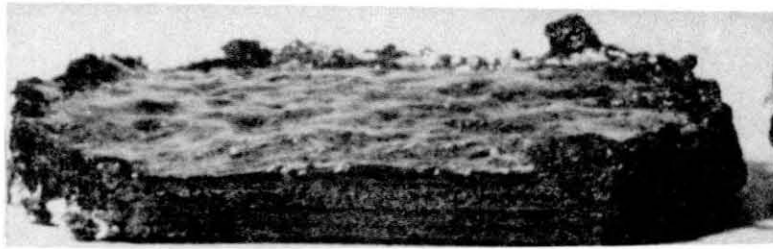
Figure 10. Closeup of Level D membrane sample taken from a blister.

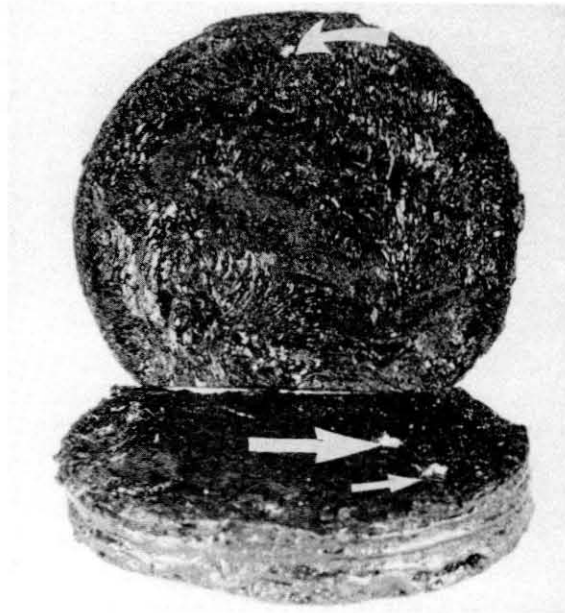
Figure 11. Particles of urethane insulation (arrows) entrapped within the plies of this membrane sample.

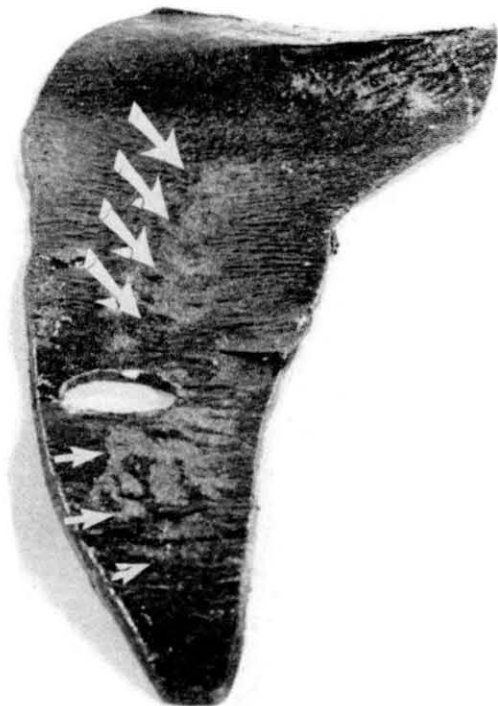
Figure 12. Arrows point to areas with insufficient bitumen coating. (A 2-in.-diameter sample was removed.)

frequently occur at that location because hot bitumen usually bubbles and froths when mopped onto the facer during construction. Blisters then start from the numerous little air voids that are trapped beneath the felts as they are laid during construction. Generally this problem can be avoided by placing a thin layer of air-permeable insulation between the urethane and the built-up membrane. However, no bitumen bubbling was evident within the blisters we opened, which indicated that this was not a problem during construction. The evidence we saw suggested that each blister was caused by voids due to a thin, non-uniform bitumen mopping and not to entrapped air bubbles. For example, Figure 12 shows that the underside of one Level D blister was smooth but not completely bitumen-coated. The same was true for the other two blisters. This lack of bitumen moppings is considered to be the cause of these blisters, which corroborates the core sample findings previously discussed.

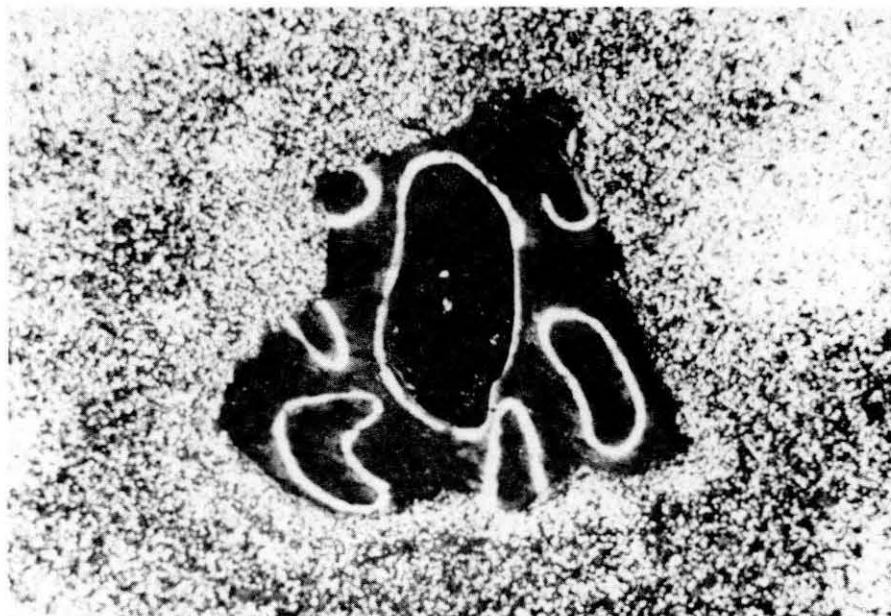
Surrounding each blister several smaller blisters were noted (Fig. 13). This indicates that the many voids seen within the core samples are widespread and are developing into blisters.

Figure 13. Numerous smaller blisters were seen once the gravel was removed.
