Effects of Variable Tire Pressure on Road Surfacing

Volume I: Design, Construction, Behavior Under Traffic, and Test Results

by *Robert W. Grau*
Geotechnical Laboratory

Technical Report GL-93-20
August 1993

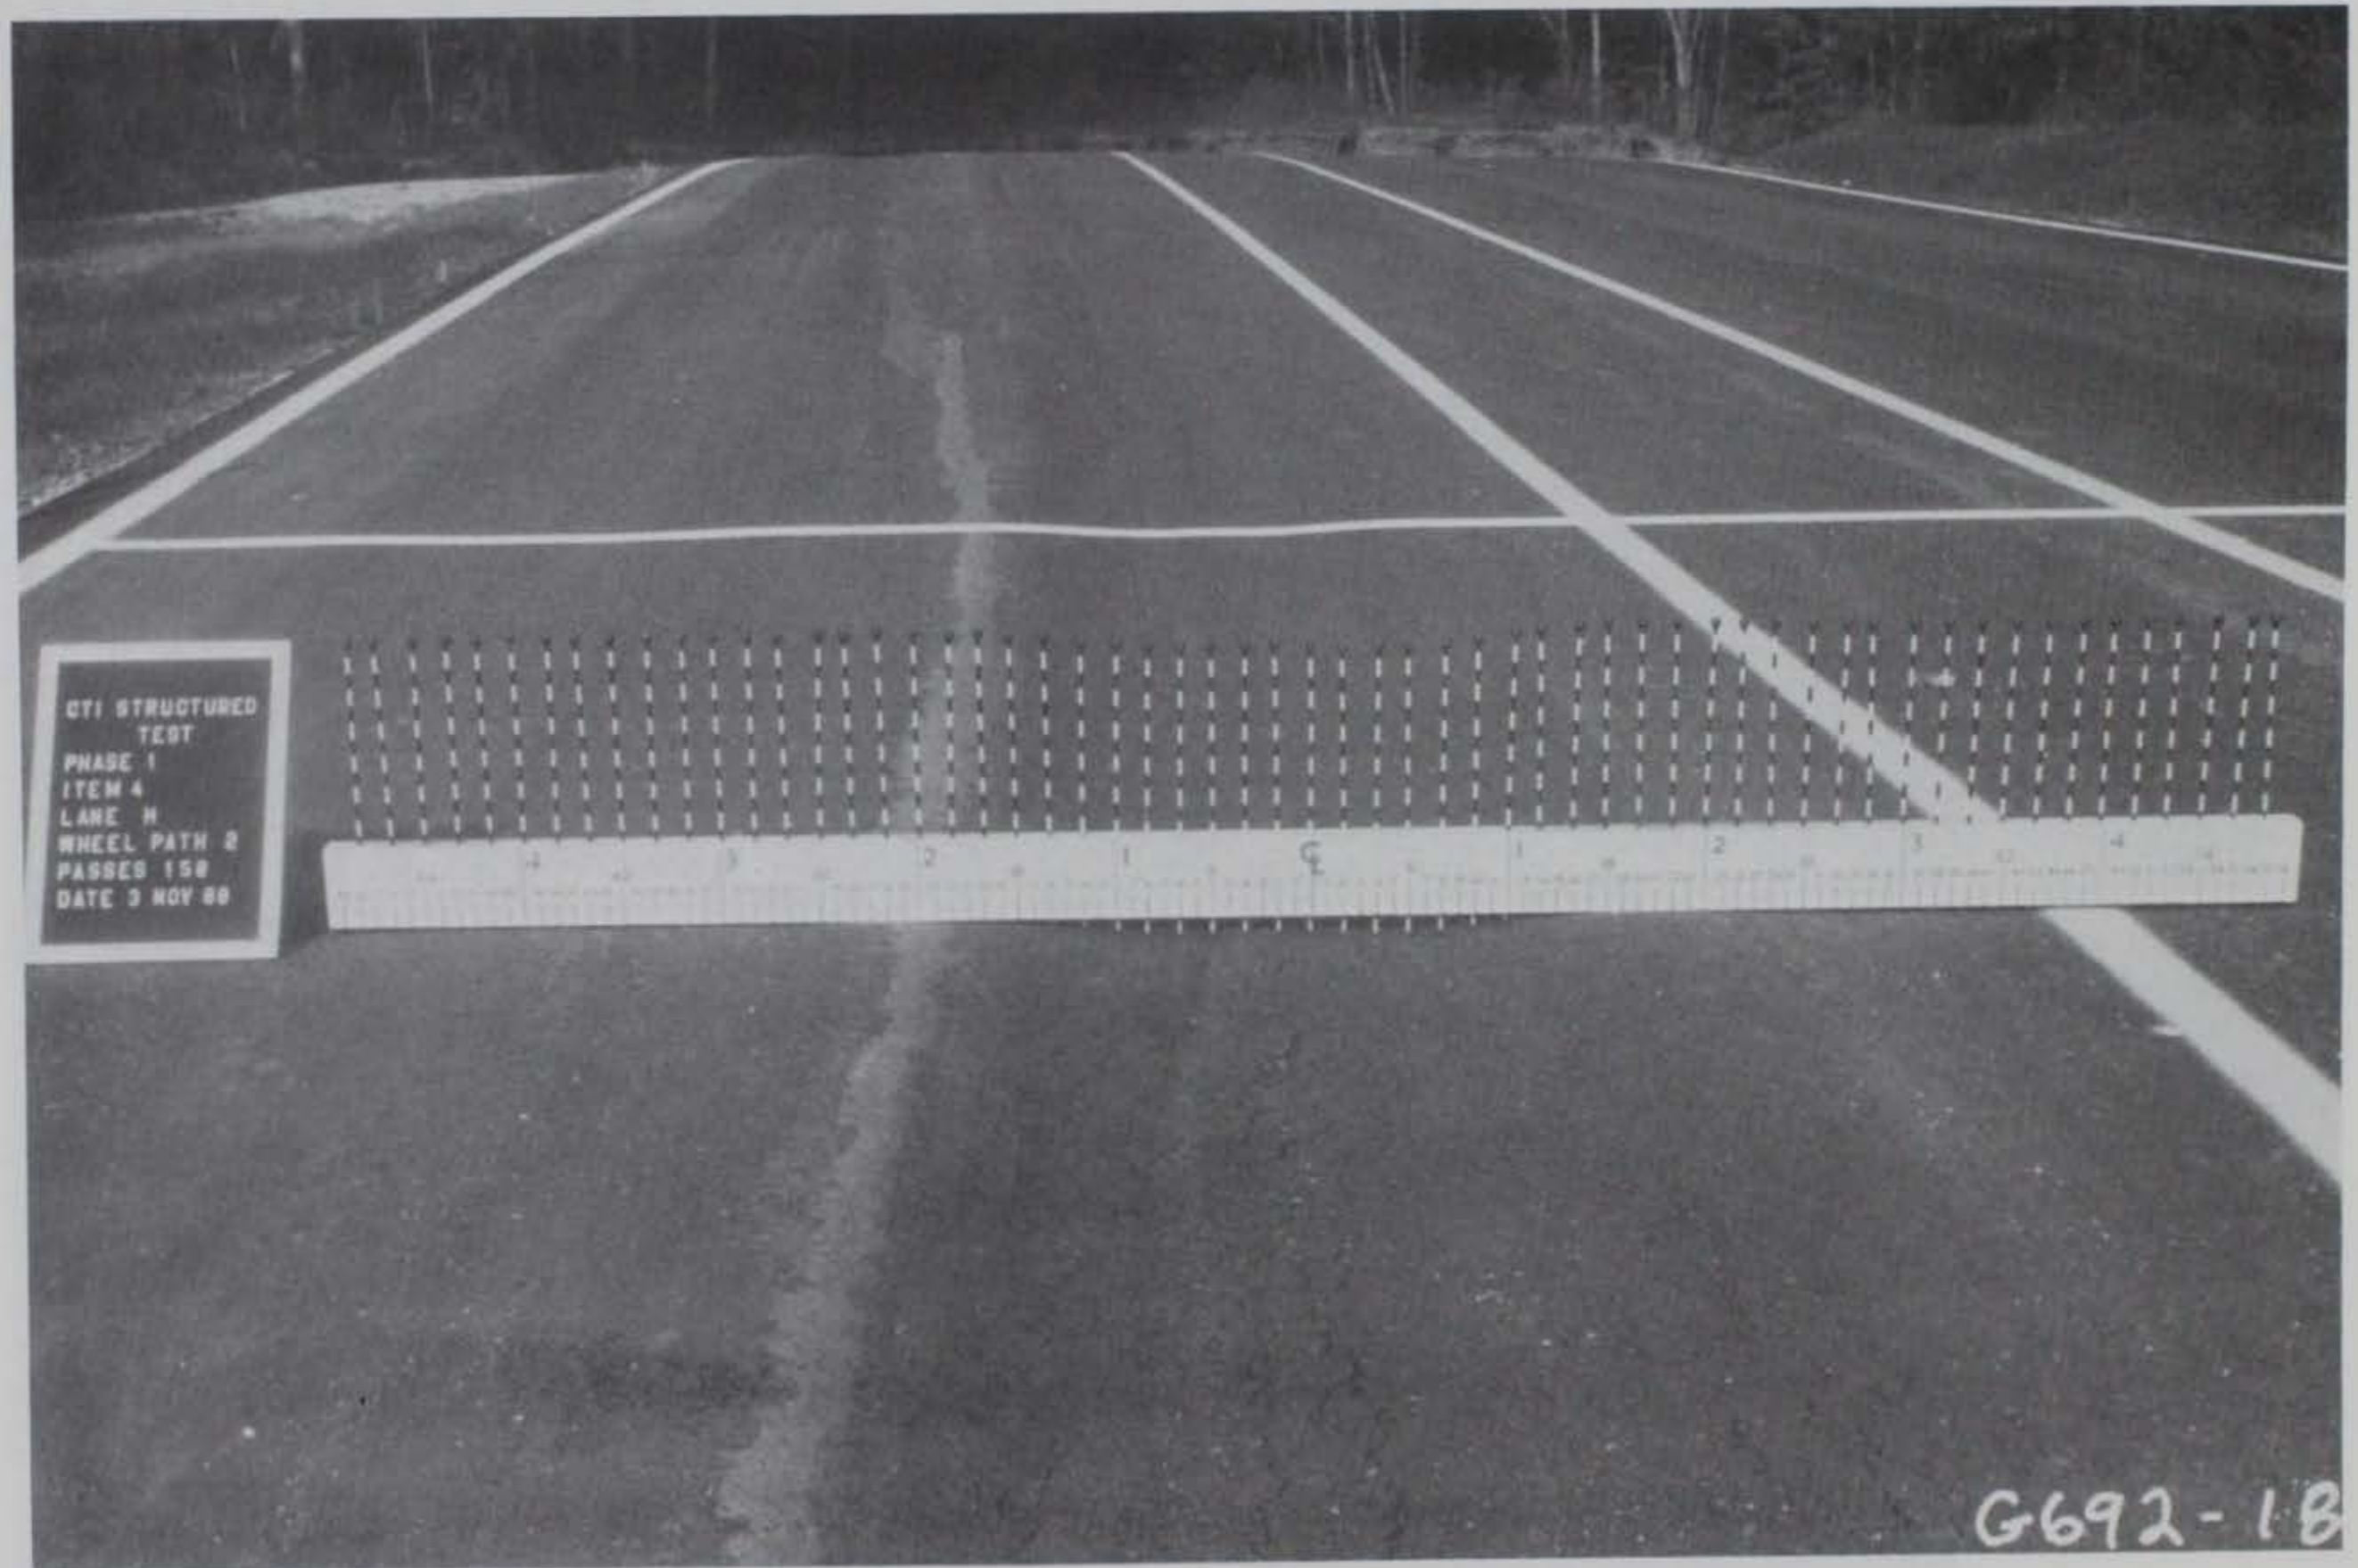
Photo 13. Item 4, wheel path 2, general view of initial failure, 158 passes

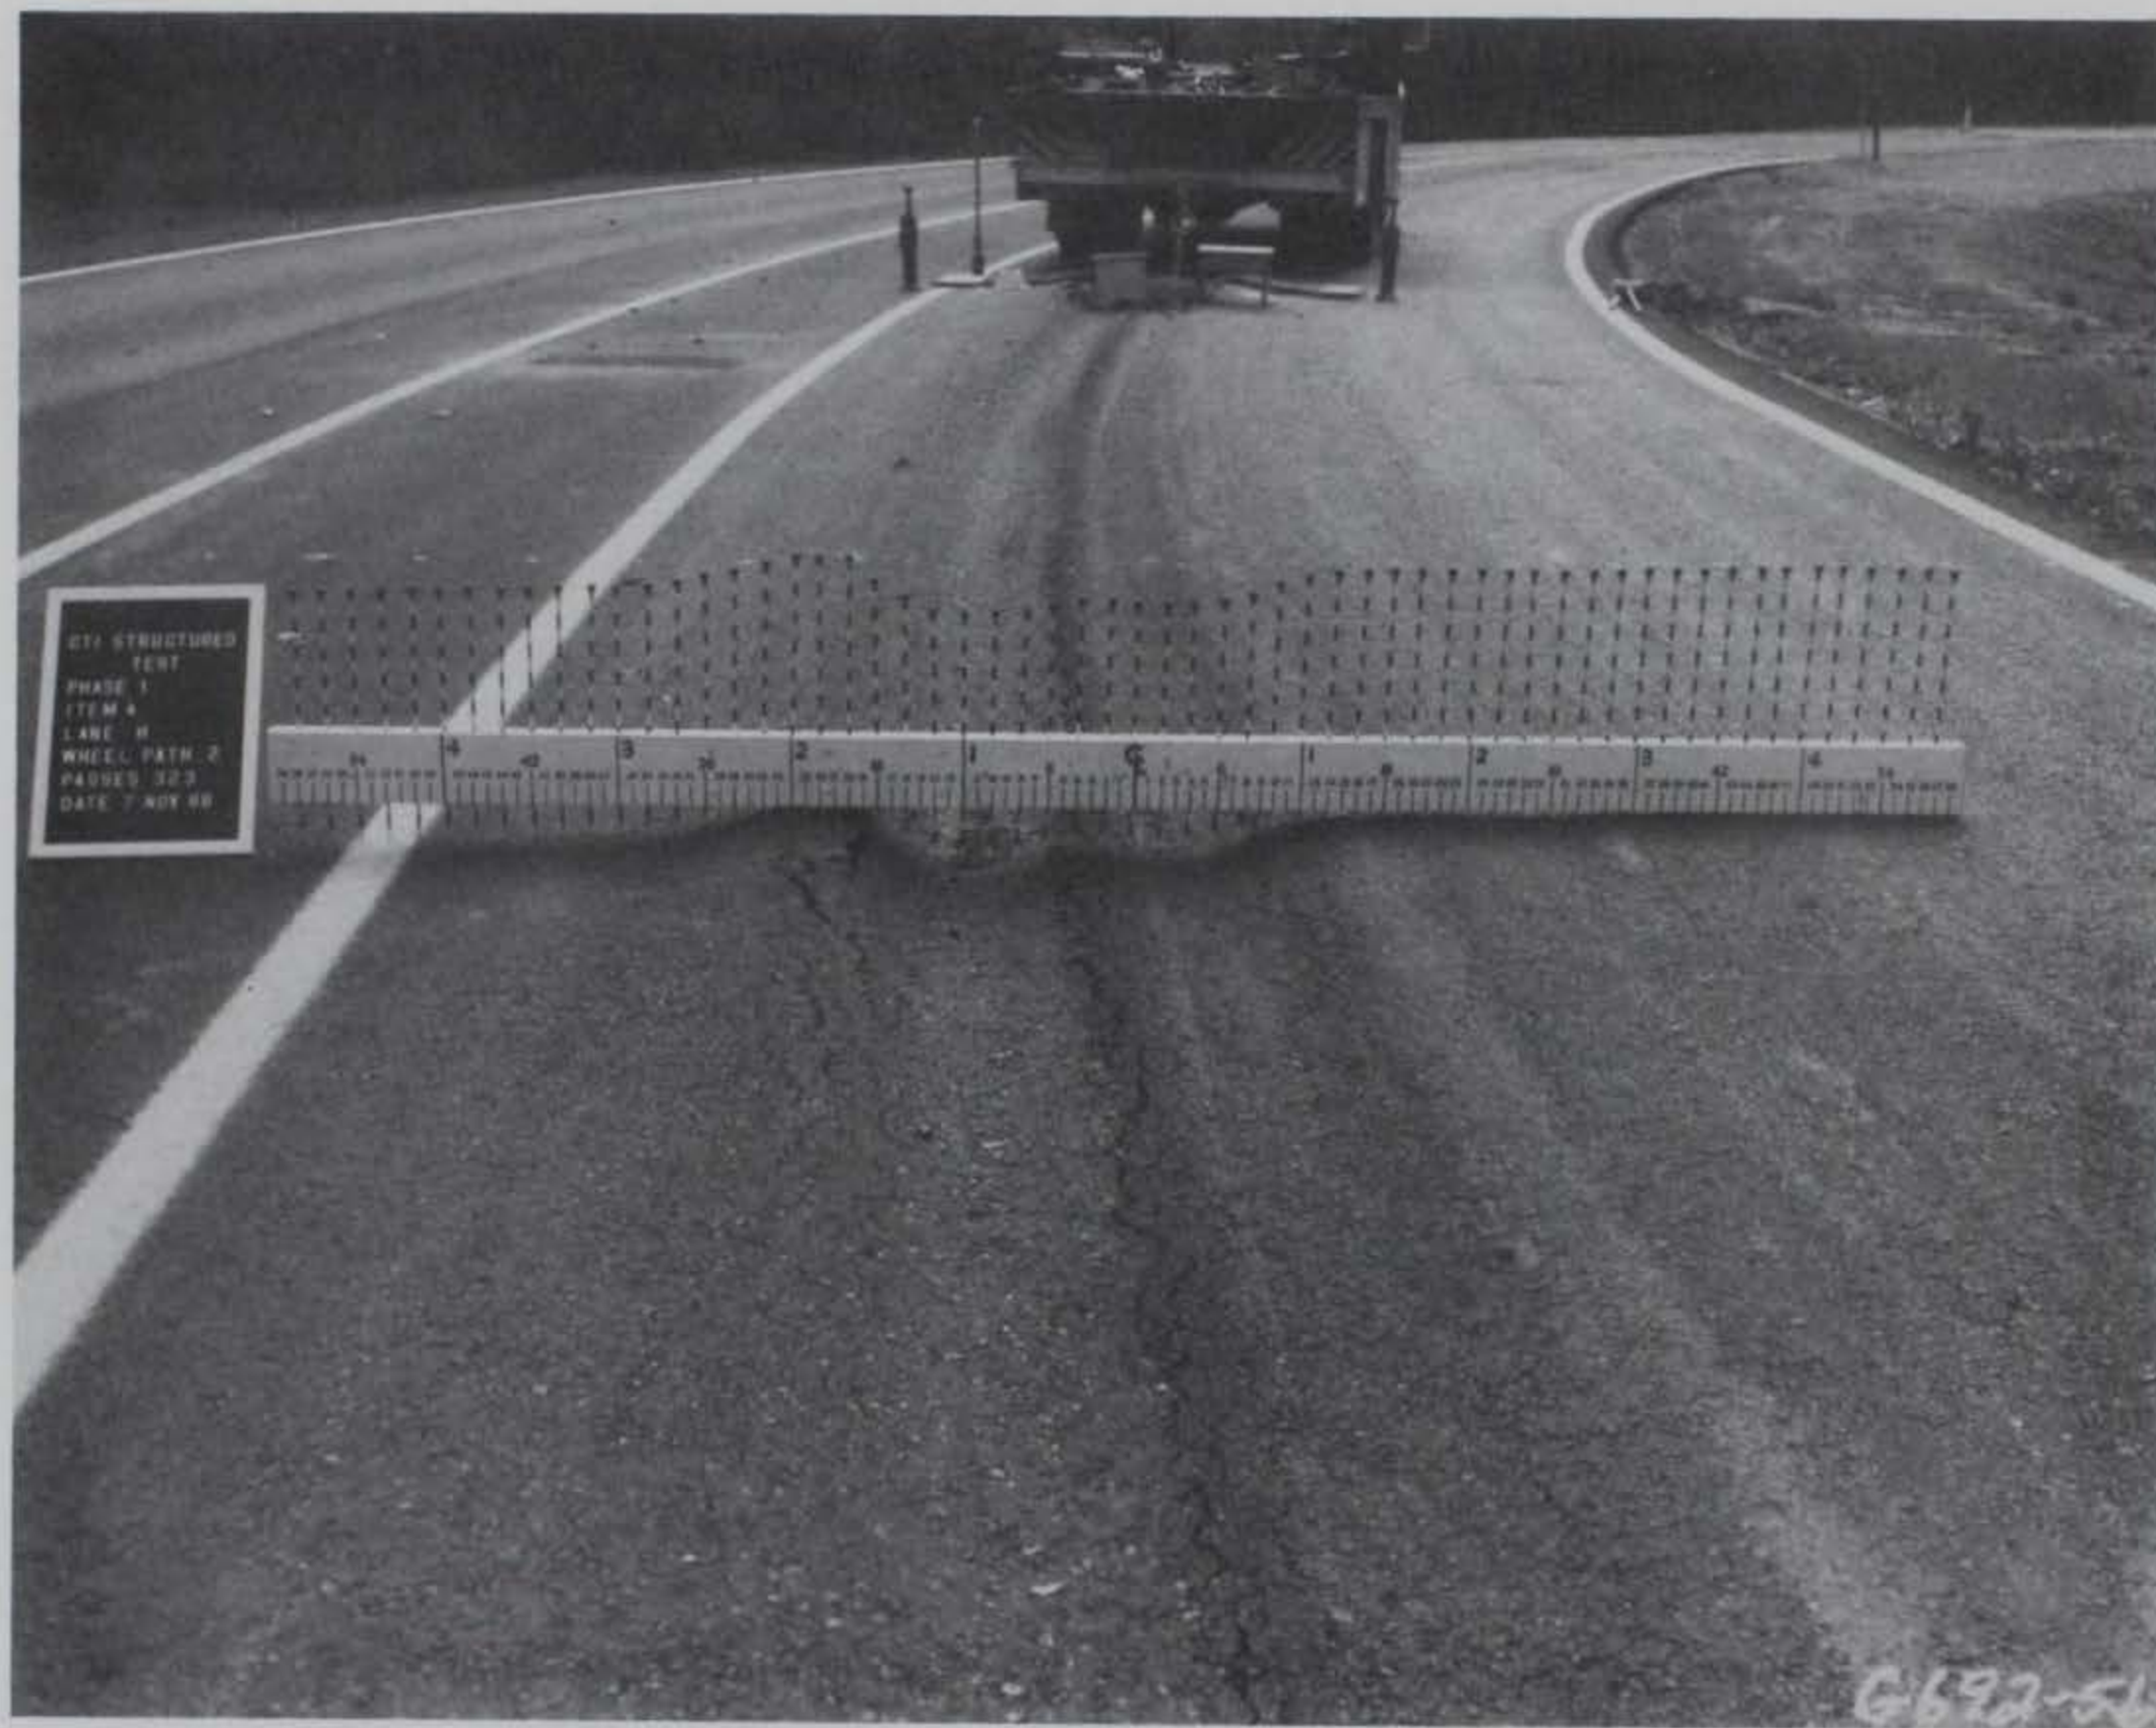
Photo 14. Item 4, wheel path 2, general view of second failure, 323 passes

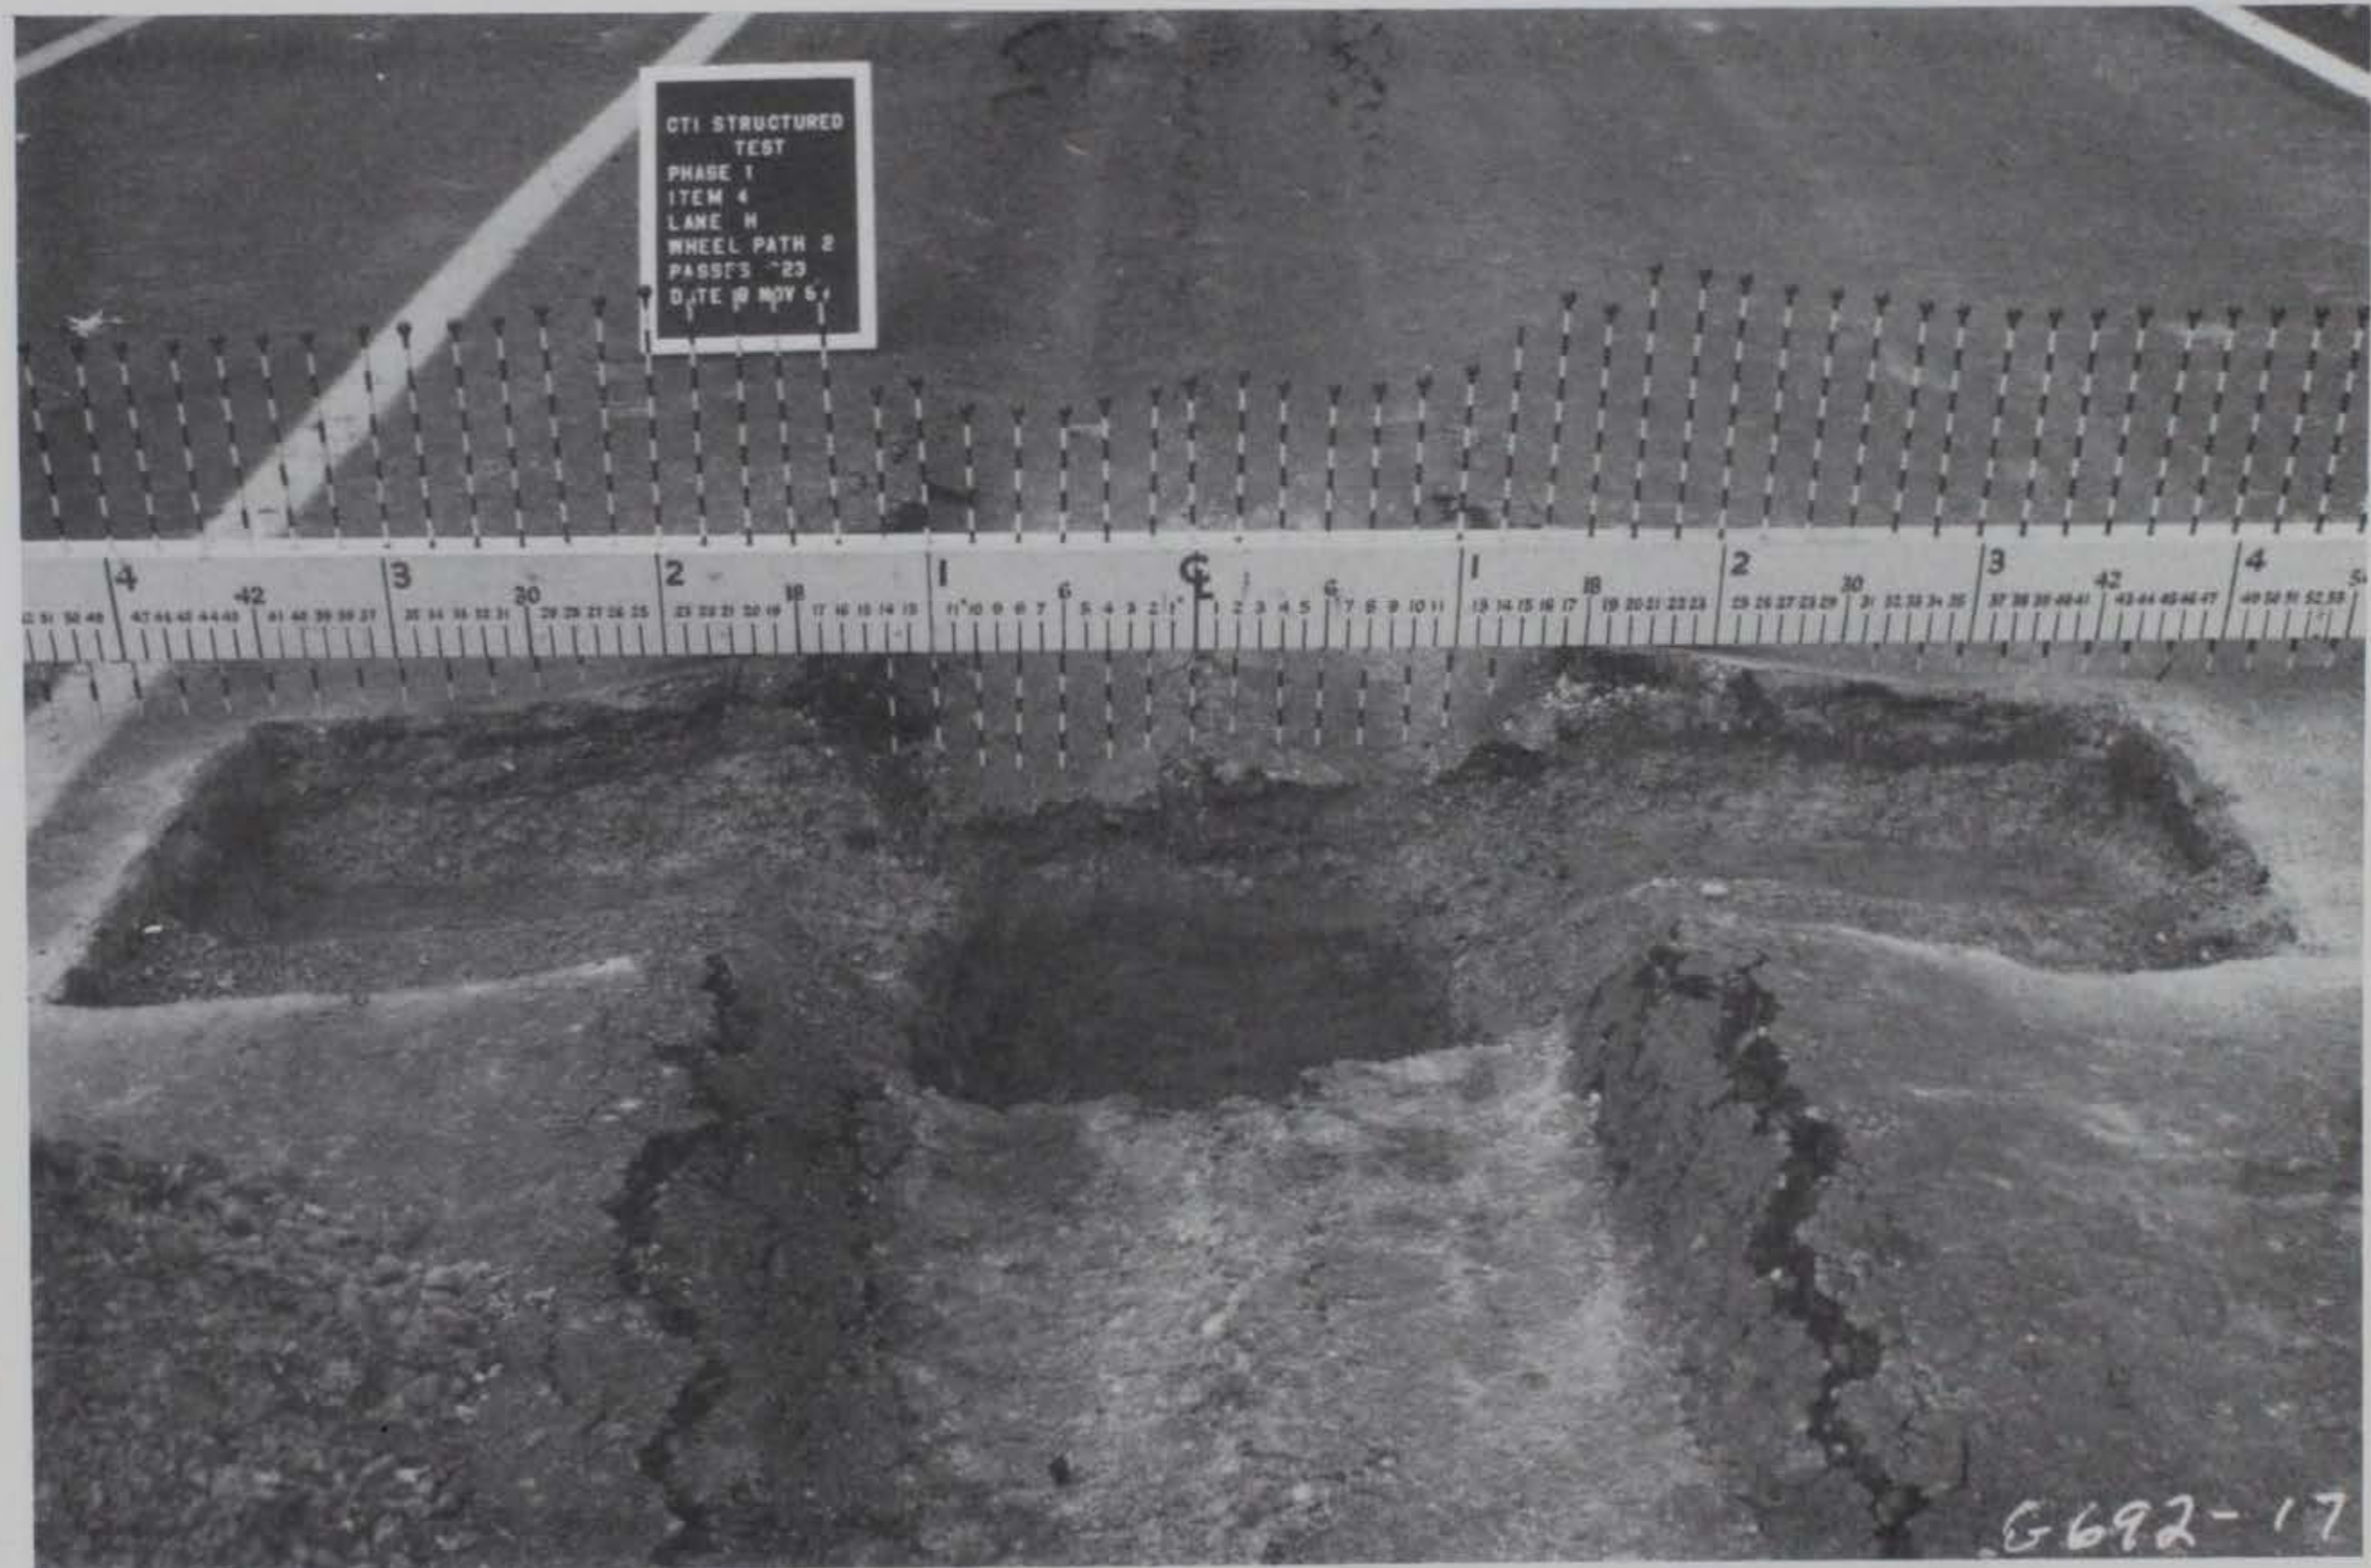
Rod and level readings were made of each of the investigation trenches so that pit profiles such as that shown in Figure 15 for the test pit excavated in item 4 after 323 passes can be plotted. These data are in the XSECT directory. A view of the test pit excavated in item 4 is shown in Photo 15. CBR test results, layer thicknesses, and other pertinent data for all failures are presented in Table 3. The layer thicknesses presented in Table 3 were determined from rod and level readings taken as each layer was removed. Severe shear deformation developed in the base and subgrade materials of all failures except the failure in item 10. Shear deformation was also indicated by the loss of strength of the subgrade material at failure as compared to the before traffic strengths. The average as-constructed strengths of the subgrade material for items 4, 5, and 6 were 10, 12, and 13 CBR, respectively, as compared to 7.5, 5, and 6 CBR at failure. The base material strengths in items 4 and 5 were low after construction and at failure. The strengths before traffic averaged 23 CBR and at failure 22 CBR. The base course in item 6 had a strength of 24 CBR before traffic and 49 CBR at failure. The failure in the high pressure lane of Item 10 was attributed to severe shoving of the AC. The average respective strengths of the base and subgrade materials after construction were 39 and 21 CBR, while those after failure were 21 and 16 CBR.

Photo 15. Item 4, wheel path 2, test trench after 323 passes

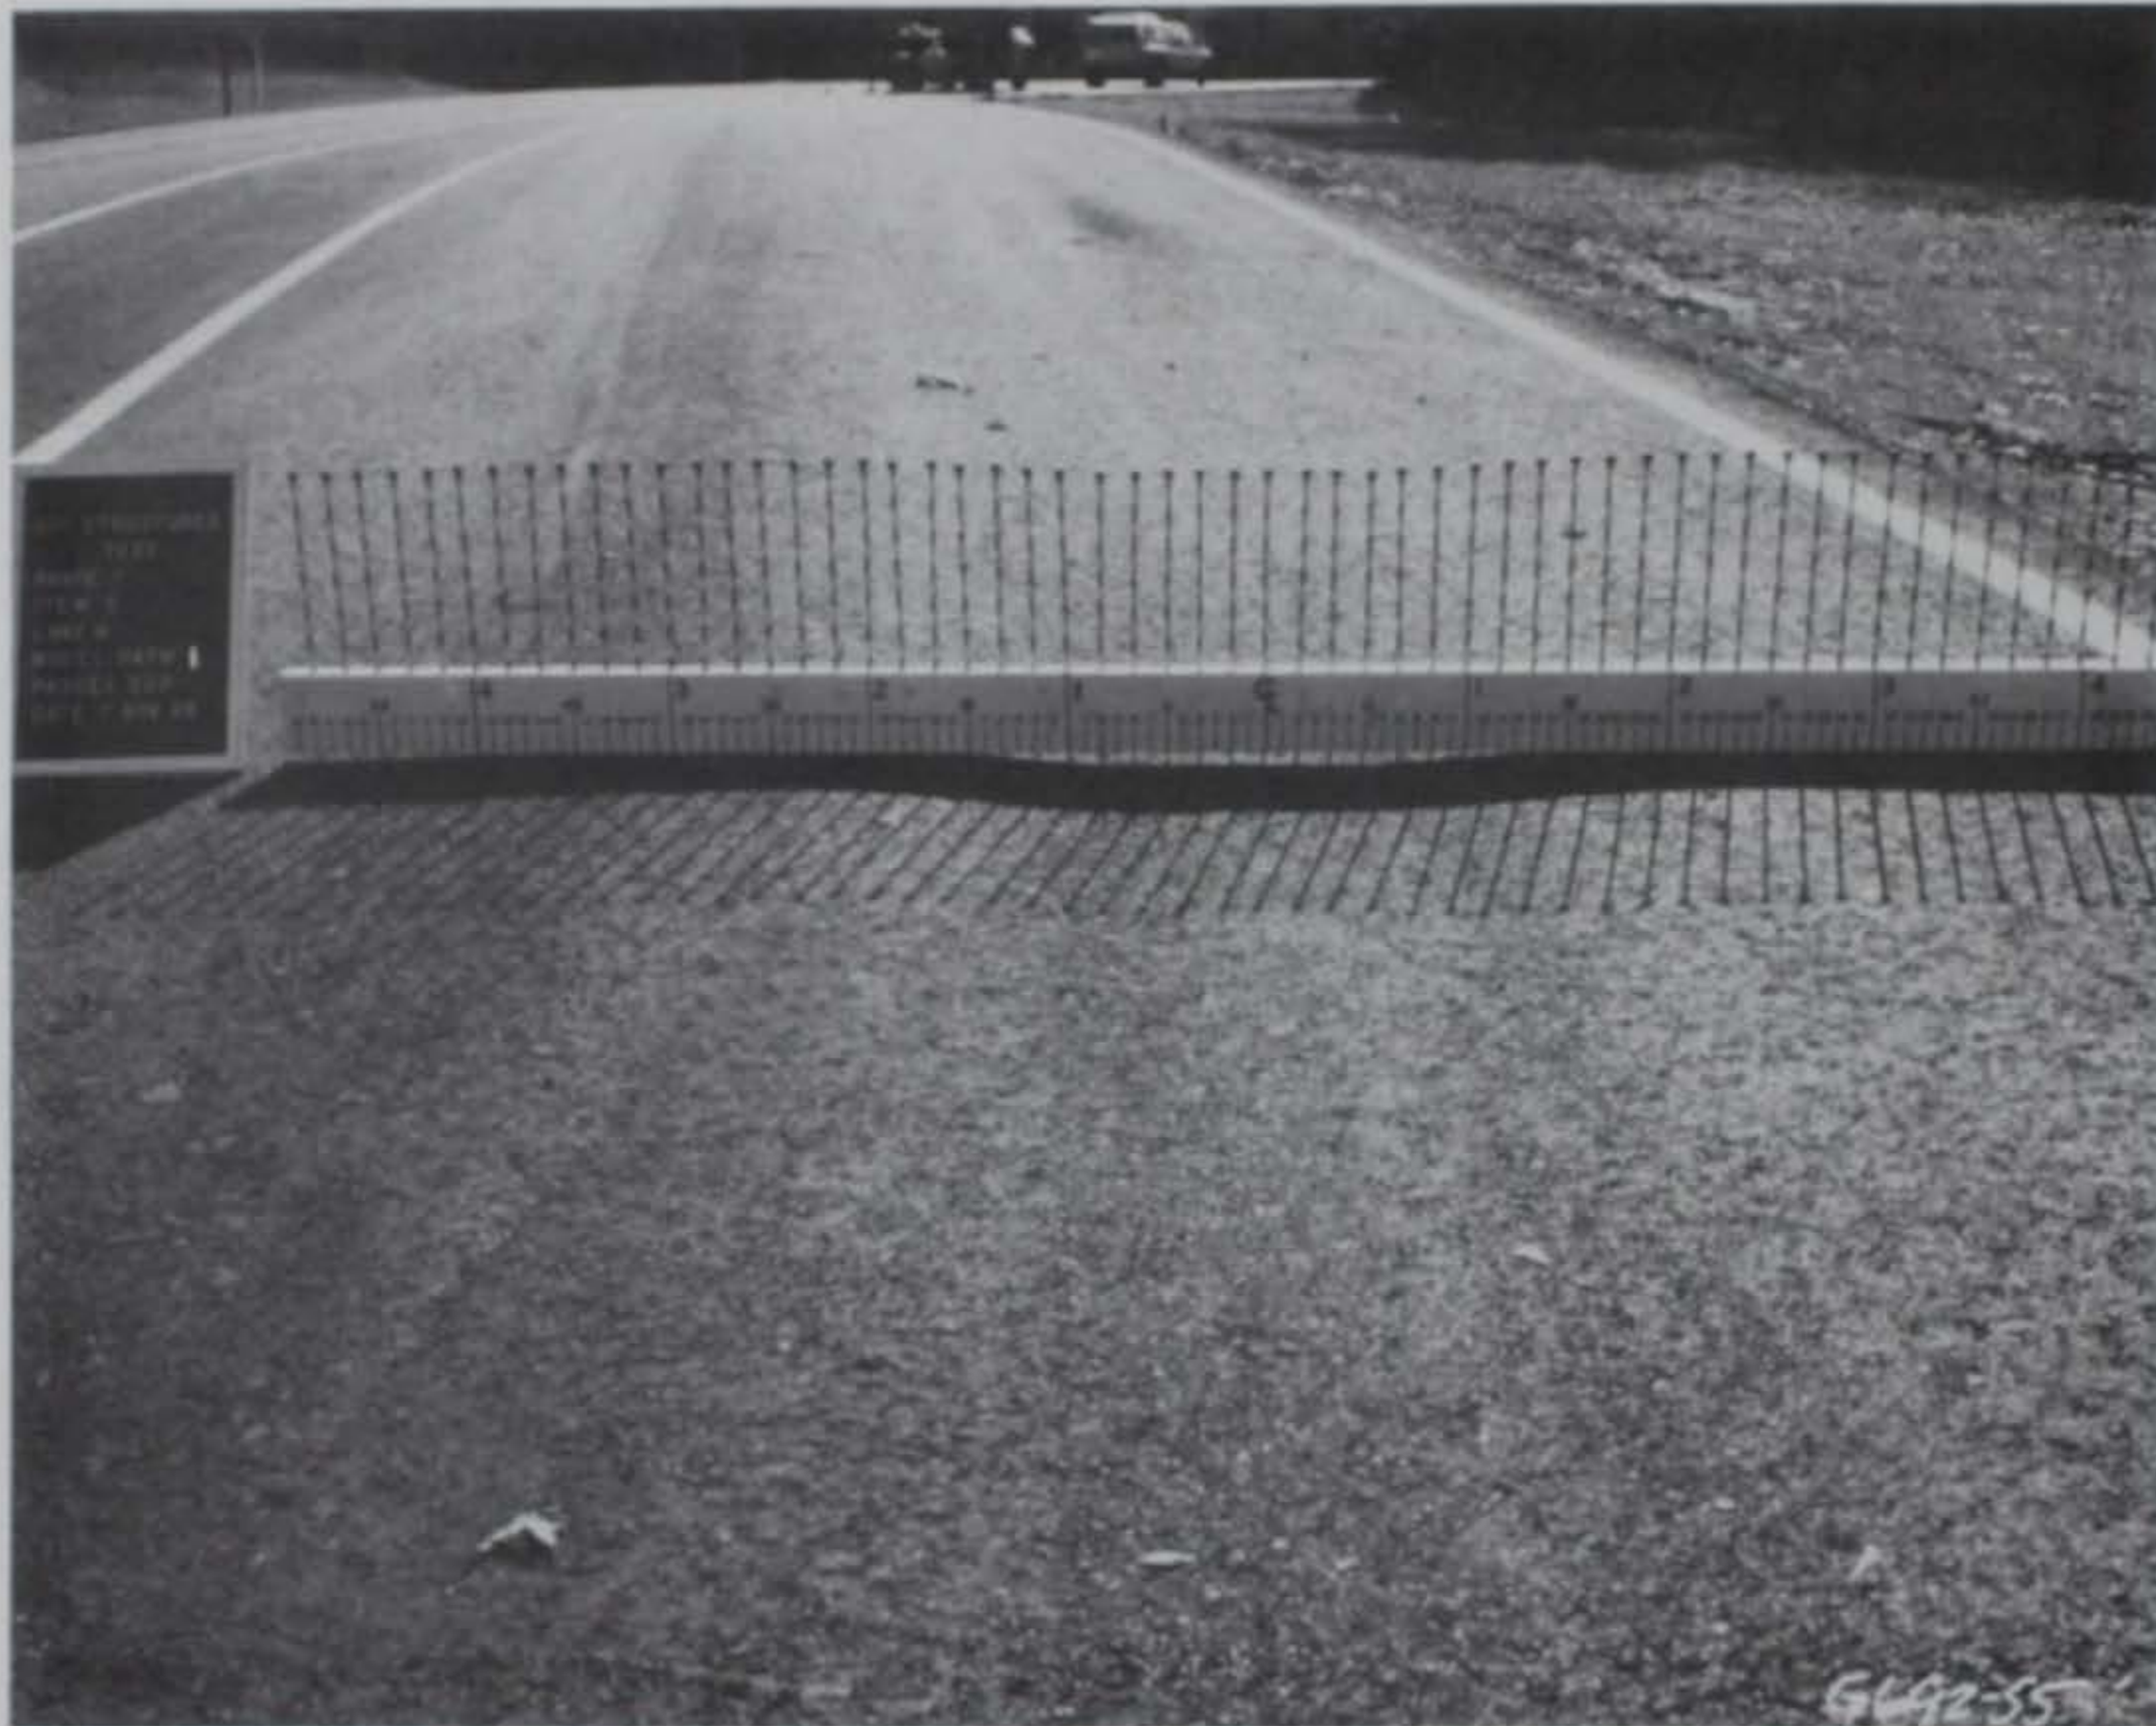
Photo 16. Item 5, high-tire pressure lane, maximum 1-in. rutting after 323 passes

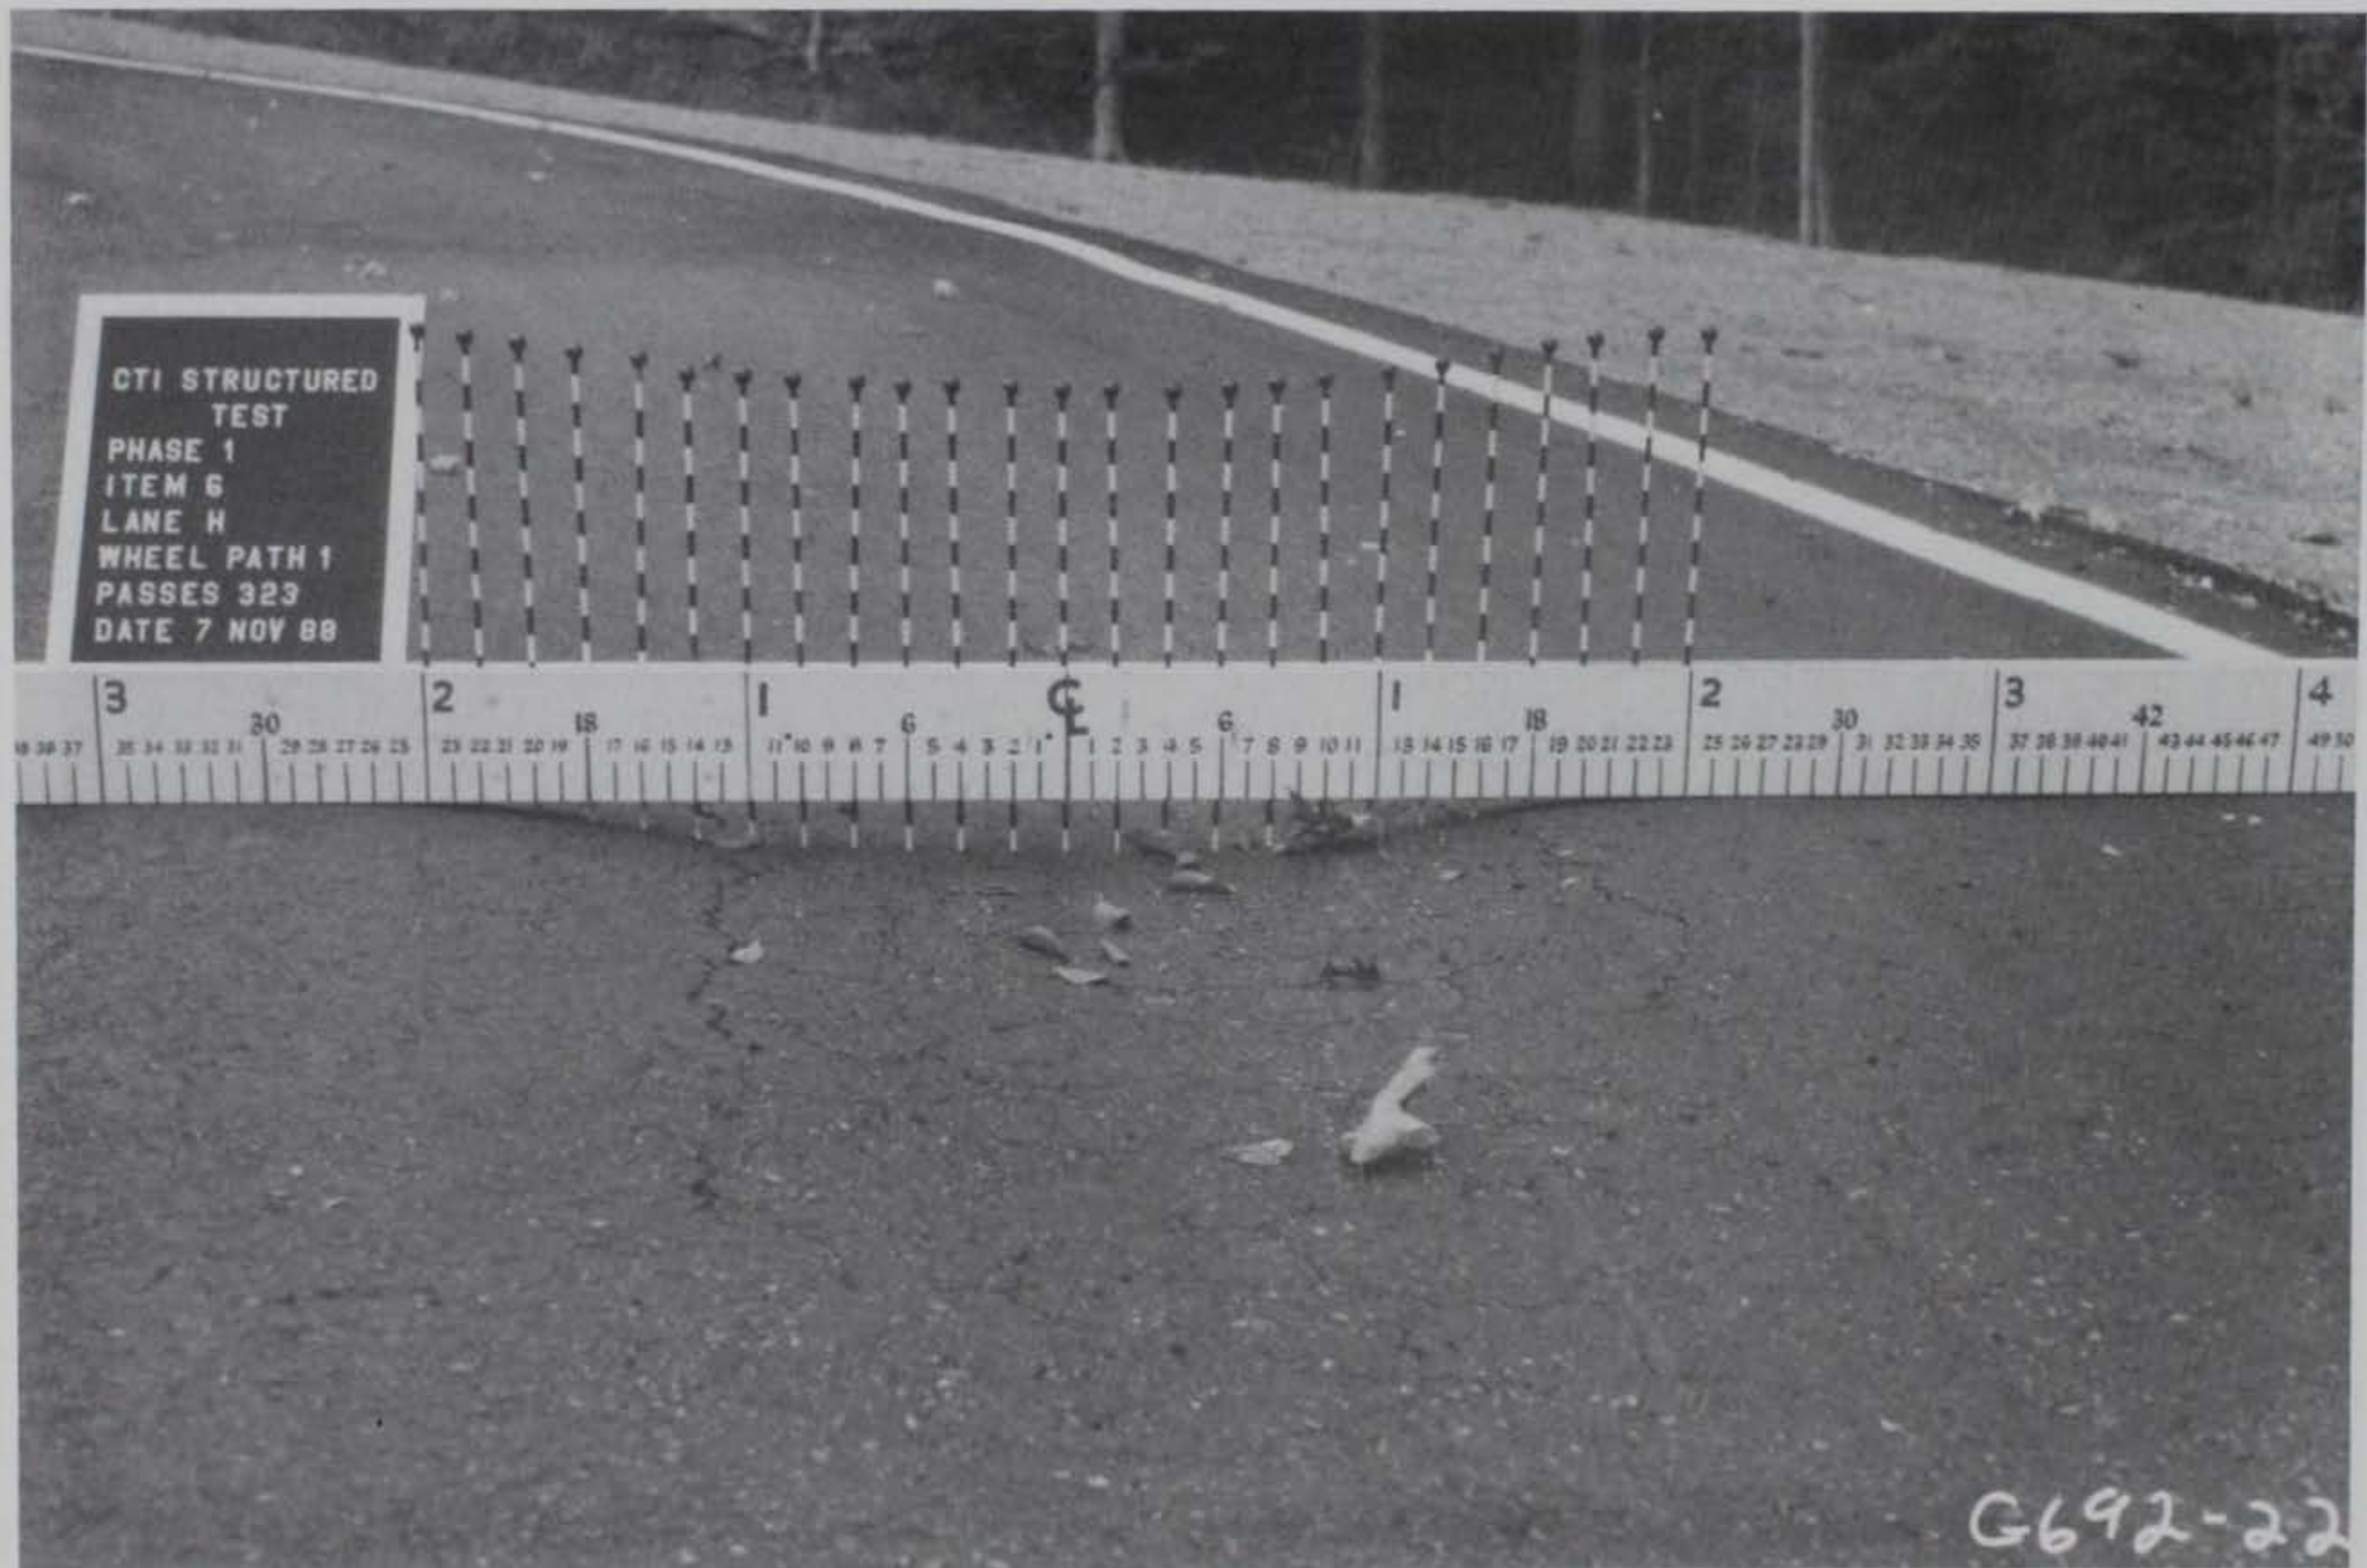
Photo 17. Item 6, high-tire pressure lane, 2.25-in. rutting in localized area after 323 passes

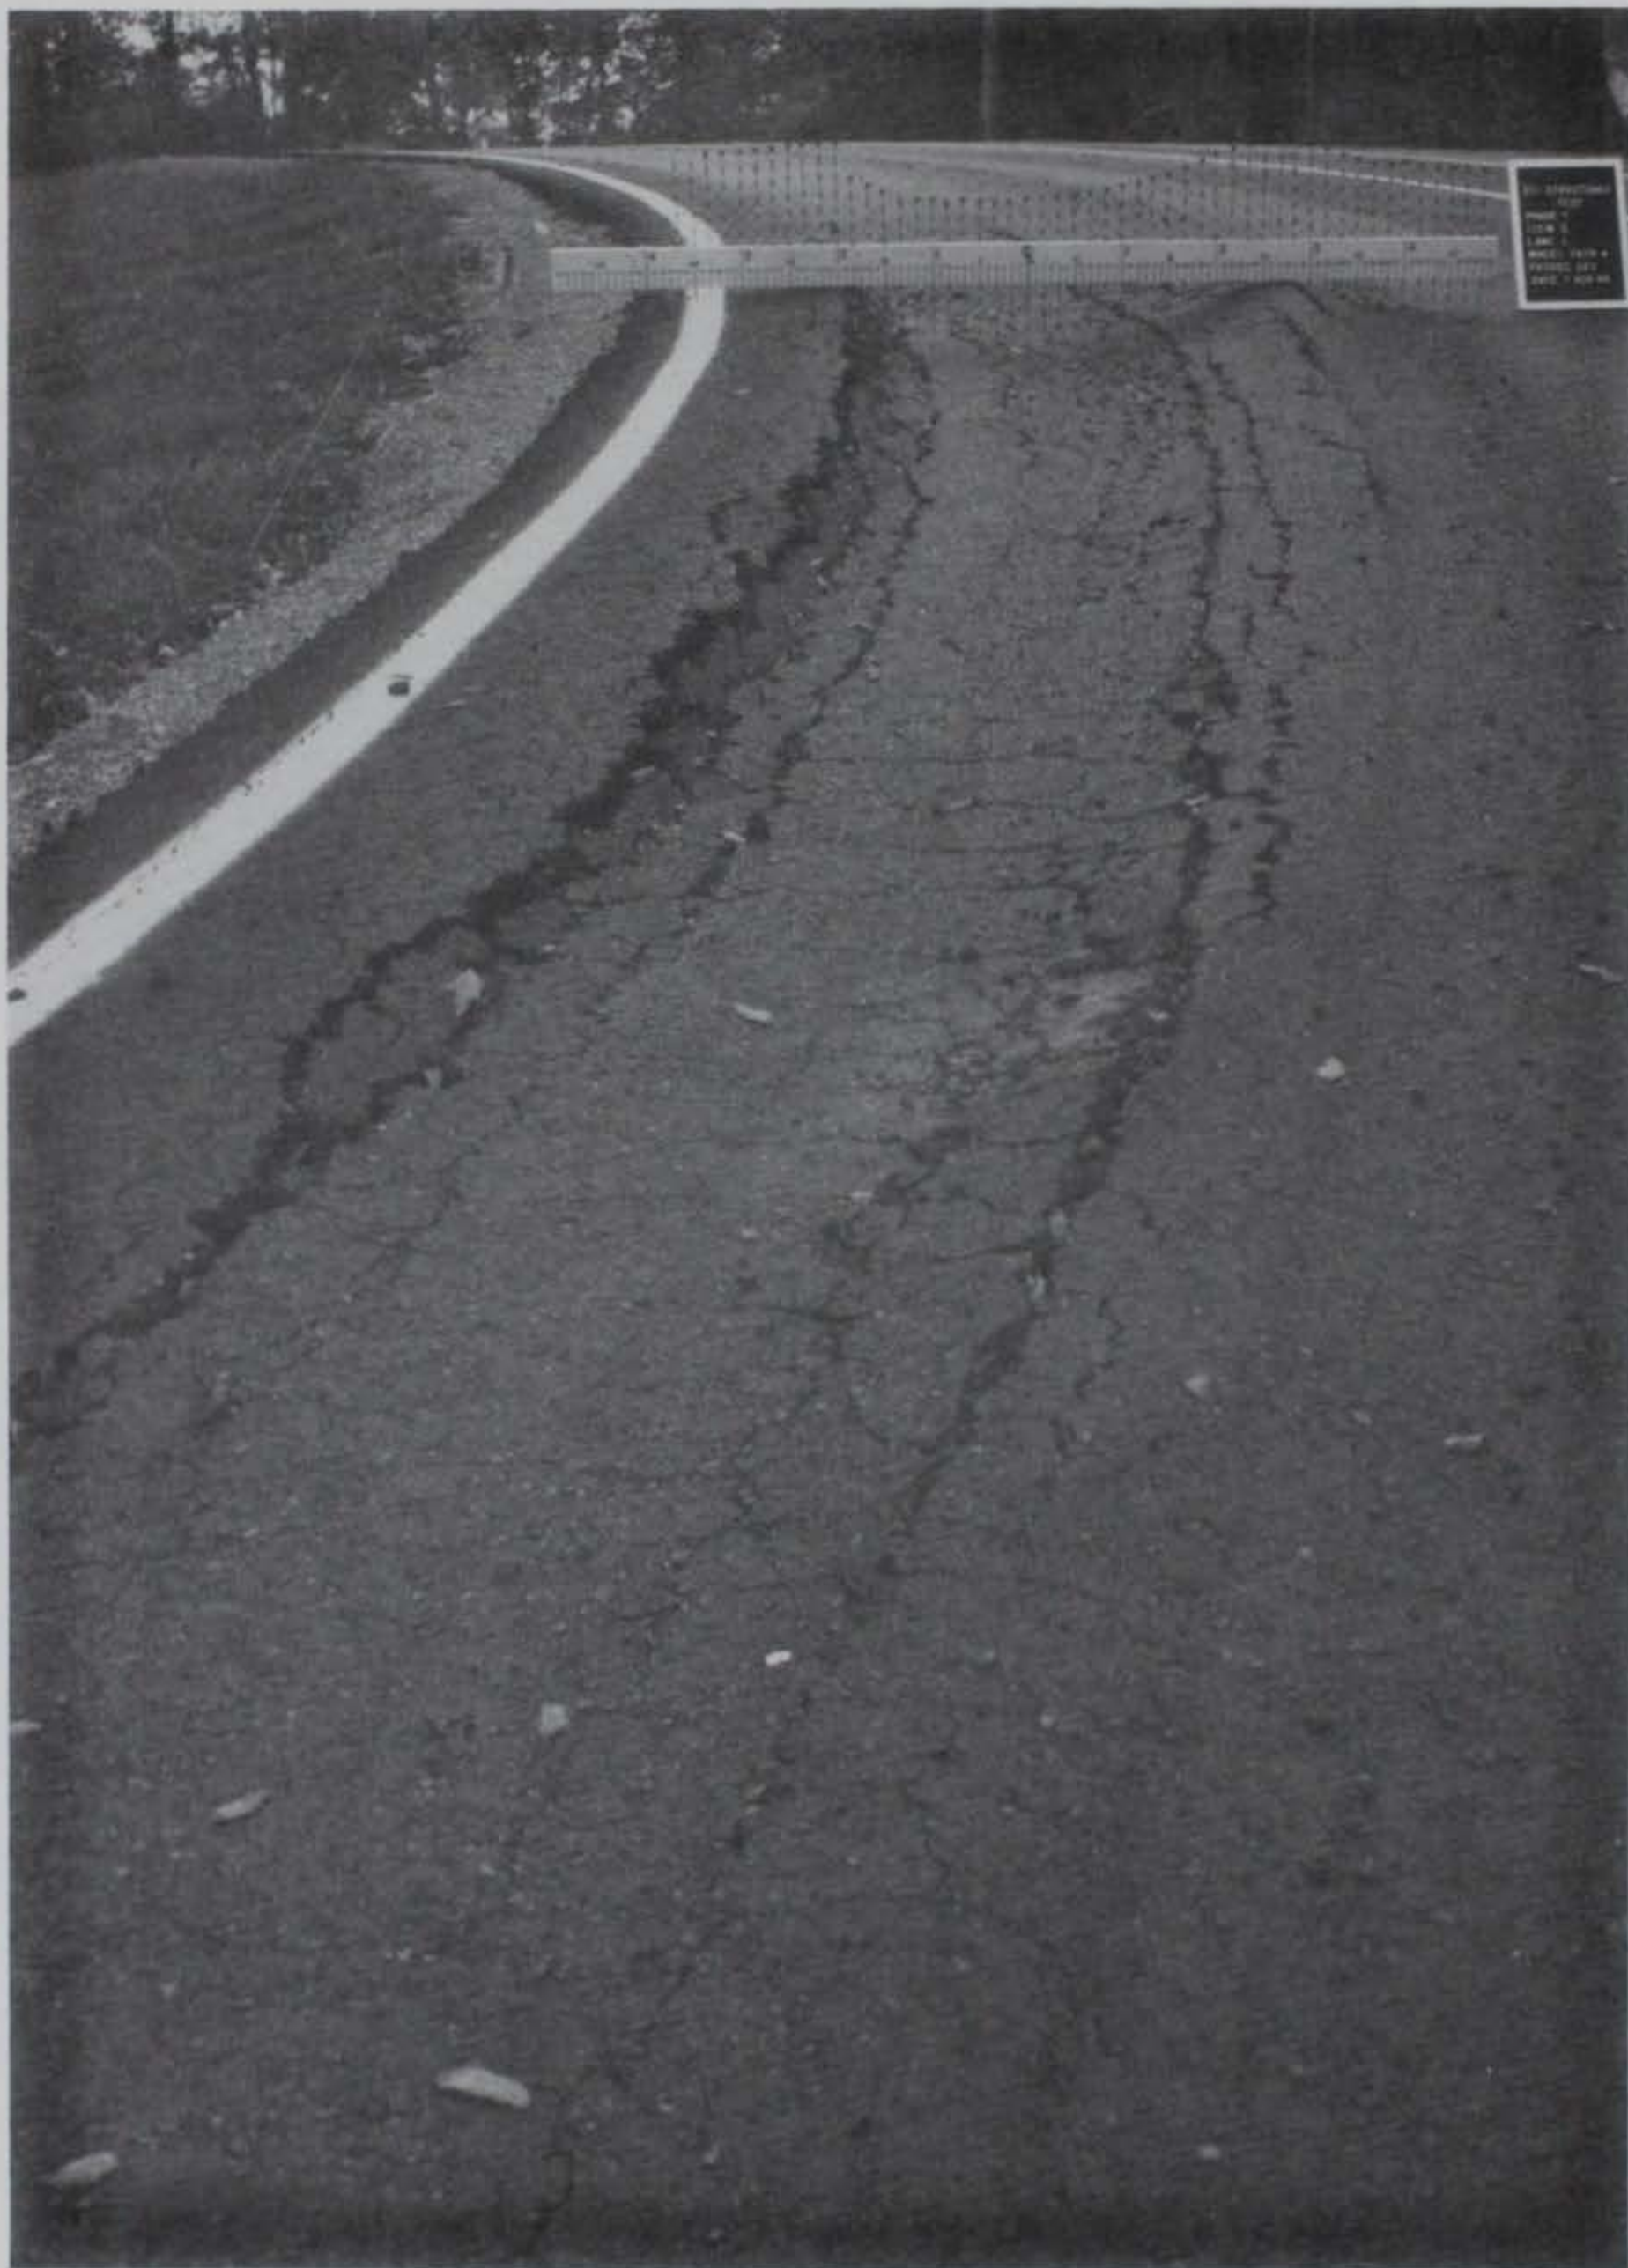
Photo 18. Item 5, wheel path, high-severity rutting and cracking in a localized area
