Effects of Variable Tire Pressure on Road Surfacing

Volume I: Design, Construction, Behavior Under Traffic, and Test Results

by *Robert W. Grau*
Geotechnical Laboratory

Technical Report GL-93-20
August 1993

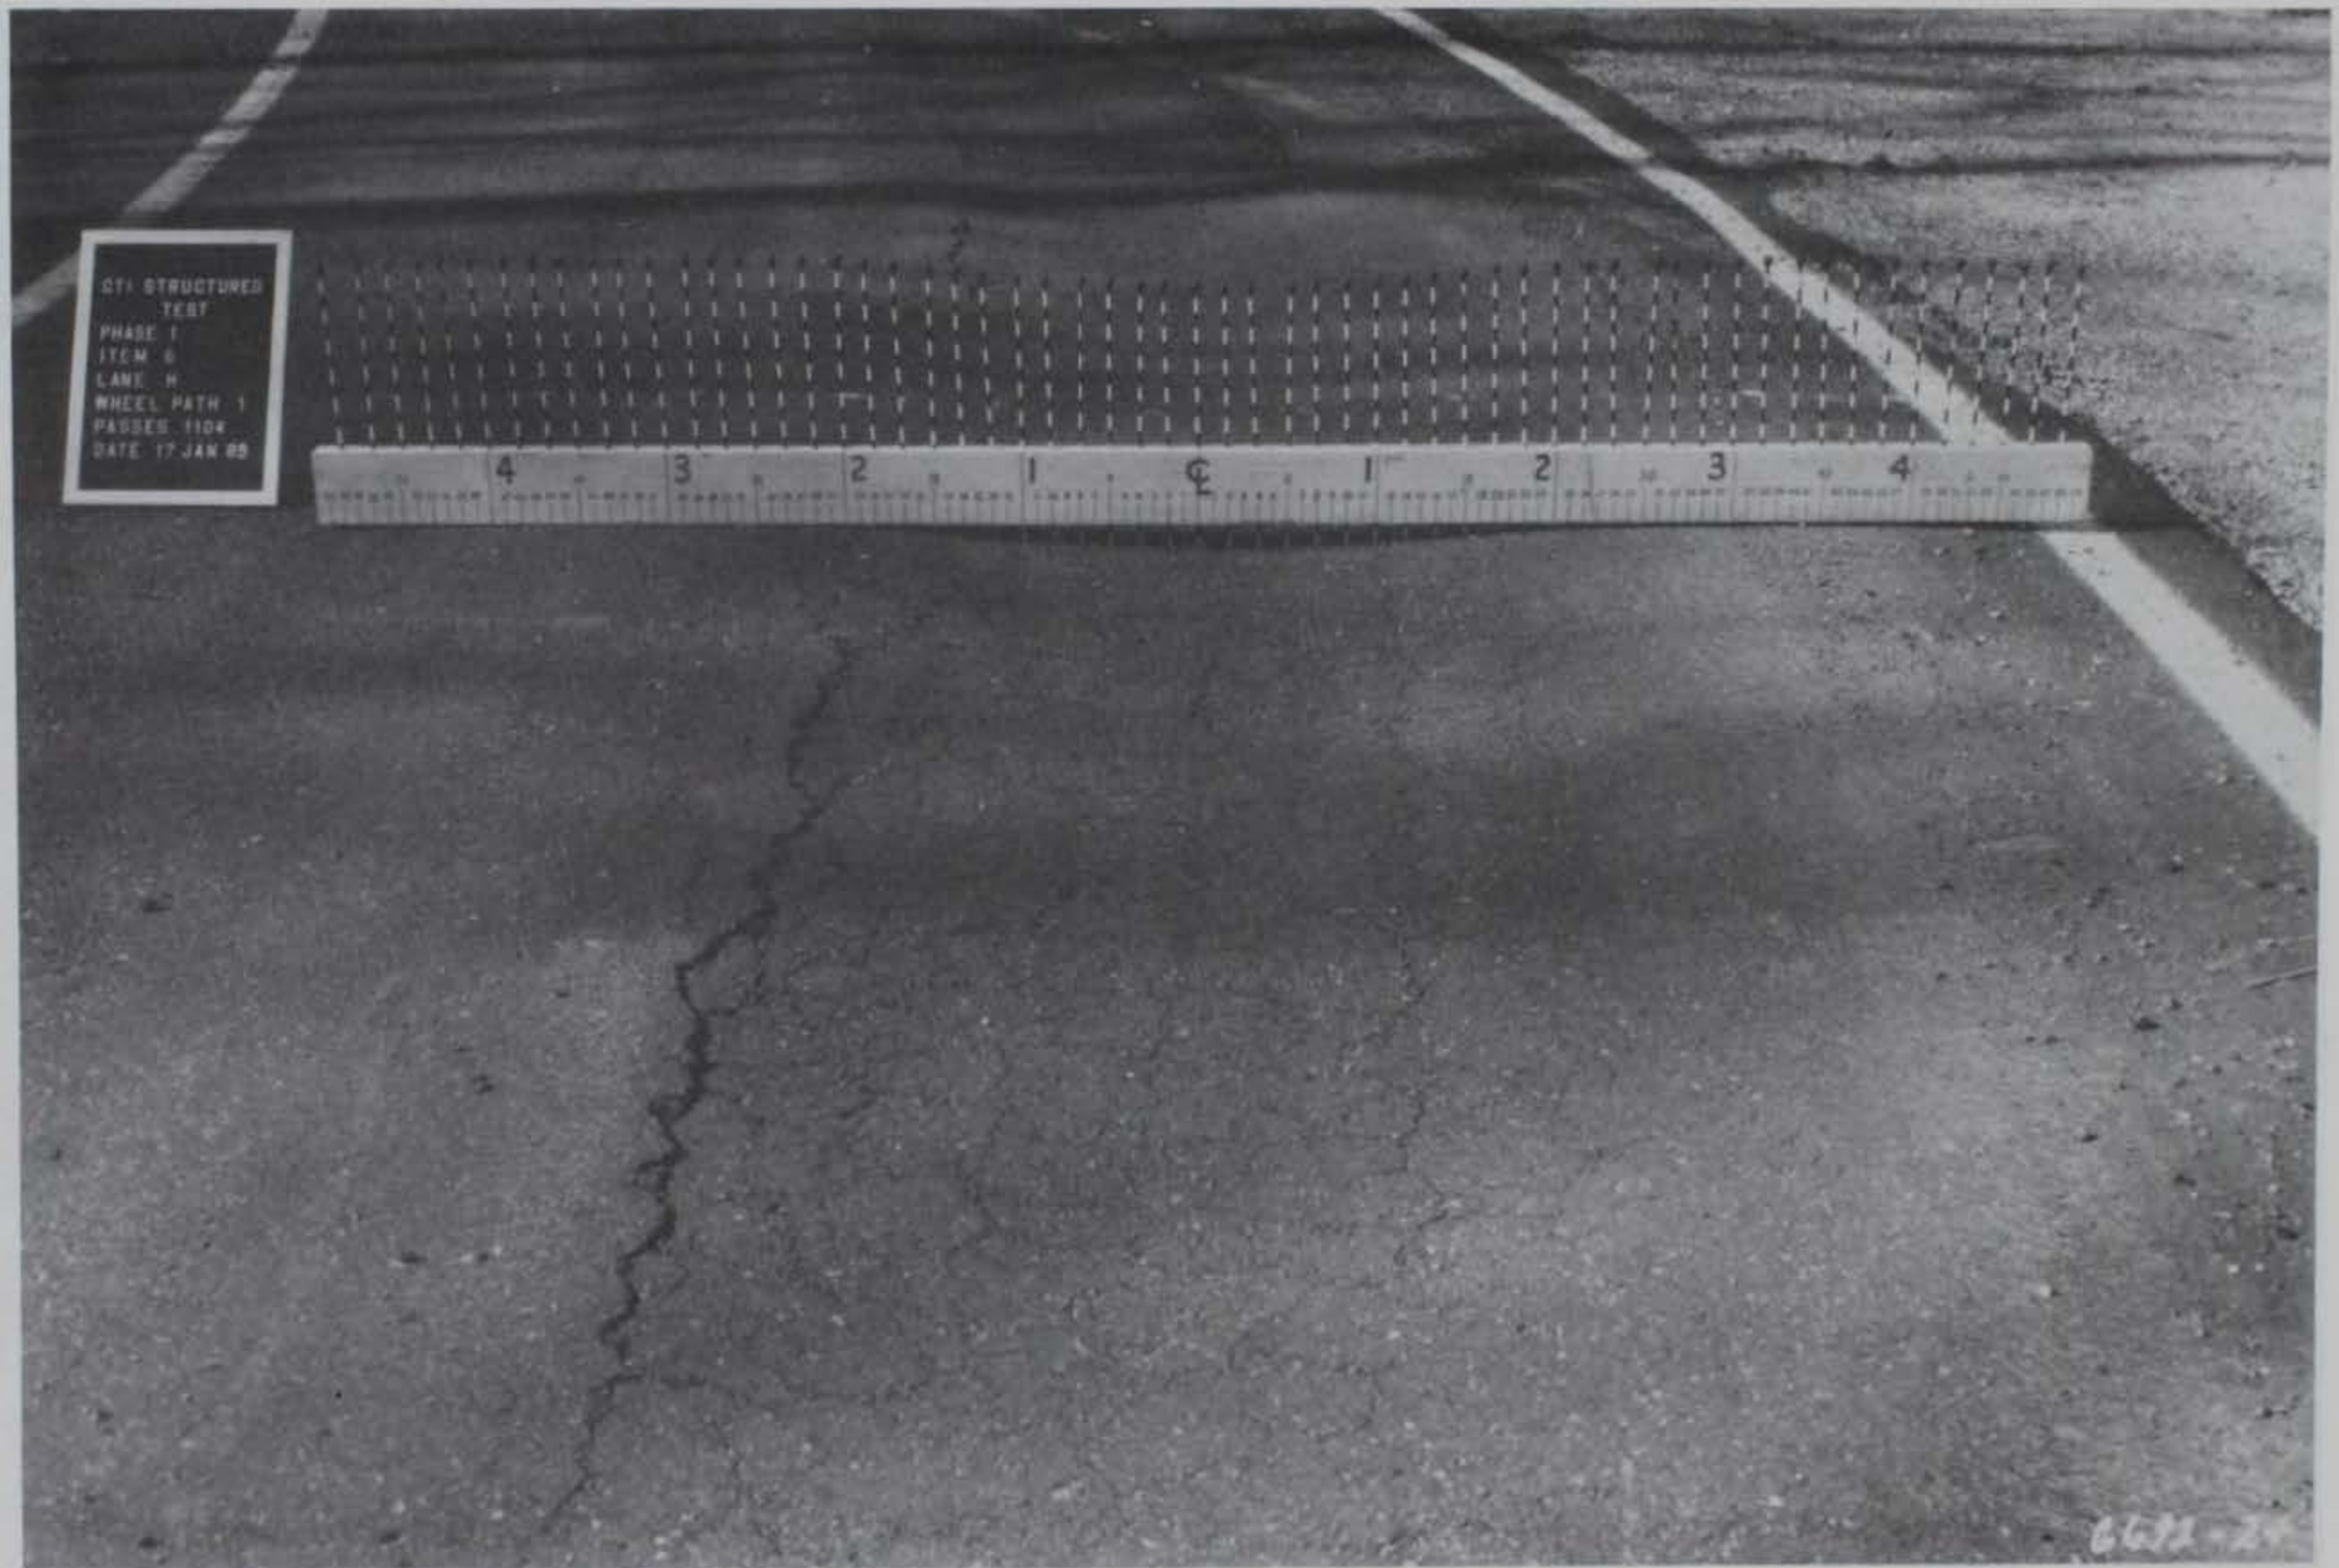
Photo 19. Item 6, high-tire pressure lane general view of failed area after 1,104 passes

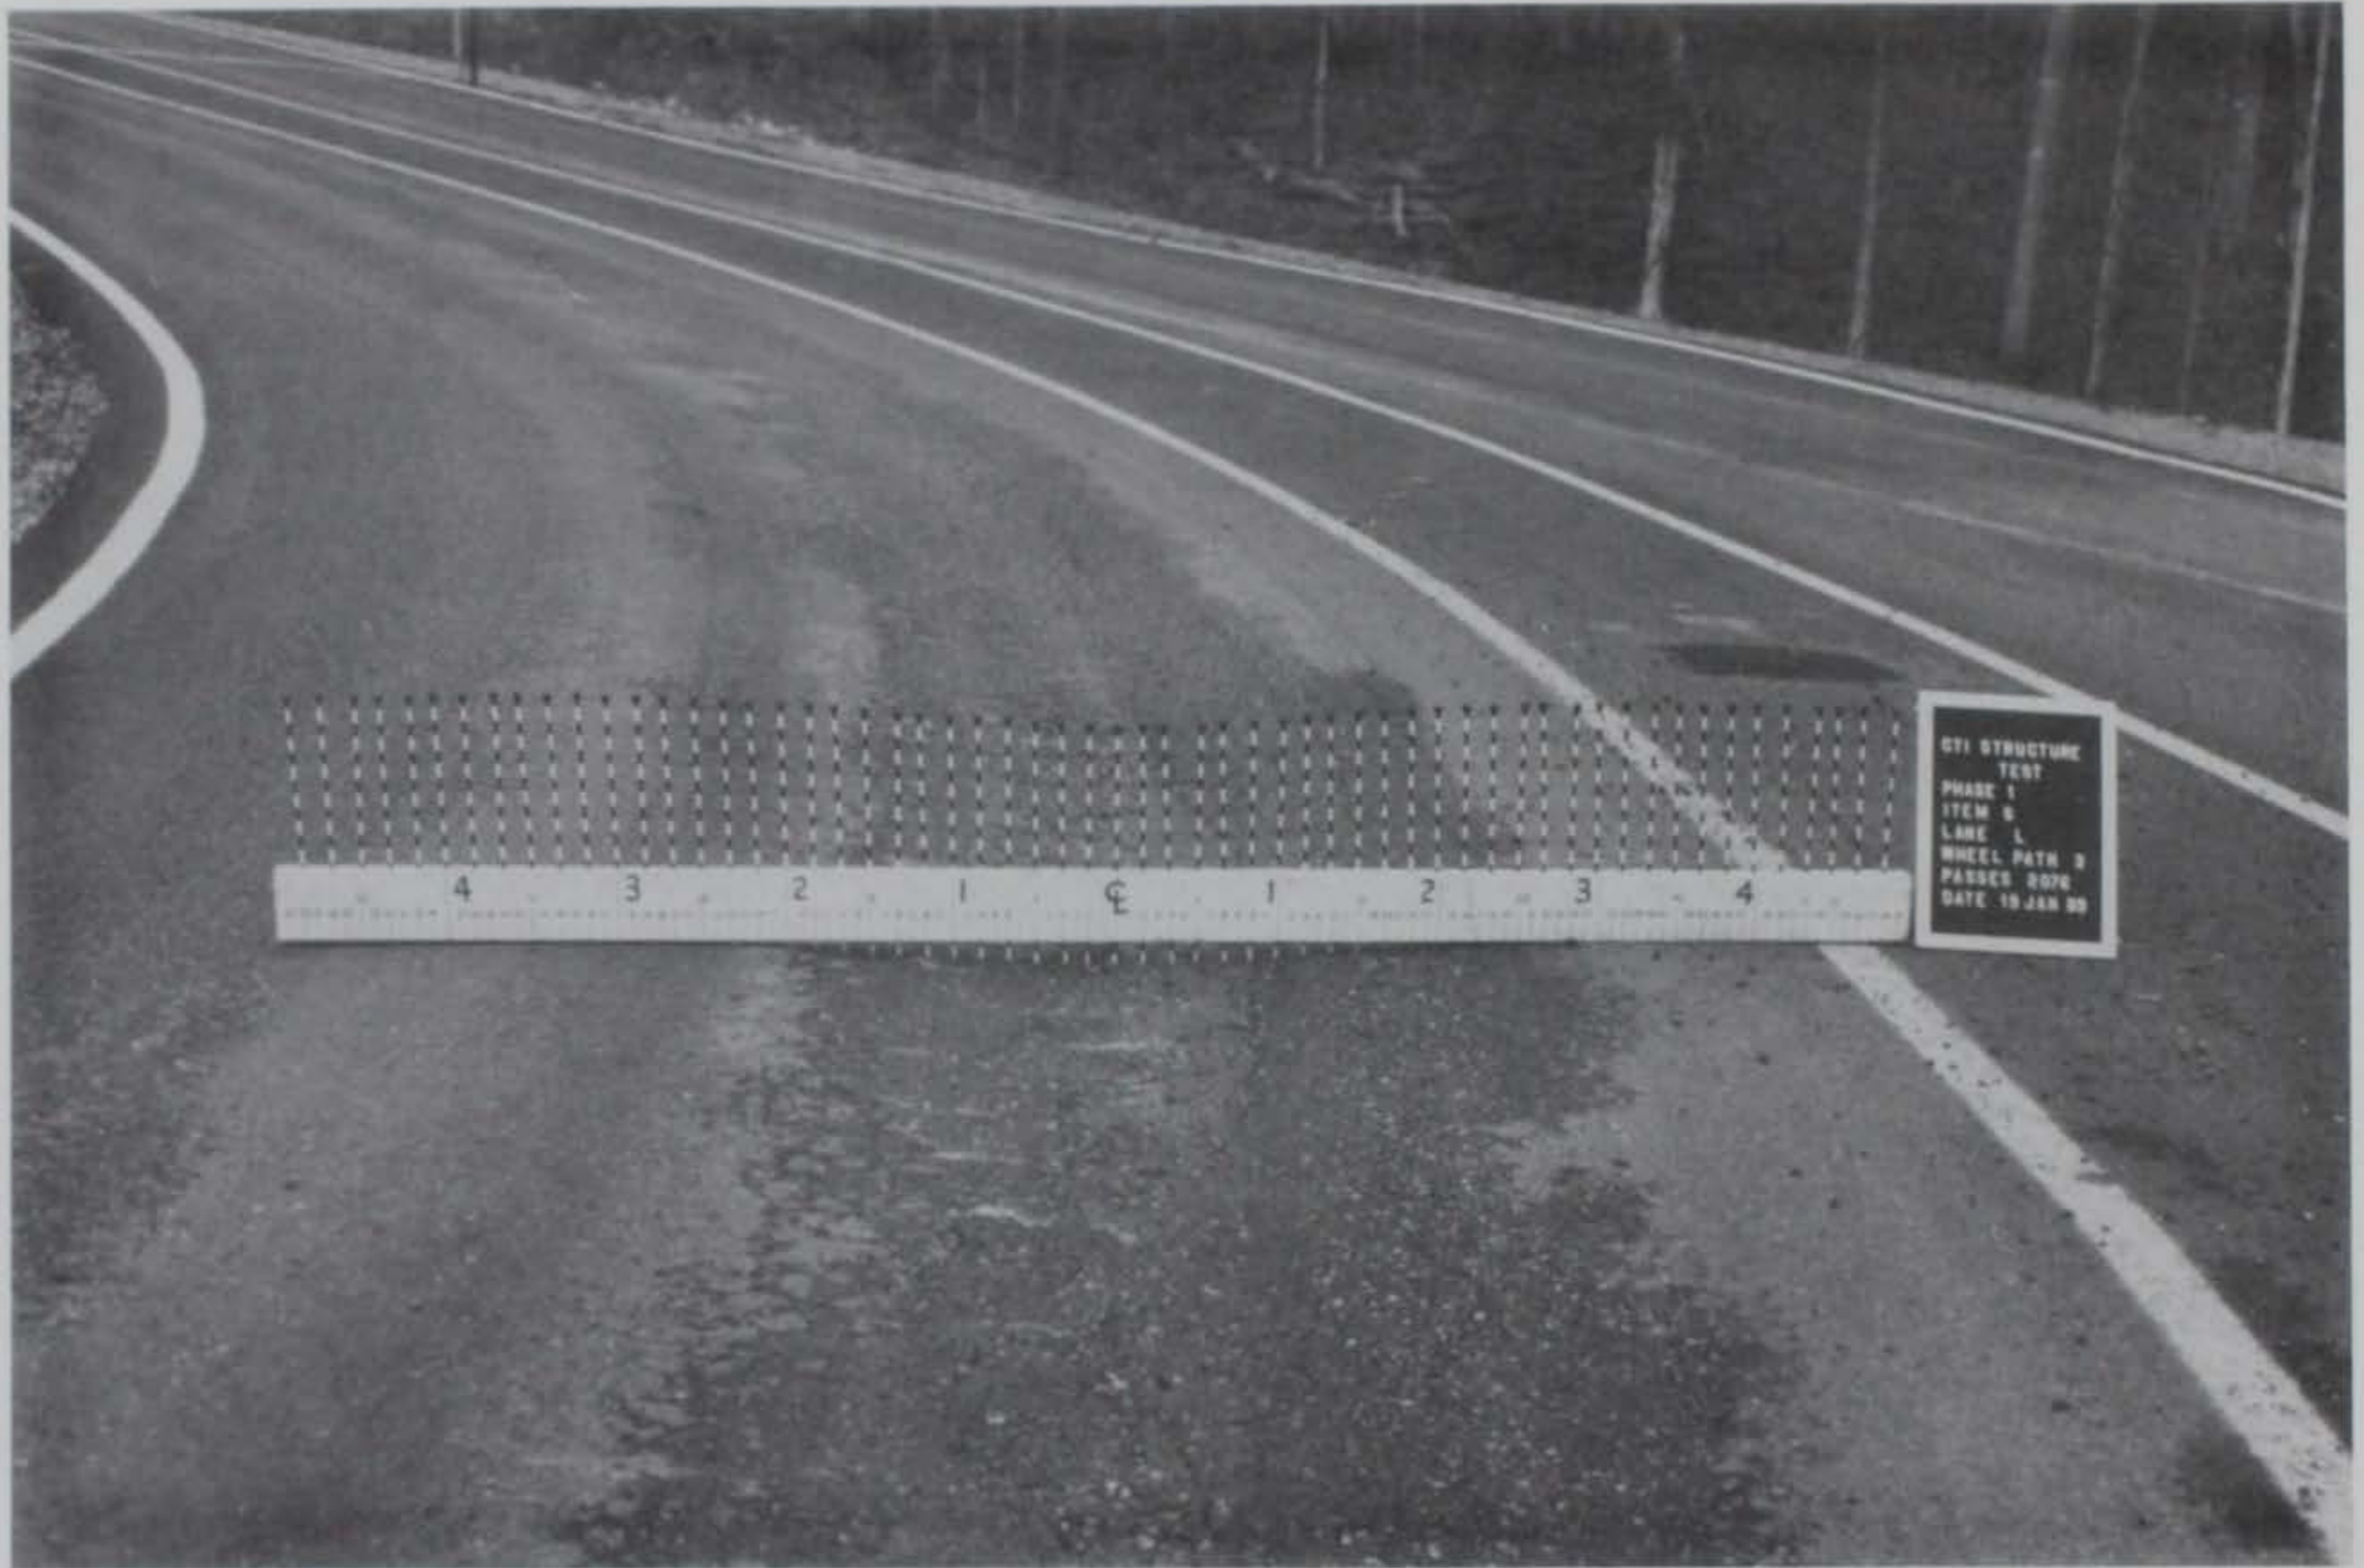
Photo 22. Item 6, wheel path 3, general failure after 2,076 passes

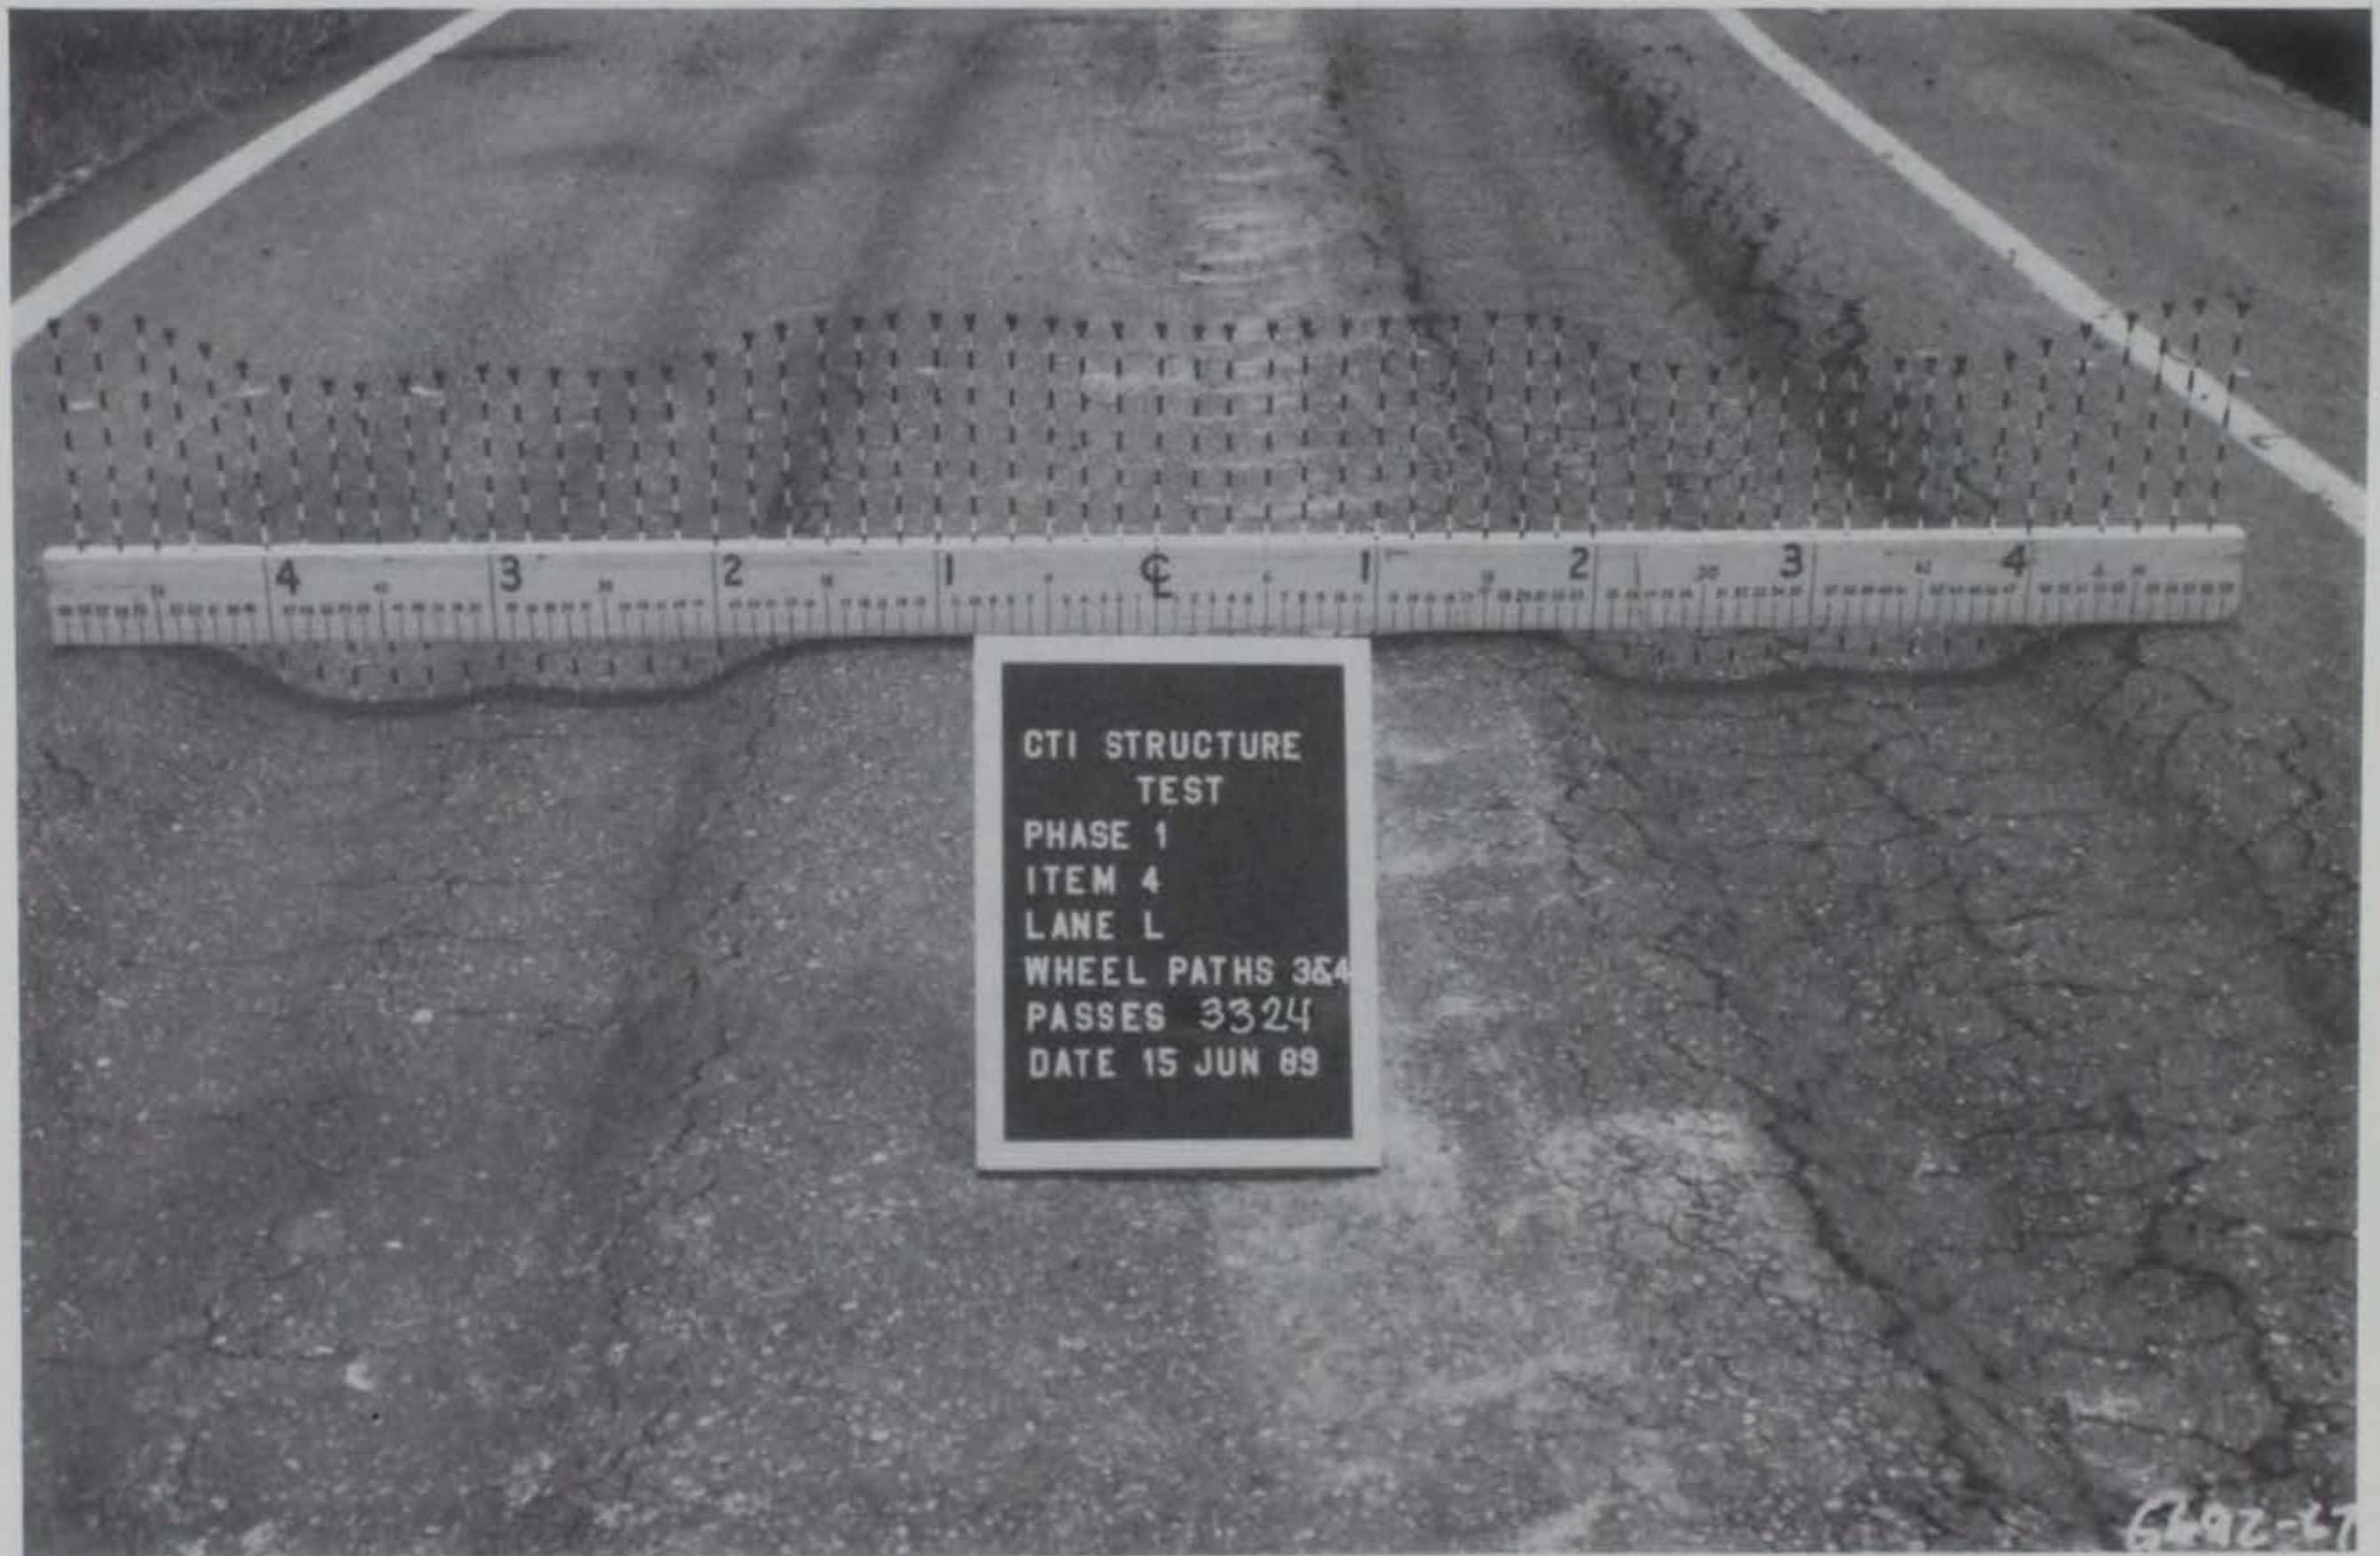
Photo 23. Item 4, low-tire pressure lane, general view of failure after 3,324 passes

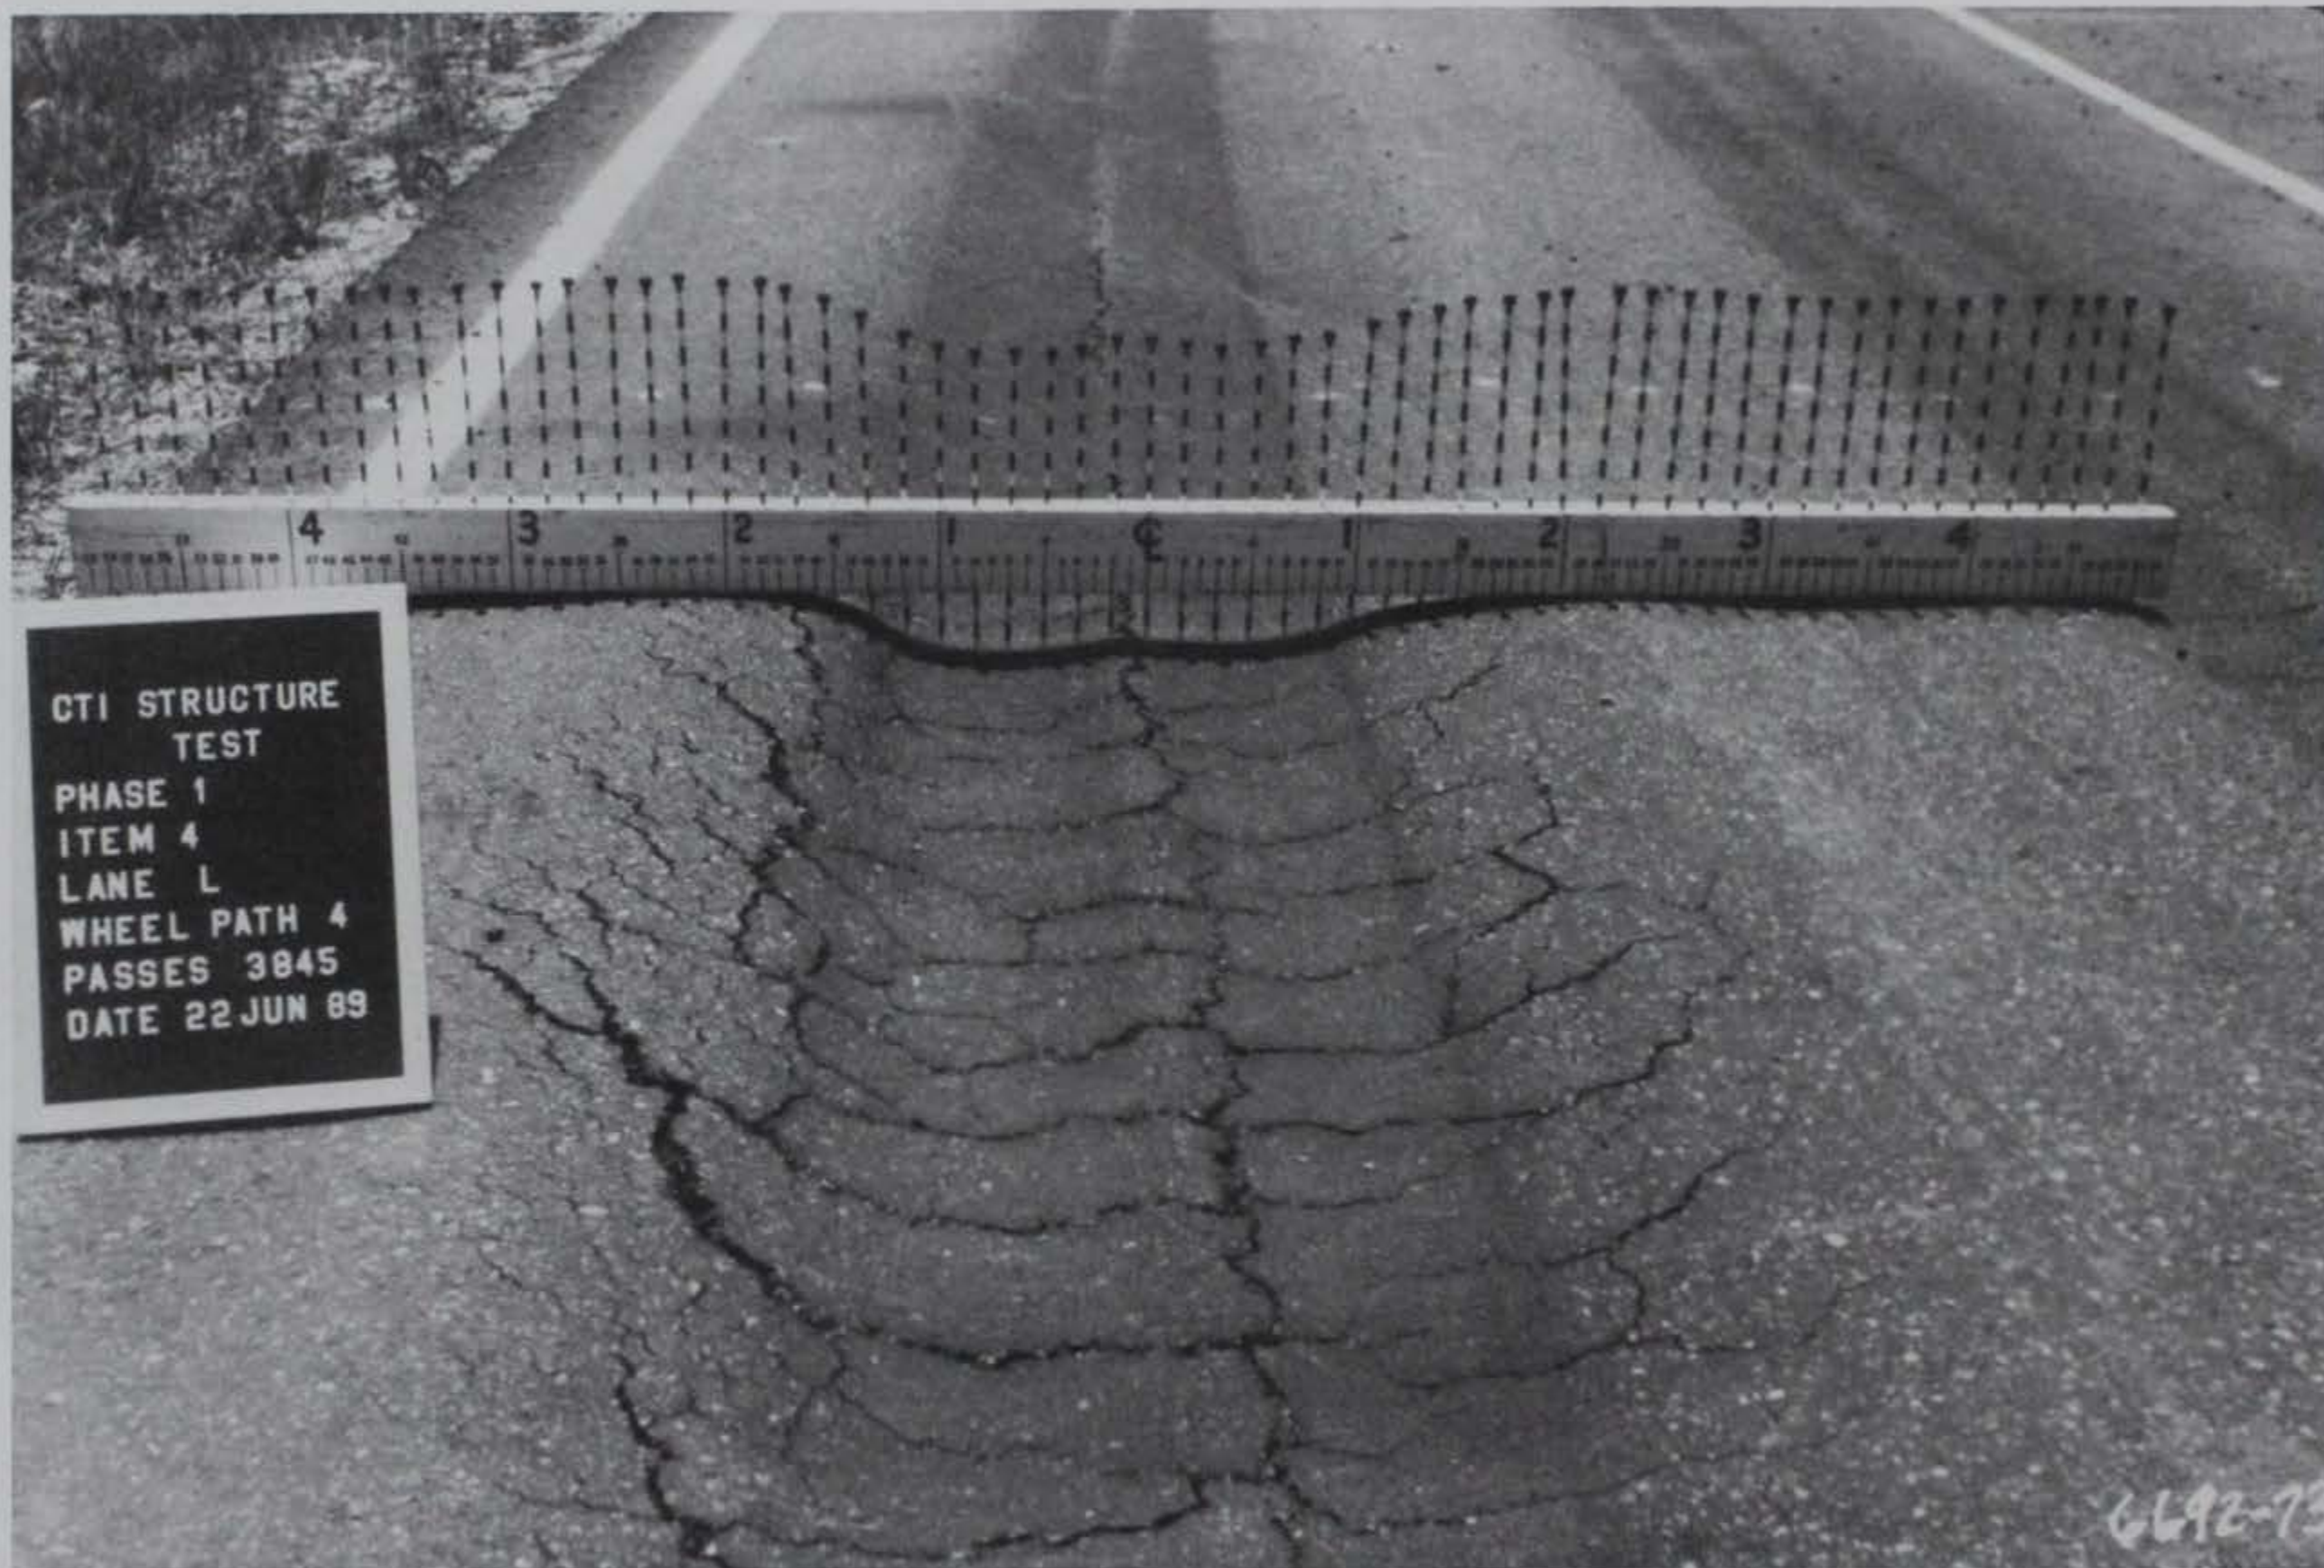
Photo 24. Item 4, wheel path 4, failure after 3,845 passes

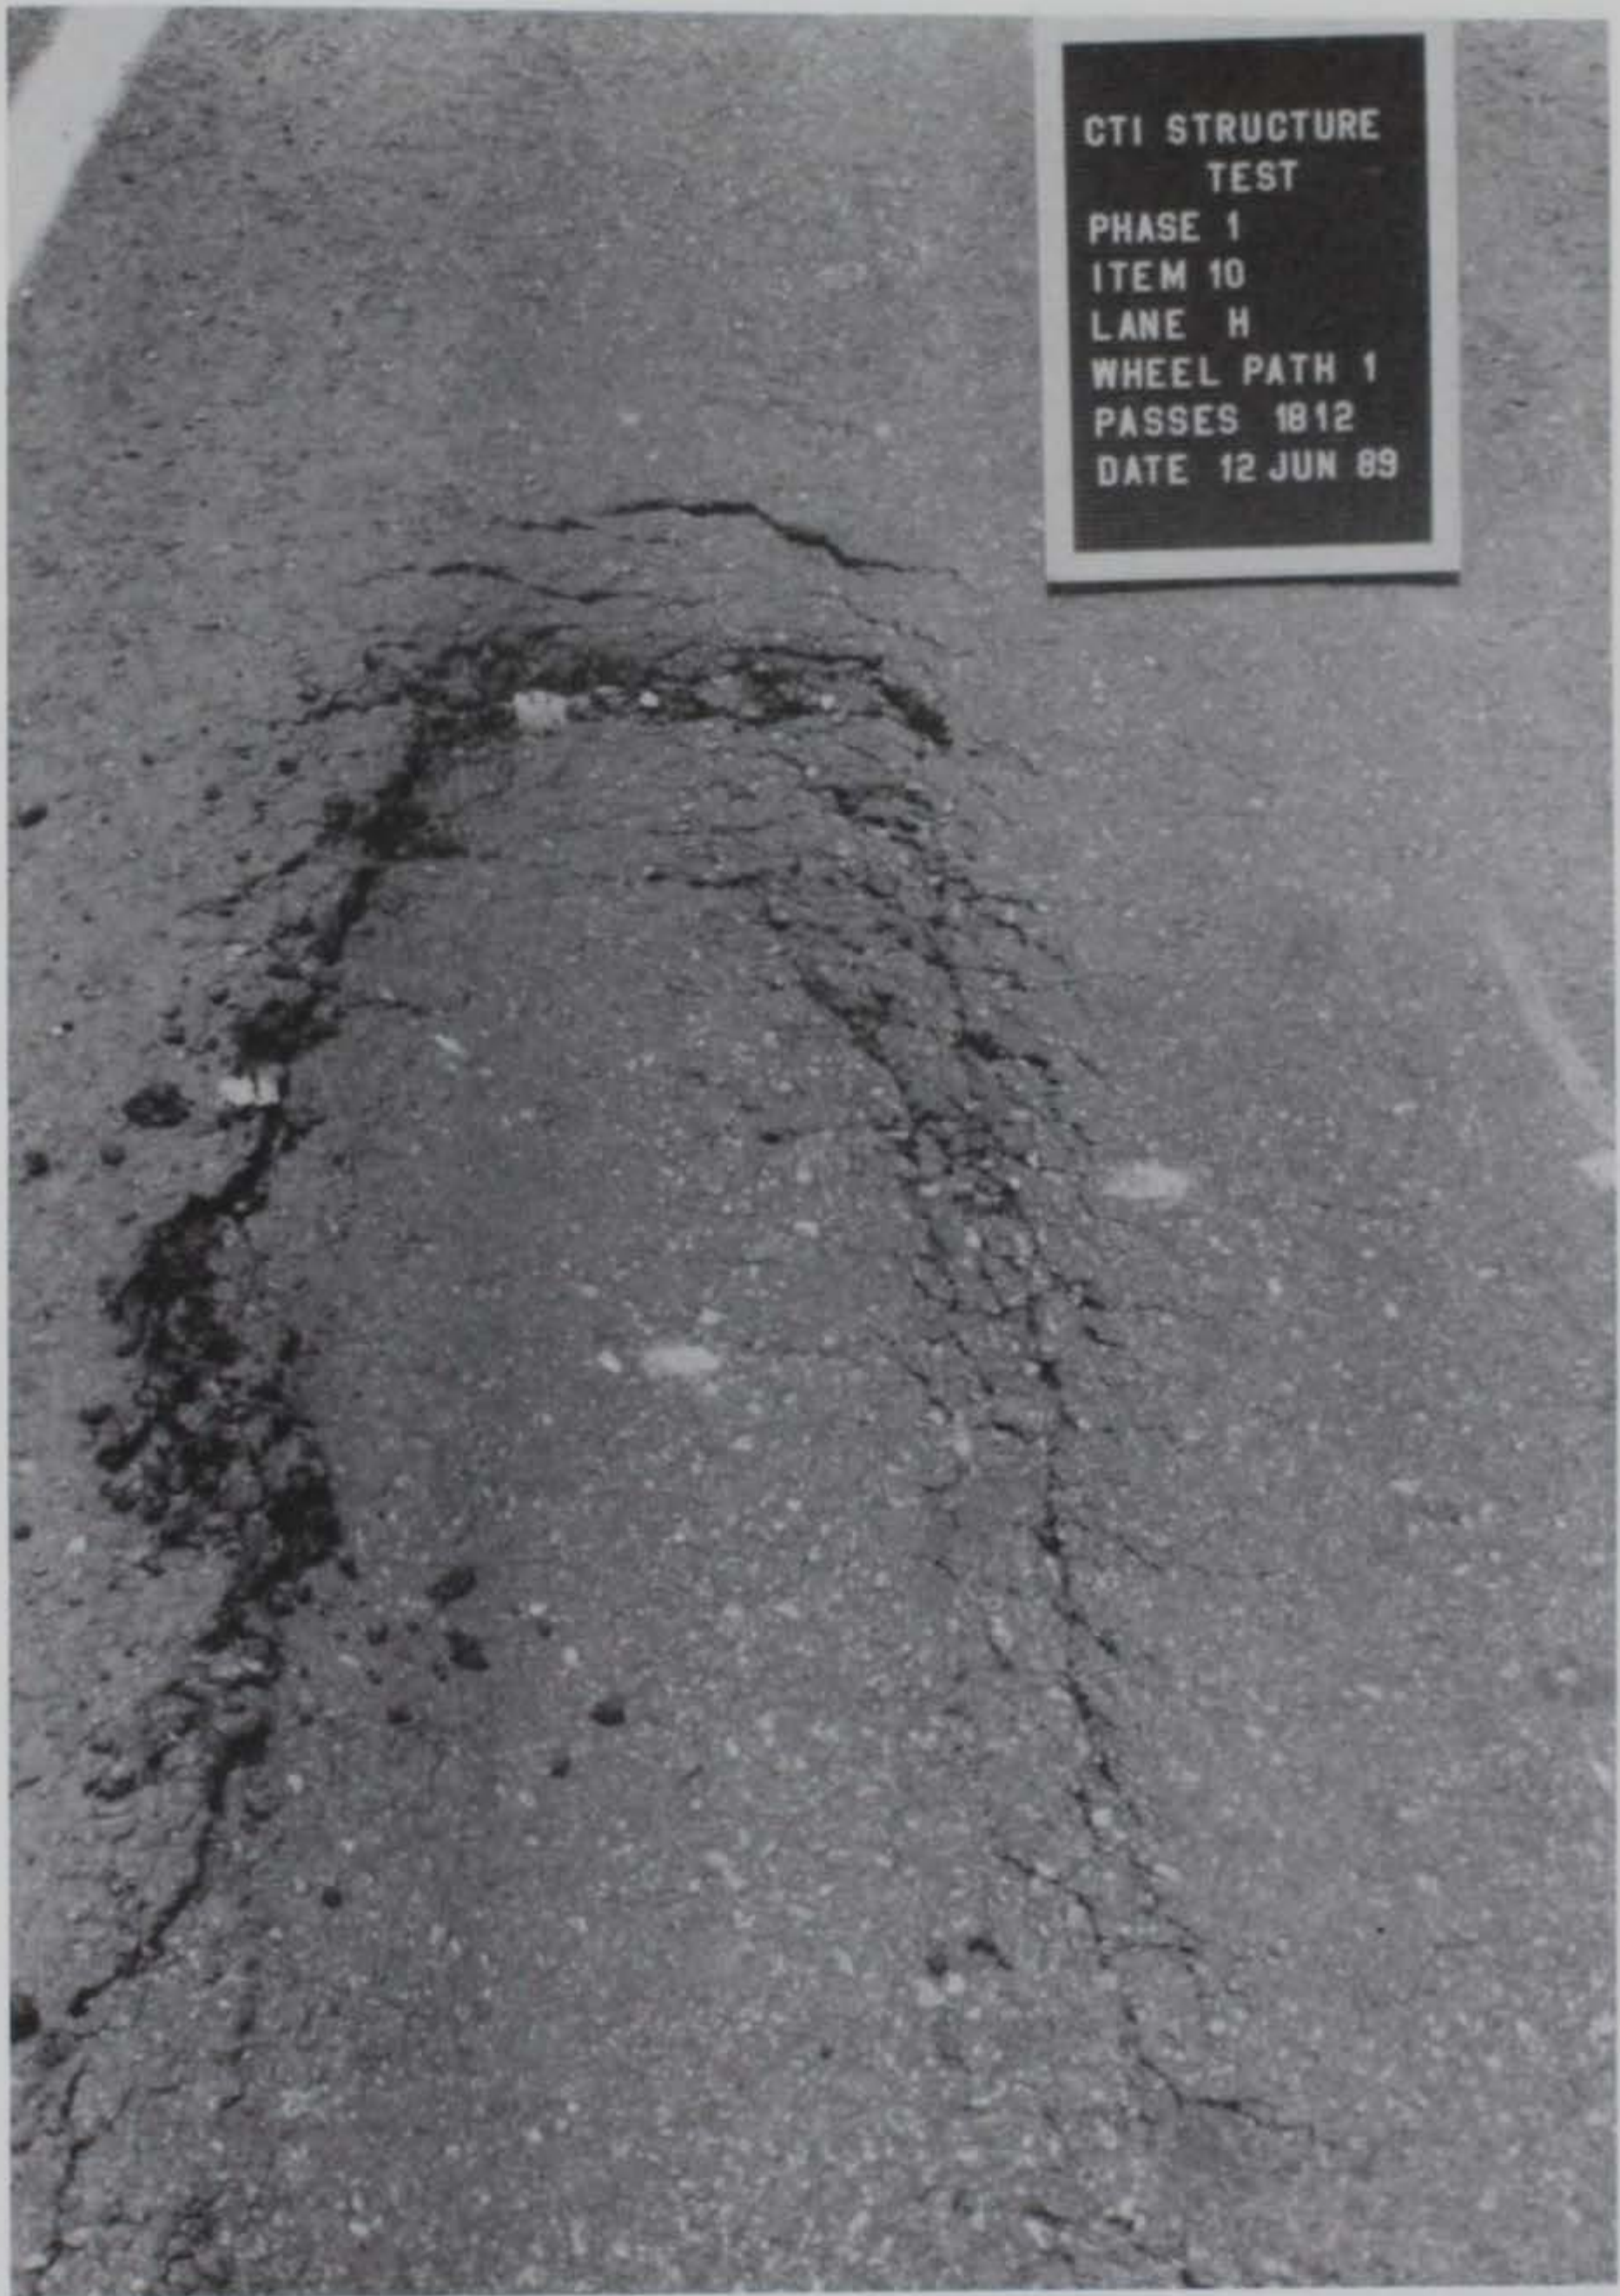
Photo 31. Item 10, wheel path 1, high-severity shoving after 1,812 passes

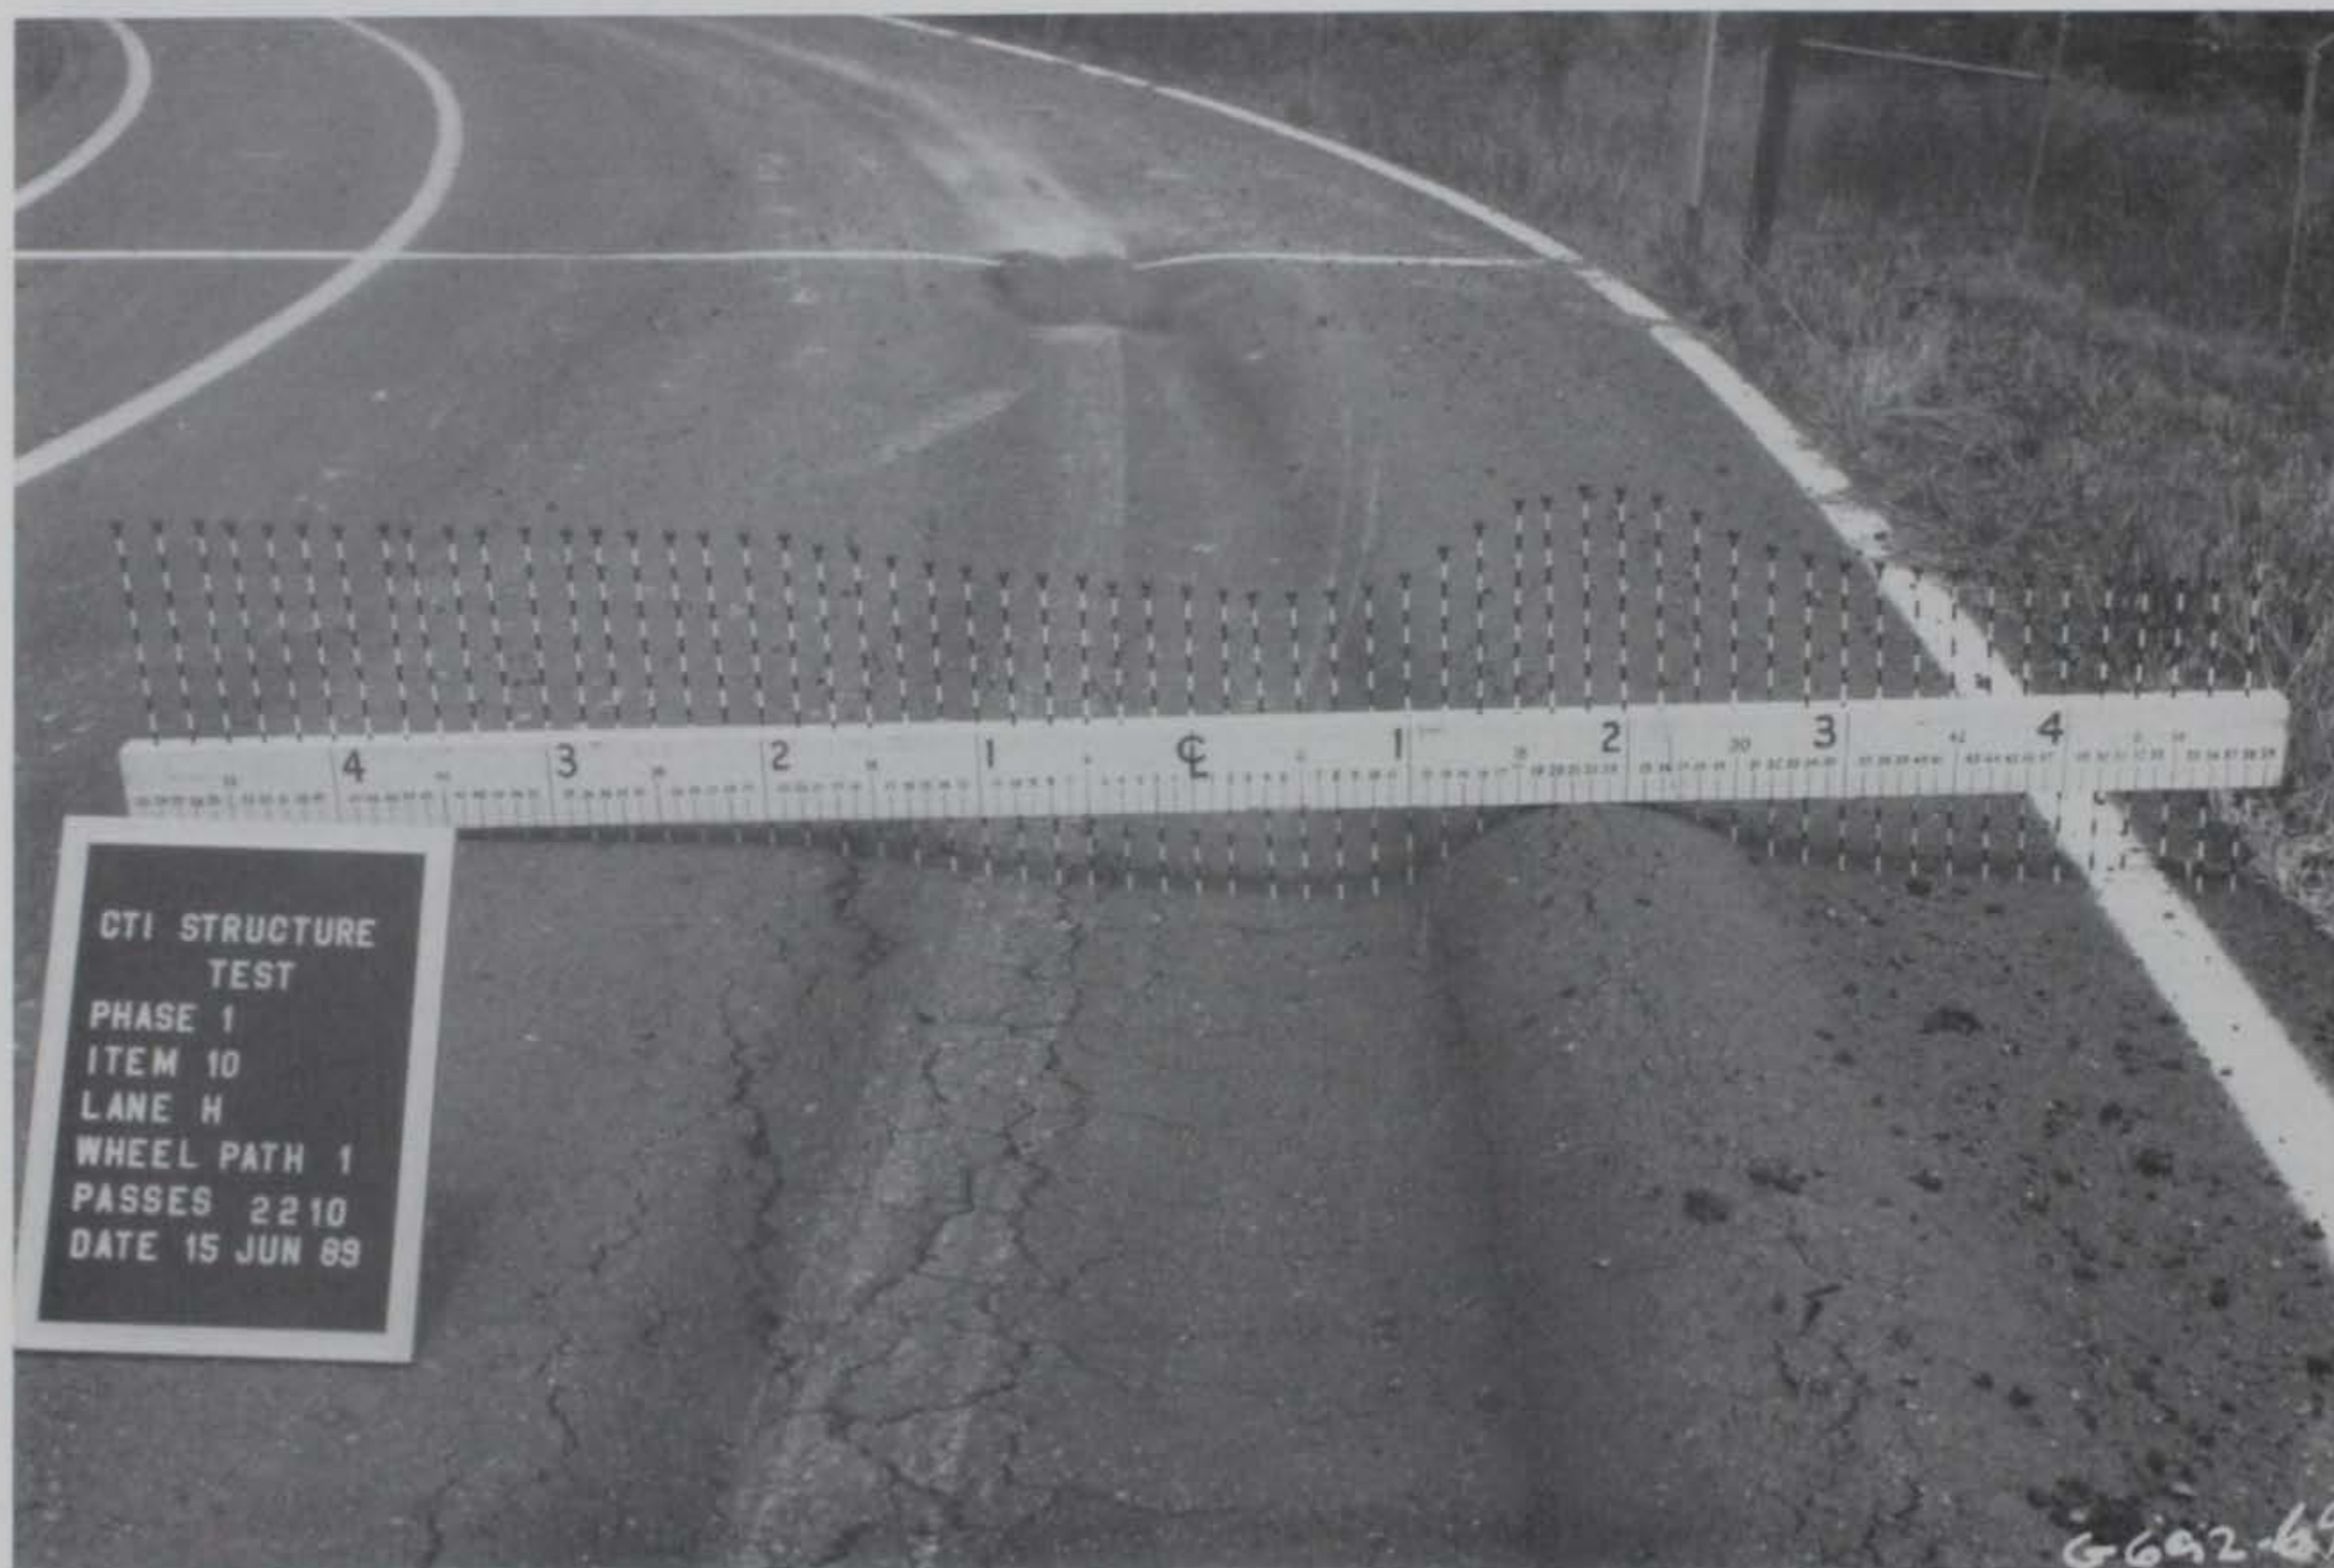
Photo 32. Item 10, wheel path 1, high-severity rutting and cracking, failure after 2,210 passes
