Effects of Variable Tire Pressure on Road Surfacing

Volume I: Design, Construction, Behavior Under Traffic, and Test Results

by *Robert W. Grau*
Geotechnical Laboratory

Technical Report GL-93-20
August 1993

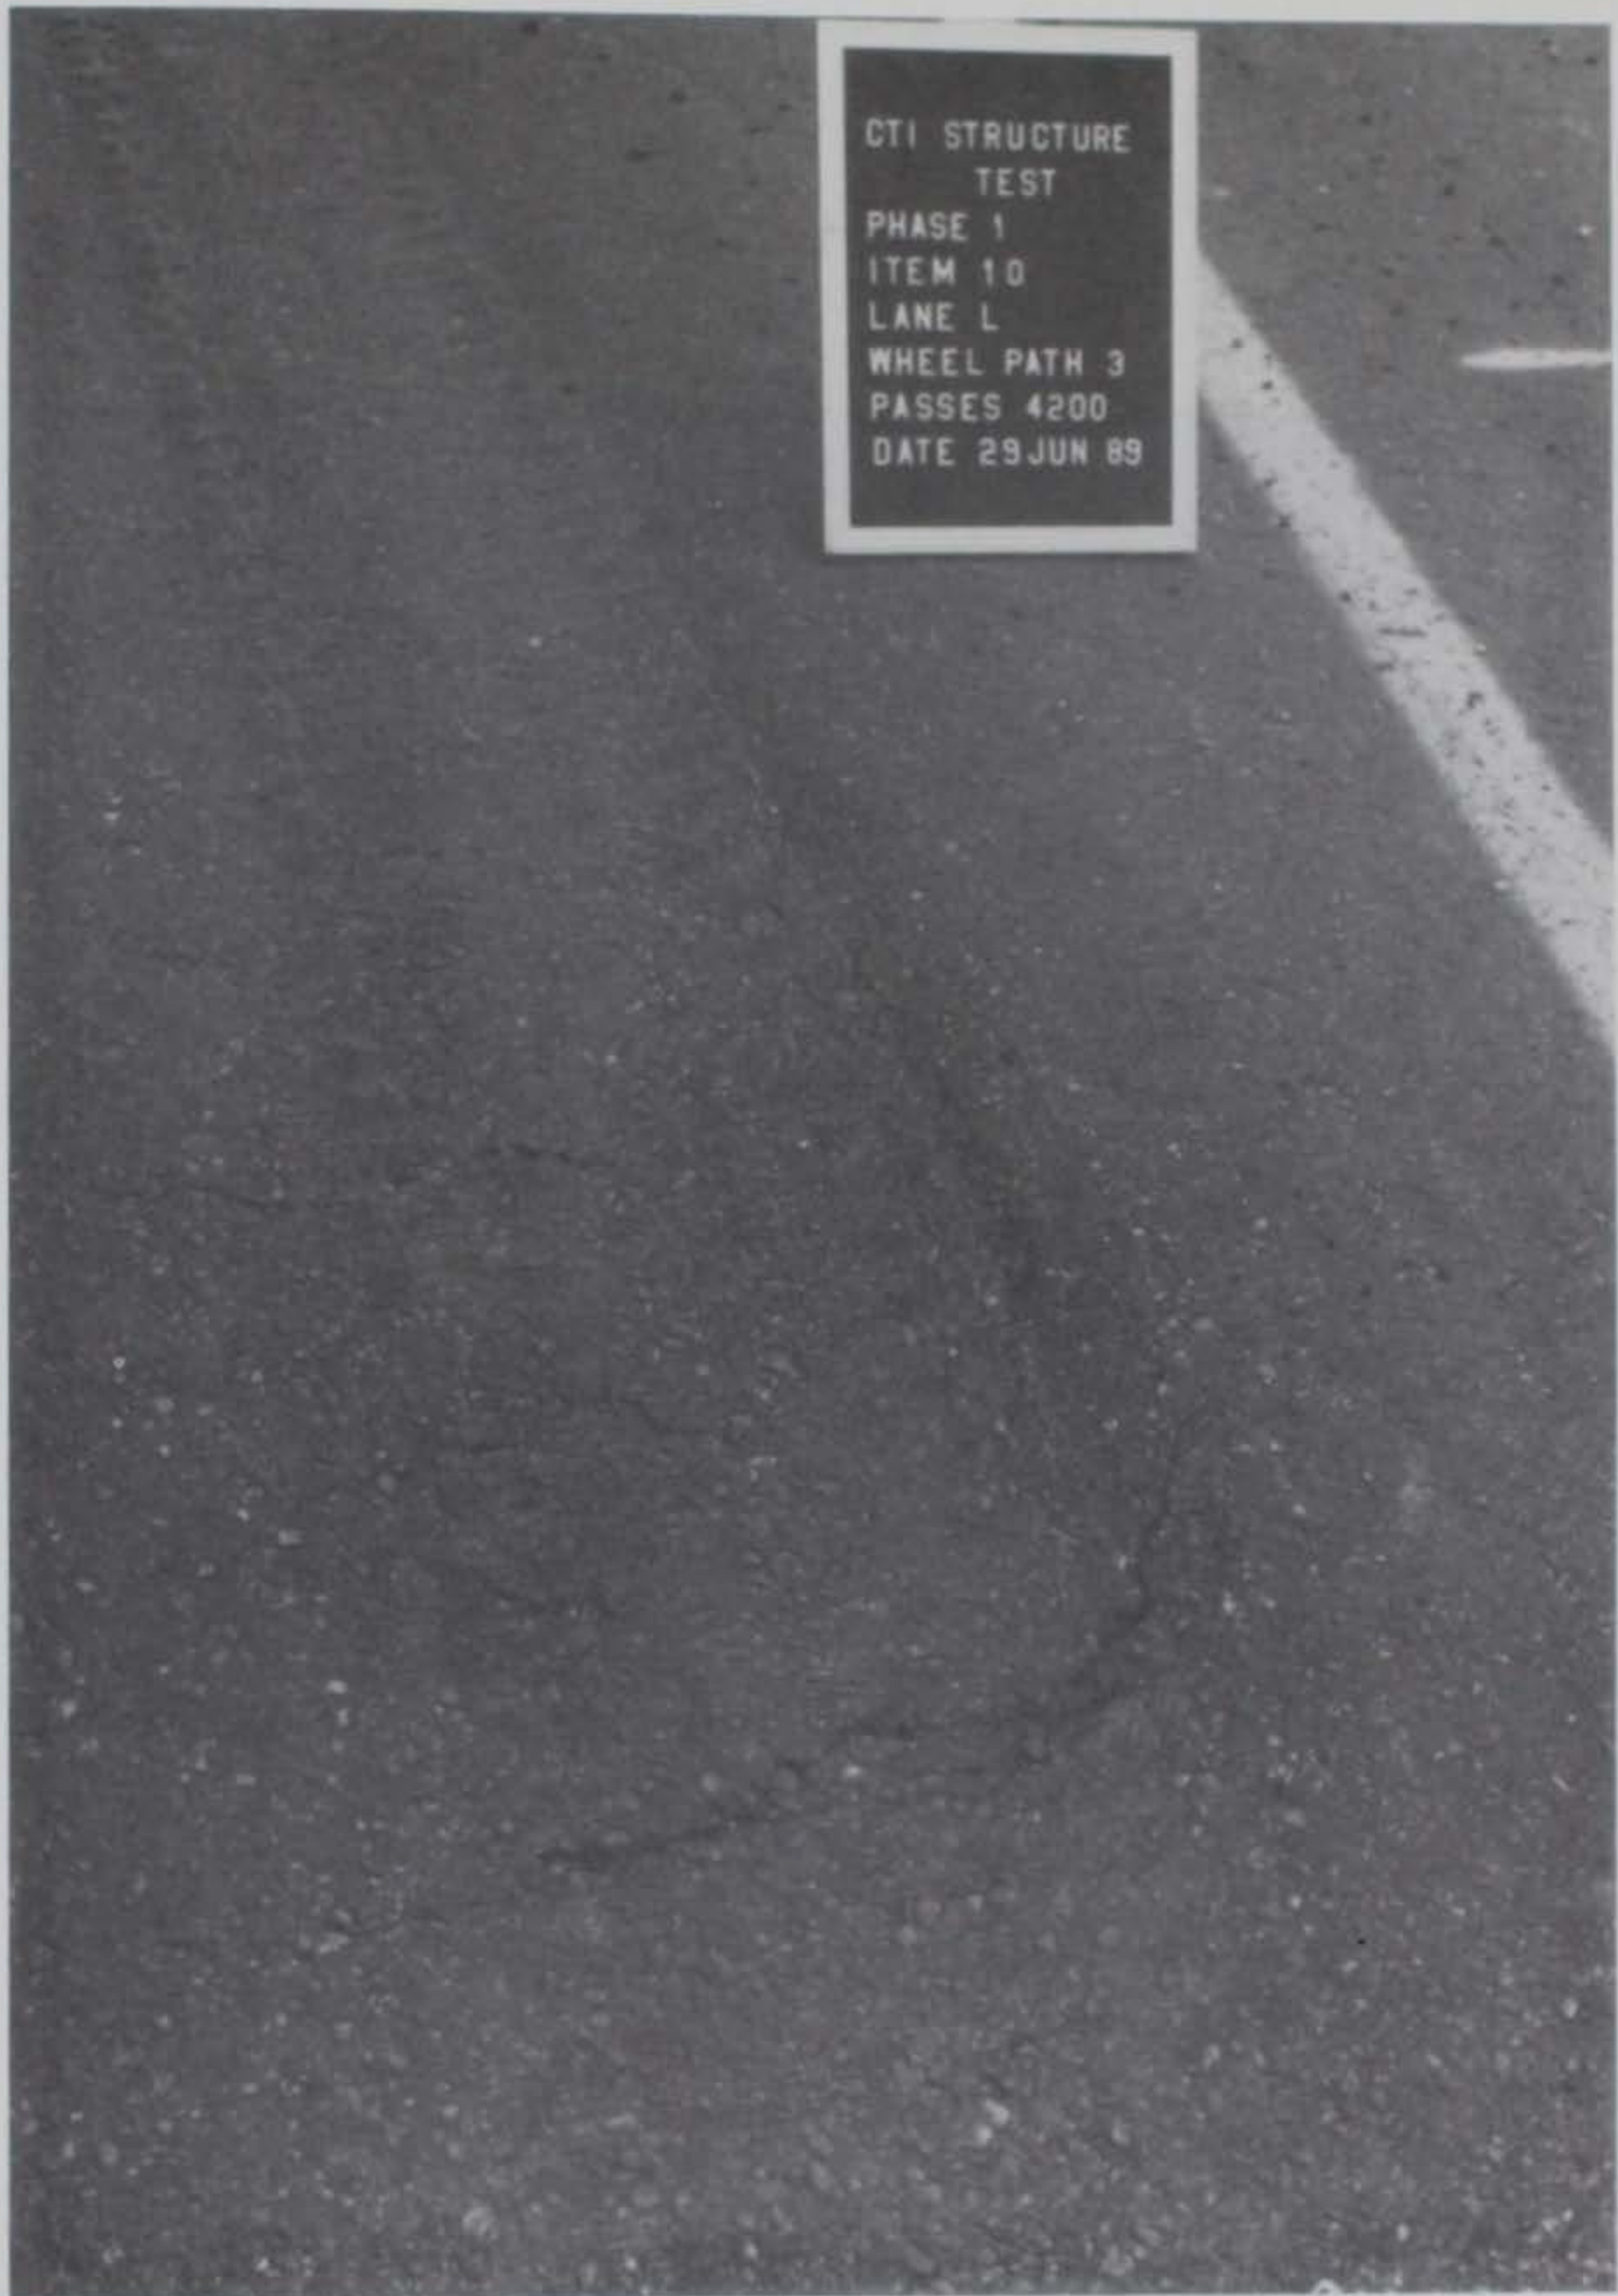
Photo 33. Item 10, wheel path 3, low-severity shoving after 4,200 passes

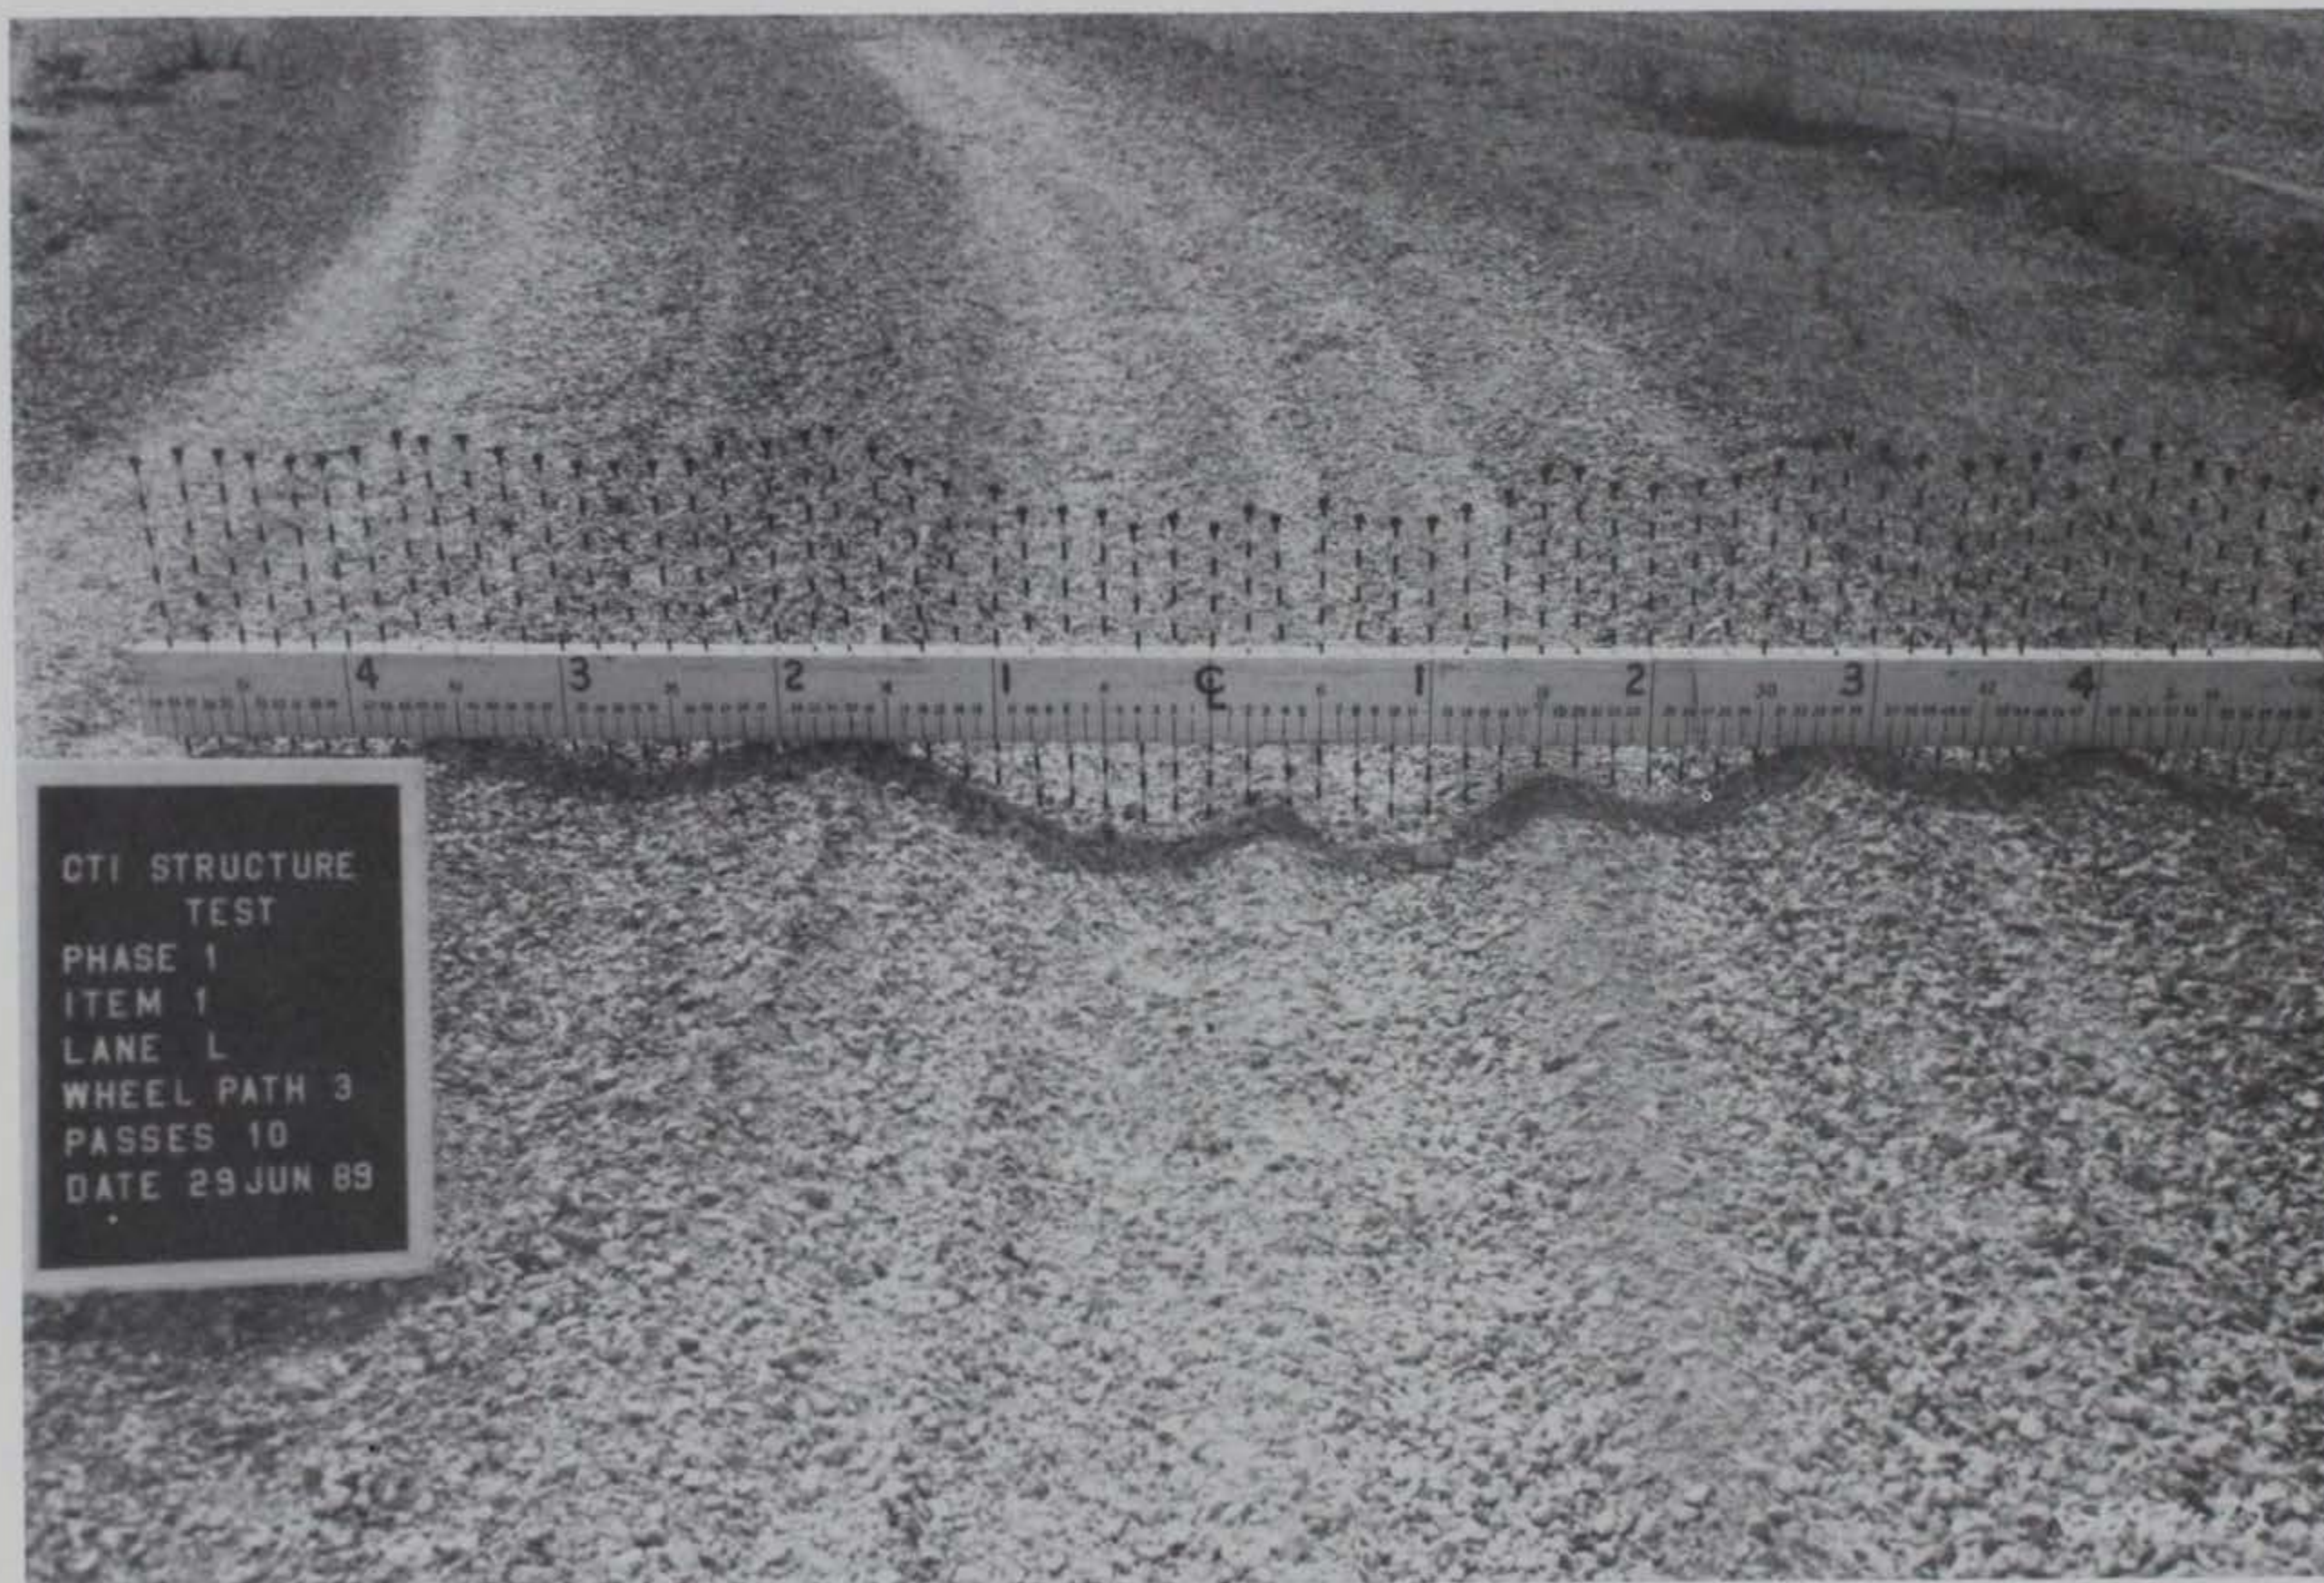
Photo 41. Item 1, low-pressure tire lane 5.5 in. rutting after 10 passes

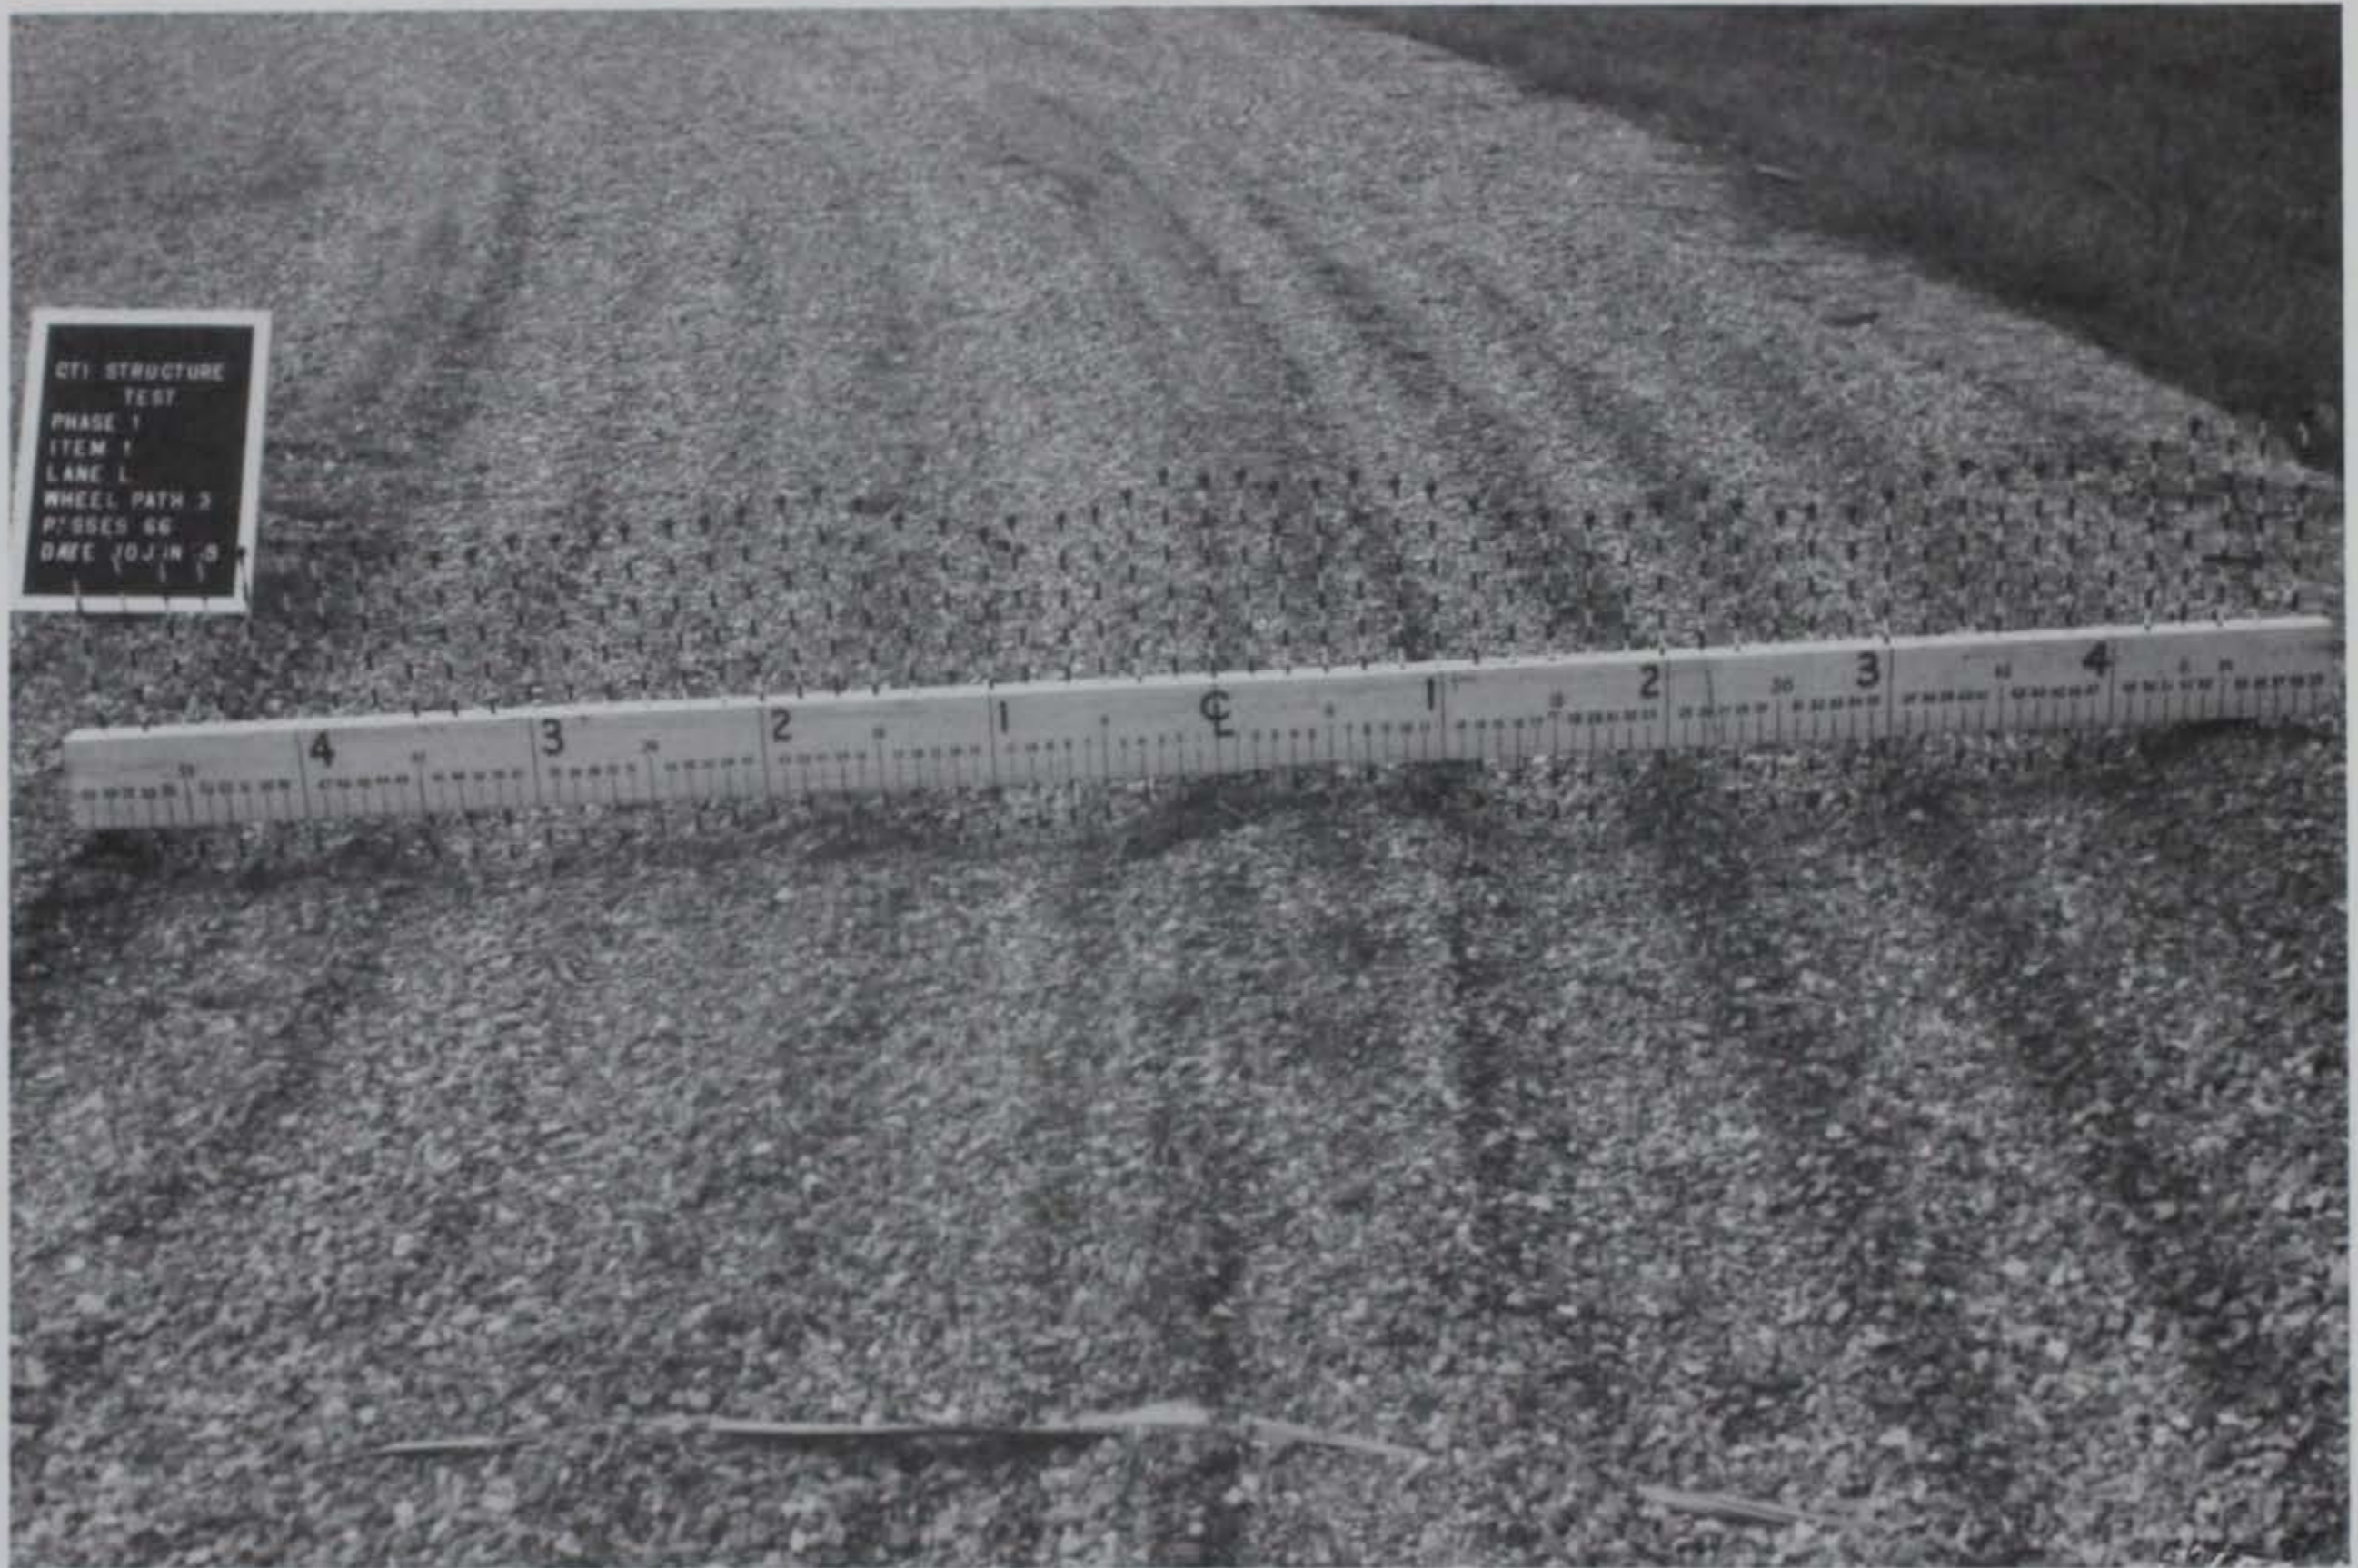
Photo 42. Item 1, low-pressure tire lane, failure after 66 passes

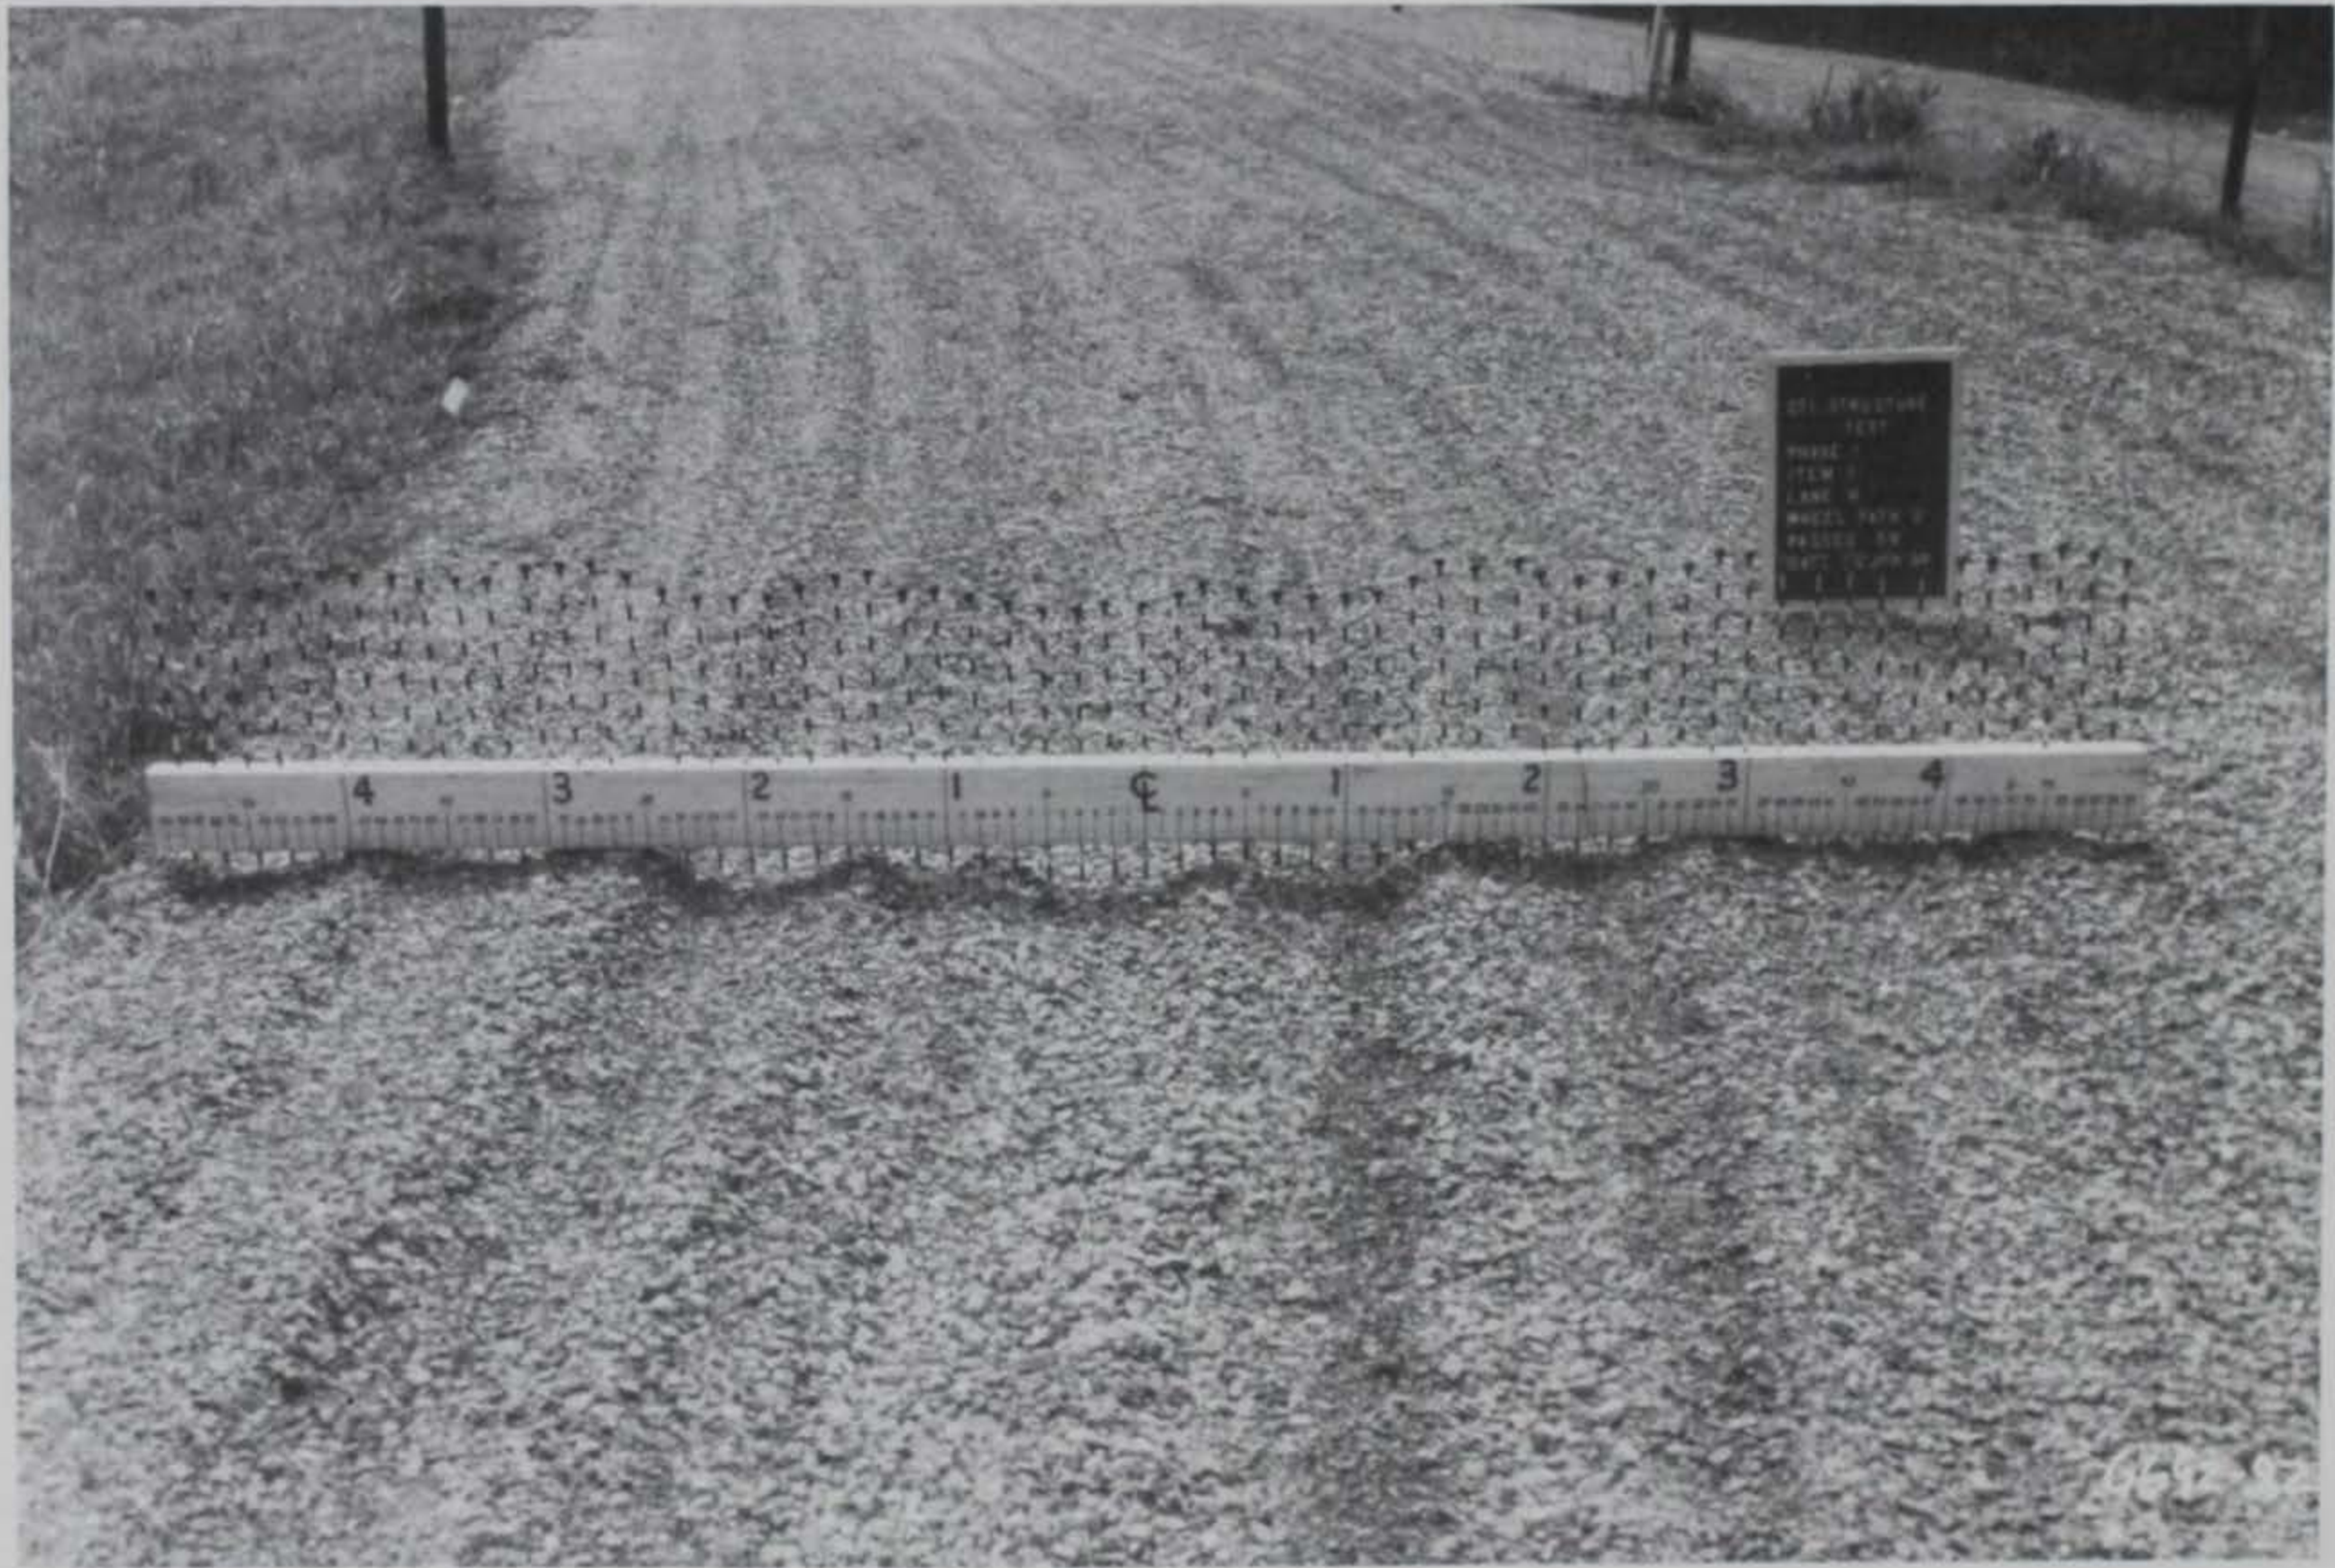
Photo 43. Item 1, high-pressure tire lane, failure after 58 passes

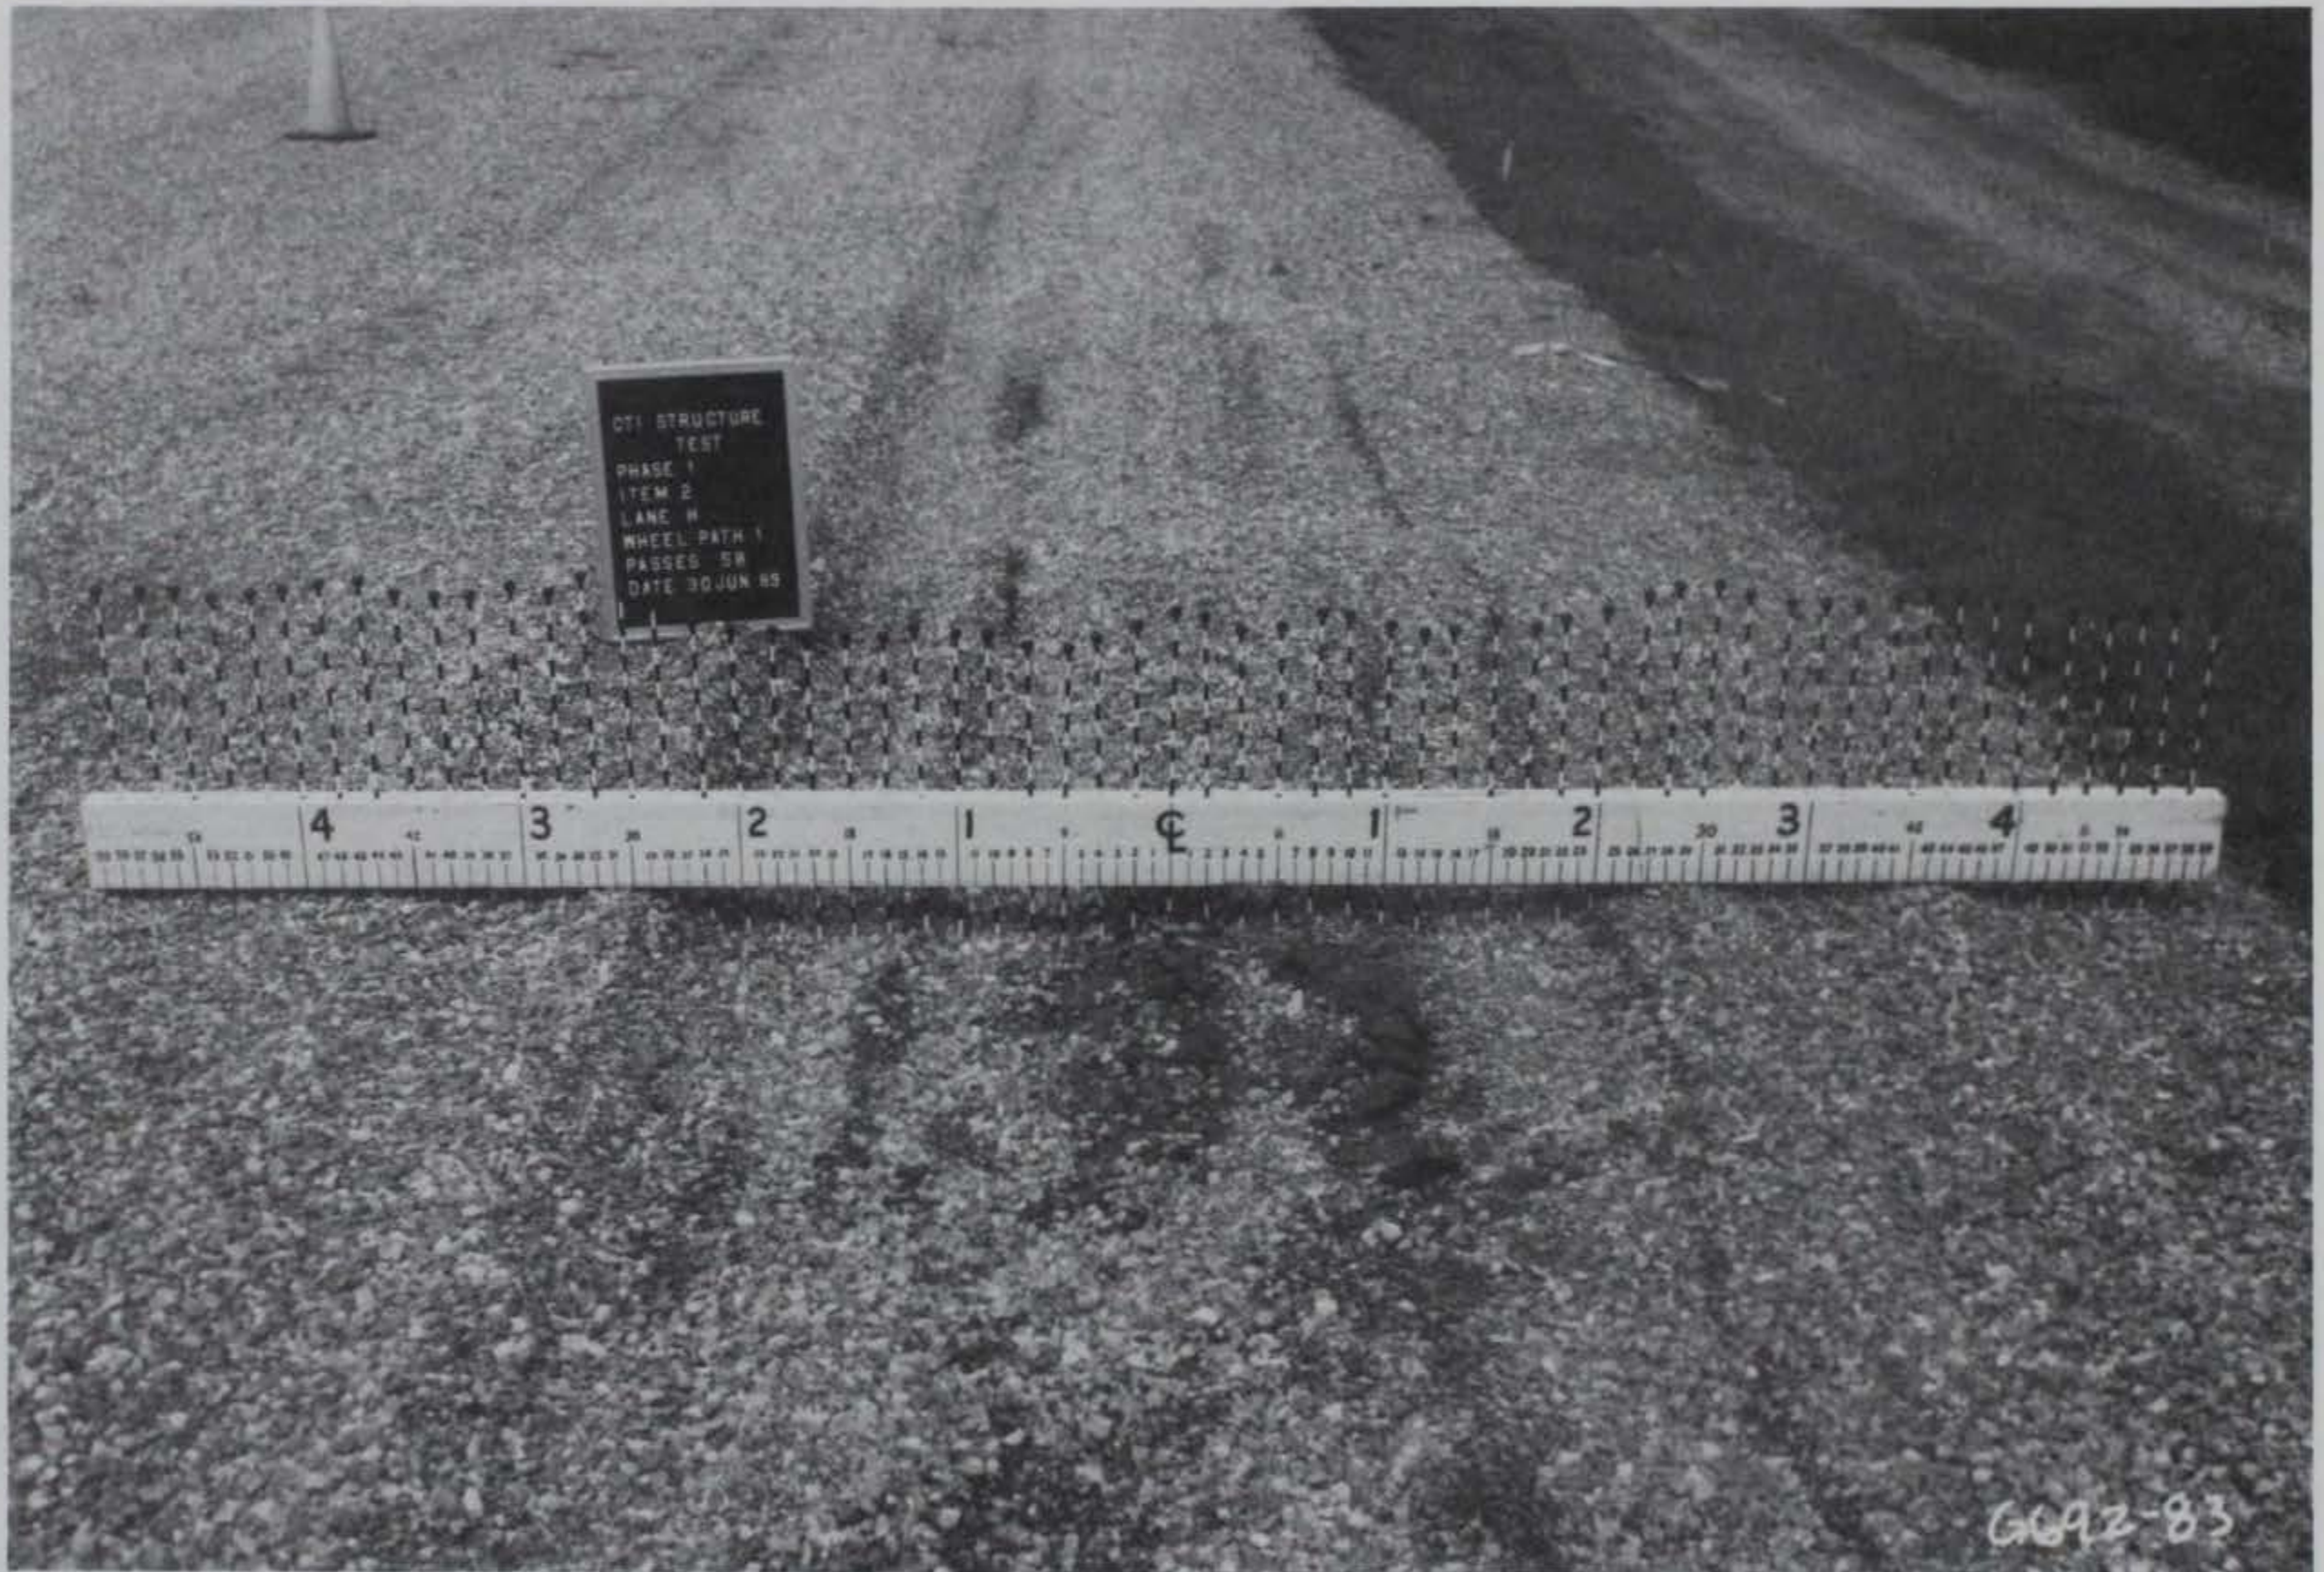
Photo 44. Item 2, high-pressure tire lane, failure after 58 passes

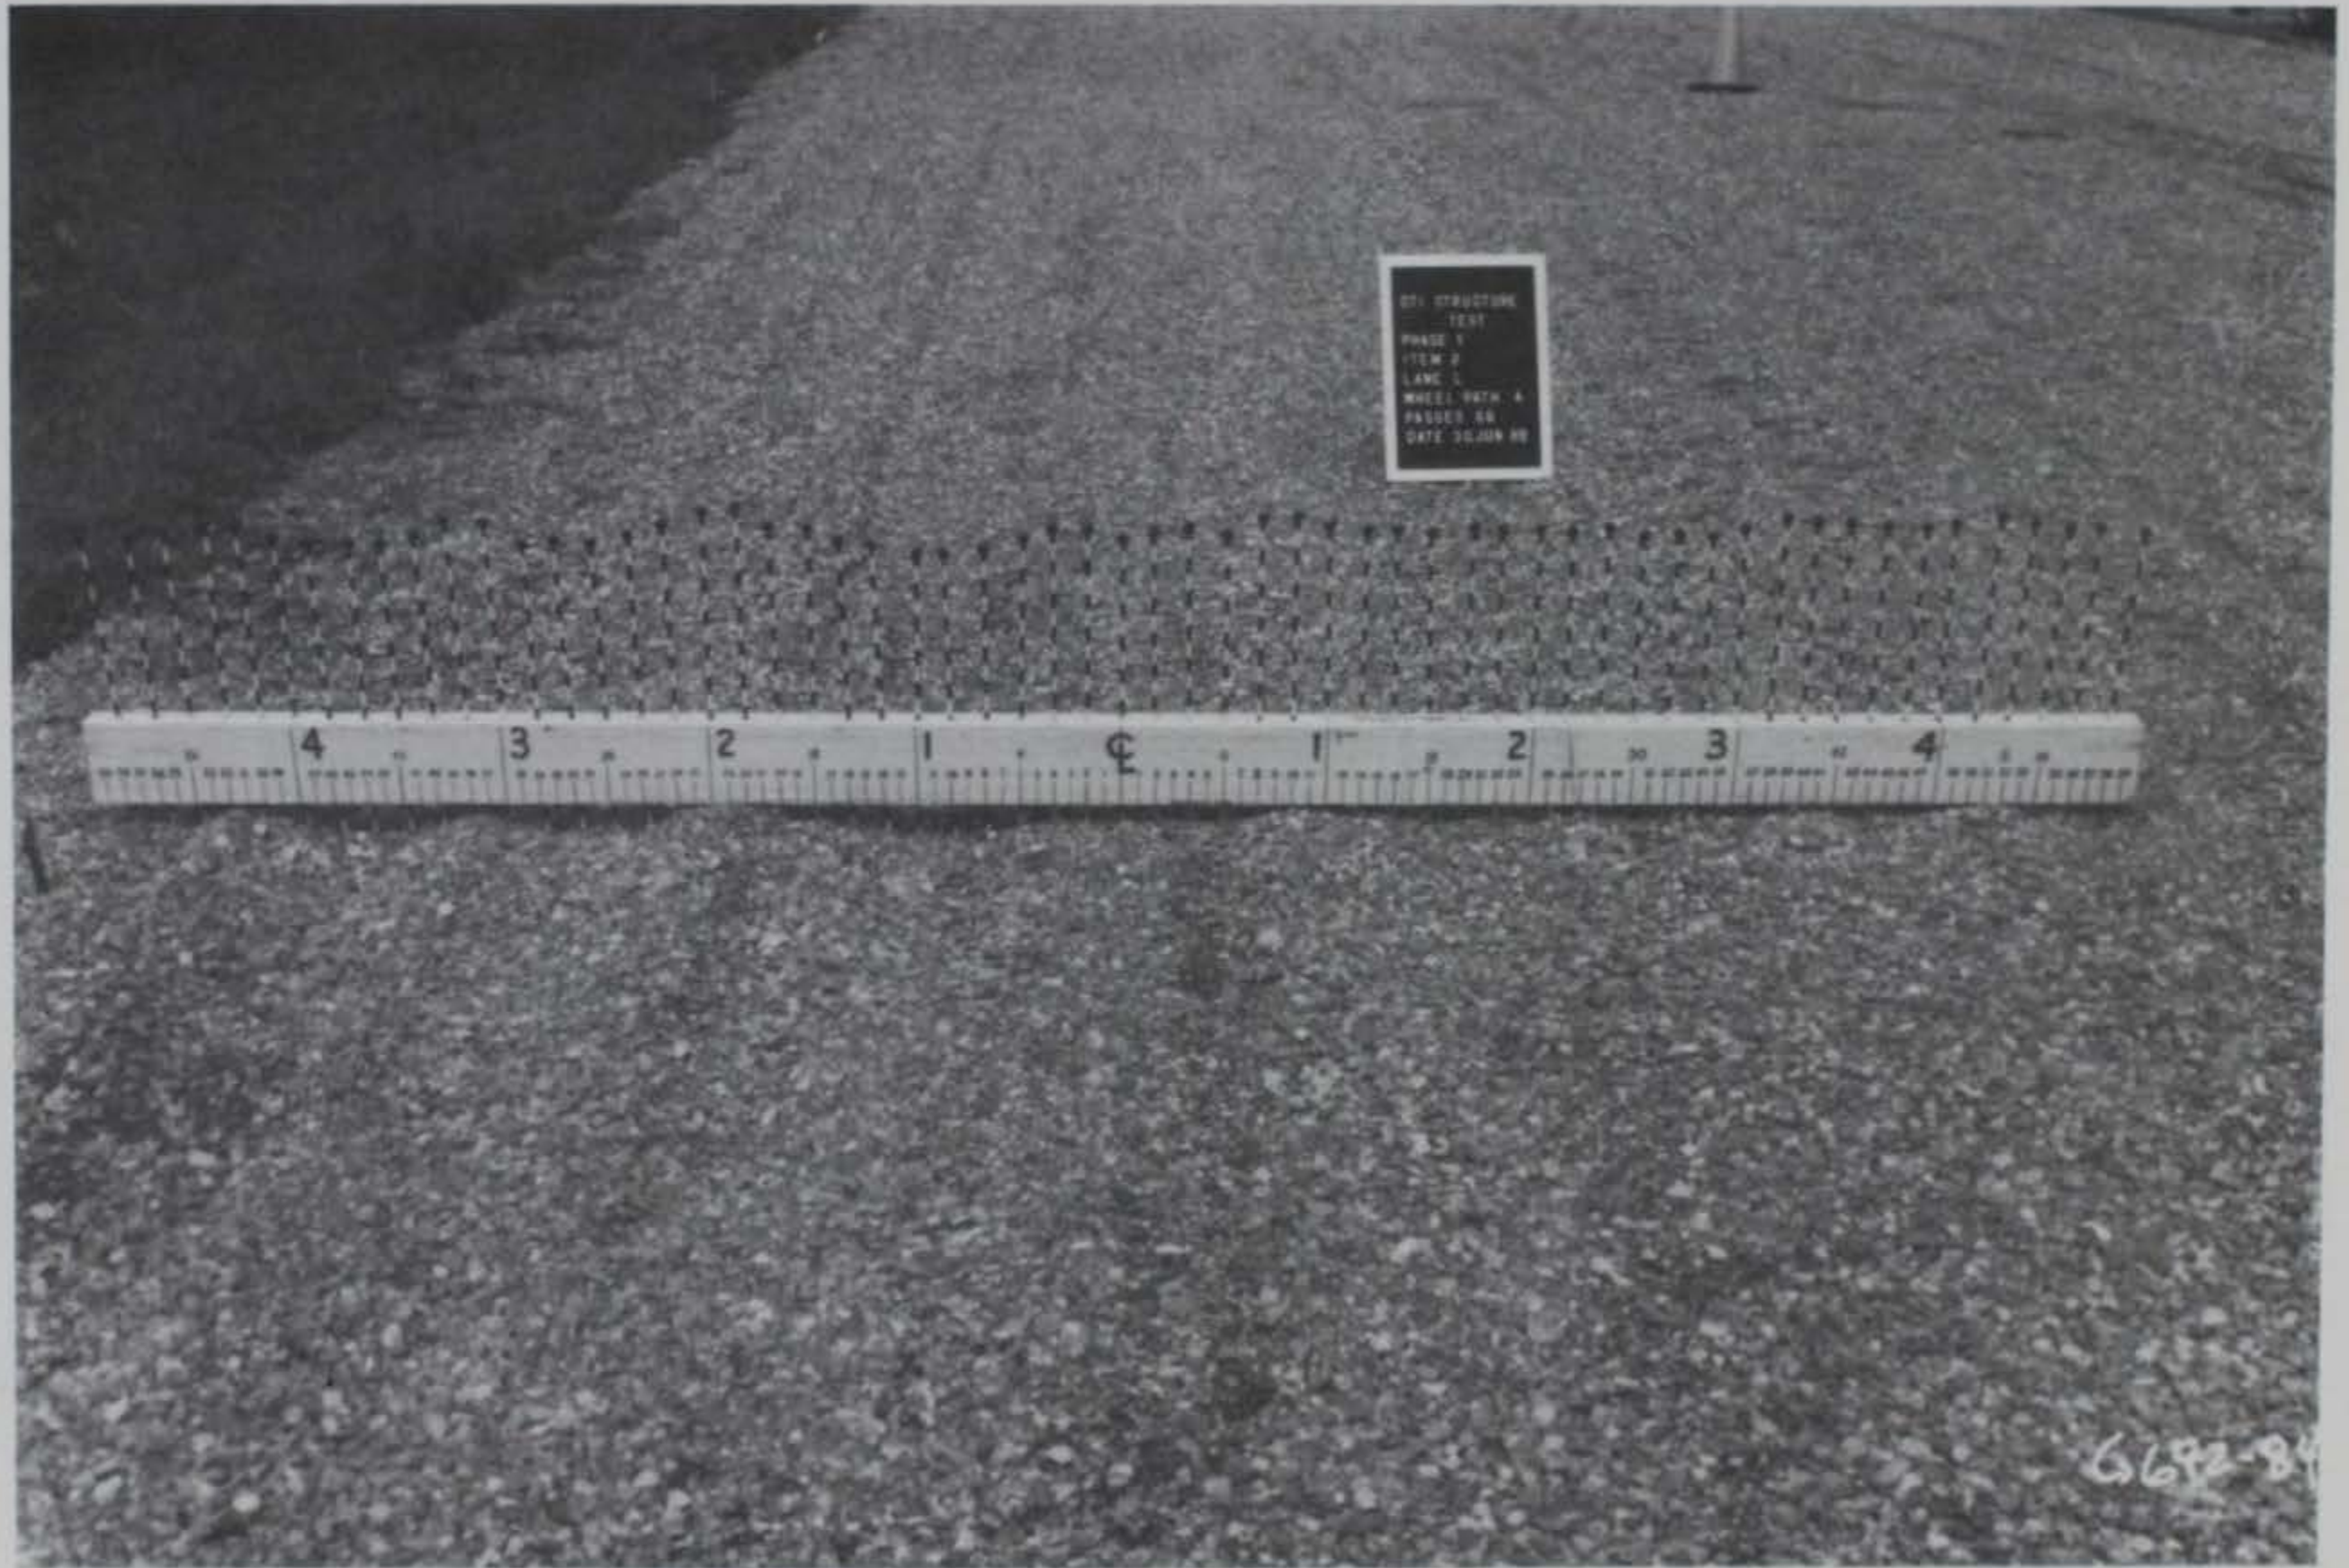
Photo 45. Item 2, low-pressure tire lane, failure after 66 passes
