Effects of Variable Tire Pressure on Road Surfacing

Volume I: Design, Construction, Behavior Under Traffic, and Test Results

by *Robert W. Grau*
Geotechnical Laboratory

Technical Report GL-93-20
August 1993

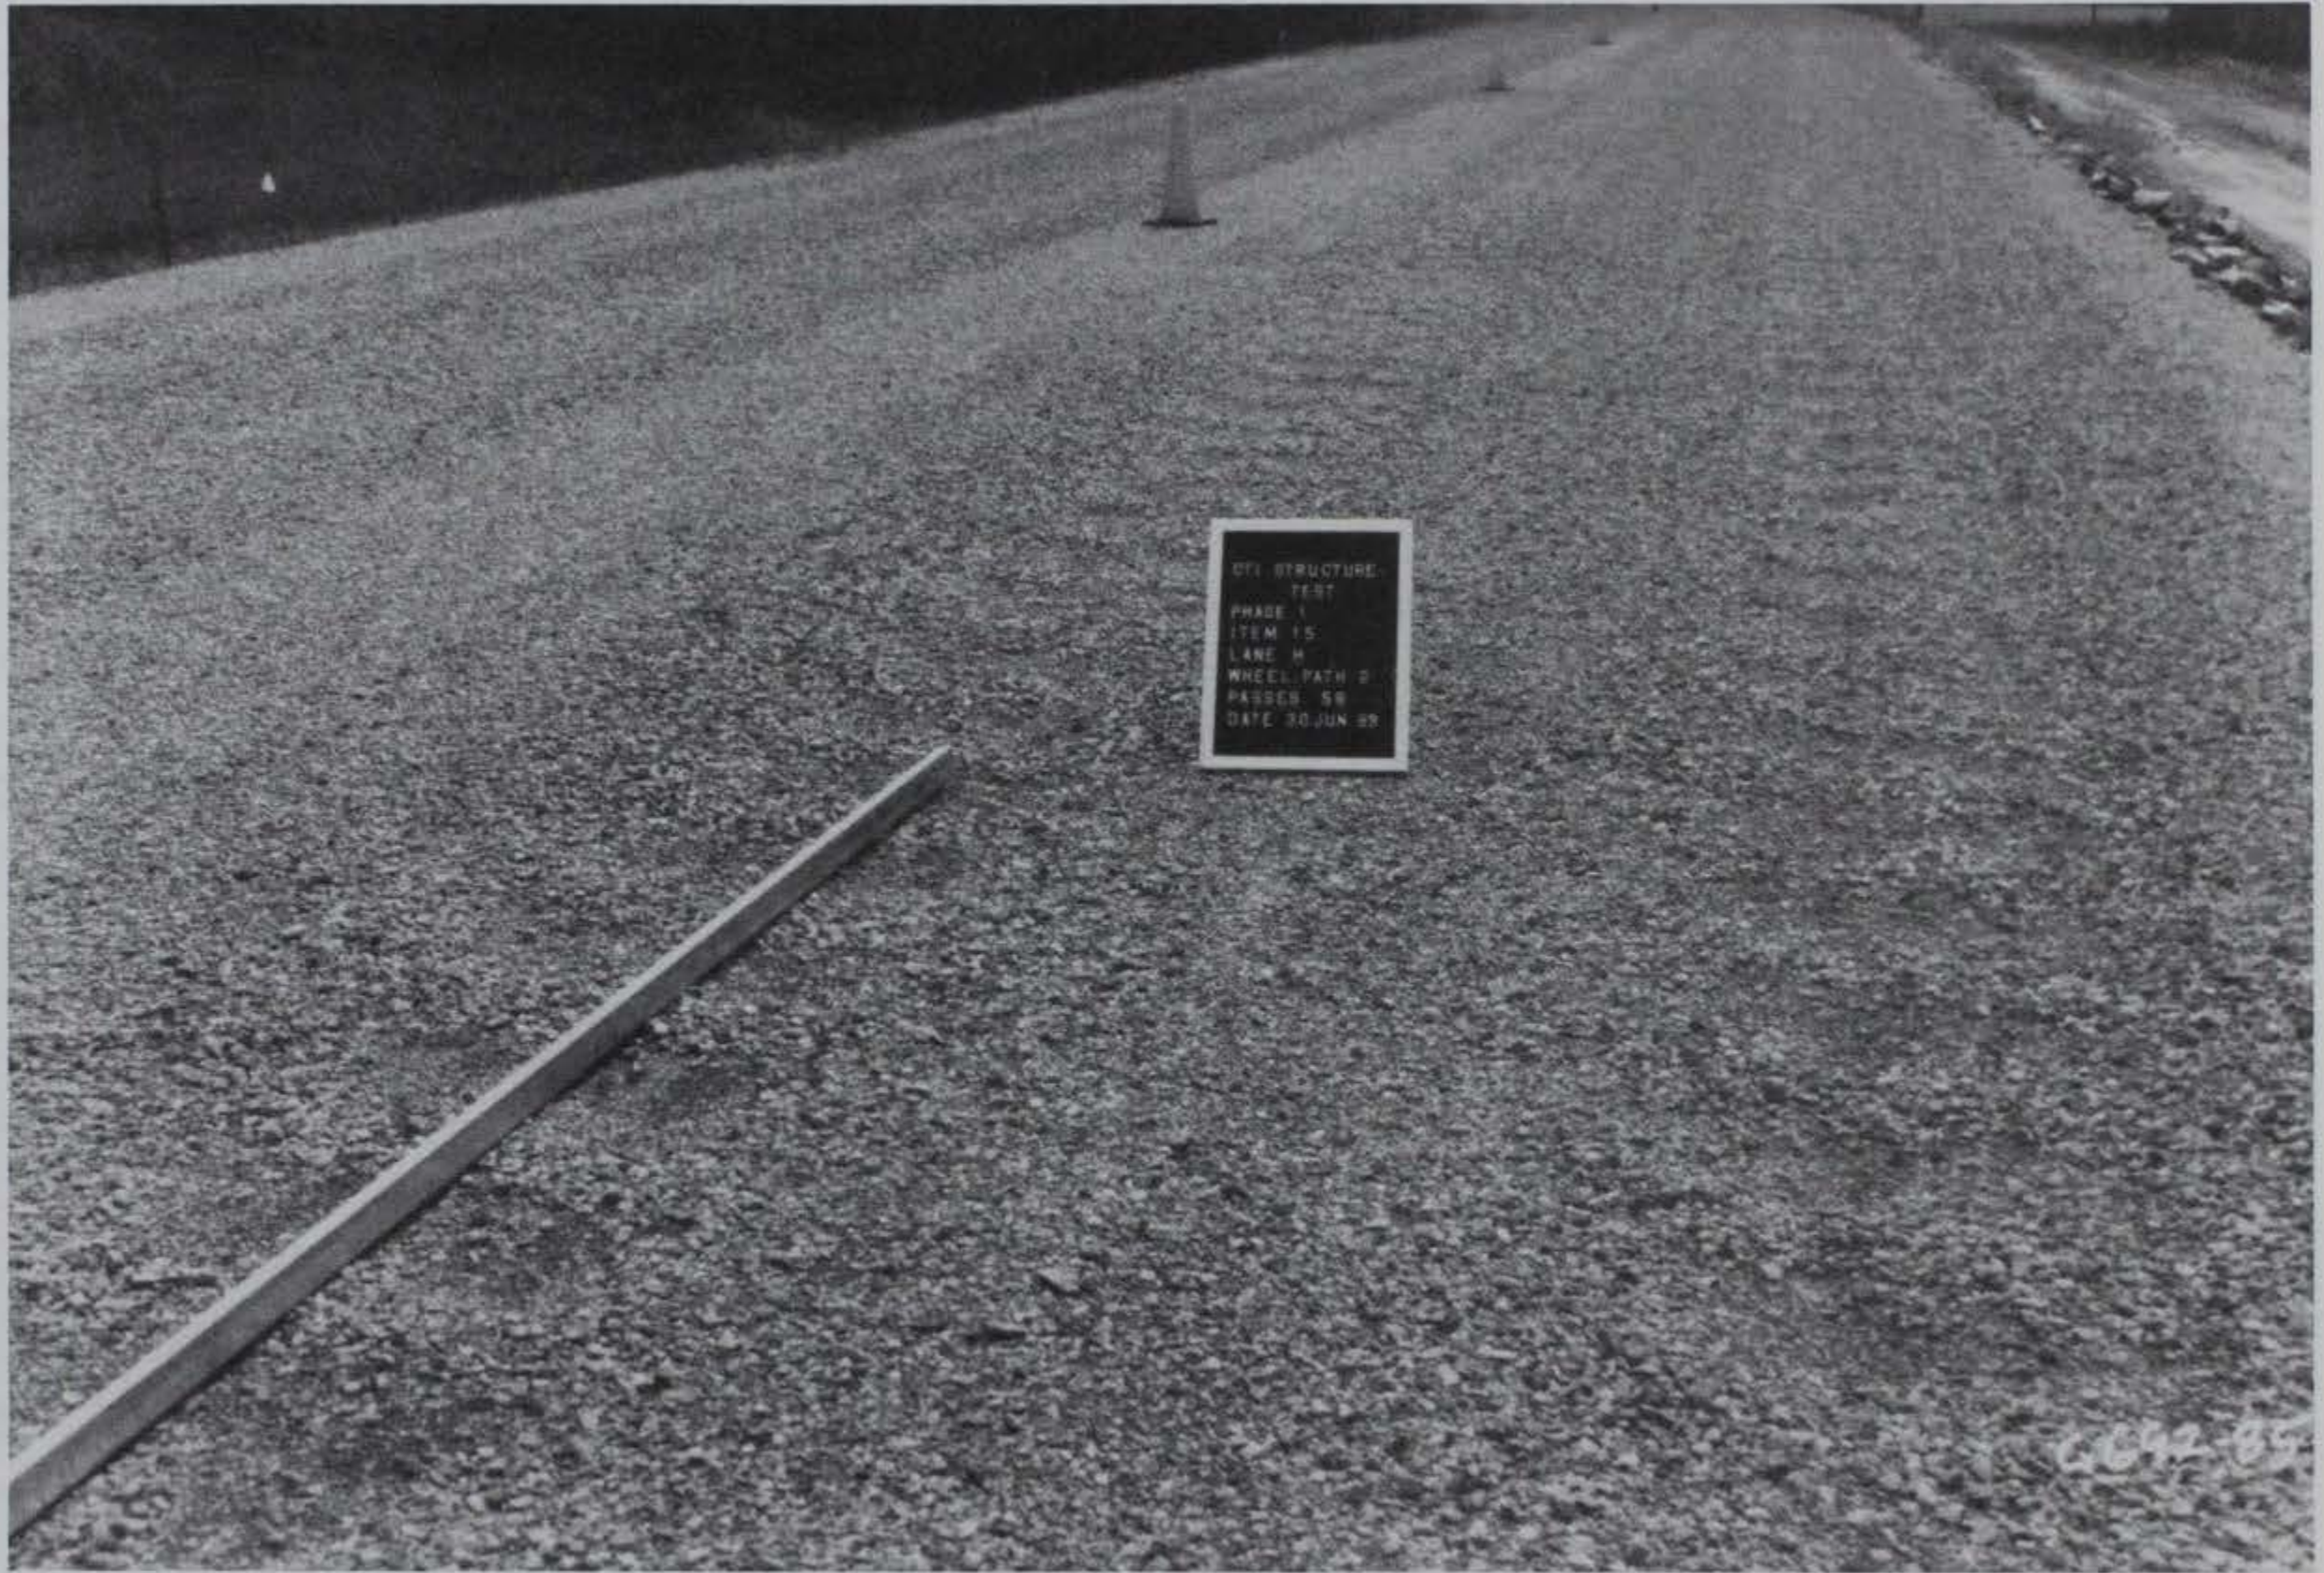
Photo 46. Item 15, high-pressure tire lane, low-severity washboarding after 58 passes

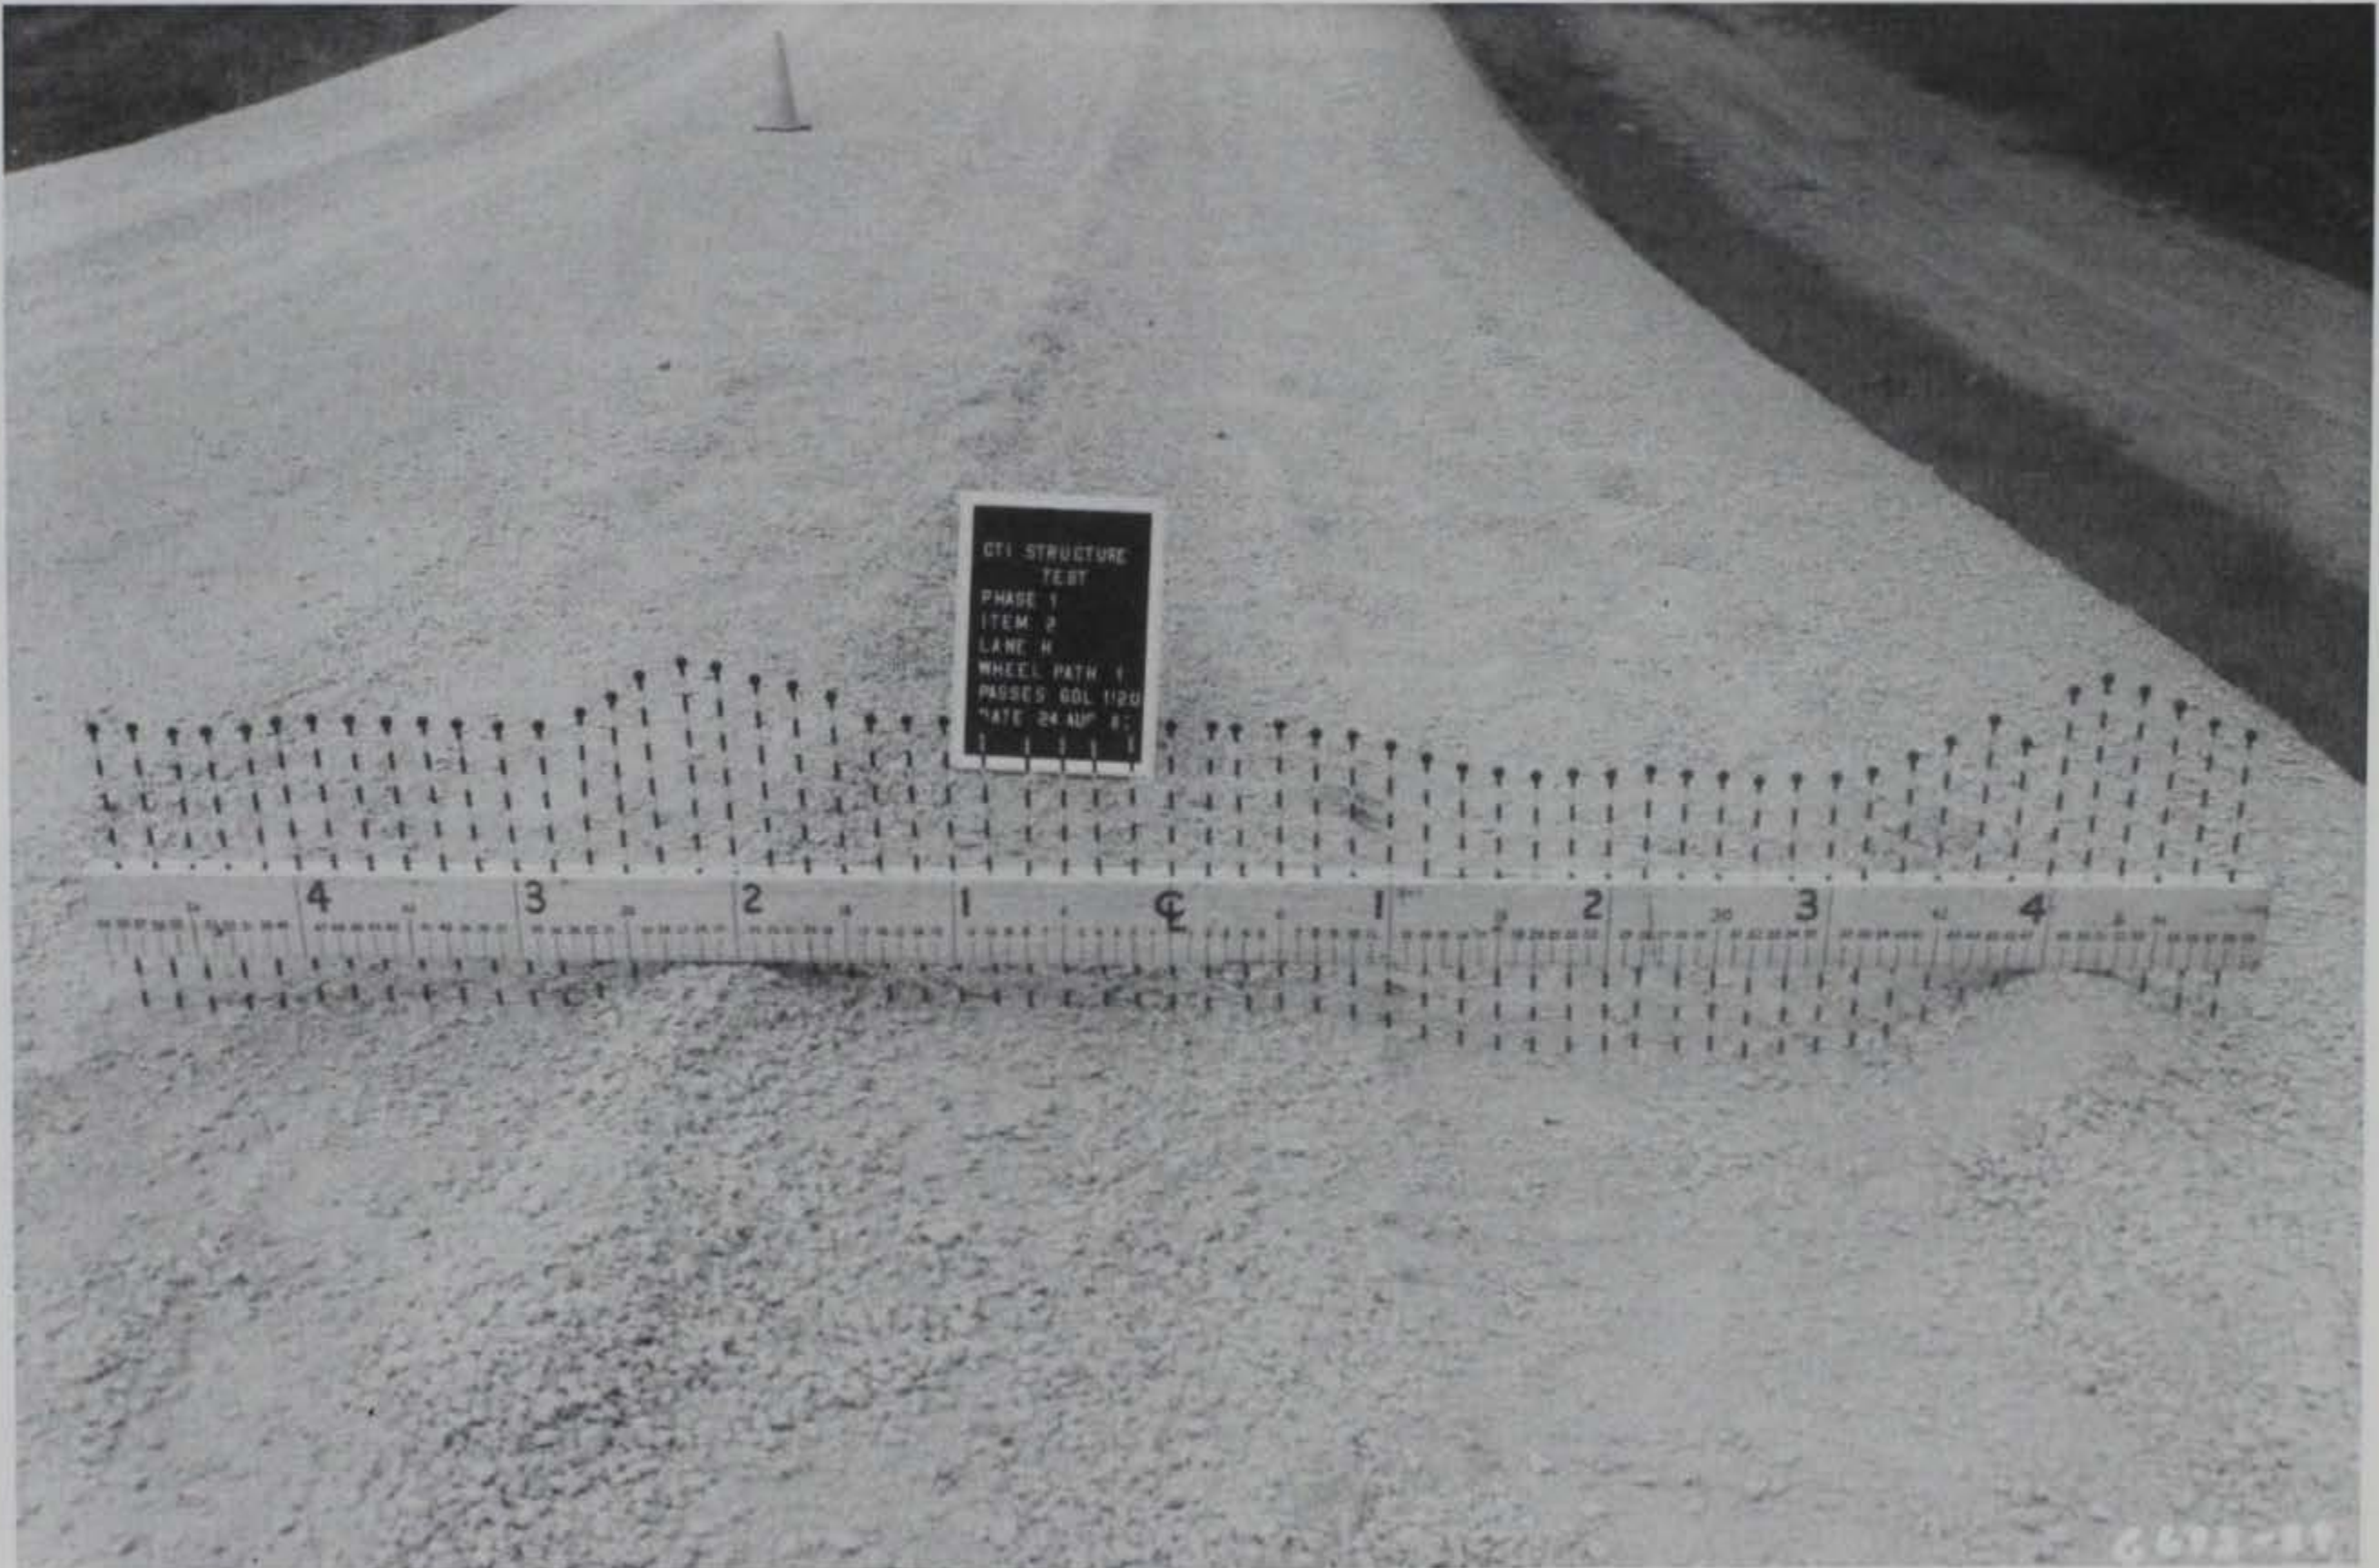
50 passes. The corrugation was 2.5 in. deep, and the truck driver reduced speed in order to safely maneuver over item 2. After 112 passes, severe washboarding was measured throughout the high-tire-pressure lane of item 2. At this time, this item was judged as failed and required blading. An overall view of the high-tire-pressure lane of item 2 after the 112 unloaded passes is shown in Photo 47, and a close-up of the washboarding is shown in Photo 48. Unloaded traffic was applied directly after blading which resulted again in washboarding. After 10 passes, the high-tire-pressure truck again had to reduce speed and after 35 passes the corrugations were 2.5 in. deep. When traffic was switched to loaded (trucks running downhill), the maximum depth of washboarding decreased about an inch. The high-tire-pressure unloaded traffic continued to cause severe distress in item 2, and after 584 loaded and 556 unloaded passes this item was graded for the fourth time. Monitoring performance of this item and lane was discontinued after the fourth failure. The maximum rut depth was measured at each time, and item 2 was judged failed as shown in Table 25. Very little distress was observed in the low-tire-pressure lane of Item 2, and grading was never required. The greatest distress occurred when a pothole occurred in the no-test-section area adjacent to this item which resulted in washboarding migrating into item 2. However, as shown in Photo 49, the low-pressure tires seemed to dampen out the bouncing of the truck which resulted in no corrugation 15 to 20 ft from the pothole. The horizontal curves in item 1 performed approximately the same under low- and high-tire-pressure traffic. Neither required grading after being overlaid. The high-pressure-tire lane received 2,586 and 1,172 passes of loaded and unloaded traffic, respectively, and the low-tire-pressure lane received a total of 3,023 loaded and 1,384 unloaded passes of the log truck. By the end of traffic, the only distress observed was minor rutting in both lanes and low-severity corrugation in the high-tire-pressure lane. Photos 50 and 51 show general views of the high- and low-tire-pressure lane, respectively, of item 1 depicting the above distresses.

Photo 47. Item 2, high-pressure tire lane, failure after 112 unloaded passes

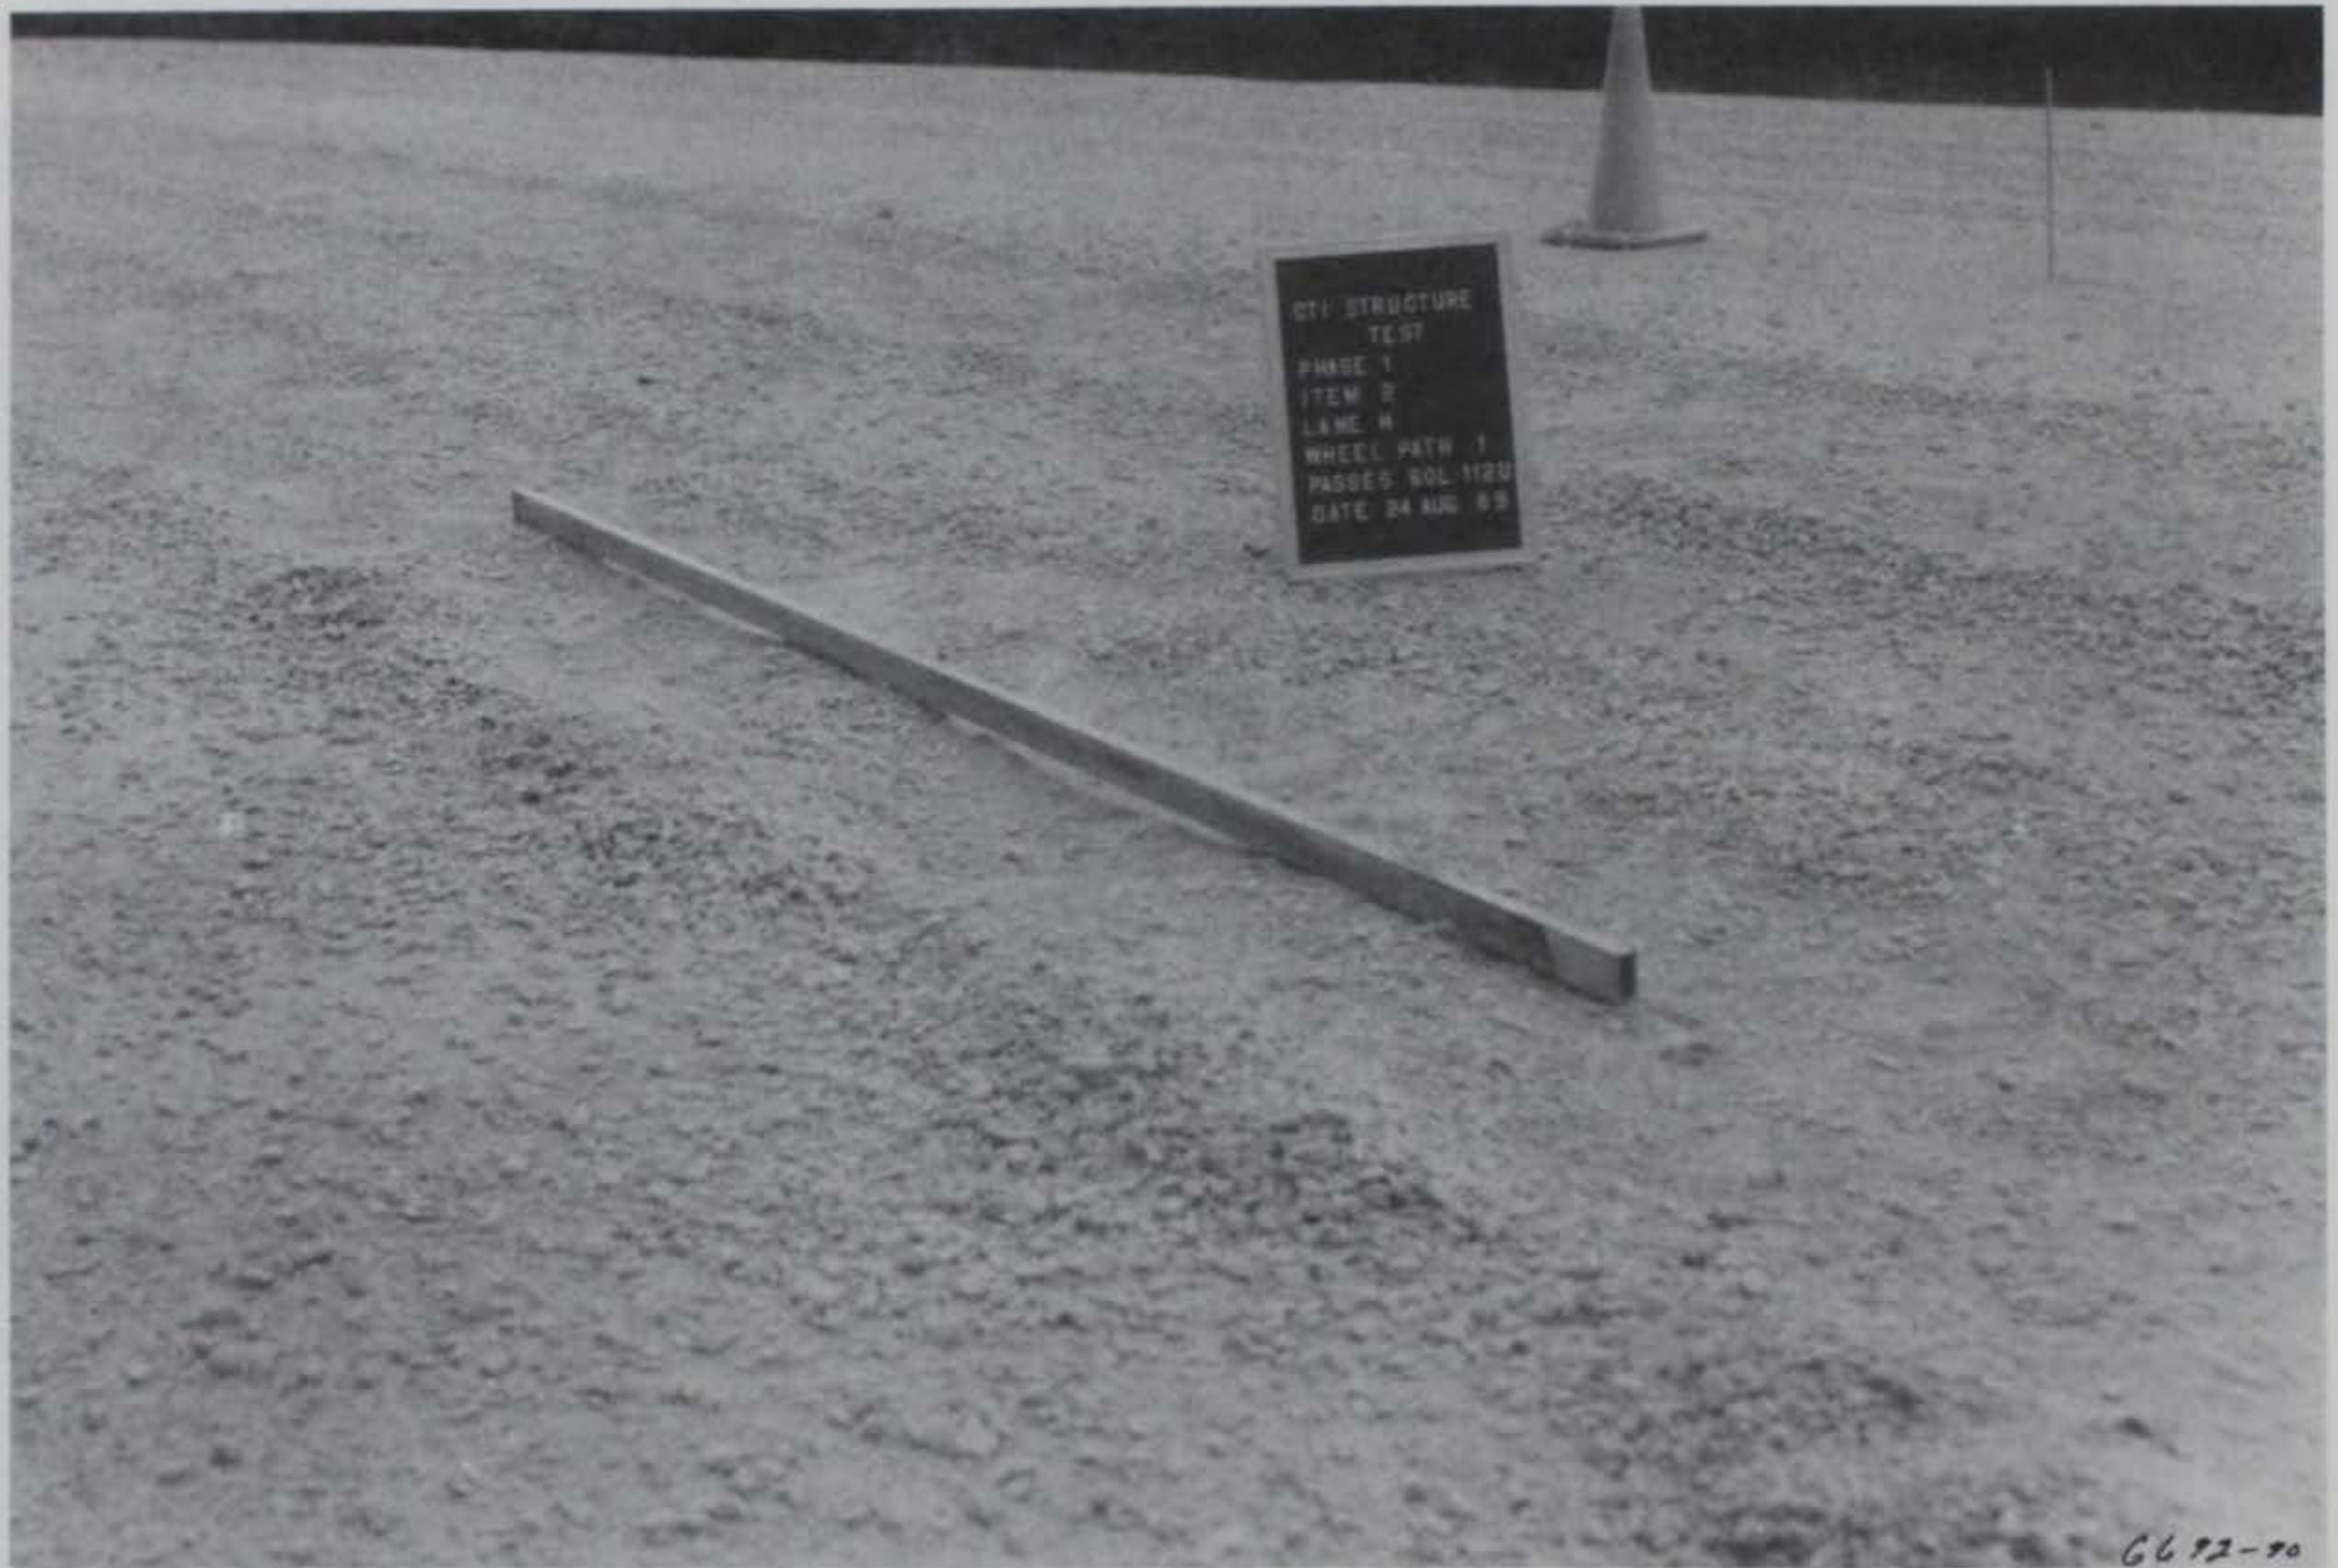
Photo 48. Item 2, high-pressure tire lane, close-up of high-severity washboarding after 112 unloaded passes

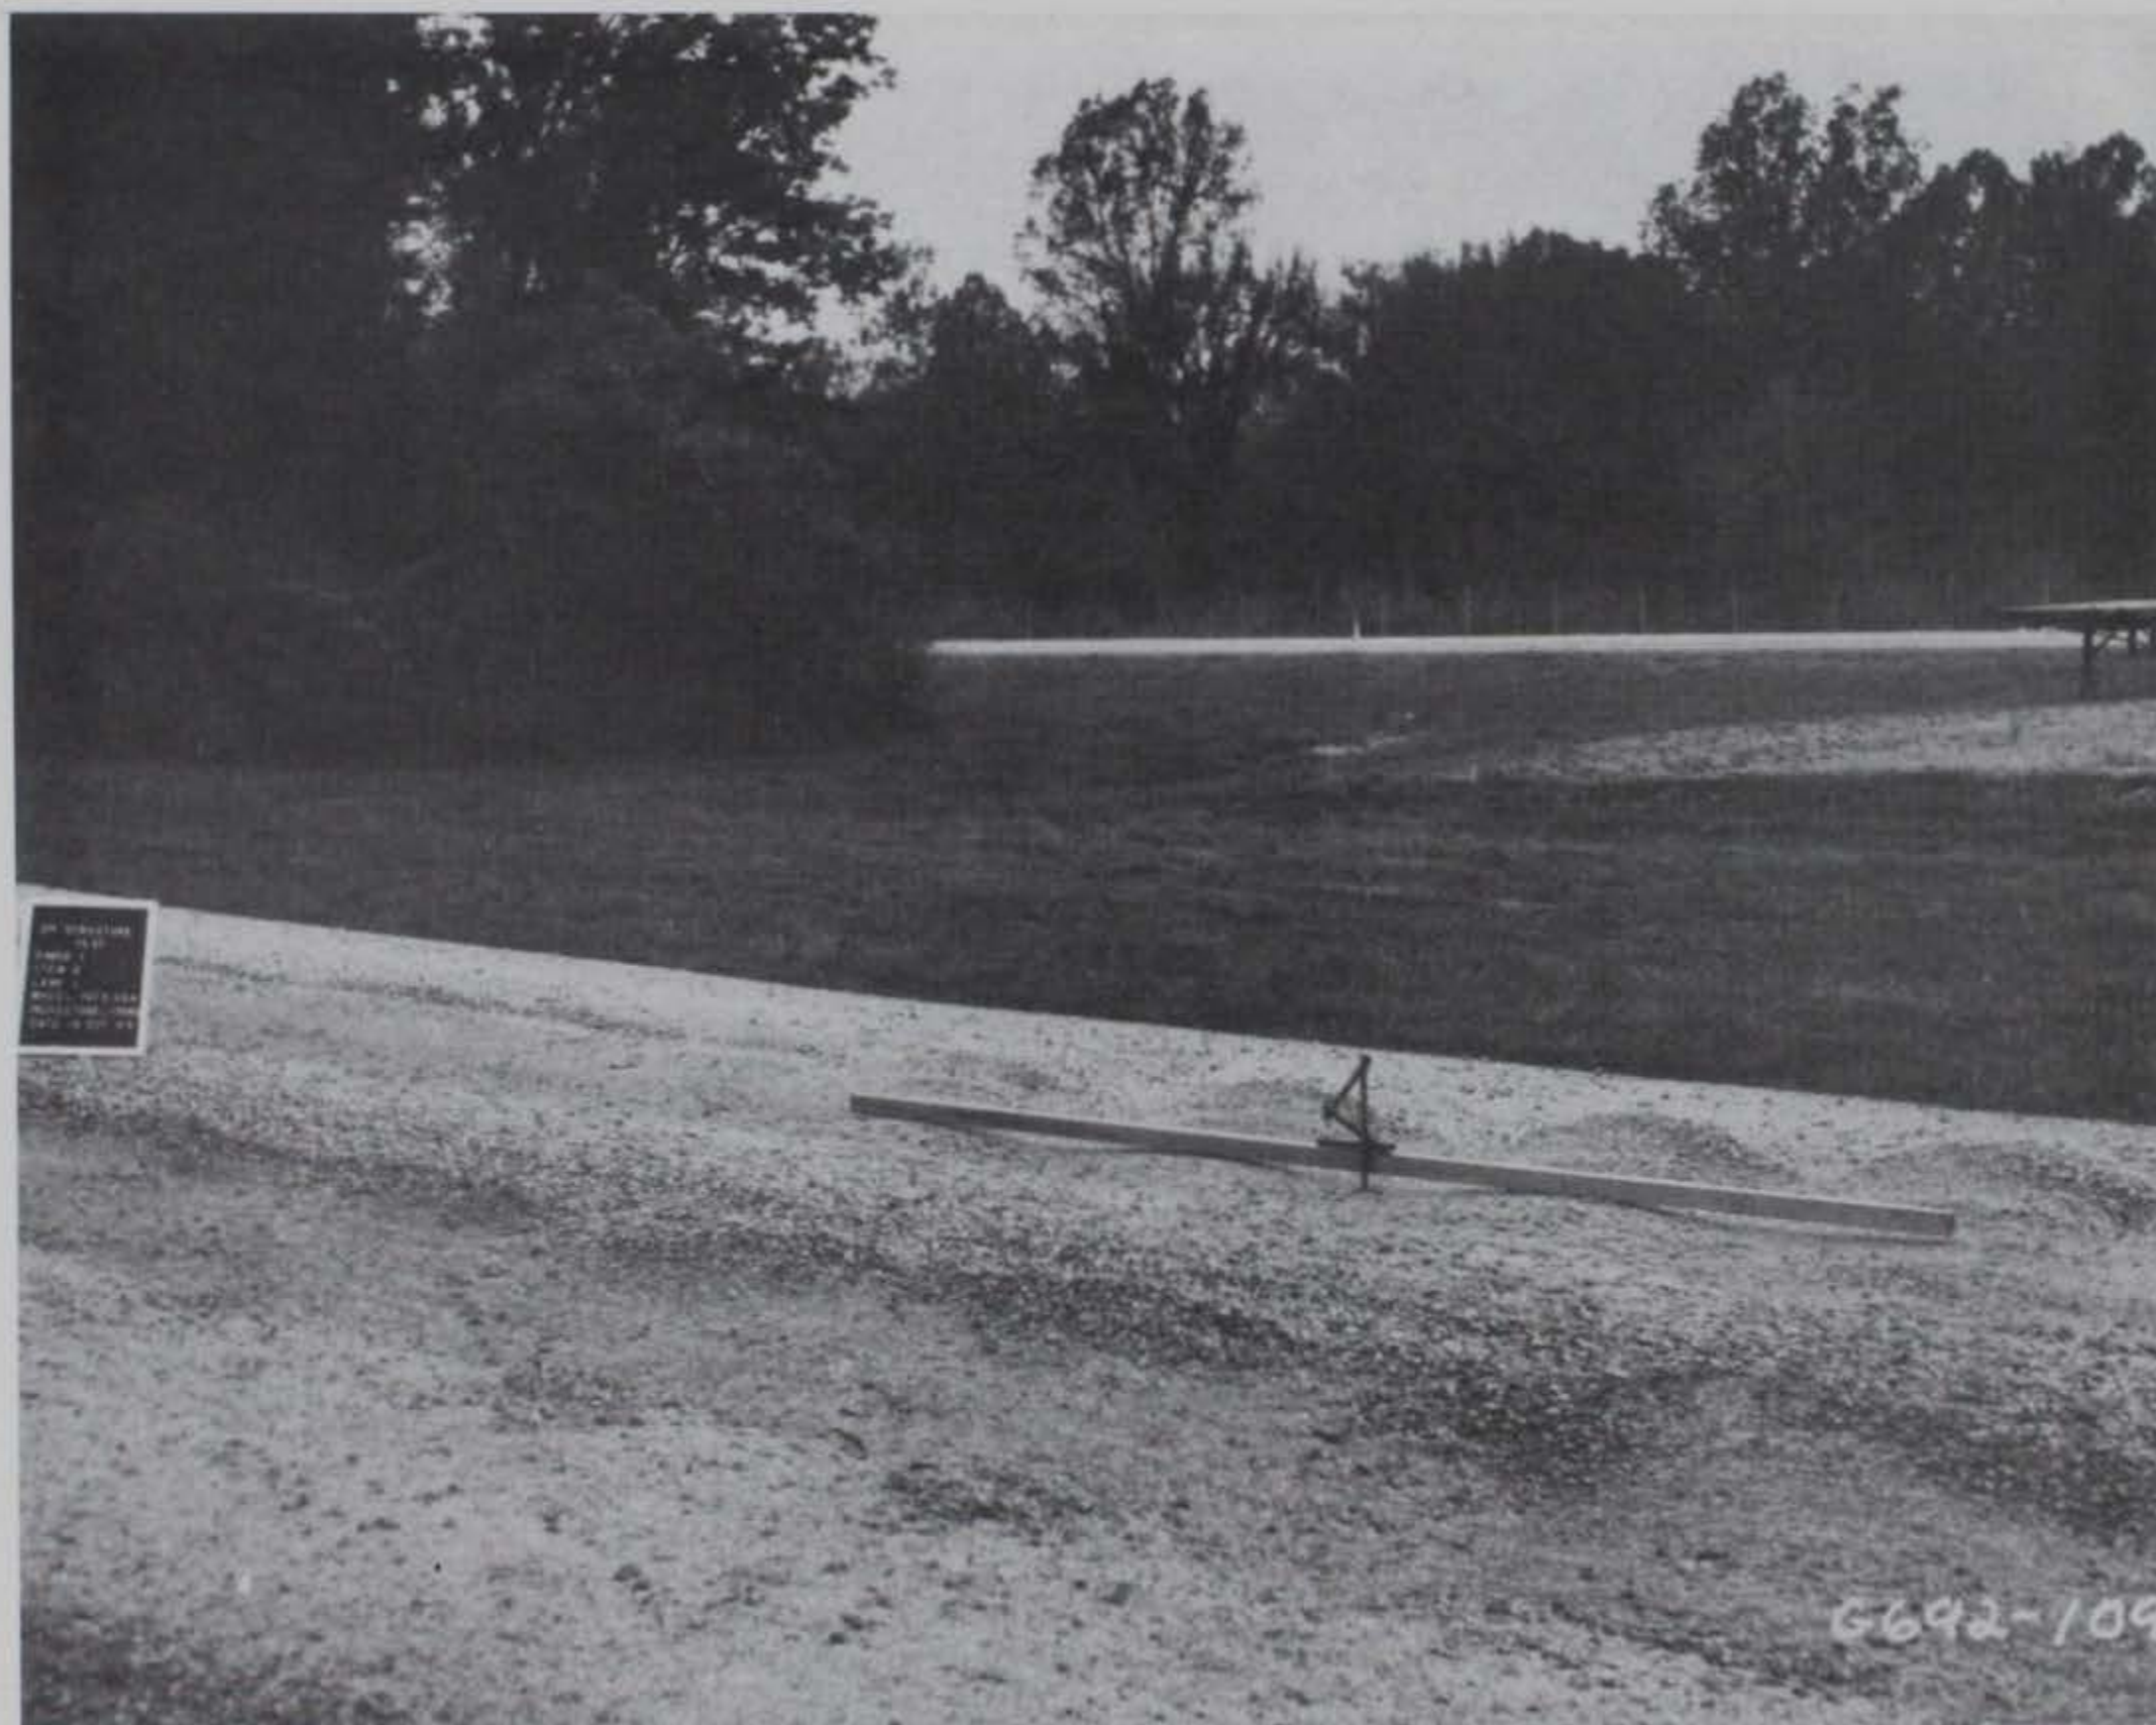
Photo 49. Item 2, low-pressure tire lane, long intervals between corrugation

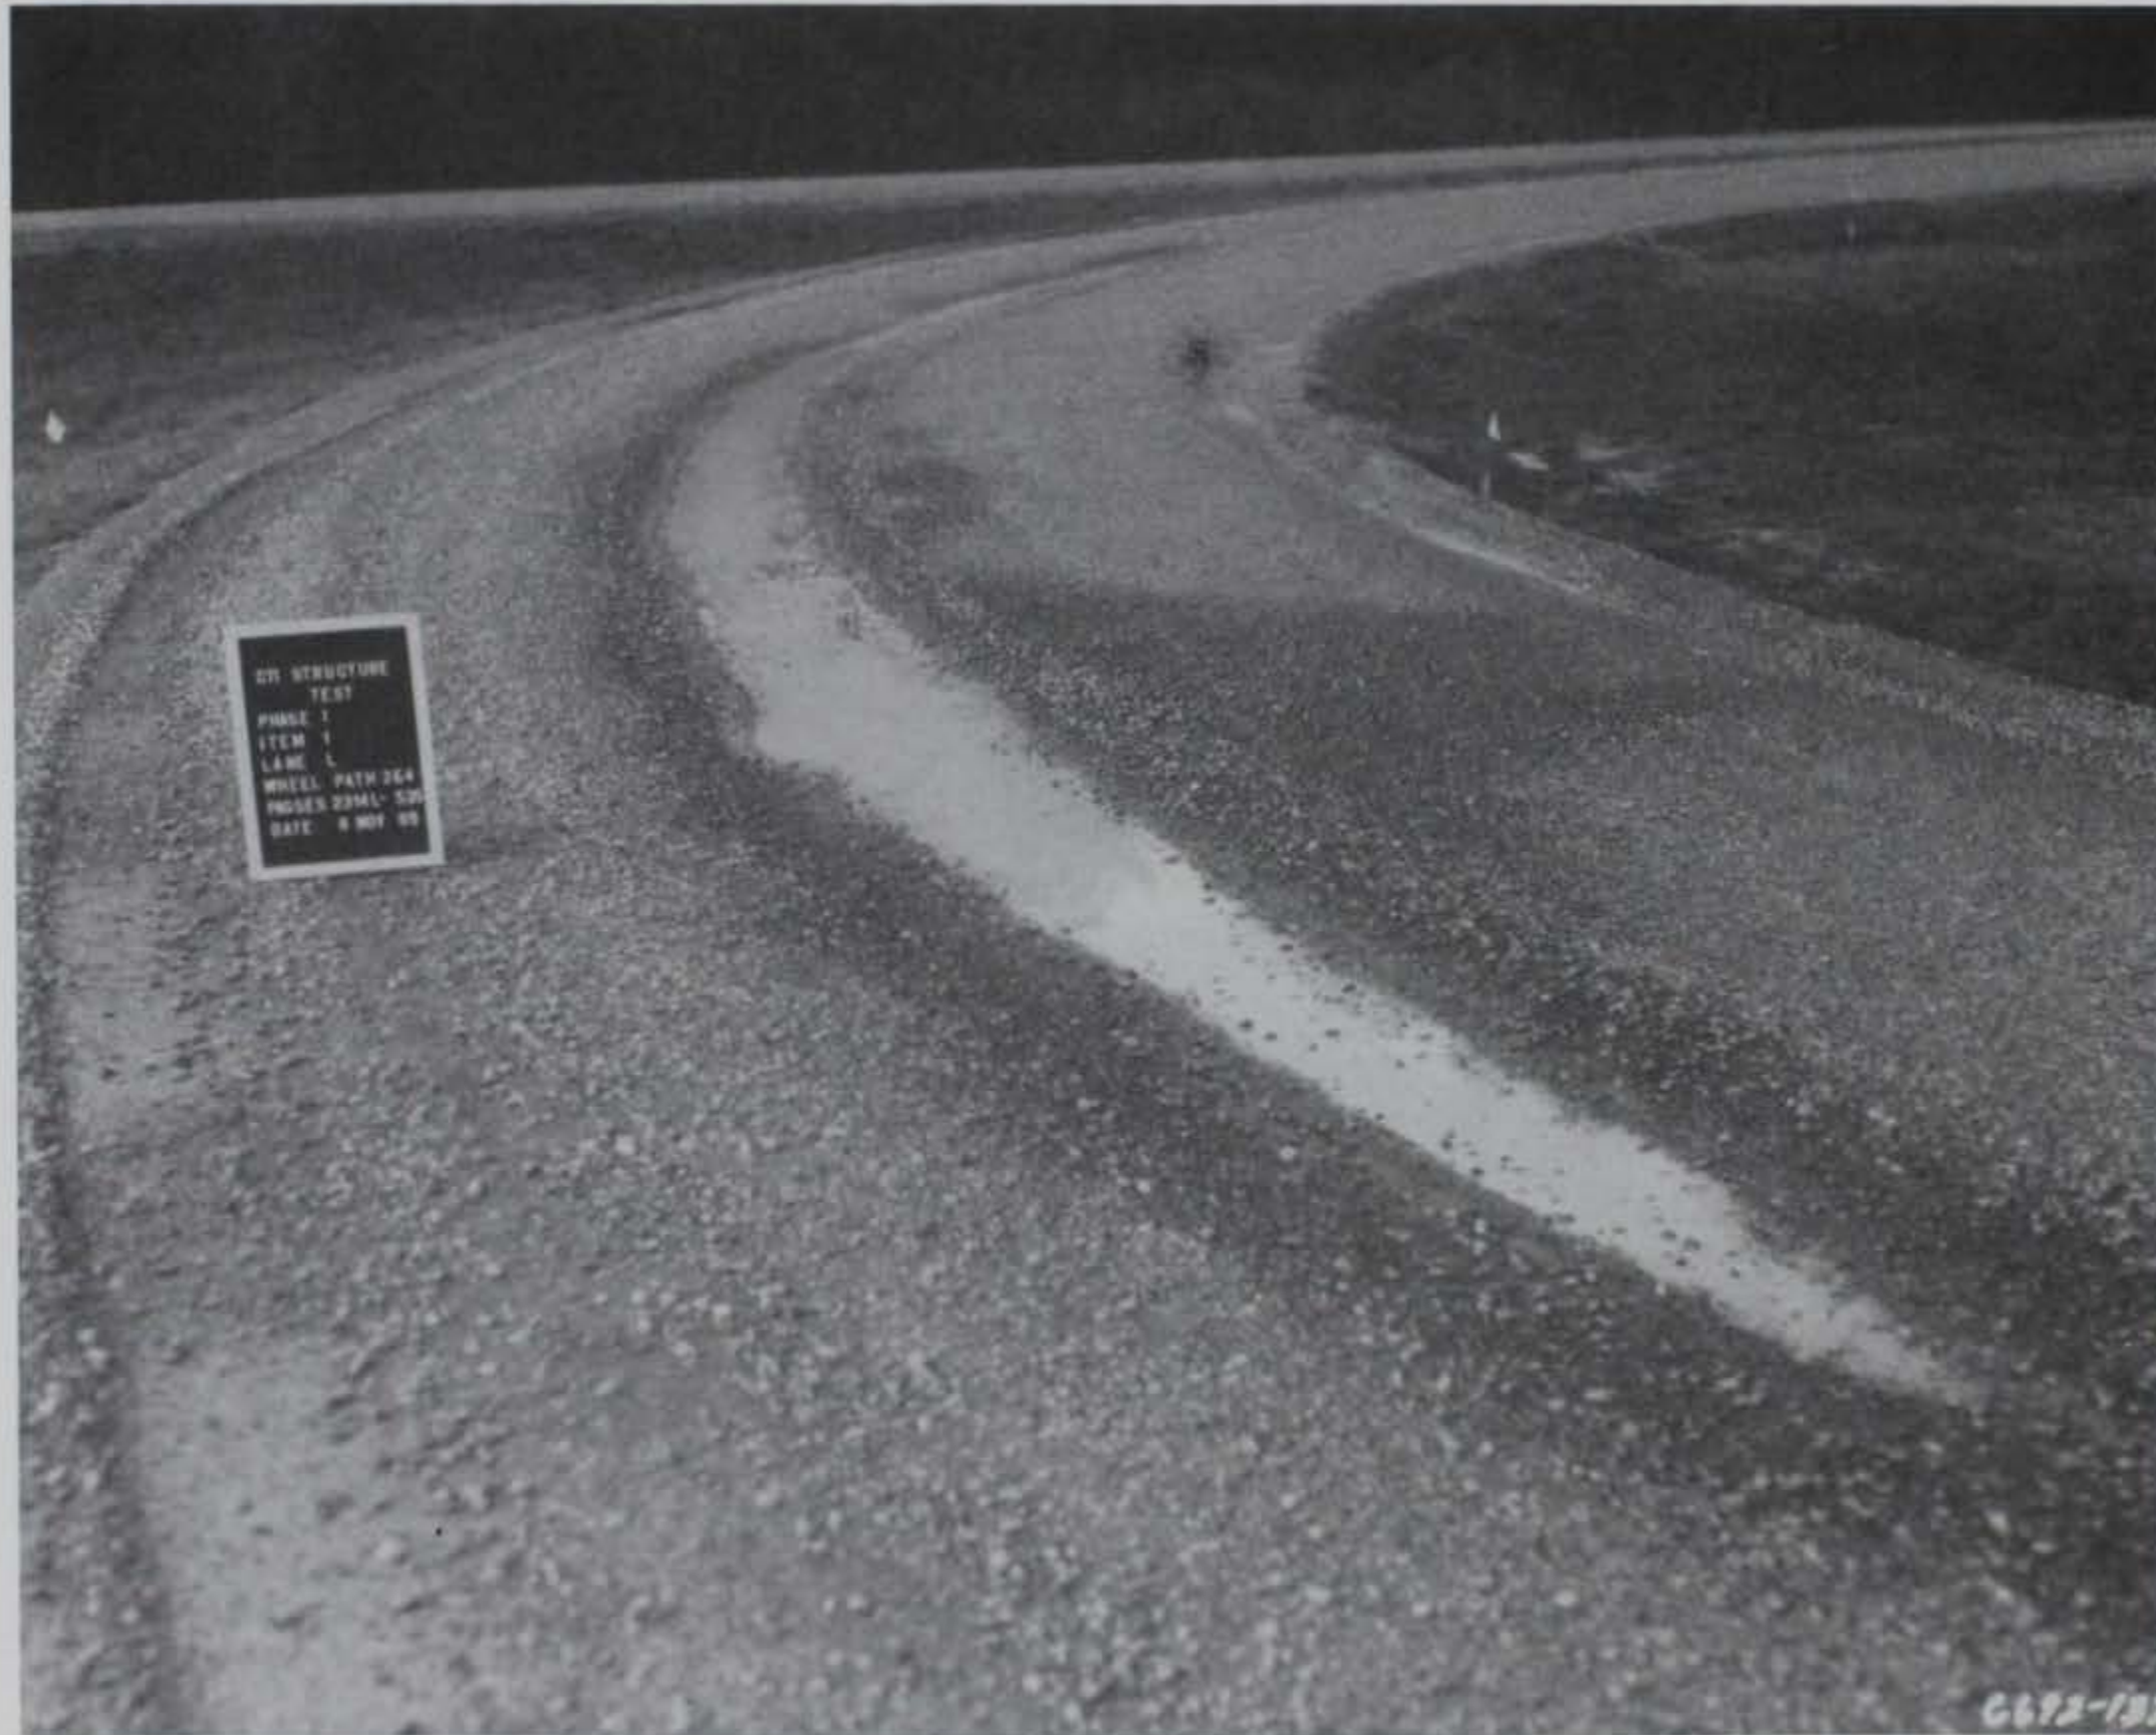
Photo 51. Item 1, low-pressure tire lane, low-severity rutting at the end of traffic

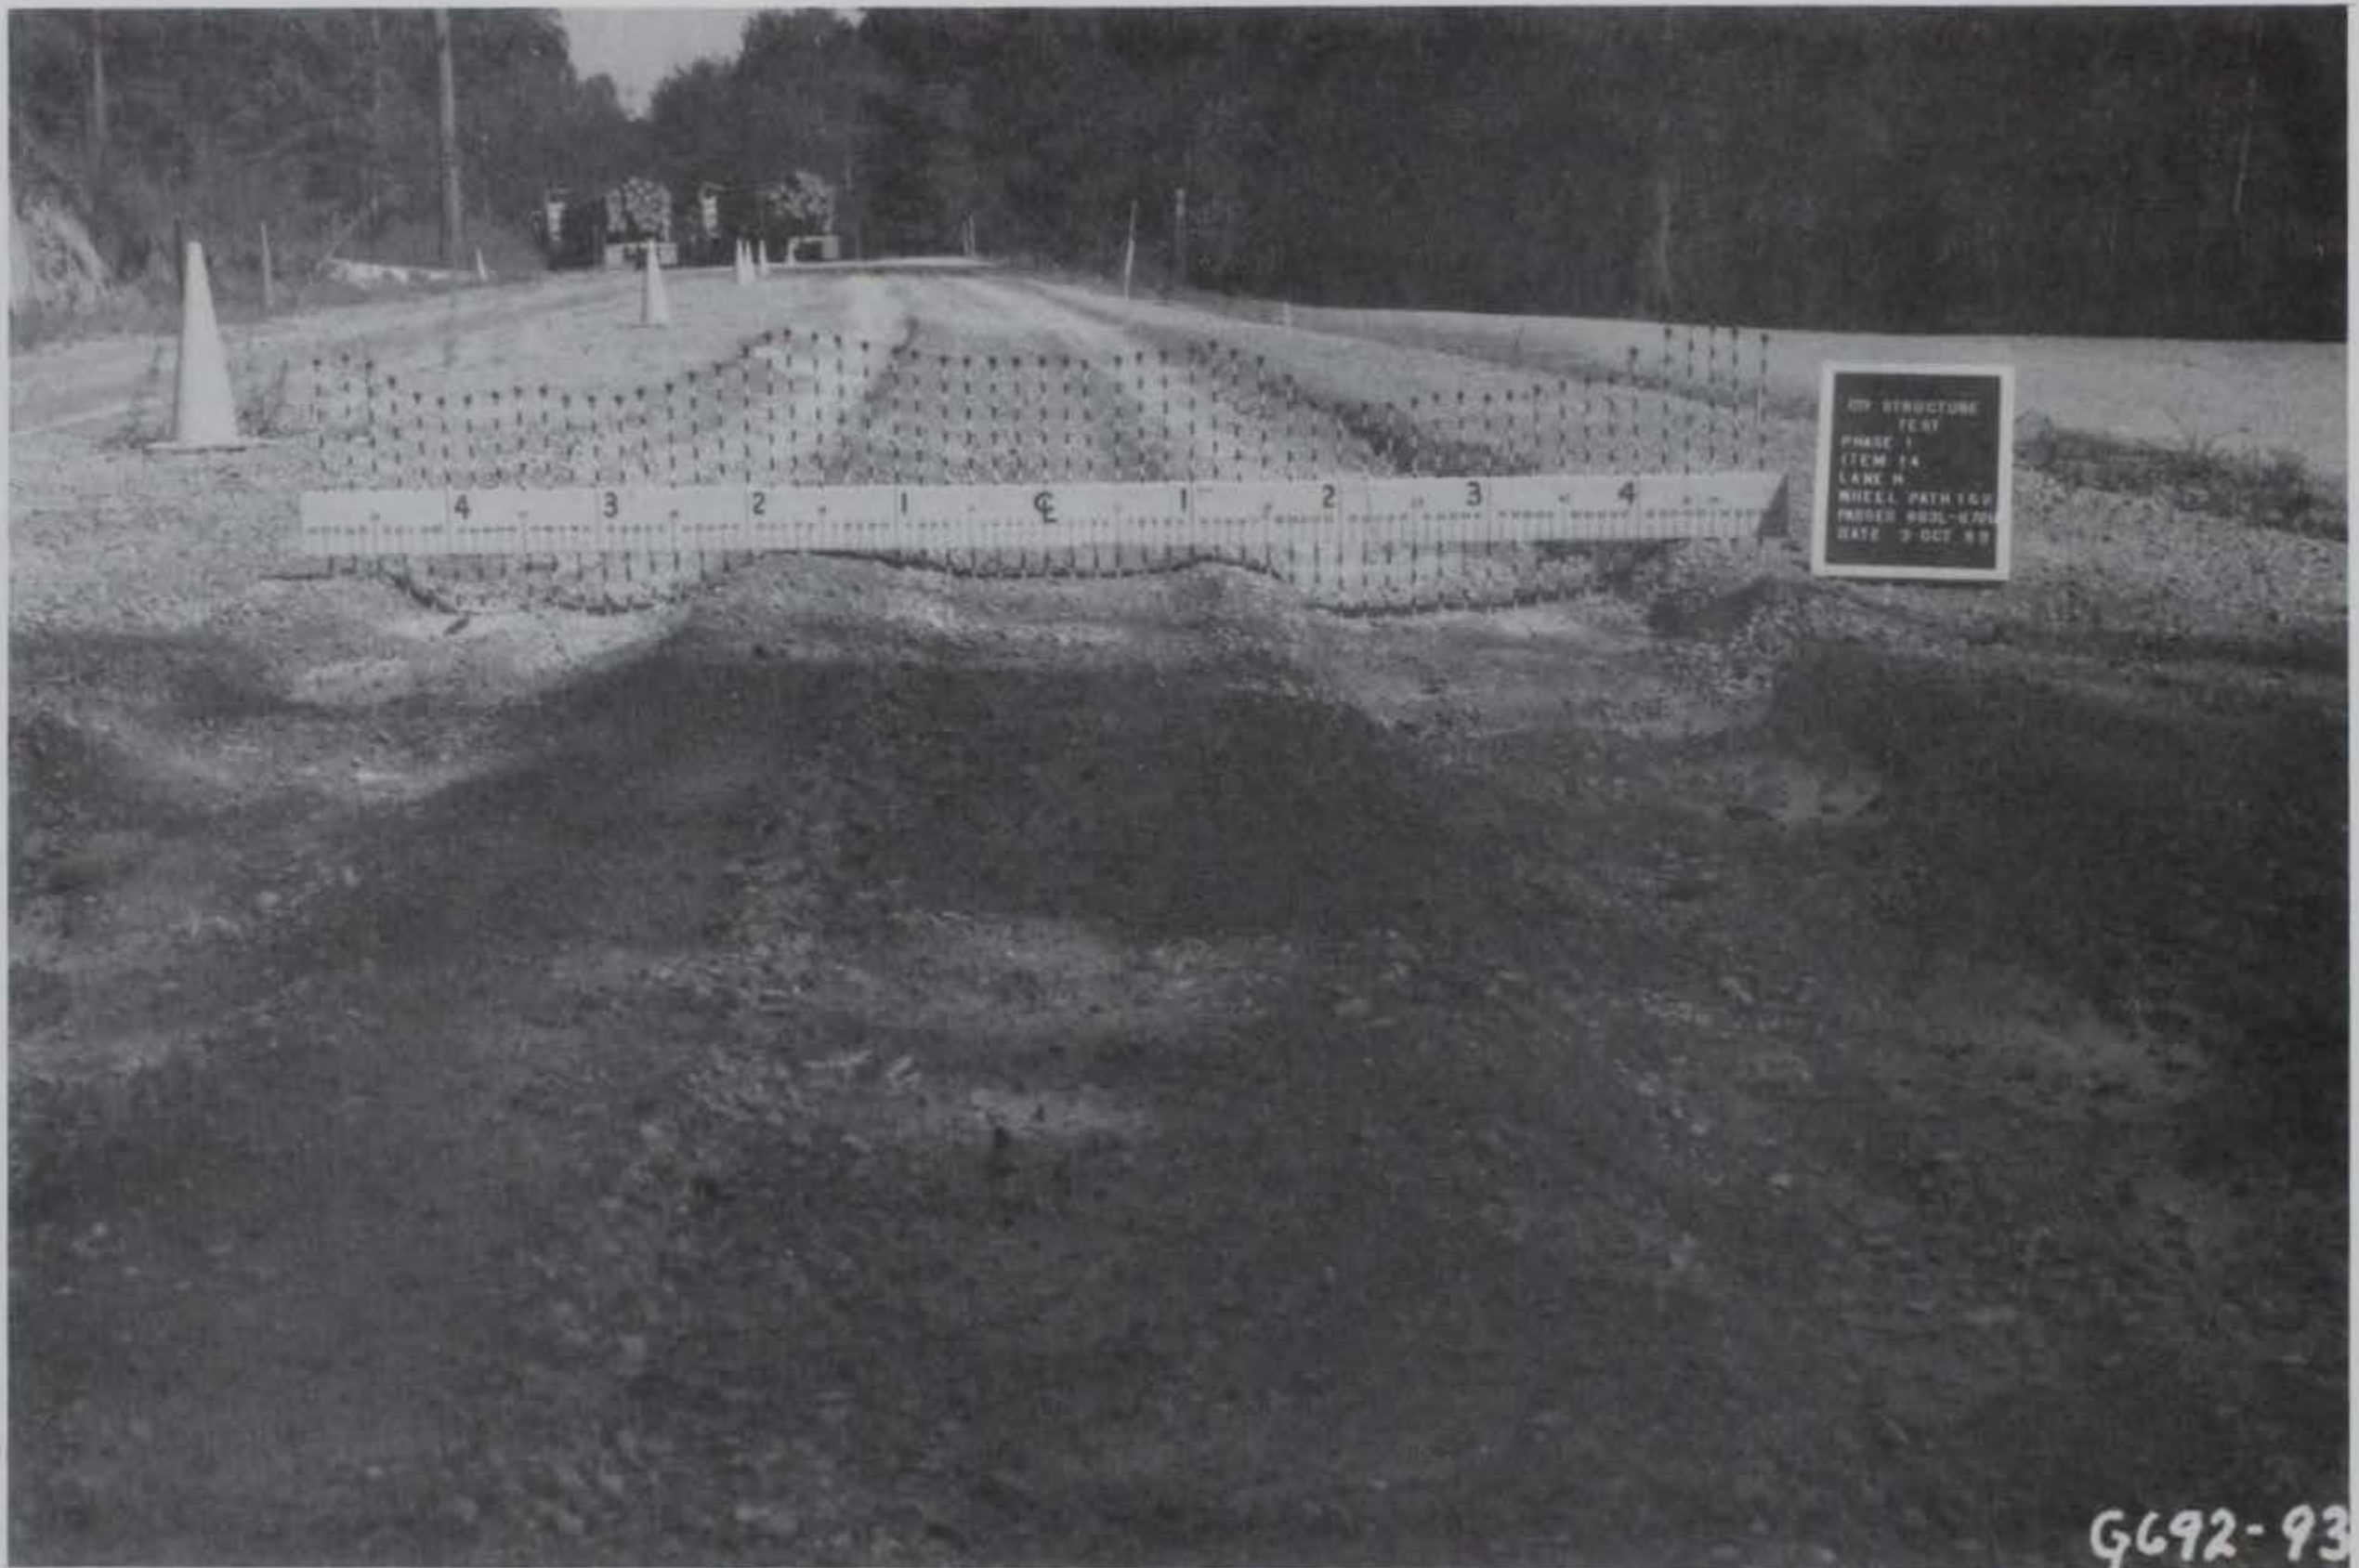
Photo 52. Item 4, high-pressure tire lane, high-severity rutting after 90 passes over a wet subgrade
