Effects of Variable Tire Pressure on Road Surfacing

Volume I: Design, Construction, Behavior Under Traffic, and Test Results

by *Robert W. Grau*
Geotechnical Laboratory

Technical Report GL-93-20
August 1993

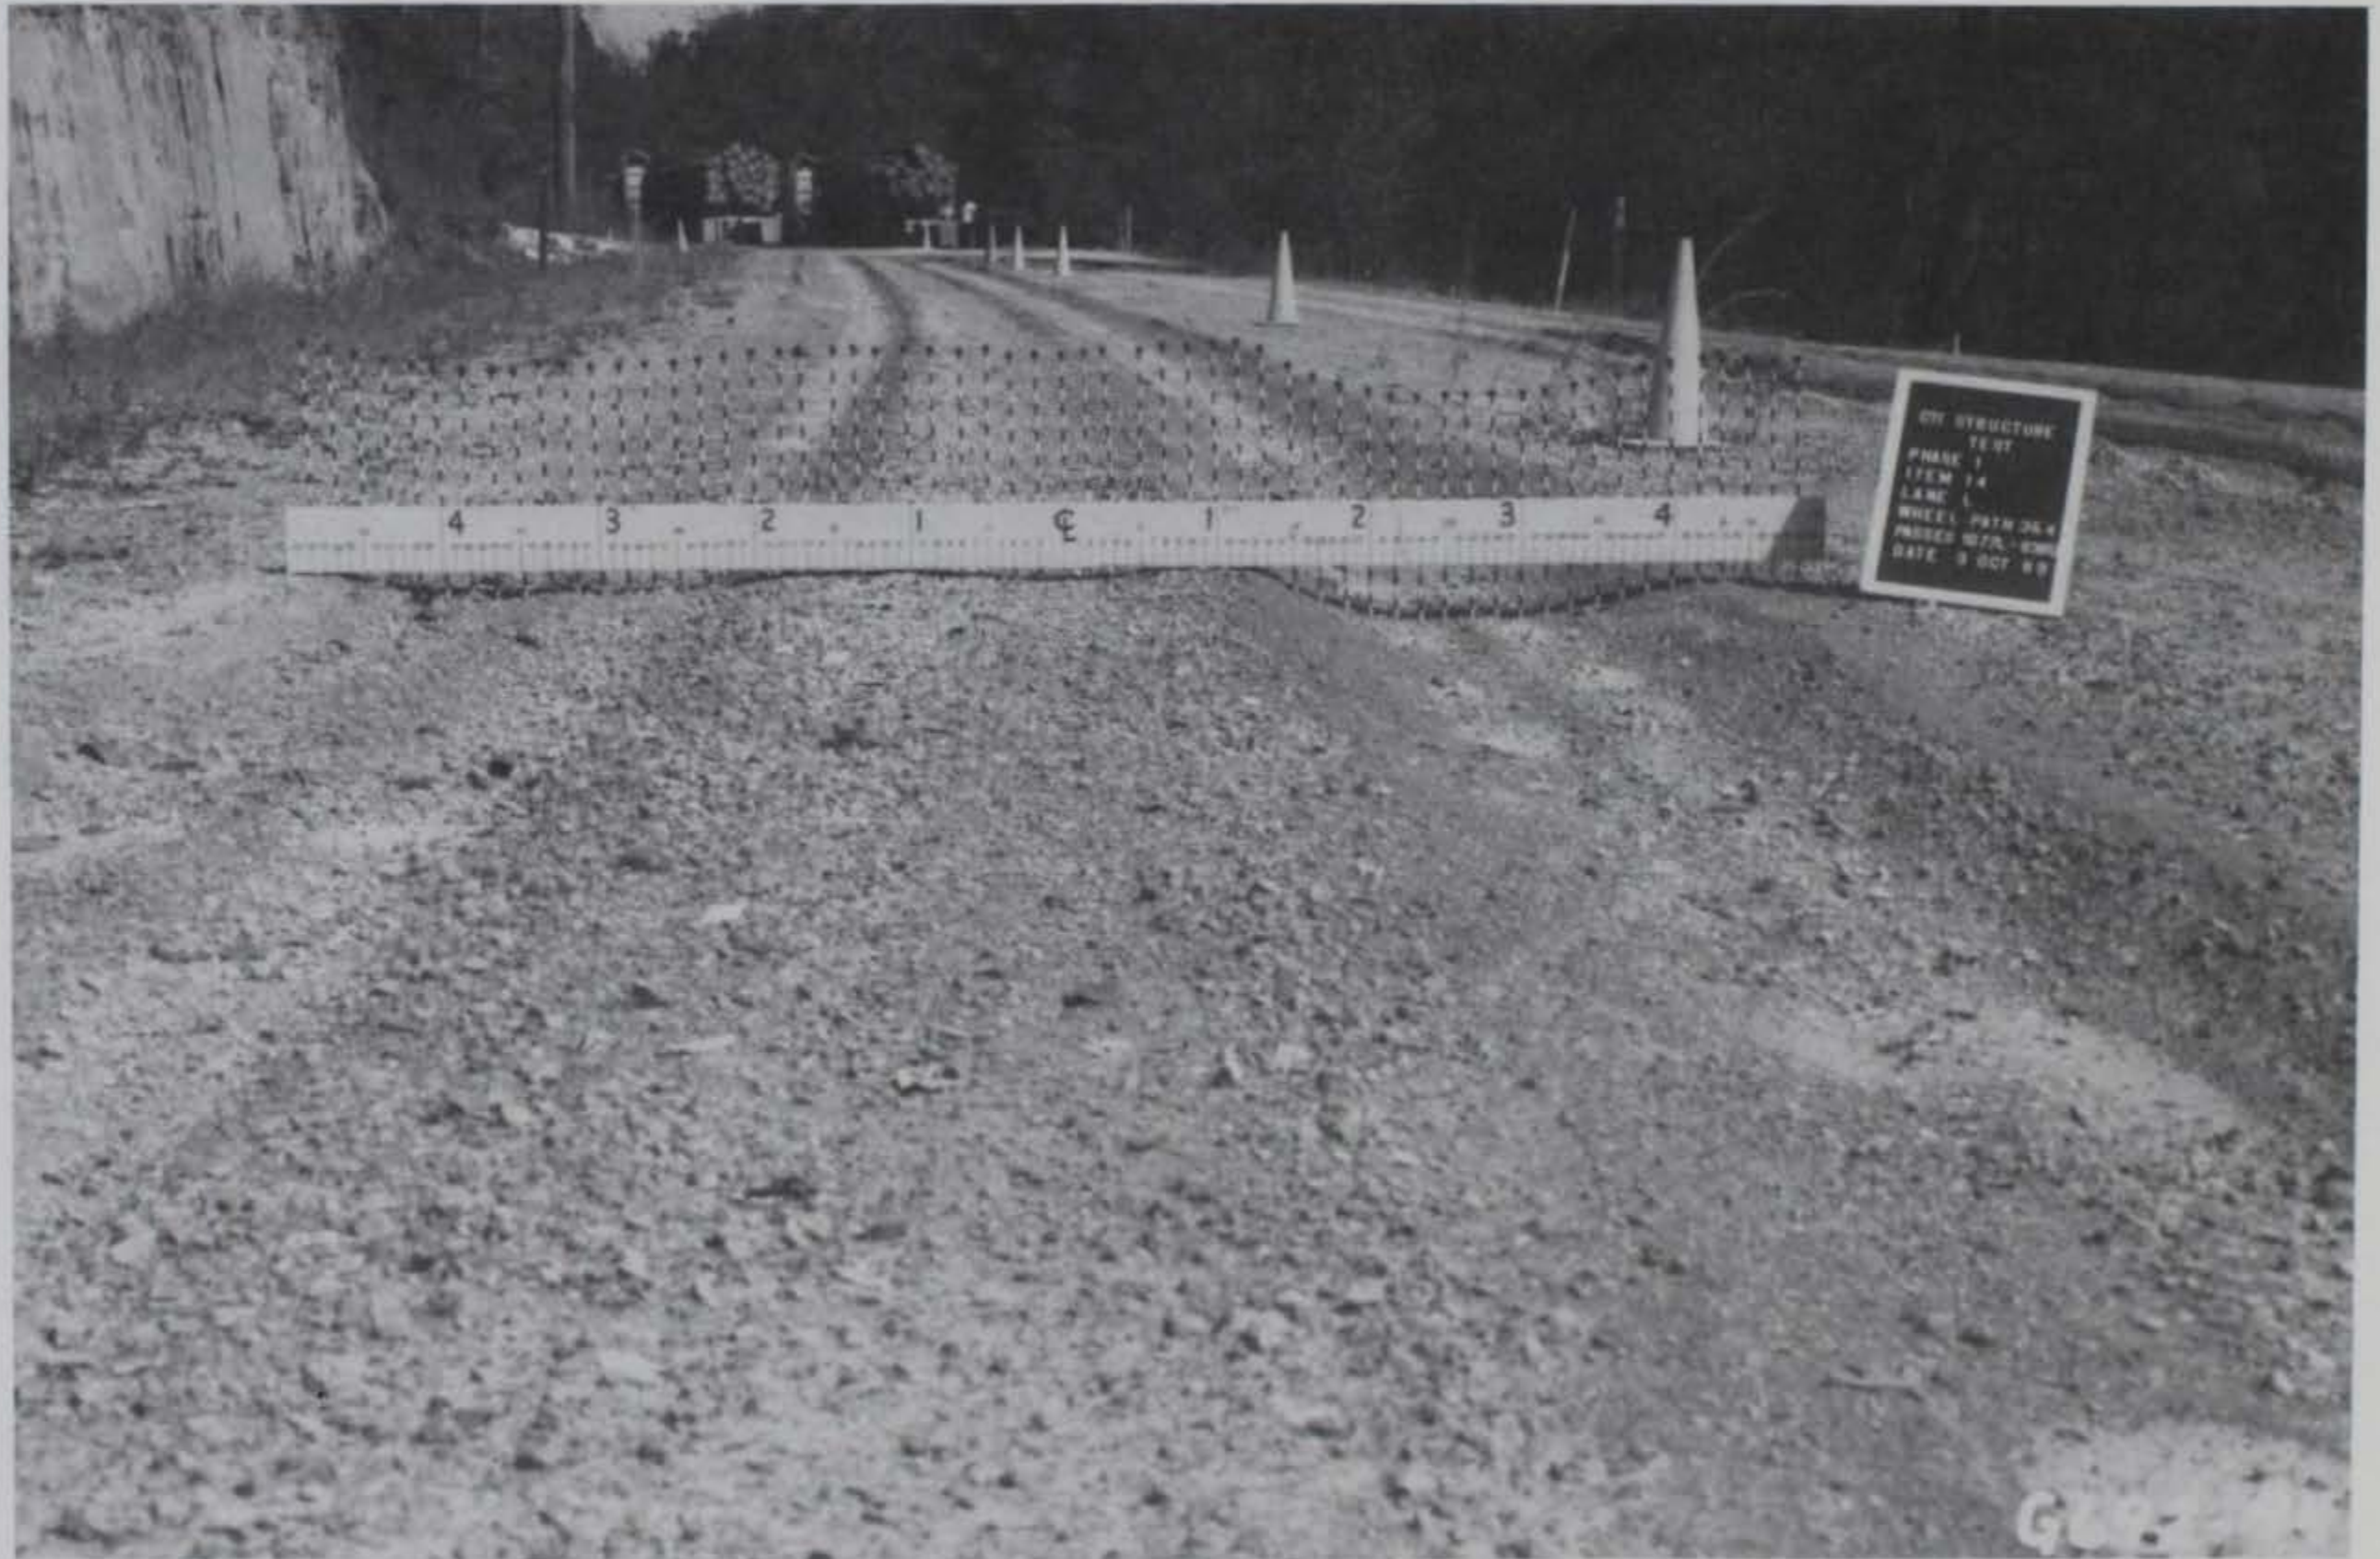
Photo 53. Item 14, low-pressure tire lane, high-severity rutting after 90 passes over a wet subgrade

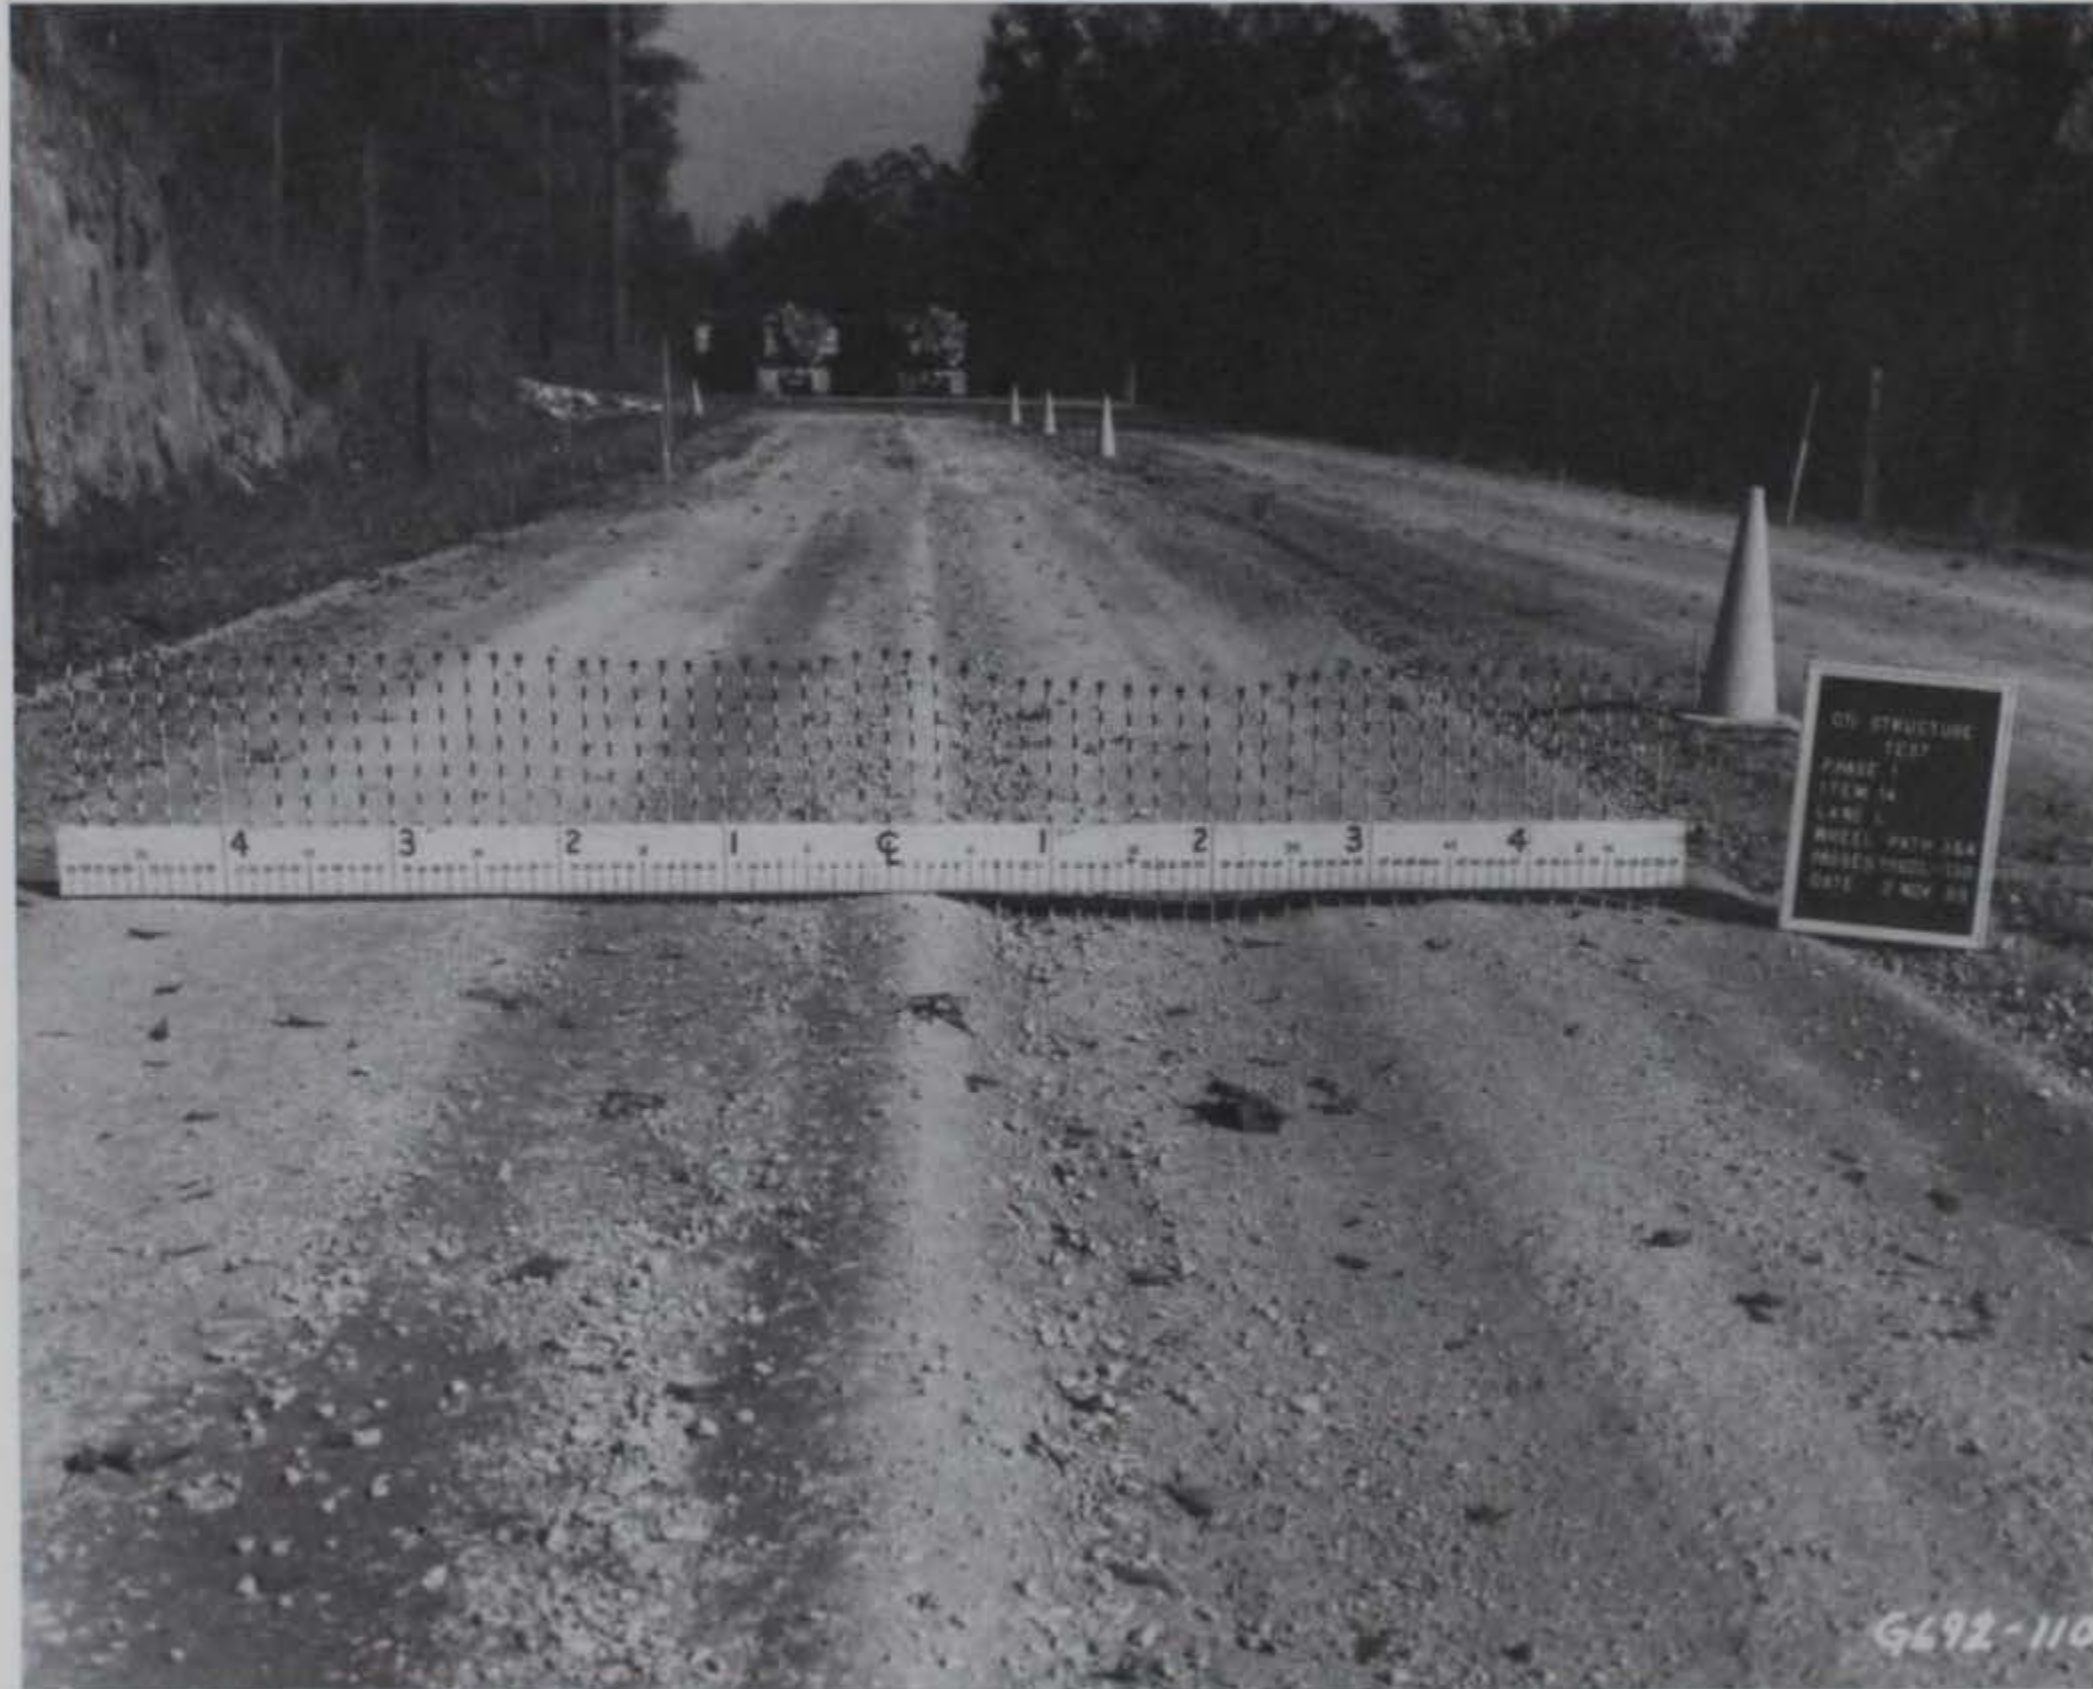
Photo 55. Item 14, low-pressure tire lane, high-severity rutting after 130 passes during induced failure plan

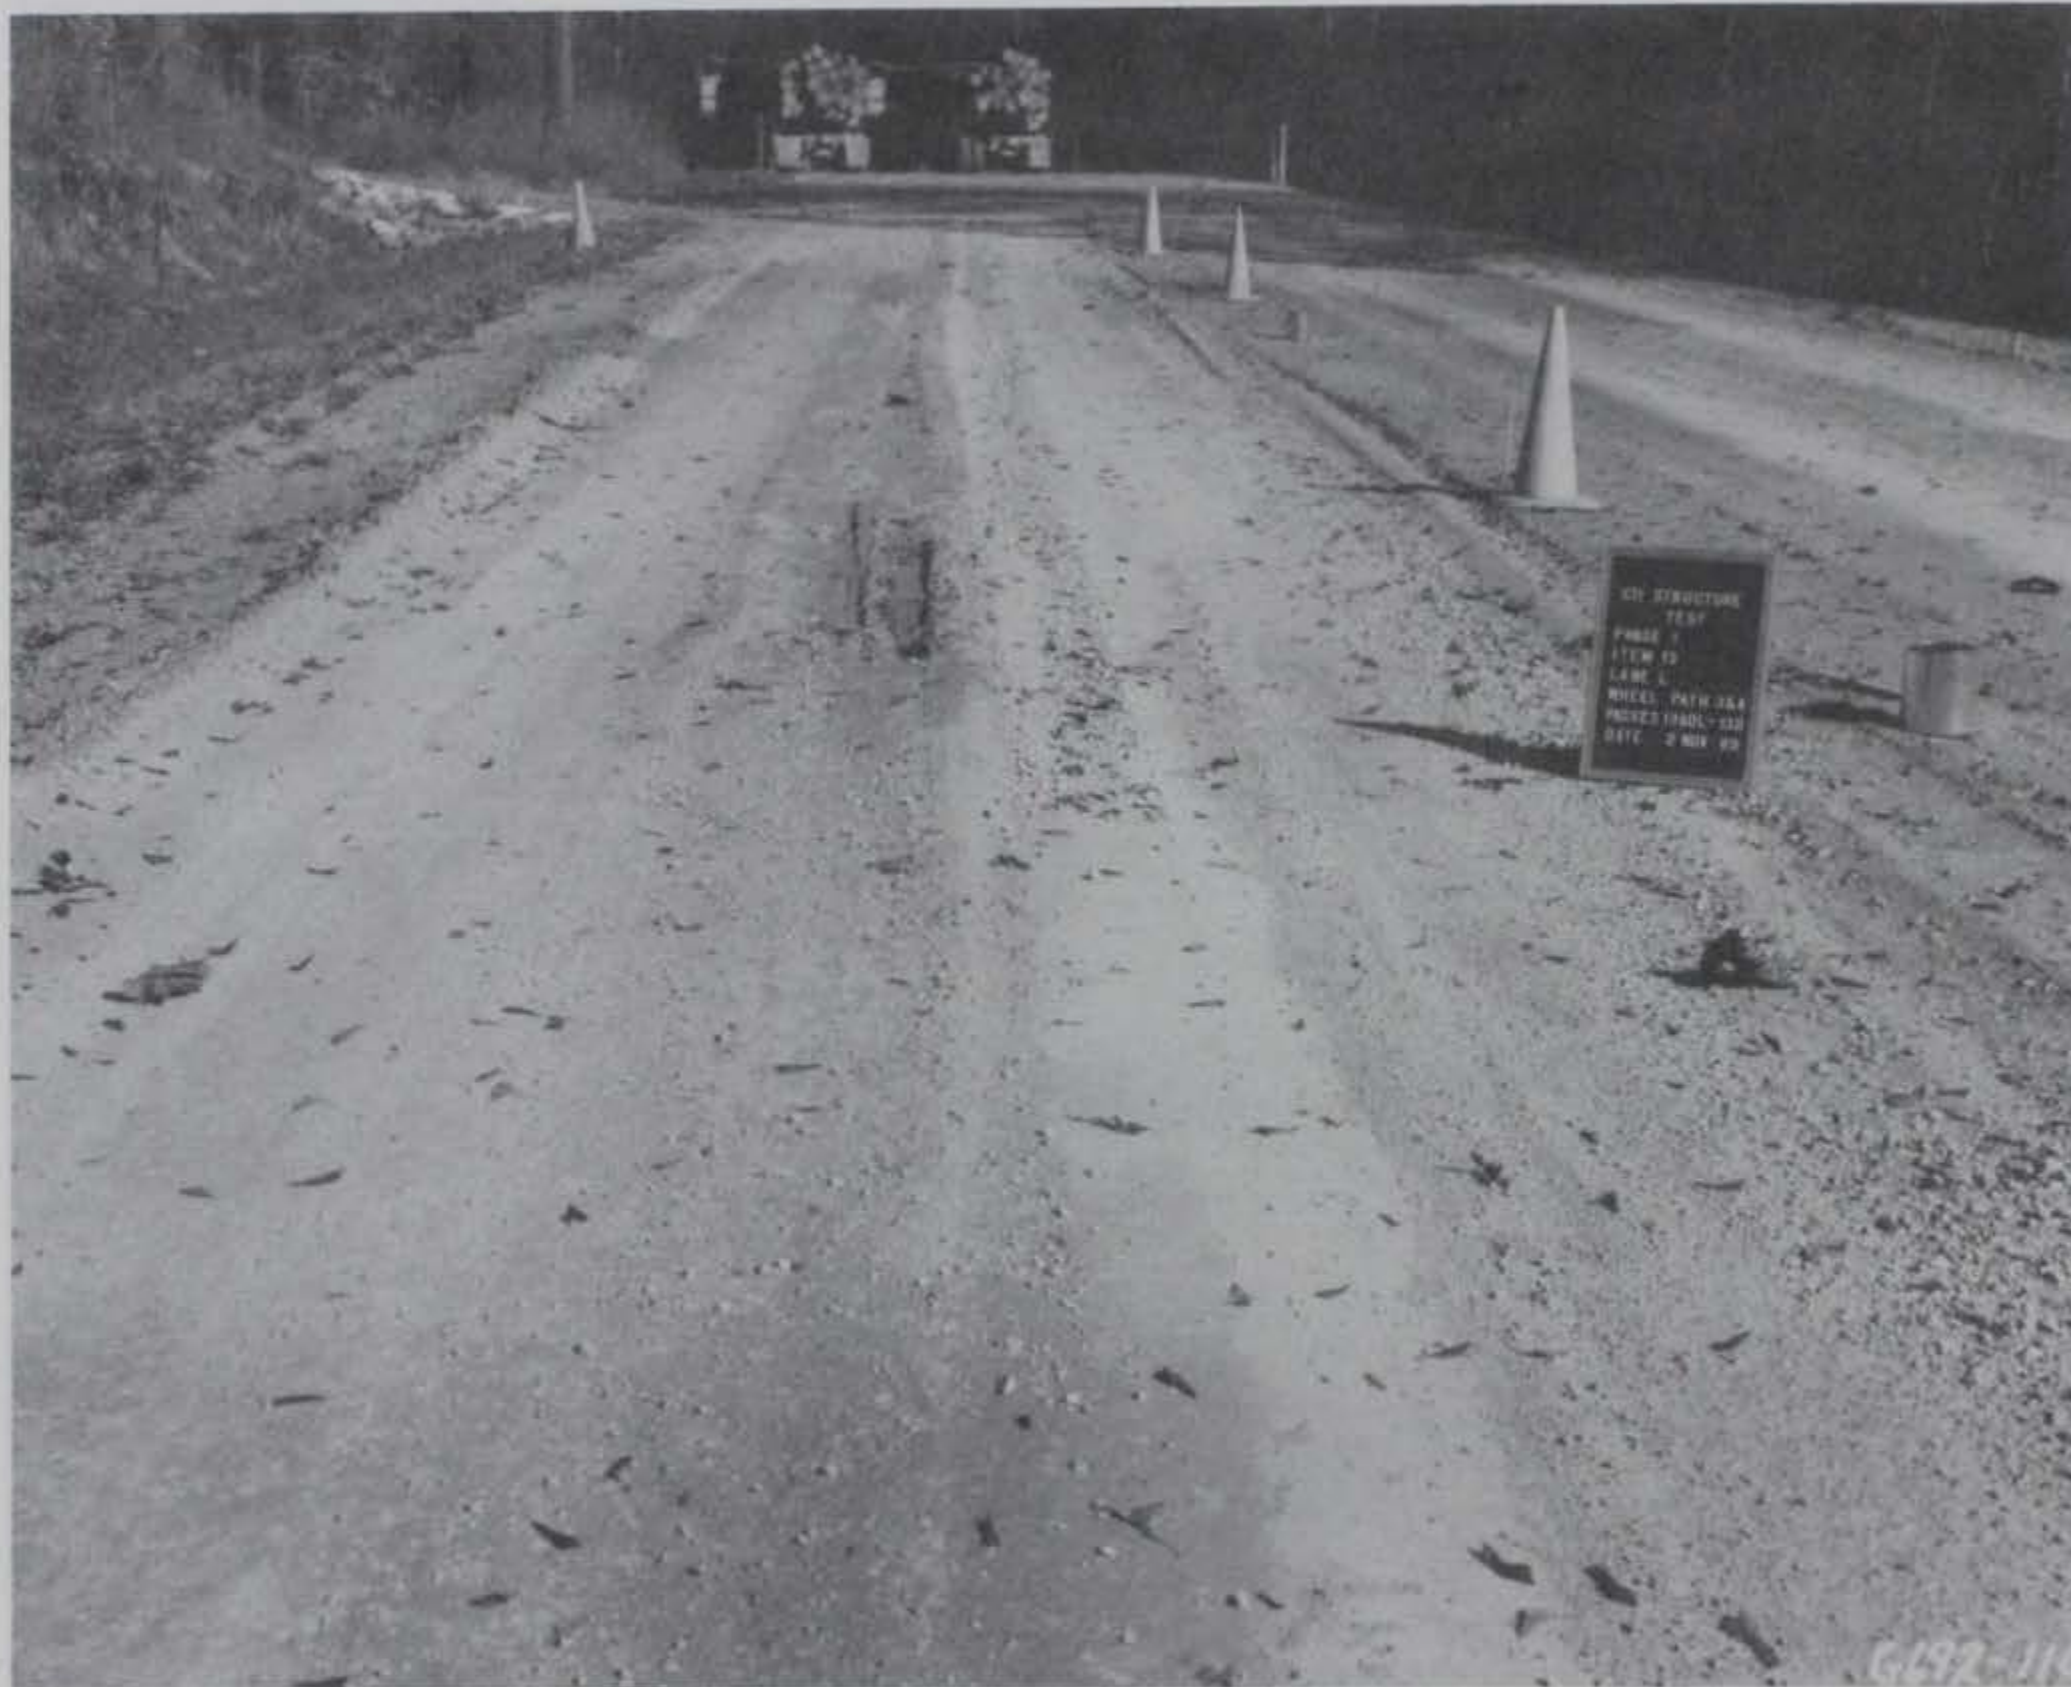
Photo 56. Item 13, low-pressure tire lane, general view after 130 passes during the induced failure plan

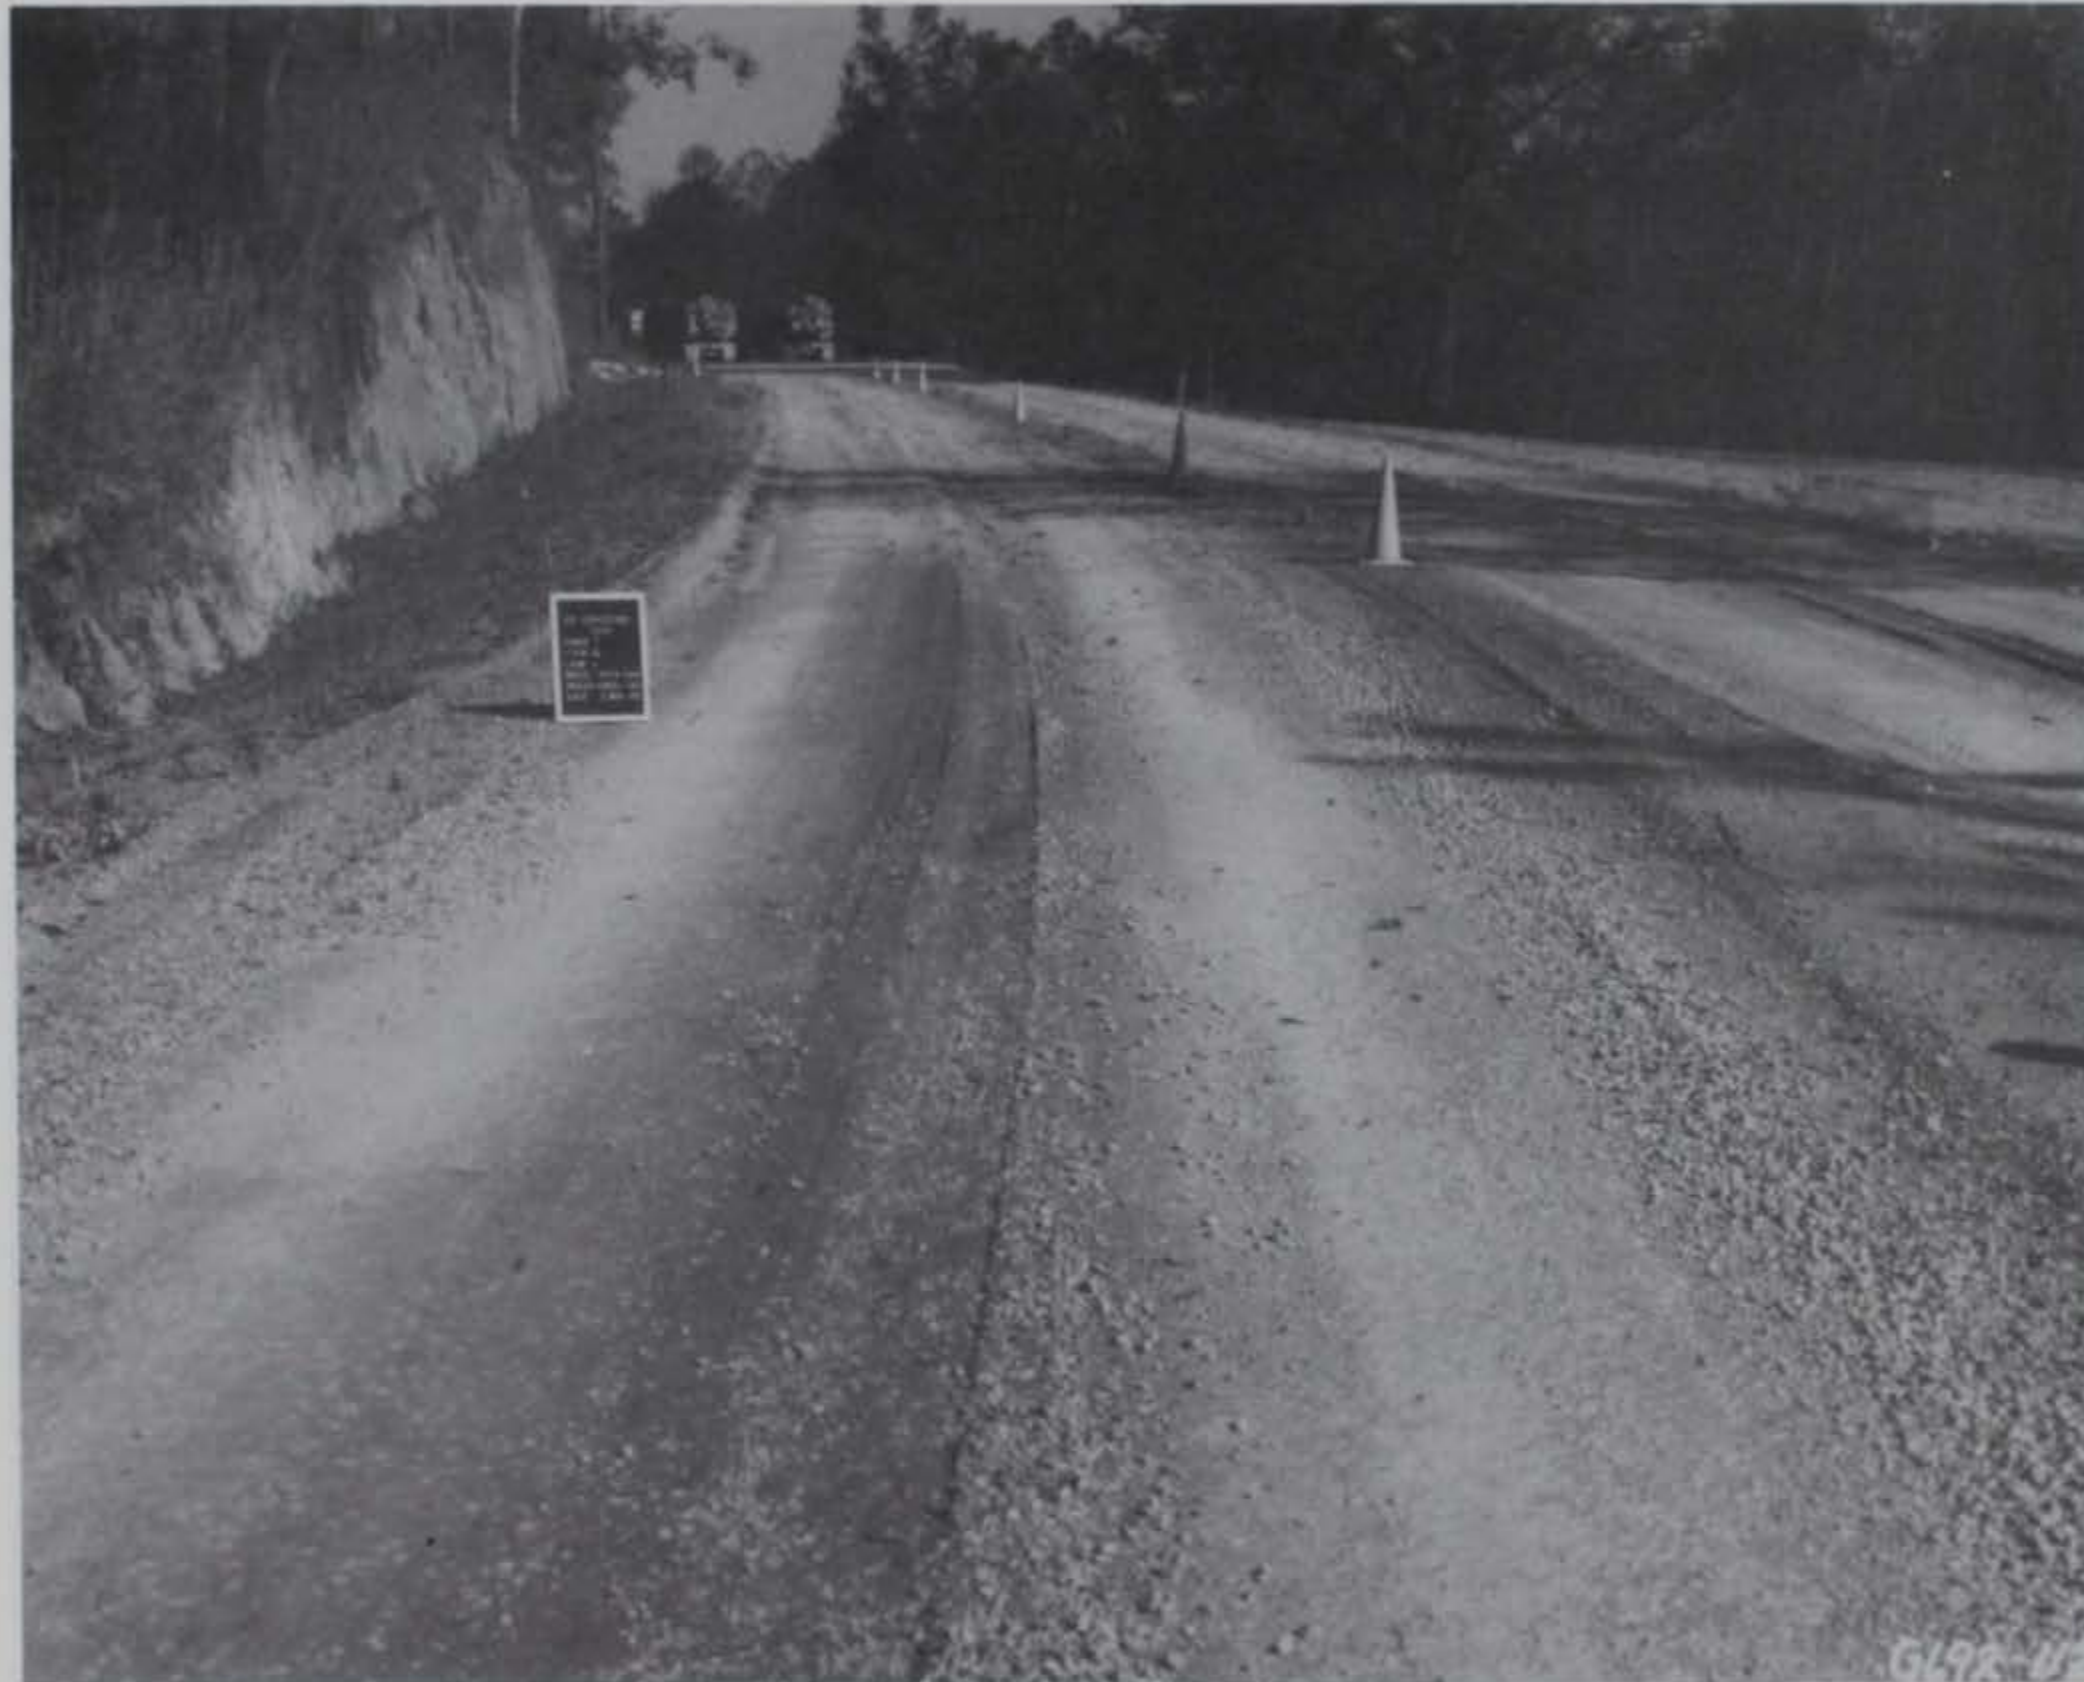
Photo 57. Item 14, low-pressure tire lane, general view after 130 passes during the induced failure plan

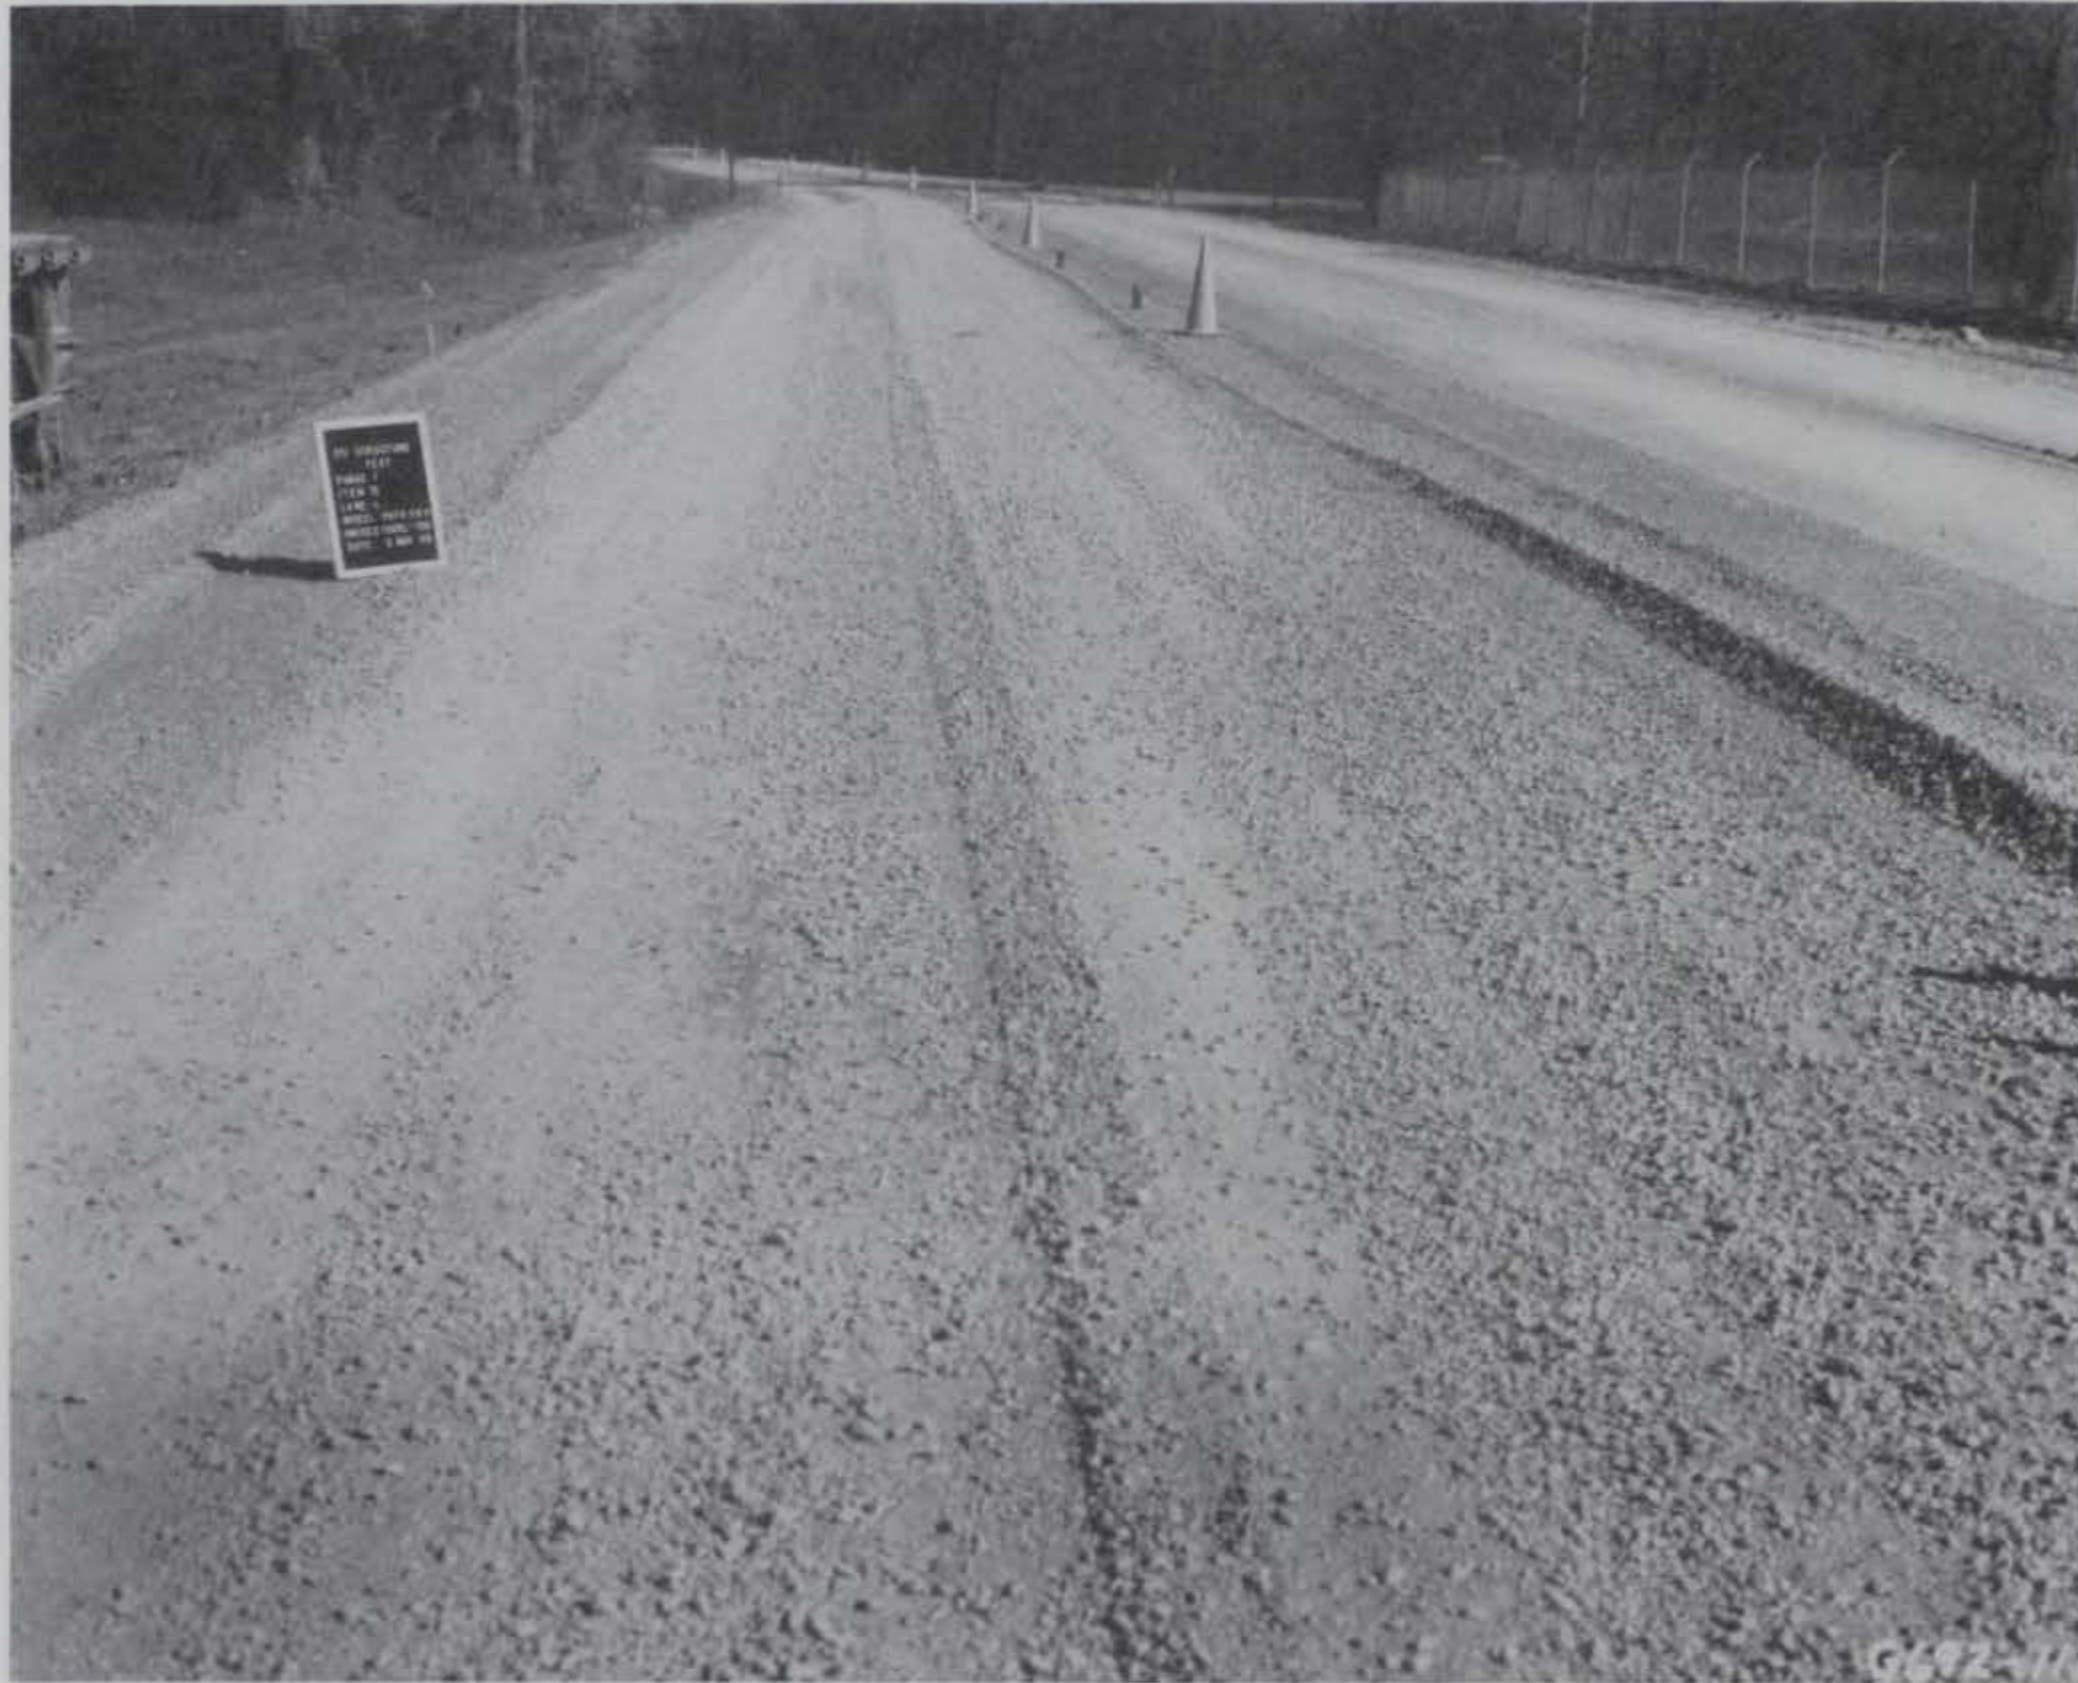
Photo 58. Item 15, low-pressure tire lane, general view after 130 passes during the failure induced plan

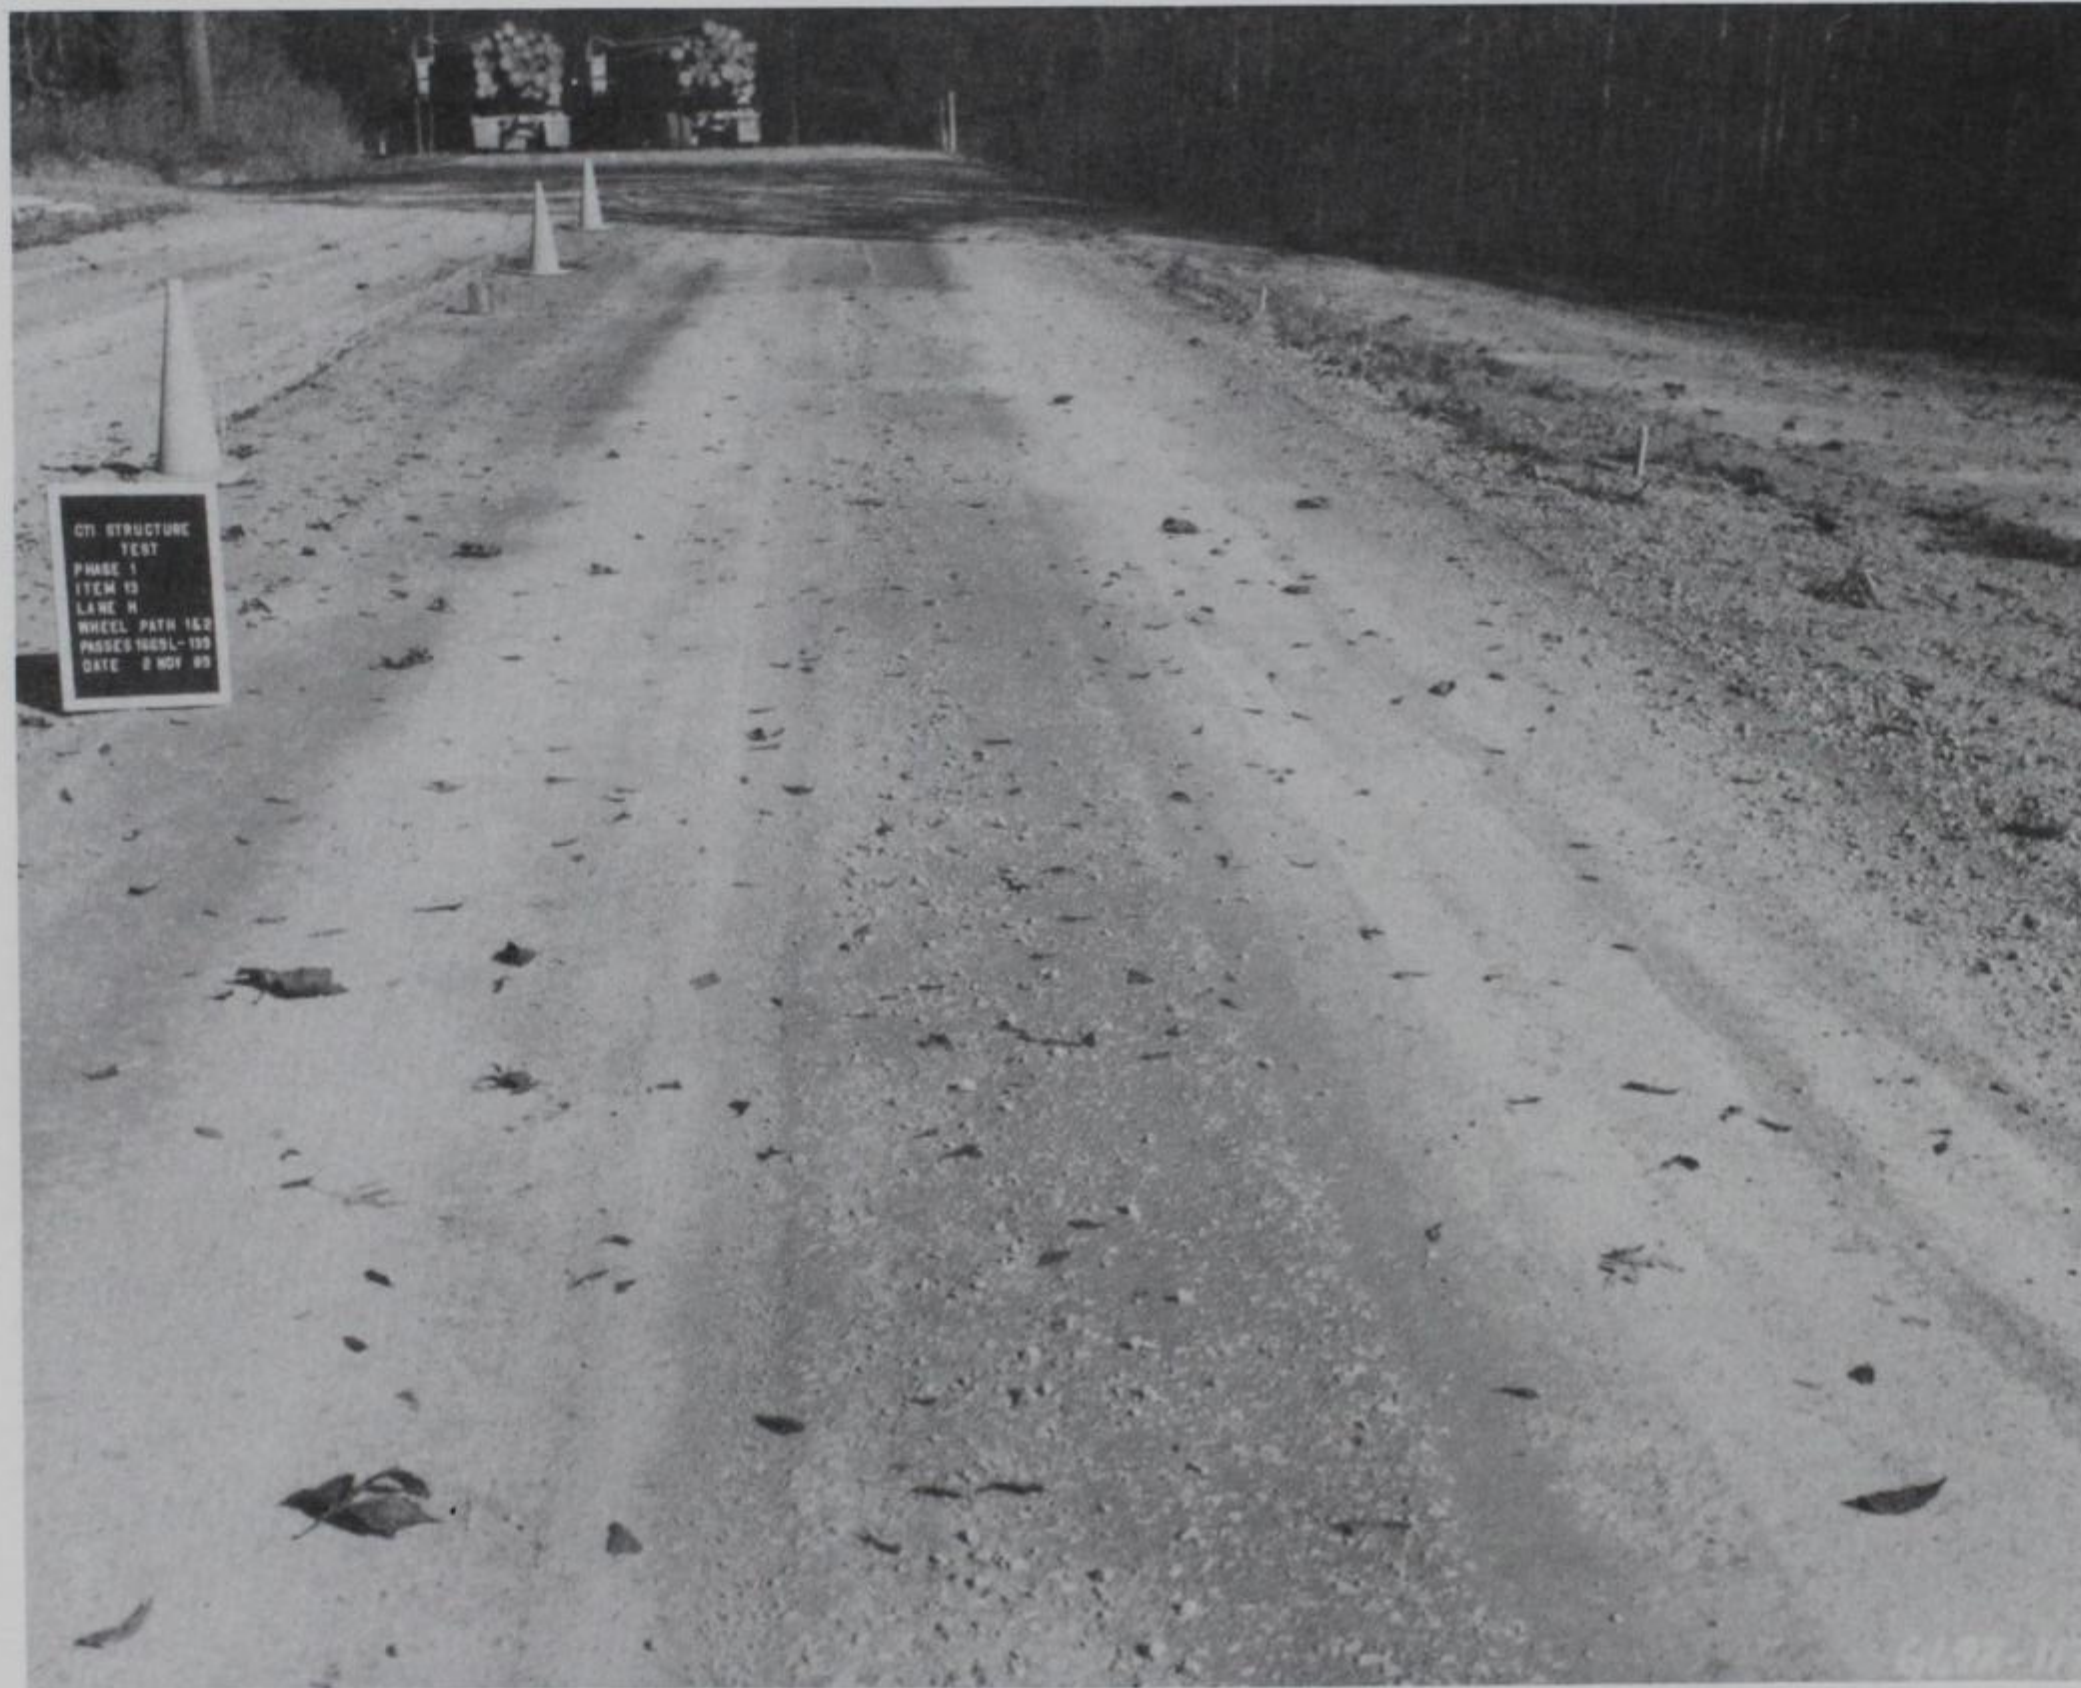
Photo 59. Item 13, high-pressure tire lane, general view after 139 passes during the induced failure plan
