Effects of Variable Tire Pressure on Road Surfacing

Volume I: Design, Construction, Behavior Under Traffic, and Test Results

by *Robert W. Grau*
Geotechnical Laboratory

Technical Report GL-93-20
August 1993

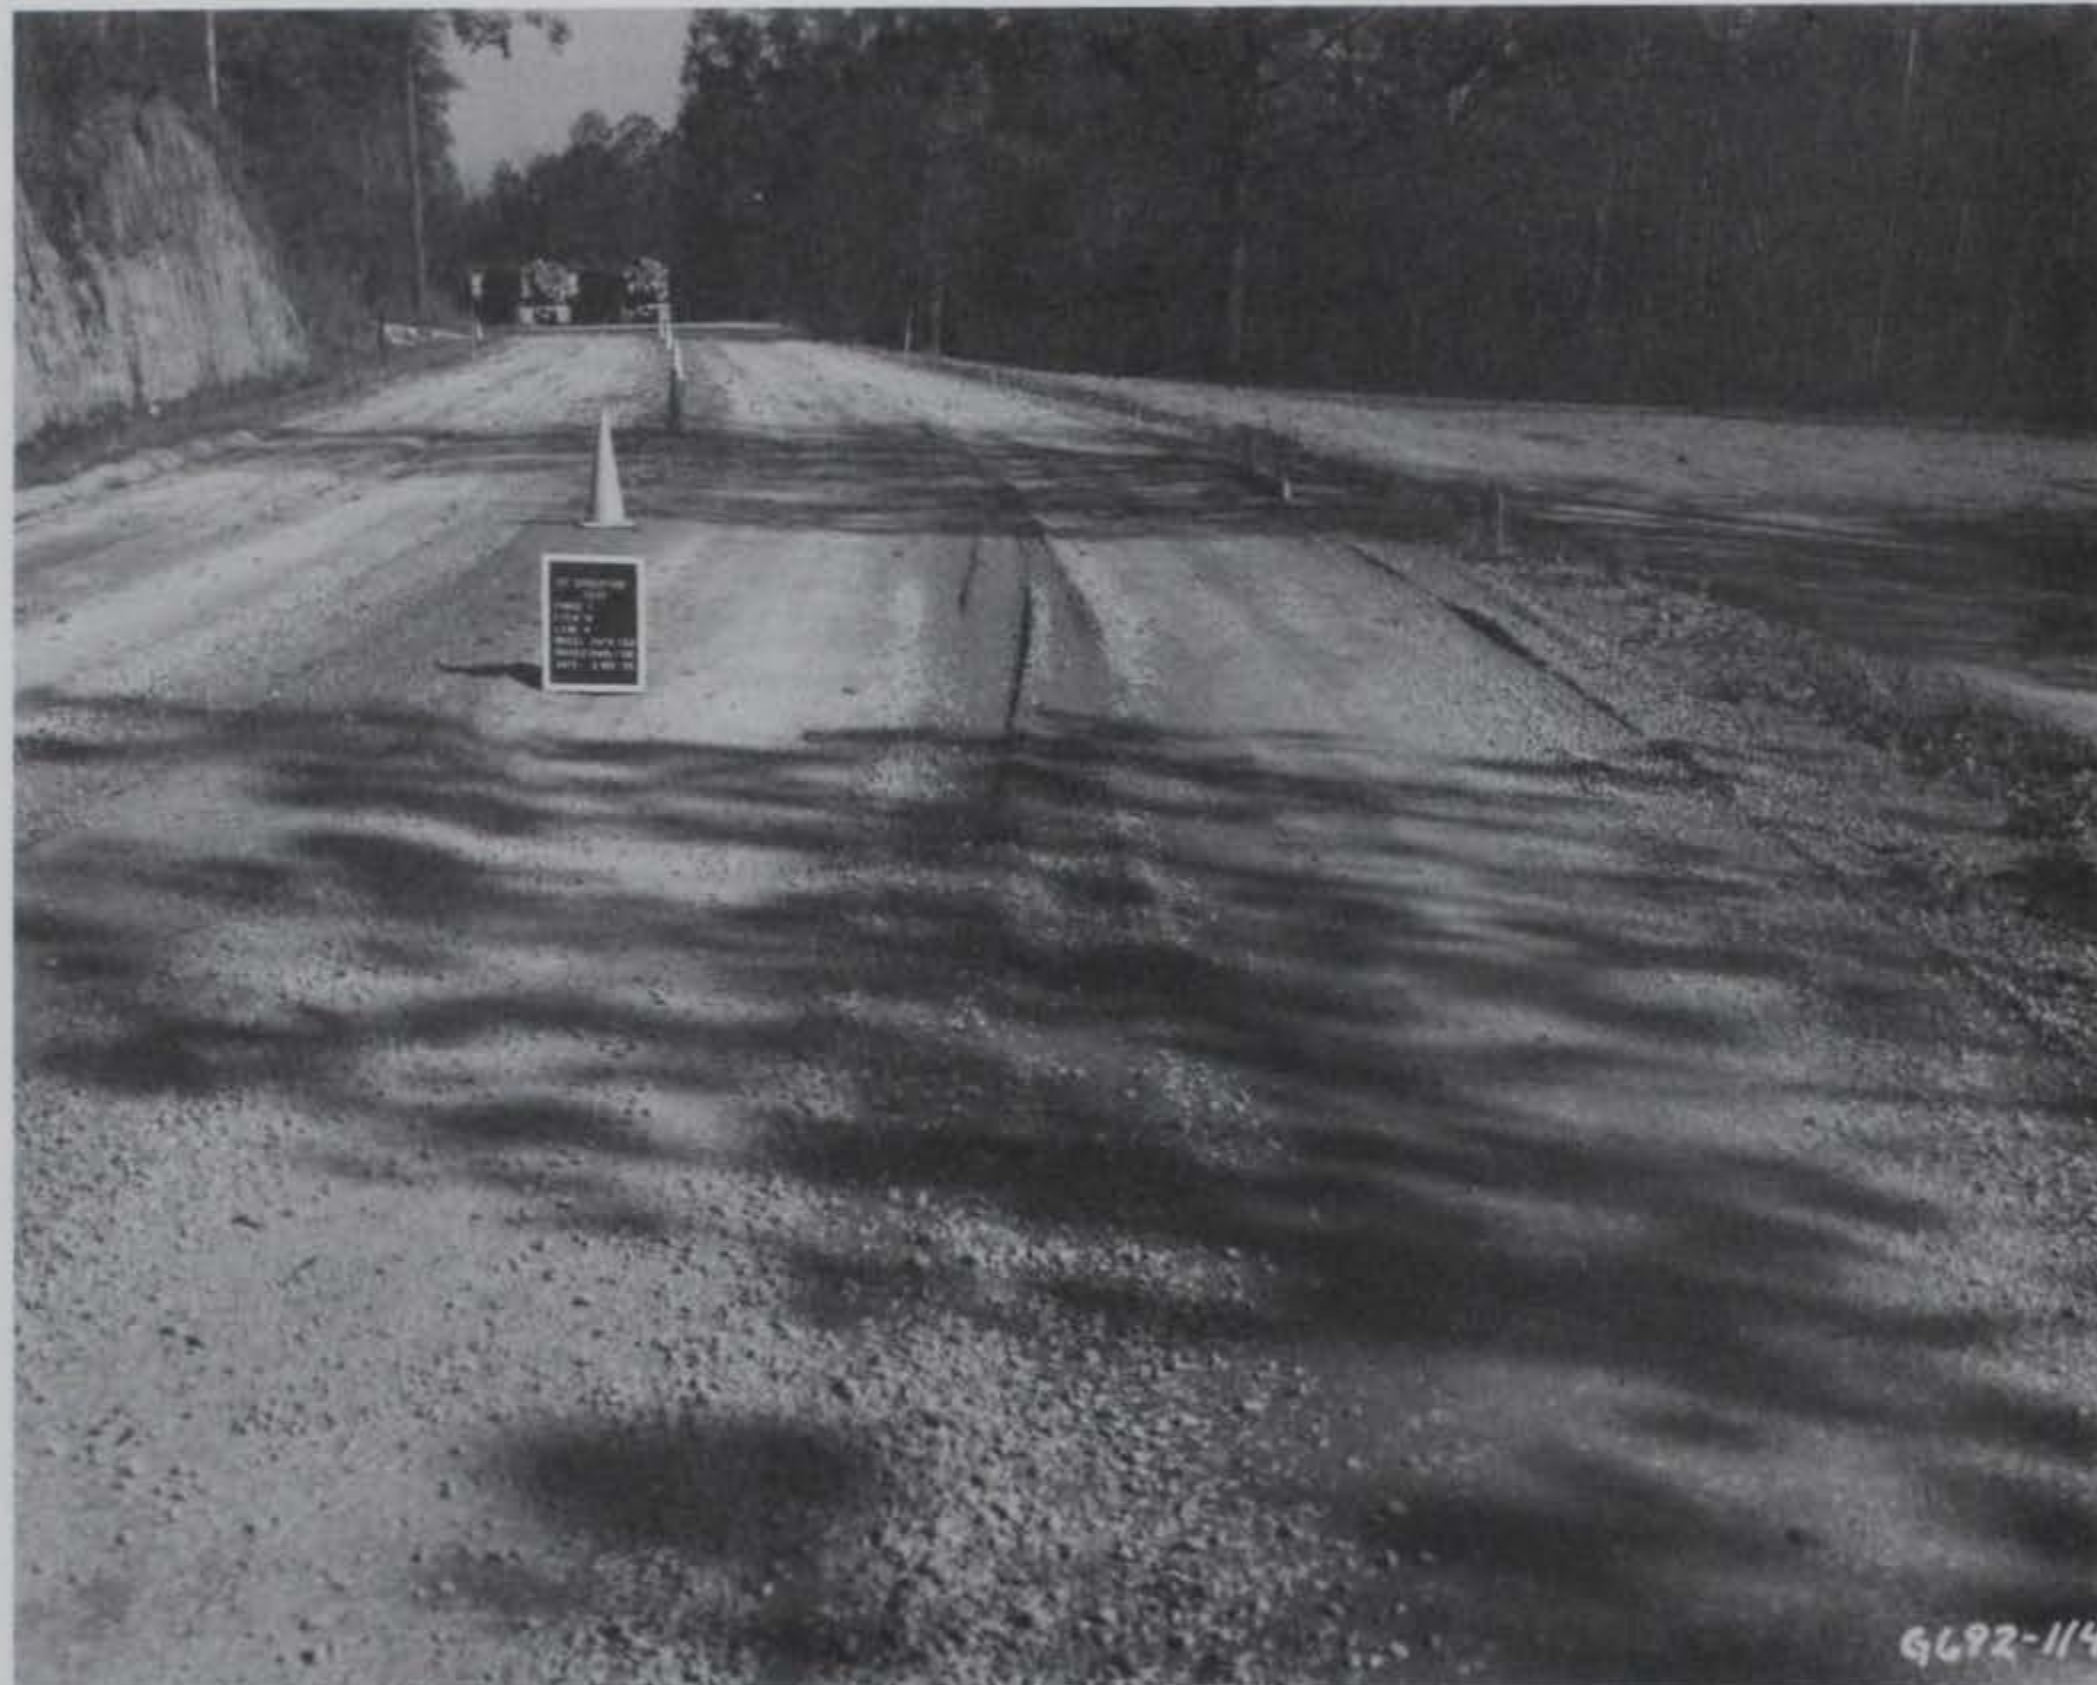
Photo 60. Item 14, high-pressure tire lane, general view after 139 passes during the induced failure plan

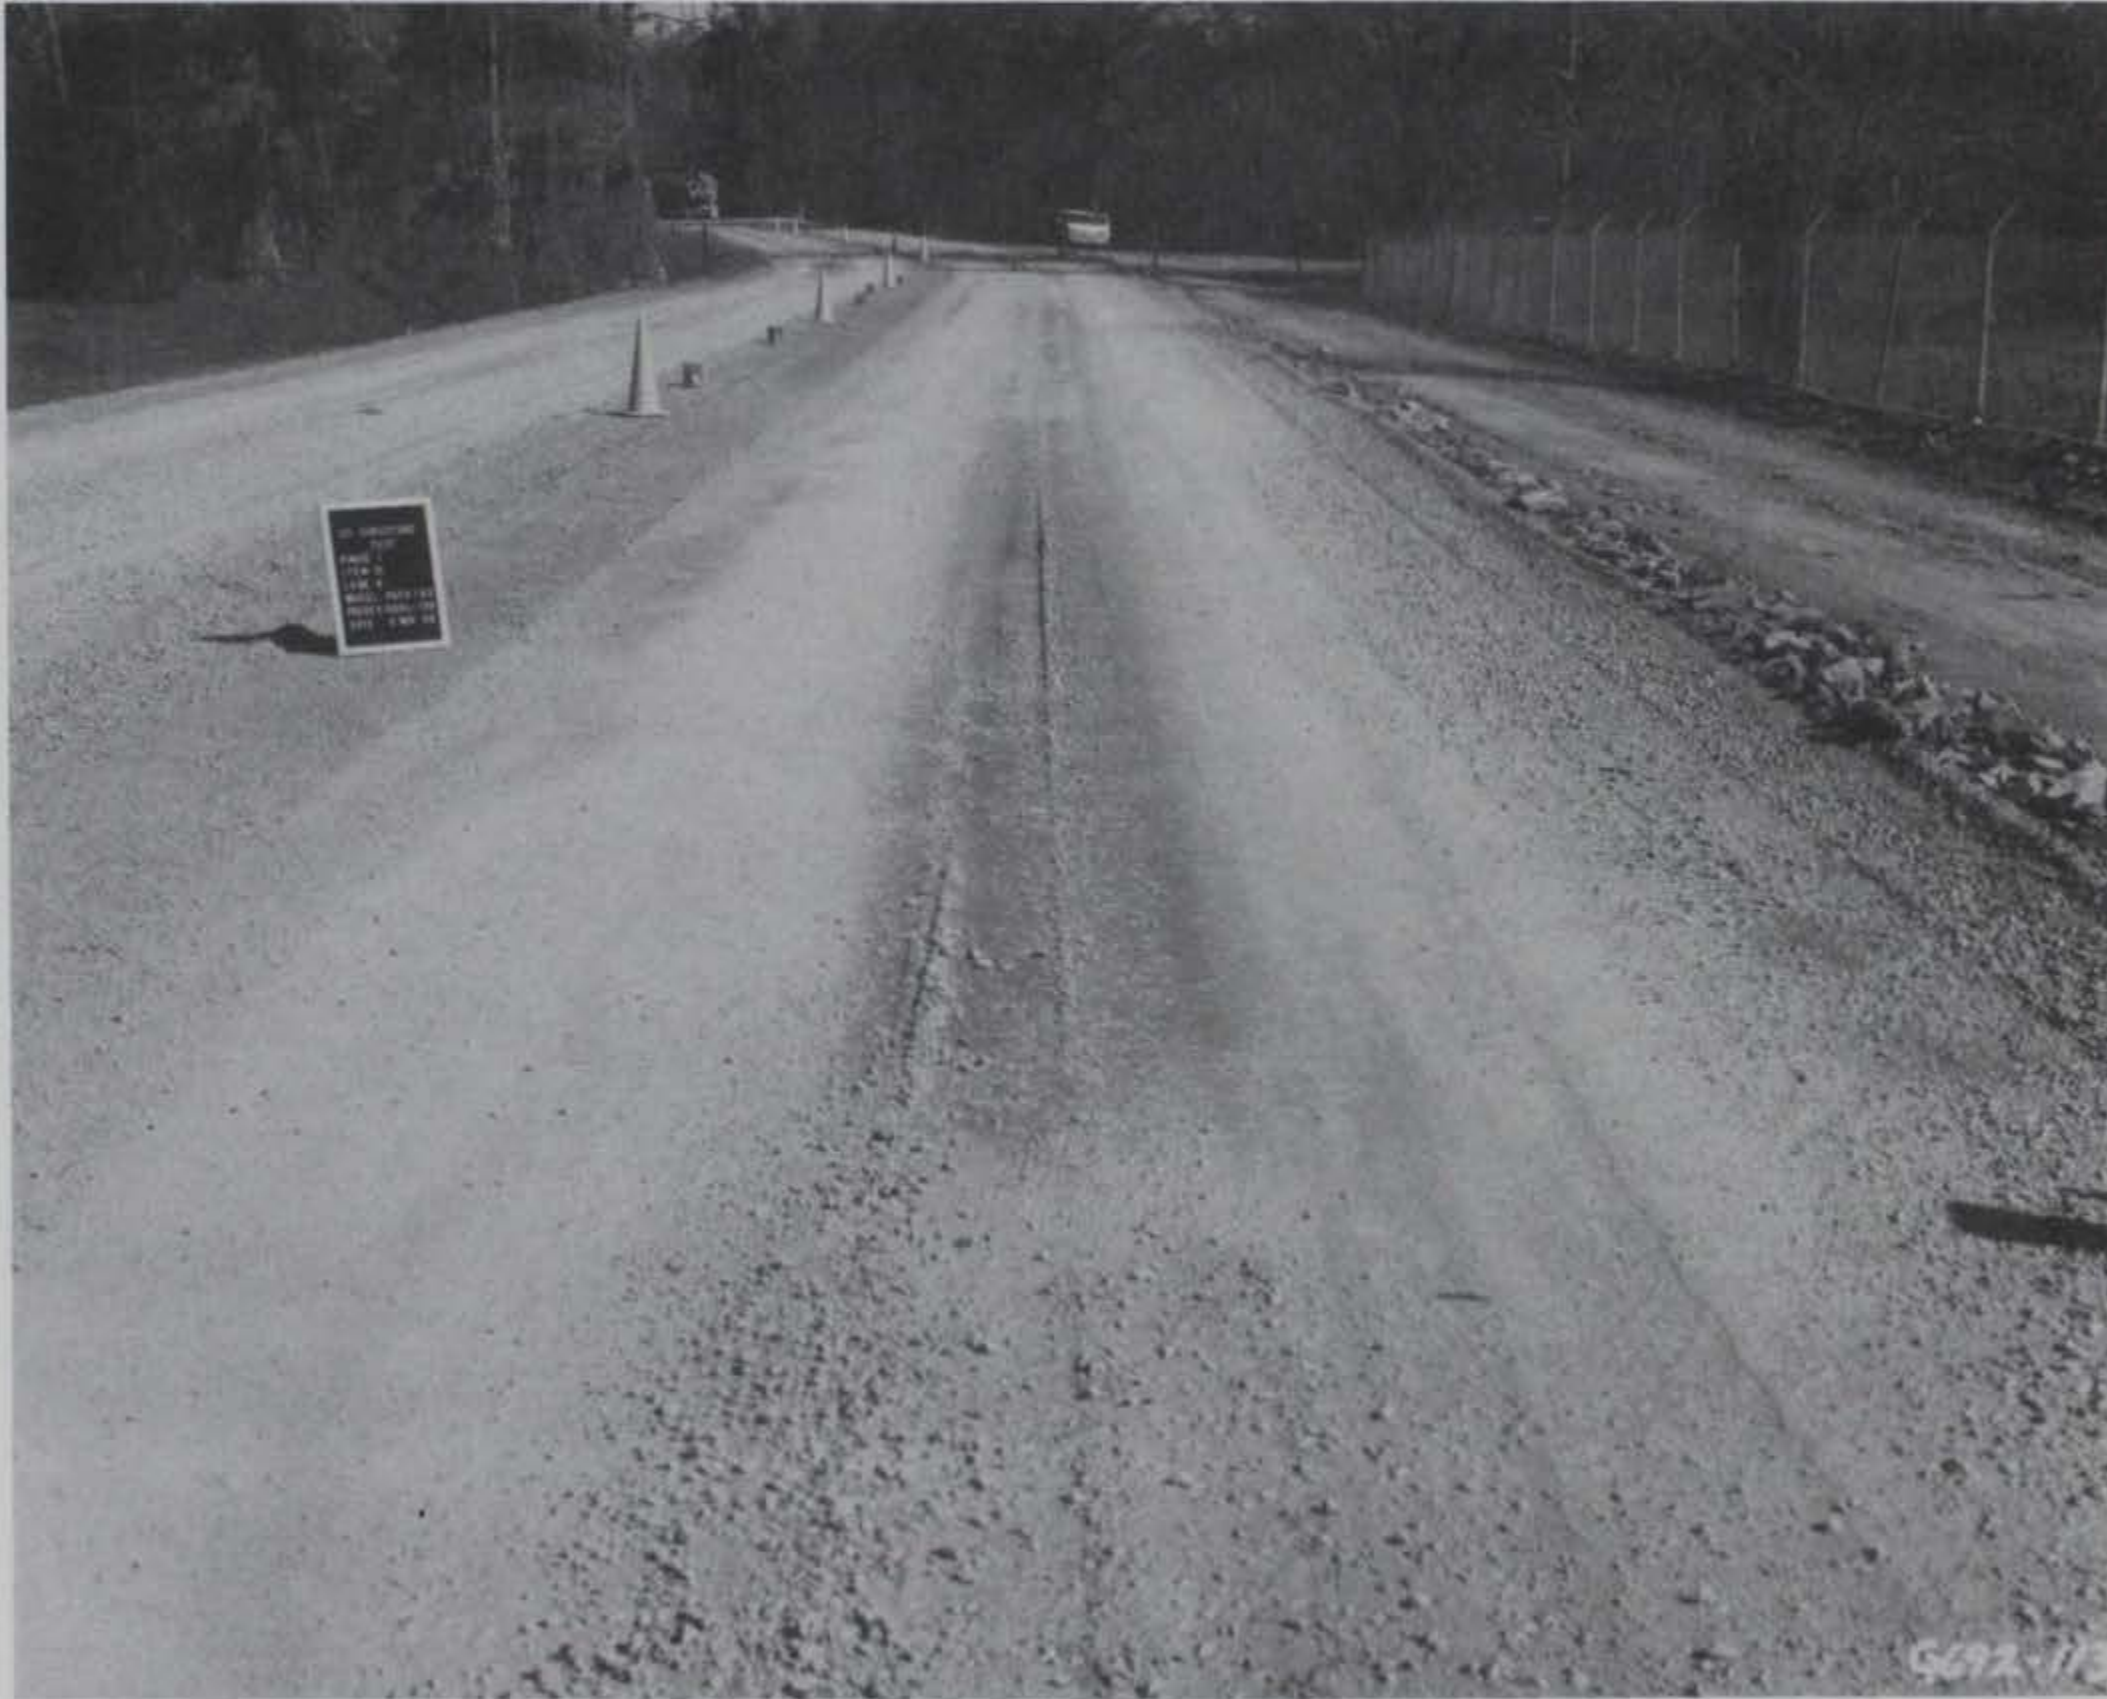
Photo 61. Item 15, high-pressure tire lane, general view after 139 passes during the induced failure plan

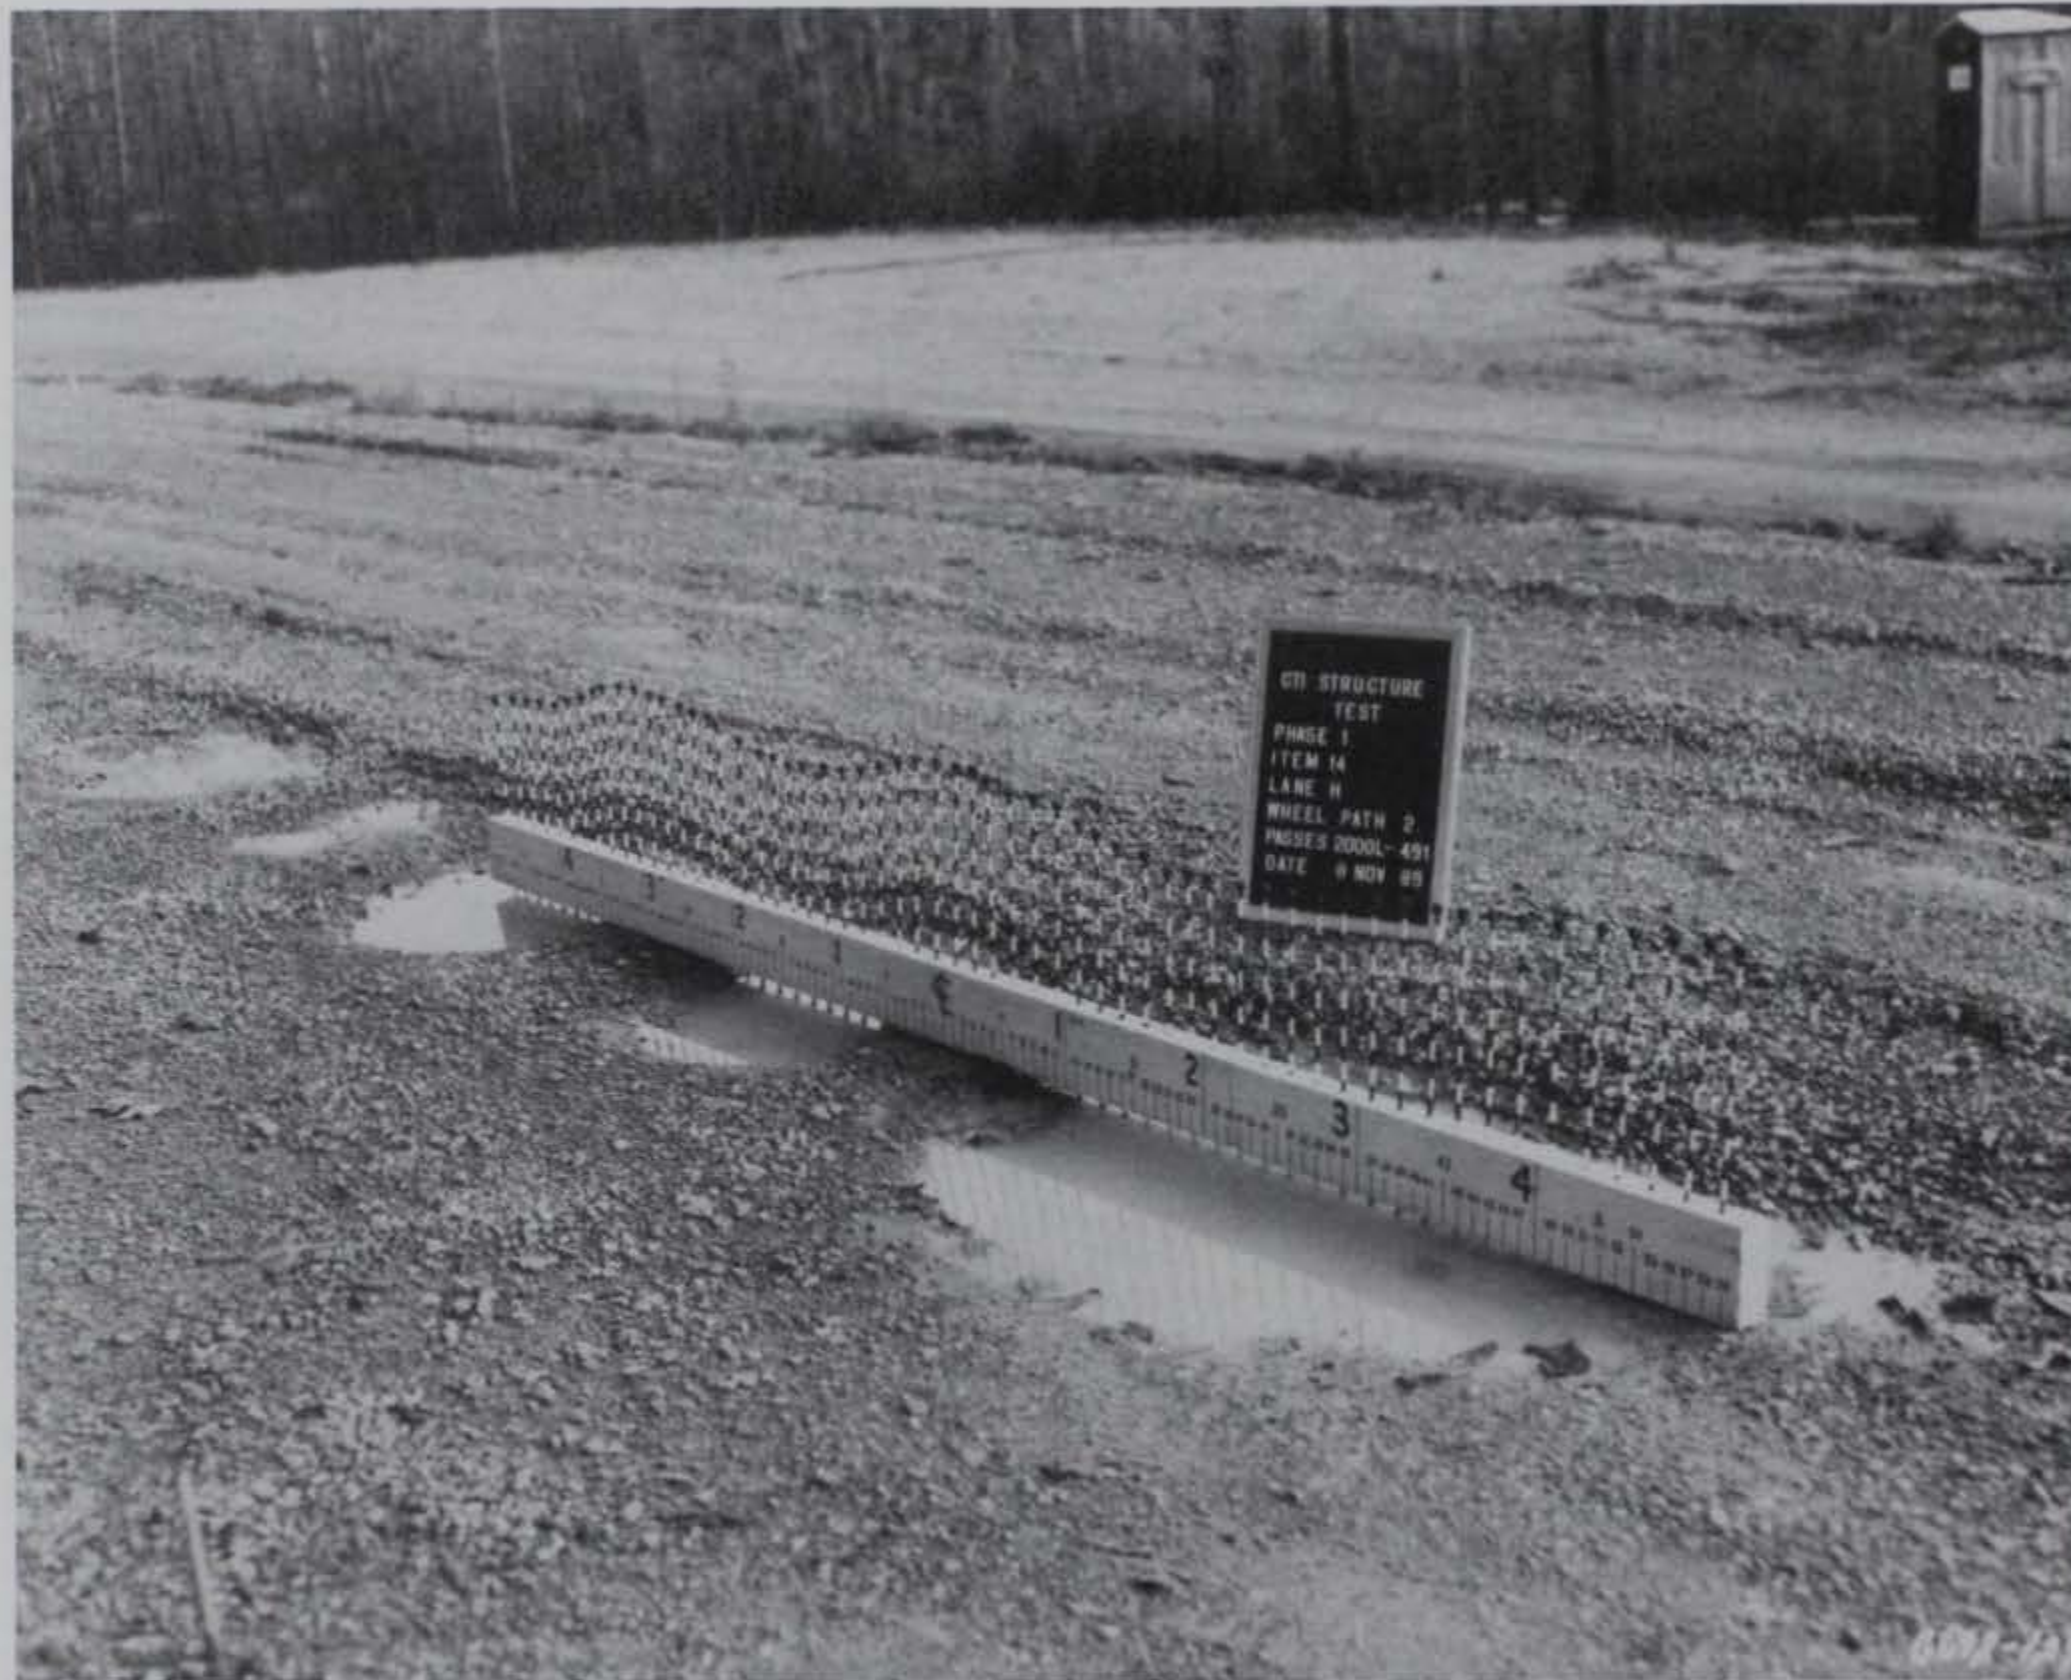
Photo 62. Item 14, high-pressure tire lane, high-severity washboarding after 491 passes during the induced failure plan

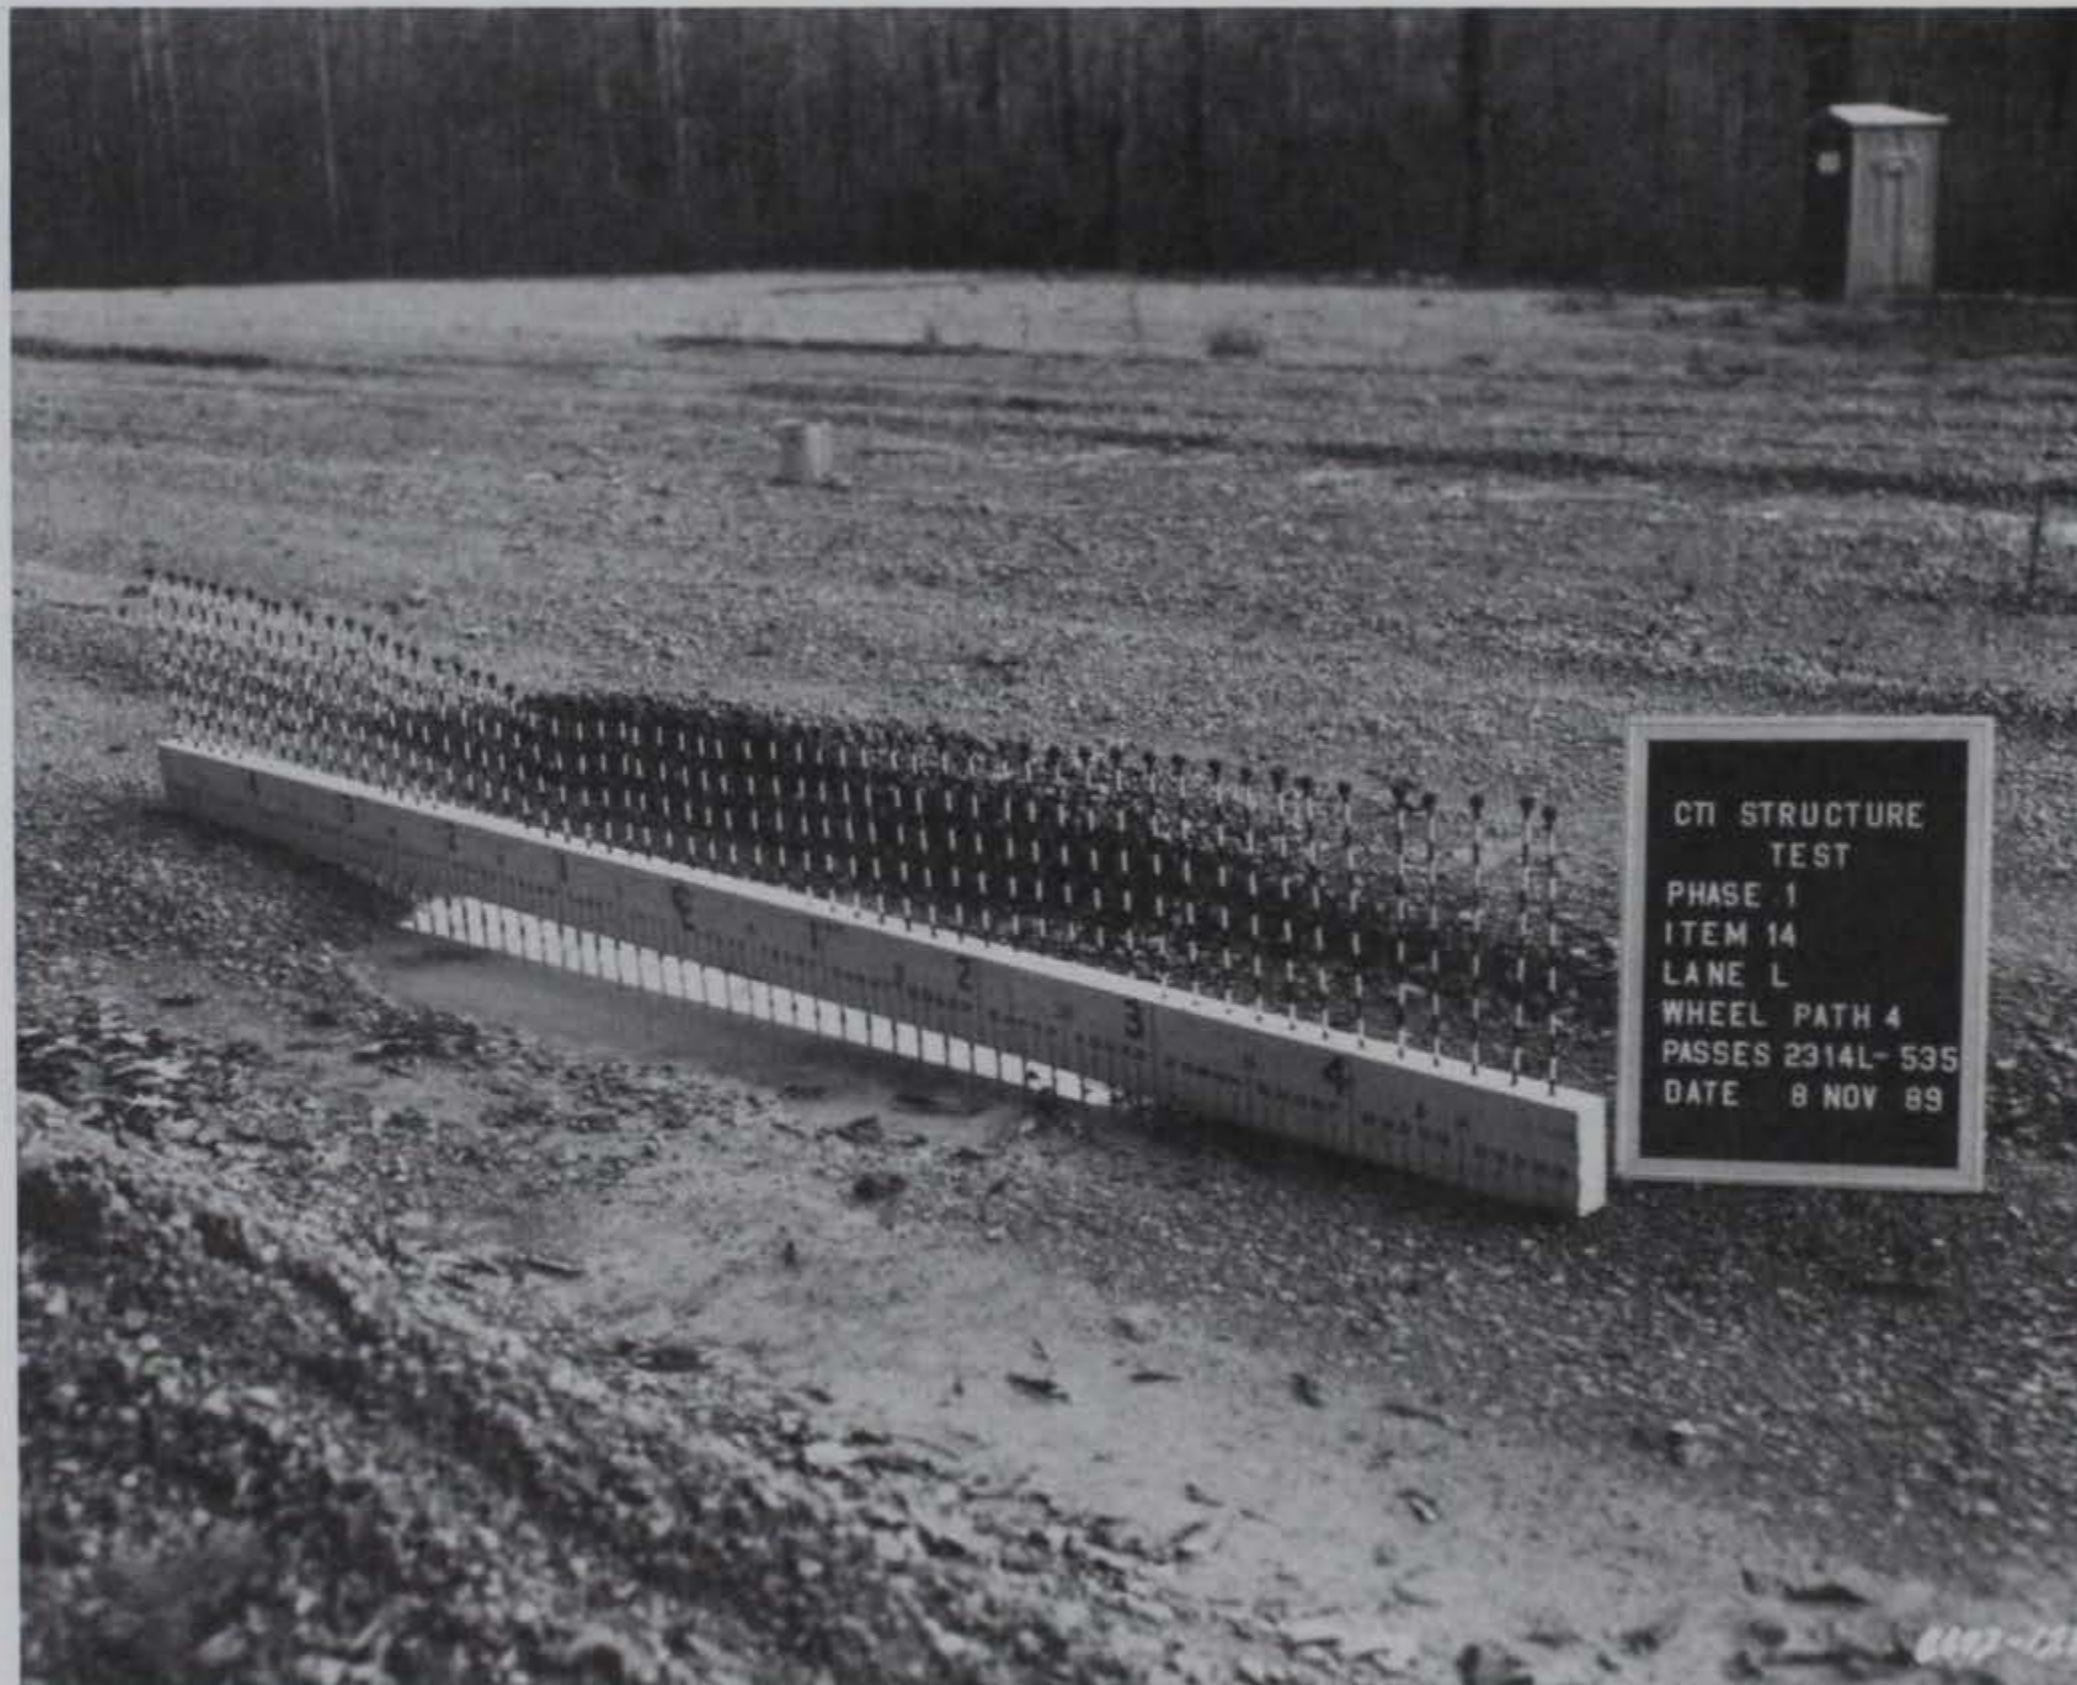
Since the surface distress was not increasing with traffic in items 13 to 15 and it was very desirable to obtain failure in these items before the winter rains set in, an induced failure plan was implemented on 24 October 1989. This plan called for an irrigation system to simulate rainfall to weaken the roadway structure at a controlled rate, to apply only loaded traffic, and to take DCP and rut depth measurements. Before the first watering cycle each lane was graded and then trafficked with 25 passes of the log trucks to compact the loose material in the wheel paths before watering. After each rain simulation, DCP measurements were taken in order to monitor the aggregate and sub-grade strengths. On 31 October 1989 watering and traffic testing was begun under this plan and continued until all test traffic was stopped on 22 November 1989. A summary showing dates, water applied, amount of traffic, and general remarks made during this period is shown in Table 26. Low-severity rutting developed in all items after 0.75 in. of simulated rainfall and 10 passes in each lane. The only other distress observed at this time was a high severity pothole in the low-tire-pressure lane of items 13 and 14. Very little additional distress was observed during the next 120 passes and 1.00 in. of rain. Overall the rutting rated as low severity in the high-tire-pressure lane of items 13 and 15 and as medium in all other lanes and items. The maximum distress observed at this time was the high-severity rutting in wheel path 3 of item 14 as shown in Photo 55. Overall views of items 13 to 15 after 130 passes in the low-tire-pressure lane under the induced failure plan are shown in Photos 56 to 58. General views of the high-tire-pressure lane of items 13 to 15 at this time are shown in Photos 59 to 61. As can be detected from these six photos, the surfaces of each item and lane were relatively smooth with no major rutting or washboarding. As additional traffic was applied, the distresses became more pronounced, and failure was reached once in the high-tire-pressure lane of item 14 after 491 passes due to high-severity rutting and washboarding. Failures also occurred in the high-tire-pressure lane of item 15 after 506, 855, and 1,035 passes. There were no failures in the low-tire-pressure lane. Photo 62 shows the high-severity washboarding detected in the high-tire-pressure lane of item 14 at failure. For comparison purposes, a view of the maximum distress in the low-tire-pressure lane of Item 14 at the same time the high-tire-pressure lane was rated as failed is shown in Photo 63. This high-severity pothole shown in Photo 63 originally developed after about 10 passes and was only about a foot long. As traffic continued, this pothole became

Photo 63. Item 14, low-pressure tire lane, high-severity pothole after 535 passes during the induced failure plan

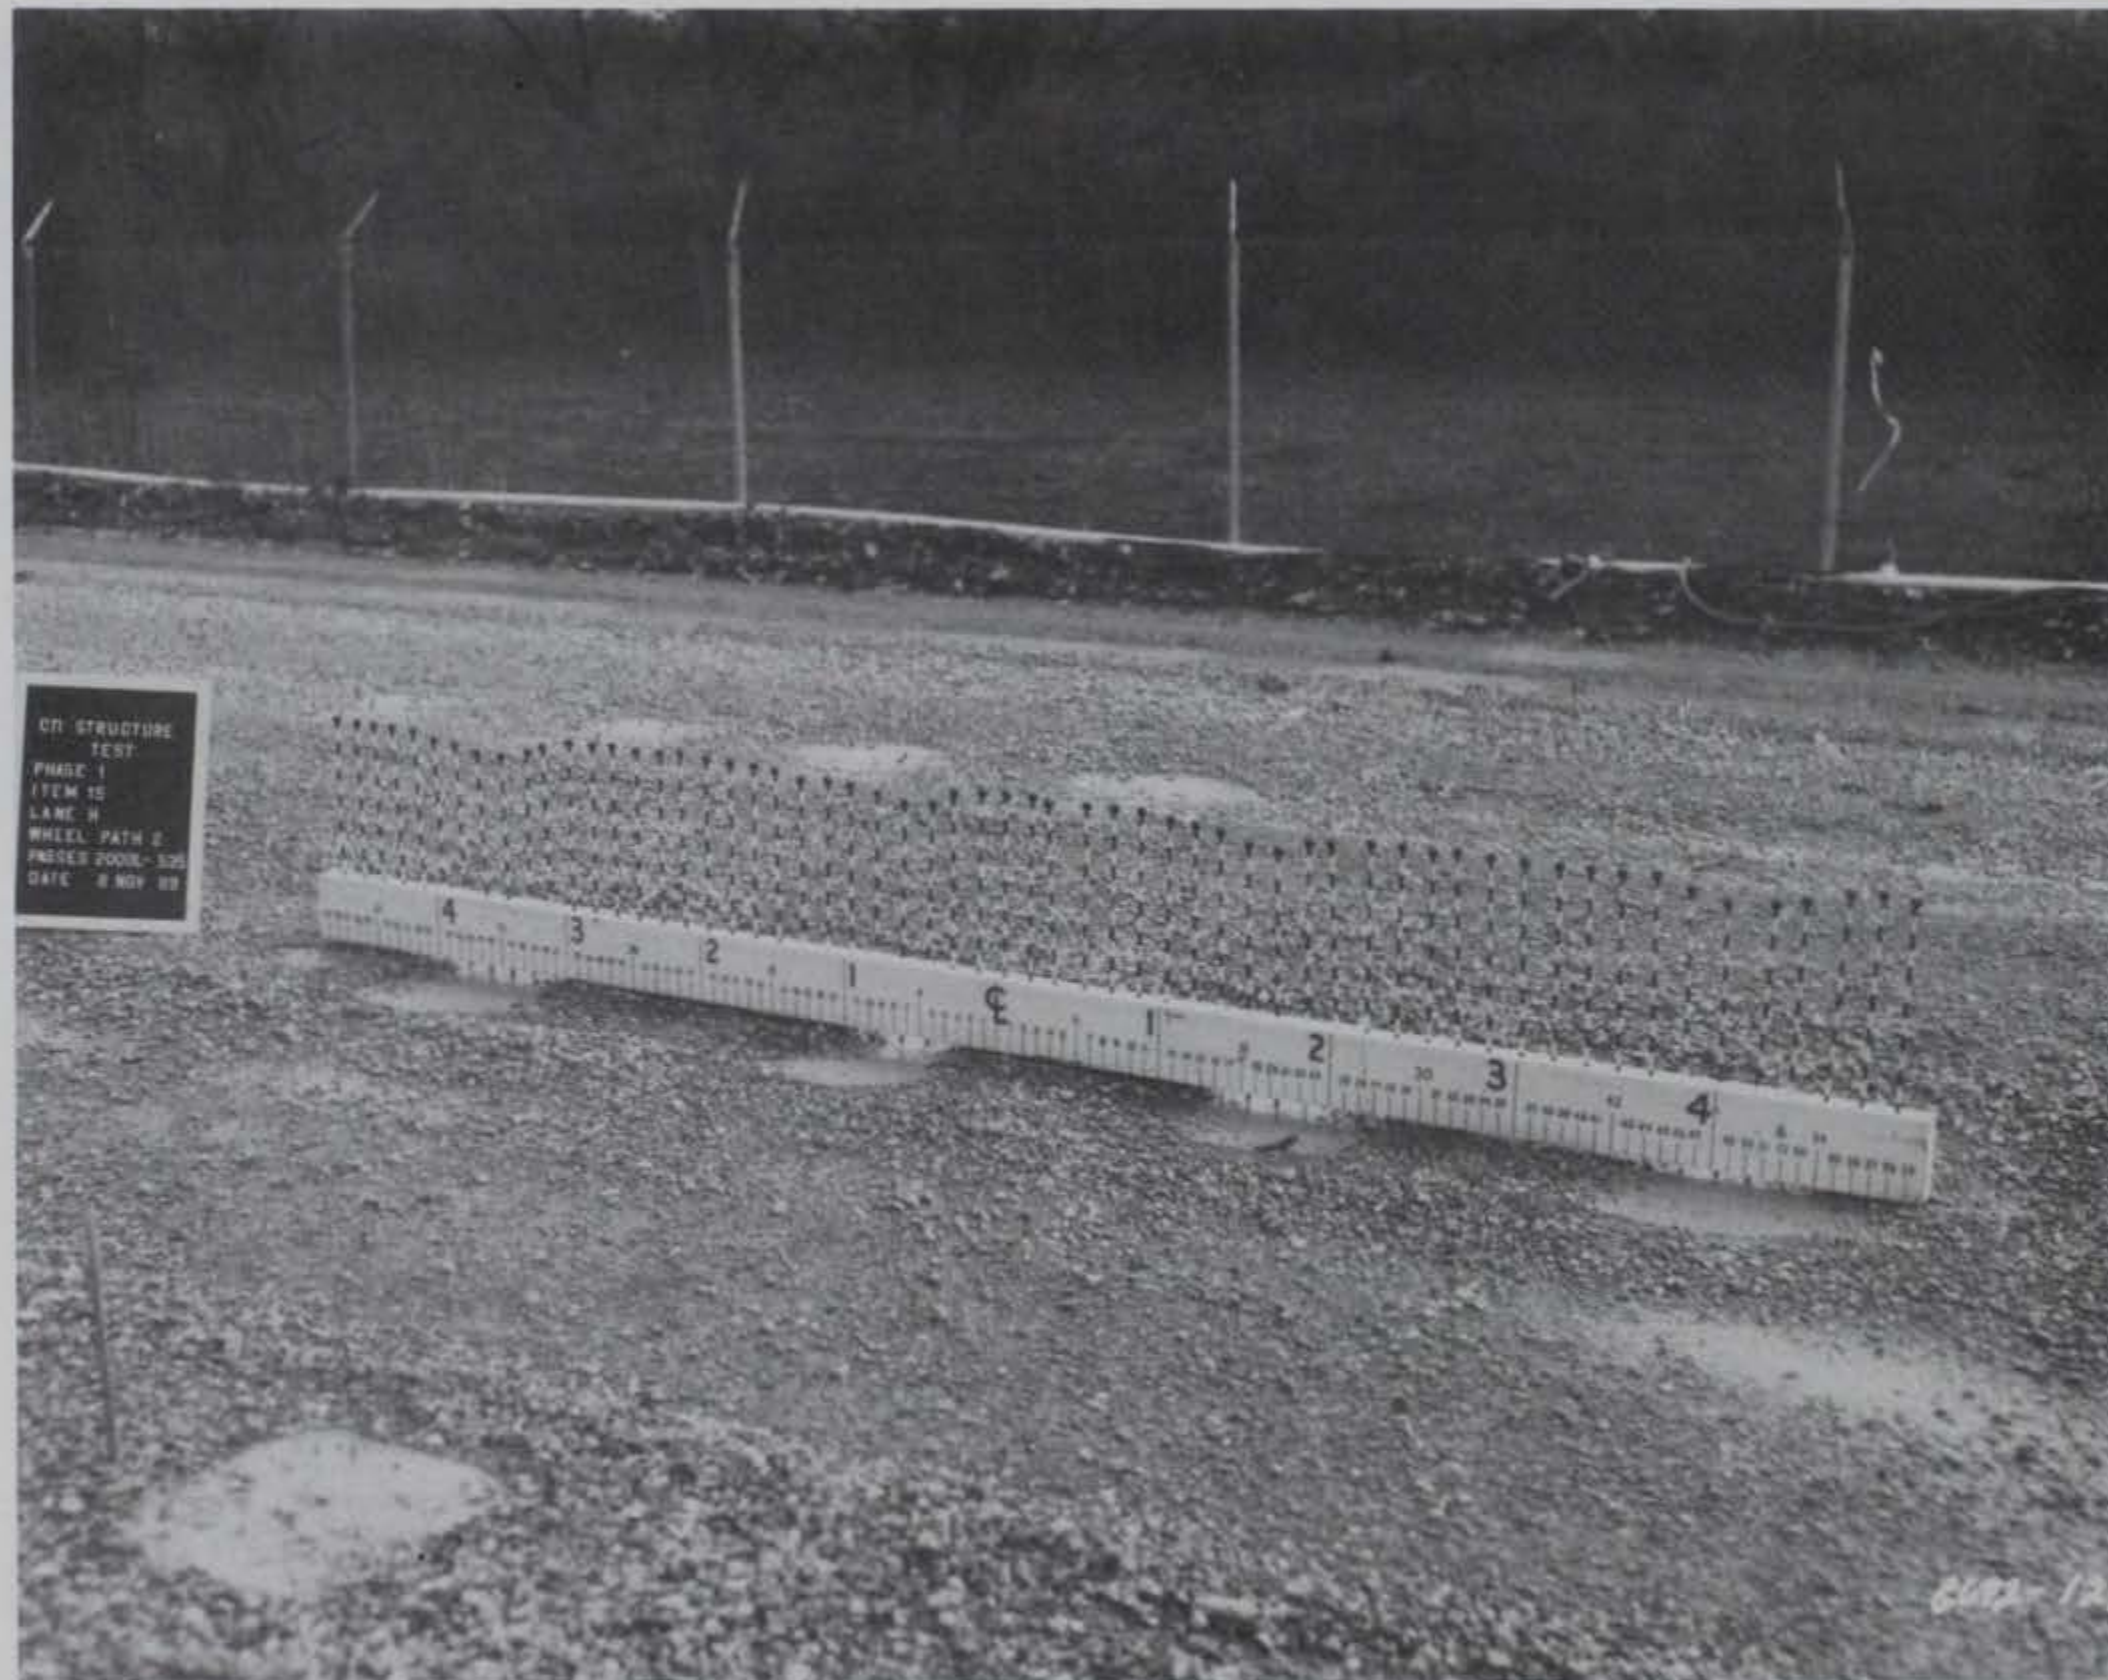
Photo 65. Item 15, high-pressure tire lane, typical high-severity washboarding after 535 passes during the induced failure plan

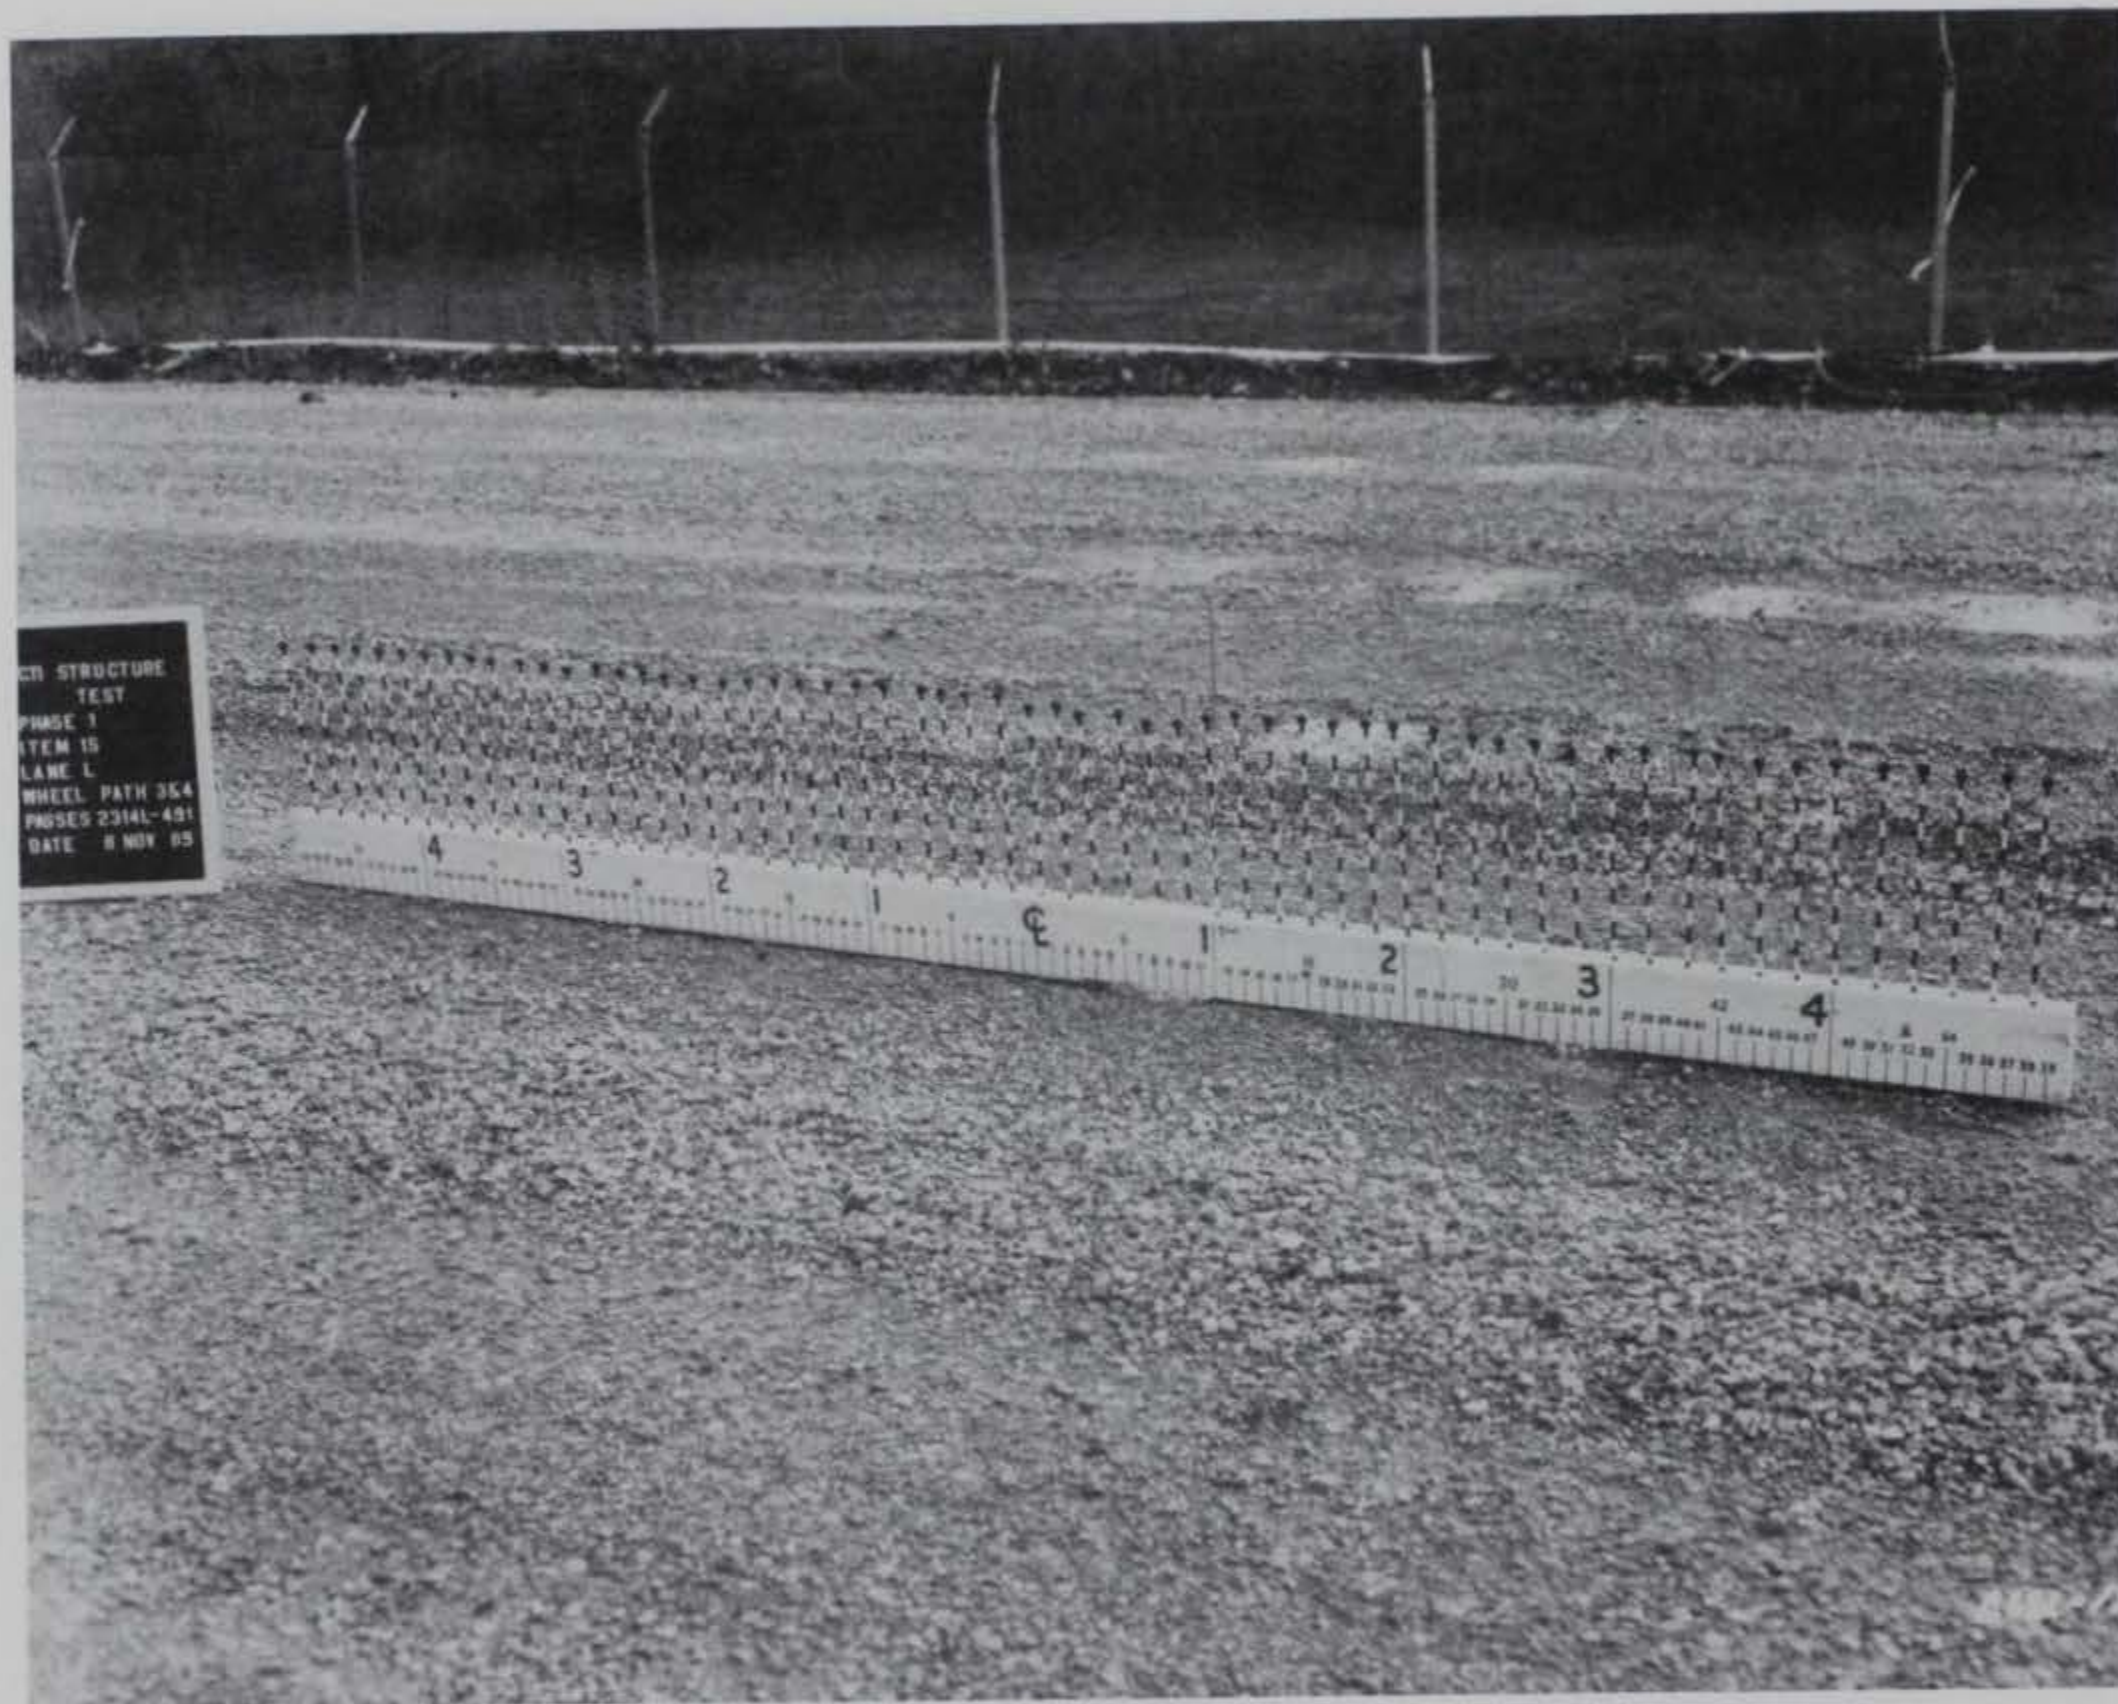
Photo 66. Item 14, low-pressure tire lane, typical low-severity washboarding after 491 passes during the induced failure plan
