Effects of Variable Tire Pressure on Road Surfacing

Volume I: Design, Construction, Behavior Under Traffic, and Test Results

by *Robert W. Grau*
Geotechnical Laboratory

Technical Report GL-93-20
August 1993

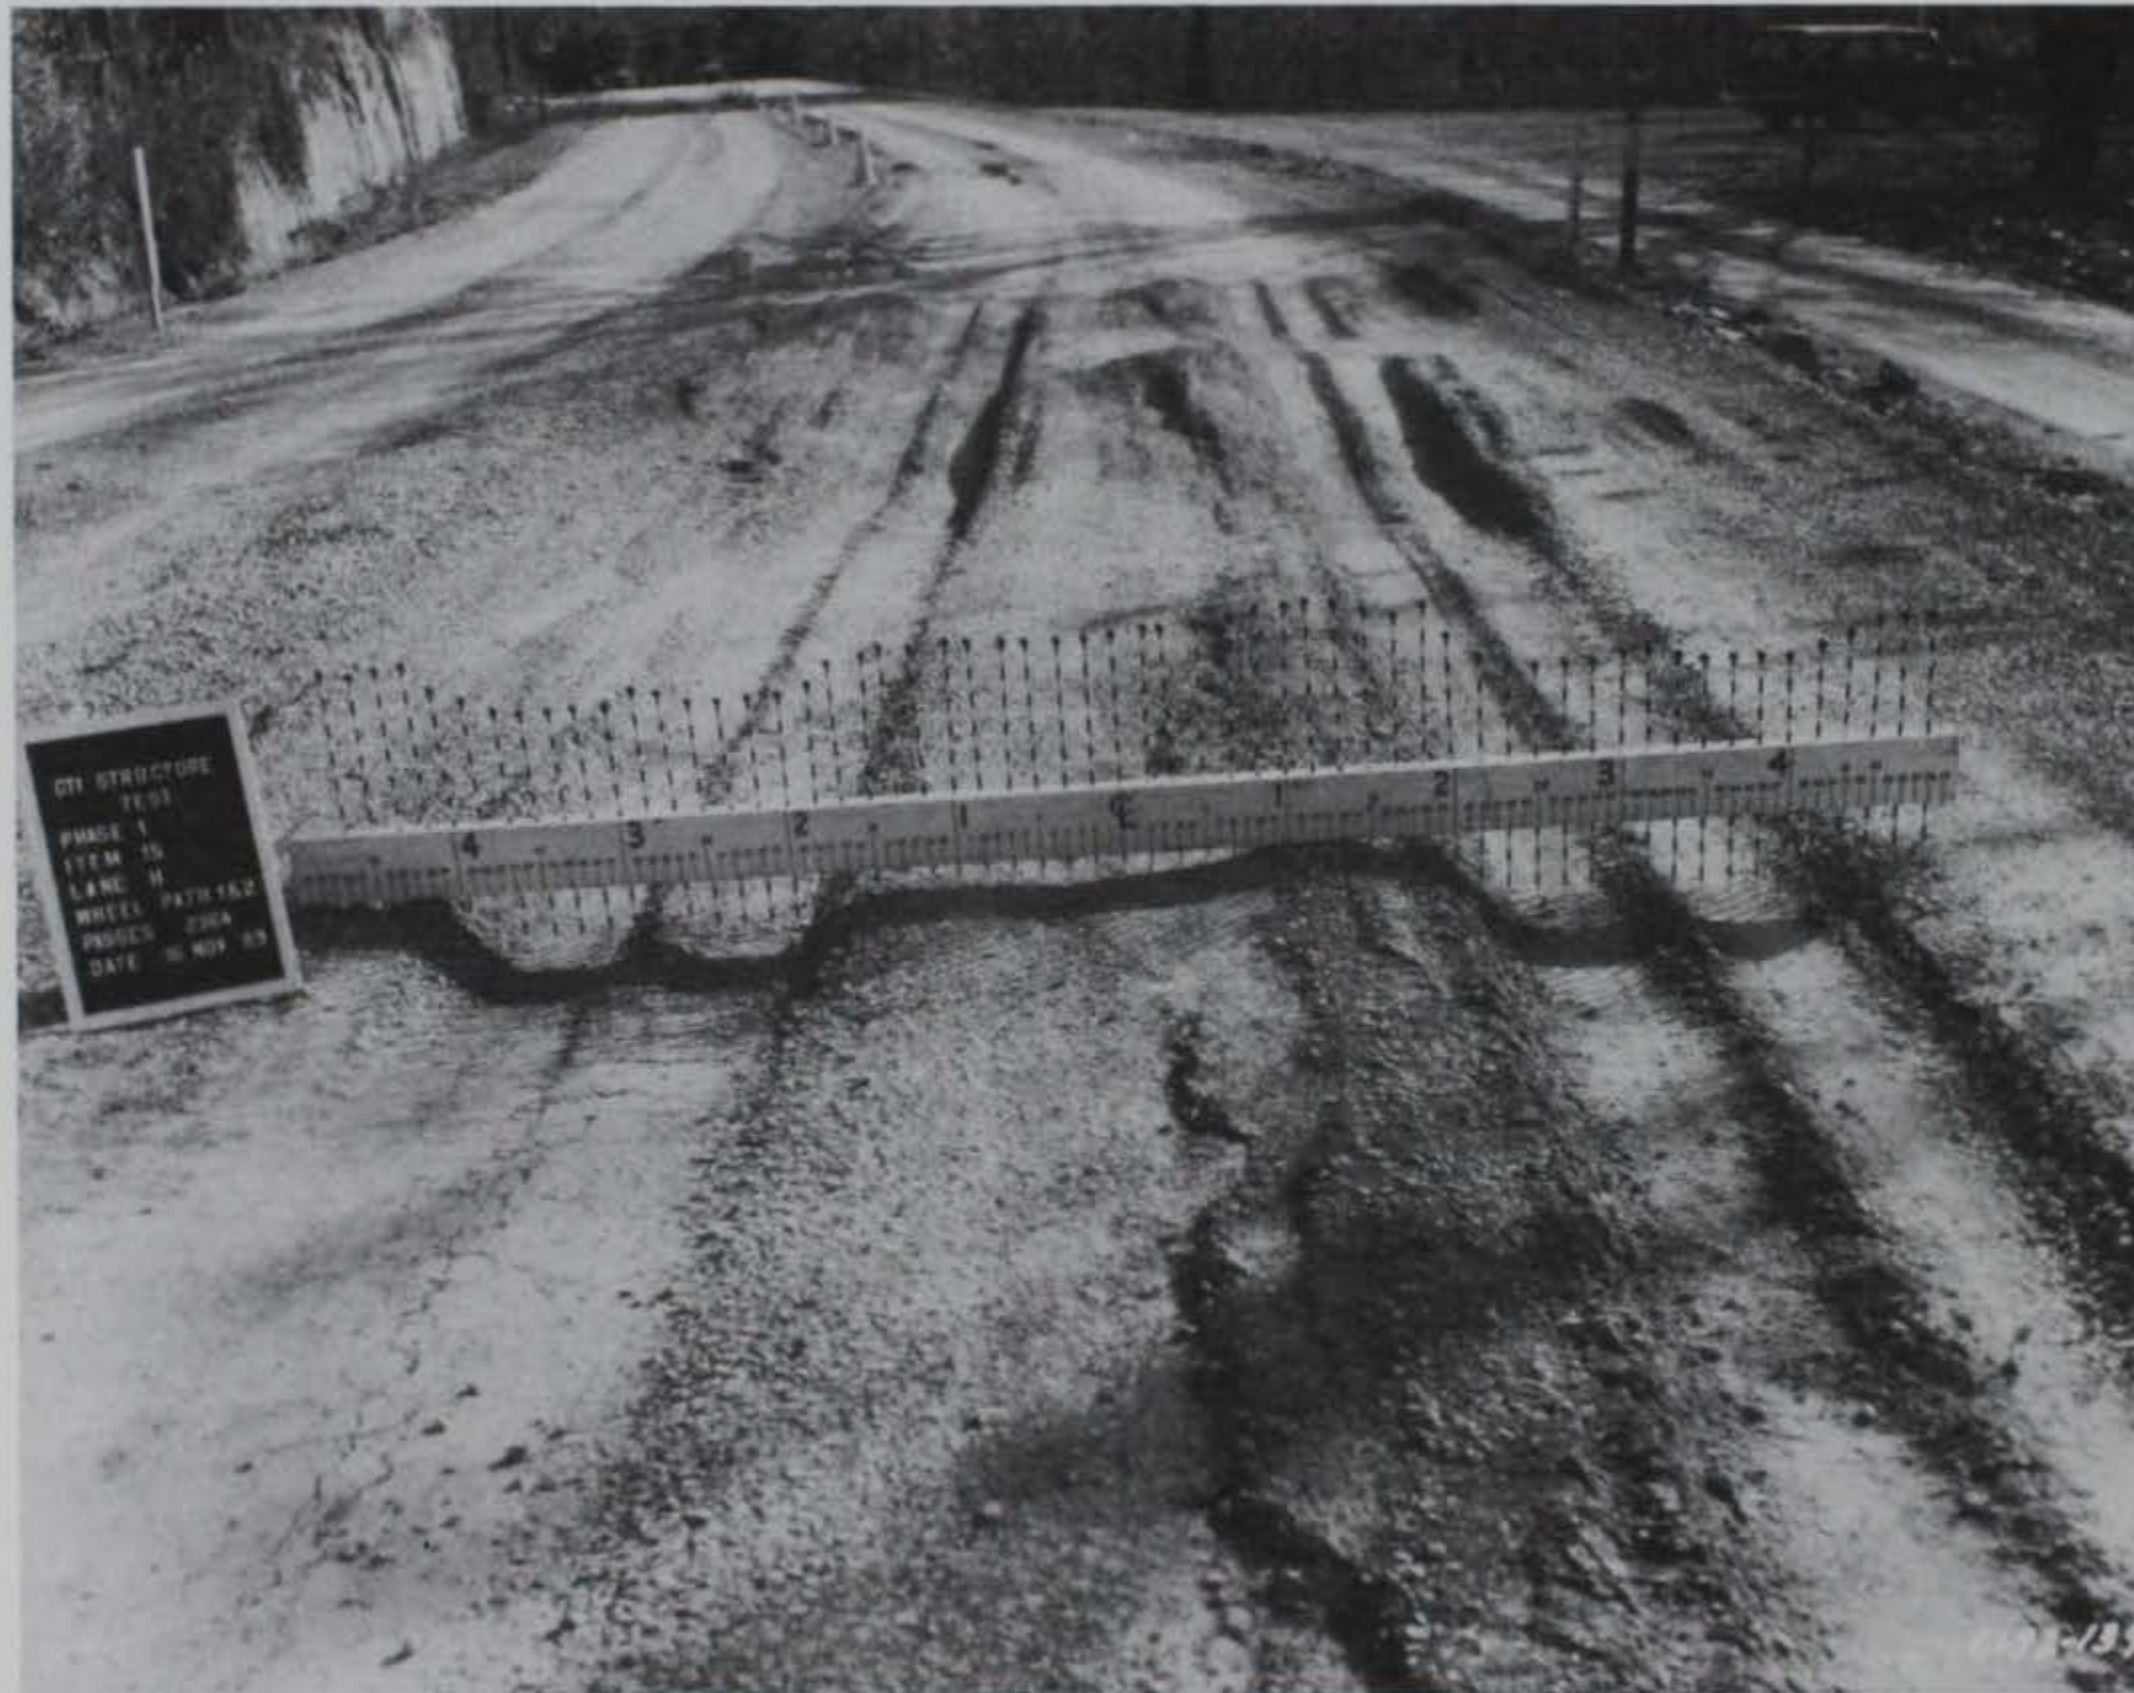
Photo 67. Item 15, high-pressure tire lane, severe rutting and loose aggregate after 913 passes of induced traffic for a total of 2364 loaded passes

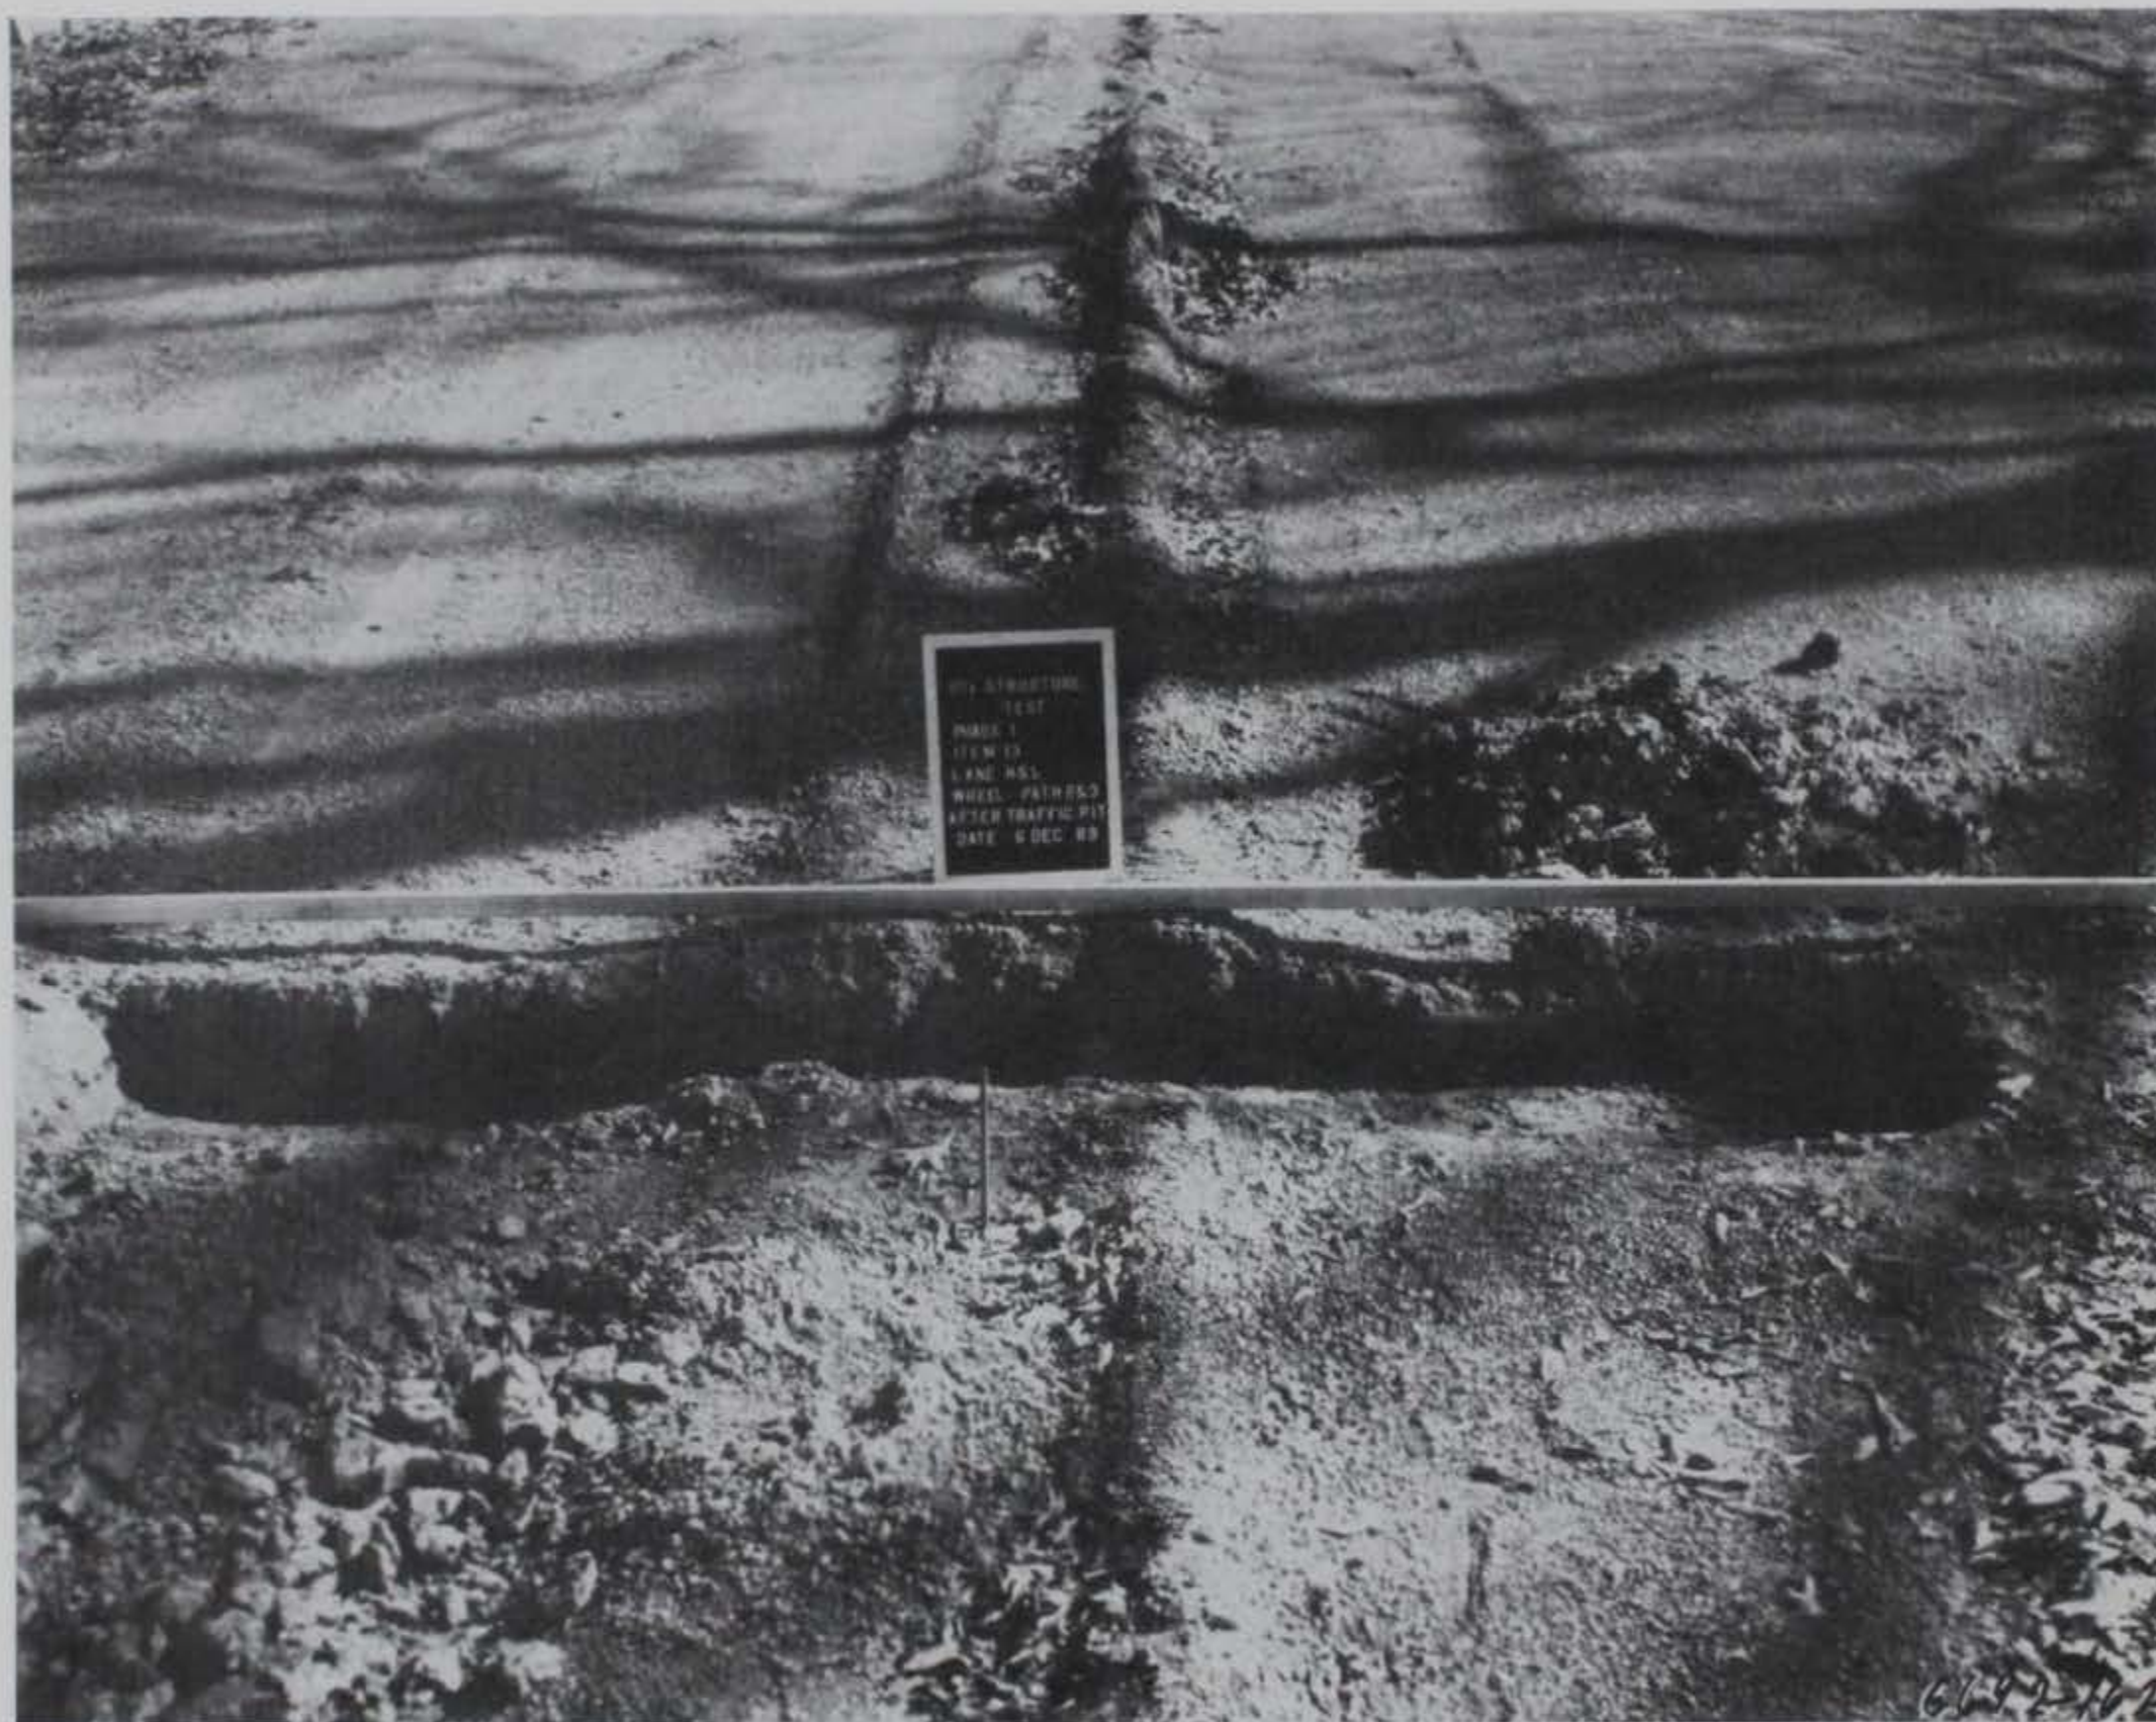
After most of the failures, the rut depth measurements were complimented with one or more of the following: photos, cross section and profile measurements, condition survey, DCP measurements, and/or NDT. A discussion or description of many of the failures is in the "visual observations" section of this report and include typical photos of areas judged failed. Cross section and profile measurements, condition survey results, and DCP and NDT measurements taken after failure of a particular item are stored in enclosed computer files. Test trenches were not excavated across the traffic lane after it was judged failed. Therefore, CBR, water content, and density measurements were not available for the failed areas. Once test traffic was applied on a regular bases, the top priority was to fail as many items as possible in a short time period because of limited funds and the possibility of damaging and uncontrollable rainfall. Therefore, test trenches were omitted and only limited data were taken after each failure. Traffic was discontinued on the 22 November 1989, and in early December test trenches were excavated in items 13, 14, and 15. At this time CBR, moisture content, density, and thickness determinations were made in the second and third wheel paths of the aggregate and subgrade materials. These data are summarized in Table 3. A general view of the post traffic test pit excavated in item 13 is shown in Photo 68.

Photo 68. Item 13, general view of the post-traffic test pit
