MISCELLANEOUS PAPER CERC-87-21

FLOATING TIRE BREAKWATER TESTS PICKERING BEACH, DELAWARE

Peter J. Grace, James E. Clausner

December 1987 Final Report

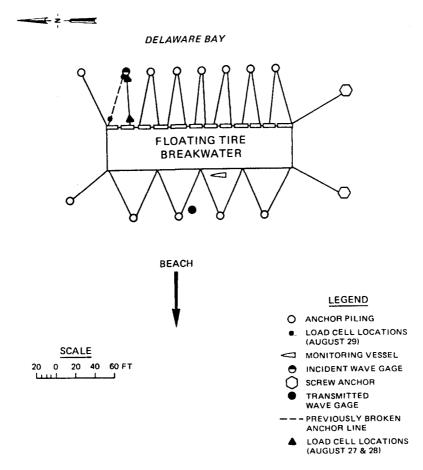
Figure 7. Project site

29. Preparation of the test site and DAS was scheduled on the first day of the week-long effort. This involved (a) assembly of the incident wave gage, (b) preparation of waterproof connections, (c) installation of the two anchor line load cells, (d) placement of solid supports to secure the wave gages and all cables, and (e) positioning of buoys to mark sailing lines to be followed by the wake generating vessel. The original test plan called for installation of the two load cells on one of the northern corner anchor lines; however, the first visit to the site revealed that this line was broken and the adjacent anchor line was instrumented instead (Figure 7).
