**US Army Corps
of Engineers**
Waterways Experiment
Station

Coastal Engineering Research Program

Scour Hole Problems Experienced by the Corps of Engineers; Data Presentation and Summary

Final report

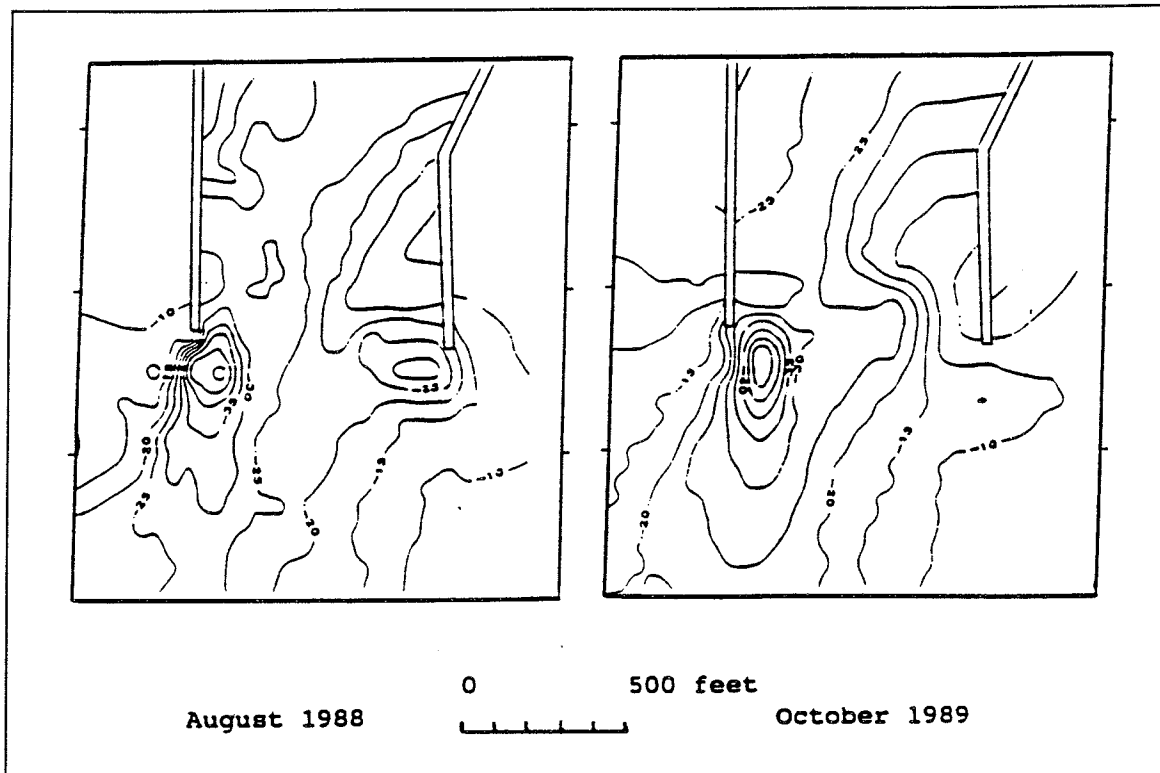
Figure 3. 1988 and 1989 bathymetry of Moriches Inlet

Between 1987 and 1989, both jetties at Moriches Inlet were refurbished at a cost of approximately \$4 million. It was found during the general design memorandum study phase that deterioration of the west jetty head was due in large part to undermining caused by the presence of the deep scour hole located just seaward of the jetty head. The scour hole is thought to be caused by swift ebb currents flowing out the east branch channel, moving diagonally across the entrance channel, and passing seaward of the west jetty tip. The intersection of the ebb jet with incoming waves creates an eddy which is thought to contribute to the scour problem.

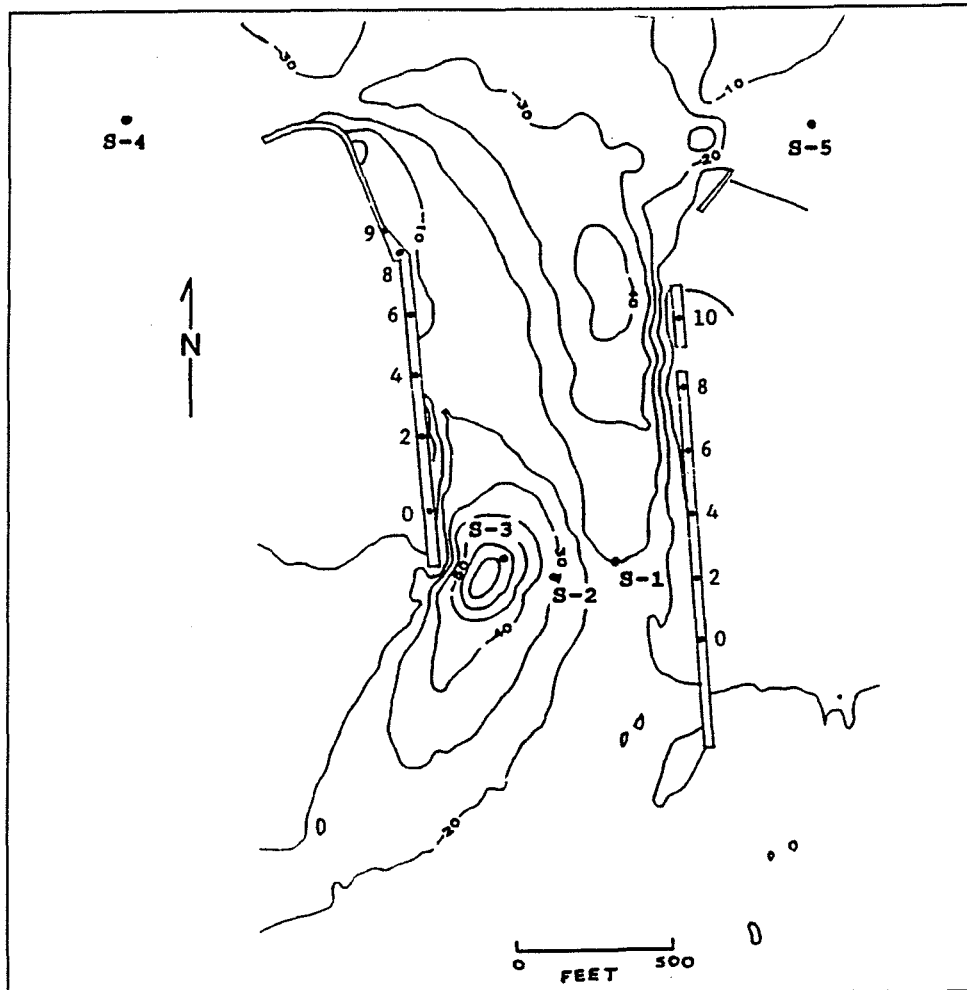
Figure 4. Shinnecock Inlet scour hole

A 70-ft-deep scour hole has developed at Shinnecock Inlet adjacent to the west jetty as shown in Figure 4. This scour hole is similar to the one at Moriches Inlet; however, the problem is more severe at Shinnecock because the west jetty has been undermined and 60 - 70 ft of the jetty head has disappeared. There is also concern that the scour hole might enlarge to the point that additional toe protection material may be lost and more of the structure will be damaged.

The location and shape of the scour hole suggests that it was formed in a similar manner as hypothesized for Moriches Inlet. Strong ebb flows from the east channel are entering the inlet diagonally and flowing across the channel until they interact with either the jetty structure or the unsheltered incident wave field. In either case, it appears that large-scale rotational flows may be generated that mobilize sediment which is swept away by the current. This hypothesis is supported by the observed "scallop" shape of the hole, which is

typical of scour caused by strong currents. There was also a diver report stating that currents created a whirlpool effect in the vicinity of the scour hole.

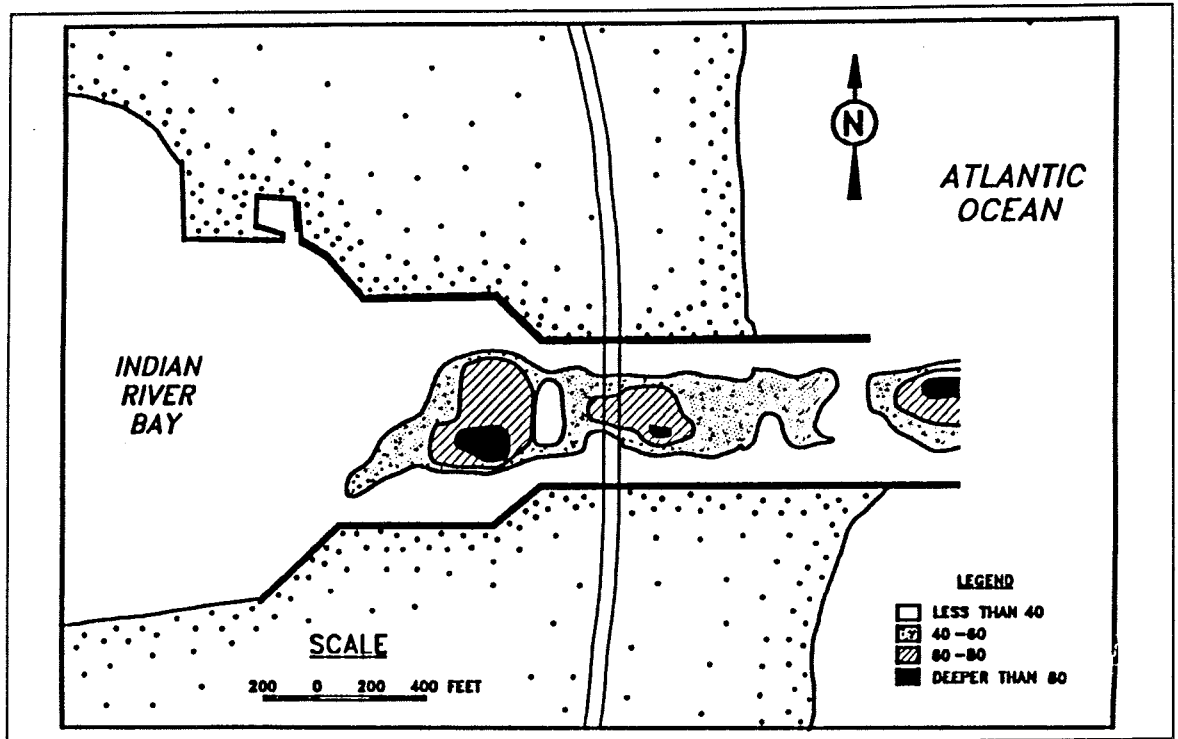
Figure 7. 1988 bathymetry, Indian River Inlet

Since construction of the Federal project, the inlet has gradually increased in depth, from elevations approximately -14 ft mlw to -40 ft mlw. Figure 7

shows 1988 bathymetry conditions, and Figure 8 presents inlet cross-sectional area at different dates since construction. The increase up until the mid-1970's was gradual. In the mid-1970's the inlet cross-sectional area increase accelerated. During this same period, several large, localized scour holes formed at the tip of the north jetty and immediately on either side of the bridge piers. The scour holes at the bridge piers have depths greater than elevation -90 mlw and are continuing to deepen. The scour hole at the jetty tip has caused structural failure, and approximately 300 ft of jetty has been lost. Scour at the bridge has caused remedial action to be taken by the Delaware State Department of Transportation. In 1989 the state spent \$2.7 million to place rubble material adjacent to the bridge piers in order to halt undermining.

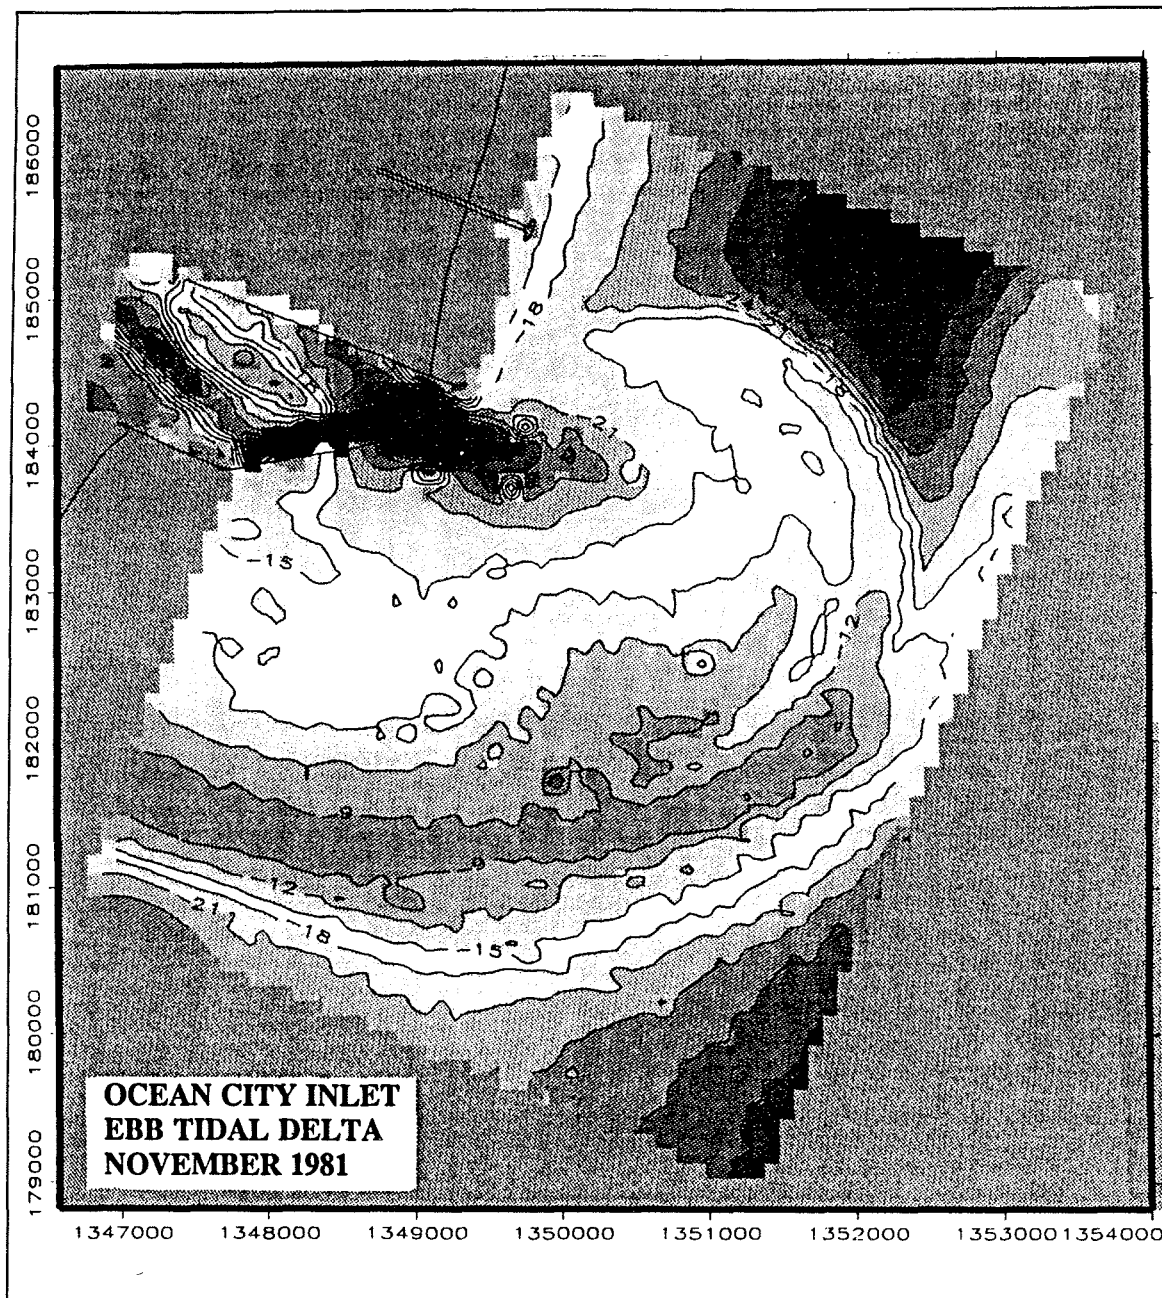
Figure 11. Scour hole at Ocean City, Maryland

Soon after construction, the natural inlet channel migrated toward the south jetty causing scour and undermining along an 800-ft-long section of the structure. The degraded south jetty section was not immediately repaired because the inlet/jetty system remained functionally operable. A scour hole also developed near the tip of the south jetty. Figure 11 illustrates the scour at the south jetty, based on survey data taken in November 1981.

In 1984 the Baltimore District filled the scour hole adjacent to the south jetty with sand hydraulically dredged from the inlet. The elevation was raised to -30 ft NGVD and capped with rubble stone weighing 50 to 200 lb. The cap was approximately 2 ft thick. In addition, an armor berm was created along this section of jetty, 2,000 ft long and 200 ft wide. Side-scan sonar was used to inspect the cap and berm in 1984 and 1990, and no subsequent erosion was found (Bass, Fulford, and Underwood, in preparation).

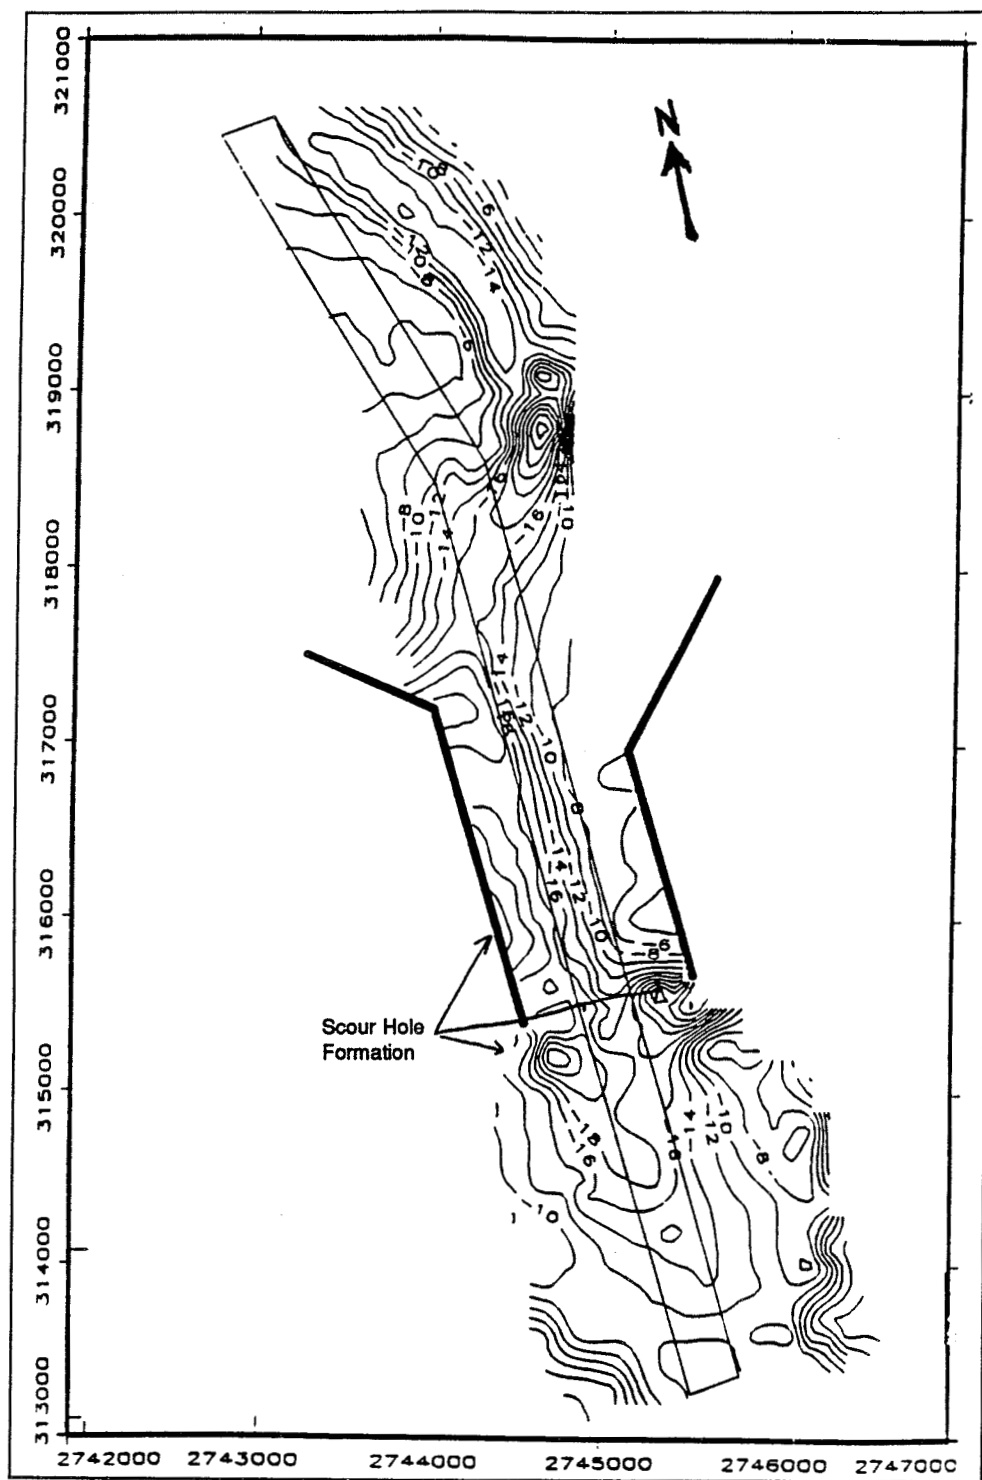
Figure 18. Scour holes at Little River Inlet

Scour at the tip of the east and west jetties appears to be caused by tidal current and structure interactions. The west jetty scour hole is approximately 10 to 15 ft deeper than the surrounding bottom. The hole at the east jetty is larger than the west jetty scour hole. The east scour hole began to form around October 1982 and had increased to a depth greater than 25 ft mlw by April 1983. In December 1983, material dredged from the inlet was used to fill the east scour hole. This filling was short-lived, however, as the deepening trend continued, and at this writing the hole was deeper than 30 ft mlw. The cause of scour at the jetty tips was suggested by Chasten and Seabergh (in preparation) to be due to tidal current and structure interaction. The deeper scour hole occurring at the east jetty is probably due to the proximity of the ebb tidal shoal, causing increased current speeds around the jetty tip.

Scour is also occurring along the west jetty adjacent to the inlet channel, and the cause appears to be different from that at the tips. Along this section, natural thalweg migration appears to be shifting the channel toward the jetty, scouring to a depth of about 20 to 25 ft mlw. Prior to construction of the navigation project, the natural channel shifted frequently; and at the time of construction of the west jetty, the natural channel was toward the southwest and Waties Island (Chasten and Seabergh, in preparation). This flow route was closed off as the west jetty was constructed and the ebb tidal flow began channelizing along the west jetty. In December 1983, dredged material from the inlet was placed in the scour hole but has since eroded away, and the hole continues to enlarge. Figure 19 shows a survey taken along the west jetty prior to dredged material placement and following placement. Note that the deepening trend continued immediately following fill placement.

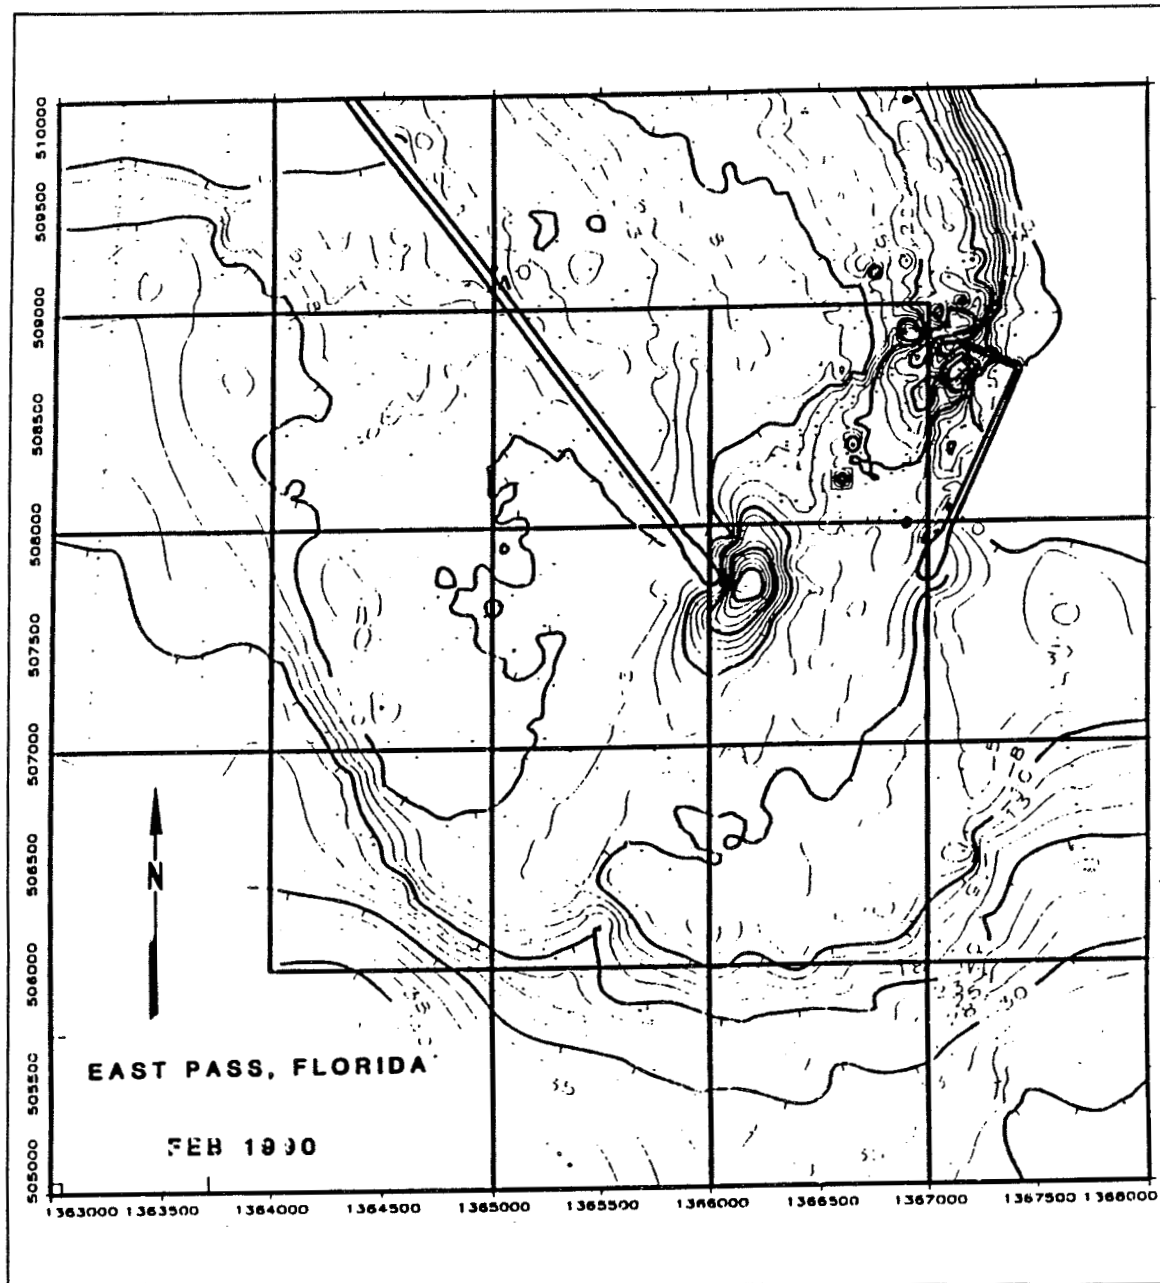
Figure 28. East Pass scour holes (Morang 1992)

In the 1980's, a 55-ft-deep scour hole developed that ultimately resulted in the loss of the spur dike at a rate of nearly 100 ft/year. This scour hole represents scouring nearly 25 - 30 ft below the normal bottom depth in the area. Figure 28 shows a plan view of the location of the scour hole at the spur groin and another scour hole at the tip of the west jetty.

To minimize adverse scour, the report recommends the following (Morang 1992):

- a. The spur groin can be rebuilt with extensive toe protection to prevent collapse. The scour hole near the tip of the spur would have to be filled and then armored to prevent future scour. While the use of concrete and rubble fill in the past provided only temporary relief, an engineered approach employing precisely placed armor units might be more successful.
- b. The scour hole at the tip of the west jetty should also be filled and capped with armor stone to prevent damage to the jetty.

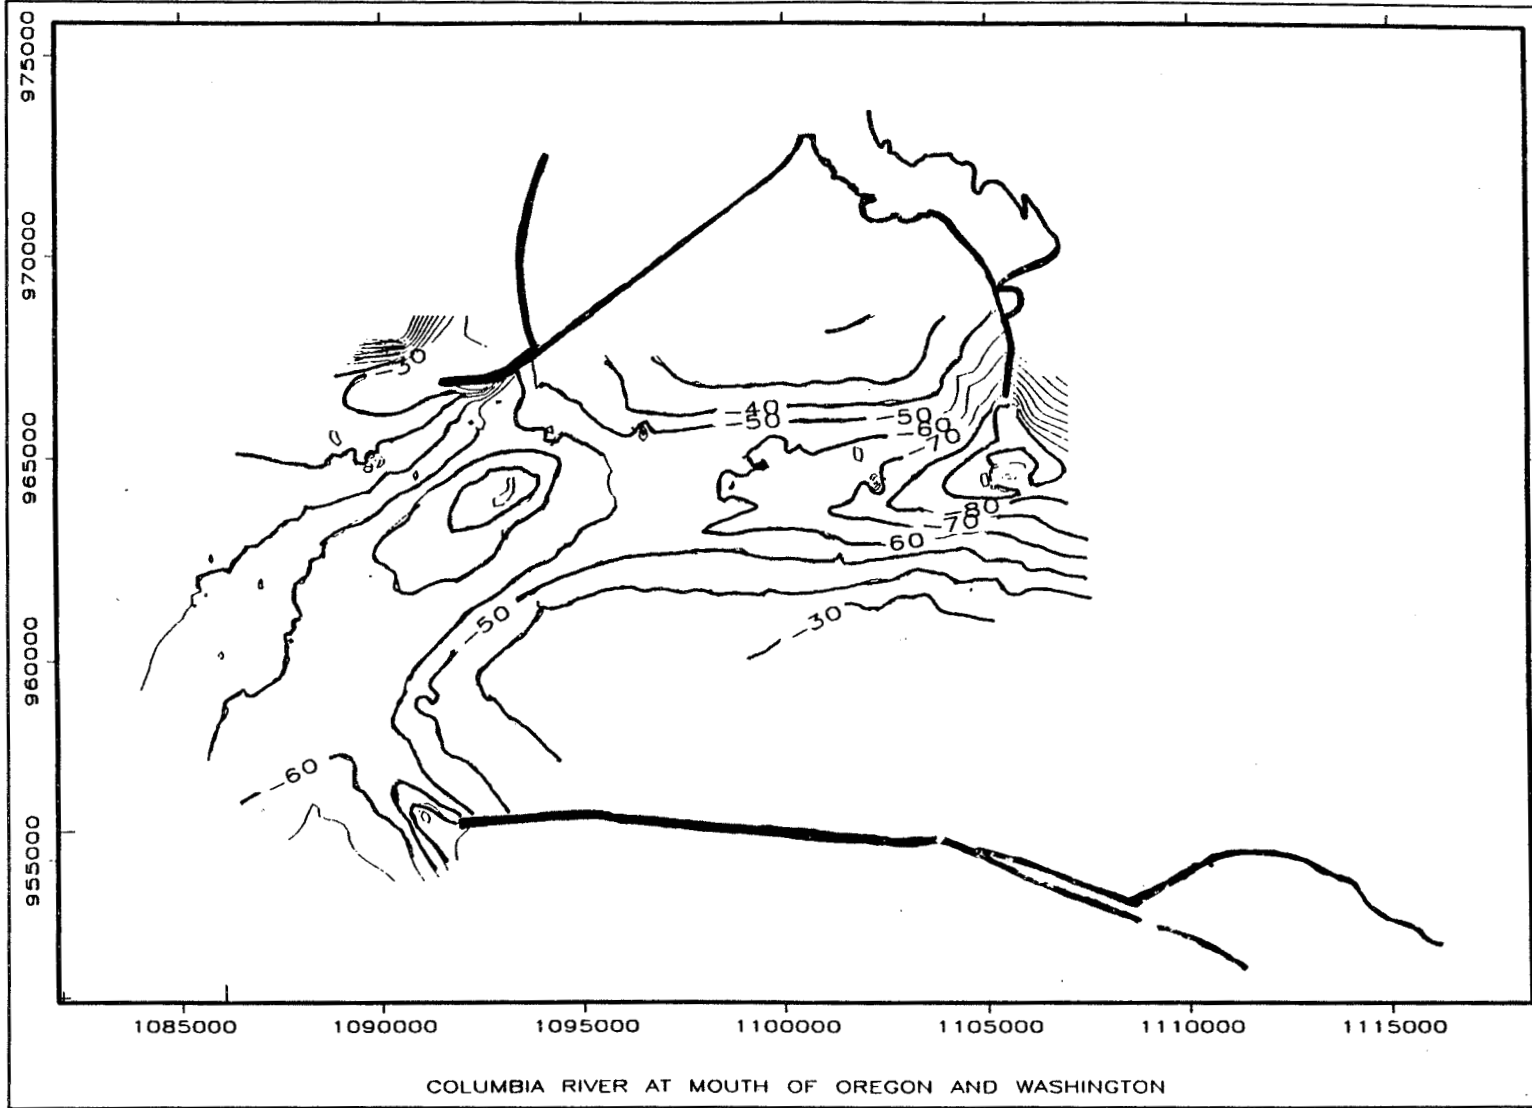
Figure 39. Columbia entrance bathymetry

A large scour hole is located just south of the submerged end of the north jetty (Figure 39). This hole tends to scour to depths on the order of 80 ft
