MISCELLANEOUS PAPER CERC-86-3

# FLOATING BREAKWATER PROTOTYPE TEST PROGRAM: SEATTLE, WASHINGTON

March 1986

Final Report

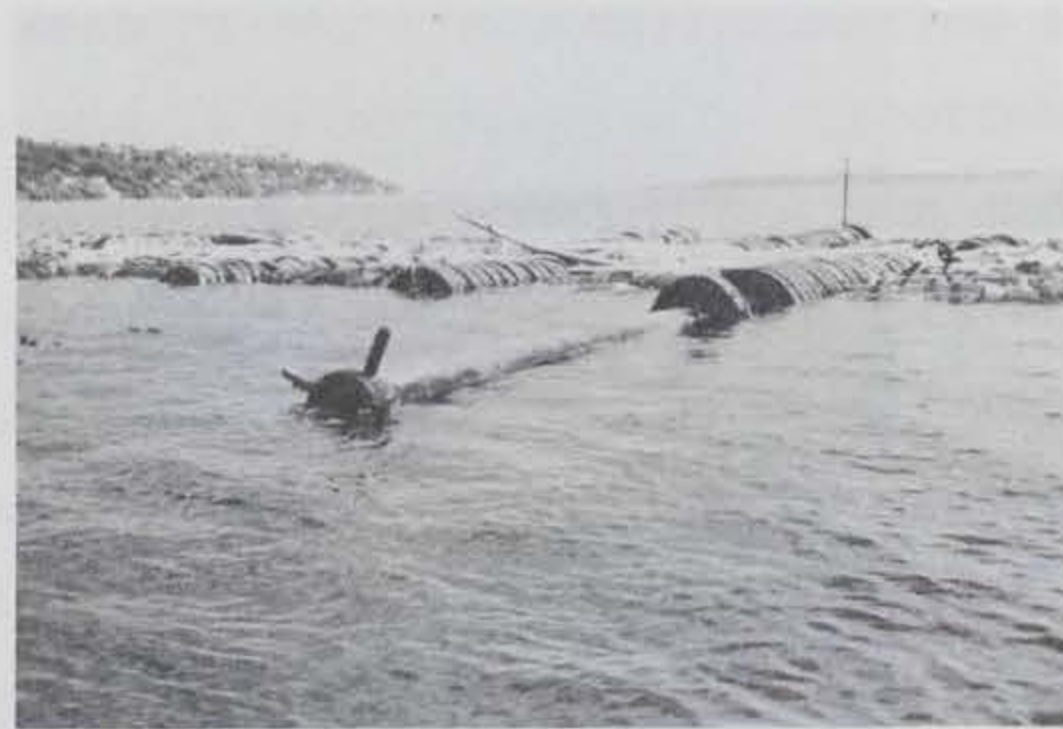
For nearly a year, the pipe-tire breakwater proved to be remarkably durable. Except for minor repairs to the keeper pipes, it withstood the winter storms of 1982 without any maintenance (photograph 23). But in June 1983, almost a year to the day after the pipe-tire breakwater was installed, the first problem of any consequence developed. After a minor storm, routine inspection revealed that one of the longitudinal pipes had broken (photograph 24). A closer inspection revealed that the 45-ft pipe had been fabricated from a 40-ft section and a 5-ft section. A poor weld between the two sections had finally failed because of a combination of corrosion and fatigue, allowing the two pipe sections to pull out of the tires. One month later, when a second pipe failed in exactly the same manner, a decision was made to terminate testing of the pipe-tire breakwater. During the removal process, the anchor lines were inspected, and no major problems were found in the nylon anchor lines or connecting hardware. After the breakwater was removed, it was surplused and eventually reinstalled at a private marina in southern Puget Sound. Monitoring of the long-term durability of this unit is planned.

Photo 24. A broken longitudinal pipe pulling out of the tires.

g. The keeper pipes on the pipe-tire breakwater should be redesigned. If a single 4-in.-diam by 40-in.-long keeper pipe were welded in place, the expensive 4-way cross coupler and 2-in. ID pipes which were vulnerable to corrosion and loosening could be eliminated. Also, designers should consider the potential for corrosion of all small metal parts such as cotter keys.

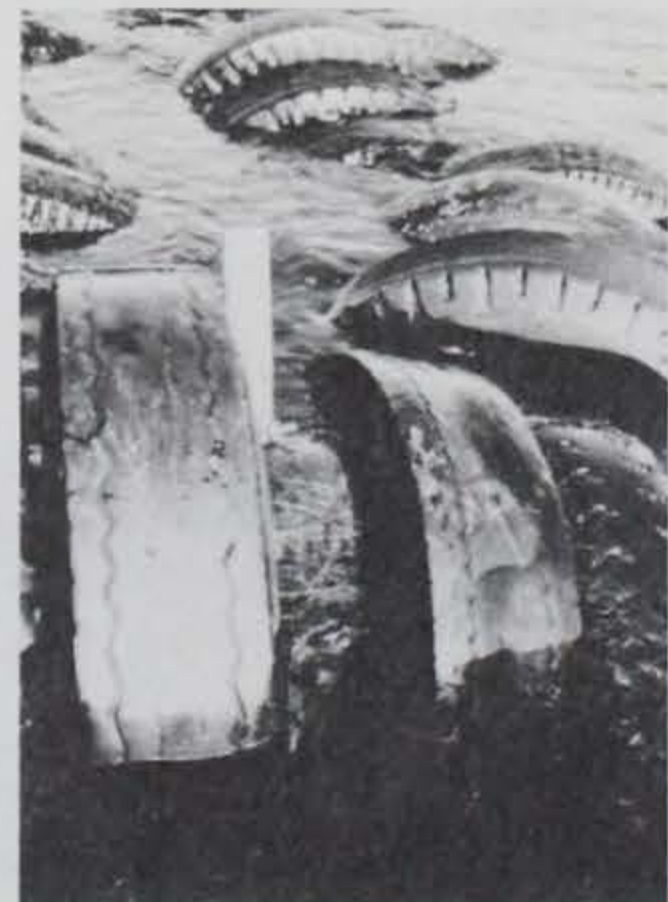
Photo B-30. Photo showing keeper pipe repair which prevented additional tires from falling off.

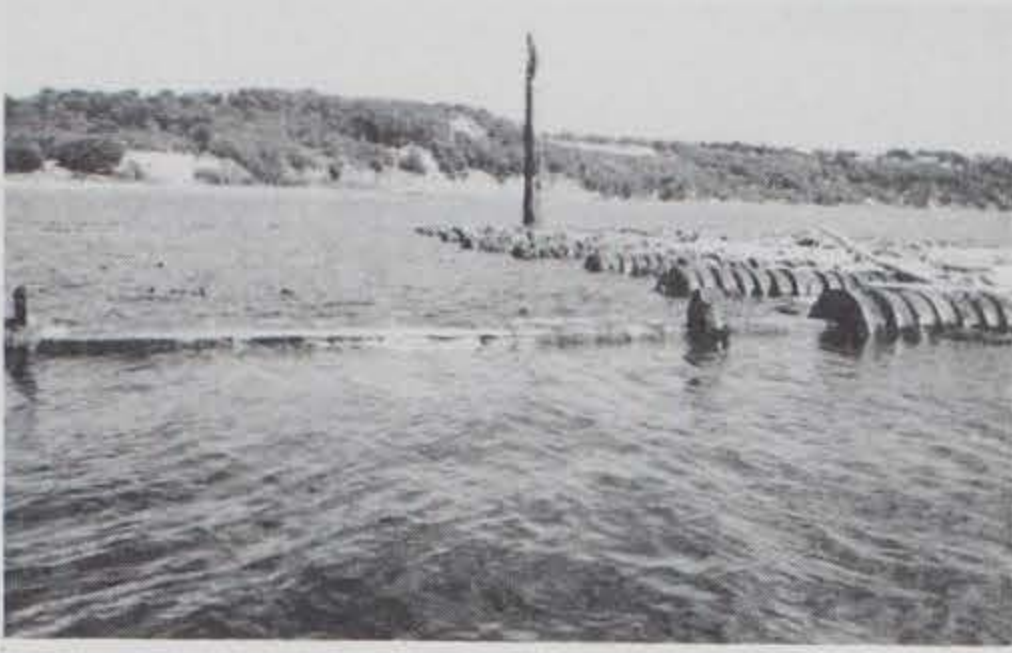
Photo B-31. A 45-ft pipe pulling out after breaking at a welded joint.

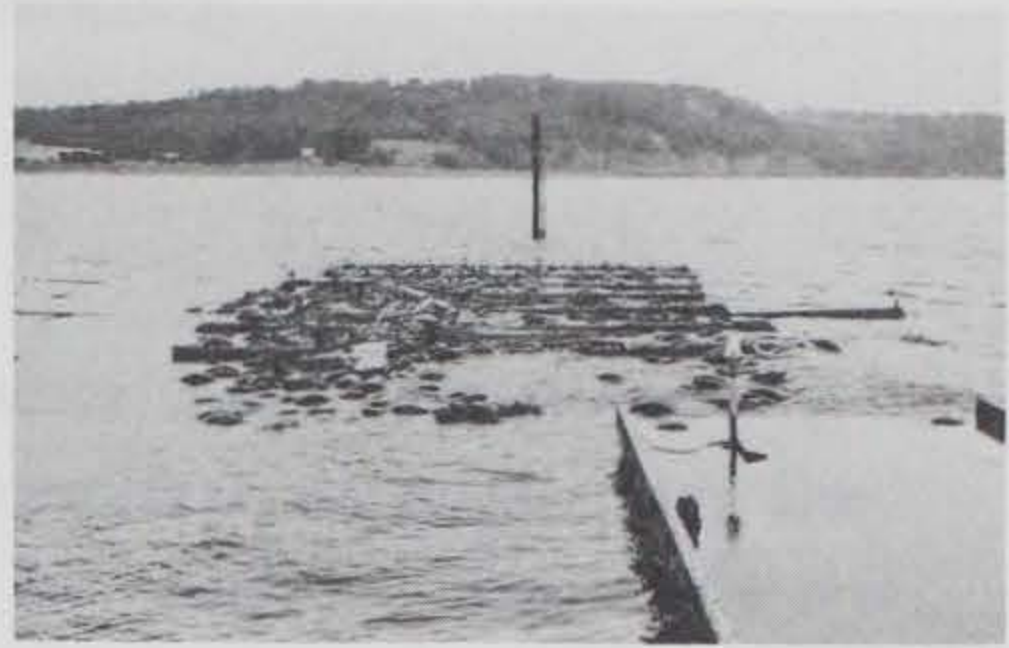
Photo B-32. The center pipe protruding from the breakwater after failure of keeper pipes.

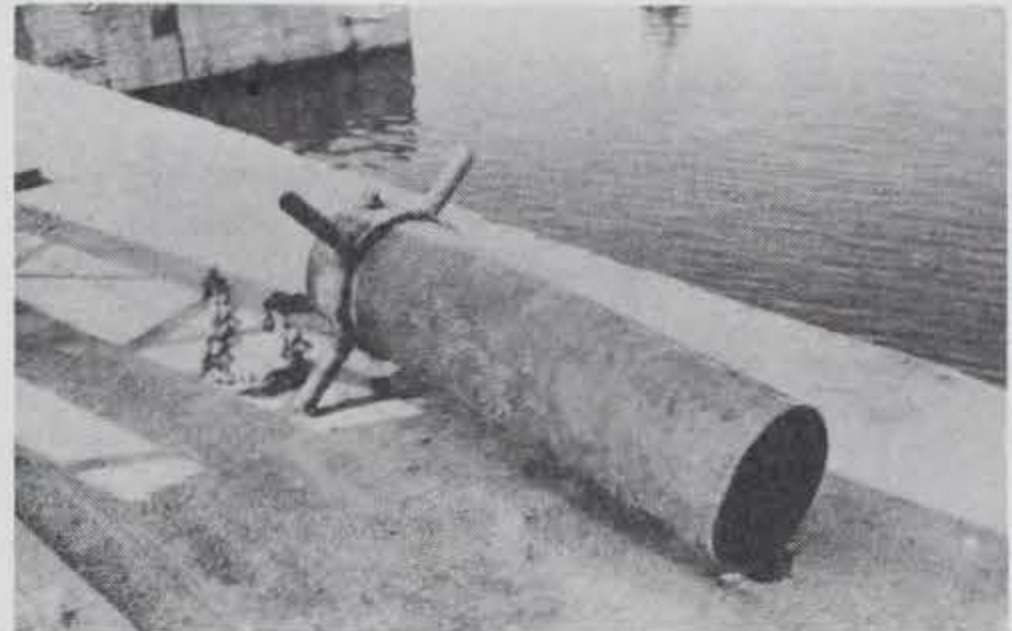
Photo B-34. Photo showing a clearly broken 5-ft section of pipe indicating an incomplete weld.

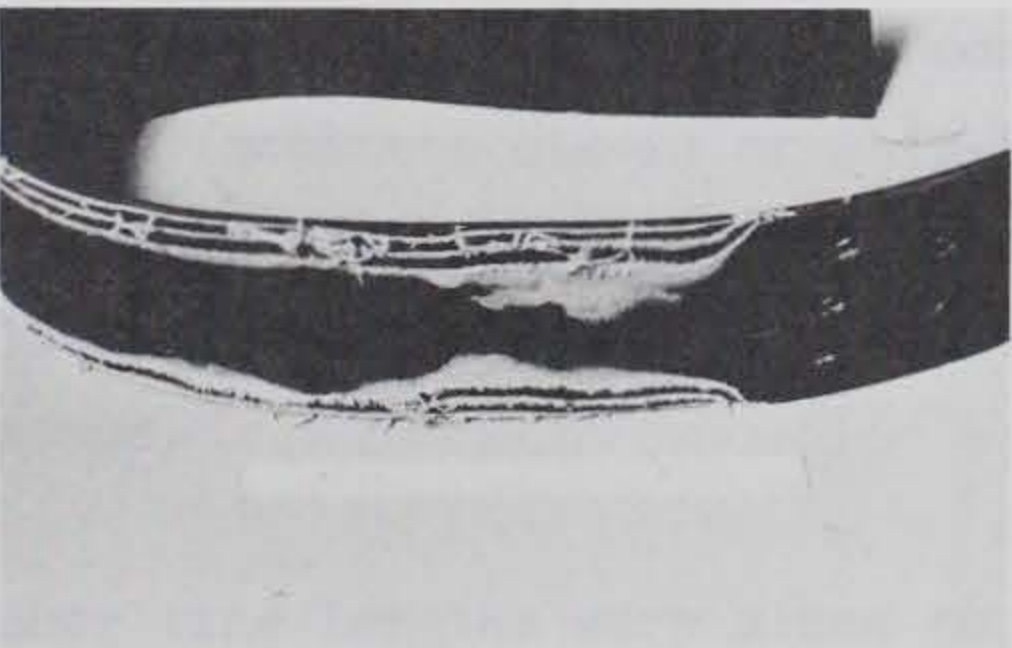
Photo B-35. Photo depicting a loop of worn belting (approximately 20 percent).

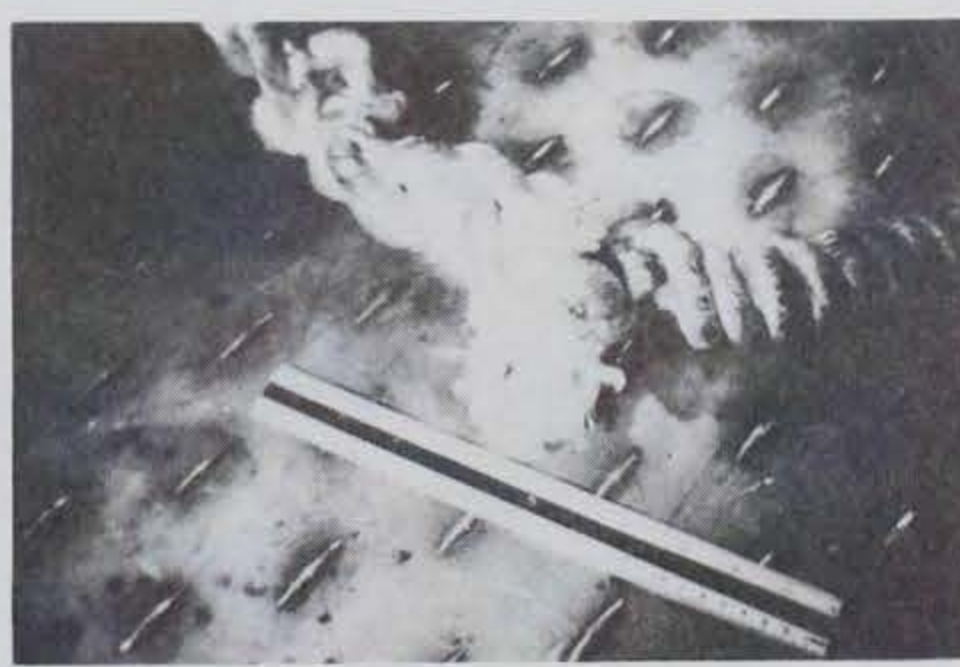
Photo C-6. Photo depicting nylon rope after failure.

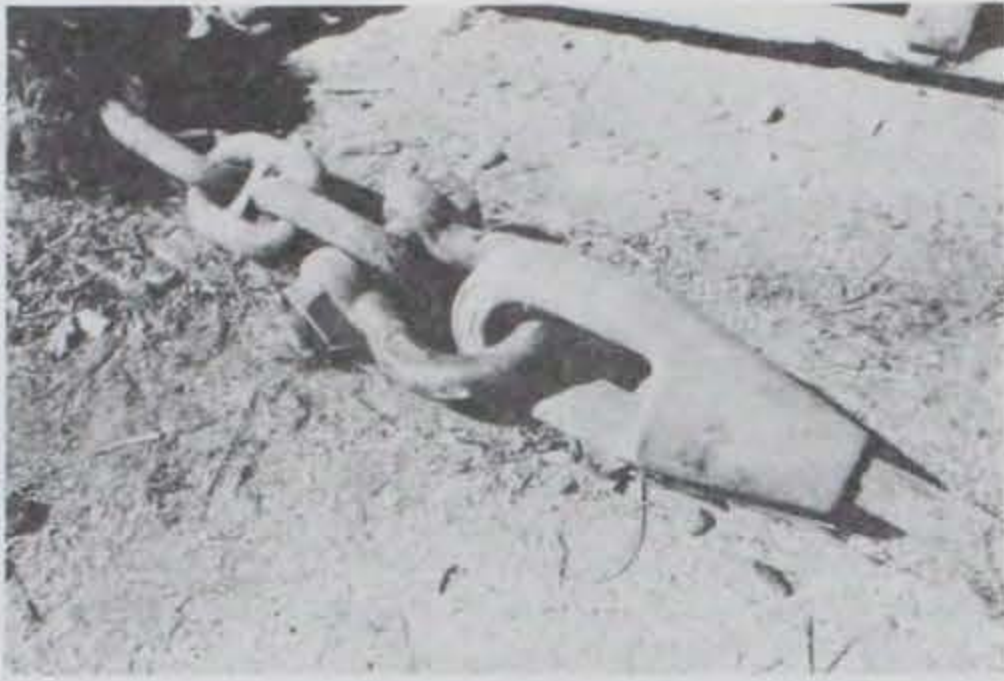
Photo C-19. Photo depicting good condition of anchor line hardware at test completion.

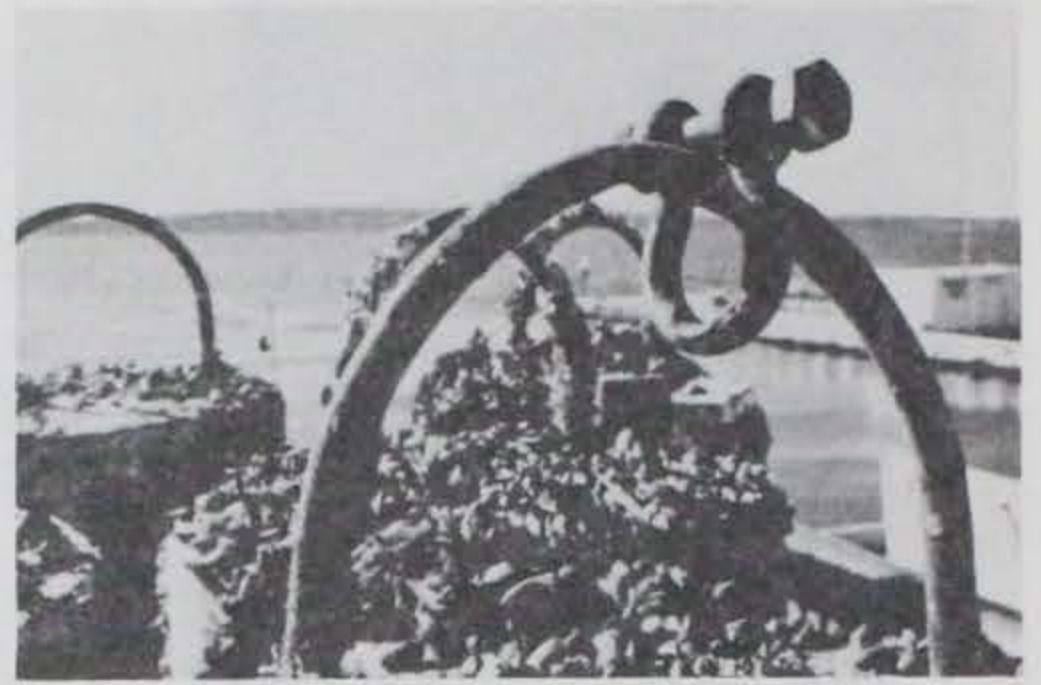
Photo C-20. Photo depicting shackles that attached clump weights to worn anchor lines.

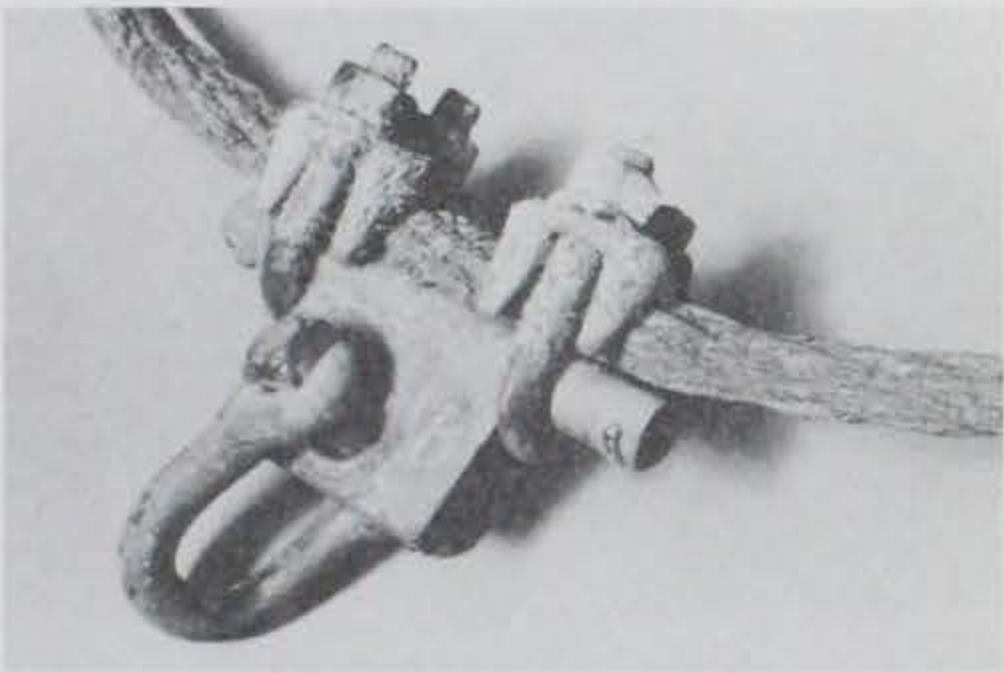
Photo C-21. Photo depicting clump weight attachment hardware (note corroded steel bridge rope anchor line).

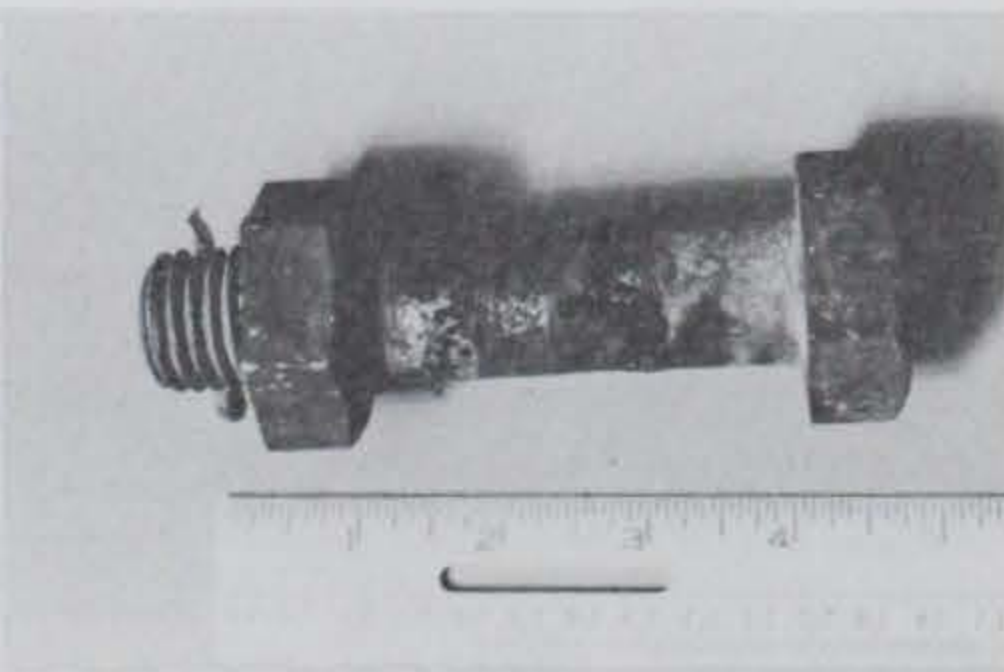
Photo C-23. Photo depicting corrosion of the mild steel cotter key in a shackle bolt.

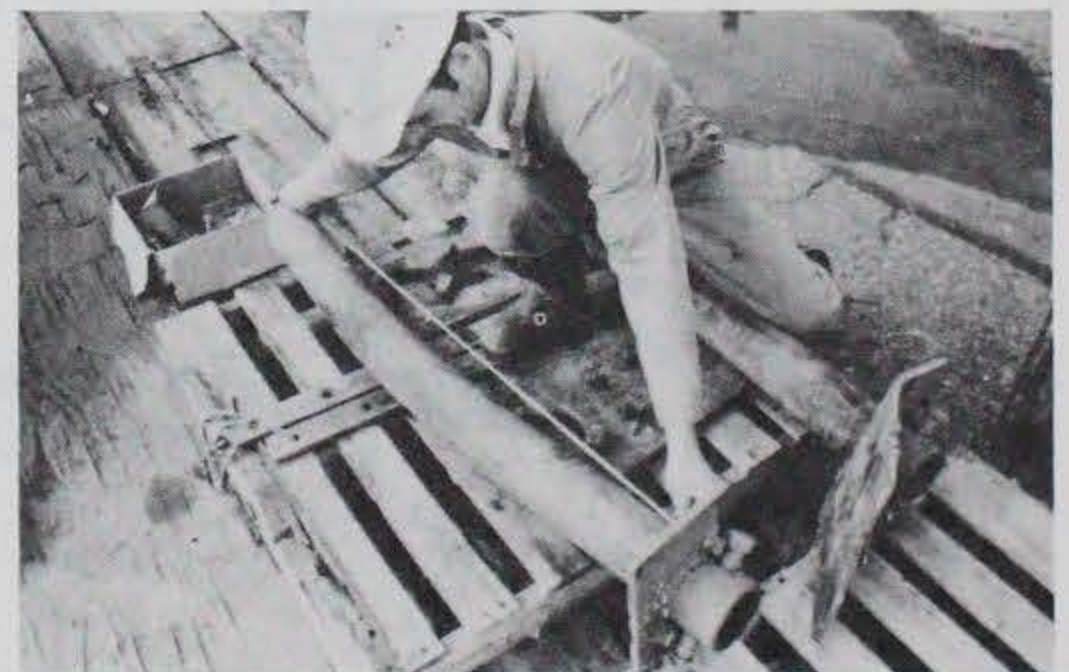
Photo D-6. Photo depicting failure of U-shaped brackets after 7 weeks.

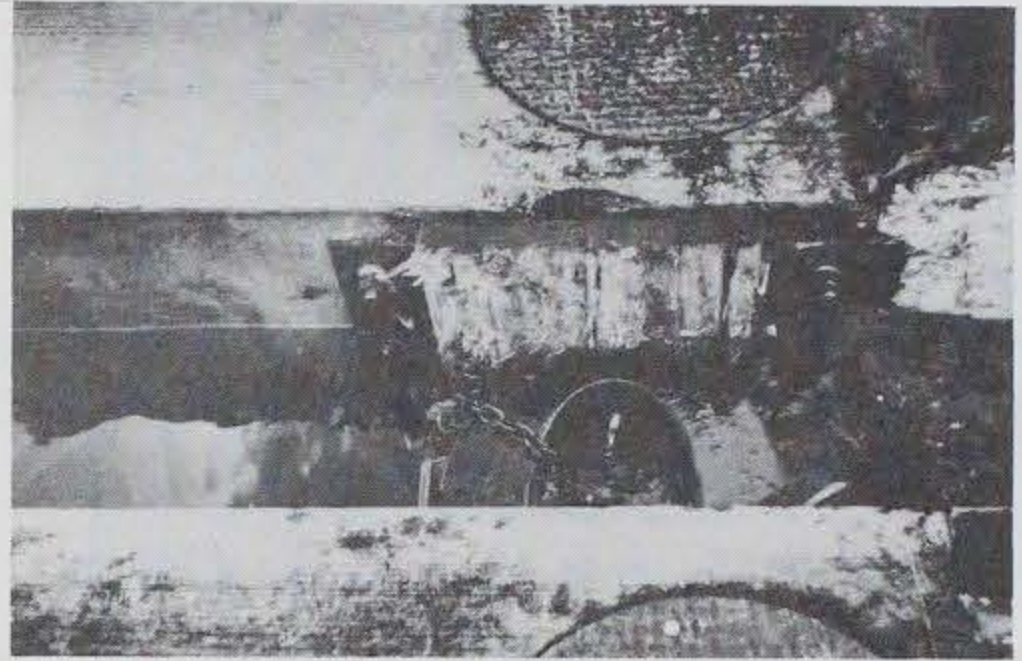
Photo D-10. Photo depicting worn condition of soft fir bumper plates after 2 months.

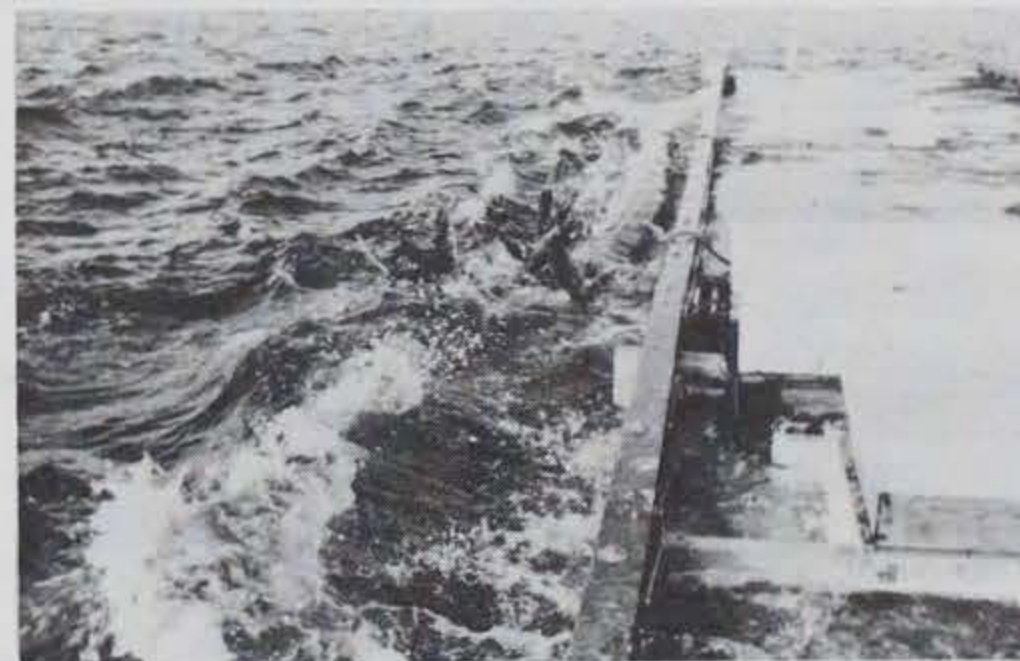
Photo F-18. A large log destroying several wave buoys and pressure transducers.

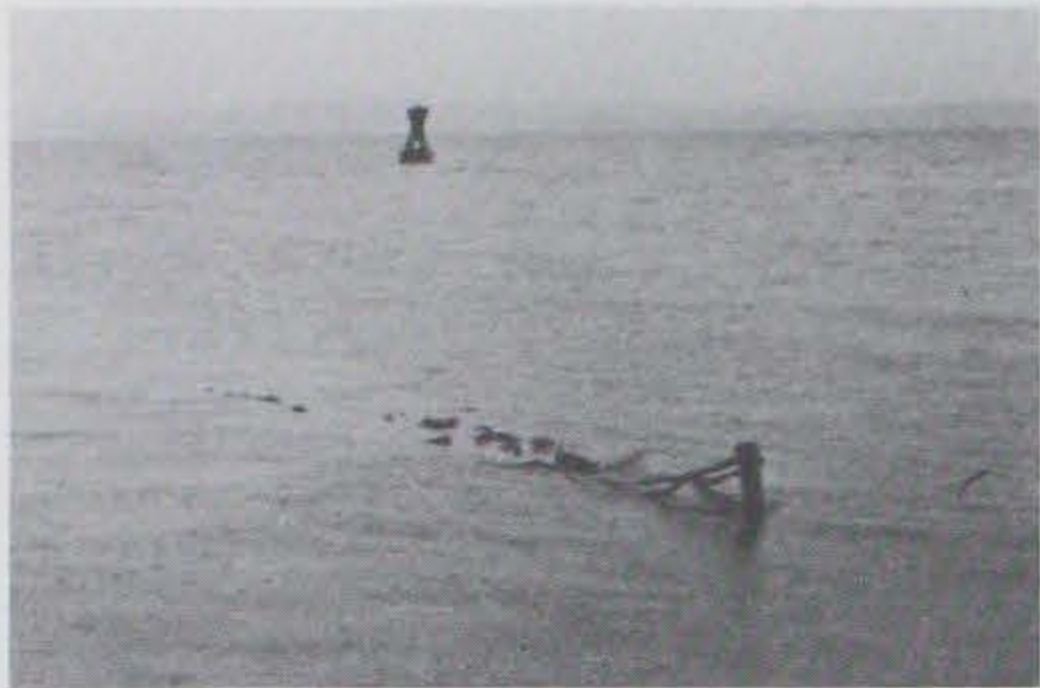
Photo F-19. Photo showing drifting kelp typical of debris which caused damage continuously.
