MISCELLANEOUS PAPER CERC-86-2

GENERALIZED MONITORING OF SEASCAPE® INSTALLATION AT CAPE HATTERAS LIGHTHOUSE, NORTH CAROLINA

February 1986

The National Park Service
Cape Hatteras Seashore
North Carolina

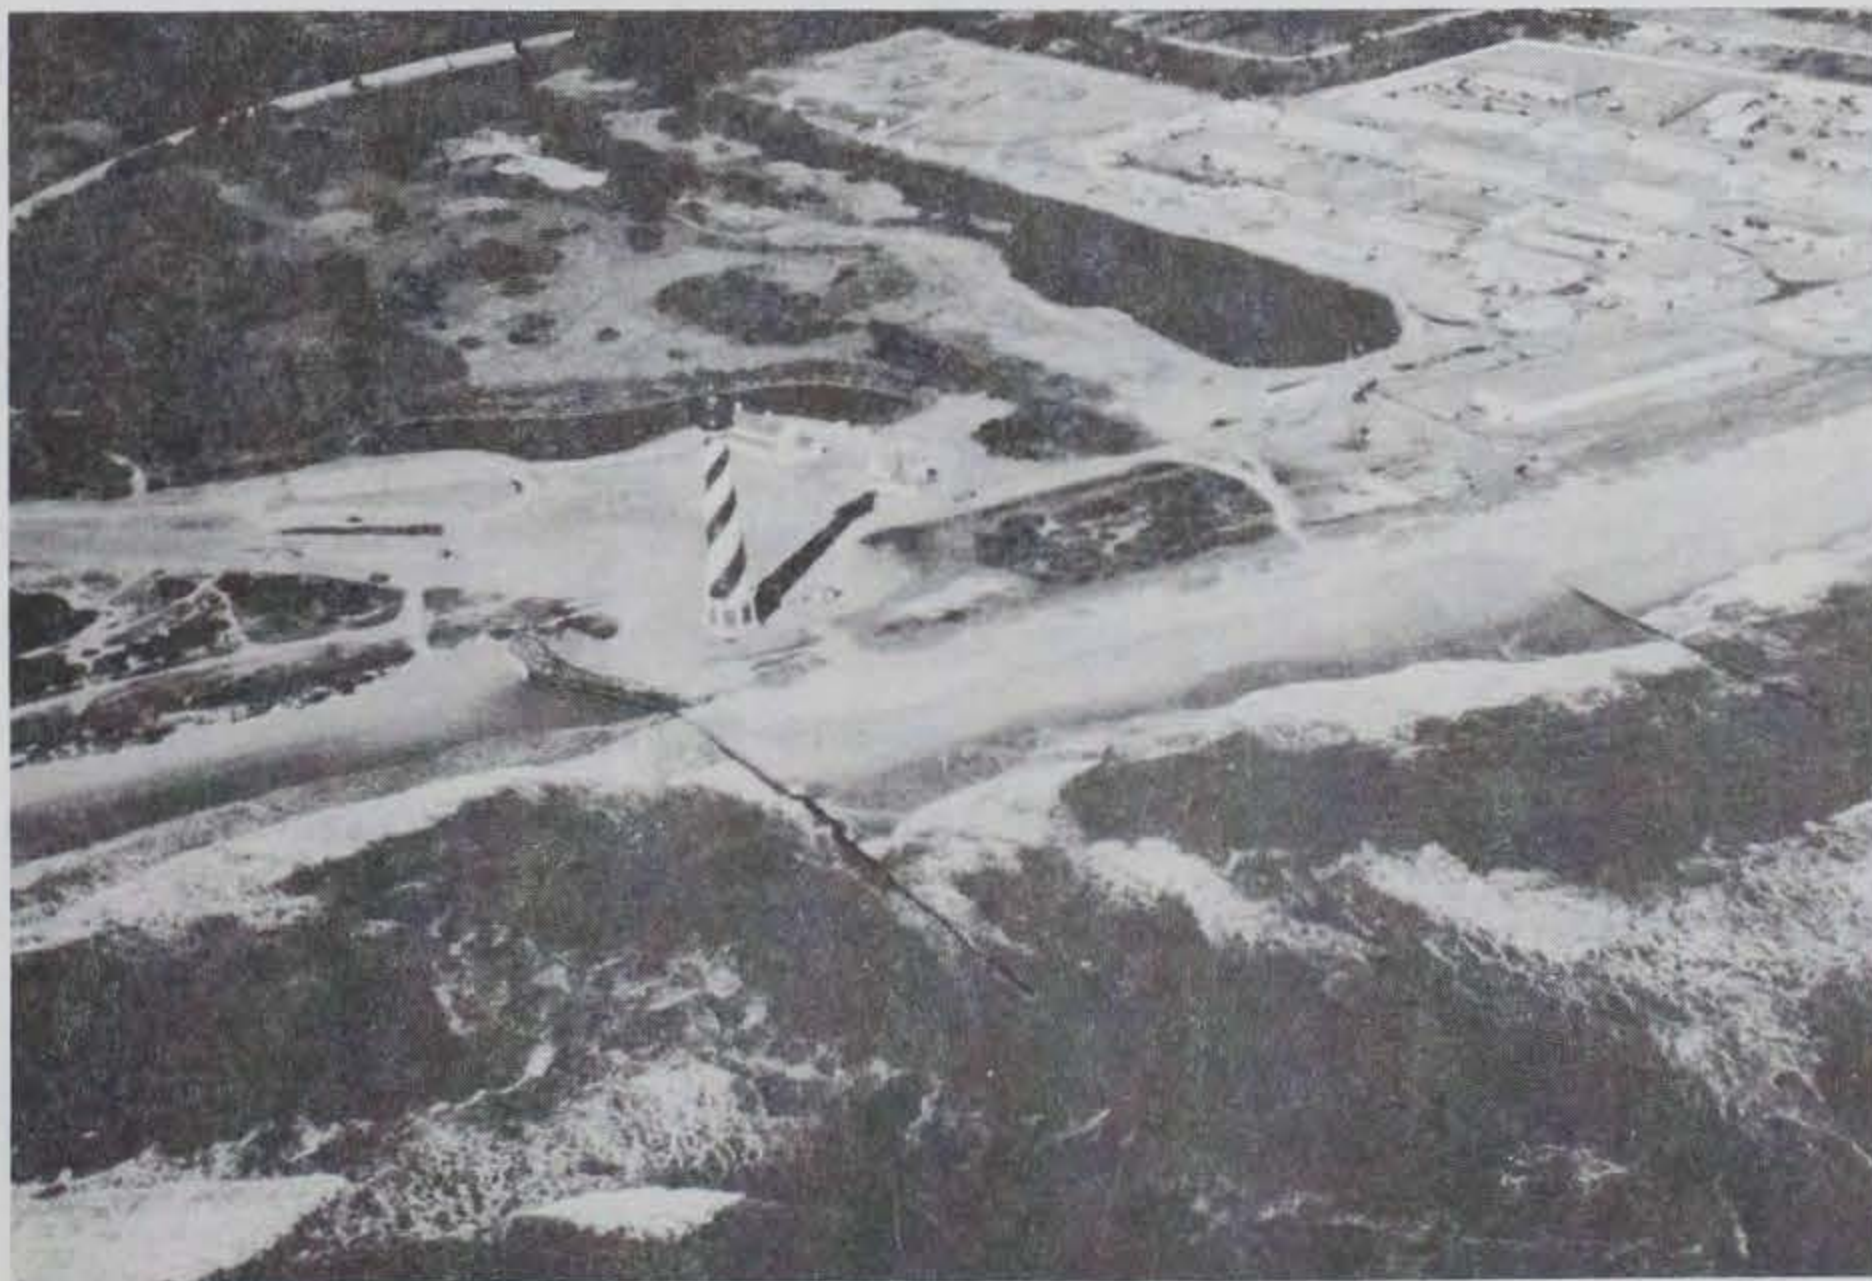
In March 1980 during a severe winter storm, the shoreline immediately south of and adjacent to the southernmost groin eroded to within 70 feet of the lighthouse. Taken during 1982, photo 2 shows the eroded condition south of the lighthouse. As a result of this erosion episode, strong public concern was expressed for the future security of the historic lighthouse with a consensus that NPS take action to provide immediate and long-term protection for the structure. Landward extensions of the southernmost groin in 1980 and 1982 provided immediate protection to the southern exposure of the

Photo 2 Eroded Condition South of South Groin

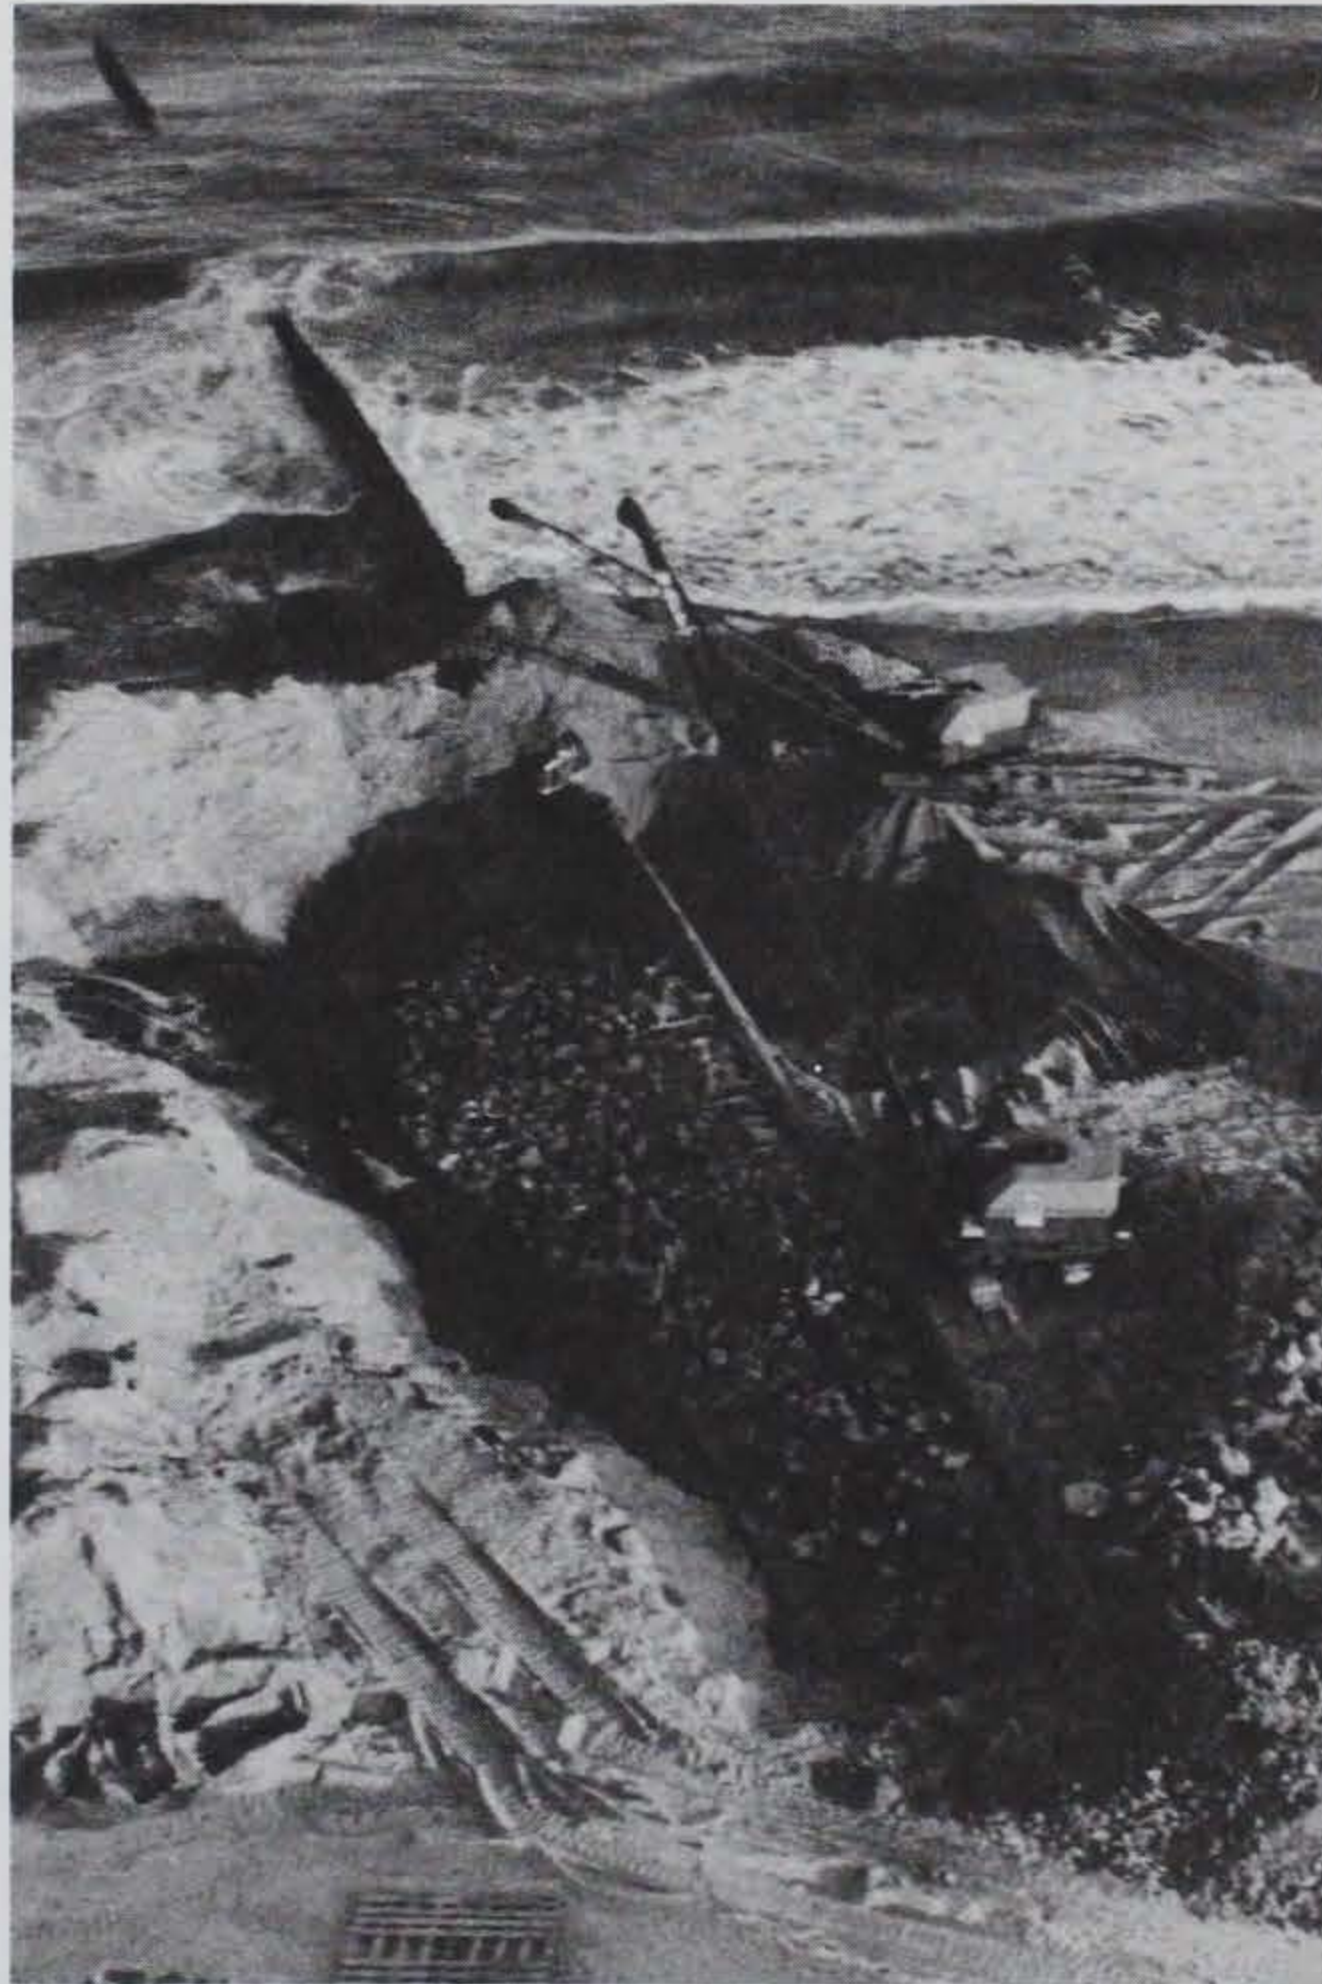
Photo 3 Construction of Scour Protection
Apron Around South Groin

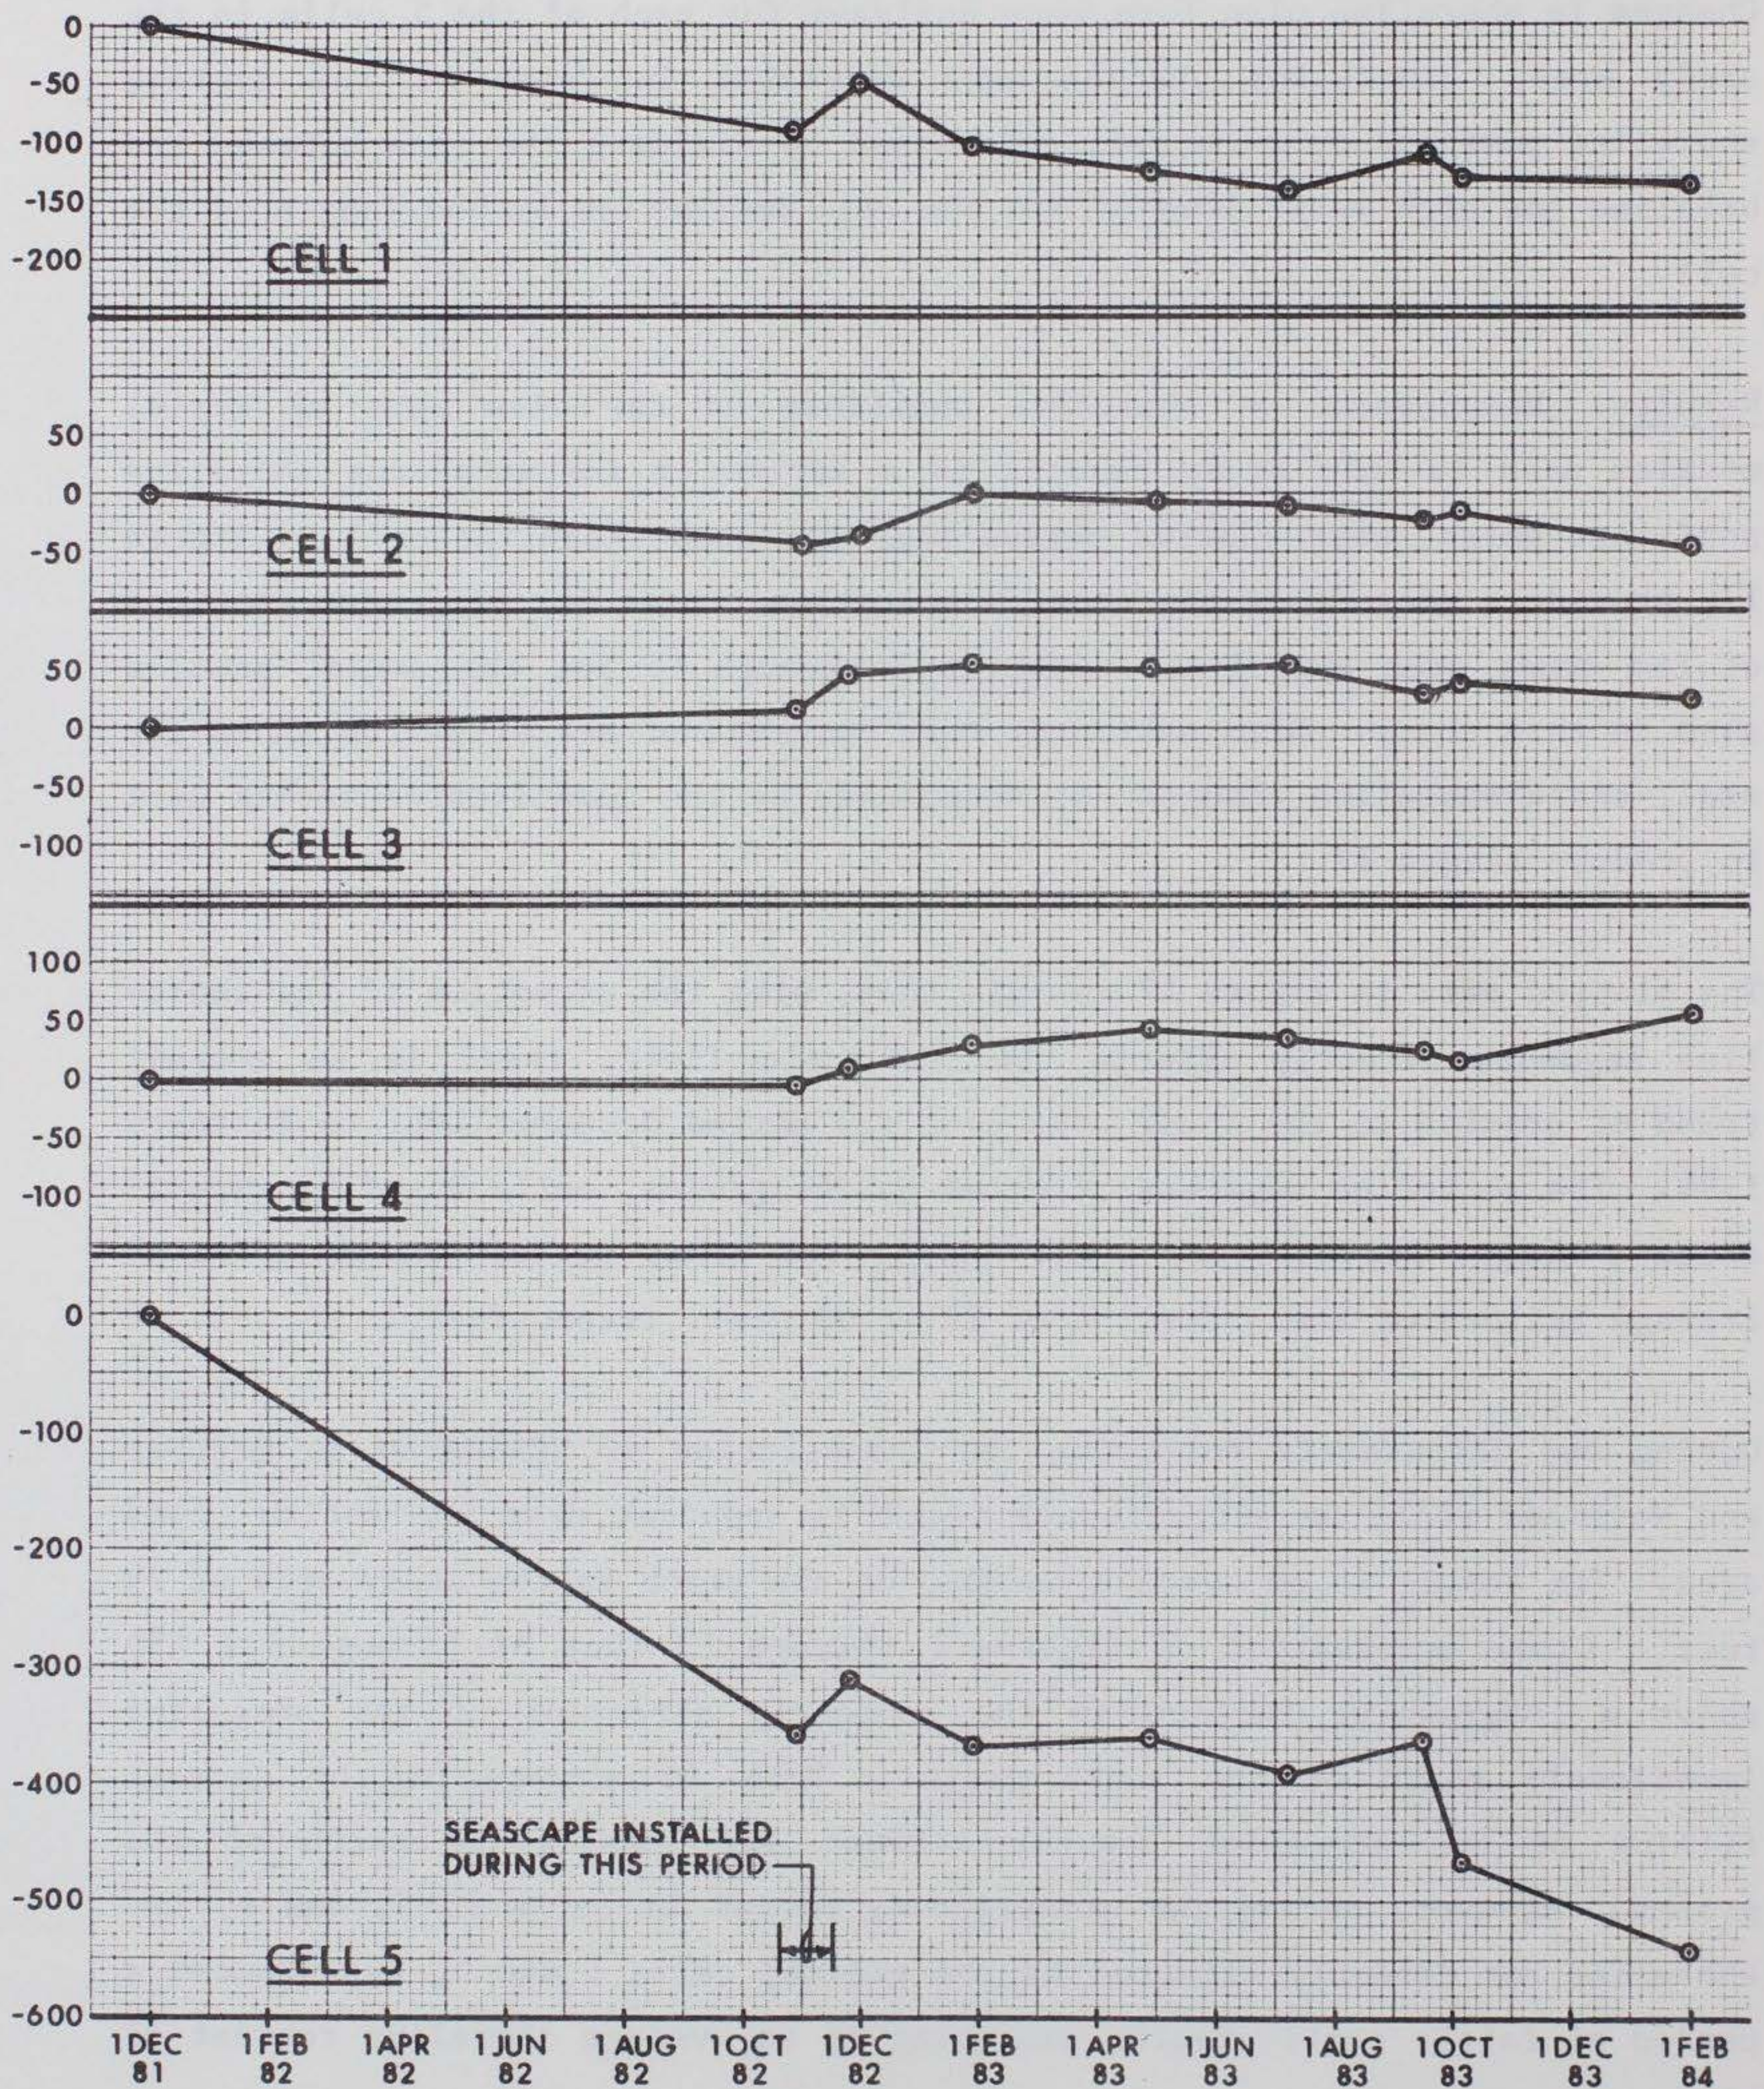
FIGURE 17

The plotted data in figure 17 reveals that, with the exception of the shoreline segments directly affected by the groin field, there is an overall trend of erosion in the study area over the period December 1981 to February 1984. The shoreline segments affected by the groins, cells 3 and 4, experienced a slight accretionary trend during the study period amounting to an average buildup of the shoreline of 25 to 60 feet, respectively.

During and immediately following the installation of SEASCAPE® in October and November 1982, an accretionary trend is apparent over the entire study area. The result is an average buildup of the beach in the study area of 25 feet. Close examination of figures 8 through 13 (Oct 82 through Jul 83) shows a progressive buildup in the southerly direction of the shoreline immediately south of the south groin. This is accompanied by general filling of the shoreline segment between and immediately north of the groins. However, during the accretionary period in cells 2, 3, and 4, the shoreline not directly affected by the groins, cells 1 and 5, experienced a period of fairly rapid erosion amounting to an average shoreline retreat of 80 feet.

AVERAGE SHORELINE POSITIONS IN EACH
STUDY AREA CELL, DECEMBER 1981 TO FEBRUARY 1984
(FROM AERIAL PHOTOGRAPHS)

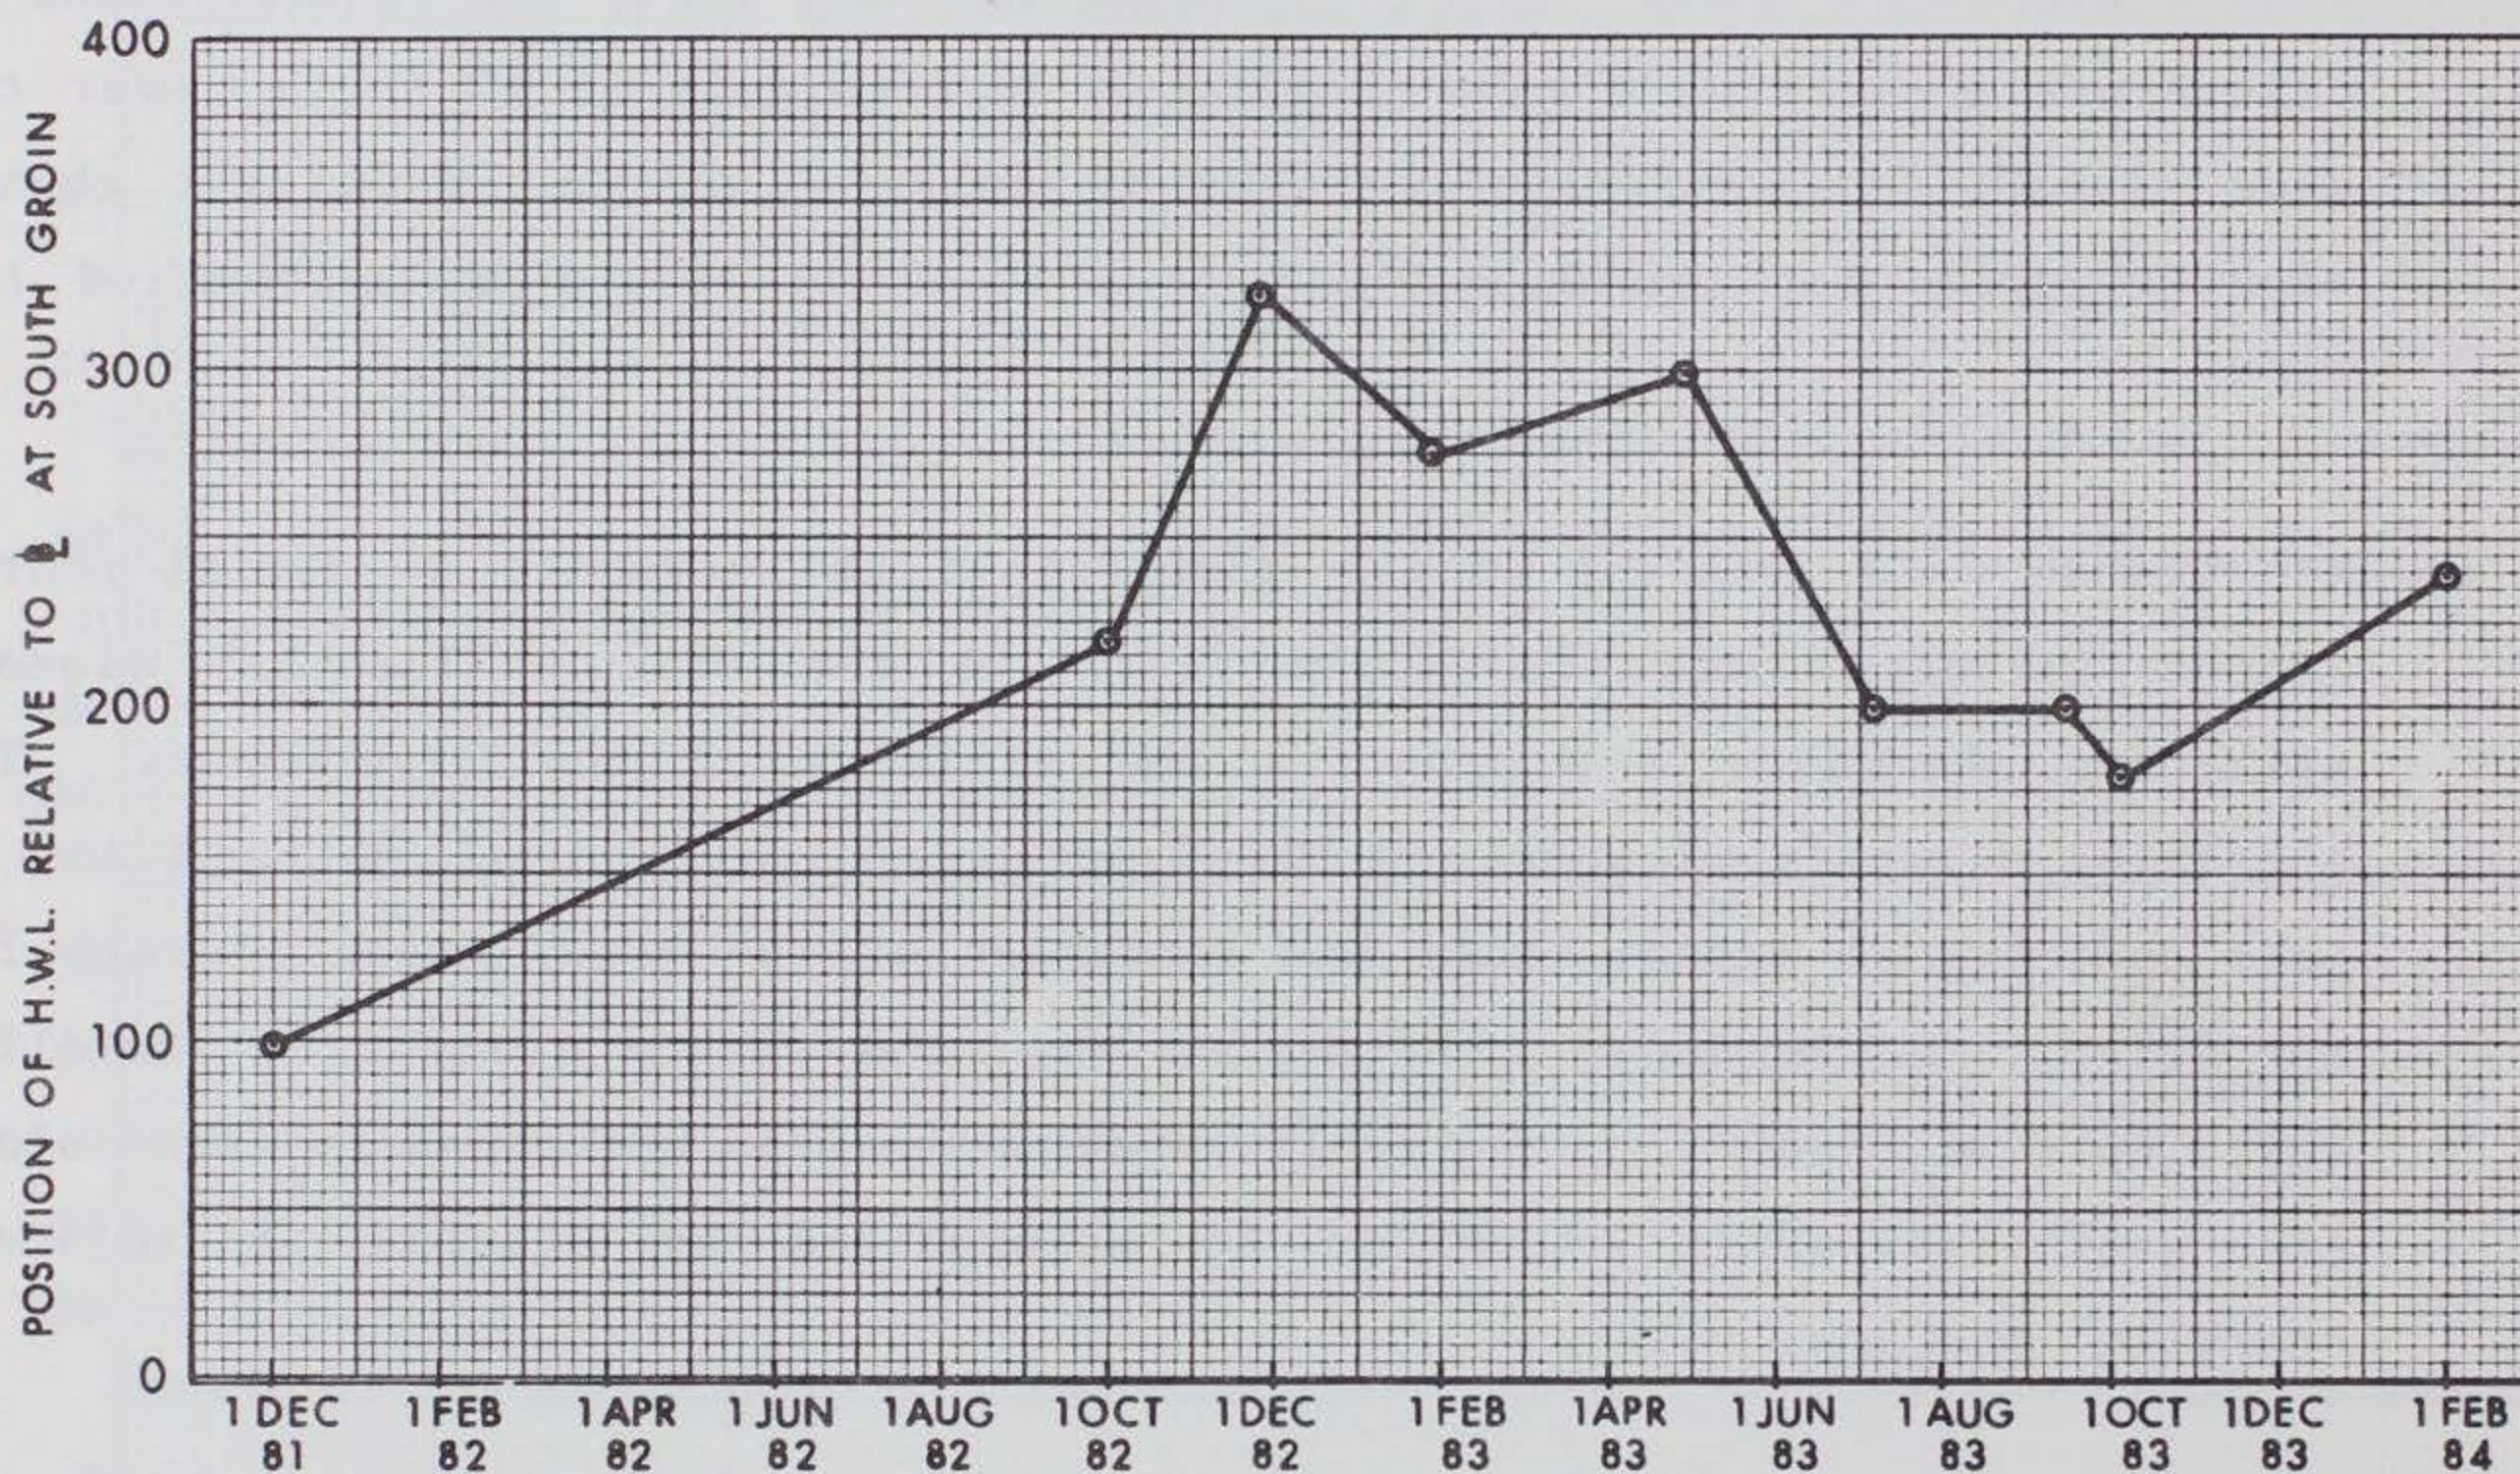
FIGURE 18

Changes in the shoreline position immediately south of the south groin, the area of specific interest in this study, are plotted in figure 18. The position of the shoreline at the south side of the groin measured from the baseline is plotted for each aerial photo date. Comparison with the plots in figure 17 for cells 3 and 4 shows a direct correlation between buildup in the area south of the groin with accretion of the entire shoreline affected by the groin field. This favorable shoreline condition has generally existed throughout the history of the groin field and its attendant impacts on shoreline configuration, with the singular exception of the condition generated by the March 1980 storm which induced a rapid and major temporary retreat of the beach immediately adjacent to and south of the southernmost groin. The fact that the immediate shoreline reach south of the groin field is favorably affected by the groin structures can be attributed to several factors. First, the groin field site is along a section of shore which

SHORELINE POSITION SOUTH OF SOUTH GROIN
AT CAPE HATTERAS DECEMBER 1981 TO FEBRUARY 1984
(FROM AERIAL PHOTOGRAPHS)

experiences a large volume of littoral transport ranging in magnitude to 1.5 million cubic yards per year and moving predominantly from north to south. This high volume of sediment transport is very large by comparison to the entrapment capacity of the 3-groin structures comprising the existing field, particularly on considering that the outer sections of the groin have been significantly damaged over time and that considerable quantities of littoral sediments pass through the groin system in a southerly direction. Additionally, the inner portions of the groins, extending landward from the high water line are low relative to the subaerial beach profile. This has allowed for passage of sediment through the inner portions of the groin field. Transport through the groin field is evidenced by a continuous beach berm and foreshore slope from north to south through the groin field, and the general absence of the saw-tooth pattern of upcoast accretion and downcoast erosion adjacent to groins which characterizes high groin structures. In regard to the effects of the March 1980 storm, causes of the anomalous rapid retreat of the shore immediately south of and adjacent to the southern groin are indeterminant but, in all probability, those causes were associated with the particular wave characteristics and wave direction generated by the storm. In any case, the storm also further damaged the outer portion of the southern groin and left a substantial gap between the inner and outer sections of the south groin structure. This structural gap serves as an excellent passageway for littoral sediments moving southward from the center - south groin compartment to the shore immediately south thereof. In return, the remaining outer section of the southern groin acts to diffract the predominant waves from the north to east ocean sector, resulting in a localized wave pattern which serves to accumulate sediments south of and adjacent to the southern groin.

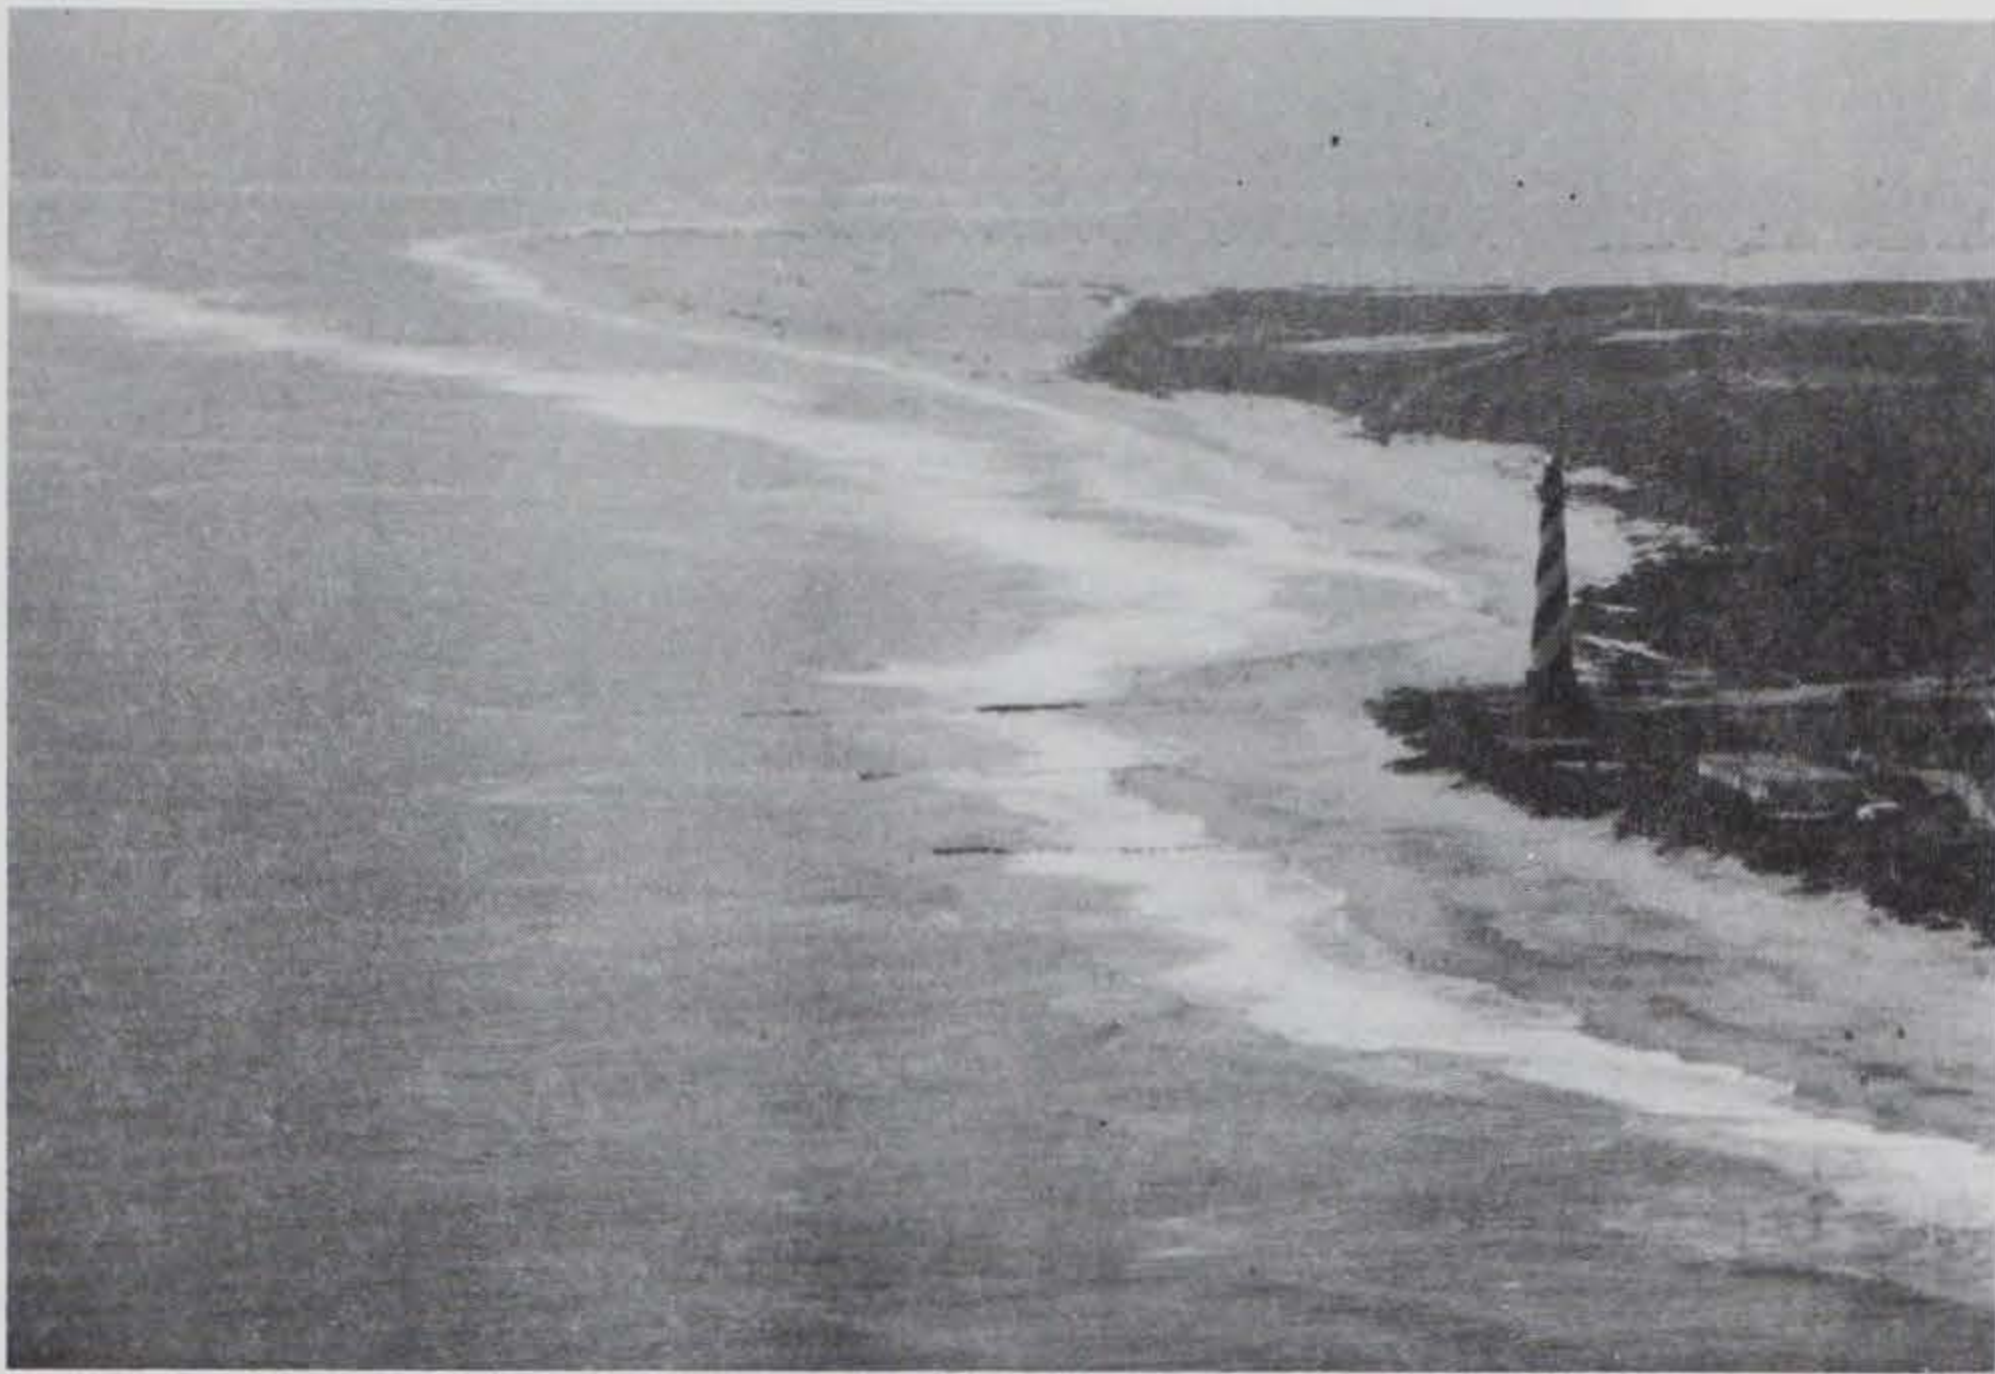
Observations. The oblique photographs show the highly irregular and dynamic nature of the shoreline at Cape Hatteras. Photos 8, 9, 10, and 11 show the distinctive bulge in the shore alignment caused by the groin field. An offshore bar emerges from the south side of the south groin (see photos 10

Photo 8 Cape Hatteras Shoreline, Looking Southwest -
October 15, 1982

and 11) and extends south parallel to shore. South of the Cape Point the breaking waves show the bar feature extending out into the ocean southeast of the Cape (shown in photos 8 and 9).

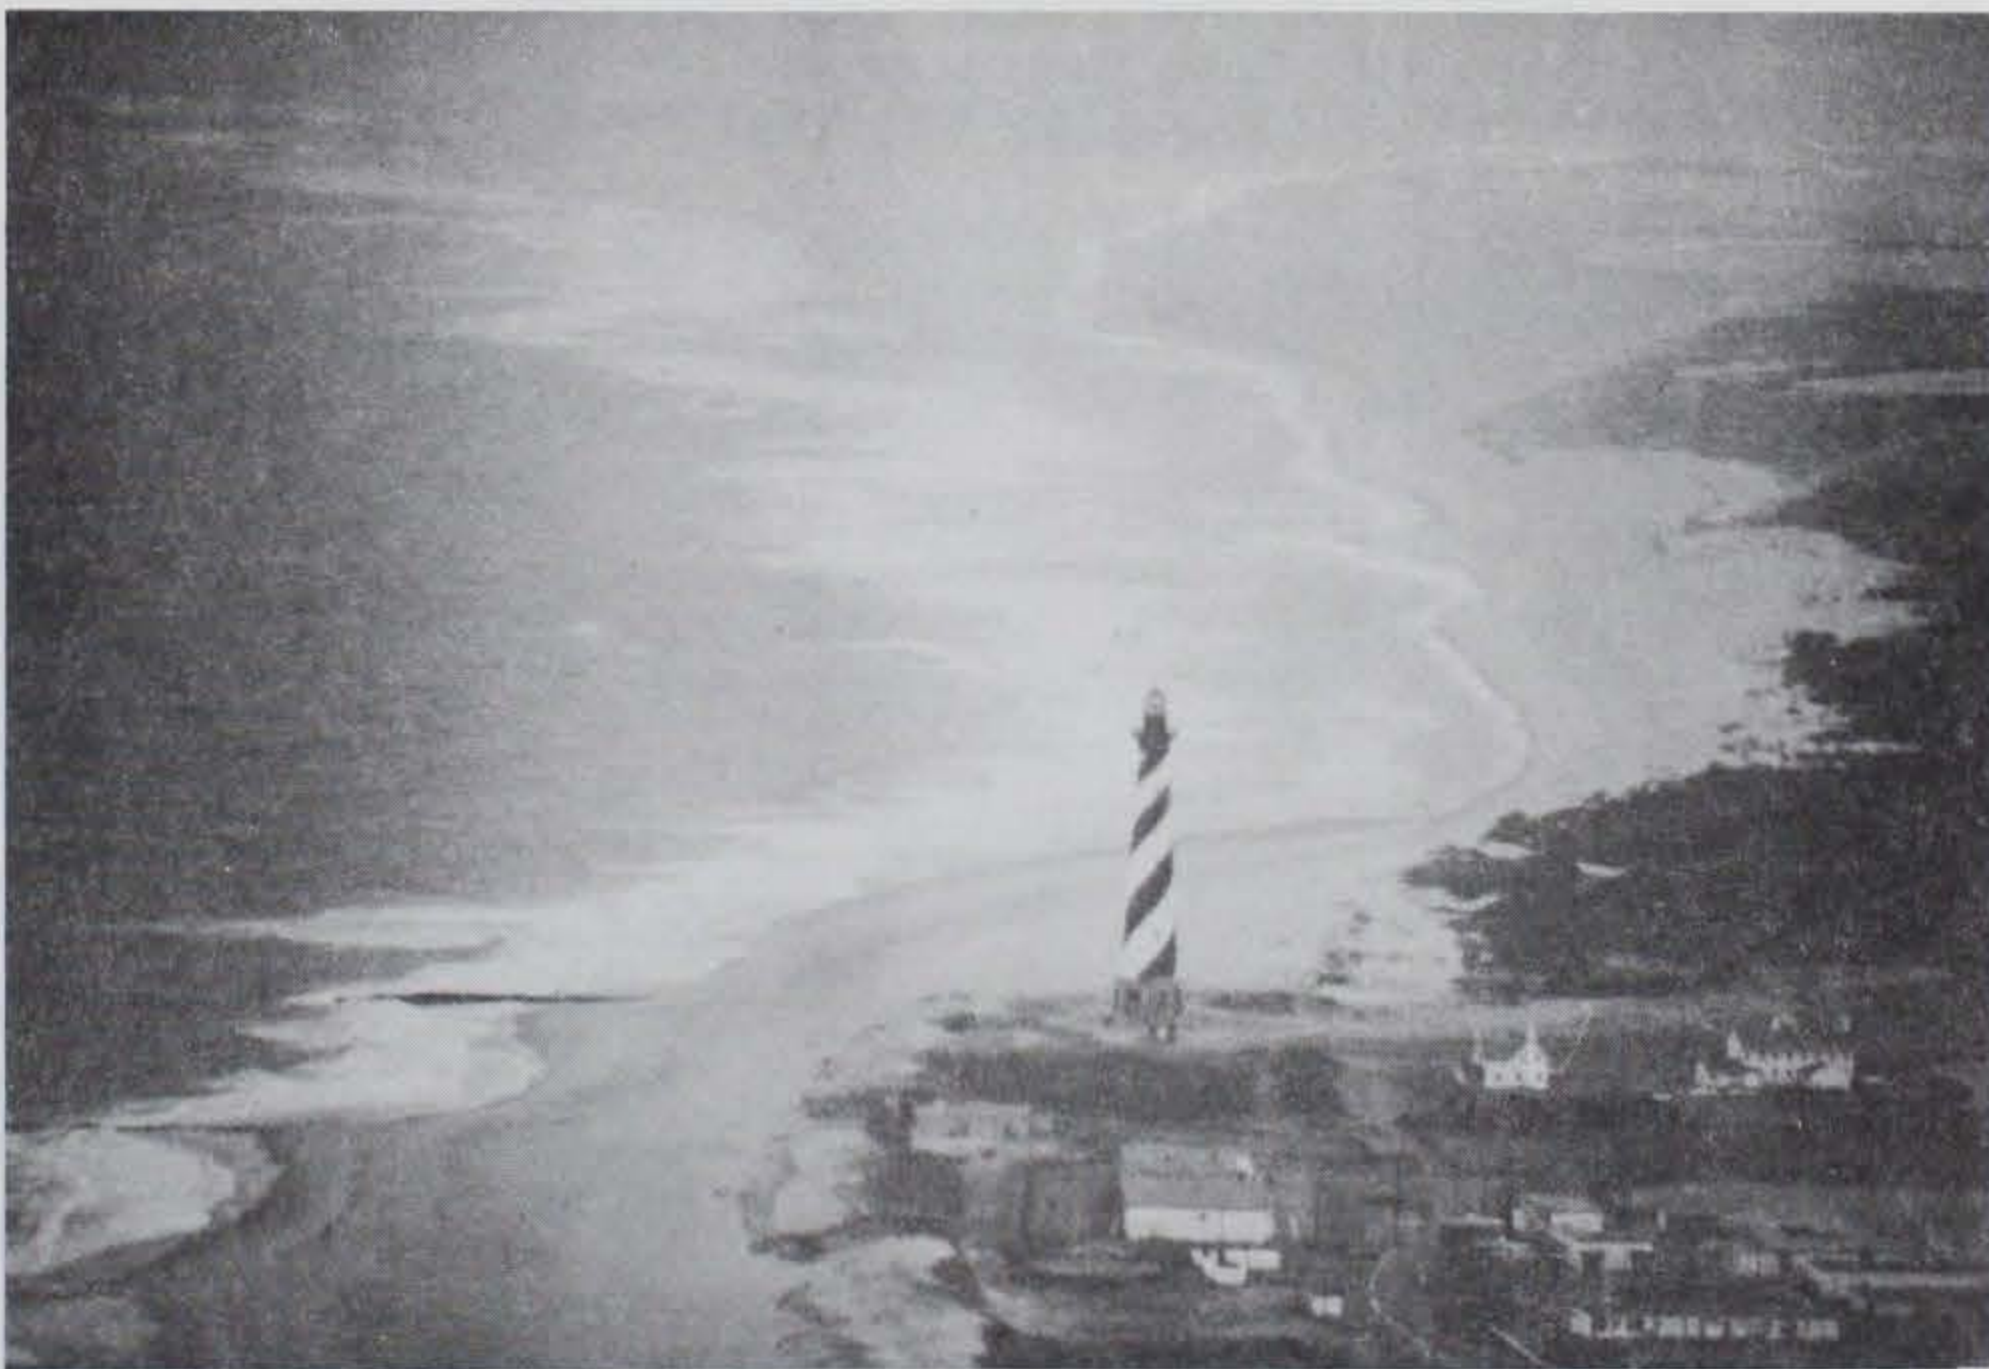
Photo 9 Cape Hatteras Shoreline, Looking South -
October 15, 1982

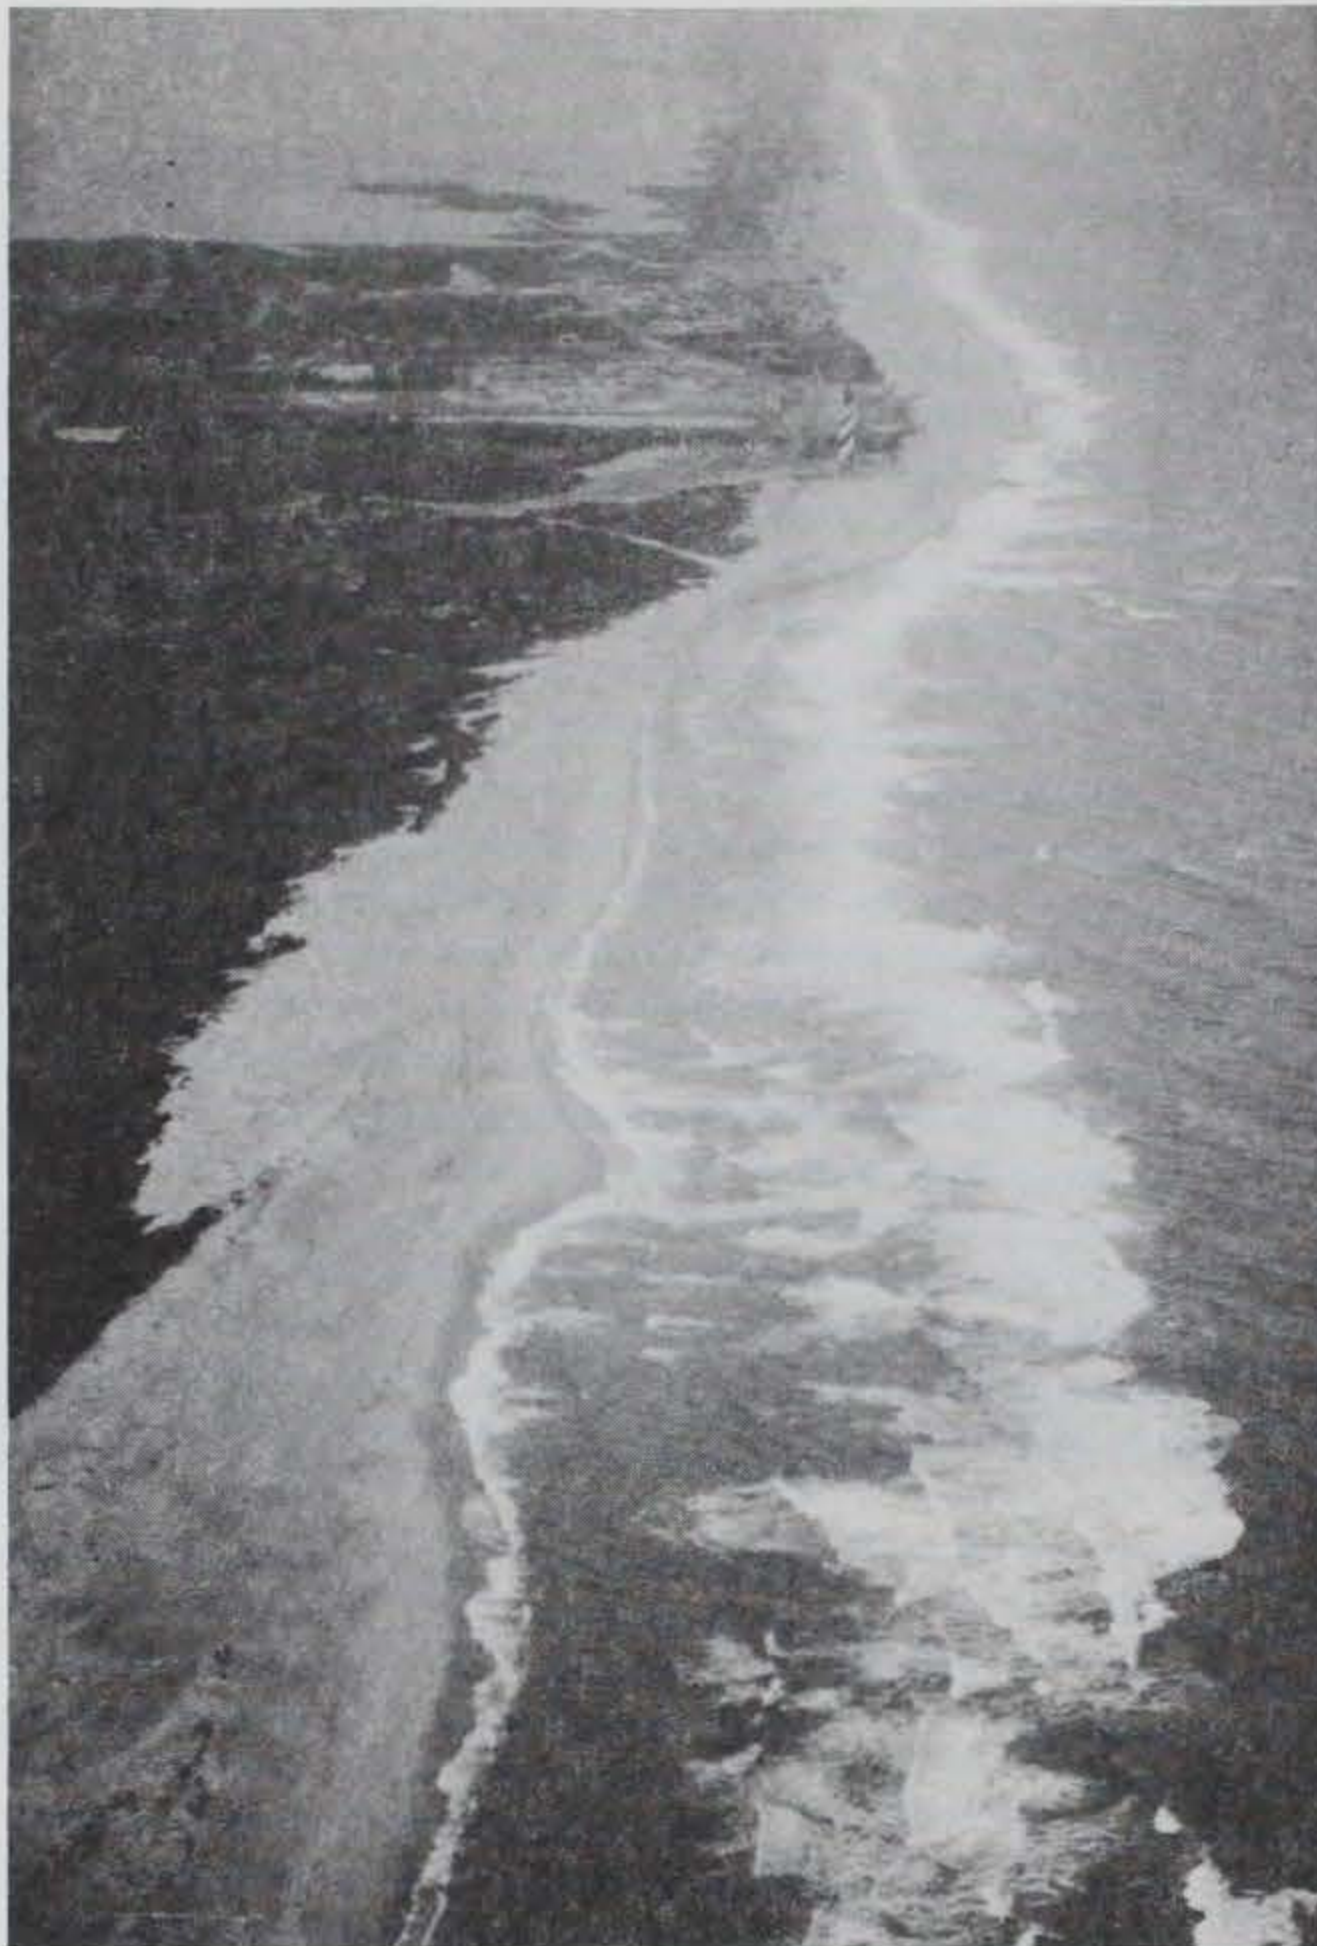
Photo 10 Cape Hatteras Shoreline, Looking North -
November 18, 1982
