MISCELLANEOUS PAPER CERC-86-2

GENERALIZED MONITORING OF SEASCAPE® INSTALLATION AT CAPE HATTERAS LIGHTHOUSE, NORTH CAROLINA

February 1986

The National Park Service
Cape Hatteras Seashore
North Carolina

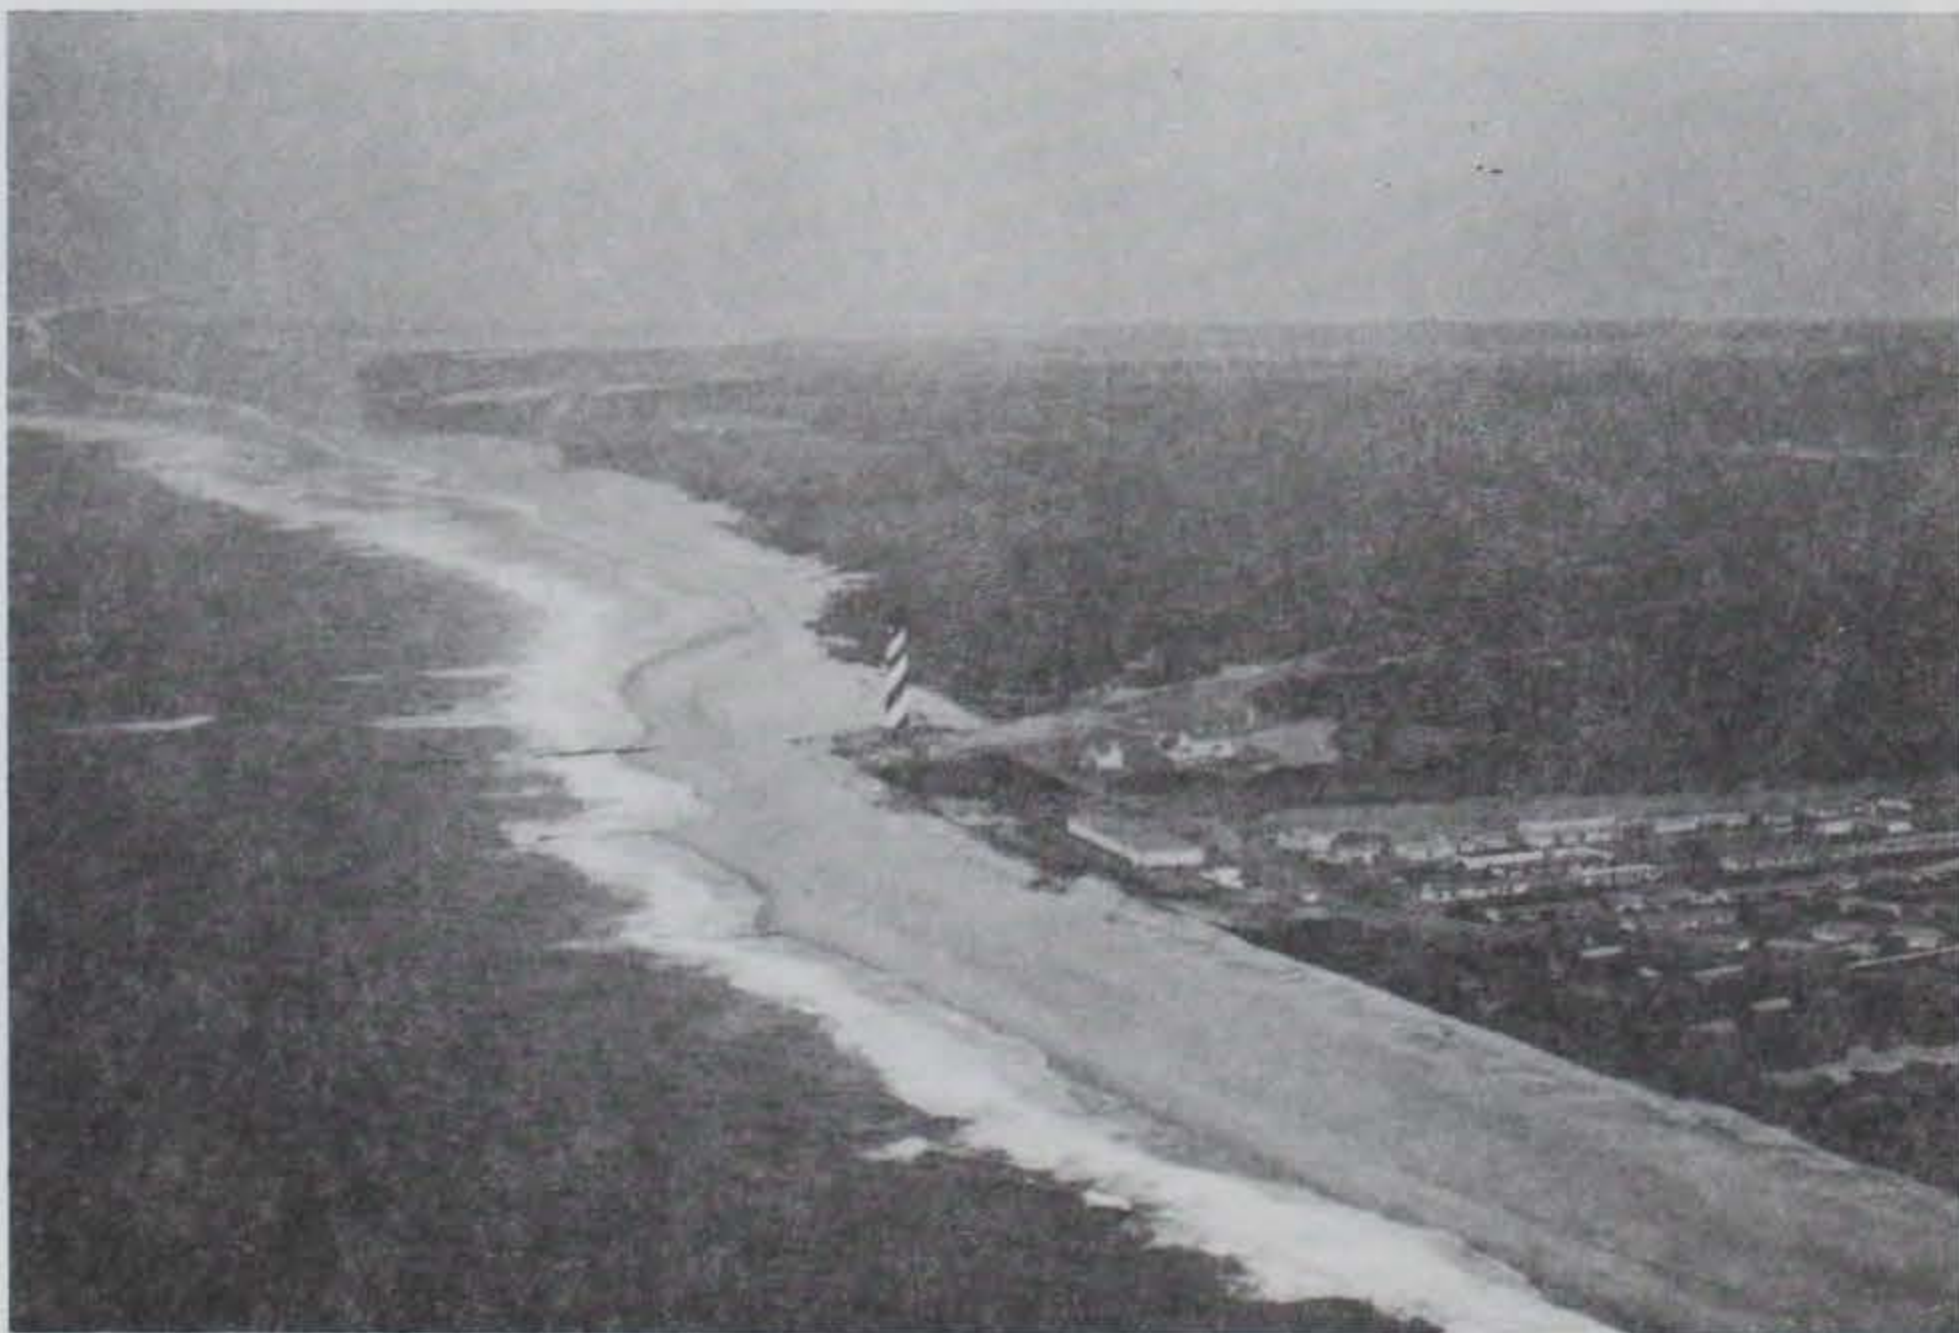
Observations. The oblique photographs show the highly irregular and dynamic nature of the shoreline at Cape Hatteras. Photos 8, 9, 10, and 11 show the distinctive bulge in the shore alignment caused by the groin field. An offshore bar emerges from the south side of the south groin (see photos 10

Photo 11 Cape Hatteras Shoreline, Looking Southwest -
November 18, 1982

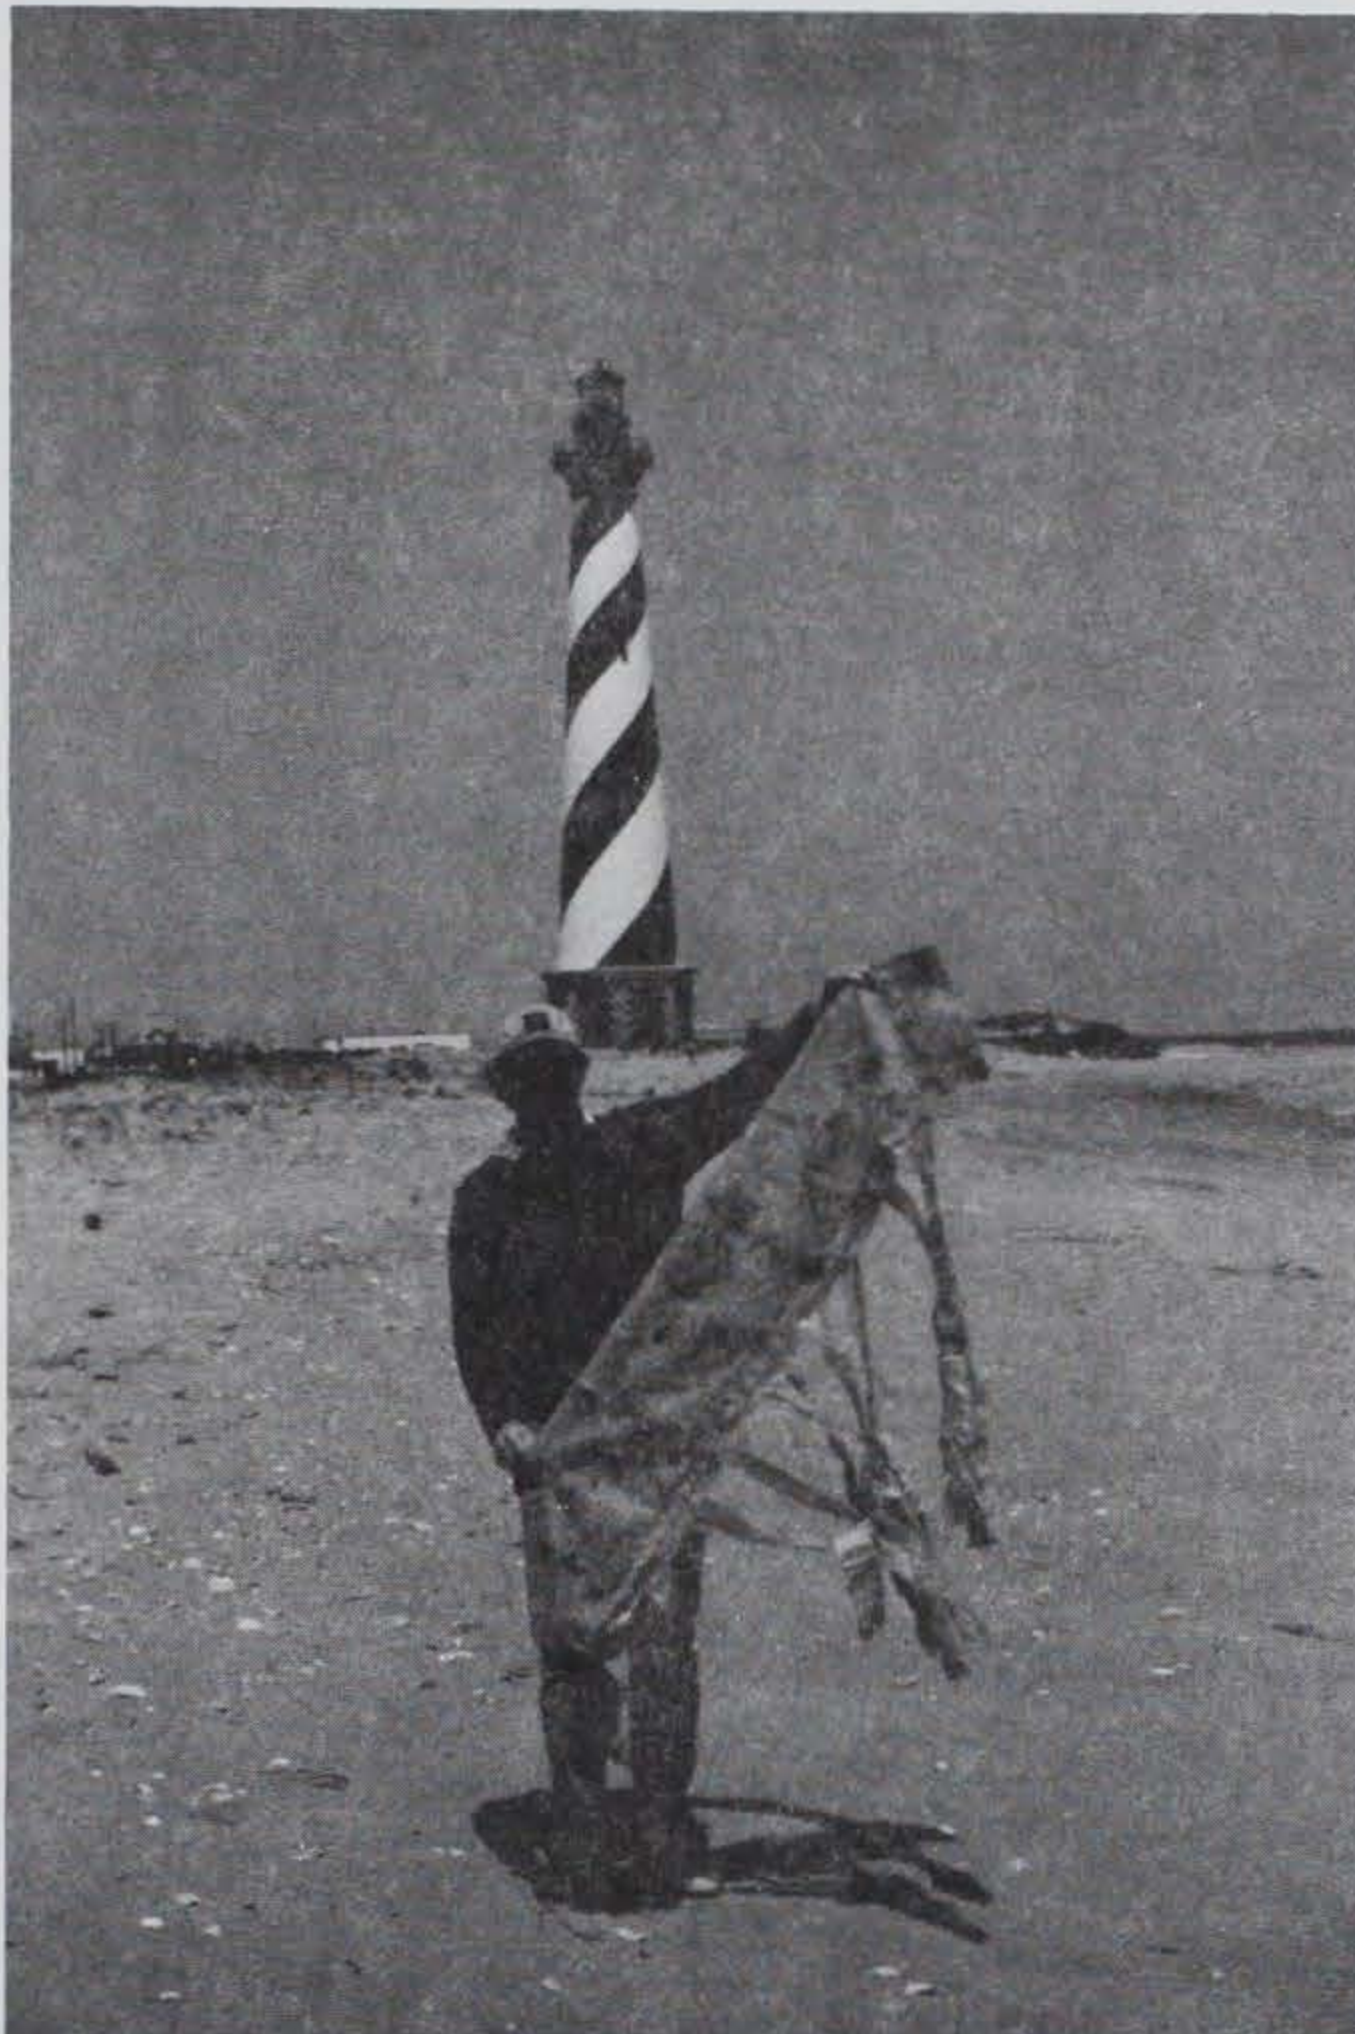
<u>Date</u>	<u>Observations</u>
October 23, 1982	Over 100 frond fragments found on beach and removed by beach patrol.
April 4, 1983	Over 2 dozen entire units found during walk over 3,000 feet of beach south of lighthouse. Material frayed and disintegrating (see photo 16).
April 27, 1983	One entire unit still filled with sand found on beach. Unit tangled and added buoyancy foam pieces lost (see photos 15 and 17).
January 10, 1984	One entire unit found approximately 3,000 feet south of lighthouse 200 feet landward from breaker zone. Unit badly deteriorated.
February 2, 1984	Two entire units found on beach 1,500 and 3,000 feet south of lighthouse. Both units badly deteriorated.

Photo 15 SEASCAPE® Unit Found on Beach - April 27, 1984

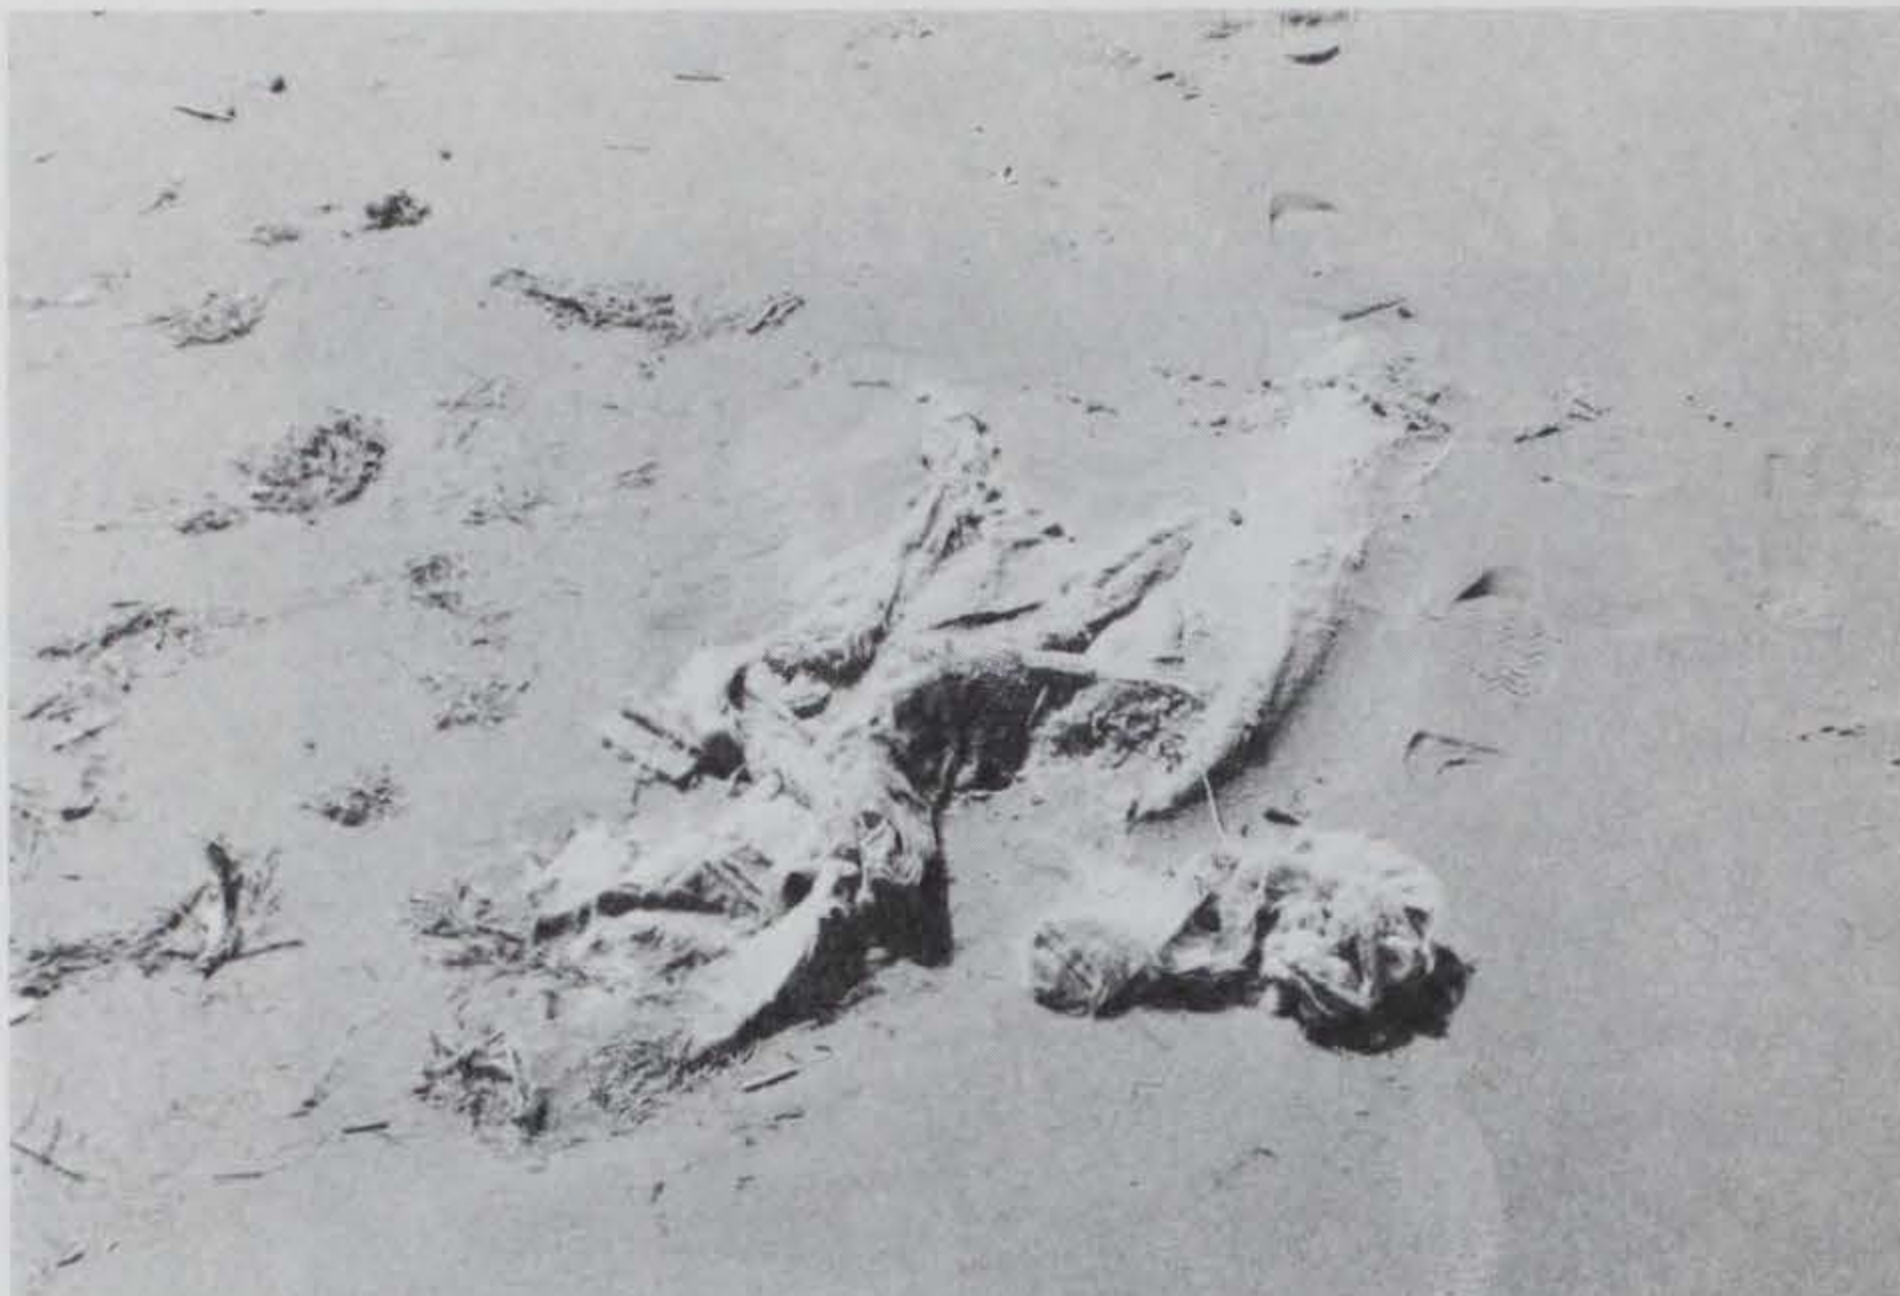
Photo 16 SEASCAPE® Fragments on Beach - April 4, 1984

7. There was evidence of significant fragmentation of the SEASCAPE® units following installation. The number of fragments observed on the beach indicates that the units were unable to withstand the abrasion they were subjected to in the turbulent surf zone environment. Additionally, the condition of entire SEASCAPE® units and fragments of units observed in the study area, indicated rapid deterioration of the Typar® material in the nearshore ocean environment.

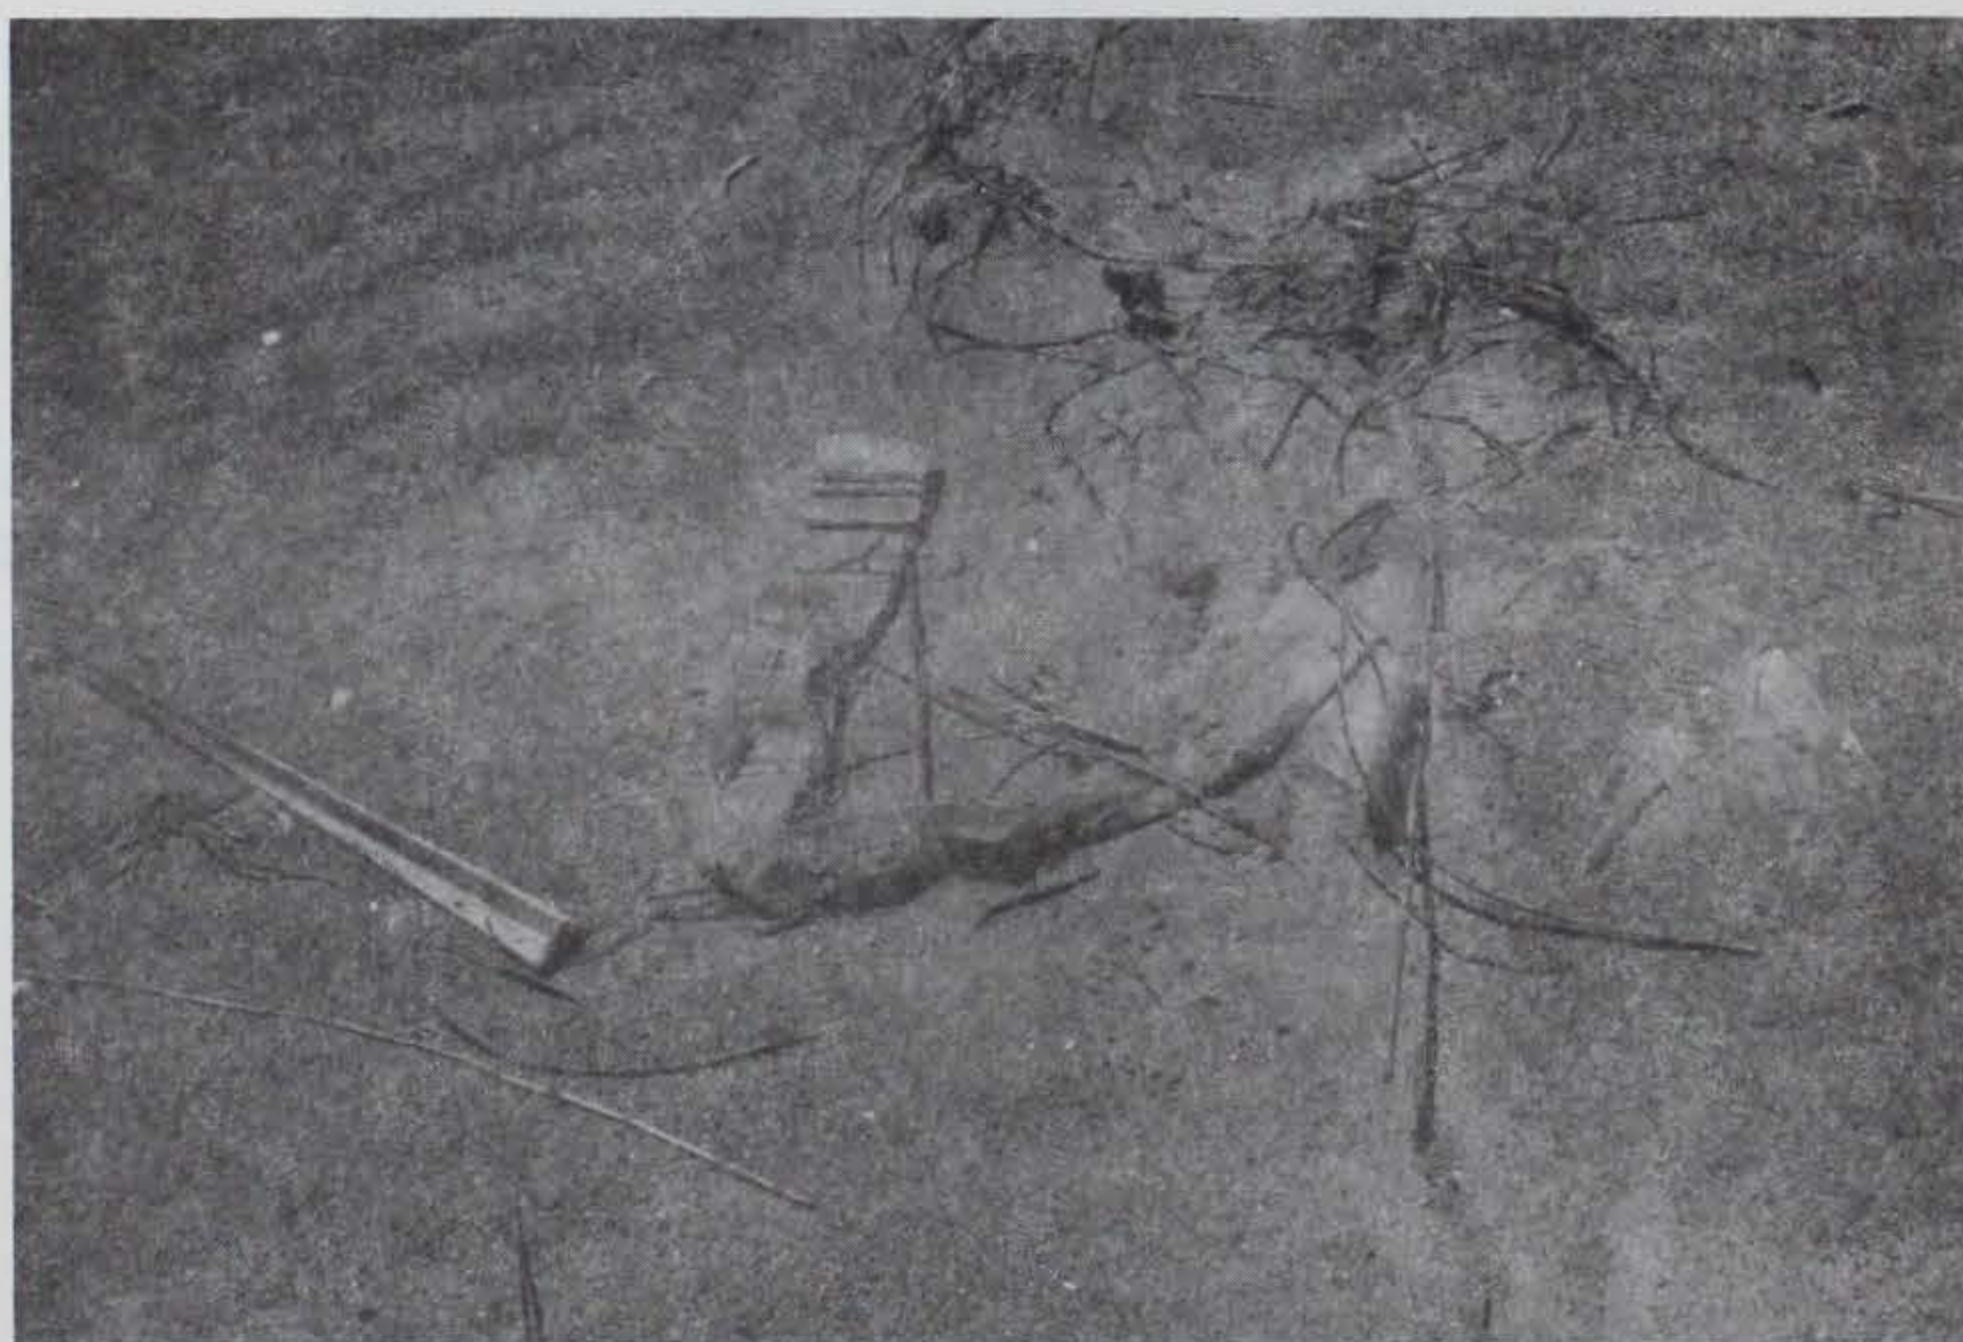
Photo 17 SEASCAPE® Fragments on Beach - April 27, 1984
