## **Pythian Powerhouse and Laundry**

Historic Building Survey

## **Final Report**

(Building No. 503)

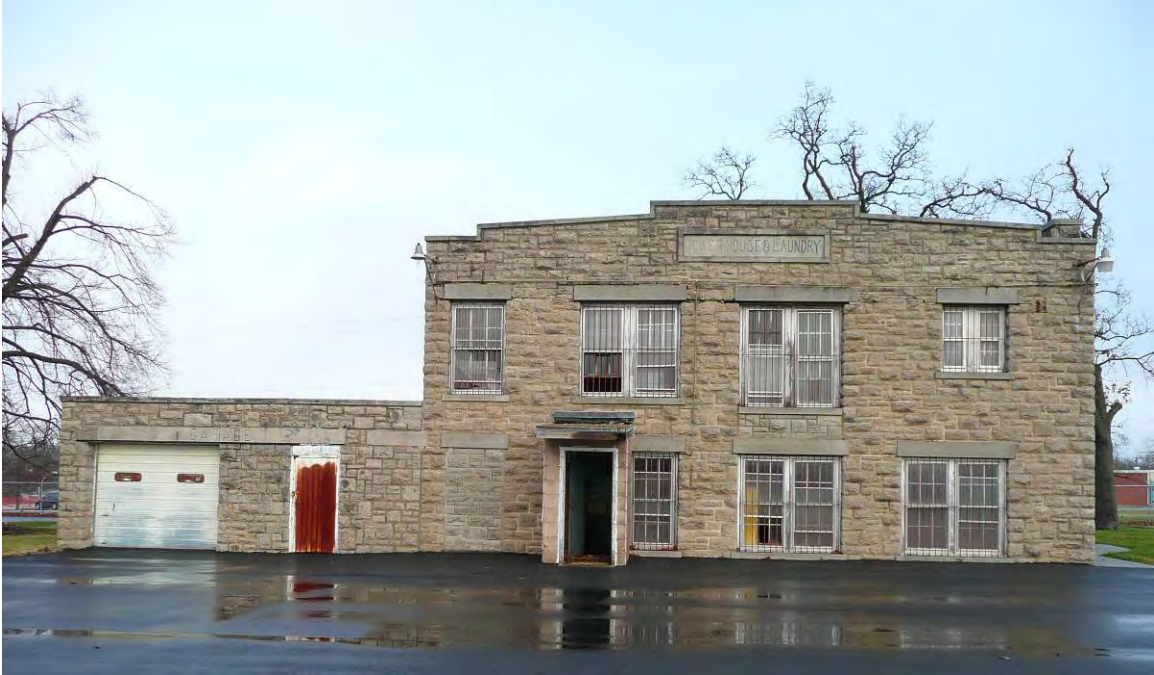
The south elevation (Photo 1) is the main elevation of the building that faces an open, paved parking lot and the rear of the Pythian Home. The south elevation is two different heights. The left side of the elevation is one-story and houses what use to be the garage space (Photo 2). This portion is covered with a sloped roof and a straight parapet with concrete capping. A metal replacement overhead garage door provides access into the one-story interior space. A replacement single metal entry door is located to the right of the garage door opening. This door is showing signs of severe rust damage. A concrete lintel stretches across the garage door opening and is located above the replacement metal door and the letters "GARAGE" are etched into the concrete (Photo 3). To the right of the door on the one-story portion of the exterior wall, an original window has been removed and the opening has been filled in with stone. The concrete lintel remains above the filled opening (Photo 4). The right side of the south elevation is two stories in height and is dominated by several paired wood double-hung windows. This portion of the building is covered with a sloped roof defined by a stepped parapet with concrete capping. There is one single window opening that has been filled in with stone. This window is located on the first floor and to the right of the other filled opening described above. The concrete lintel is intact. To the right of this filled window is a vestibule addition (Photo 5). A small wood structure has been constructed in front of the original single entry door. The vestibule is clad with asbestos cement siding and has a shed roof covered with asphalt shingles. Adjacent to the vestibule is a single six-over-six wood double-hung window (Photo 6). Two sets of paired six-over-six wood double-hung windows are located on the right side of the first floor. The second floor of the exterior wall contains a single six-over-six wood double-hung window, two sets of paired six-over-six wood double-hung windows, and a set of smaller paired four-over-four wood double-hung windows. Located above the windows in the center of the wall is a concrete sign. Etched in the sign are the letters "POWER HOUSE & LAUNDRY" (Photo 7). Two decorative light fixtures are located at the top edges of the exterior wall (Photo 8).

**Photo 1 – south elevation; overall view**

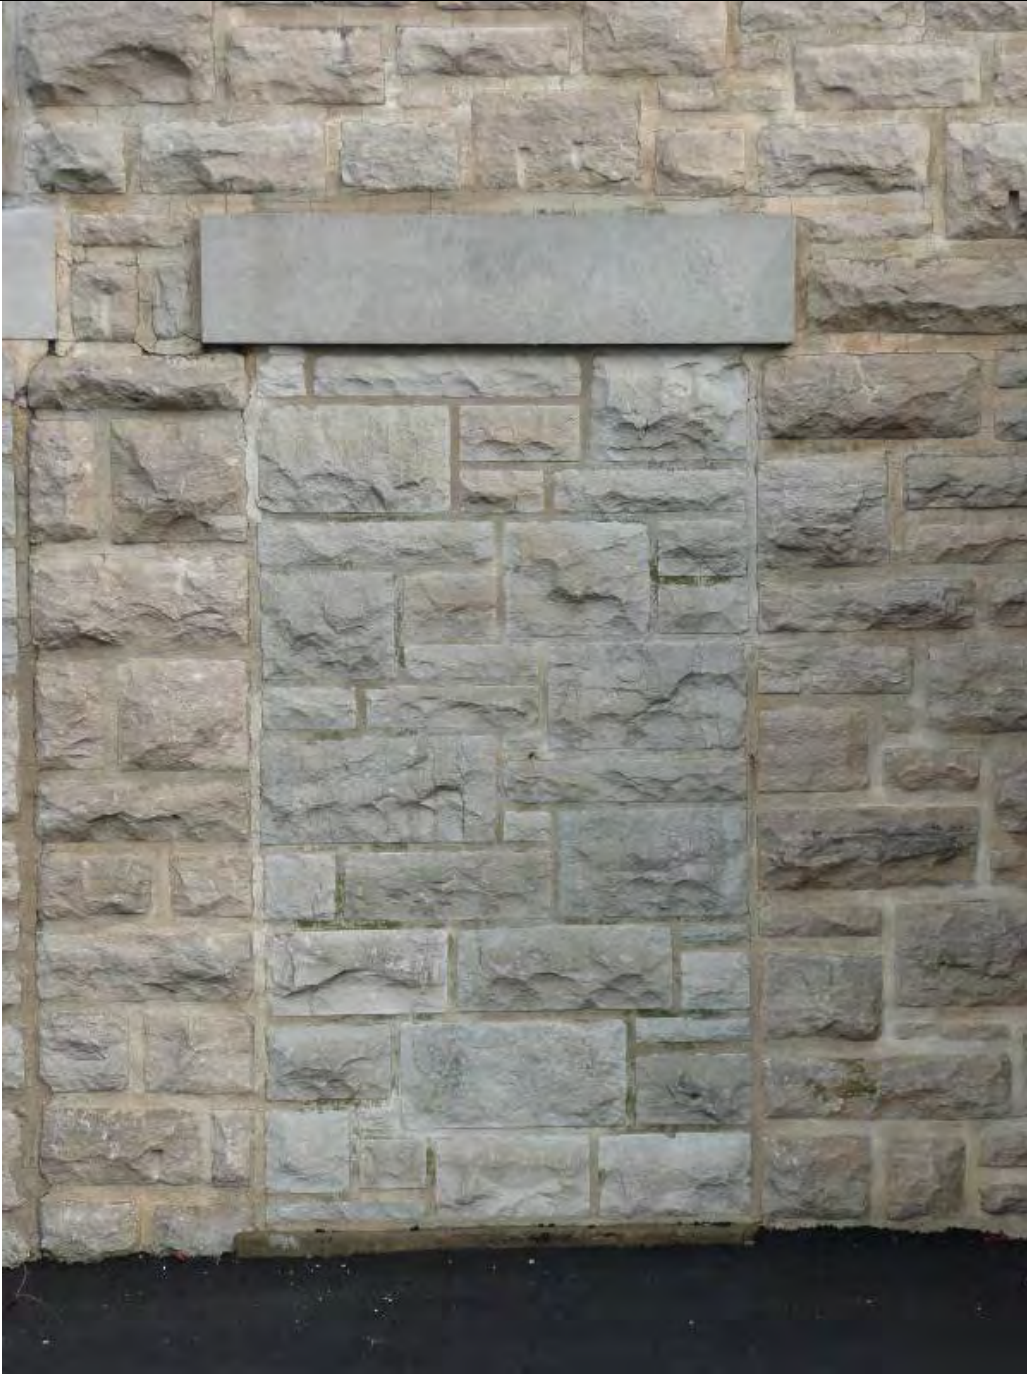
It is unknown if the one-story garage on the west side of the two-story Powerhouse and Laundry building was original to the design or if it was added at a later date. Also there is a window modification on the south elevation second floor. It is believed that the paired windows in the middle of the second floor replace a door opening (Photo 21). This door opening would have been added during World War II to provide access to the laundry area on the second floor. The windows that currently fill in the door opening are slightly larger than the other paired wood double-hung windows found on the building and the limestone located below the opening is slightly different in texture and in color.

**Photo 4 – view of modified filled window opening on south elevation**

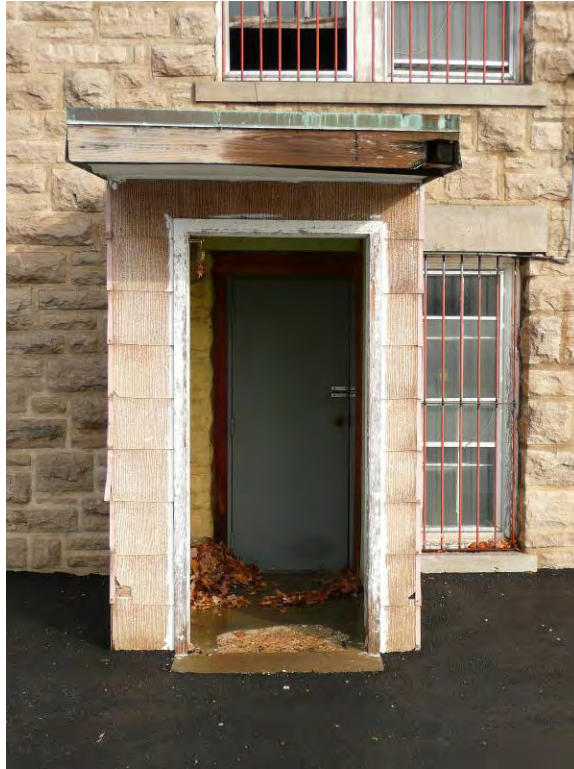
**Photo 6 – close-up of window modification  
near vestibule addition on south elevation**

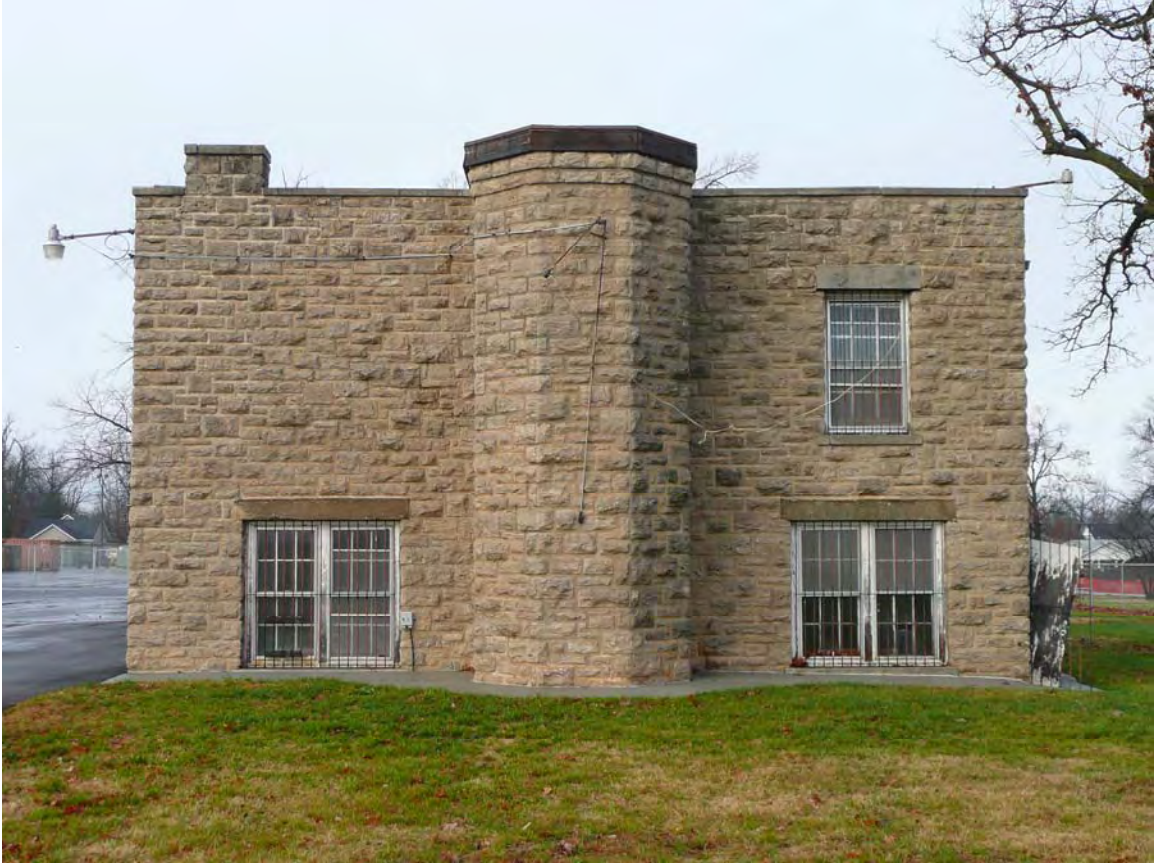
The east elevation (Photo 9) is where the original chimney stack was located. A majority of the stack is intact; however, the top portion of the stack that extended above the two-story roof height has been removed and has been capped off (Photo 10). The chimney is located in the center of the elevation and is five-sided. There are two sets of paired wood double-hung windows on the first floor; one on each side of the chimney. One single six-over-six wood double-hung window is to the right of the chim-

**Photo 9 – east elevation; overall view**

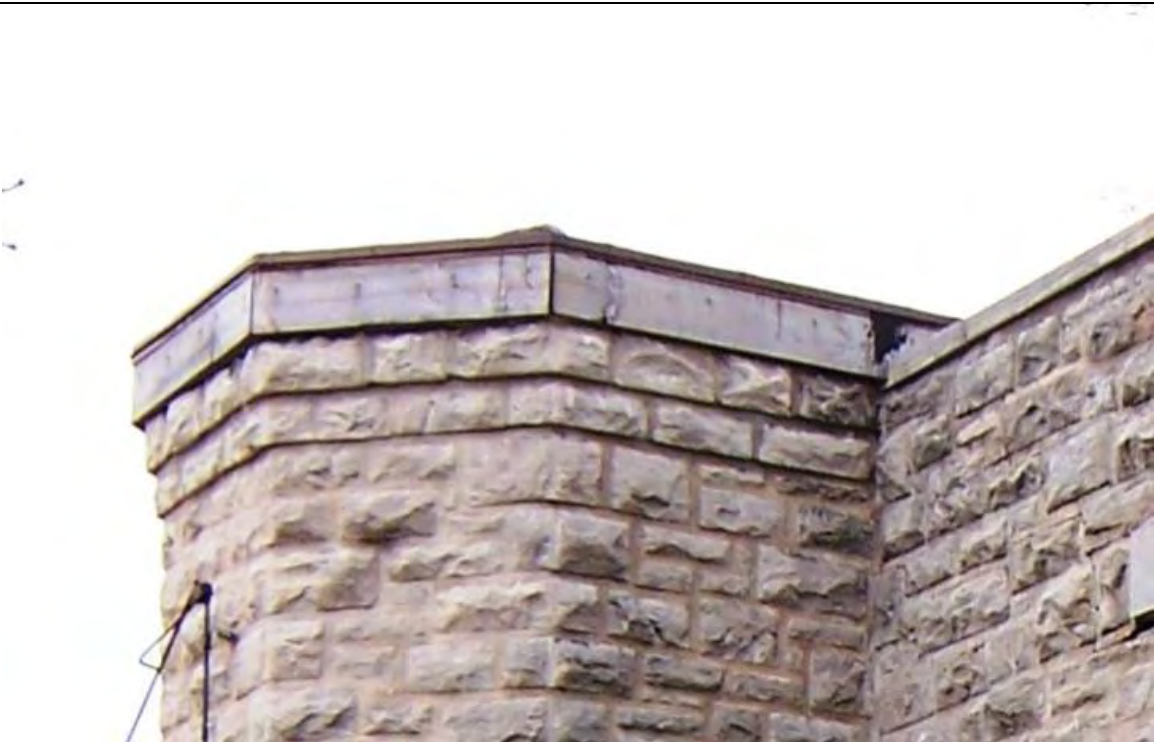
**Photo 10 – close-up of chimney stack modificaiton**

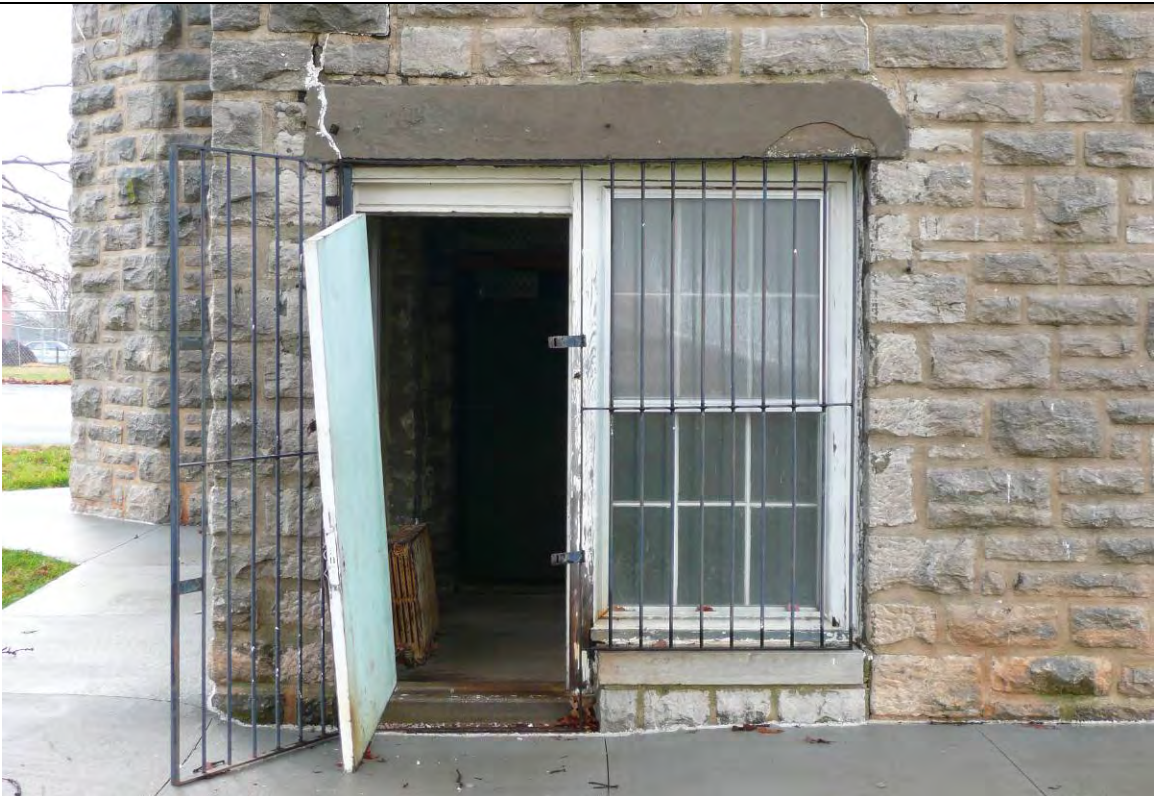
**Photo 12 – close-up of window modification on north elevation**

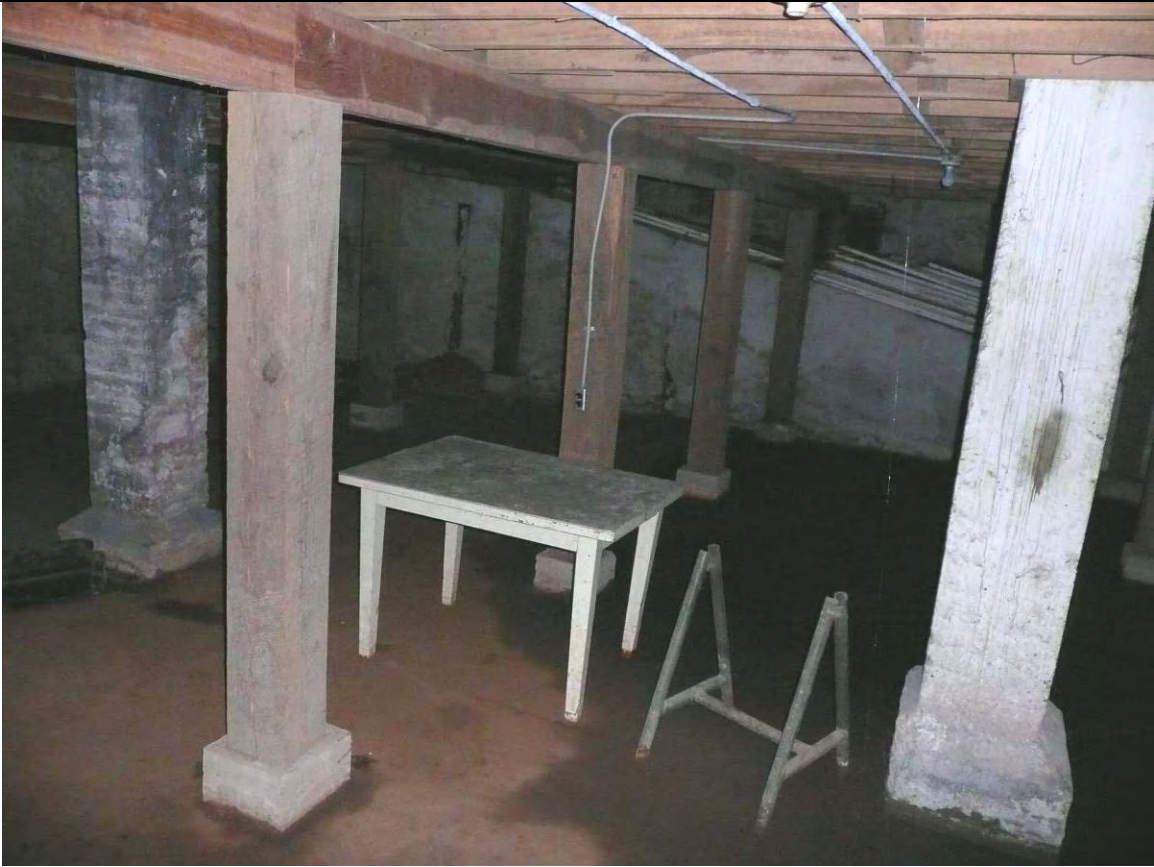
4. Structural System, Framing: The building has a simple structural system. The exterior walls are approximately 1'-10" thick cut limestone. Two concrete columns are located in the two-story space that extends from the lower level (basement) up through the second floor. These 1'-0" by 1'-0" columns are set within a concrete pier. Each column base measures 1'-6" by 1'-6". The columns are located 24'-0" from the east wall and 12'-2" and 24'-10" from the south wall (Photo 14). Newer 0'-8" by 0'-8" wood columns are spread throughout the basement to support the wood floor addition above. These columns are set within concrete foundations (Photo 15).

**Photo 15 – view of added wood columns used to support first floor**

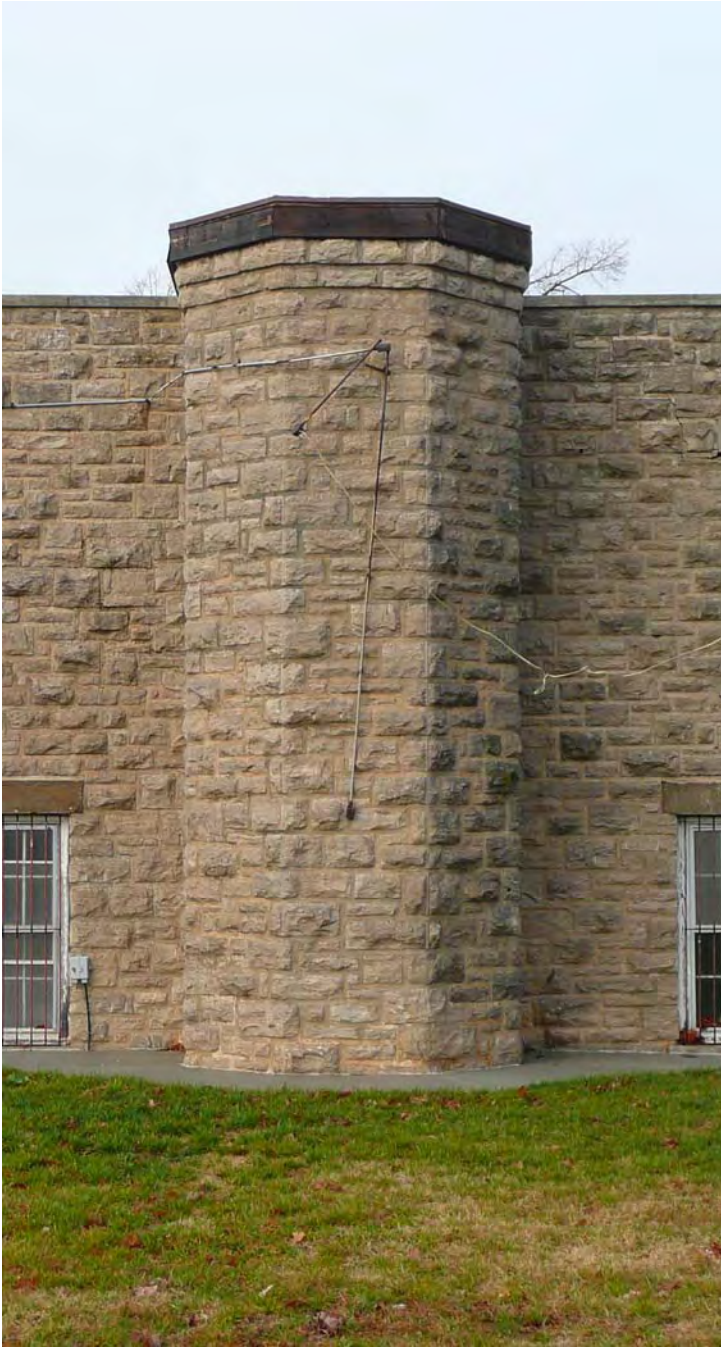
6. Chimneys: A five-sided chimney is located on the exterior of the east wall (Photo 16). The chimney is constructed of the same cut limestone. The original stack has been removed and the remaining portion of the chimney has been capped. The chimney width is 10'-0" across. The five sides measure 4'-6", 3'-8", 3'-10", 3'-8", and 4'-6". The current height of the chimney is 22'-0".

**Photo 16 – overall view of modified chimney on east elevation**

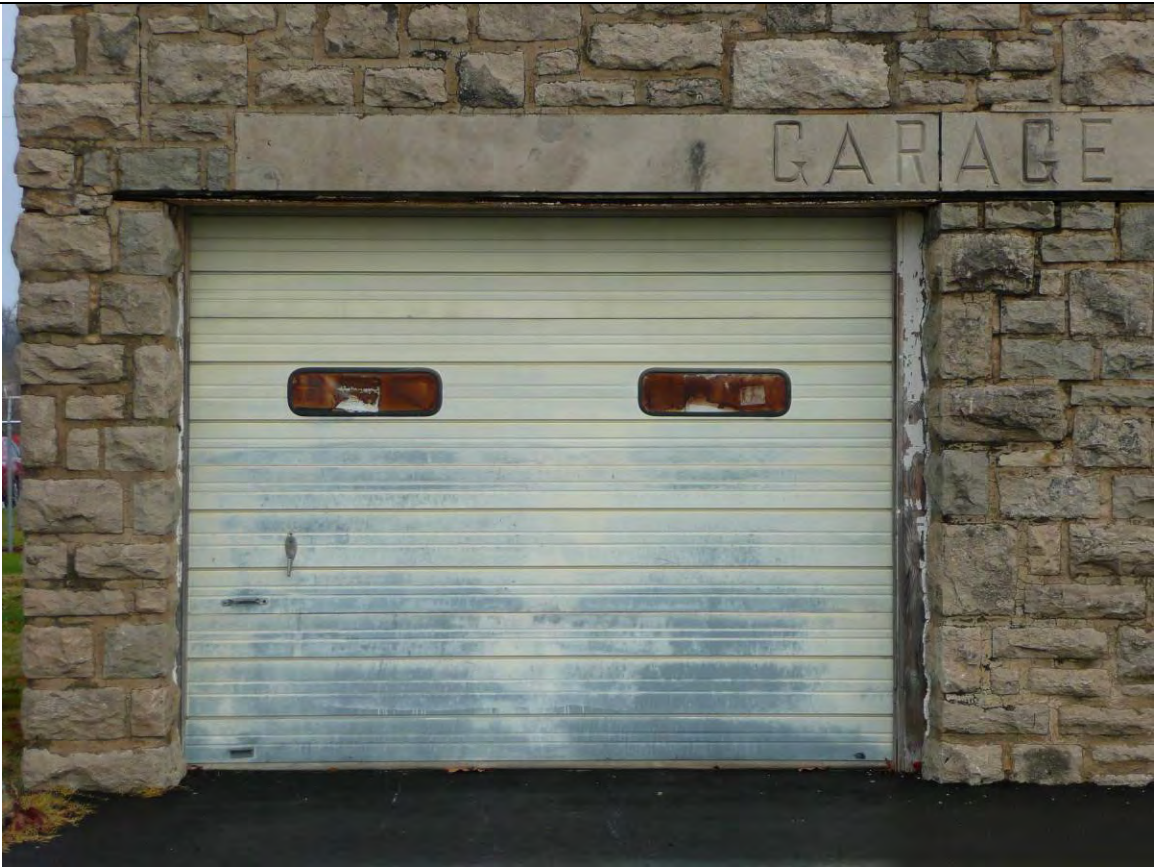
**Photo 17 – replacement metal garage door on south elevation**

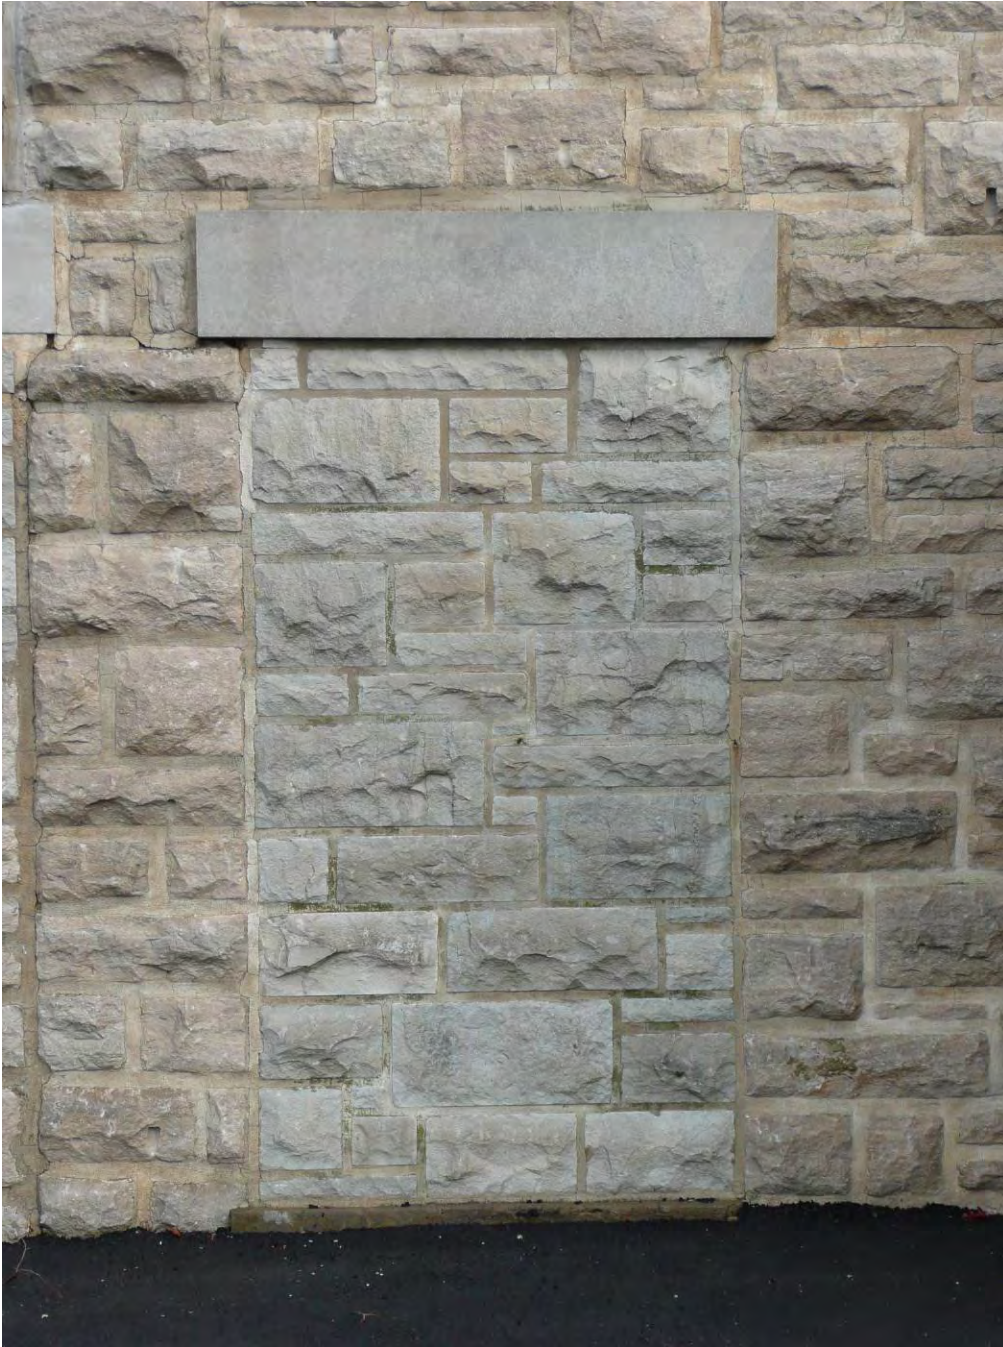
**Photo 25 – Type 7 window or door**

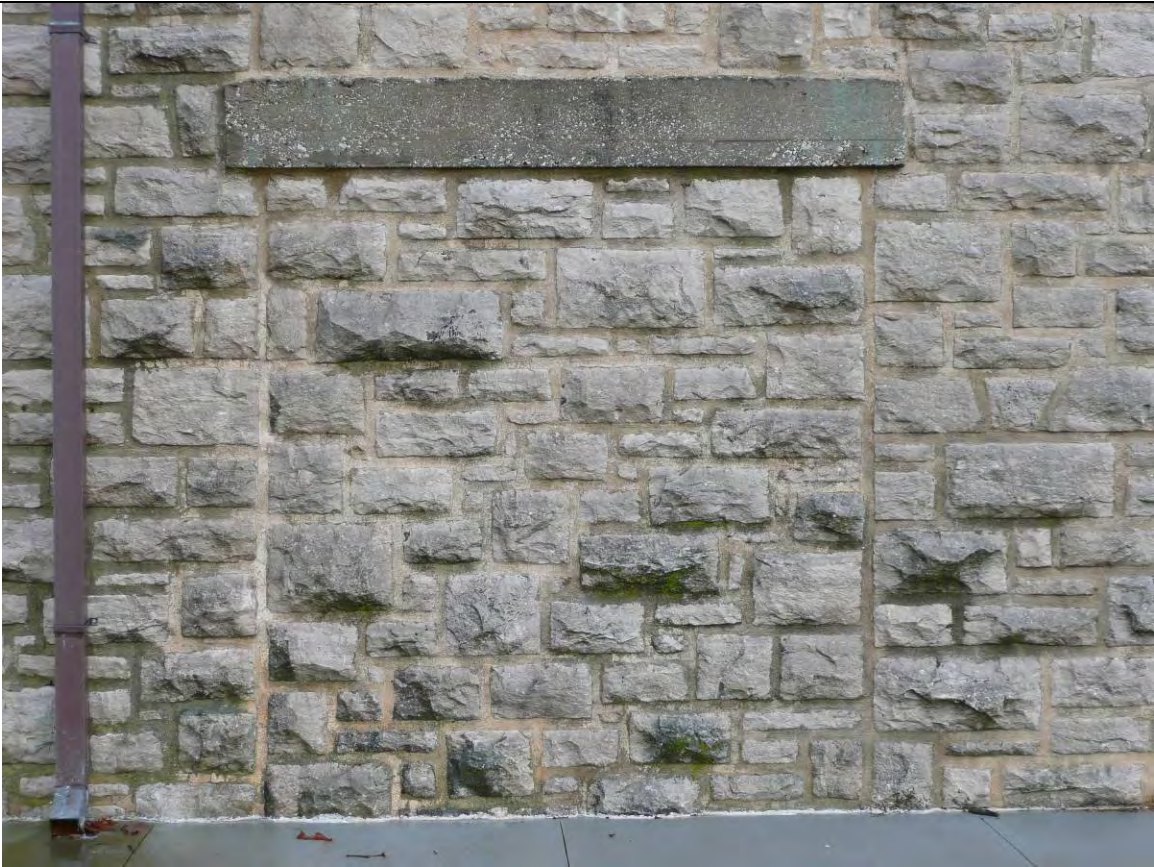
**Photo 26 – Type 8 window**

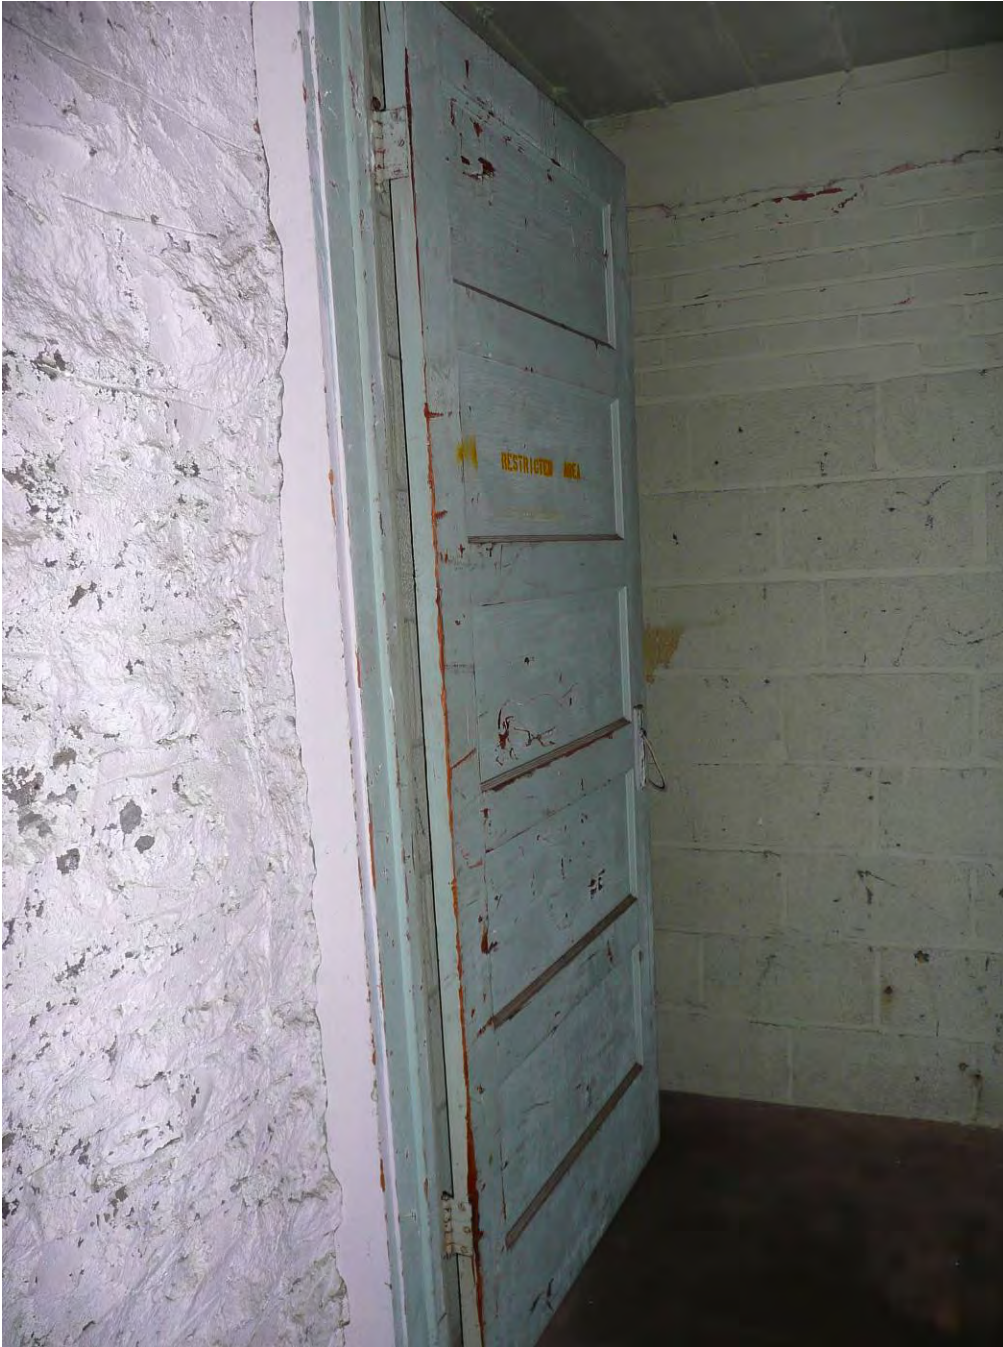
**Photo 40 – view of five-panel wood interior door and door opening filled with concrete masonry units**
