Periodic Inspections of Concrete-Armored Coastal Structures

by Robert R. Bottin, Jr.

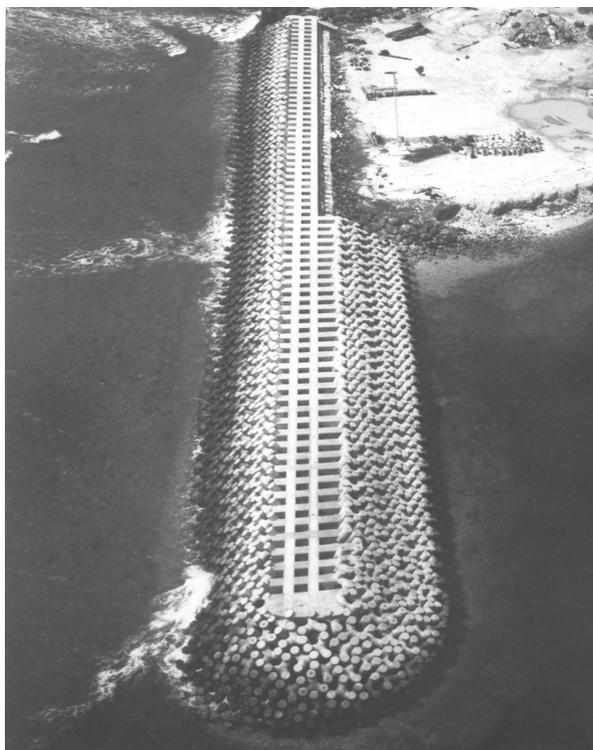
Figure 1. Ofu Harbor breakwater

During the initial photogrammetric survey of October 1996, selected tribars were targeted (three targets each) and precise positions of these units were obtained as well as centroid data and orientations of the targeted armor units. A walking survey of the structure revealed no broken armor units, however, one sea-side tribar was slightly separated from the rib cap. In addition, it was noted that some of the Swiss cheese block underlayer units along the slope had slightly separated in a vertical direction. The maximum separation was about 20.32 cm (8 in.). The geotextile bags had deteriorated and some spalling along the edges of the 510.29-kg (1,125-lb) high-strength concrete underlayer units was also noted around the head of the structure. In general, the breakwater appeared to be in excellent condition.

The August 2002 photogrammetric survey of the breakwater revealed negligible movement of the concrete armor units relative to the 1996 survey. Maximum movement of the targets established on the tribar armor units in the horizontal and vertical directions, respectively, were 0.14 m (0.45 ft) and 0.106 m (0.35 ft); and the average movements of all horizontal and vertical targets were 0.012 m (0.04 ft) and 0.021 m (0.07 ft), respectively. Maximum movements of the target armor unit centroids were 0.088 m (0.29 ft) and 0.073 m (0.24 ft) in the horizontal and vertical directions, respectively, while average movements were 0.012 m (0.04 ft) and 0.024 m (0.08 ft) in the horizontal and vertical directions. Seventy-three percent of all vertical movements and 93 percent of horizontal movements were 0.03048 m (0.1 ft) or less. Changes in rotation angles of the armor units varied from 0.0 to 4.03 deg with an average of 0.64 deg. A walking inspection of the structure in 2002 revealed no broken tribars. Fifteen sea-side tribars were slightly separated from the rib cap as opposed to one in 1996. On the entire sea side of the structure, it was noted that the Swiss cheese block underlayer units had separated along the slope between the third and fourth rows (down from the crest). Typical separations ranged from 2.54 to 10.16 cm (1 to 4 in.), and the maximum was 20.32 cm (8 in.). Some underlayer separations 2.54 to 10.16 cm (1 to 4 in.) were also noted on the harbor side of the structure. Separations between the cheese block underlayer units were more widespread as opposed to the 1996 inspection. The 510.29-kg (1,125-lb) high-strength concrete underlayer units around the head of the structure looked the same as the previous inspection. Even though slight movement in the breakwater's underlayer armor units had occurred, the breakwater appeared to be in excellent condition. It has not been subjected, however, to a major tropical storm, typhoon, or hurricane since its construction.

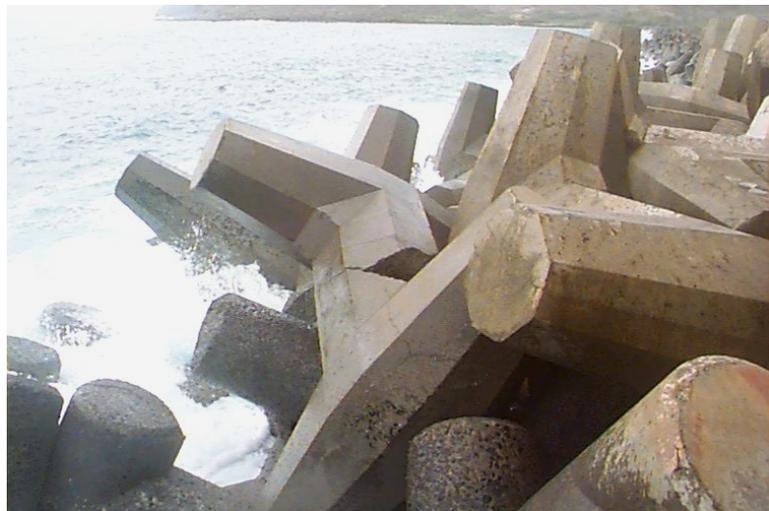
Figure 2. Trunk of Nawiliwili breakwater

During the initial photogrammetric survey of September 1995, selected armor units 16,147.89-kg (17.8-ton) tribars and 9,979.03- and 20,865.25-kg (11- and 23-ton) dolosse) were targeted (three targets each) and precise positions of these units were obtained as well as centroid data and orientations of the targeted armor units. The initial broken armor unit survey of the Nawiliwili Harbor breakwater revealed a total of 70 broken or cracked armor units above the waterline. Of the 70 broken or cracked armor units, 39 were 9,979.03-kg (11-ton) dolos, 19 were 16,147.89-kg (17.8-ton) tribars, 8 were 20,865.25-kg (23-ton) dolosse, and 4 were 16,147.89-kg (6.5-ton) tribars. Considering the types of breaks, 54 percent of the 9,979.03-kg (11-ton) dolosse and 63 percent of the 20,865.25-kg (23-ton) dolosse were determined to be mid-shank breaks. Of all the dolos breaks recorded, 77 percent were straight and 23 percent were angled. Of the 19 broken 16,147.89-kg (17.8-ton) tribars, 74 percent consisted of one leg broken off through the center of the unit. The four broken 6.5-ton tribars on the harbor-side of the breakwater appeared to have been placed in that condition. They seemed to have been fitted on the crest adjacent to the rib cap. It was noted during the inspection, that due to excessive wave action, broken/cracked armor units along the sea-side water's edge may have been missed in the previous inspection, since that portion of the structure was inaccessible by foot.

The September 2001 photogrammetric survey indicated negligible movement of the concrete armor units on the breakwater relative to the 1995 survey. Maximum movement of the targets established on the concrete armor units in the horizontal and vertical directions, respectively, was 0.1280 m (0.42 ft) and 0.1381 m (0.45 ft); and the average movement of all horizontal and vertical targets was 0.0304 m (0.1 ft) and 0.0457 m (0.15 ft). Maximum movements of the targeted armor unit centroids were 0.1036 m (0.34 ft) and 0.1127 m (0.37 ft) in the horizontal and vertical directions, respectively, while average movements were 0.0274 m (0.09 ft) and 0.0426 m (0.14 ft) in the horizontal and vertical directions. Changes in the rotation angles of the armor units varied from 0.0 to 10.2 deg with an average of 0.8 deg. A broken armor unit survey conducted during August 2001 revealed 77 broken or cracked armor units above the waterline (versus 70 in 1995). Additional broken units identified since the last survey included five 9,979.03-kg (11-ton) dolosse and two 16,147.89-kg (17.8-ton) tribars. However, as stated previously, high wave action during the 1995 walking inspection prevented a close examination of armor units on the sea-side water's edge. Of the seven additional broken units identified in 2001, six were located along the water's edge and may have been overlooked in 1995 due to the excessive wave action. Therefore, it appears that minimal armor unit breakage occurred between 1995 and 2001. Overall, the structure appeared to be in good condition.

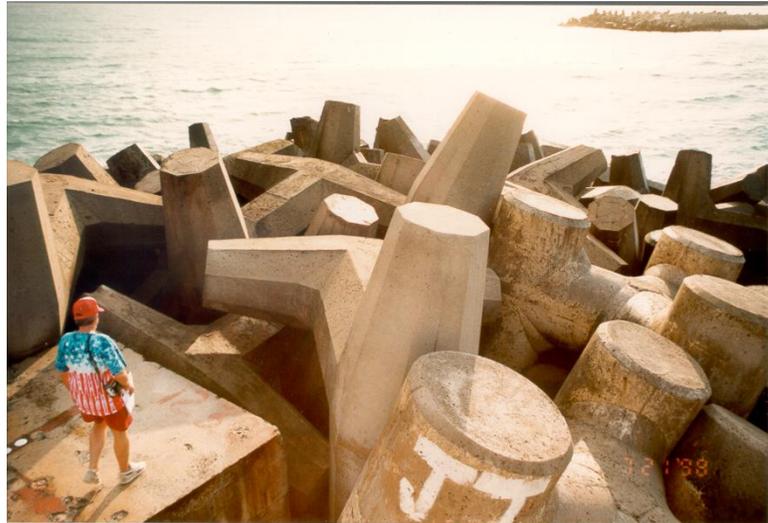
Figure 3. Head of Kahului west breakwater

The August 2001 photogrammetric survey indicated close agreement between positions of the concrete armor units relative to the 1993 survey for most of the targets. For the east breakwater, maximum movements of the targets established on the concrete armor units in the horizontal and vertical directions, respectively, were 0.94 m (3.1 ft) and 1.52 m (5.0 ft); however this level of difference occurred for only one target for the horizontal and one target in the vertical position. Both these targets were on units situated around the seaward head of the structure. The average movements of all horizontal and vertical targets on the east breakwater were 0.15 and 0.16 m (0.51 and 0.54 ft), respectively. Maximum movements of the targeted armor unit centroids on the east breakwater were 0.54 and 0.67 m (1.8 and 2.2 ft) in the horizontal and vertical directions, respectively, while average movements were 0.12 and 0.17 m (0.39 ft and 0.57 ft) in the horizontal and vertical directions. For the east breakwater, changes in the rotation angle of the armor units varied from 0.03 to 24.57 deg with an average of 3.09 deg. For the west breakwater, maximum movements of the targets in the horizontal and vertical directions were 0.13 and 0.11 m (3.8 and 1.9 ft), respectively; however, this level of difference occurred on only one armor unit. The average movements of all horizontal and vertical targets, respectively, were 0.11 and 0.06 m (0.42 and

0.36 ft). Maximum horizontal and vertical centroid movements, respectively, for the west breakwater were 0.64 and 0.18 m (2.1 and 0.6 ft), while average movements were 0.11 and 0.06 m (0.37 and 0.21 ft) in the horizontal and vertical directions. Changes in rotation angles varied from 0.0 to 17.32 deg for the west breakwater with an average of 2.02 deg. Even though some units had moved 0.91 to 1.5 m (3 to 5 ft) on the breakwaters, visual observations indicated they had not broken and continued to be functional. A broken armor unit survey conducted during August 2001 revealed 29 broken or cracked armor units above the waterline on the east breakwater and 58 on the west structure. Of the 29 broken units on the east breakwater, 19 were 5,443.10-kg (6-ton) dolosse, two were 8,164.66-kg (9-ton) tribars, four were 27,215.54-kg (30-ton) dolos, and four were 31,751.47-kg (35-ton) tribars. Of the 58 broken units on the west breakwater, four were 5,896.70-kg (6.5-ton) tribars, one was a 9,979.03-kg (11-ton) tribar, 16 were 17,236.51-kg (19-ton) tribars, 18 were 18,143.64-kg (20-ton) dolos, 11 were 27,215.54-kg (30-ton) dolos, five were 29,937.1-kg (33-ton) tetrapods, and three were 31,751.47-kg (35-ton) tribars. Concentrations of broken armor units were identified on various areas of the breakwaters. Considering the types of breaks for the 52 broken dolosse on both structures, 75 percent had shank-fluke breaks, 16 percent had fluke-shank breaks, 9 percent had mid-shank breaks. Of the dolos breaks recorded, 78 percent were straight and 22 percent were angled. Considering the types of breaks for the 35 tribars and tetrapods on the breakwaters, 89 percent included units with breaks through the center sections where one or more legs had separated, and 11 percent had just portions of a leg broken off the unit. These data establish a base from which to evaluate future breakage in subsequent surveys. Even though some breakage has occurred, the structures appeared to be in good condition overall.

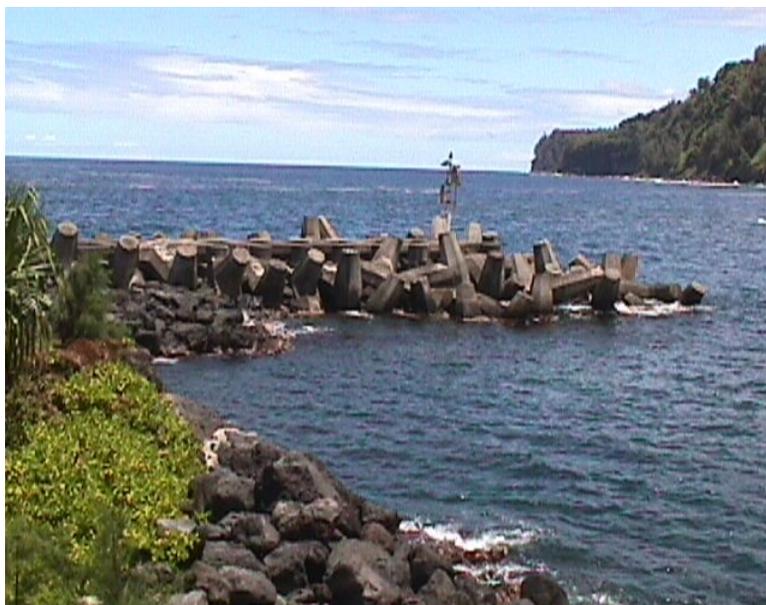
Figure 4. Laupahoehoe breakwater

relative to the x, y, and z axes were obtained as well. No broken/cracked armor units were documented during the walking inspection.

The September 2001 photogrammetric survey indicated minimal horizontal and vertical movement of the targeted units relative to the previous survey. Maximum movements of the targets in the horizontal and vertical directions, respectively, were 0.10 m and 0.13 m (0.34 ft and 0.43 ft). The average movements of all horizontal and vertical targets, respectively were 0.03 and 0.05 m (0.1 and 0.16 ft). Maximum movements of the targeted armor unit centroids were 0.0914 and 0.085 m (0.3 and 0.28 ft) in the horizontal and vertical directions, respectively, while average movements were 0.0304 and 0.0335 m (0.1 ft and 0.11 ft) in the horizontal and vertical directions. Changes in the rotation angle of the armor units varied from 0.01 to 0.36 deg with an average of 0.1 deg. No broken or cracked armor units were observed during the walking inspection. The structure is considered to be in excellent condition.

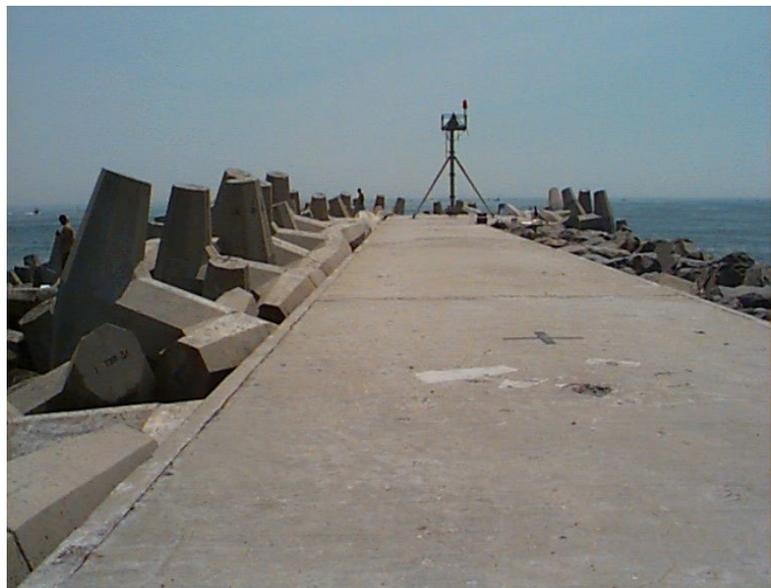
Figure 5. Manasquan north jetty

The May 1994 photogrammetric survey indicated that the targeted dolosse on the north and south jetties had been dynamic since the initial monitoring ended in 1984. Horizontal movement had ranged up to 2.01 m (6.6 ft) and vertical displacement (subsidence) as much as 1.62 m (5.3 ft). Dolos movement on the north jetty was slightly greater than those on the south. From 1984 to 1994 about 73 percent of the targeted units on the north jetty and 86 percent of the units on the south jetty had moved less than 0.3048 m (1 ft). Conversely, about 13 and 4 percent of the north and south jetty units, respectively, had moved distances greater than 0.91 m (3 ft). With regard to el changes between 1984 and 1994, 93 percent of the dolosse on the north jetty and 95 percent of those on the south structure had subsided. Between 1984 and 1994, the average movements of horizontal and vertical targets on the north jetty were 0.2743 m and 0.2438 m (0.9 ft and 0.8 ft), respectively; and on the south jetty the average movement was 0.1828 m (0.6 ft) both horizontally and vertically. The 1994 broken armor unit survey revealed 17 broken/cracked dolosse as opposed to five in 1984. Of the broken/cracked units, nine were located on the north jetty and eight were situated on the south structure. Pieces of the armor units were separated on 10 dolosse. Four dolosse were broken and being held together by rebar, and four had only hairline cracks. Considering the types of breaks, the majority (10 units) had shank-fluke breaks. There were five mid-shank breaks and two fluke-shank breaks. There were nine angled breaks and eight straight ones. Fifteen of the 17 units were

concentrated around the jetties' seaward heads. An area of concern was noted during the walking inspection at the tip of the south jetty where a broken unit had resulted in exposure of the core stone under the jetty cap. During the period October 1991 through March 1994, three major storm events (northeasters) occurred in the vicinity of Manasquan Inlet. These events probably significantly contributed to the armor unit movement and breakage at the heads of the jetties.

The August 1998 photogrammetric survey revealed significantly less dolos movement between 1994 and 1998 as detected during previous survey periods. Movement of dolos targets in the horizontal direction ranged from 0 to 0.55 m (0 to 1.8 ft), and vertical displacement ranged from 0 to 0.07 m (0 to 0.22 ft). Only three target positions on the north jetty moved over 0.15 m (0.5 ft) in the horizontal direction, and all other targets on the north structure moved 0.08 m (0.25 ft) or less. On the south jetty, all targets moved 0.06 m (0.21 ft), or less, horizontally. In the vertical direction, target movement did not exceed 0.07 m (0.22 ft) on the north jetty and 0.06 m (0.21 ft) on the south structure. Between 1994 and 1998, the average movements of the targets on the north jetty were 0.05 and 0.03 m (0.15 and 0.09 ft) in the horizontal and vertical directions, respectively. On the south jetty, the average movements of the targets in the horizontal and vertical directions, were 0.02 and 0.03 m (0.07 and 0.09 ft), respectively. During the previous surveys, the more significant movement occurred around the heads of the jetties. During this period (1997), however, the jetty heads were rehabilitated with CORE-LOCs. Some dolosse were covered and/or repositioned during this process. Therefore, no correlation in movement could be made for armor units in areas where the more significant movement had occurred previously. During the November 1998 broken armor unit survey, eight broken/cracked dolos armor units were observed. Four broken units were observed on each structure. Of the eight broken armor units observed, six were identified in the previous 1994 survey, and two were new breaks. As stated earlier, 17 broken units were observed in 1994. During the 1997 CORE-LOC rehabilitation, however, several broken dolosse were removed from the heads of the structures. Records indicate that several northeasters occurred between 1994 and 1998. During the 1998 periodic inspection, initial base data were obtained for the CORE-LOC armor units installed on the heads of the jetties. These data will establish a base from which to evaluate the effectiveness and analyze the performance of the CORE-LOCs in subsequent inspections.
