ERDC/CERL TR-02-26

# Condition Assessment of William Beaumont General Hospital Historic Buildings at Fort Bliss, Texas

Thomas R. Napier and Sheila A. McCarthy

September 2002

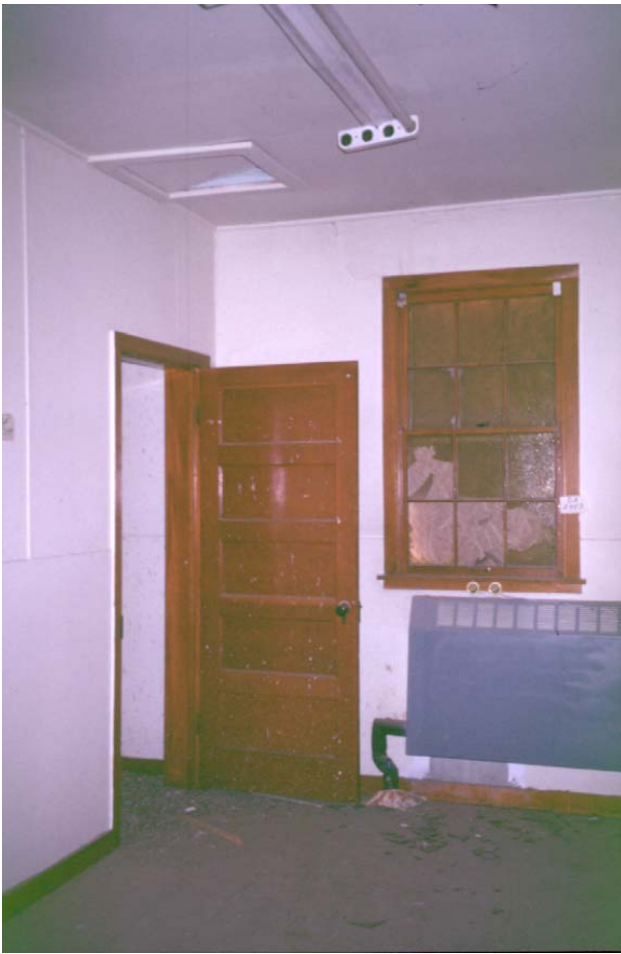
Windows in the foyer areas and sacristy remain in place, although they are boarded on the exterior. They are double hung with six-over-six sashes. In general, they are intact and not seriously deteriorated. Amber colored textured glass appears to be the original glazing material. Many panes have been broken. Some have been replaced with clear glass, and some have not been replaced at all. Serious damage was observed to only two sashes, apparently by vandalism (Drawing 2, E; Photograph 8). It should be possible to repair and refinish these windows. The window below the steeple on the south wall remains unboarded. It is intact, although it will require repair and refinishing.

**Photograph 8. Damaged sacristy window sashes.**

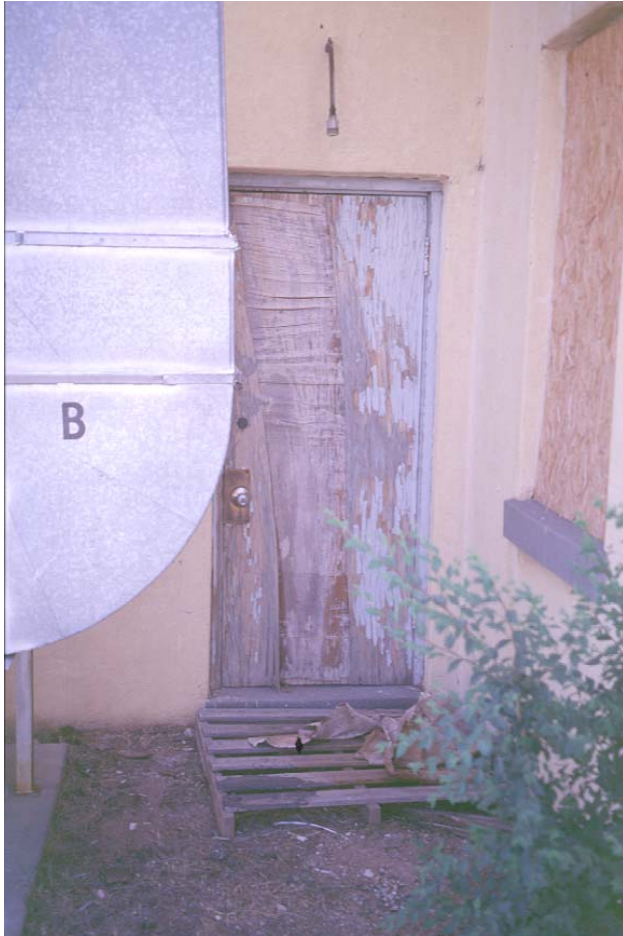
however, they are in poor condition. These doors should be repairable, although it will be more practical to replace them if similar style doors are available through salvage and reuse activities.

**Photograph 9. Deteriorated sacristy door.**

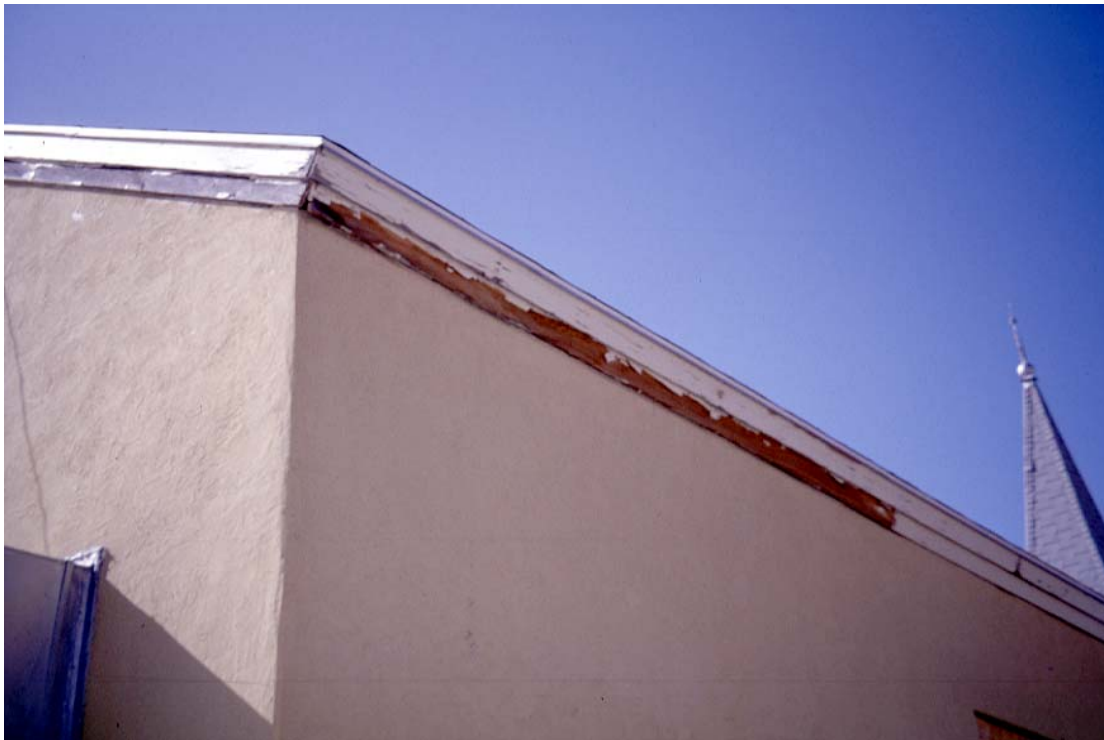
Minor deterioration of the eave trim occurs around the building. For example, paint has failed at the fascia at the north end of the east wall, at the rake trim on the north gable end (Drawing 2, G; Photograph 10), and at the rake trim at the south gable end below the steeple (Drawing 2, H). Scraping, priming, and repainting should be an effective repair.

Photograph 10. Detail of paint failure on chapel trim.

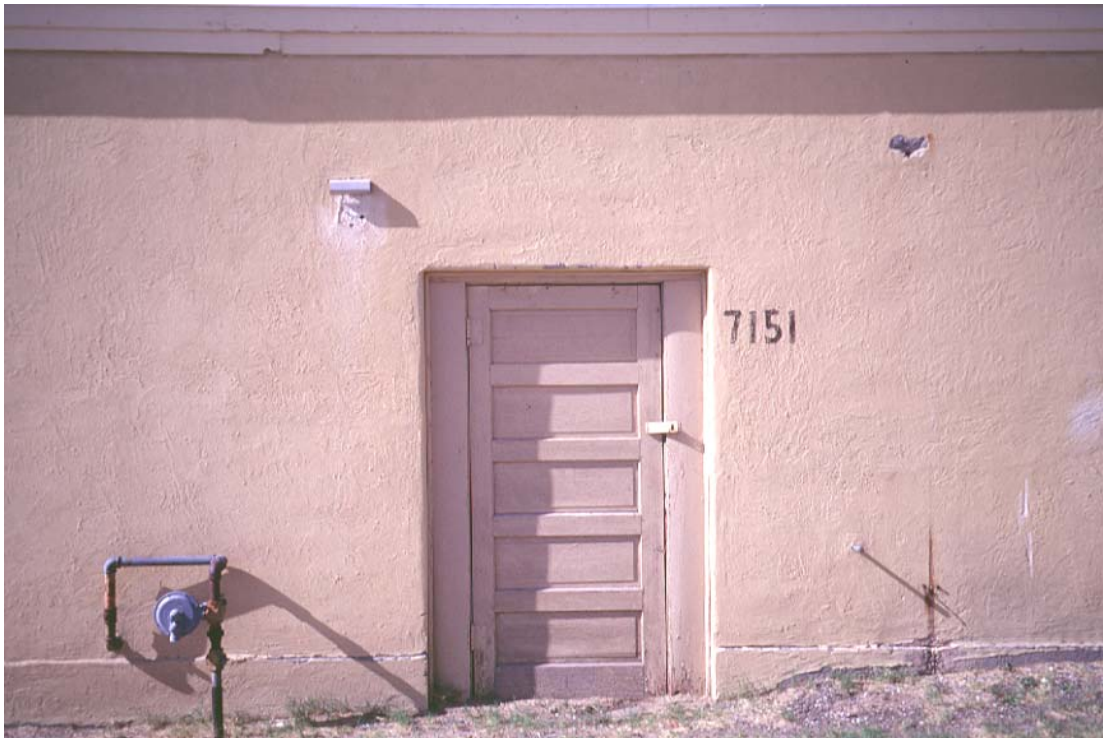
2, S; Photograph 14). No damage from water intrusion was evident in the building's floor or wall finishes near the floor. However the crawl space vents at the building's northwest corner were almost closed by the coarse soil carried by runoff, indicating runoff is entering the crawl space. Regrading to ensure positive drainage away from all sides of the buildings should be included as part of the adaptive use design.

Photograph 14. Chapel site drainage detail.

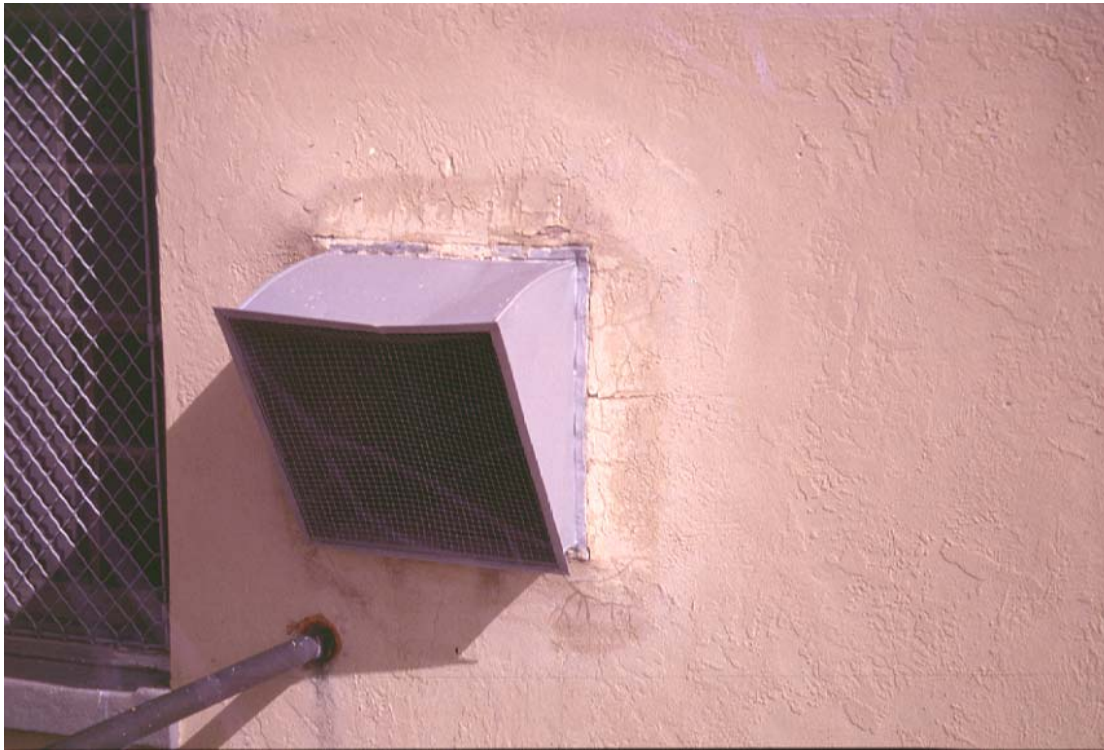
The exterior walls are in generally good condition. Minor cracking occurs around a metal vent hood at the north wall (Drawing 3, E; Photograph 16), around a light fixture over the east exit (Drawing 3, F), at pipe penetrations at the east wall (Drawing 3, G), and around the south exit at the west wall (Drawing 3, H). Louvers and grills on the north wall will require minor repair and refinishing. These repairs should present no problems when refinishing the exterior.

Photograph 16. Minor theater wall cracking around vent hood.

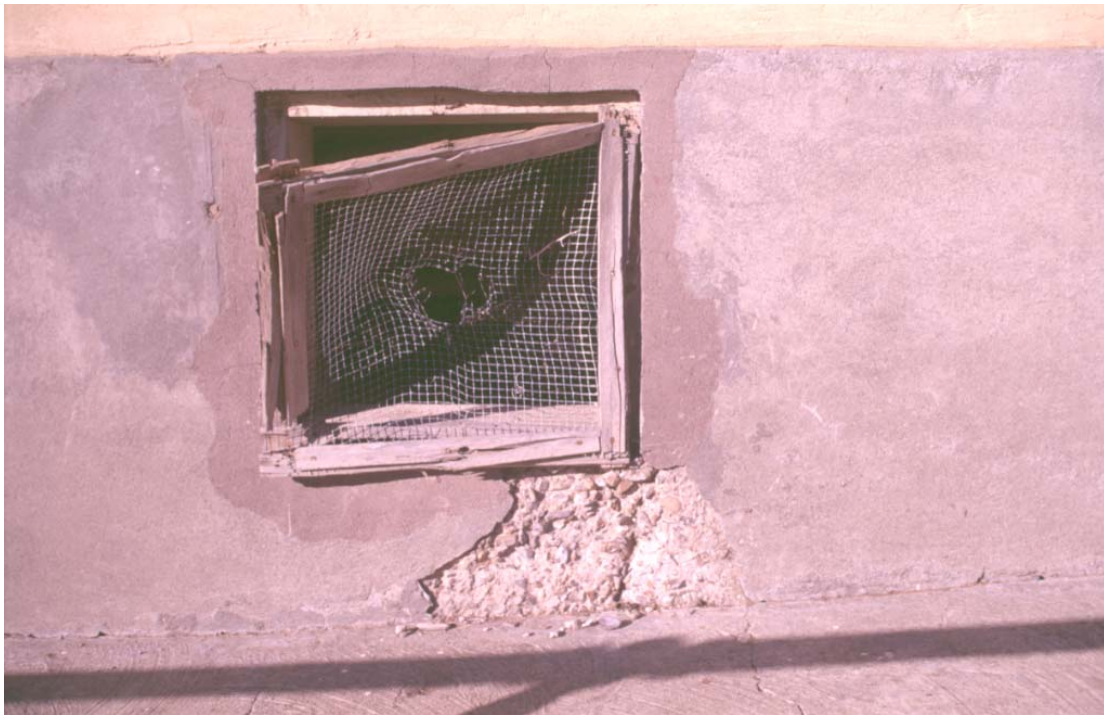
Minor cracking occurs throughout the foundation. A crack appears at the east wall, tracing from the lower corner of a crawl space vent, through the wall, and into the foundation (Drawing 4, A; Photograph 20). However, no differential movement or settlement was evident. This minor cracking should be sealed as part of the exterior refinishing. As the cracking appears to have not progressed for some period of time, repair should remain effective.

**Photograph 20. Minor gymnasium foundation cracking.**

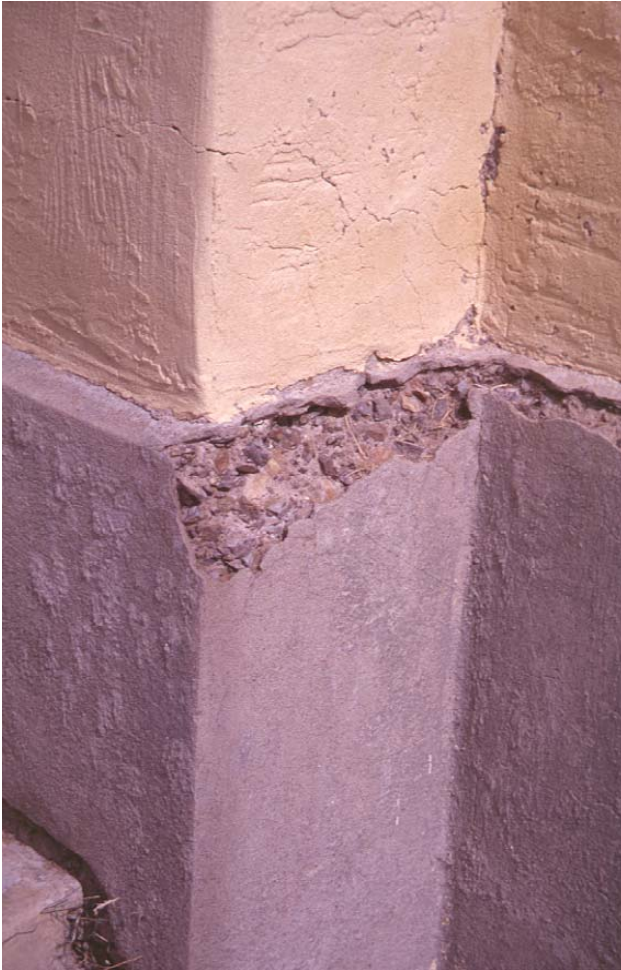
Concrete has spalled at the tops of two foundation pilasters on the north side of the building, adjacent to the loading dock (Photograph 21). Minor cracking in the wall pilasters was observed, although no settlement has occurred.

**Photograph 21. Minor gymnasium pilaster cracking.**

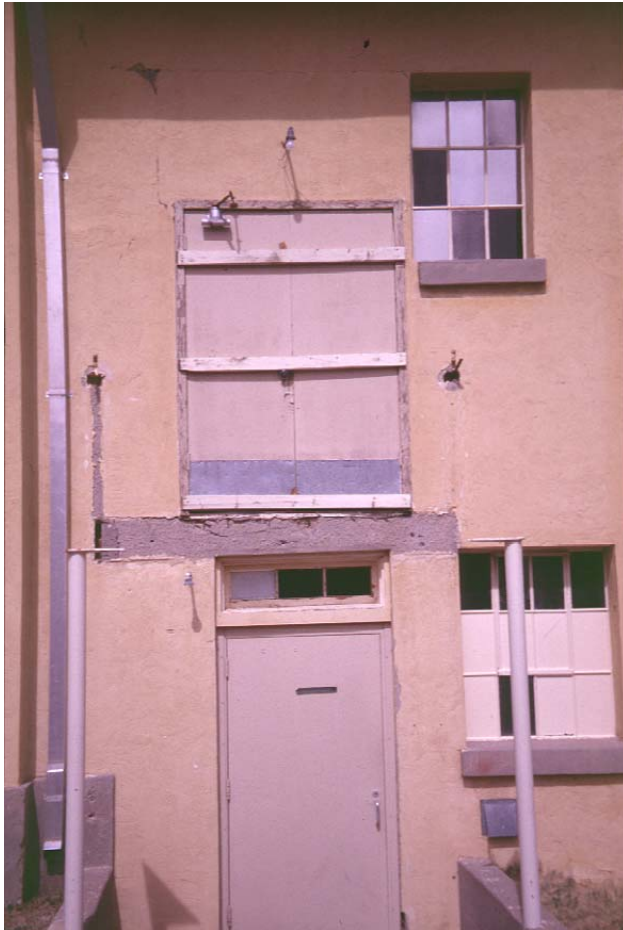
structure will be replaced in some fashion in a rehabilitation design. The damage to the wall from the removed structure will have to be repaired.

**Photograph 24. Gymnasium wall damage where fire escape was removed.**

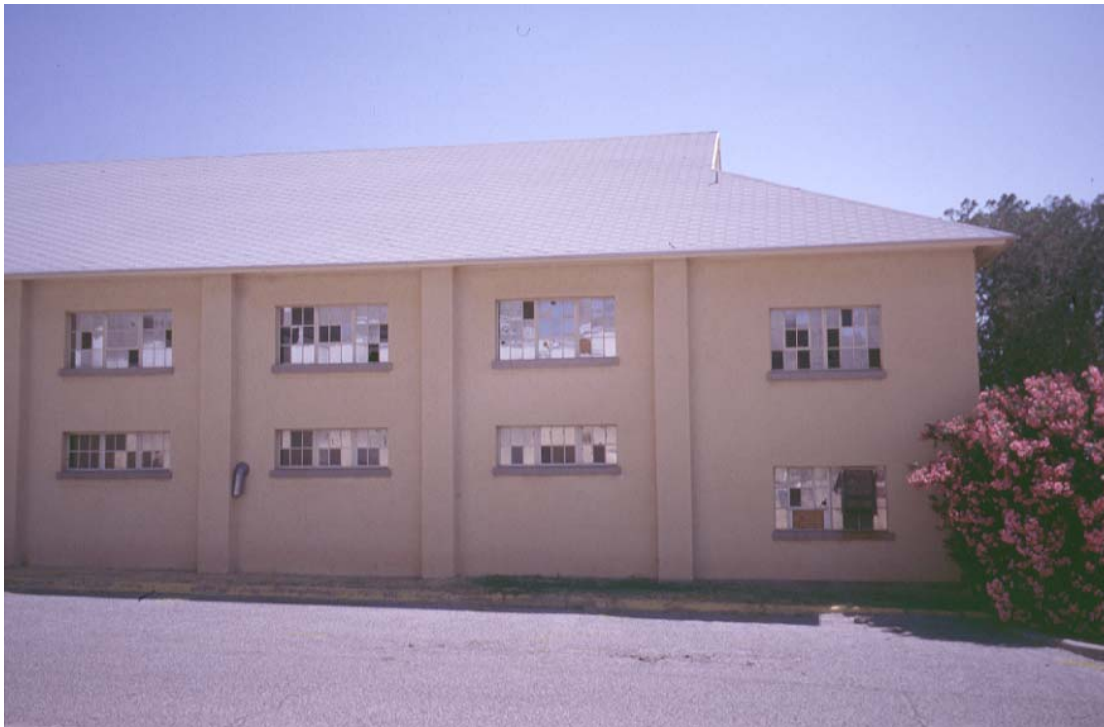
Reflective film has been installed on the glass panes. At present, many of the panes have been replaced without replacing the film (Photograph 25). In a rehabilitation or reuse design, film should be either restored to all glazing, or should be removed altogether.

**Photograph 25. Inconsistent use of film on gymnasium windows.**

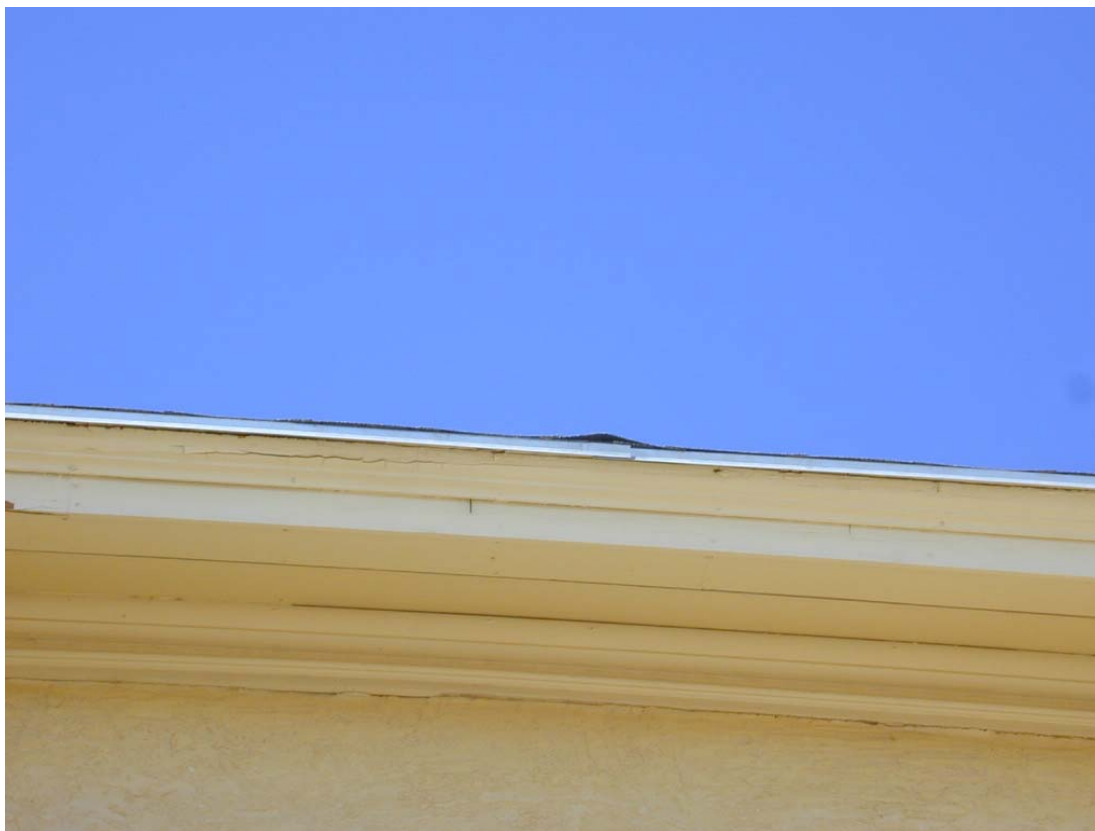
Some fish-mouthing is evident near the east and west eaves (Drawing 4, K, Photograph 28). That is, some shingles are bent so they are not laying flat upon the roof deck or the shingles below them. The metal edge flashing of the roof sheathing is also damaged in one location on the east side (Drawing 4, L). In addition, some shingles are missing at the south end of the ridge (Drawing 4, M).

**Photograph 28. 'Fish-mouth' shingle warpage on gymnasium gable.**

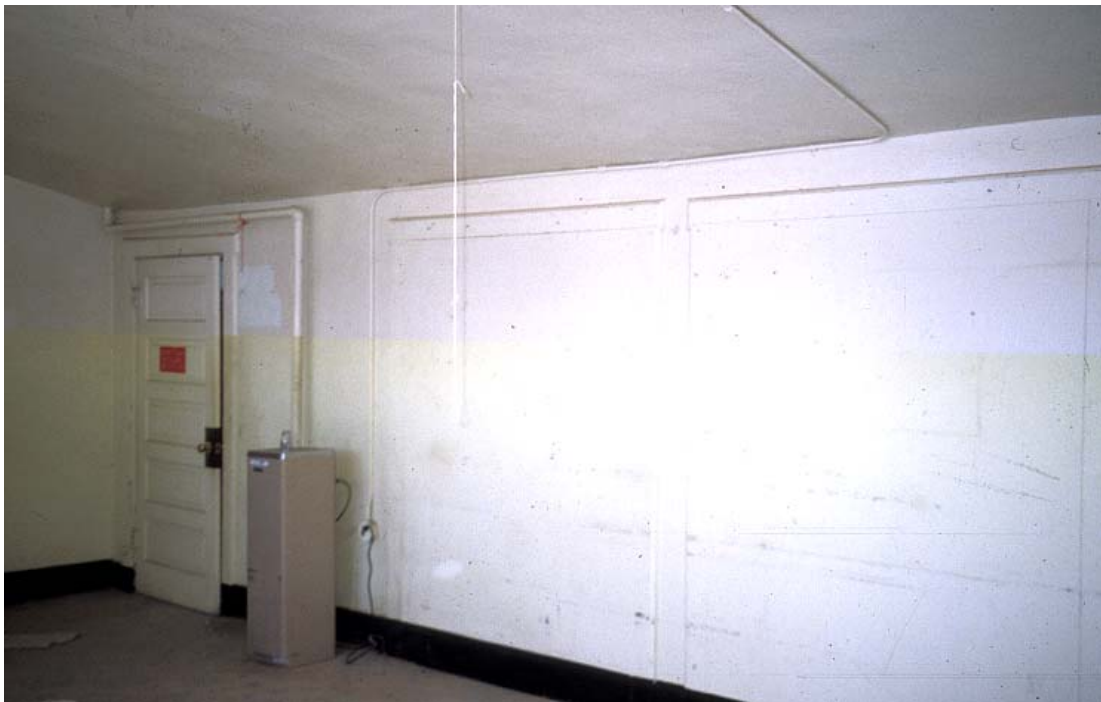
The single door from the lobby to the gym and the north locker room door remain intact. The others have been removed and the openings filled (Drawing 4, P). Padding is installed on the gym walls. The door trim remains, although it has been painted. These portals, especially the former entrance from the lobby, are significant elements in the building's design (Photograph 30). It would be possible to restore these doorways if historically appropriate replacements can be found for the doors. In deciding such a rehabilitation measure, items such as the building's future occupancy, must be considered, especially with regard to the building's function, safety, and circulation.

**Photograph 30. Historically incompatible modifications of gymnasium locker room portal.**

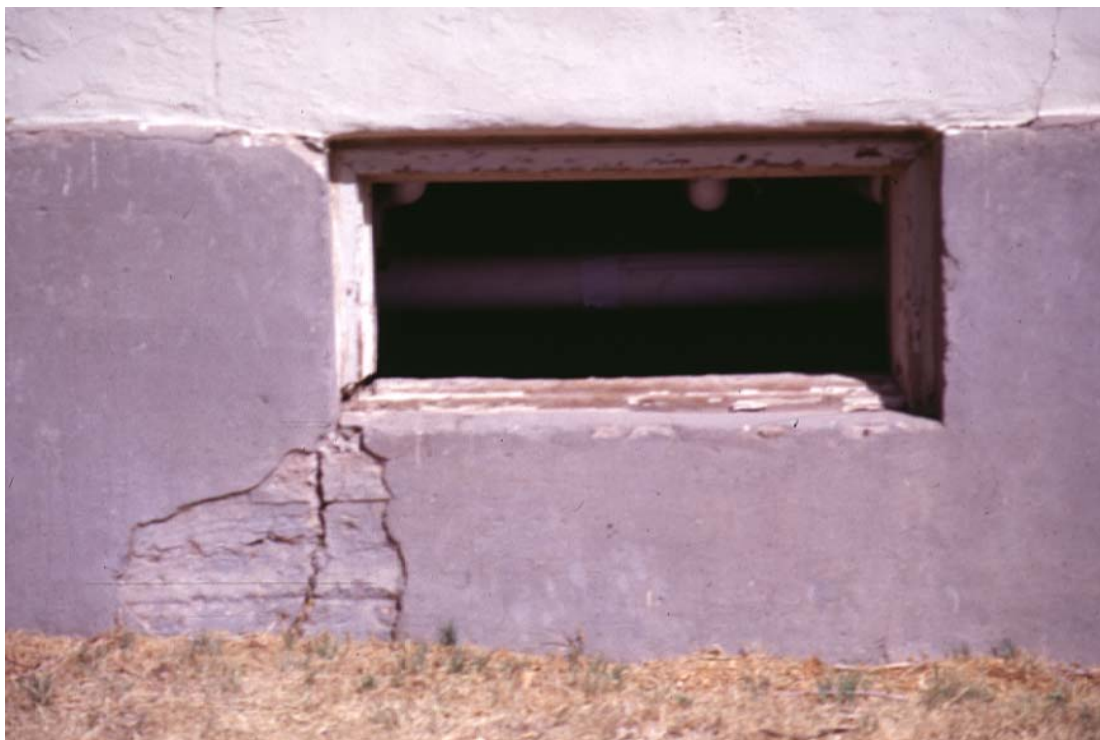
Some concrete parging is spalling away from the foundation on the south side of each building. A crack has also opened up at the lower corner of the south crawl space access opening of each building (Drawings 5 – 7, A). There does not appear to be any differential settlement. As this crack appears to be stable, filling and sealing as part of the exterior refinishing should be an effective repair (Photograph 33).

**Photograph 33. Detail of minor barracks foundation damage.**

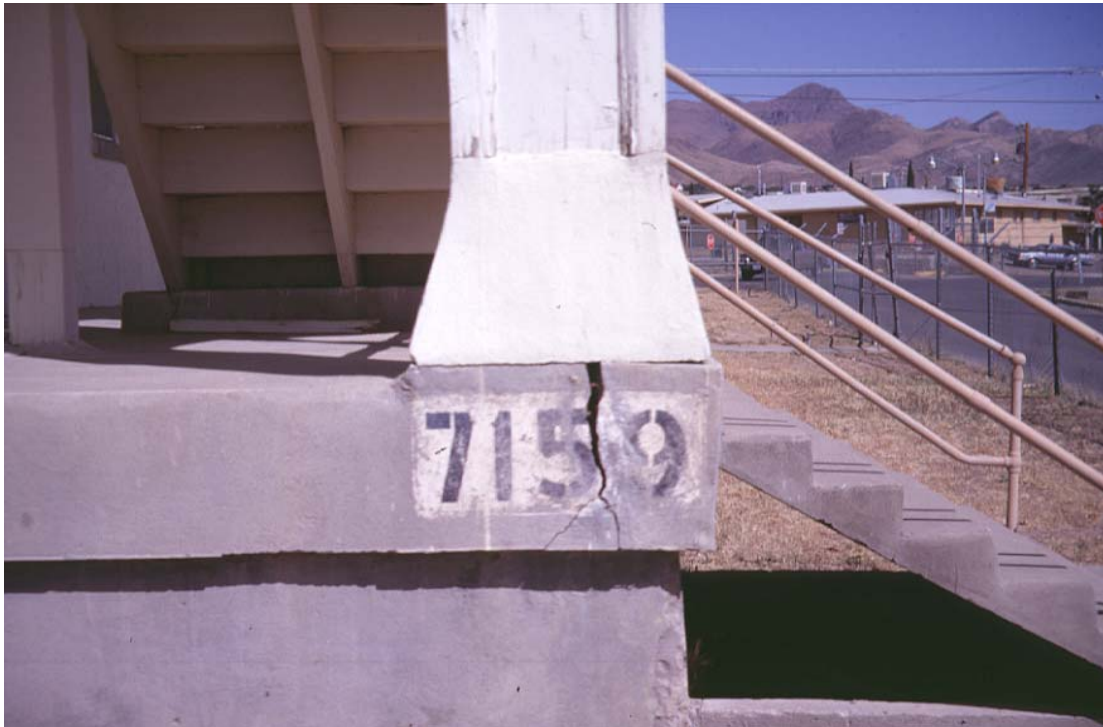
Original drawings depict a framed floor for the porch. The wooden floor has been replaced with concrete slab on all three buildings. The porch columns bear on the concrete slab at the porch's first floor. Significant cracking has occurred in each building at the exterior corners of the floor slab, at the corner columns of the porch (Drawings 5 – 7, C; Photograph 34). As a result, the corner is breaking away from the slab. No such cracking is evident at the other columns.

**Photograph 34. Detail of barracks porch slab cracks.**

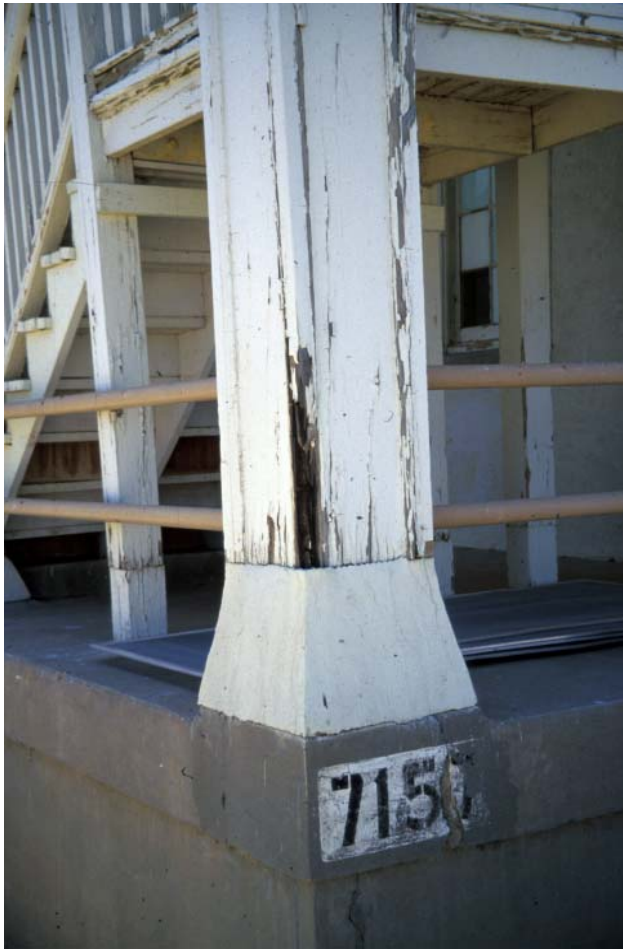
**Photograph 37. Water-damaged stucco detail on barracks porch column.**

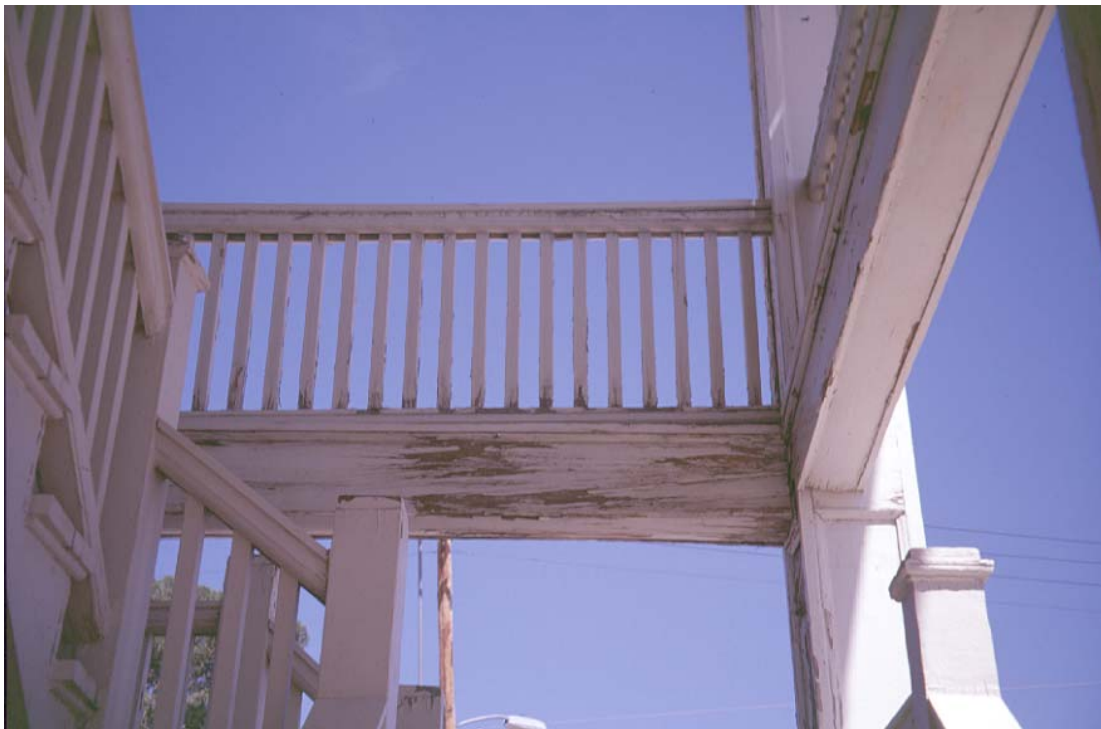
The exterior trim enclosing the porches' structural members is seriously deteriorated, especially at the stairwells at the north and south ends of the building (Drawings 5 – 7, F; Photograph 40). Painting has apparently been neglected for some time. Many, if not most, of the trim boards are severely split and warped. Many baluster pieces are missing. While some of the original trim may be repairable, extensive replacement probably will be necessary. The stucco "base" detail should be replaced to restore the original detail and prevent water accumulation.

**Photograph 40. Typical deteriorated exterior trim on barracks.**

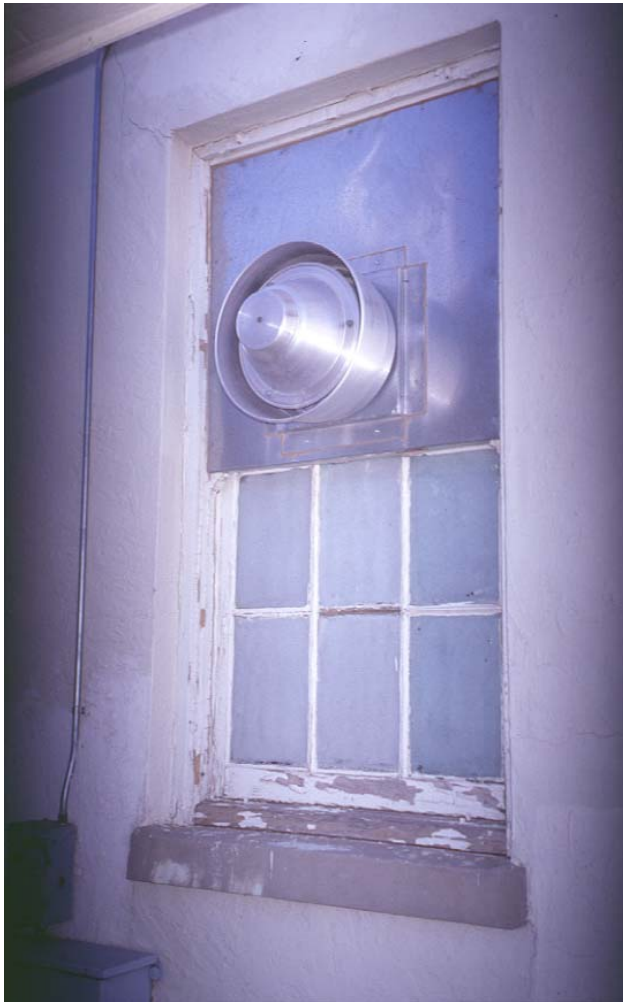
**Photograph 43. Non-historic washroom window modification.**

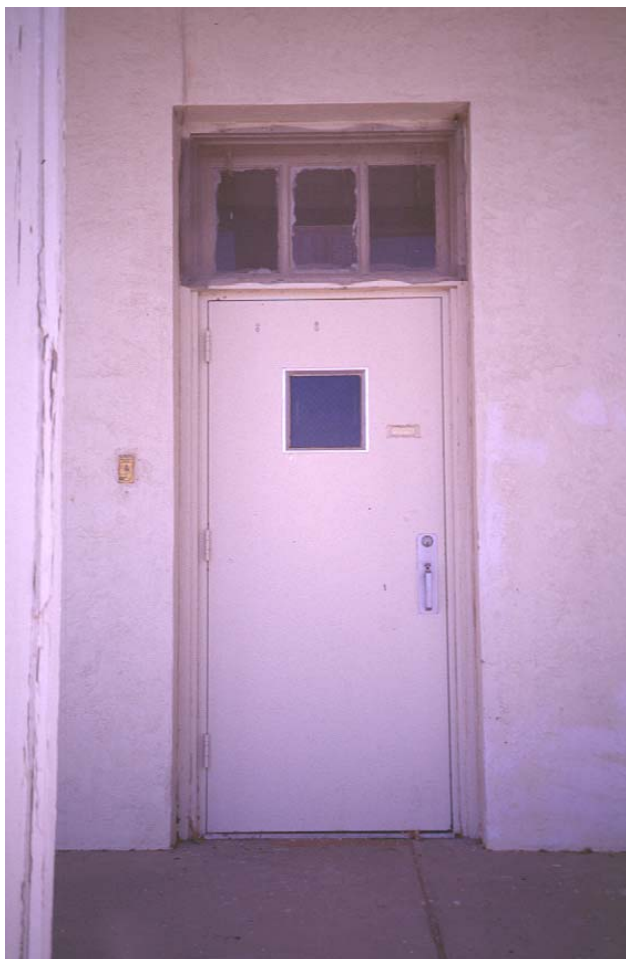
**Photograph 44. Non-historic barracks replacement door.**

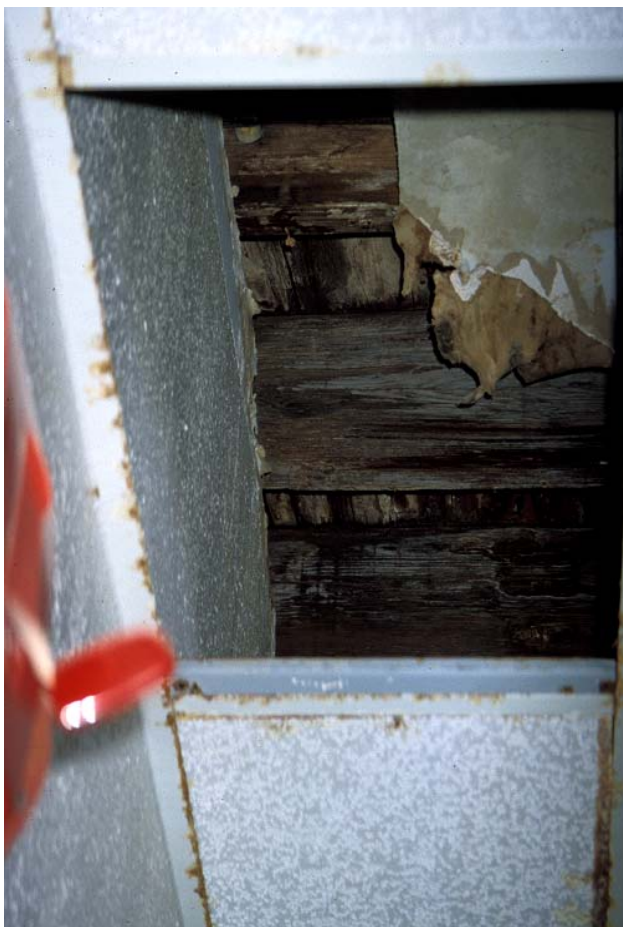
**Photograph 45. Typical water-damaged barracks ceiling in first-floor washroom.**

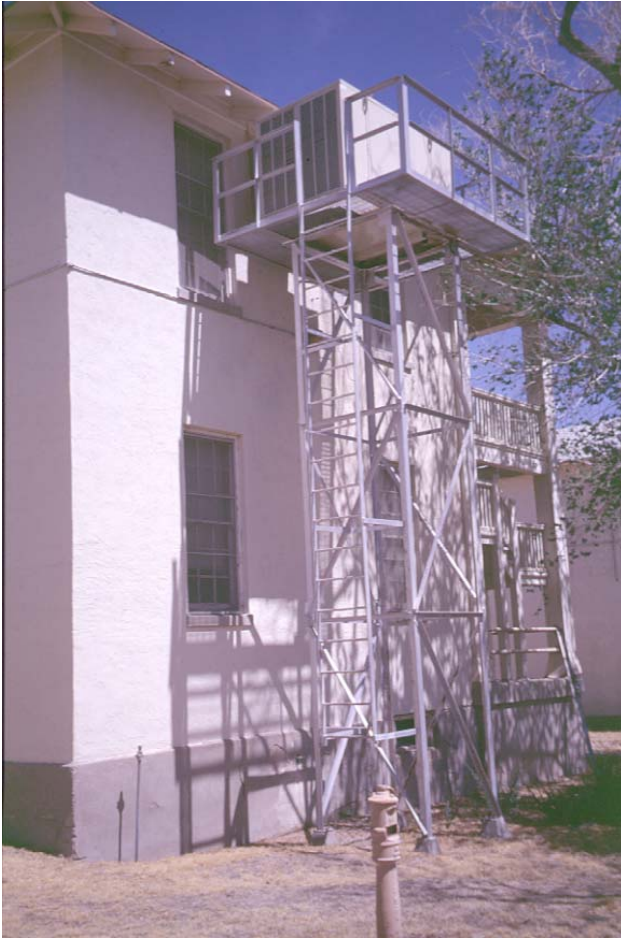
**Photograph 47. Historically inappropriate barracks cooling equipment.**

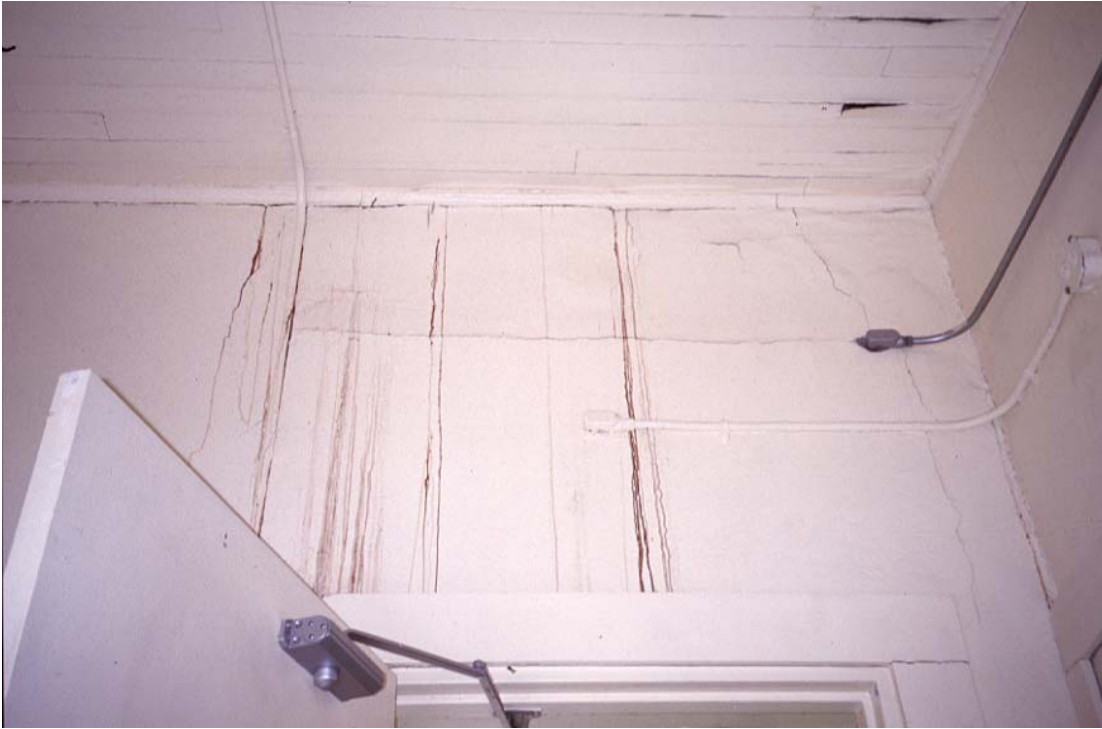
**Photograph 48. Signs of roof leakage in porch of Building 7157.**

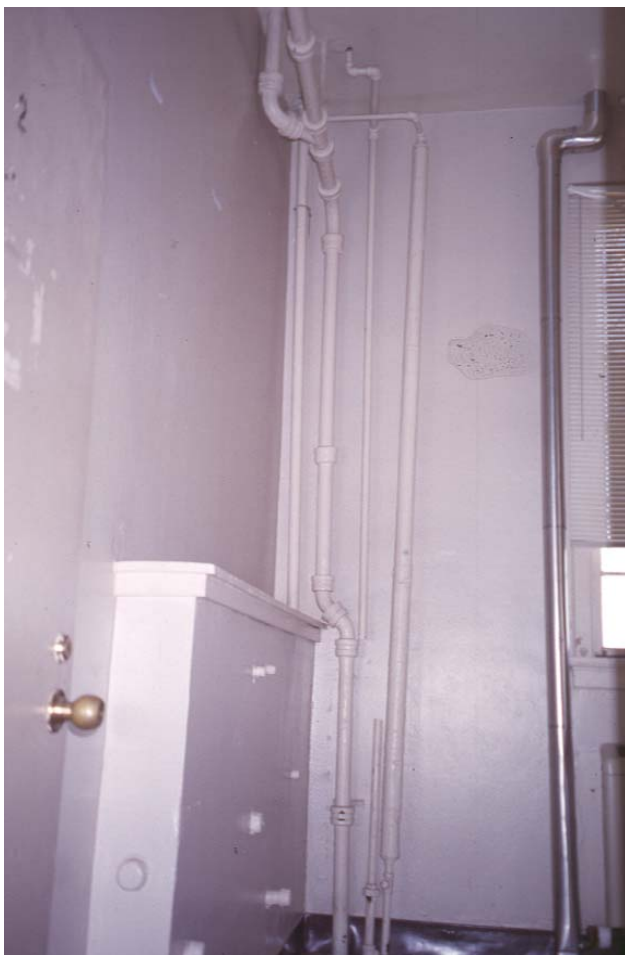
**Photograph 49. Non-historic plumbing modifications in Building 7157.**

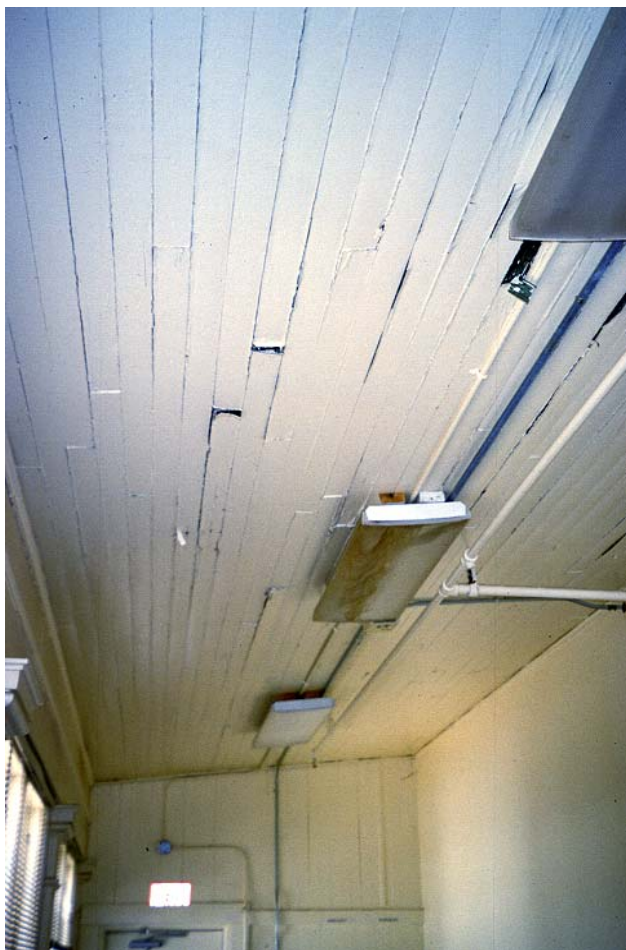
**Photograph 51. Signs of porch roof leakage in Building 7158.**

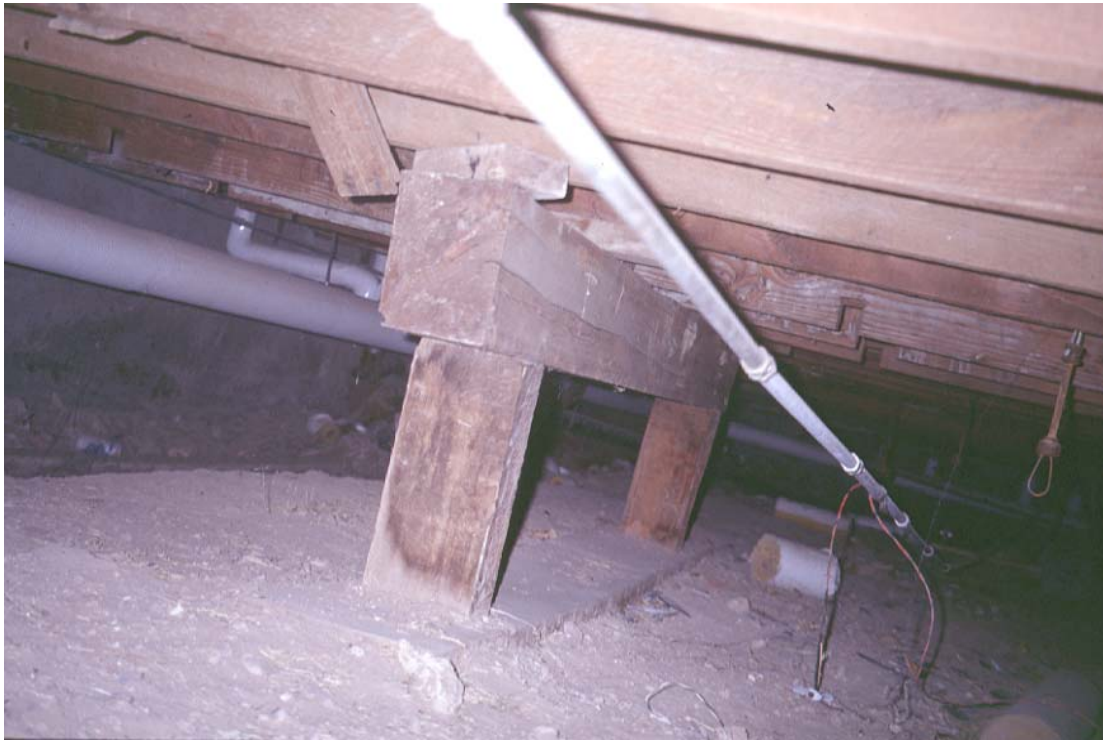
**Photograph 56. Makeshift repair of floor framing under Building 7159.**

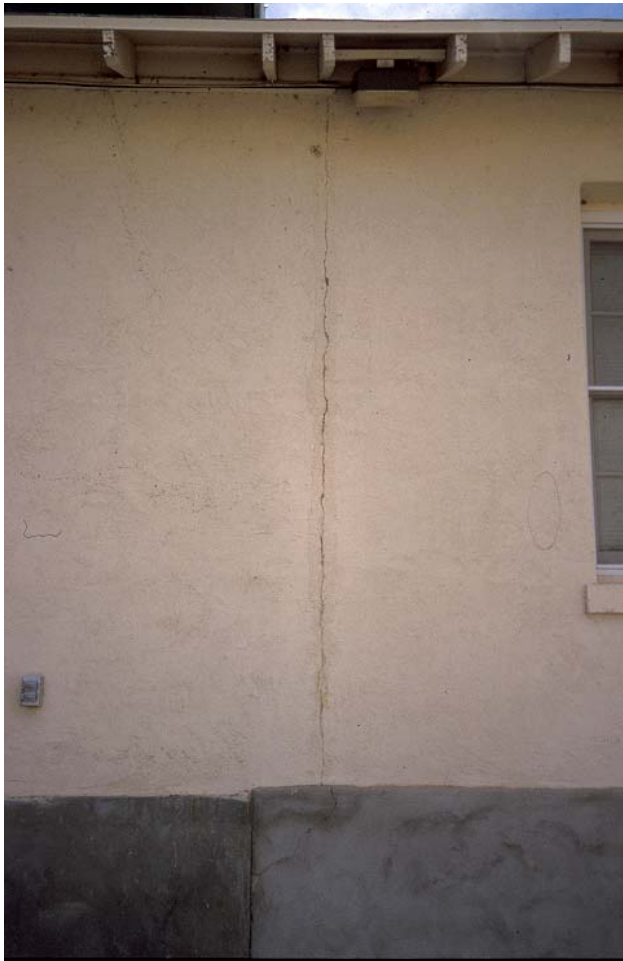
Photograph 61. BOQ foundation and wall crack.

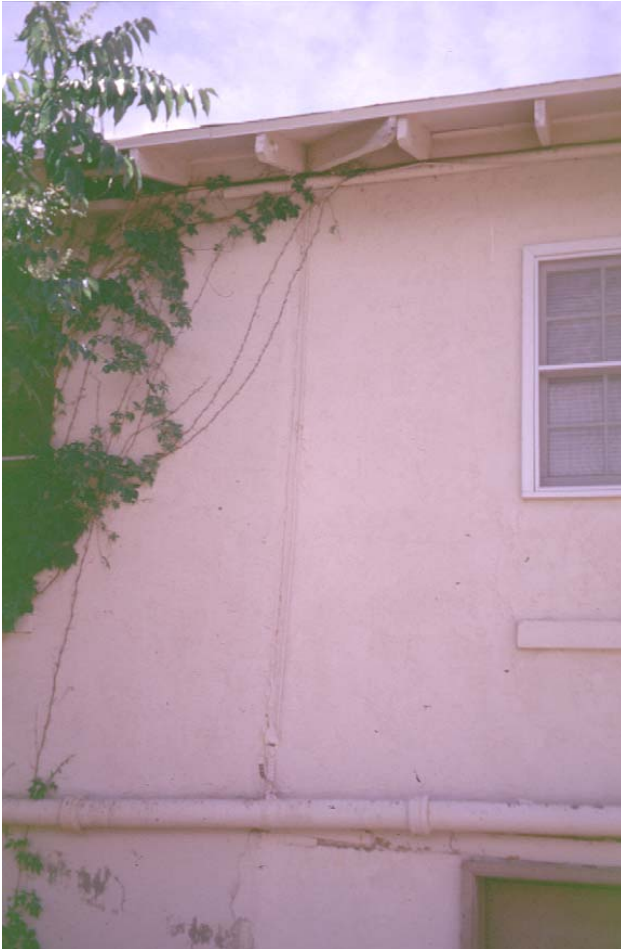
**Photograph 62. Minor BOQ wall crack.**

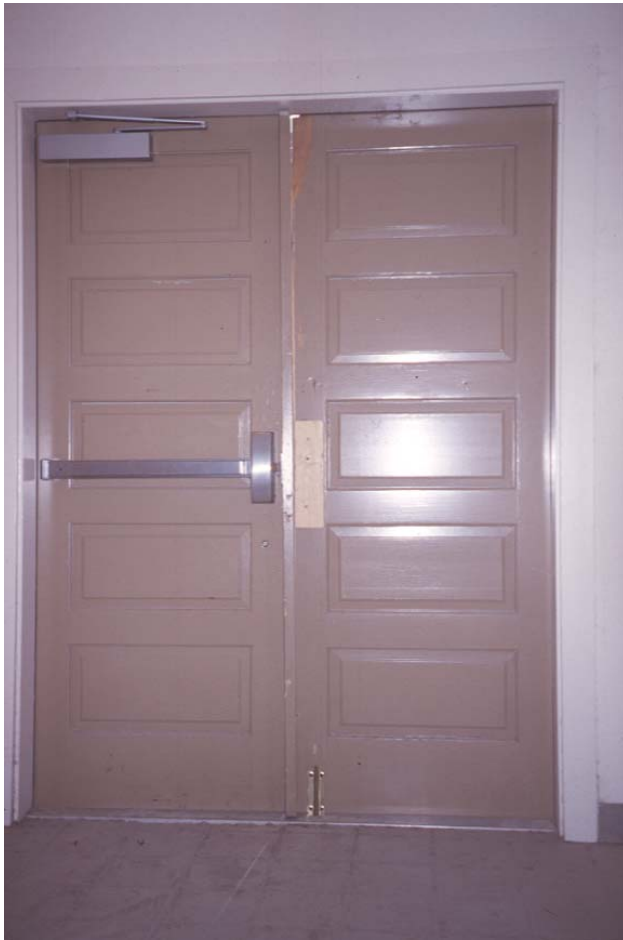
**Photograph 63. Damage to BOQ entry door.**

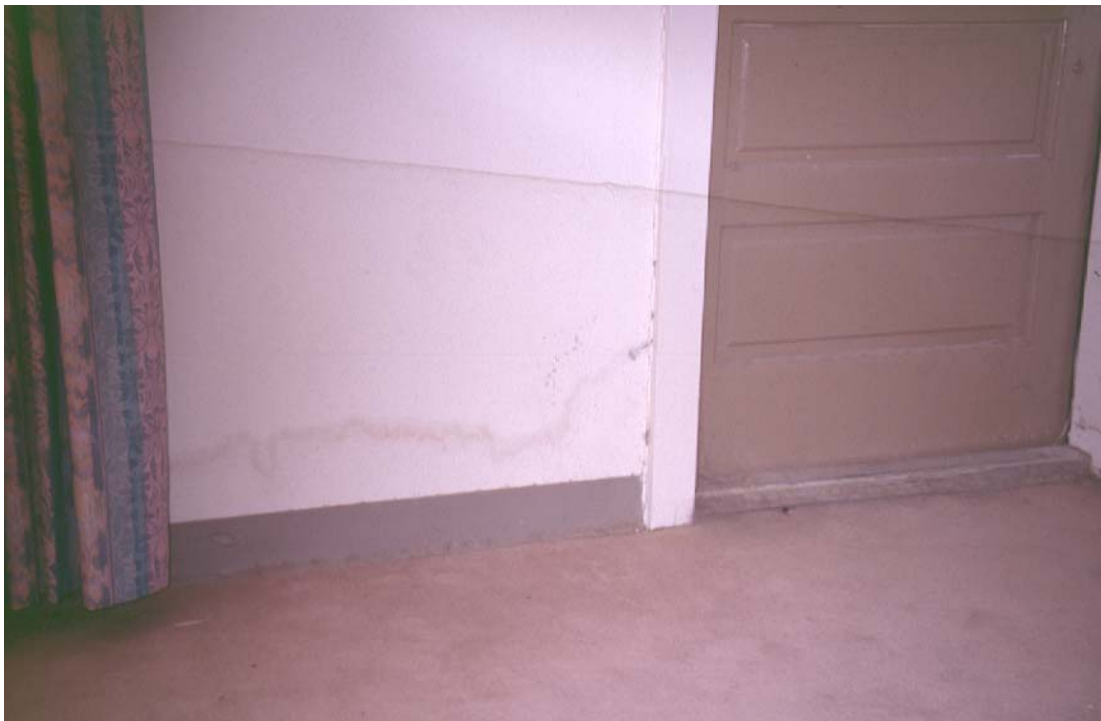
Photograph 67. Stains on BOQ wallboard indicate leaking exterior walls.

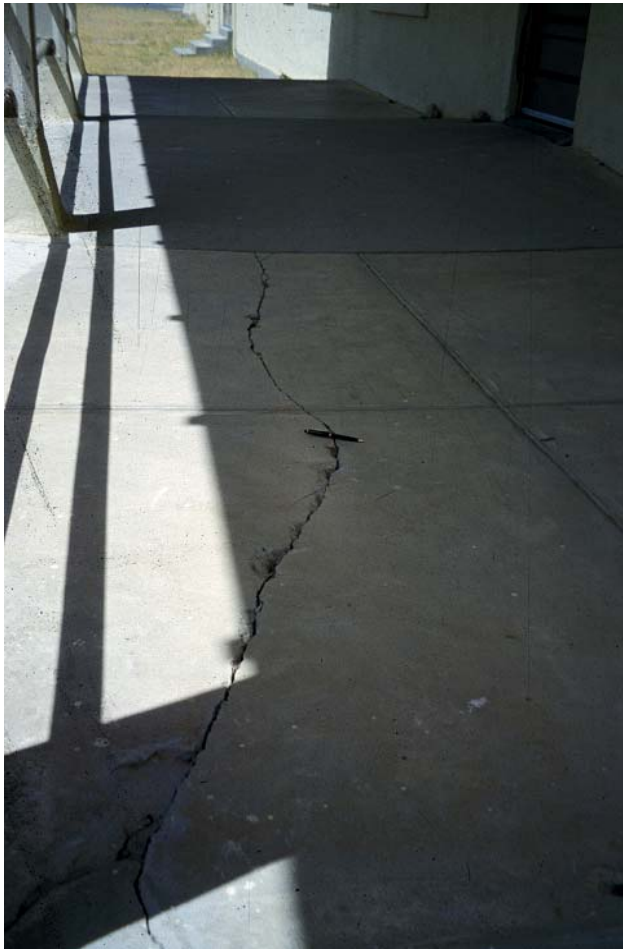
**Photograph 73. Crack in west porch of Conference Center.**

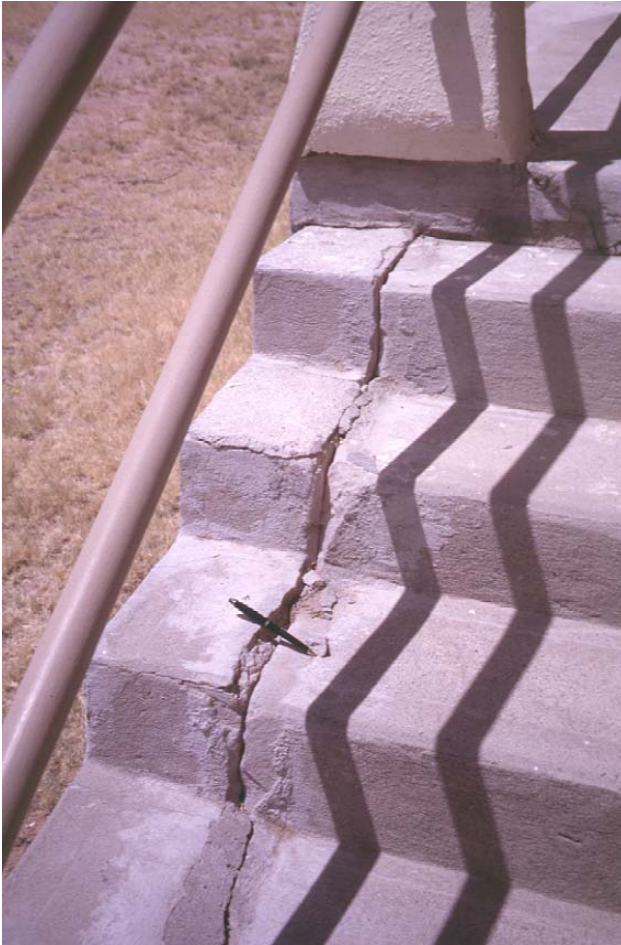
**Photograph 74. Badly cracked Conference Center stairs.**

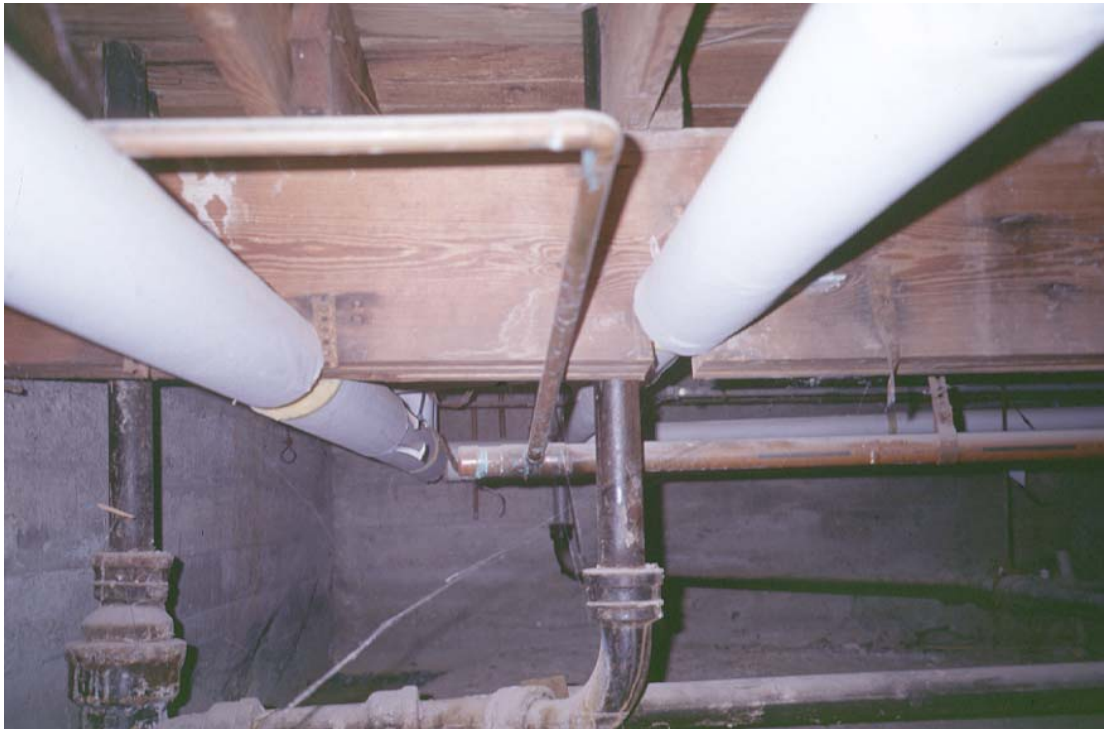
**Photograph 75. Notched floor beam in Conference Center crawlspace.**
