ERDC/CERL TR-02-26

# Condition Assessment of William Beaumont General Hospital Historic Buildings at Fort Bliss, Texas

Thomas R. Napier and Sheila A. McCarthy

September 2002

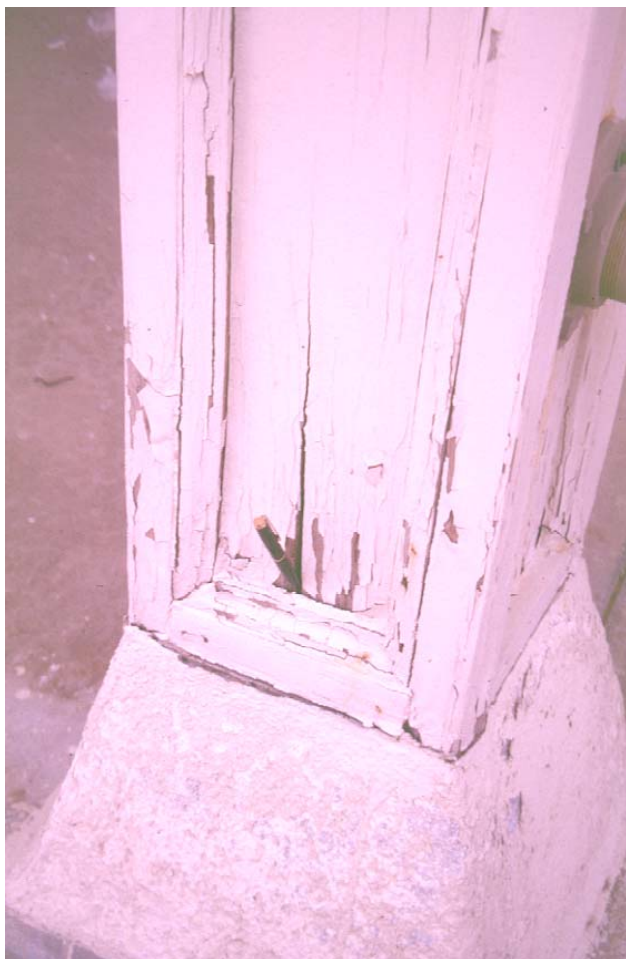
**Photograph 78. Split trim work on Conference Center's porch columns.**
